PROPERTY CONDITION ASSESSMENT

LADREY HIGH-RISE APARTMENTS - PROPERTY CONDITION ASSESSMENT
300 WYTHE STREET
ALEXANDRIA, VIRGINIA

ECS PROJECT NO. 46:11503

SEPTEMBER 11, 2025

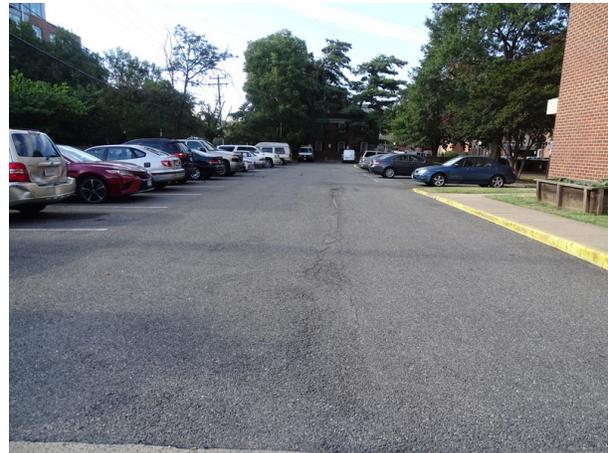
Parking is provided for approximately 35 passenger vehicles. The parking spaces are aligned east-west to provide two-way drive lanes. Asphalt-paved drive lanes are located on the east side of the site. The site contact reported that the asphalt pavement was installed in 2012. During our observation, we observed areas of blocks and alligator cracks in the drive lanes and parking spaces. The expected useful life of asphalt pavement is 20 years. We recommend an allowance to repair the asphalt pavement as needed.

Asphalt pavement in drive lanes and parking spaces - Note cracks.

Cost Recommendation	EUL	EFF AGE	RUL	Year	Cost
MILL, OVERLAY AND RESTRIPE EXISTING ASPHALT	-	-	-	1	\$30,000
REPLACE CONCRETE PAVEMENT	-	-	-	1	\$10,000
REPLACE CURB AND GUTTER	-	-	-	1	\$10,000
Total					\$50,000

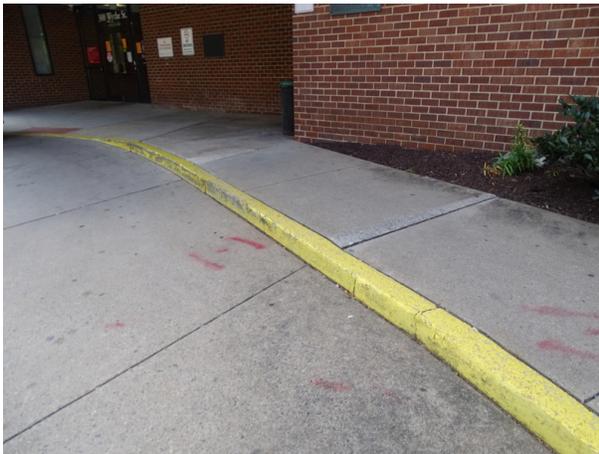
The north, south, and east sides of the building have concrete sidewalks. Regularly spaced control joints were observed. The concrete sidewalk observed crack and settled in several locations. We recommend that the settled and cracked sections of concrete sidewalks be replaced as needed.

Concrete sidewalk - Note settled.

Cost Recommendation	EUL	EFF AGE	RUL	Year	Cost
REPLACE CONCRETE SIDEWALK	-	-	-	1	\$20,000
Total					\$20,000

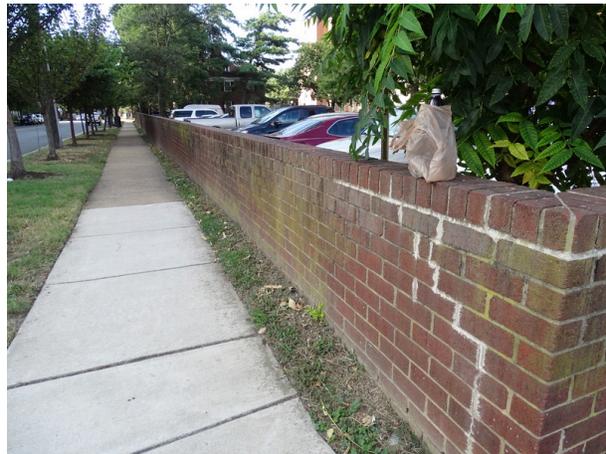
We observed the walls on the east and south sides of the site. Deteriorated mortar joints and cracks were noted. We recommend providing an allowance for replacing the mortar joints.

Typical wall - Note stains and mortar joint condition.

Cost Recommendation	EUL	EFF AGE	RUL	Year	Cost
REPOINT BRICKWORK AT EAST AND SOUTH WALLS	-	-	-	1	\$20,000
Total					\$20,000

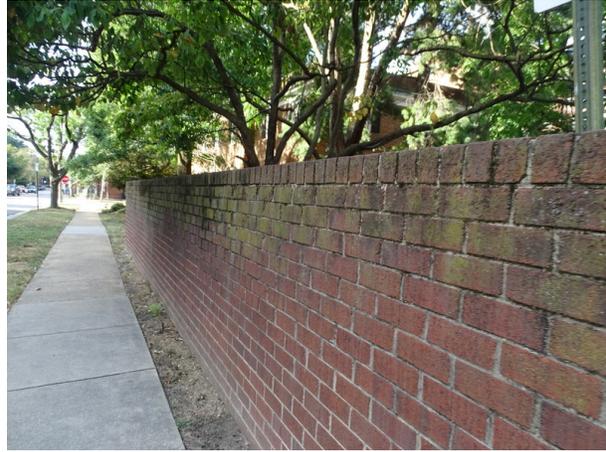
Typical wall - Note stains and mortar joint condition.

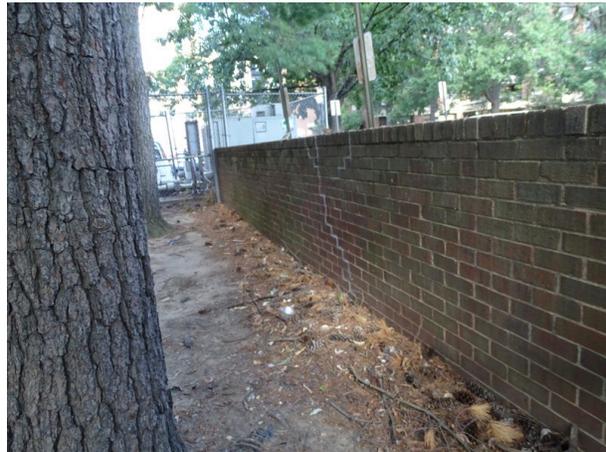
Typical wall - Note stains and mortar joint condition.

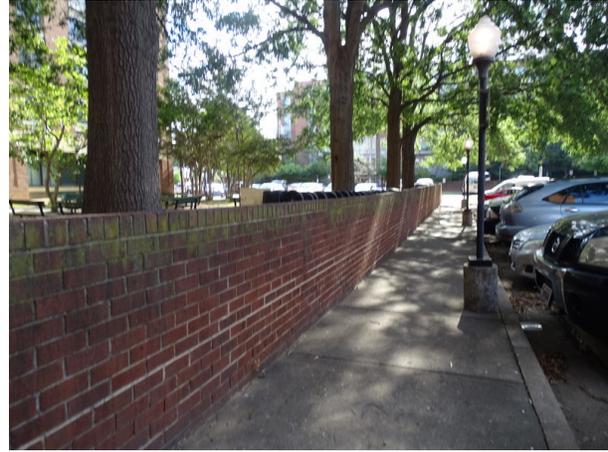
Typical wall - Note stains and mortar joint condition.

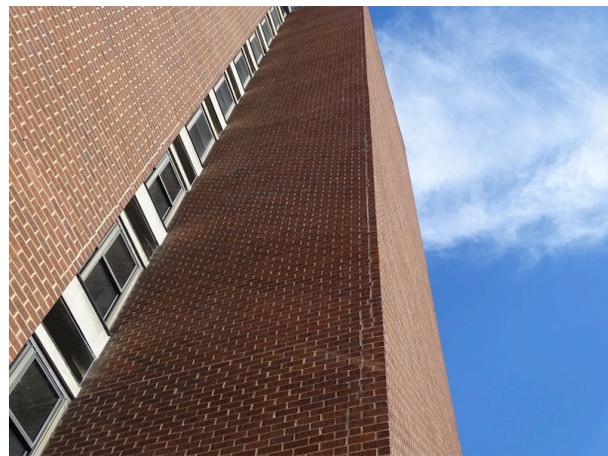
Exterior wall finishes at east side - Note mortar joint condition.

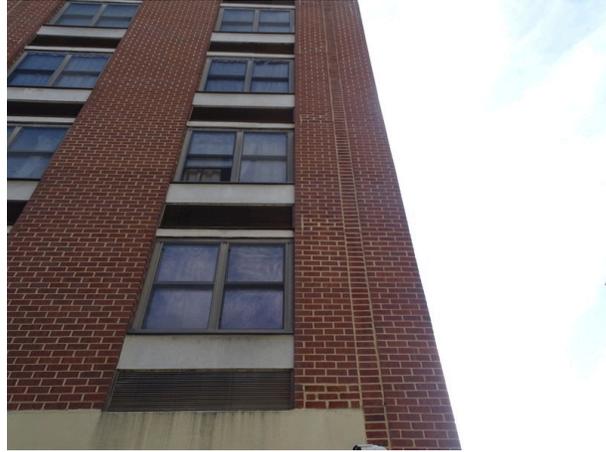
Exterior wall finishes at south side - Note stains.

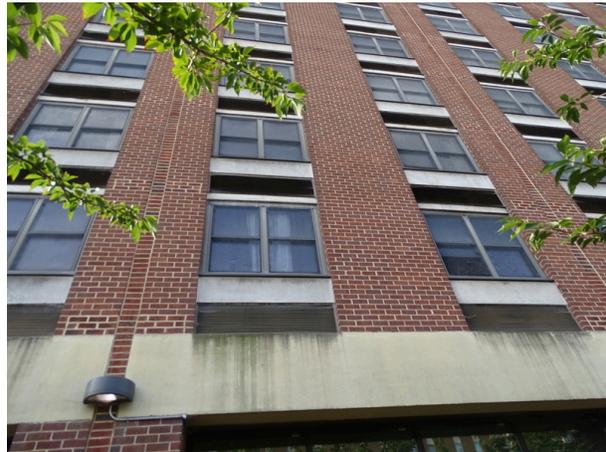
Exterior wall finishes at north side - Note stains.

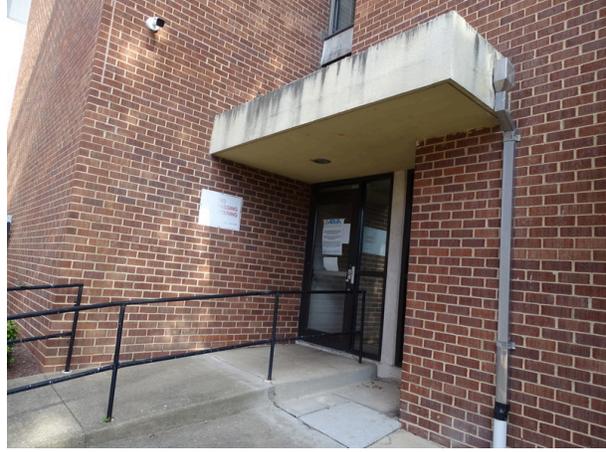
Exterior wall finishes at south side - Note stains.

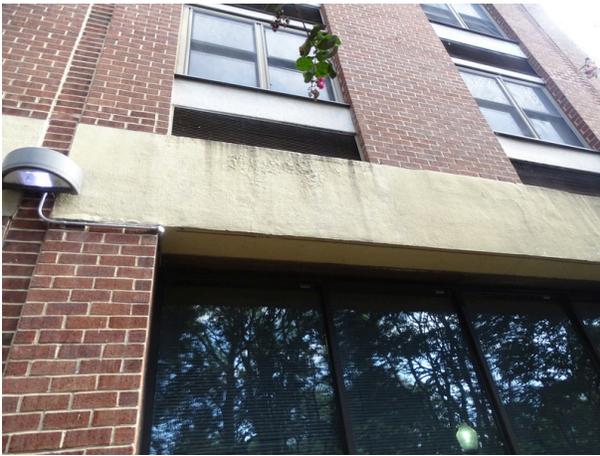
Exterior wall finishes at south side - Note water intrusion.

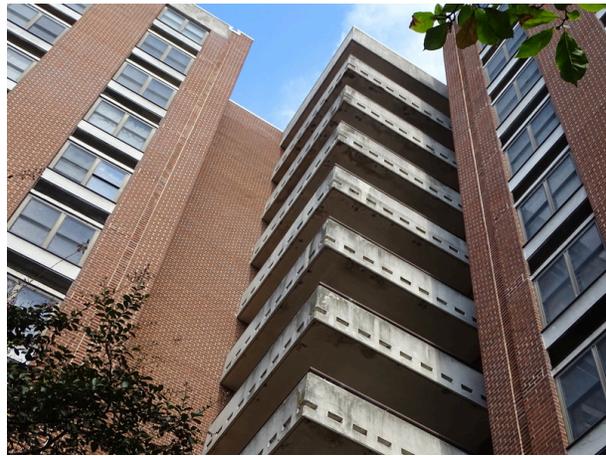
Exterior wall finishes at south side - Note stains.

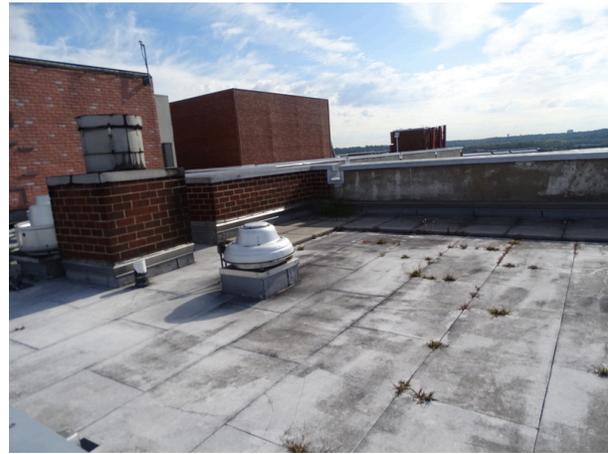
IRMA Roofing System – Note cracks and vegetation were observed.

3.3.6 Roofing Systems																				
REPLACE IRMA ROOFING SYSTEM	20	19	1	10,000	SF	\$25.00	\$250,000	100%	\$250,000										\$250,000	
REPLACE GREEN ROOFING SYSTEM	20	19	1	1,200	SF	\$40.00	\$48,000	100%	\$48,000										\$48,000

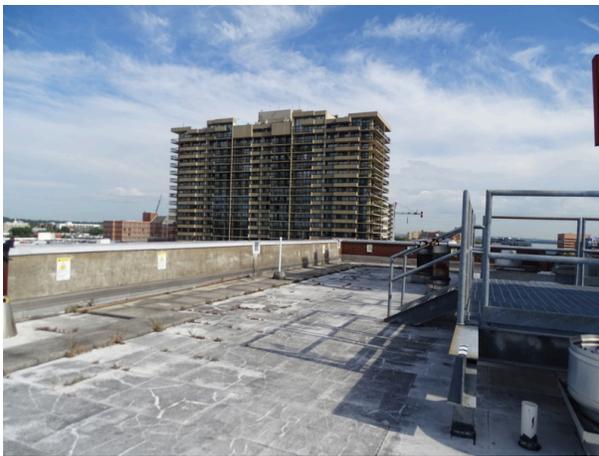
IRMA Roofing System – Note cracks and vegetation were observed.

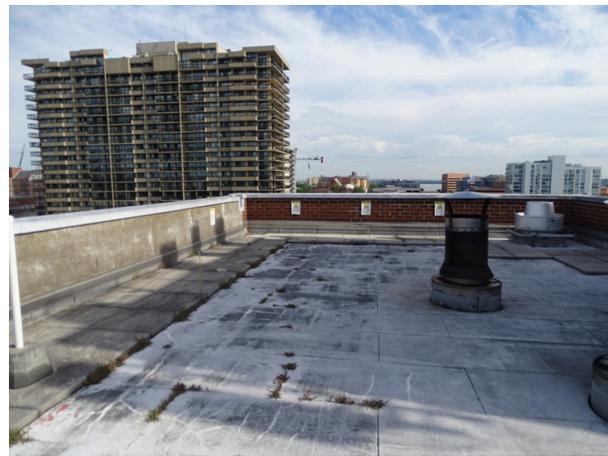
IRMA Roofing System – Note cracks and vegetation were observed.

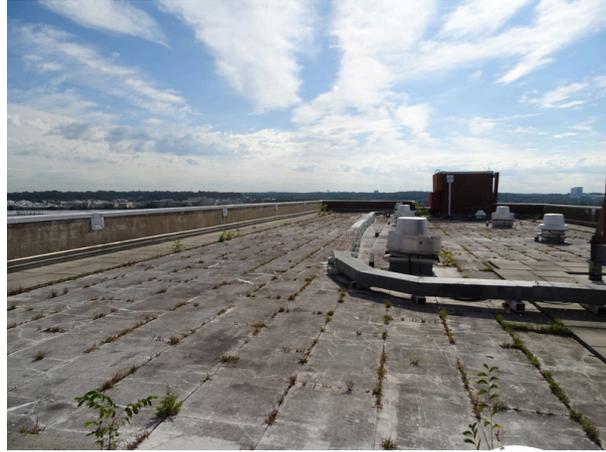
IRMA Roofing System – Note cracks and vegetation were observed.

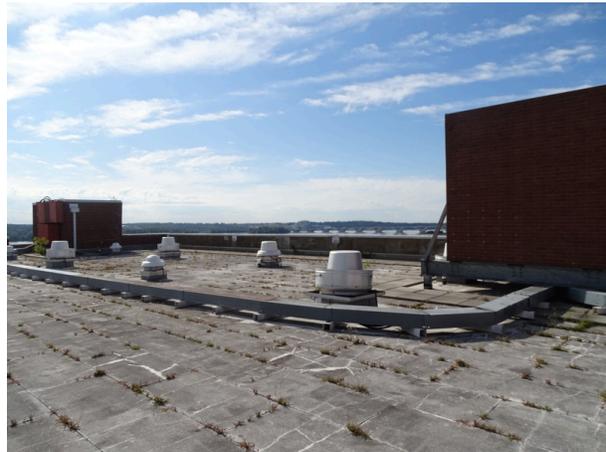
IRMA Roofing System – Note cracks and vegetation were observed.

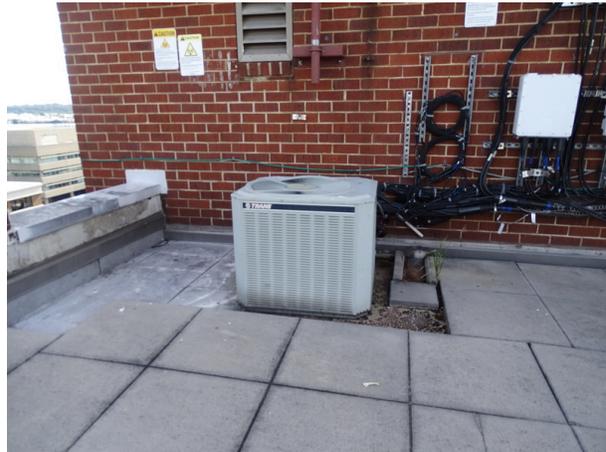
IRMA Roofing System.

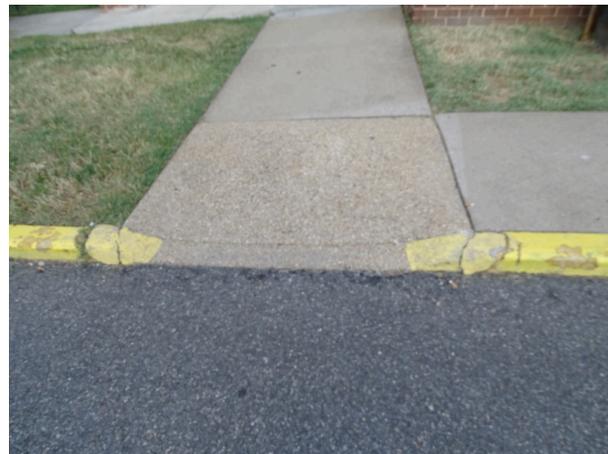
Accessible curb ramp - Note the truncated dome is missing.

Item	Quantity	Unit	Unit Cost	Replacement Percent	Immediate Total
4.1 ADA Accessibility Compliance					
INSTALL TRUNCATED DOMES AT CURB RAMPS	3	EA	\$800.00	100%	\$2,400
PROVIDE VAN ACCESSIBLE SPACES	1	EA	\$500.00	100%	\$500
Total Repair Cost					\$2,900.00

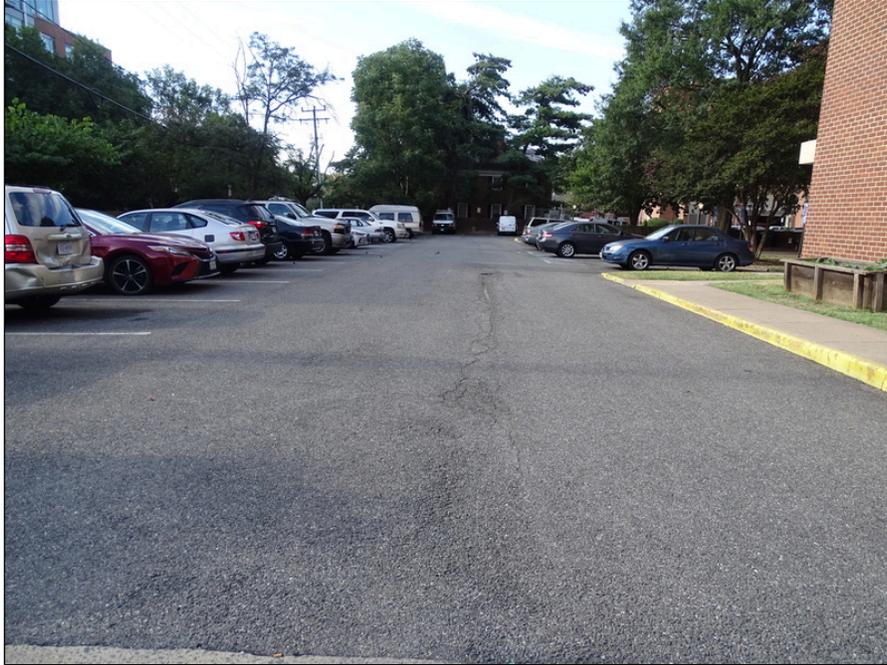
6 - Asphalt pavement in drive lanes and parking spaces - Note cracks.

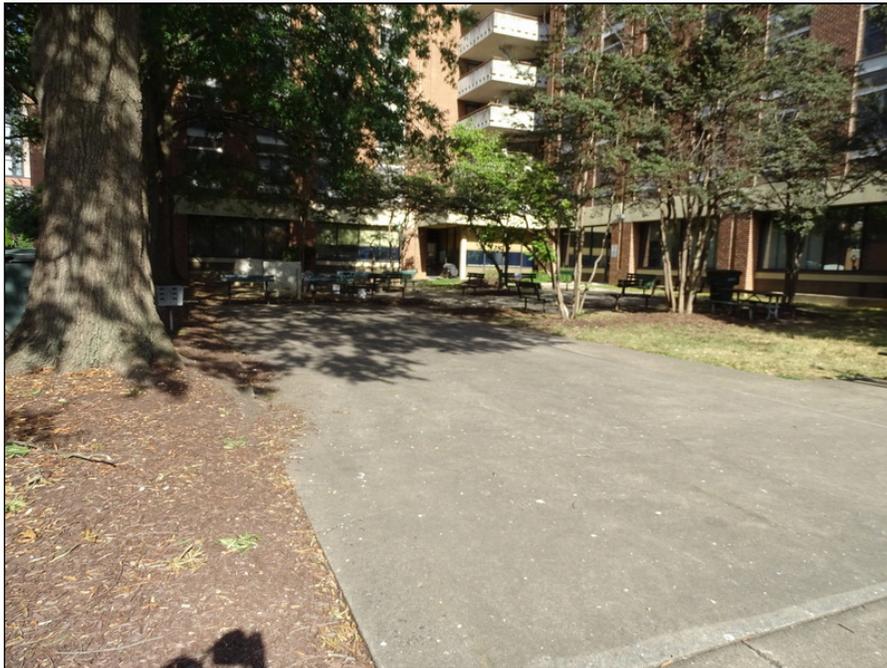
7 - Asphalt pavement in drive lanes and parking spaces - Note cracks.

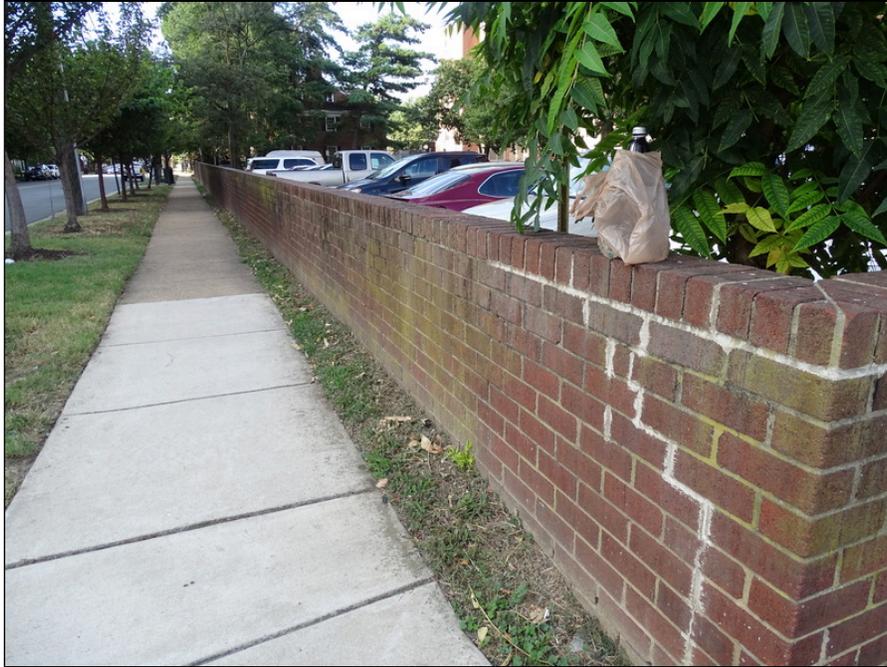
27 - Typical wall - Note stains and mortar joint condition.

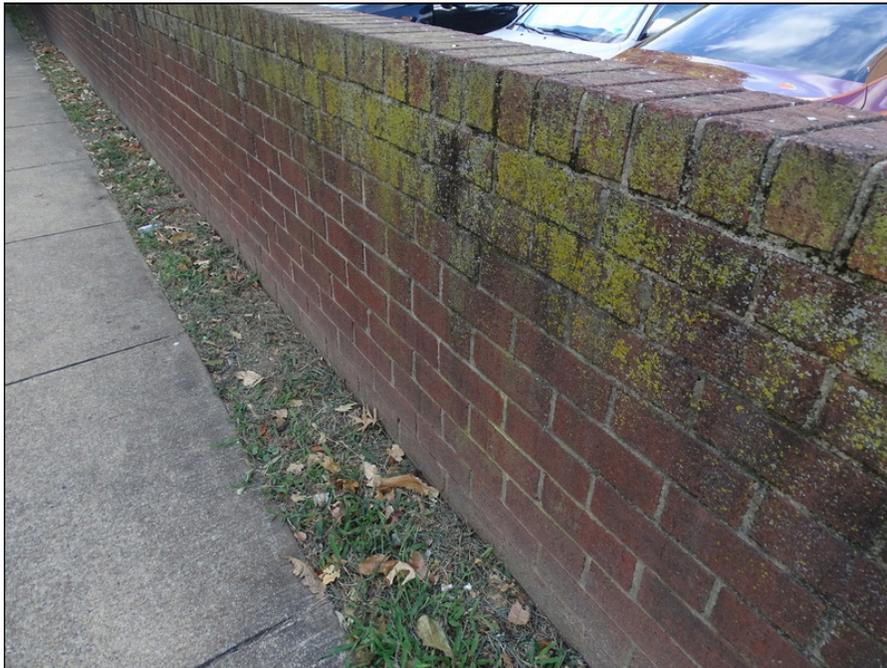
28 - Typical wall - Note stains and mortar joint condition.

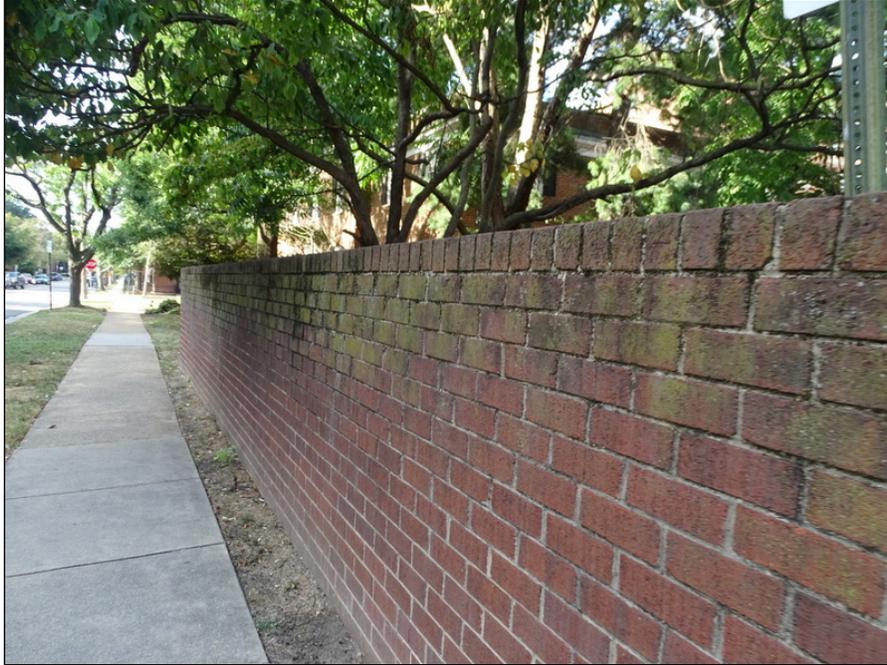
29 - Typical wall - Note stains and mortar joint condition.

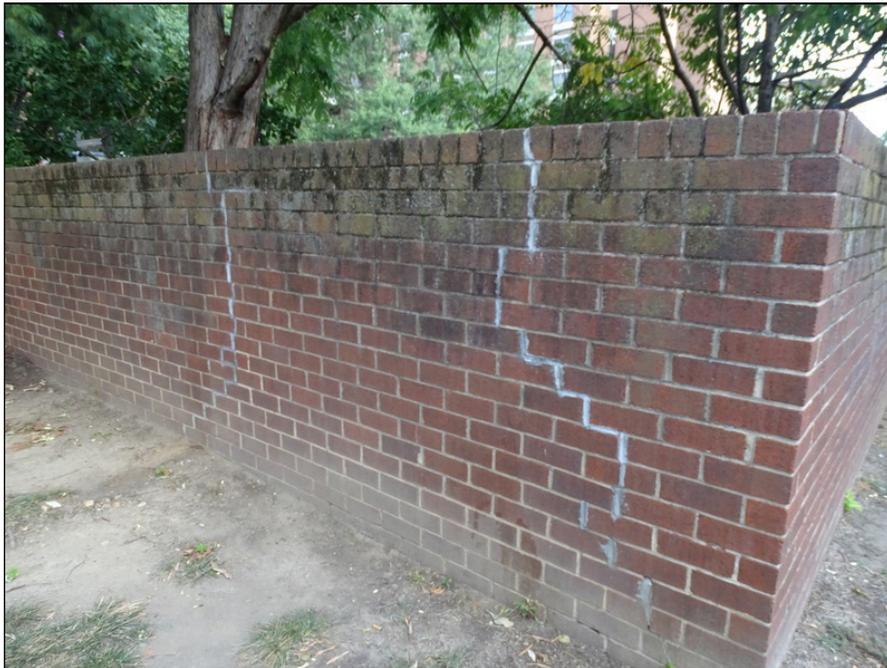
30 - Typical wall - Note stains and mortar joint condition.

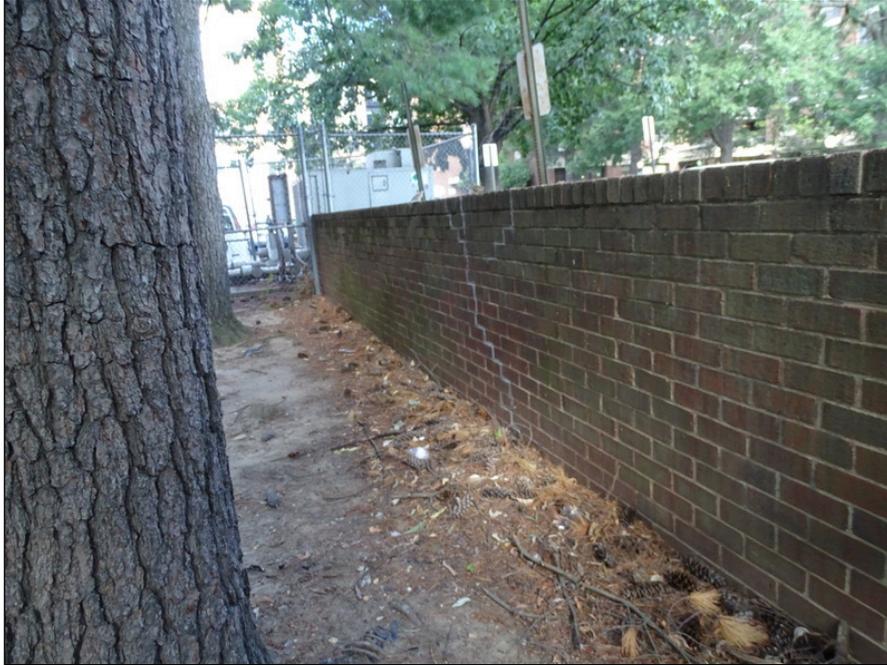
31 - Typical wall - Note stains and mortar joint condition.

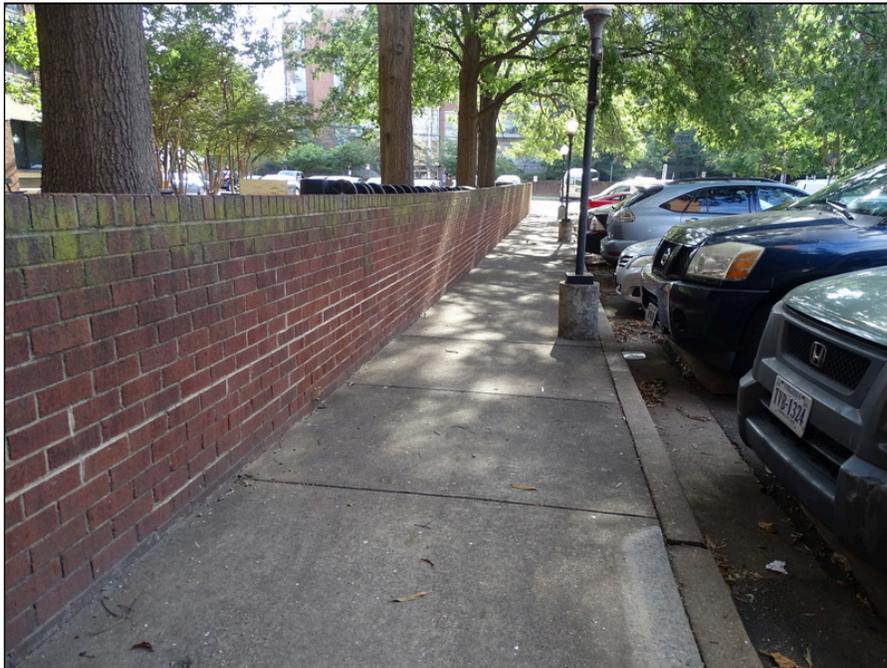
32 - Typical wall - Note stains and mortar joint condition.

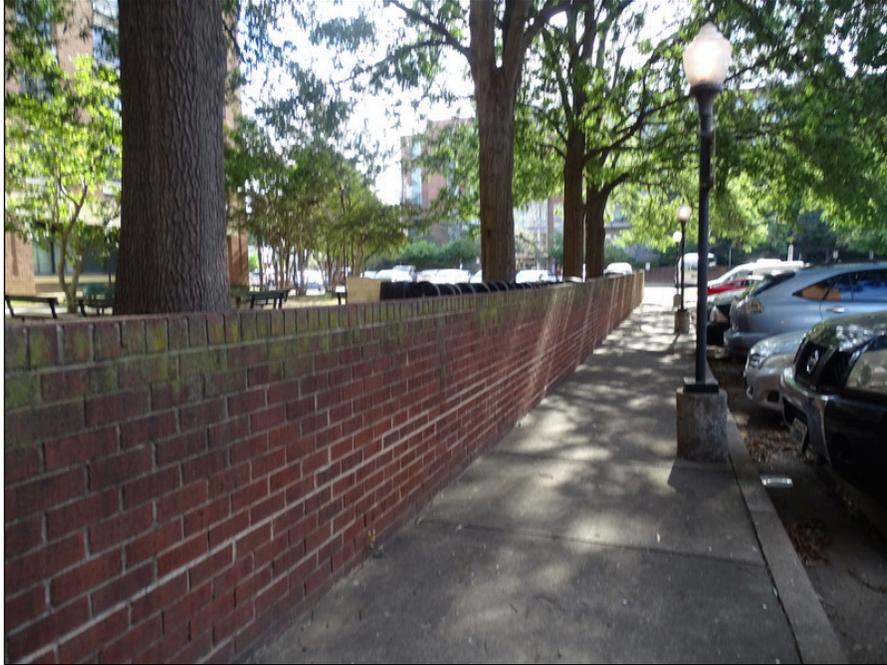
33 - Typical wall - Note stains and mortar joint condition.

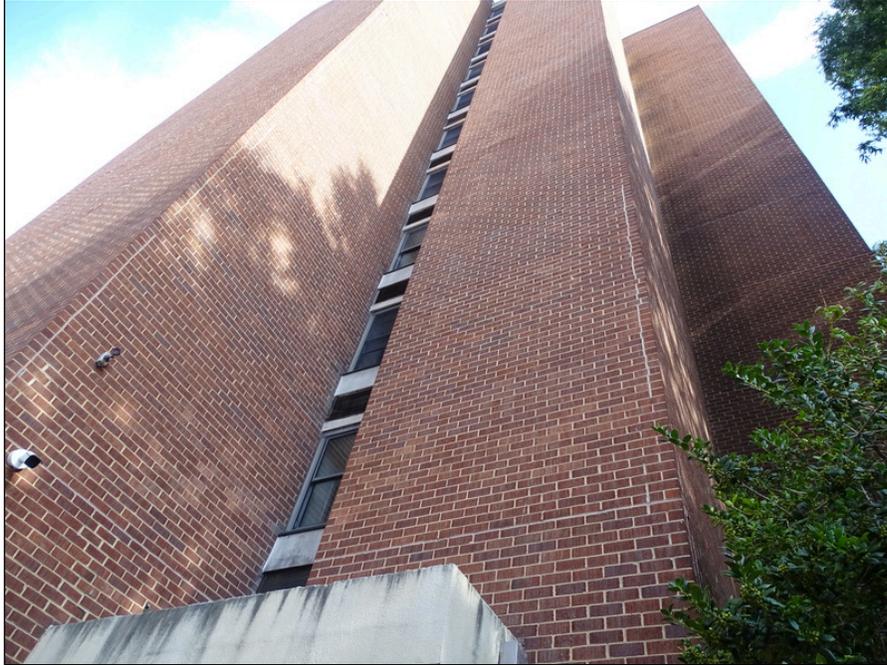
37 - Exterior wall finishes at south side - Note mortar joint condition.

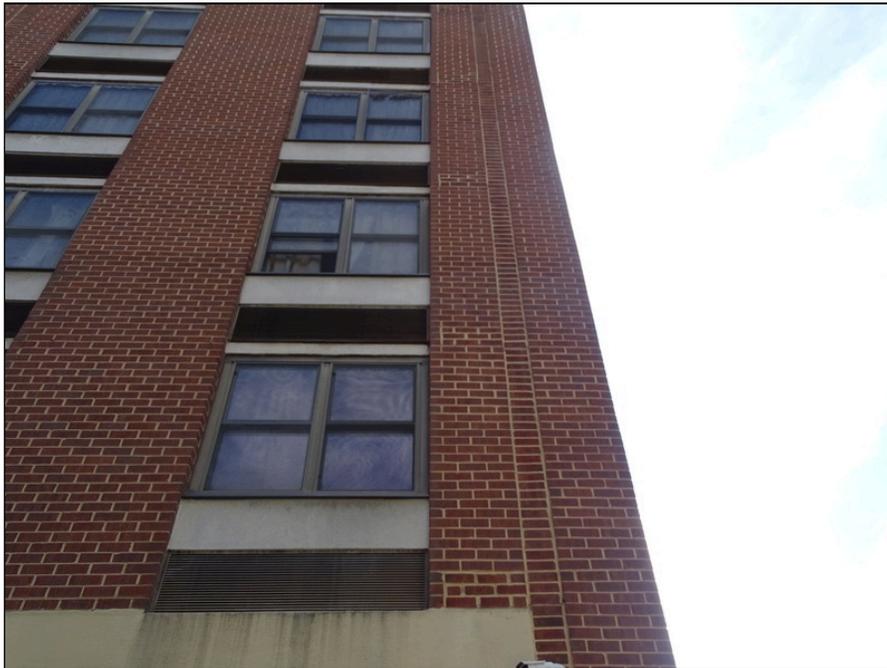
38 - Exterior wall finishes at south side - Note stains.

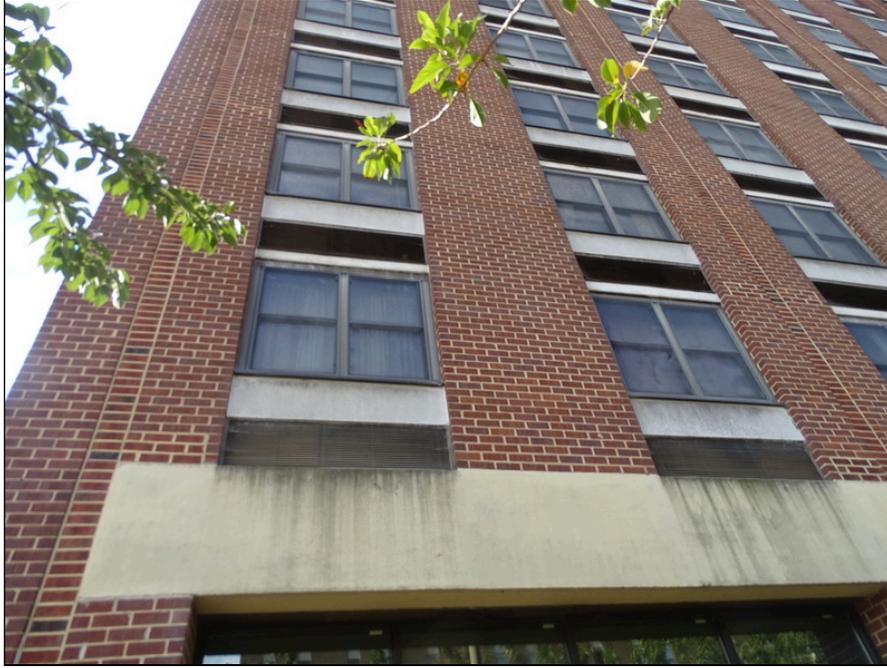
39 - Exterior wall finishes at north side - Note stains.

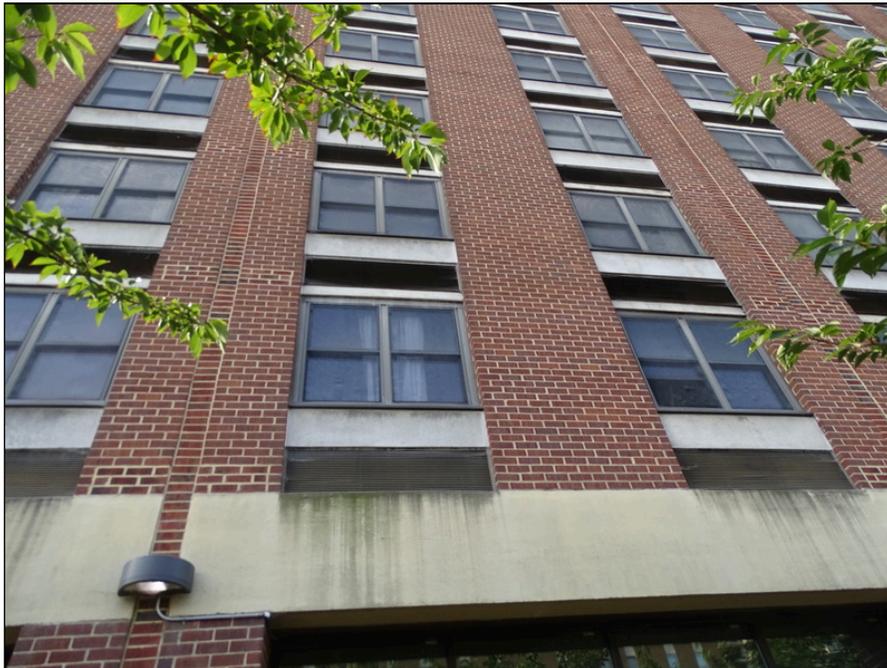
40 - Exterior wall finishes at north side - Note stains.

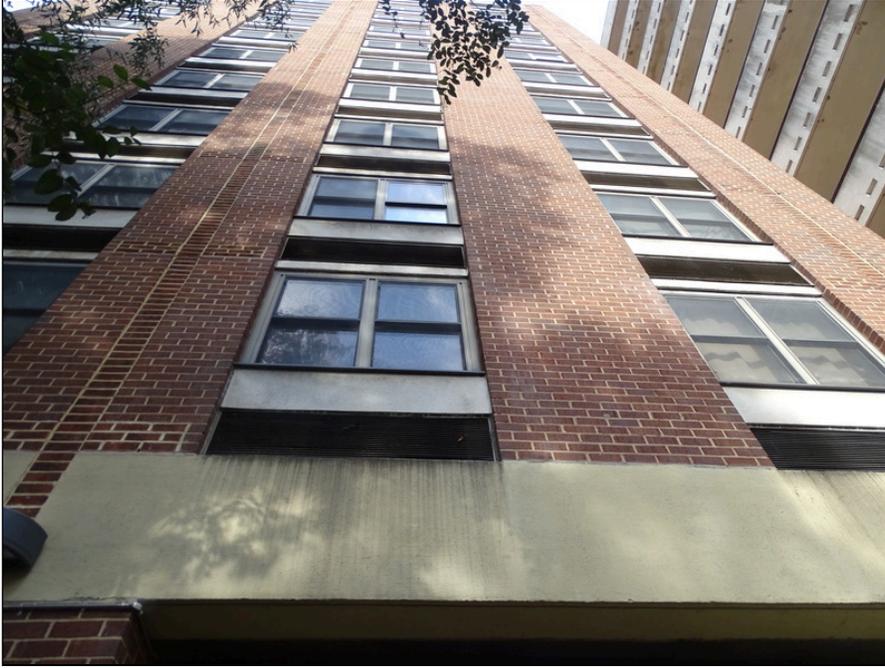
41 - Exterior wall finishes at north side - Note stains.

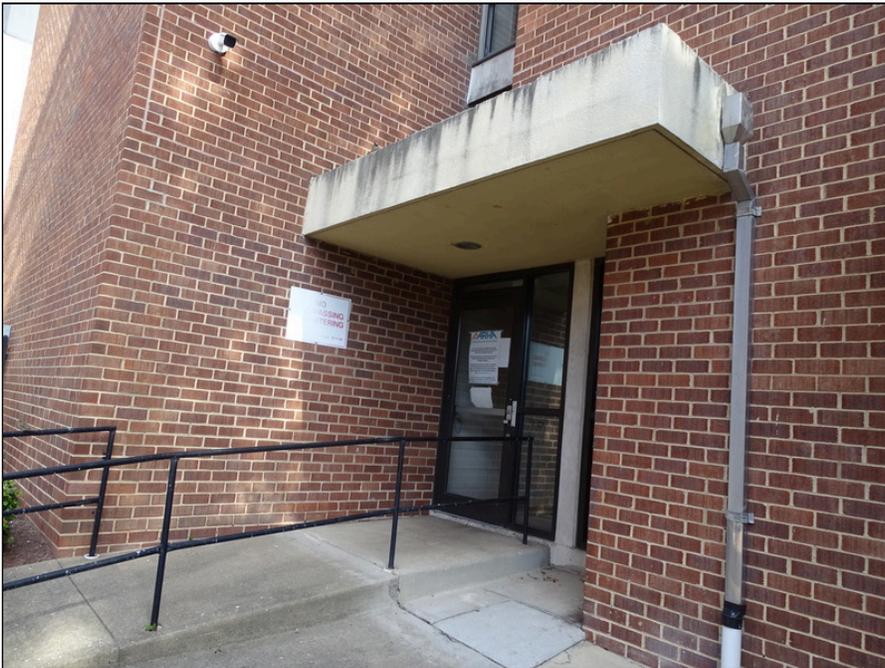
42 - Exterior wall finishes at south side - Note stains.

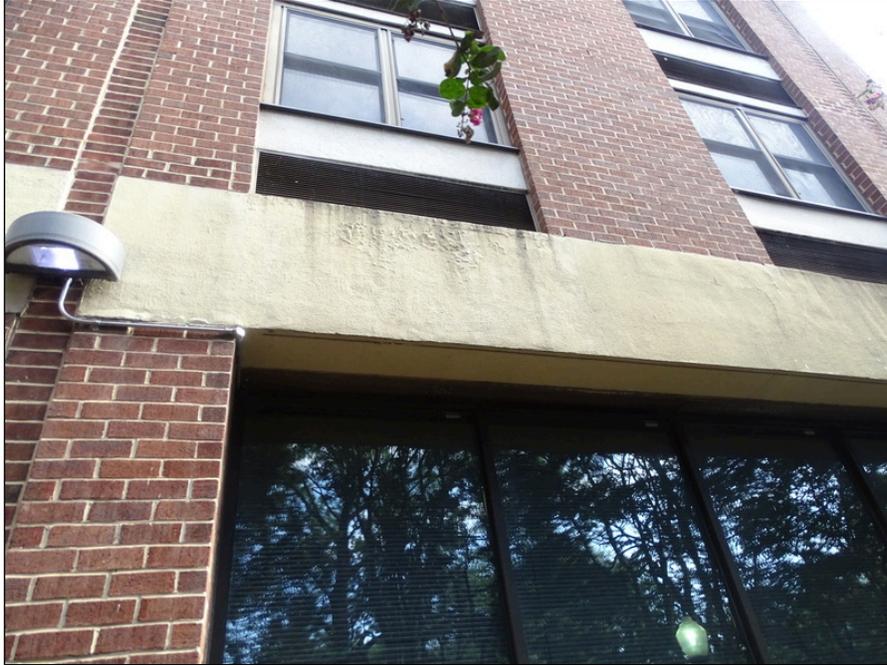
43 - Exterior wall finishes at south side - Note water intrusion.

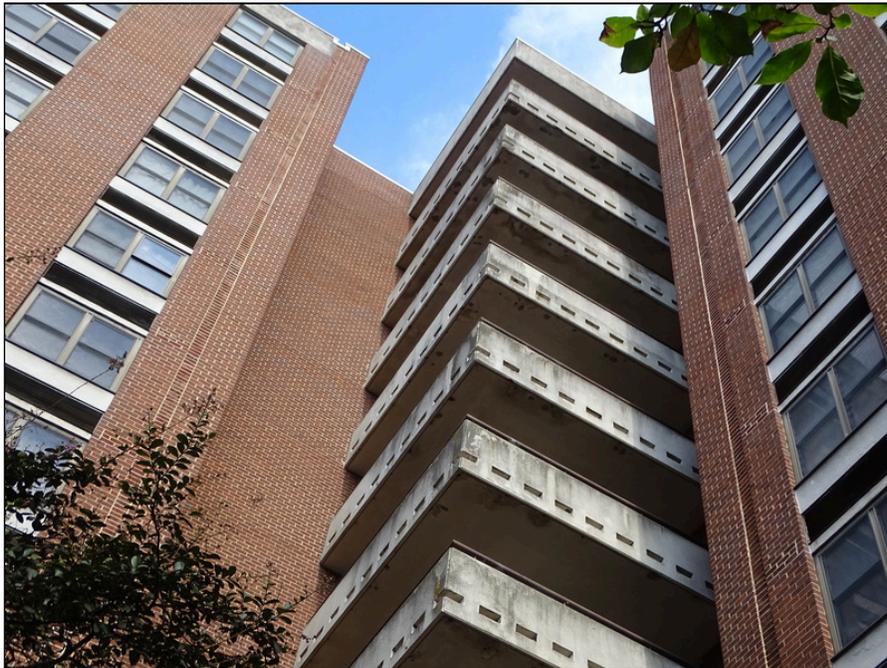
44 - Exterior wall finishes at south side - Note stains.

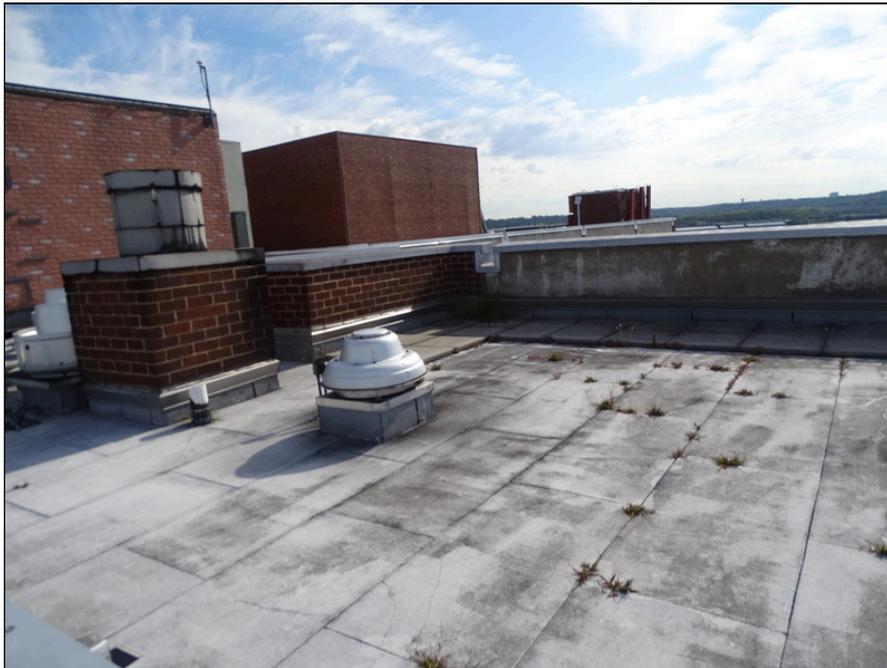
60 - IRMA Roofing System – Note cracks and vegetation were observed.

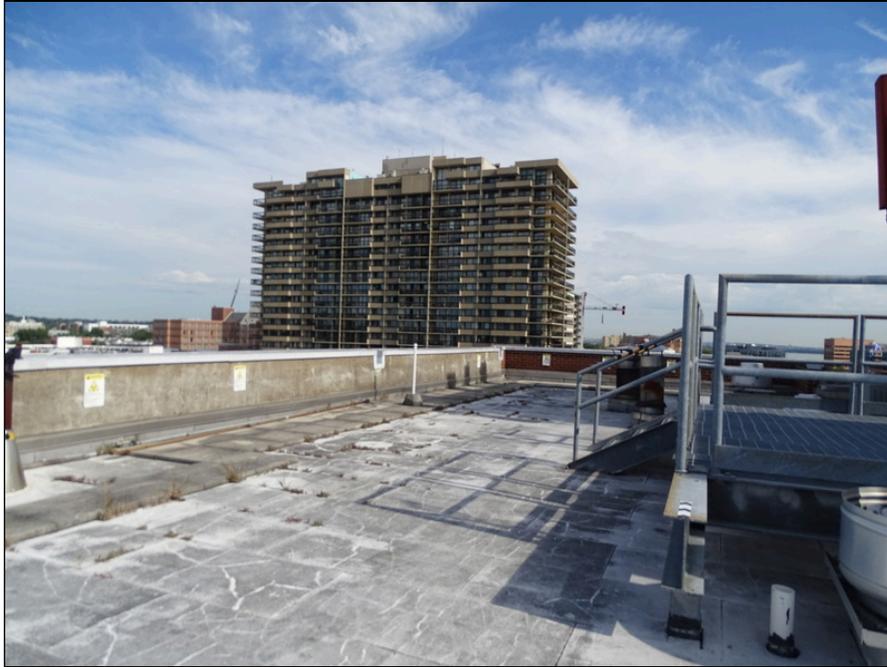
61 - IRMA Roofing System – Note cracks and vegetation were observed.

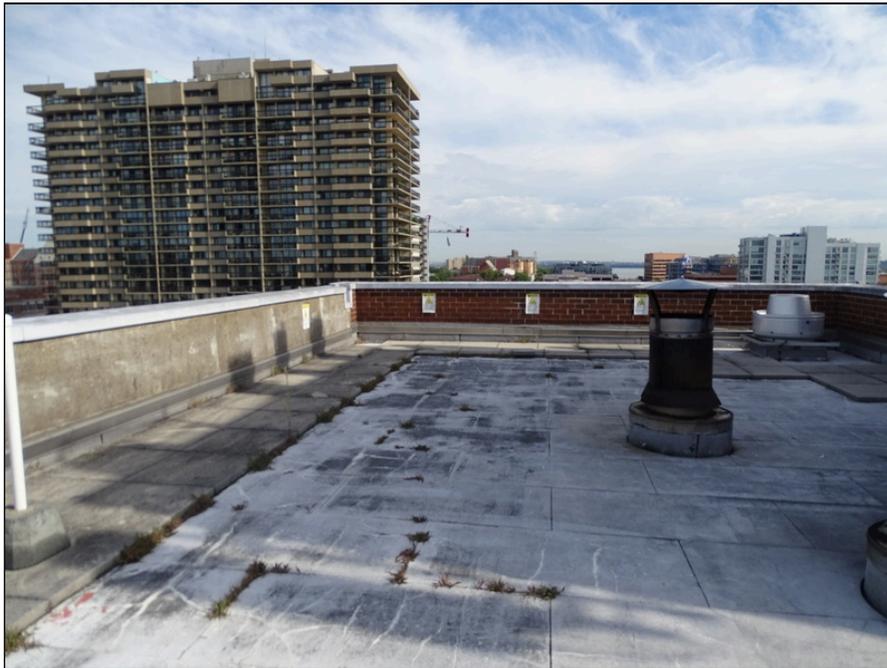
62 - IRMA Roofing System – Note cracks and vegetation were observed.

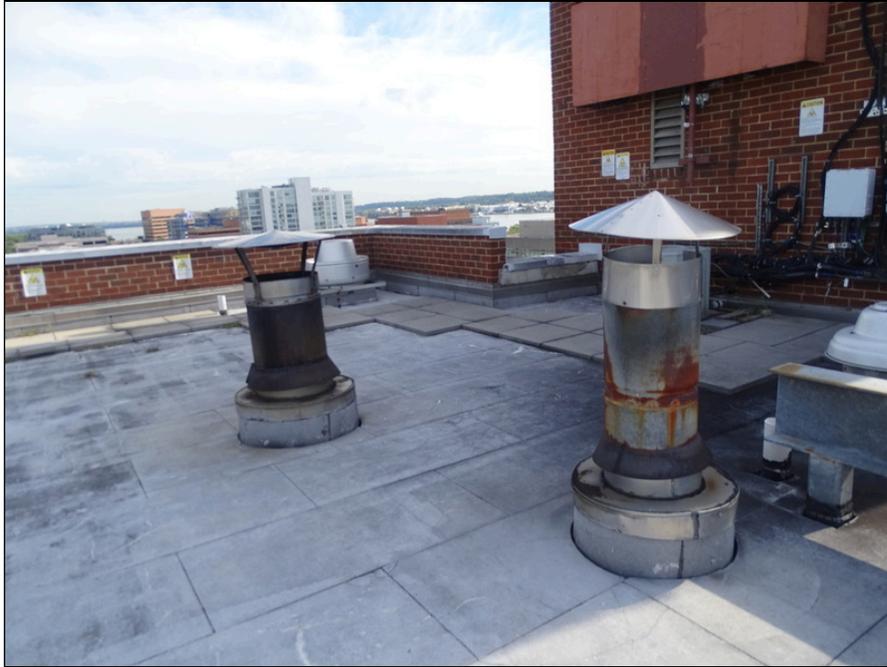
63 - IRMA Roofing System – Note cracks and vegetation were observed.

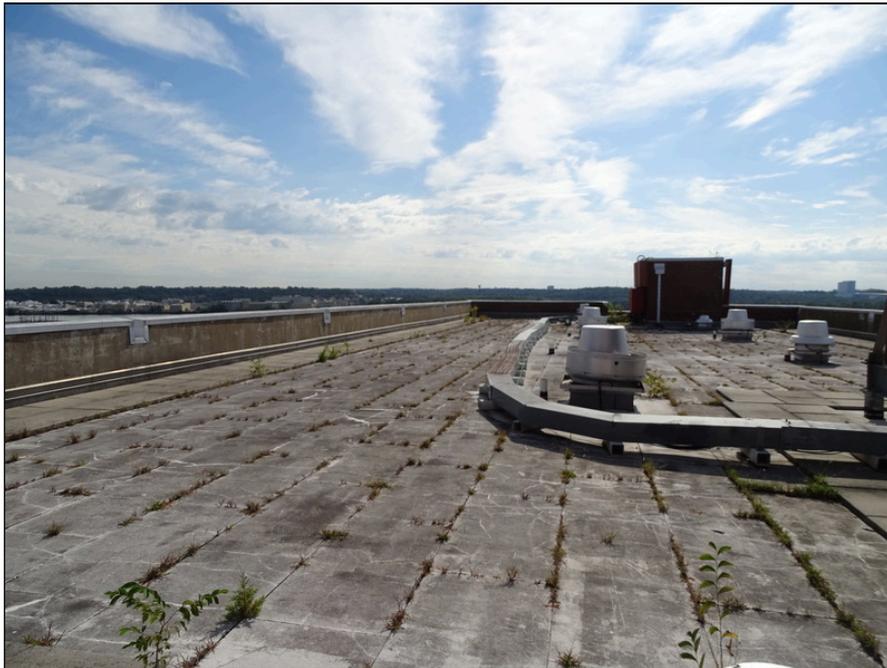
64 - IRMA Roofing System – Note cracks and vegetation were observed.

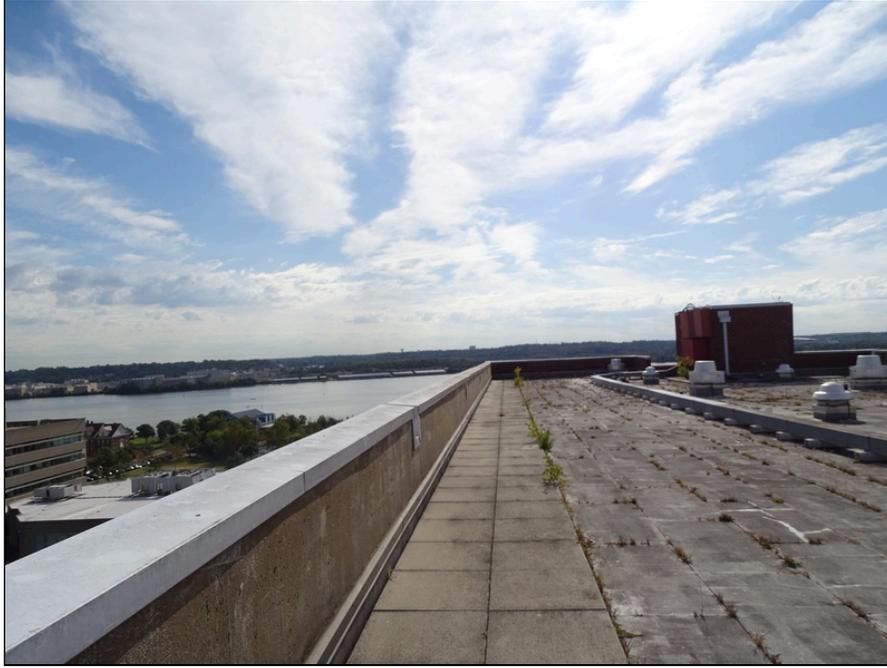
65 - IRMA Roofing System – Note cracks and vegetation were observed.

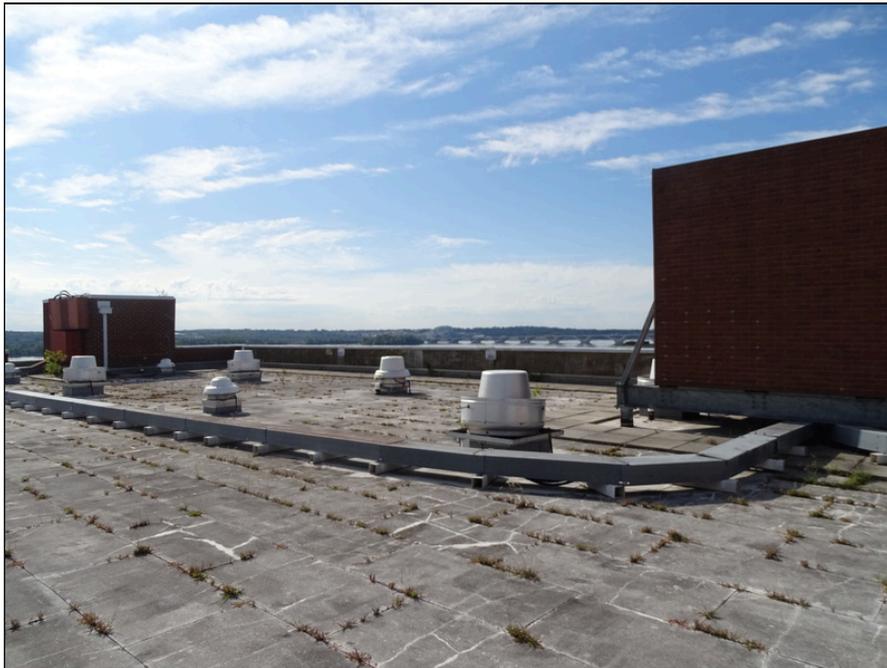
66 - IRMA Roofing System – Note cracks and vegetation were observed.

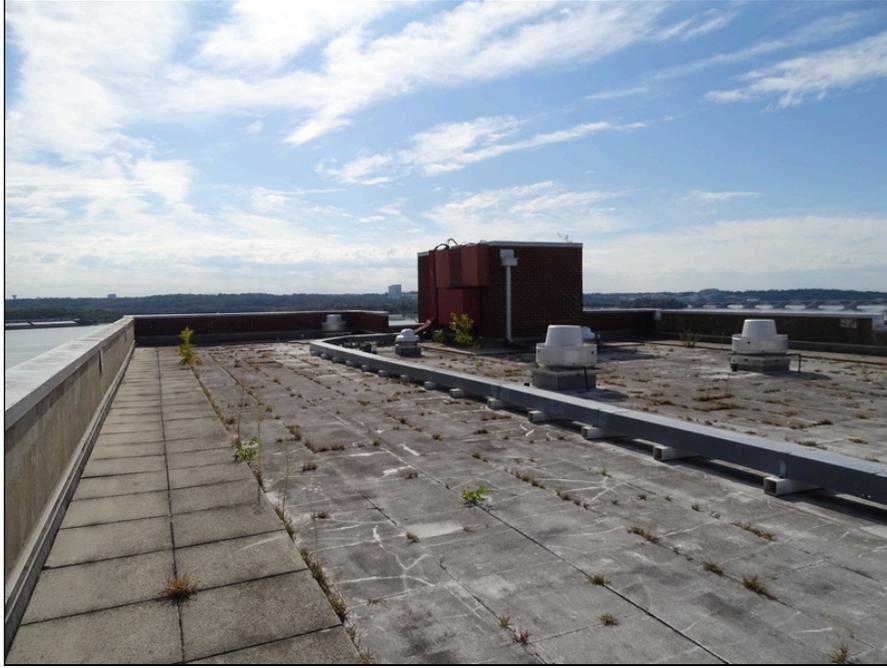
67 - IRMA Roofing System – Note cracks and vegetation were observed.

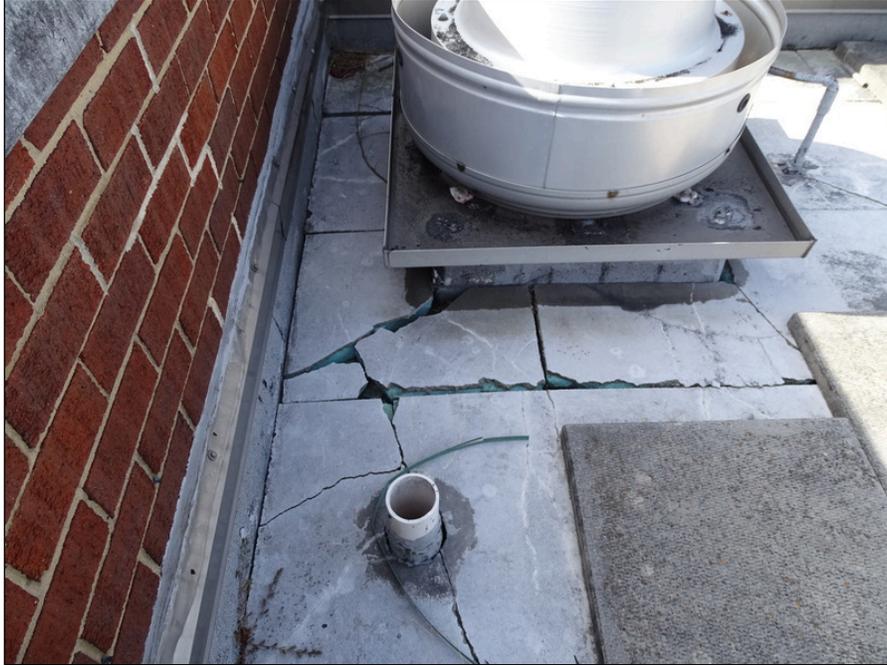
69 - IRMA Roofing System – Note cracks were observed.

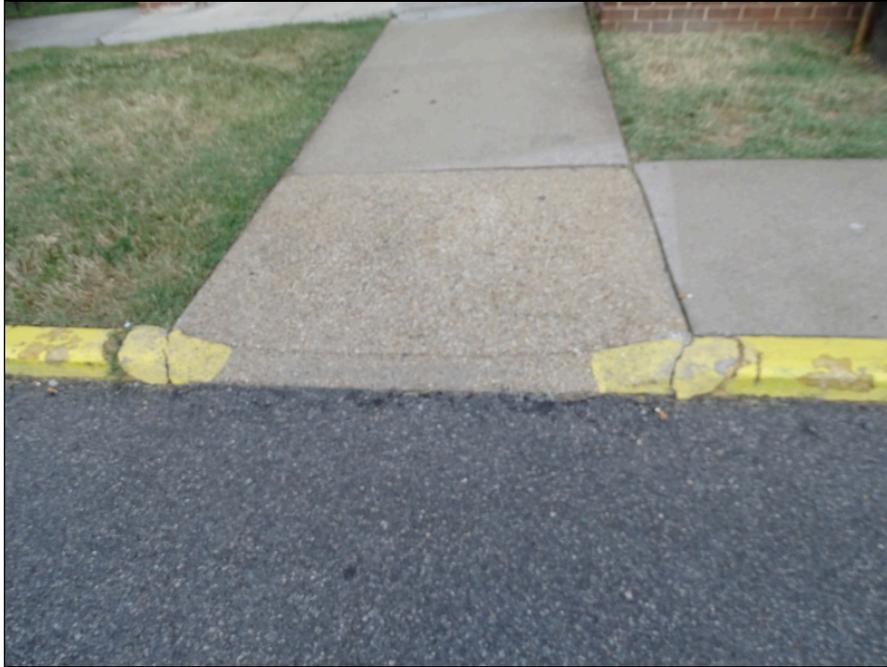
139 - Accessible curb ramp - Note the truncated dome is missing.
