## Murray-Dick-Fawcett House Historic Structure Report

Report by Glavé & Holmes Architecture for the Office of Historic Alexandria,  
City of Alexandria, Virginia | April 19, 2024

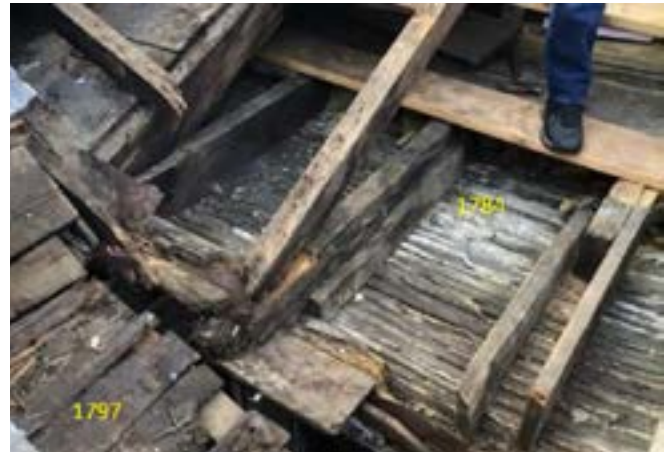
Figure 5b. - Roof and joists at NW corner of 1784 Addition during roof repair of 2022 looking SW. Note the modern sisters flanking the badly deteriorated joist to right at the former corner chimney location, making it hard to find evidence of a chimney. According to contractor Hank Handler, during the 2022 repair he saw charred debris at the next joist to the west, possibly indicating a chimney there [Al Cox photo, Exterior Restoration PowerPoint, Historic Alexandria, Alexandria VA].

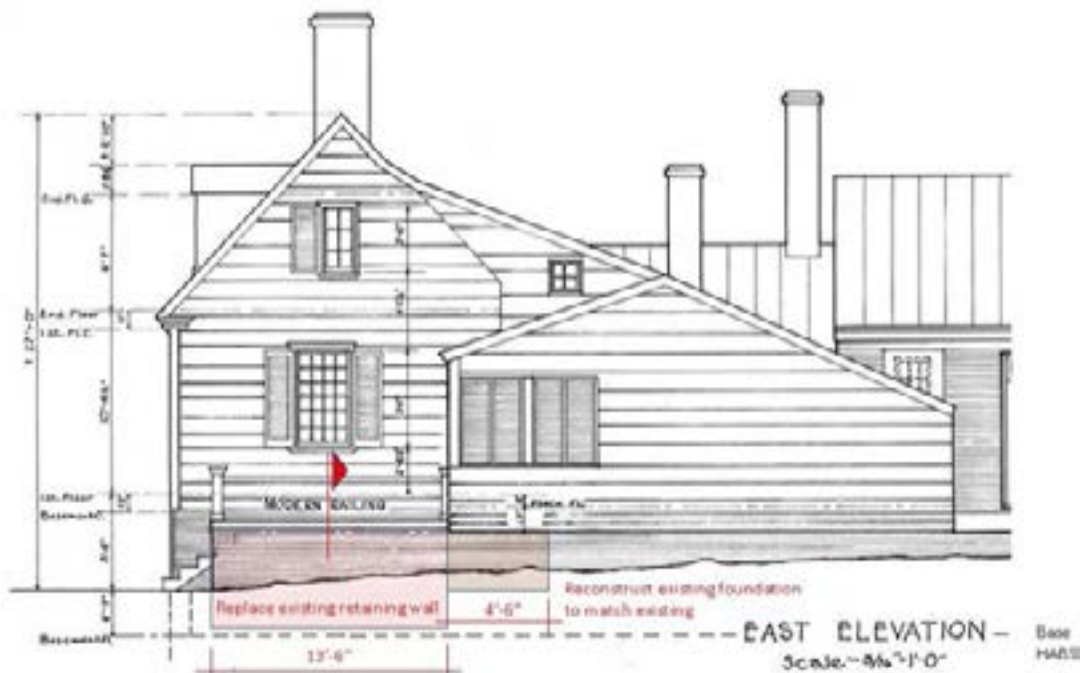
Figure 12a. - East Elevation showing stoop and porch foundation repairs c2021

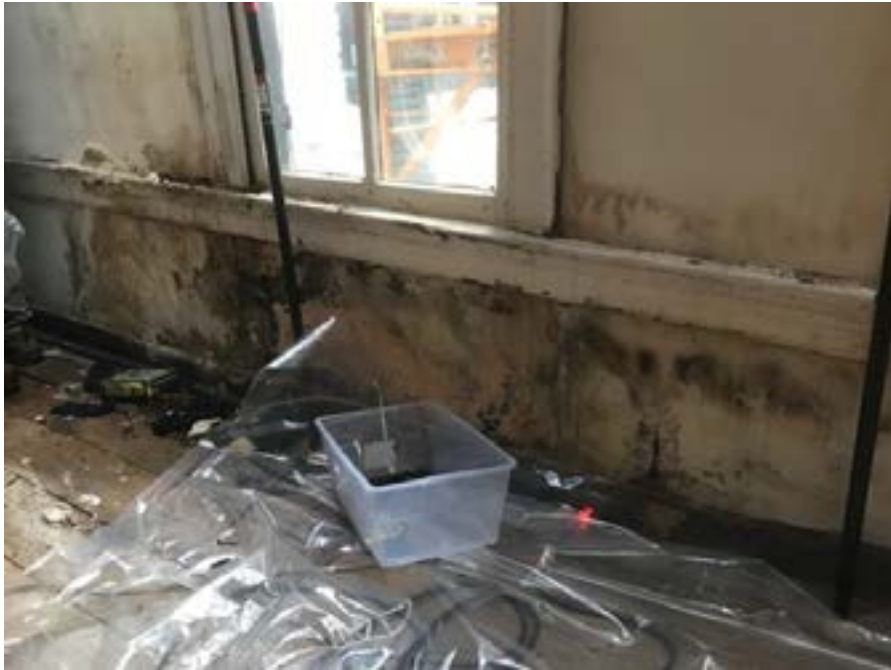
Figure 12d. - Al Cox, Photo of south face of north wall in NE Chamber before reconstruction, 2022.

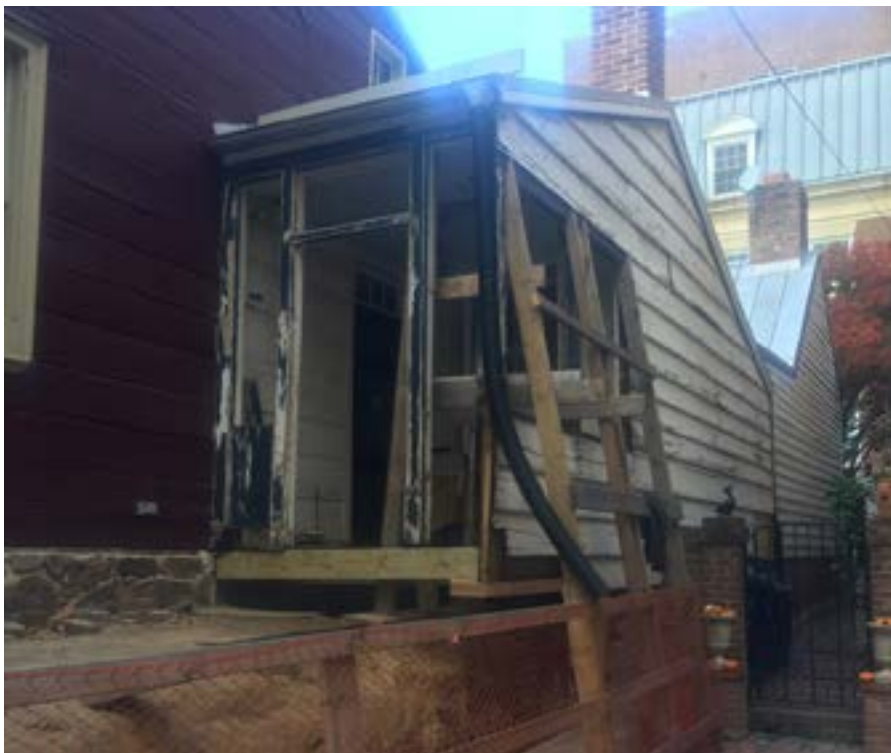
Figure 12e. - Al Cox, Photo of East Extension during repairs and insertion of new foundation, 2022..

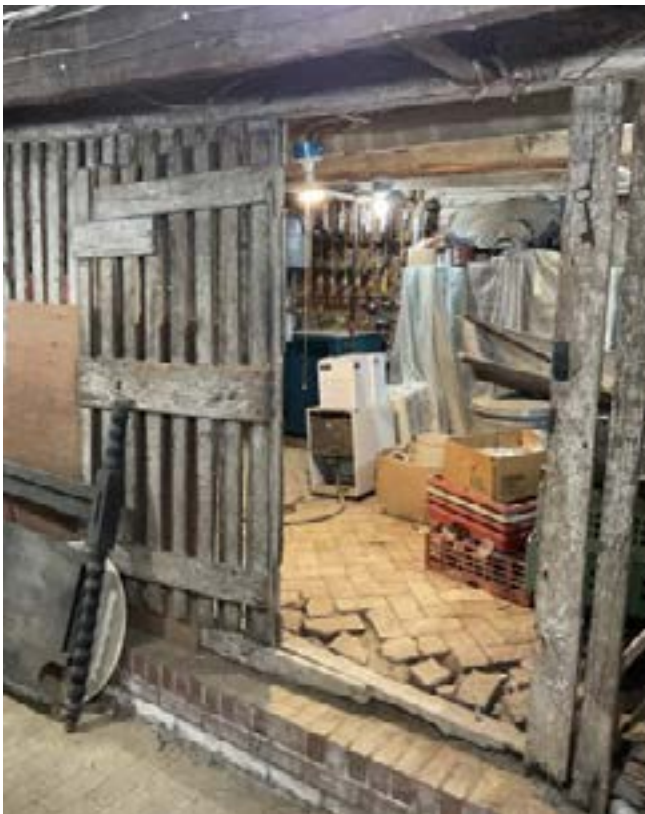
Figure 15k. - 1784 Cellar, slat partition looking southwest into the "Milk Room."

- Repair the deteriorated mortar at the former cellar door opening infill to the west of the chimney base.
- Retain and conserve the historic slat wall and brick floor in Room 002.

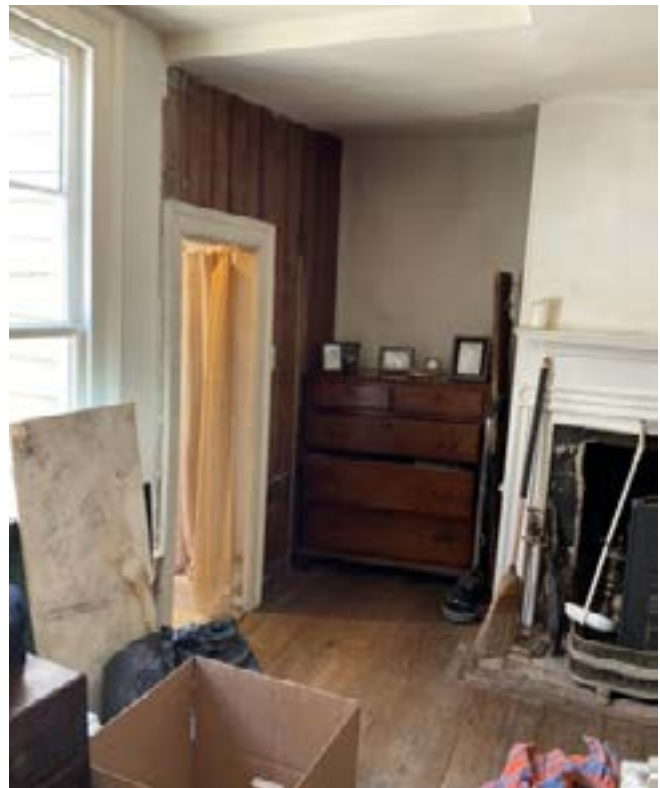
Figure 15p. - Room 107, (Northeast Chamber) northeast corner, looking NE. Note the door to the Closet (Room 108) in the board partition. See the repaired ceiling at the top.

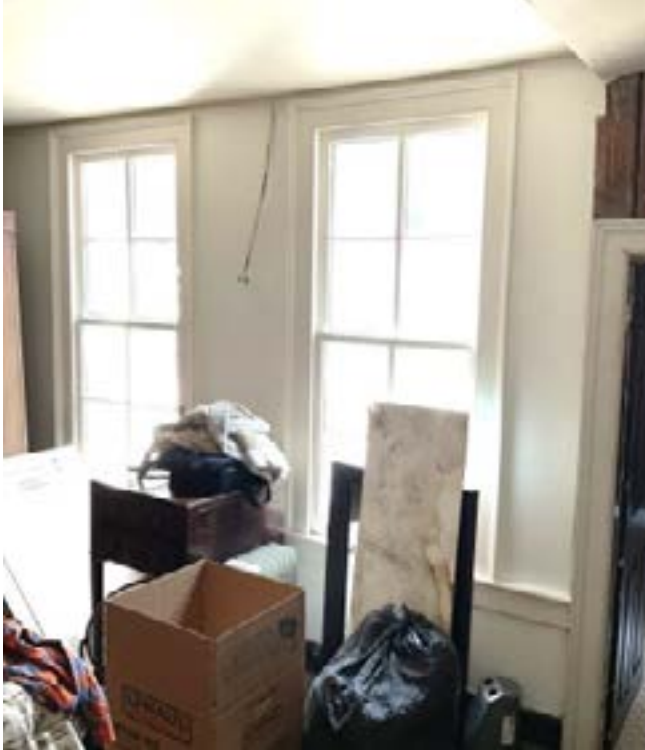
Figure 15q. - North wall of Room 107 looking northwest showing rebuilt windows and ceiling.

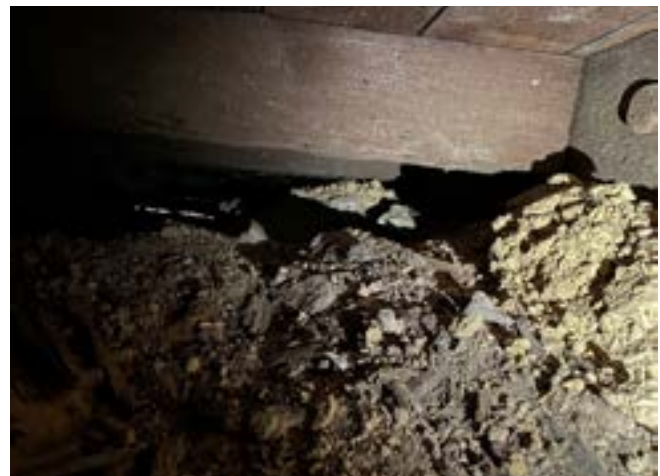
Figure 19n. Crawl space below the 1816 Extension looking at the east side of the sill of the 1784 Addition showing peg.

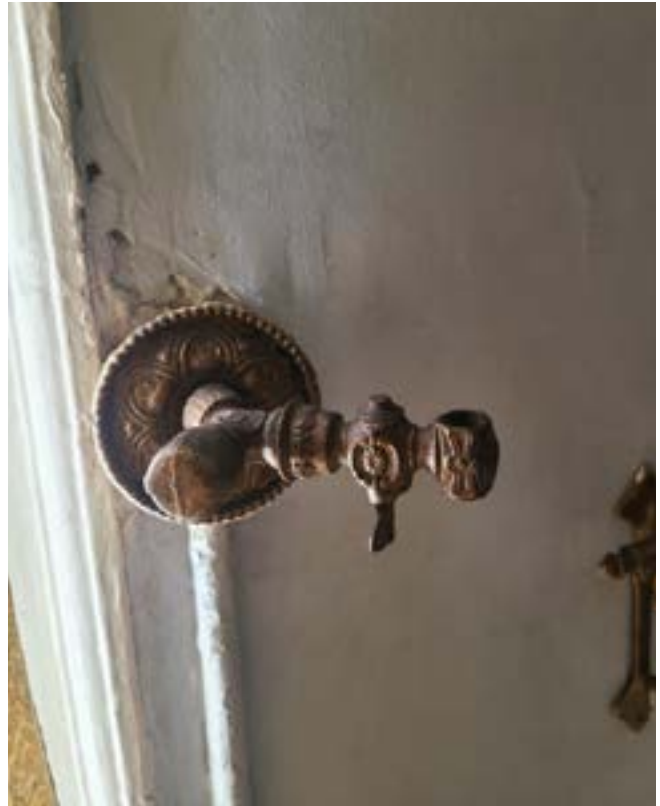
Figure 20r. - Remnants of A Second Gas Lighting Fixture

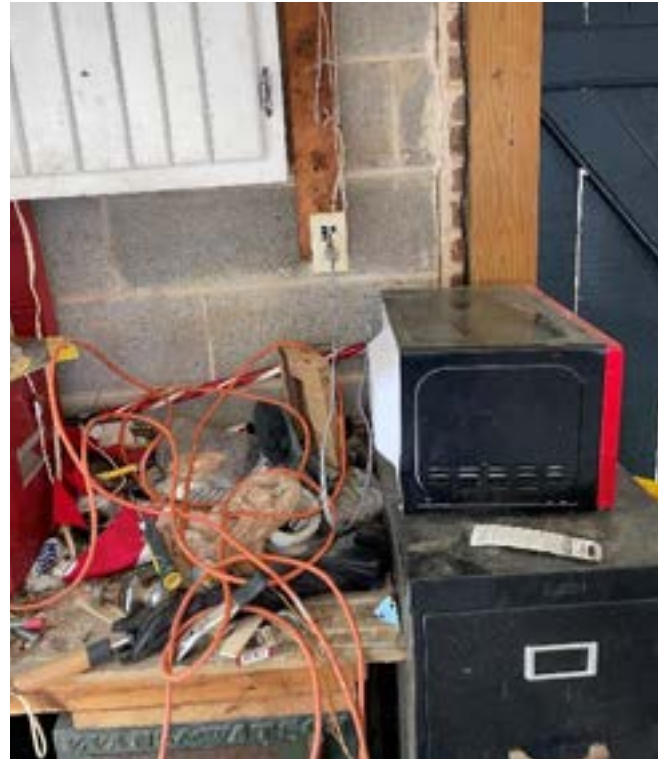
Figure 20ac. - GFCI Receptacle (Broken) in the Garage

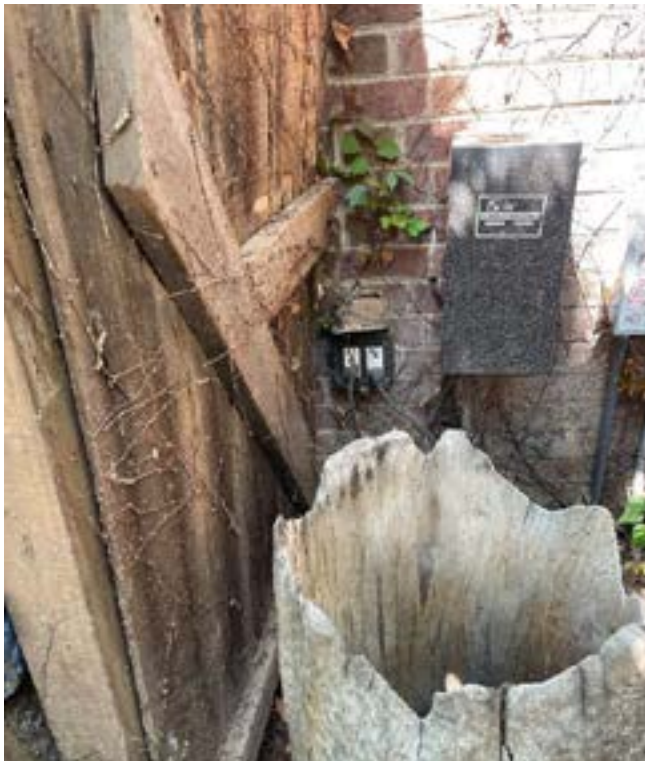
Figure 20ae. - Outdoor Receptacles with Improper Cover

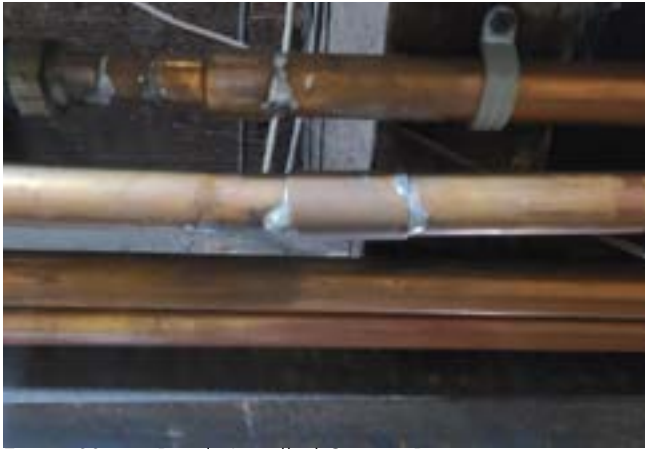
Figure 20an. - Poorly Installed Copper Piping

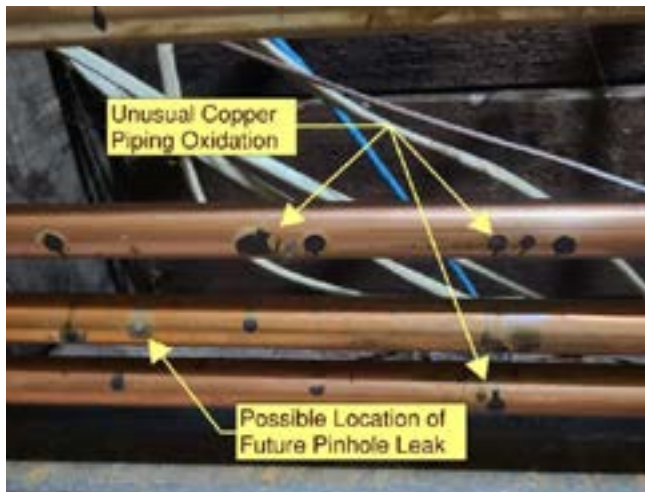
Figure 20ao. - Copper Piping Showing Signs of Deterioration
