Murray-Dick-Fawcett House Historic Structure Report

Report by Glavé & Holmes Architecture for the Office of Historic Alexandria,
City of Alexandria, Virginia | April 19, 2024 (REVISION 1)

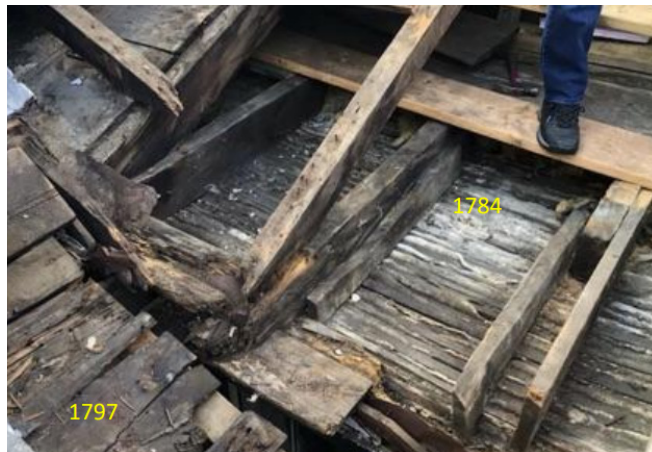
Figure 5b. - Roof and joists at NW corner of 1784 Addition during roof repair of 2022 looking SW. Note the modern sisters flanking the badly deteriorated joist to right at the former corner chimney location, making it hard to find evidence of a chimney. According to contractor Hank Handler, during the 2022 repair he saw charred debris at the next joist to the west, possibly indicating a chimney there [Al Cox photo, Exterior Restoration PowerPoint, Historic Alexandria, Alexandria VA].

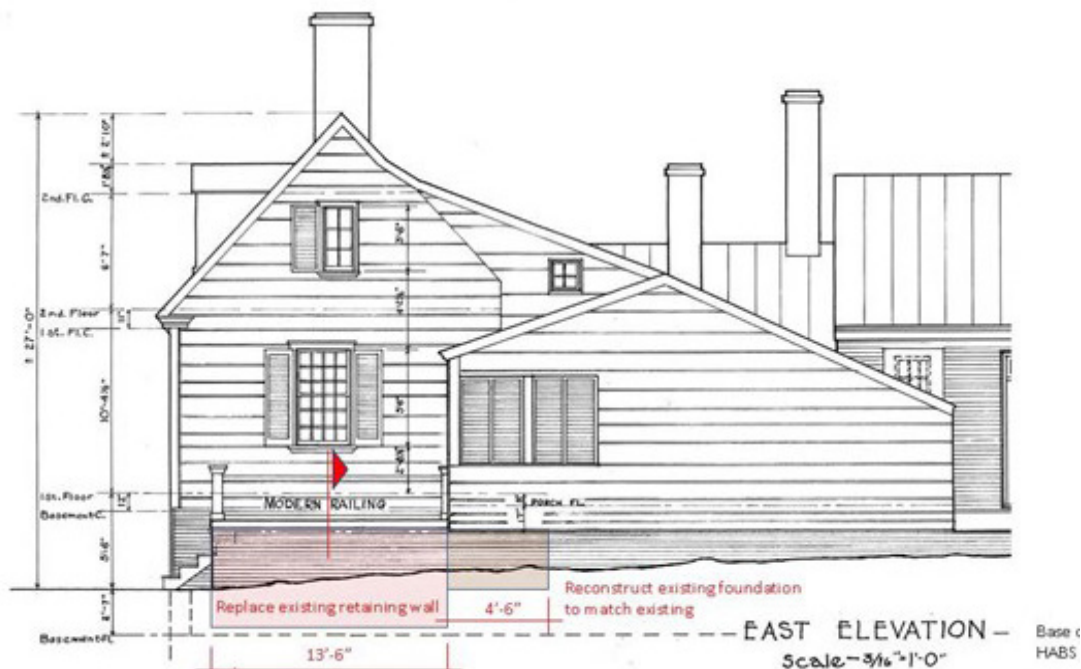
Figure 12a. - East Elevation showing stoop and porch foundation repairs c2021

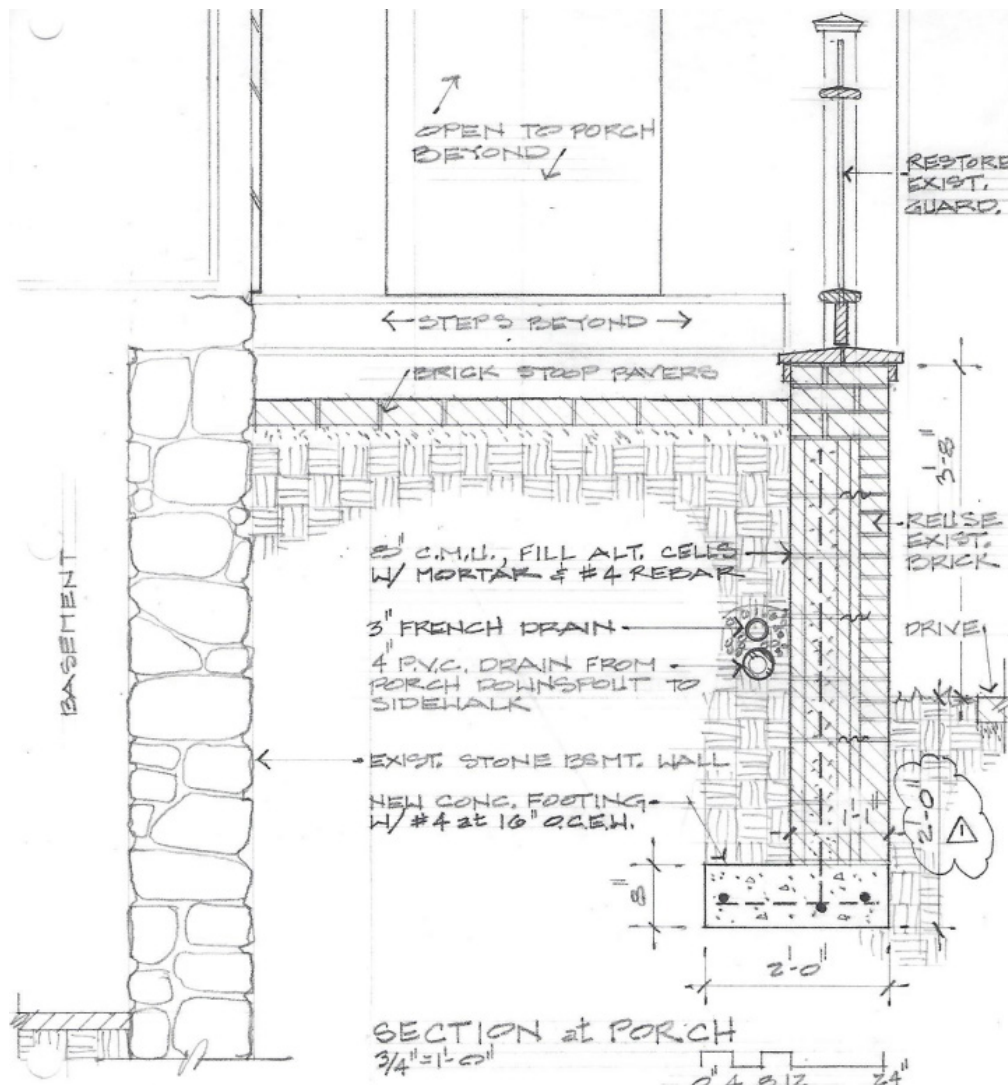
Figure 12b. - Al Cox, Section detail showing stoop and porch foundation repairs revised 10 Oct. 2022.

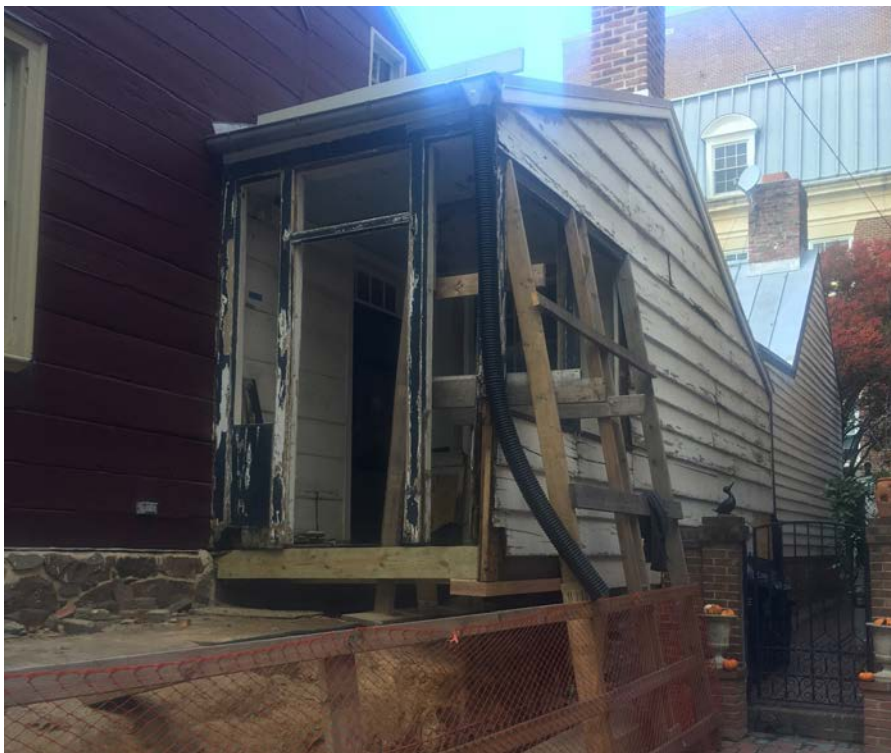
Figure 12e. - Al Cox, Photo of East Extension during repairs and insertion of new foundation, 2022..

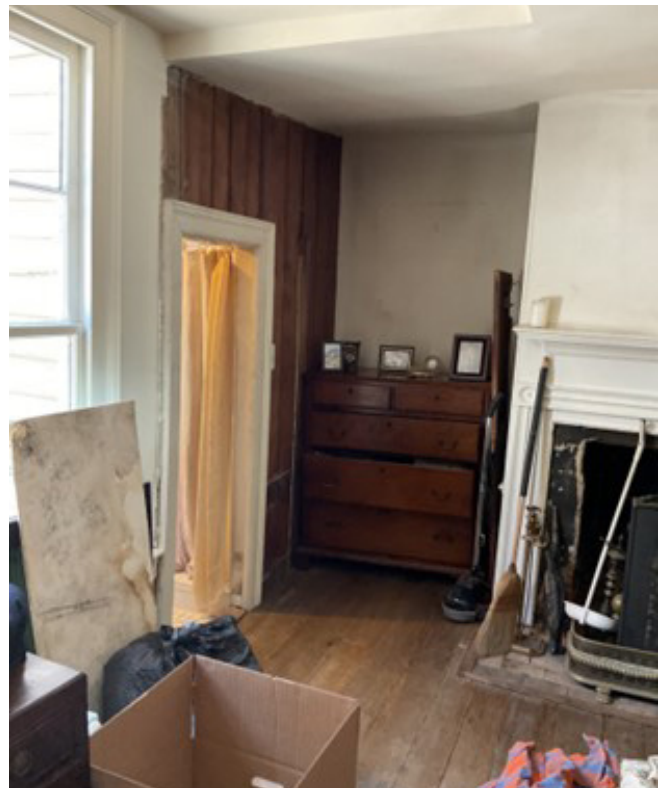
Figure 15p. - Room 107, (Northeast Chamber) northeast corner, looking NE. Note the door to the Closet (Room 108) in the board partition. See the repaired ceiling at the top.

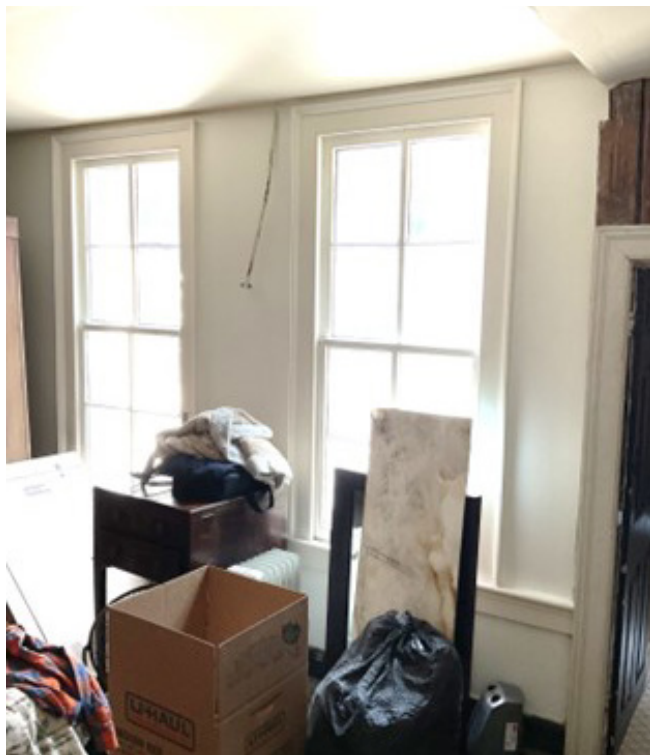
Figure 15q. - North wall of Room 107 looking northwest showing rebuilt windows and ceiling.

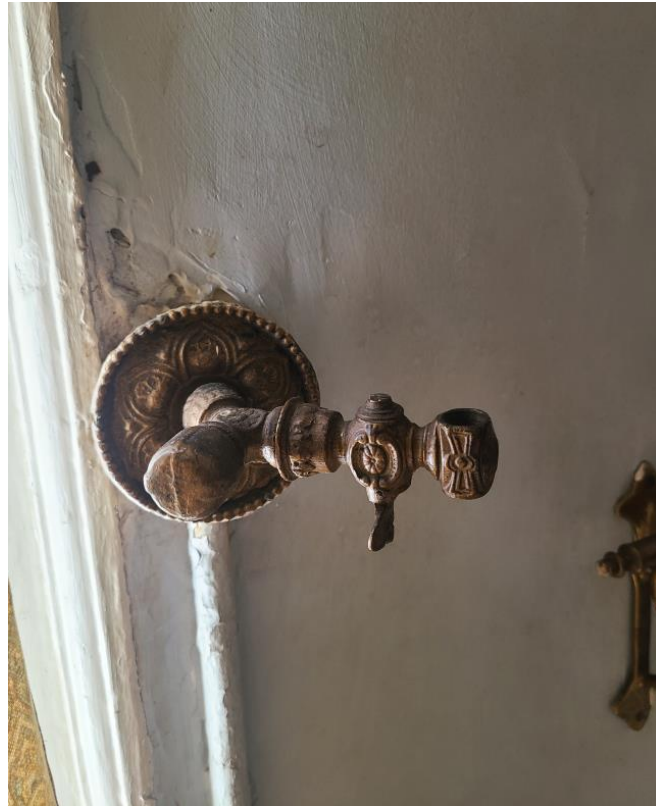
Figure 20r. - Remnants of A Second Gas Lighting Fixture

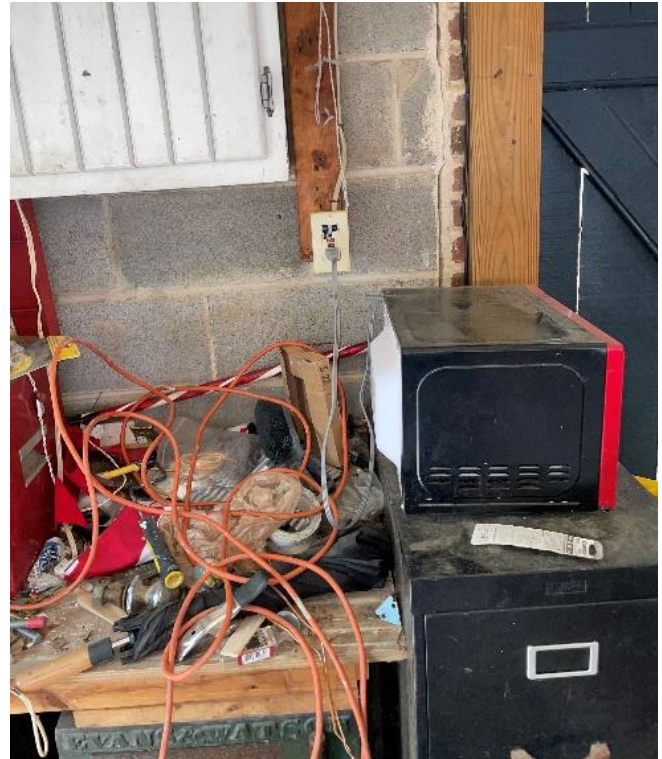
Figure 20ac. - GFCI Receptacle (Broken) in the Garage

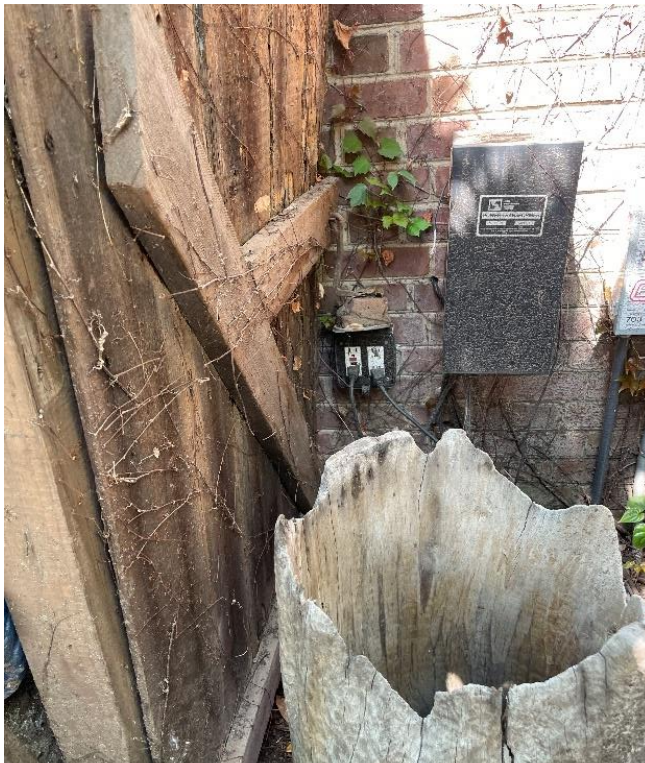
Figure 20ae. - Outdoor Receptacles with Improper Cover

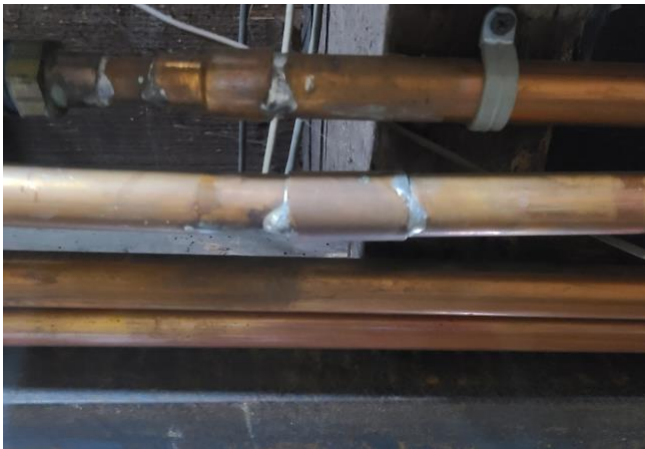
Figure 20an. - Poorly Installed Copper Piping

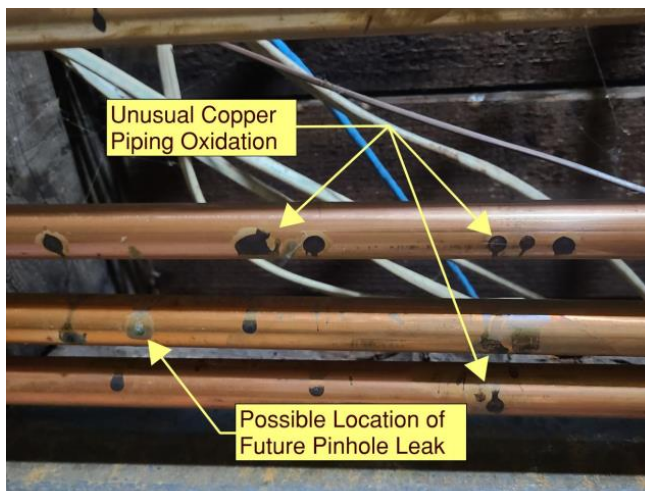
Figure 20ao. - Copper Piping Showing Signs of Deterioration
