# 1315 DUKE STREET HISTORIC STRUCTURE REPORT

Alexandria, Virginia 22314

## FINAL REPORT

June 30, 2021

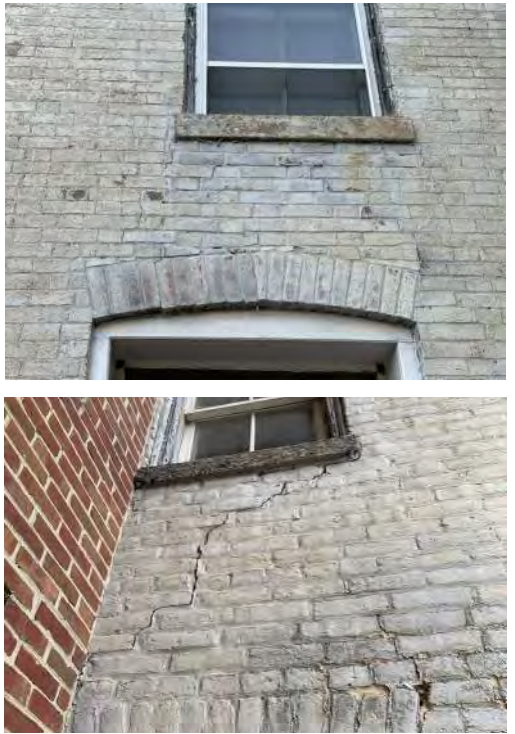
SYMBOL	CONDITION	LOCATION	EXAMPLE IMAGE
BRICK MASONRY	TJC/ TBC	Through Joint Crack & Through Brick Crack	Various locations, including South Facade of South Block and East Facade near rear entry

DESCRIPTION		POTENTIAL CAUSES	
	<p>Through Joint Crack (TJC): A crack that follows the mortar joints of the brick and doesn't translate through the brick. In some cases, these cracks result in brick displacement.</p> <p>Through Brick Crack (TBC): Movement and shifting of the brick have resulted in cracking both through the brick units and through adjacent mortar joints.</p> <p>Often these conditions occur together where a crack is found migrating through mortar joints and causing splitting of individual masonry units.</p>		Joints open due to weathering or differential stresses from movement within the building envelope. The mortar can be further damaged with salts and moisture migration.

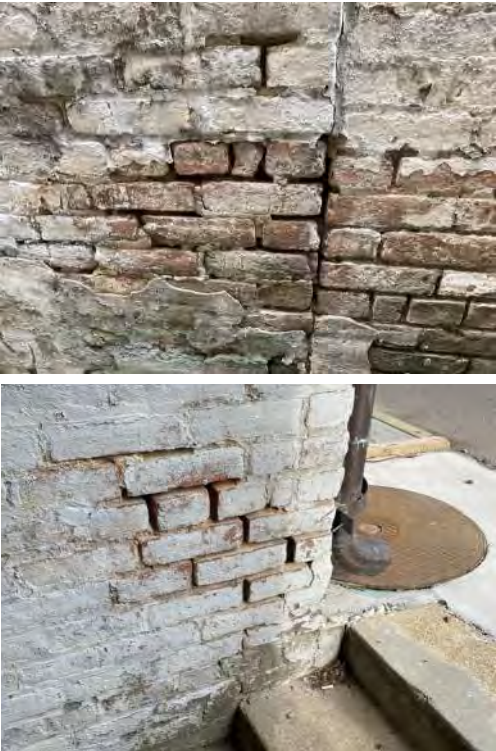
BRICK MASONRY	SYMBOL	CONDITION	LOCATION	EXAMPLE IMAGE
	OJ-B	Open Joints Brick	east and west elevations of South Block; west and north elevations of North Block

DESCRIPTION		POTENTIAL CAUSES	
	Complete or partial loss of pointing mortar. This condition allows moisture to migrate into the masonry substrate and may also result in potential structural instability		Dislocation of the brick units may be caused by differential movement within the masonry wall or deterioration of adjacent mortar caused by excessive penetration of moisture within the wall.

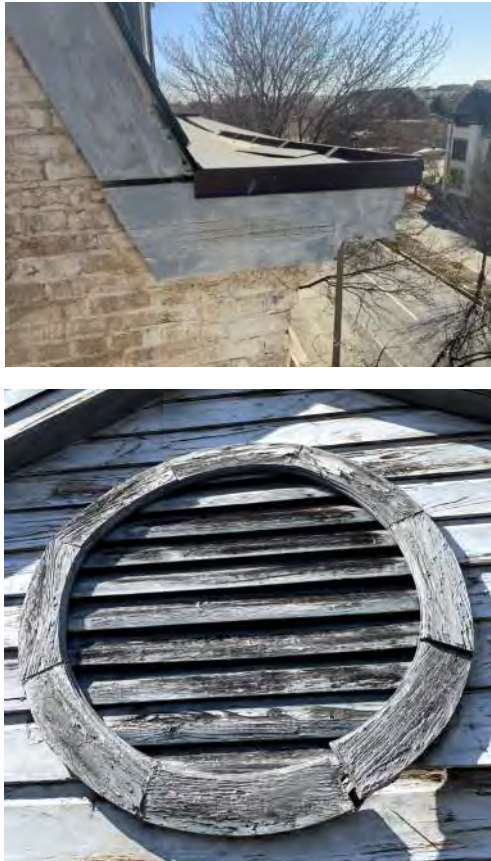
WOOD	SYMBOL	CONDITION	LOCATION	EXAMPLE IMAGE
	<b>DIS-W</b>	Dislocated Wood Element	Wood rake boards at East and West Facades of South Block  Wood trim boards at louvers in 1985 Addition

DESCRIPTION		POTENTIAL CAUSES	
	Dislocated component of wood members at window and door frames and trim.		Dislocated component of wood members at window and door frames and trim.

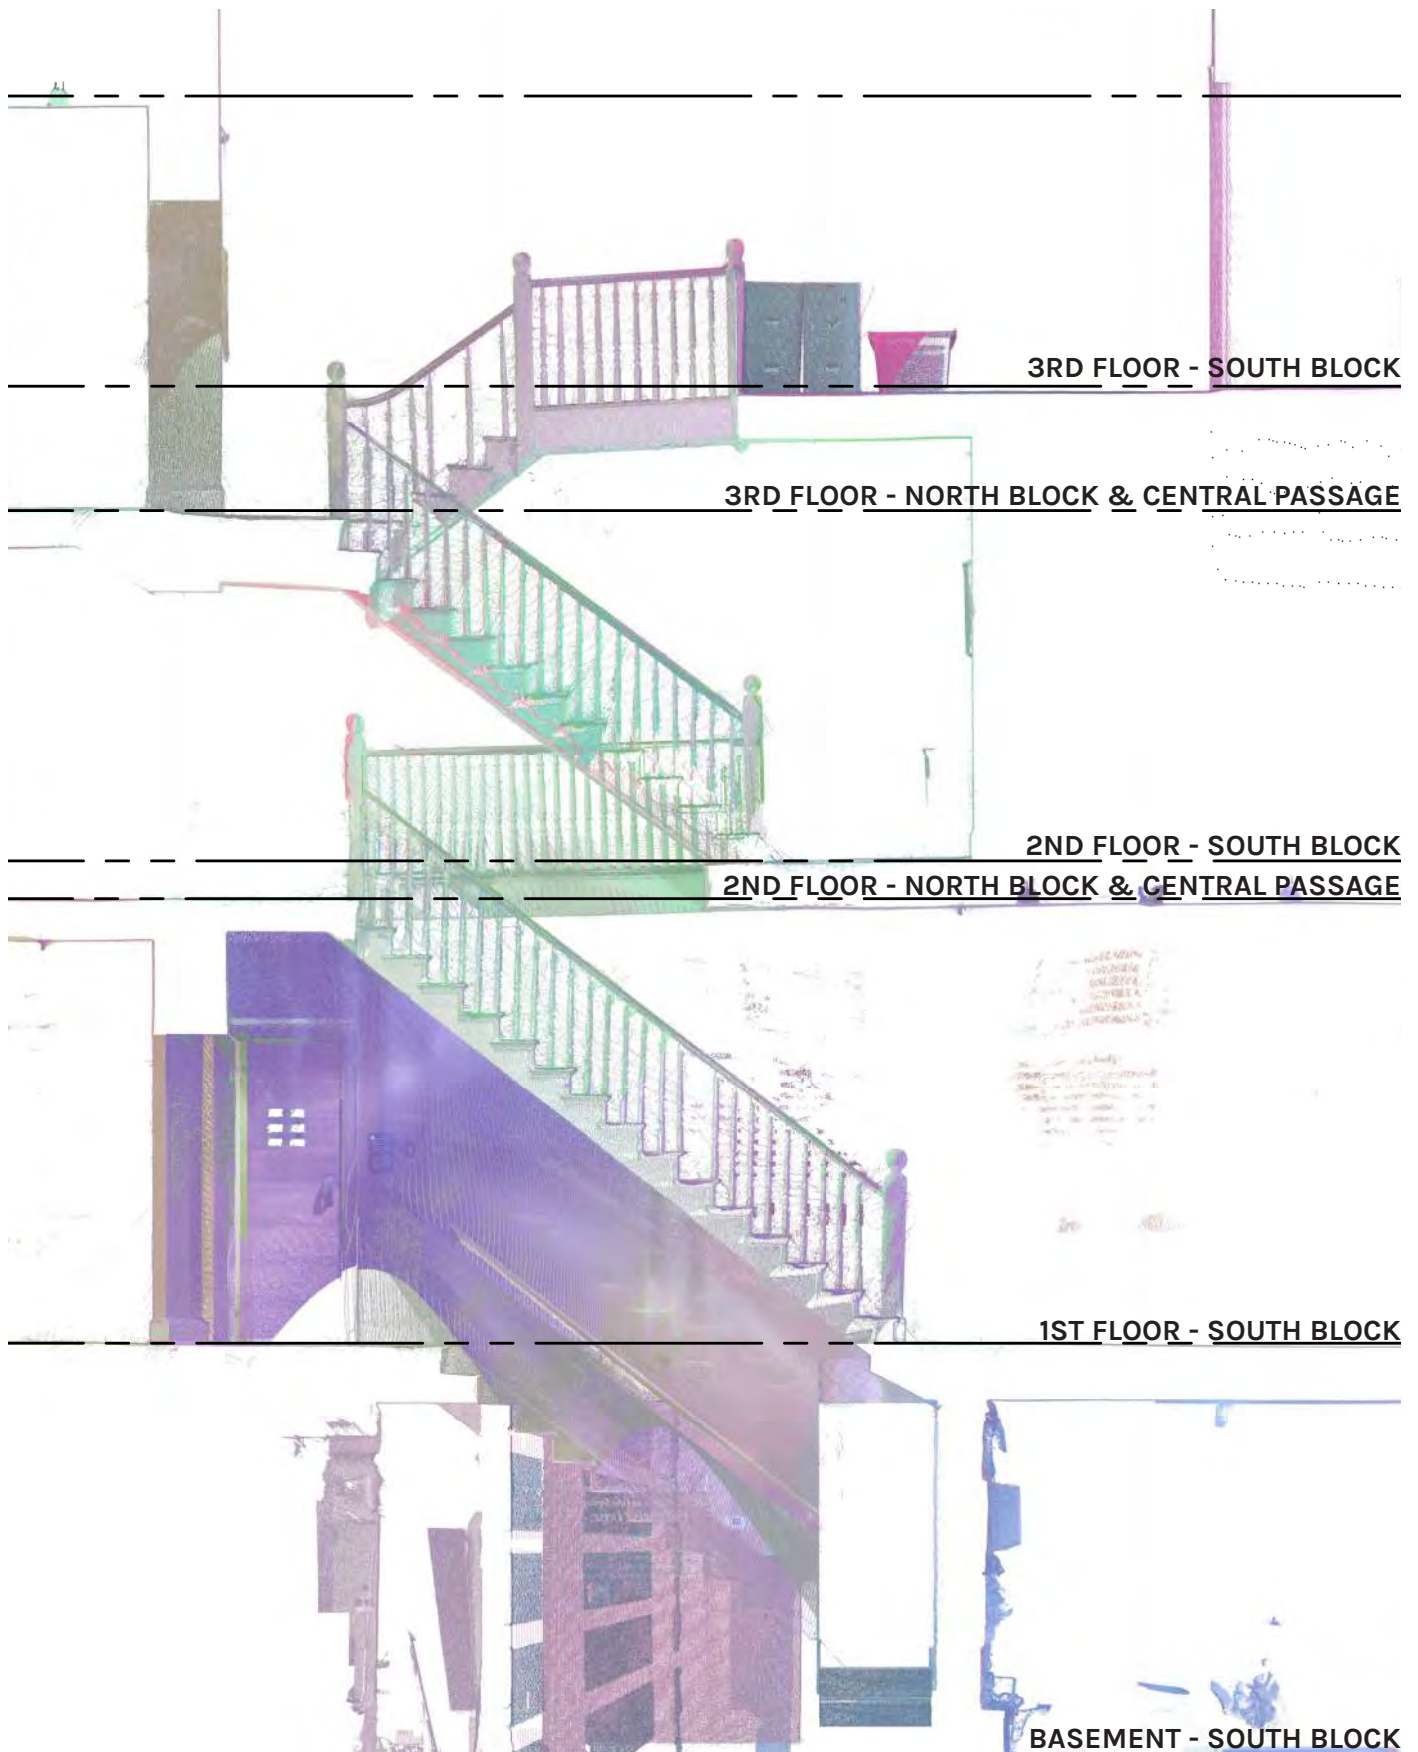
**Stair 1 Support:** As established in the structural conditions assessment, and confirmed in the laser scan documentation, there is significant deformation and settlement at Stair 1. Select dismantling in areas surrounding this stair will assist the structural engineering team in understanding the existing condition and in making appropriate repair and reinforcement recommendations.

Figure 2D-7: Section view of laser scan showing extent of structural deformation and settlement at Stair 1.

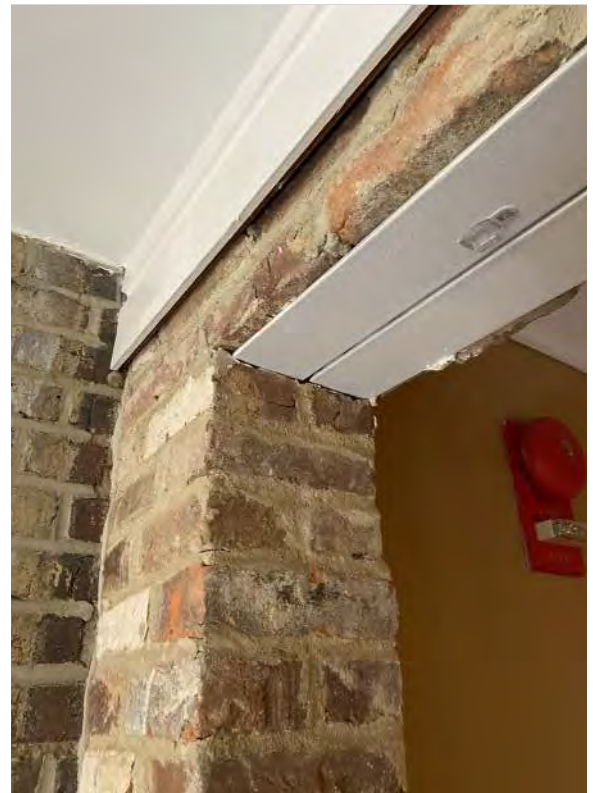
**Figure 2D-9:** Exposed lintel at corridor in front of elevator.

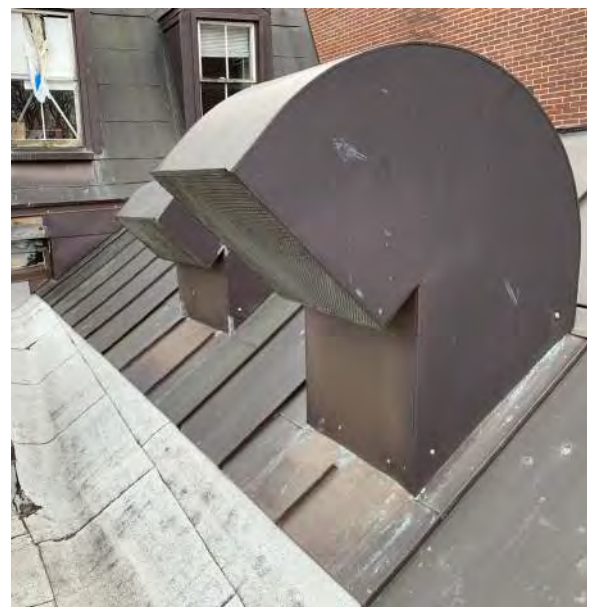
**Figure 2D-20** Air intake and toilet exhaust

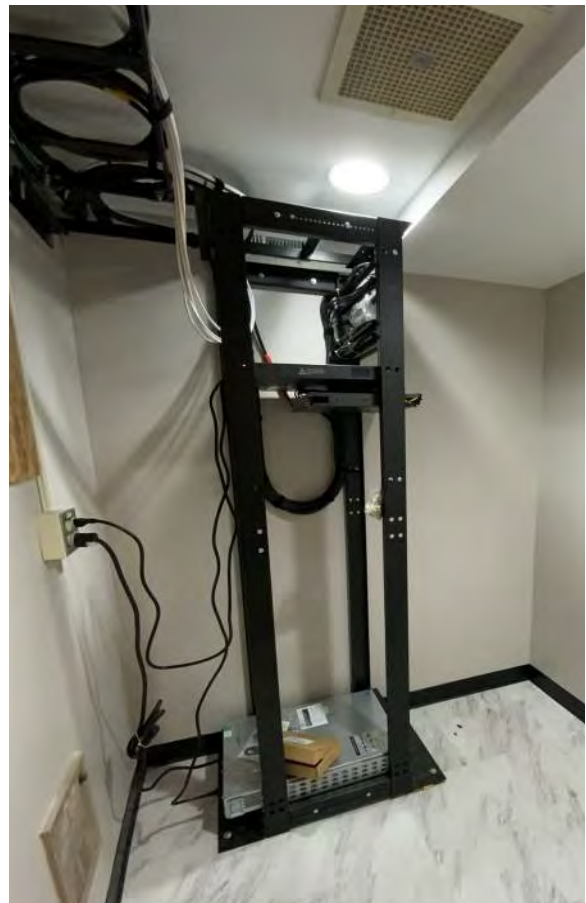
**Figure 2D-21:** Former restroom converted into Server Room.

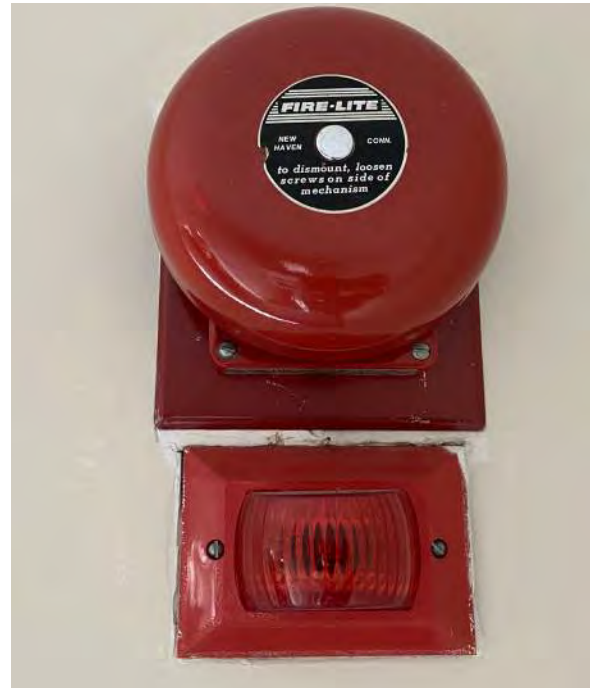
Figure 2D-36: Fire alarm audible bells and non-ADA compliant flashers.

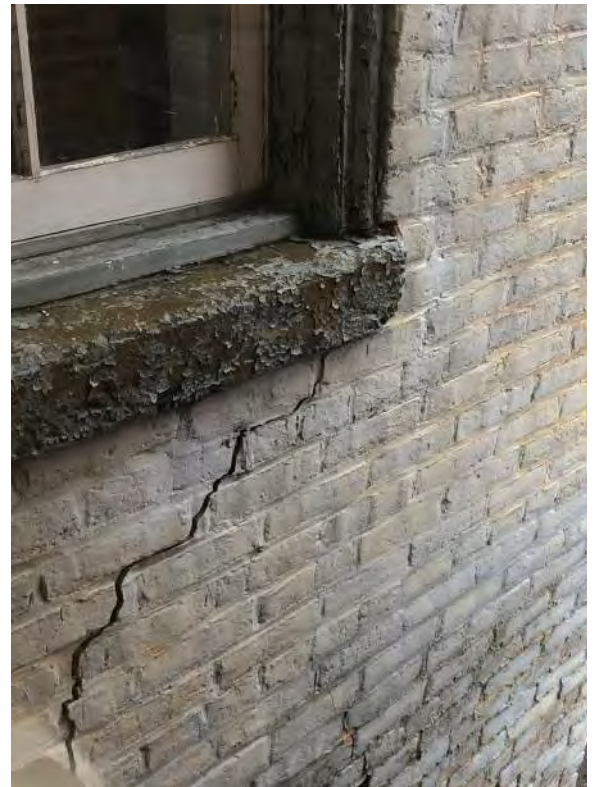
Figure 2E-2: Crack in brick masonry near rear entrance to building.

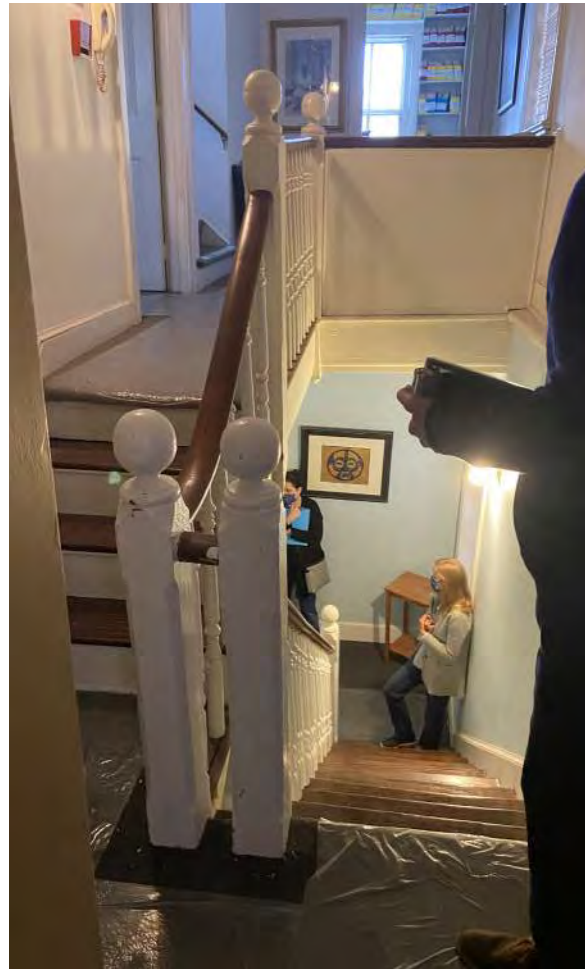
Figure 2E-4: Stair 1 deformation

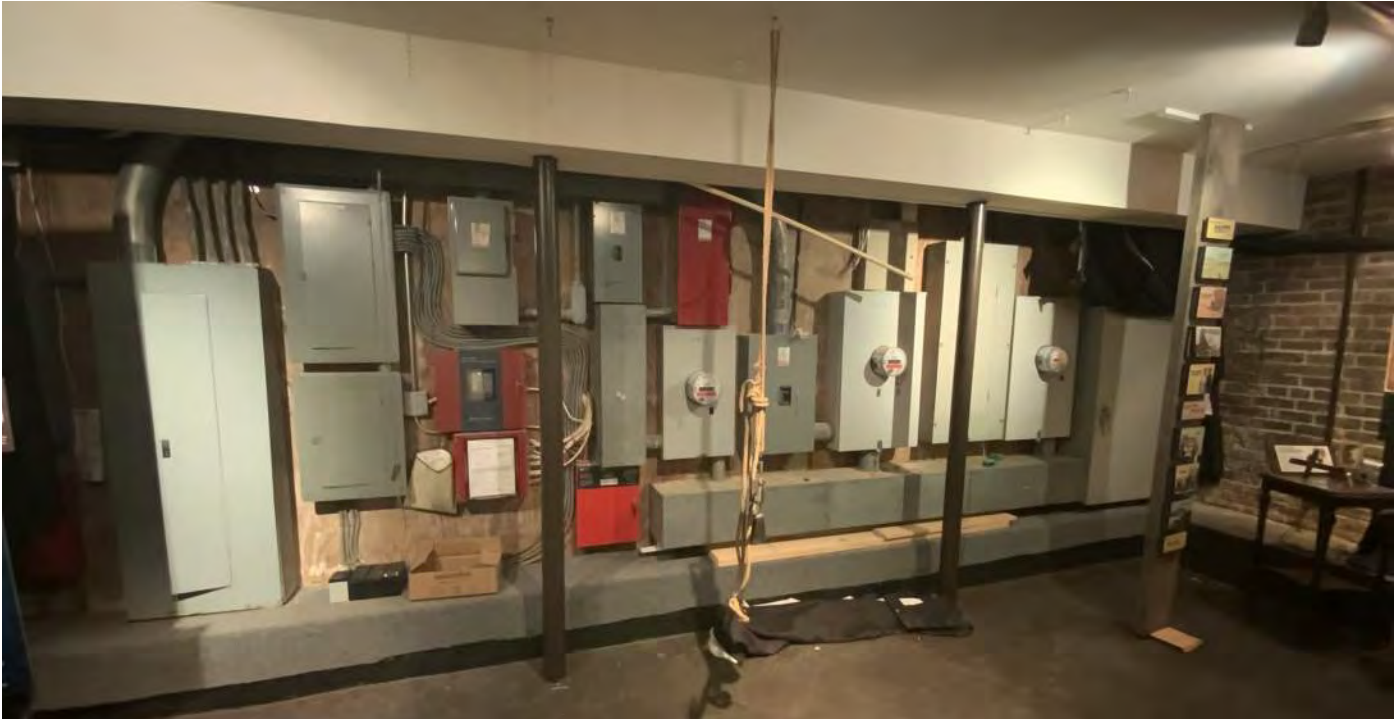
**Figure 2E-9:** Existing south wall of basement in South Block where the electrical service, panelboards, and other fire alarm and security devices are located.

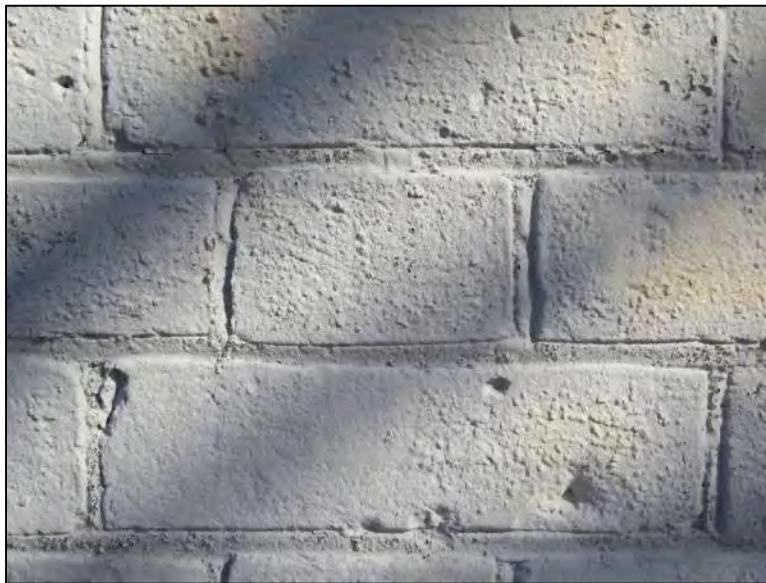
**Figure 10: Detail of south facade pointing. Note the struck joint profile.**

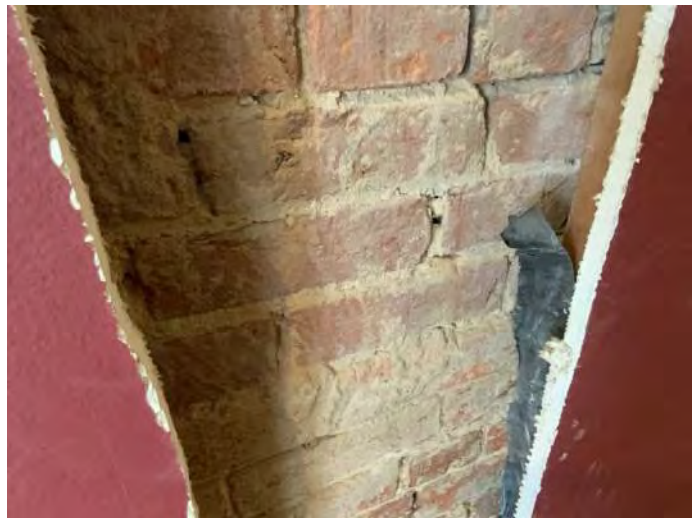
**Figure PR1-2:** One of two openings cut in existing drywall finish along west wall of Corridor 102. Existing wood stud framing found installed along historic brick masonry. A few cut nails were found within the mortar joints.

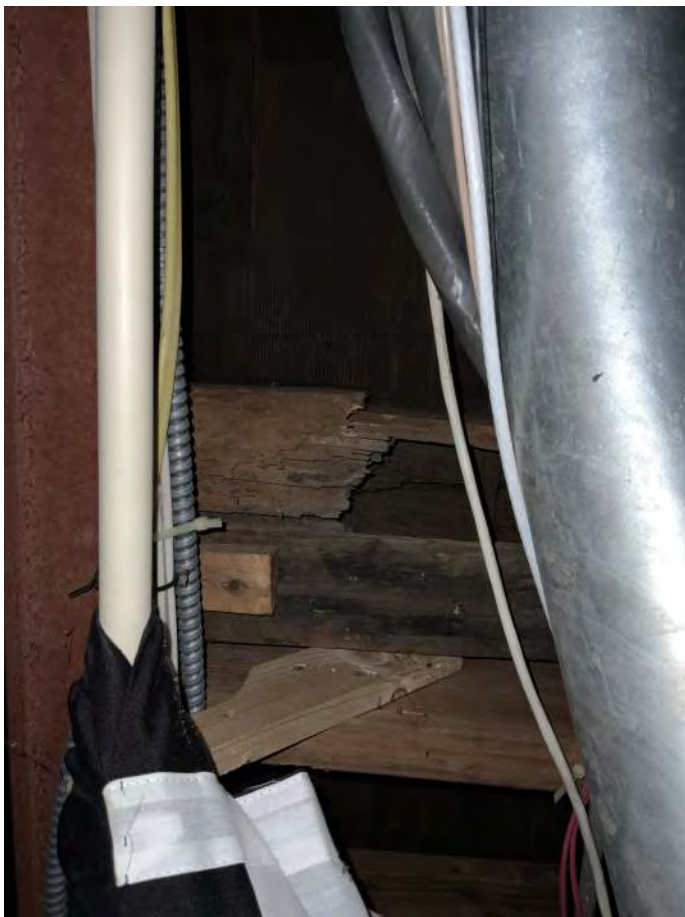
**Figure PR19-1:** Evidence of significant wood rot and deterioration at the bearing end of historic floor joists.

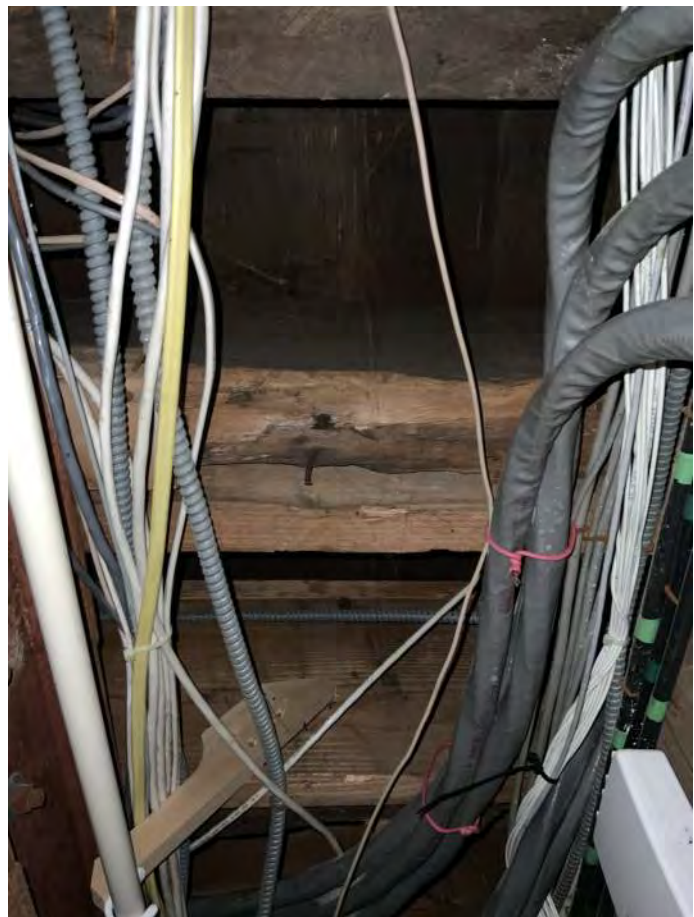
**Figure PR19-2:** Evidence of significant wood rot and deterioration at the bearing end of historic floor joists.
