EXHIBITS

EXHIBIT 1:

JOINT TASK FORCE & SUBCOMMITTEE MEETINGS

A2 Services, Inc. Facility Survey of City of Alexandria - City Hall

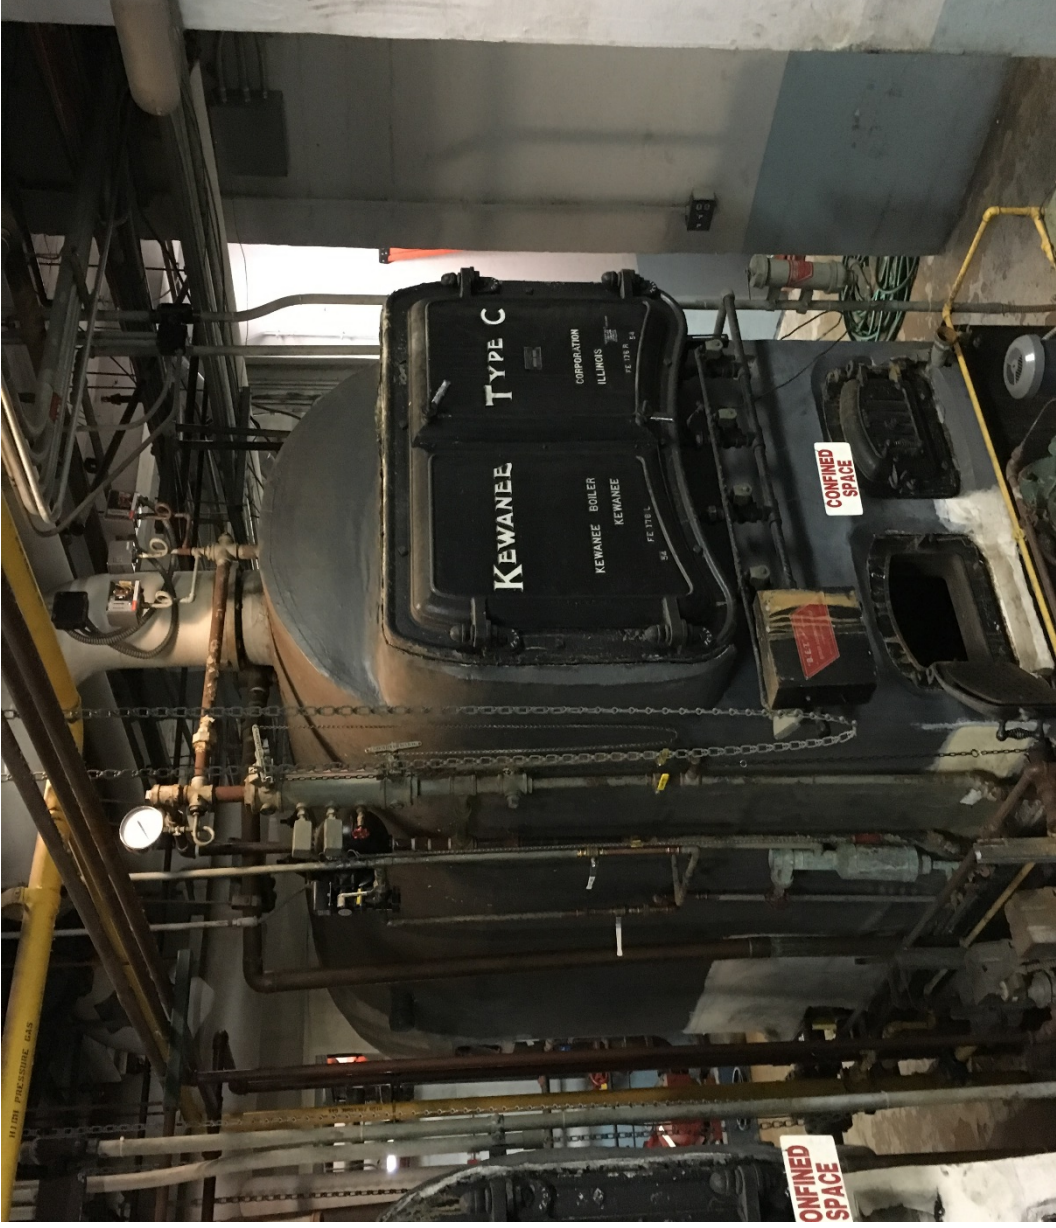
- Finding # - 1. As discussed above the two low pressure steam boilers are in poor condition. These should be considered for replacement soon. Actually the entire heating and cooling system is reaching the end of its useful life. The City of Alexandria should consider a complete heating and cooling system replacement. The City Hall facility would be a good candidate for new variable refrigerant flow heating and cooling system. Roof top dedicated outside air units with heat recovery could provide ventilation. These units would allow the site to meet the ASHRAE 62.1 and 62.2 standards for indoor air quality. This type of system would be the most efficient system available and would be the least expensive and disruptive to fit into this historic building.

Finding # 1 Photo. This picture is of one of the old brick set fire tube boilers. These units are in poor condition.

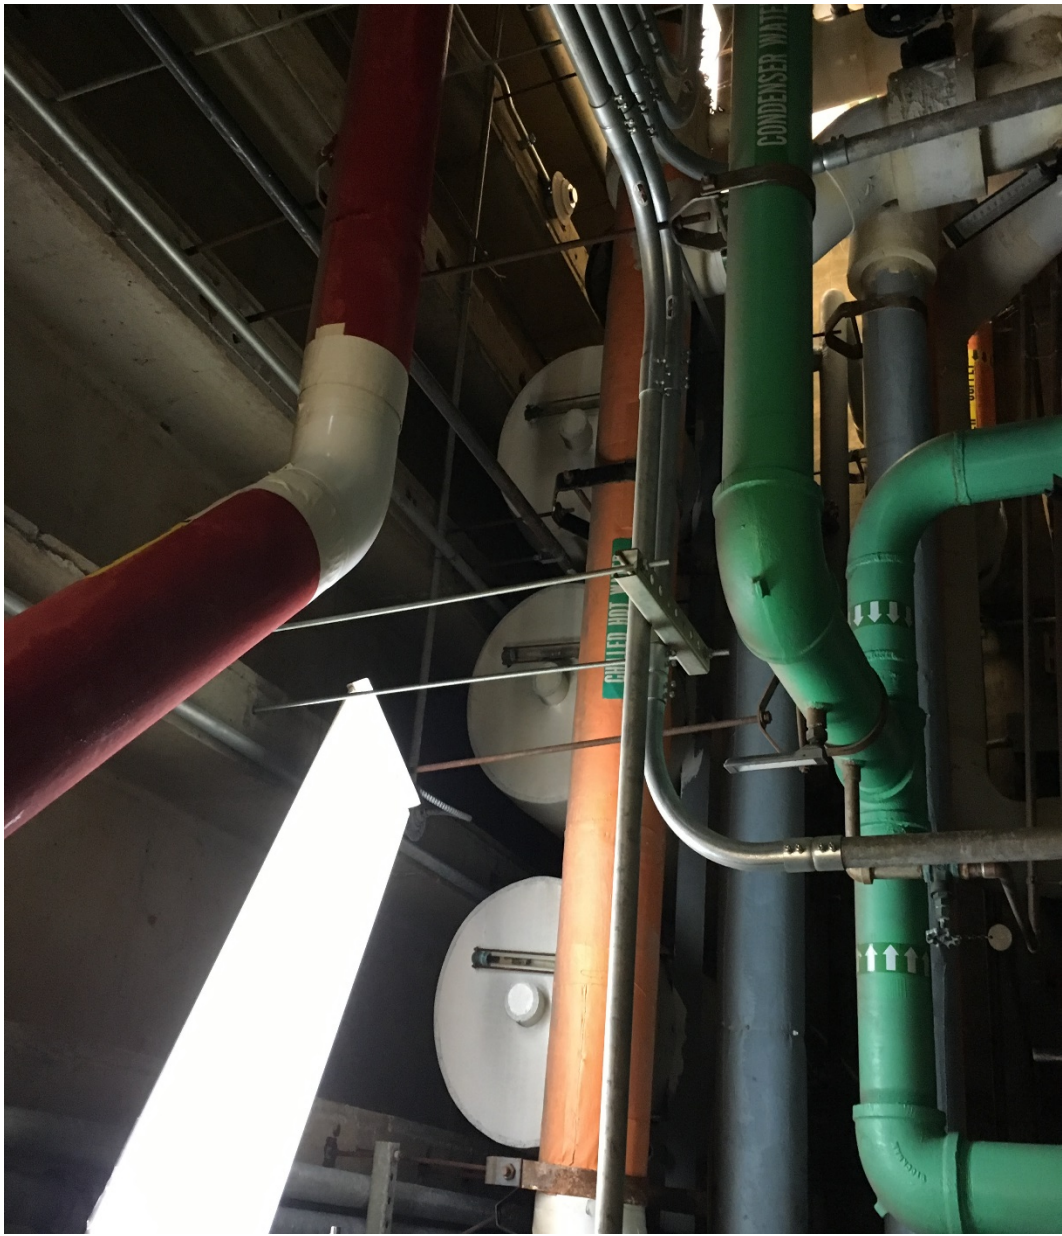
- Finding # - 2. The hydronic system expansion tanks are flooded and are out of service. This allows the system water pressure to increase and decrease with the system temperature changes. This condition can cause the system pressure to exceed the design pressure during heating season. This will cause the system relief valves open to relieve the pressure wasting chemicals and possibly causing leaks on the heating coils in the building.

Finding # 2 Photo. The 3 tanks shown in this picture are the closed system expansion tanks. These need to be repaired and the proper air cushion established to allow the systems water to expand and contract without changing the system pressure.

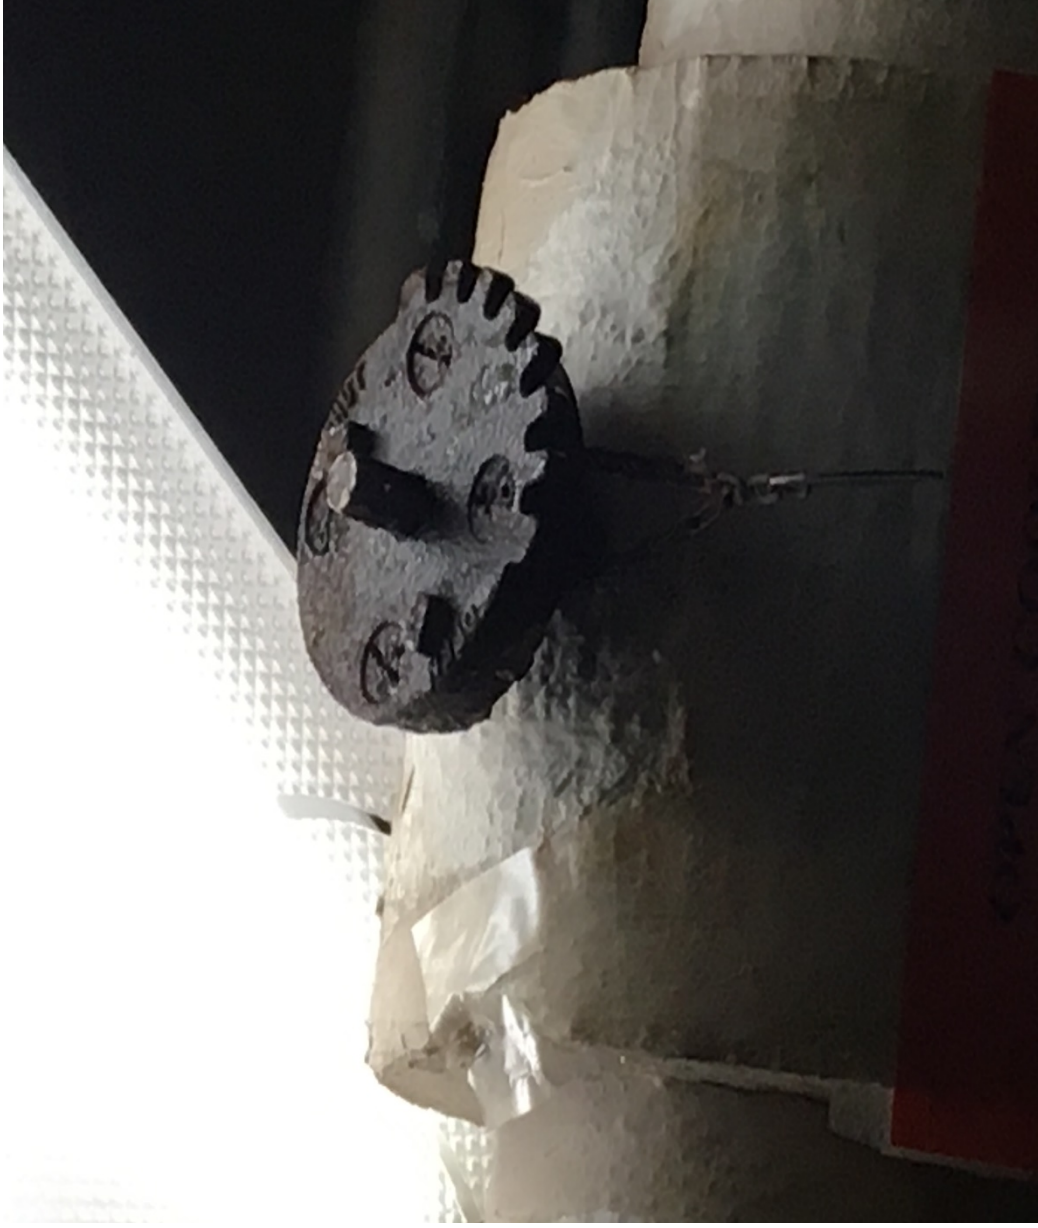
- Finding # - 3. A2 noted that at least two hydronic system manual valves which were have broken handles. **REVISION - While the valves are operable through the use of wrench rather than the designed turning knob, it is recommended that the valves be replaced.**

Finding # 3 Photo. This picture is an example of one valve which needs to be replaced.

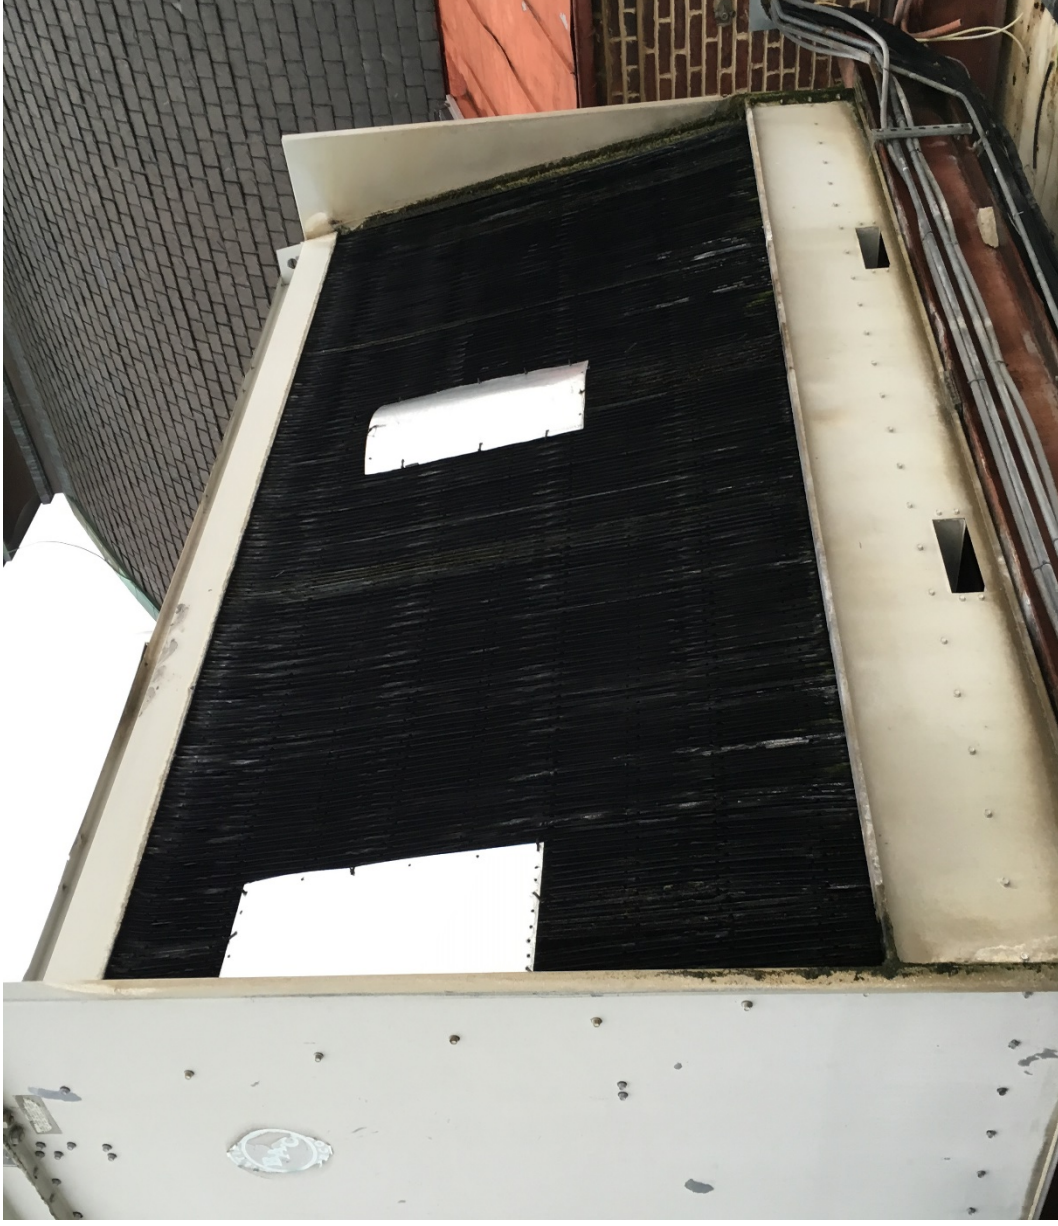
- Finding # - 4. The cooling tower fill is damaged and has been temporarily repaired with some sheet metal to stop the tower water from blowing onto the roof. The fill should be replaced.

Finding # 4 Photo. This picture notes the temporary sheet metal repair to the cooling tower fill.

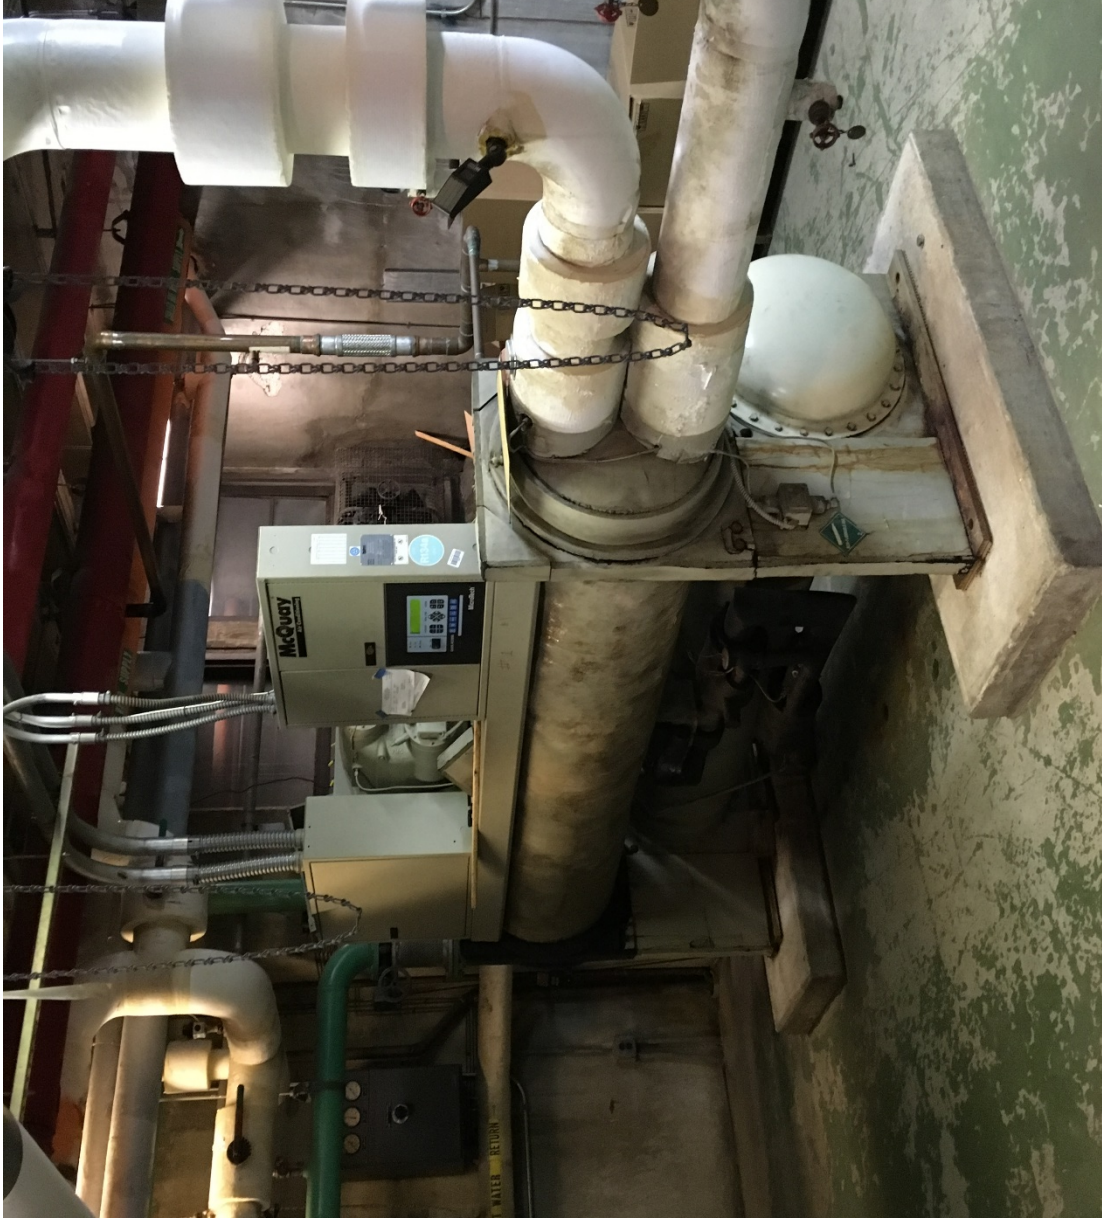
- Finding # - 5. The McQuay R-22 chillers provide chilled water for the site in summer. These machines are operating well but are inefficient and use R-22 which has been taken off the market. As stated earlier, R-22 is an HCFC which was identified in 1990 by the clean air act to be an ozone depleting compound, thus has been taken out of production. R-22 is still available at increasing cost. There are compliant refrigerants that can replace the R-22 but these will decrease the system efficiency on already inefficient machines.

Finding # 5 Photo. This picture notes one of the R-22 centrifugal chillers.

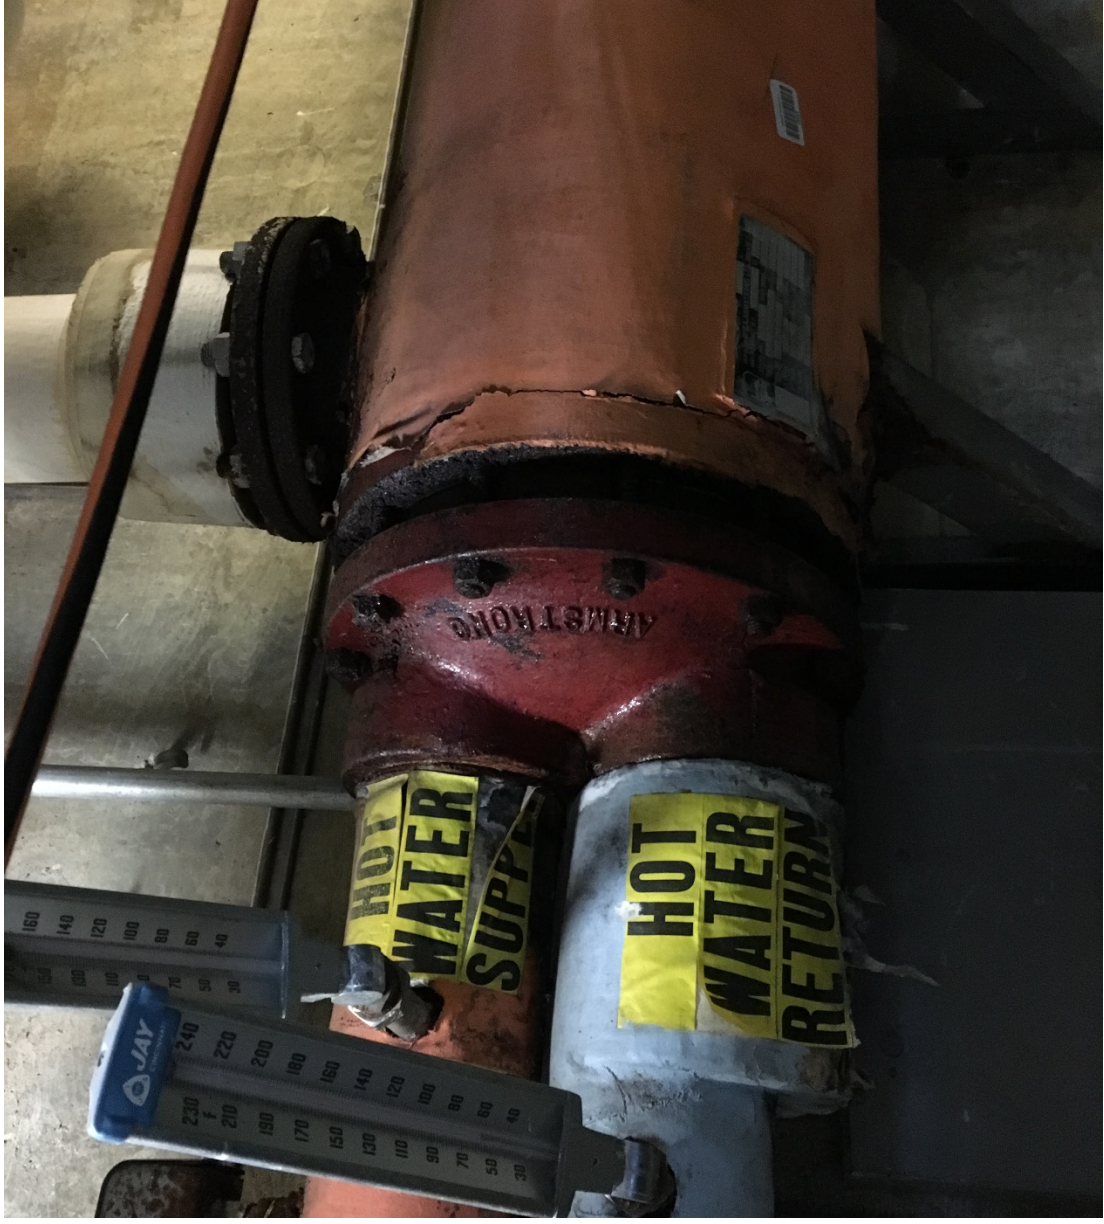
- Finding # - 7. The steam heat exchanger head is leaking. The unit's tube bundle should be pulled cleaned and closed with new gaskets.

Finding # 7 Photo. This picture is of the heat exchanger which heats the whole building. The head is leaking while in operation and should be repaired.

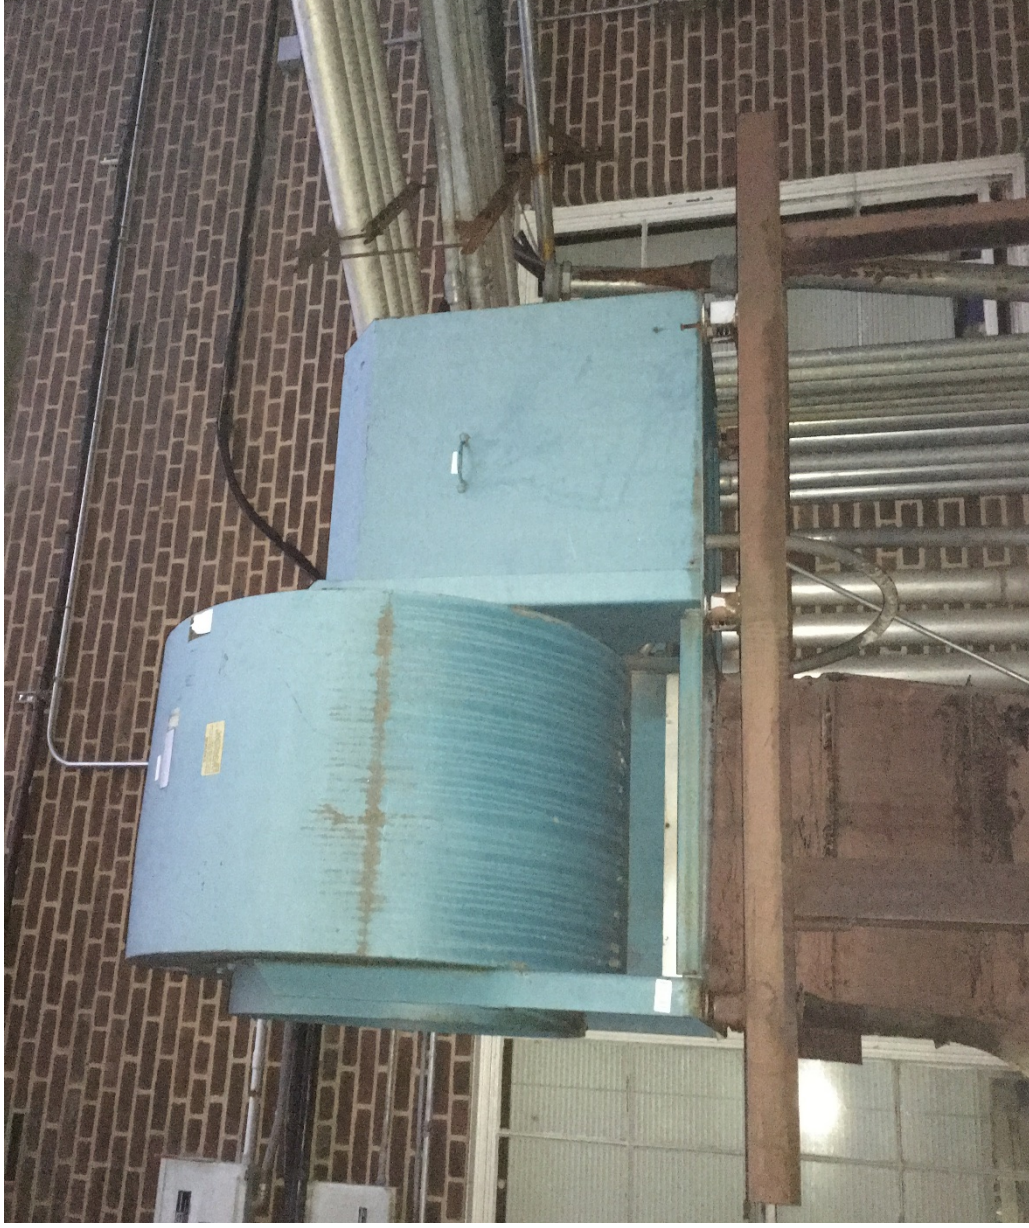
Finding # 9 Photo. This picture is of the second OA fan which most likely causes more issues. It simply dumps unfiltered cold air into the building.

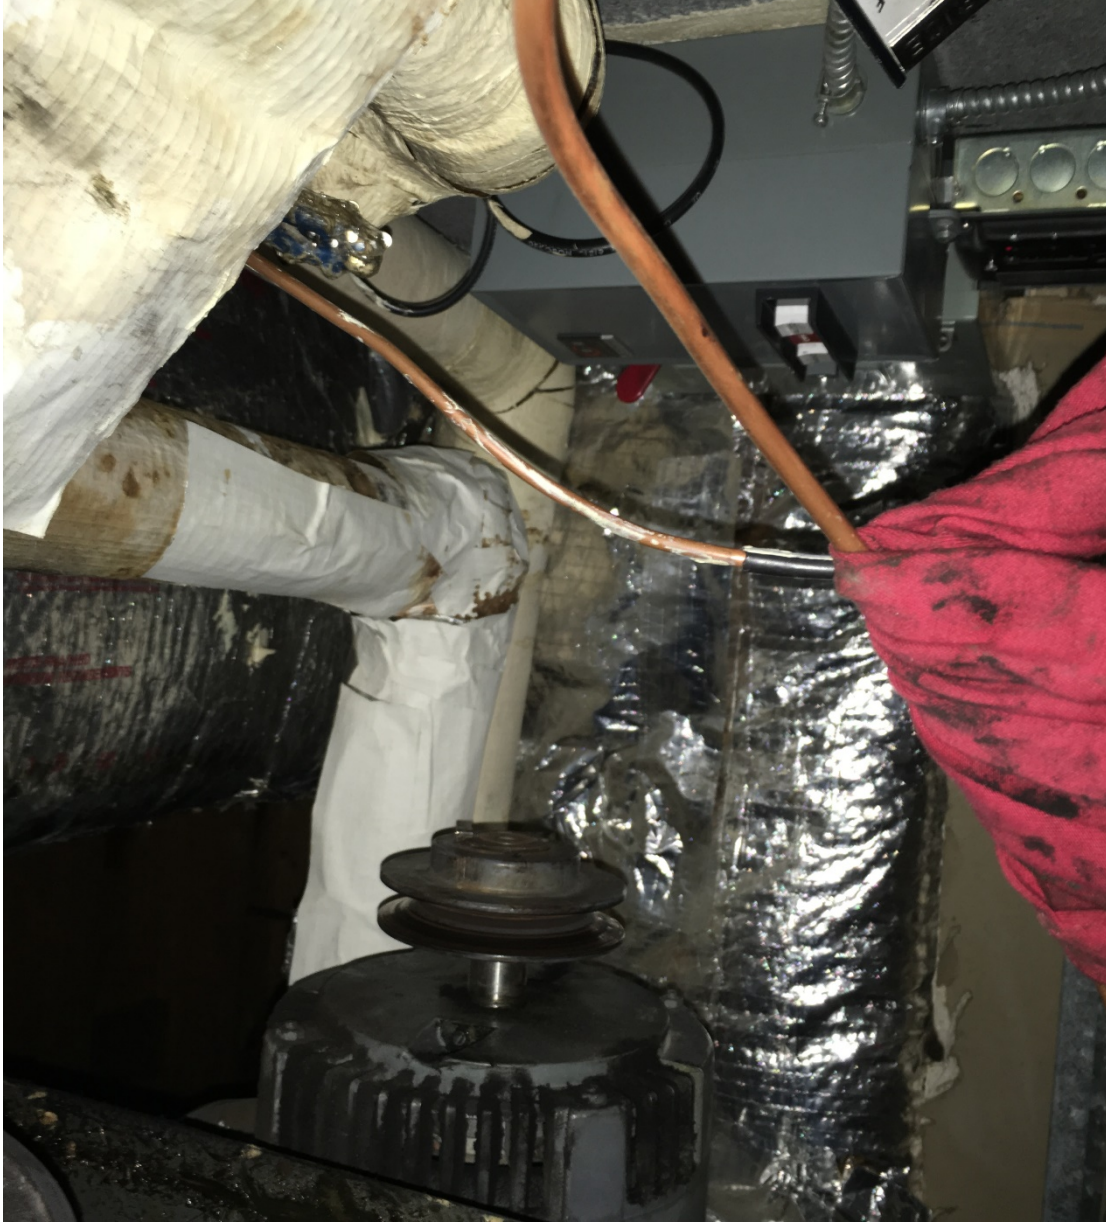
Finding # - 10. There are 20 ceiling hung air handlers which heat and cool the office spaces on the floors. These units are very hard to access for maintenance. There is one unit in the print shop which failed a few years ago and hasn't been repaired because of the problem accessing it. **REVISION – Per DGS the unit has been serviced. Please provide a copy of the work order. That said, as documented by the picture (no belts) the unit remains inoperable.**

Finding # 10 Photo. This picture is of the air handler in the print shop which the fan bearings have failed. It is very hard to access.

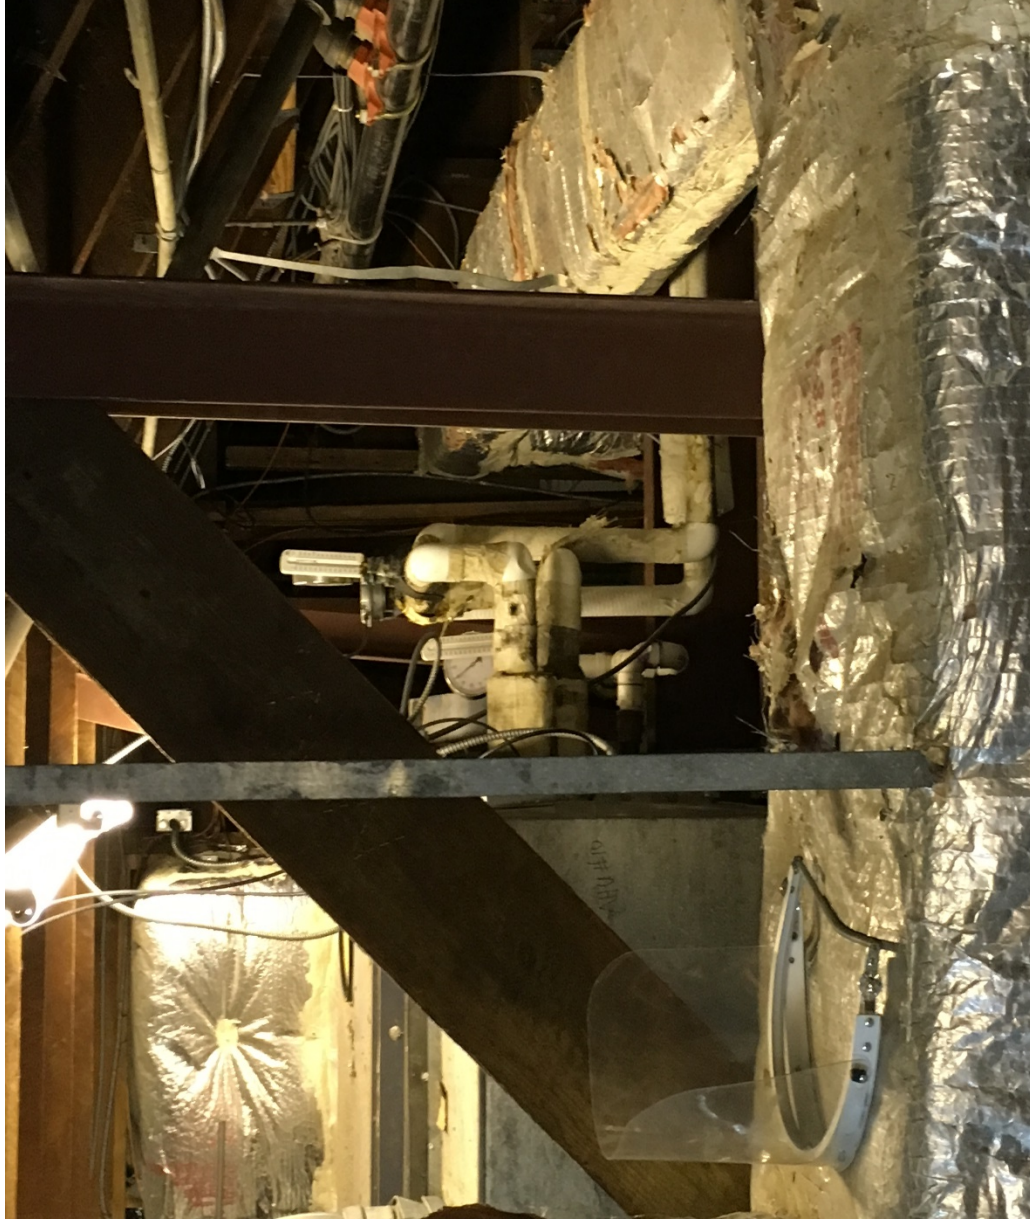
Finding # - 11. There are also 5 air handlers in the building attic. These units do pull outside air through the perimeter wall near the fans. One problem with these units is the condition of the duct work insulation which has failed. This condition will cause condensate leaks into the areas below in summer.

Finding # 11 Photo. This picture is of one of the attic air handlers with damaged duct work insulation. This will cause condensate leaks in summer.

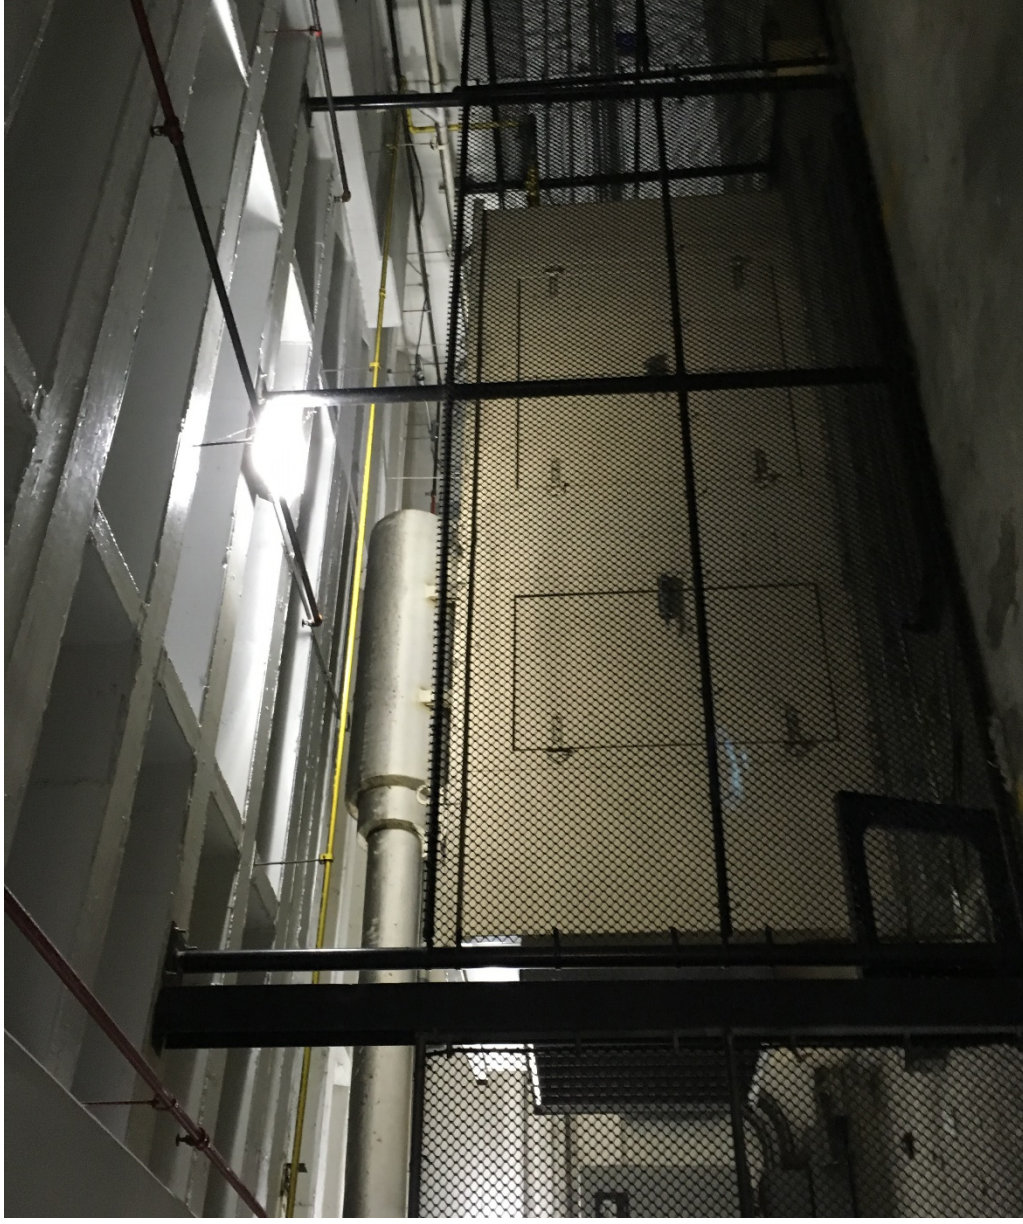
Finding # 16 Photo. A2 recommends that the emergency generator transfer switches be transferred and tested under load at least every 2 months. This picture is of the emergency generator.

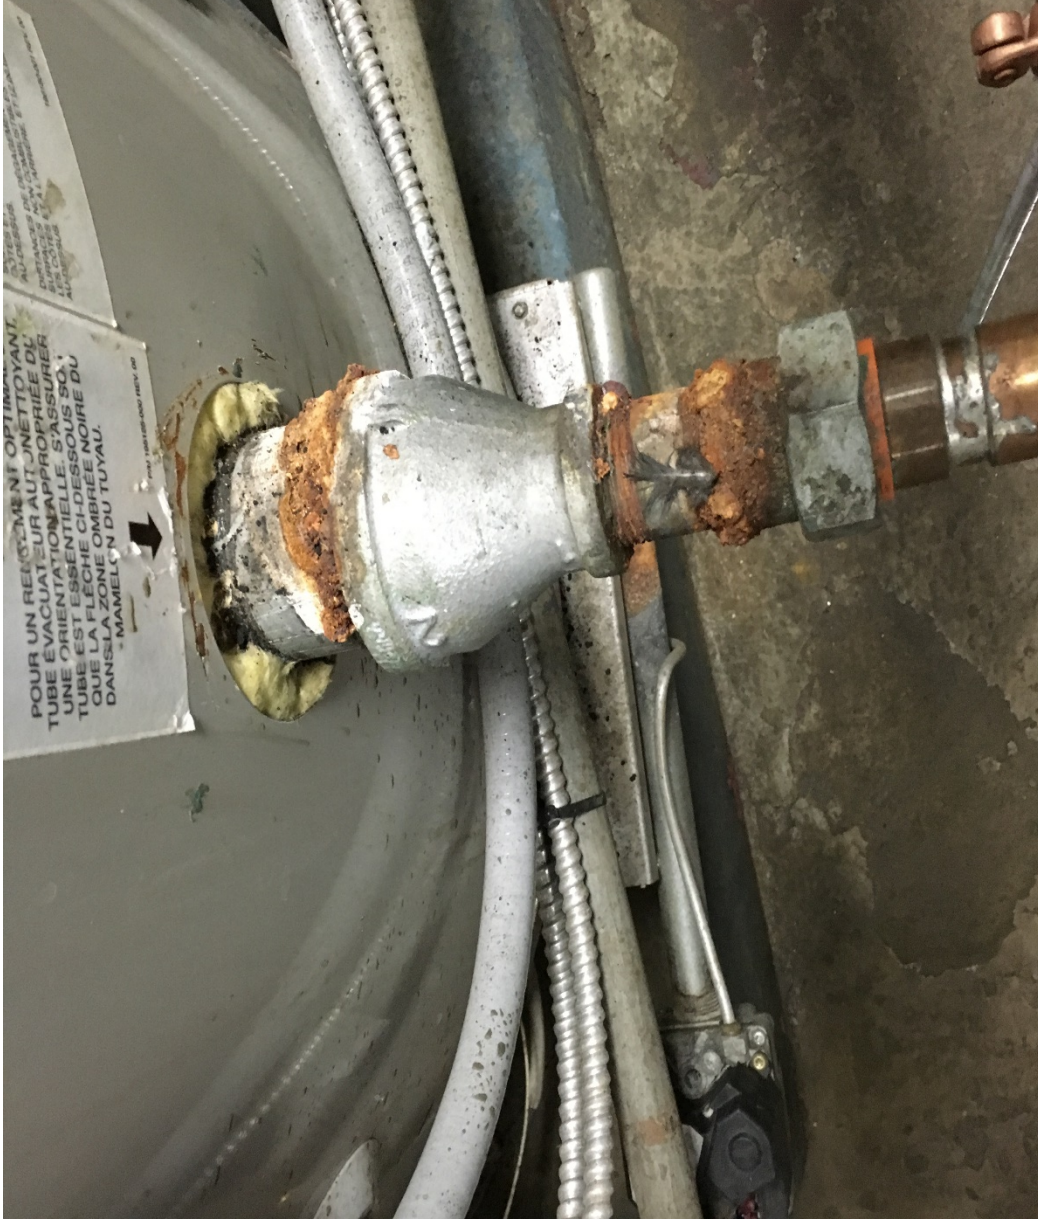
Finding # - 18. The cold water makeup line feeding the domestic hot water heater in the boiler room should be repaired before it fails. This line was installed using dissimilar metals allowing electrolysis to occur. The fittings will need to be replaced with die-electric components to eliminate this dissimilar metal corrosion.

Finding # 18 Photo. This picture notes the corroded inlet water fittings to the domestic water heater in the boiler room.

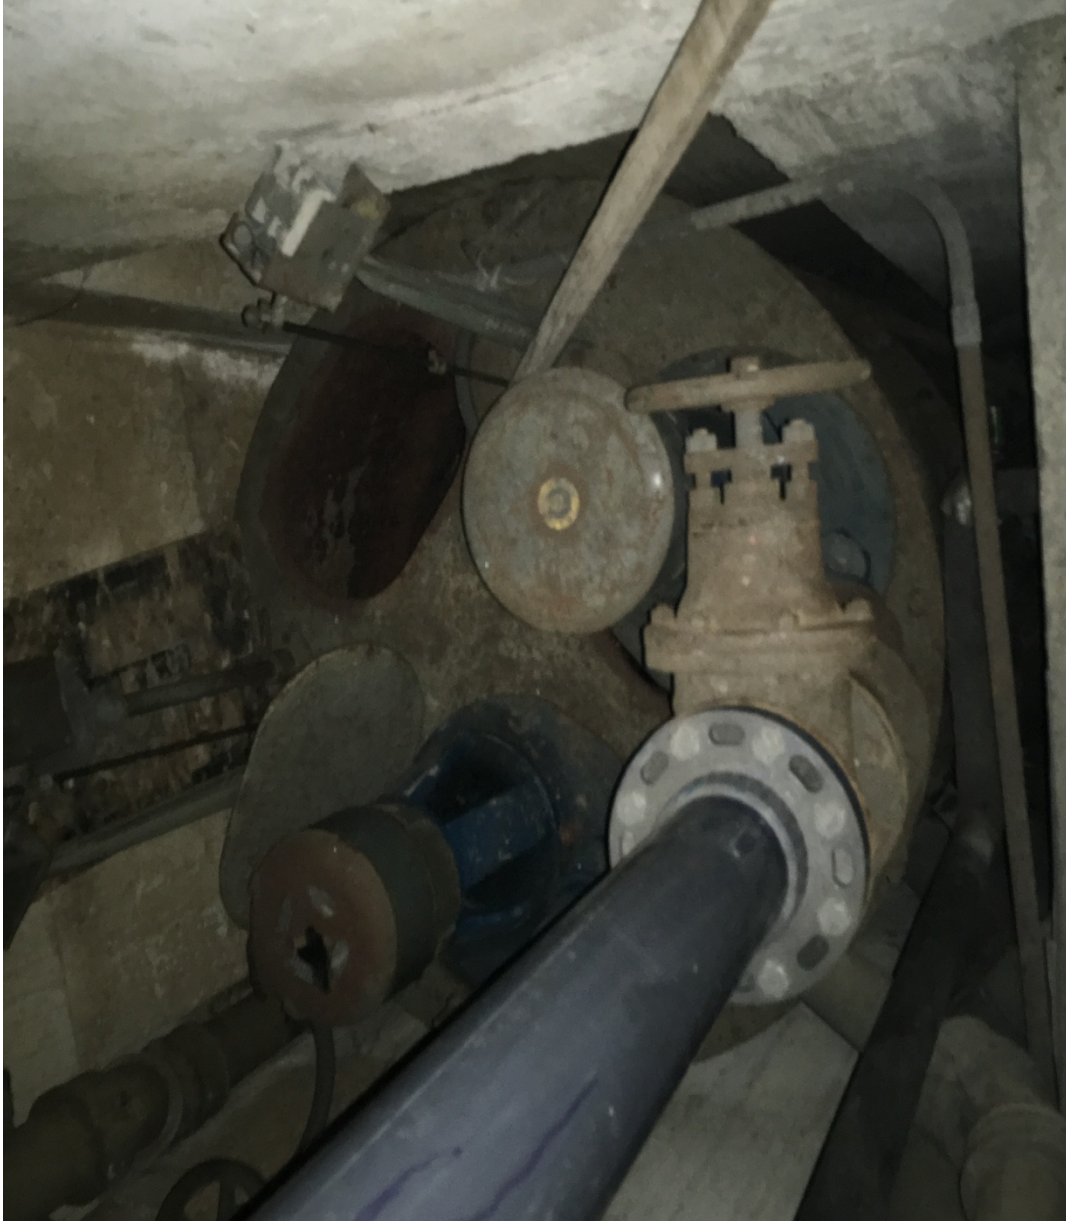
Finding # - 20. There is another set of old shaft driven sump pumps in the lower garage pit which are still operational. It would be wise to consider replacing these pumps. They should be replaced with submersible style pumps which will provide twenty years of service with little maintenance. The ground water sump pumps in the garage are critical and are the only way to get water out of the garage.

Finding # 20 Photo. This picture notes the old shaft driven sump pumps which are noisy. If they fail the garage could flood.

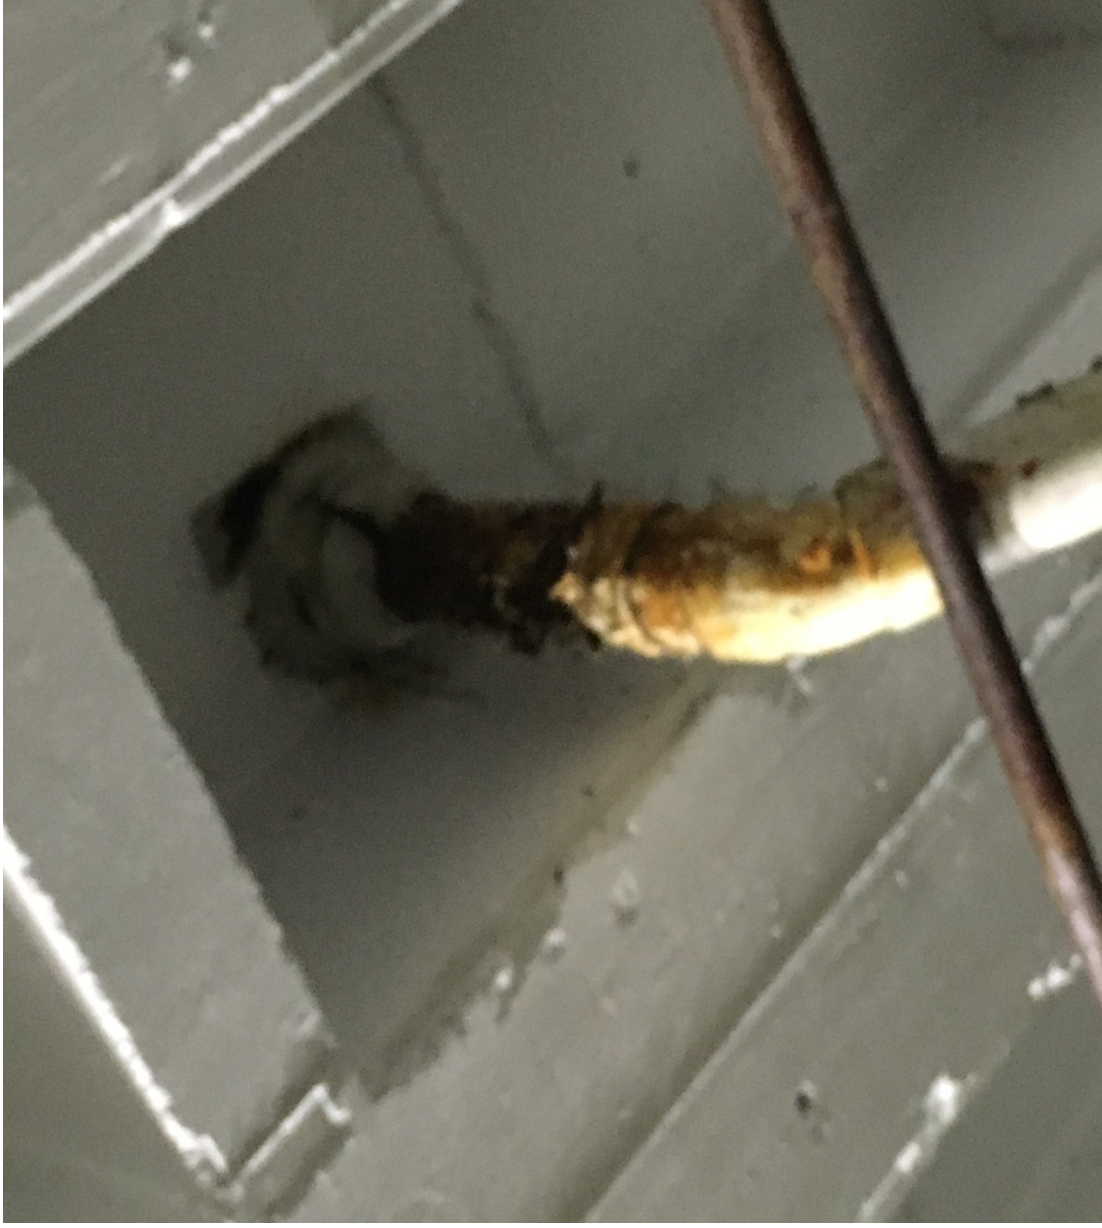
Finding # 23 Photo. This picture is of one planter drain which is leaking into the garage.

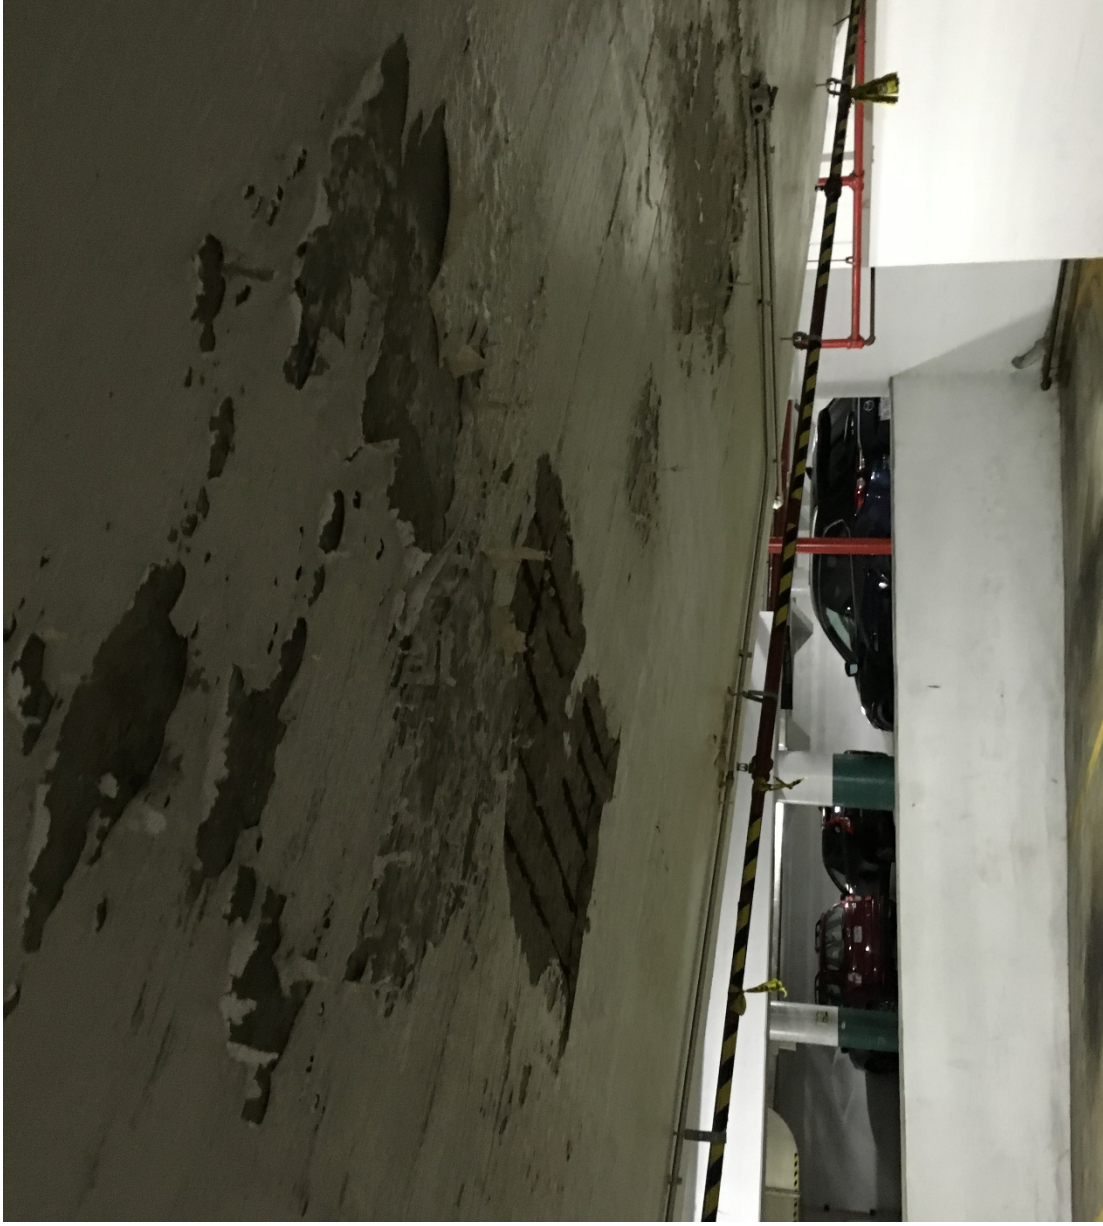
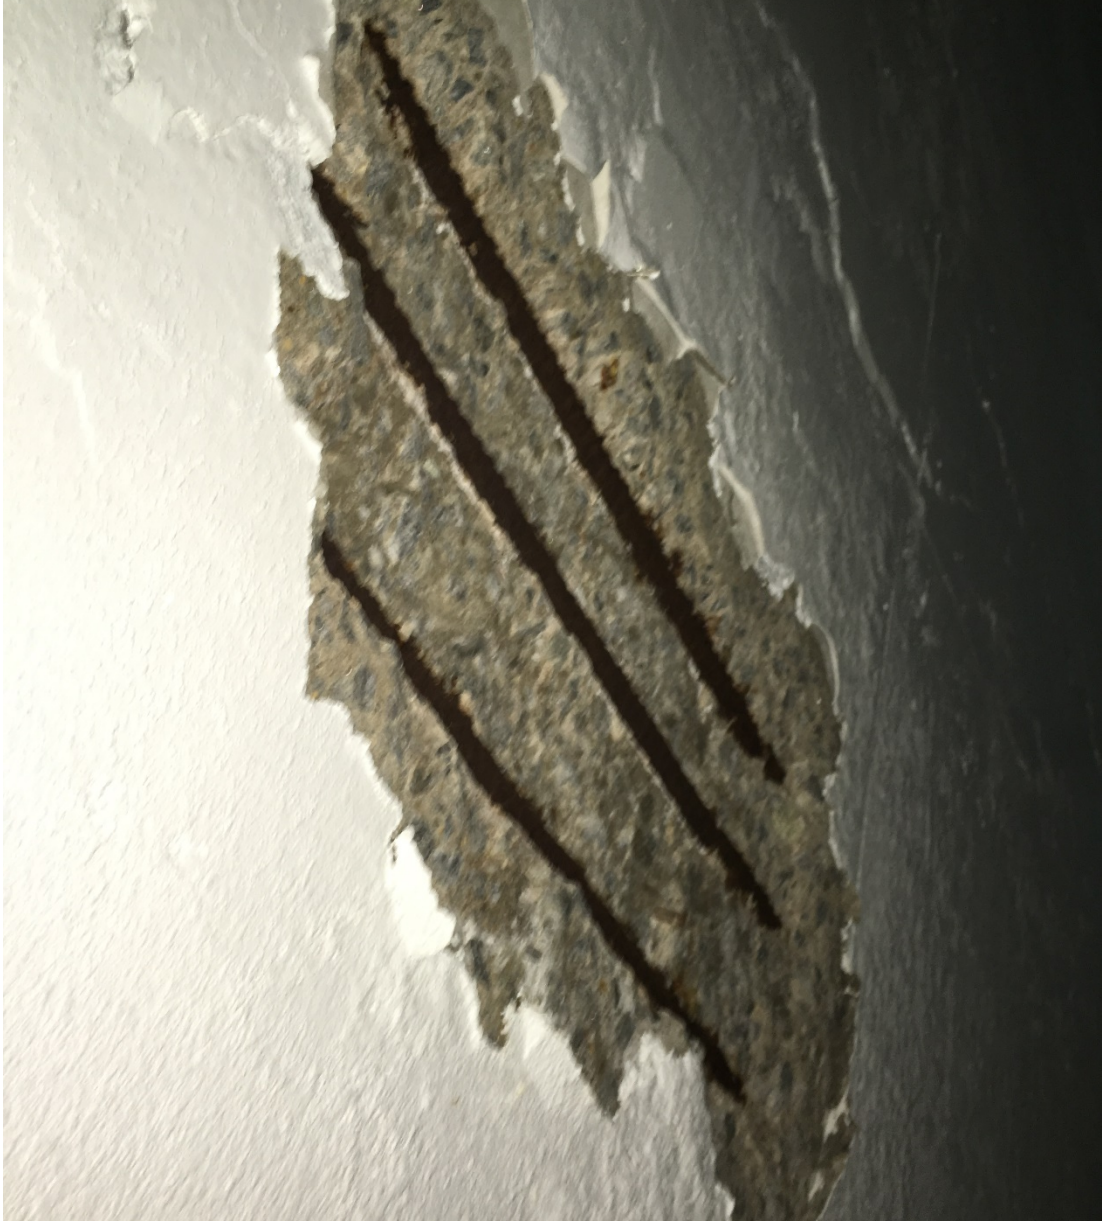
Finding # 24 Photo. This picture is one example of structural damage in the garage from water infiltration.

Finding # 24 Photos Continued. This picture is another example of structural damage in the garage.

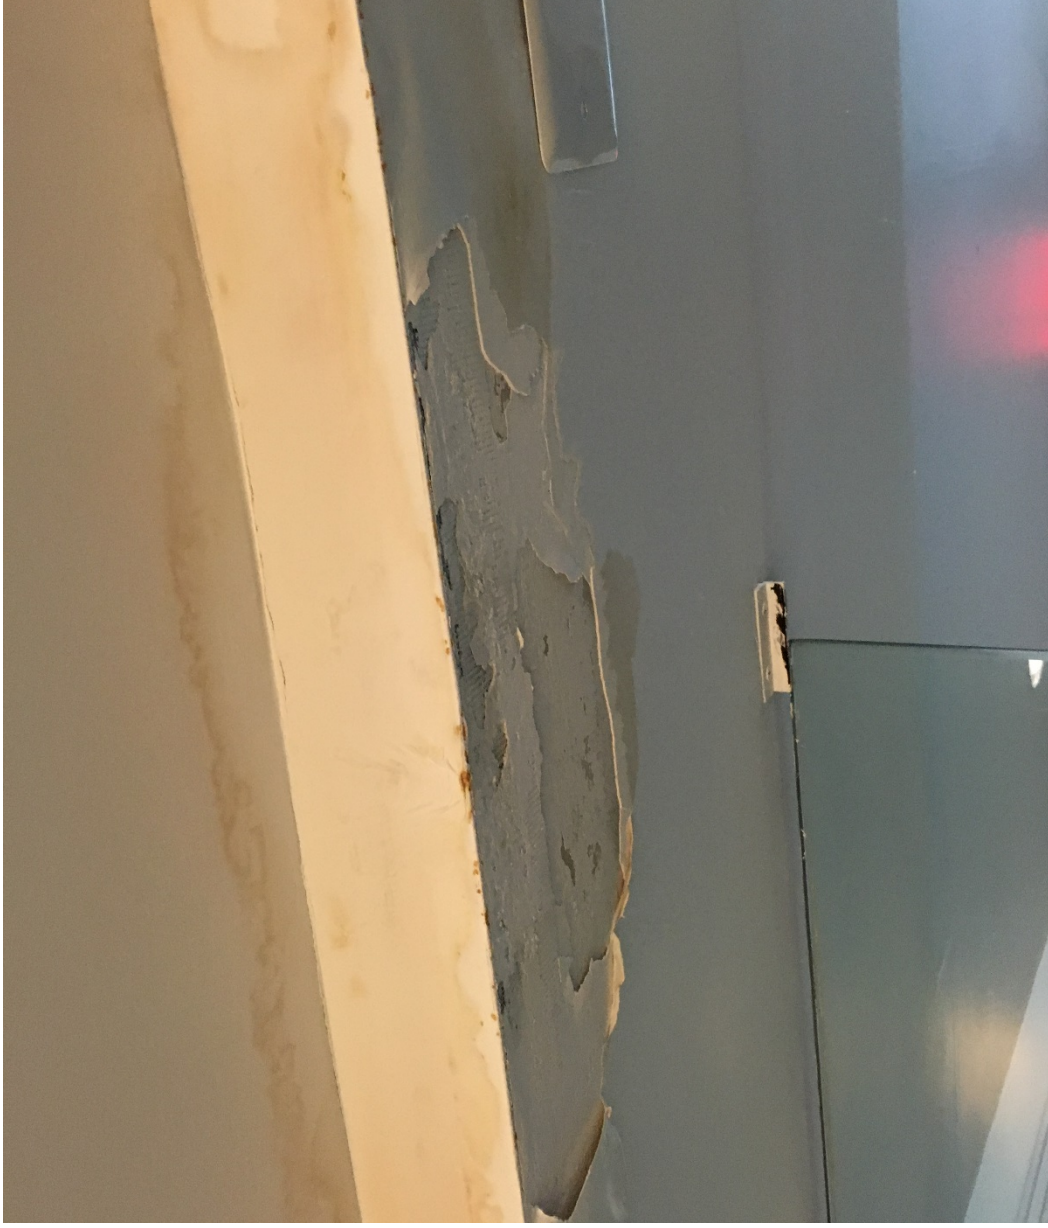
Finding # 26 Photo. This picture notes the water damaged dry wall bulk head outside room 3230. This is from a roof leak.
