EXHIBITS

EXHIBIT 1:

JOINT TASK FORCE & SUBCOMMITTEE MEETINGS

A2 Services, Inc. Facility Survey of City of Alexandria - City Hall

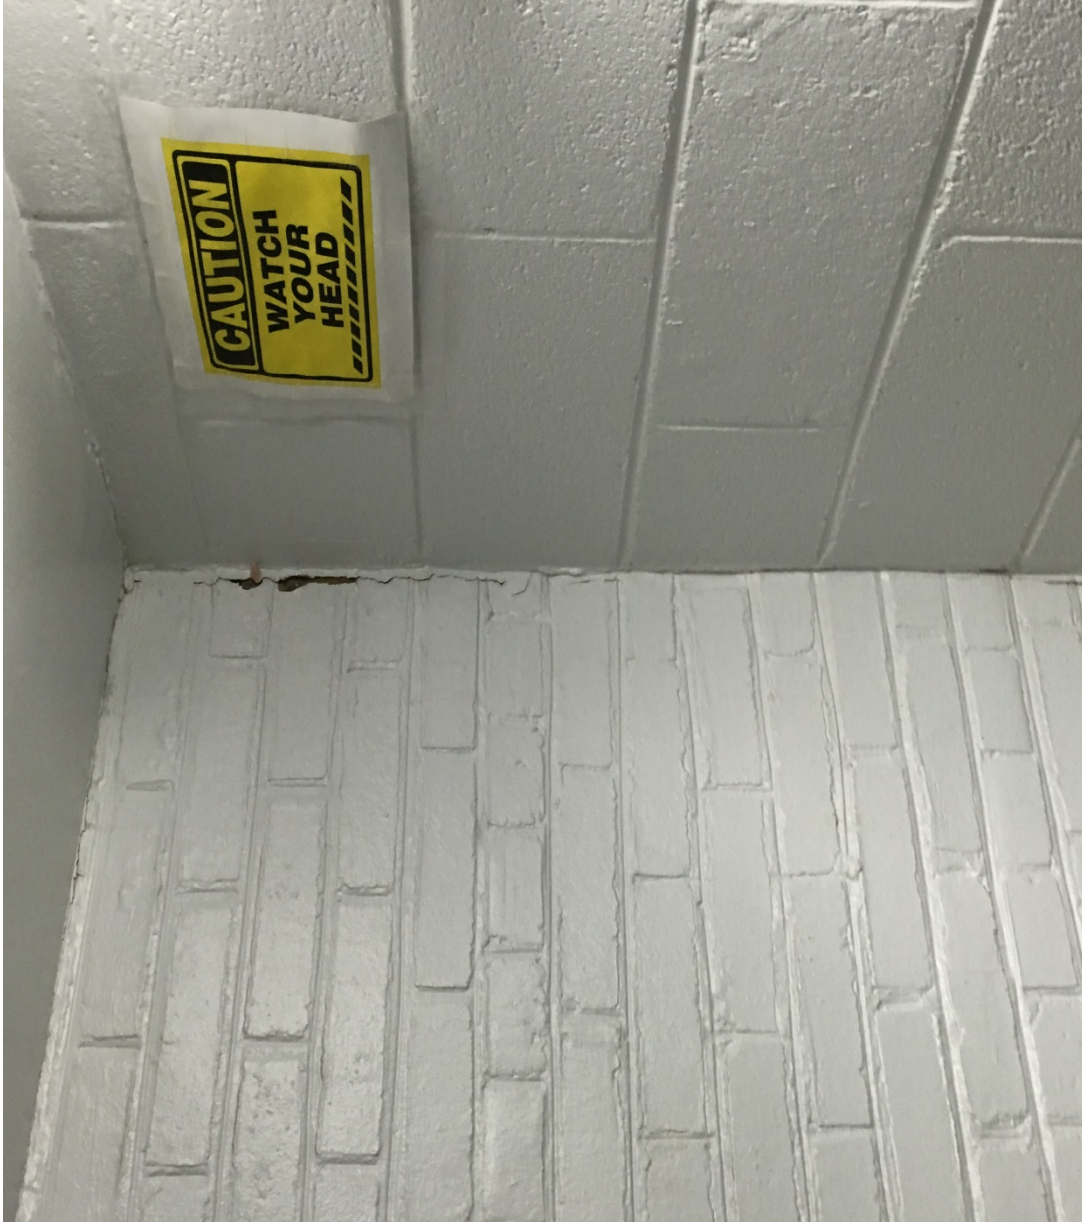
Finding # 27 Photo. This picture notes the crack between the block and the brick walls where water is entering stairway #1.

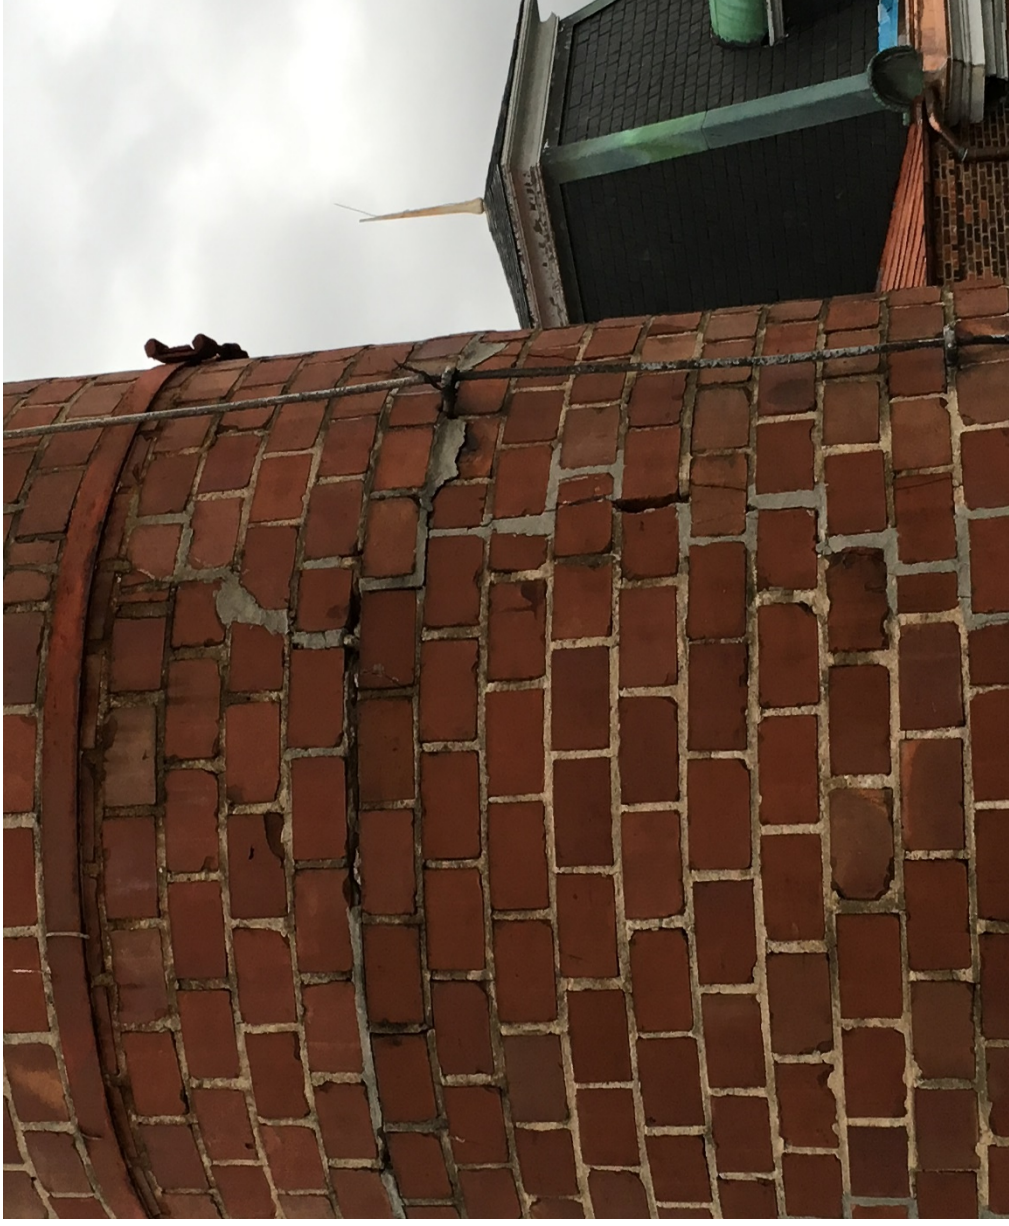
Finding # 28 Photo. This picture notes the structural damage to the brick chimney.

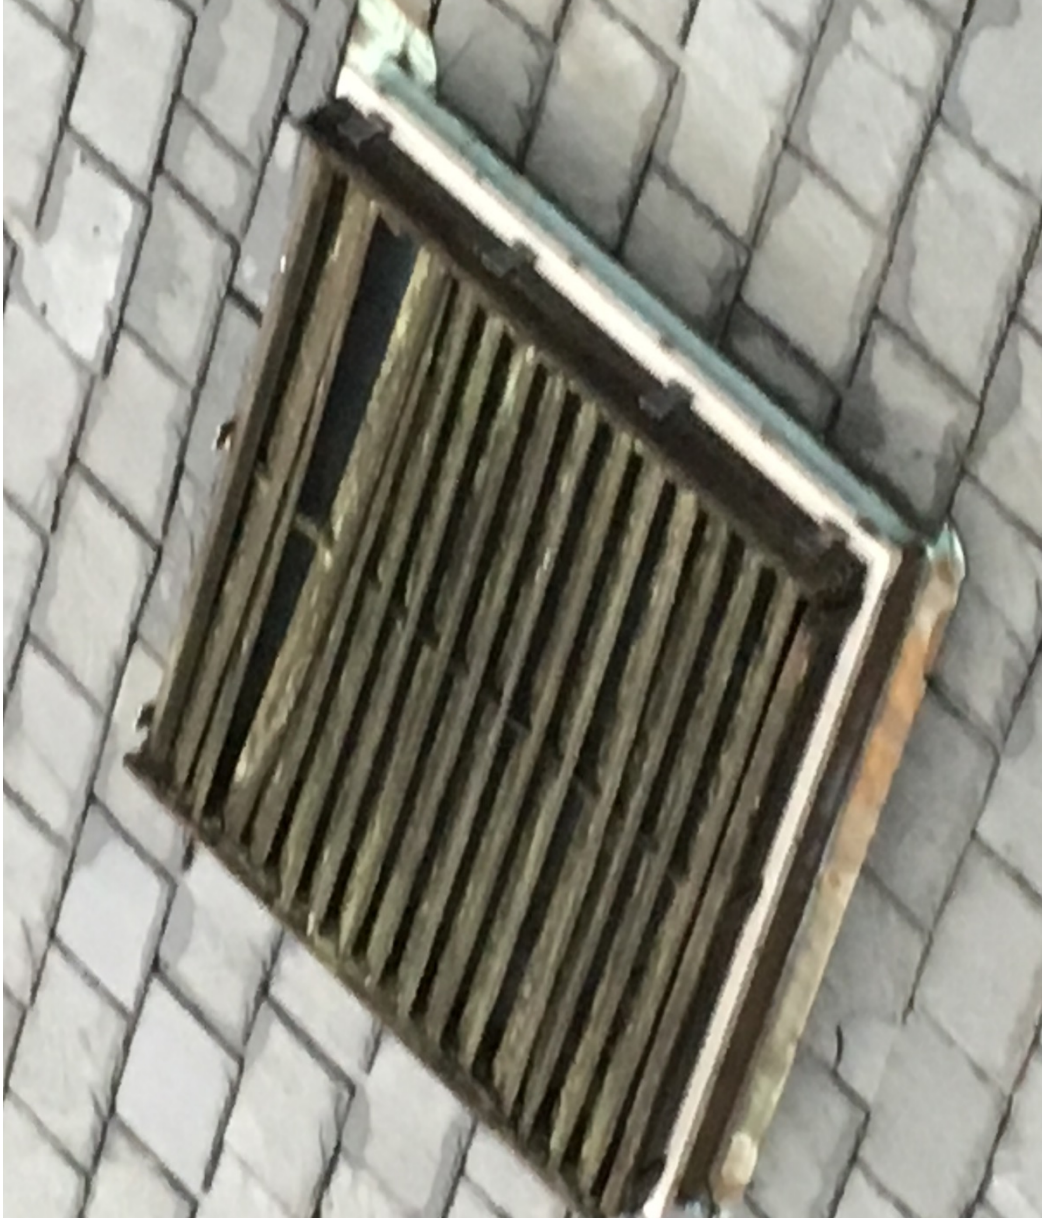
Finding # 29 Photo. The picture notes the rotten wooden louver which will need to be replaced.

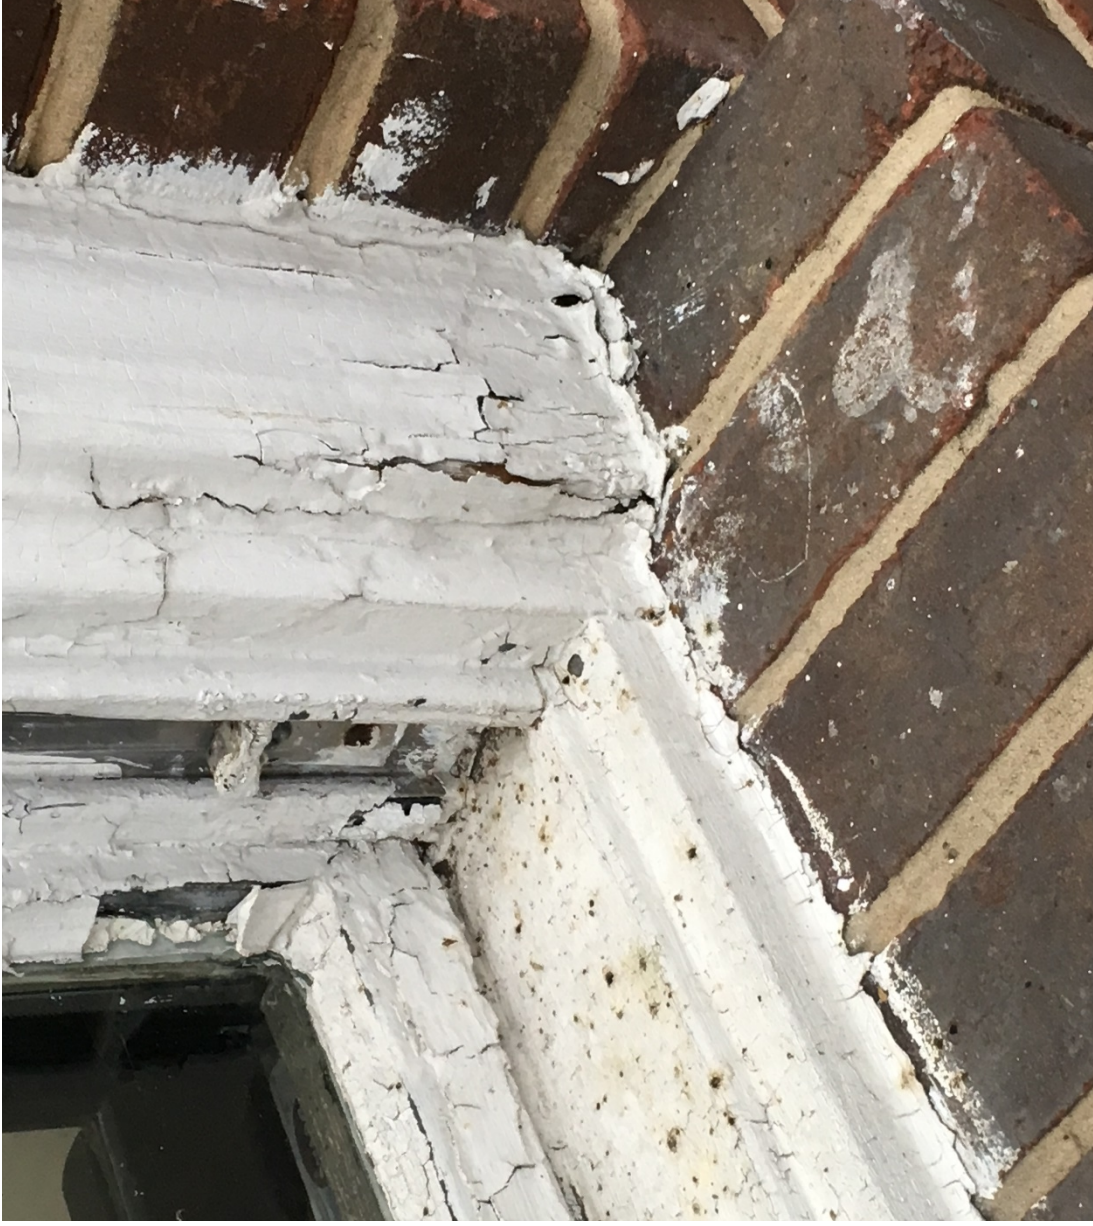
Finding # 30 Photo. This picture is an example of the damaged windows wood work.

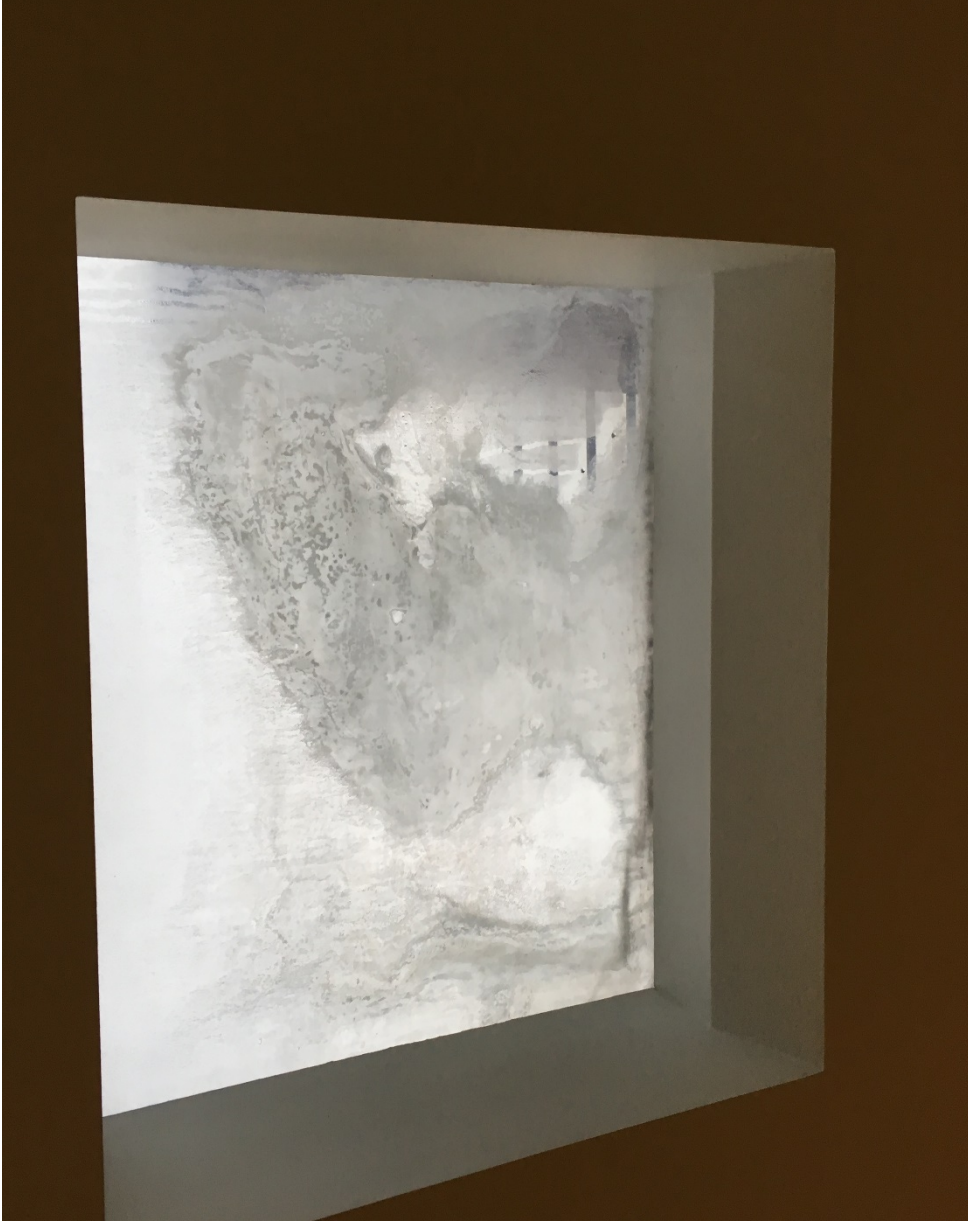
Finding # 31 Photo. This picture is one of the leaking skylights on the 5th floor.

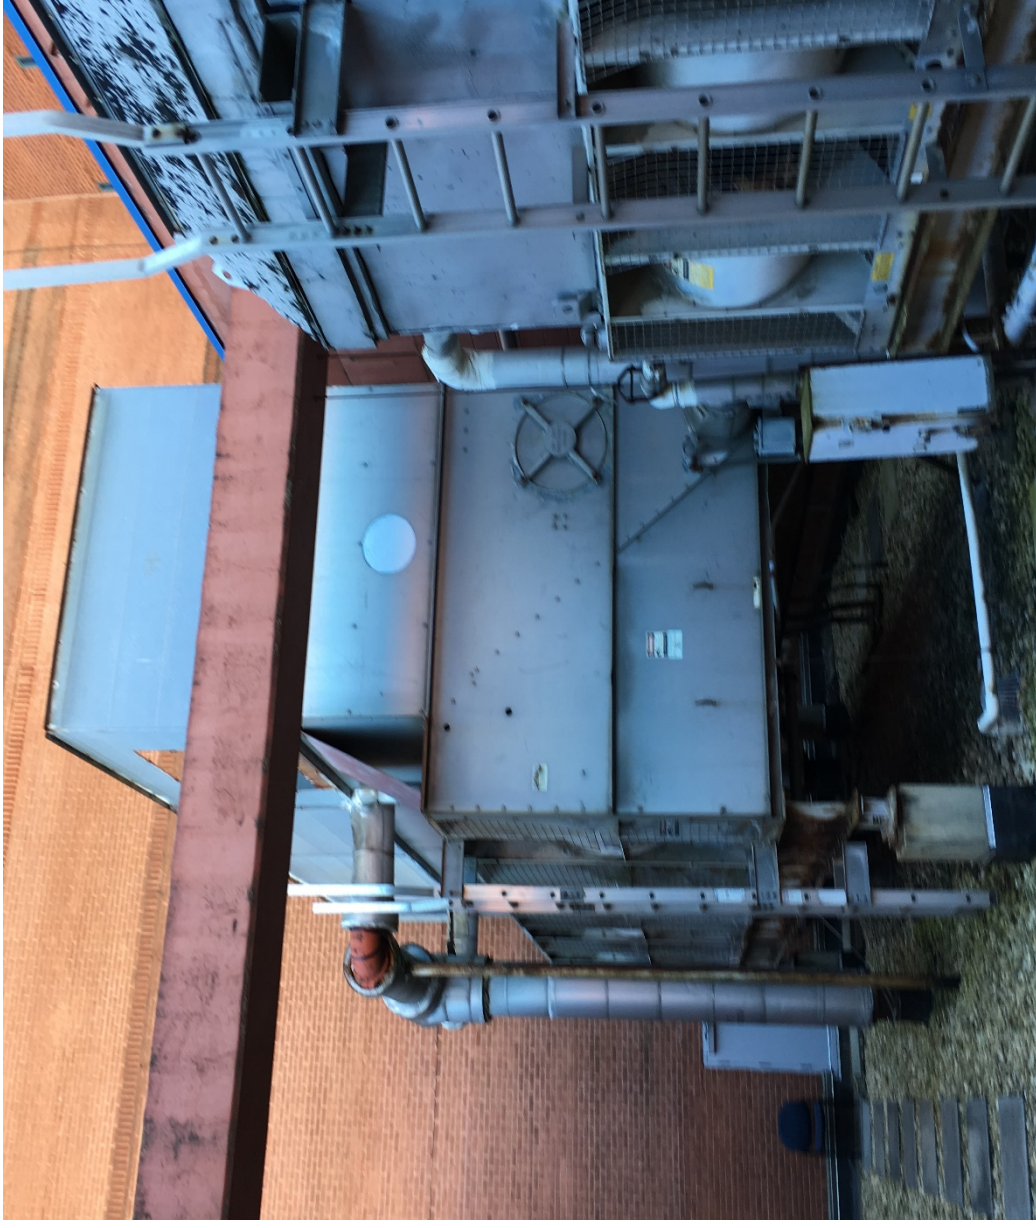
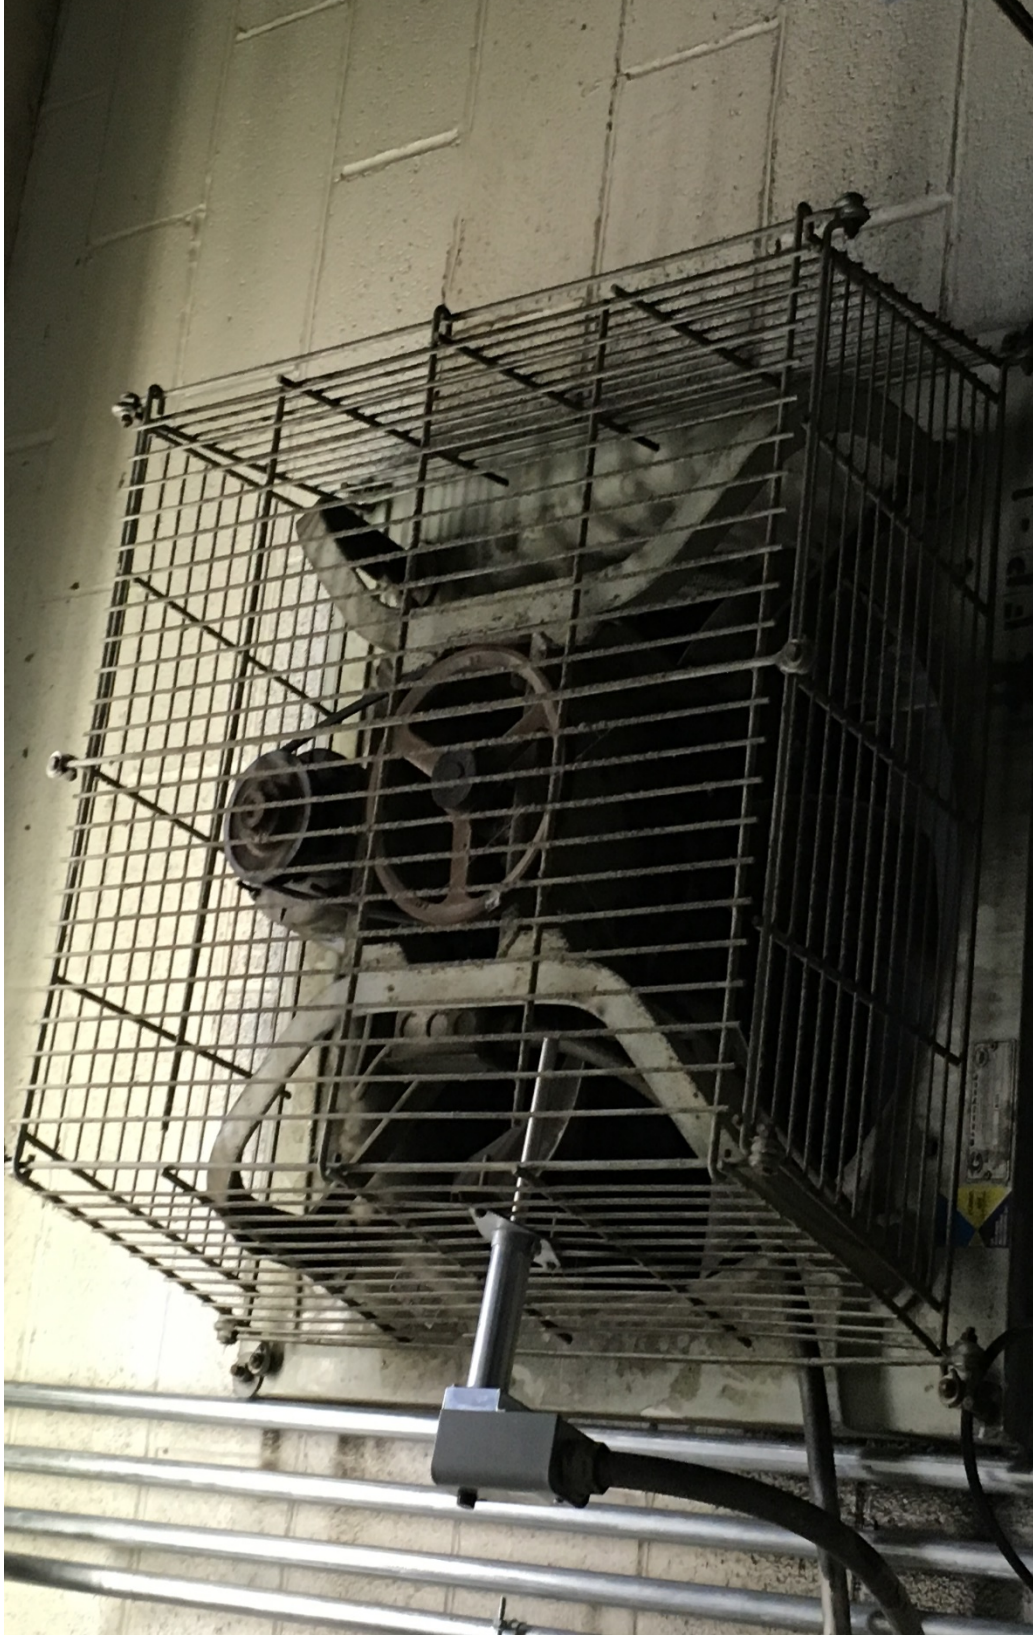
Finding # - 3 Equipment abandoned in place. This picture is of an abandoned in place cooling tower on the roof.

Finding # - 3 Equipment abandoned in place continued. This picture is a wall mounted exhaust fans left in place. There is also a damper assembly related to this fan.

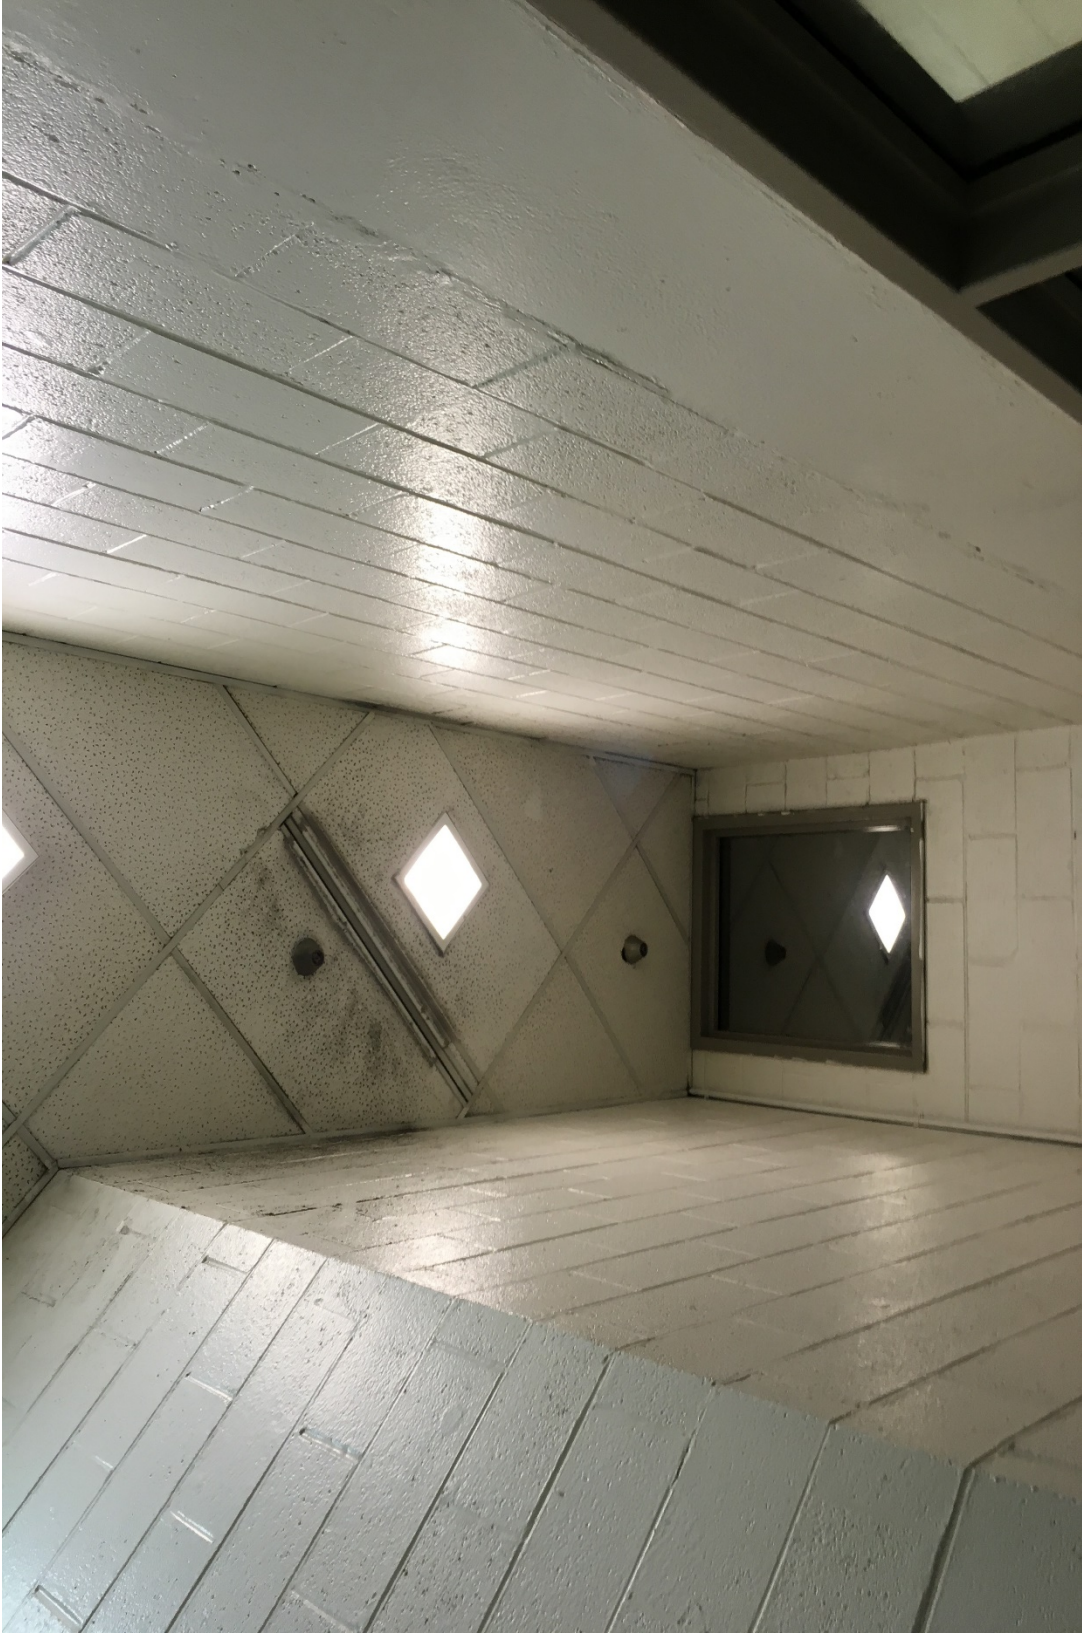
Finding # - 4 This picture is an example of how hard the ceiling diffusers, ceiling tile and light fixtures are to reach.

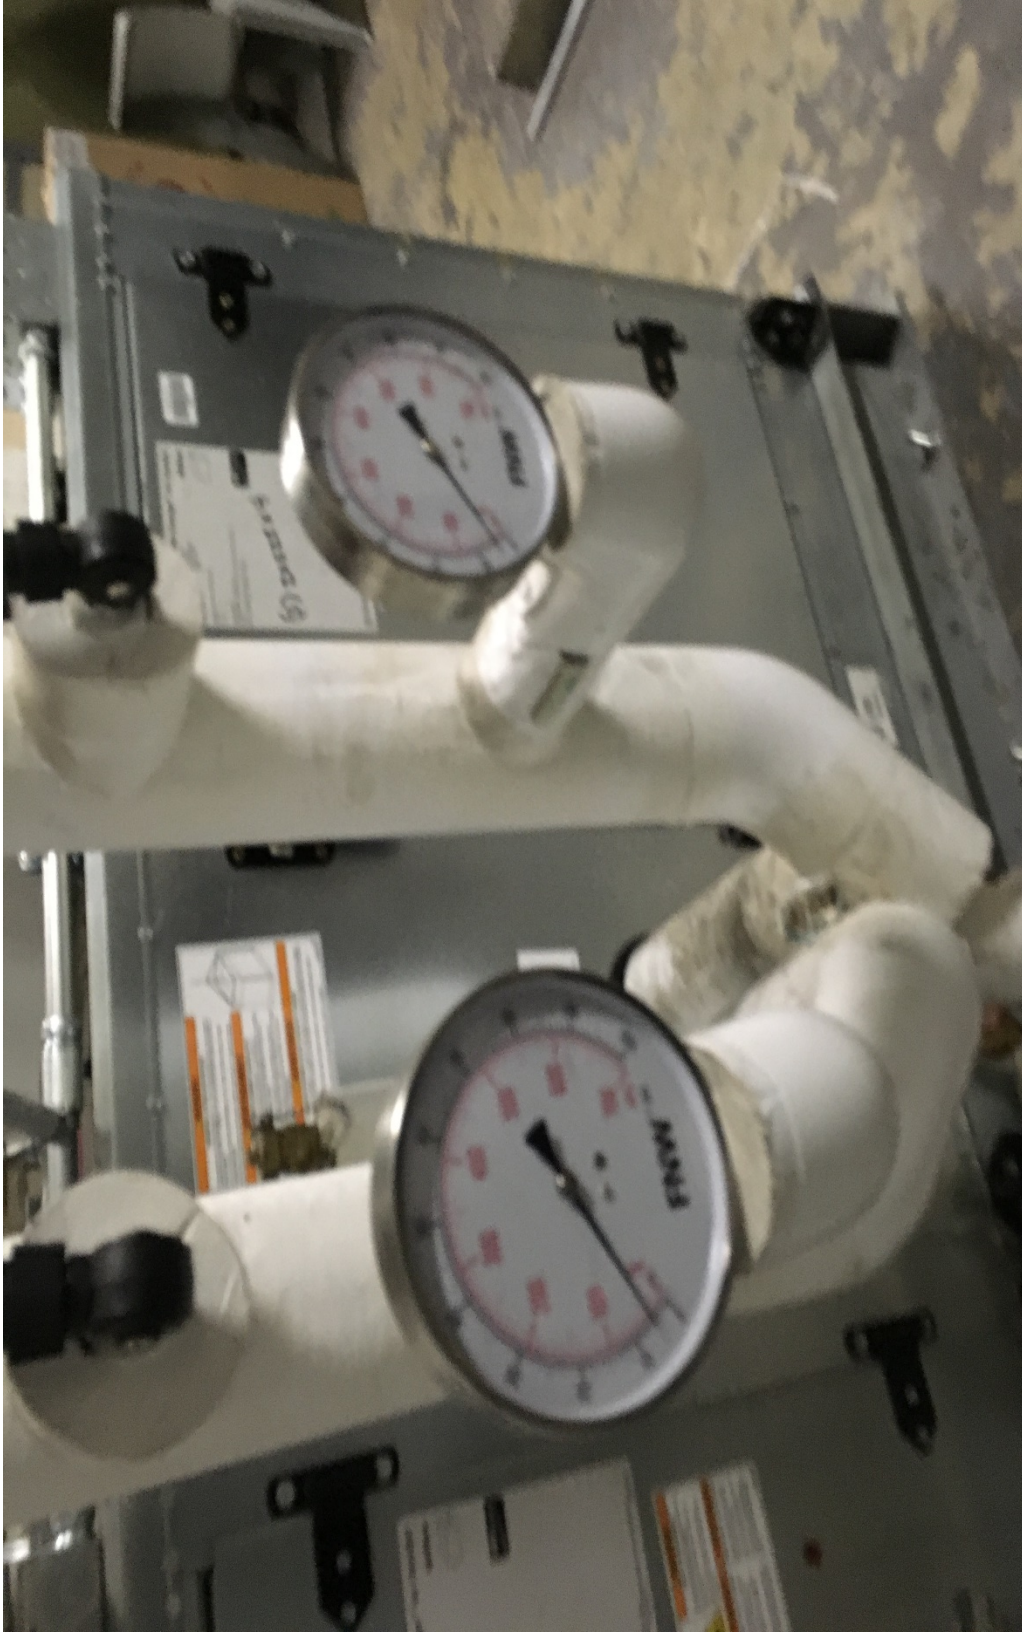
Finding # - 5 This picture notes the chilled water flow problems at the jail penthouse air handlers. Section R-3. The picture while blurred indicates that the pressure gauges are reading 5 PSIG and less. This should be reading up around 20 PSIG.

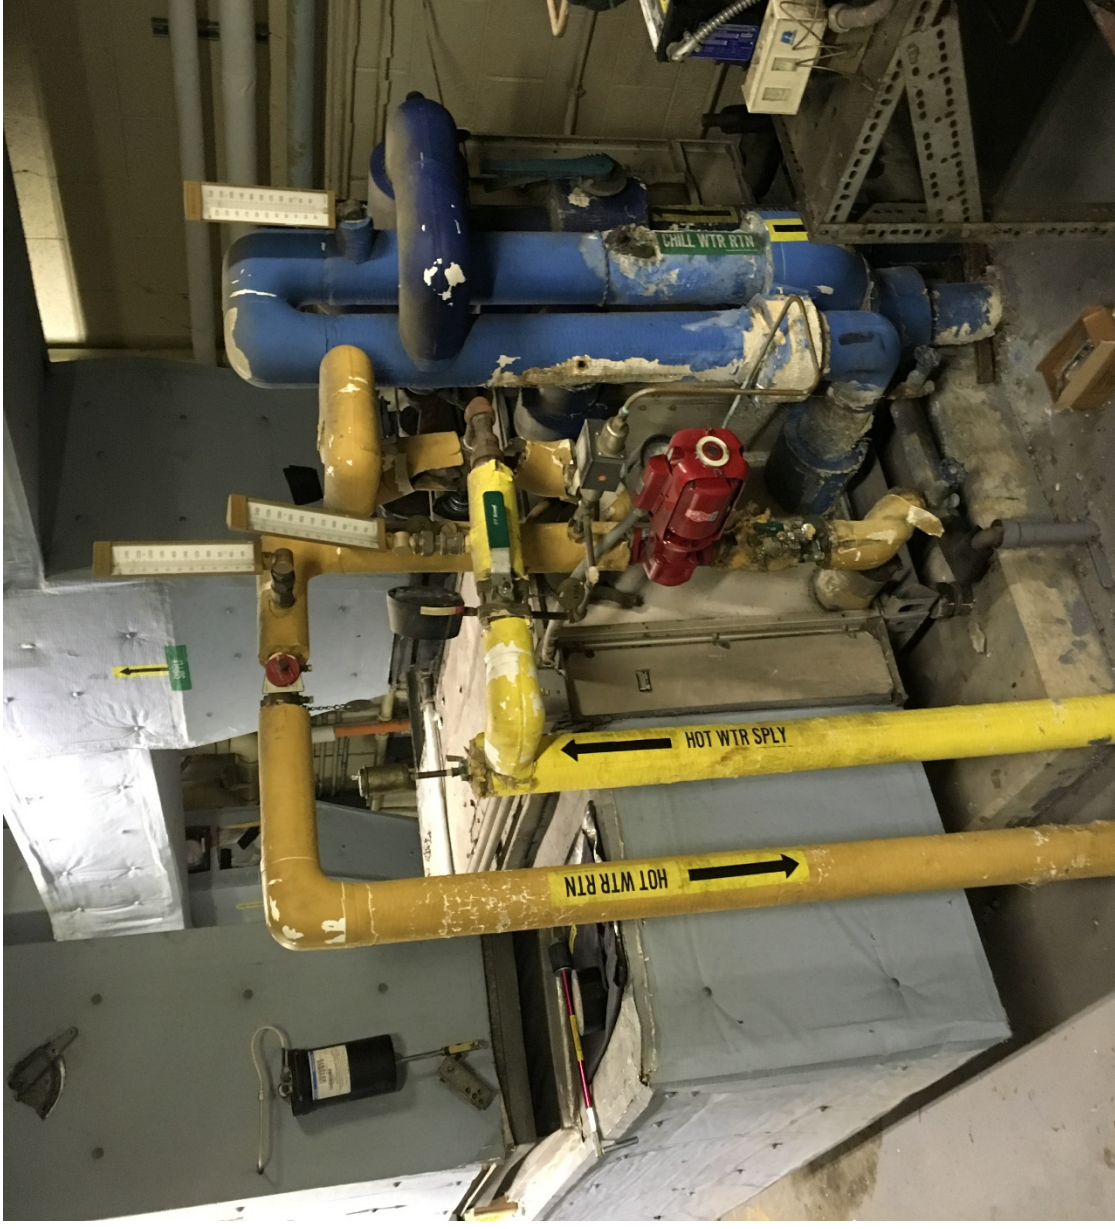
Finding # - 7 Section R-2 air handlers which are in poor condition.

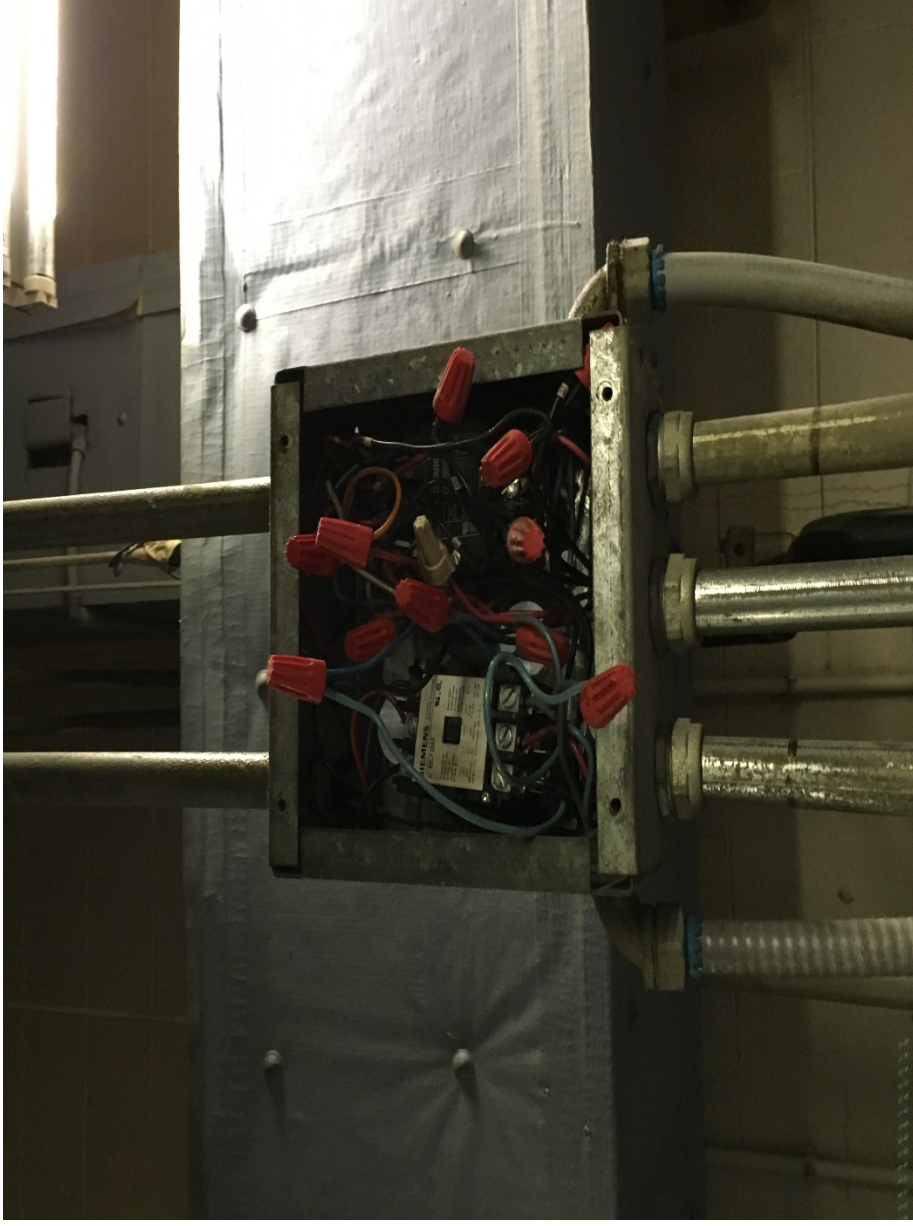
Finding # - 8 This picture is one example of the poor repair work being completed by the contractor maintaining this equipment, (i.e. no landing or mount in the control box).

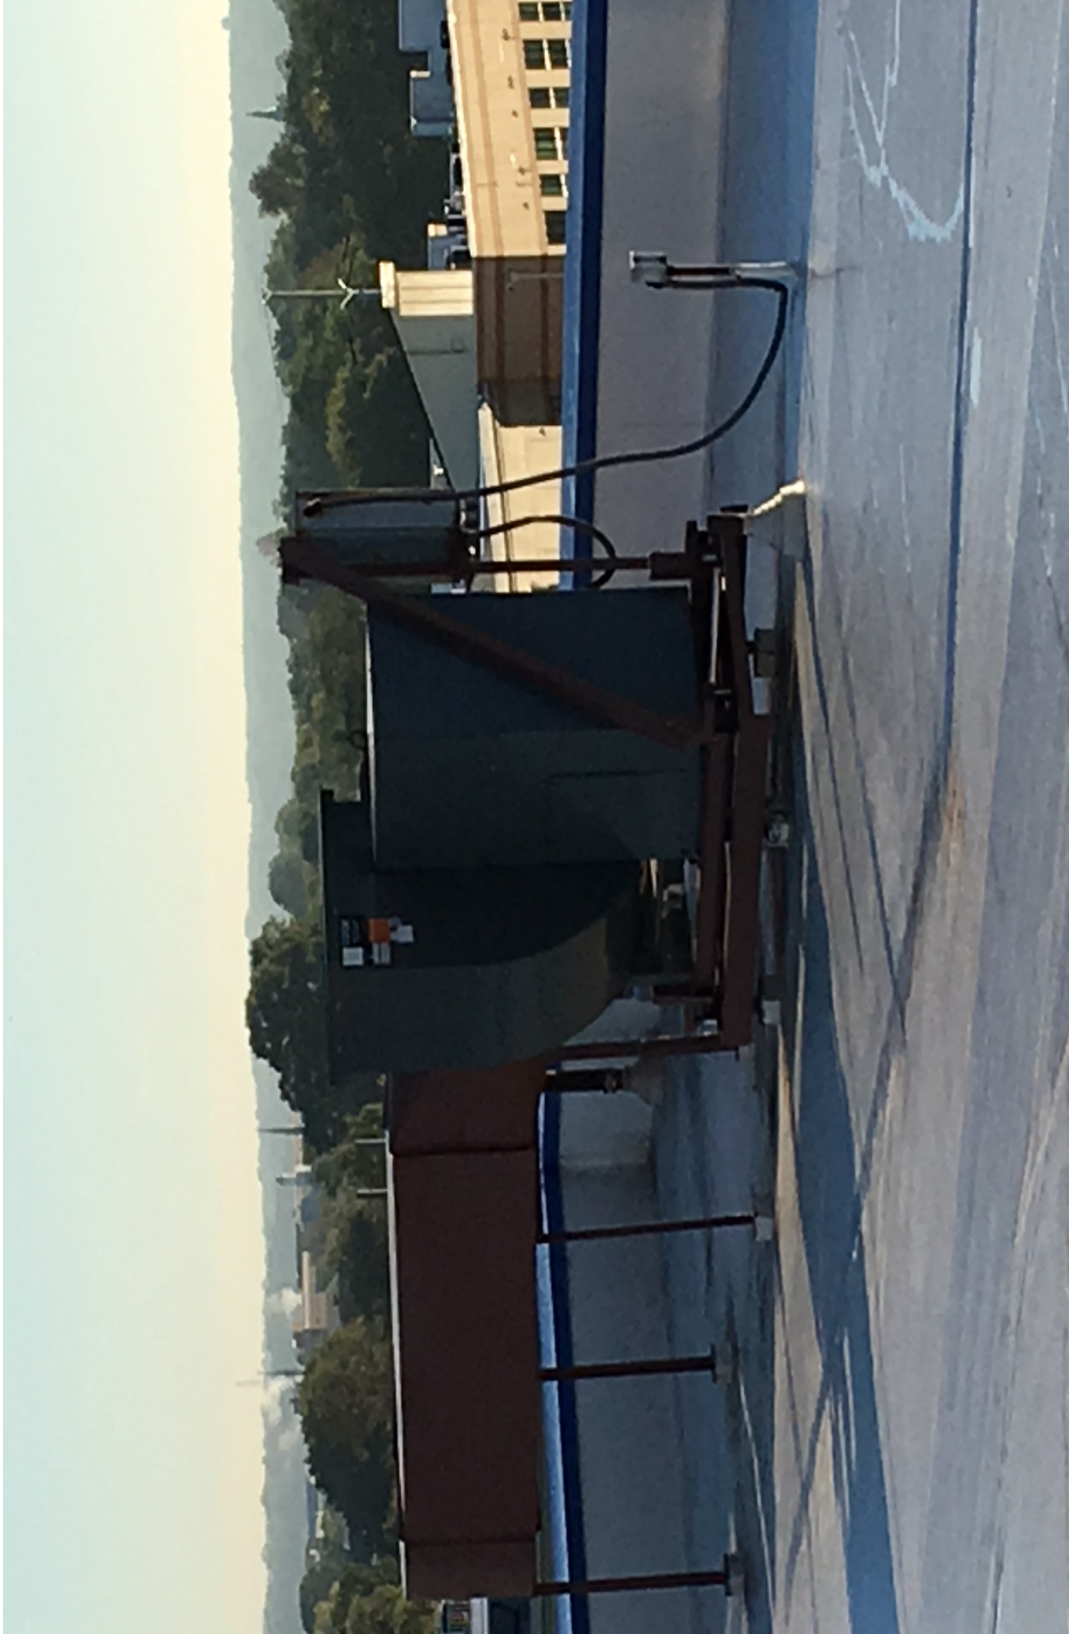
Finding # - 9 This picture is of exhaust fan that serves the kitchen hood system. The belt is loose and needs to be repaired.

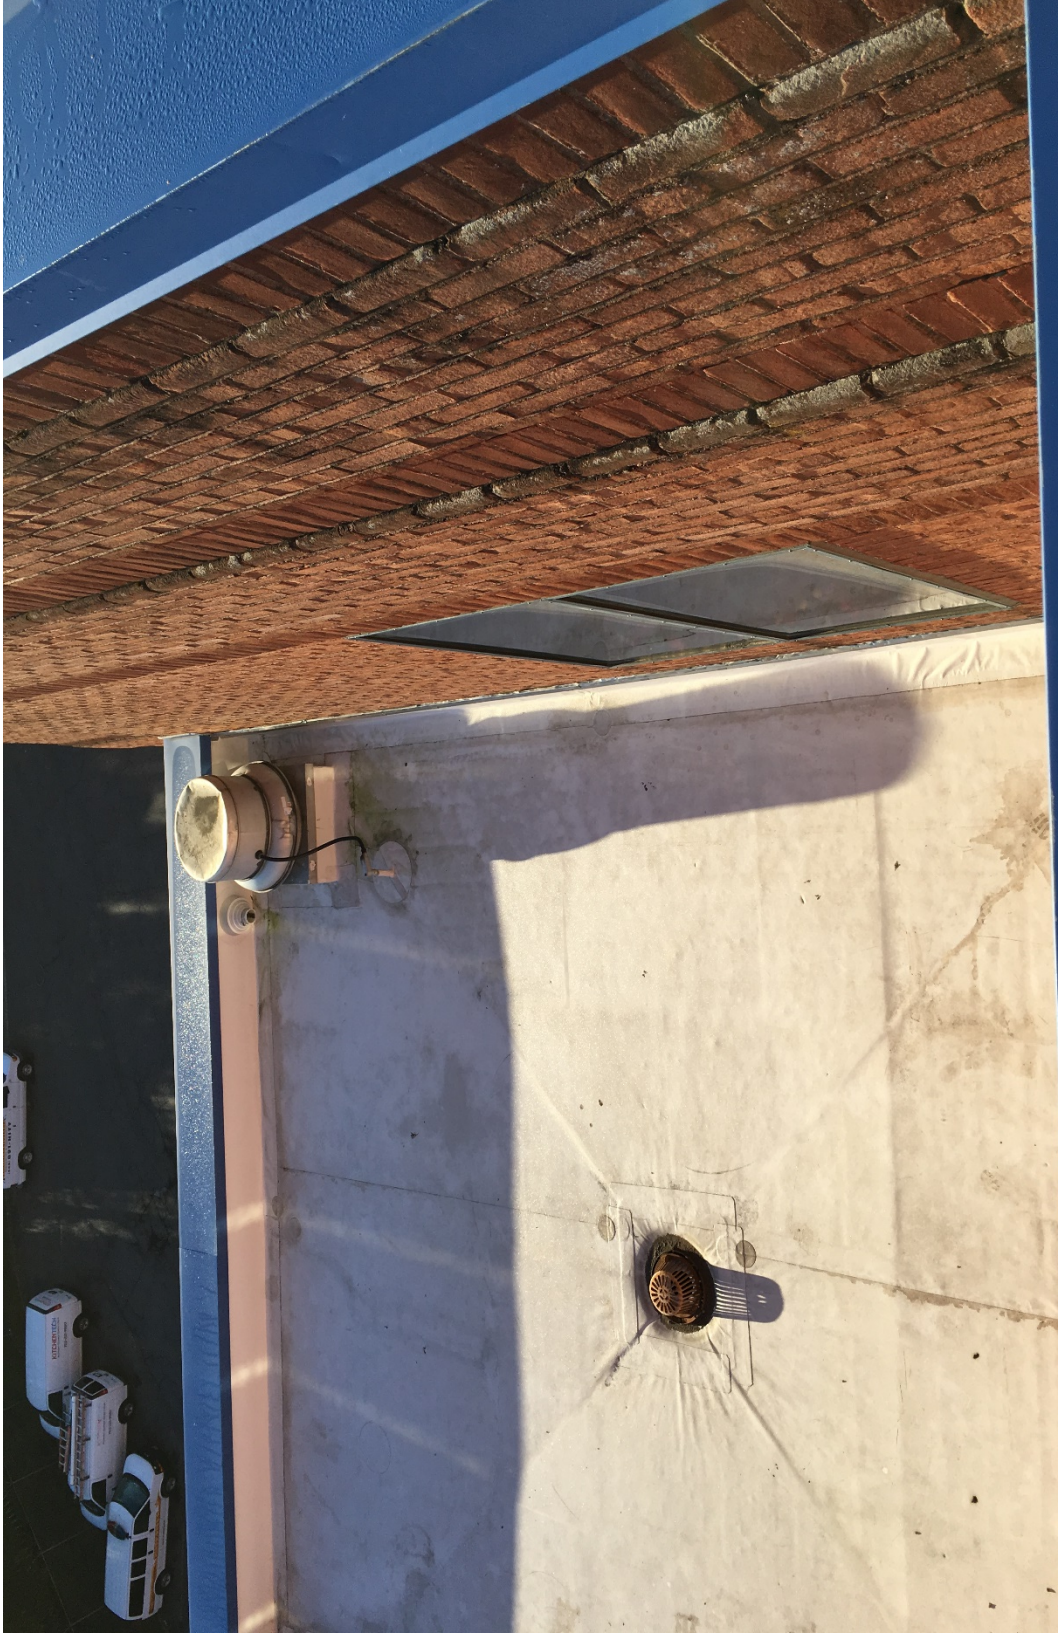
Finding # - 10 This exhaust should have an OSHA approved safety ladder installed to allow safe access to service the fan.

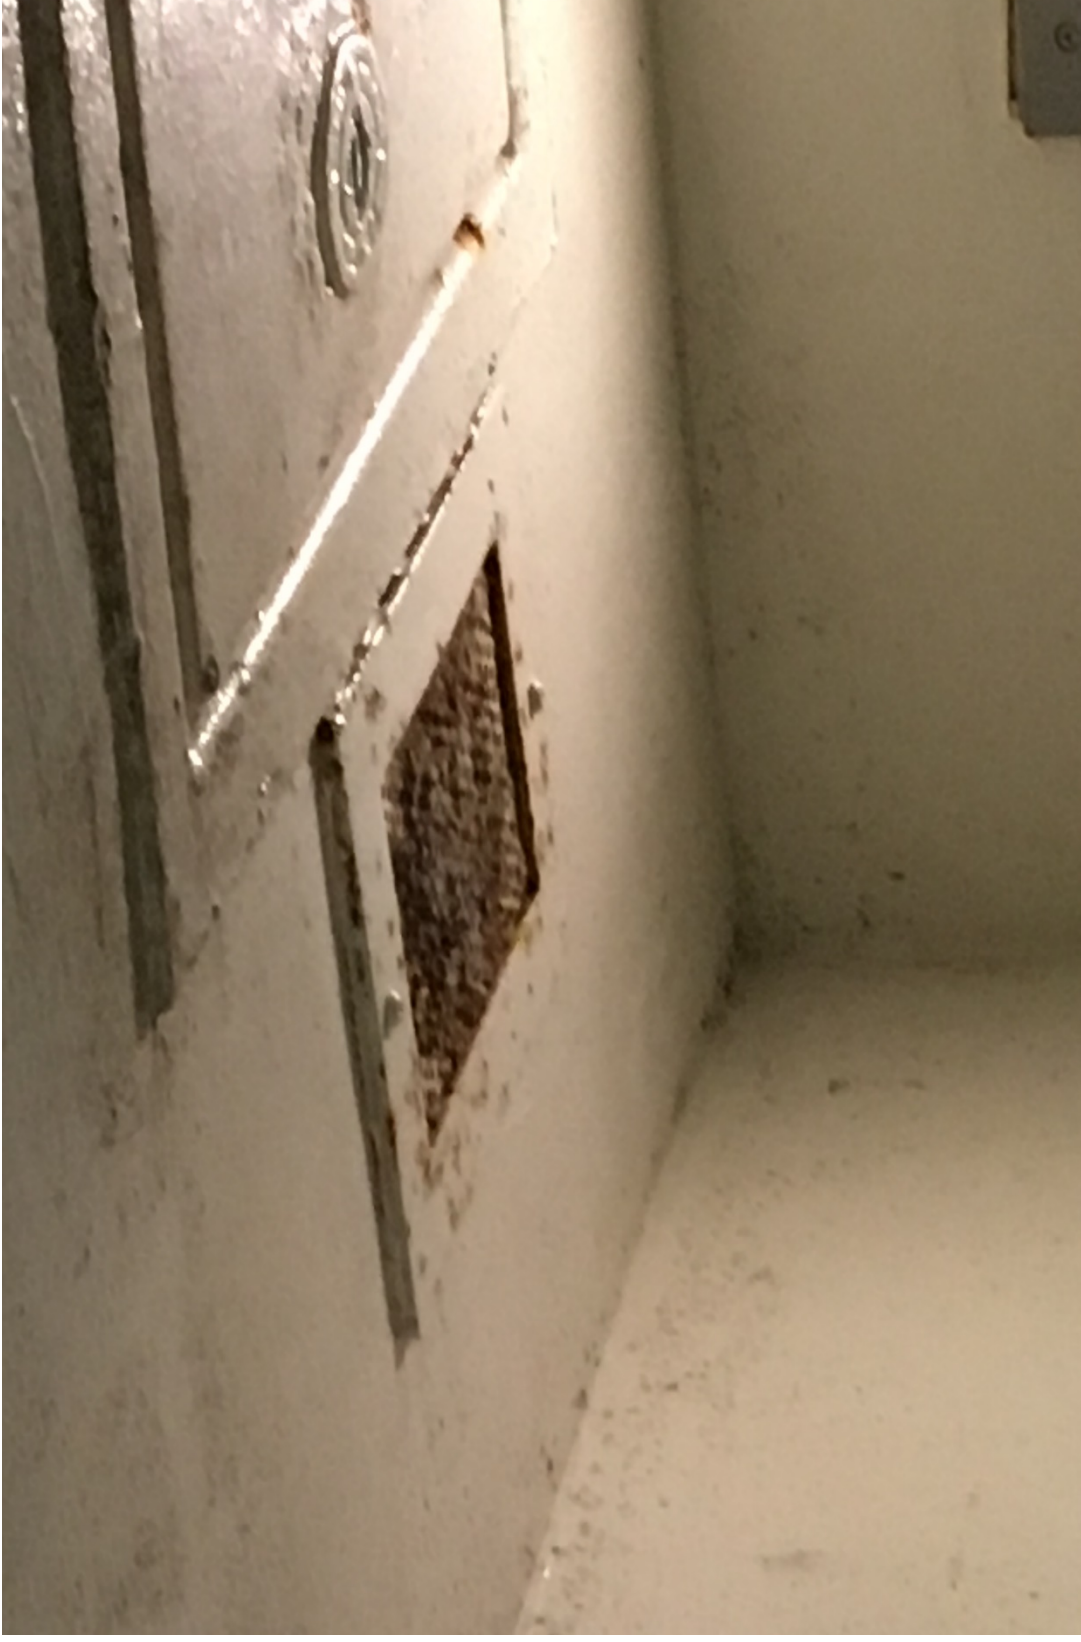
Finding # - 11 Numerous exhaust grills in the jails housing area shower stalls should be replaced.

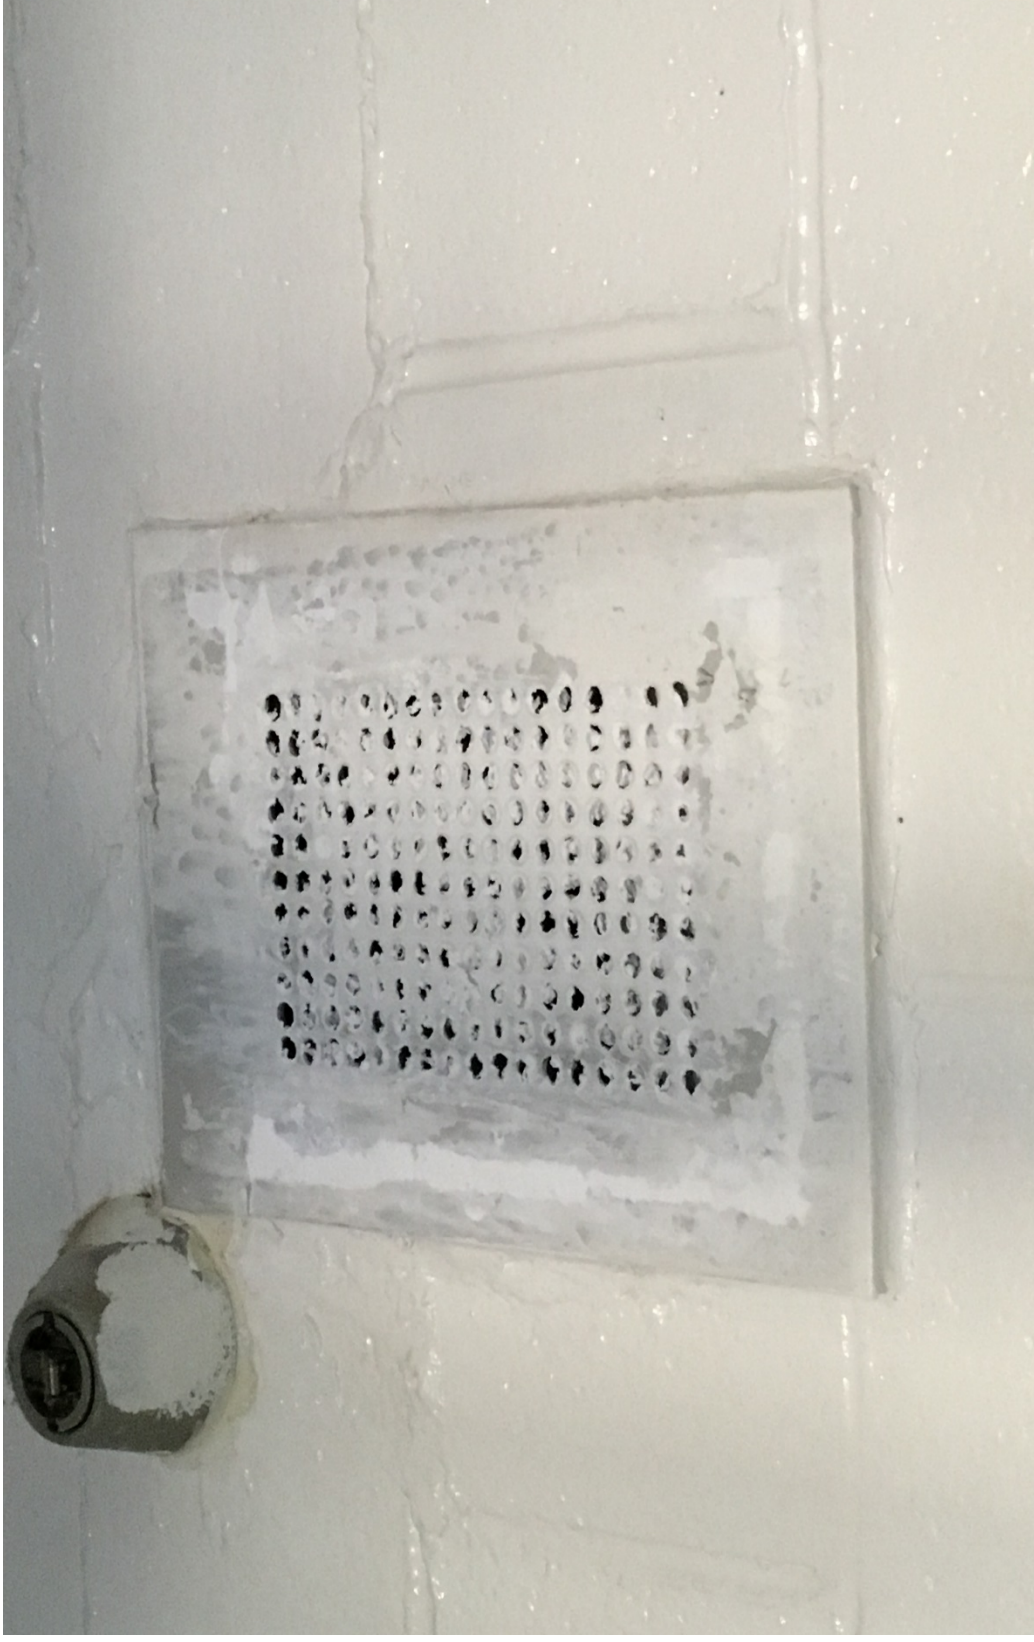
Finding # - 12 Numerous supply grills in the jail cells need to be replaced with the inmates have damaged them.
