EXHIBITS

EXHIBIT 1:

JOINT TASK FORCE & SUBCOMMITTEE MEETINGS

A2 Services, Inc. Facility Survey of City of Alexandria - City Hall

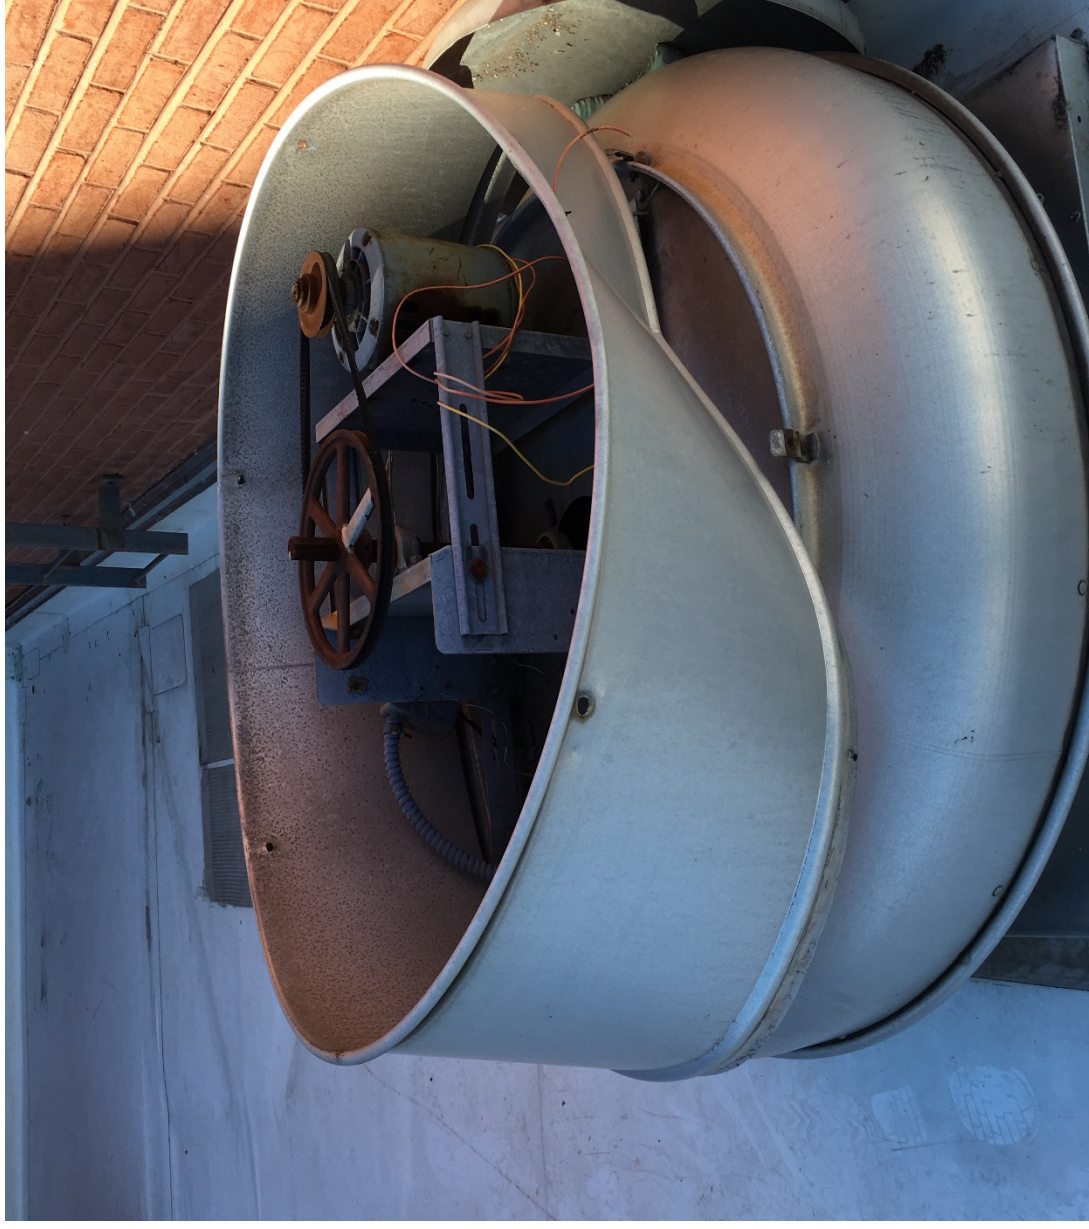
Finding # - 13 One roof top exhaust fan has failed. It should be repaired then put back into service.

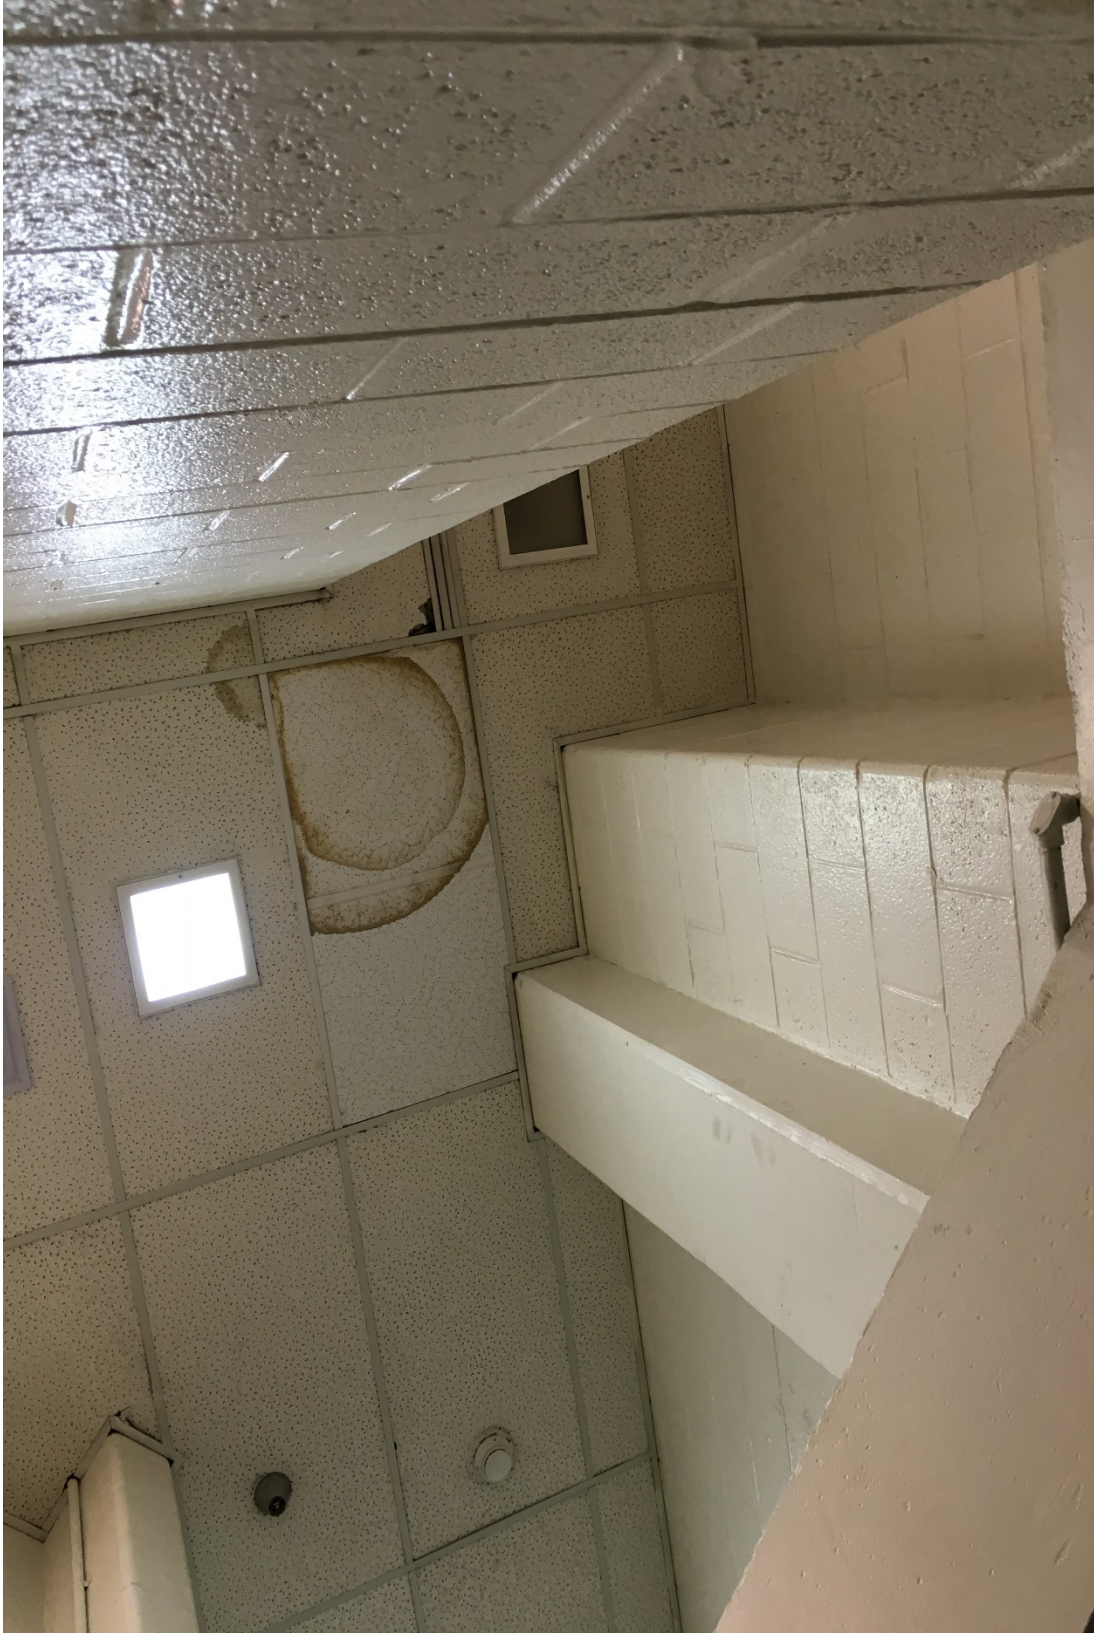
Finding # - 16 This picture is an example of ceiling access to light fixtures, ceiling tile and diffusers. This is in a stairwell.

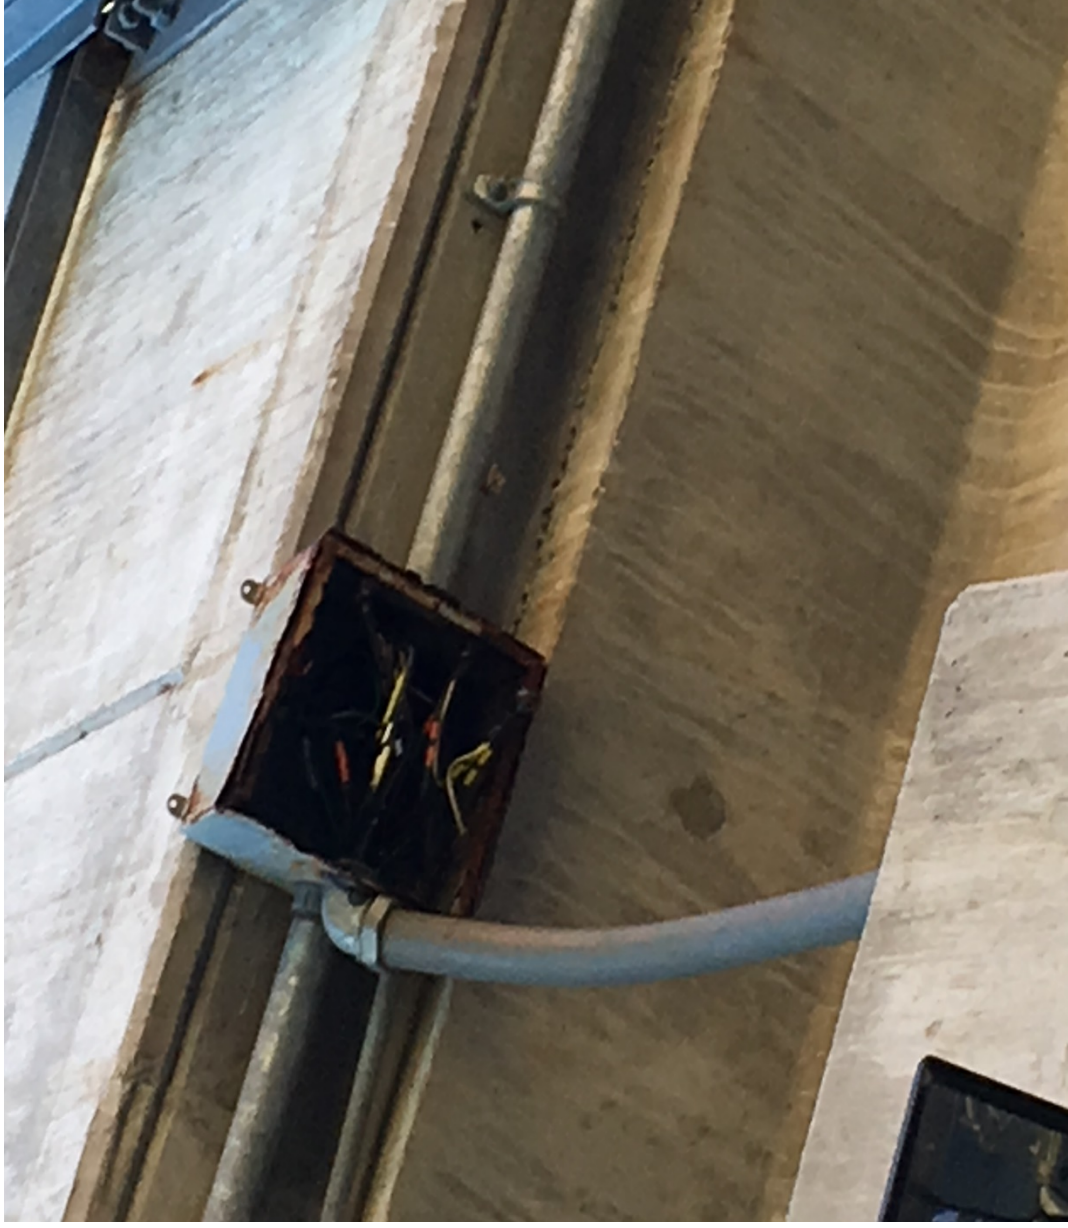
Finding # – 17 This picture shows the rusted away electrical piping and junction boxes which are rusting away. This electrical service feeds the parking area lights under the beltway access ramp and will require a bucket truck.

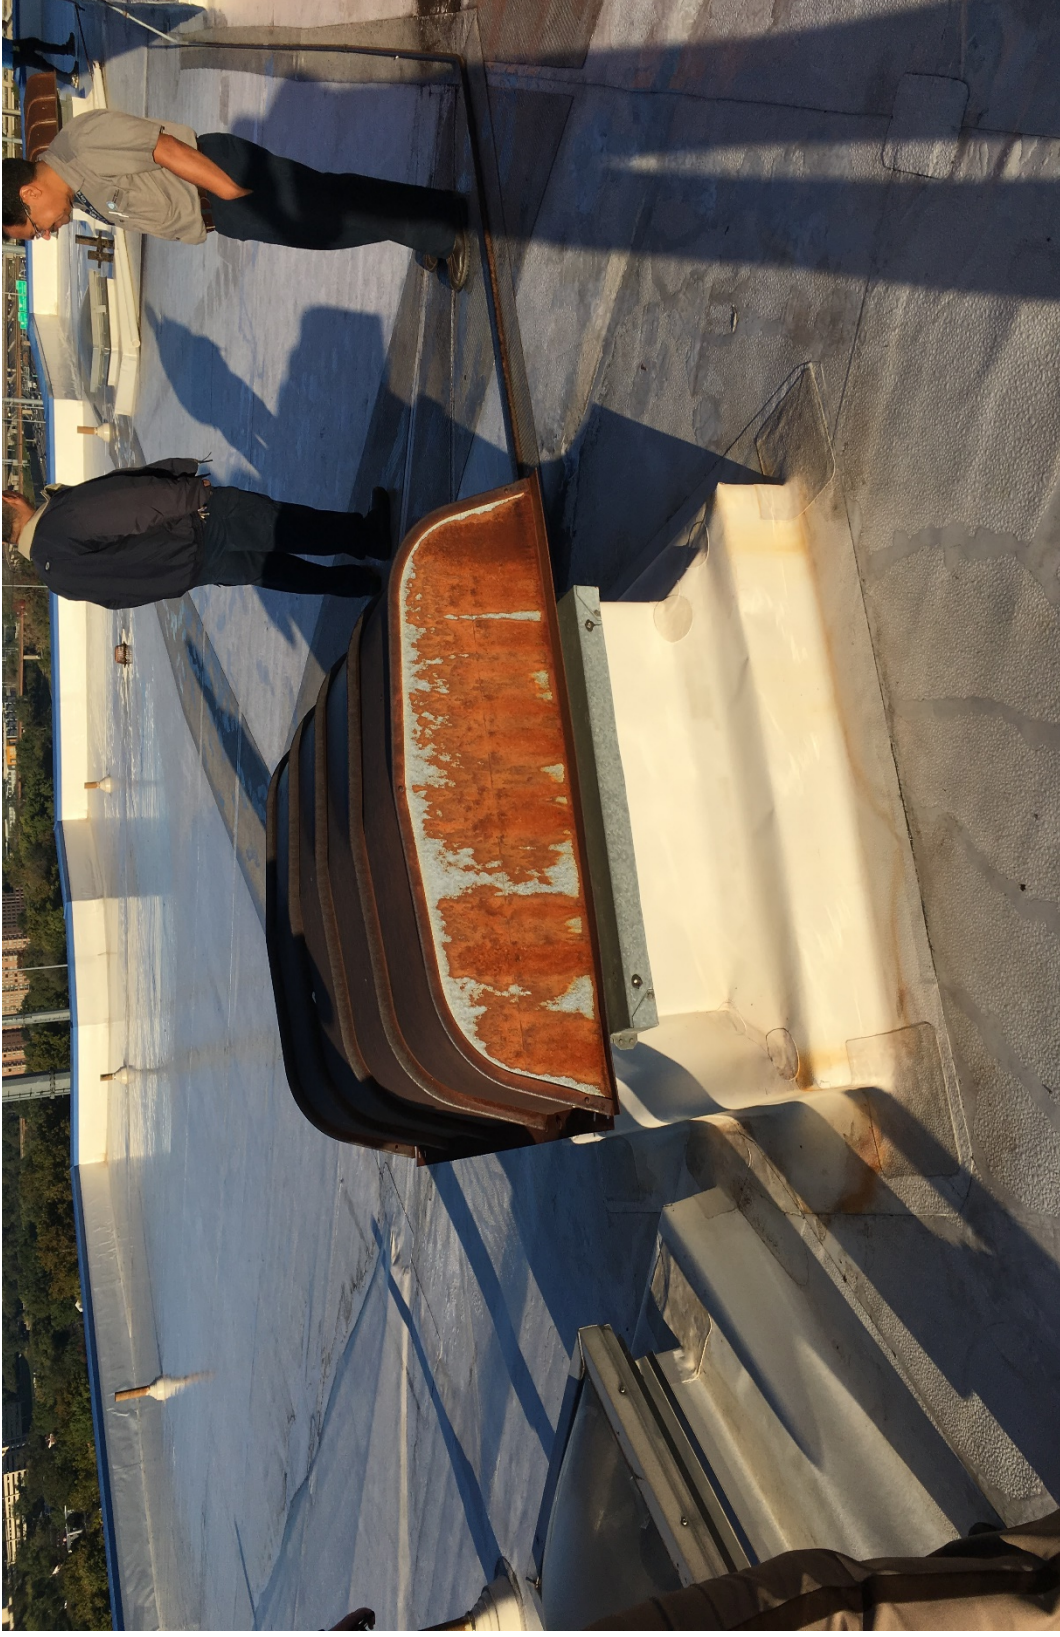
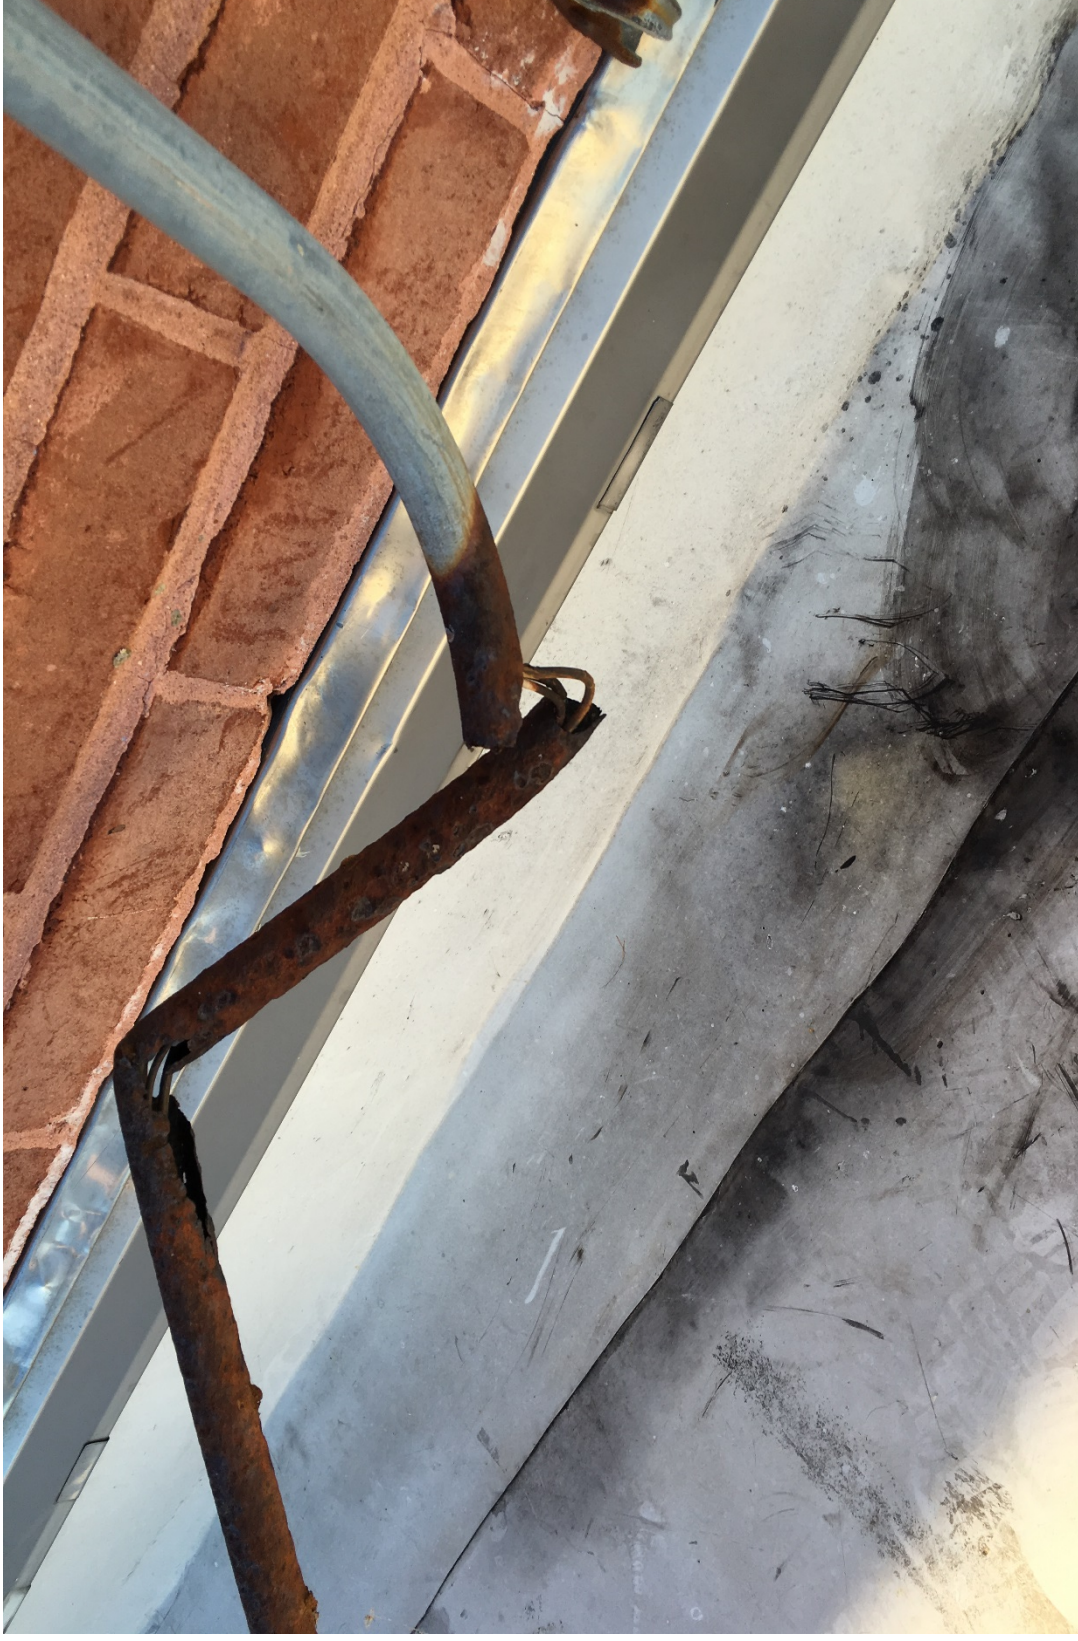
Finding # - 18 This picture is of the building vent dampers where the power wiring and conduit should be repaired.

Finding # - 18 continued. This picture is of the damager power wiring and conduit to the damper assembly.

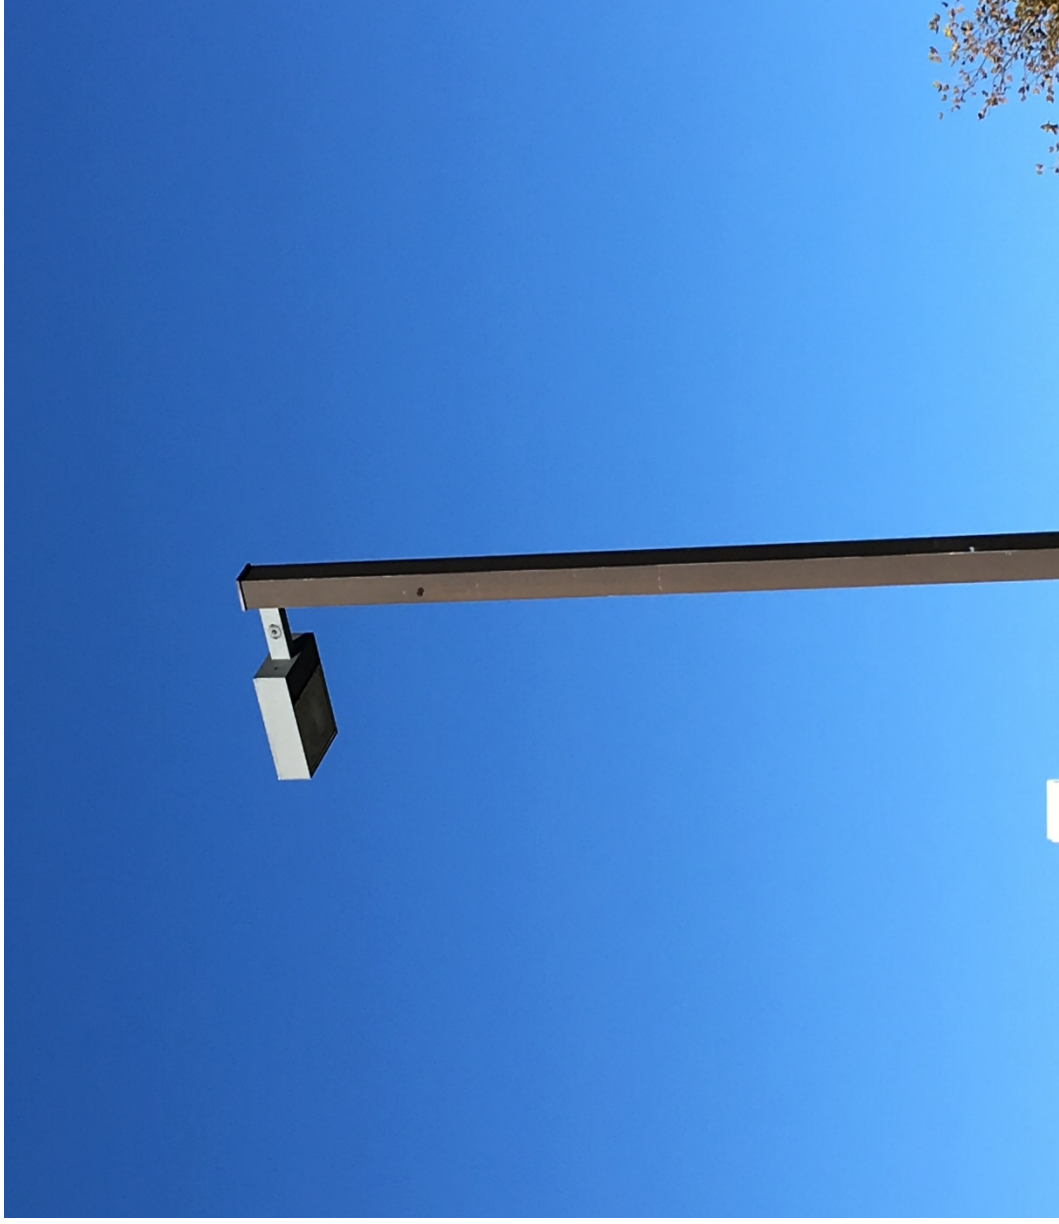
Finding # - 19 This picture is of one the exterior pole light which cannot be accessed for repairs or re-lamping without an outside contractor using a bucket truck.

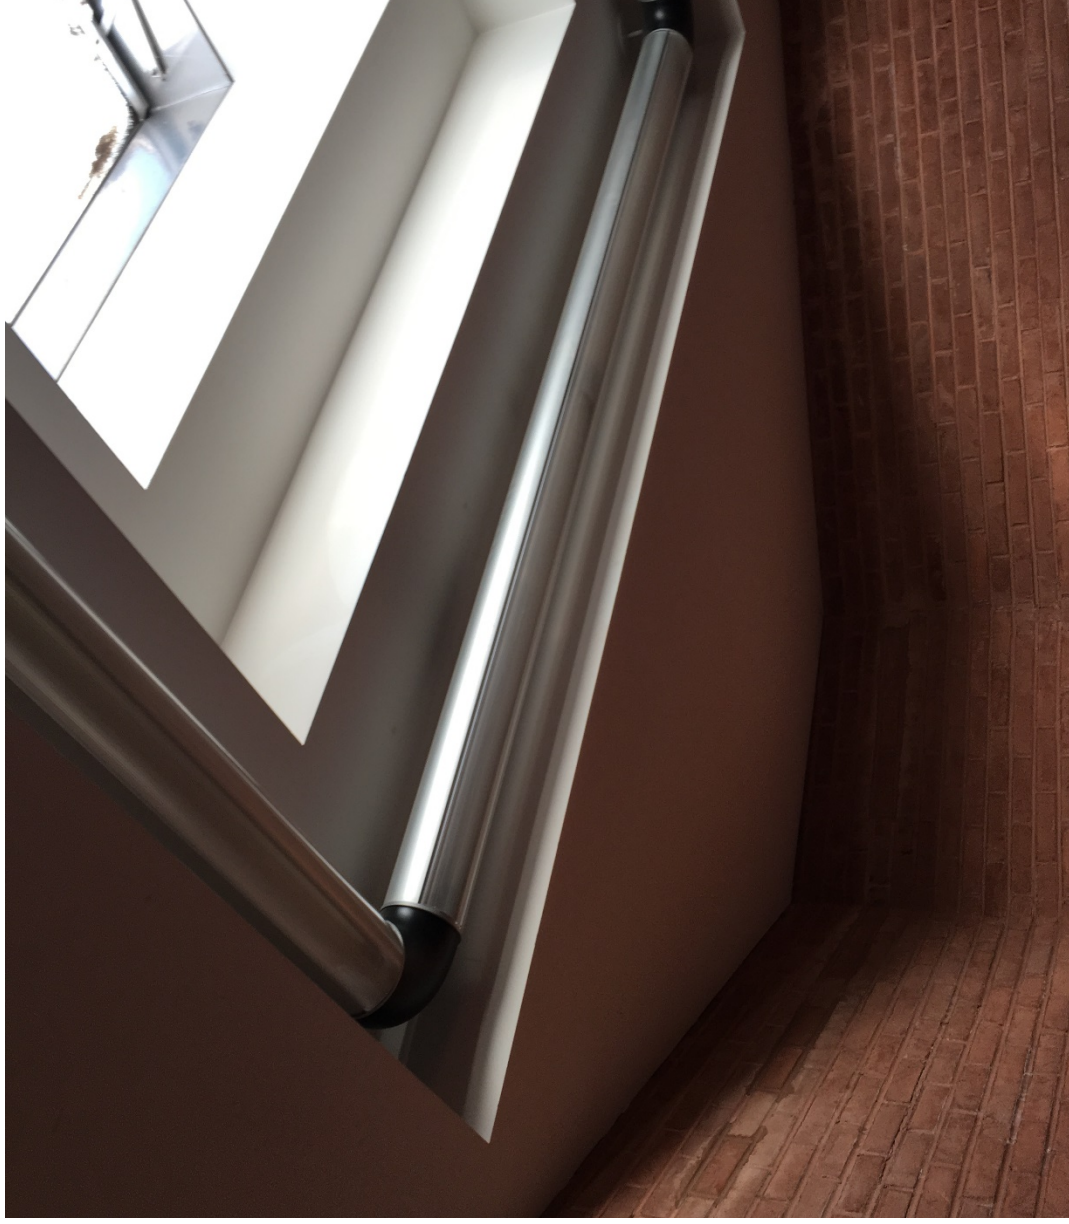
Finding # - 20 This picture is one of the lights in the sheriff's office stairwell which cannot be accessed to change the bulbs or repair the fixtures.

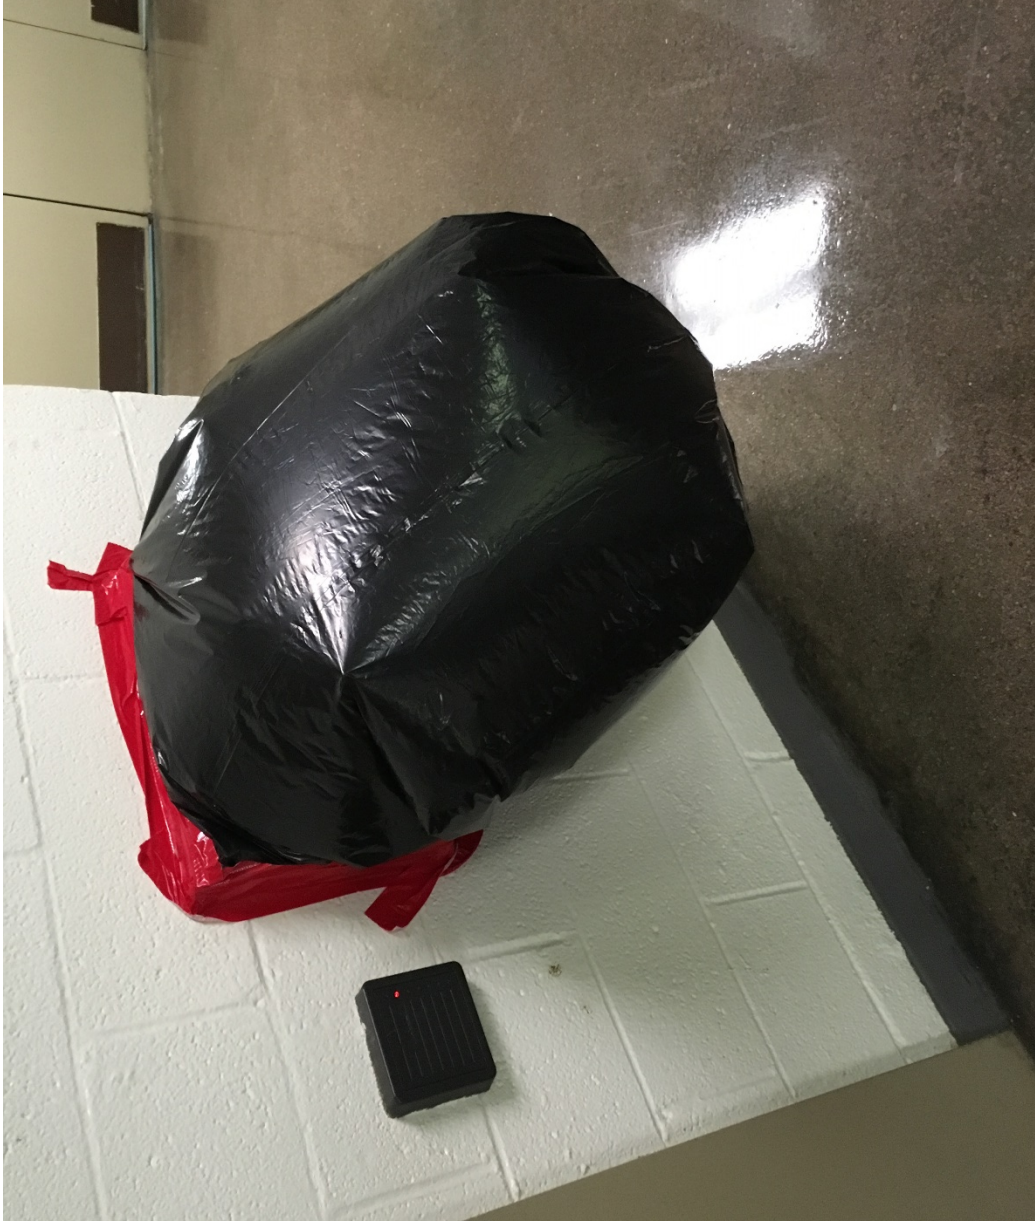
Finding # - 23 This picture is of the water fountain in the jail which will need the block wall cut away for repairs.

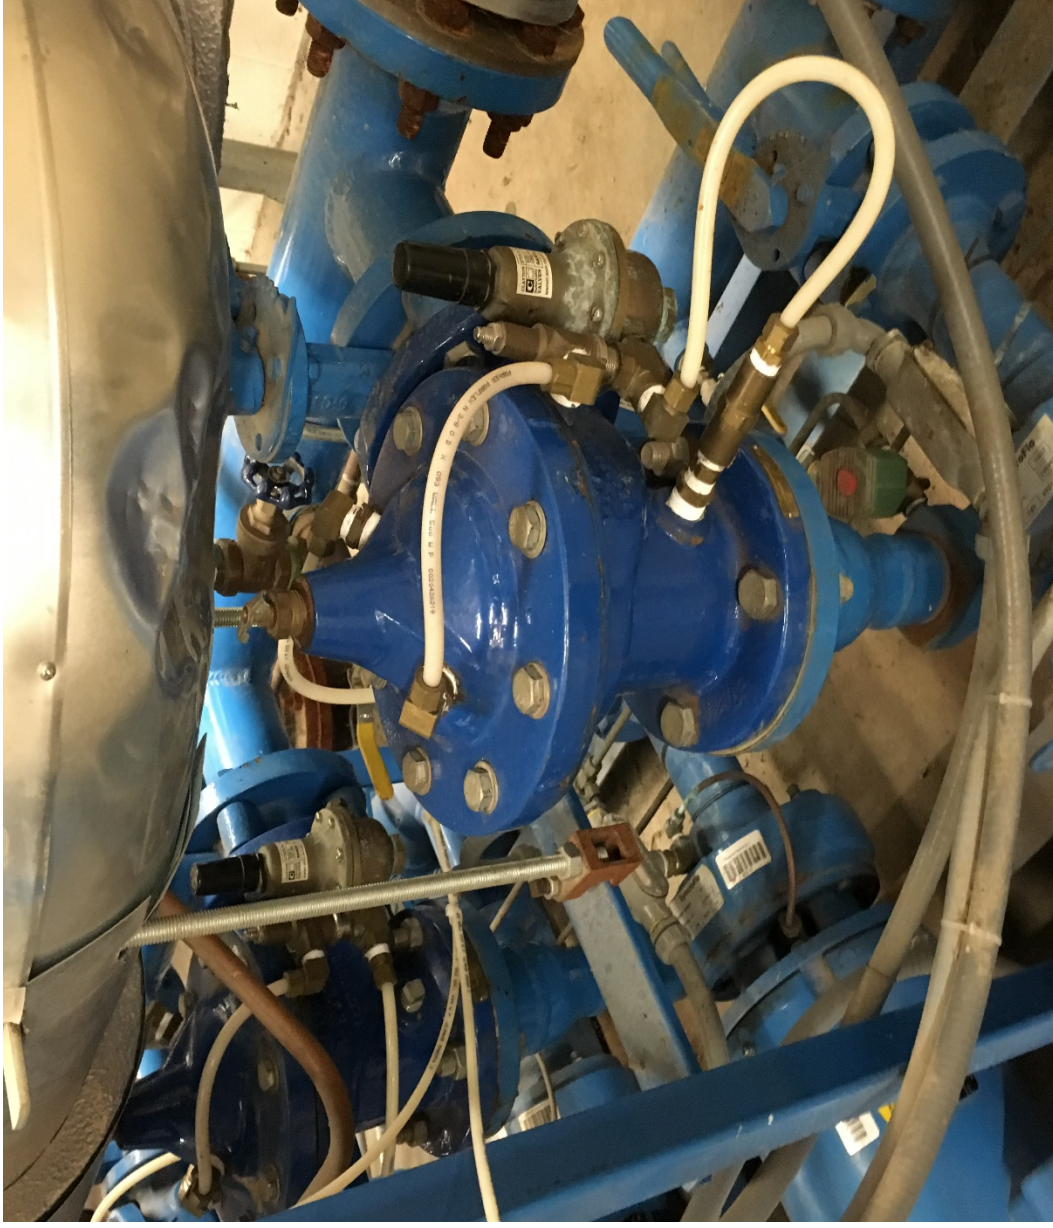
Finding # 24 A2 recommends consideration of installing VFDs on the domestic water booster pumps.

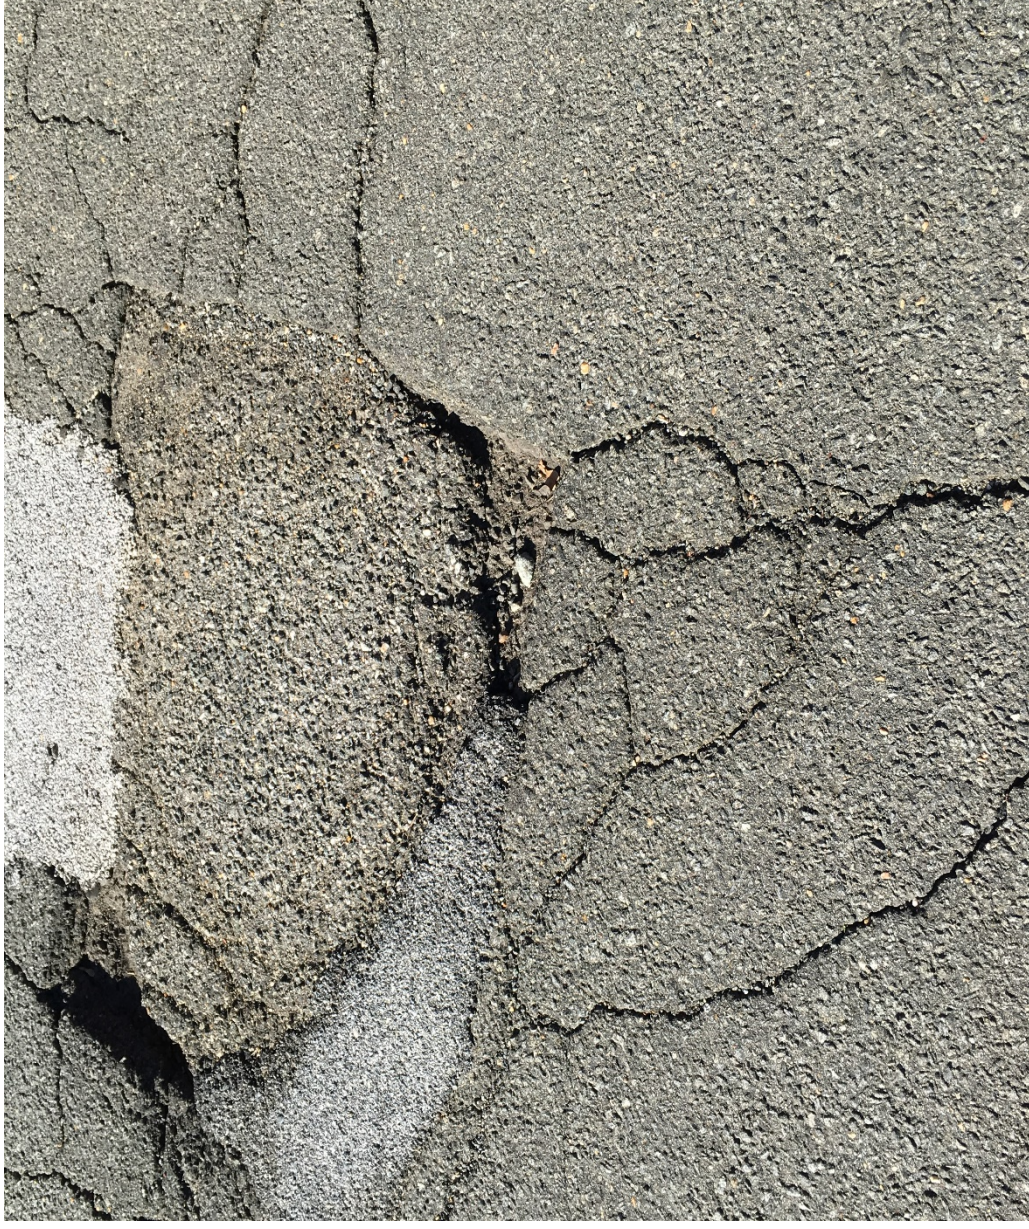
Finding # - 25 This picture is one example of asphalt damage in the parking areas and driveways. There are many areas with damage similar to this condition.

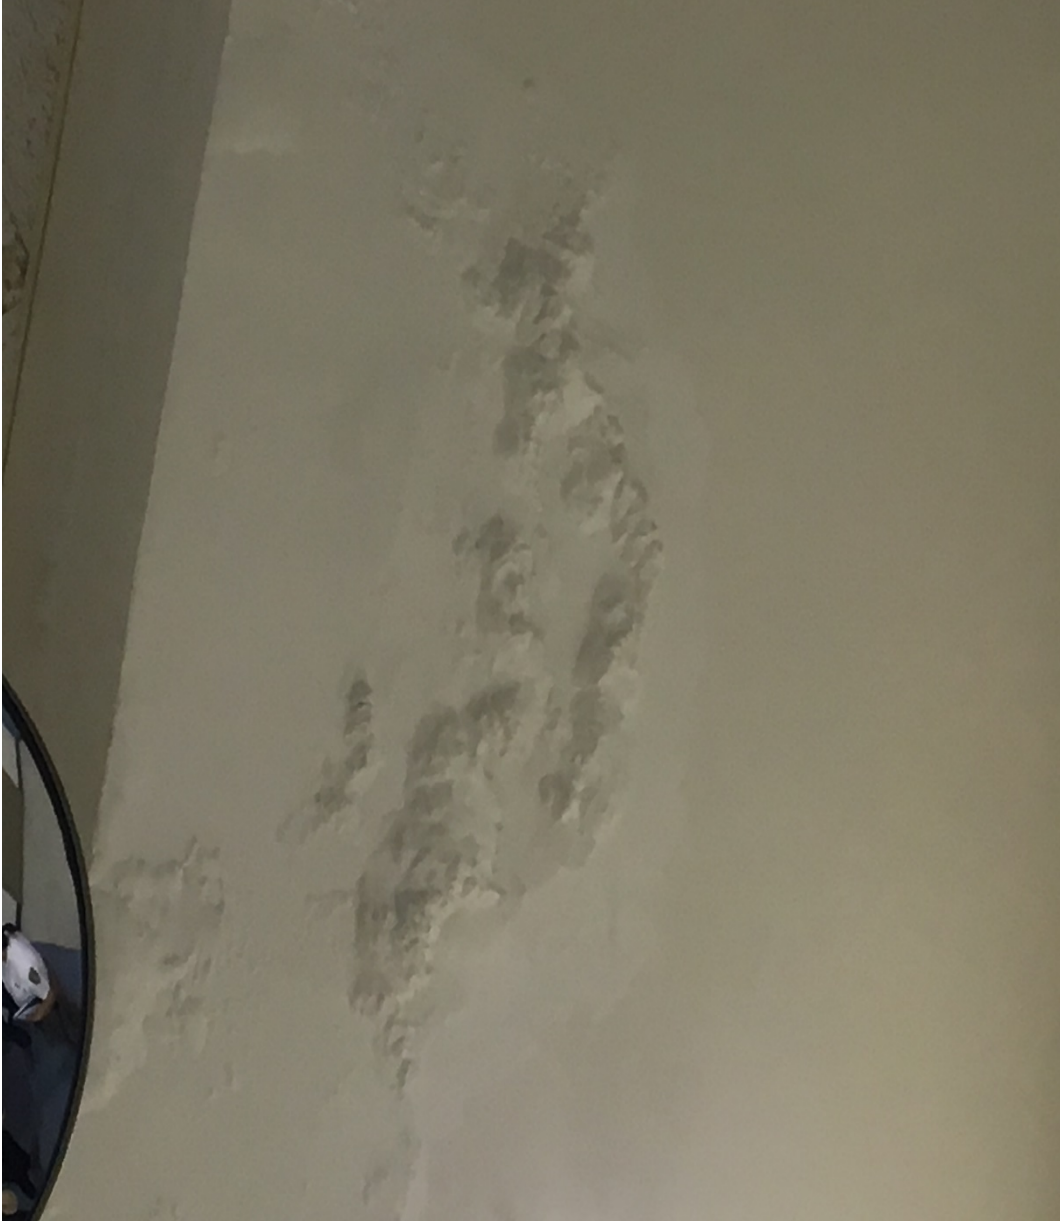
Finding # - 26 This picture denotes water damaged on the concrete slab in 3CF which appears to be caused by a leak from the roof or areas above.

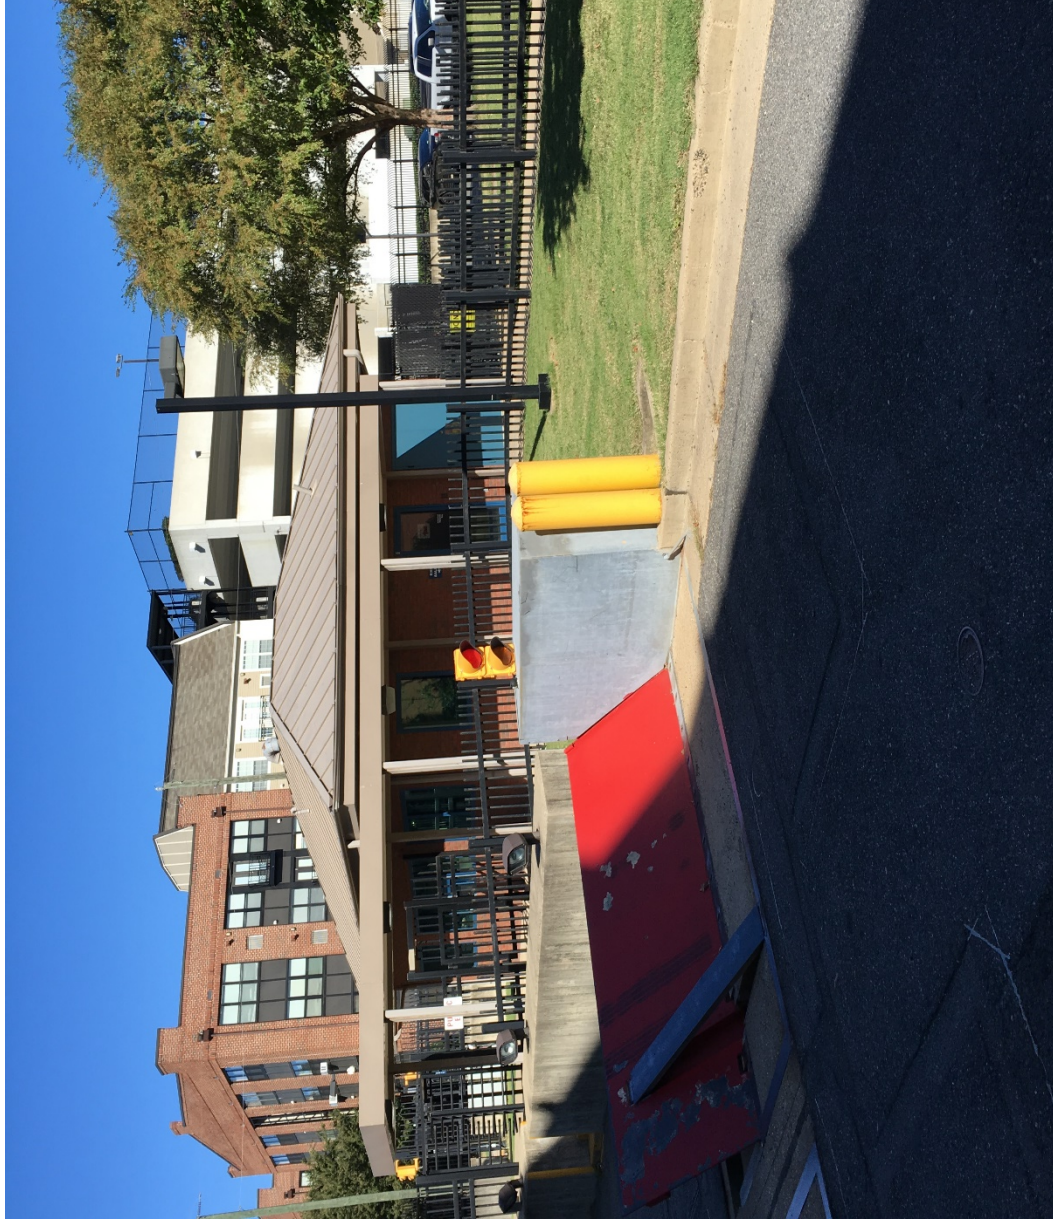
Finding # - 27 The heavy gates and security fencing at the entrances and around the facility are in need of repairs.
