A2 Services, Inc.
Facility Survey of City of Alexandria - City Hall

A2 Services (A2) toured the Alexandria City Hall facility on October 12, 2017. City Hall is an historic building in Old Town Alexandria and is located at 301 King Street, Alexandria VA 22314. A2 arrived on site at 0700AM and met Mr. Marvin Rodriguez, the Chief Engineer for the site. It was noted that Mr. Rodriguez is also responsible for three other nearby sites, and manages two maintenance men for these four sites.

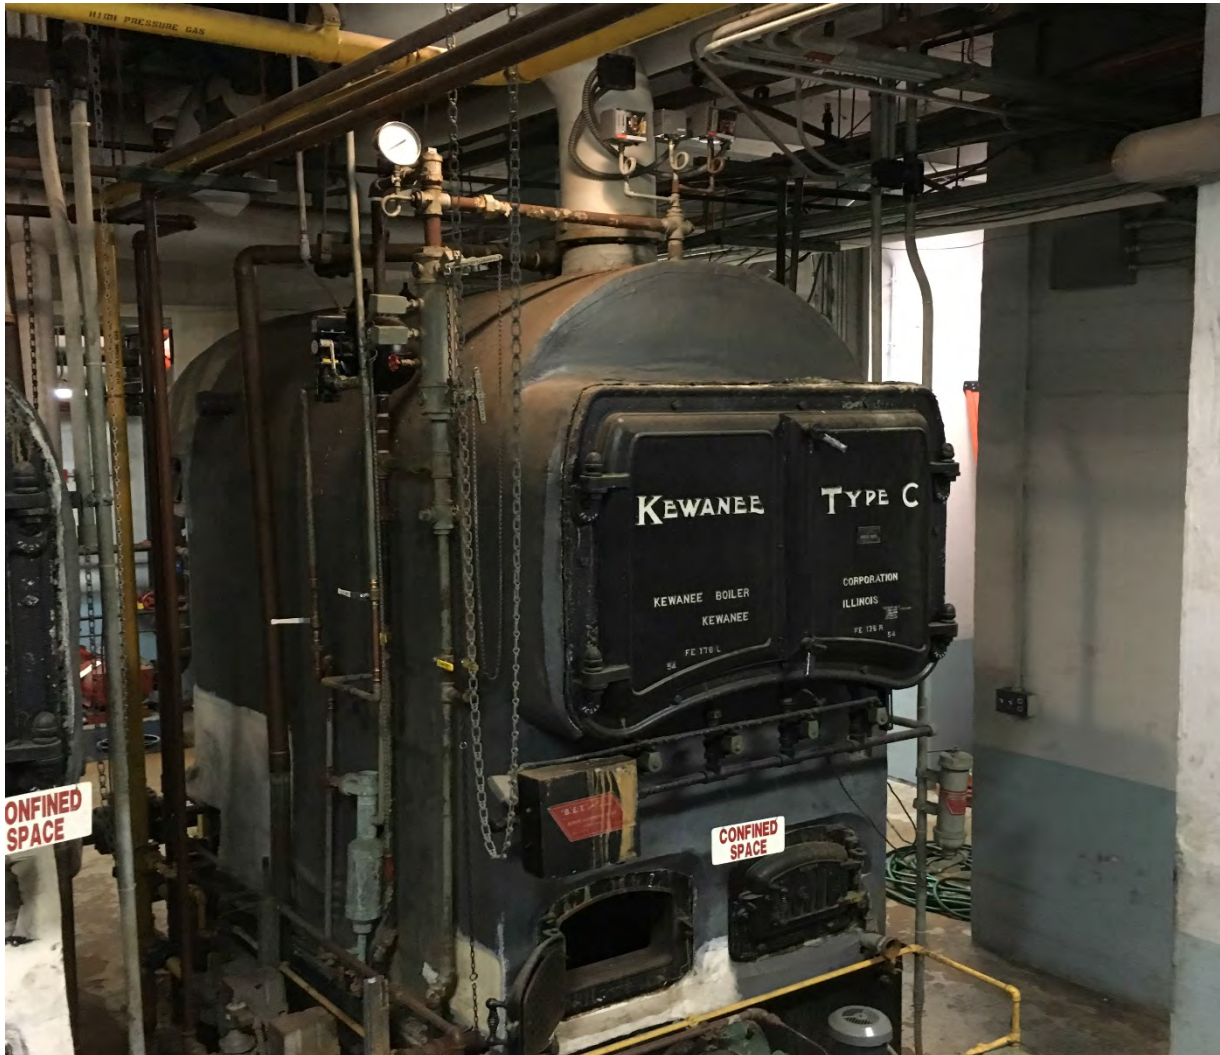
Finding # - 1. As discussed above the two low pressure steam boilers are in poor condition. These should be considered for replacement soon. Actually the entire heating and cooling system is reaching the end of its useful life. The City of Alexandria should consider a complete heating and cooling system replacement. The City Hall facility would be a good candidate for new variable refrigerant flow heating and cooling system. Roof top dedicated outside air units with heat recovery could provide ventilation. These units would allow the site to meet the ASHRAE 62.1 and 62.2 standards for indoor air quality. This type of system would be the most efficient system available and would be the least expensive and disruptive to fit into this historic building.

Finding # 1 Photo. This picture is of one of the old brick set fire tube boilers. These units are in poor condition.

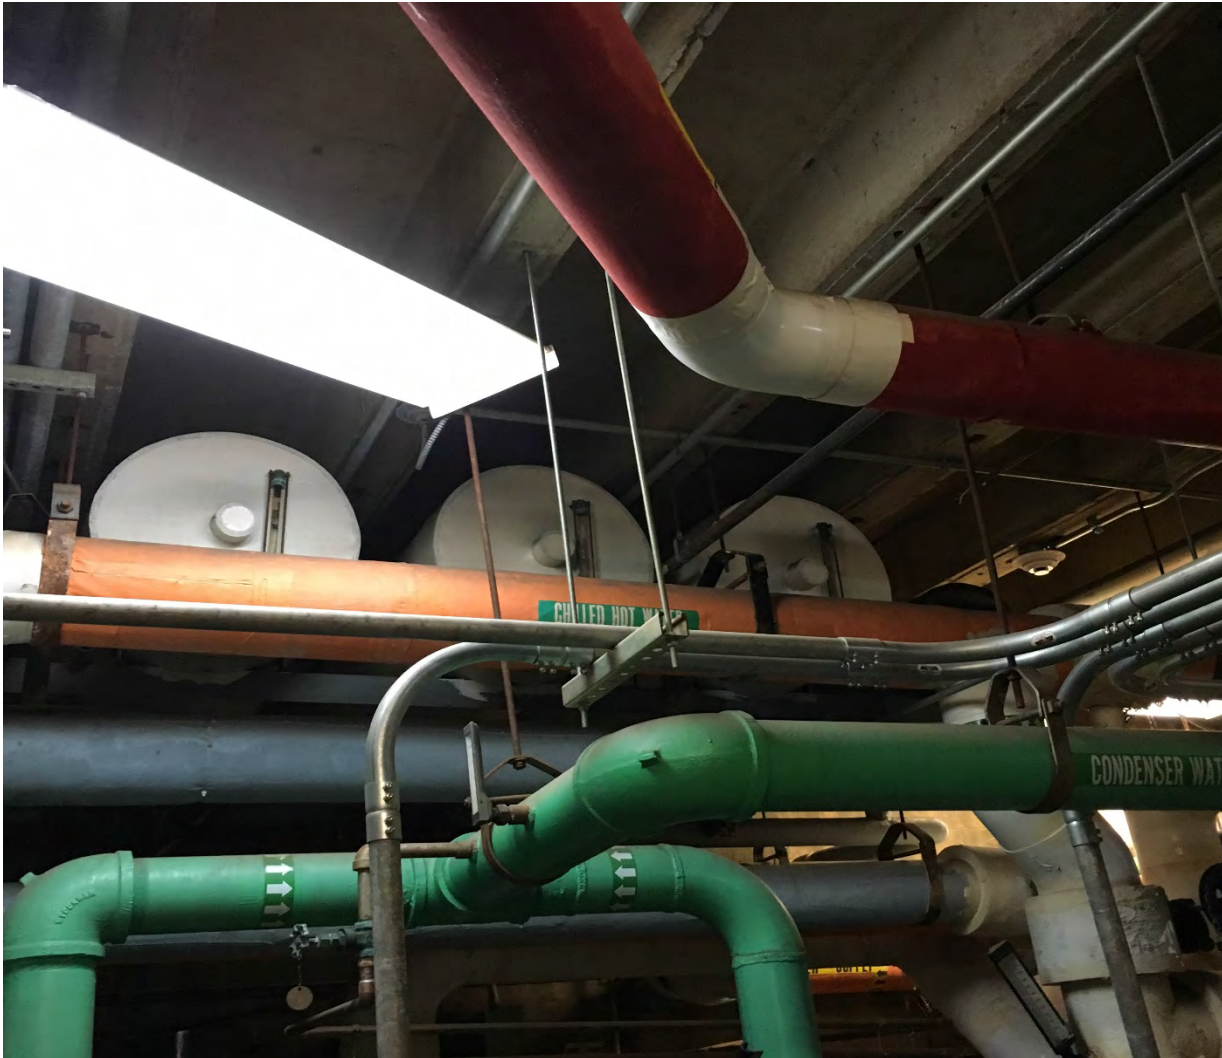
Finding # - 2. The hydronic system expansion tanks are flooded and are out of service. This allows the system water pressure to increase and decrease with the system temperature changes. This condition can cause the system pressure to exceed the design pressure during heating season. This will cause the system relief valves open to relieve the pressure wasting chemicals and possibly causing leaks on the heating coils in the building.

Finding # 2 Photo. The 3 tanks shown in this picture are the closed system expansion tanks. These need to be repaired and the proper air cushion established to allow the systems water to expand and contact without changing the system pressure.

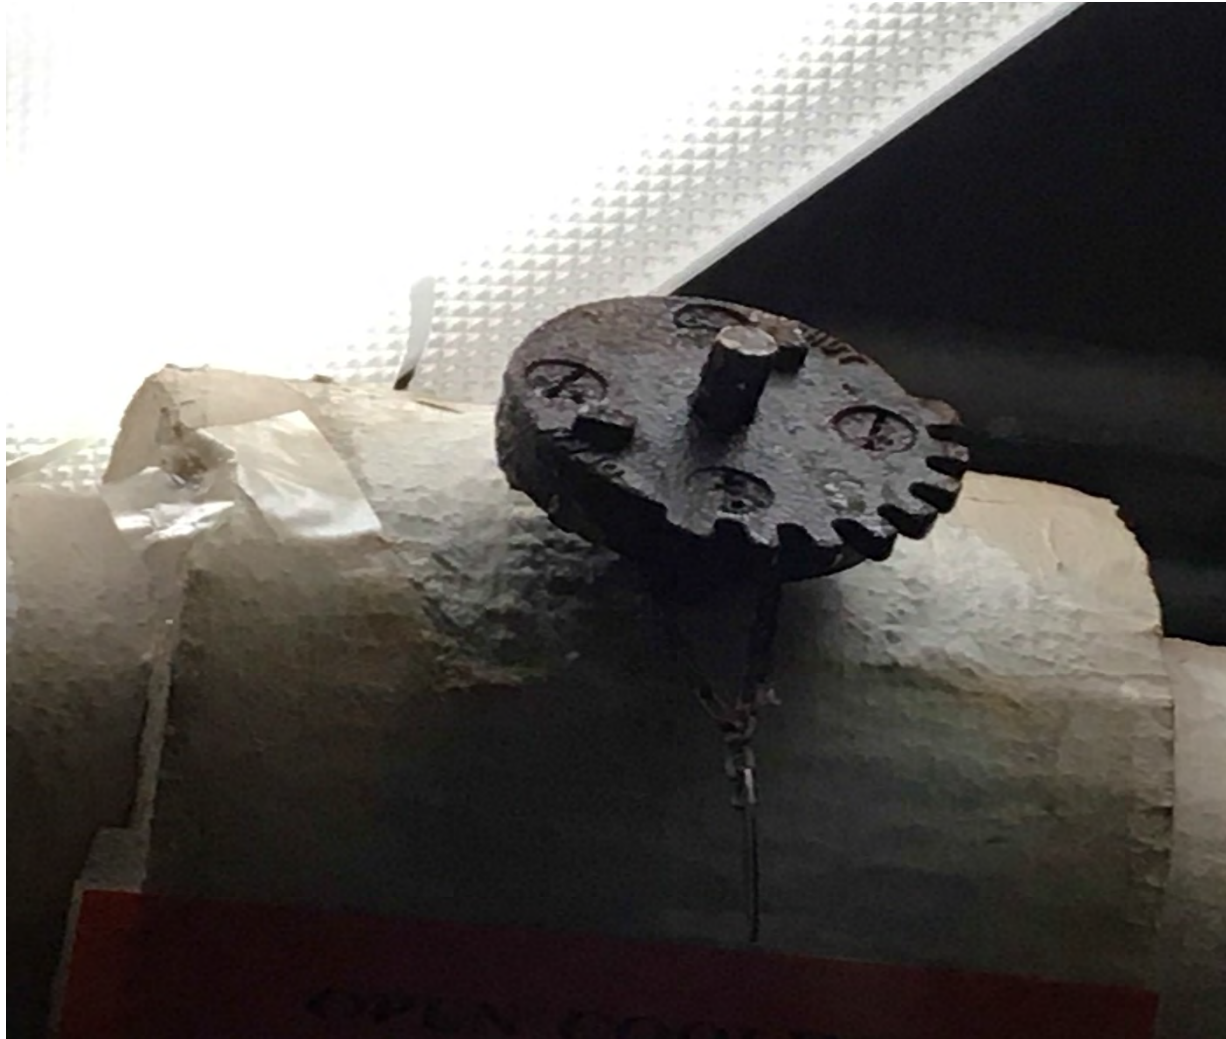
Finding # - 3. A2 noted that at least two hydronic system manual valves which were have broken handles and do not operated. These are needed to change the system from heating to cooling and should be replaced.

Finding # 3 Photo. This picture is an example of one valve which needs to be replaced.

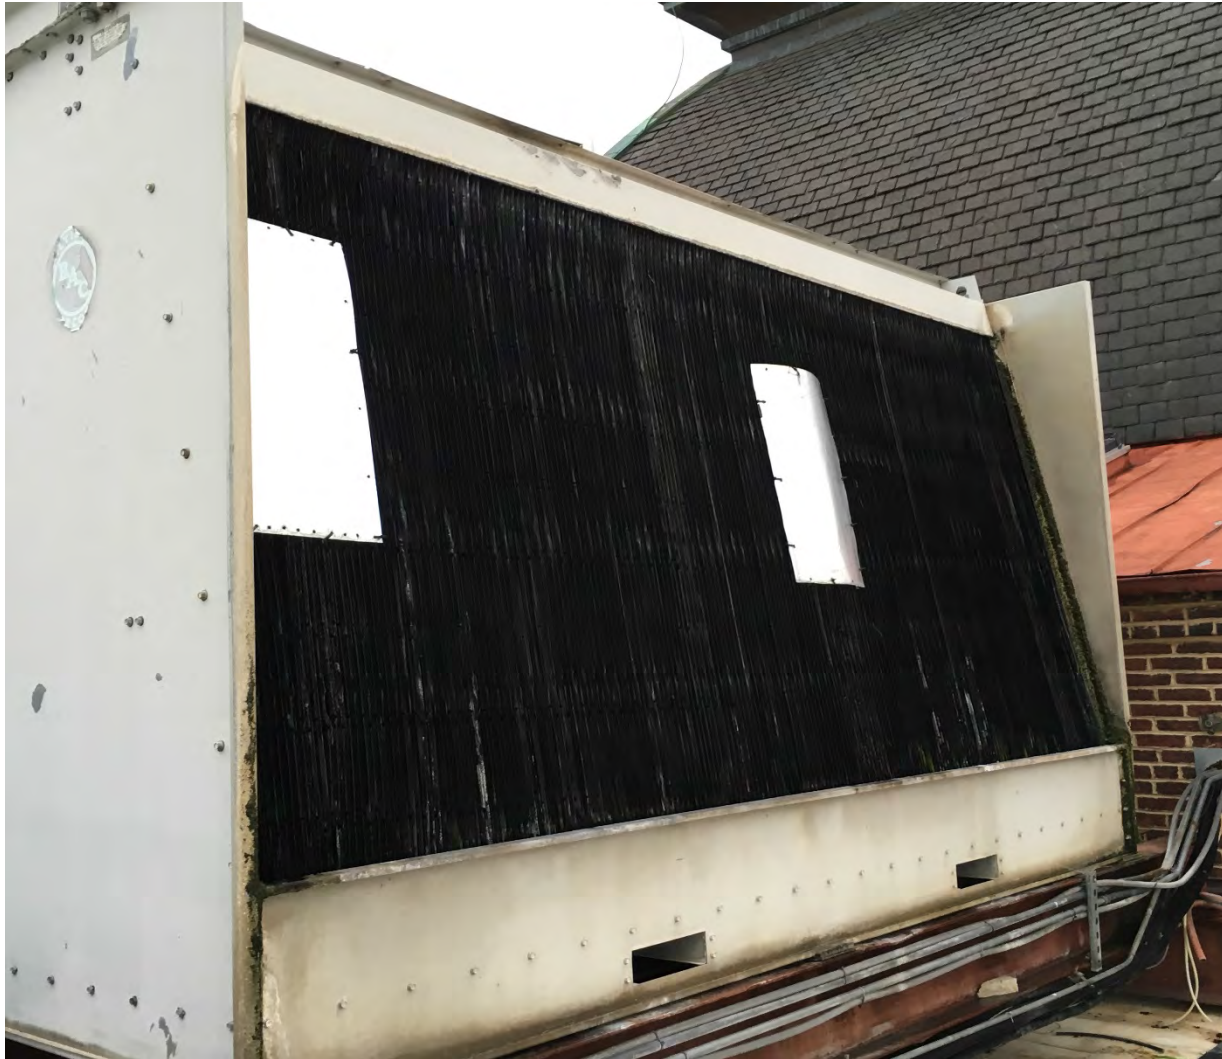
Finding # - 4. The cooling tower fill is damaged and has been temporarily repaired with some sheet metal to stop the tower water from blowing onto the roof. The fill should be replaced.

Finding # 4 Photo. This picture notes the temporary sheet metal repair to the cooling tower fill.

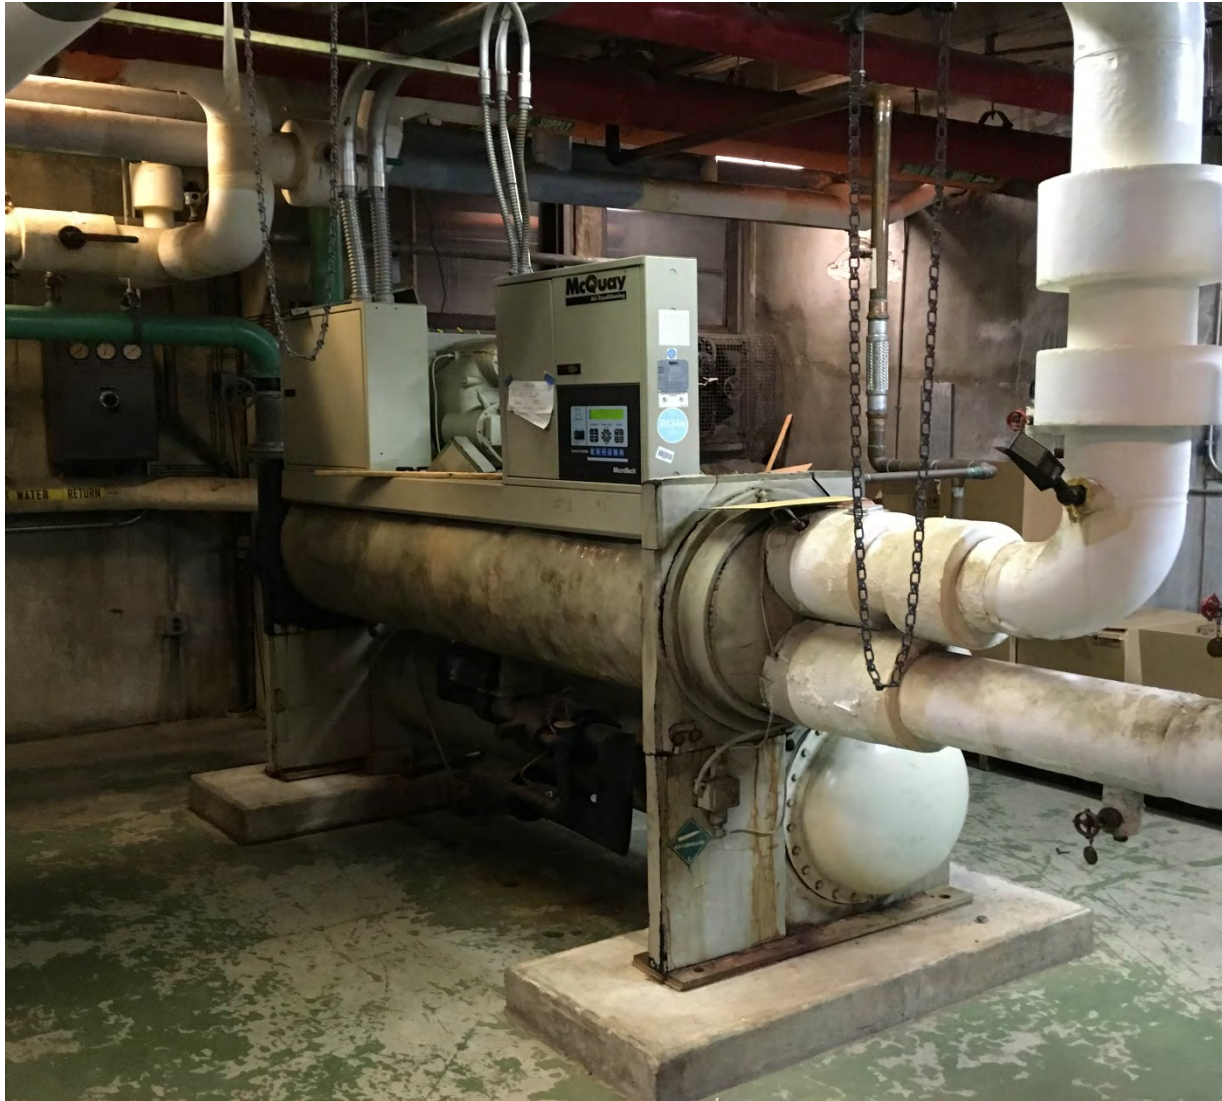
Finding # - 5. The McQuay R-22 chillers provide chilled water for the site in summer. These machines are operating well but are inefficient and use R-22 which has been taken off the market. As stated earlier, R-22 is an HCFC which was identified in 1990 by the clean air act to be an ozone depleting compound, thus has been taken out of production. R-22 is still available at increasing cost. There are compliant refrigerants that can replace the R-22 but these will decrease the system efficiency on already inefficient machines.

Finding # 5 Photo. This picture notes one of the R-22 centrifugal chillers.

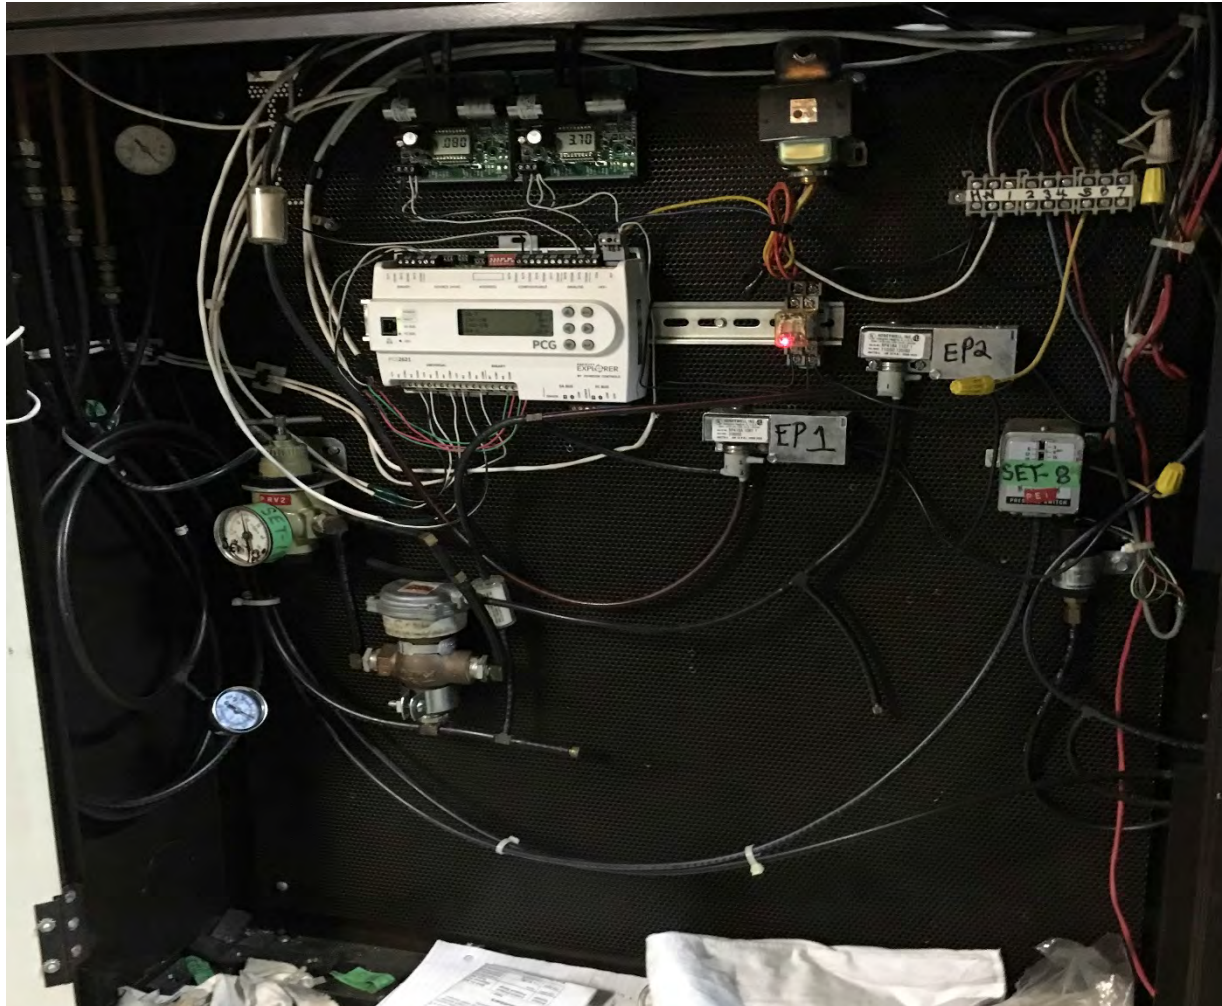
Finding # - 6. The central plant and air handler controls are pneumatic. The controls are operating but will eventually need to be replaced. There is at least one actuator which should be replaced now. The steam control valve and actuator for the hot water convertor are in poor shape. If this device fails during the winter, the facility will not have heat.

Finding # 6 Photo. The picture is an example of the old pneumatic controls used to operate the boiler room systems and the air handlers systems in the building.

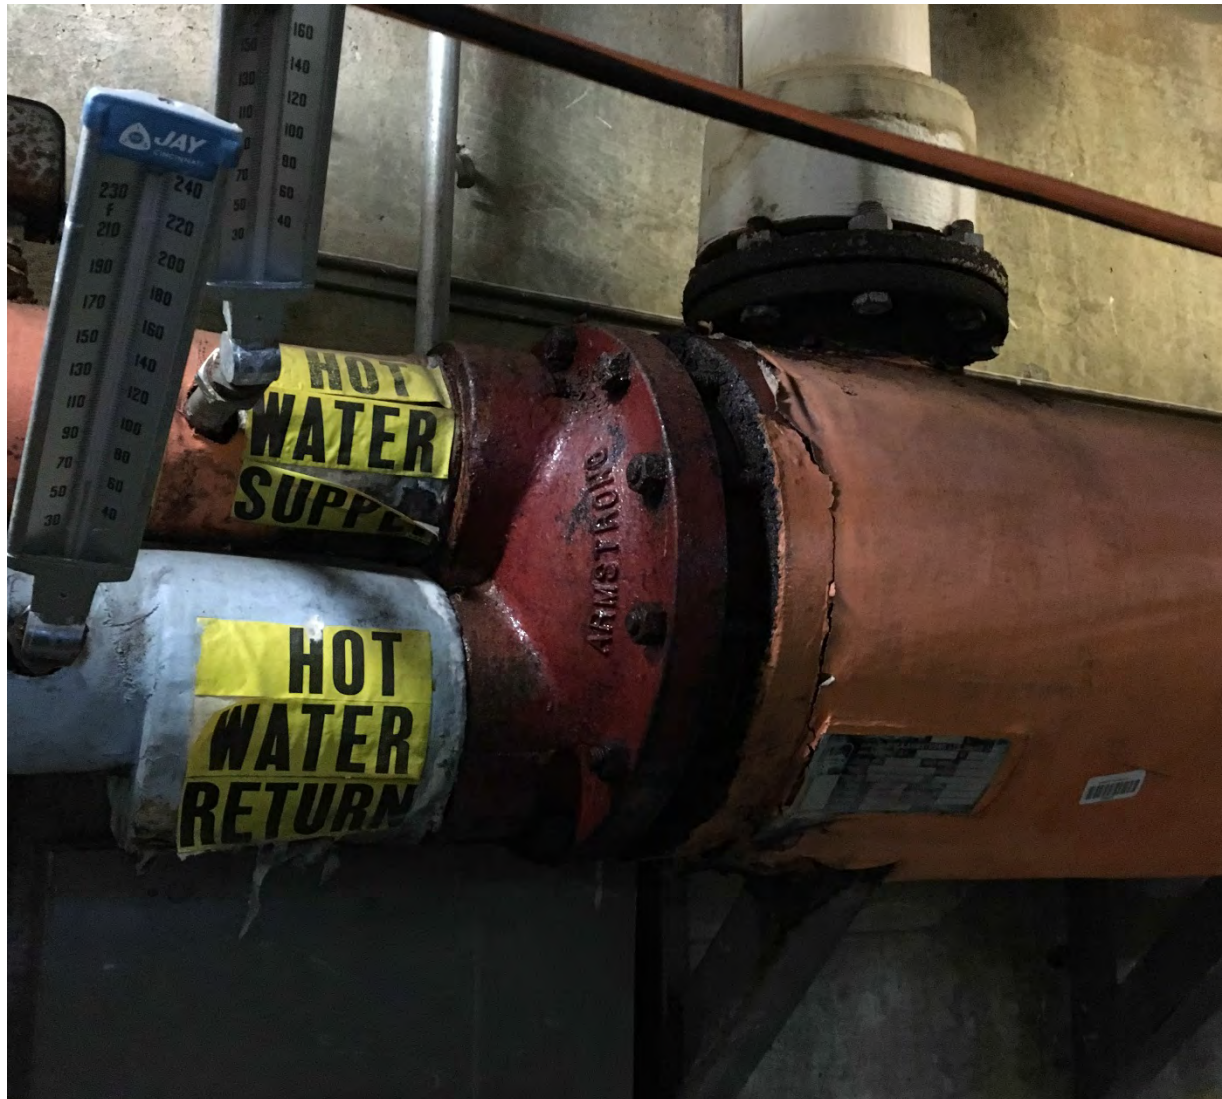
Finding # - 7. The steam heat exchanger head is leaking. The unit's tube bundle should be pulled cleaned and closed with new gaskets.

Finding # 7 Photo. This picture is of the heat exchanger which heats the whole building. The head is leaking while in operation and should be repaired.

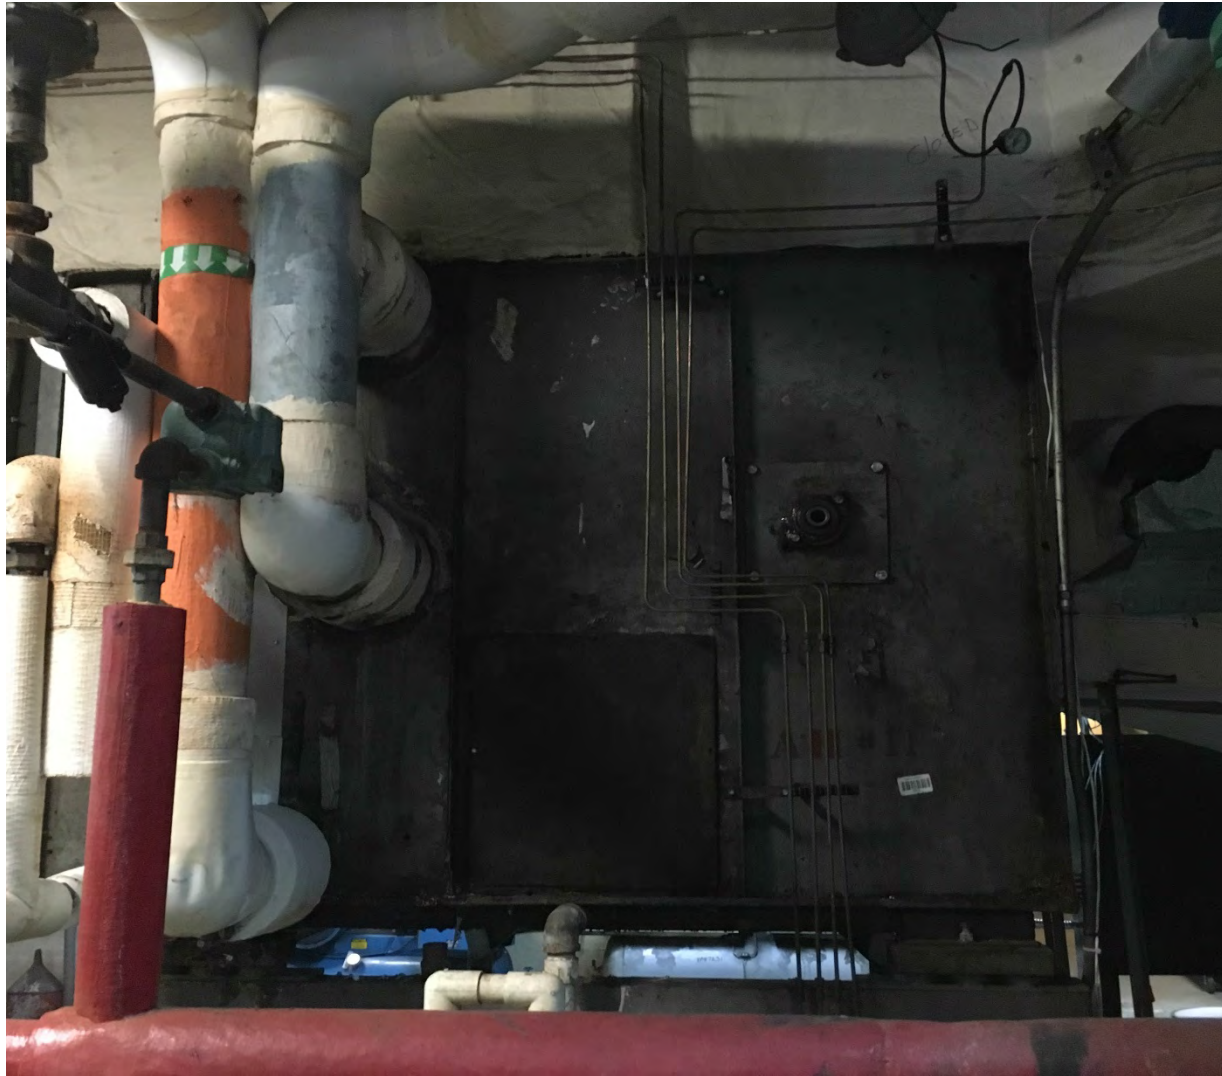
Finding # - 8. The main outside air fan for the building is small and only dumps conditioned outside air into the central corridor of the building. It appears that the fan coils do not have outside air vents and the ceiling hung air handlers do not have outside air fed to them either. This should be further investigated to make sure this finding is correct. The concern is a possibility that the office areas in the building may not be getting good fresh air ventilation.

Finding # 8 Photo. This picture is of the main outside air fan which filters, heats or cools the incoming air for building ventilation.

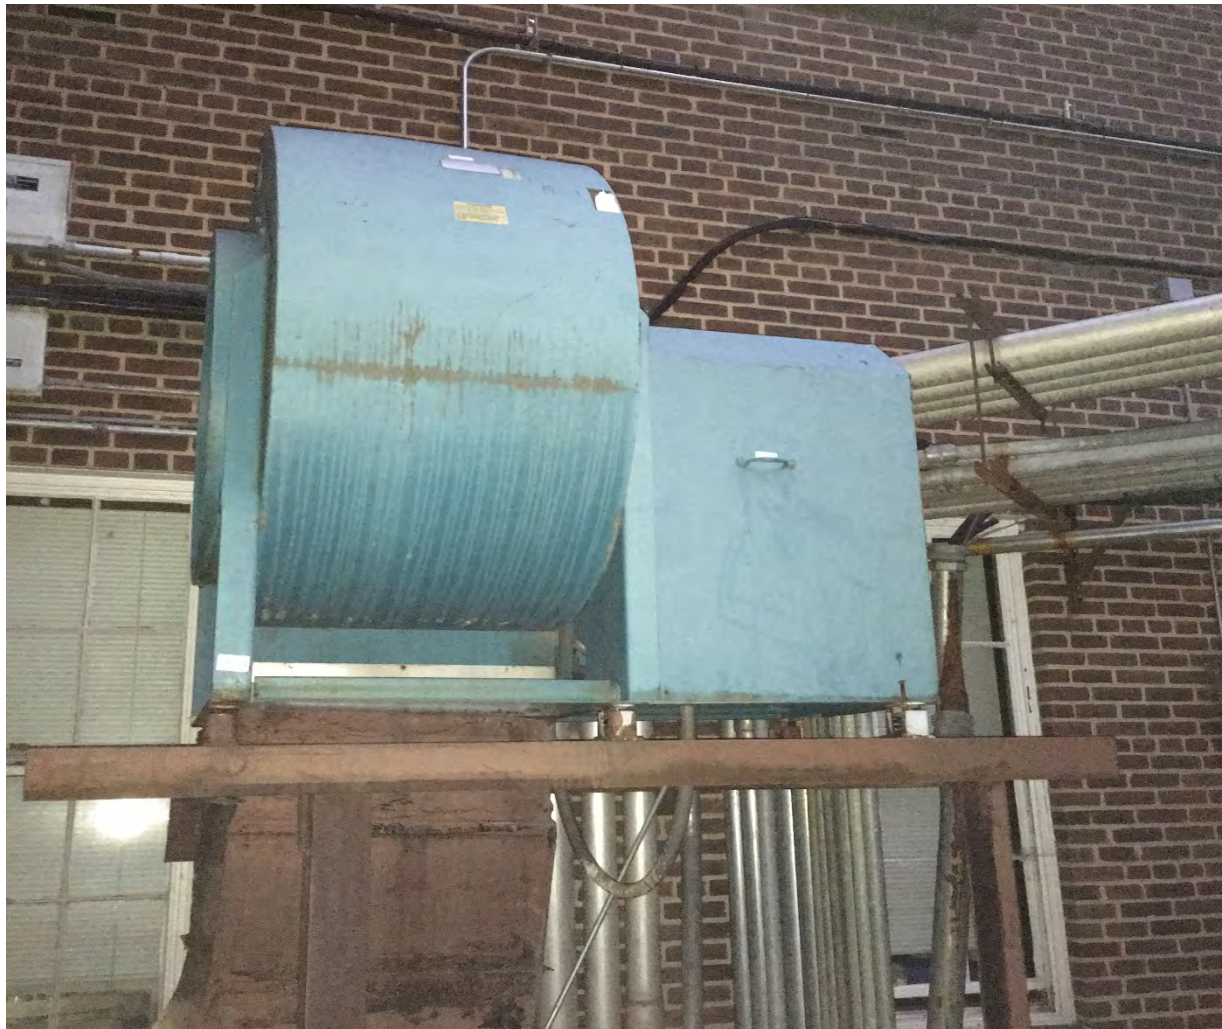
Finding # - 9. There is a second outside air fan which dumps unconditioned outside air into the building. This fan only operates when the outside air temperature is between 30 and 50 degrees. Pumping 30 to 50 degree outside into the building must be causing cold complaints in areas where it enters the building.

Finding # 9 Photo. This picture is of the second OA fan which most likely causes more issues. It simply dumps unfiltered cold air into the building.

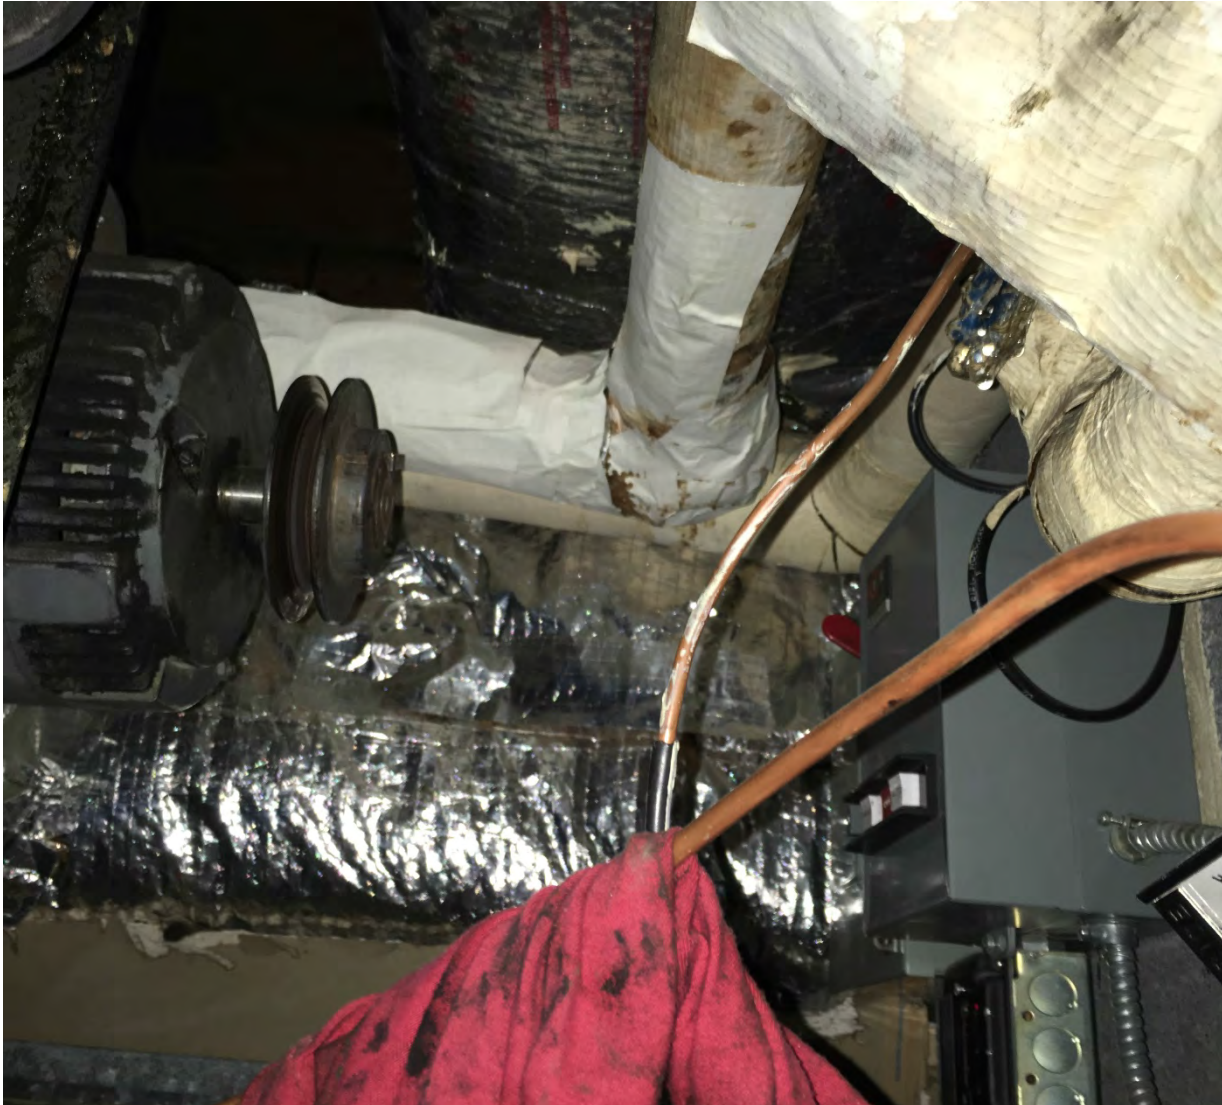
Finding # - 10. There are 20 ceiling hung air handlers which heat and cool the office spaces on the floors. These units are very hard to access for maintenance. There is one unit in the print shop which failed a few years ago and hasn't been repaired because of the problem accessing it.

Finding # 10 Photo. This picture is of the air handler in the print shop which the fan bearings have failed. It is very hard to access.

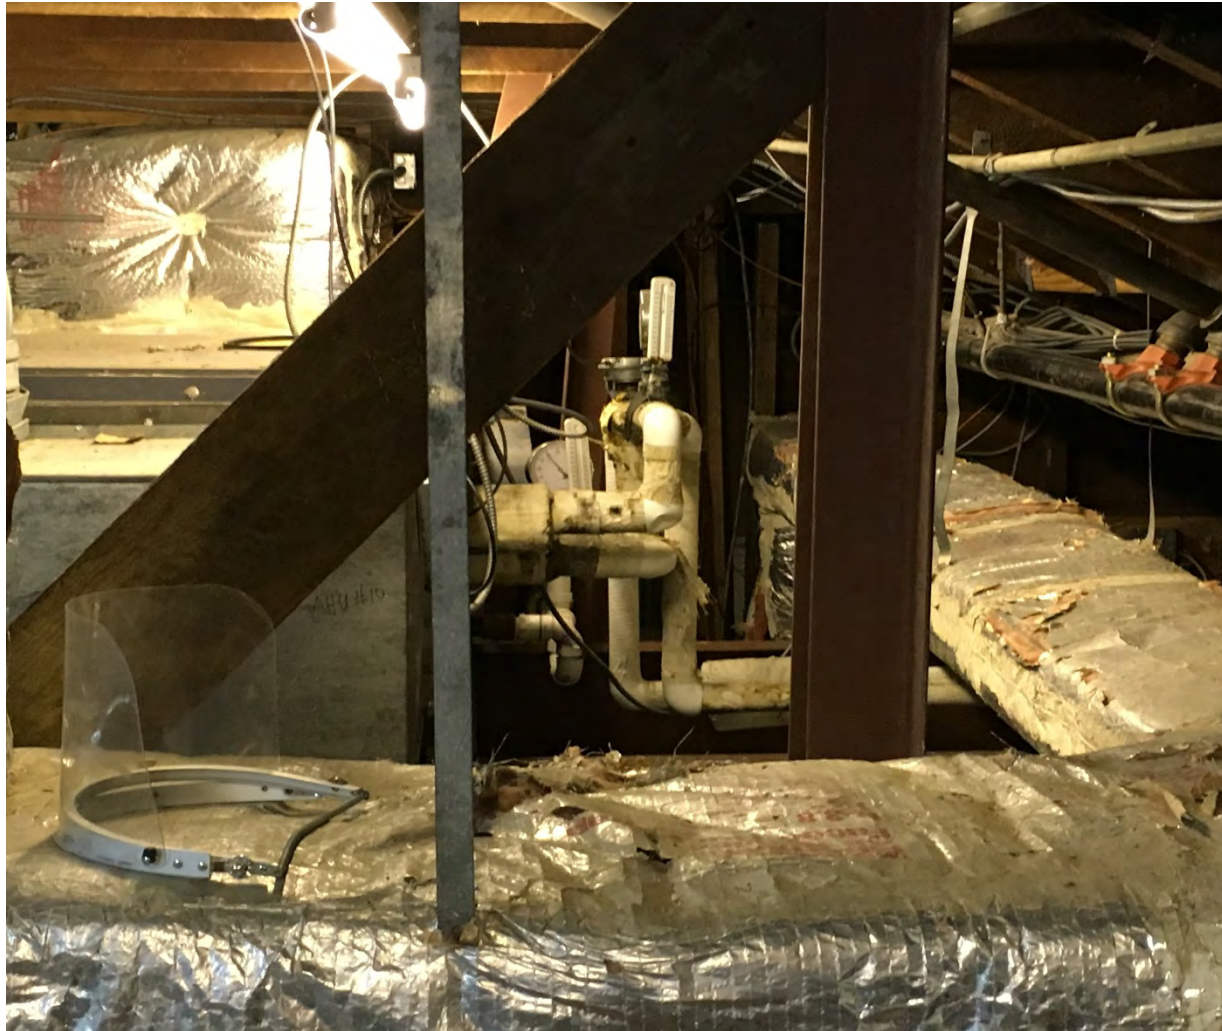
Finding # - 11. There are also 5 air handlers in the building attic. These units do pull outside air through the perimeter wall near the fans. One problem with these units is the condition of the duct work insulation which has failed. This condition will cause condensate leaks into the areas below in summer.

Finding # 11 Photo. This picture is of one of the attic air handlers with damaged duct work insulation. This will cause condensate leaks in summer.

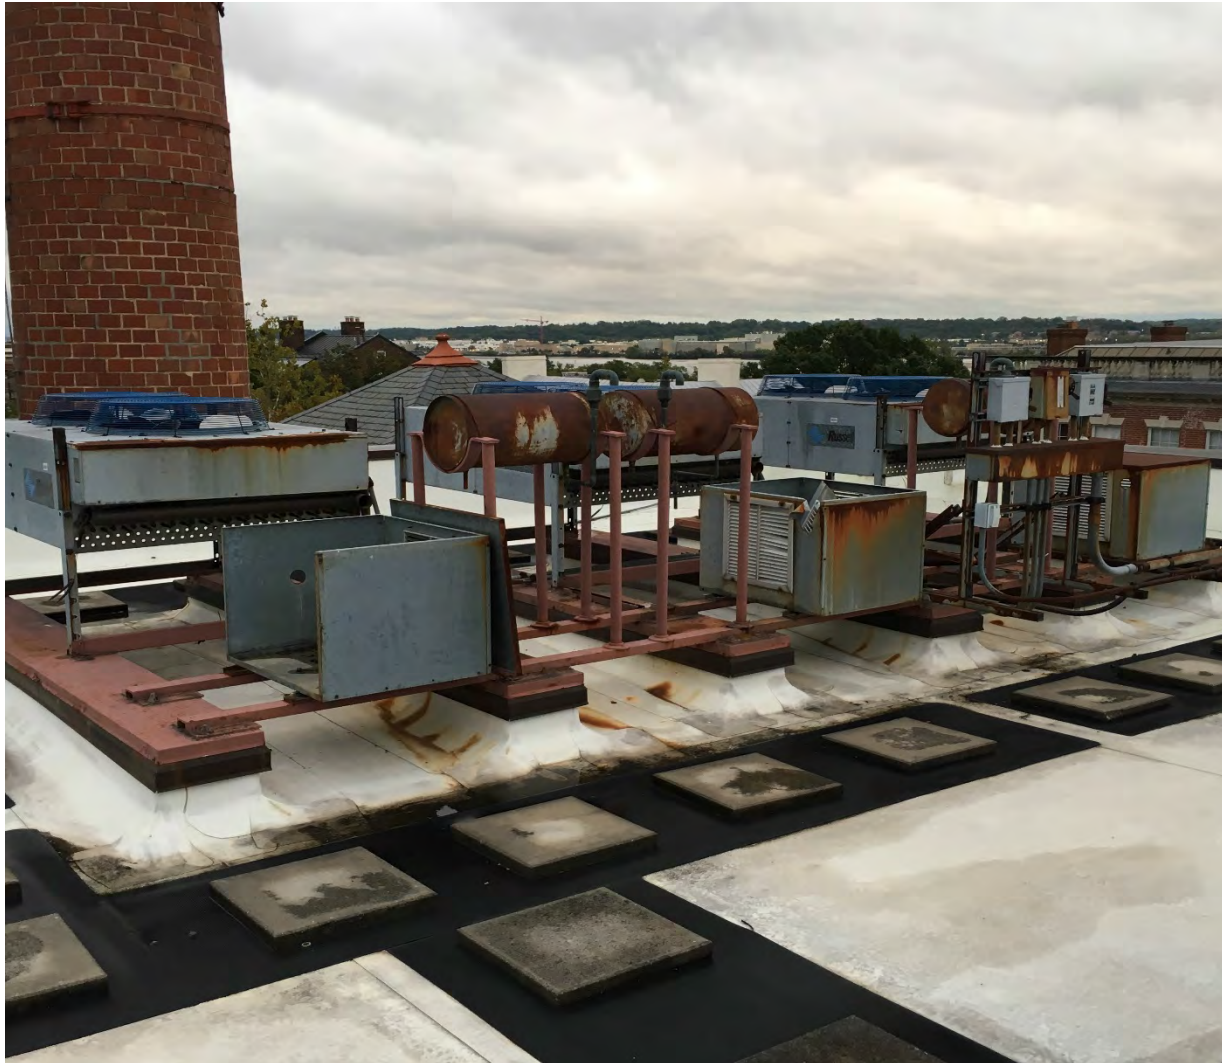
Finding # - 12. Two old dry coolers have been abandoned in place on the roof. This equipment should be removed and the roof penetrations patched and sealed over. This condition may start to cause leaks into the site.

Finding # 12 Photo. This picture notes the old dry cooler equipment abandoned in place.

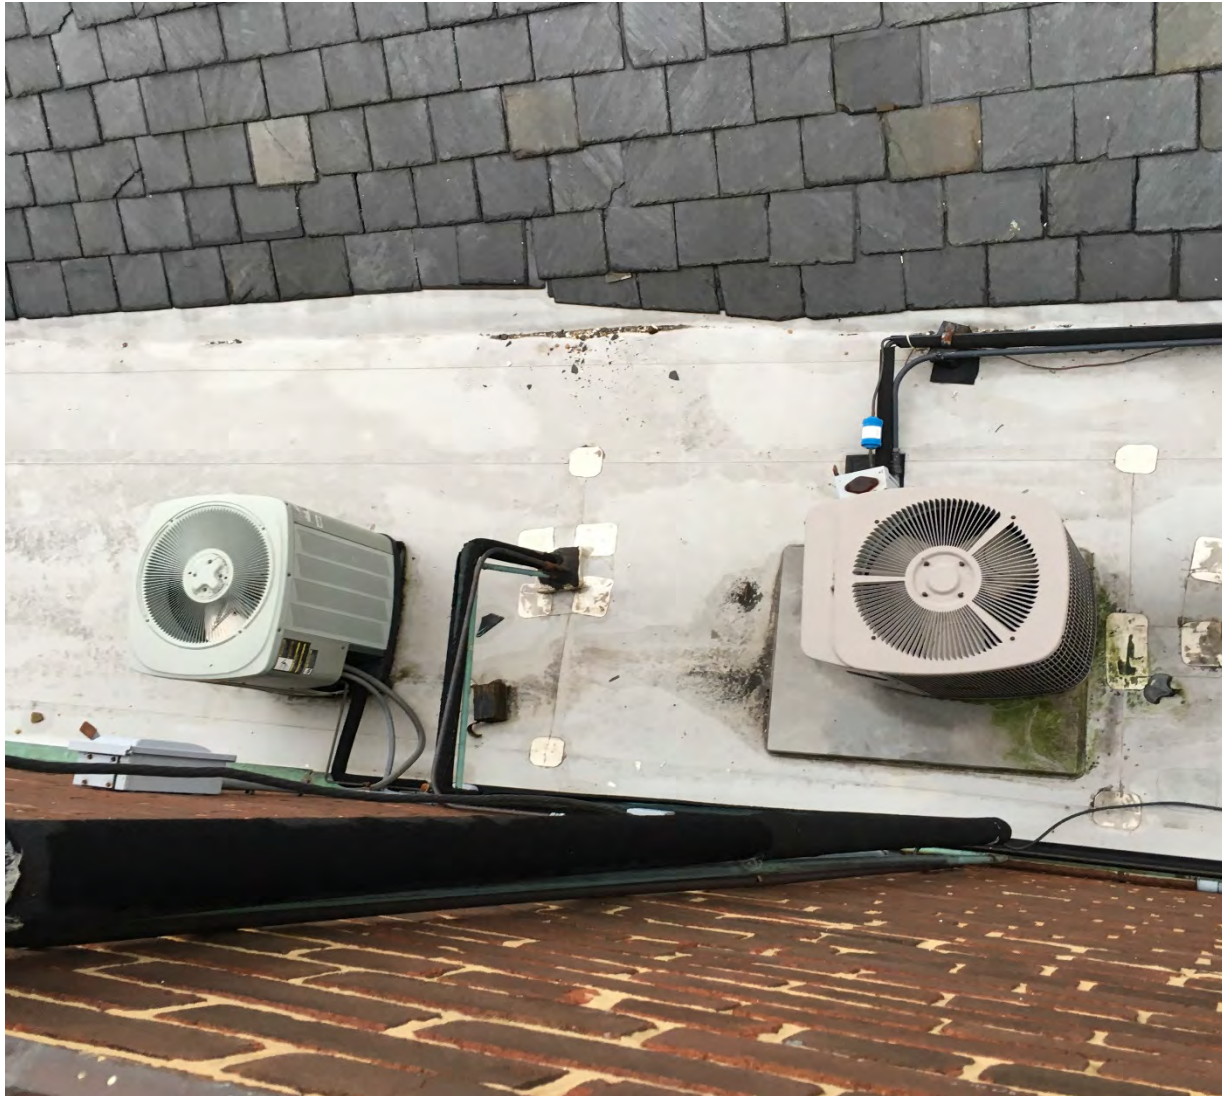
Finding # - 13. There are 24 split system heat pumps which are placed around the building to handle extra heating and cooling requirements in the building. Many of these units are very hard to access for repairs or service.

Finding # 13 Photo. This picture notes the difficult access to the HVAC units.

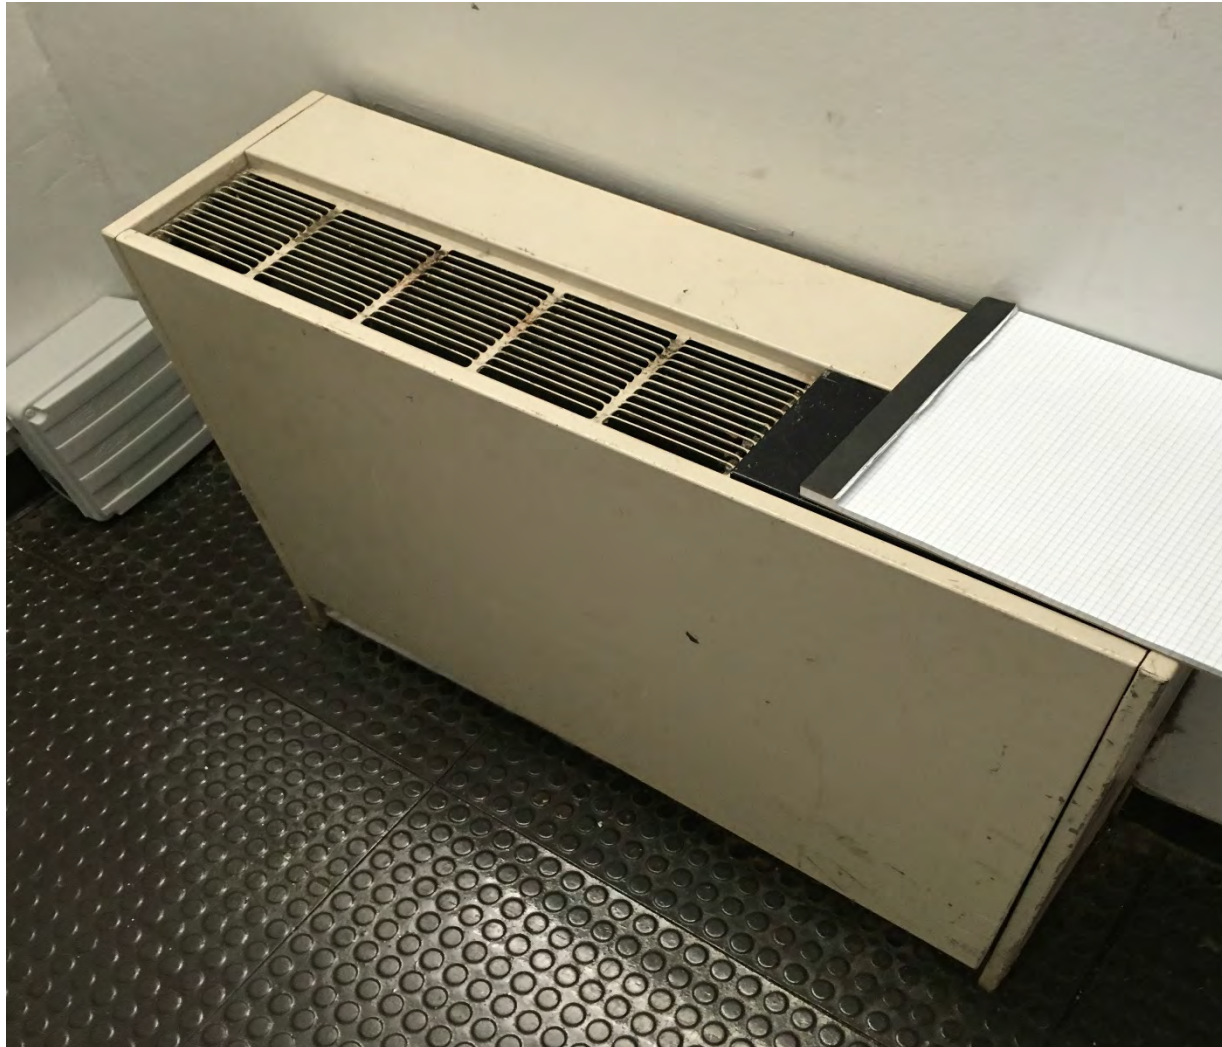
Finding # - 14. There are 180 fan coil units which are located under windows in offices and in areas around the building perimeter. These units need to be serviced and flushed regularly to eliminate condensate leaks. In many offices the staff have furniture in front of this equipment or covered so they cannot operate properly. This condition adds a lot of preparation time to get these units open for service. This equipment also causes condensate leaks in summer. The unit's condensate pans and drains should be flushed 2 to 3 times throughout the summer to eliminate the leaks.

Finding # 14 Photo. This picture is an example of one perimeter fan coil unit. This one is in an entrance way off the courtyard.

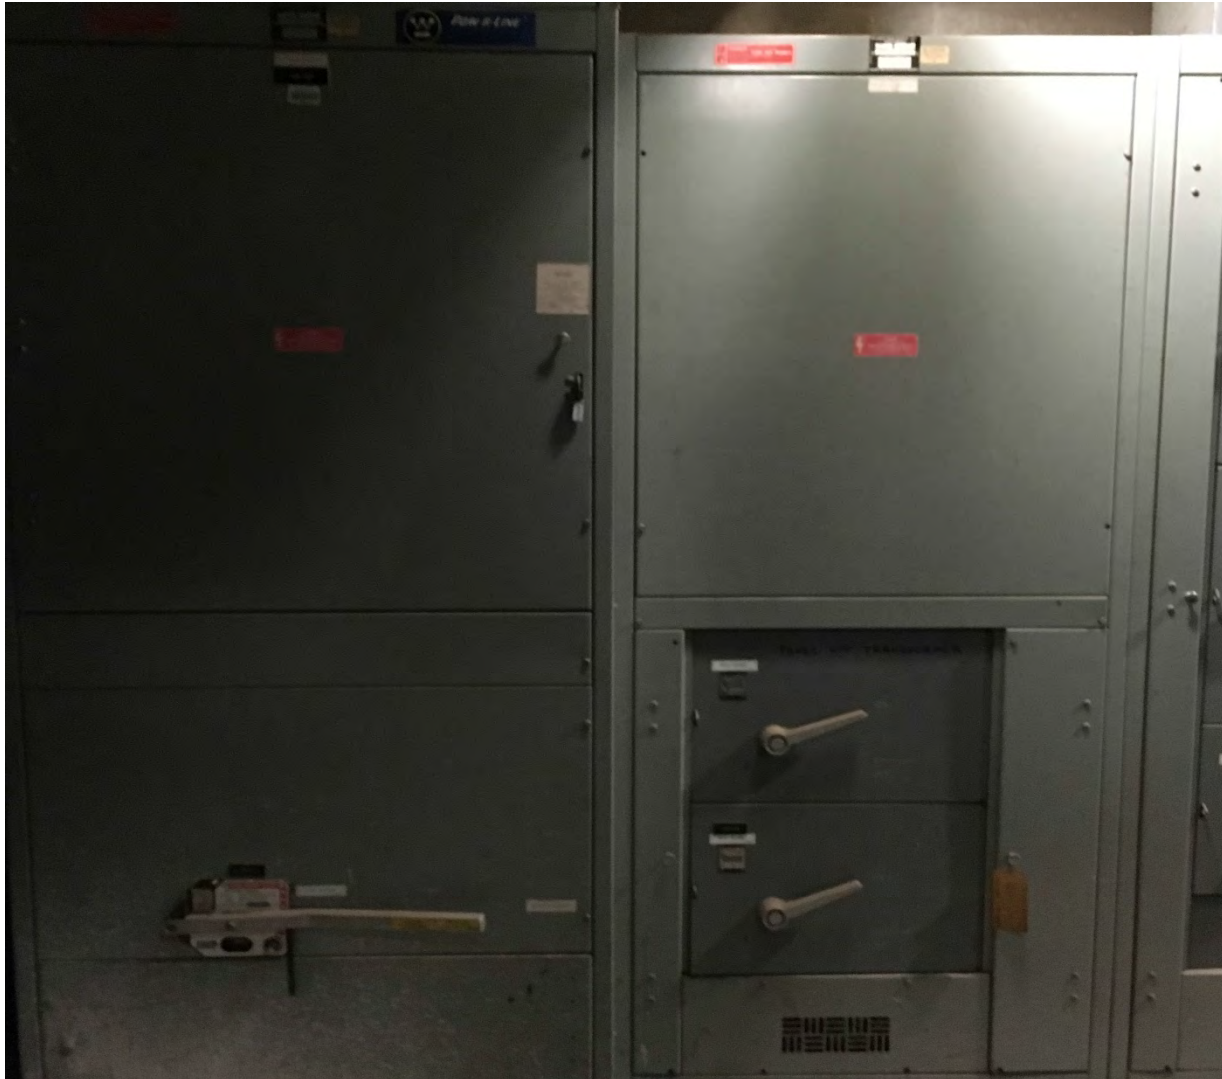
Finding # - 15. The main electrical panels and breakers panels at the site do not look as if they are being tested and serviced. All electrical systems should be thermally scanned with an infra-red camera to identify any overheating components or loose connections. This testing will identify such issues before a failure of the electrical system occurs. A2 recommends that all electrical gear be opened, thermally scanned then cleaned and all terminations checked of tightness every 2 to 3 years at a minimum. This an important risk management task that should be implemented. This maintenance is a code requirement.

Finding # 15 Photo. This picture is an example of one main switch gear which does not look like it has been shut down for cleaning and tighten-up work. Infra-Red testing should also be implemented.
