A2 Services, Inc.
Facility Survey of City of Alexandria - City Hall

A2 Services (A2) toured the Alexandria City Hall facility on October 12, 2017. City Hall is an historic building in Old Town Alexandria and is located at 301 King Street, Alexandria VA 22314. A2 arrived on site at 0700AM and met Mr. Marvin Rodriguez, the Chief Engineer for the site. It was noted that Mr. Rodriguez is also responsible for three other nearby sites, and manages two maintenance men for these four sites.

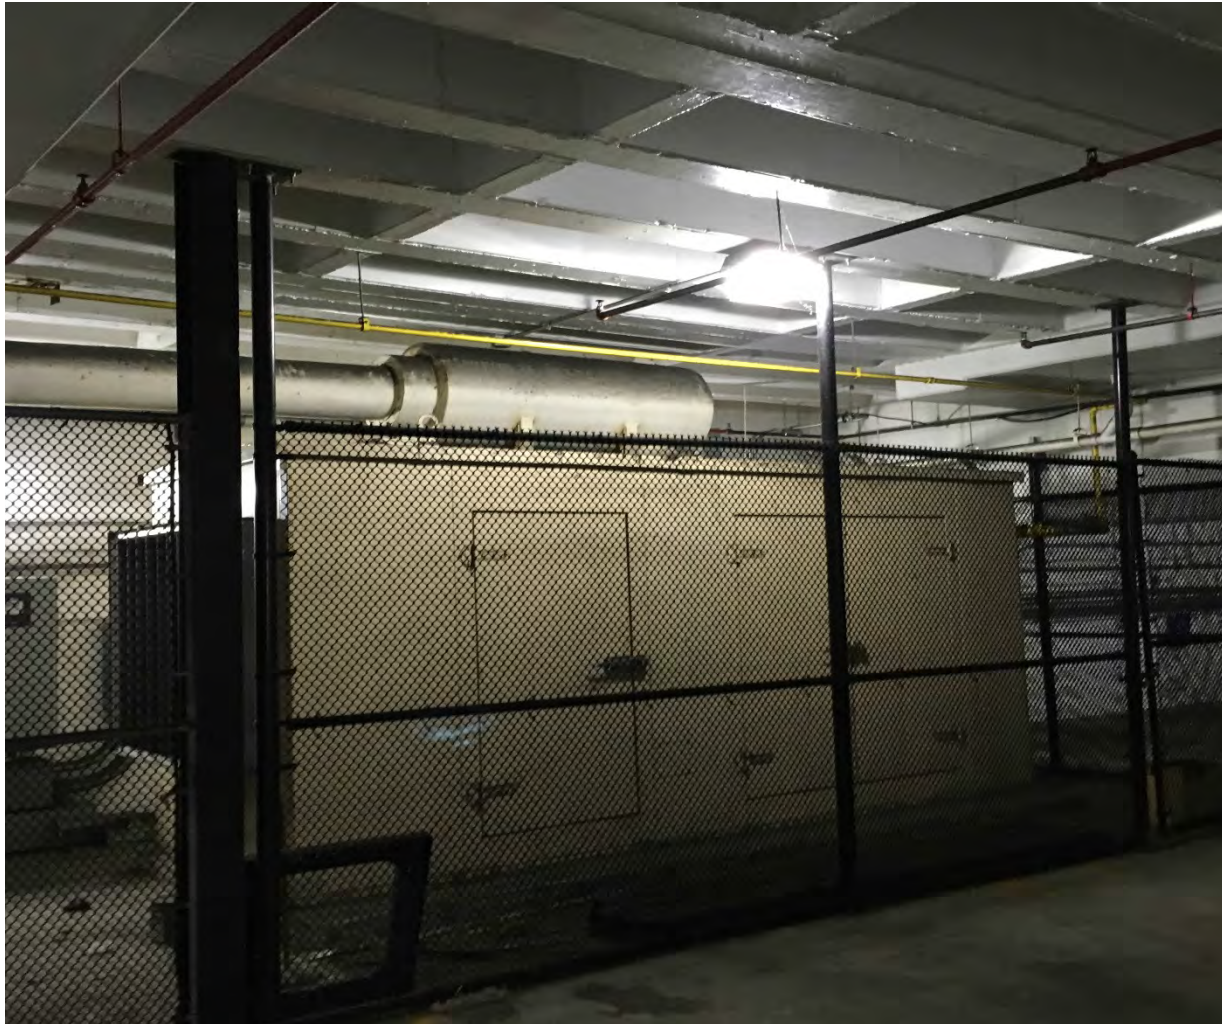
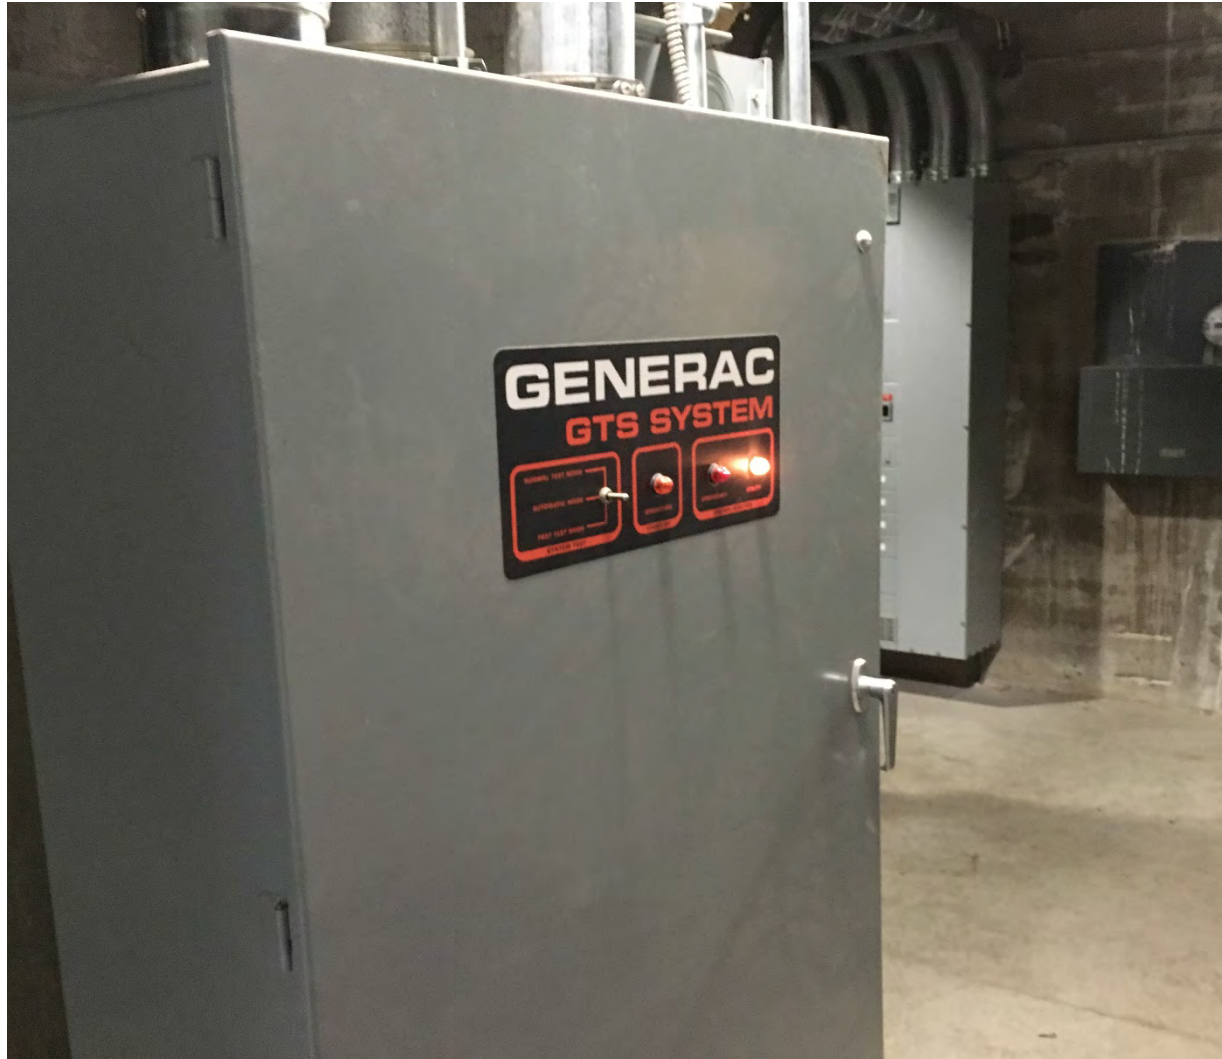
Finding # - 16. The buildings emergency generator starts weekly on a timer and runs with no load for 30 minutes. About one month ago the generator was full load tested, however the building emergency transfer switches are not being tested and transferred from normal power to emergency. This testing is very important to make sure that emergency power will be transferred to the required systems in the building on loss of outside power. This work should be implemented.

Finding # 16 Photo. A2 recommends that the emergency generator transfer switches be transferred and tested under load at least every 2 months. This picture is of the emergency generator.

Finding # 16 Photos Continued. This picture is of one of the emergency transfer switches which should be tested.

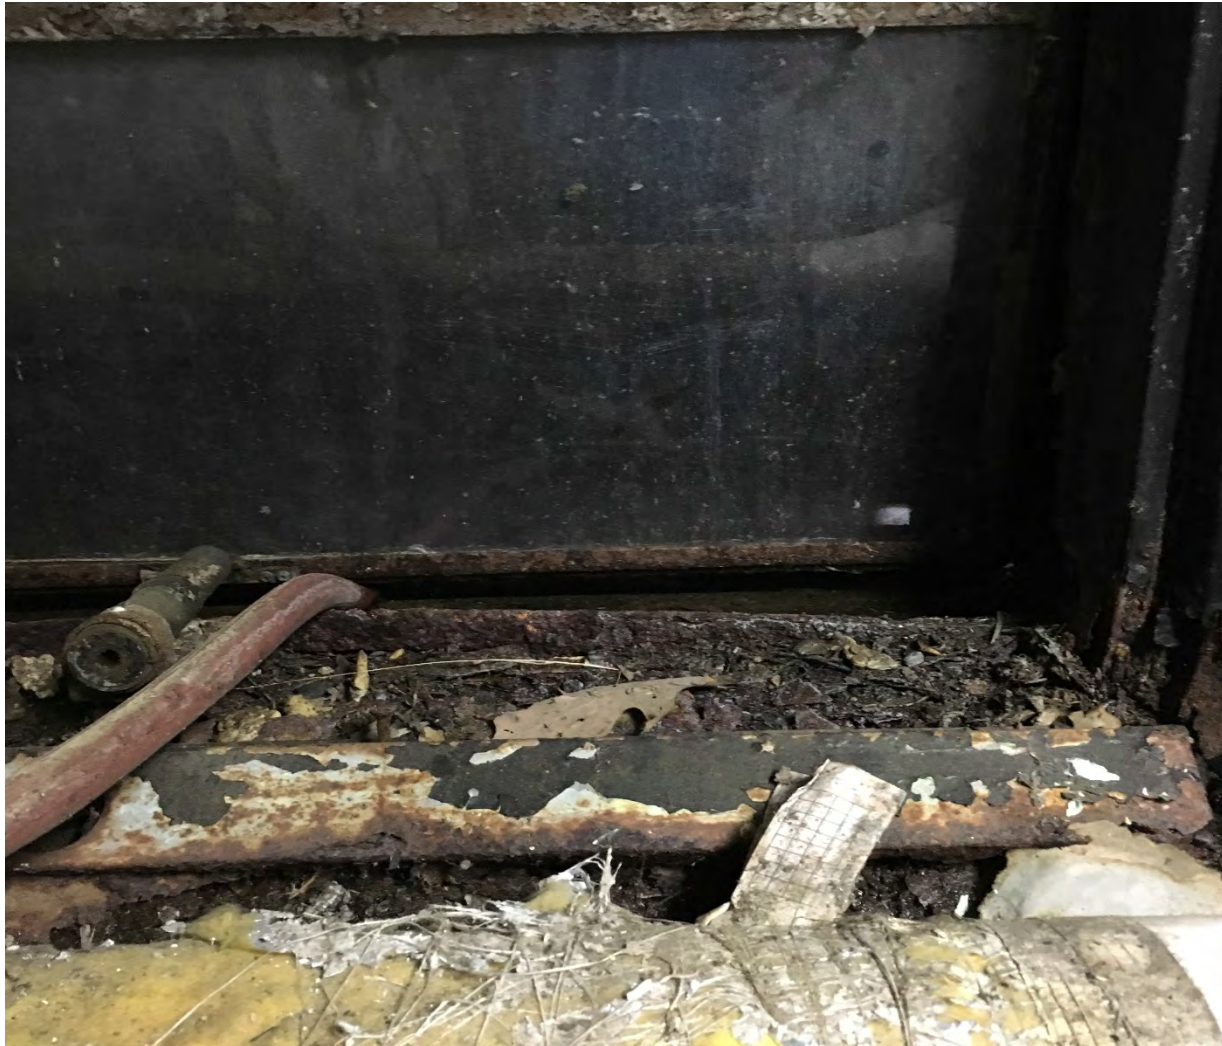
Finding # - 17. The outside air shaft drain outside the boiler room is plugged up allowing water to enter the boiler room through a window. This drain should be snaked or repaired.

Finding # 17 Photo. This picture notes the window where water is entering the boiler room from the outside air shaft.

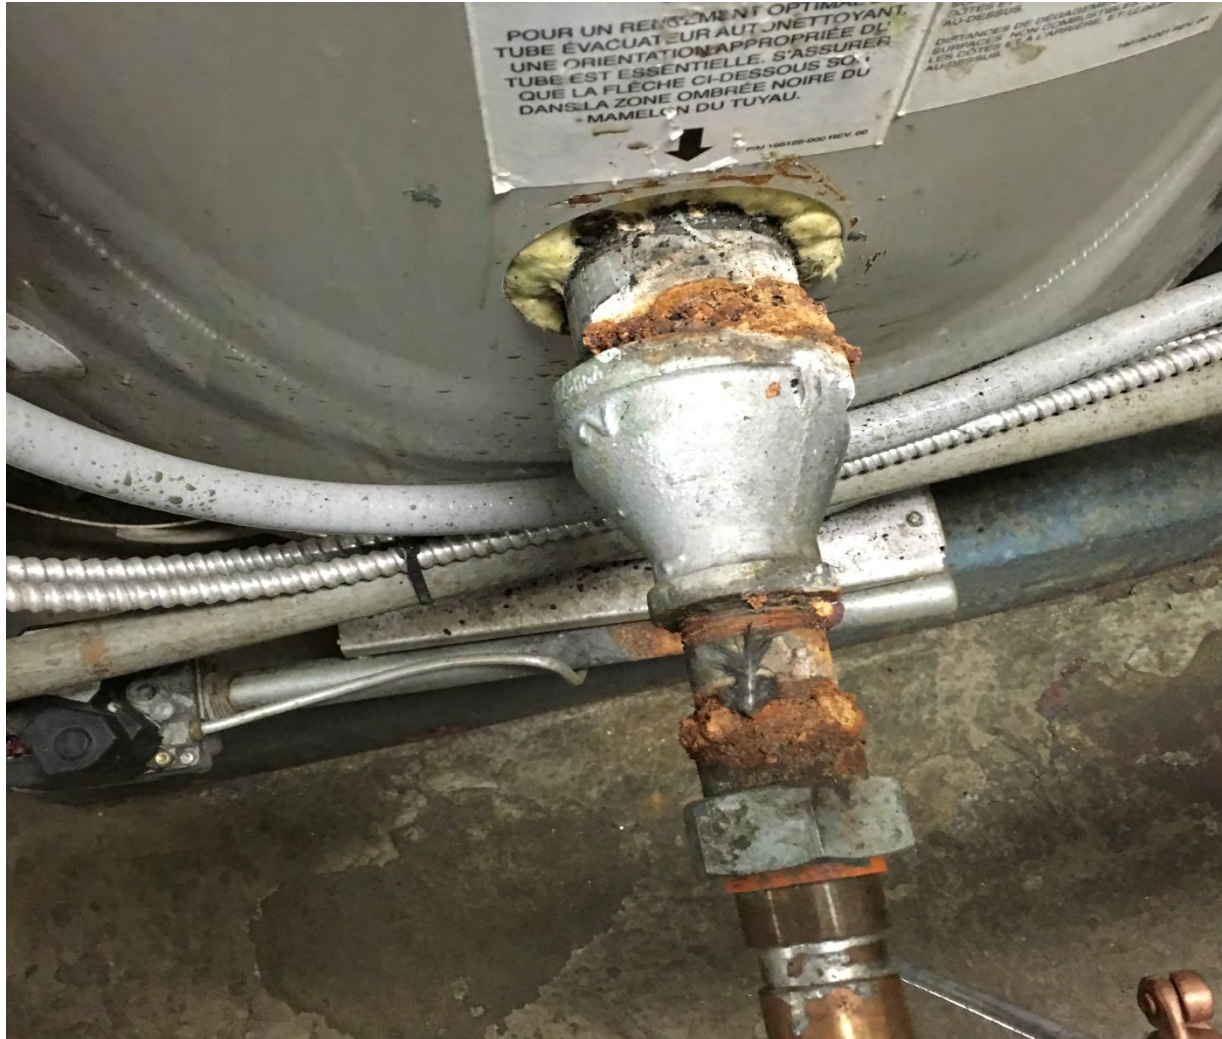
Finding # - 18. The cold water makeup line feeding the domestic hot water heater in the boiler room should be repaired before it fails. This line was installed using dissimilar metals allowing electrolysis to occur. The fittings will need to be replaced with die-electric components to eliminate this dissimilar metal corrosion.

Finding # 18 Photo. This picture notes the corroded inlet water fittings to the domestic water heater in the boiler room.

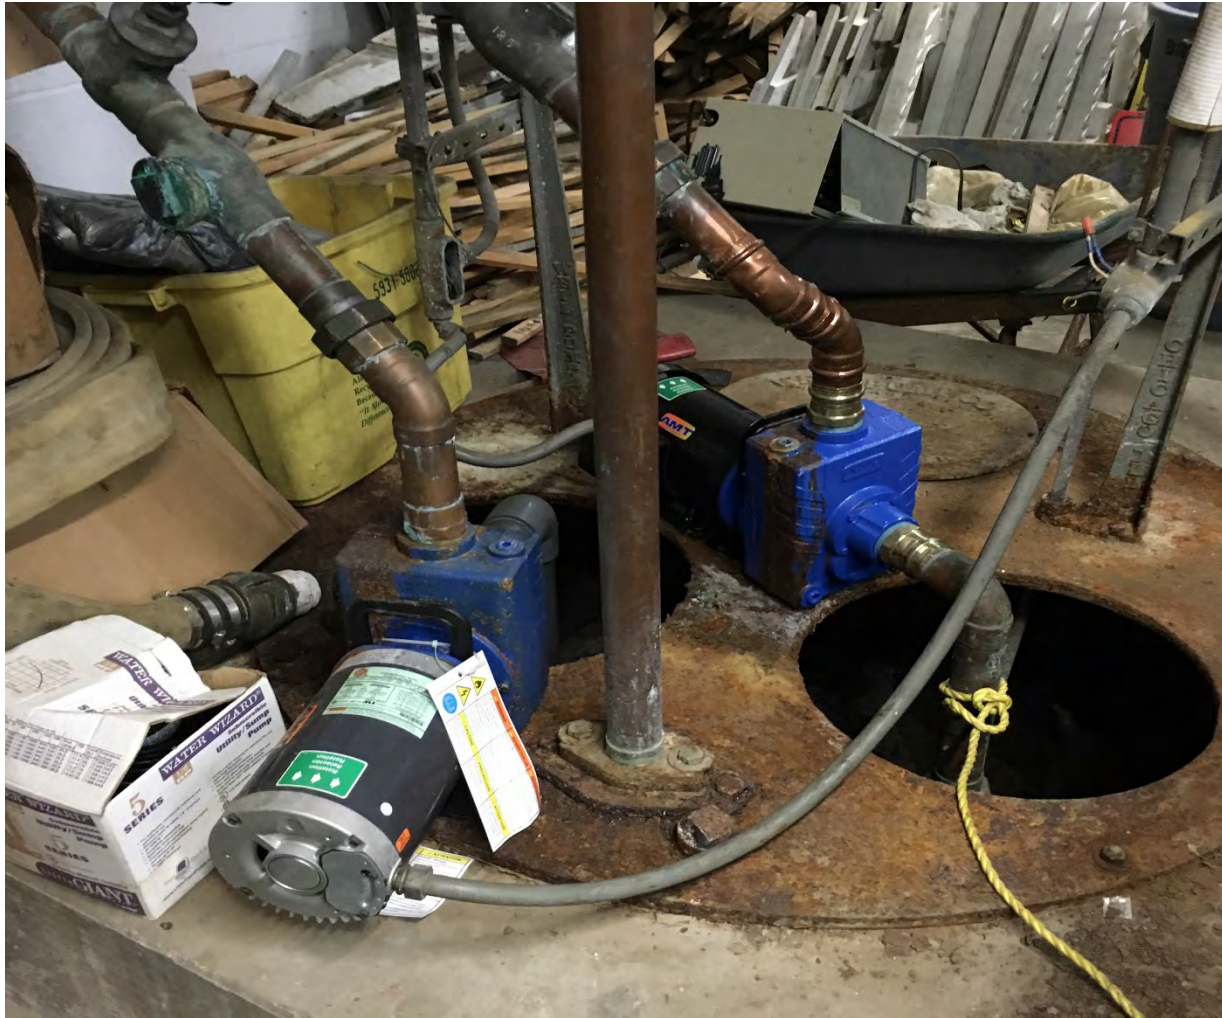
Finding # - 19. Two new sump pumps were recently installed in the upper garage ground water sump. These two pumps are not the correct pump for the application. These two new pumps are standard well pumps with foot valves instead of the correct submersible type pump. The problem is when the foot valve sticks and these pumps loose suction these units will stop pumping.

Finding # 19 Photo. This picture notes the two new pumps being used at the upper garage sump pit. These should have been submersibles.

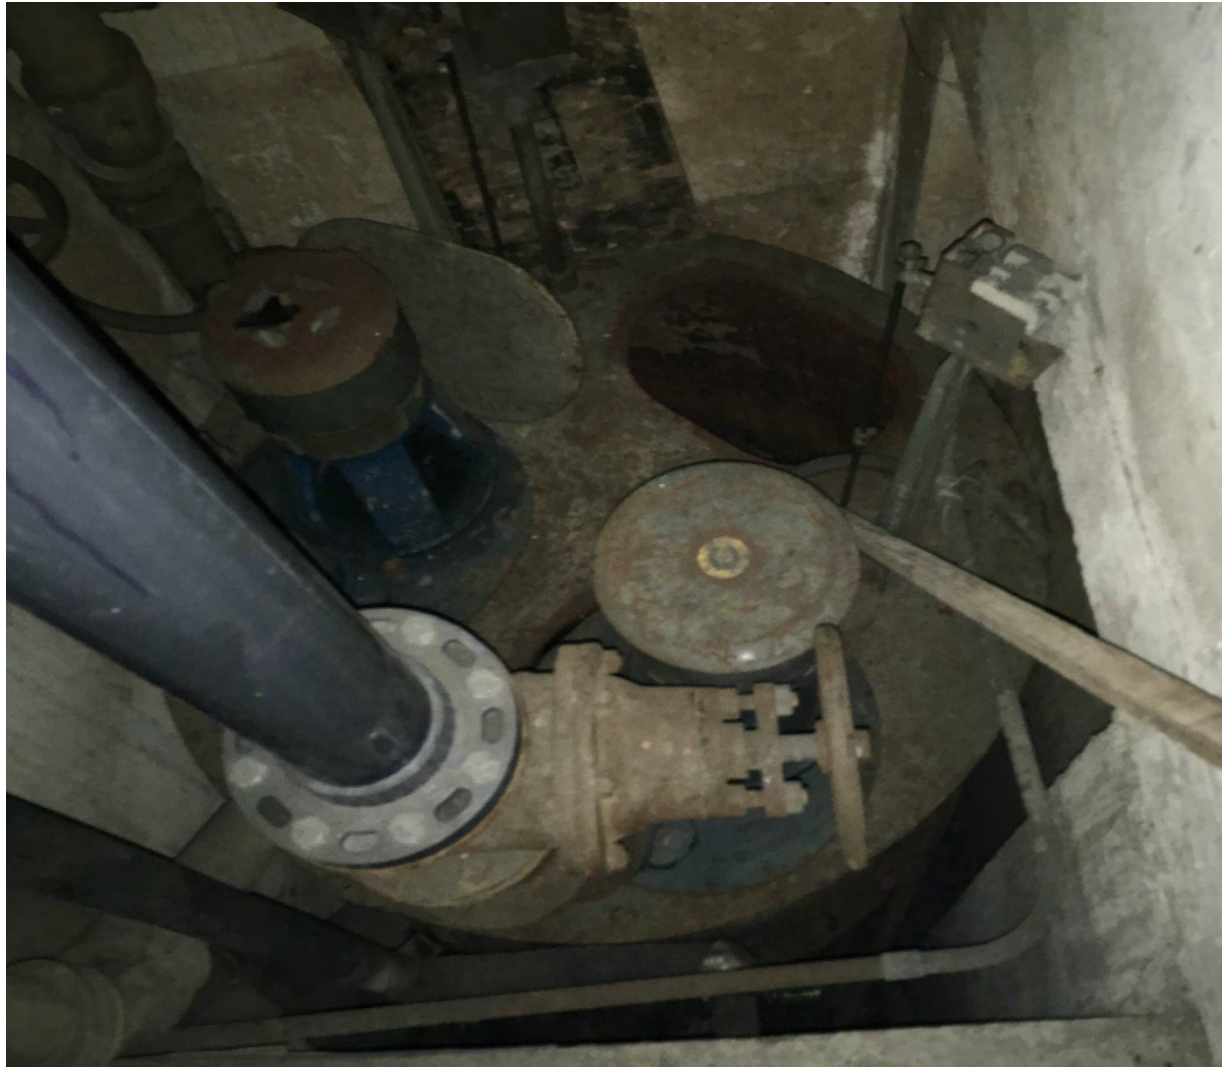
Finding # - 20. There is another set of old shaft driven sump pumps in the lower garage pit which are still operational. It would be wise to consider replacing these pumps. They should be replaced with submersible style pumps which will provide twenty years of service with little maintenance. The ground water sump pumps in the garage are critical and are the only way to get water out of the garage.

Finding # 20 Photo. This picture notes the old shaft driven sump pumps which are noisy. If they fail the garage could flood.

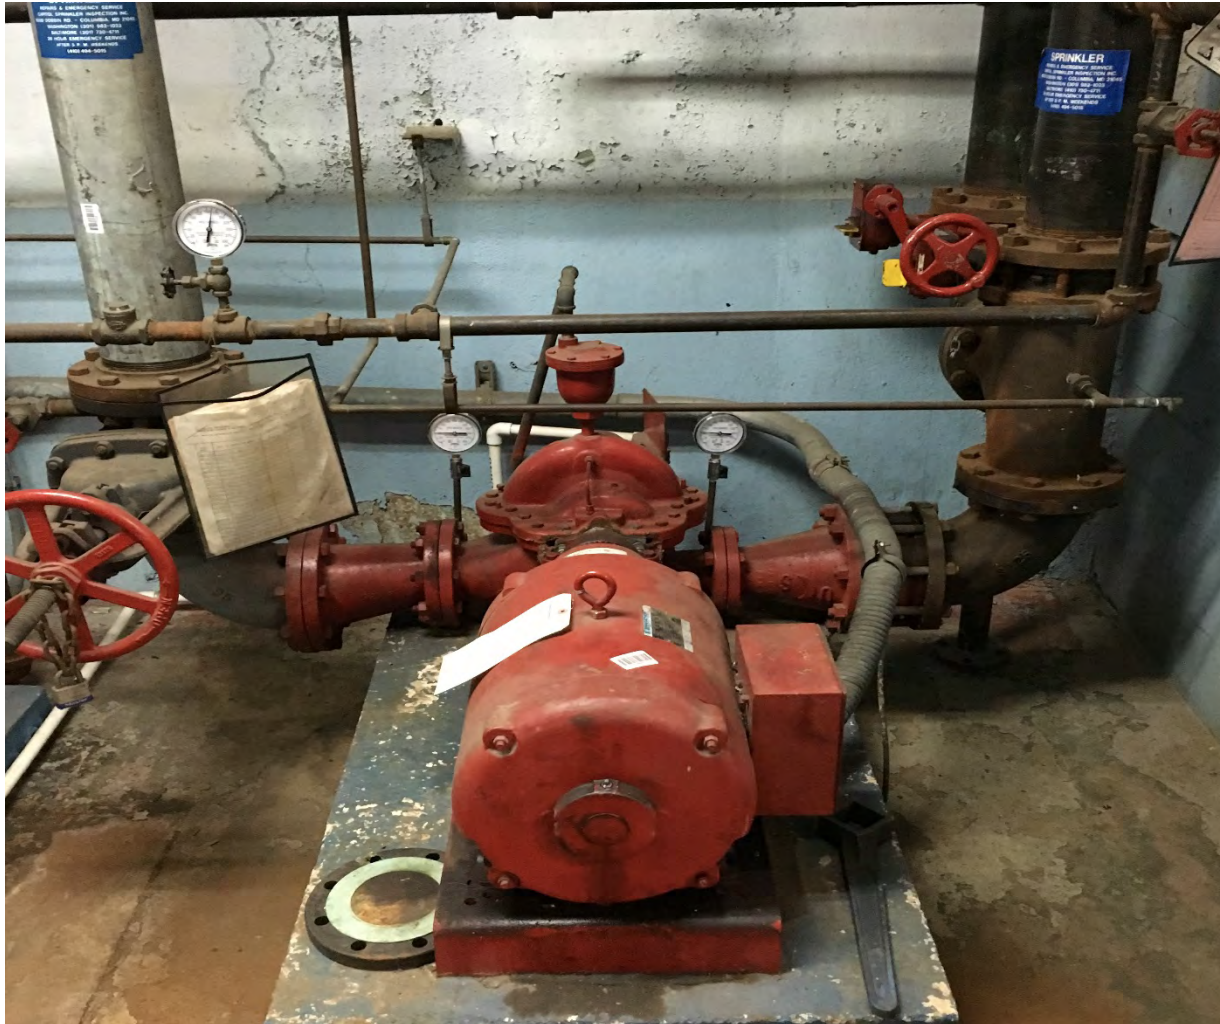
Finding # - 21. The building Fire Pump is located in the boiler room. NFPA code requires that this pump be tested weekly with no flow. An annual flow test to the street is also required. No test tags are shown on the pump showing that this PM was being done.

Finding # 21 Photo. This picture notes the fire pump in the boiler room. The pump needs to be tested weekly with no flow and once a year with full flow to the street. This is required to make sure the pump will operate correctly in an actual fire event.

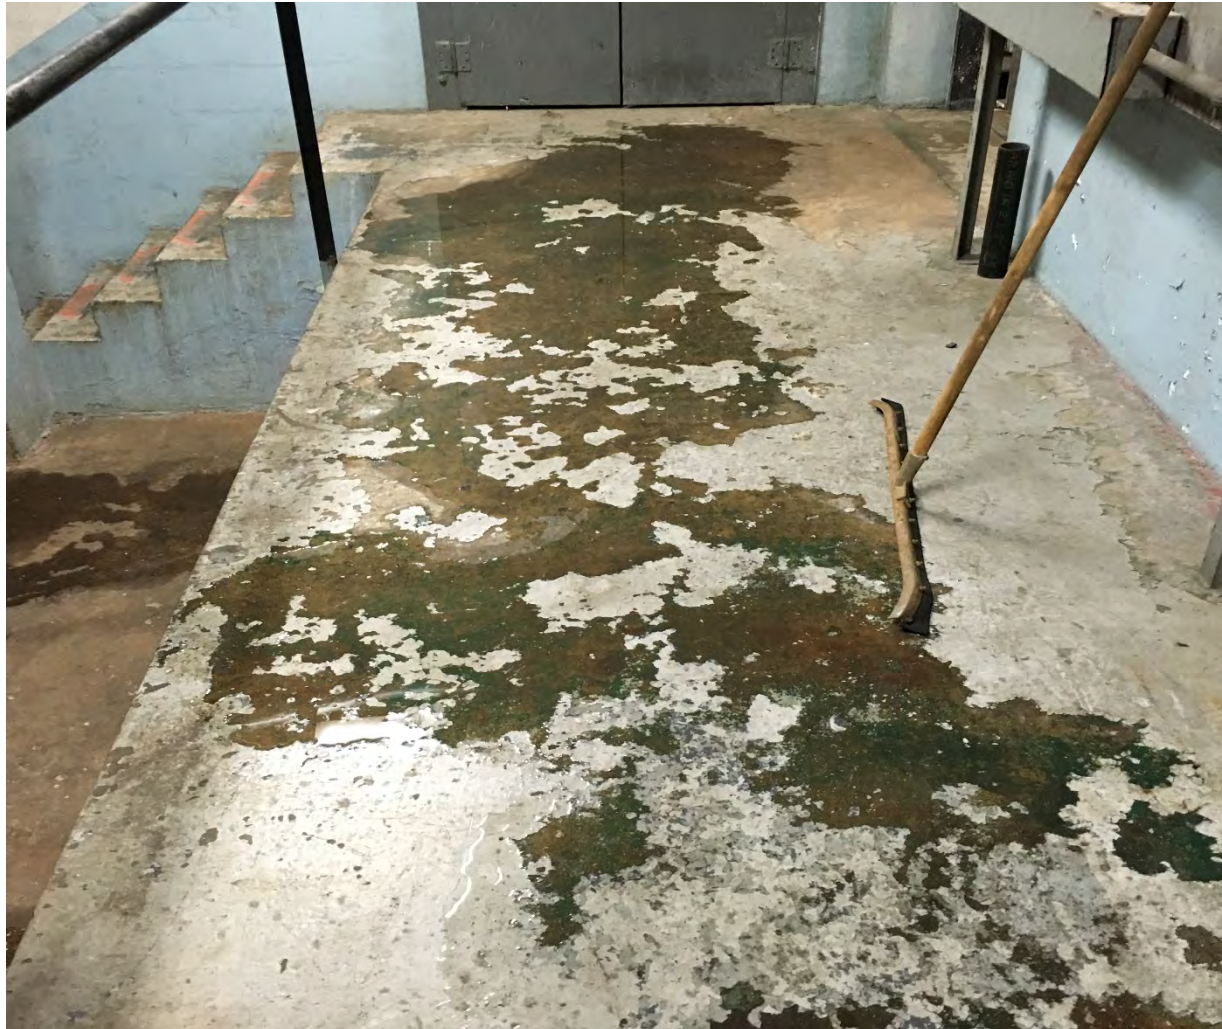
Finding # - 22. Ground water is entering the boiler room through the floor slab at the boilers causing problems. This should be investigated and corrected. This type of water infiltration will damage the building matt slab.

Finding # 22 Photo. This picture notes the water on the boiler room floor which is coming in through the floor slab.

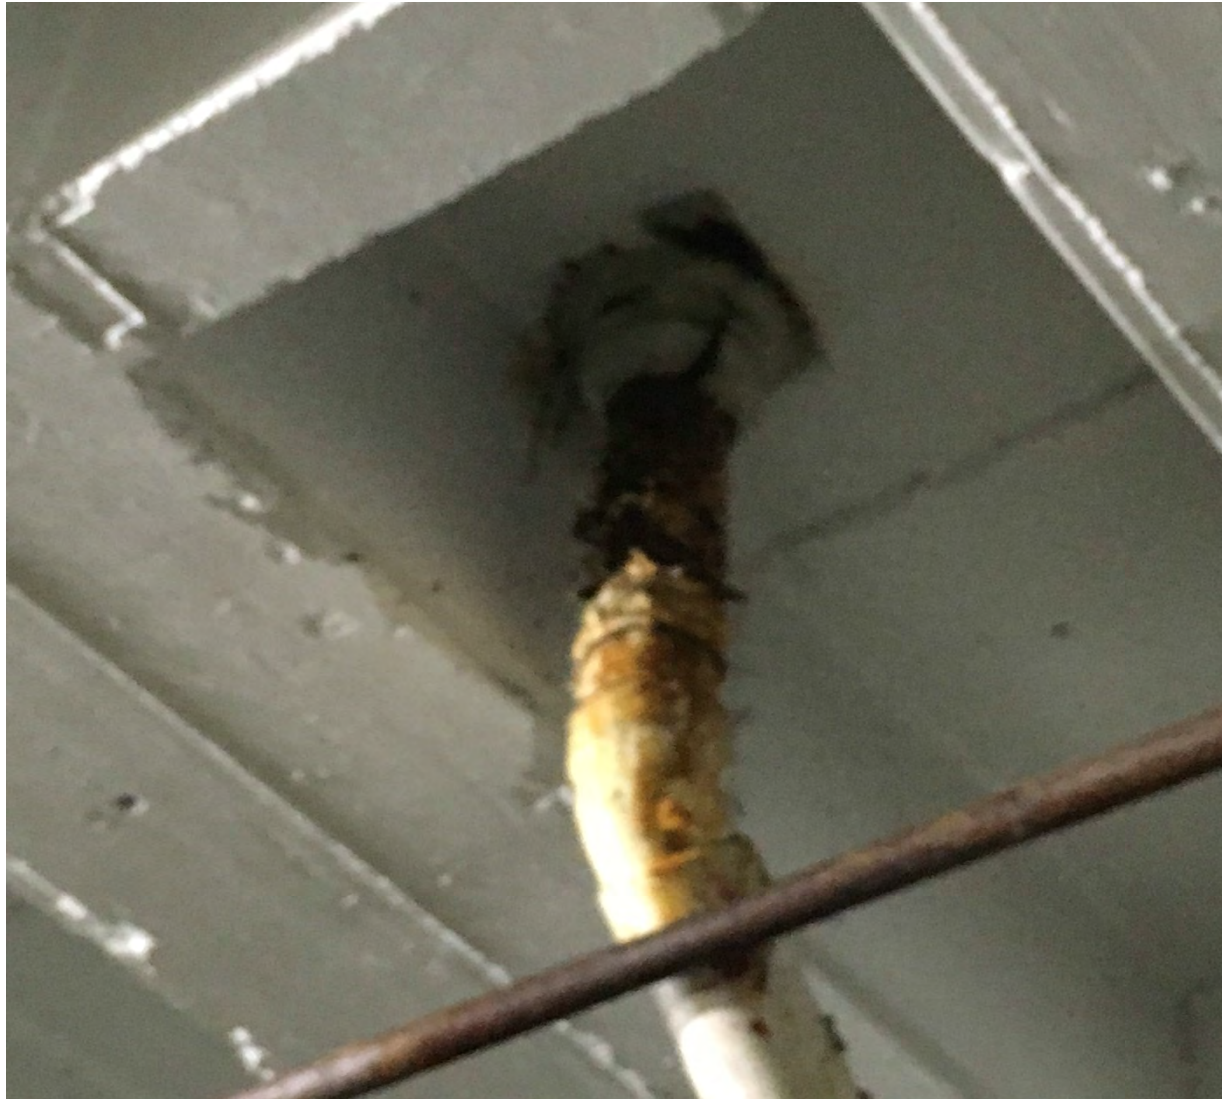
Finding # - 23. The courtyard planter drains are leaking into the garage causing concrete damage.

Finding # 23 Photo. This picture is of one planter drain which is leaking into the garage.

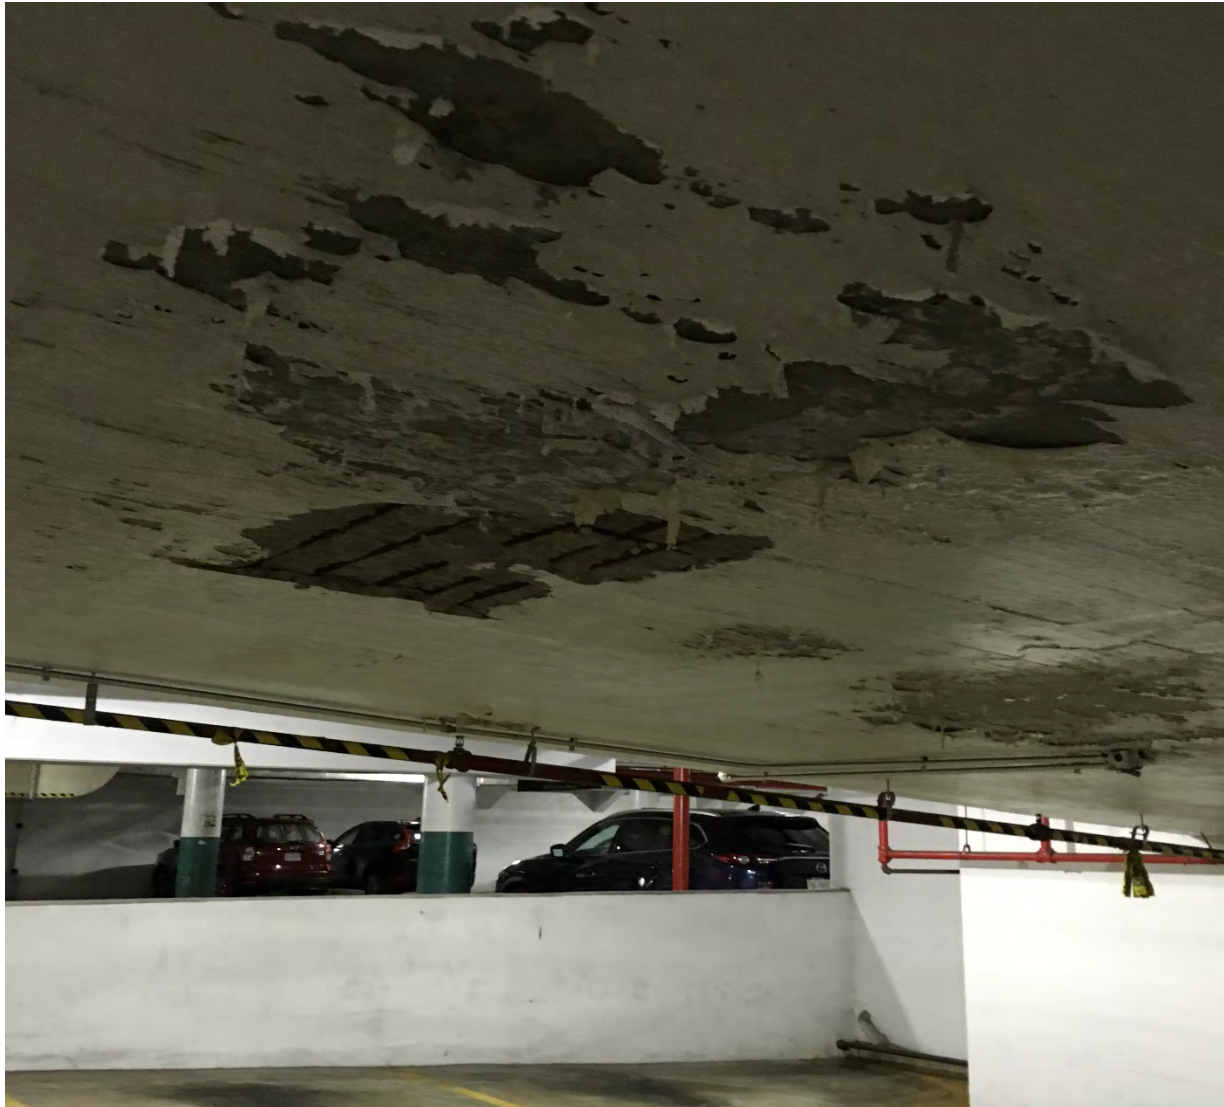
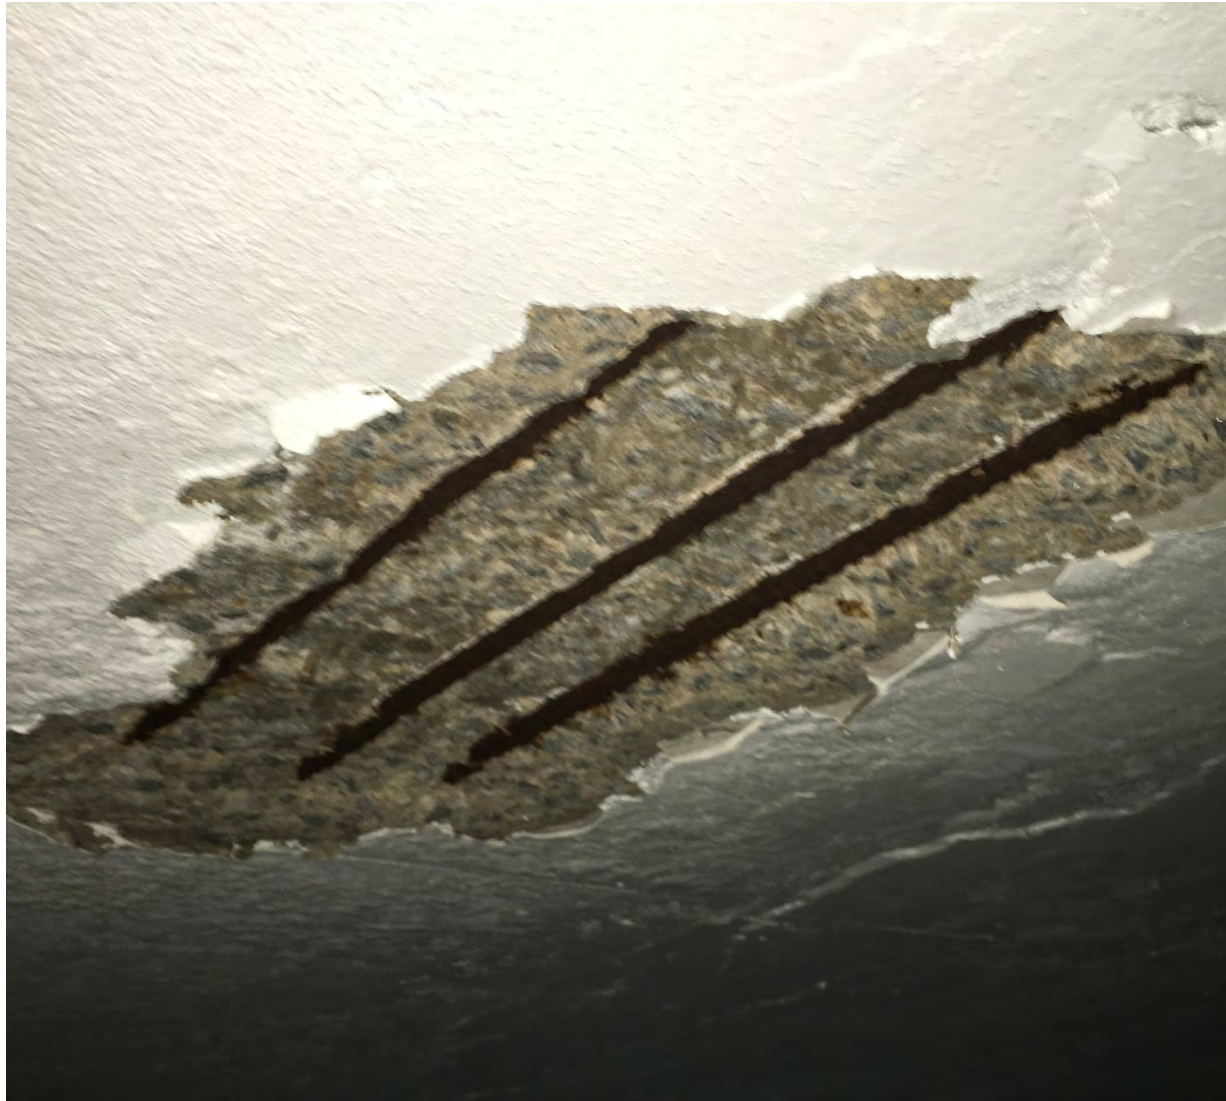
Finding # - 24. There are numerous structural cracks and leaks allowing water to damage the garage walls, floors and ceiling slabs. These issues should be repaired before they create more damage.

Finding # 24 Photo. This picture is one example of structural damage in the garage from water infiltration.

Finding # 24 Photos Continued. This picture is another example of structural damage in the garage.

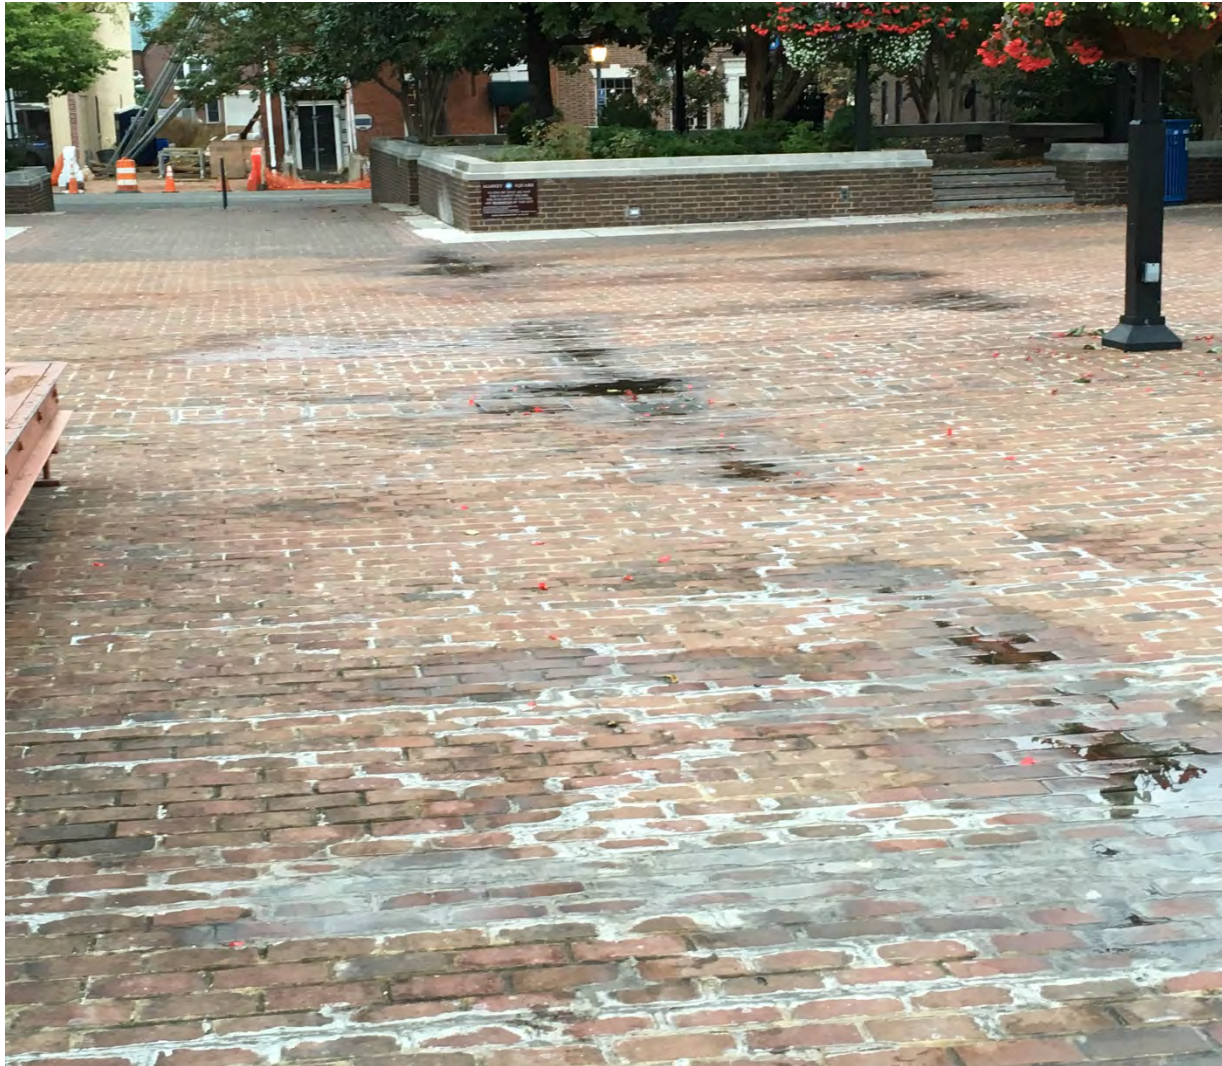
Finding # - 25. The courtyard brick work has a few areas where it looks as if water is also getting into the garage. The water leaks into the garage are causing noticeable damage.

Finding # 25 Photo. This picture notes a section of the brick work on the courtyard deck which looks to be adding to the water issues in the garage.

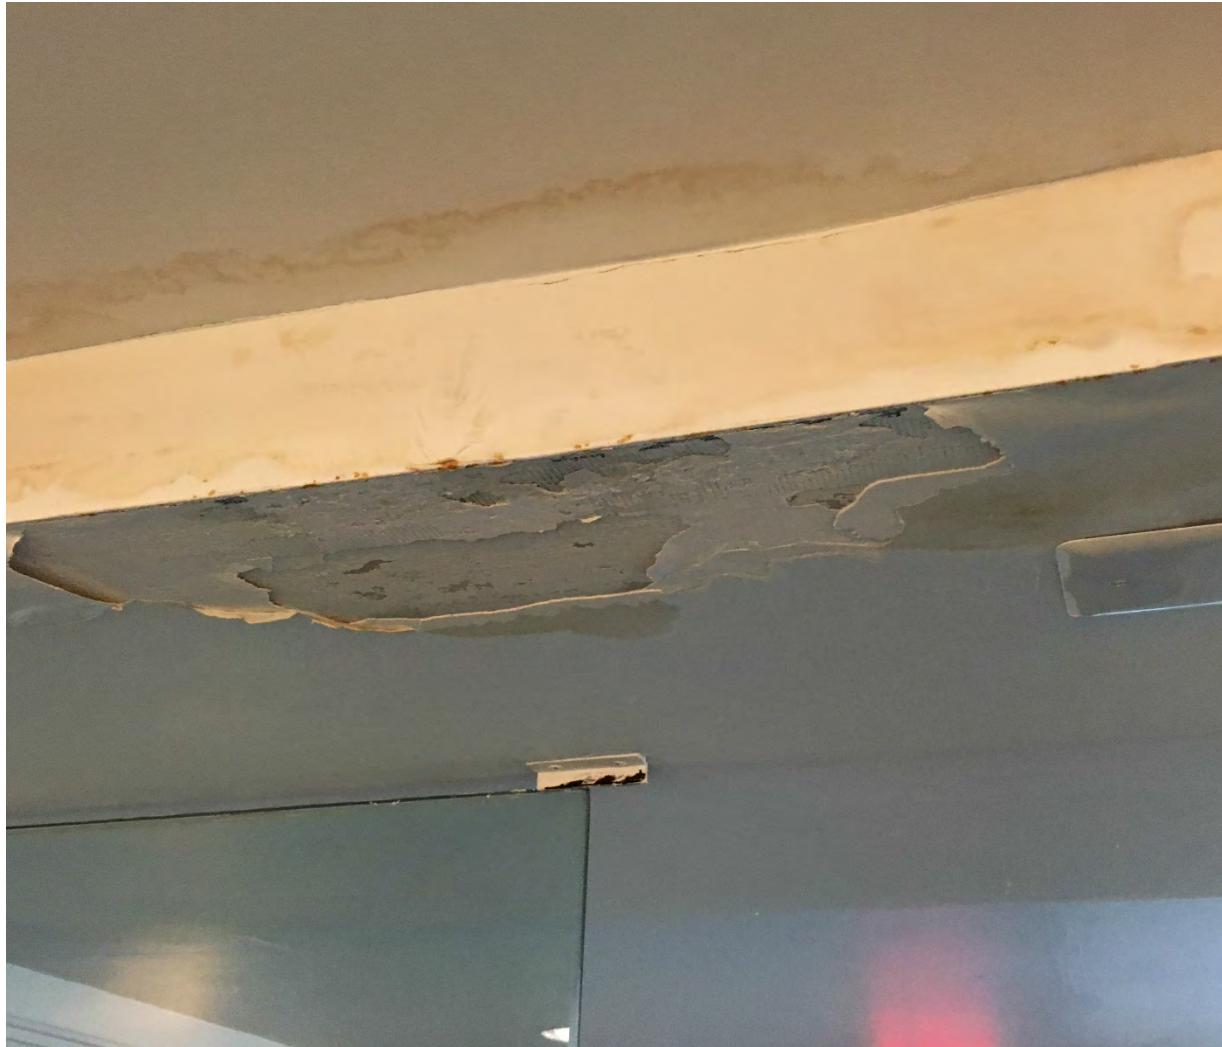
Finding # - 26. There is a roof leak into the building outside room 3230 and is damaging the drywall bulkhead at the glass doors.

Finding # 26 Photo. This picture notes the water damaged dry wall bulk head outside room 3230. This is from a roof leak.

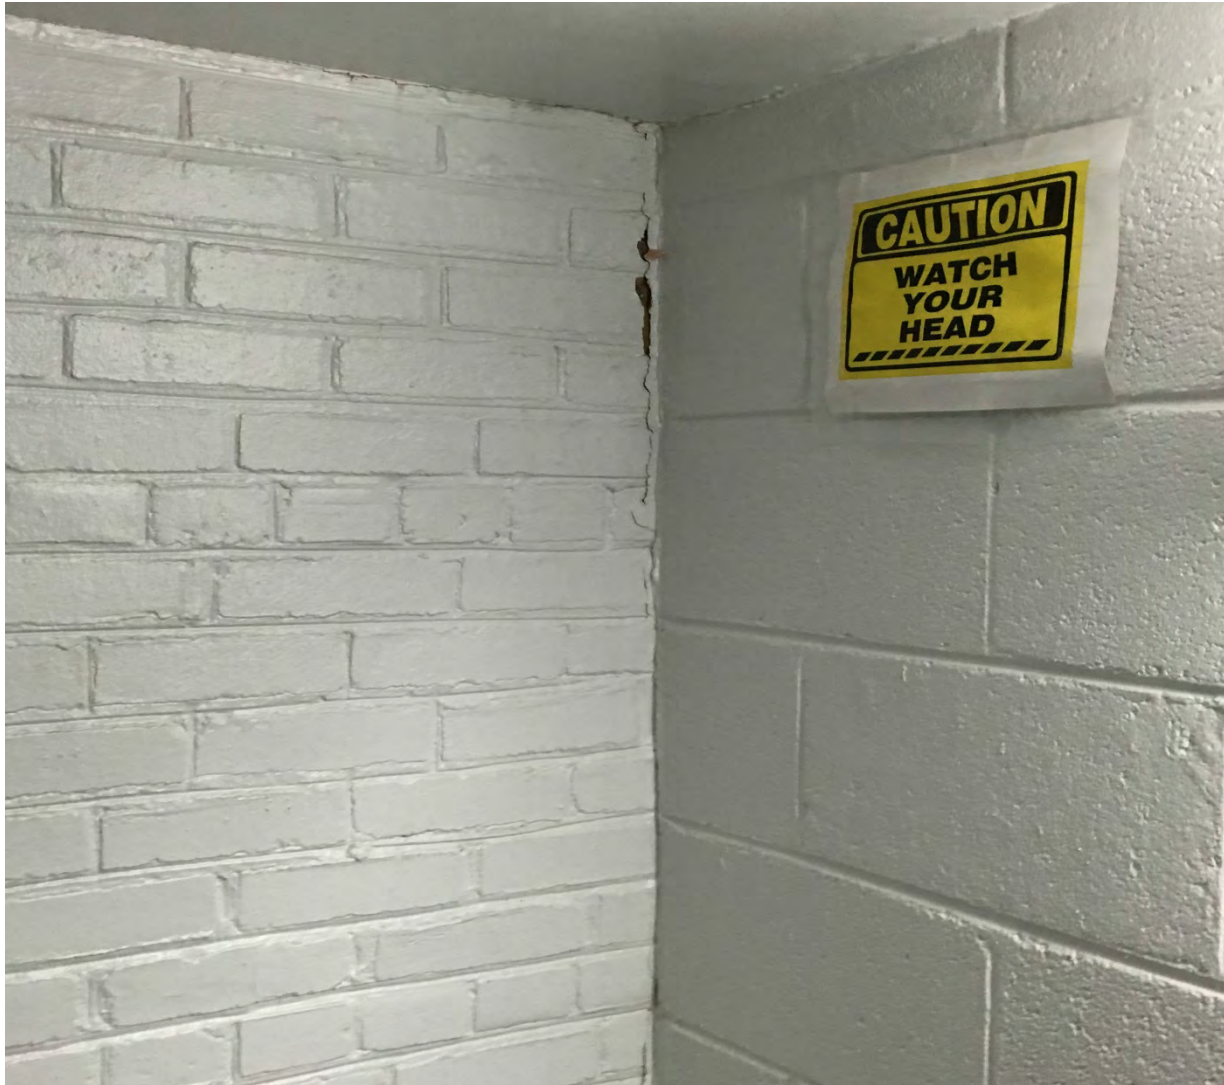
Finding # - 27. Stairwell #1 has a water leak through the wall from outside and will need to be repaired.

Finding # 27 Photo. This picture notes the crack between the block and the brick walls where water is entering stairway #1.

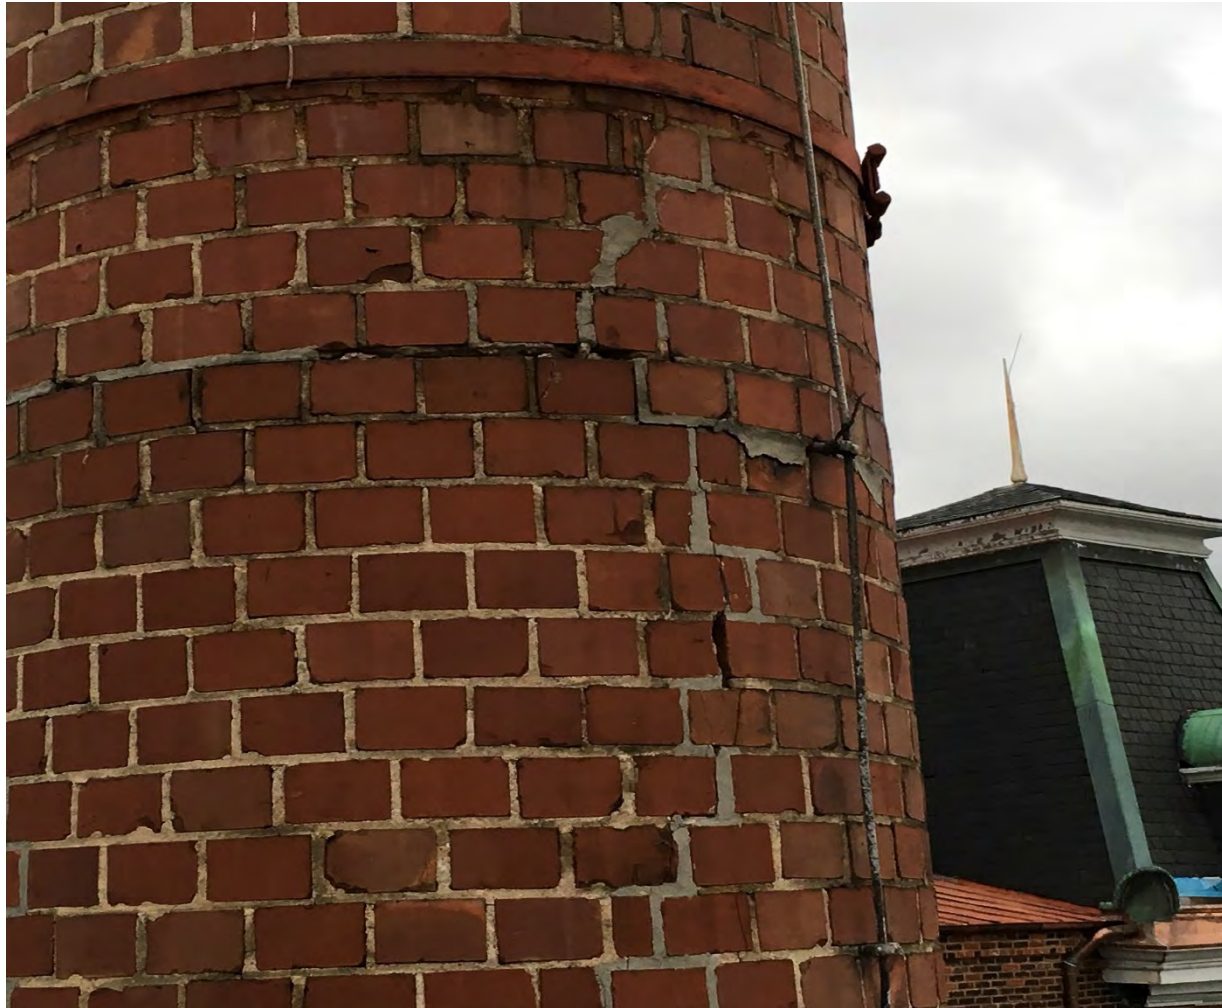
Finding # - 28. The boiler chimney is structurally damaged. Metal clamps have been installed to help compensate but the damage is pretty severe.

Finding # 28 Photo. This picture notes the structural damage to the brick chimney.

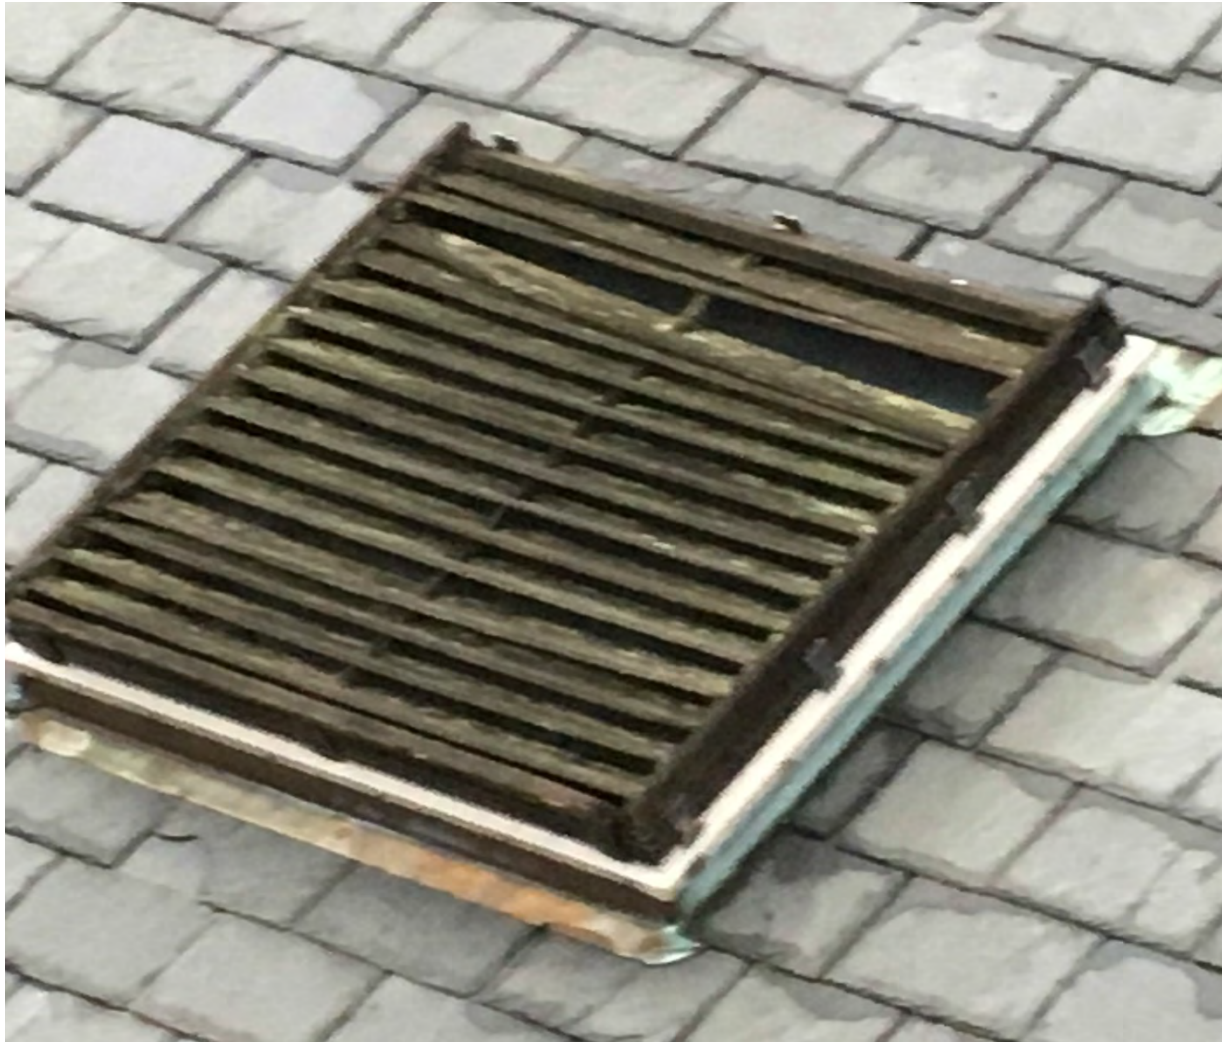
Finding # - 29. There is one wooden louver in the east side slate roof which is deteriorating and needs to be replaced.

Finding # 29 Photo. The picture notes the rotten wooden louver which will need to be replaced.
