A2 Services, Inc.
Facility Survey of City of Alexandria - City Hall

A2 Services (A2) toured the Alexandria City Hall facility on October 12, 2017. City Hall is an historic building in Old Town Alexandria and is located at 301 King Street, Alexandria VA 22314. A2 arrived on site at 0700AM and met Mr. Marvin Rodriguez, the Chief Engineer for the site. It was noted that Mr. Rodriguez is also responsible for three other nearby sites, and manages two maintenance men for these four sites.

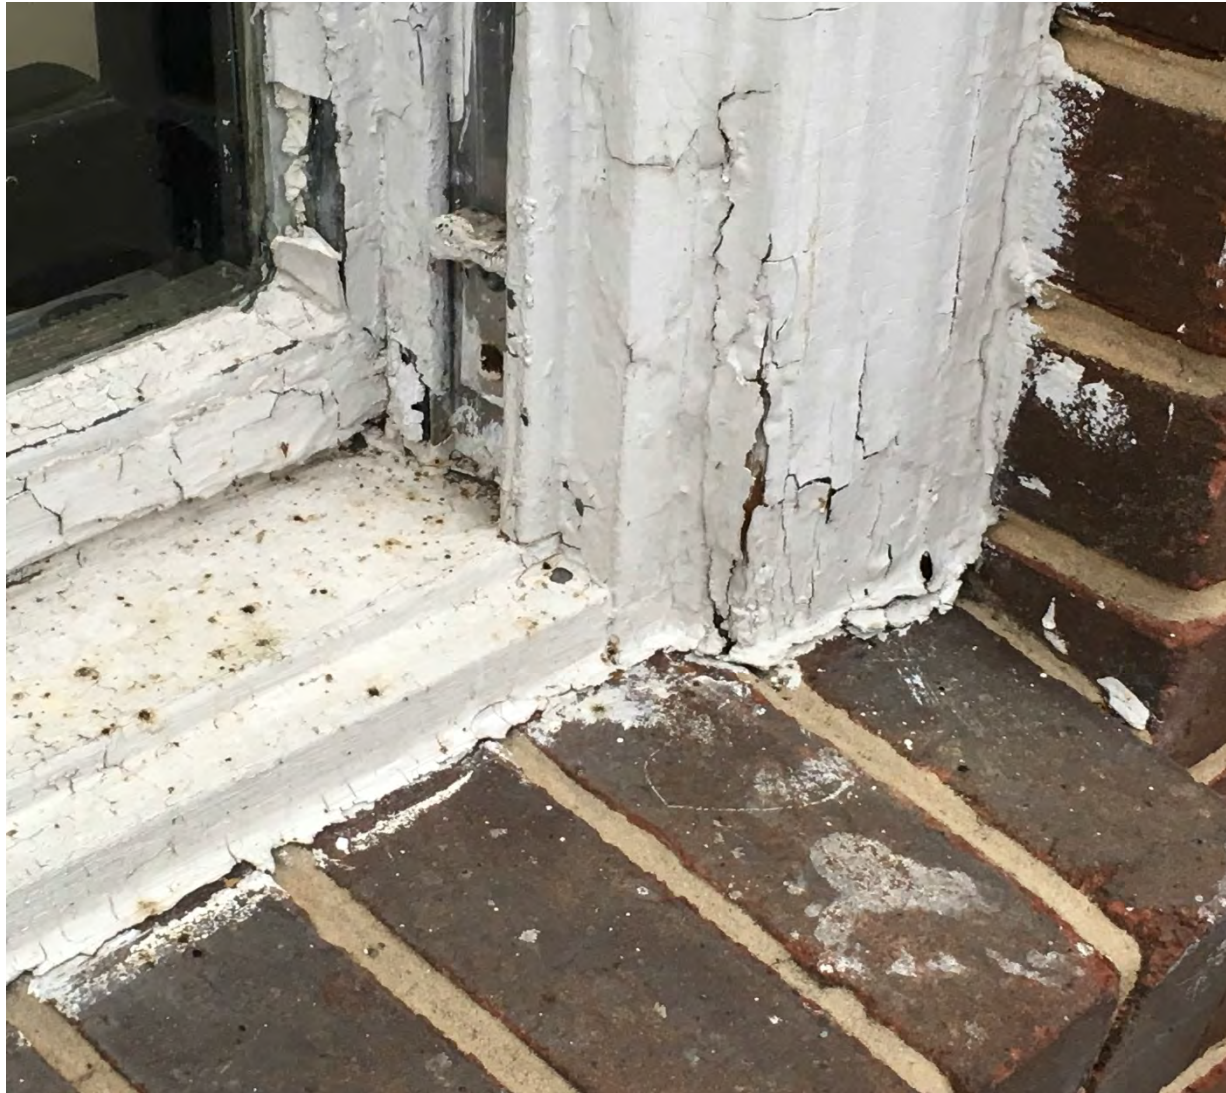
Finding # - 30. The historic single pane windows are in extremely poor condition. These old windows are allowing water infiltration into the perimeter walls and are very inefficient.

Finding # 30 Photo. This picture is an example of the damaged windows wood work.

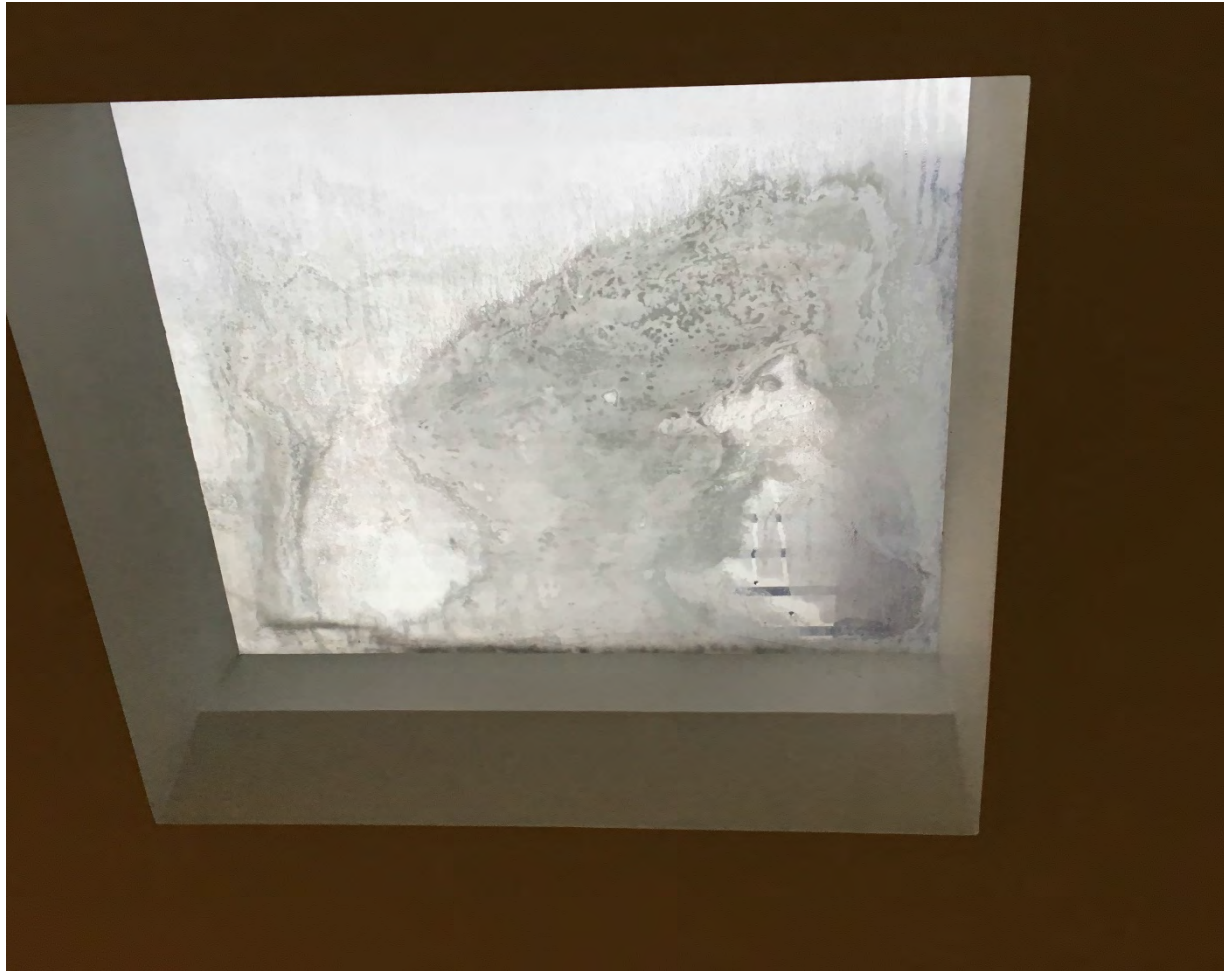
Finding # 31 Photo. This picture is one of the leaking skylights on the 5th floor.

Photo	#	Description of Deficiency/Issues	Location - Floor/Room
ARCHITECTURAL	29	A wooden louver on the east slate roof is in poor condition and needs to be replaced.	
	30	The historic wooden multi-pane windows are in very poor condition and need to be repaired. These windows are single pane.	
	31	Skylights in the fifth floor lunch area leak and need to be repaired.
