A2 Services, Inc.
Facility Survey of the City of Alexandria Fire Station #208

A2 Services (A2) toured City of Alexandria Fire Station #208 on September 27, 2017. The station is located at 175 North Paxton Street in Alexandria VA. Upon arriving at 0700AM A2 met Captain Lynn and Lieutenant Europe who explained the site concerns related to the facility. Following the initial discussions, Fireman Bobby Kennedy escorted A2 throughout the site.

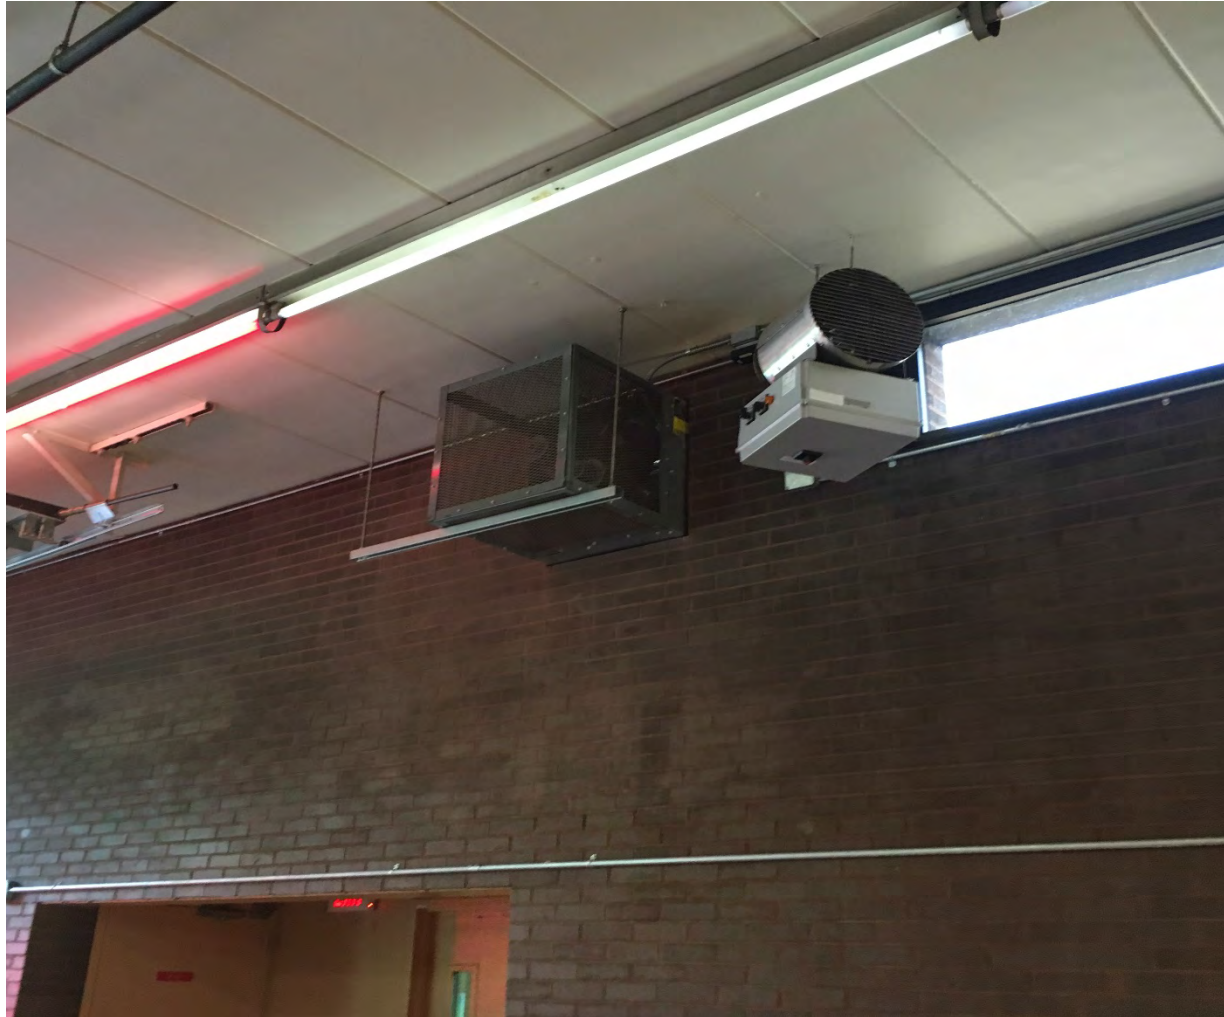
1. Fire Department Engine Bays have Truck Exhaust Systems. The purpose of this system is to remove the engine exhaust from the Engine Bay area while the trucks are running and warming up. In theory this system should be able to allow the bay doors to be closed while the trucks are running on cold days or in bad weather while also maintaining acceptable indoor air quality for the firemen. The system being used is a small wall mounted exhaust fan and a set of fresh air dampers at the rear of the bay. The concern is that this system isn't sized to move enough air to actually accomplish its purpose. Because of this the doors are being opened to keep the engine bay clear of fumes. On very cold days this allows the bay area to also become quite cold. Other Fire Departments use air vacuum systems which have hoses suspended from the ceiling and hook up to the truck exhaust pipes. The truck exhaust is then removed to the outside through a fan system. This system would be a better approach than the one in use at this time.

Photo # - 1. This picture is of the wall mounted engine exhaust fan which removes the truck exhaust fumes from the engine bay.

Name of Facility:		Alexandria Fire Station # 8	
Photo	#	Description of Deficiency/Issues	Location - Floor/Room
MECHANICAL	1	The engine bay exhaust system used is simply a wall mounted exhaust fan and a fresh air damper to ventilate the truck engine exhaust fumes. They do not have the standard Air Vacuum exhaust removal systems to reduce CO2 in the bay. This is an operational and IAQ concern.	Engine bay
	2	The engine bay heating system uses ceiling hung electric unit heaters. These probably keep the bay warm with all the doors closed but not with the doors open. Recommend ceiling hung gas fired infra-red heating units like they have in the back of the bay. This would heat much better and be more efficient than the electric.	Engine bay
	3	The outdoor condensing units should have their coils cleaned. They are fairly dirty at this time.	Rear and side of building
	4	The mechanical room exhaust fan backdraft damper is coming apart and should be replaced.	Rear of building

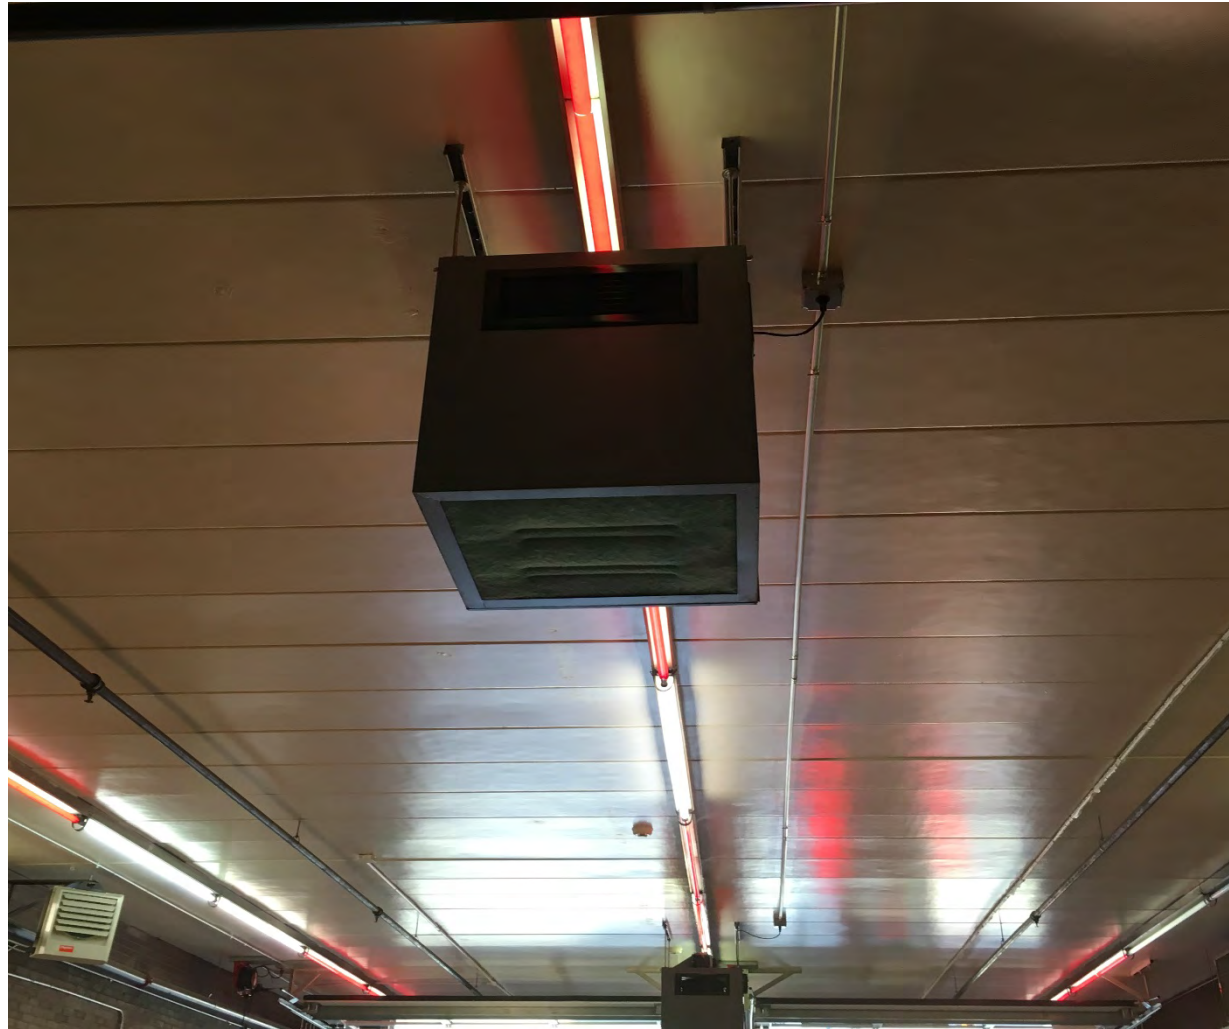
2. The Engine Bay Heating System uses ceiling hung electric unit heaters. These electric units can maintain a good temperature within the bay while the doors are closed but cannot keep up with the doors open. The installation of 3 new gas fired infra-red heating units would make it much more comfortable for the firemen when the doors have to be open in very cold weather. The installation of a new Engine Exhaust Air Vacuum system for the trucks would possibly eliminate this issue allowing the doors to stay closed more often.

Photo # - 2. This picture is of one of the main electric unit heaters which heat the engine bay area.

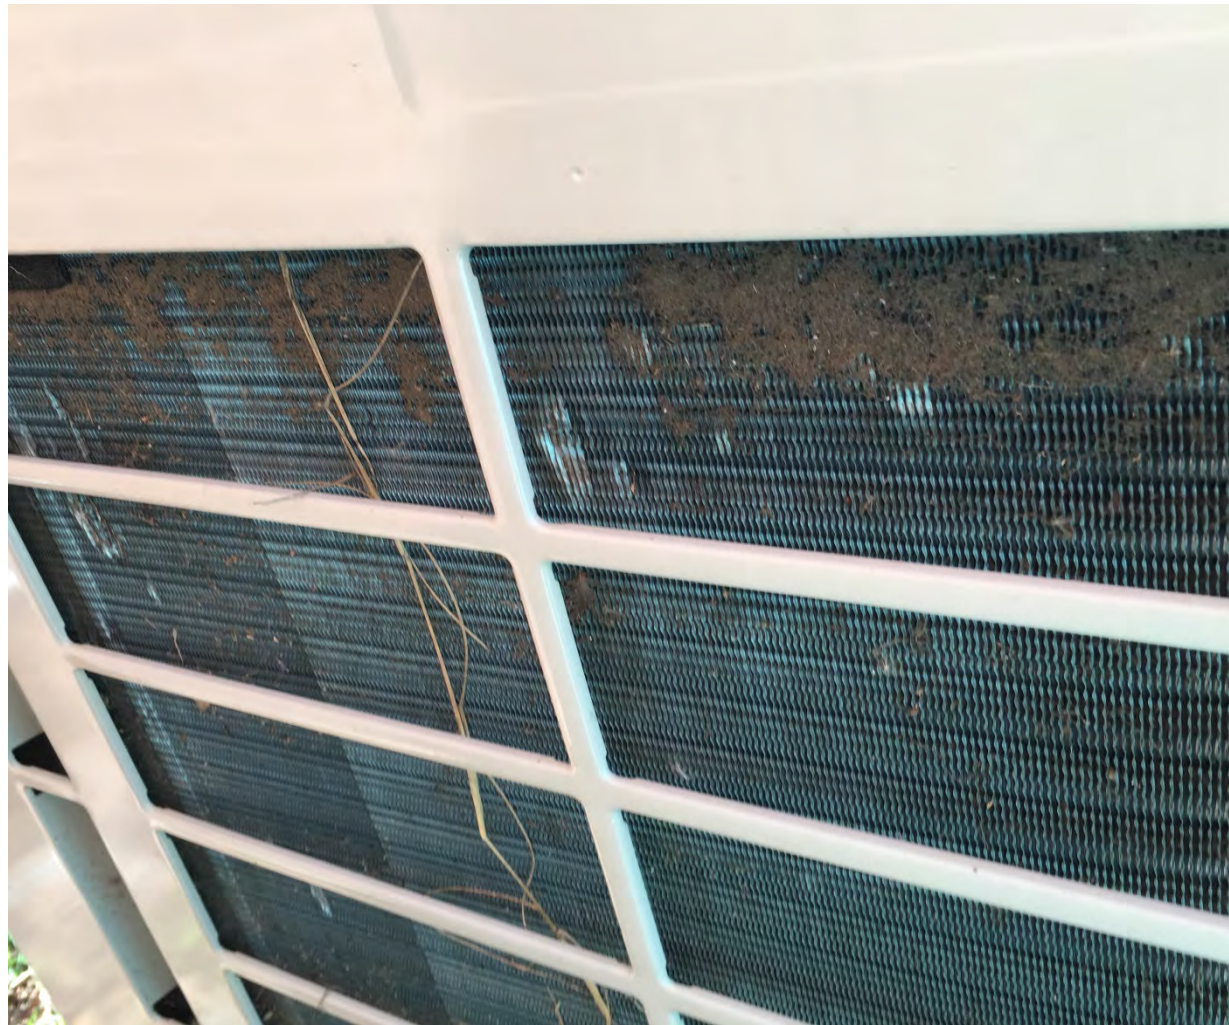
3. The other areas of the fire station are heated and cooled by several separate systems. There are variable refrigerant flow split systems, and several package split systems. These units all have air cooled refrigerant condensing coils on the outdoor units which require good air flow to maintain their efficiency. After inspection of these coils we found that they need to be properly cleaned. This should be done at least once a year with a non corrosive coil cleaner and then rinsed down with clean water.

Photo # - 3. This picture is of one of the VRF condensing coils which needs to be cleaned. Clean coils on an air cooled split system is critical to efficient heating and cooling.

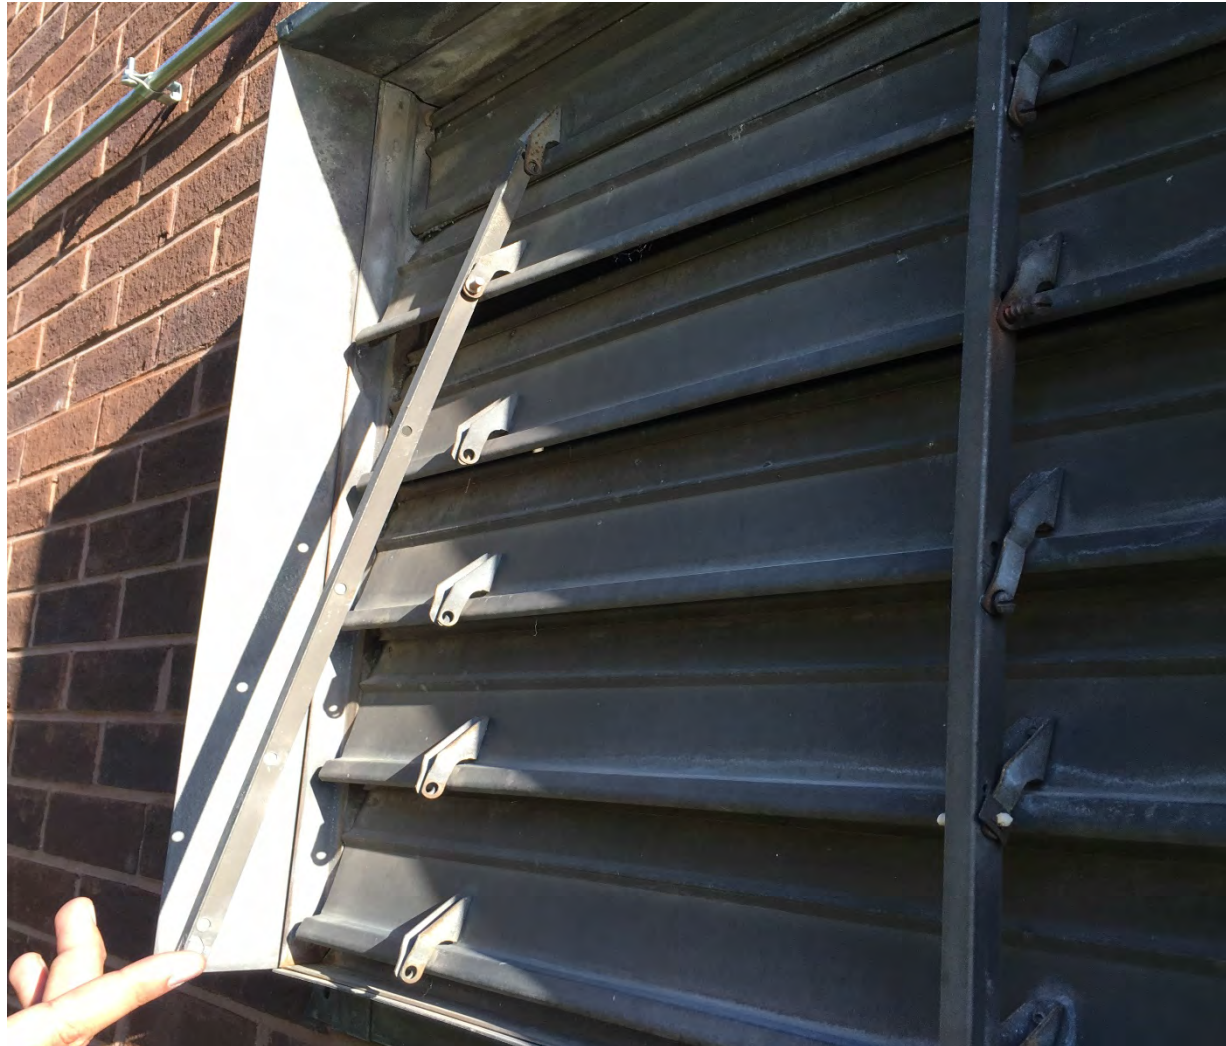
4. The mechanical room on the lower level and at the rear of the building houses one of the main heating and cooling indoor air handling units, the domestic hot water heater and the emergency generator. A wall mounted exhaust fan is used to cool this room in summer. The backdraft damper for this fan is coming apart and will fail. This damper closes when the fan shuts down and stops windblown rain or cold air from entering the room from outside. This dampers assembly needs to be replaced soon.

Photo # - 4. This picture is of the mechanical room exhaust fans backdraft damper which is falling apart.

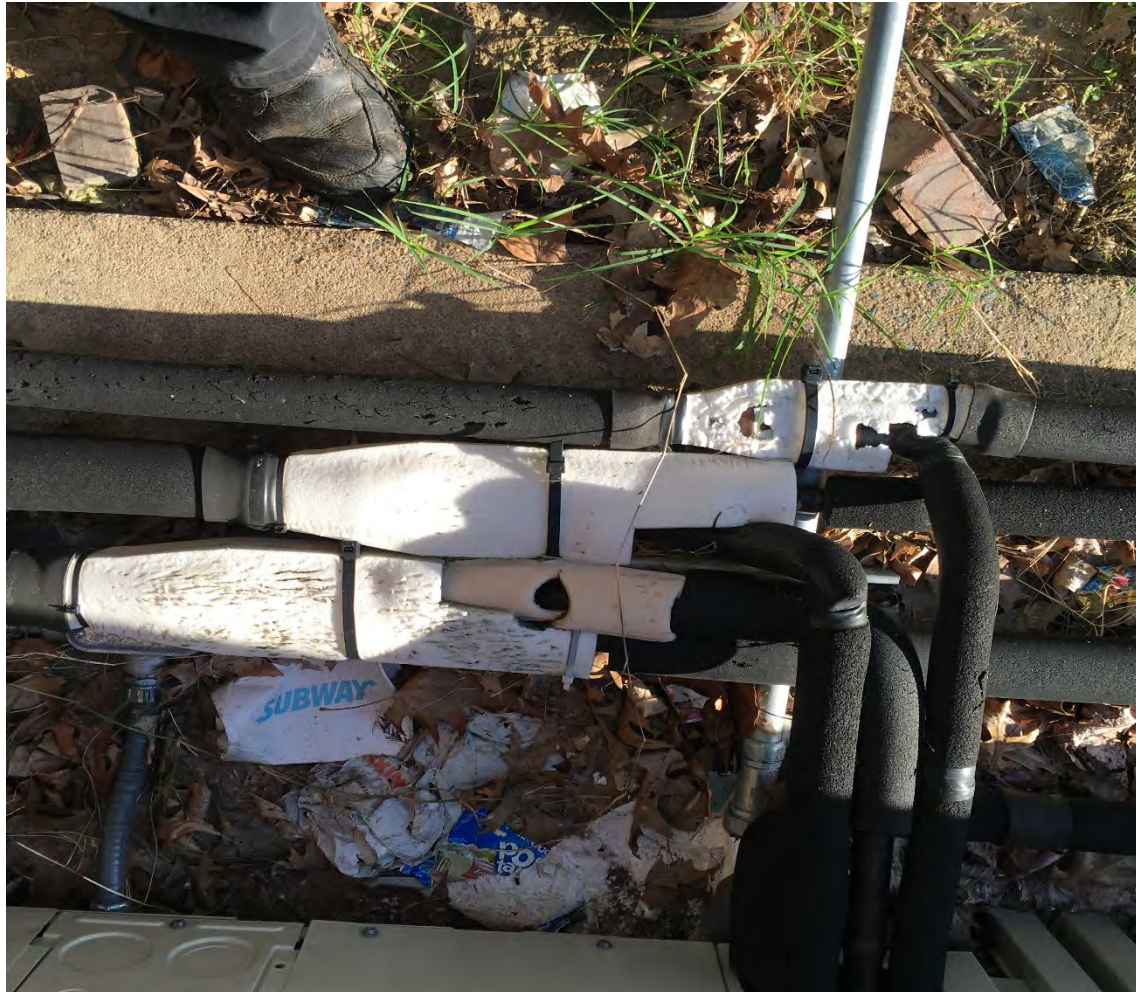
5. The outdoor refrigerant piping insulation on the variable refrigerant flow systems is damaged. Good insulation is critical to allow these systems transfer heat back and forth between the indoor and outdoor units. The damaged insulation also increases the energy usage required to condition the space. The Armor-flex insulation is a good product but it does not stand up well to outdoor weather conditions and should have been wrapped with a protective vinyl cover. This damaged insulation should be replaced and the entire run of outdoor refrigerant pipe then covered with a proper vinyl protective wrap.

Photo # - 5. This picture notes the refrigerant piping where the thermal insulation has failed. The white sections need to be replaced and then all the all the outdoor piping needs to be wrapped in vinyl.

5	The variable refrigerant flow units piping insulation is damaged and will need to be replaced.	Side of building
	6	The thermostat in the weight room controls the weight room unit and the one next door in the storage area. This causes the other systems in the storage area to fight each other. Recommend that the storage room have a separate new T-stat installed and the stat in the weight room would only control that area.	Weight room
Photo	#	Description of Deficiency/Issues	Location - Floor/Room
ELECTRICAL	7	Emergency generator battery charger is not operating. This should be corrected to make sure the battery has the power needed to start the unit on loss of utility power.	Mechanical room
	8	The emergency generator doesn't have the capacity to operate the entire facility on loss of power. Most of the fire departments I have surveyed are considered Mission Critical and all the internal building systems function as if they never lost power	Mechanical room

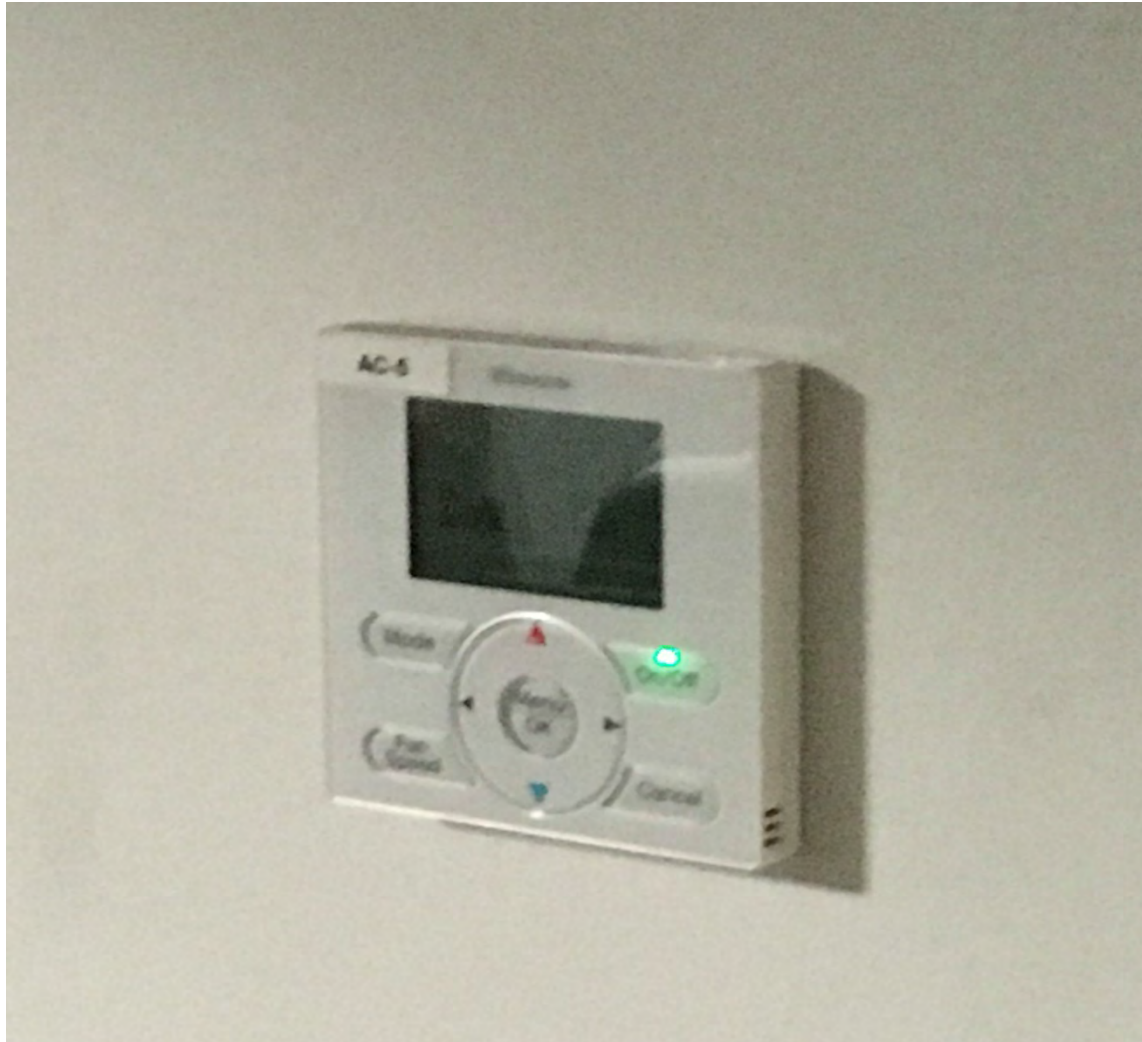
6. The weight room indoor heating and cooling unit is controlled by a thermostat on the wall by the door into the storage area next to the weight room. This t-stat also controls another unit in the store room next door. The storage area next to the weight room has 3 different heating and cooling systems which tend to fight each other. A2 recommends that one new thermostat be installed on the storage room unit that is controlled by the t-stat in the weight room. This would allow better control of the space temperature in the storage areas next door.

Photo # - 6. This picture is of the thermostat for the weight room which also controls the unit next door in the storage area. Installing one new t-stat on the unit next door will help control temperatures in both areas.

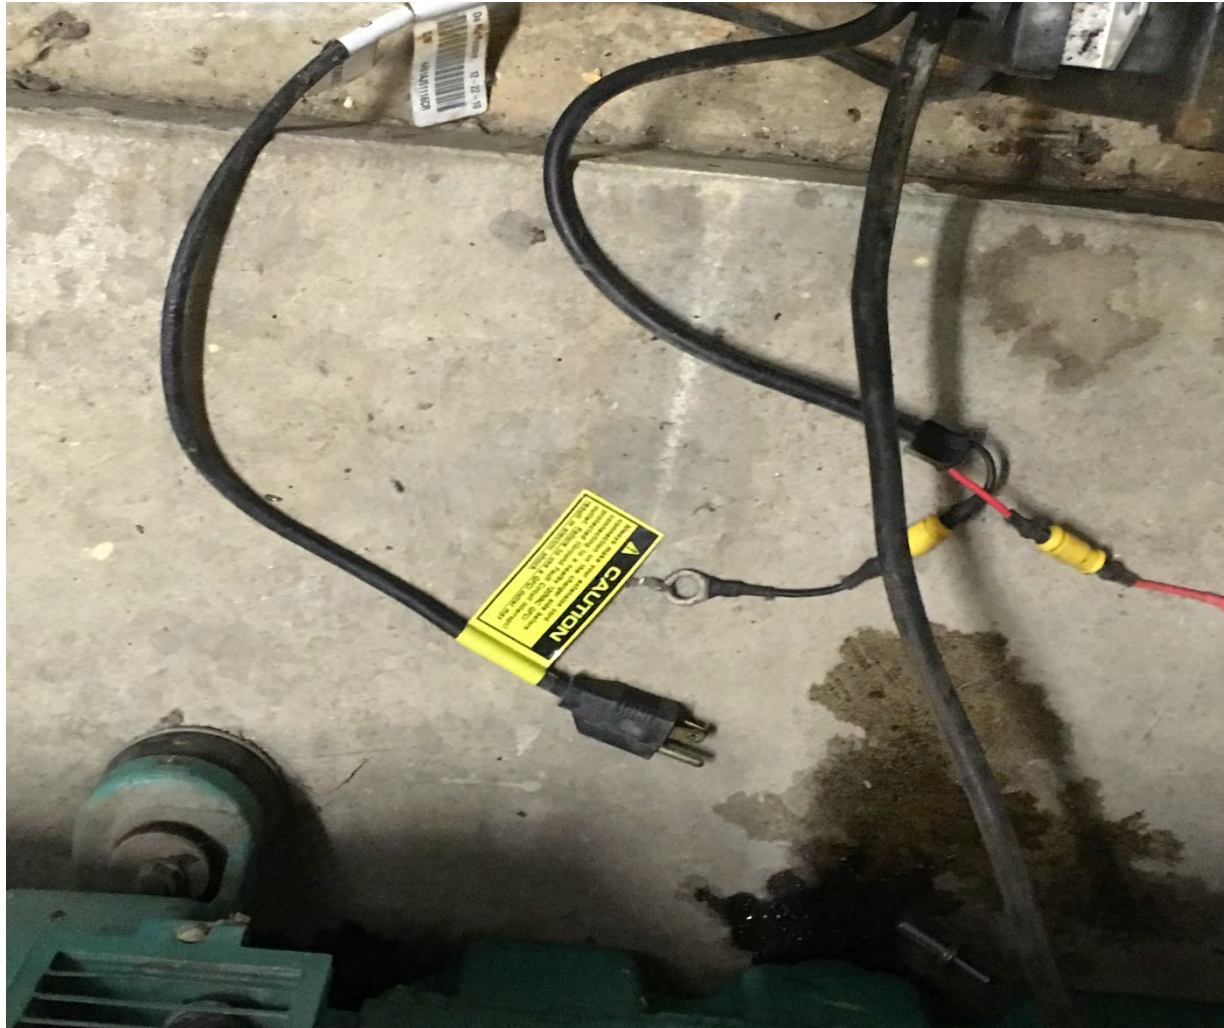
7. The site has a small natural gas fired emergency generator which handles lights and critical equipment only. The generator battery charger is unplugged and may have failed. This should be investigated to make sure the battery has sufficient power to start the generator in an emergency.
8. All the Fire Stations that A2 has surveyed in the past are considered and designed to be a fully functional mission critical facility. This basically means that when to utility power goes down, the fire station is still fully functional and includes all heating, cooling, lights, wall outlets, and all critical communications equipment. Everything still operates as if the utility power was still on. A2 recommends that Alexandria City consider upgrading their emergency power systems to allow this.

Photo # - 7. This picture is of the power disconnected from the emergency generator battery charger.

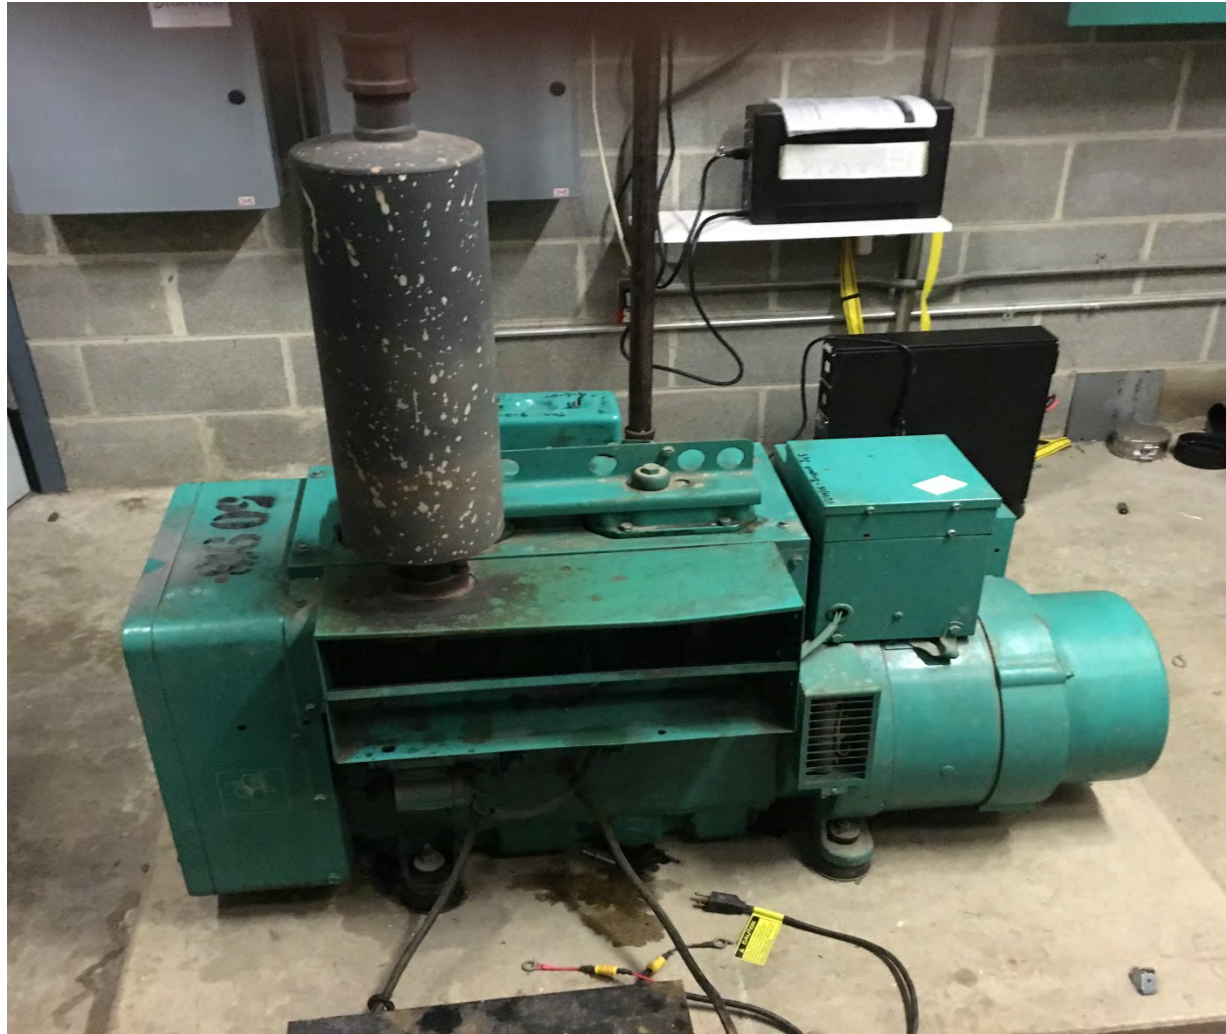
9. The emergency generator and its emergency transfer switches are not being tested under load. This is normally done in critical facilities on a monthly basis to identify any problems before an actual emergency event occurs. A2 recommends that these testing procedures be put into place.

Photo – 8 and 9. This picture is of the gas fired emergency generator. This is not sized to handle the whole facility and has not been tested under load.

9	The emergency generator system is not being tested under load. This should be done on a regular basis to verify the power transfers to the generator on loss of utility power.	Mechanical room
	10	It doesn't look as if proper electrical maintenance is being performed. Annual Infra-red testing, cleaning and tightening of electrical terminations should ongoing.	Mechanical room

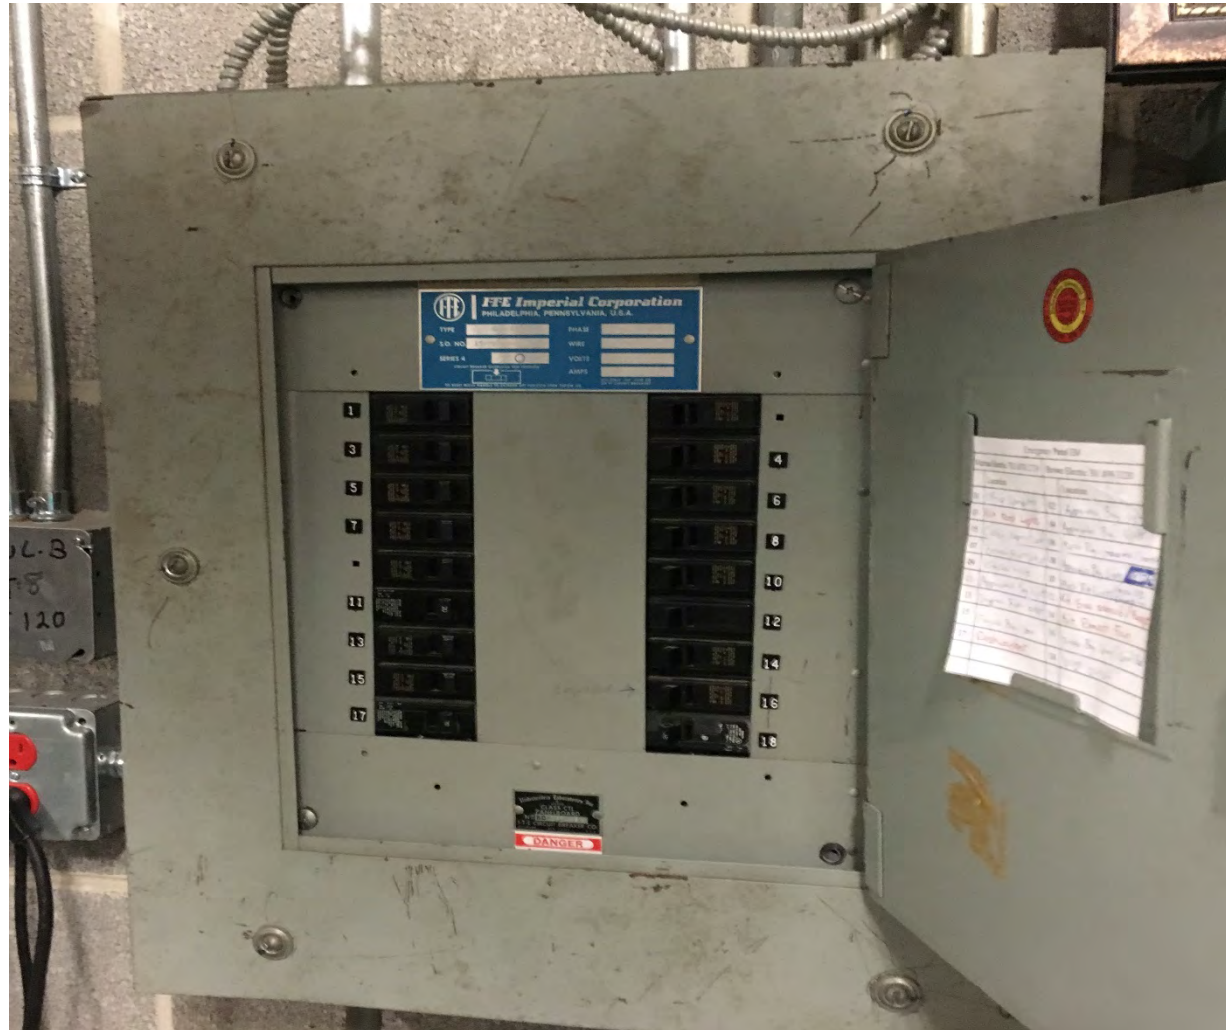
10. The main electrical panel and breakers panels at the site do not appear as if they are being tested and serviced. All electrical systems, especially in critical facilities should be thermally scanned with an infra-red camera to identify any overheating components or loose connections. This testing will identify such issues before they cause a failure of the electrical system. A2 recommends that all electrical gear be opened, thermally scanned then cleaned and all terminations checked of tightness on an annual basis. This an important risk management task that should be implemented.

Photo # - 10. This picture is an example of one electric panel which should be thermally scanned, cleaned and tightened up annually.

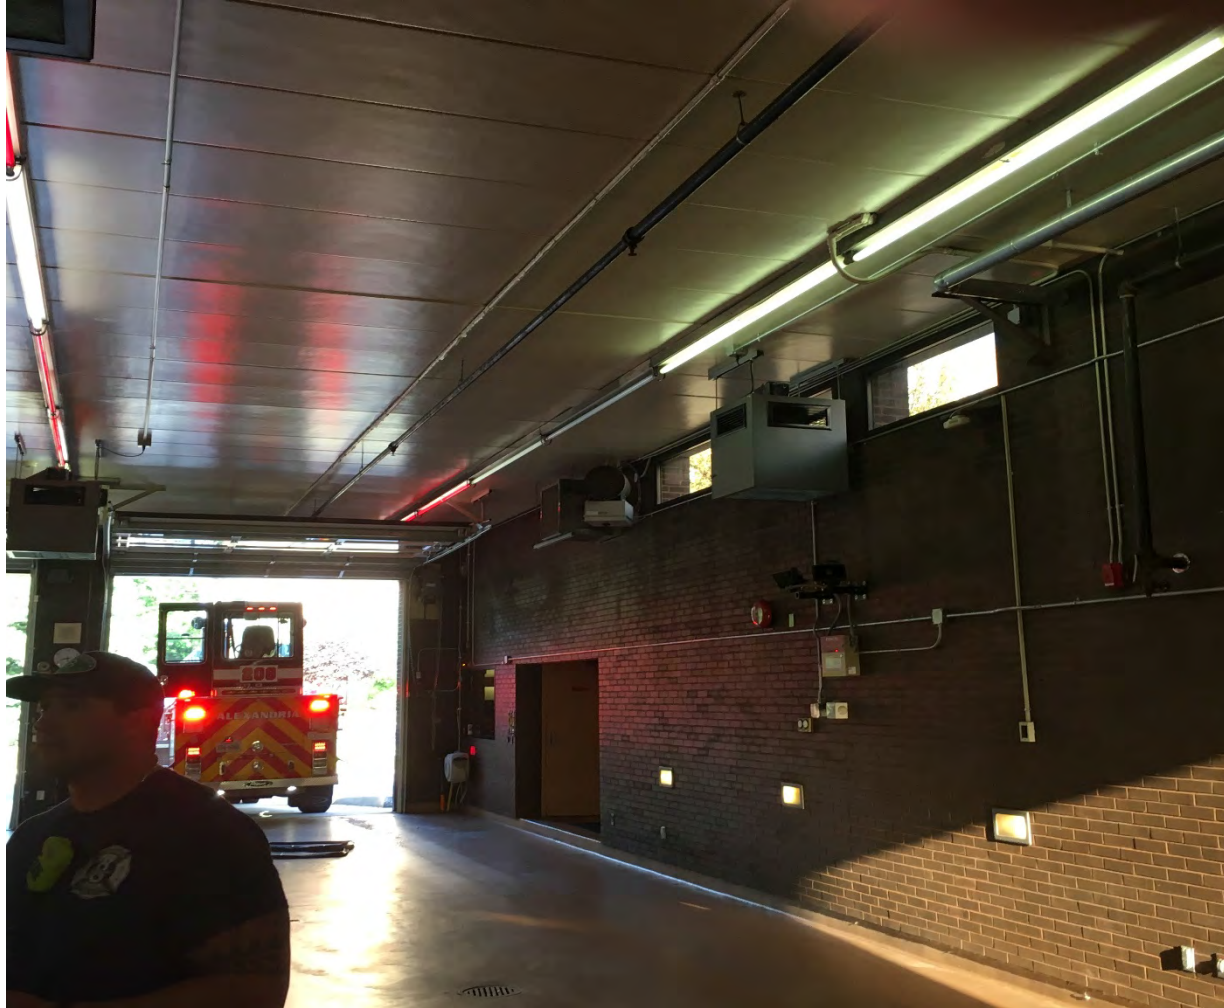
11. The engine bay roof is leaking onto the trucks. This issue has already been identified by the fire department staff. A2 was told that the roof repairs are being scheduled for repair.

Photo # - 11. This picture is of the engine bay ceiling area where the roof is leaking.

Photo	#	Description of Deficiency/Issues	Location - Floor/Room
PLUMBING			
Photo	#	Description of Deficiency/Issues	Location - Floor/Room
STRUCTURAL	11	The engine bay roof leaks. I am told that it is scheduled for replacement.	Engine bay
	12	The gear room skylite leaks down onto the firemans gear below. The skylight need to be resealed.	Gear room
	13	The stairwell skylite at the rear of the engine bay also leaks and will need to be repaired.	Front Driveway
	14	The main engine bay concrete driveway has a bad cracked and broken area on the north side near the sidewalk. Once water and ice get under this damage it will worsen the repair costs.	Next to engine bay
	15	The parking lot and other paved areas in the rear of the building are cracked up badly and should be repaved.	Rear and side of building
Photo	#	Description of Deficiency/Issues	Location - Floor/Room
ARCHITECTURAL

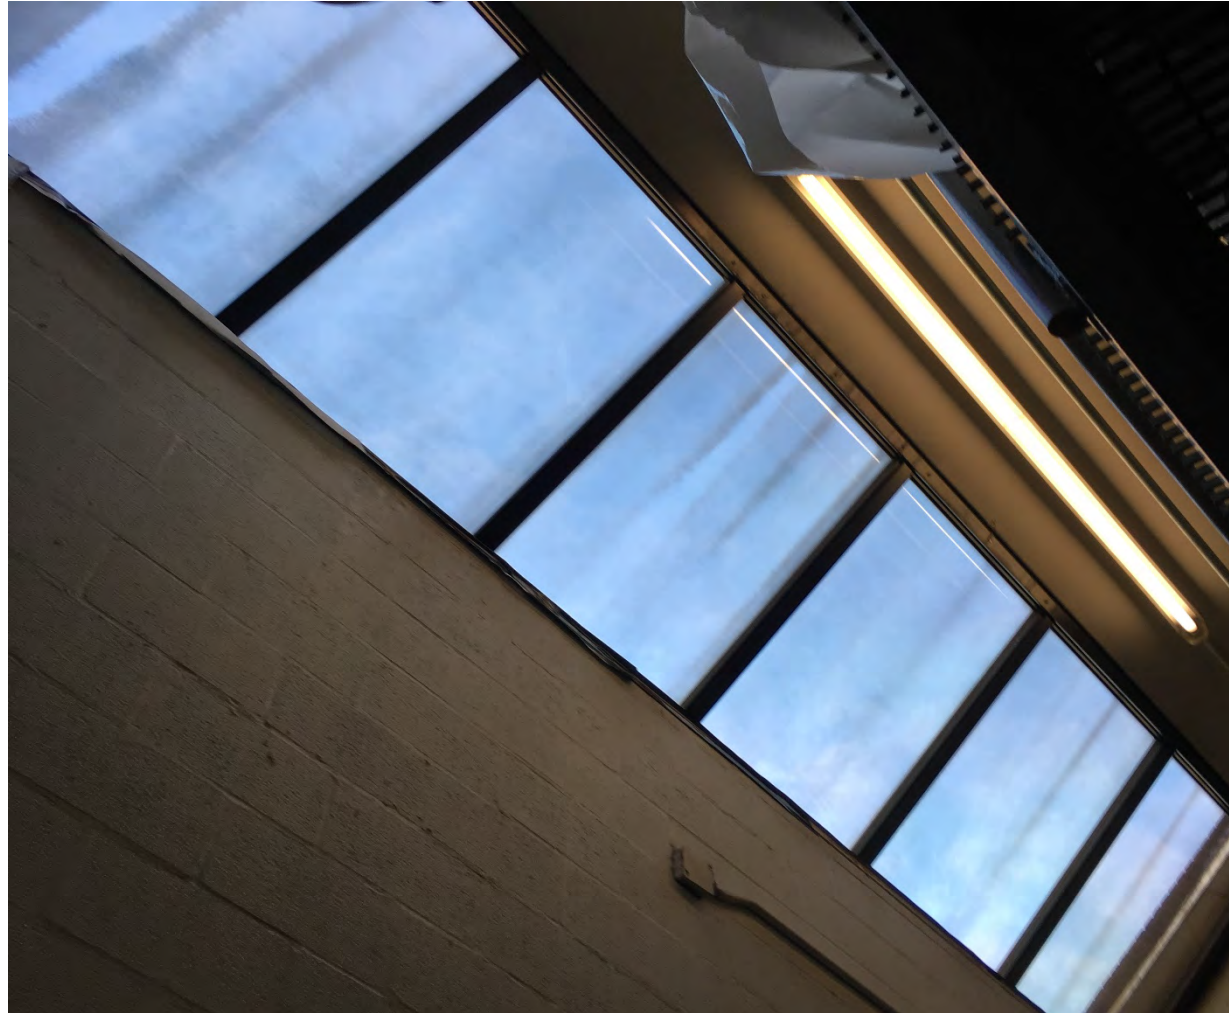
12. The main firemen's gear room is located just off the rear of the engine bay. The skylight in the ceiling is leaking onto the equipment and gear. We recommend that the skylight be repaired.

Photo – 12. This picture is of the firemen's equipment and gear room skylight which is leaking on the equipment.

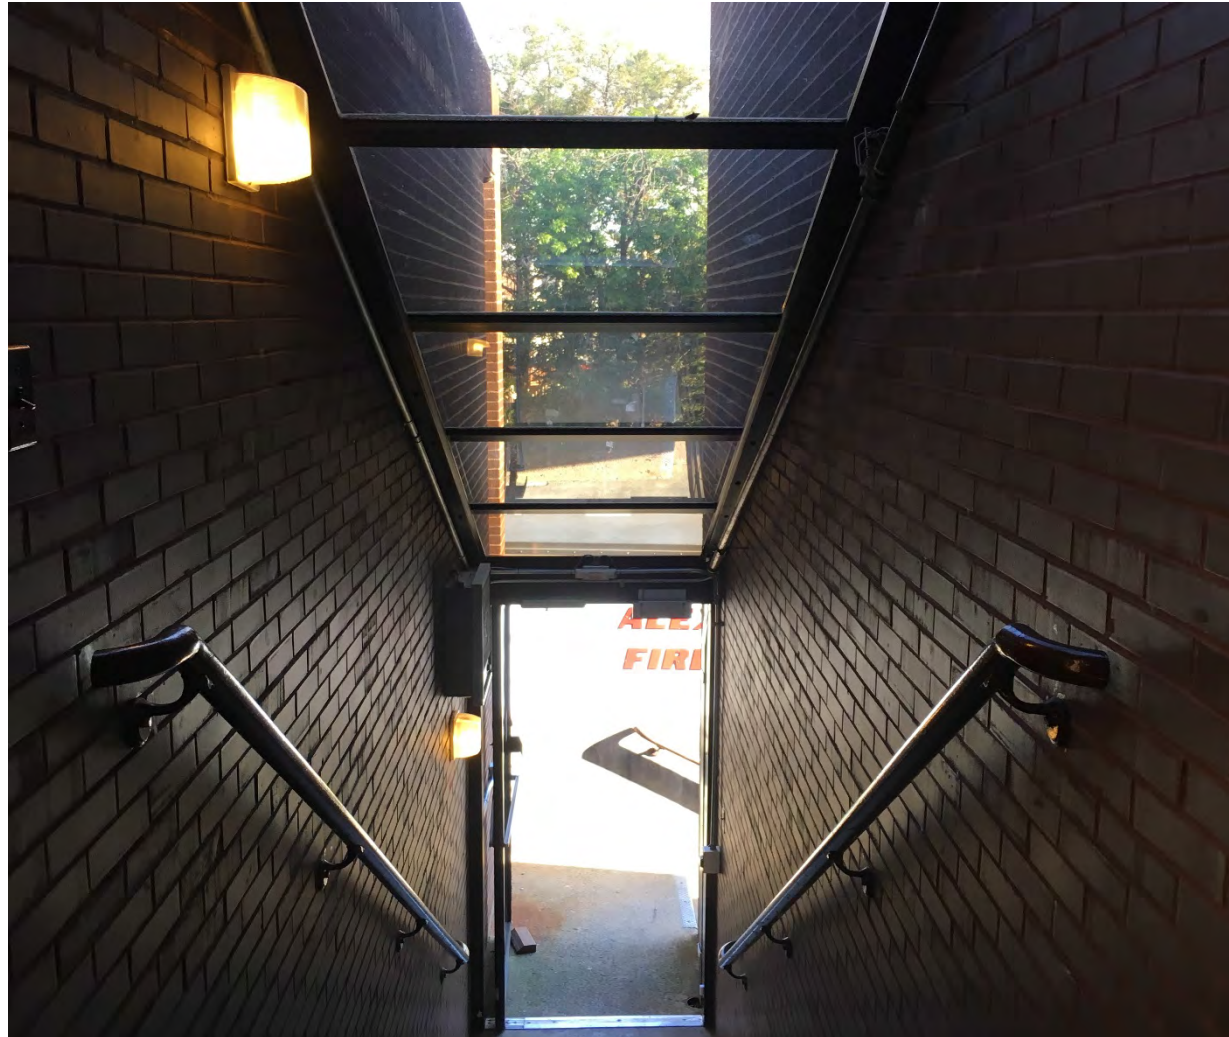
13. The stairwell at the rear of the engine bay also has a skylight which is leaking. This one is not as bad as in the gear room but should also be repaired in unison with the gear room repair to save costs.

Photo – 13. This picture notes the second skylight in the stairwell which is also leaking.

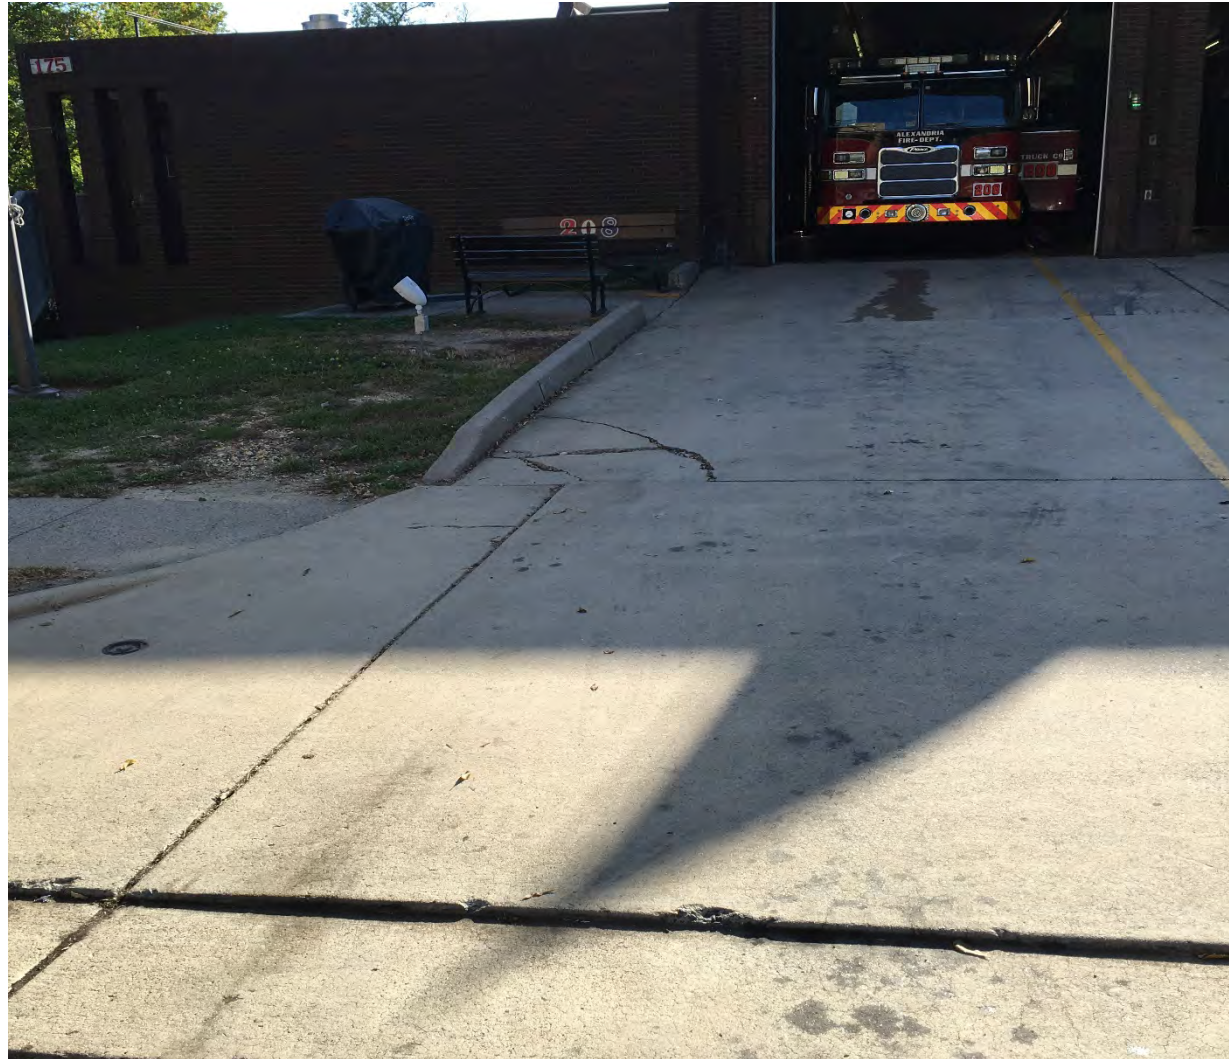
14. The main concrete driveway into the engine bay has one bad broken area on the right as you drive out. This should be repaired before rain or water gets under the damage and freezes causing the damage to increase.

Photo – 14. This picture notes the concrete driveway damage which will need repair.

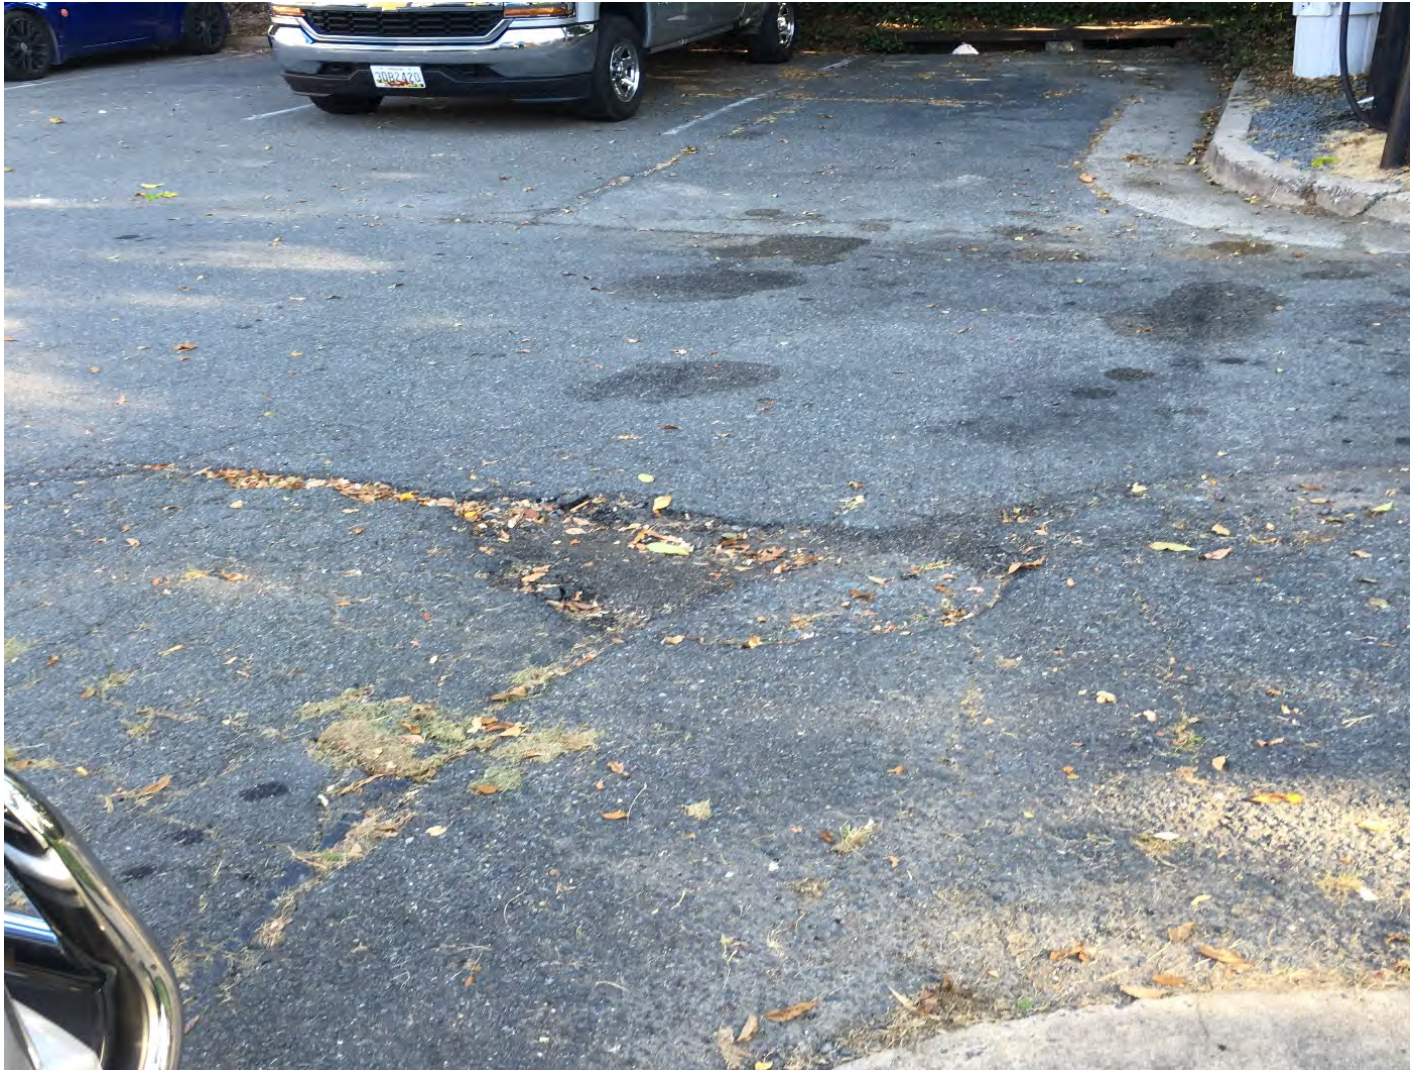
15. The asphalt parking lot and driveway areas at the side and rear of the building are in poor condition and cracked up badly. This is another situation where water getting into the cracks will freeze and increase damage. A2 recommends that this be at least liquid sealed before the damage increases.

Photo – 15. This picture is an example of the cracked and damaged asphalt at the parking lot area.
