CONSERVATION ASSESSMENT REPORT
for the
PUBLIC ART WORKS
ALEXANDRIA, VIRGINIA

Prepared for:
Matthew Harwood
Public Art Manager, Office of the Arts
City of Alexandria Recreation, Parks & Cultural Activities
1108 Jefferson Street
Alexandria, VA 22314

Prepared by:
Conservation Solutions, a Division of EverGreene Architectural Arts

REVISED: March 7, 2019

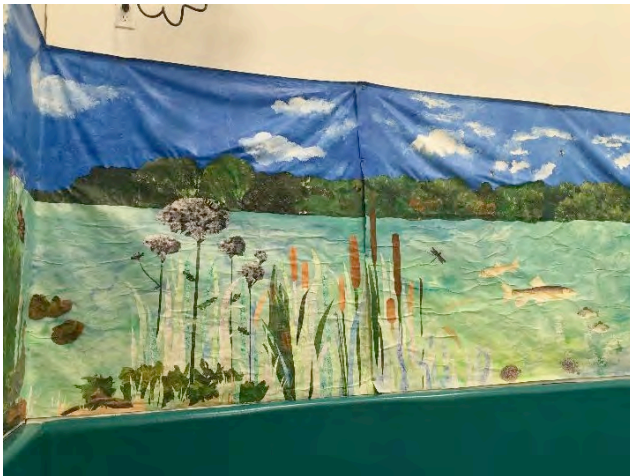
Figure 3: Typical section of canvas exhibiting uneven stretching and bowing due to a lack of structural framework.

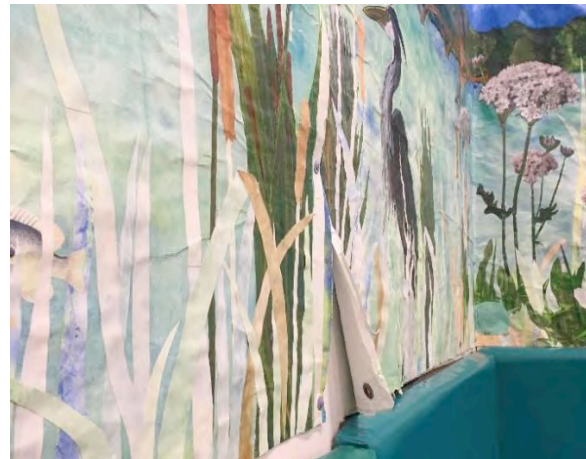
Figure 4: Detail of a peeling edge, possible due to picking/handling by children.

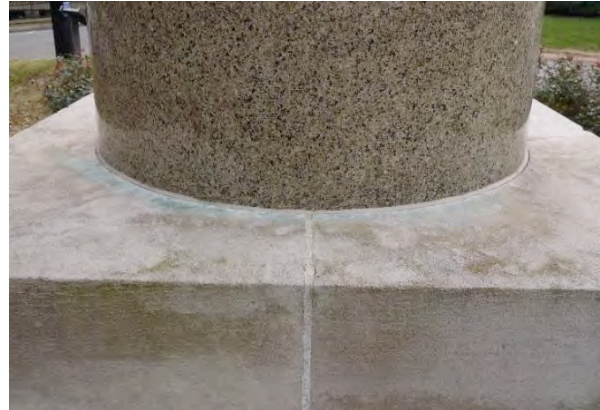
Figure 4. Detail of copper corrosion stains on the limestone base from the bronze plaque.

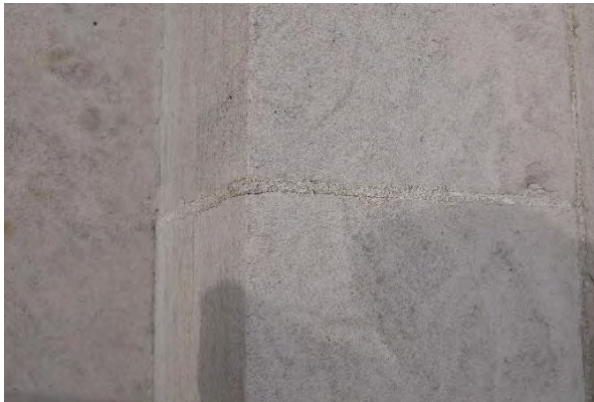
Figure 5. Detail of typical caulk joint at base.

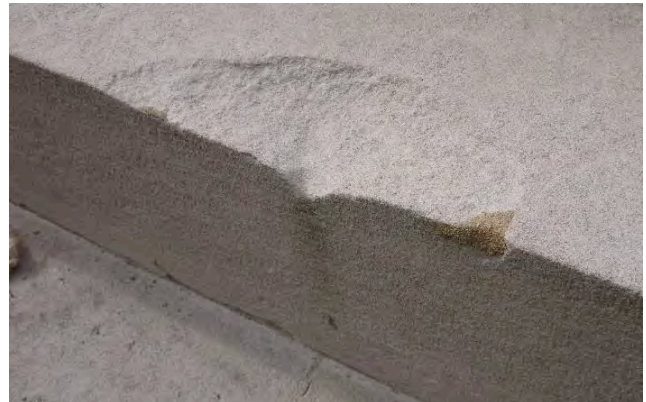
Figure 6. Limestone spall along the base.

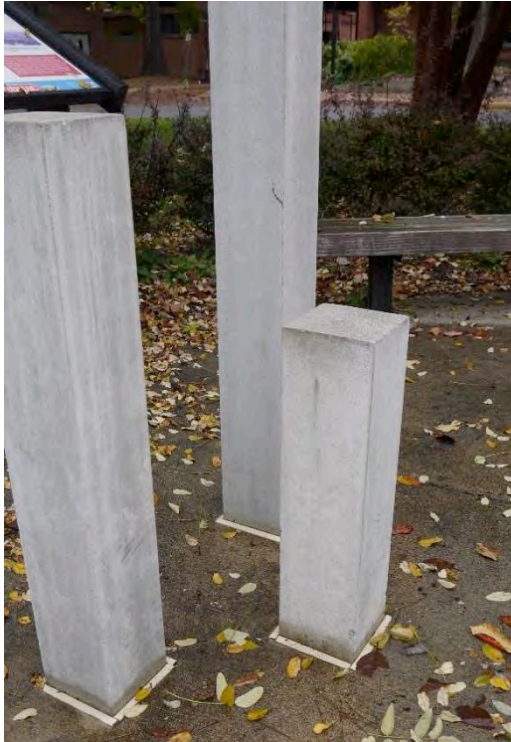
Figure 3. Detail of typical water run- off/streaking pattern down the face of the pillars

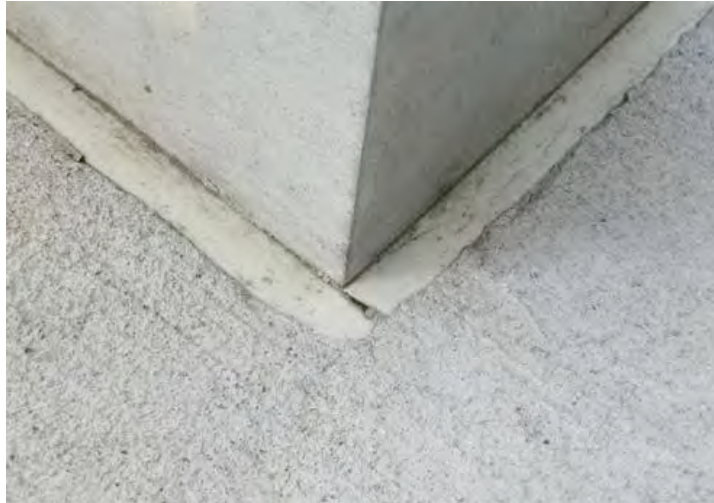
Figure 4. Detail of rigid plastic sealant embedded around the base of a pillar.

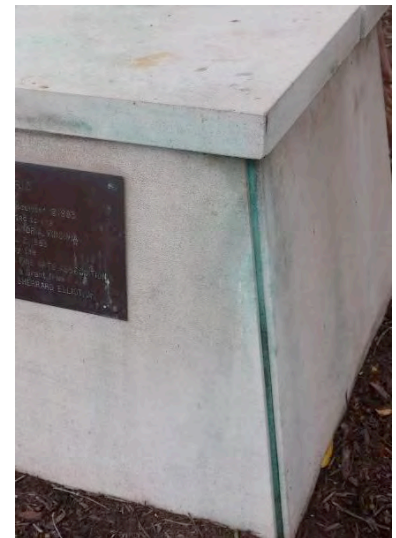
(Left to Right): Figure 1. *Brio* measures 8' in height including plinth. Figure 2. The cast stones of the pedestal have become displaced. Figure 3. Copper staining has discoloured the joints.

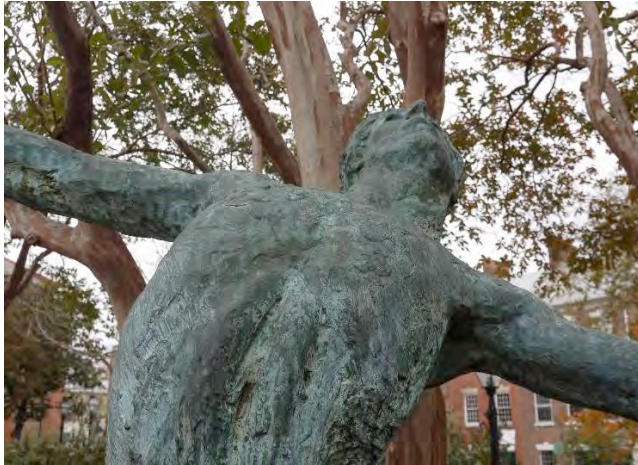
(Left) Figure 4. Detail of general discoloration and soiling on the head and torso of the figure.

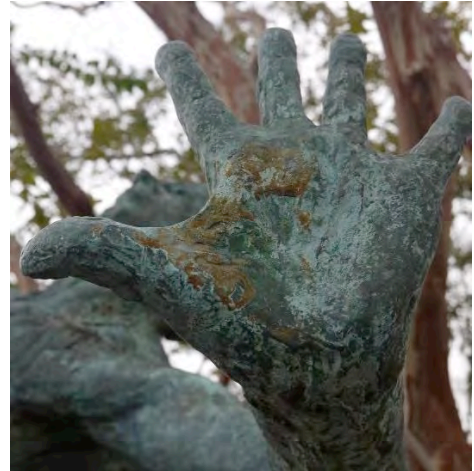
(Right) Figure 5. Detail of advanced corrosion and possible iron staining on the hand of the figure.

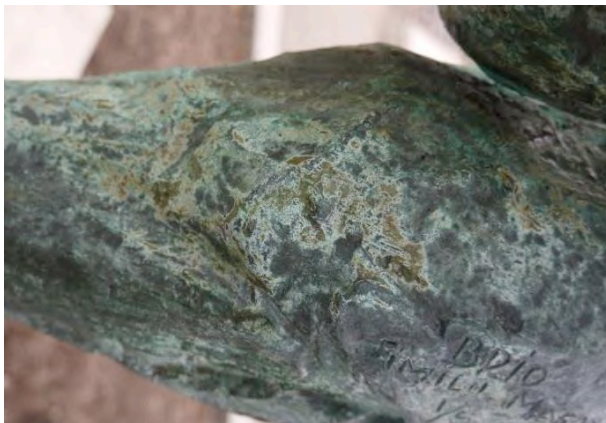
(Left) Figure 6. Detail of patina and additional surface staining.

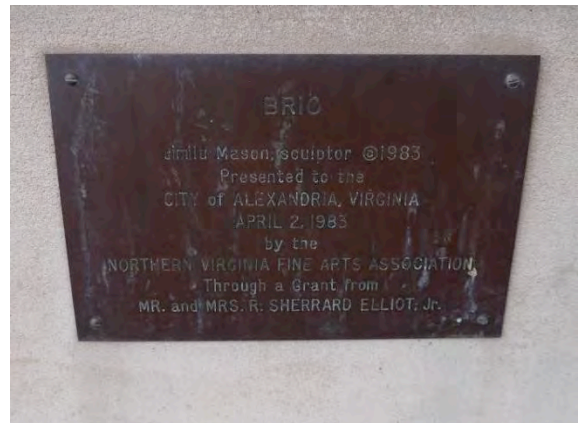
(Right) Figure 7. Dedicatory plaque with pervasive corrosion of the surface.

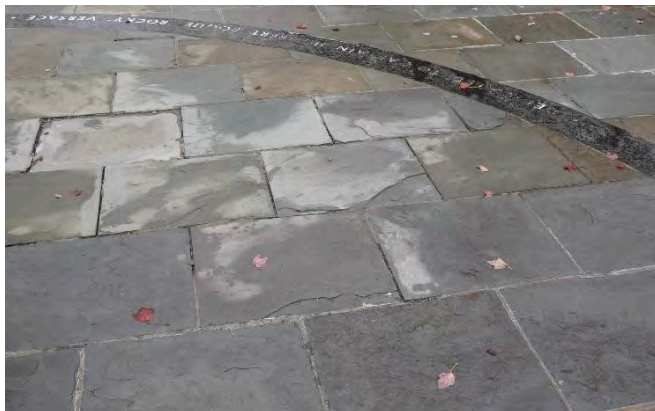
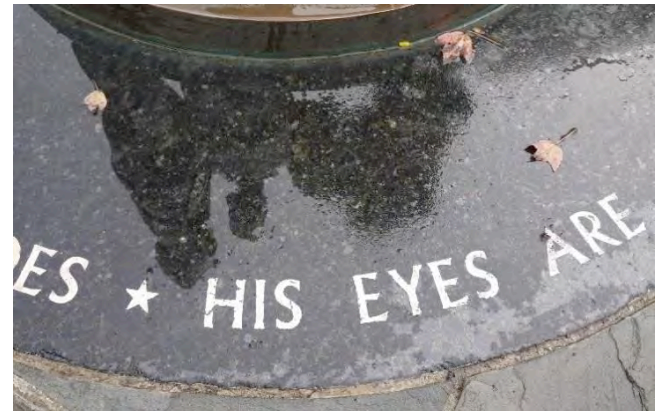
(Left) Figure 3. Slate pavers exhibit minor flaking and mortar loss typical to a highly-trafficked surface. (Right) Figure 4. Paint is flaking from within the lettering on the inscribed granite pavers.

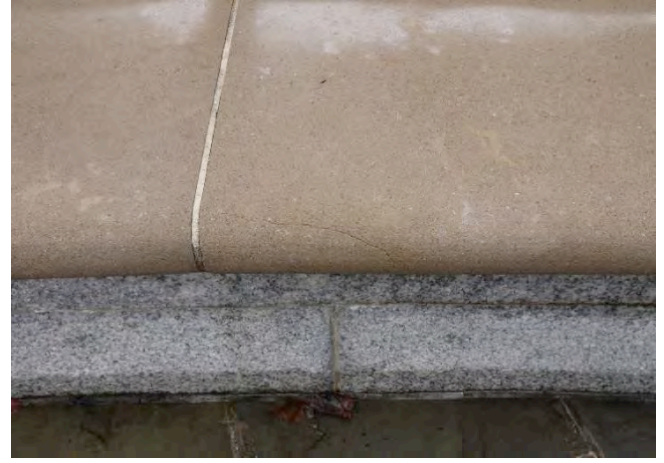
(Right) Figure 6. Staining and discoloration is typical on the granite blocks under the limestone bench.

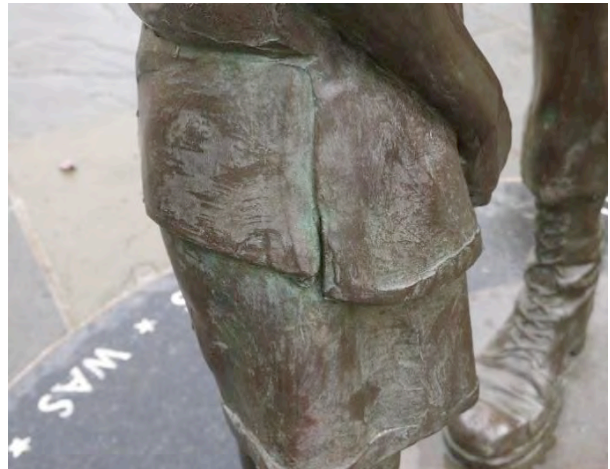
(Right) Figure 8. Minor corrosion has developed in the recesses and folds of the bronze figures. They catch and retain water.

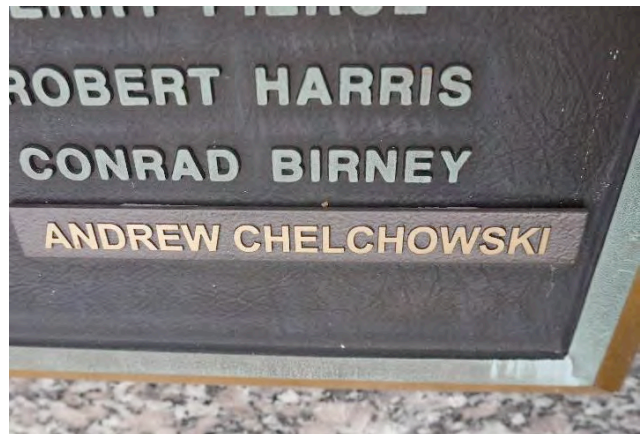
Figure 2. Plaque shows signs of corrosion.

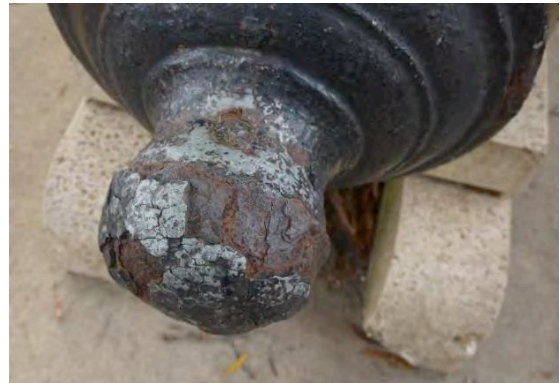
Figure 2. Detail of advanced corrosion.

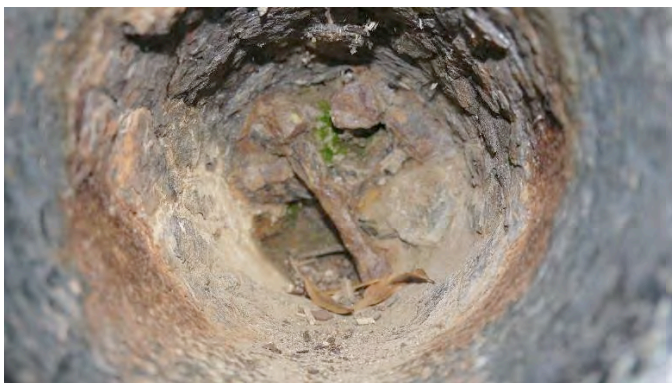
(Left) Figure 3. Interior of muzzle with debris and corrosion. (Right) Figure 4. Emblem on canon.

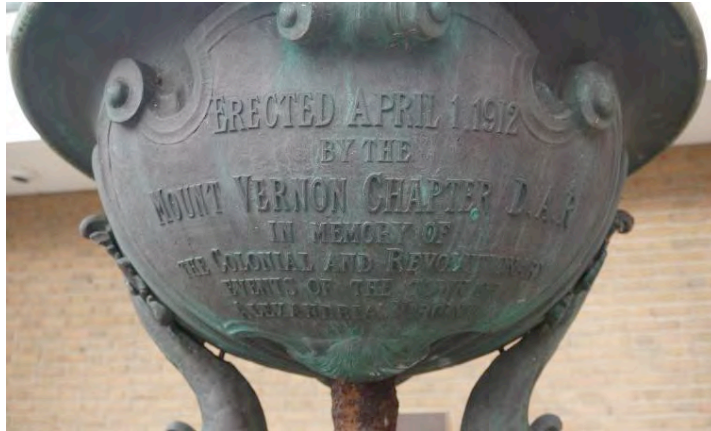
Figure 3. Corrosion on dedicatory inscription on the underside of the upper fountain basin.

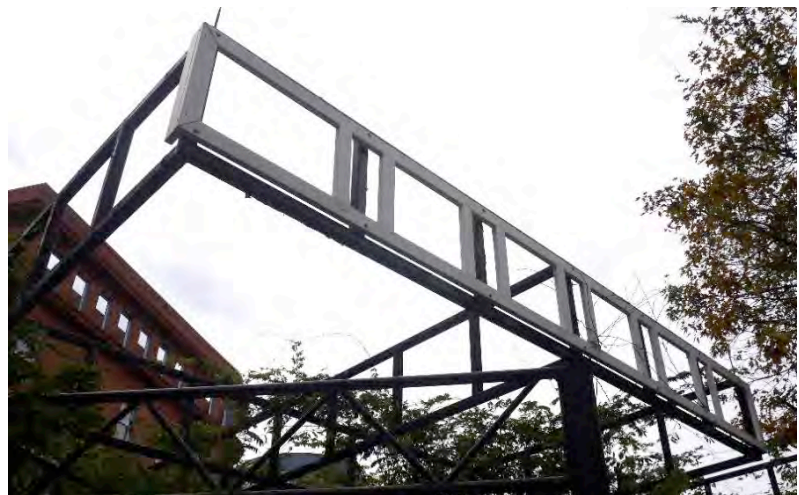
(Right) Figure 4. A secondary wood trellis, painted white is in poor condition.

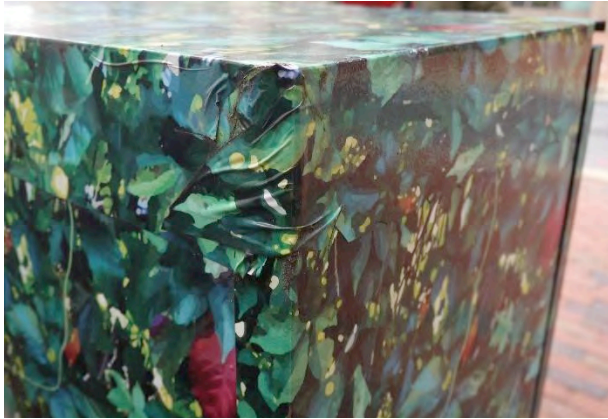
Figure 5. The vinyl wrap surface of the didactic plaque is bubbling in select locations.

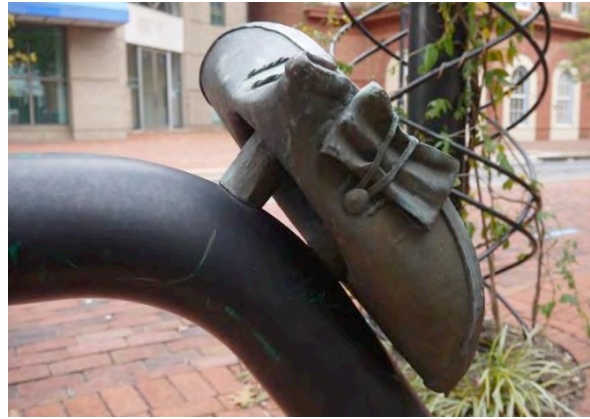
Figure 6. The steel and bronze water fountain exhibits surface deterioration including loss of protective coatings and corrosion.

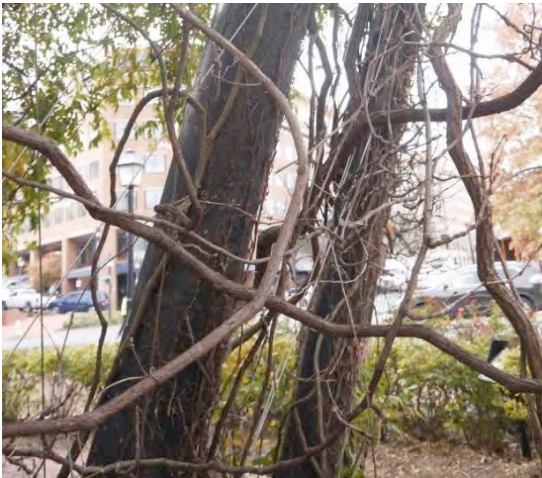
Figure 7. Vegetation on steel introduces water to the metal surface.

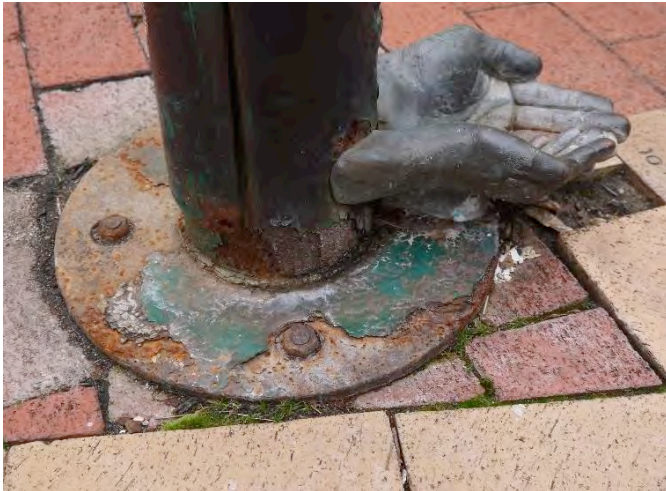
(Left) Figure 11. Detail of advanced corrosion on the steel base of the water fountain with bronze sculptural features.

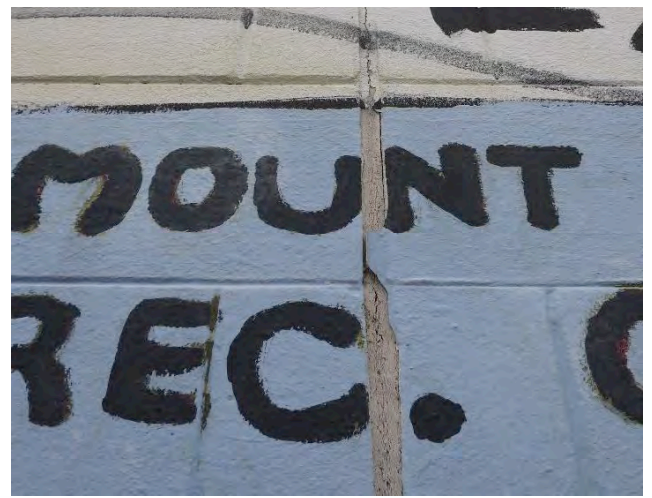
(Right) Figure 8. Paint is failing where it was applied over flexible sealant along the expansion joint.

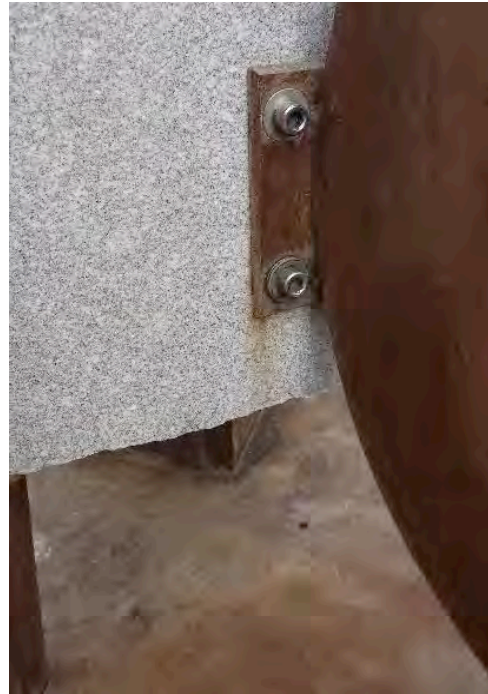
Figure 2. Detail of iron staining the granite.

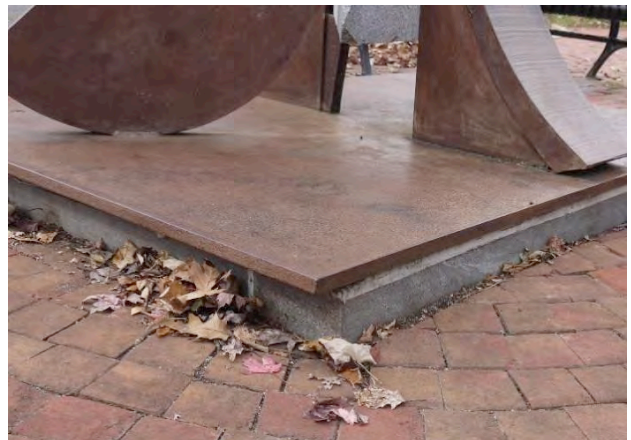
Figure 4. Iron staining of the granite base and vegetative growth in the pavers abutting the sculpture.

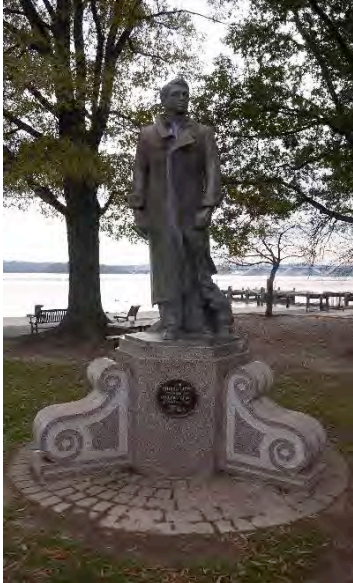
(Left to Right) Figure 1. General view of the Shipbuilder sculpture. Figure 2. Detail of surface corrosion and soiling. Figure 3. General view of decorative granite scroll.

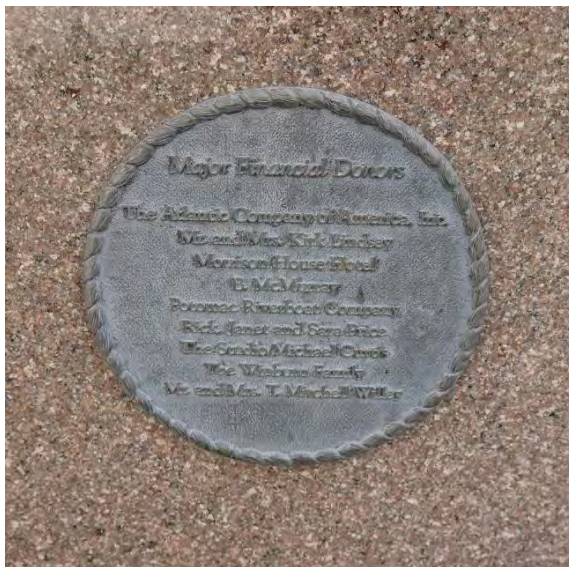
(Left) Figure 4. Two of the three circular plaques have little to no wax coating remaining and are corroded.

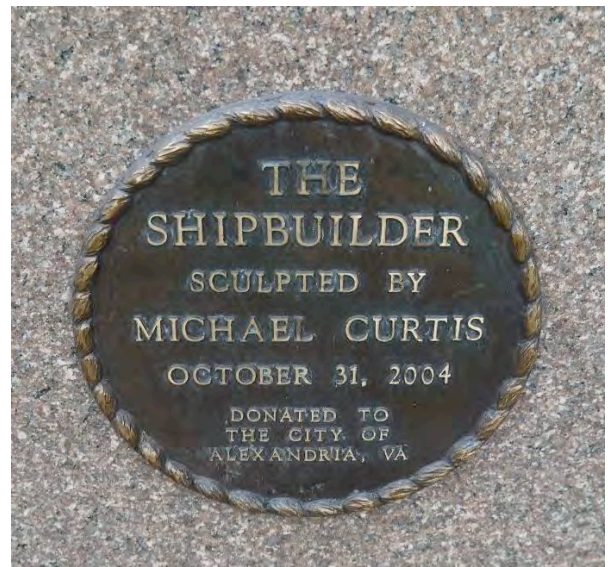
(Right) Figure 5. Front plaque displays little corrosion.

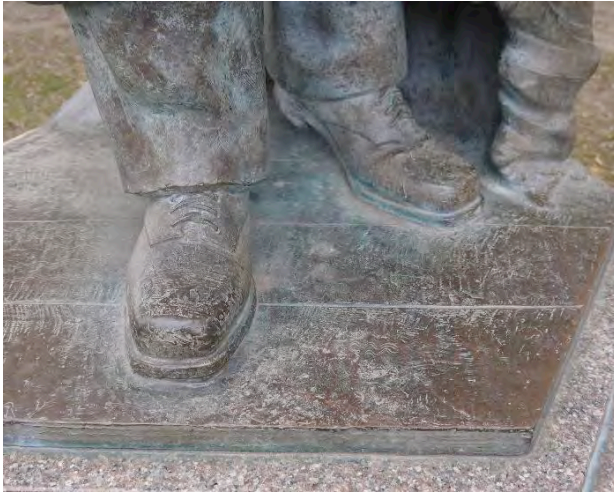
(Left) Figure 6. Minor pitting on edges of figure's shoes, may be an original casting flaw.

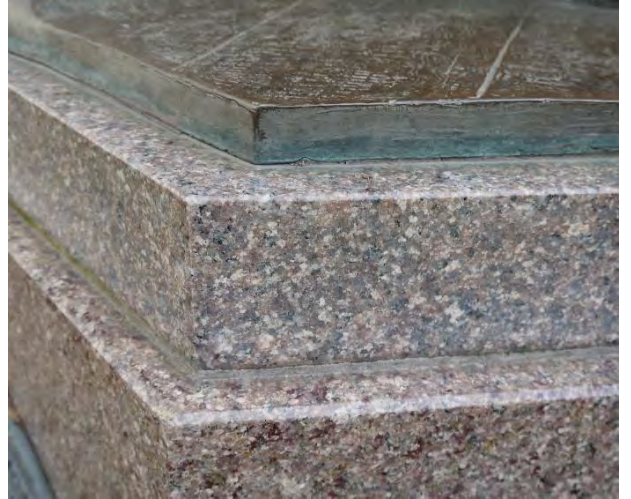
(Right) Figure 7. Detail of minor corrosion along edges of bronze base.

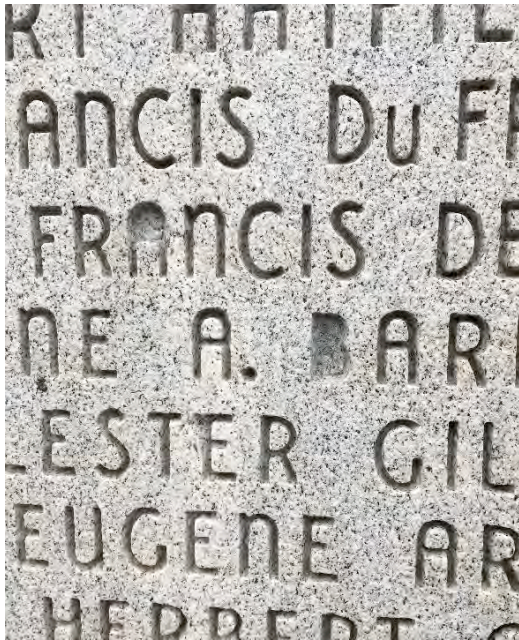
Figure 3. Small stone stubs from within "A"s and "B"s have begun to spall off.

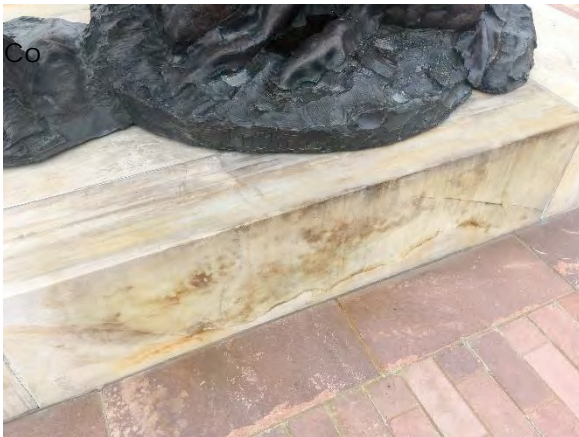
(Left) Figure 3. Sandstone wall exhibits iron and copper staining.

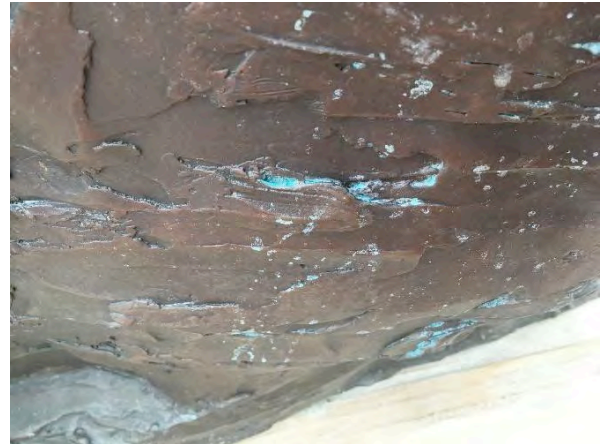
(Right) Figure 4. Bronze surface with pockets of corrosion.

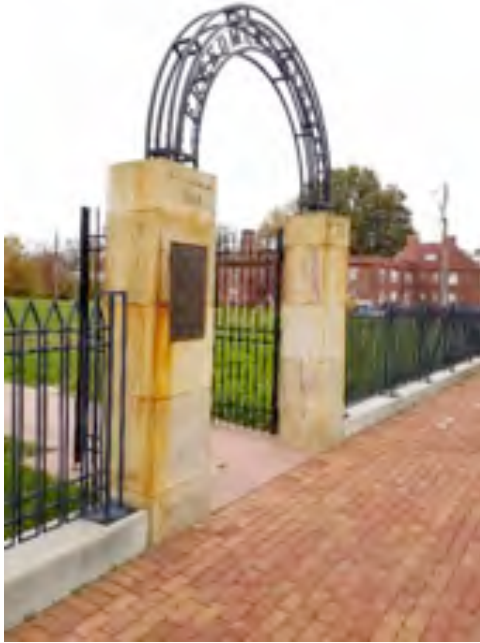
(Left) Figure 5. Cemetery entrance; the sandstone pier shows severe iron-staining from the ferrous bolts. (Right) Figure 6. View of the north wall (interior facing) with bronze plaques.

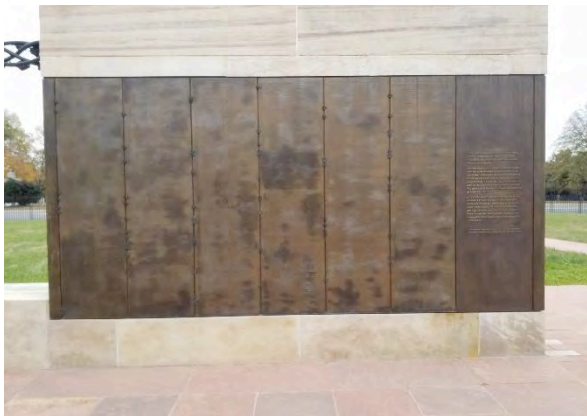
Figure 7. View of the north wall (exterior facing). Iron staining in this location is inherent to the stones.

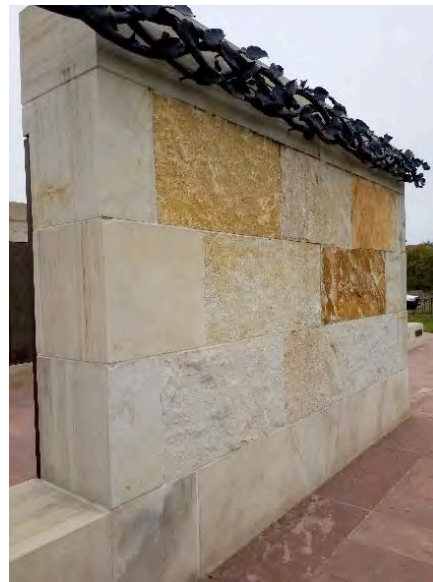
Figure 8. East wall (interior facing) with blanching and discolored patinated bronze plaques.

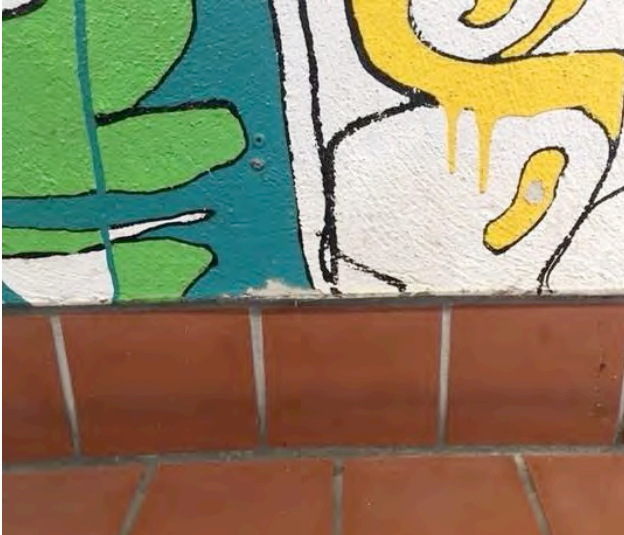
Figure 3. Detail of flaking paint along lower edge of wall.

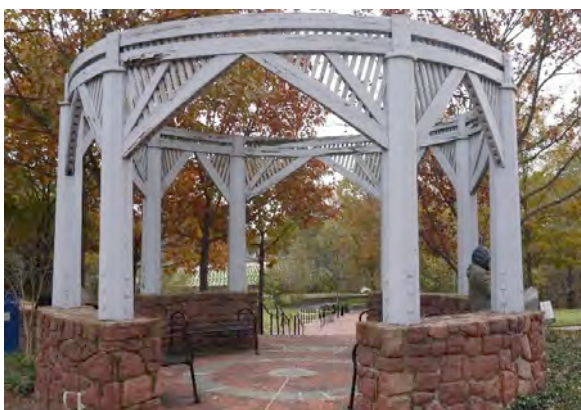
(Left) Figure 1. Part A, wooden trellis in poor condition.

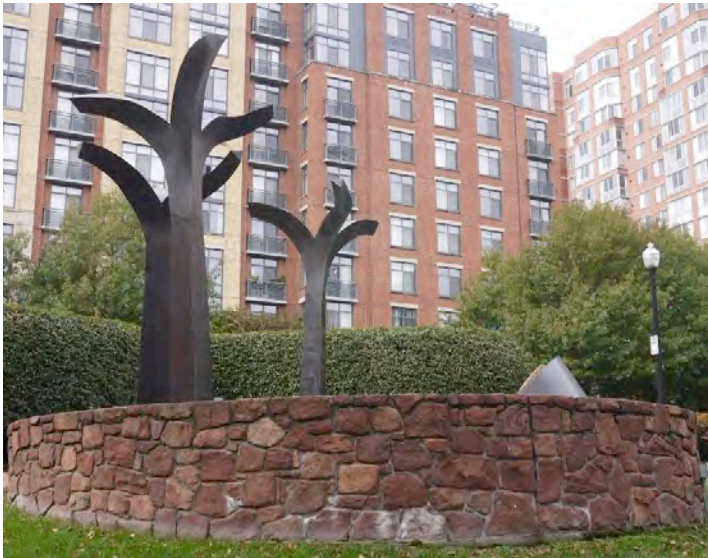
(Left) Figure 5. Overall view of Part C. Wall is exhibiting efflorescence and deteriorated mortar joints.
