CONSERVATION SOLUTIONS inc

ART ▸ ARCHITECTURE ▸ ARTIFACTS

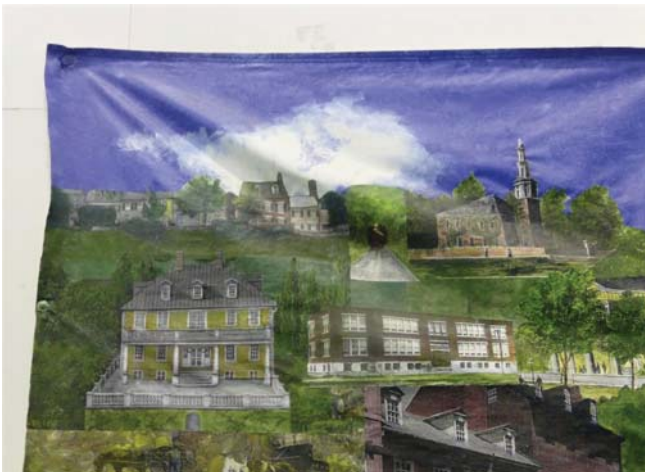
Figure 3: Typical section of canvas exhibiting uneven stretching and bowing due to a lack of structural framework. Otherwise in excellent condition.

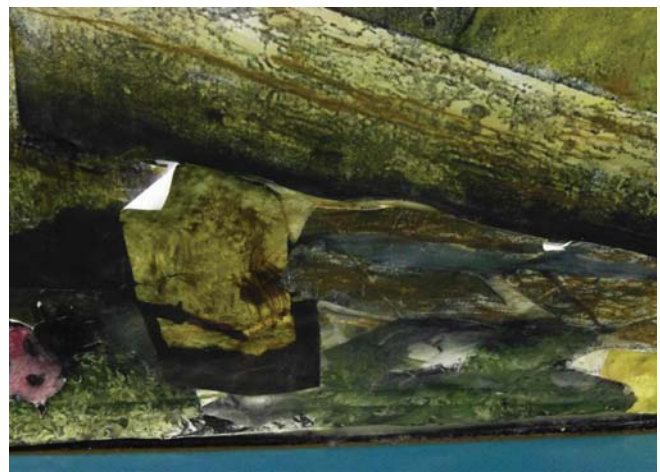
Figure 4: Detail of a peeling edge, possibly due to picking/handling by children.

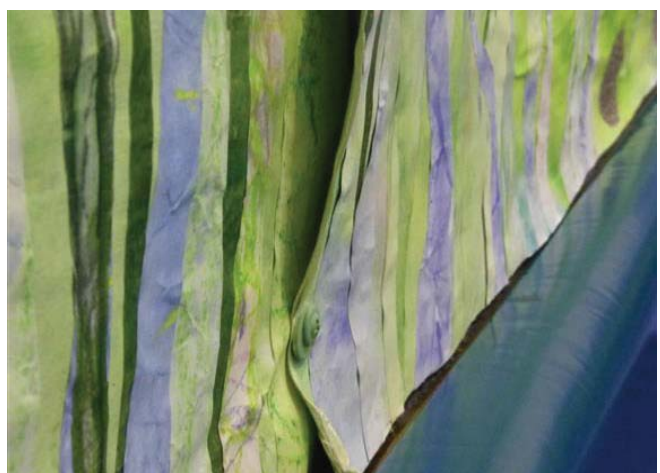
Figure 6: Detail of sagging/bowing associated with improper fastening of the canvas to the wall (note screw and washer).

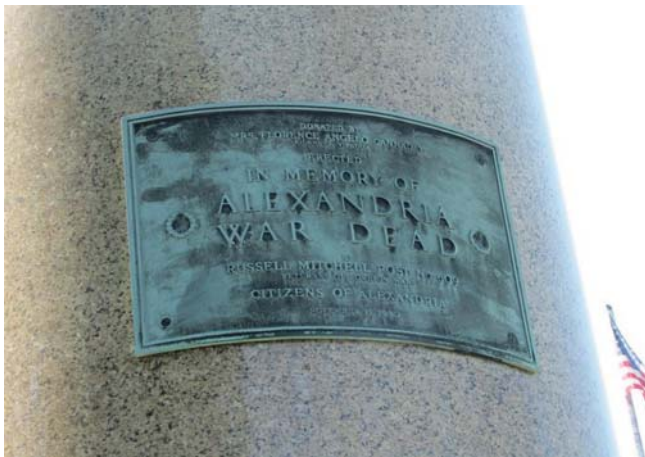
Figure 9: The uncoated plaque has developed an even light green patina of corrosion.

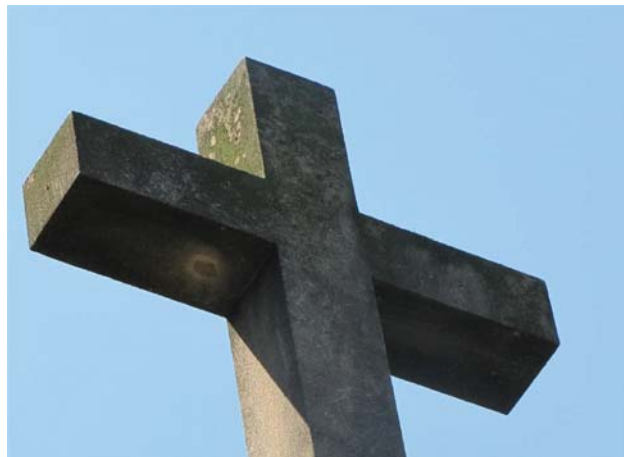
Figure 10: Detail of the cross atop the monument exhibiting extensive black and green biological soiling.

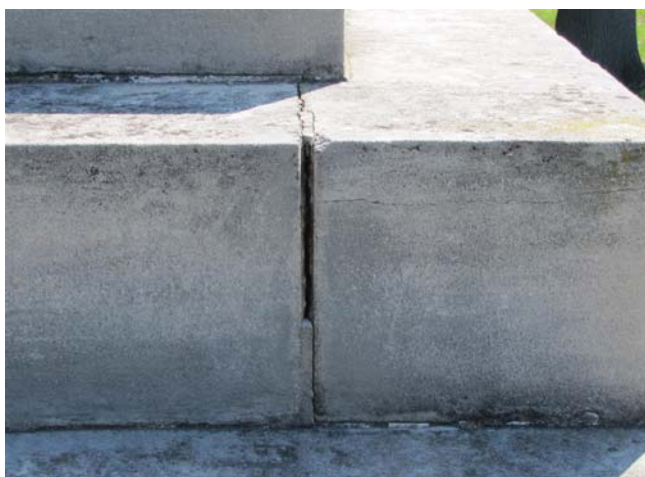
Figure 11: Typical joint exhibiting failing and lost mortar.

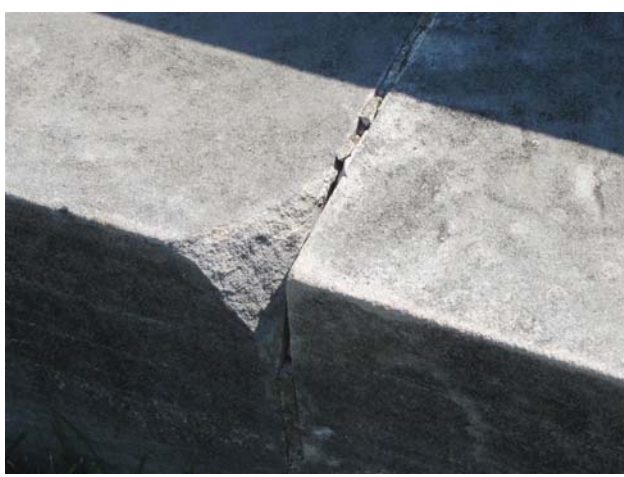
Figure 12: Typical limestone spall along an exposed edge.

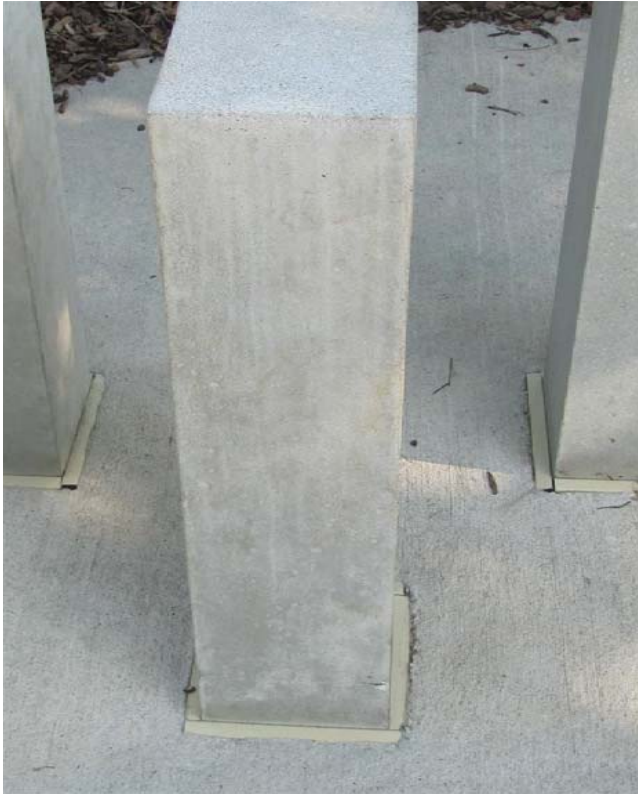
Figure 15. Detail of typical water run-off/streaking pattern down the face of one of the pillars.

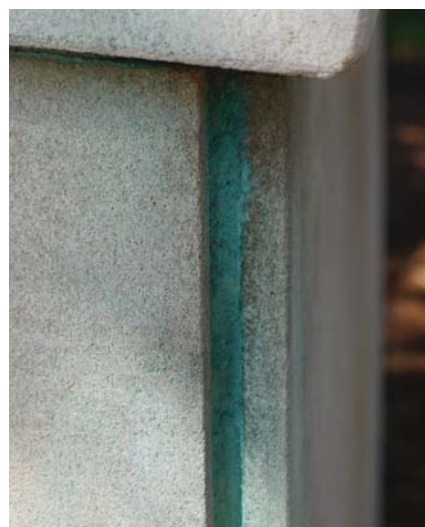
Figure 19. Copper staining has discolored the joints.

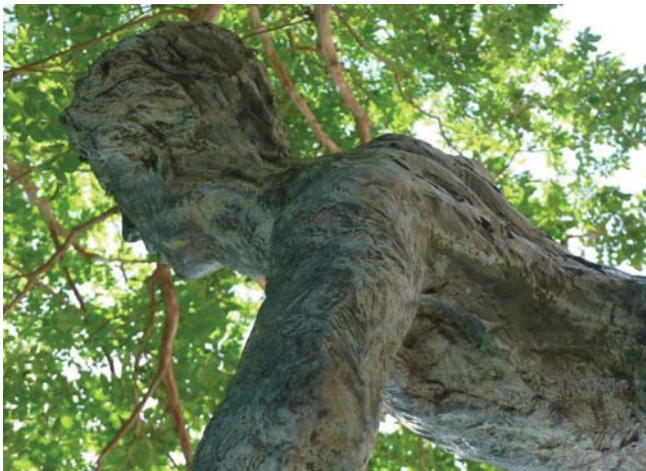
Figure 20. Detail of discoloration on the head and torso of the figure, general.

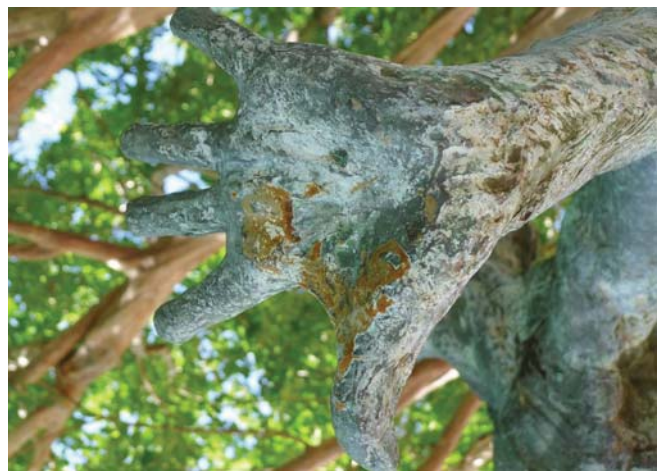
Figure 21. Detail of advanced corrosion and possible iron staining on the hand of the figure.

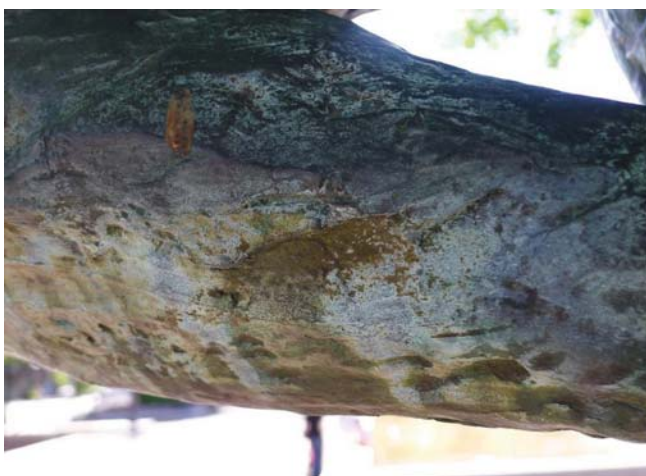
Figure 22. Detail of patina and additional surface staining.

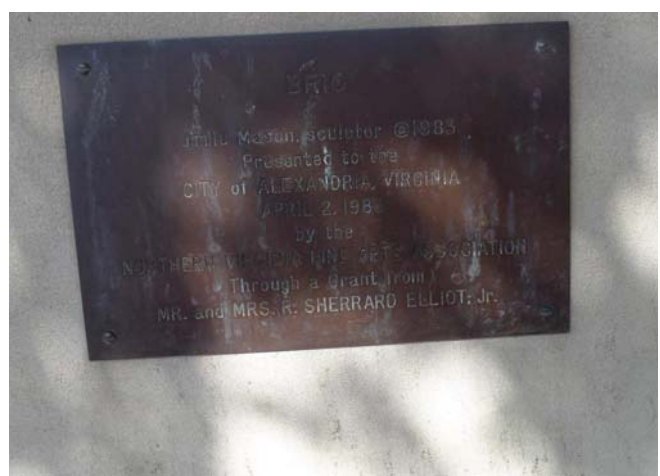
Figure 23. Dedicatory plaque with pervasive corrosion of the surface.

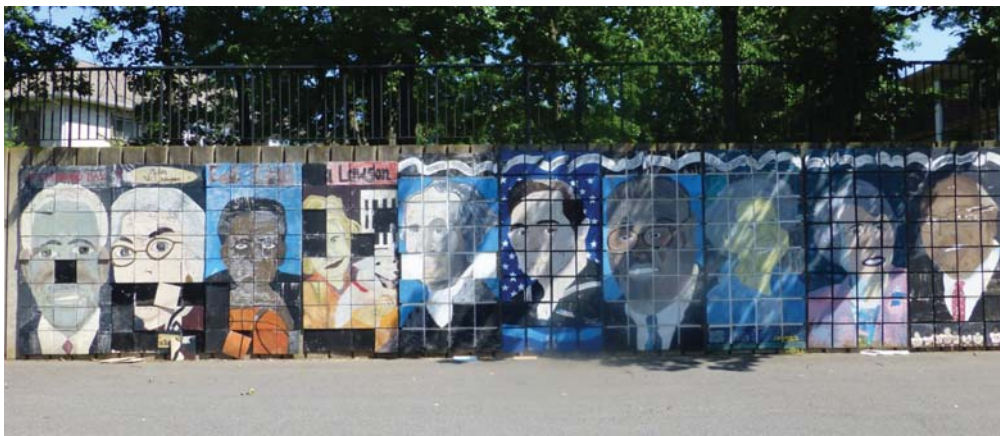
Figure 24. The community project mural exhibits advanced deterioration due to extensive failure of the plywood.

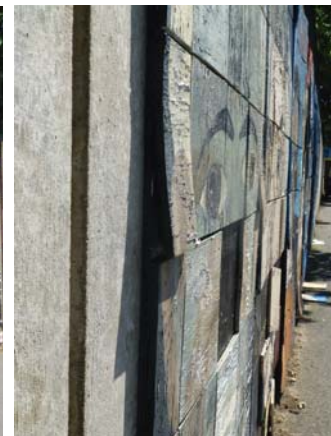
Figure 25. The plywood panels have warped.

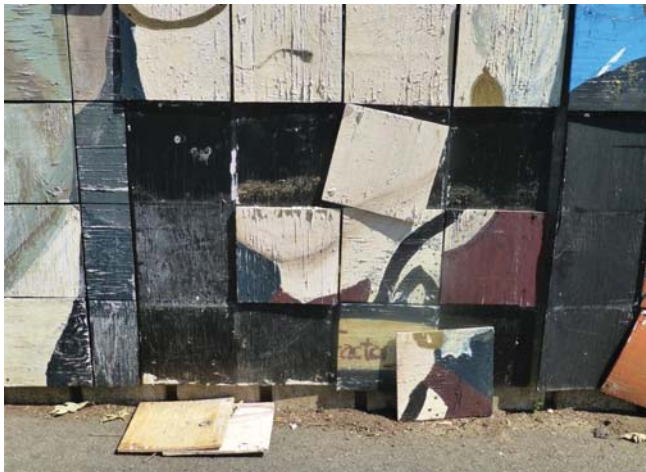
Figure 26. Detail of discoloration on the head and torso of the figure, general.

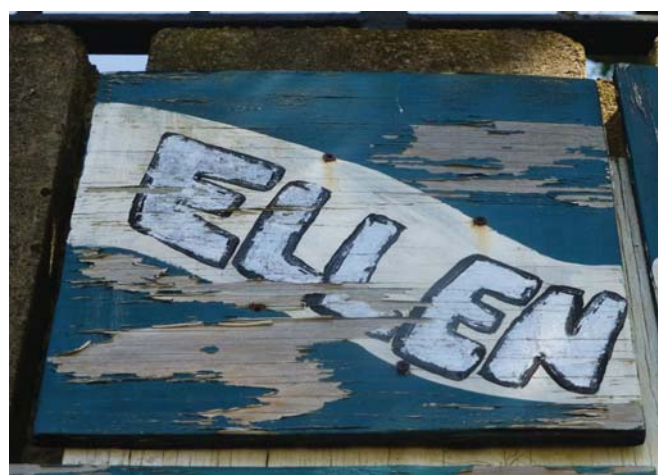
Figure 29. Corrosion of ferrous screws has led to staining and failure of the fasteners, typical.

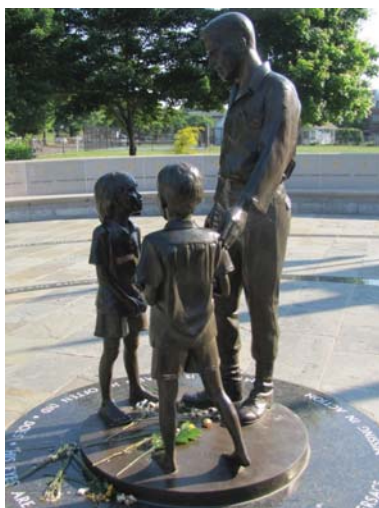
Figure 30. The statue of Captain Rocky Versace measures approximately 6' in height.

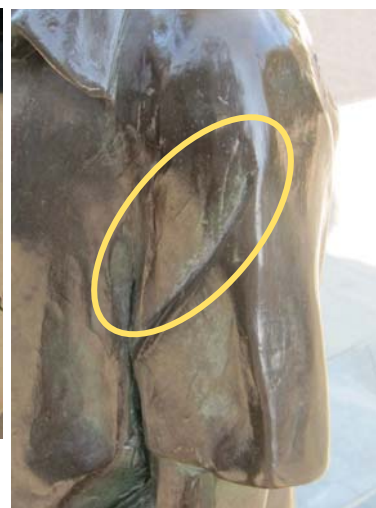
Figure 32. An accumulation of excess wax on the edge of the sleeve has begun to fail.

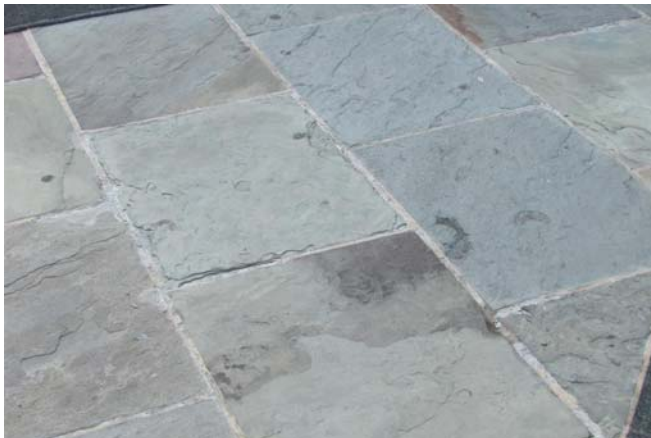
Figure 33. Slate pavers exhibit minor flaking and mortar loss typical to a highly-trafficked surface.

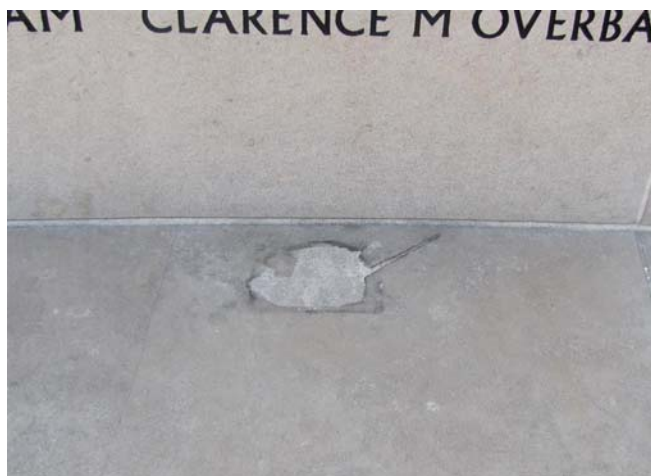
Figure 35. Localized stain on the limestone bench.

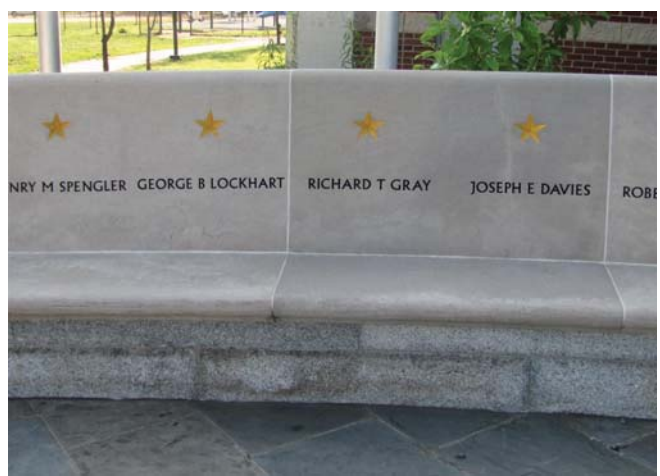
Figure 36. Staining and discoloration is typical of the granite blocks under the limestone bench.

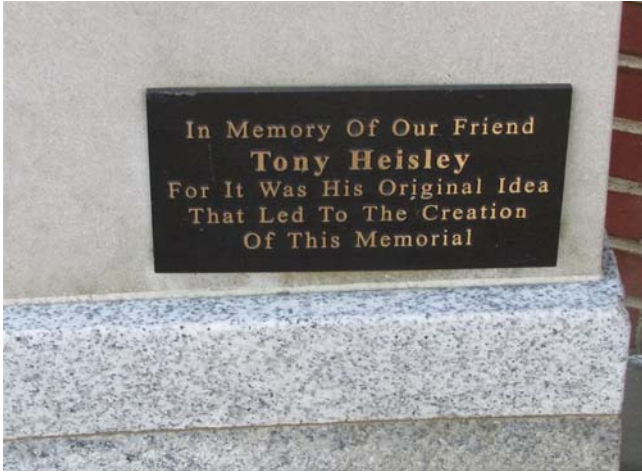
Figure 37. The dedicatory bronze plaque is in excellent condition.

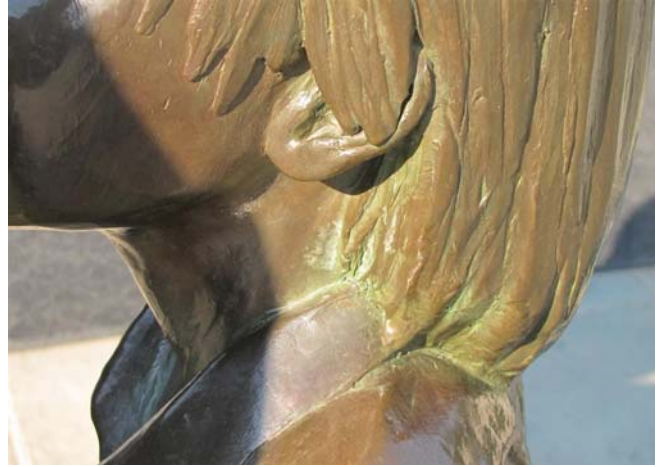
Figure 38. Minor corrosion has developed in recesses and folds that catch and hold onto water and are difficult to clean

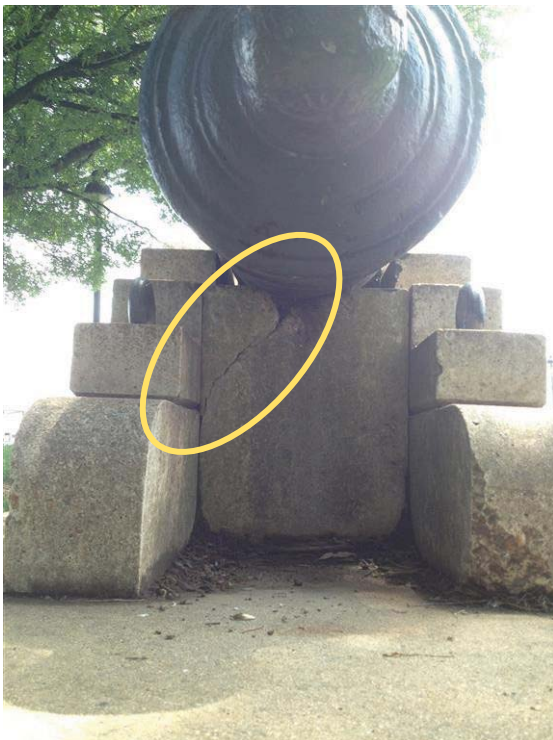
Figure 41. The concrete carriage has cracked and exhibits dimensional losses, suggesting the cannon may not be sufficiently supported.

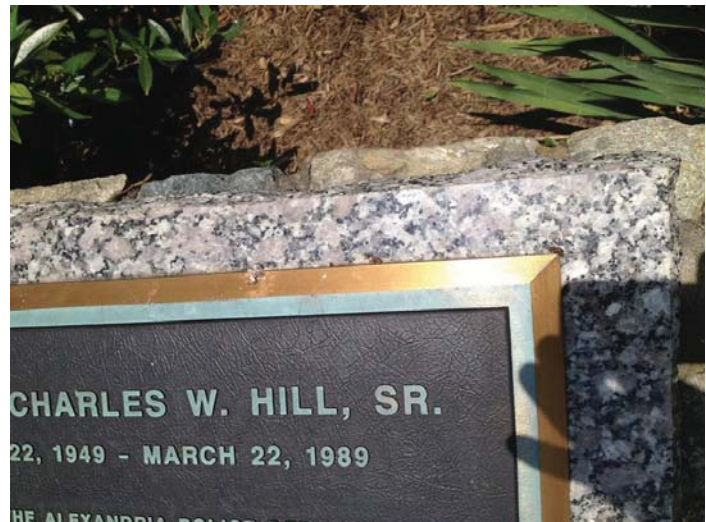
Figure 42. A light blue-green patina has developed on all raised bronze surfaces.

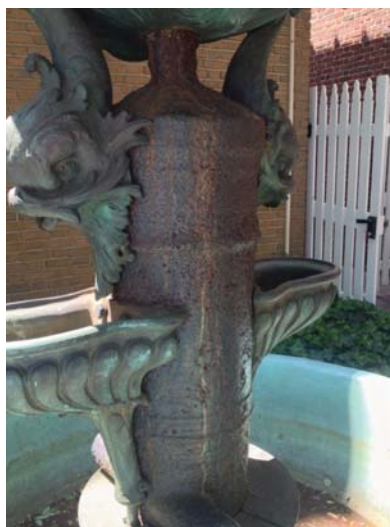
Figure 44. The cannon exhibits severe corrosion and pitting.

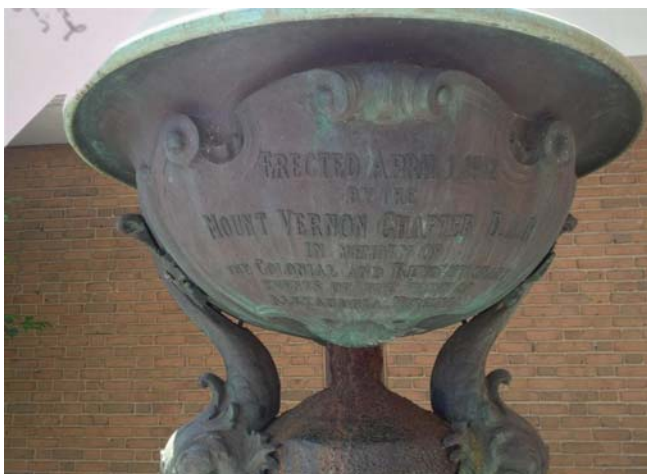
Figure 45. Dedicatory inscription on the underside of the upper fountain basin

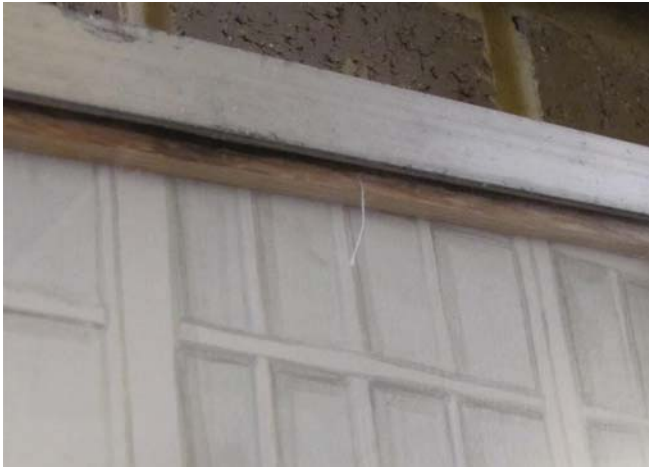
Figure 49. Errant fiber trapped inside one of the frames.

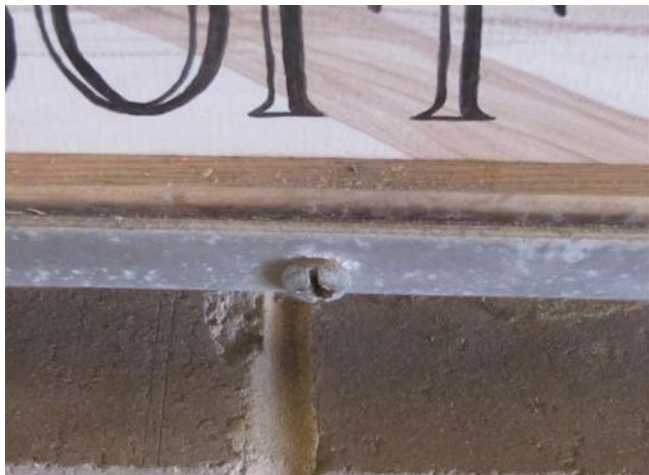
Figure 51. Minor pitting and corrosion of aluminum frame and fastener.

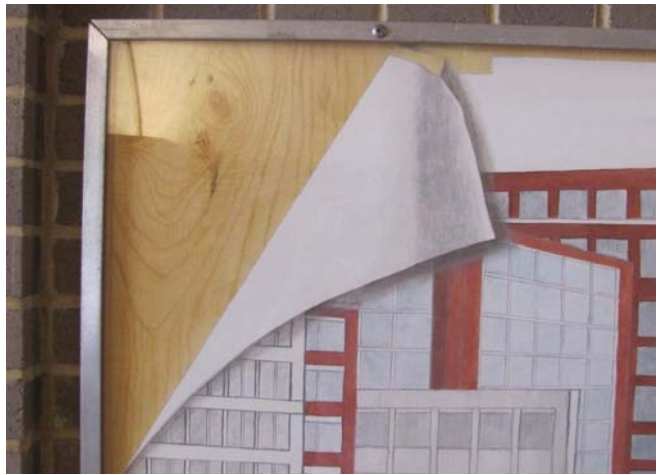
Figure 52. Detail of decorative, faux-finished corner of one of the street scenes.

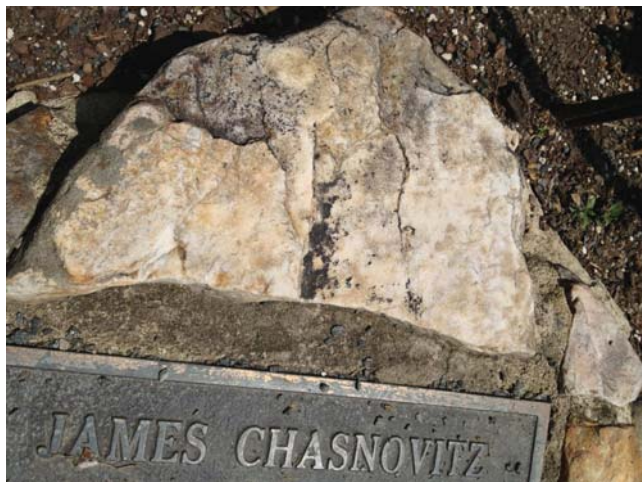
Figure 54. Detail of general soiling and the deteriorated plaque.

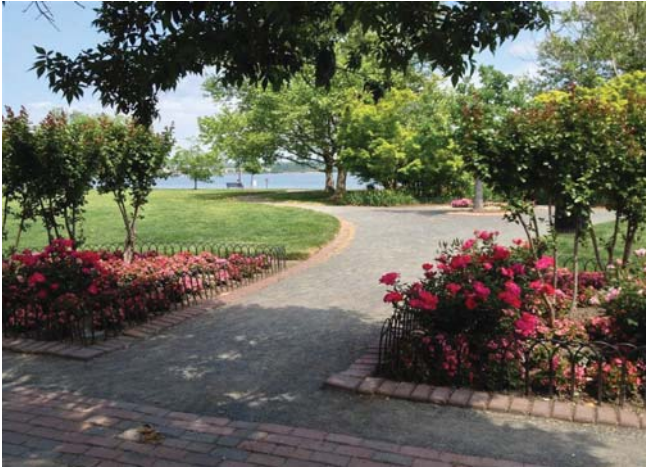
Figure 55. Overall view of the park, paths, and planting beds.

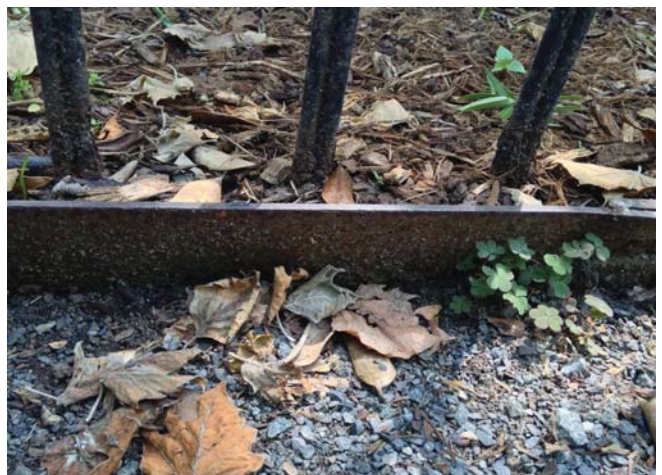
Figure 58. Steel bed liners and the fencing exhibit corrosion.

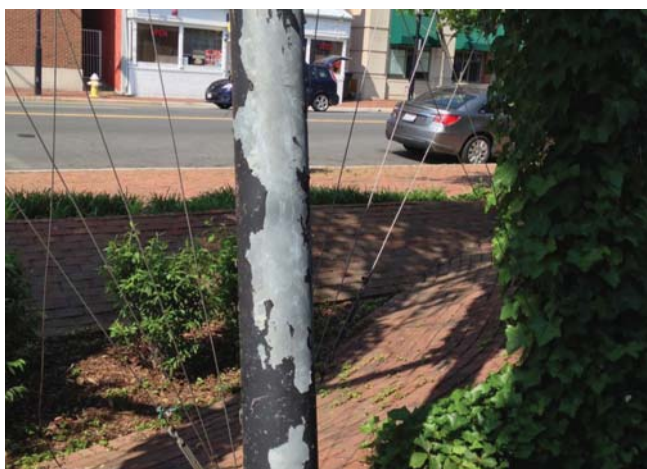
Figure 61. Typical paint loss on a steel structural member revealing the galvanized surface below.

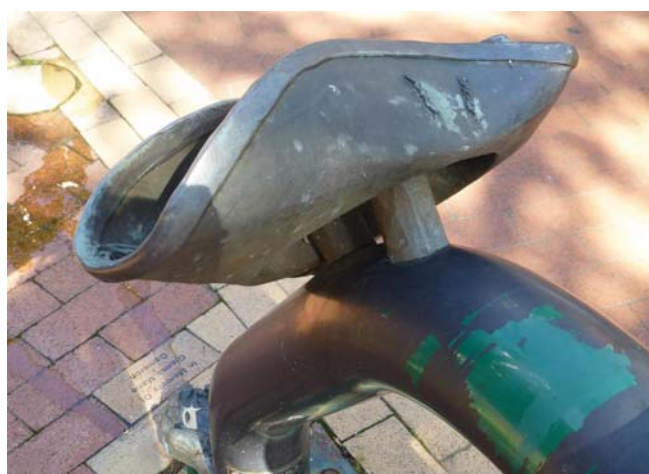
Figure 64. The steel and bronze water fountain exhibits surface deterioration including loss of protective coatings and corrosion.

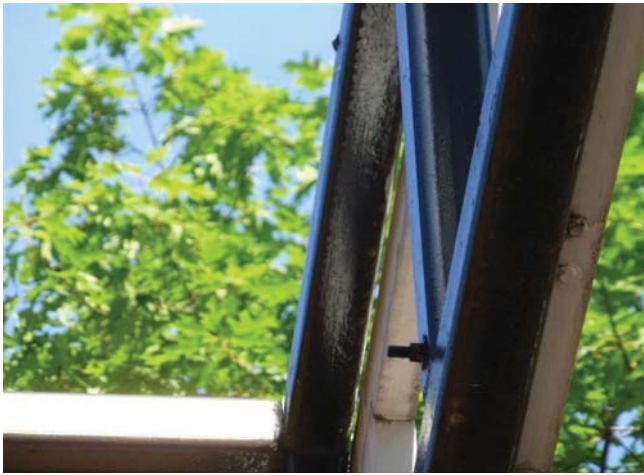
Figure 65. Bolts through the trellis introduce a potential point of weakness and allow water to impact the metal.

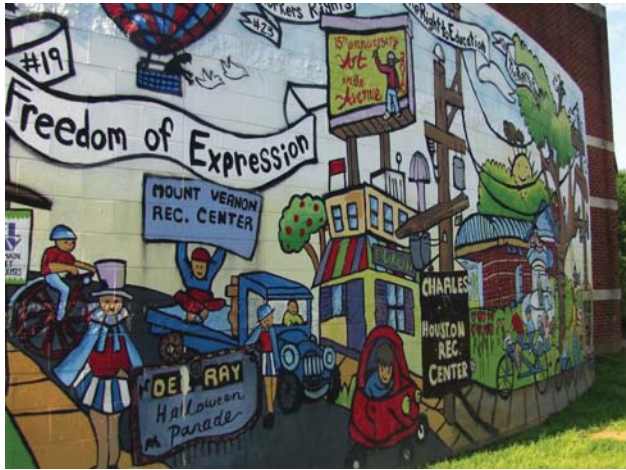
Figure 73. General view of the mural showing the excellent condition overall.

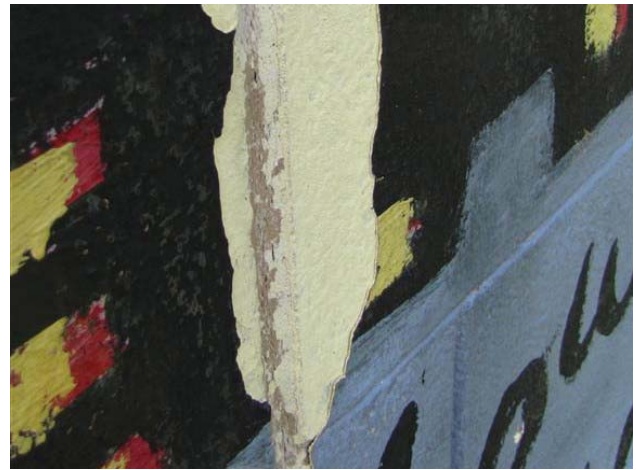
Figure 74. Peeling paint along the vertical expansion joint.

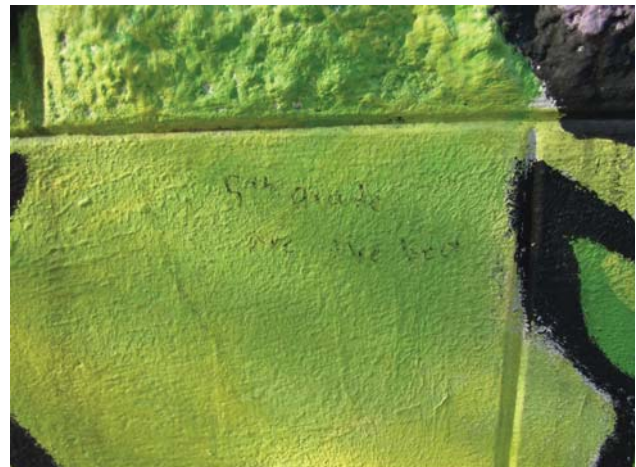
Figure 76. A single incidence of graffiti was observed.

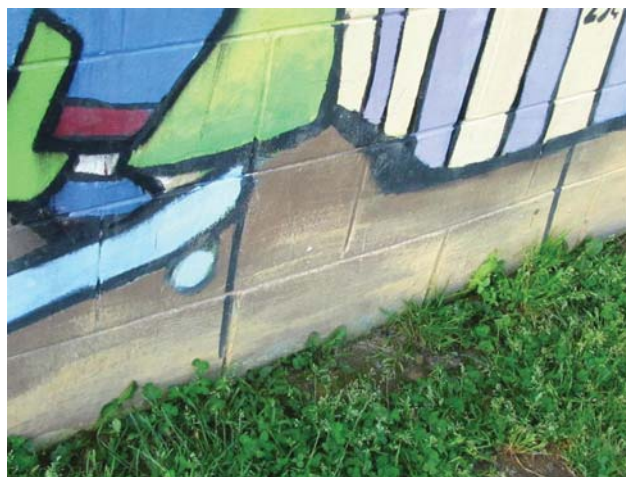
Figure 77. Splashback from the ground below has soiled the lowermost 12" of the mural

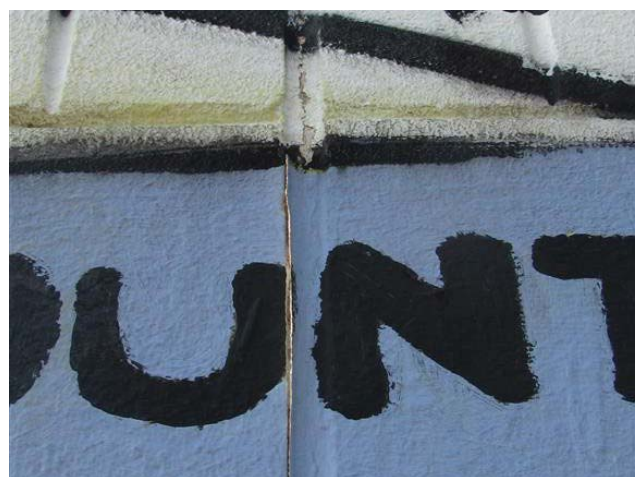
Figure 78. Paint is failing where it was applied over flexible sealant along an expansion joint.

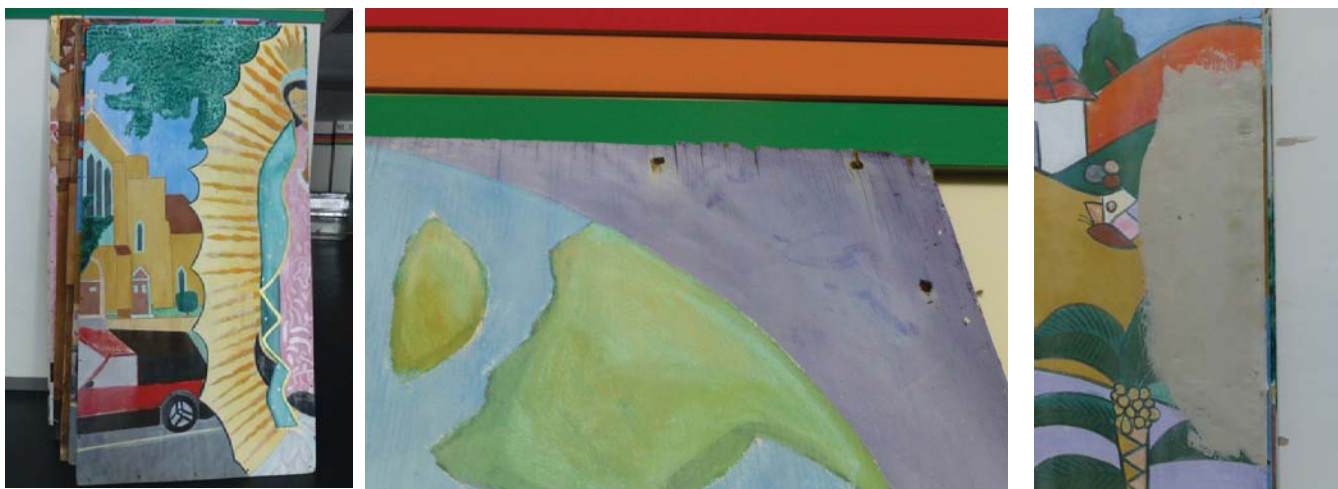
Figure 79 (left). Each panel measures approximately 4'x8'. **Figure 80 (center):** The edges of each board are warped and frayed. **Figure 81 (right):** An area of rot has been cut out and new wood spliced in.

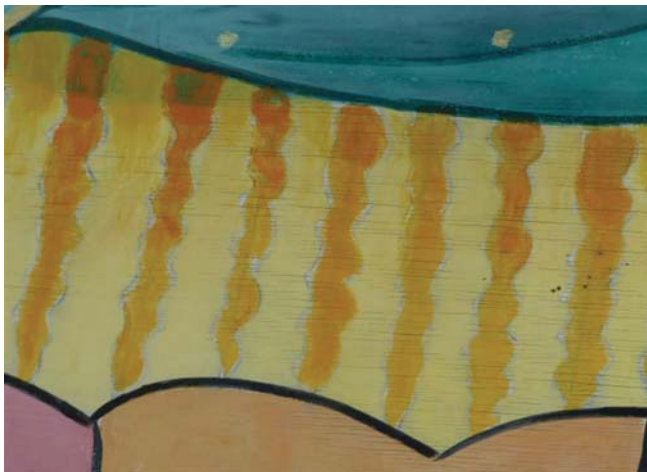
Figure 82. Shrinkage and warping of the plywood panel has led to cracking of the surface paint.

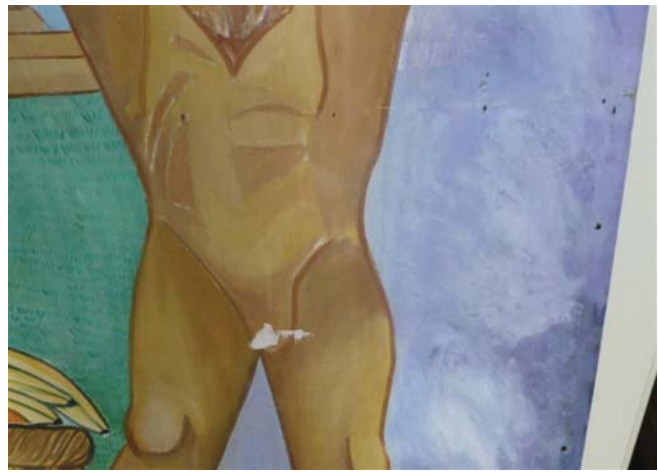
Figure 83. An incidence of graffiti

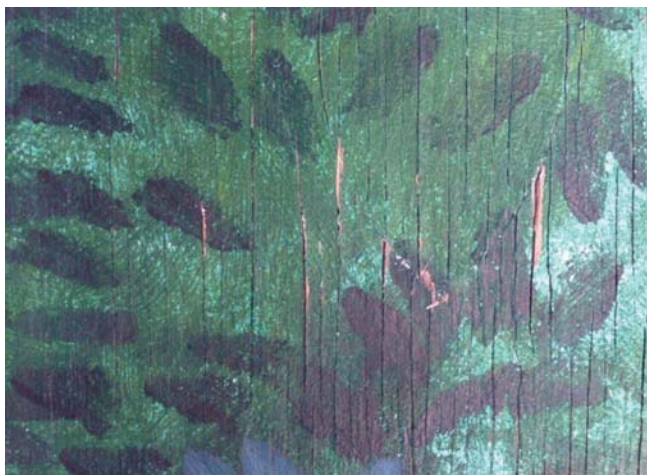
Figure 84. Paint loss associated with shrinkage cracks.

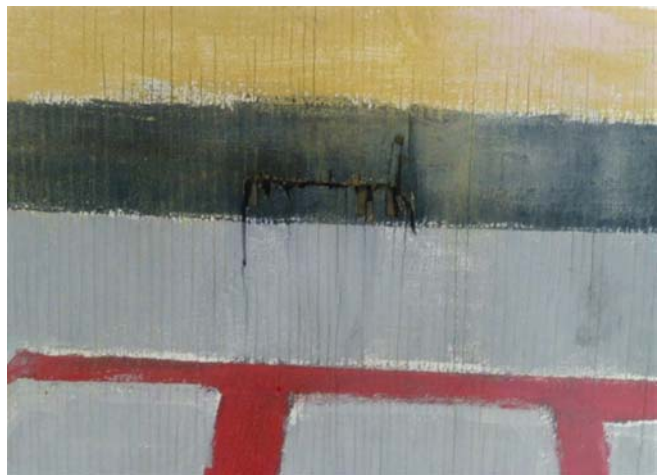
Figure 85. Example of a splintering wood surface.

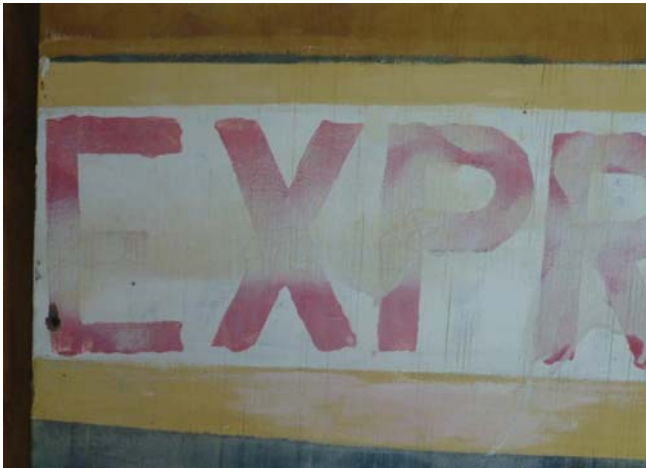
Figure 86. Graffiti spray-paint was observed in select locations.

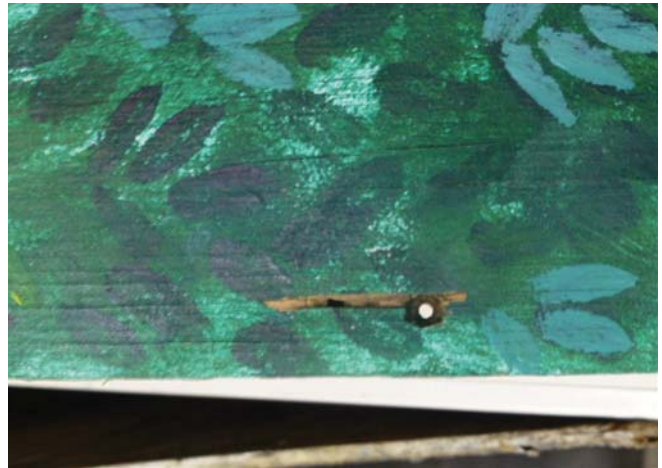
Figure 87. Accelerated deterioration and loss around an existing screwhole (now empty).

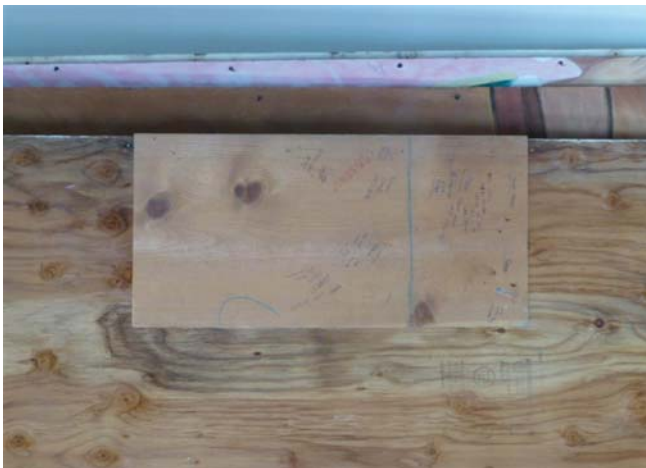
Figure 88. Wood blocking on the reverse of a panel used to support one of the major patching repairs.

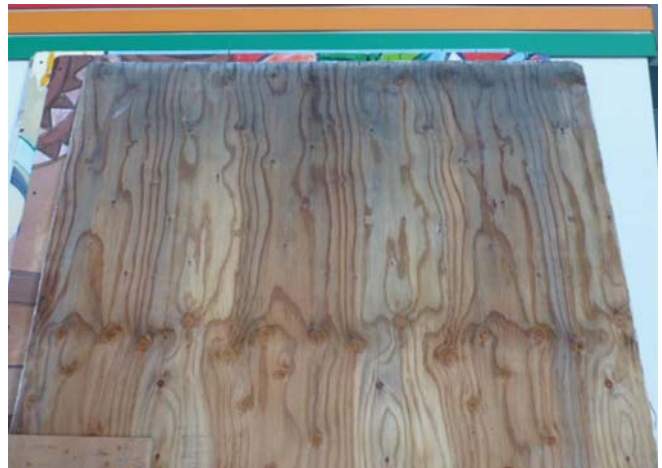
Figure 89. Water damage and discoloration are typical at the lower edges of the panel (here turned upside-down).

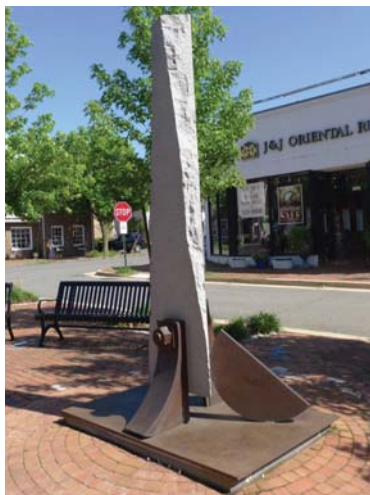
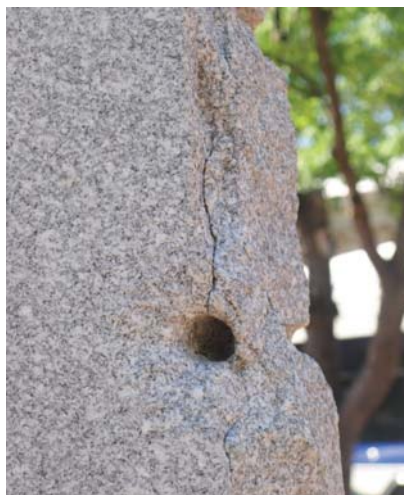
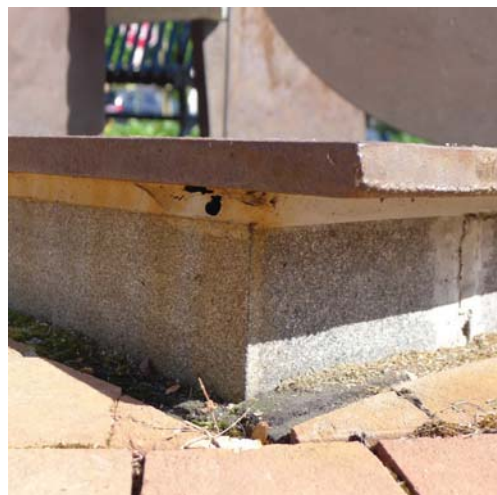
Figure 89 (left). The totem measures 113' x 66' x 44' ; **Figure 90 (center).** Detail of a vertical microcrack along the edge of the stone; **Figure 91 (right).** Detail of iron staining and failed caulk under the steel base.

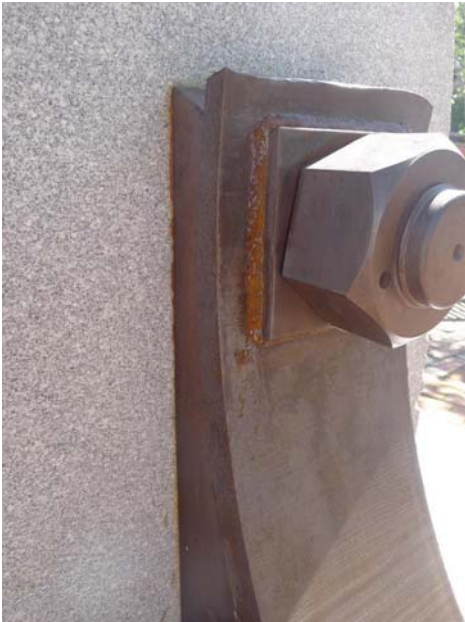
Figure 92. Corrosion and iron staining at the juncture where the steel flange meets the granite totem.

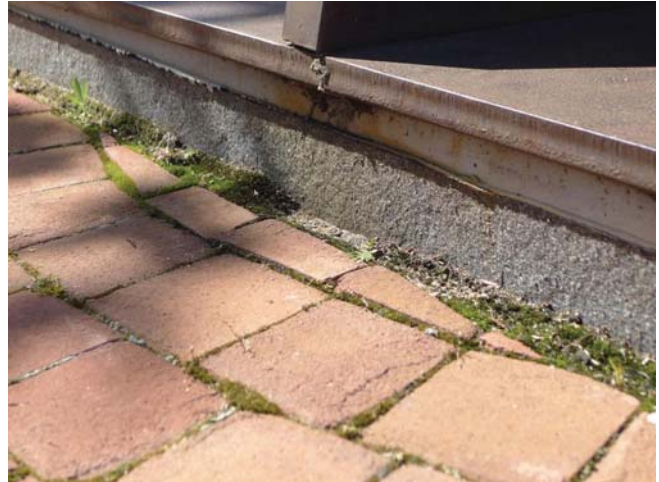
Figure 93. Iron staining of the granite base and vegetative growth in the pavers abutting the sculpture.

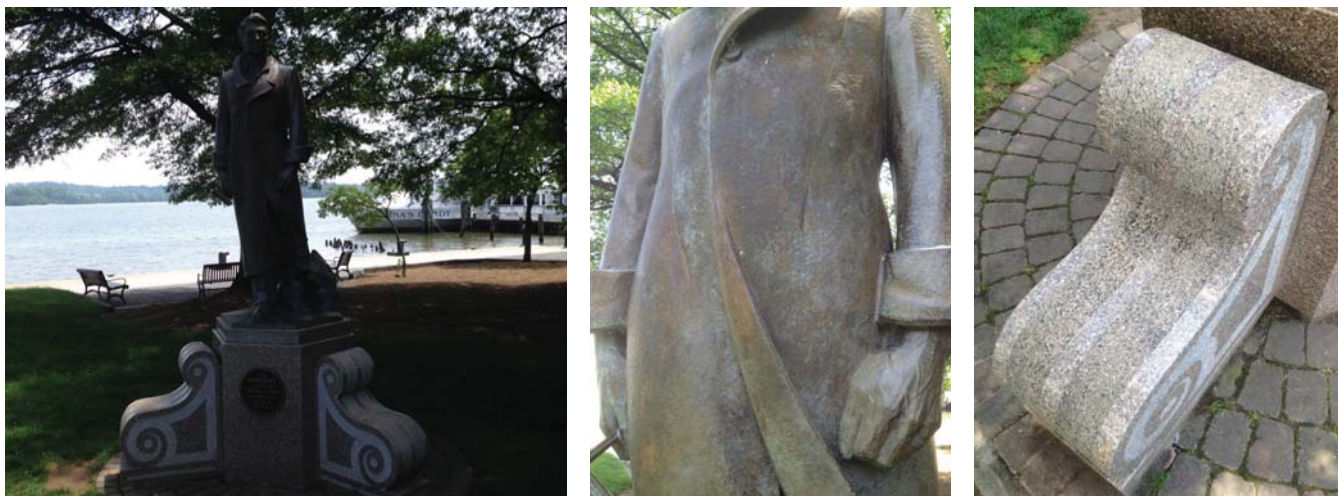
Figure 94 (left). General view of the *Shipbuilder* sculpture; **Figure 95 (center).** Detail of surface corrosion and soiling; **Figure 96 (right).** General view of one of three decorative granite scrolls.

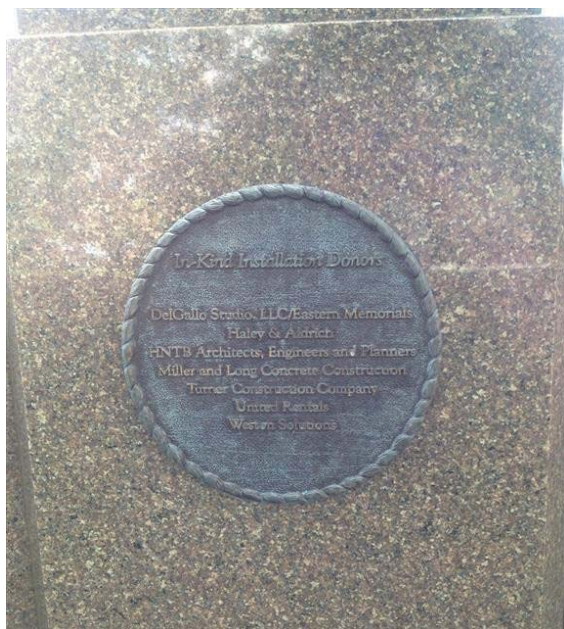
Figure 97. The light blue-green coloration of the plaque is likely an intentional patina rather than corrosion.

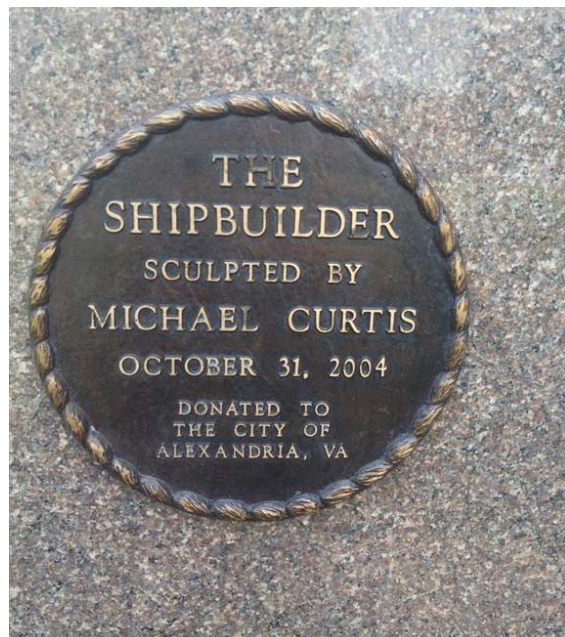
Figure 98. Some of the highlights on the raised lettering of the dedicatory plaque have become discolored.

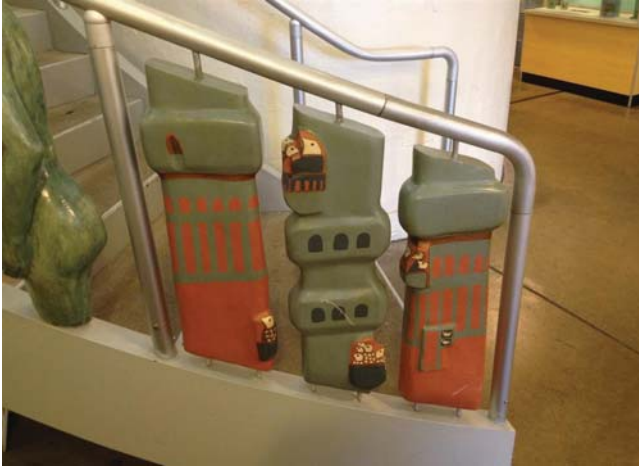
Figure 103. 3 painted wood, sculptural balusters by Murney Keleher

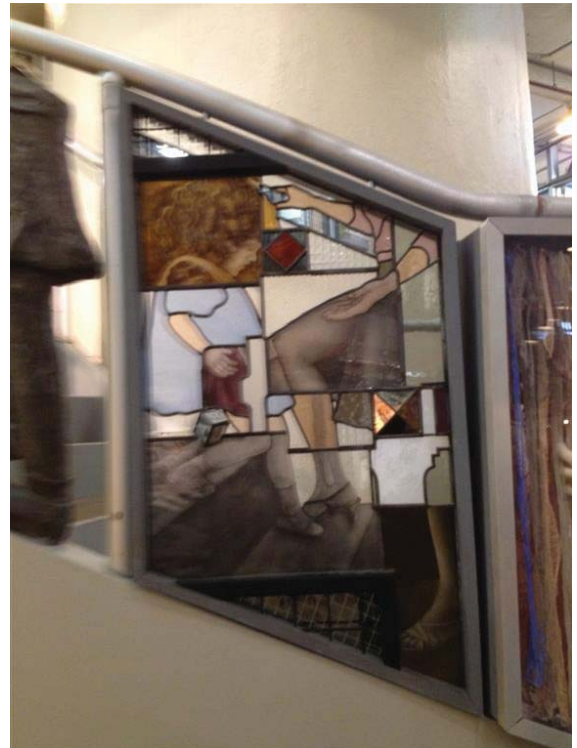
Figure 108. Stained glass by Mark Anderson

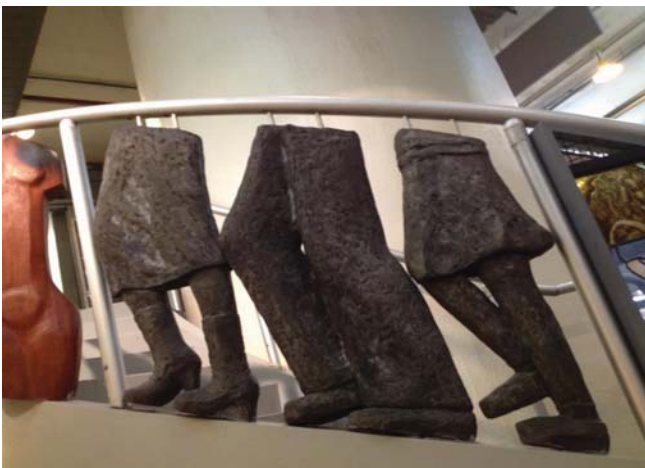
Figure 109. Lead sculpture by Betty Rice Seim

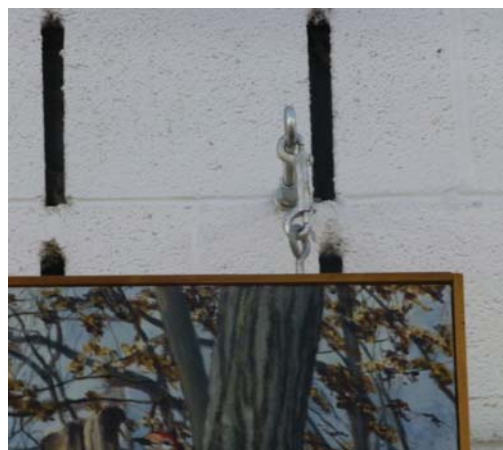
Figure 116: Detail of the mounting hardware used to affix the panels to the wall.

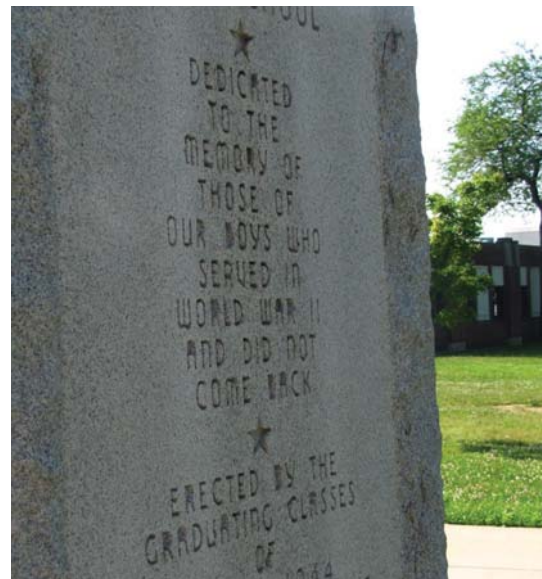
Figure 118: Detail of limited staining down one of the inscription panels of the monument.

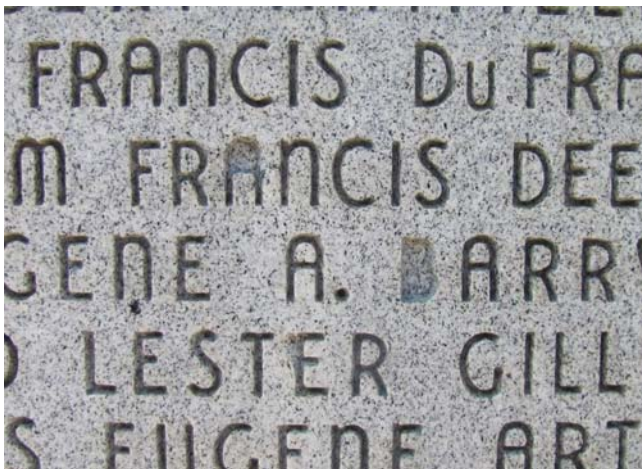
Figure 119. Small stone stubs from within As and Bs have begun to spall off.

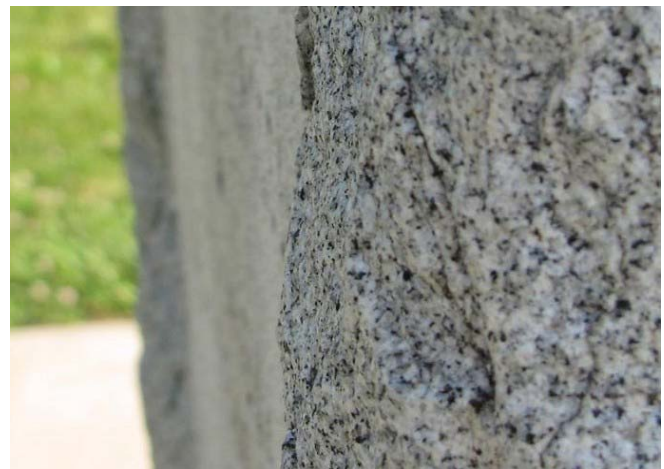
Figure 120. Vertical microcrack may develop into a spall.

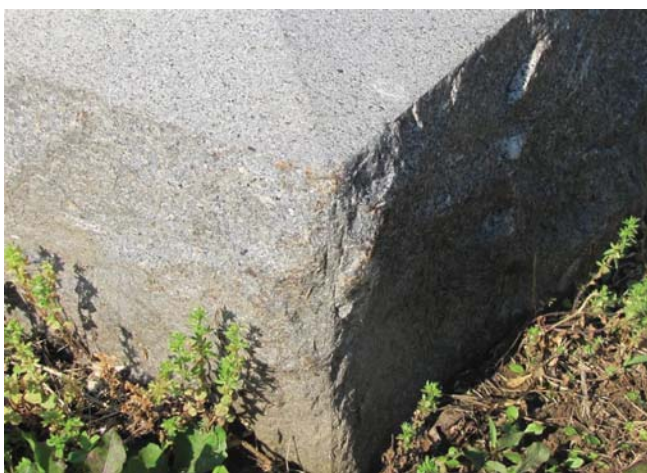
Figure 121. Iron staining on the edge of the plinth suggests abrasion from a lawnmower

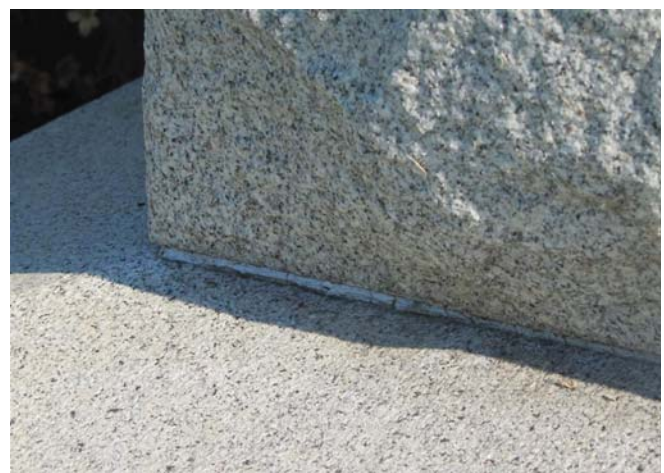
Figure 122. The lead joint between the obelisk and plinth is in excellent condition
