Fort Ward Park and Museum Area Management Plan

Appendix I FORT WARD PARK DRAINAGE MASTER PLAN

URS Corporation, 2014

FORT WARD PARK DRAINAGE MASTER PLAN

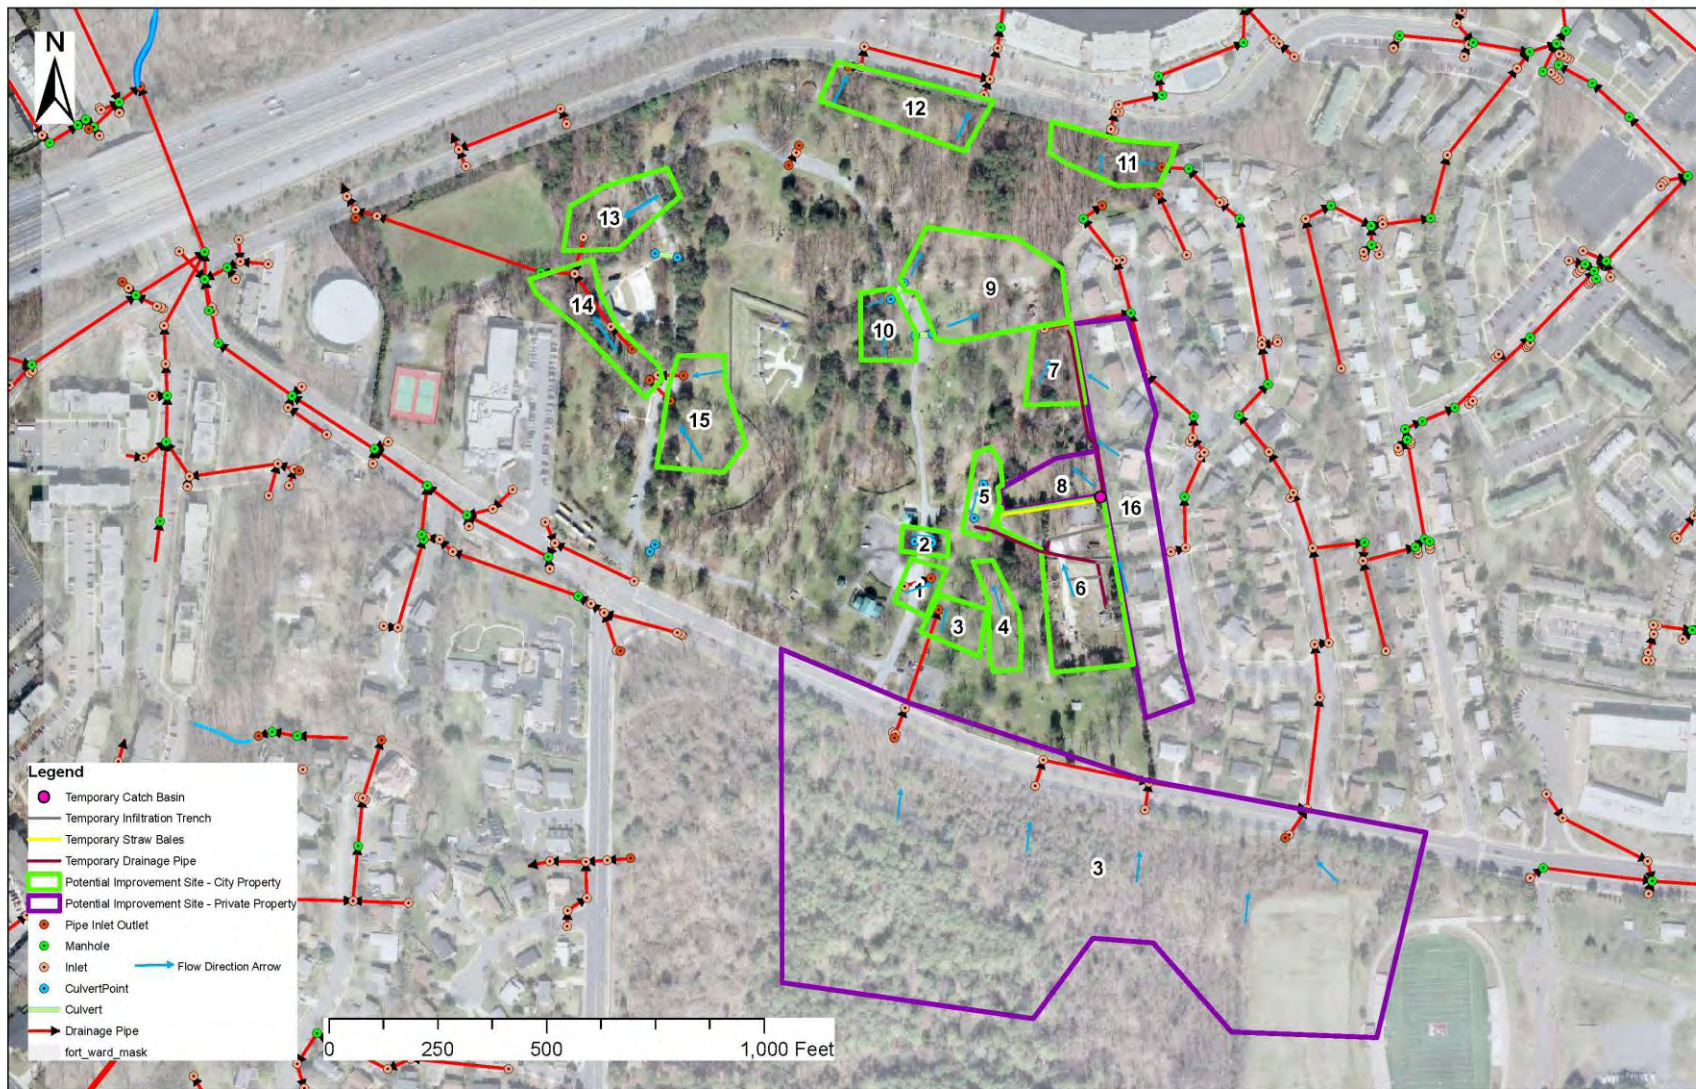
Figure 3: Fort Ward Park Sites for Potential Improvement

Deficiencies include nuisance flooding, sedimentation and erosion, flooding during more extreme events, or a combination. Figure 3 shows the locations of the 16 sites.

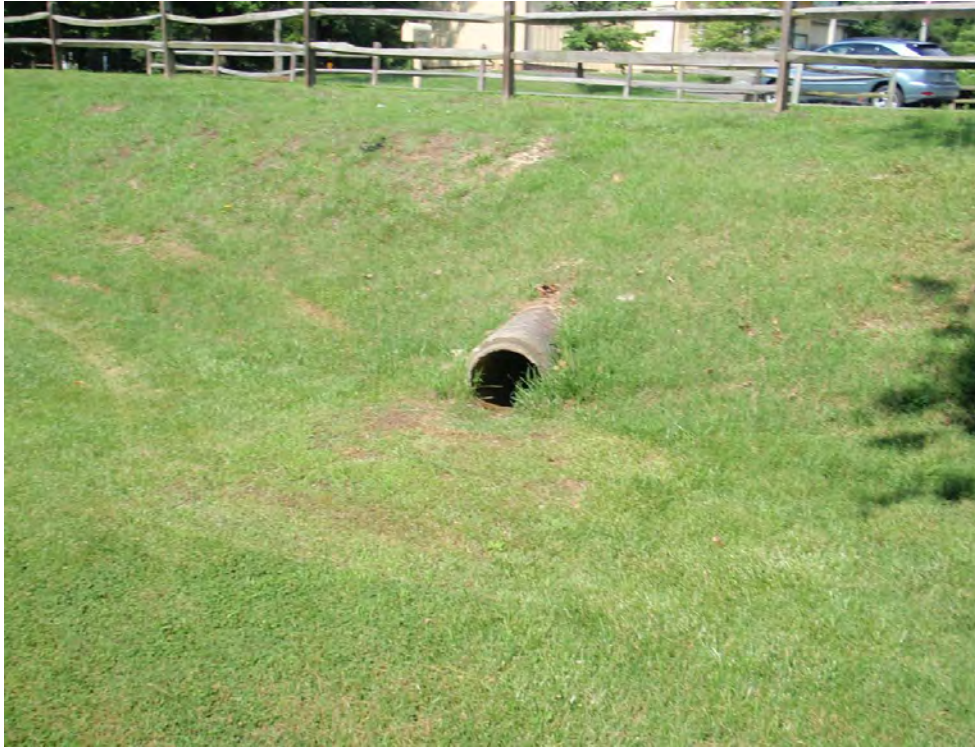
Figure B-4: Outlet of the 15-inch concrete pipe. No erosion was observed(Location ID #29)

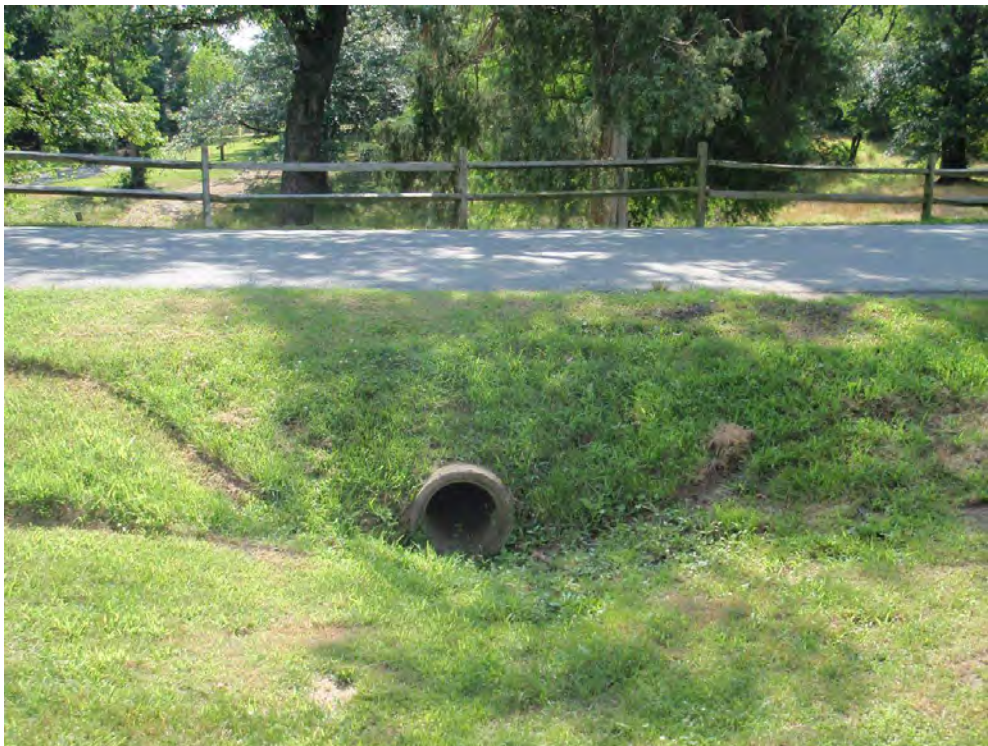
Figure B- 5: Inlet of the 15-inch concrete pipe next to the parking lot (Location ID #25). Observed a small ponding area at the inlet

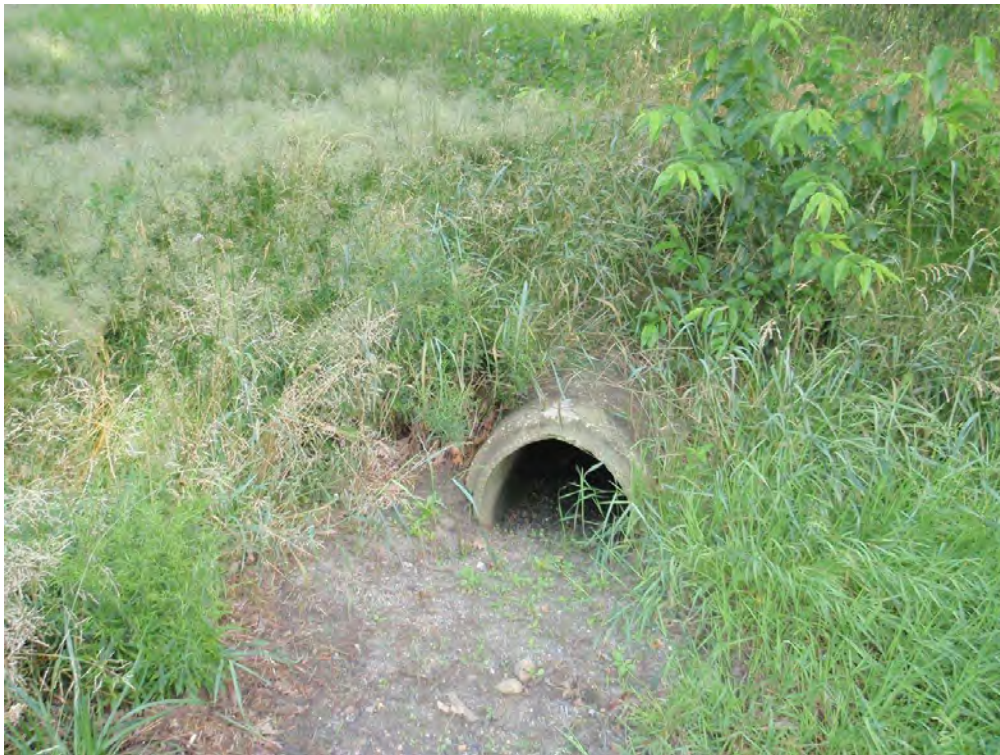
Figure B- 9: Outlet of 18-inch concrete pipe. Observed built-up debris and sedimentation, which may come from roadway (Location ID #30)

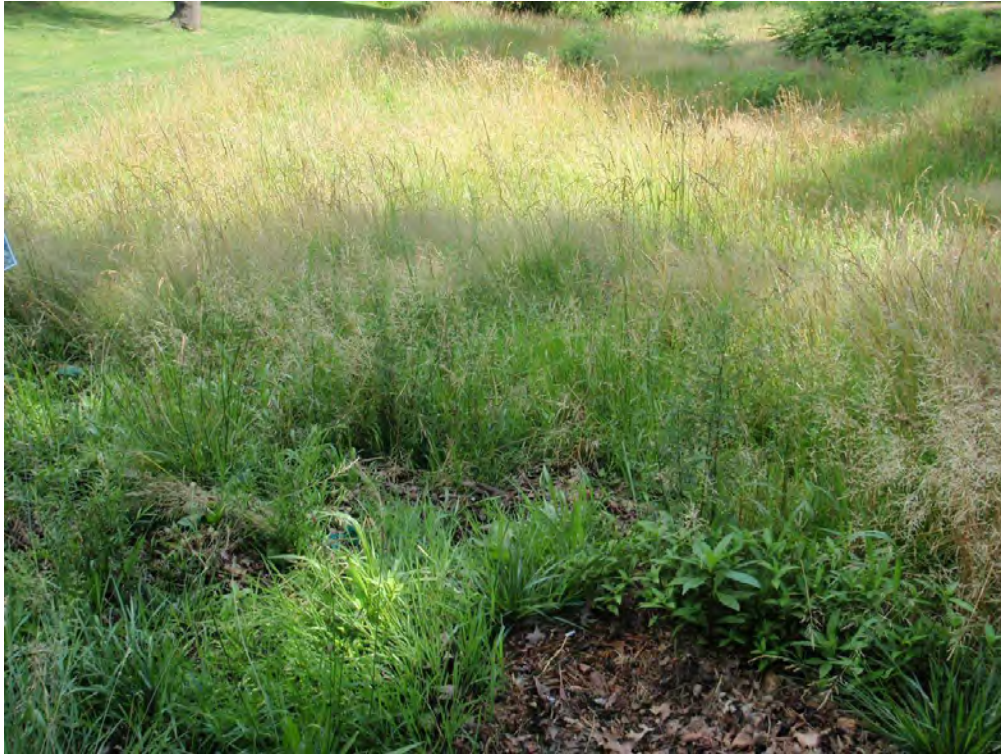
Figure B- 10: Downstream of the 18-inch concrete pipe. Observed built-up debris (Location ID #31)

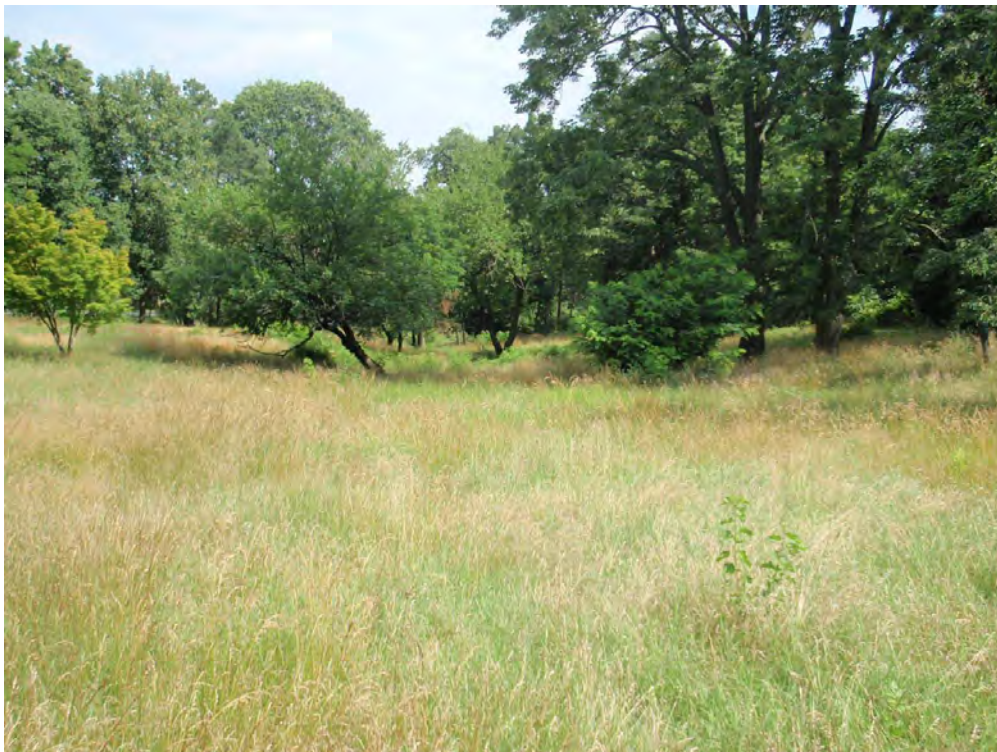
Figure B- 13: The swale. No erosion observed (Location ID #35)

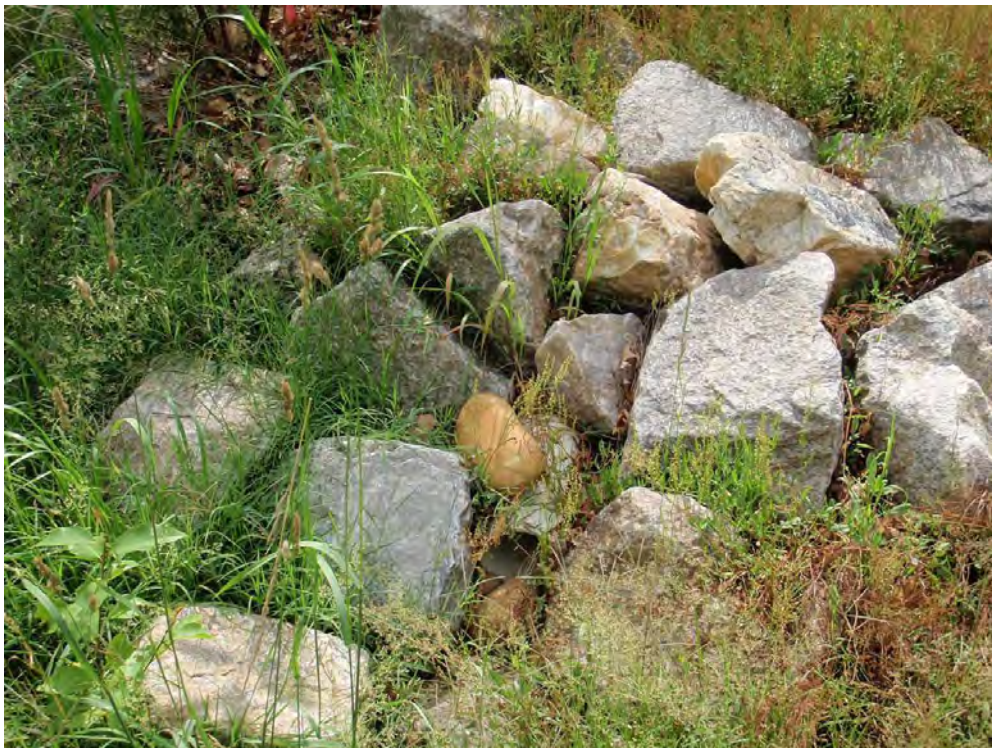
Figure B- 15: Blocked Outlet for 6-inch PVC underdrain pipe. Observed built-up debris and tree branches (Location ID #38)

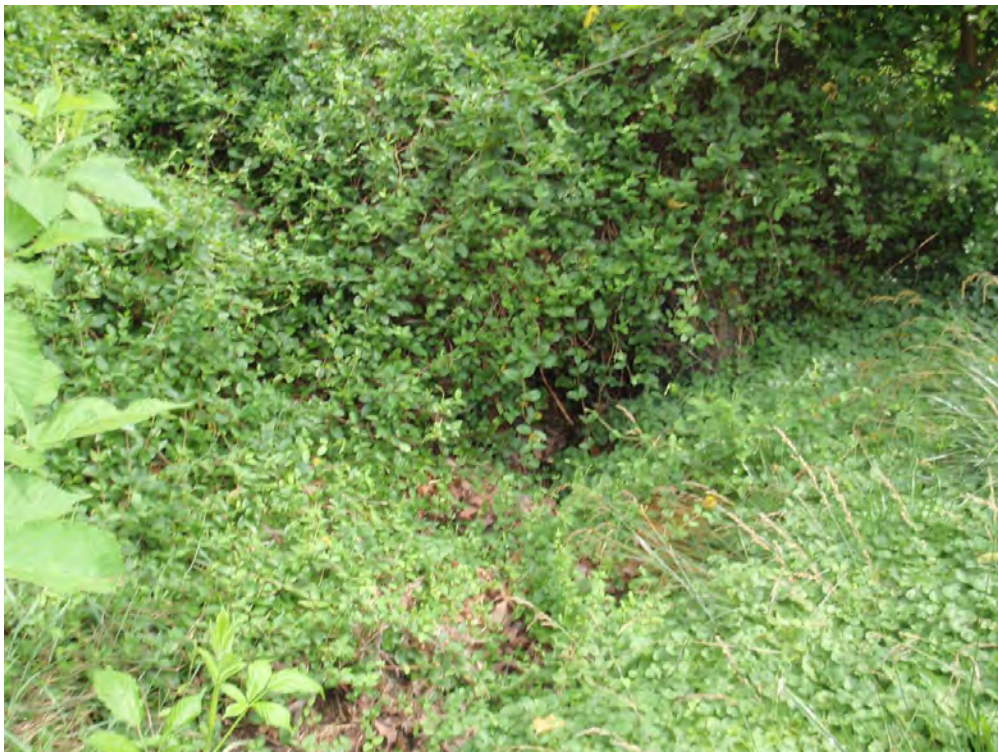
Figure B- 17: Inlet of the 36-inch culvert. Observed built-up tree branches at the inlet (Location ID #40)

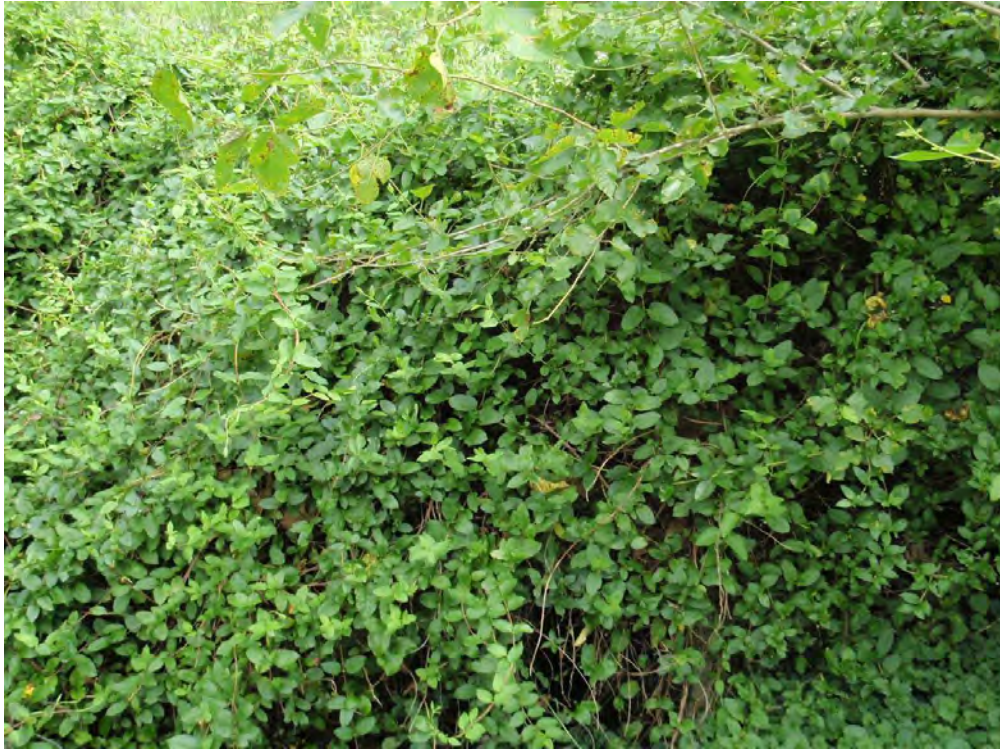
Figure B- 18: Inlet of the 36-inch culvert. Observed built-up tree branches at the inlet (Location ID #41)

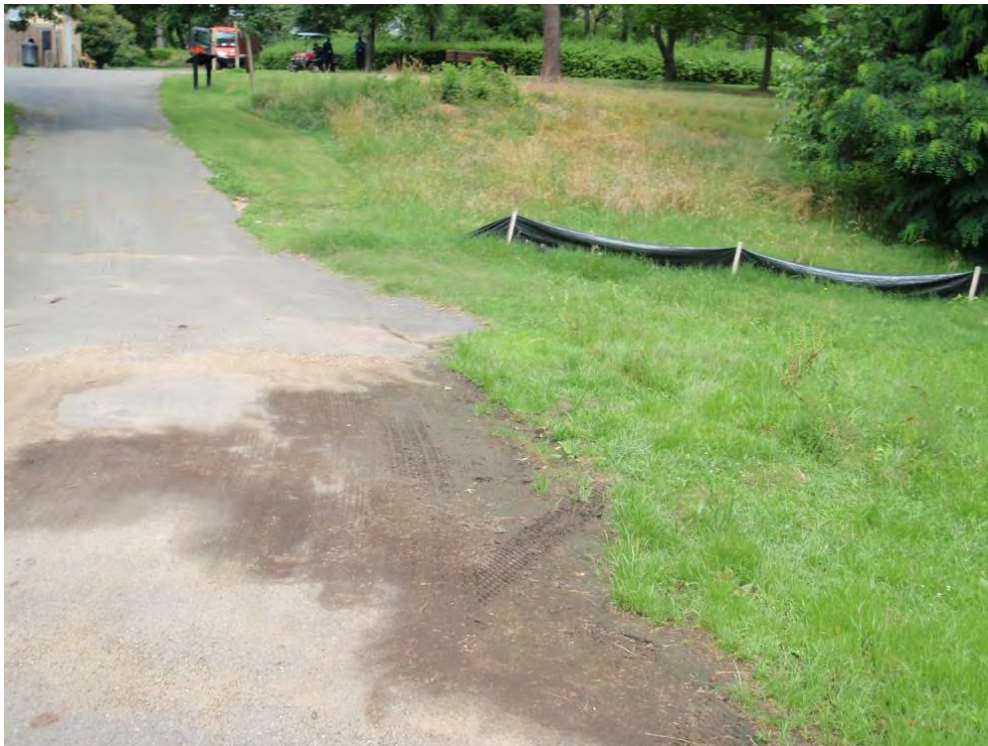
Figure B- 19: Road Crossing of the 36-inch culvert. Observed sedimentation at the road (Location ID #42)

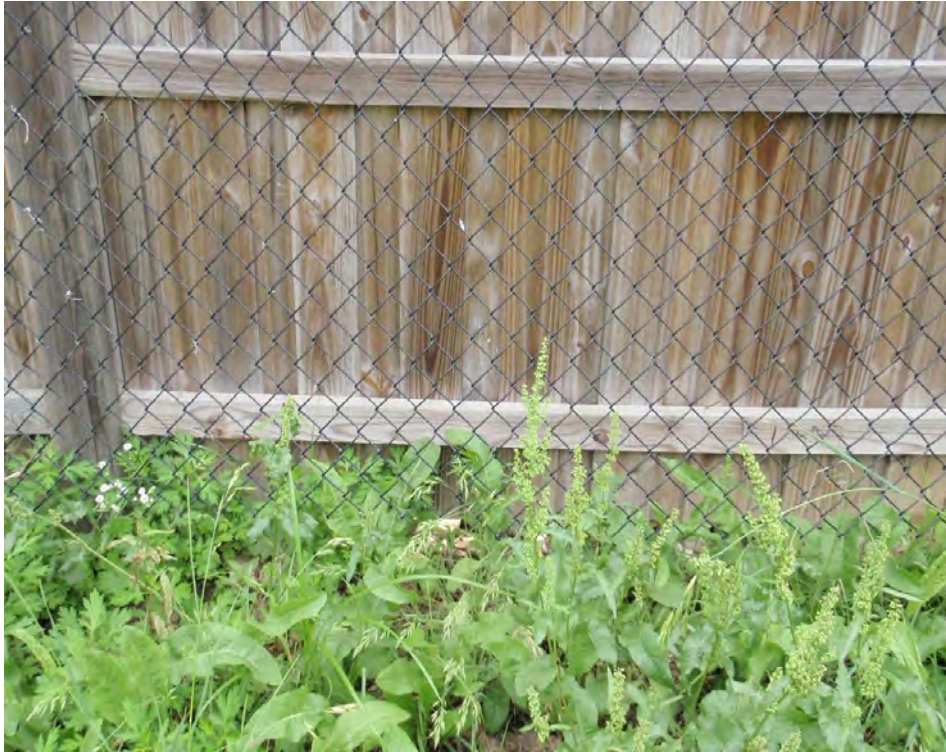
Figure B- 24: Area adjacent to the backyard of a private property. The area was seeded to improve drainage and prevent erosion. No erosion was observed (Location ID #47)

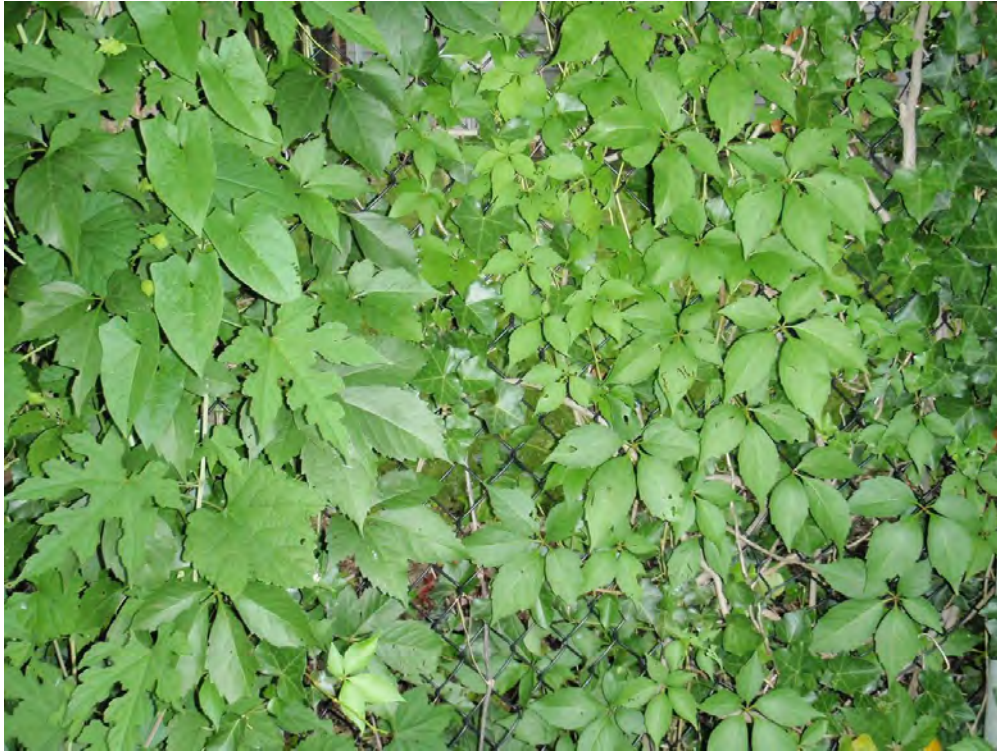
Figure B- 34: Area near a private property upstream of the trench drain. Observed dryness after the storm (Location ID #57)

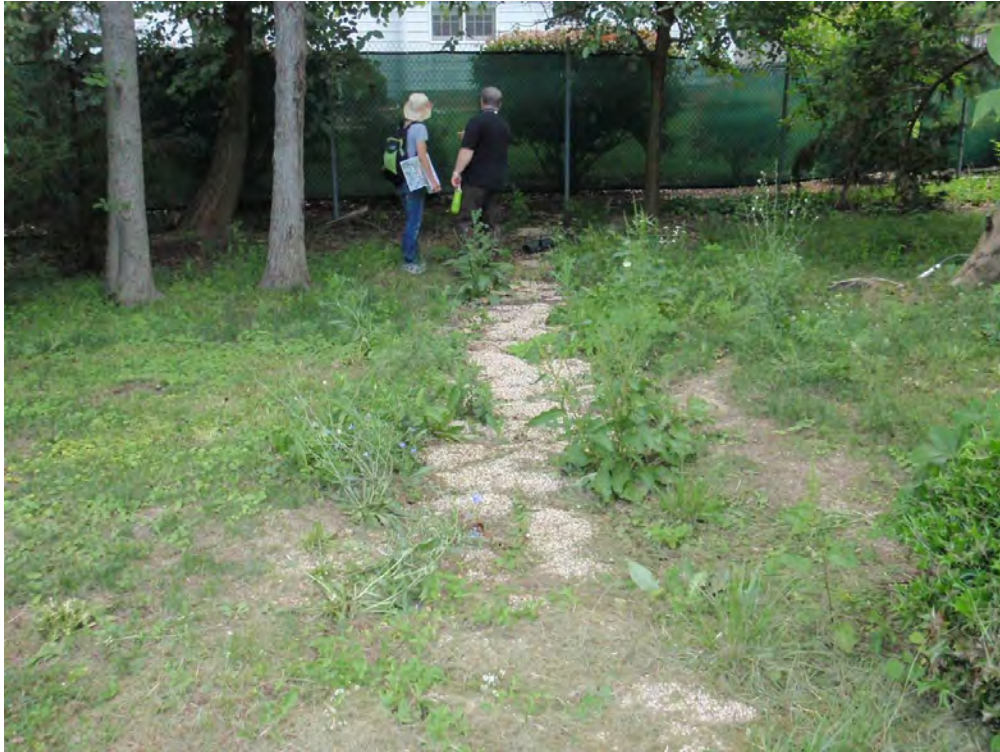
Figure B- 36: Trench drain. Homeowners covered the bare soil with mulch which helped to improve the drainage. Observed dry ground after the storm (Location ID #59)

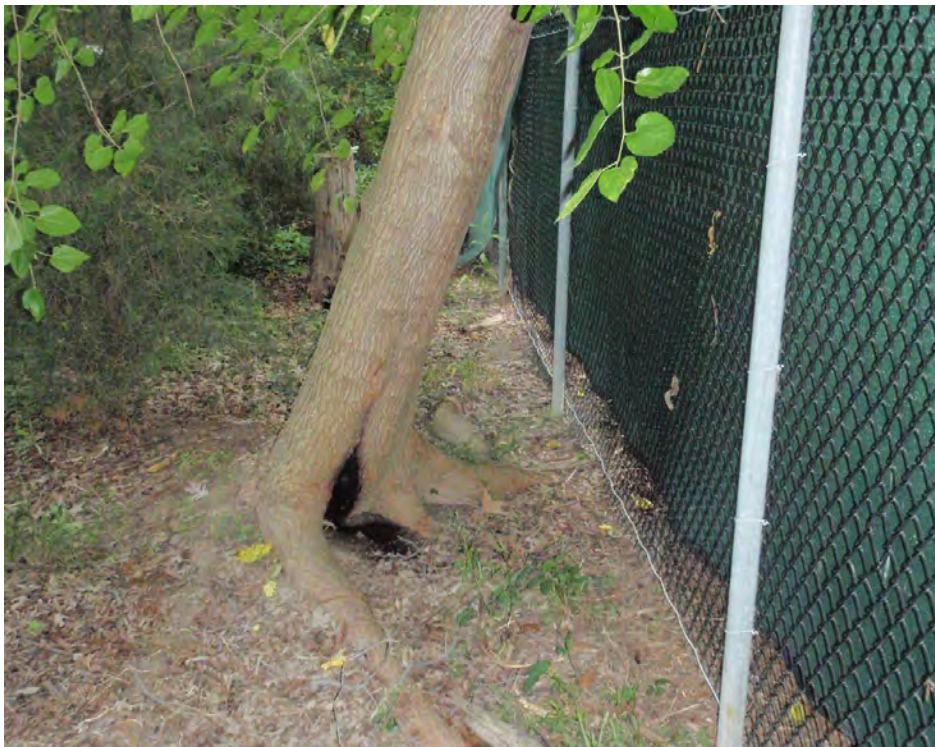
Figure B- 37: Fence along the private properties. Observed dry ground after the storm (Location ID #60)

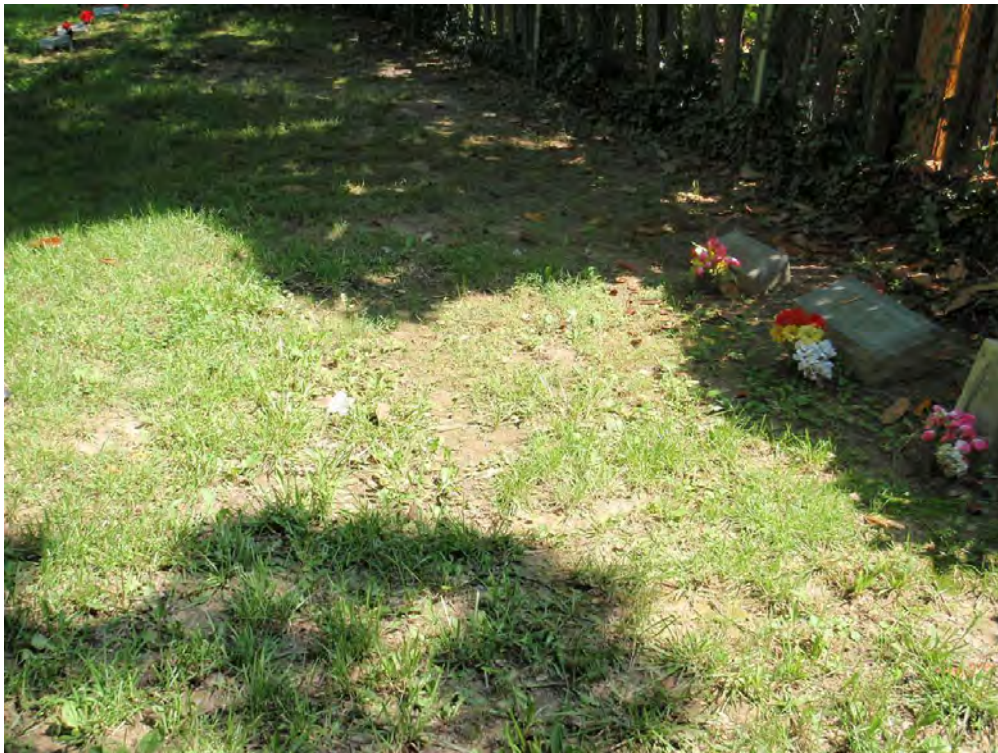
Figure B- 47: Three grave stones (at the southeast corner) (Location ID #70). Used to be ponded after storms. Observed dry ground after the storm due to the interim drainage solution

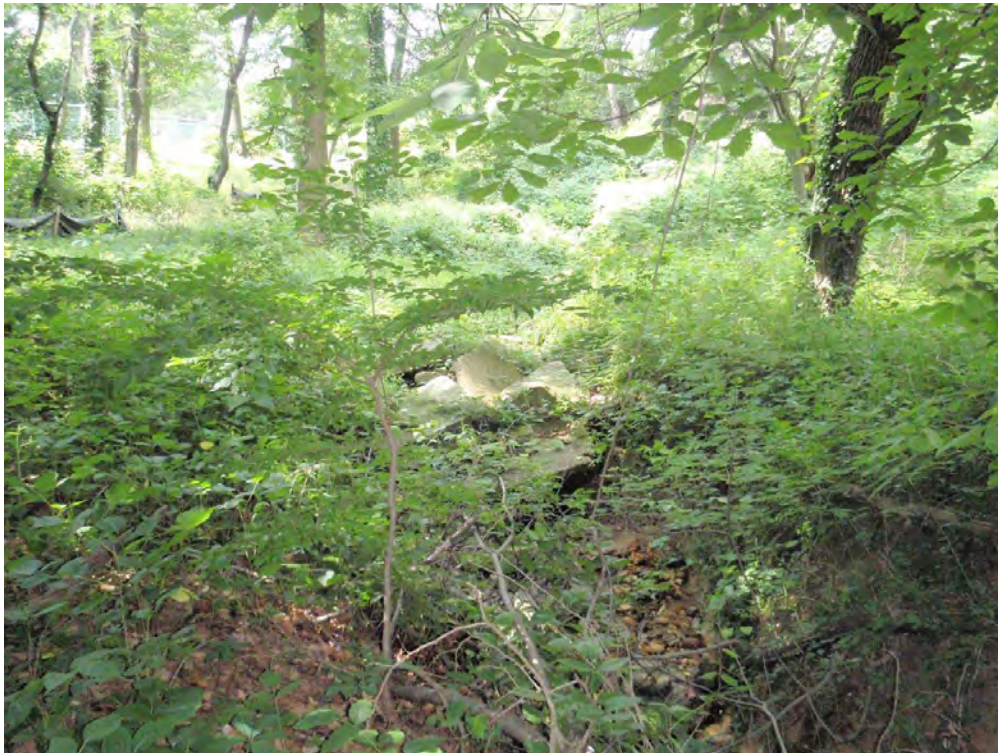
Figure B- 53: Stream. Observed debris in the channel. (Location ID #77)

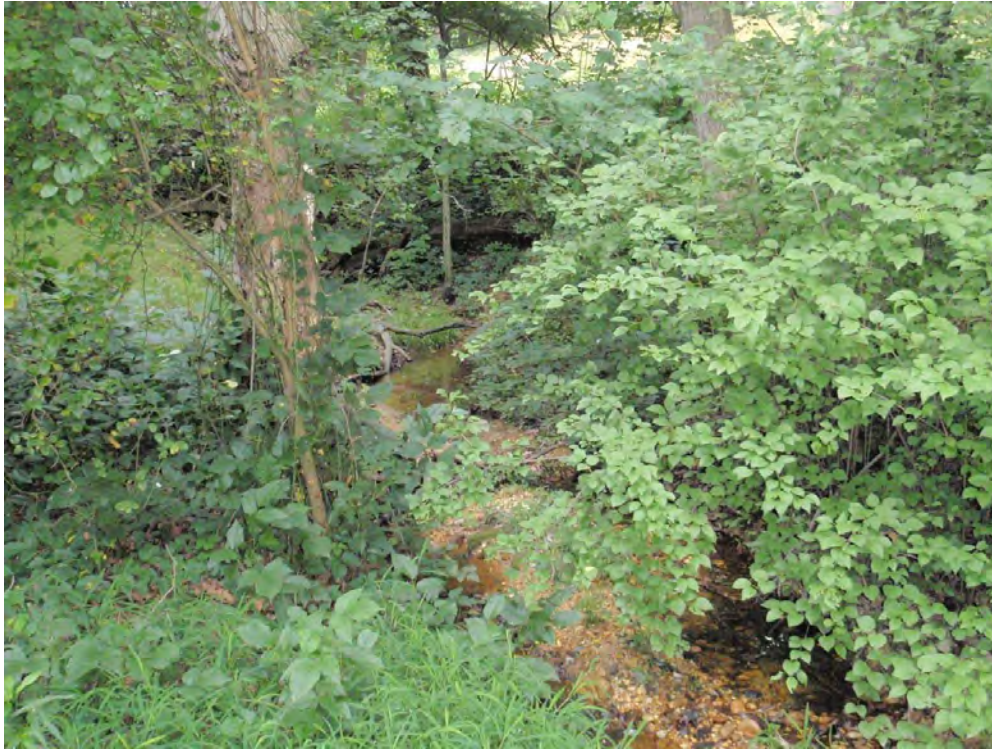
Figure B- 58: Streambed (Location ID 82). Observed channel erosion

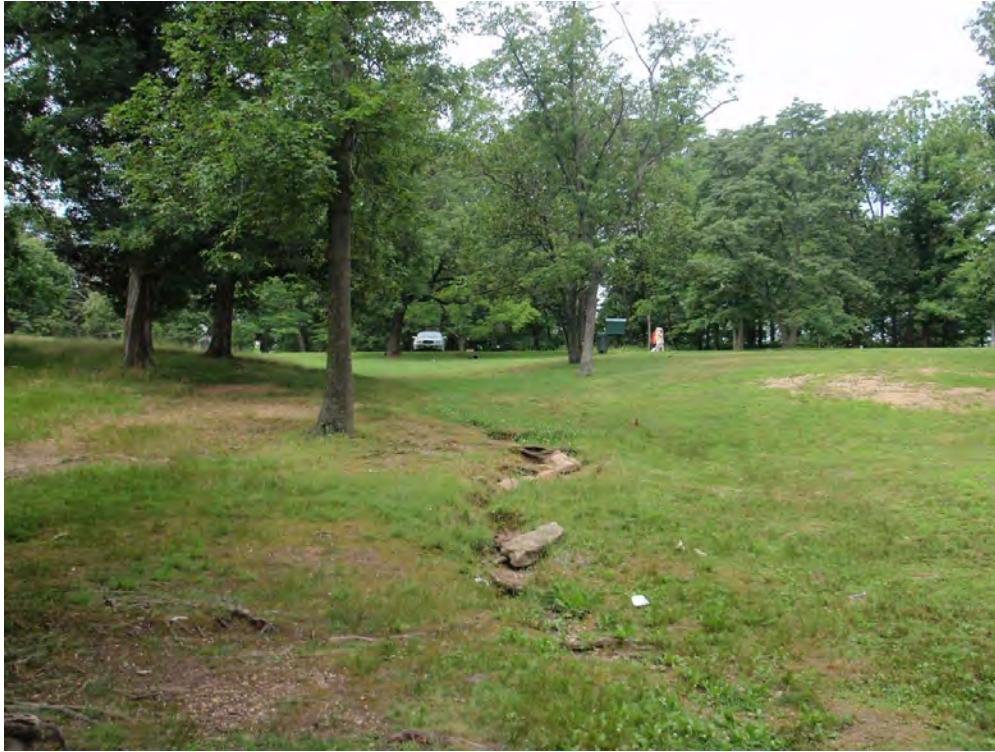
Figure B- 62: Channel upstream of the playground (Location ID #87). Observed erosion

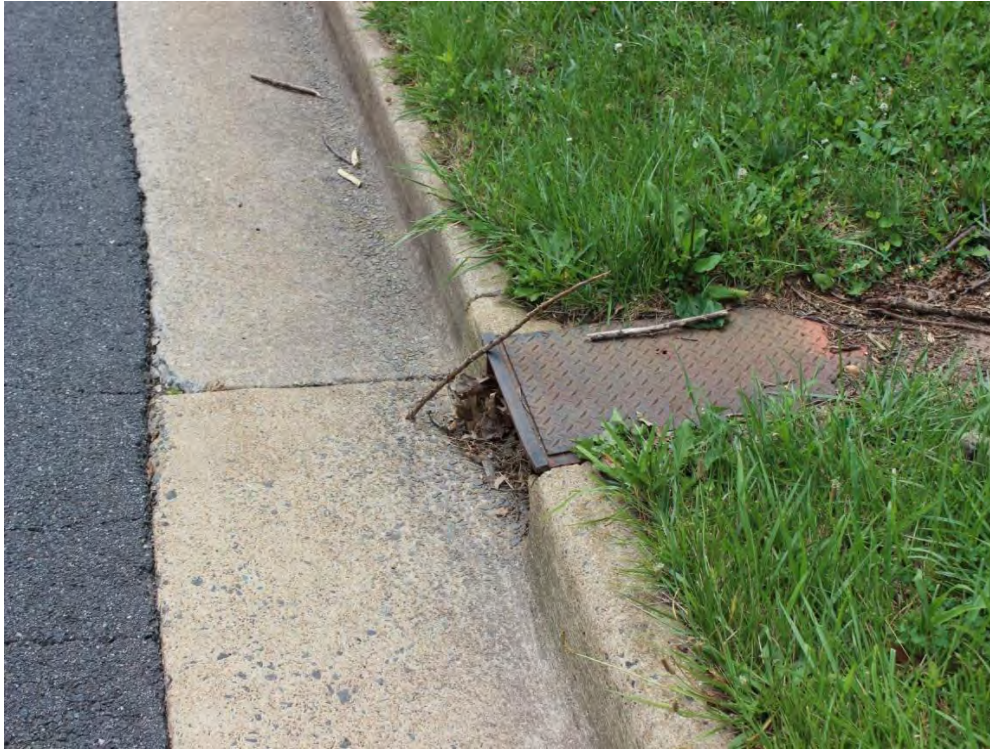
Figure B- 76: Outfall from the Park along N. Van Dorn Street (Location ID #103). Observed outlet clogged by debris

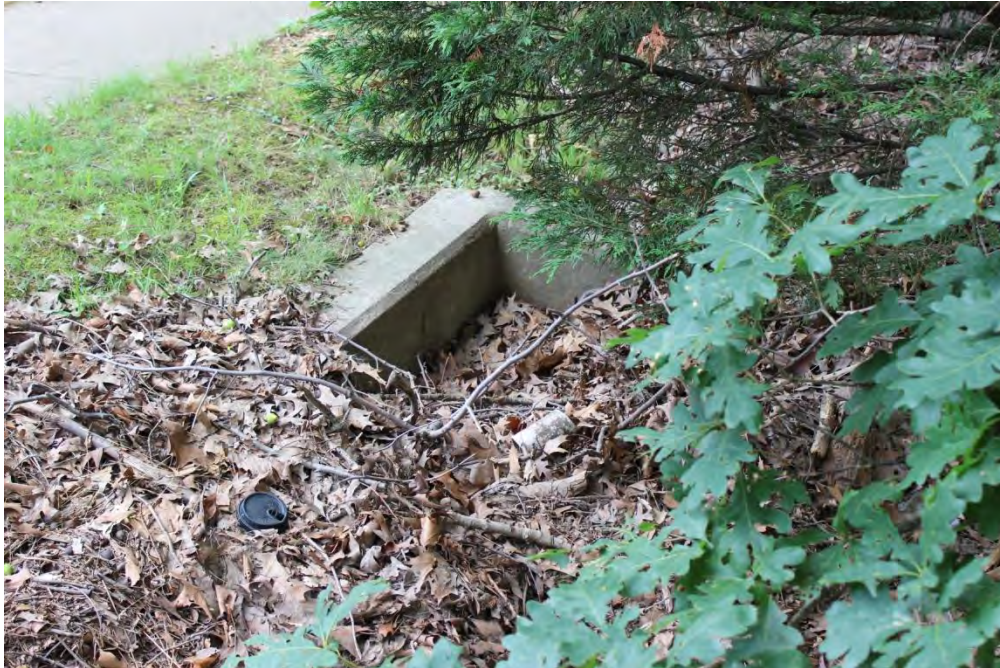
Figure B- 82: Inlet outfall at the Park property line (Location ID #109). Observed clogged inlet

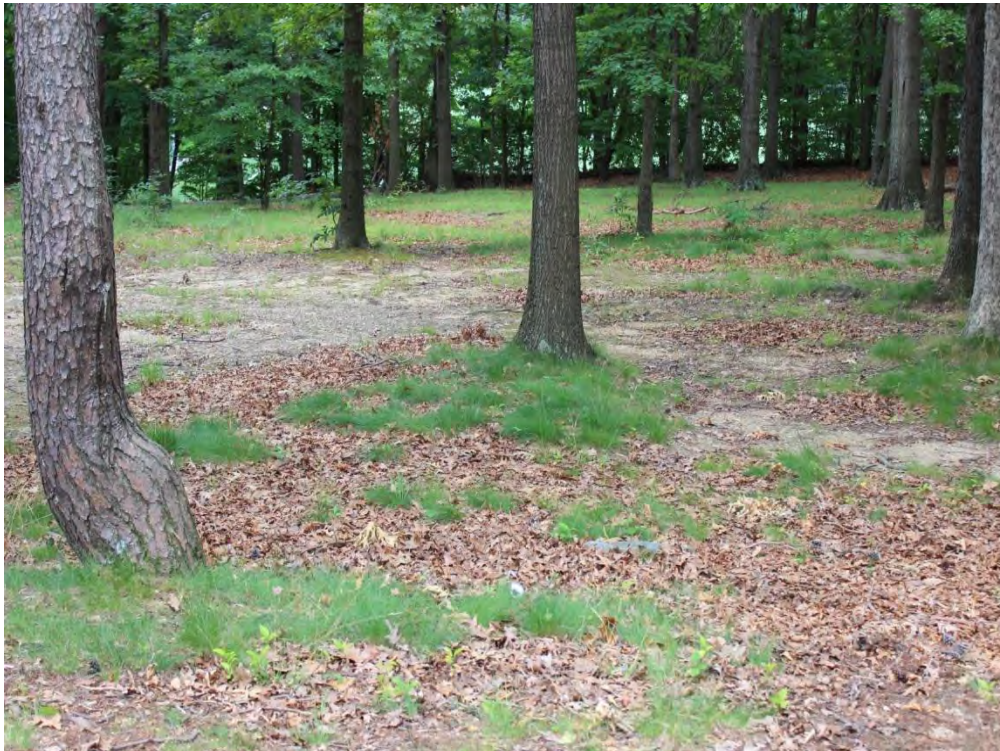
Figure B- 83: Open space (Location ID #110). Observed bare ground

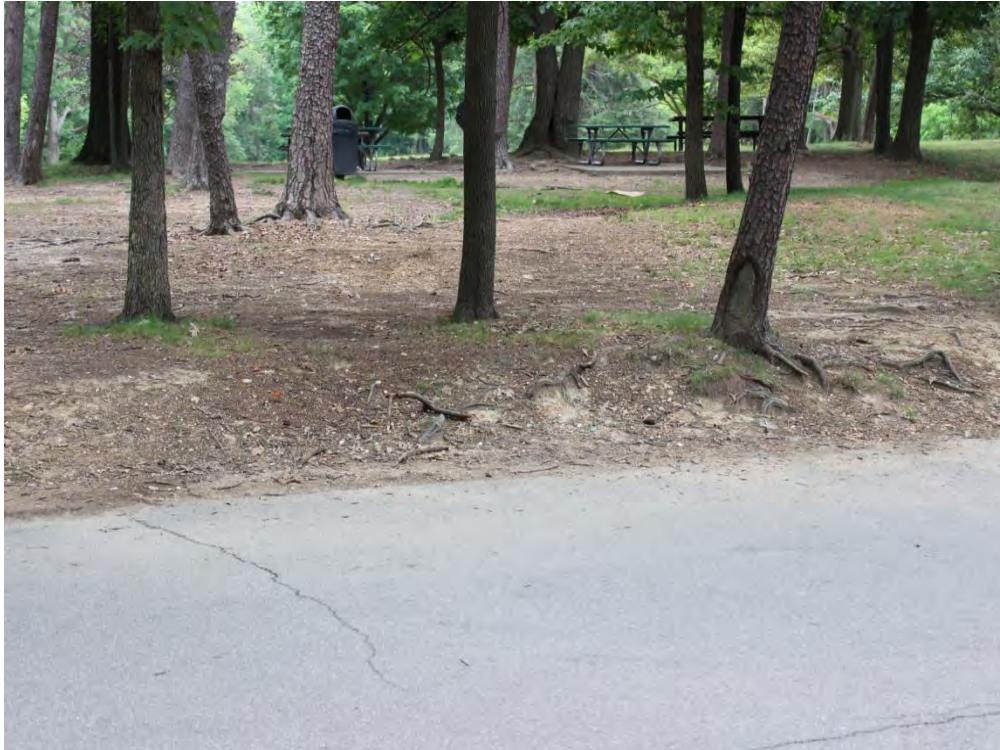
Figure B- 84: Open space (Location ID #111). Observed bare ground

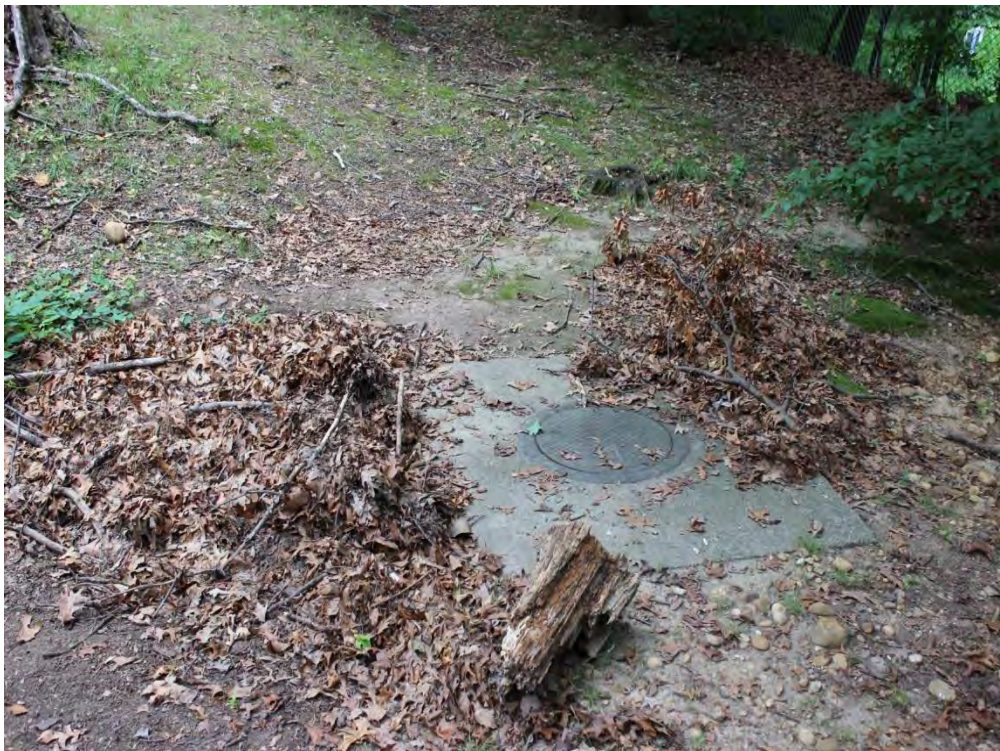
Figure B- 85: Inlet (Location ID #112). Observed built-up debris clogging the inlet

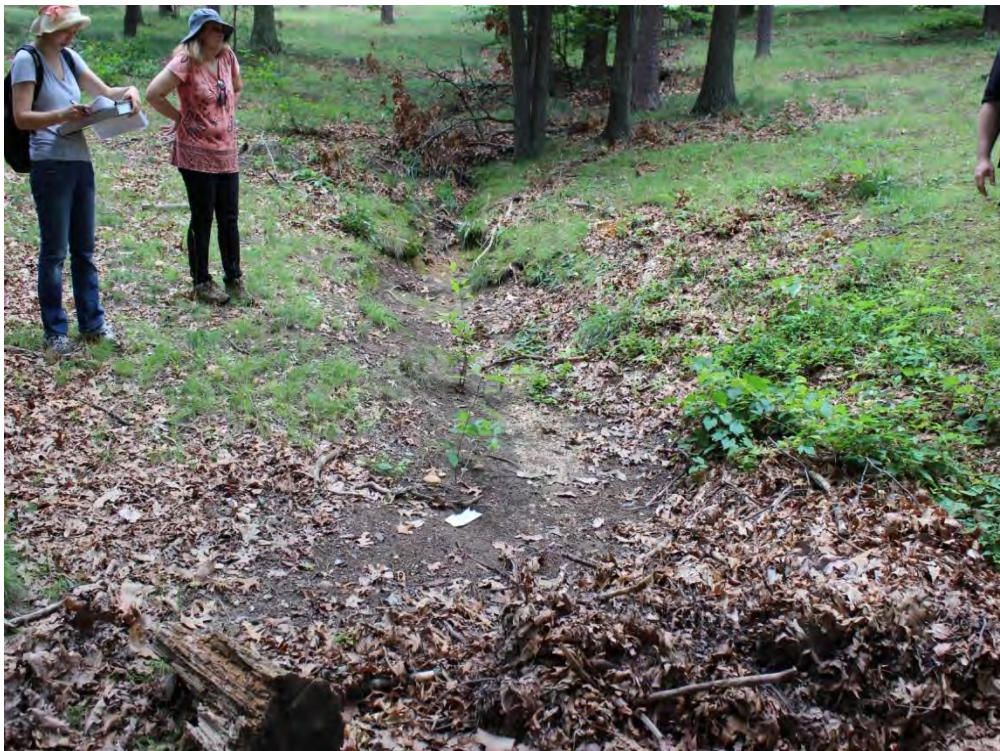
Figure B- 87: Upstream area of the inlet (Location ID #114). Observed debris and sedimentation

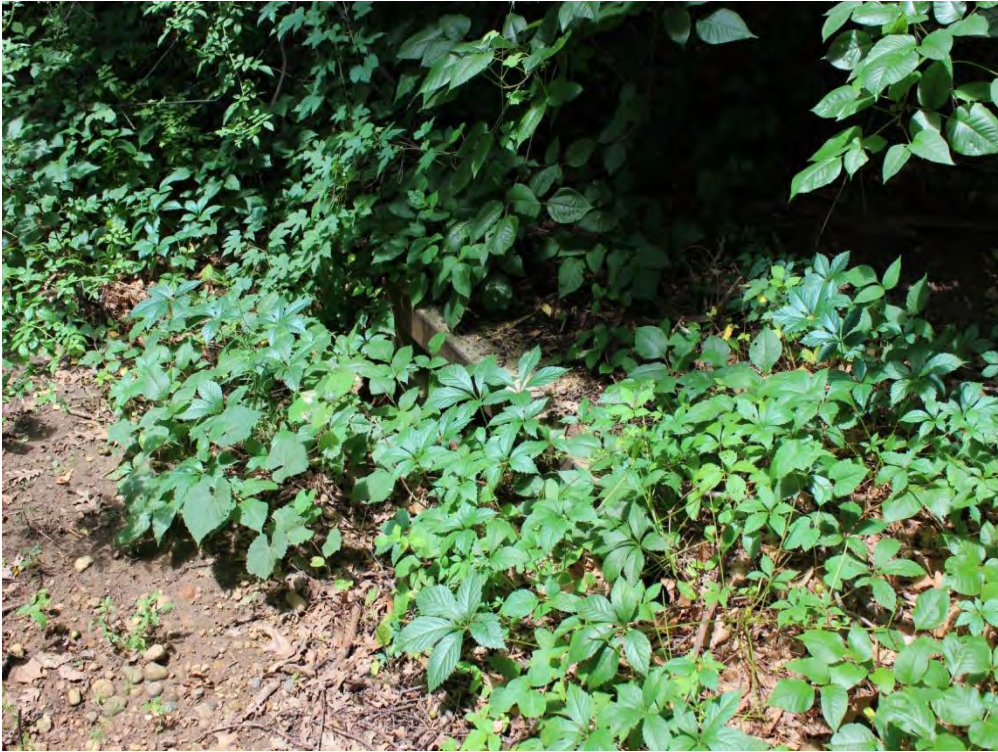
Figure B- 88: Inlet (Location ID #115). Observed vegetation clogging the inlet

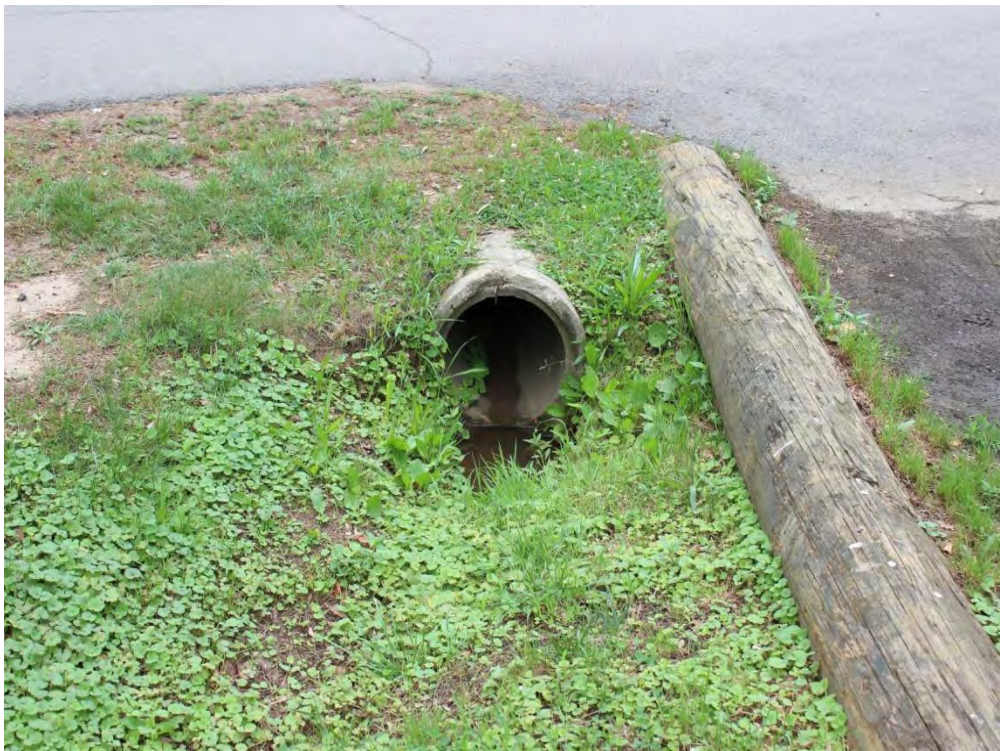
Figure B- 95: Inlet of the 15-inch culvert crossing (Location ID #122). Observed depression at the inlet

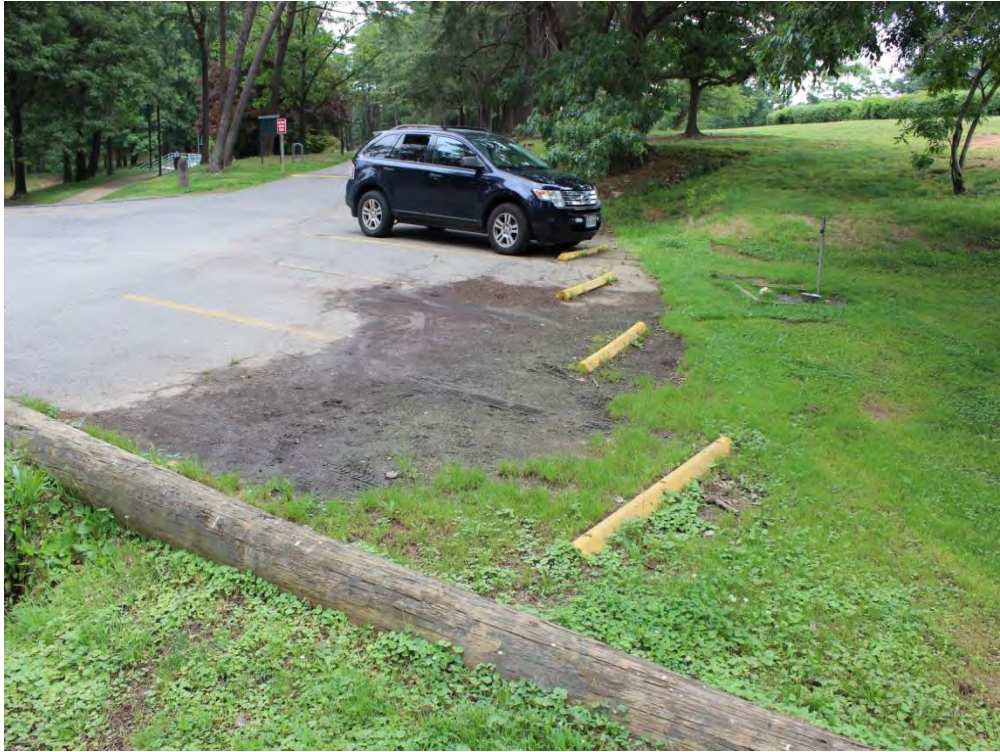
Figure B- 96: Parking lot next to the Inlet (Location ID #126). Observed sedimentation at the parking lot

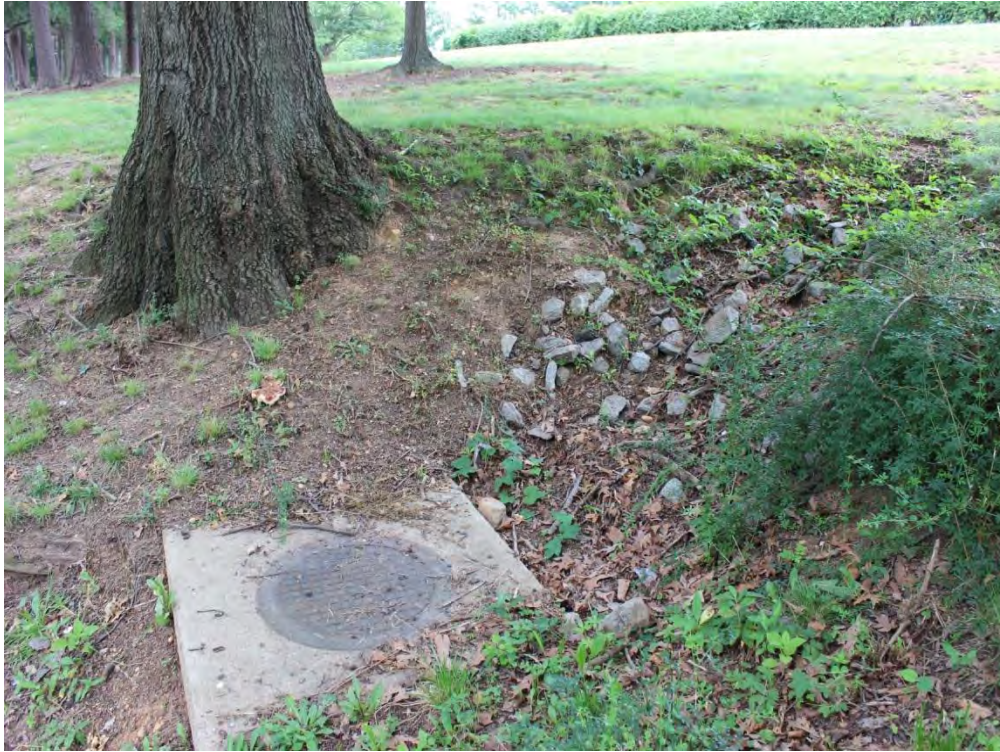
Figure B- 98: Inlet adjacent to the west Side of the fort (Location ID #124). Observed debris at the inlet
