Fort Ward Park and Museum Area Management Plan

Appendix I FORT WARD PARK DRAINAGE MASTER PLAN

URS Corporation, 2014

FORT WARD PARK DRAINAGE MASTER PLAN

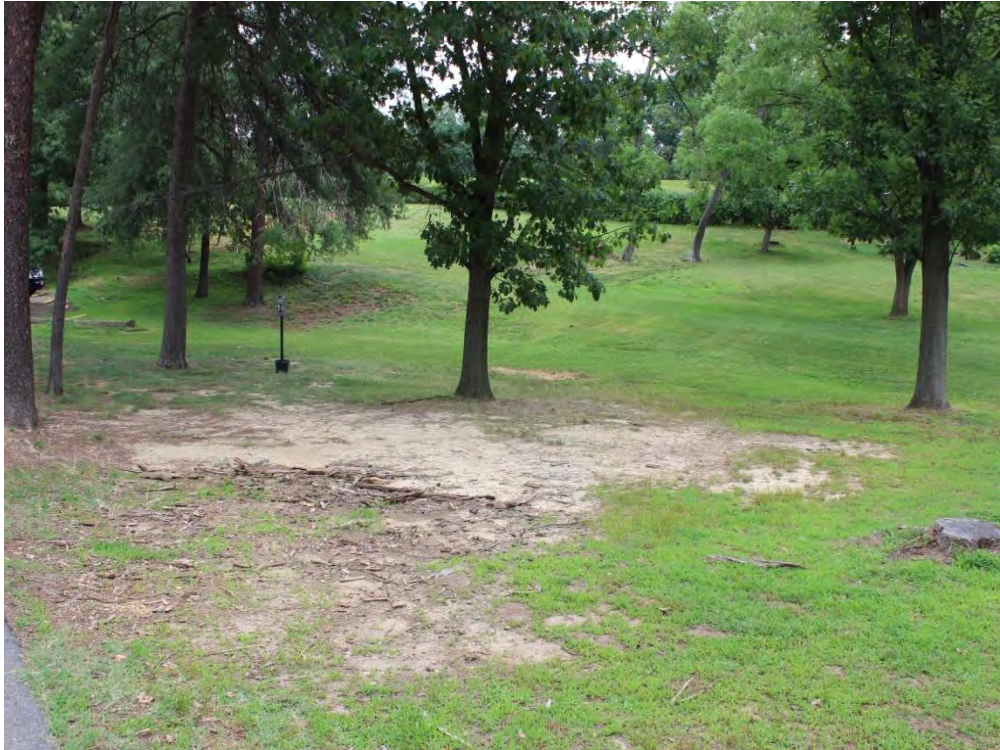
Figure B- 100: Open space (Location ID #127). Observed bare ground

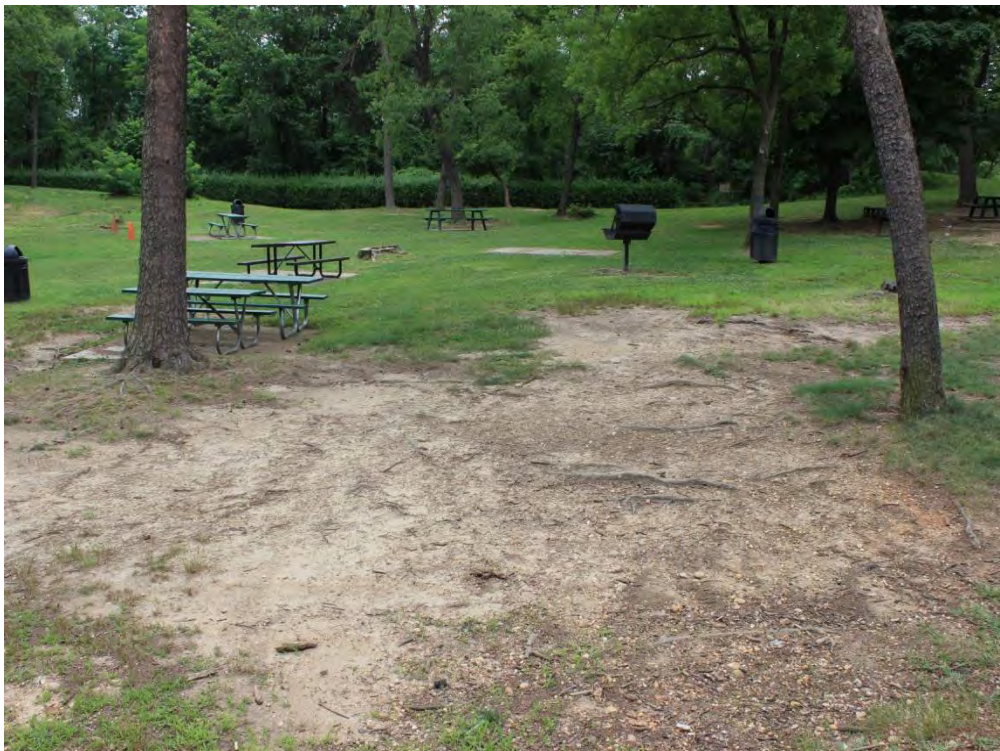
Figure B- 101: Open space (Location ID #128). Observed bare ground

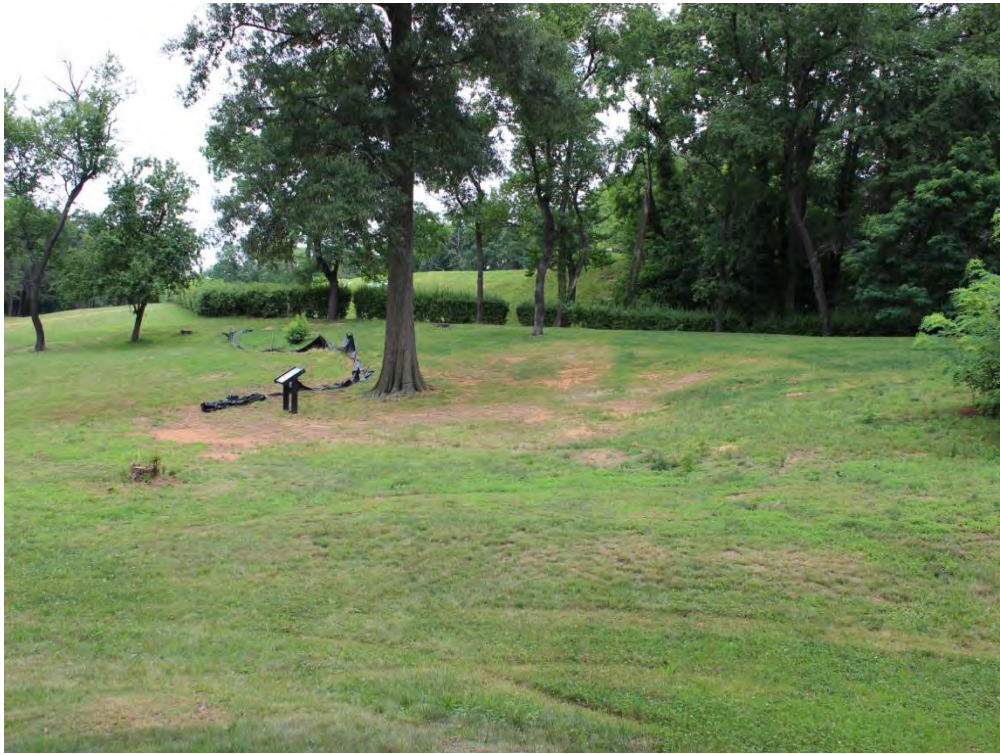
Figure B- 102: Open space (Location ID #129). Observed bare ground near the silt fence

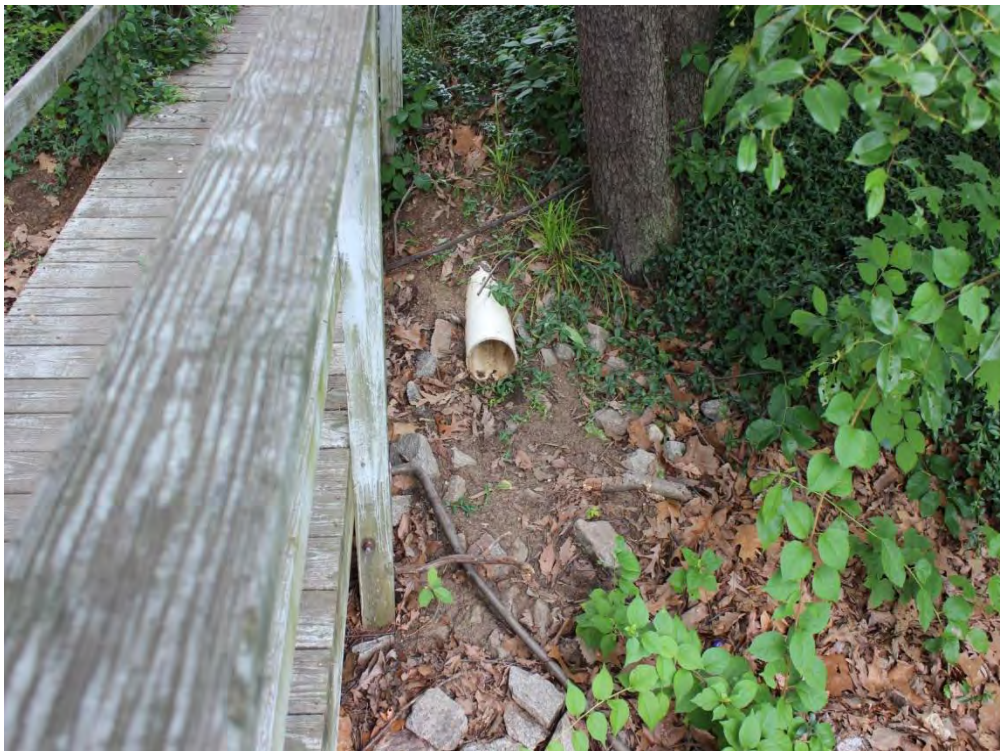
Figure B- 105: PVC Outlet by the footbridge. Observed clogging during previous storm events (Location ID #132)
