City of Alexandria, Virginia - Department of Project Implementation

# 1315 DUKE STREET HISTORIC STRUCTURE REPORT

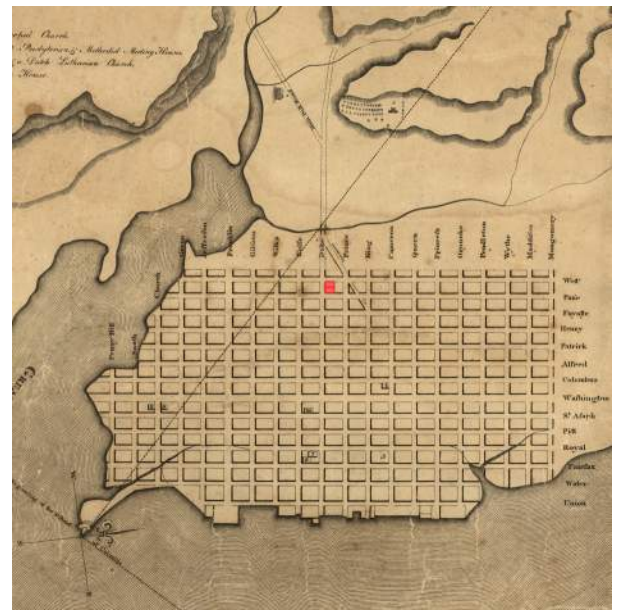
**Figure 2A-1:** Detail from *Plan of the Town of Alexandria in the District of Columbia*, published in 1798, showing the location of the two adjacent 1/2-acre lots on Duke Street purchased by Robert Young in 1812. [George Gilpin, Thomas Clarke, and John V. Thomas, *Plan of the Town of Alexandria in the District of Columbia* (Alexandria: I Thomas, 1798), Library of Congress, Geography and Map Division, <https://lccn.loc.gov/91681006>]

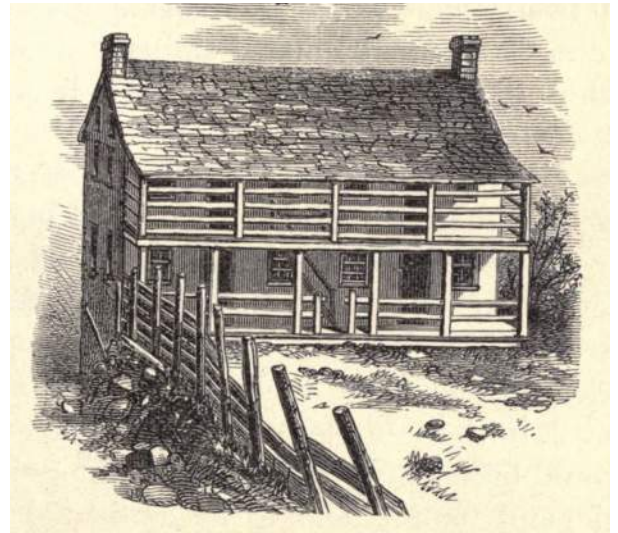
**Figure 2A-8:** Engraving of the jail at Lumpkin's slave pen in Richmond. From Charles H. Corey's *A History of the Richmond Theological Seminary*. [Charles H. Corey, *A History of the Richmond Theological Seminary* (Richmond, VA: J. W. Randolph Company, 1895), 47.]

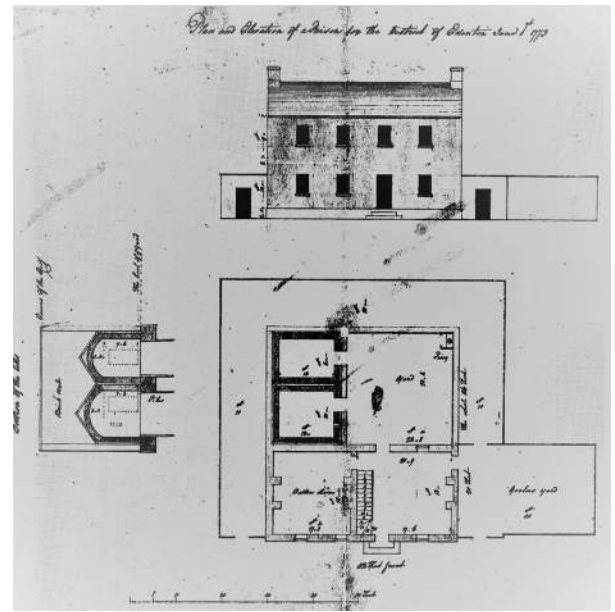
**Figure 2A-9:** Architect John Hawks' 1773 plan for the Chowan County Jail in Edenton, North Carolina, as reproduced in *The Courthouses of Early Virginia*. [Carl R. Lounsbury, *The Courthouses of Early Virginia: An Architectural History* (Charlottesville, VA: University of Virginia Press, 2005), 257.]

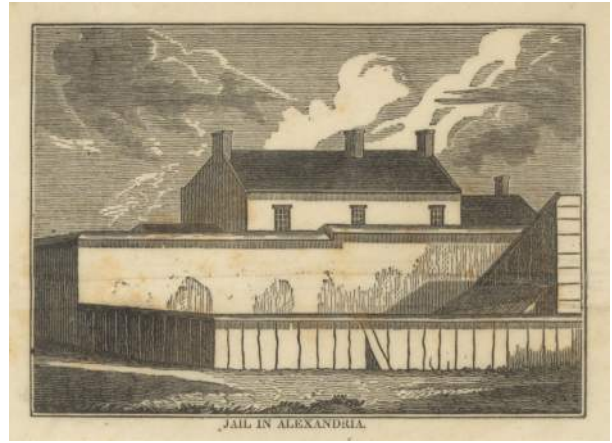
**Figure 2A-10:** Detail from the American Anti-Slavery Society broadside published in 1836. The image depicts a jail in Alexandria. [William S. Dorr and American Anti-Slavery Society, *Slave market of America*, Washington, D.C., Alexandria, Virginia, 1836. Library of Congress, Rare Book and Special Collections Division, <https://lccn.loc.gov/2008661294>]

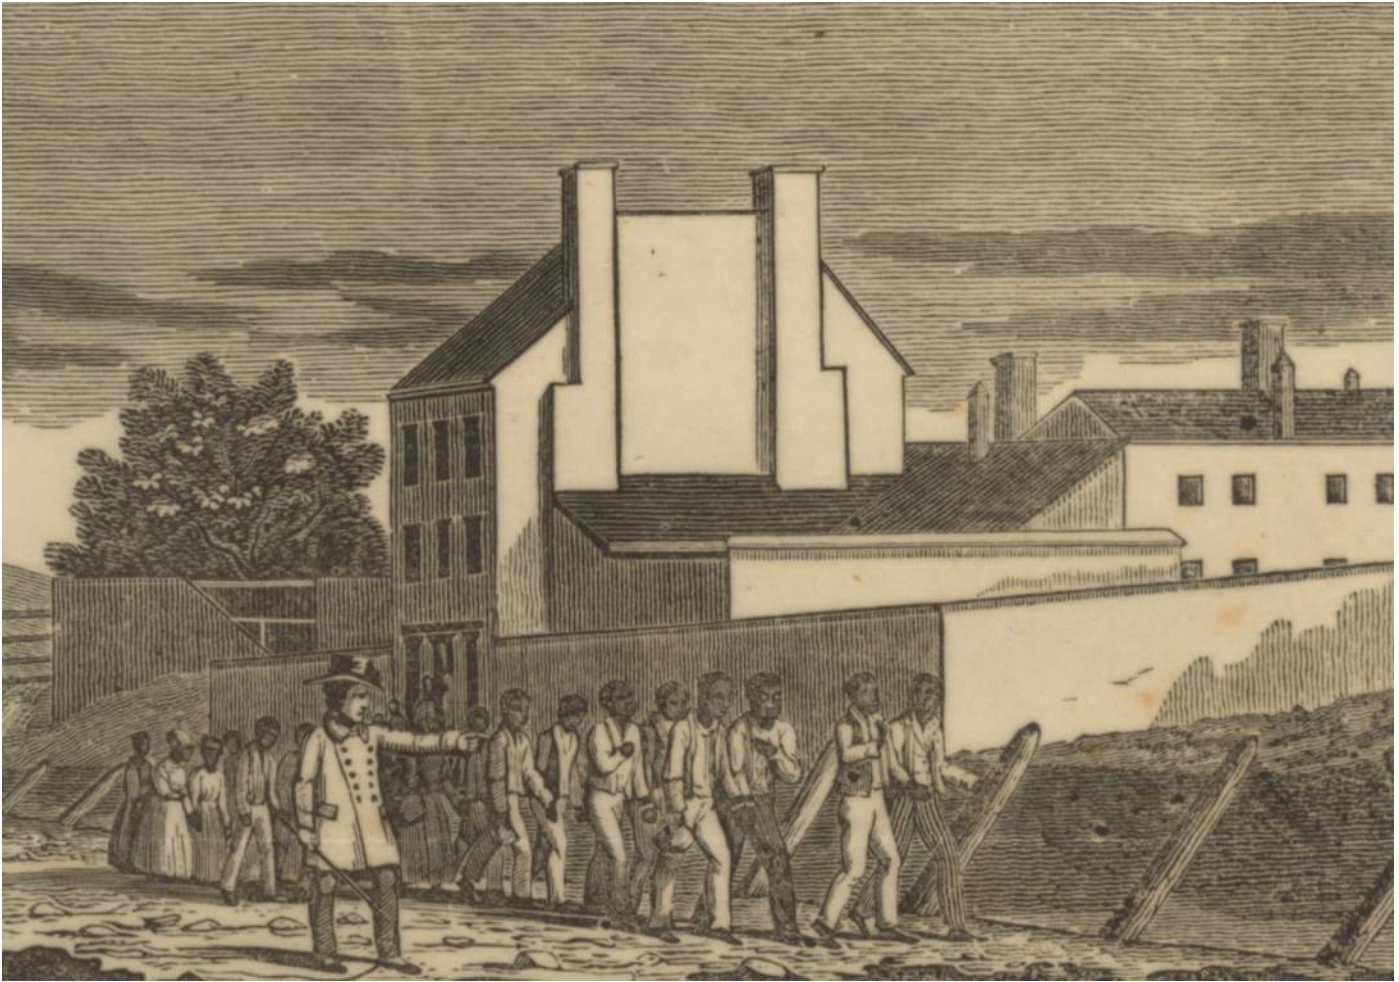
**Figure 2B-2:** Detail from the American Anti-Slavery Society broadside titled *Slave market of America* and published in 1836. [William S. Dorr and American Anti-Slavery Society, *Slave market of America*, Washington, D.C., Alexandria, Virginia, 1836. Rare Book and Special Collections Division, Library of Congress]

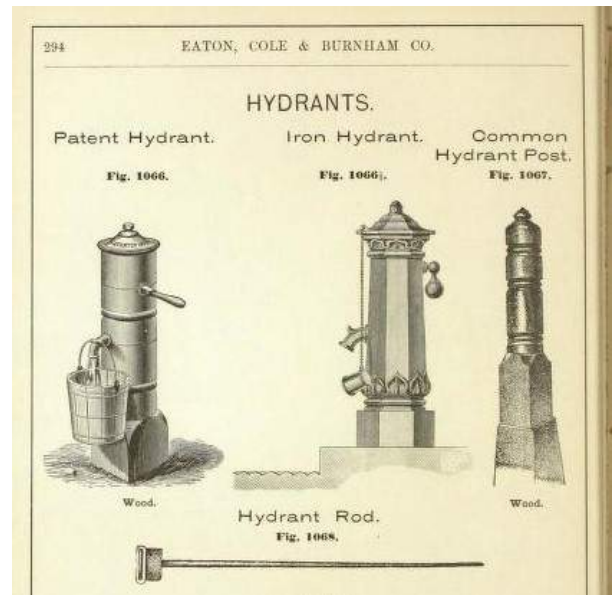
**Figure 2B-3:** Page from a plumbers’ supply catalog showing (on far right) a wood hydrant post similar to that seen in a historic photograph of what is believed to be the yard of 1315 Duke Street. [Eaton, Cole & Burnham, Co. *Illustrated catalogue of wrought iron pipe, brass and iron steam, gas and water goods, plumbers’ supplies*. Eaton, Cole & Burnham, Co., 1875. Available from Association for Preservation Technology, Building Technology Heritage Library at <https://apt.memberclicks.net/apt-building-technology-heritage-library>]

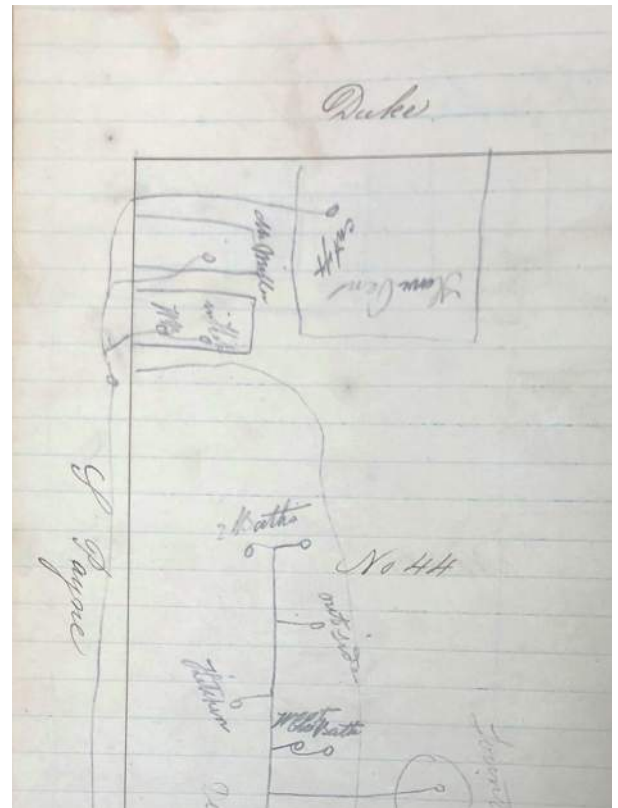
**Figure 2B-5:** Detail from an 1867 Alexandria Water Company ledger showing a sketch of the block No. 44 (bound by Duke Street on the south, Payne Street on the east, West Street on the west, and Prince Street on the north). The slave pen is labeled at the top of the page, and a water line is drawn extending from Payne Street to the property. The water hook up to the slave pen is noted as "cut off." [Alexandria Water Company, Drawings of Squares and Names of Owners, Tenants, 1867, Virginia American Water Company Collection (MS103), Series II: Company Records, 1859-60, Alexandria Library, Local History and Special Collections Branch, Alexandria, Virginia]

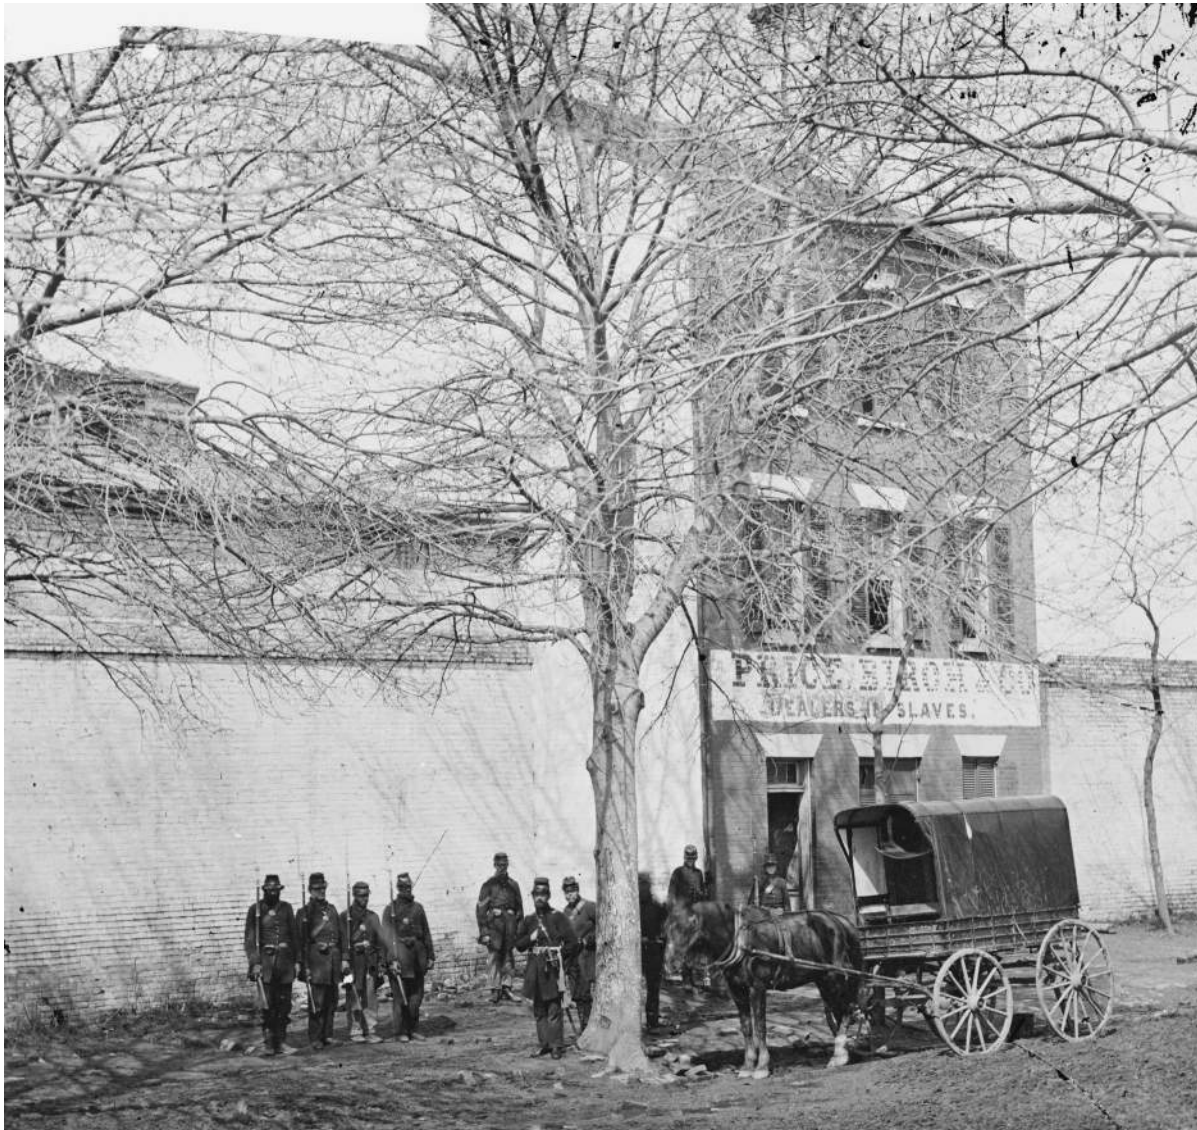
<sup>211</sup> *Ibid*, 105-106.

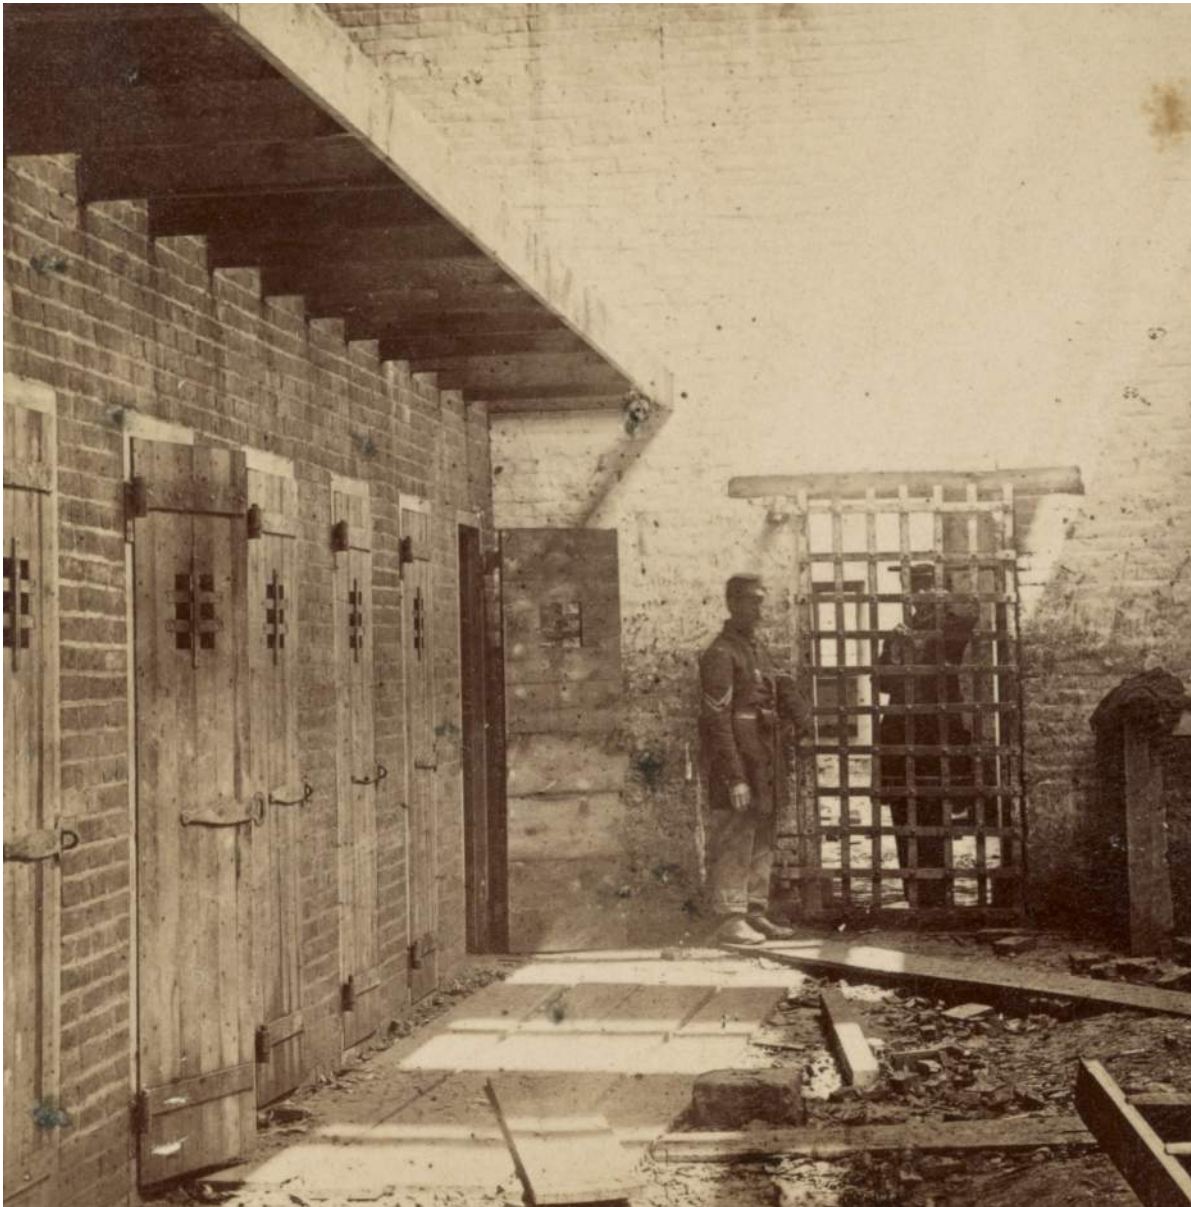
**Figure 2B-8:** Civil War-era photograph of what is believed to be the interior of the former men’s yard which, by this time, had been converted into a military prison. The cells on the left of the image are believed to have been built by the army to hold prisoners in solitary confinement. The pattern of the light and shadows cast on the floor of the space in this image seems to indicate that the photograph was taken after the monitor roof was built to enclose the space. [Alexandria, Virginia, 1861-1865, Prints and Photographs Division, Library of Congress]

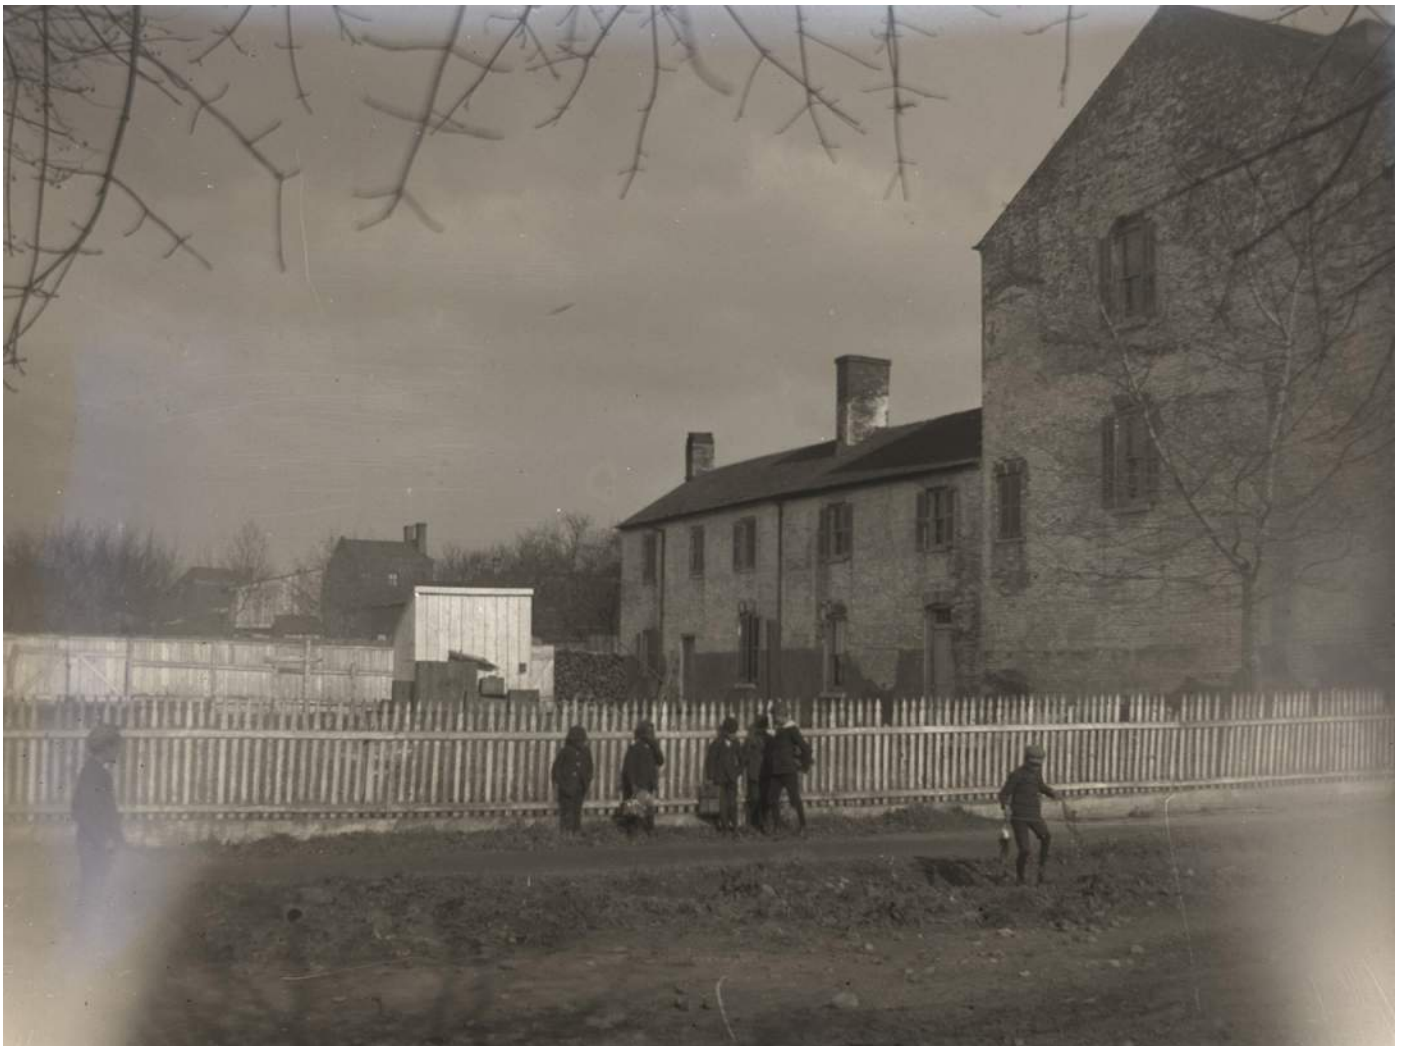
**Figure 2B-13:** This view of the west facade of the South Block, Central Passage, and North Block was taken looking northeast from the Duke Street circa 1900. The image captures the building before the construction of the mansard roof over the South Block and before the addition of the third floor over the rear wing. The shape of the monitor roof that enclosed the former men's yard during Period 3 appears as a ghost on the west facade of the South Block, which by this date has three window openings. There is a picket fence along the south property line of the empty lot west of 1315 Duke Street and a small, frame shed, or possibly a privy, standing within the lot near the alley behind the properties. [Alexandria Library Special Collections]

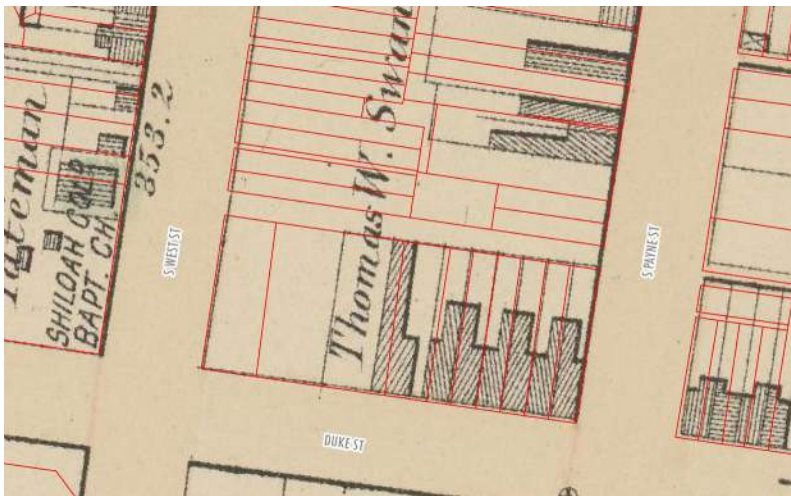
**Figure 2B-14:** Detail from Hopkins' "City Atlas of Alexandria," published in 1877 as reproduced in Skolnik, Office of Historic Alexandria, "Building and Property History, 1315 Duke Street, Alexandria, Virginia," January 2021. [Geography and Map Division, Library of Congress]

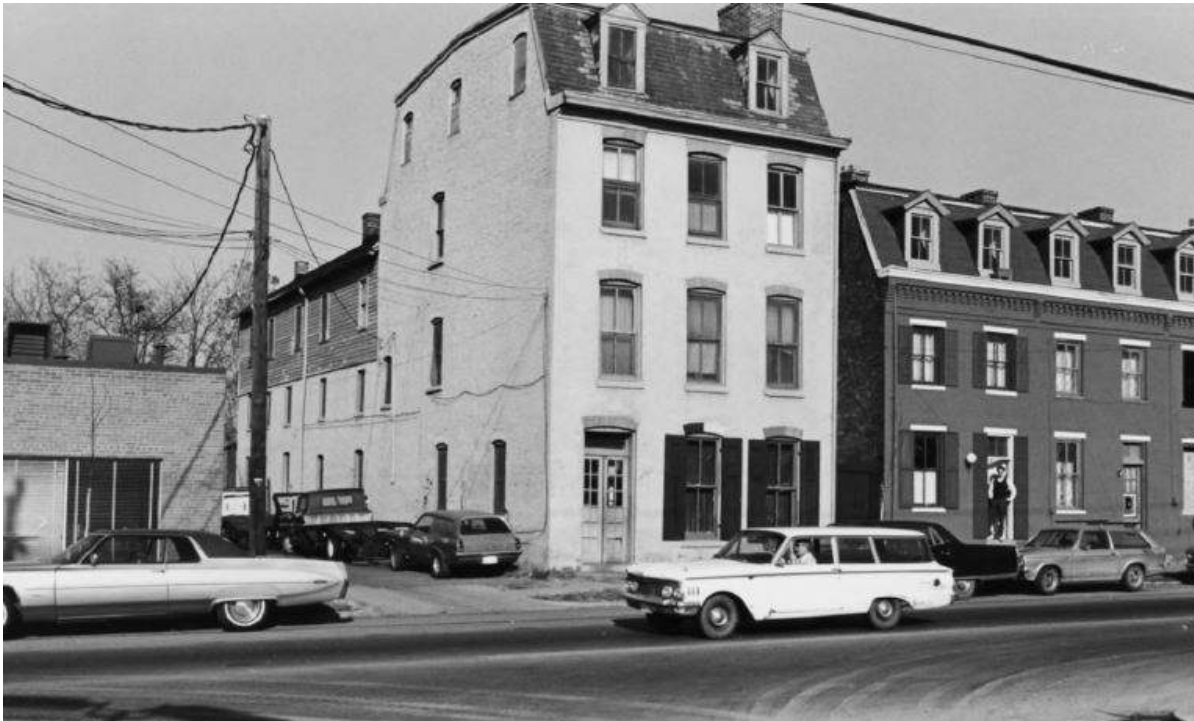
**Figure 2B-18:** This image from the National Historic Landmark nomination for 1315 Duke Street was taken in 1976. By this date, the property had functioned as an apartment building for over five decades and had become run down. ["Franklin & Armfield Office," National Historic Landmark Nomination]

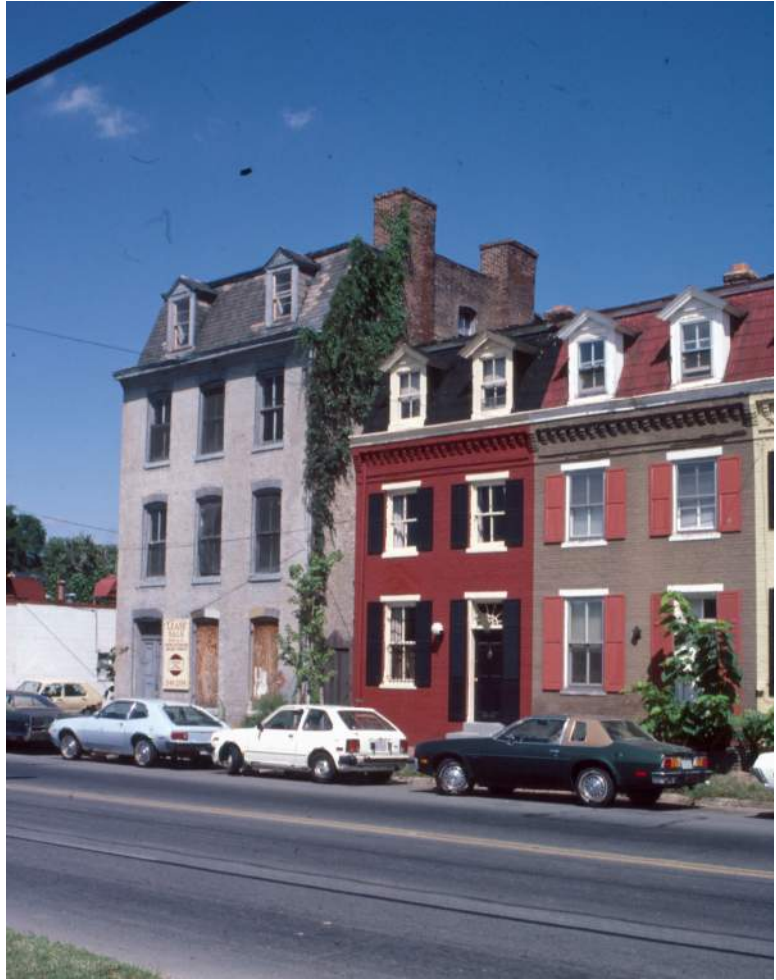
**Figure 2B-19:** View of 1315 Duke Street looking northwest from Duke Street, circa 1984. [Office of Historic Alexandria]

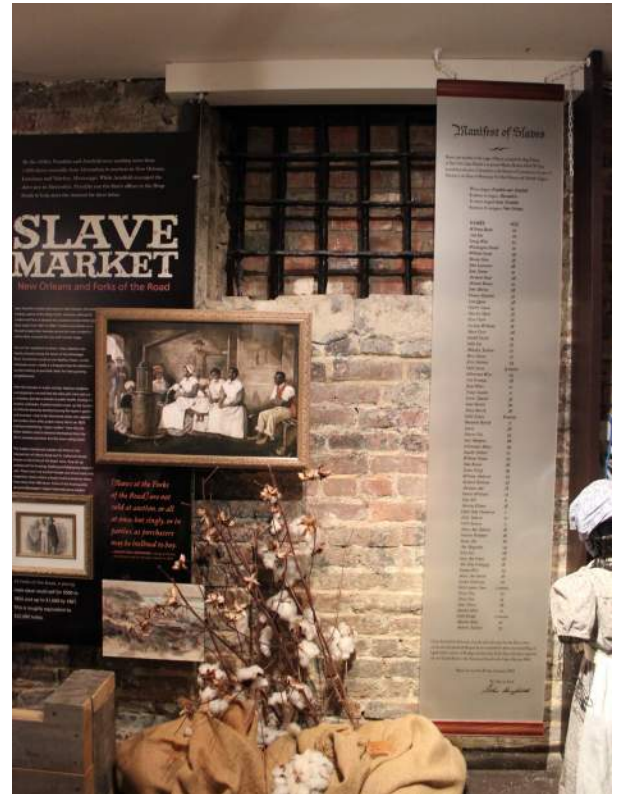
Figure 2B-22: Museum exhibit in the basement of 1315 Duke Street, 2021. [Robinson & Associates, Inc.]

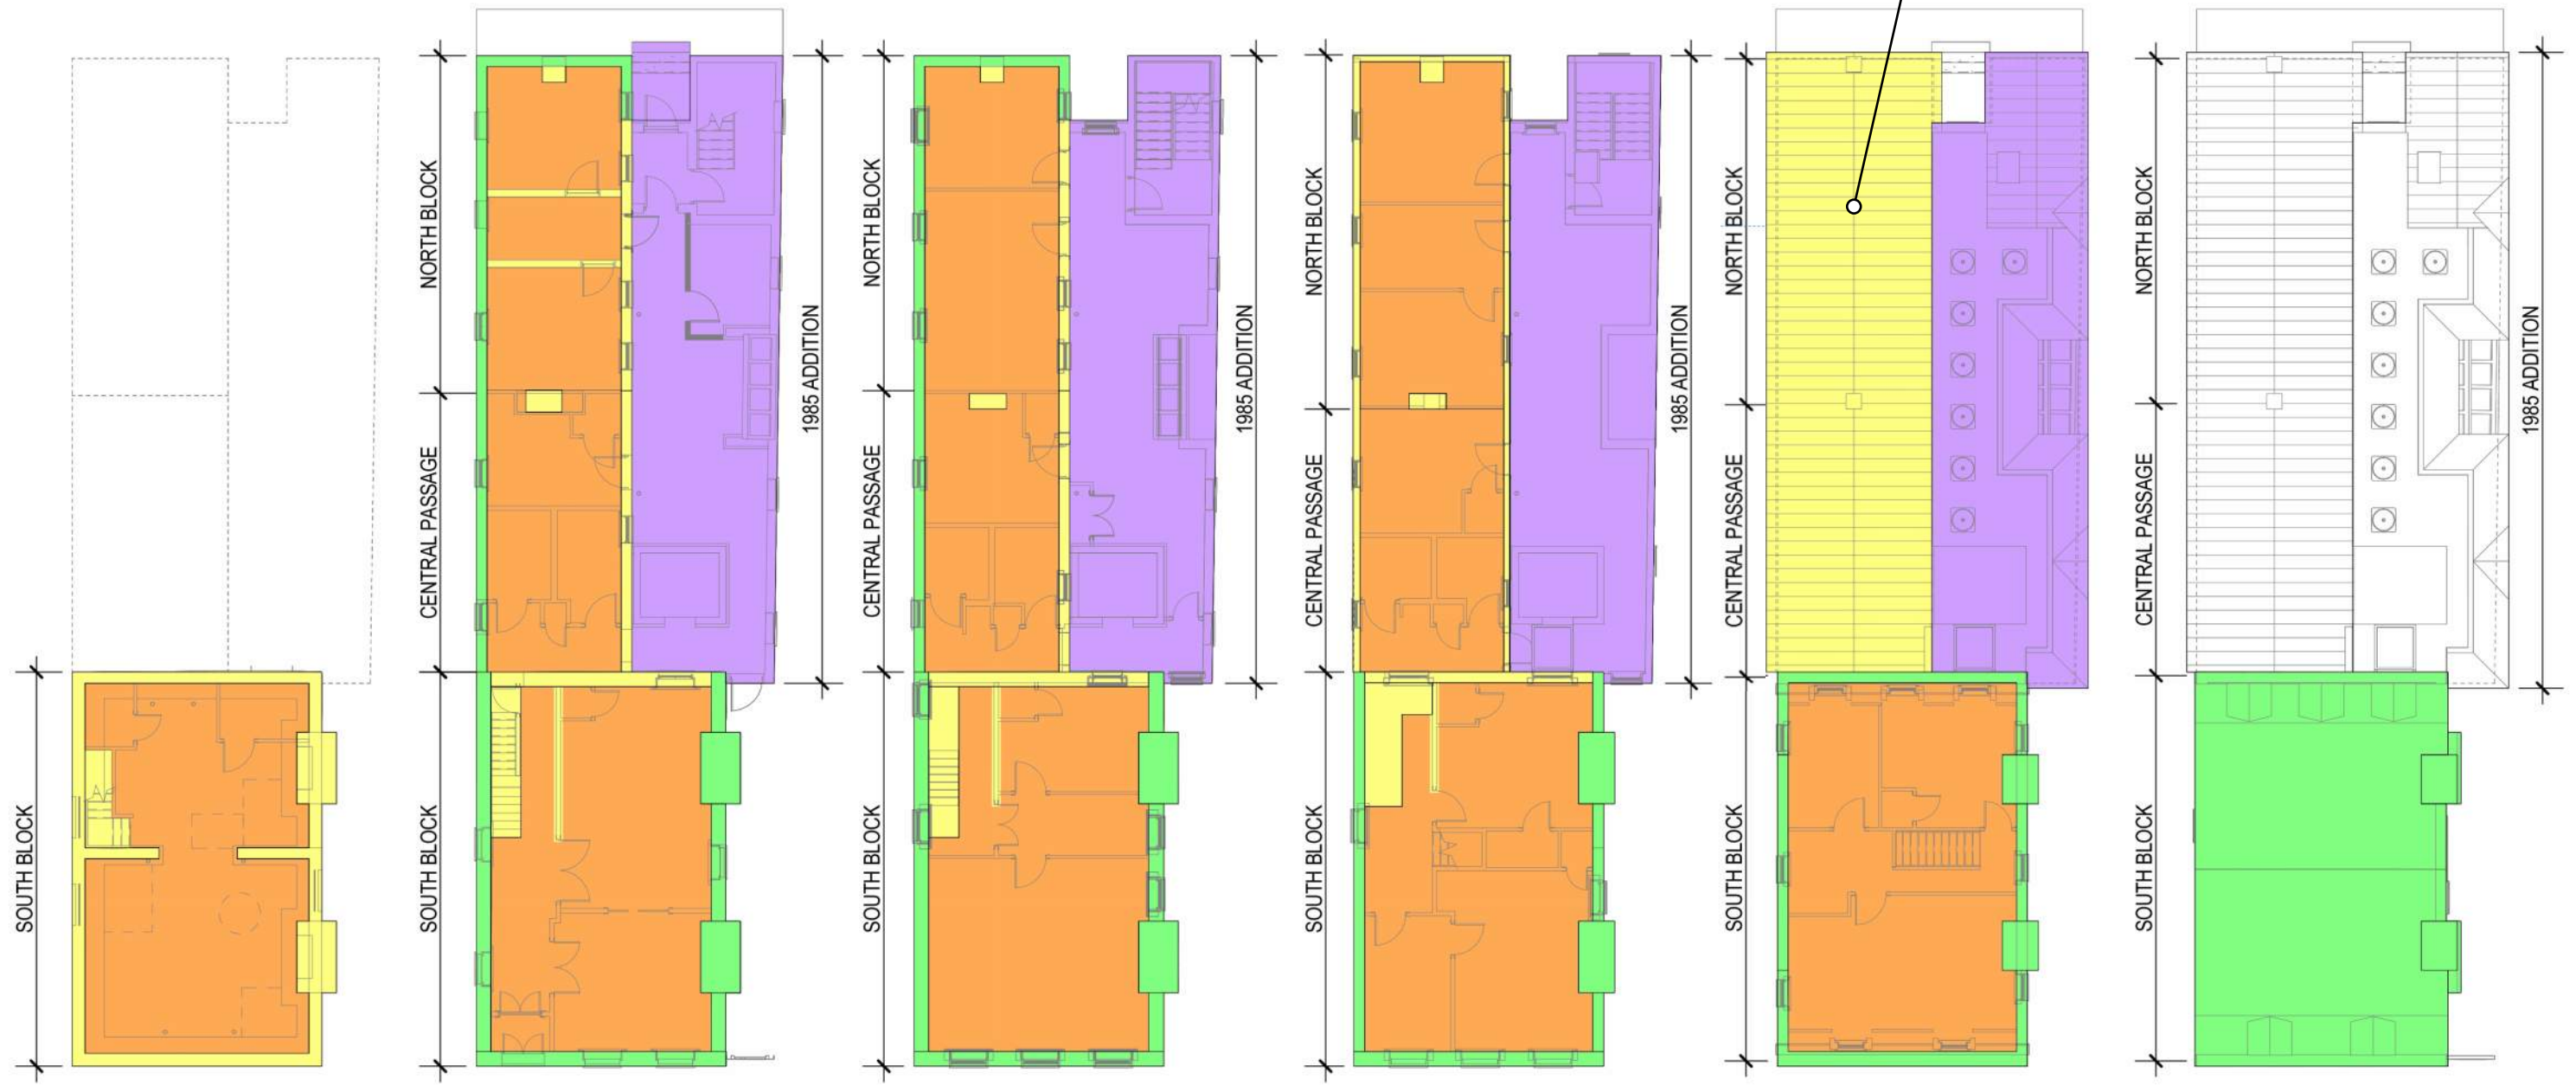
ROOF STRUCTURE OF CENTRAL PASSAGE AND NORTH BLOCK DATE TO PERIOD 4. ROOFING ASSEMBLY REPLACED IN PERIOD 5.

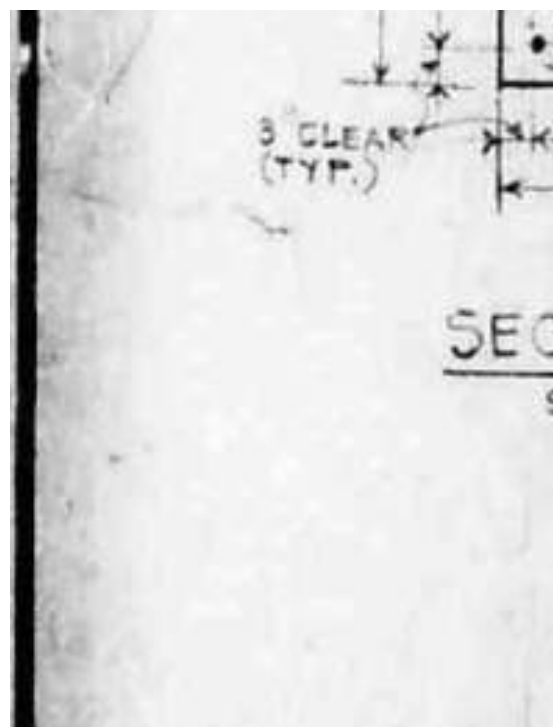
Figure 2C-3: Section from sheet S1 of 1984 Dunston Renovation drawings showing foundations of new addition.

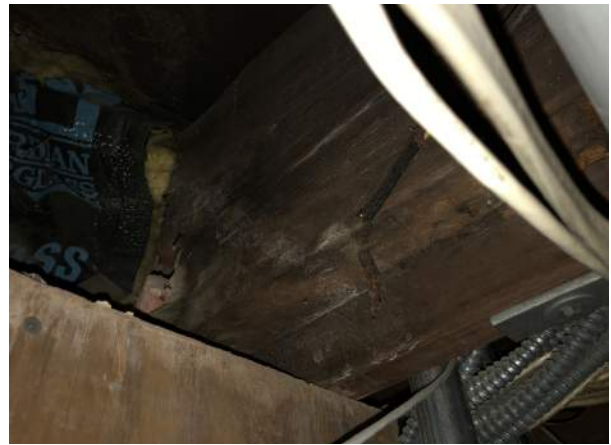
**Figure 2C-4:** Joist end visible from basement. Note the poor condition of the joists near the end.

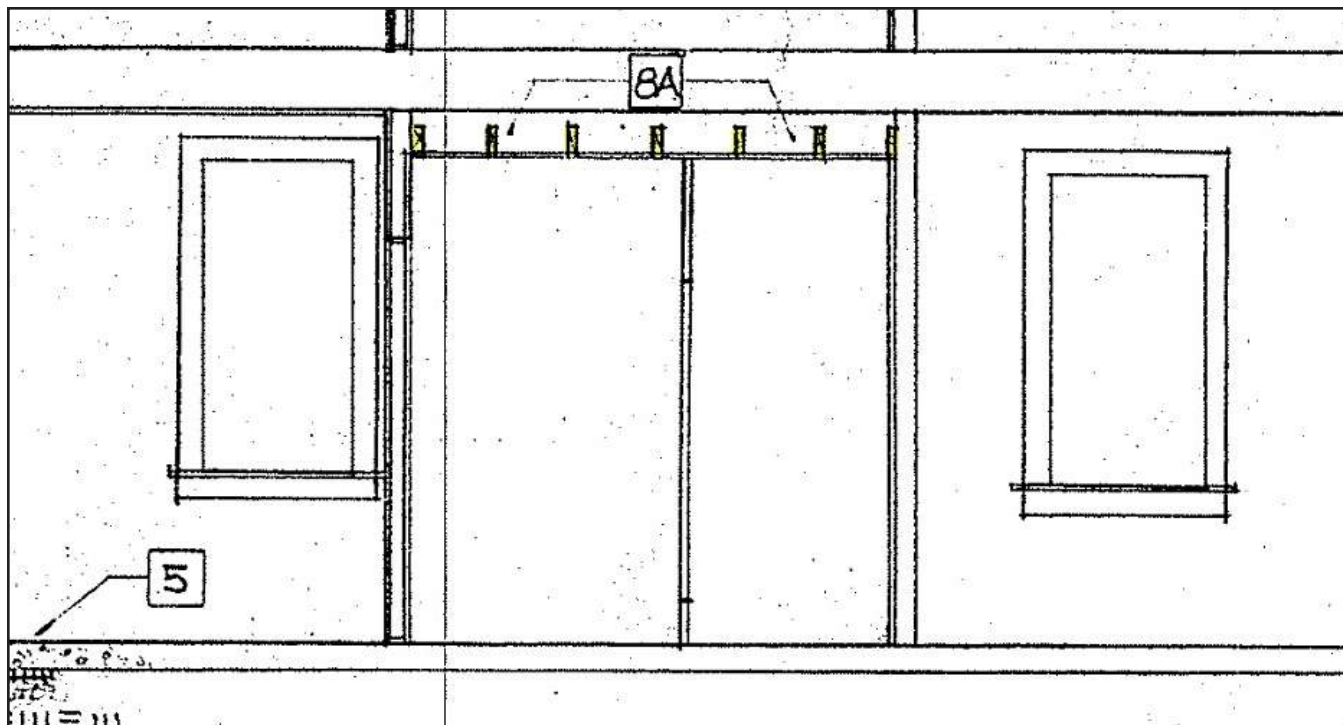
Figure 2C-5: 1980s Building section showing addition of 2x4 ceiling joists above bathrooms

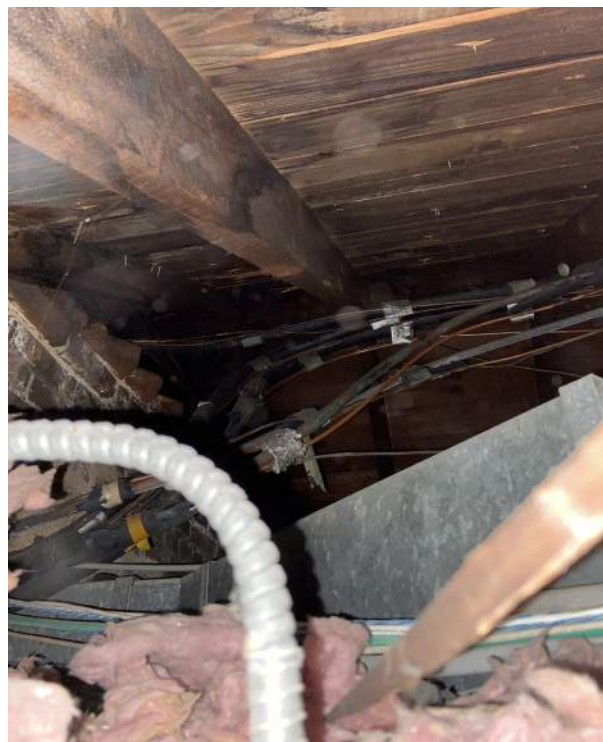
Figure 2C-9: Northwest portion roof, viewed above ceiling light.

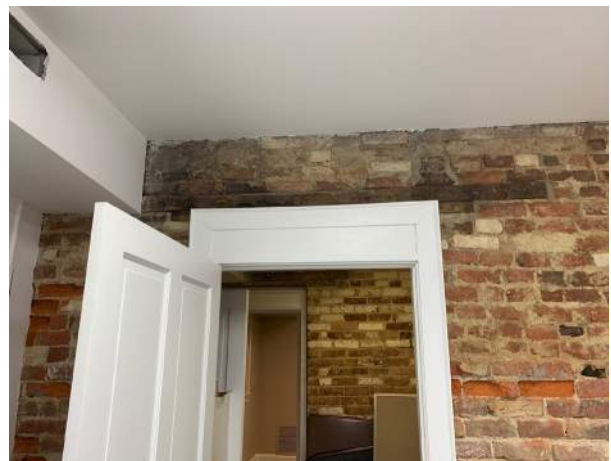
Figure 2C-13: First floor brick demising walls between Rooms 112, 114, and 116. These walls were plastered over in early 2020 but the City of Alexandria.

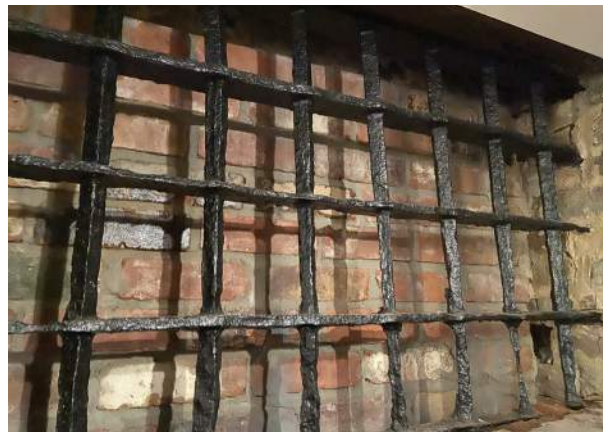
Figure 2C-14: Wrought iron grating within basement

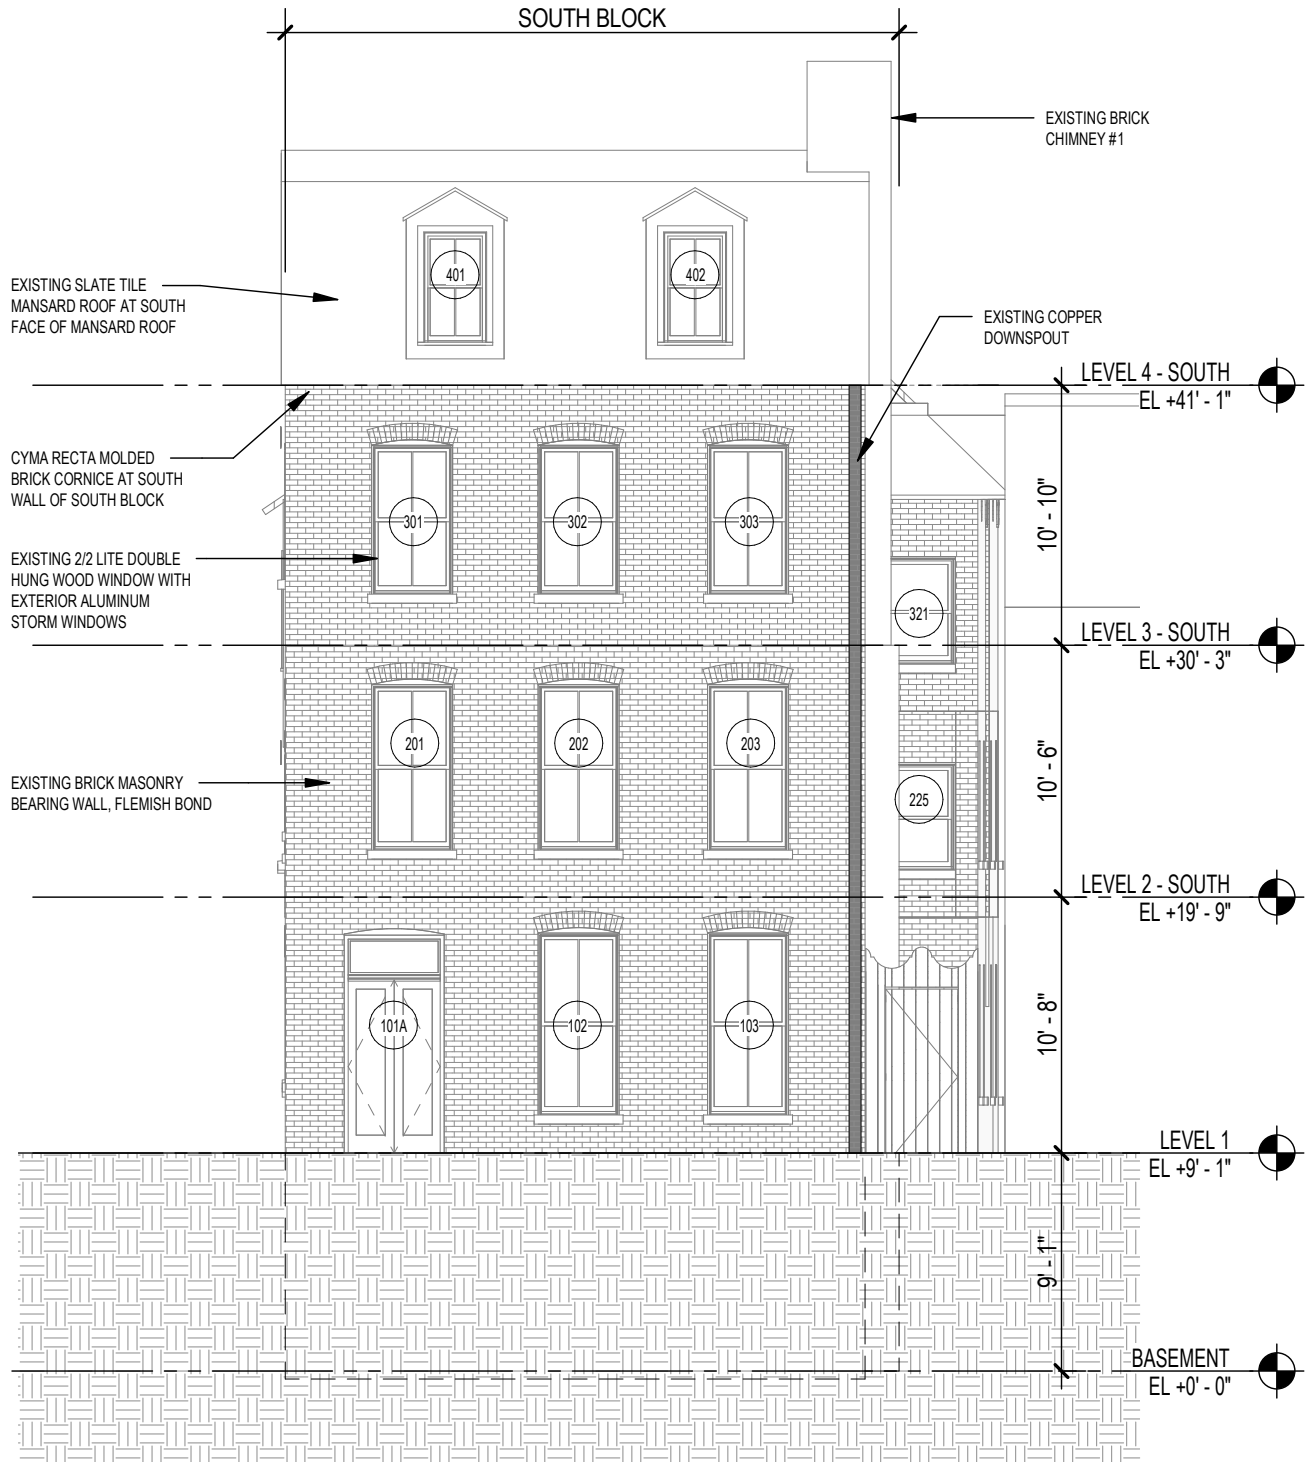
GRAPHIC SCALE: 1/8" = 1'-0"

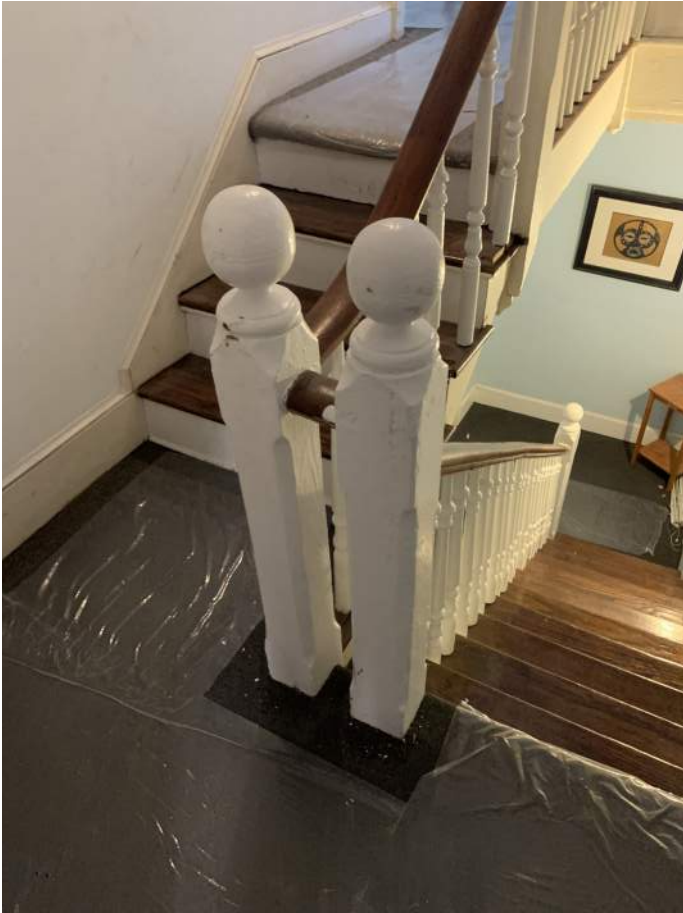
Stair 1, Intermediate Landing between Second and Third Floors

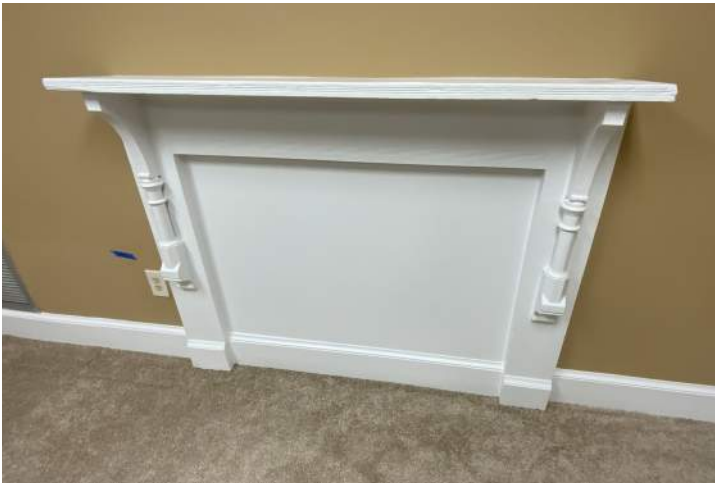
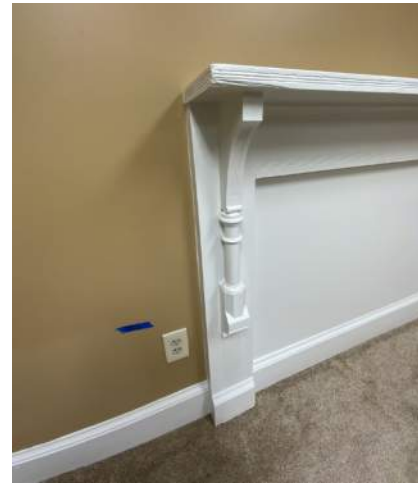
Conference Room 214, Fireplace Surround/ Mantle

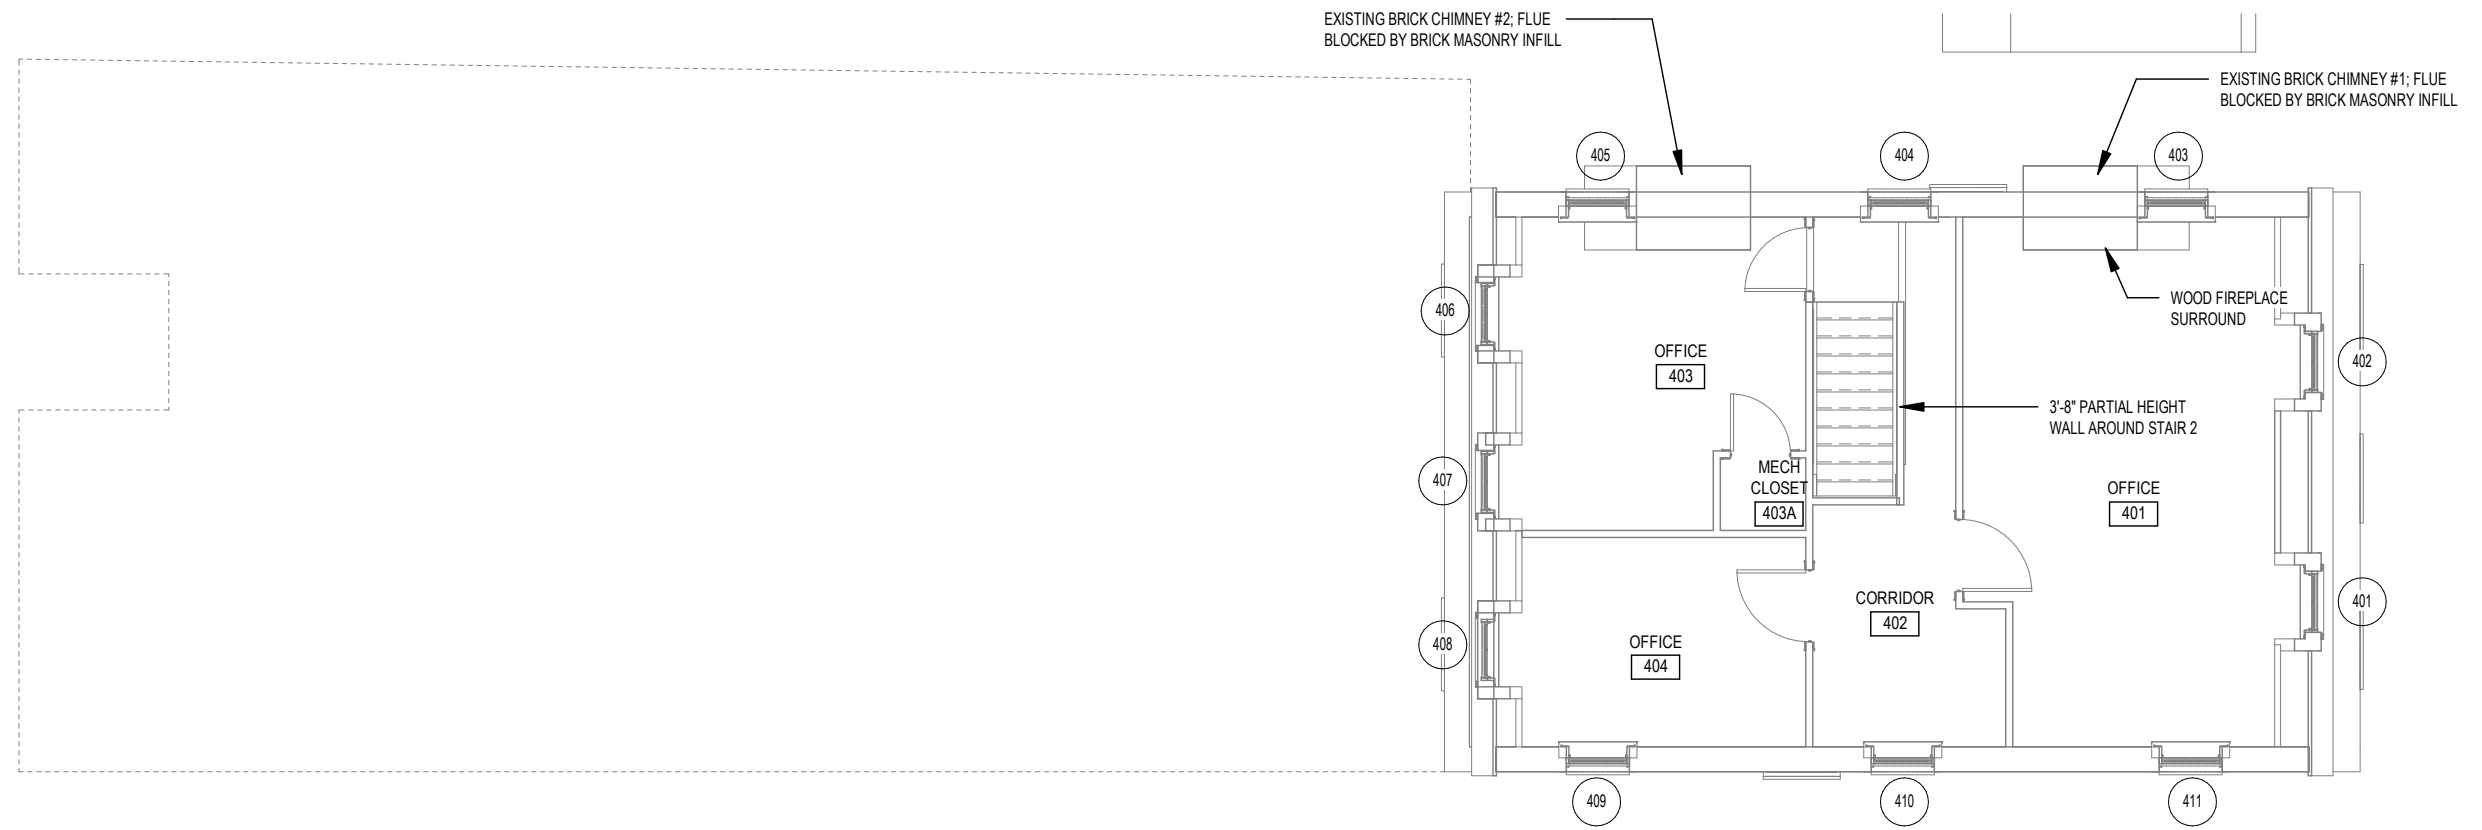
GRAPHIC SCALE: 1/8" = 1'-0"

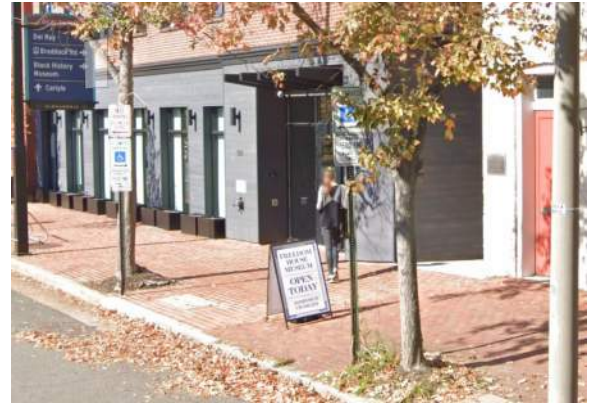
**Figure 2D-1:** Dedicated accessible parking space in front of 1315 Duke Street

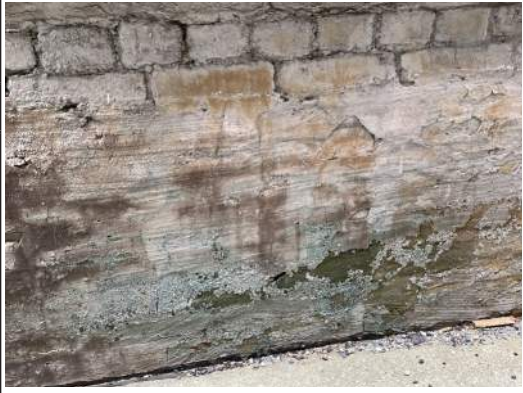
<b>DESCRIPTION</b>		<b>POTENTIAL CAUSES</b>	
	Unwanted growth or infestation of fungi, algae, microbes, or plants that may result in organic staining and bio-deterioration of the pore structure of the masonry.		Biological growth is associated with excess moisture in protected areas and is related to fluctuations in temperatures. It often occurs where there is not adequate drainage of rainwater. It also provides the perfect environment for insect and animal infestations and may indicate elevated moisture levels within the substrate.
