City of Alexandria, Virginia - Department of Project Implementation

# 1315 DUKE STREET HISTORIC STRUCTURE REPORT

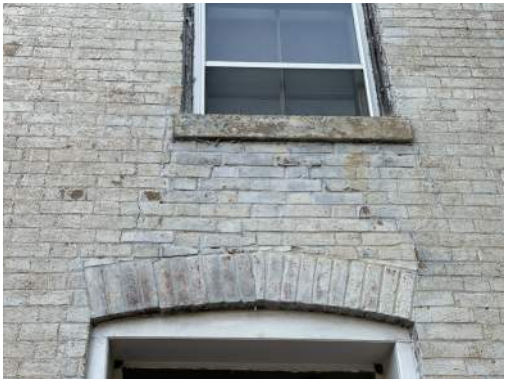
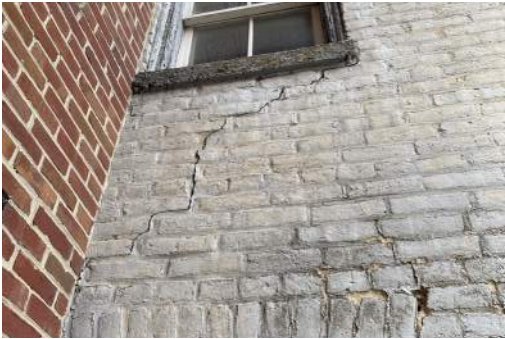
<b>DESCRIPTION</b>		<b>POTENTIAL CAUSES</b>	
	<p>Through Joint Crack (TJC): A crack that follows the mortar joints of the brick and doesn't translate through the brick. In some cases, these cracks result in brick displacement.</p> <p>Through Brick Crack (TBC): Movement and shifting of the brick have resulted in cracking both through the brick units and through adjacent mortar joints.</p> <p>Often these conditions occur together where a crack is found migrating through mortar joints and causing splitting of individual masonry units.</p>		<p>Joints open due to weathering or differential stresses from movement within the building envelope. The mortar can be further damaged with salts and moisture migration.</p>

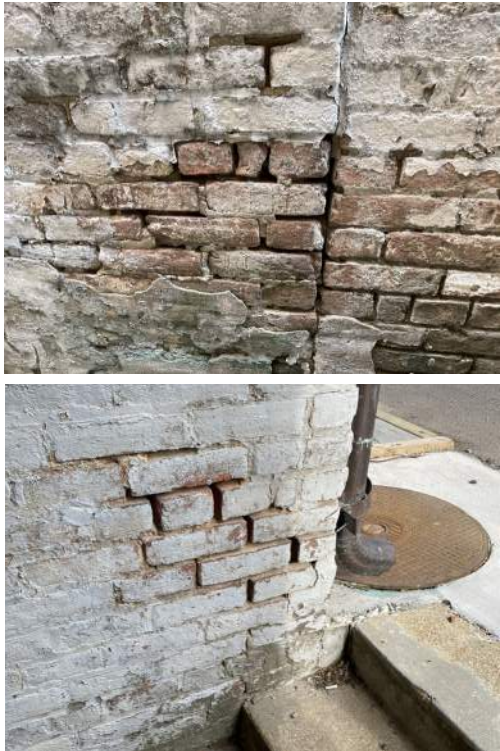
DESCRIPTION		POTENTIAL CAUSES	
Complete or partial loss of pointing mortar. This condition allows moisture to migrate into the masonry substrate and may also result in potential structural instability		Dislocation of the brick units may be caused by differential movement within the masonry wall or deterioration of adjacent mortar caused by excessive penetration of moisture within the wall.

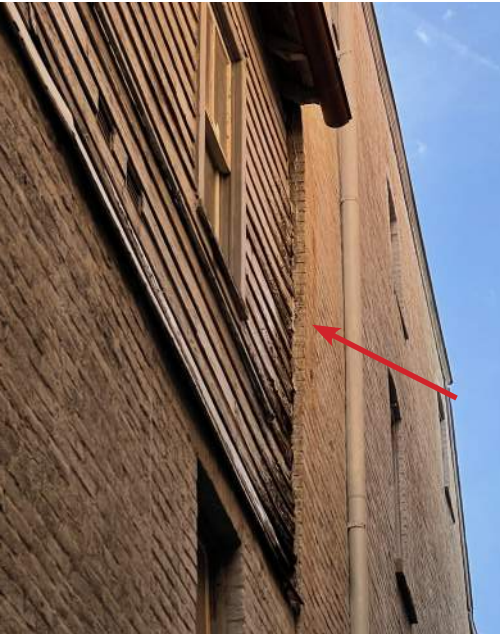
DESCRIPTION		POTENTIAL CAUSES	
Brick units that have shifted out of plumb or are not level.		Dislocation of the brick units may be caused by differential movement within the masonry wall or deterioration of adjacent mortar caused by excessive penetration of moisture within the wall.

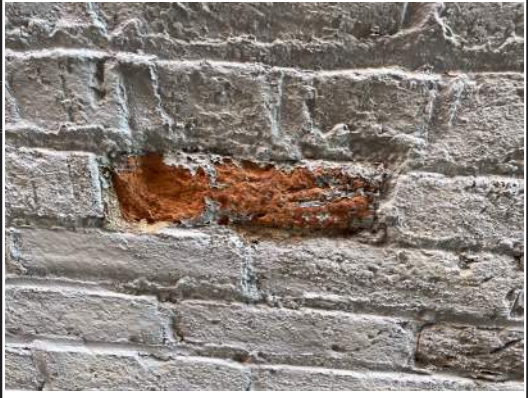
DESCRIPTION		POTENTIAL CAUSES	
Detachment of brick fragment from brick unit.		Spalled bricks may be caused by pressure within wall, expansion of embedded ferrous elements or from repair materials that are overly hard in comparison to the surrounding substrate.

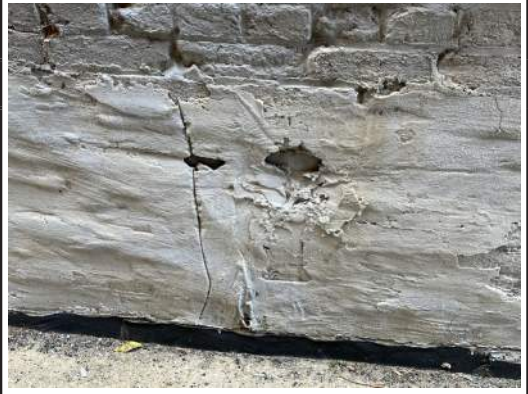
DESCRIPTION		POTENTIAL CAUSES	
Previous repair of the masonry which is physically or aesthetically incompatible with the historic fabric.		Previous penetrations through the brick which have been abandoned have required patching. The patching materials are not sympathetic to the historic fabric and may fail as a result of improper testing of the repair system or a misunderstanding of the long-term effects of the repair from weathering.

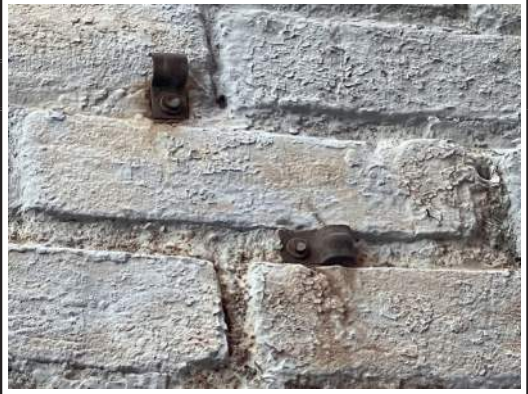
DESCRIPTION		POTENTIAL CAUSES	
Ferrous metal strips set into mortar joints to surface mount materials to the brick masonry.		Prolonged exposed to water will cause ferrous metals to rust and deteriorate. The rusting and corrosion of the metal will cause mortar loss and possible spall of the brick.

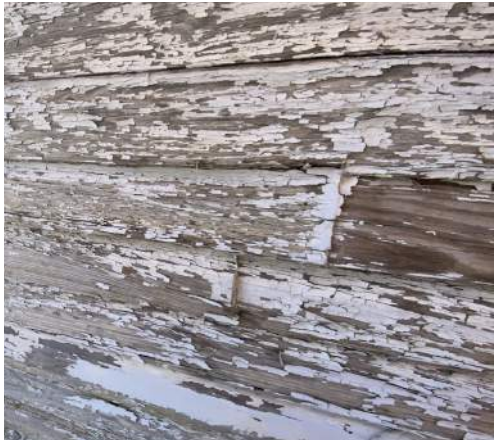
DESCRIPTION		POTENTIAL CAUSES	
<p>Failure of paint coating, which acts as a protective sacrificial layer against weathering. The loss of paint exposes the wood substrate to moisture penetration, deterioration and eventually will lead to wood rot</p>		<p>Most paint coatings fail due to age and weathering. In some cases, when the substrate is not prepared correctly or is too wet, the coating cannot maintain a bond and will fail. Paint loss is most severe at areas of high weathering, such as window sills, base of frames, projecting elements and horizontal members.</p>

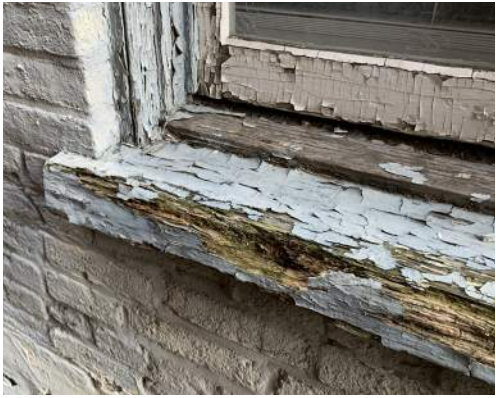
DESCRIPTION		POTENTIAL CAUSES	
<p>Decay of wood substrate, eventually leading to failure and loss of material. This process is accelerated by moisture, fluctuations in temperature and poor maintenance.</p>		<p>Failure of protective paint coating and prolonged exposure to direct weathering.</p>

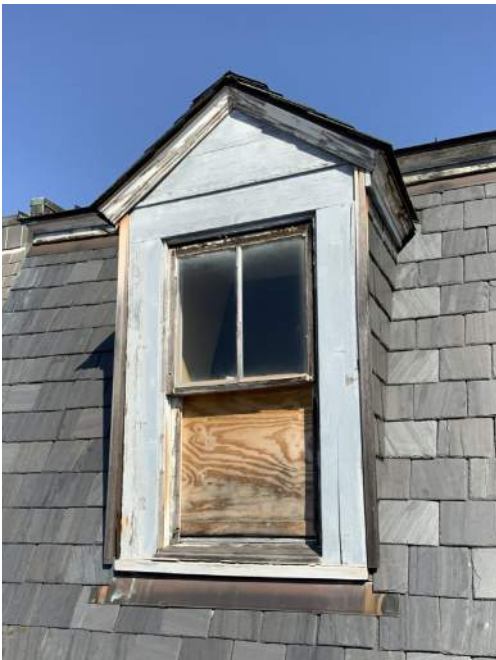
DESCRIPTION		POTENTIAL CAUSES	
<p>Missing component of wood members at window and door frames and trim.</p>		<p>Severe wood rot will eventually lead to disintegration of material and result in the loss of the element.</p>

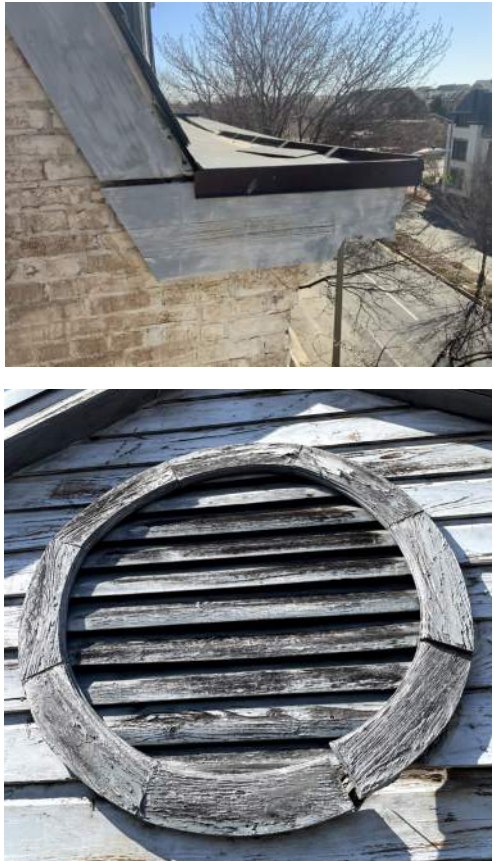
DESCRIPTION		POTENTIAL CAUSES	
Dislocated component of wood members at window and door frames and trim.		Dislocated component of wood members at window and door frames and trim.

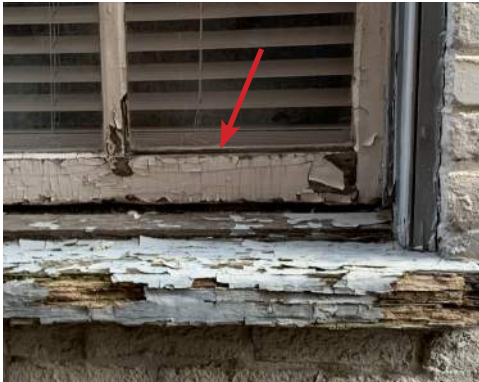
DESCRIPTION		POTENTIAL CAUSES	
The glazing putty that seals the edges of the existing glazing panes is cracked and missing in many locations		Continuous weathering leads to breakdown and drying out of the putty material, leaving these areas vulnerable to moisture penetration.

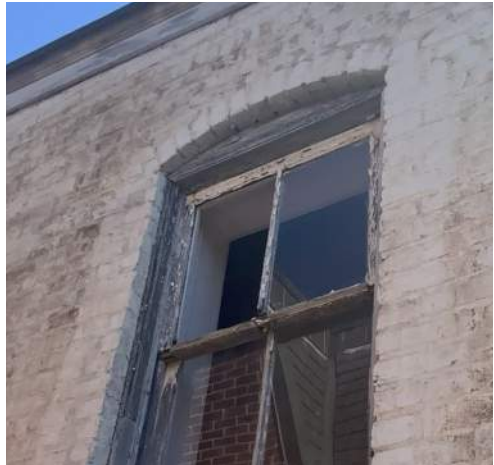
DESCRIPTION		POTENTIAL CAUSES	
Broken or missing glazing in window lites.		Impact from debris can result in broken glazing.

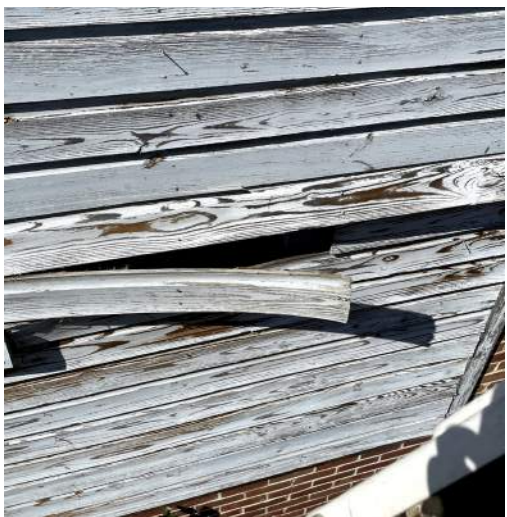
DESCRIPTION		POTENTIAL CAUSES	
Bowing and detached wood siding		Moisture build-up within exterior wall assembly results in delamination and detachment of building materials

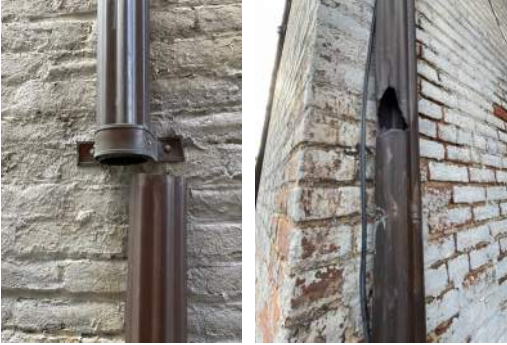
DESCRIPTION		POTENTIAL CAUSES	
Detached and damaged downspouts		impact damage resulting is detached or damaged copper downspouts

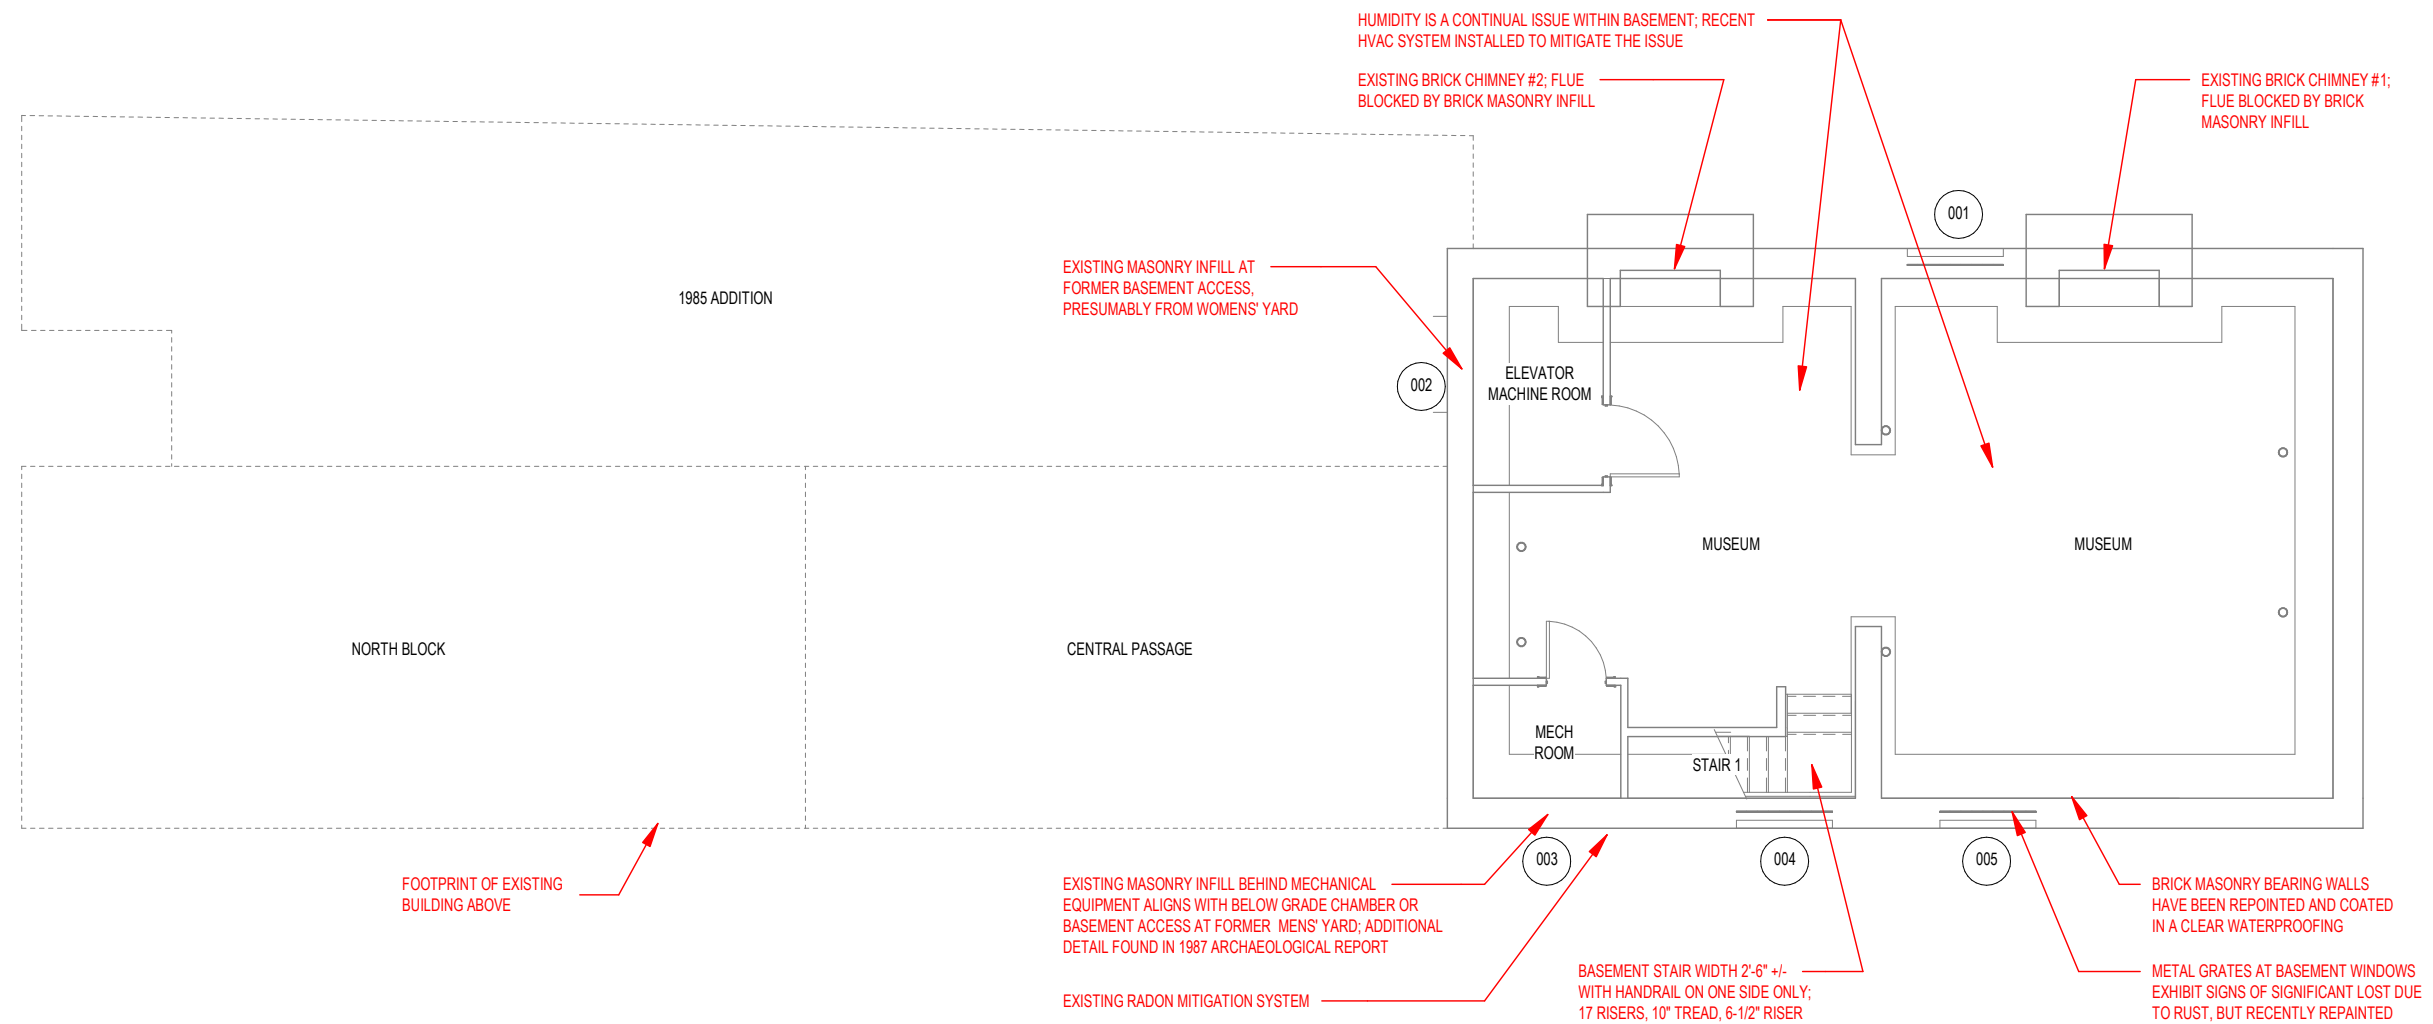
**CONDITIONS ASSESSMENT LEGEND**

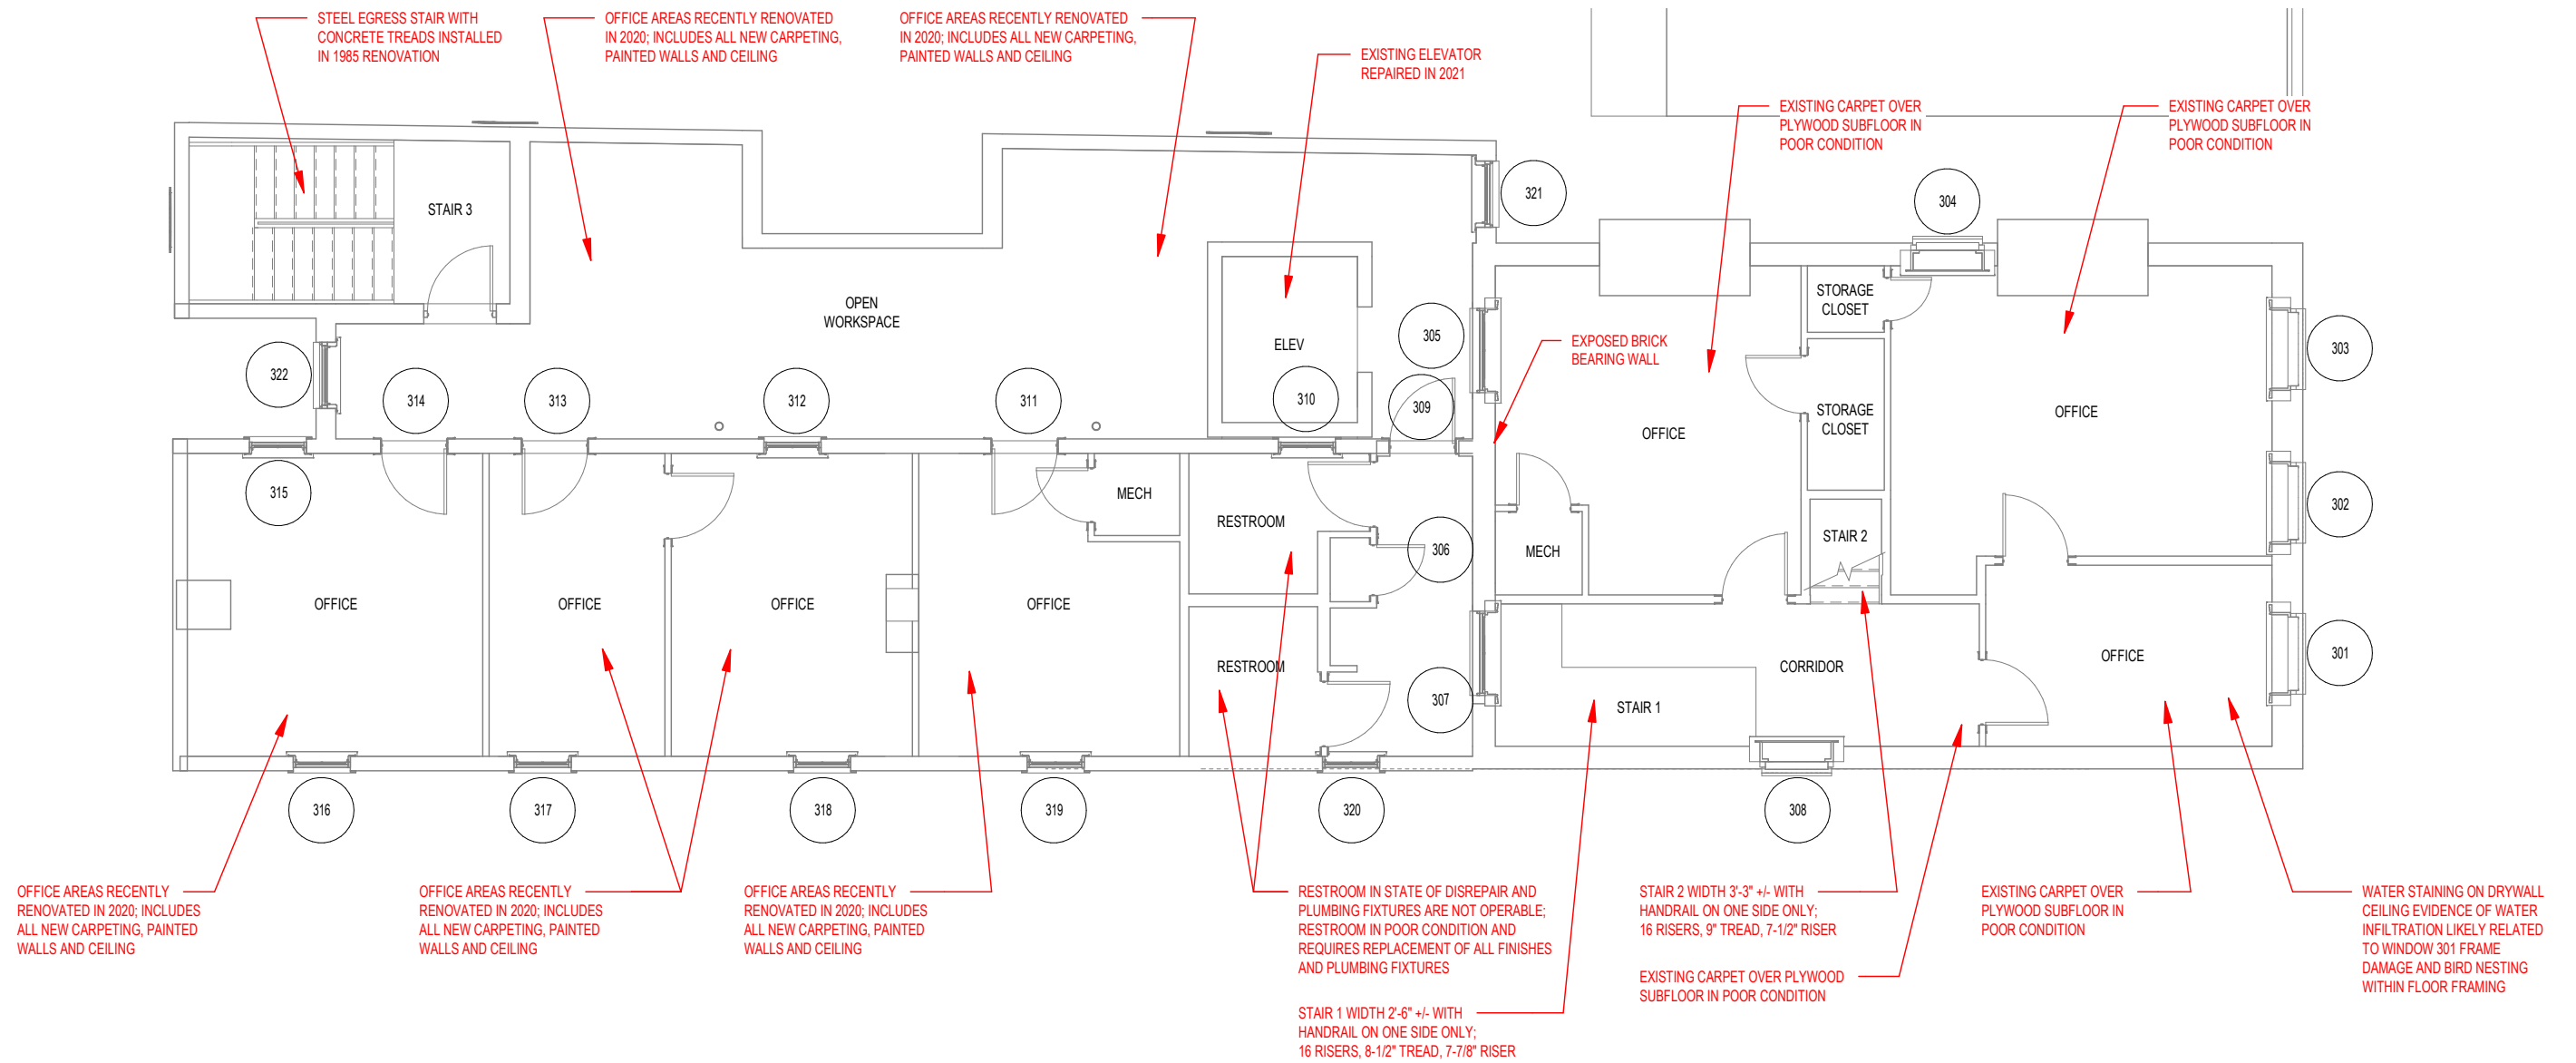
**CONDITIONS ASSESSMENT LEGEND**

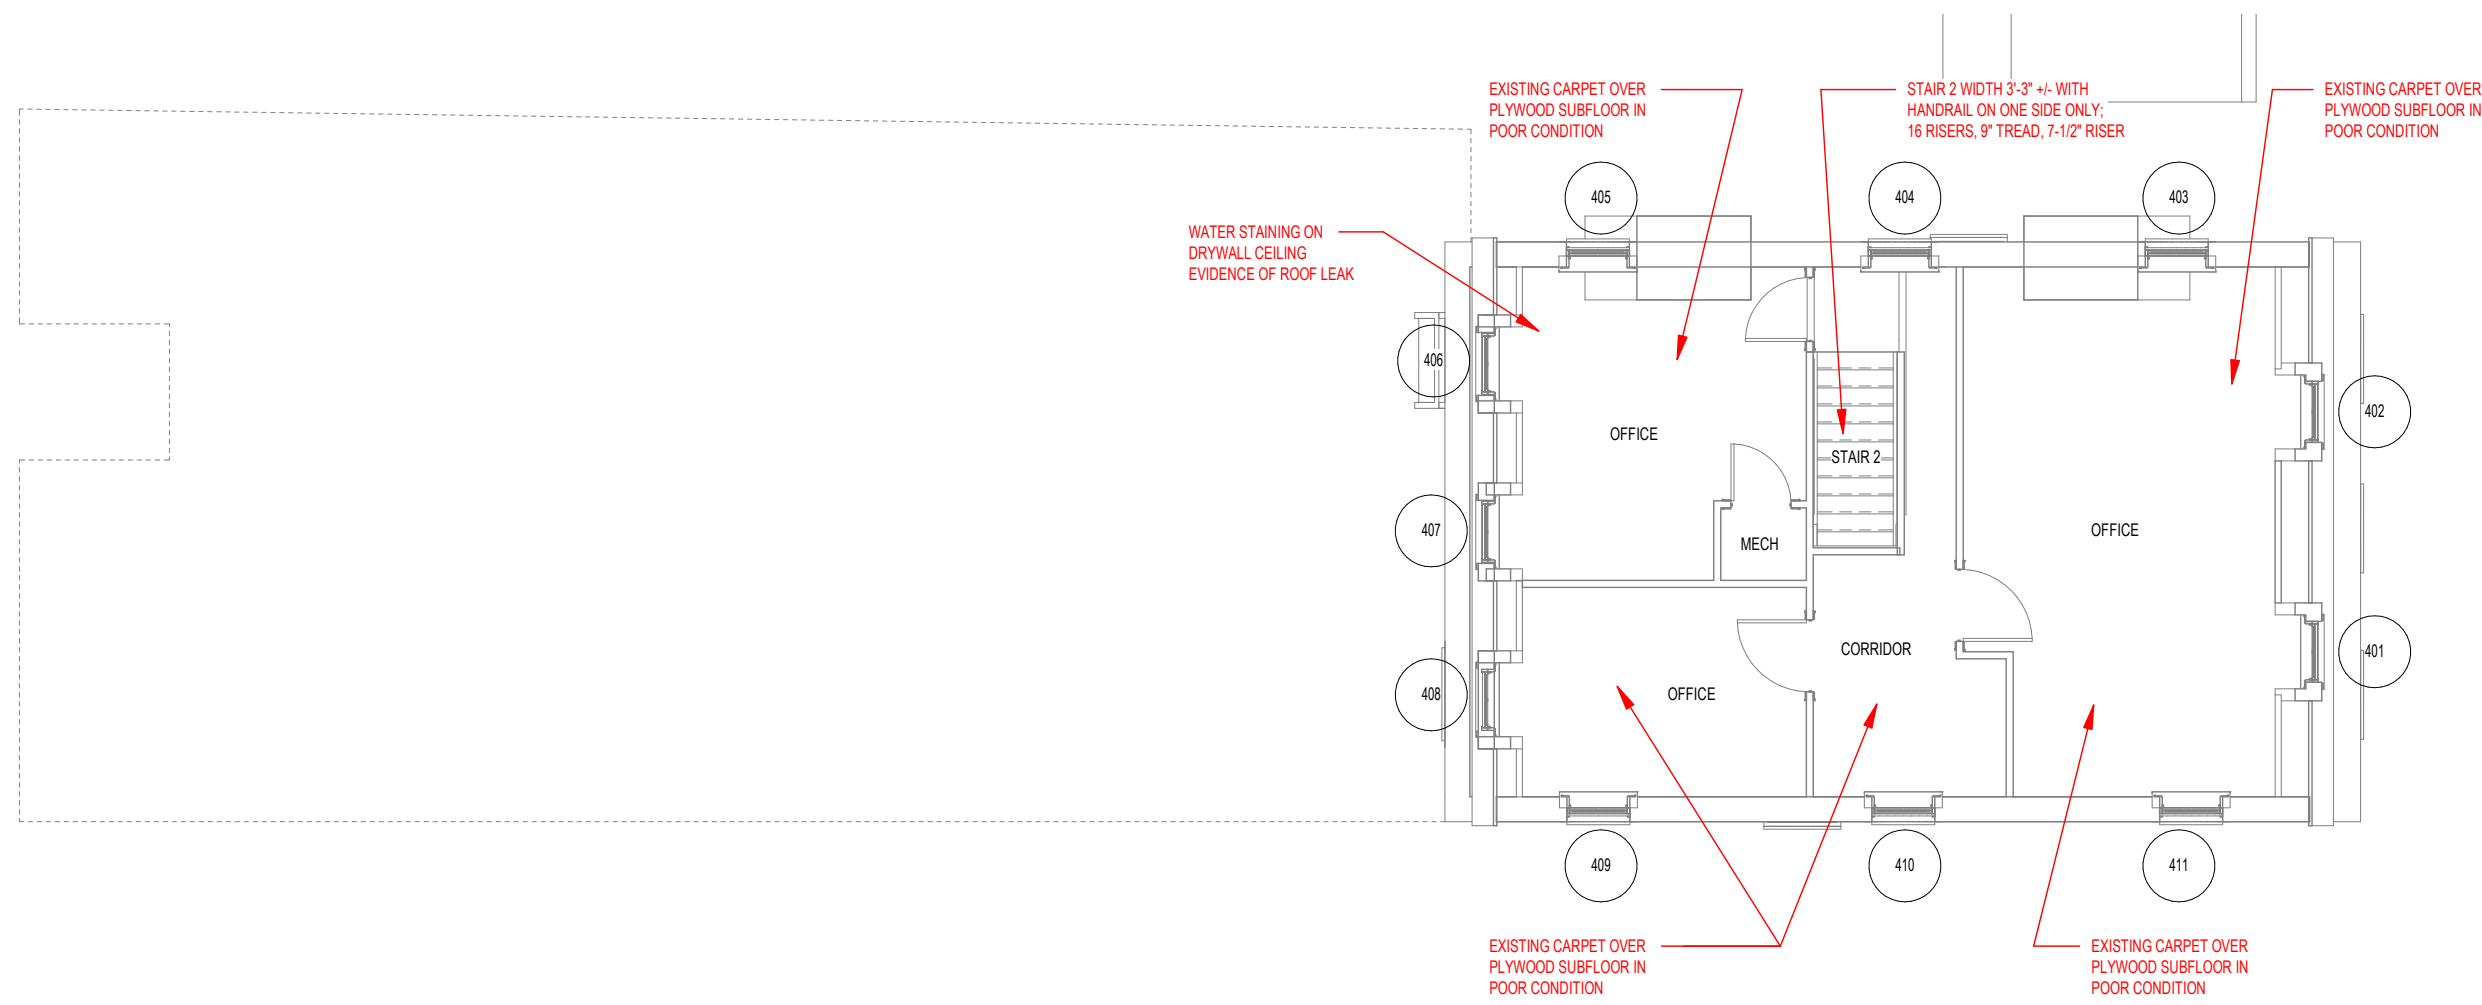
**CONDITIONS ASSESSMENT LEGEND**

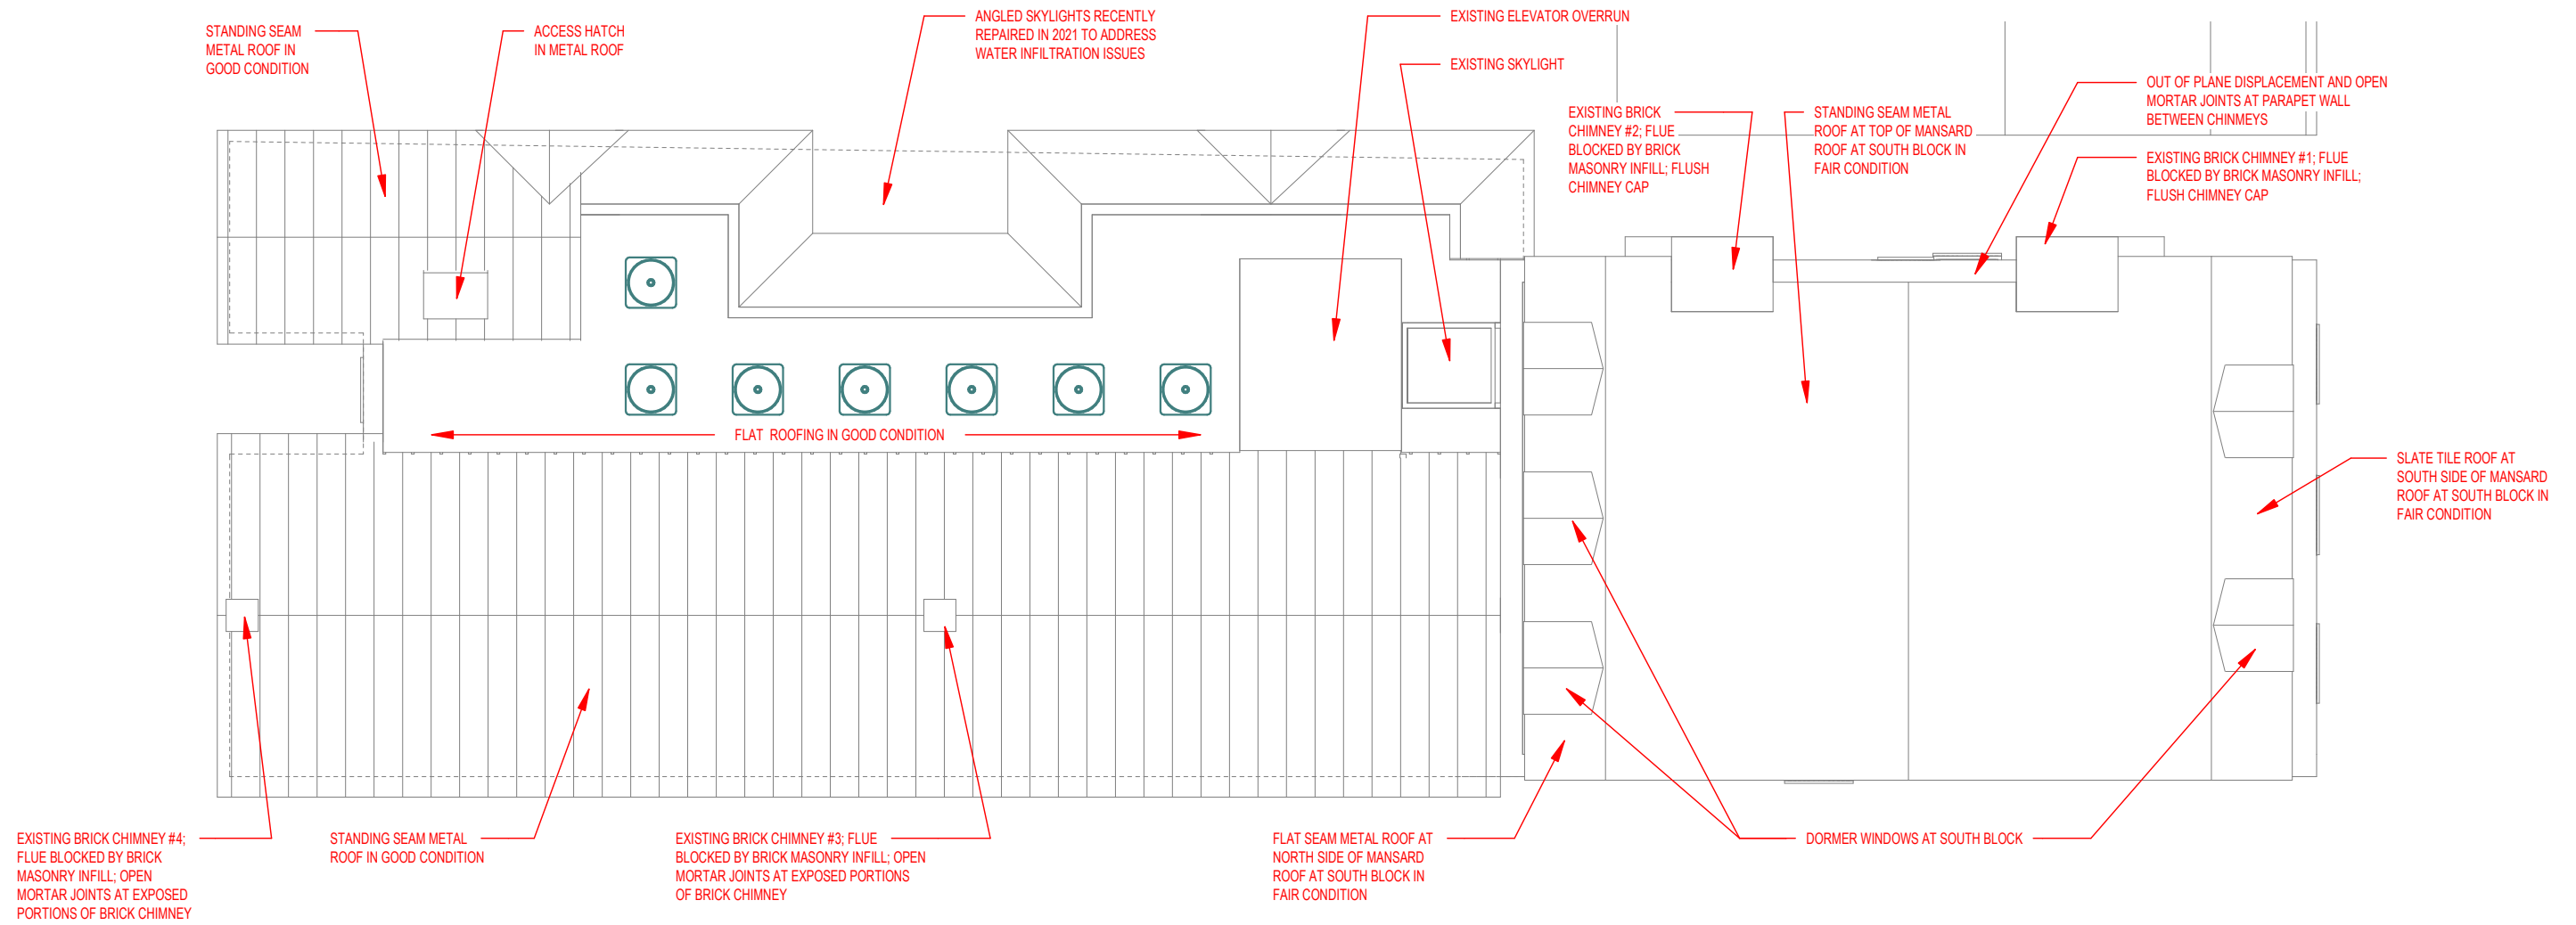
**CONDITIONS ASSESSMENT LEGEND**

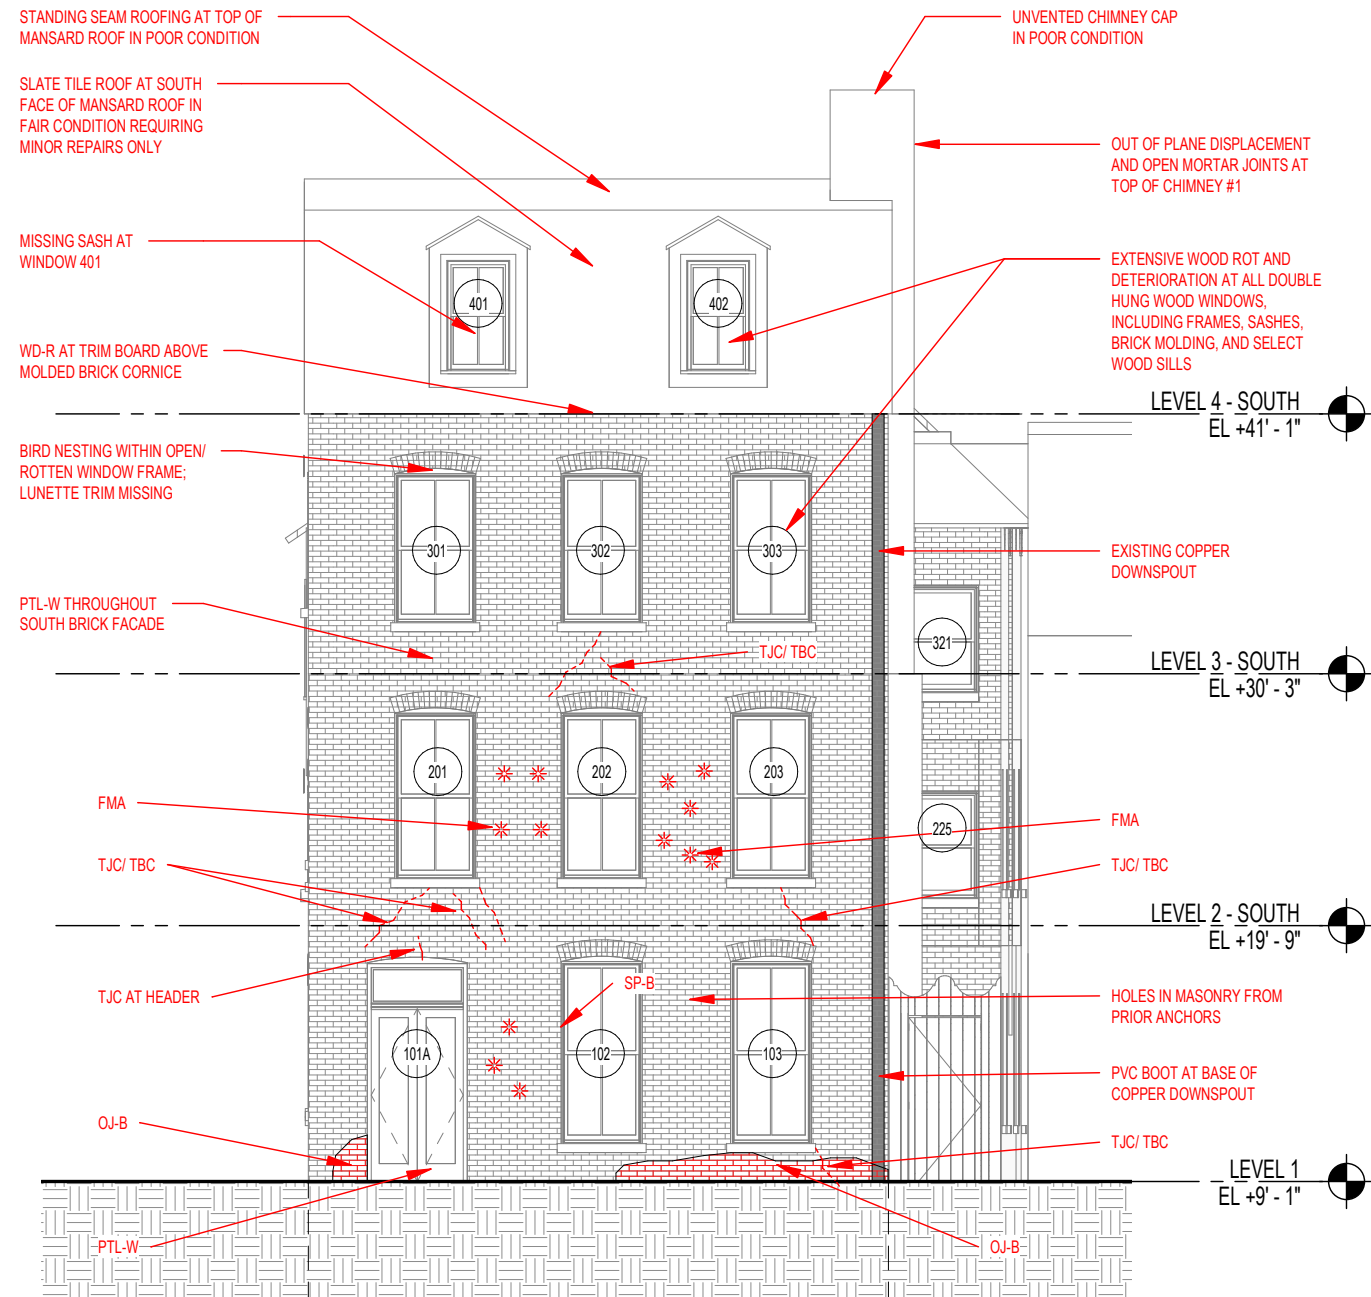
# CONDITIONS ASSESSMENT - SOUTH & NORTH ELEVATIONS

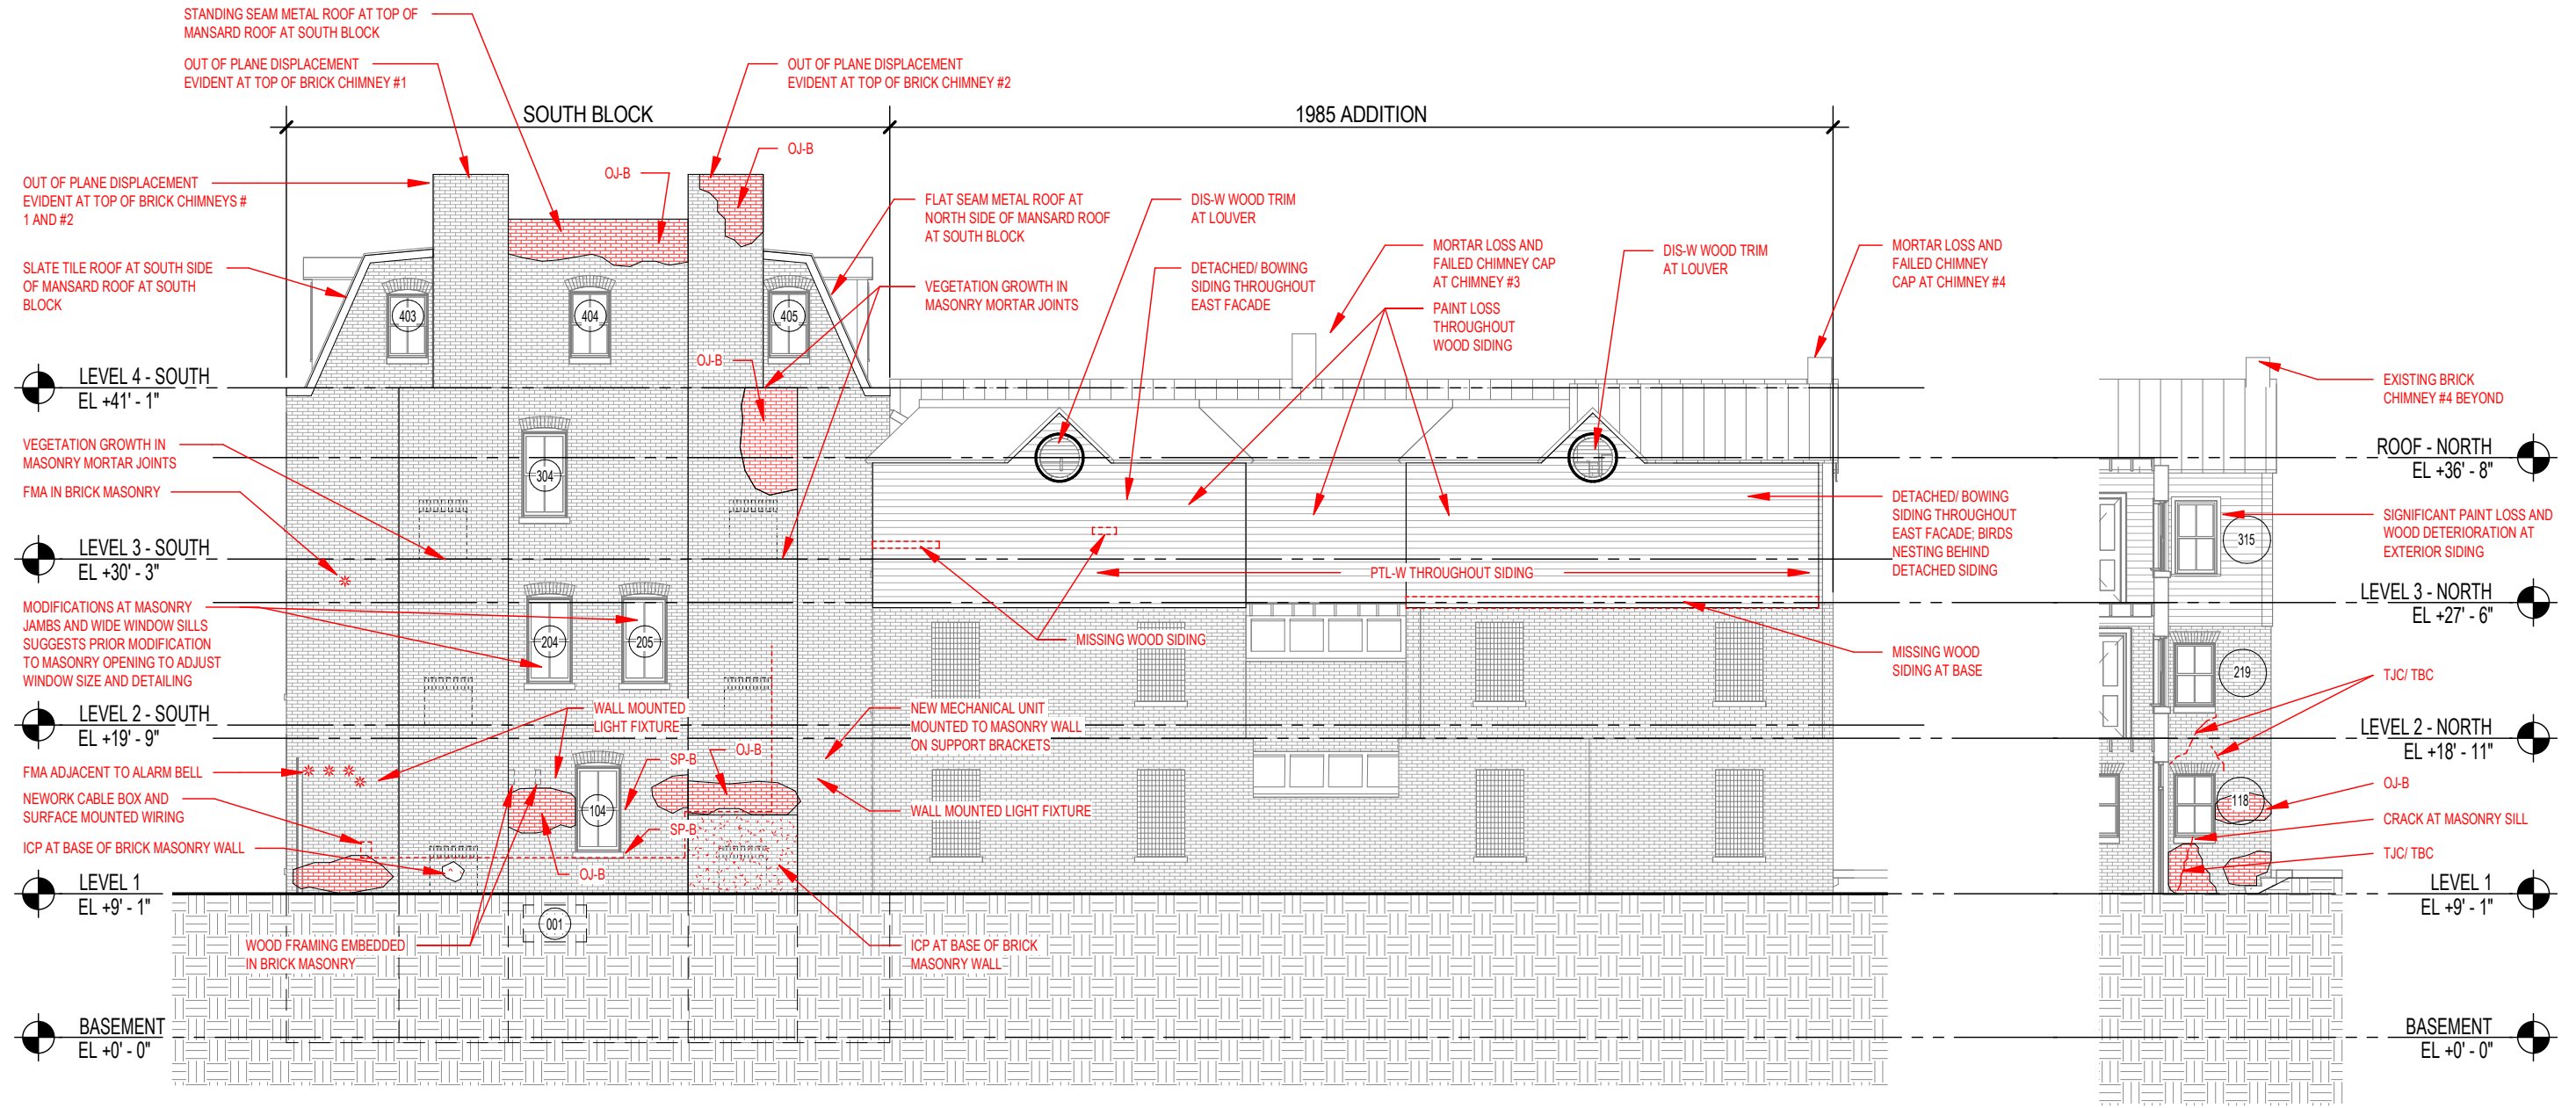
# CONDITIONS ASSESSMENT - EAST ELEVATION

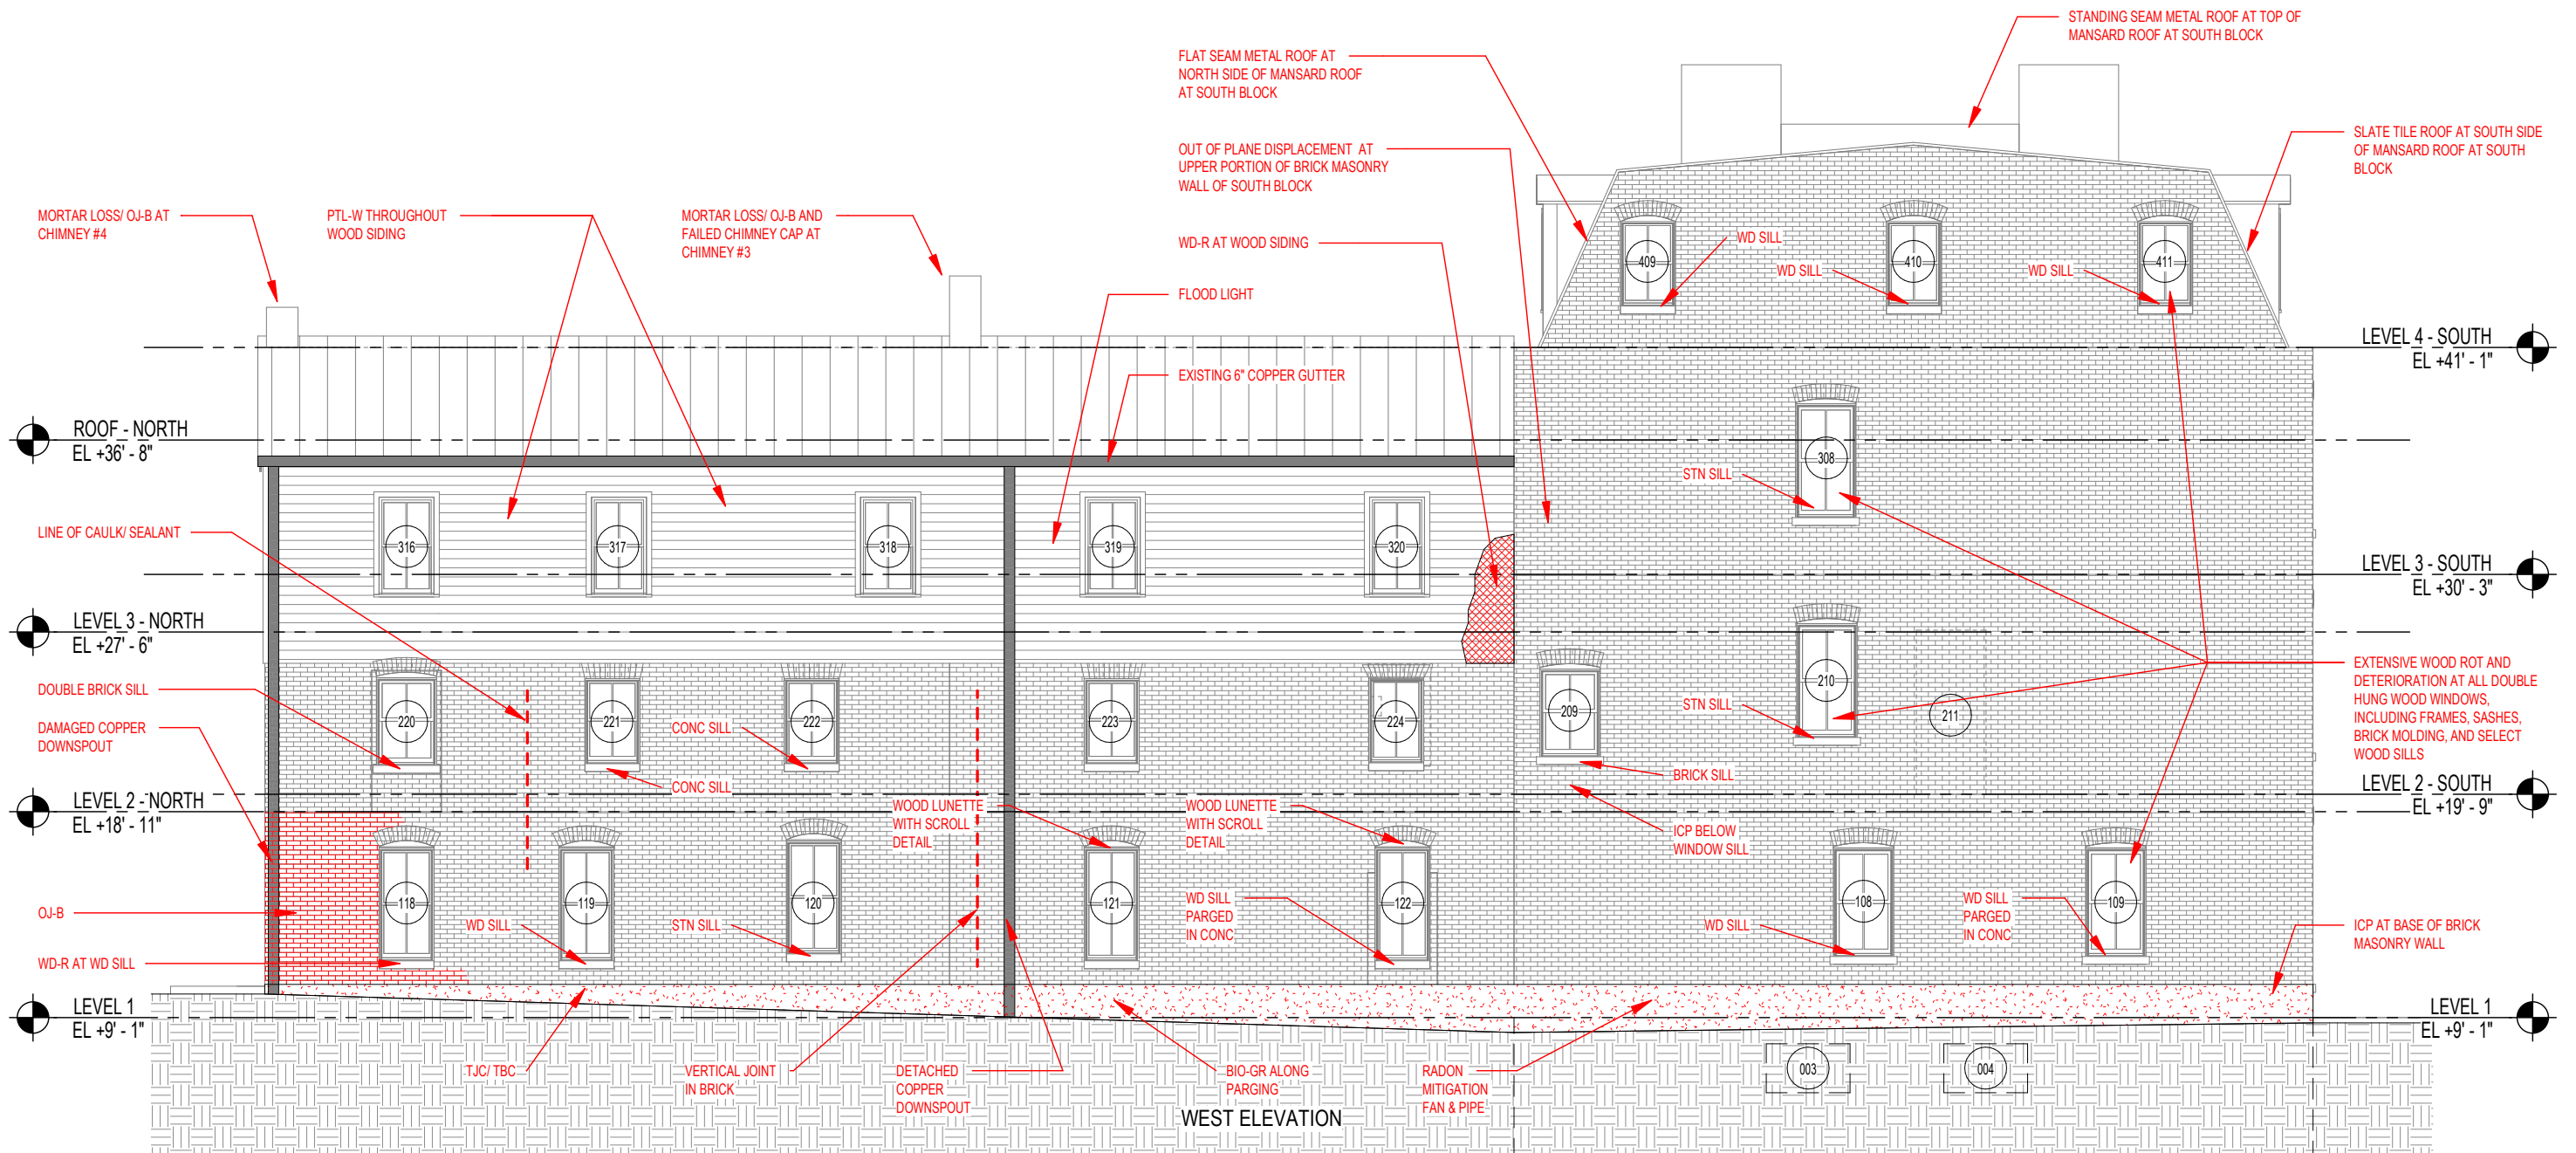
**CONDITIONS ASSESSMENT LEGEND**

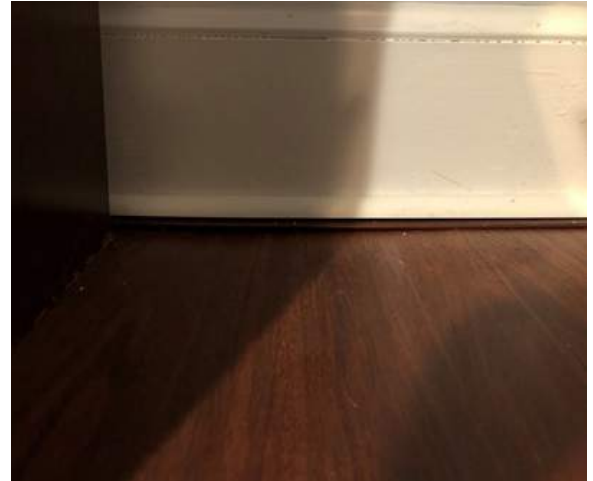
**Figure 2D-5:** Gap evident in baseboard trim at second floor office, opposite the corridor wall from Stair 1.
