City of Alexandria, Virginia - Department of Project Implementation

# 1315 DUKE STREET HISTORIC STRUCTURE REPORT

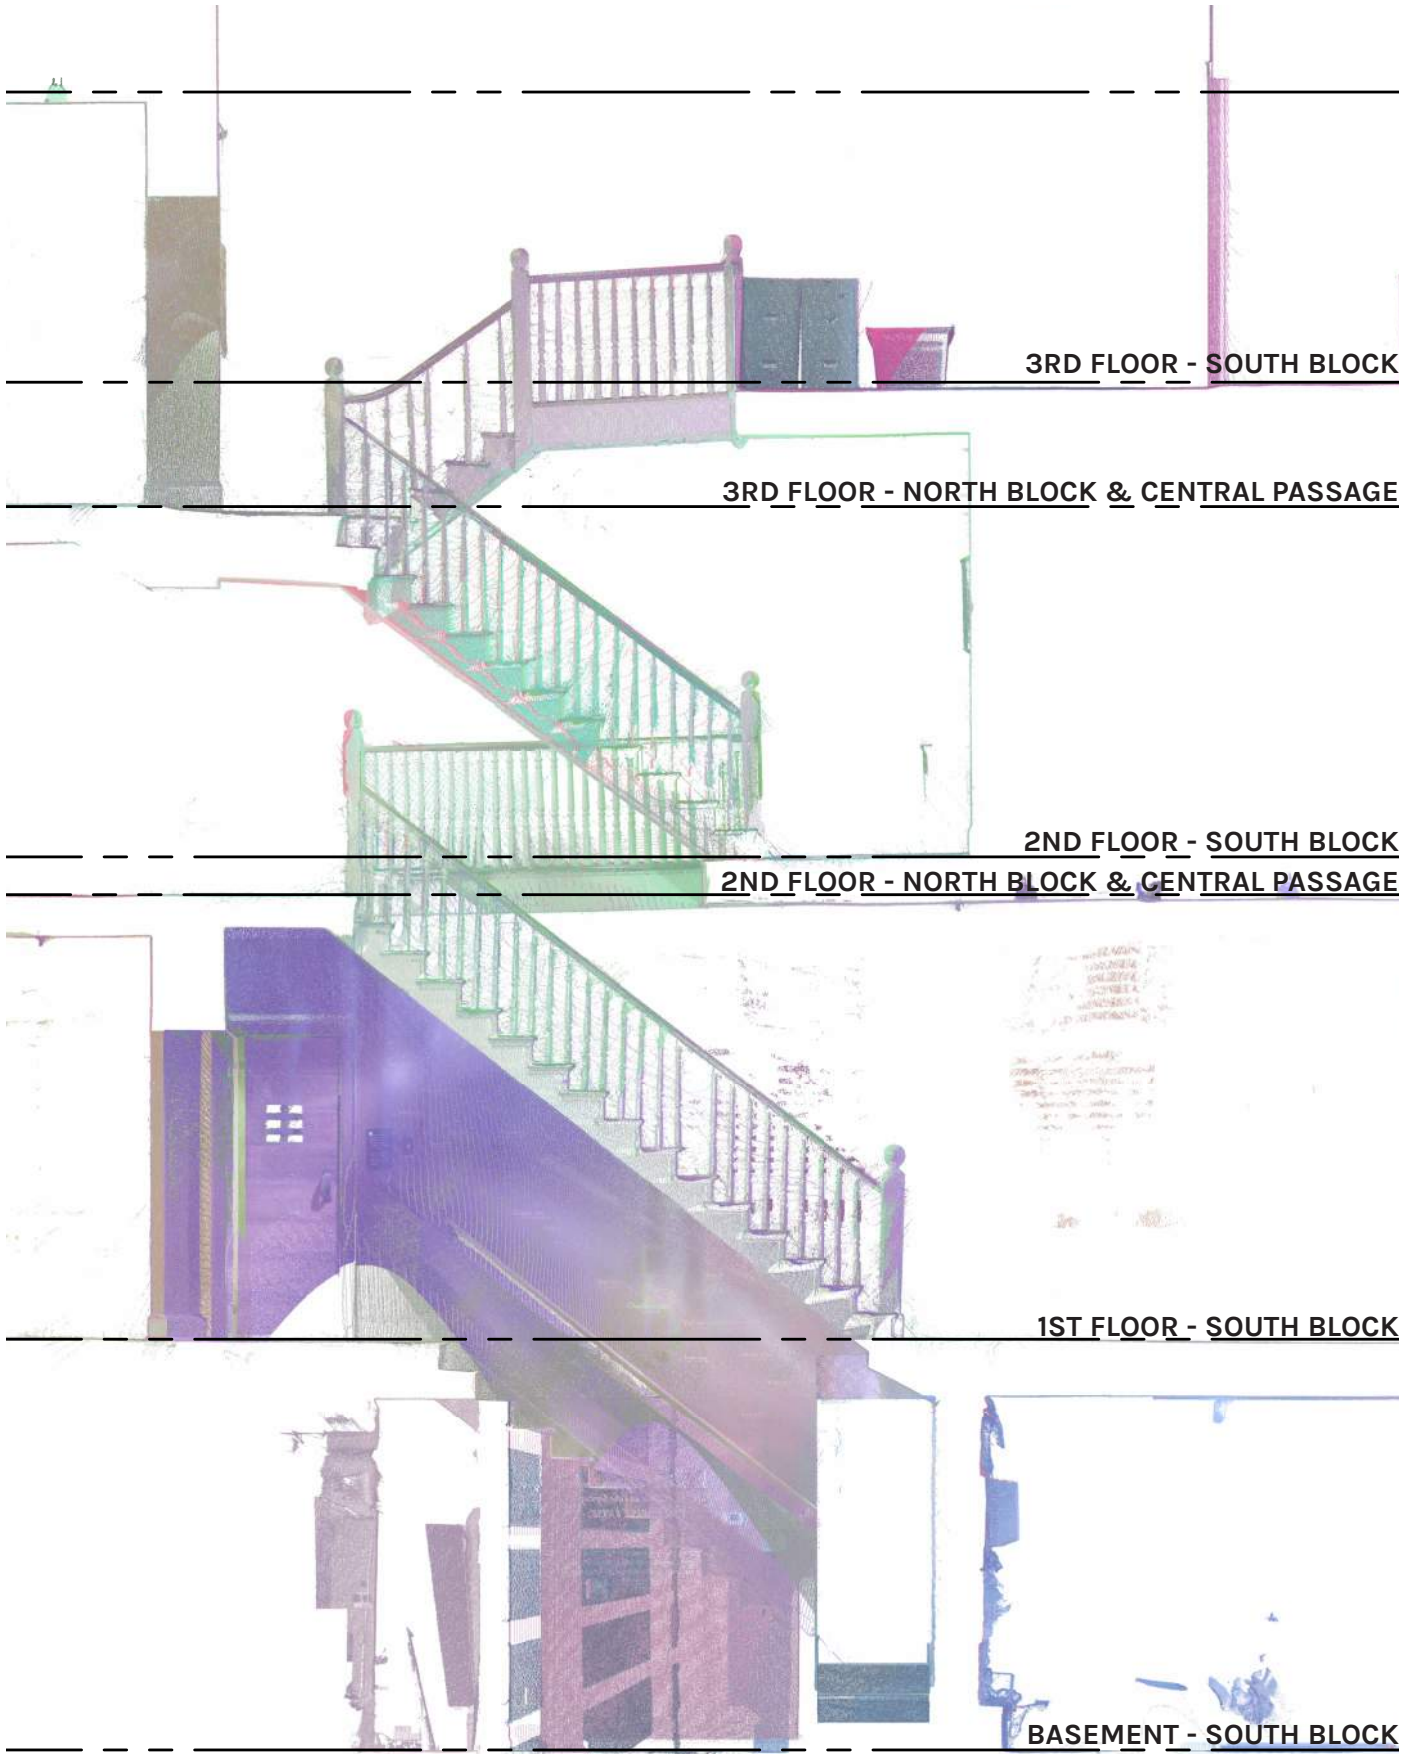
Figure 2D-7: Section view of laser scan showing extent of structural deformation and settlement at Stair 1.

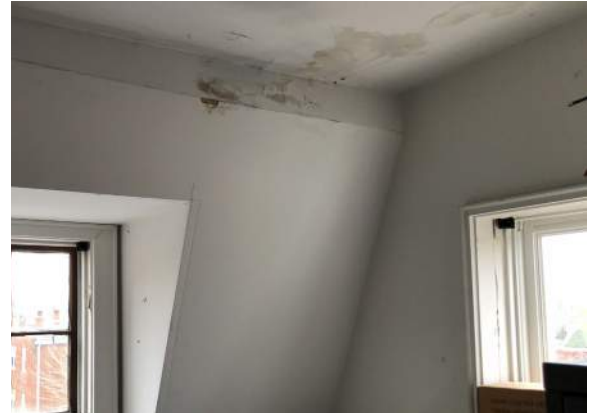
Figure 2D-8: Staining and bubbling of drywall finish in northeast corner of mansard roof within Office 403 in the South Block.

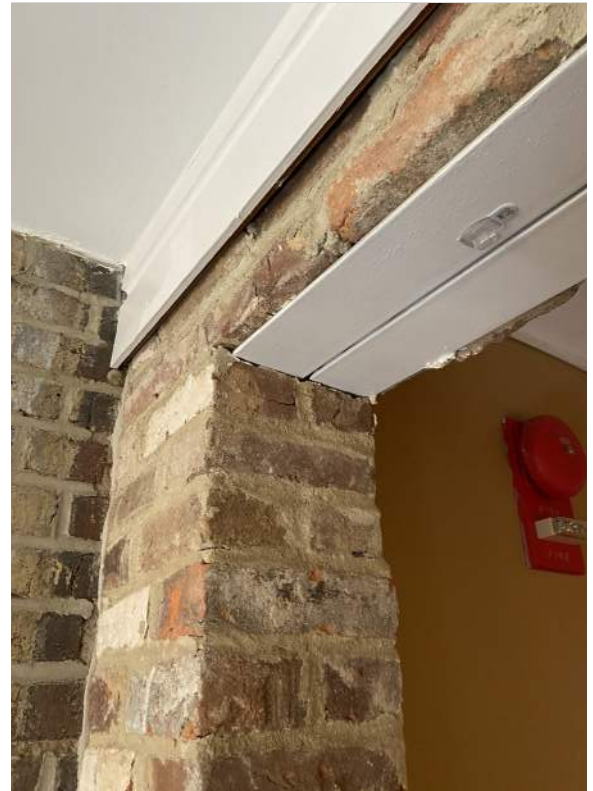
Figure 2D-9: Exposed lintel at corridor in front of elevator.

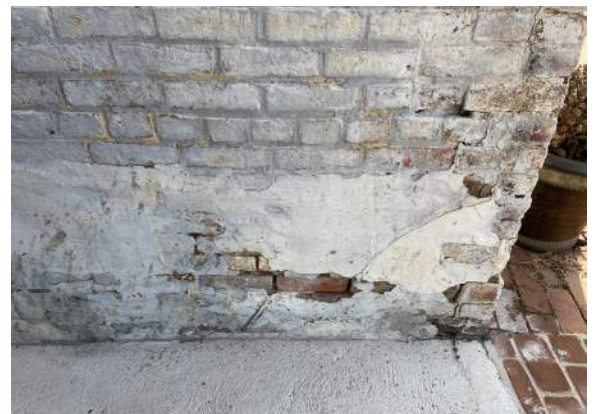
Figure 2D-10: Failed parge coat and mortar loss near grade at southwest corner of South Block

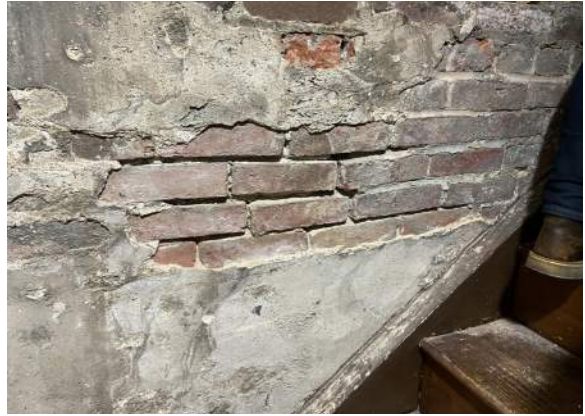
**Figure 2D-11:** Failing parge coat observed at east wall of Basement at Stair 1, located along west foundation wall.

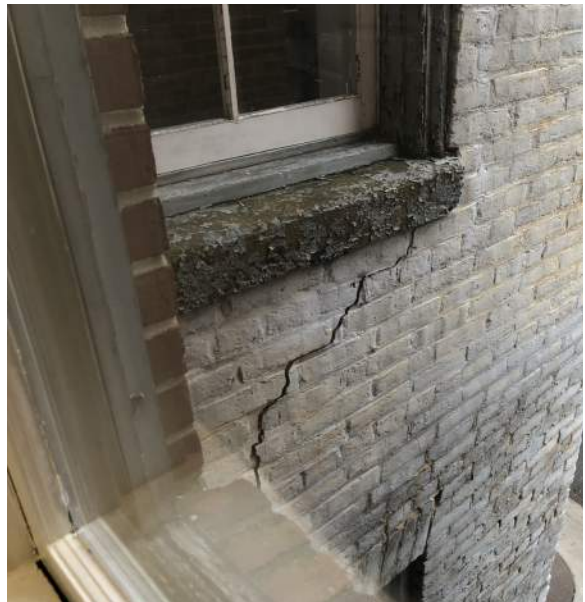
**Figure 2D-12:** Large crack at east return of North Elevation, located under masonry opening 219 of the North Block.

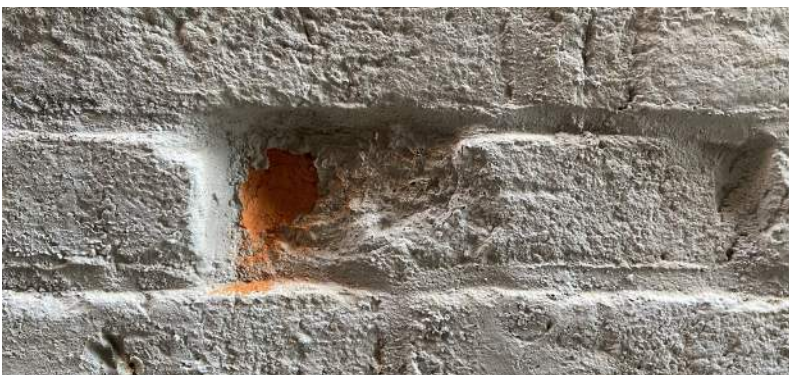
**Figure 2D-13:** Spalled brick face at west elevation.

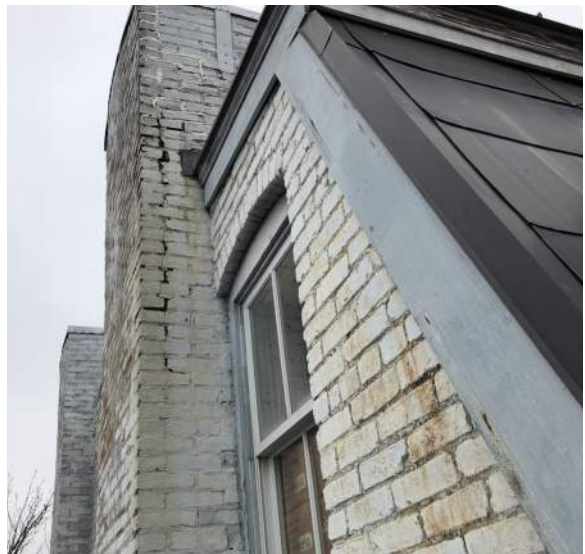
**Figure 2D-14:** Upper portion of east elevation of South Block; Note the poor condition of Chimney #2 and the prior repairs.

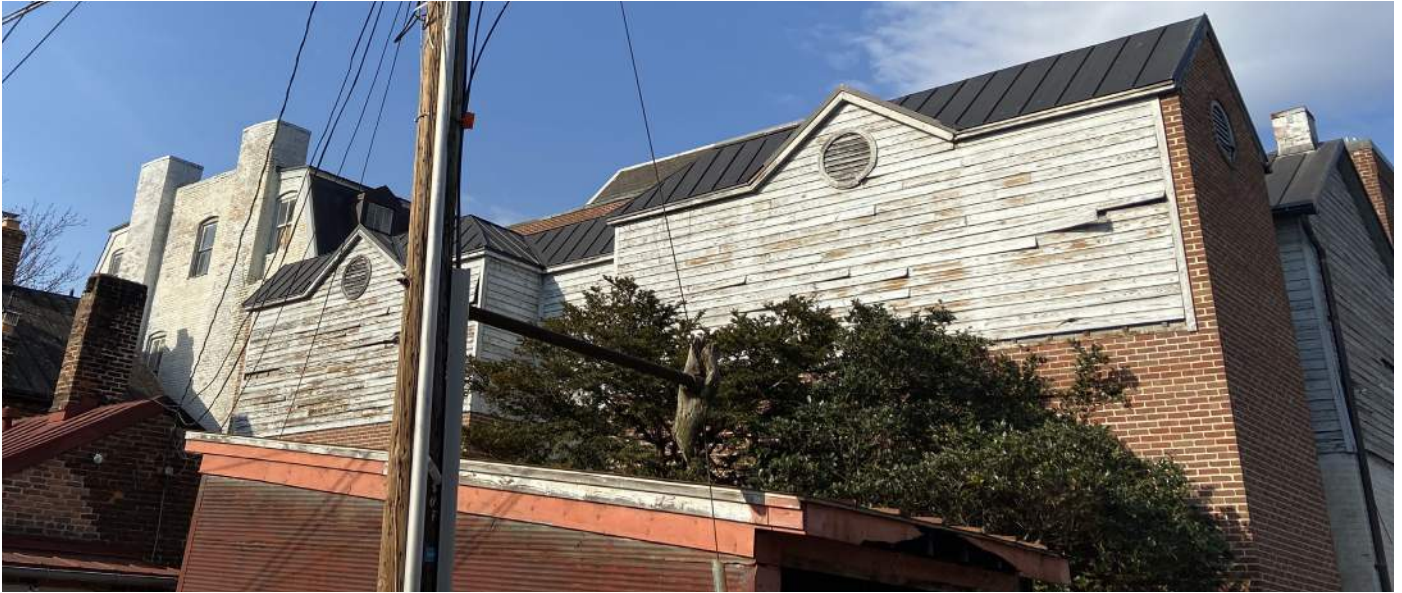
Figure 2D-15: Overall view of east elevation as seen from the rear alley.

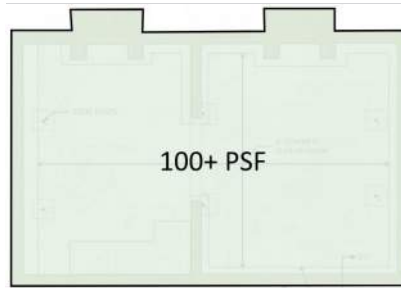
# LIVE LOAD CAPACITY DIAGRAMS

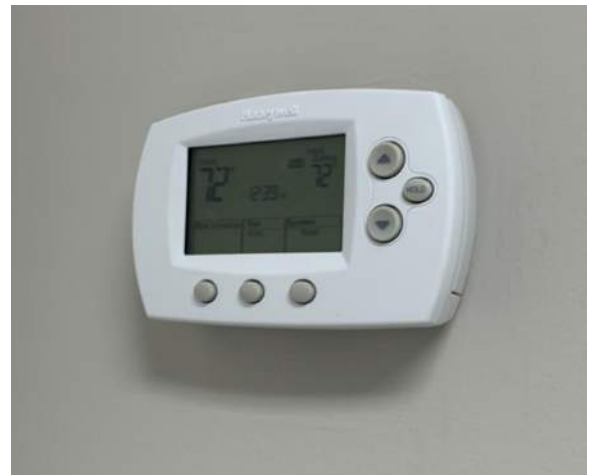
**Figure 2D-18:** Thermostat providing temperature control to air conditioning unit

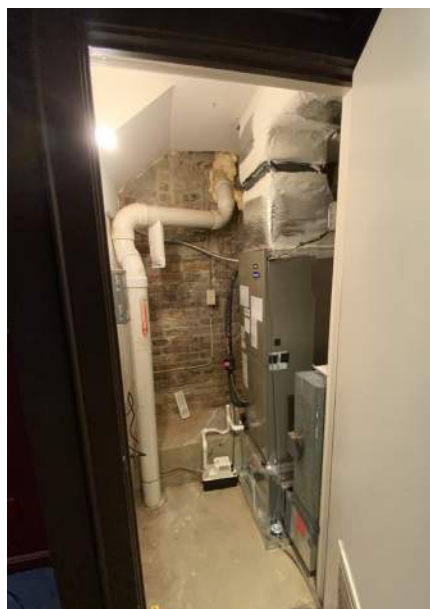
**Figure 2D-19:** AHU-1 with condensate return pump located in basement mechanical closet

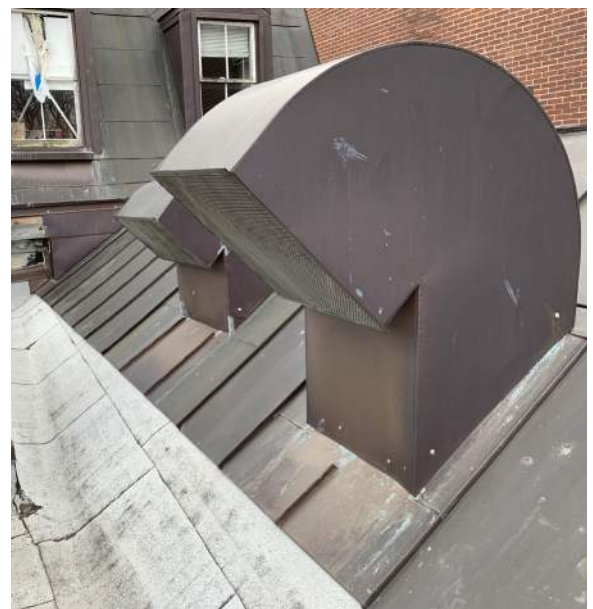
**Figure 2D-20** Air intake and toilet exhaust

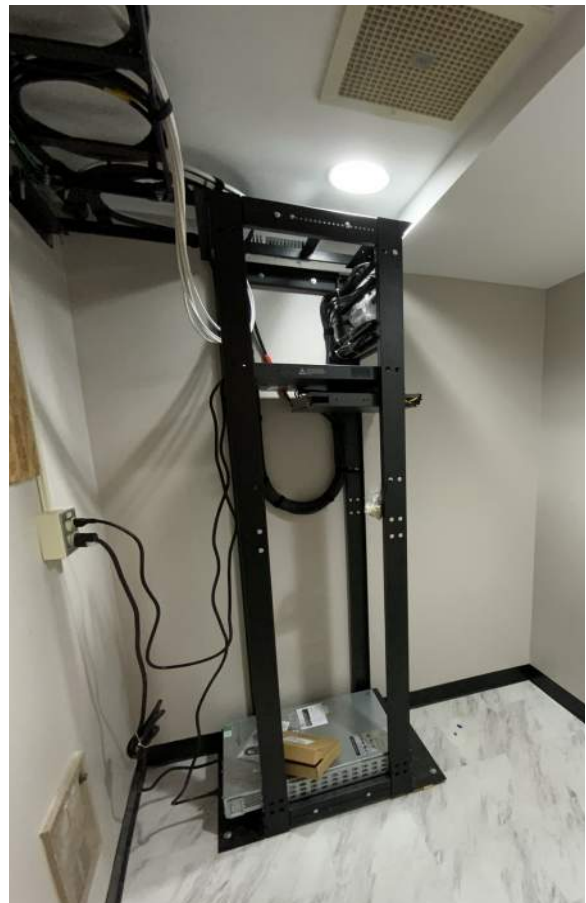
**Figure 2D-21:** Former restroom converted into Server Room.

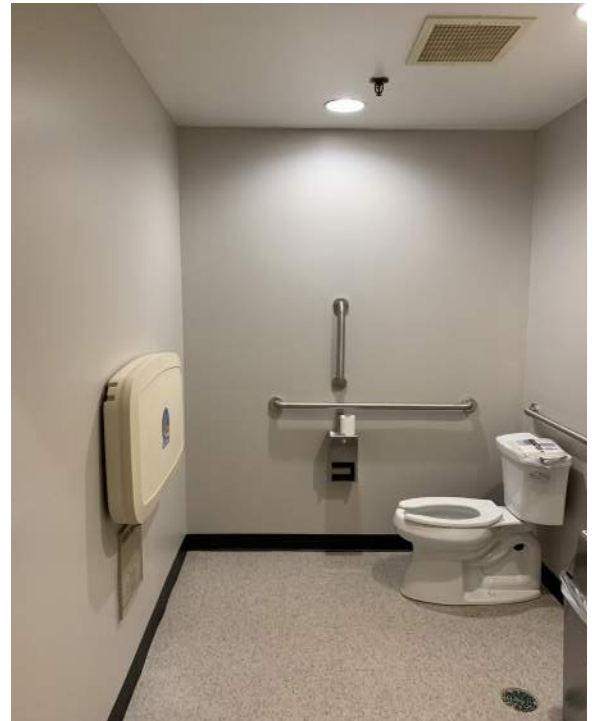
Figure 2D-22: Restroom 106 located on the first floor.

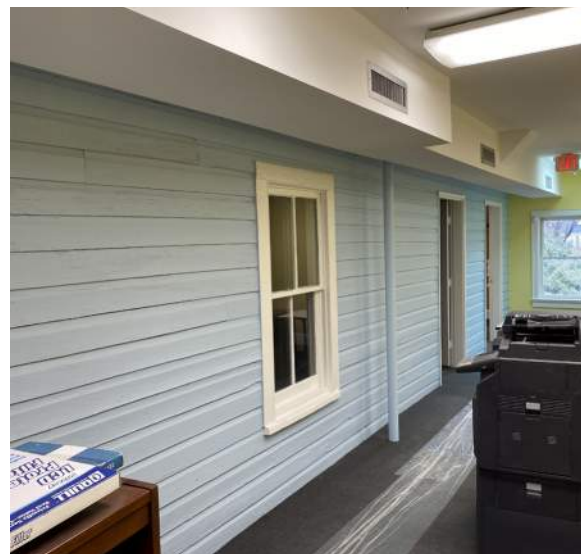
Figure 2D-30: Historic wood cladding on third floor wall at Central Passage and North Block.

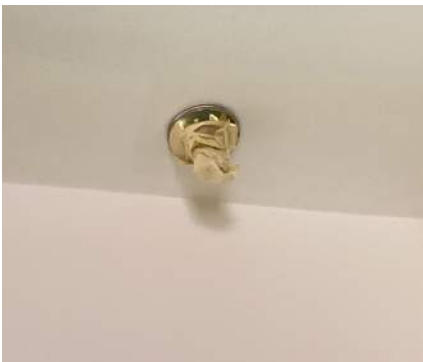
Figure 2D-33: Sprinkler head covered by masking tape.

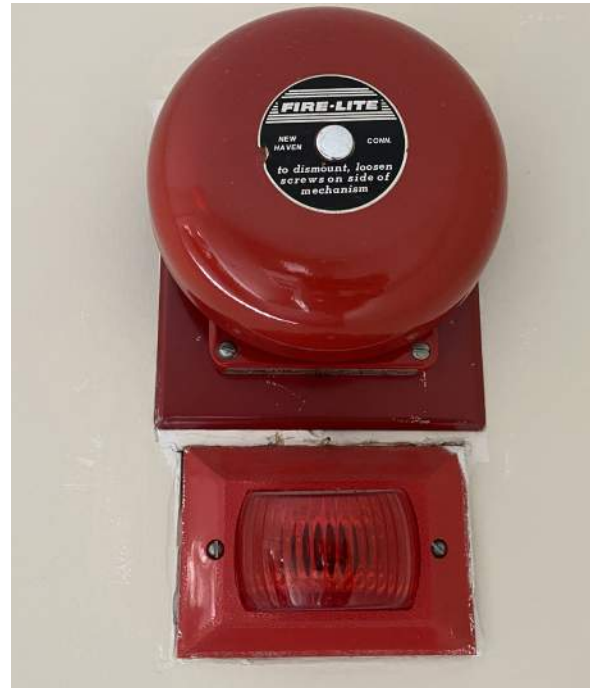
Figure 2D-36: Fire alarm audible bells and non-ADA compliant flashers.

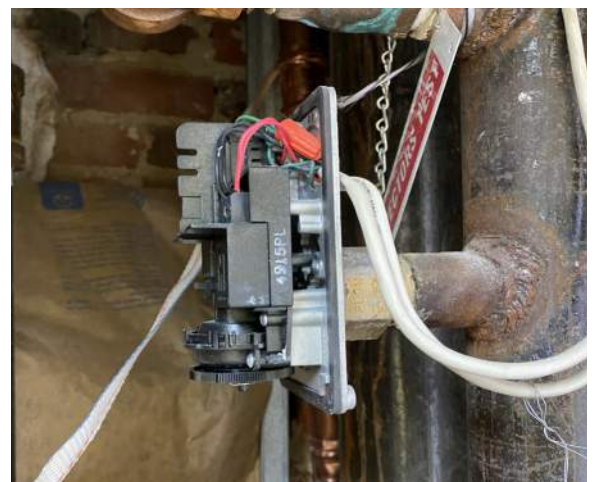
Figure 2D-39: Cover plate missing on water flow switch.

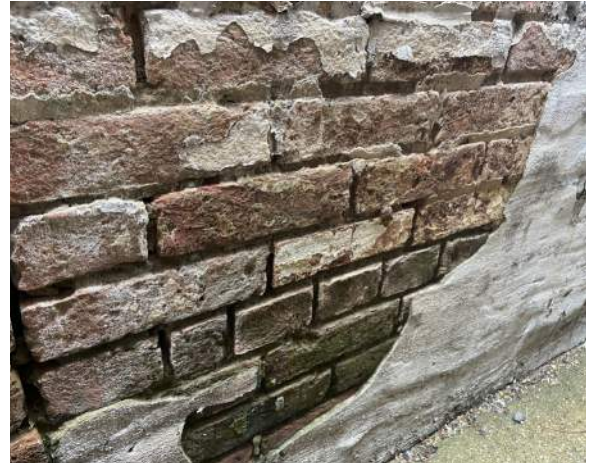
Figure 2E-1: Missing mortar in west alley near grade.

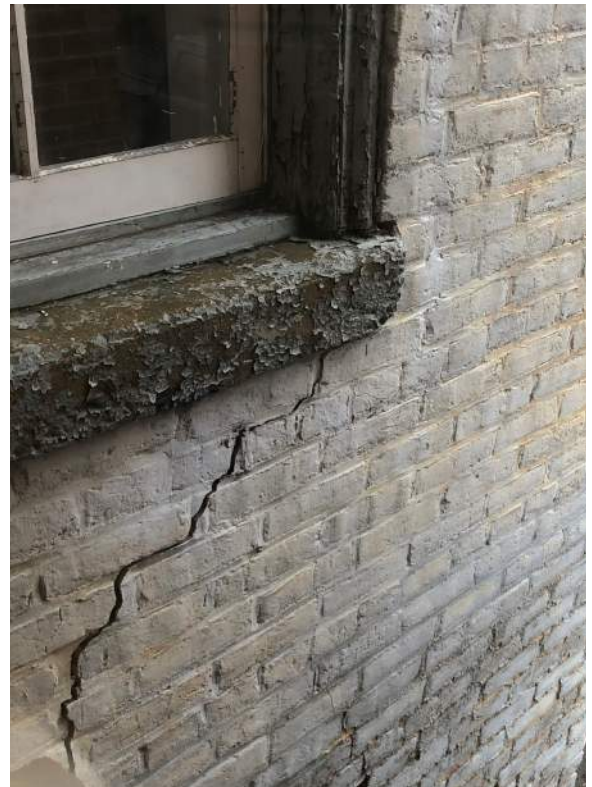
Figure 2E-2: Crack in brick masonry near rear entrance to building.

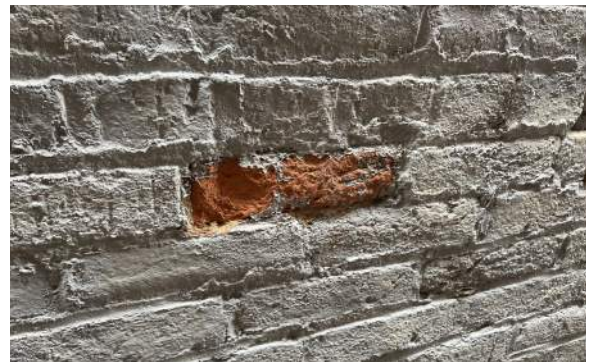
Figure 2E-3: Spall in brick masonry unit.

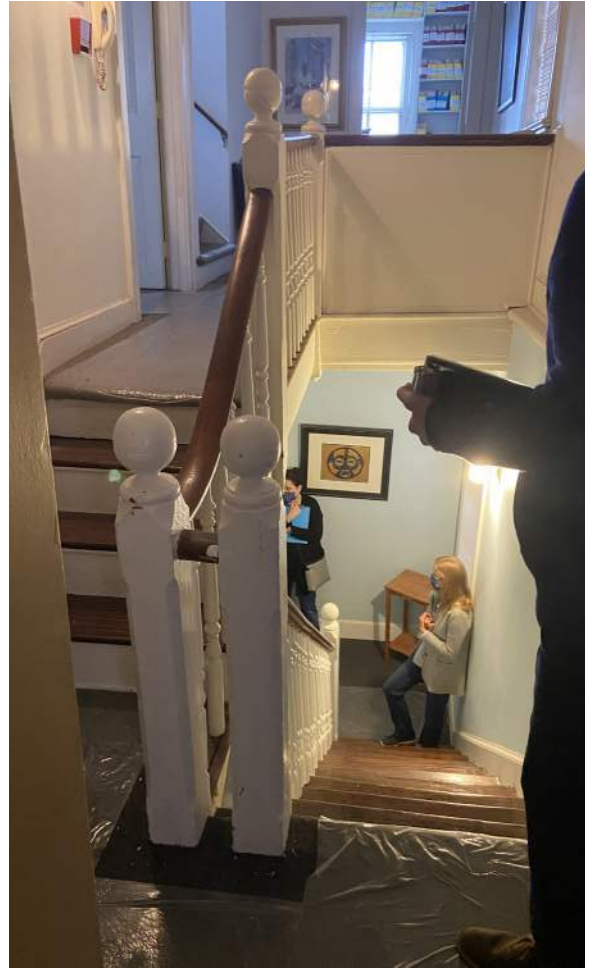
Figure 2E-4: Stair 1 deformation

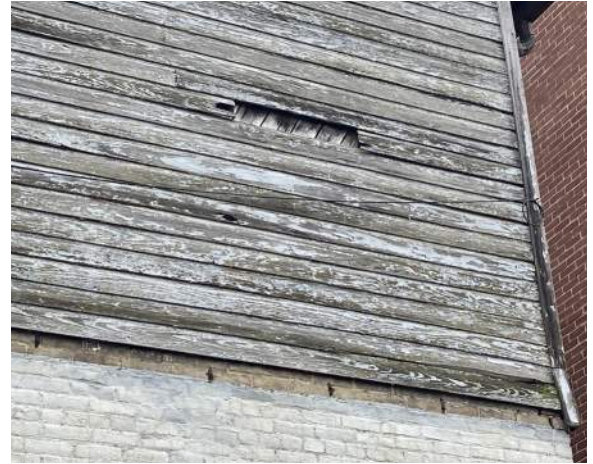
Figure 2E-6: Sheathing and siding damage at historic North Block (Period 4B).

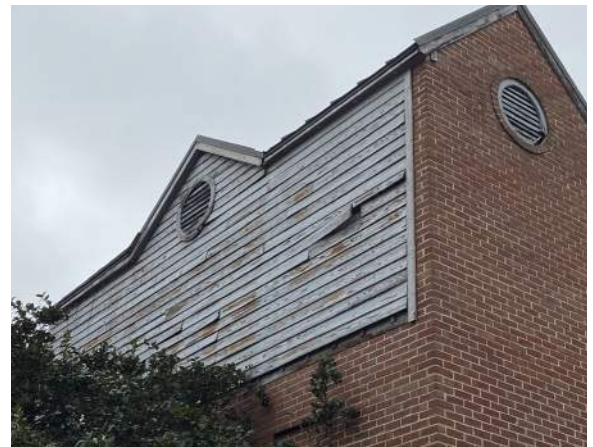
Figure 2E-7: Sheathing and siding damage at 1985 Addition (Period 5).

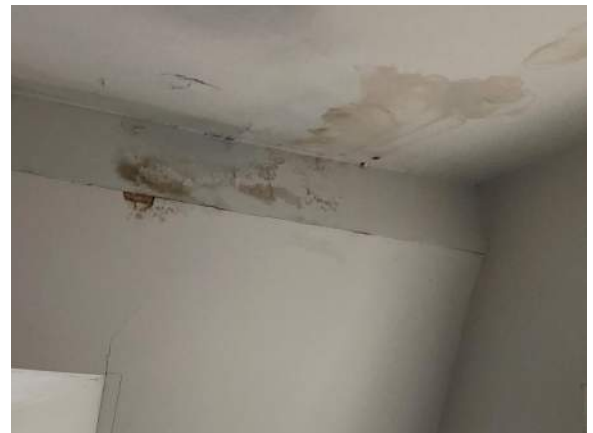
Figure 2E-8: Water damage at ceiling in Office 403 on fourth floor/ mezzanine.

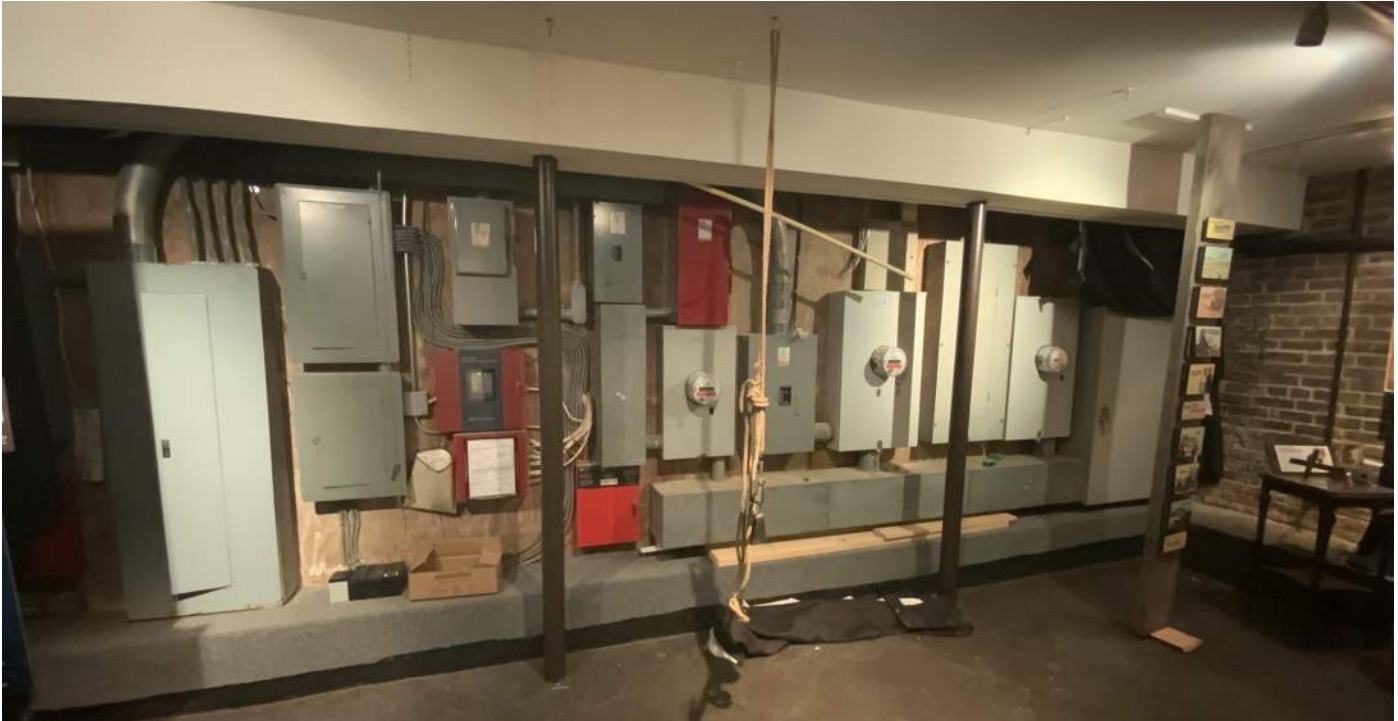
**Figure 2E-9:** Existing south wall of basement in South Block where the electrical service, panelboards, and other fire alarm and security devices are located.

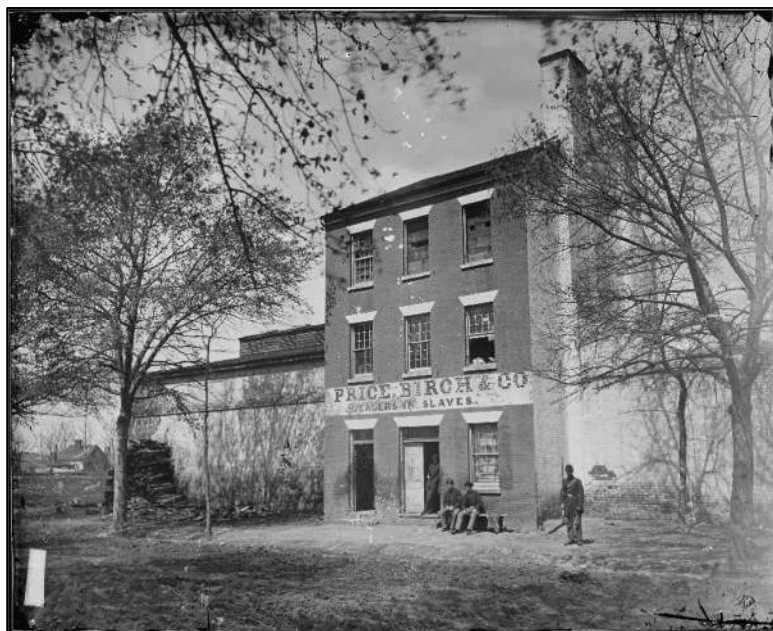
Figure 1: Front of "slave pen", Andrew J. Russell (or Mathew Brady), 1861<sup>11</sup>

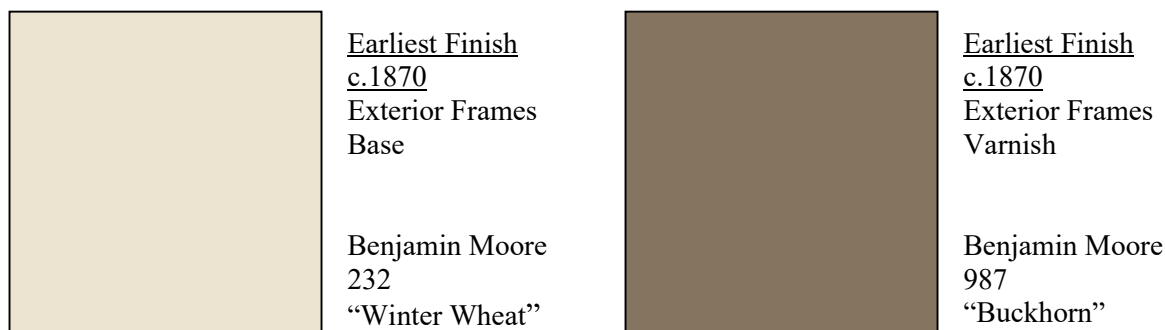
*This is not a paint. A translucent varnish should be matched to this color.*

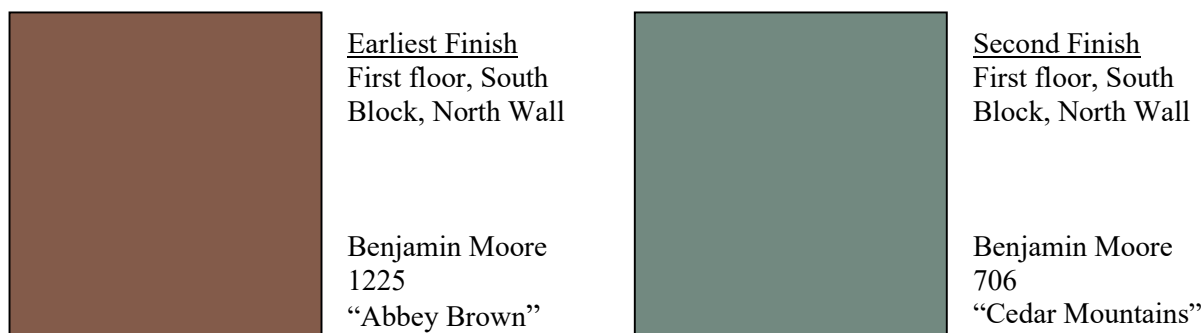
### *First Floor – East Wall*

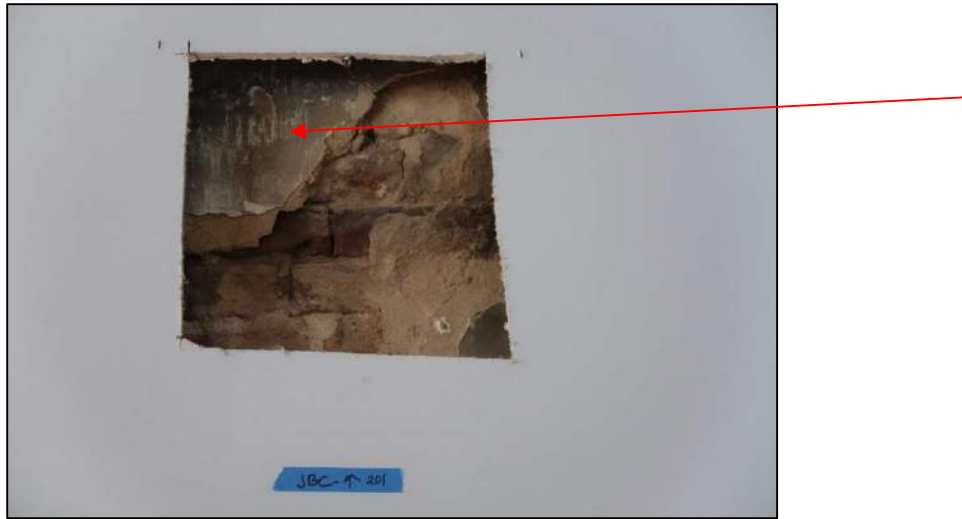
**Figure 4: Probe #6 at west wall of second floor, Sample PT-201.**

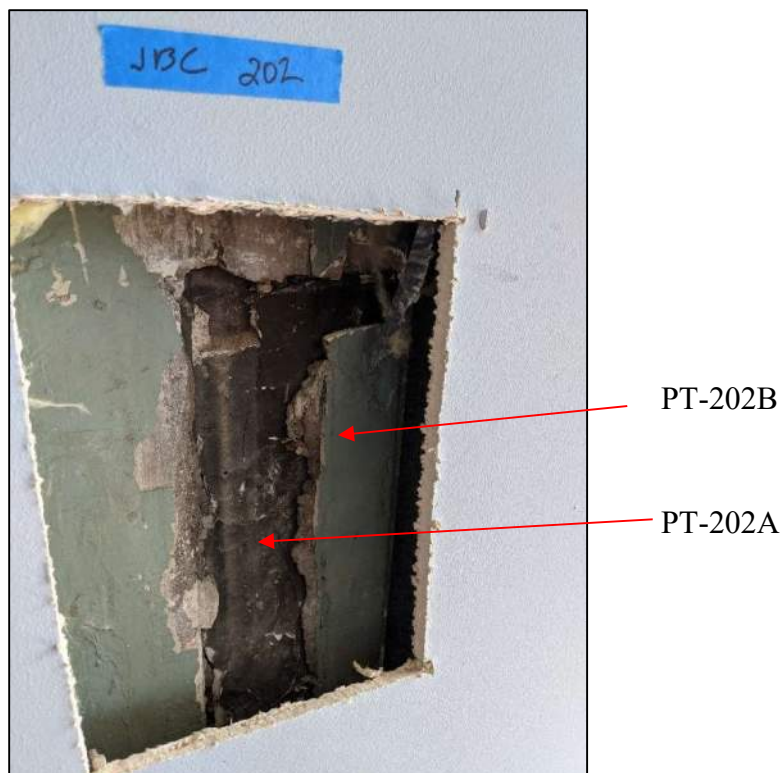
**Figure 5: Probe #5 at second floor fireplace.**

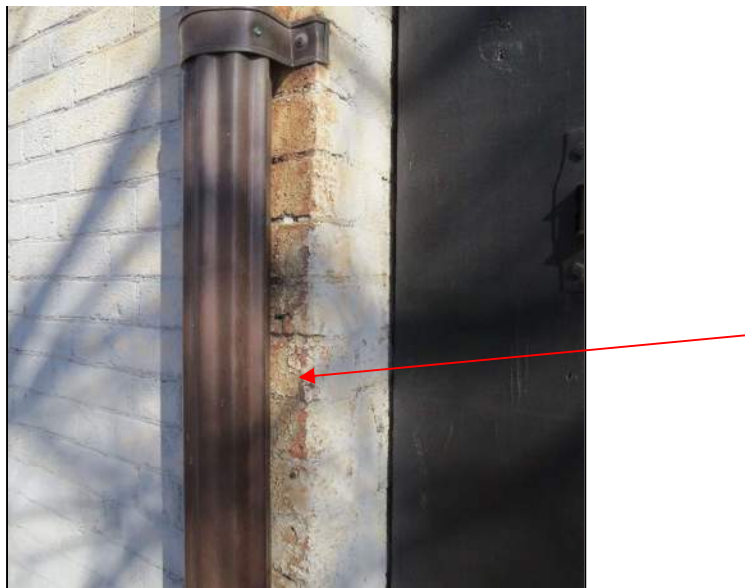
**Figure 7: Location of sample M-1.**

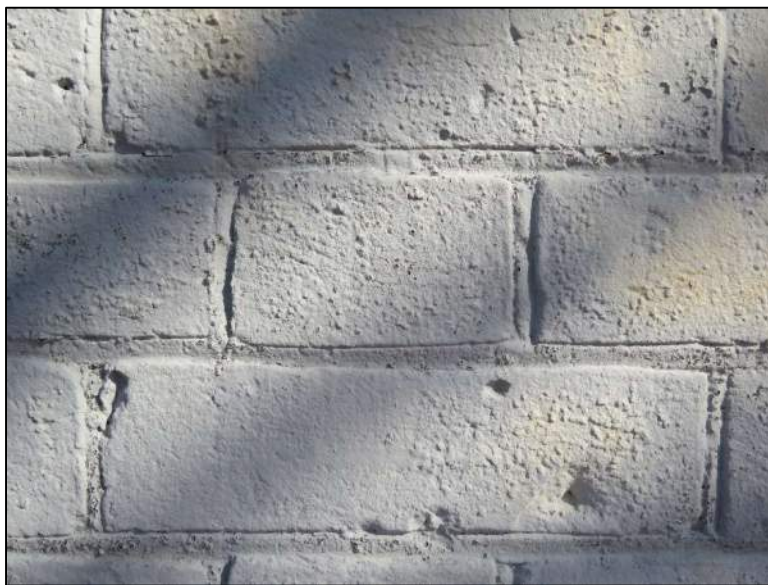
**Figure 10: Detail of south facade pointing. Note the struck joint profile.**

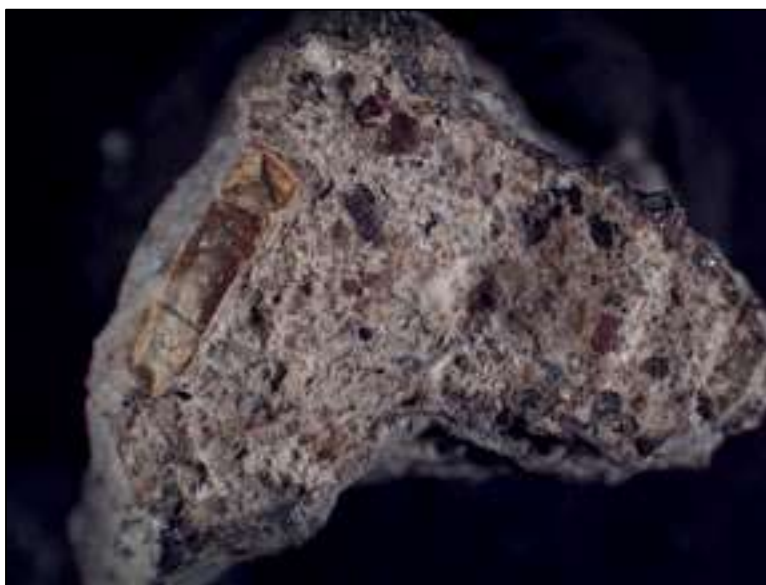
**Figure 16: Sample M-4 under simulated daylight illumination, 7.5x.**

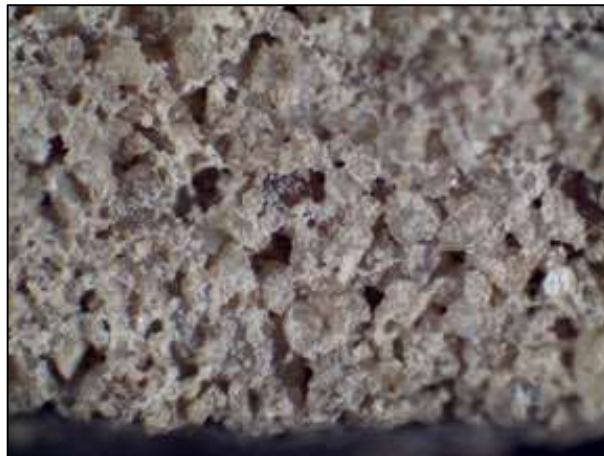
**Figure 33: Cross-section of Sample M-5, 20x.**

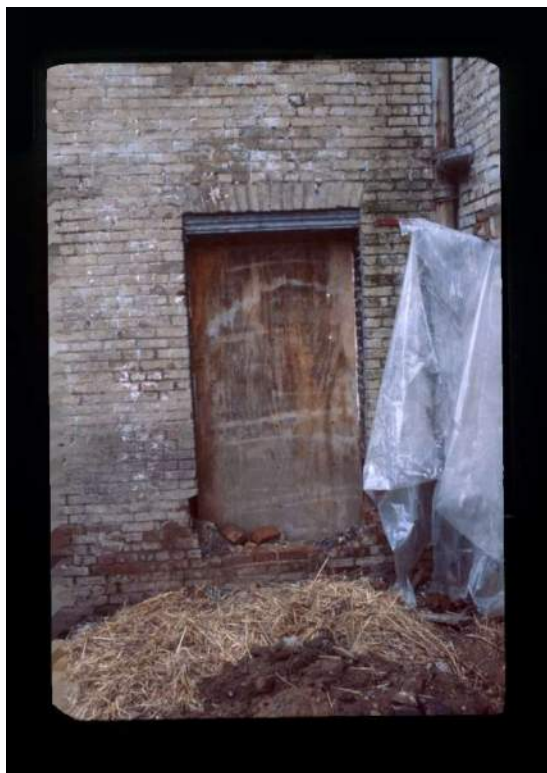
**Figure 34: Image of Window 105 c.1980.**

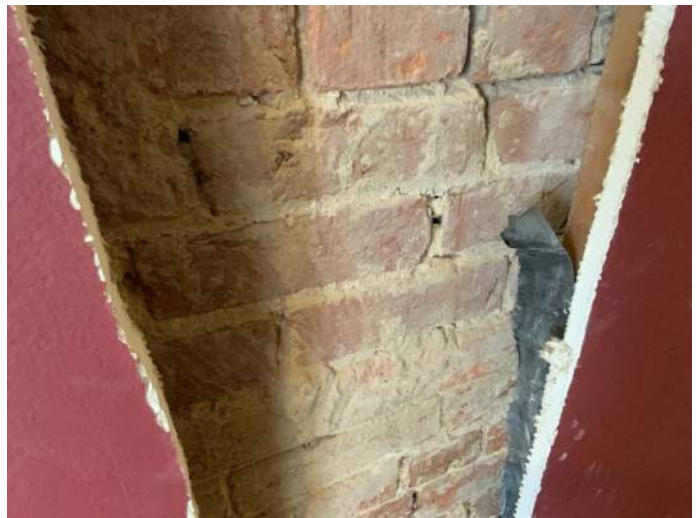
**Figure PR1-2:** One of two openings cut in existing drywall finish along west wall of Corridor 102. Existing wood stud framing found installed along historic brick masonry. A few cut nails were found within the mortar joints.

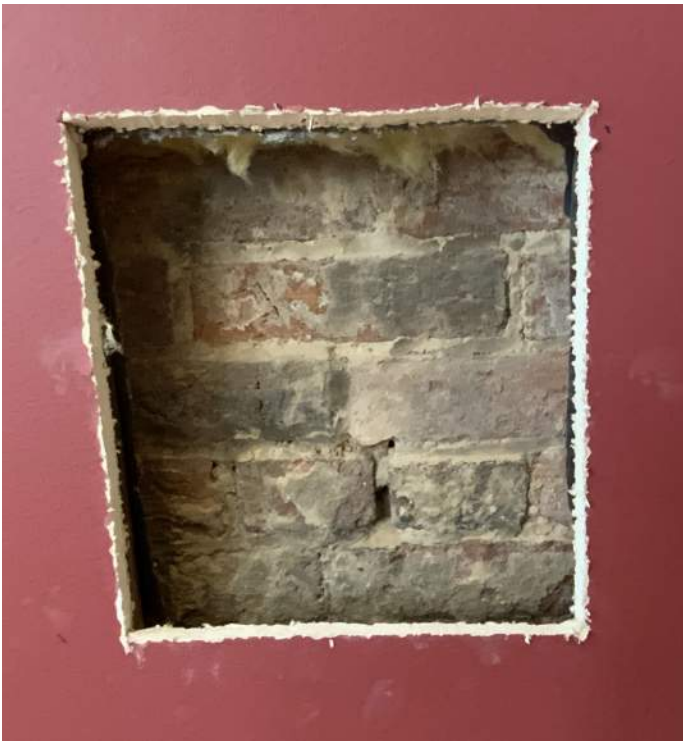
**Figure PR1-3:** One of two openings cut in existing drywall finish along west wall of Corridor 102.

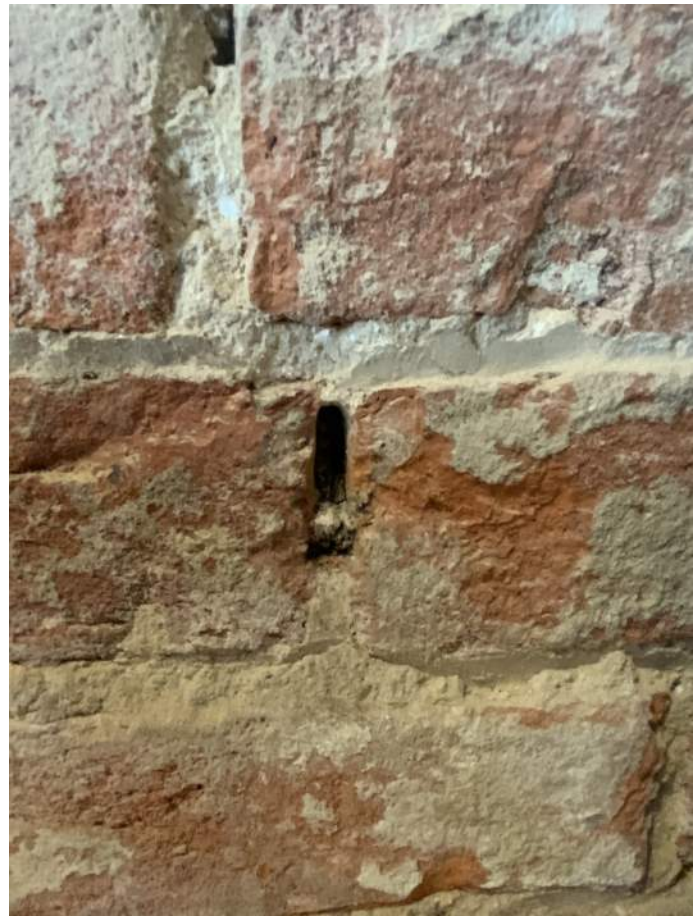
**Figure PR1-4:** Fragment of wood blocking found within the mortar joint.

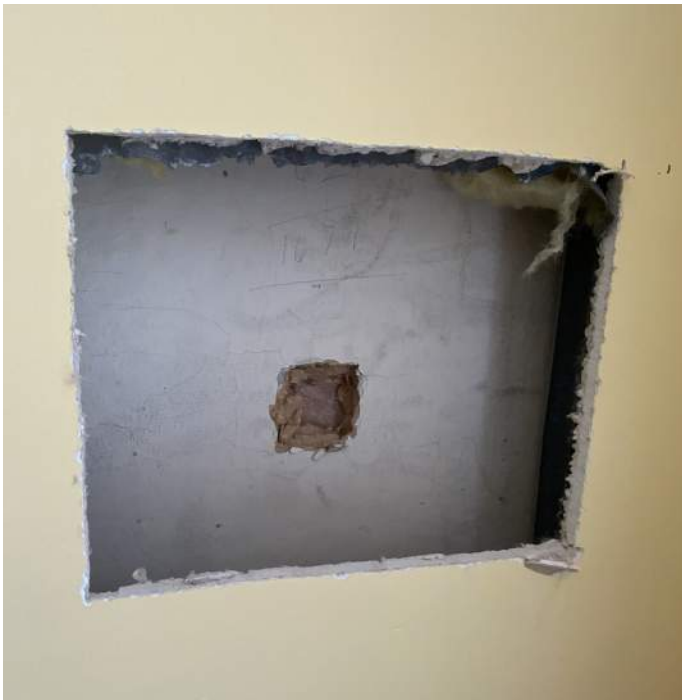
**Figure PR2-1:** Opening cut in existing drywall along east wall of Reception 103 just south of Chimney #1.

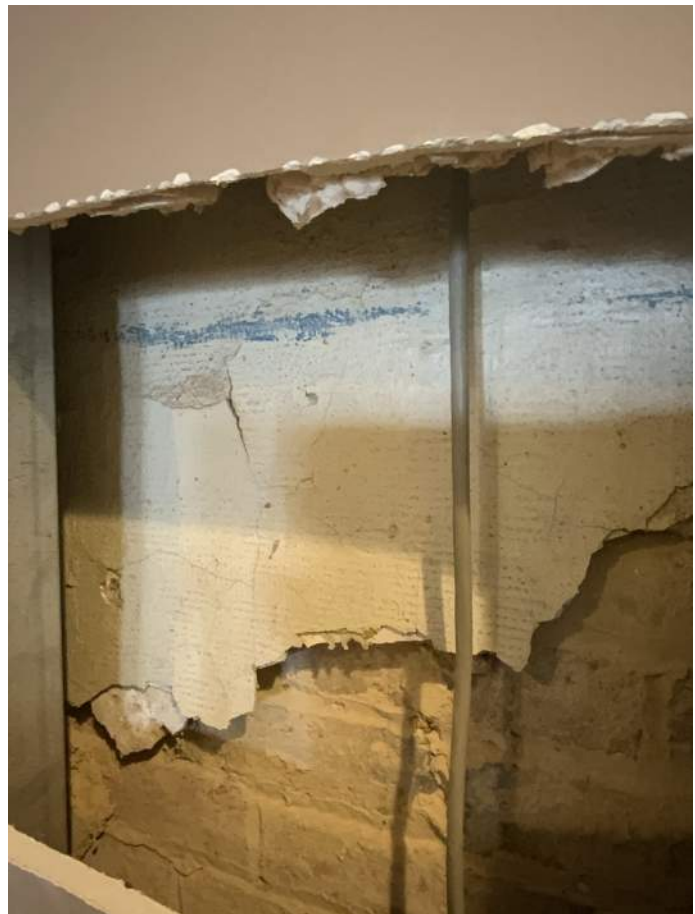
**Figure PR3-2:** Detail of historic 3-coat plaster found behind modern drywall finish.

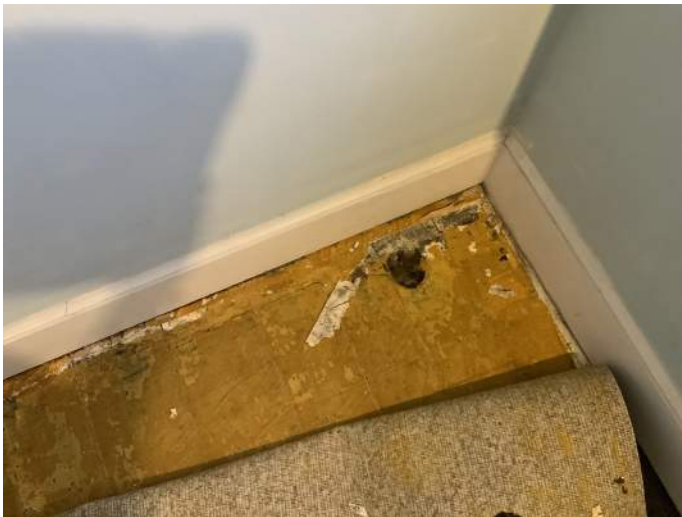
**Figure PR4-1:** Detail of historic wood flooring located under existing carpet .

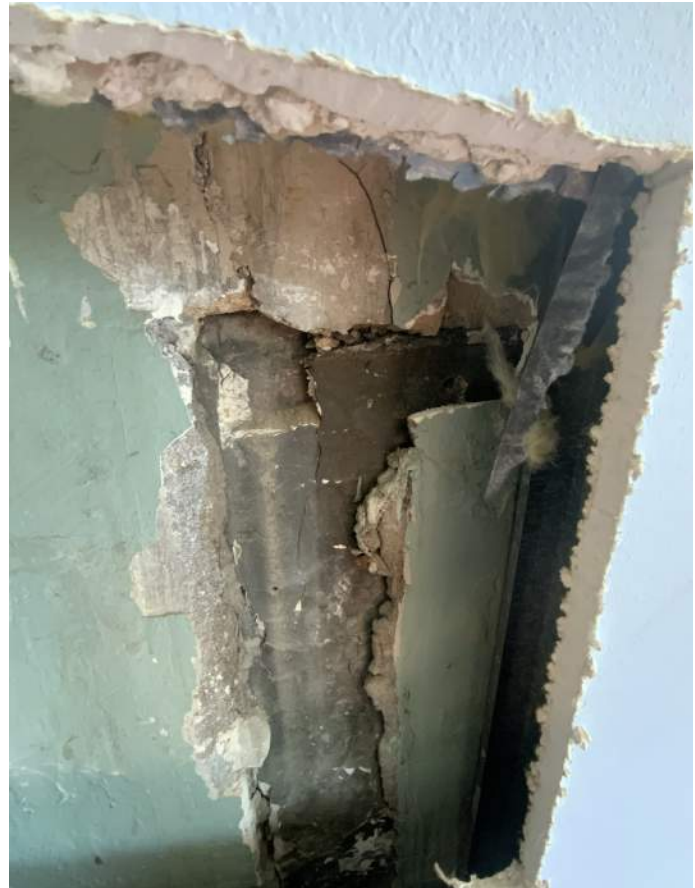
**Figure PR5-2:** Detail of historic plaster finishes found at investigative probe #5.

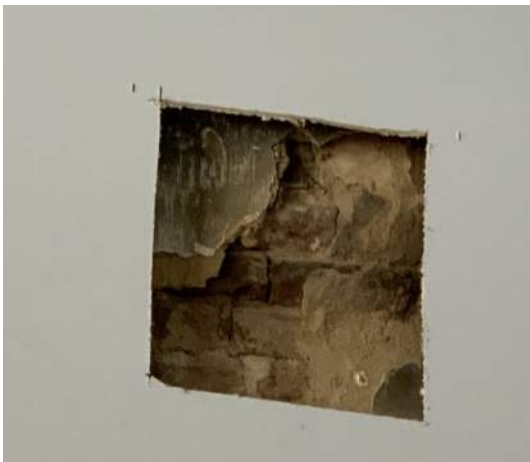
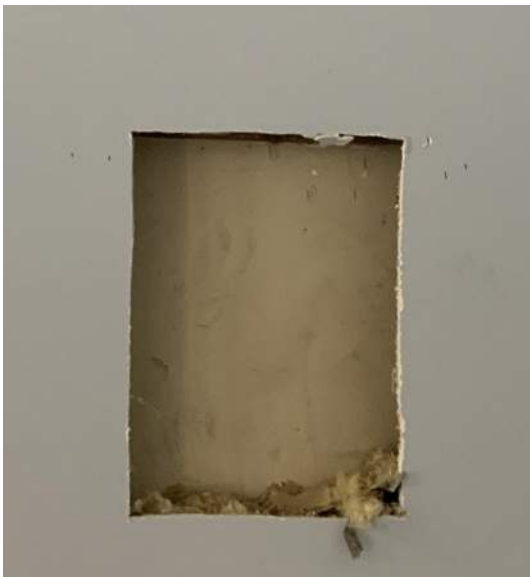
**Figure PR6-1:** Upper and lower openings cut in existing drywall along west elevation of Conference Room 201.

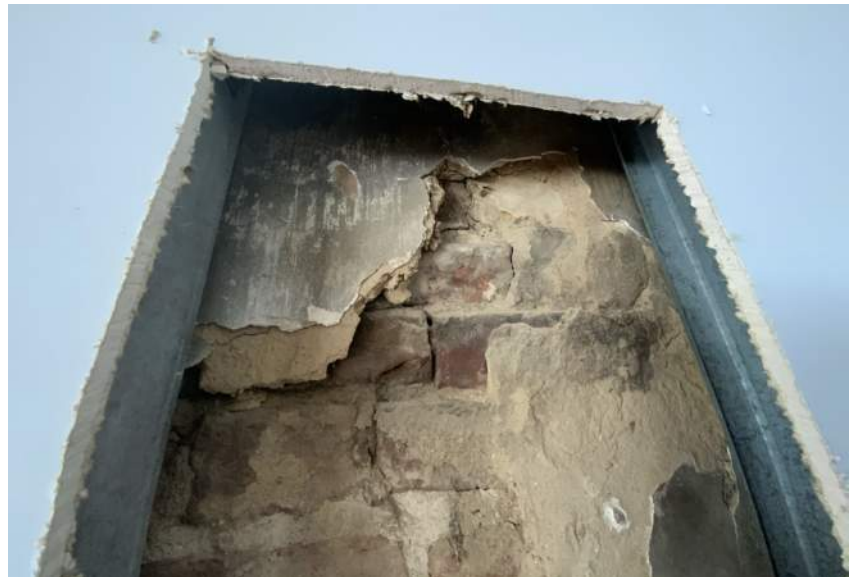
**Figure PR6-2:** Detail of historic plaster finishes found at investigative probe #6.

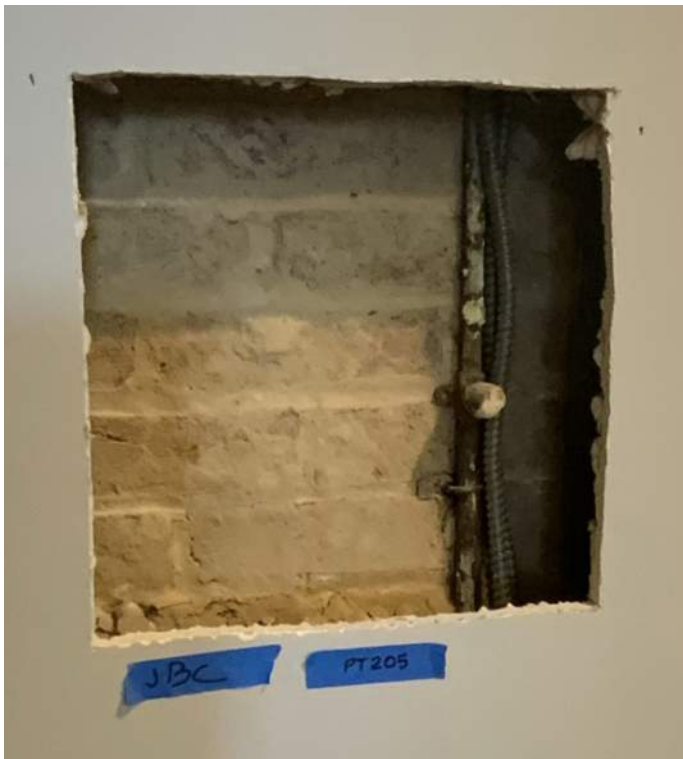
**Figure PR7-1:** Opening cut in existing drywall along north elevation of Office 203.

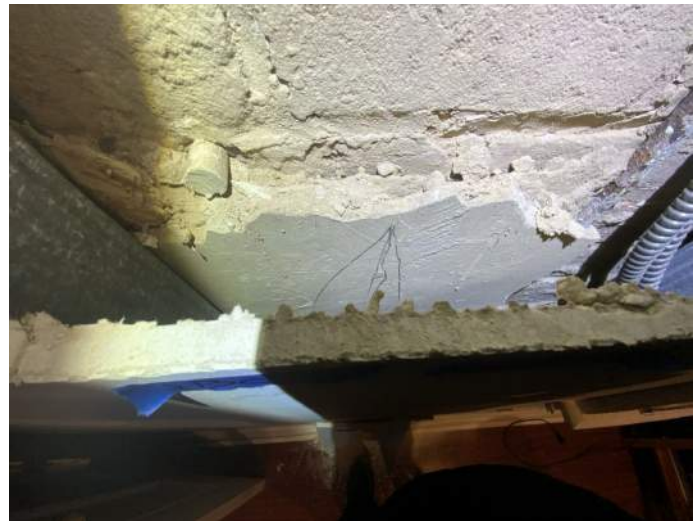
**Figure PR7-2:** Detail of historic plaster finishes found at investigative probe #7.
