City of Alexandria, Virginia - Department of Project Implementation

# 1315 DUKE STREET HISTORIC STRUCTURE REPORT

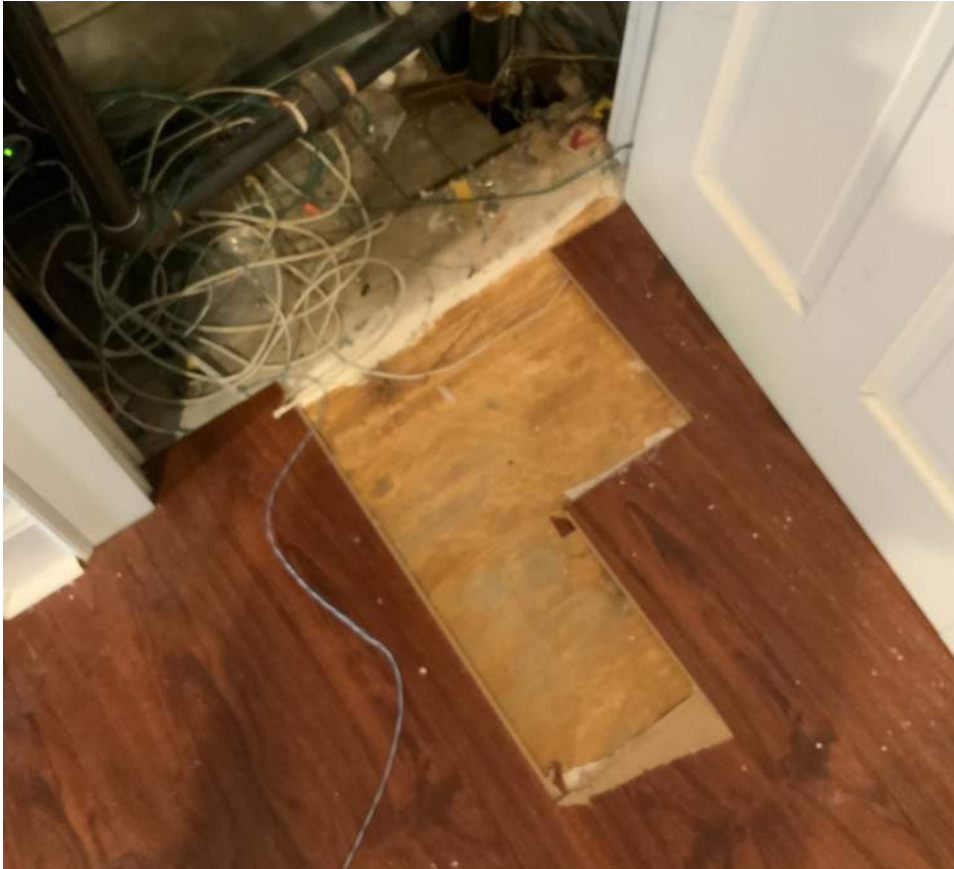
**Figure PR8-1:** Plywood subfloor uncovered beneath the existing laminate floor. The wood flooring in the adjacent mechanical closet may be original.

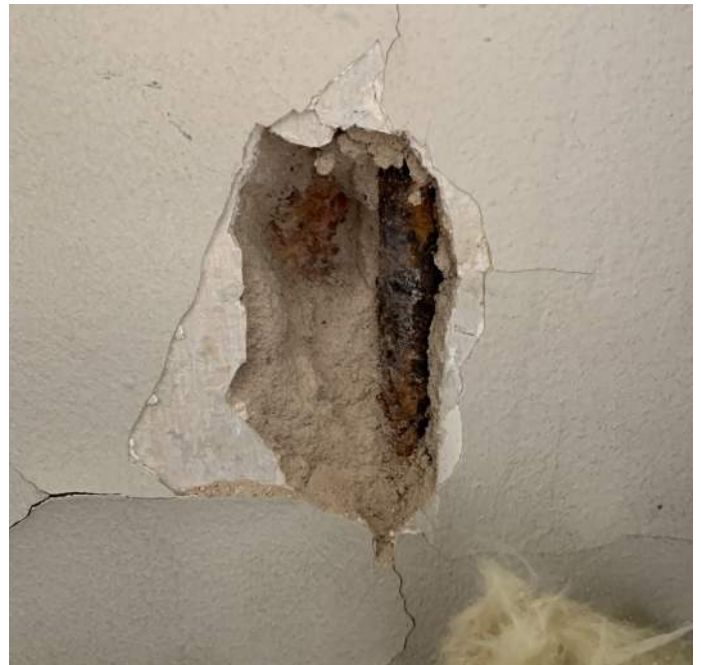
**Figure PR10-2:** Detail of historic plaster finishes found at investigative probe #10.

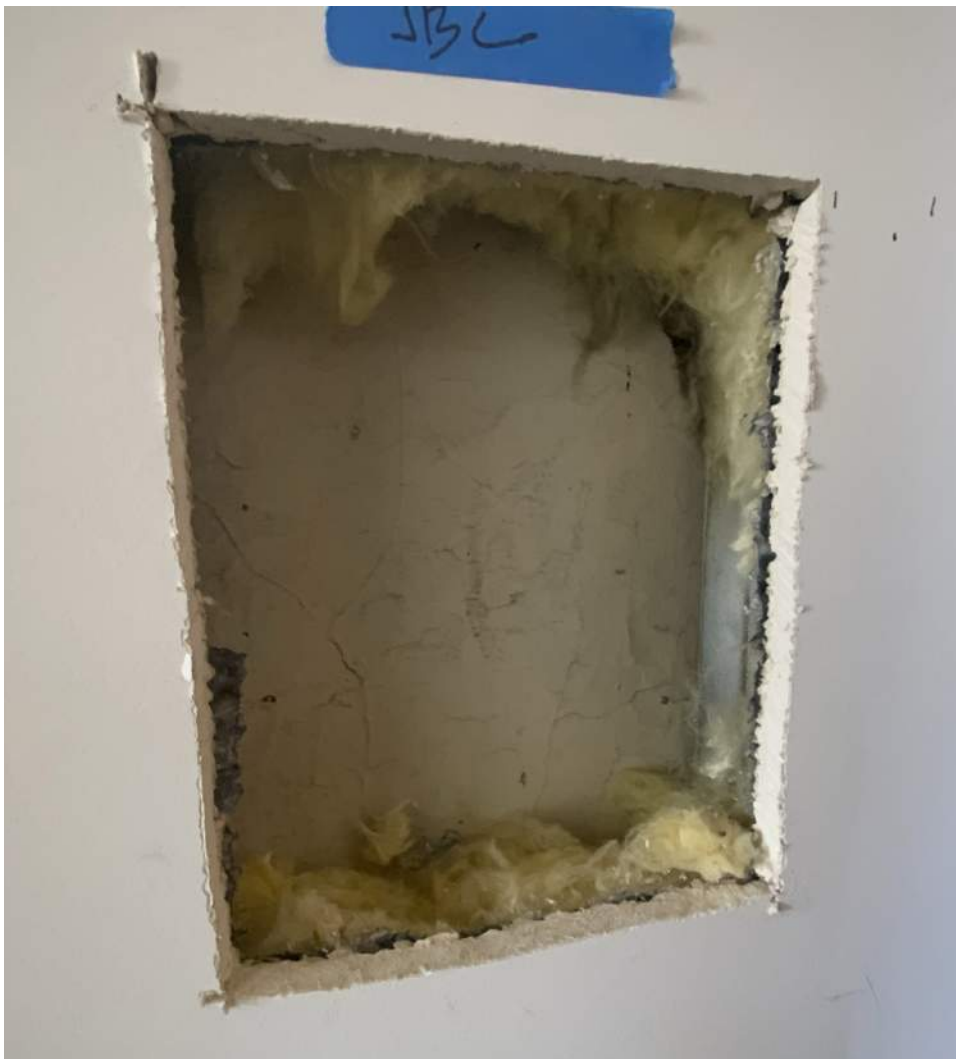
**Figure PR11-1:** Opening cut in existing drywall along the west wall of Corridor 303.

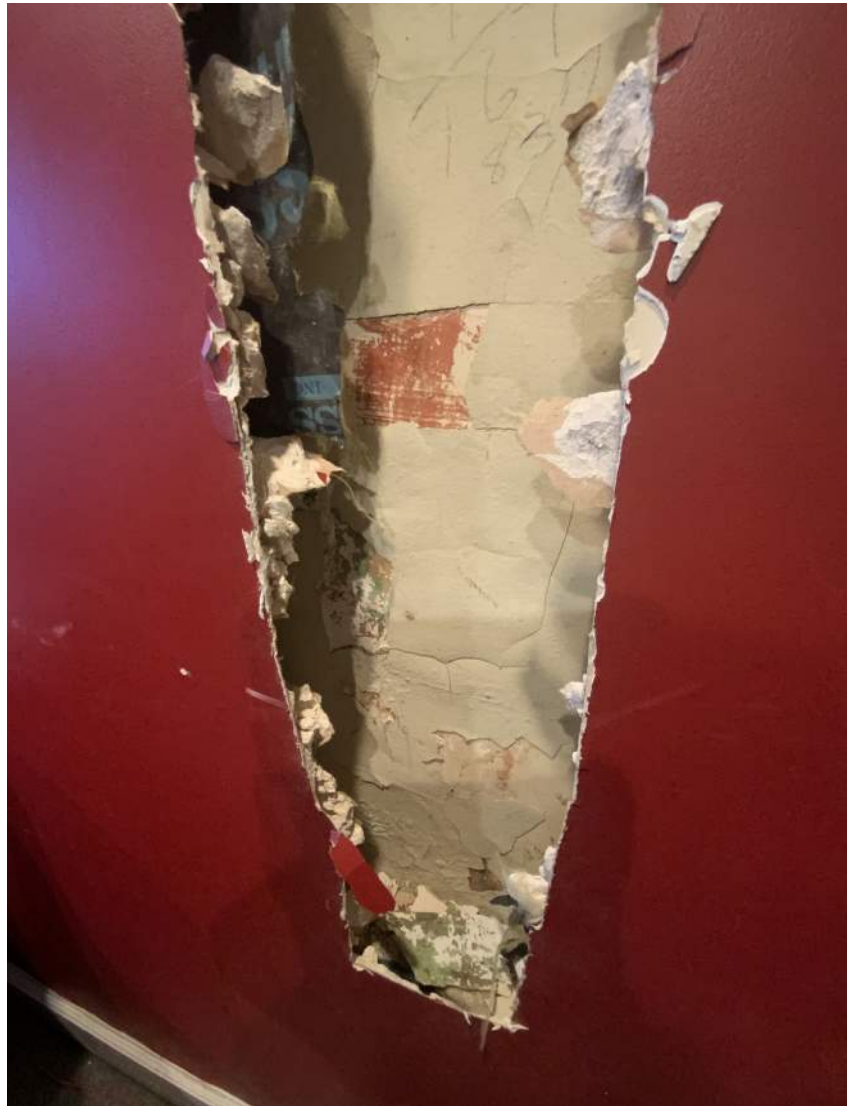
**Figure PR12-2:** Detail of historic plaster finishes found at investigative probe #12.

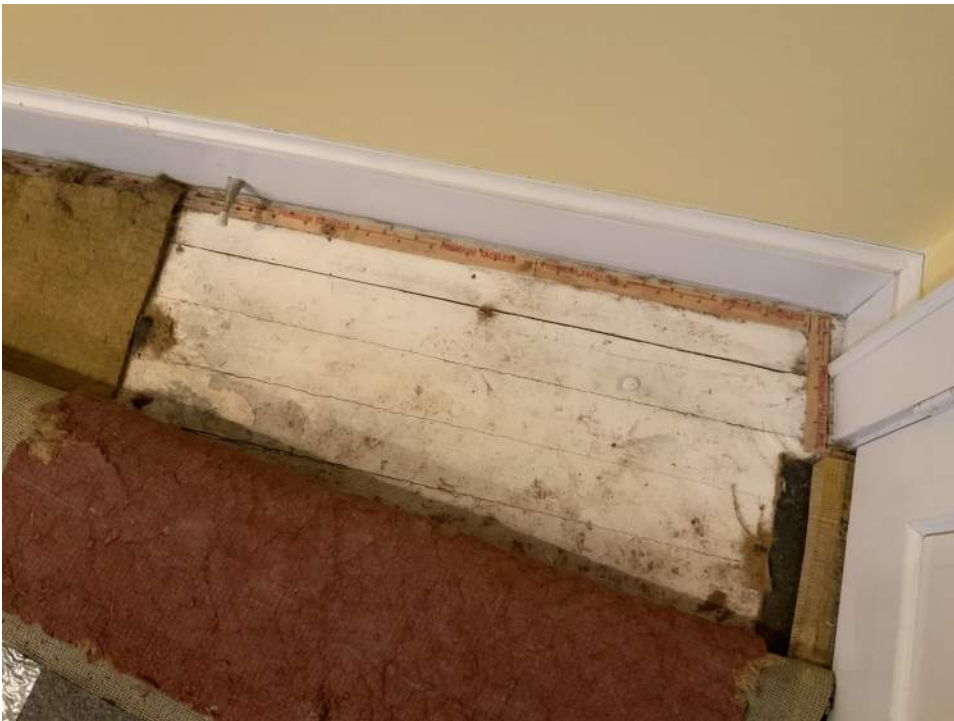
Figure PR13-1: Detail of historic wood flooring located under existing carpet .

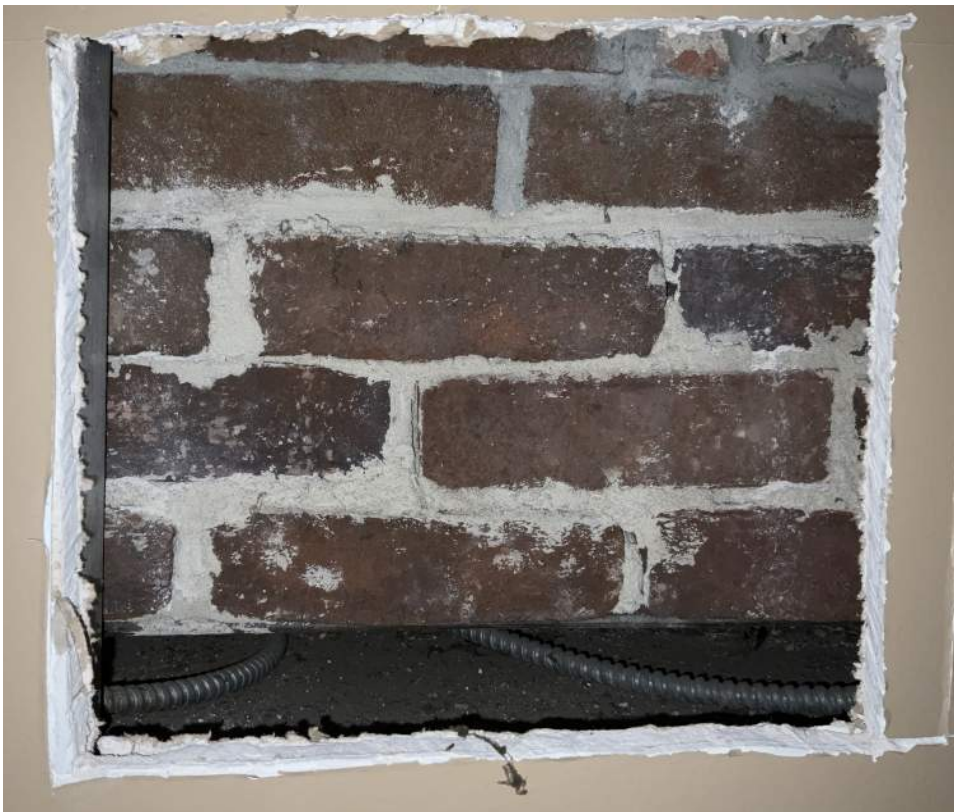
**Figure PR14-1:** Opening cut in existing drywall along the south wall of Corridor 305A above masonry opening 308.

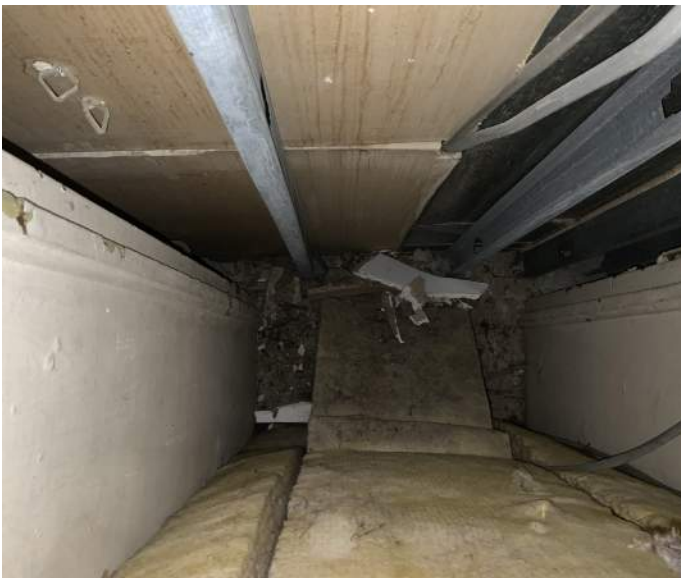
**Figure PR15-1:** Prior door opening located within in the north wall of the South Block.

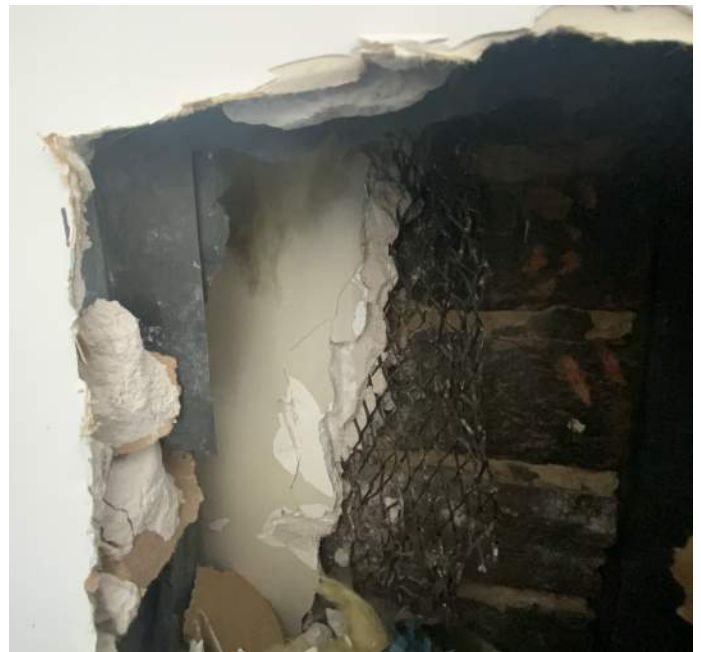
**Figure PR18-2:** Detail of historic plaster finishes found at investigative probe #18.

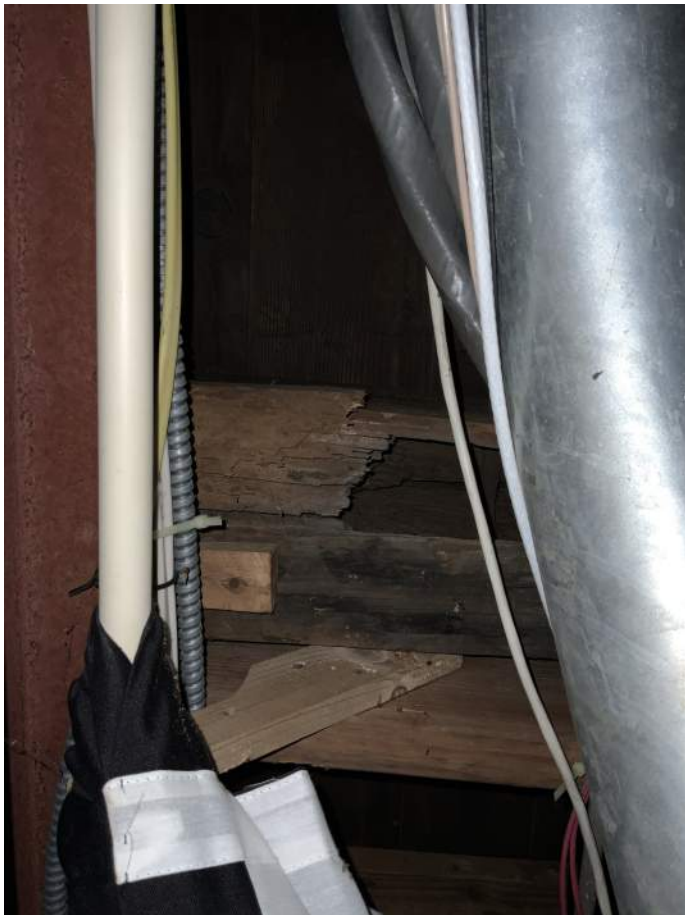
**Figure PR19-1:** Evidence of significant wood rot and deterioration at the bearing end of historic floor joists.

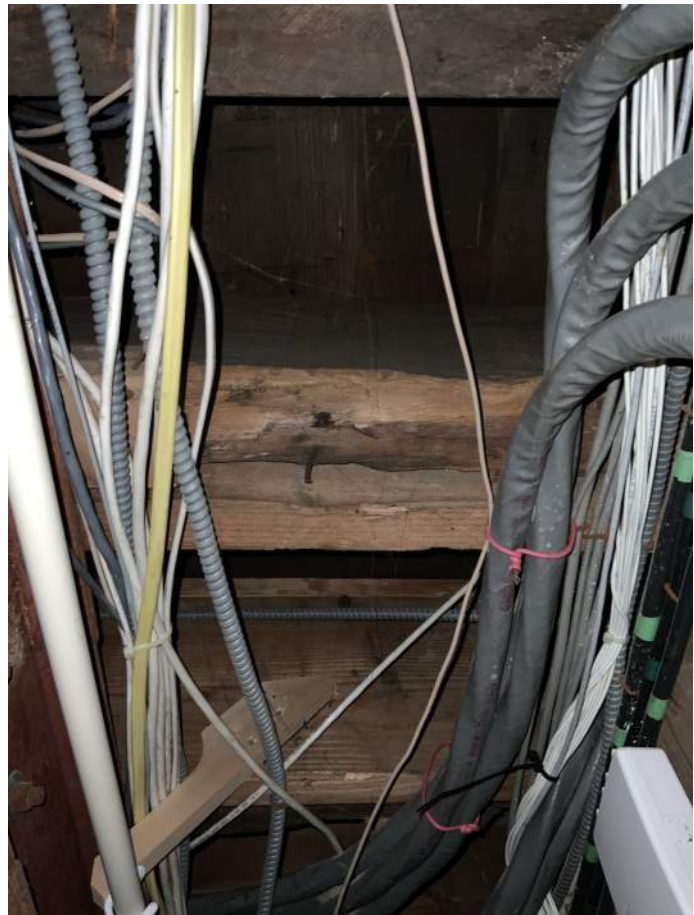
**Figure PR19-2:** Evidence of significant wood rot and deterioration at the bearing end of historic floor joists.

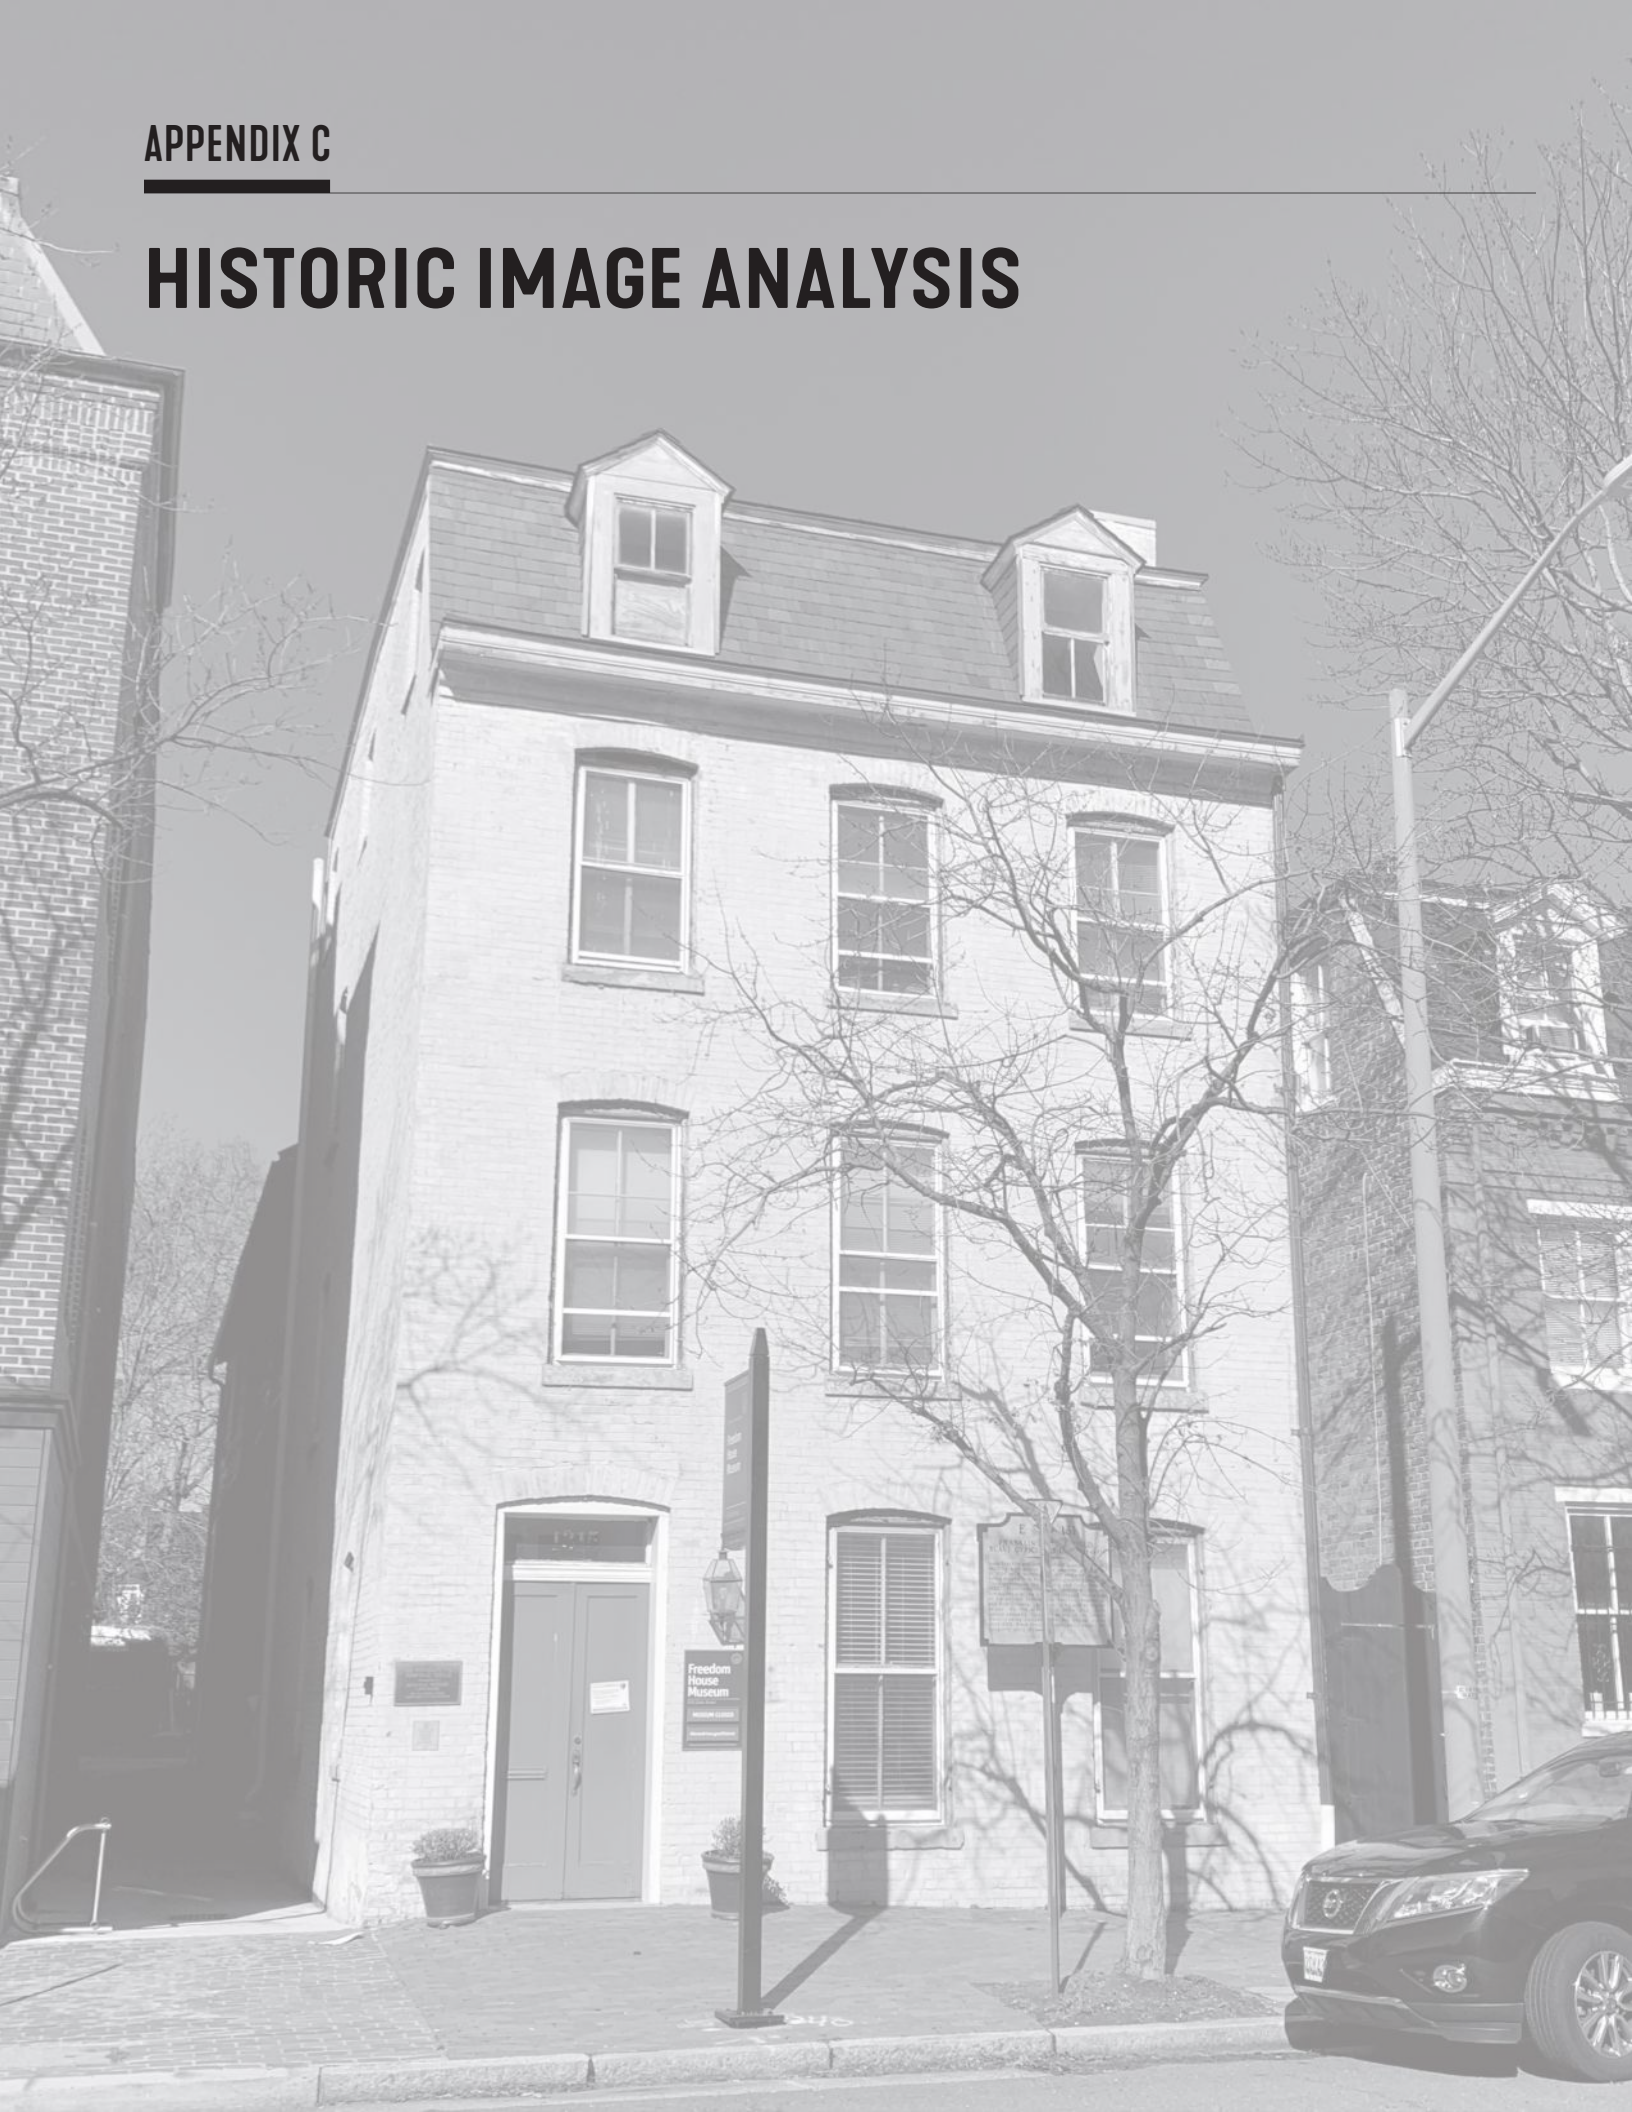
*This page has been left blank intentionally.*

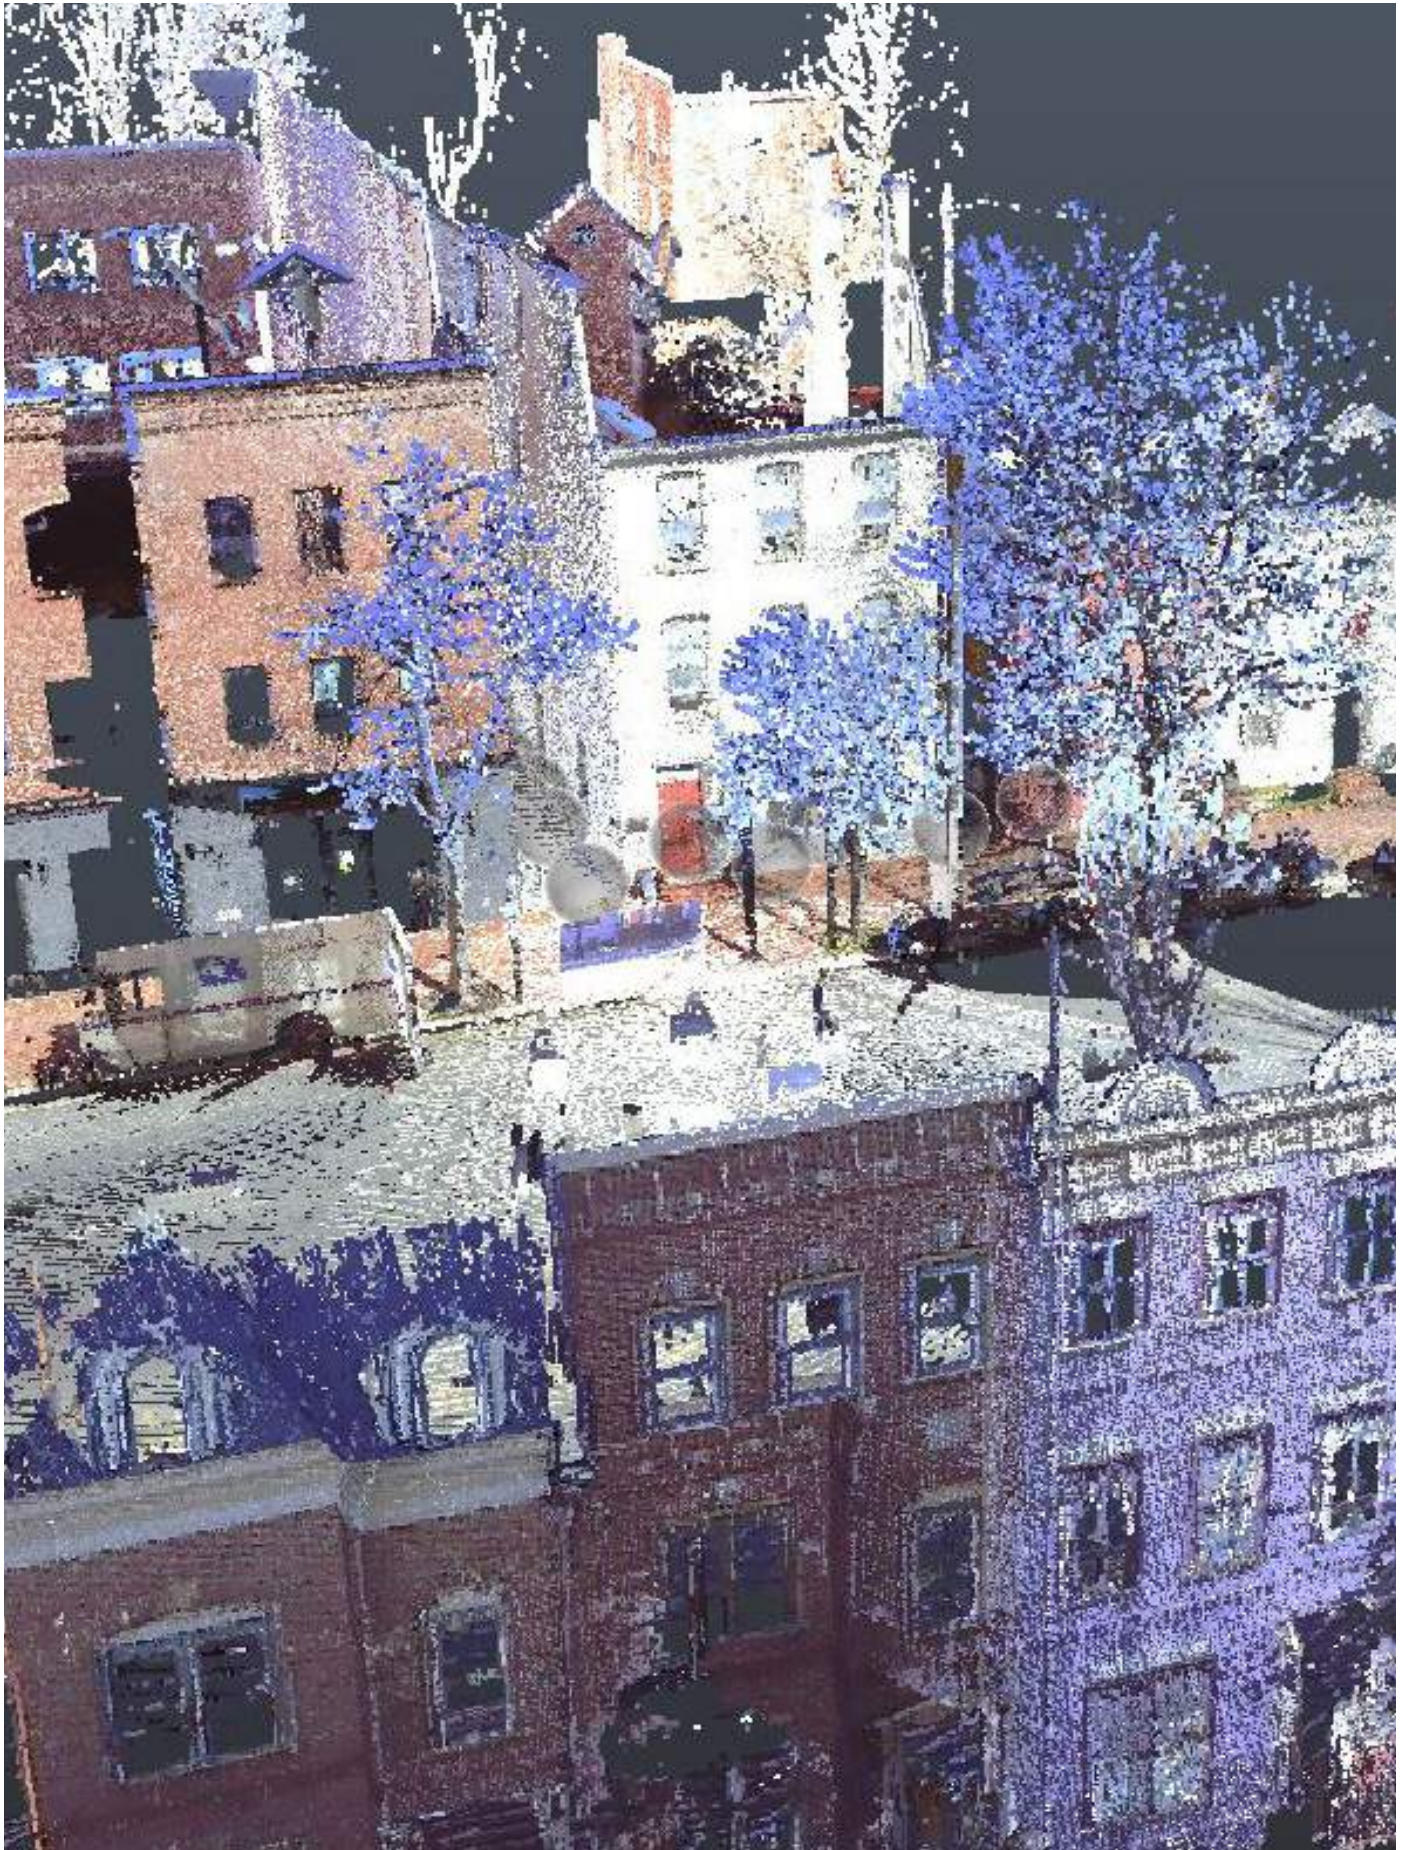
One notable finding, which was confirmed with dimensional accuracy in the point cloud, is the structural deformation and deflection of Stair 1. This deformation is very evident on the second and third floor landings of Stair 1. A more detailed description of this condition is provided by Silman in Part 2D of this Historic Structure Report.

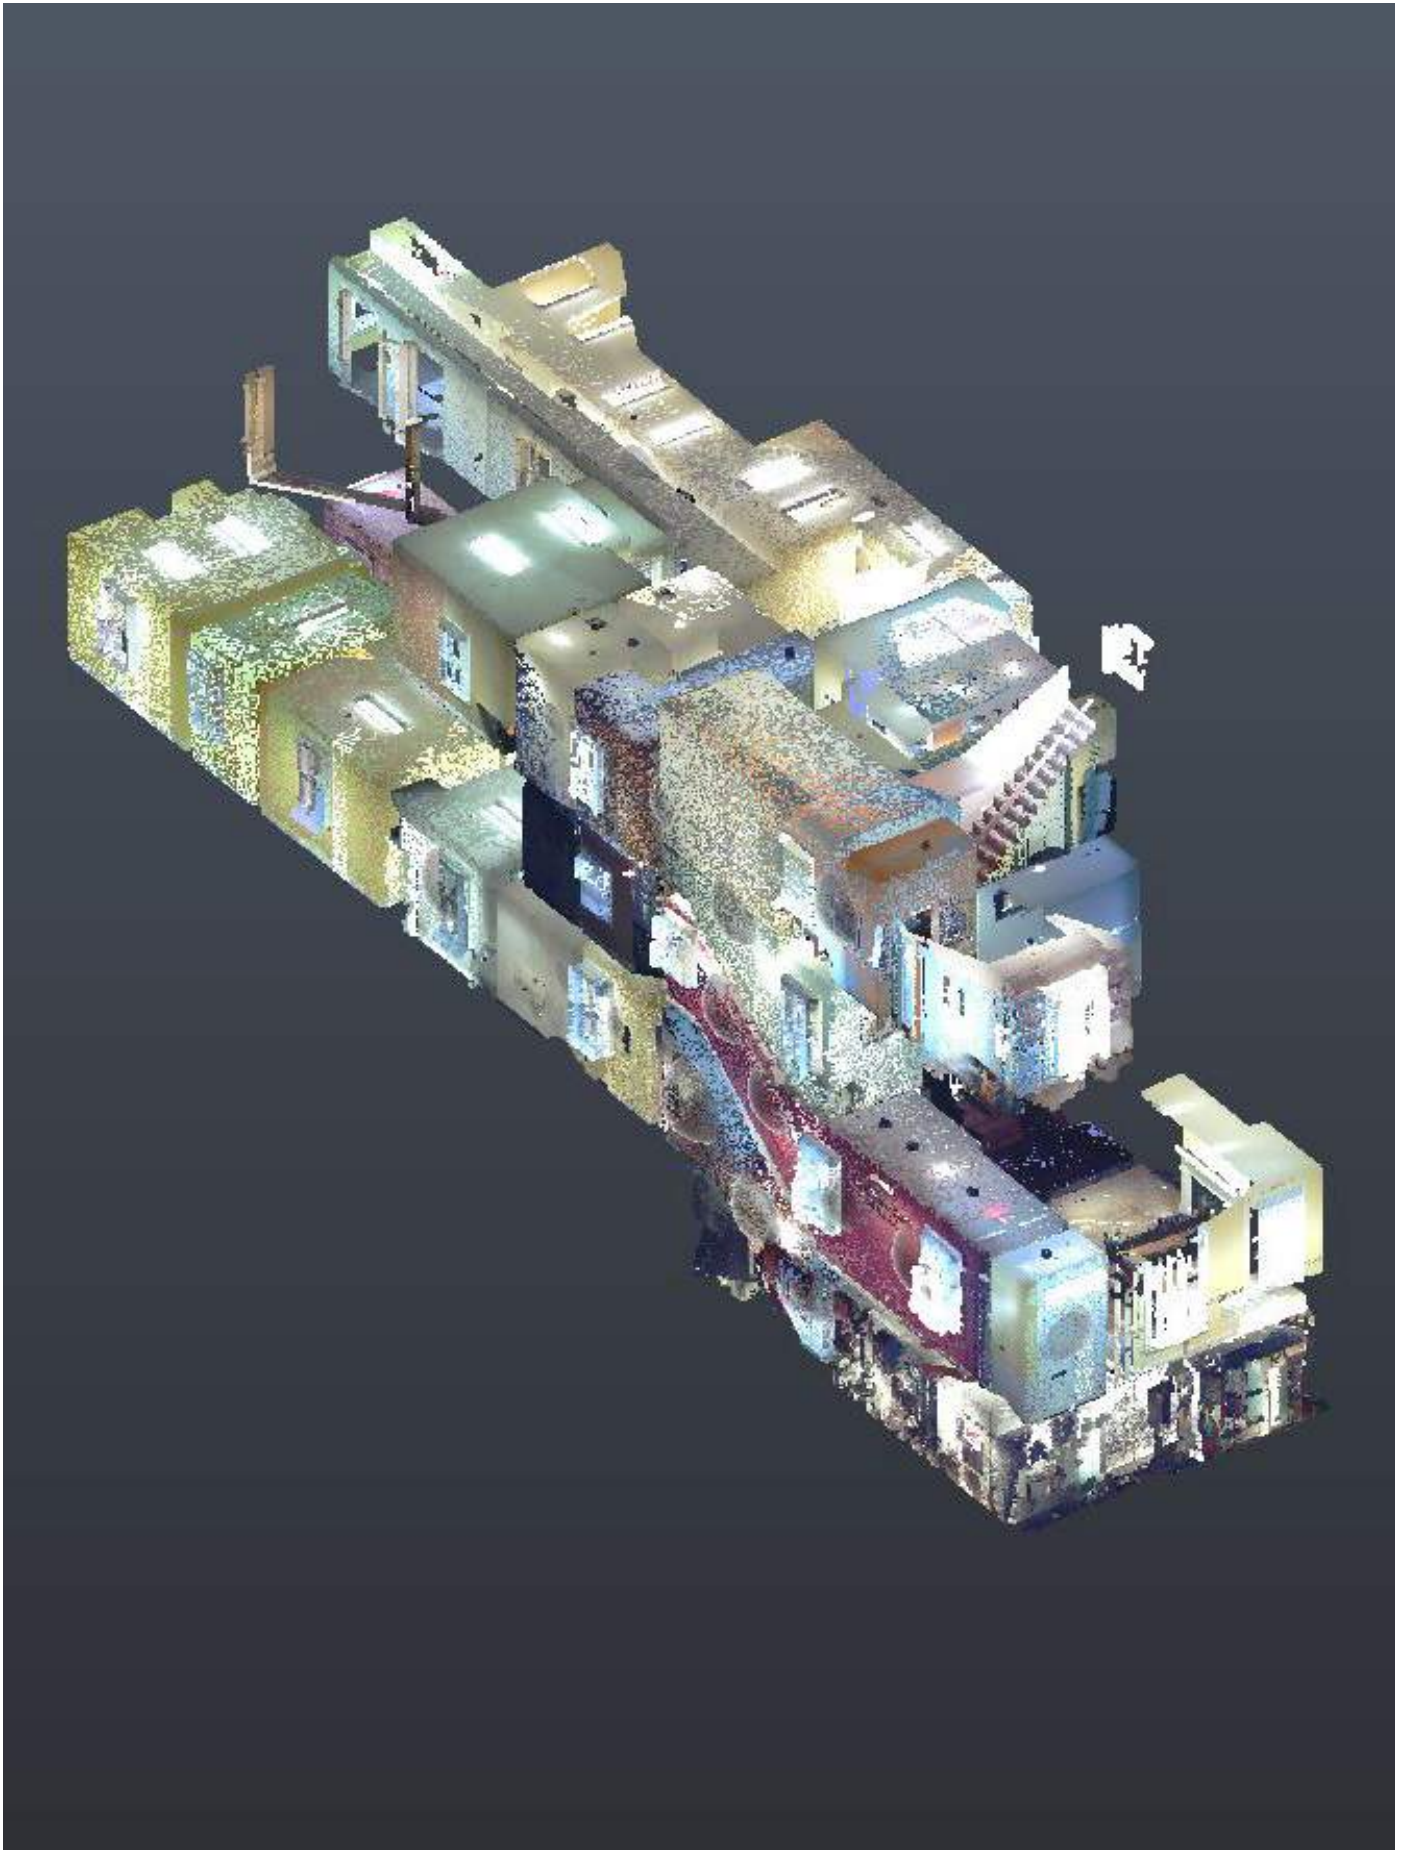
East/ West Section of Point Cloud
