Preston Plantation & Cemetery

North Potomac Yard City of Alexandria, Virginia wssi #21486.11

Archeological Disturbance Assessment

May 2021

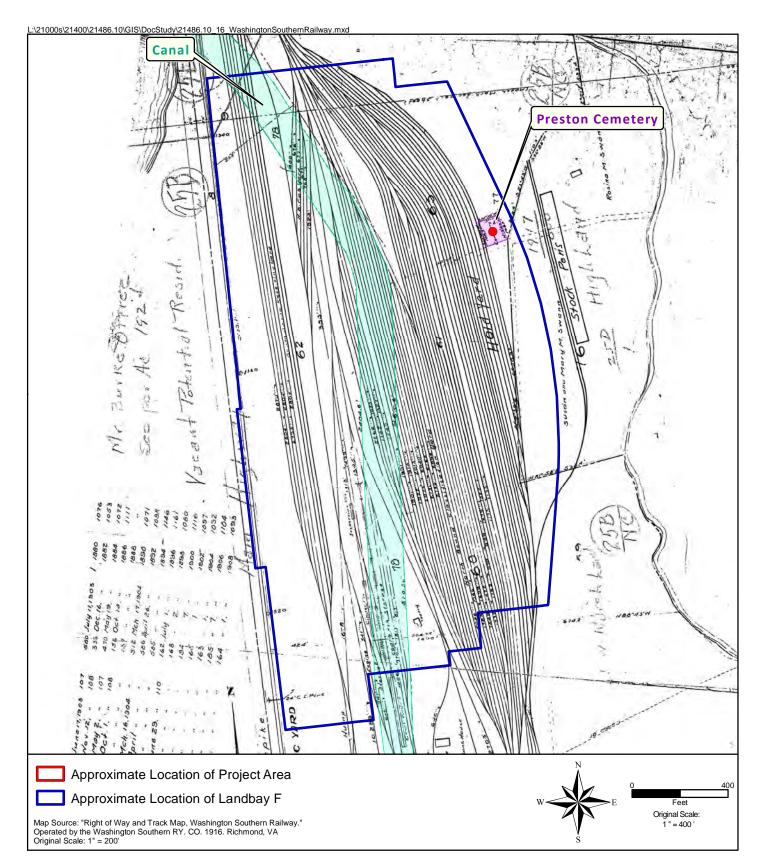
Figure 2: 1916 Right of Way and Track Map Washington Southern Railway Showing Location of the Preston Cemetery

Two test trenches (Trenches 3 and 4) were excavated in the location of the plantation and revealed that as much as 23 feet of original soil had been removed from this area. Adams concluded that any features on the much higher topographic relief had been obliterated. The test trench profiles near the reported location of the Preston cemetery (Trenches 2, 5-6) showed fills consisting of gravel and cinder ballast overlying clay horizons. No evidence of grave shafts, other cultural features, or buried historic ground surfaces (pre-1906) were found. According to a 1922 account of the Preston cemetery relocation, the graves were found between 8-12 feet below the surface at that time. A 1916 railroad map shows the cemetery next to the tracks, but by 1953/1973, the tracks covered this entire area (Figures 2-3).

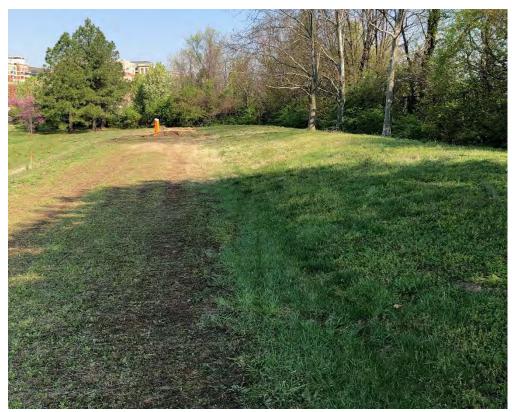
Figure 5: Overview of Trench 1 Area, Facing North

Trench 1 was located within a fenced stormwater pond facility at the northern end of the former movie theater parking lot (Figure 5). A groundwater monitoring well had recently been excavated near the northern end of the proposed trench (Figure 6); therefore, the trench was repositioned further to the south to avoid disturbing the well, and so that it would now intersect both of the 1996 trenches (see Figure 4).

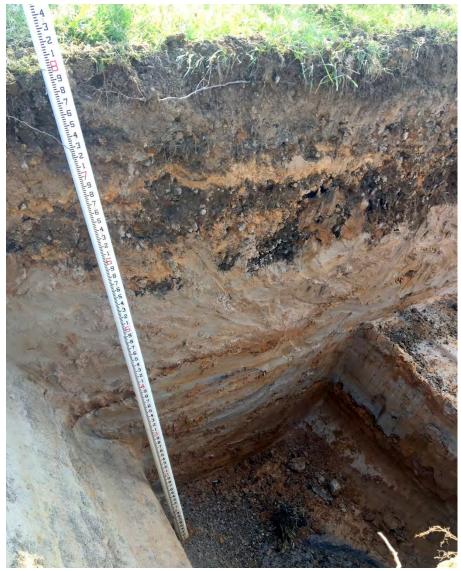
Figure 7: East Profile of Trench 1

Trench 1 measured 100 feet in length and was excavated to a depth of 5-8 feet below the surface. The soil profile exhibited four fill horizons overlying subsoil, which was reached at approximately five feet below surface (Figures 7-8). No artifacts or cultural features were observed within the trench.

Trench 1 East Profile

Fill overburden/topsoil: 0.0-0.7 feet below surface – [10YR 4/3] brown sand sandy loam

Fill 1: 0.7-1.3 feet below surface – [10YR 5/8] yellowish brown sand with 20% gravel

Fill 2: 1.3-2.5 feet below surface – [10YR 2/1] black silty clay loam with 20% gravel

Fill 3: 2.5-5.0 feet below surface – [10YR 6/4] light yellowish brown with sandy clay

B1 Horizon: 5.5-6.6 feet below surface – [10YR 5/6] yellowish brown mottled with [10YR 5/1] gray sandy clay

B2 Horizon: 6.6-8.0 feet below surface – [10YR 5/8] yellowish brown clay

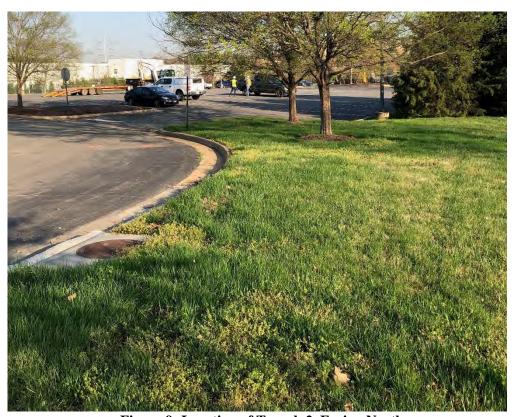
Figure 9: Location of Trench 2, Facing North

Trench 2 was located within the grassy slope between the former movie theater parking lot and the CSX railroad tracks (Figure 9 and see Figure 4). Trench 2 measured approximately 50 feet in length, 4-5 feet in width, and was excavated to a maximum depth of 9.0 feet below surface (Figures 10 and 11). The trench was placed to document the disturbance within the former Preston cemetery. Because of the limited exaction space, the trench was not stepped back to allow safe evaluation of the soils; WSSI staff archeologists did not enter the trench.

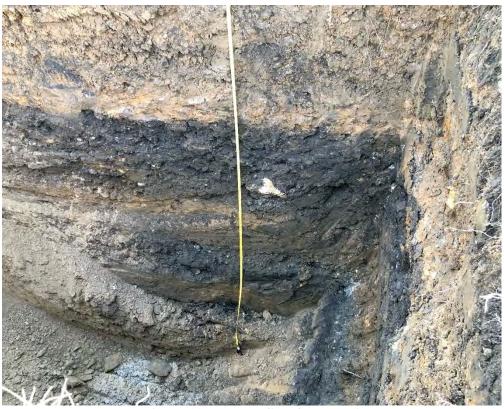
Figure 11: East Profile of Trench 2

The soil profile consisted of five fill horizons overlying subsoil, which was reached at approximately 7.5 to 9 feet below surface (Figure 12 and see Figure 11). No artifacts or cultural features were observed within the trench.

Trench 2 East Profile

Fill overburden/topsoil: 0.0-1.0 feet below surface – [10YR 4/3] brown sand sandy loam

Fill 1: 1.0-2.9 feet below surface – [10YR 5/6] yellowish brown sandy clay with 20% gravel

Fill 2: 2.9-3.9 feet below surface – [10YR 2/1] black compacted gravel

Fill 3: 3.9-4.9 feet below surface – [7.5YR 5/6] strong brown sandy clay

Fill 4: 4.9-5.9 feet below surface – [10YR 2/1] black compacted gravel

B2 Horizon: 5.9-8.0 feet below surface – [7.5YR 4/6] strong brown clay
