# Aspire Alexandria

(1112 First Street)

## Documentary Study & Archaeological Evaluation

Final Report

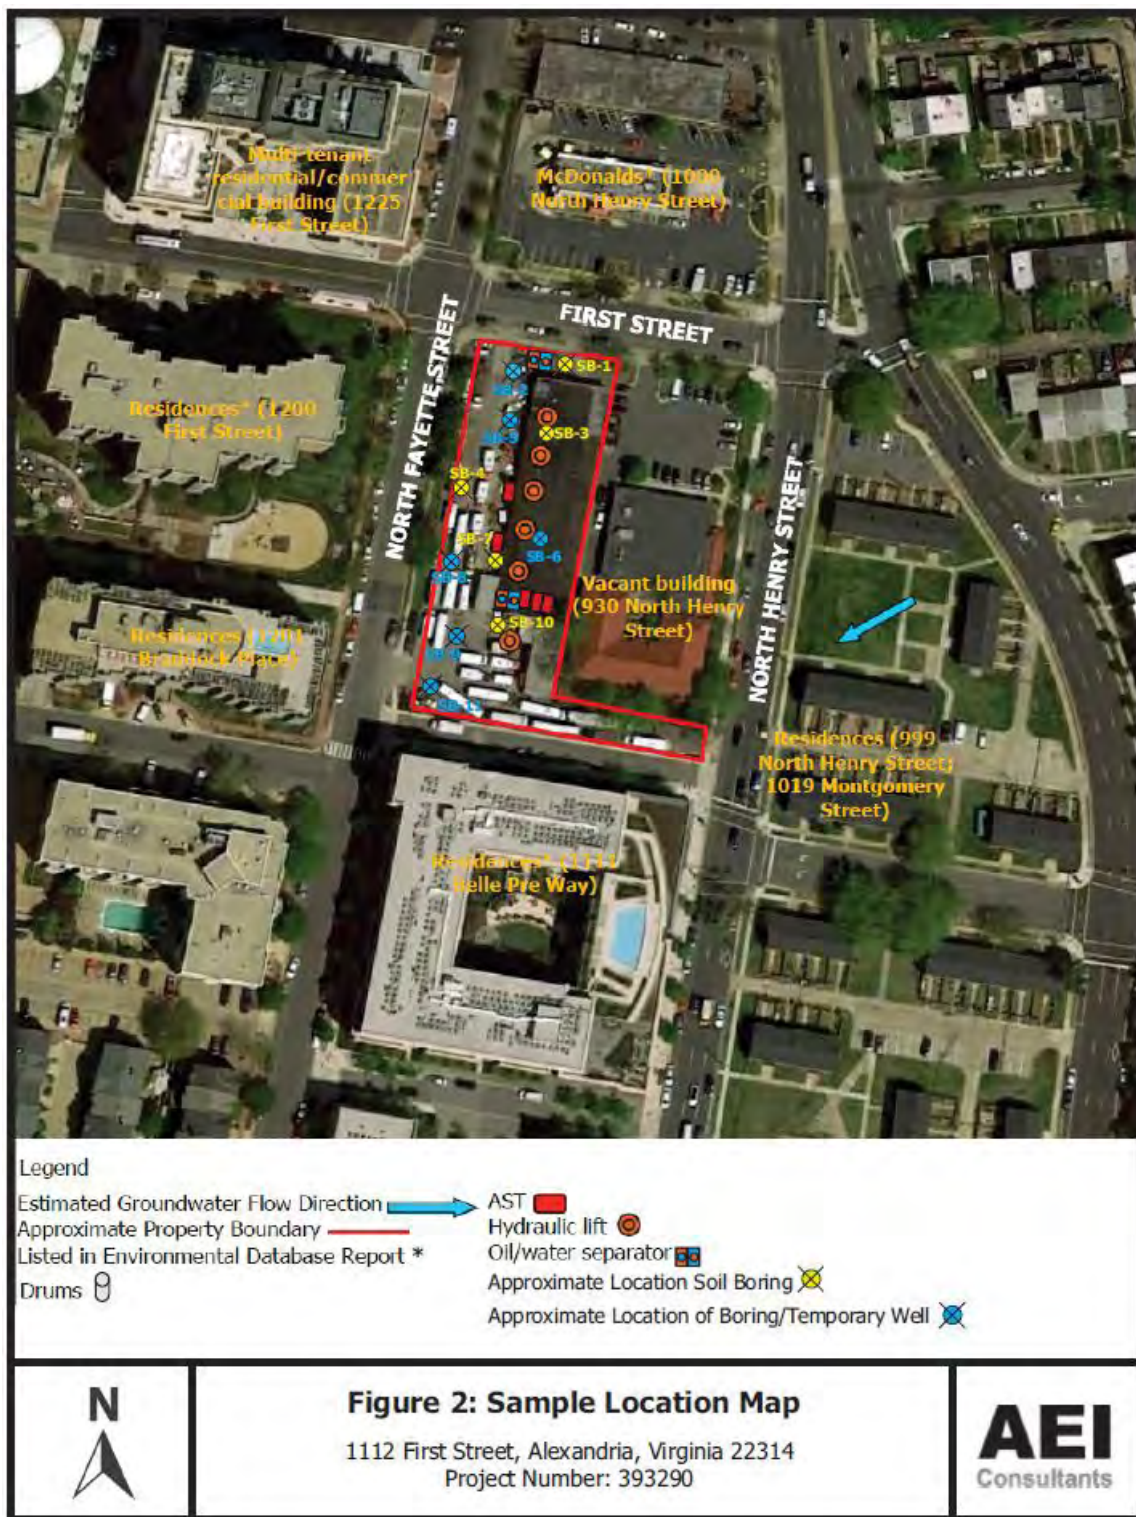
**Figure 15: Location of Test Bores (AEI 2019)**

Eleven soil bores were drilled across the property (Figure 15). Most of the soil profiles showed a shallow, two-foot-deep fill deposit overlying a “gray-brown clay” stratum that ranged in depth from 10 to 18 feet in depth. The uppermost fill soils in Bores SB-9, SB-10 and SB-11 were more substantial and ranged from 5-10 feet in depth; glass, ash, cinder, and slag were also noted in these fills. Finally, SB-07 may have been excavated through a brick feature, as the boring terminated (reached refusal) at 9 feet below surface. The profile exhibited four fills; the lowermost was a 3.5-foot-thick brick and ashy fill soil.

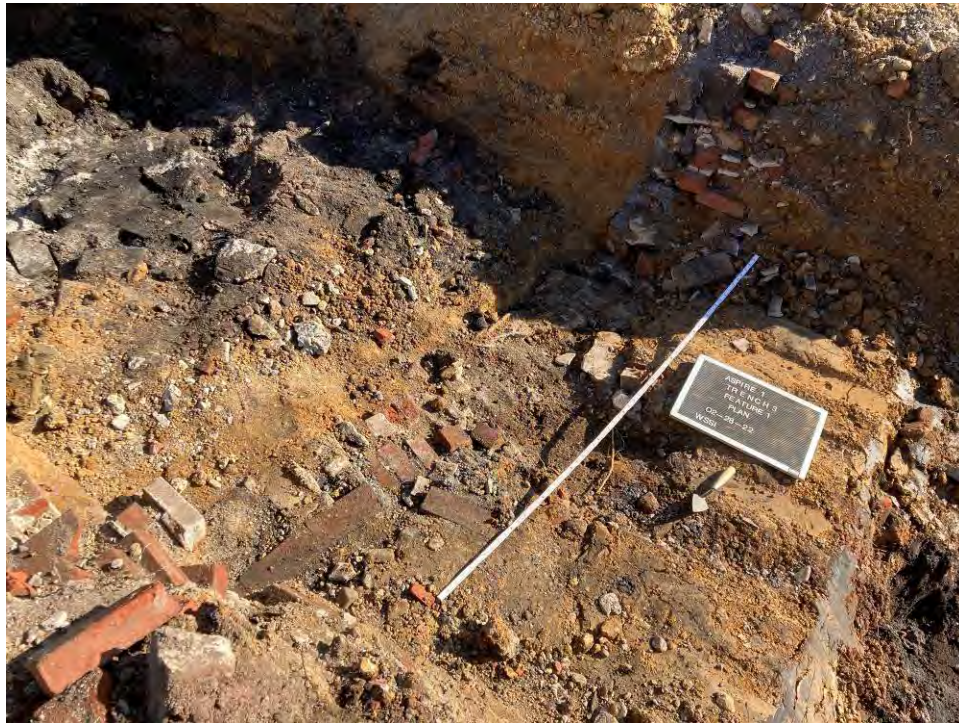
**Figure 25: Trench 3, Feature 1, Plan View**

Feature 1 (Figure 25) was a brick foundation and brick rubble located to the west of the autobody shop foundation, which was exposed within Trench 3 approximately 4 feet below ground. The soils over the feature in this location consisted of a roughly 1-foot-thick black destruction layer overlying a high quantity of brick rubble. Once the feature was fully exposed, the bricks and mortar appeared to be likely mid-20<sup>th</sup> century.

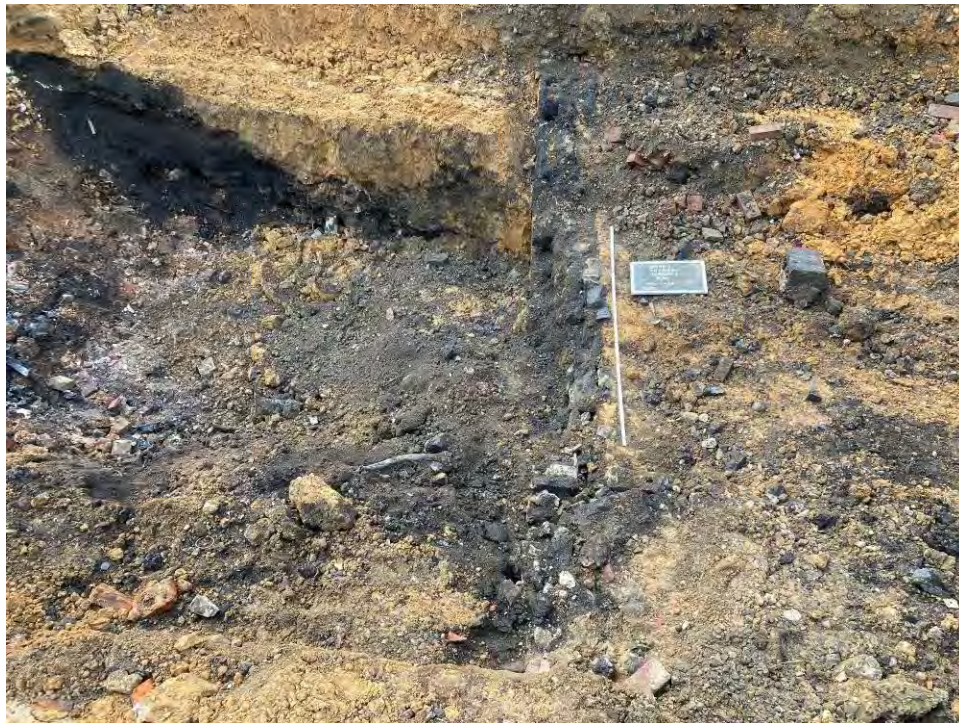
**Figure 27: Trench 4, Feature 3  
View to South**

A concrete block structure located in the center of Trench 4 was designated Feature 3 (Figure 27). The north-south aligned foundation wall was laid two course wide and was at least six courses deep and extended at least to the depth of Feature 5, discussed below. The feature abutted a brick course in the north wall of the trench. The feature was surrounded by two separate destruction layers. The feature was recorded and photographed; given the modern nature of the foundation, no further work was conducted. This cinderblock foundation was encountered again in both the block excavation and the construction monitoring phases of work on the site.

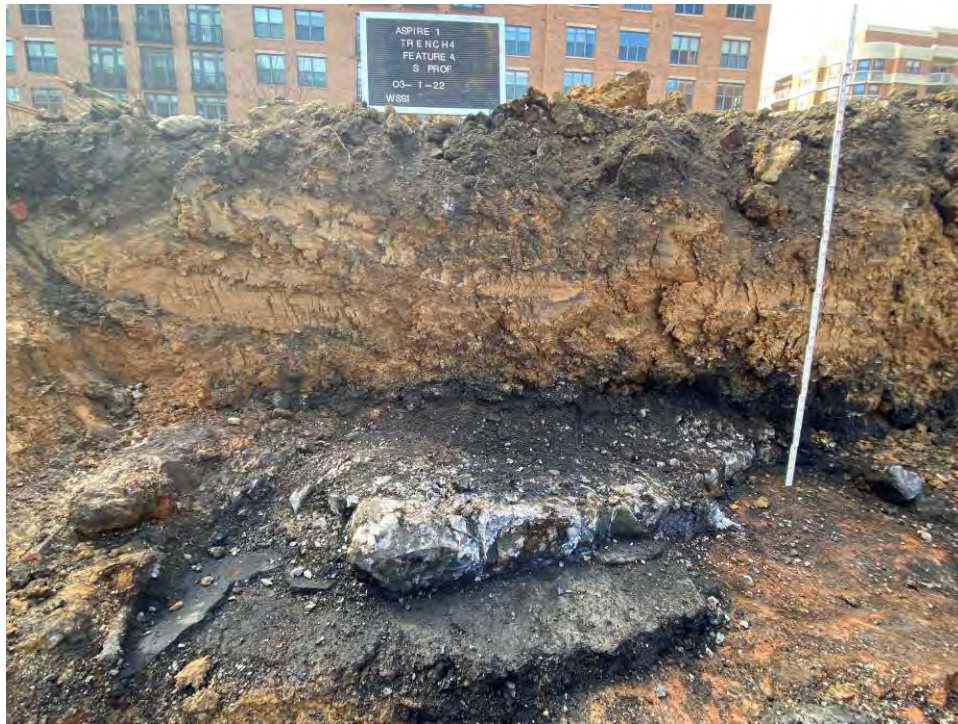
**Figure 28: Trench 4, Feature 4  
View to Southeast**

Feature 4 was a concrete floor which was exposed in the southeast corner of the Trench 4, approximately 4 feet below ground surface (Figure 28). The floor remnant was covered by what appears to be molten glass that resolidified, which was approximately 0.5 feet thick. While it seems surprising that the molten glass would have been left in place, the trench yielded a large quantity of solid glass that formed a hardened layer that could not be broken through by hand. Our documentary research revealed a newspaper article that reported that the tank furnace of the factory collapsed on November 14, 1906, spilling molten glass onto the factory floor (Mullen and Carroll 2019). A similar occurrence likely happened when the factory burned down in 1917. It is probable that this feature represents a surviving corner of the factory floor.

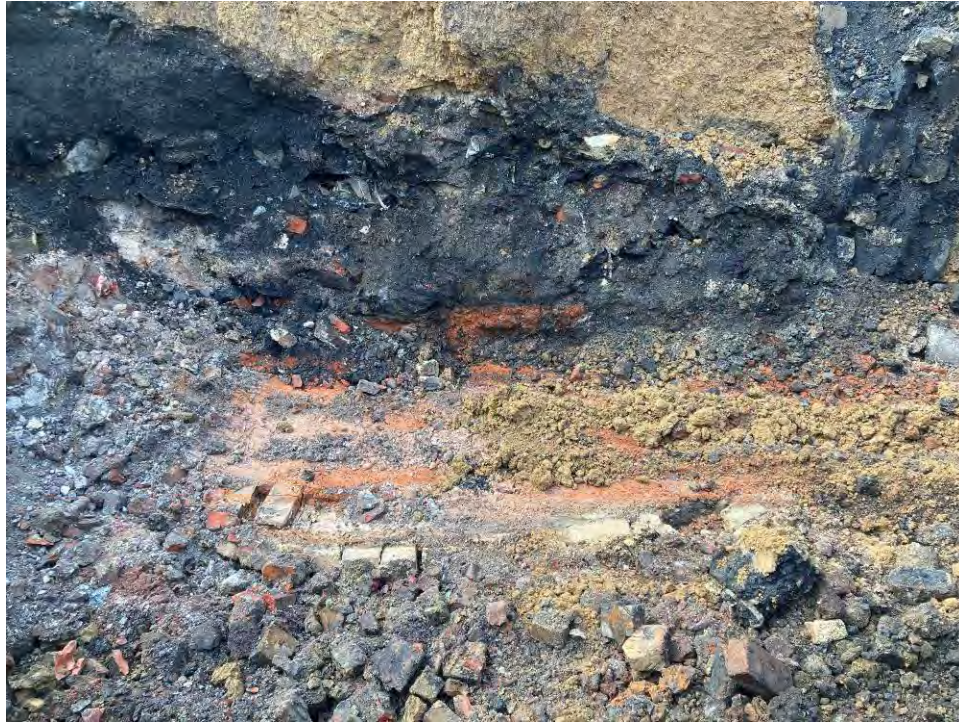
**Figure 29: Trench 4 Feature 5  
View to South**

Feature 5 was identified at the base of Trench 4, approximately 10 feet down below ground surface (Figure 29). Due to the depth of the feature and the instability of the trench walls, it could not be fully investigated during trench excavation. It was determined that the brick feature was possibly the remains of a foundation; a large quantity of brick rubble extends across the trench floor east of the brick feature. The brick rubble appears to be truncated by Feature 3 to the west, indicating that Feature 3 was of newer construction. It is likely that the Feature 5 identified during trench excavations was likely Feature 2 identified during block excavation, which was the upper part of the furnace foundation.

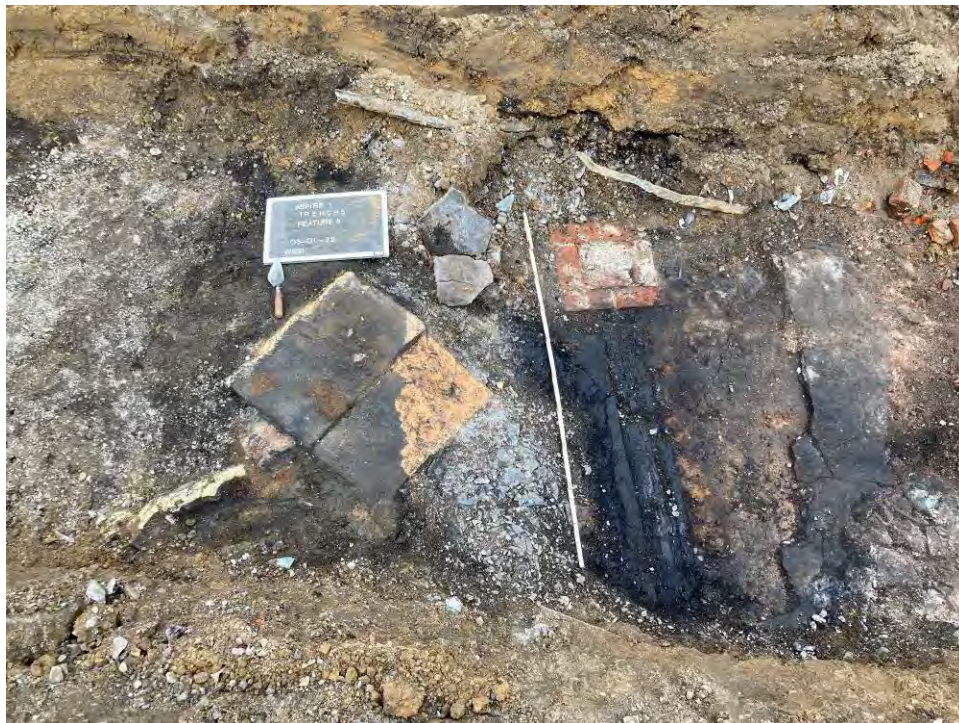
**Figure 30: Trench 5 Feature 6  
View to North**

Located in Trench 5, Feature 6 appears to be more of the glass factory concrete floor, covered by a glass layer. The feature is roughly south of the concrete floor remnant (Feature 4) that was exposed in Trench 4. A concrete pier, brick pier, and a charred wooden beam were uncovered to the west of the floor (Figure 30); the extent of the trench excavation did not provide enough context to appropriately interpret the components of this feature at the time. Multiple piers were recorded in the vicinity of Trench 5, which could potentially be the pier in this feature. However, the concrete pier was not relocated during block excavation.

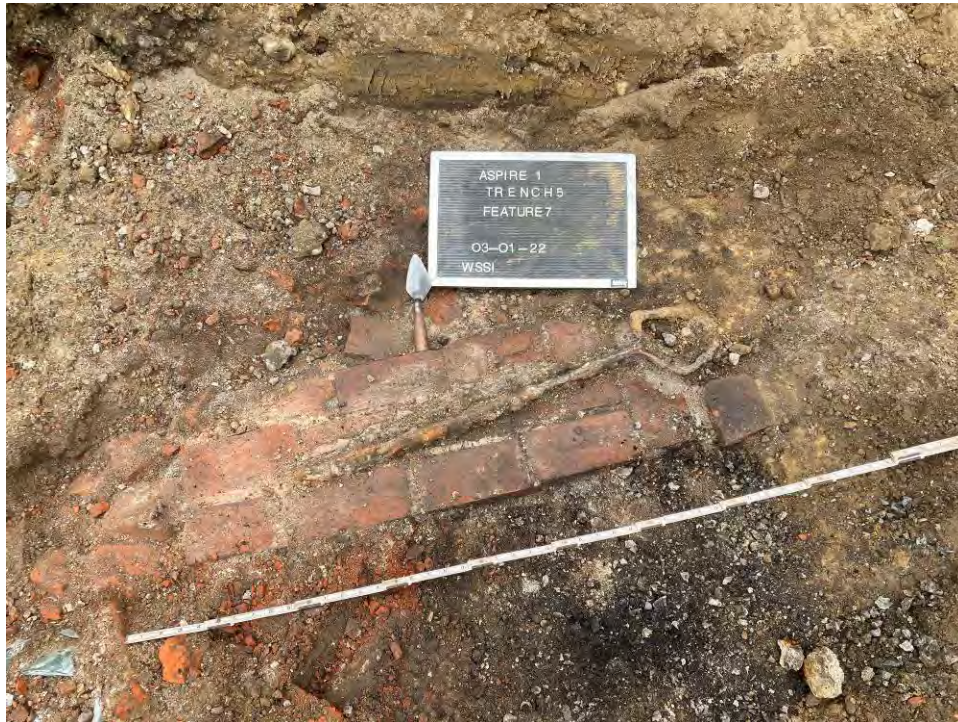
**Figure 31: Trench 5 Feature 7  
View to North**

Located in Trench 5, Feature 7 (Figure 31) was located approximately 4 feet to the east of Feature 6, near the northeast corner of the trench. The feature consists of a brick foundation, two courses wide, with a ferrous metal tool or lever apparently affixed to the feature the foundation is at a slightly higher elevation than the concrete floor (Feature 6). The feature was photographed, recorded, and covered in order that it could be further exposed during block excavation.

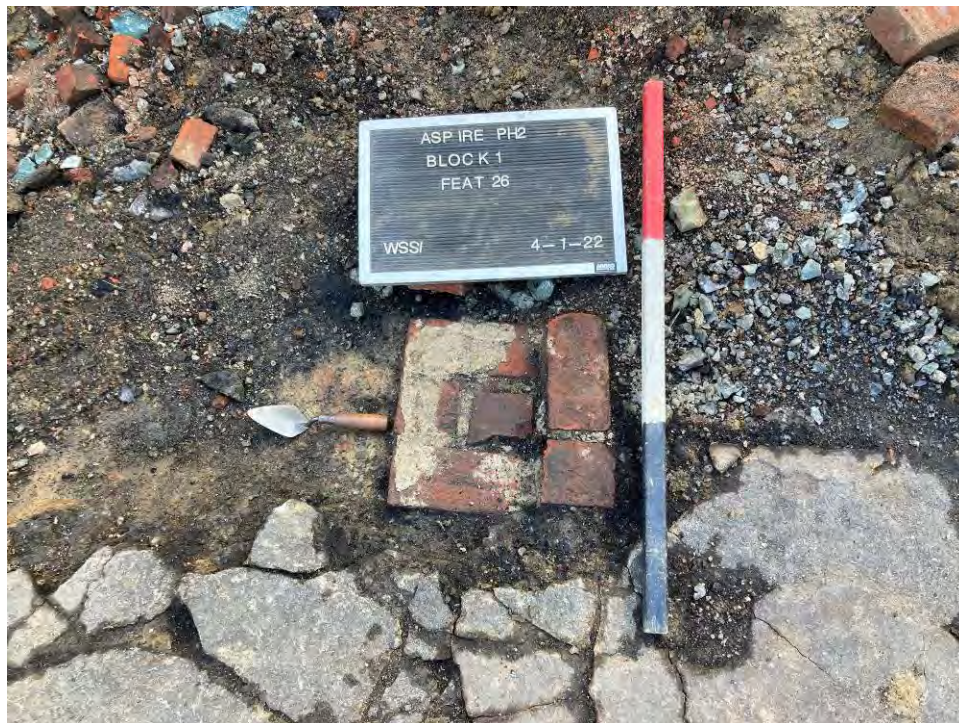
**Figure 33: Feature 26, Representative Brick Pier, Intact  
View to East**

The brick piers were all located beneath the 10YR 2/1 black destruction layer found across most of the study area and are therefore likely associated with the Alexandria Glass Works factory. It is likely more modern construction and previous testing (archeological and geoboring) disturbed these types of smaller features and there were originally more brick piers on the site. A complete list of brick piers can be found in Table 2.

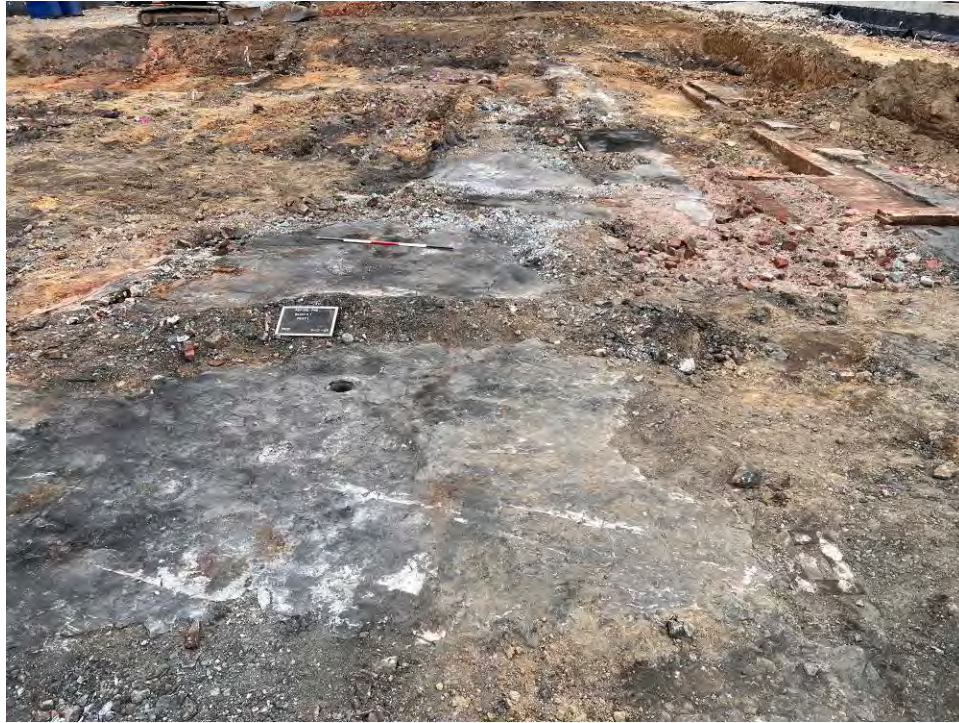
**Figure 36: Feature 1 - Portion of Concrete Floor  
View to North**

Based on historic research, the resolidified molten glass layer is either from the 1907 factory fire in which the furnace caught fire, or the 1917 fire which shut down the factory. As the 1912 Sanborn map specifically denotes a concrete floor in the main building, it is more likely that the molten glass was a result of the latter. This means that destruction layer, located immediately above the molten glass layer, likely dates to 1917 as well. No artifacts directly associated with the feature were collected. No further work was conducted on this feature.

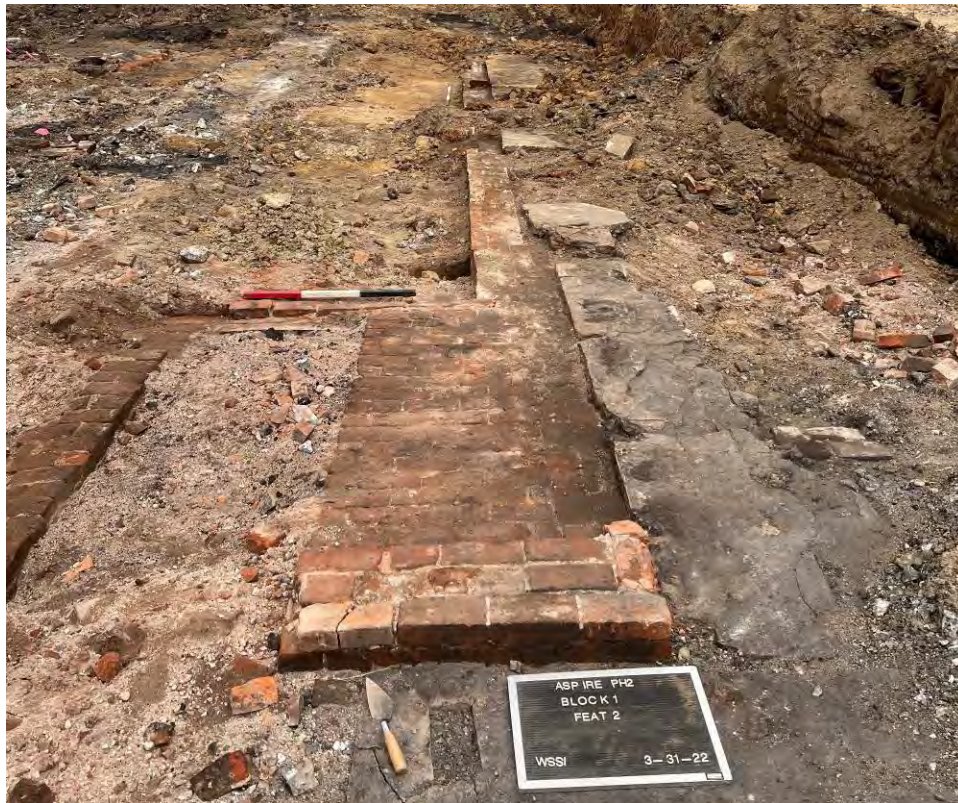
**Figure 38: Feature 2**  
**View to North**

The fill surrounding the feature was dense with rubble and destruction fill; a test pit was dug along the western wall of the feature to explore the depth, but no artifacts were recovered. The feature was survey located and recorded. No further work was conducted on this feature.

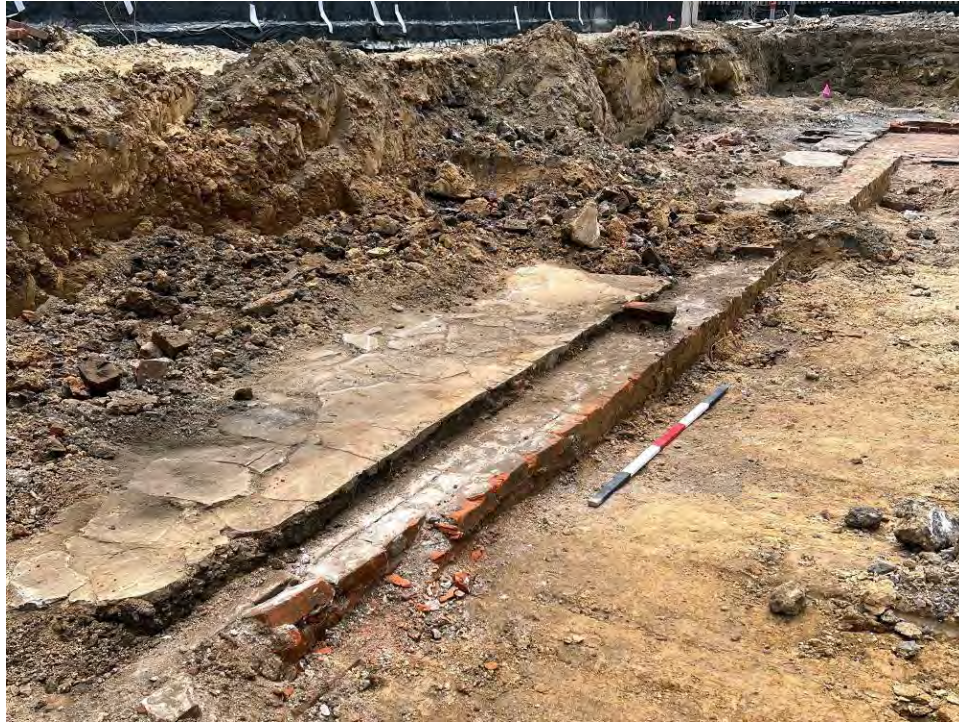
**Figure 39: Feature 2  
View to Southeast**

Feature 2 is a brick foundation connected to a larger brick pad along eastern boundary of the site measuring 57 feet in length (see Figure 32; Figure 38 and Figure 39). The brickwork on the foundation wall went at least 13 courses deep but only three courses wide. The pad was significantly wider. Since there are brick piers and the remains of the concrete floor to the east of the feature, it can be surmised that this foundation was on the interior of the glass factory. Based on the features location when referenced to the 1907 and 1912 Sanborn maps, it is likely that this foundation is related to the eastern lehr oven.

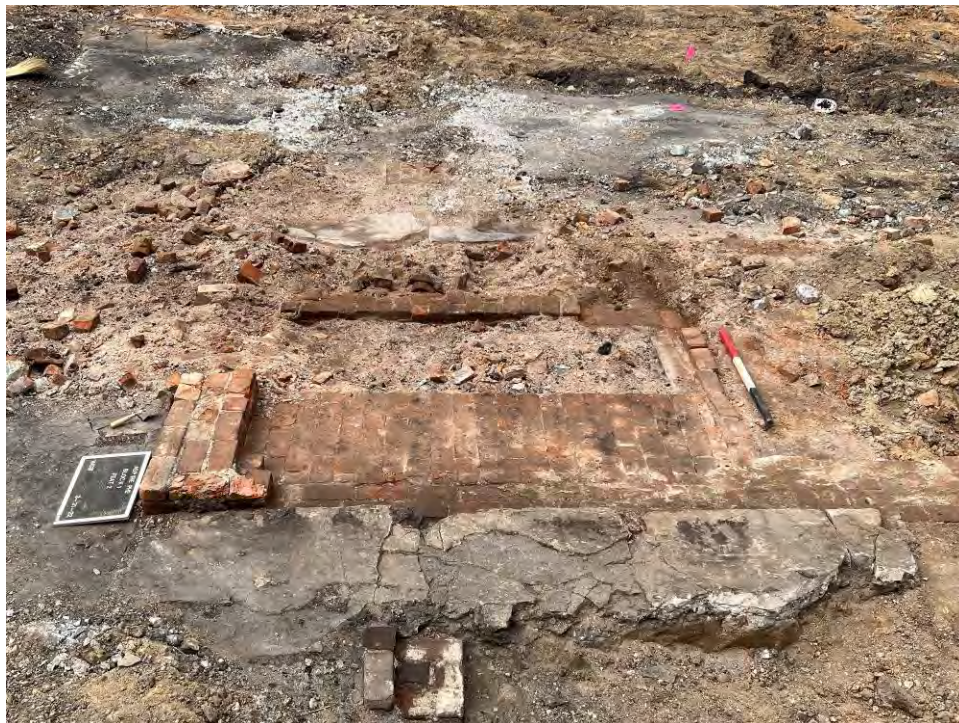
**Figure 40: Feature 2  
View to East**

The remains of the concrete floor of Feature 1 on the east side of Feature 2 have a clean line along the feature, indicating that the concrete floor did not cover the foundation and part of the feature may be a floor. The southern portion of Feature 2 expands into an H-shaped brick foundation measuring 7 feet in width, possibly the mouth of the furnace (Figure 40).

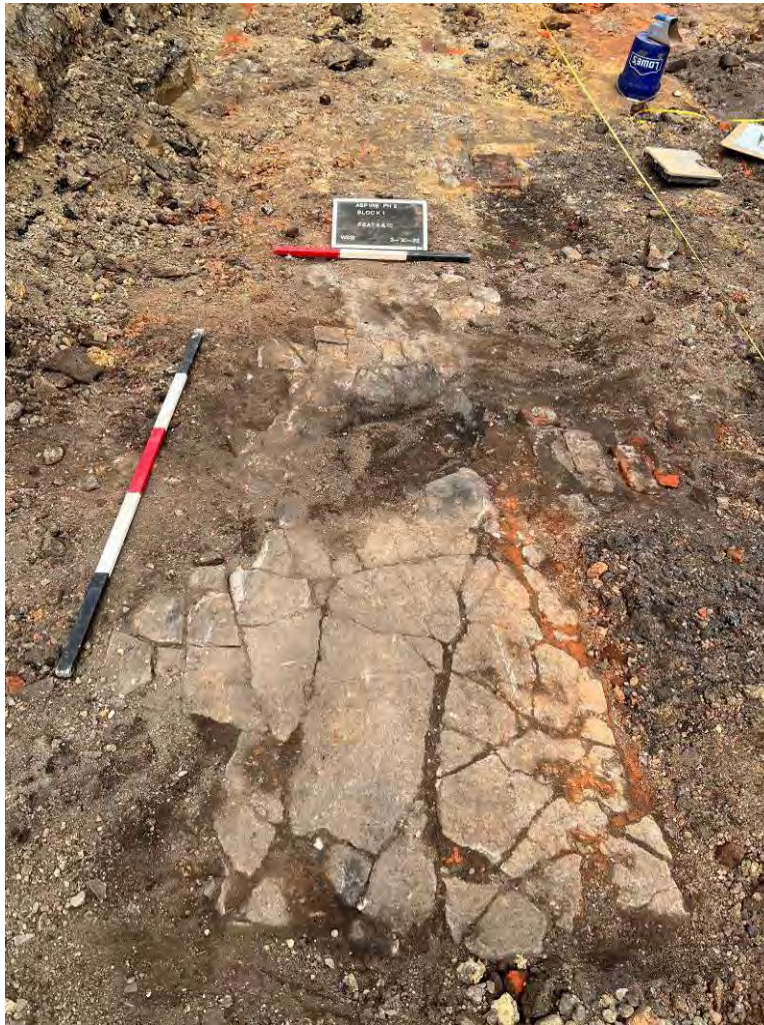
**Figure 41: Feature 29 and 10  
View to Northeast**

An adjacent brick pier was also recorded with the feature was also which was recorded. The fill surrounding the feature was dense with rubble and destruction debris; no artifacts were recovered. The feature was survey located and recorded. No further work was conducted.

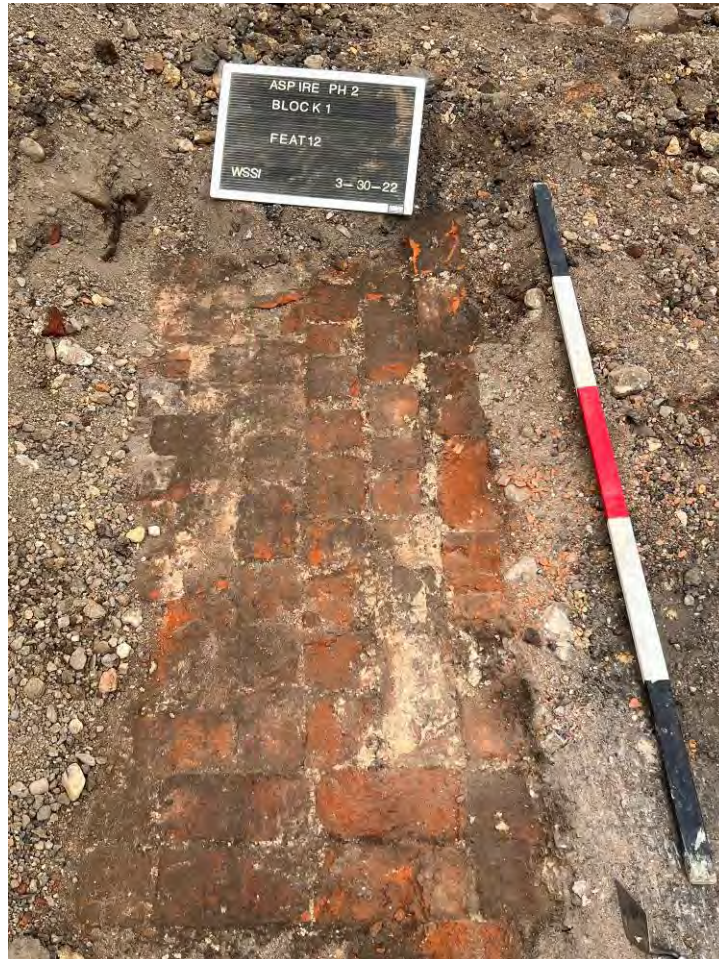
**Figure 42: Feature 12  
View to North**

Feature 12 is a brick floor or platform that was located in the southwest corner of the site during the block excavation (Figure 42; see Figure 32). The extant portion of the feature measures 2.5 by 5.5 feet and may be part of a larger feature that was disturbed by later use of the site. The surrounding matrix was compact destruction fill, and no artifacts were observed or recovered. The feature was survey located and recorded but was not relocated during construction monitoring.

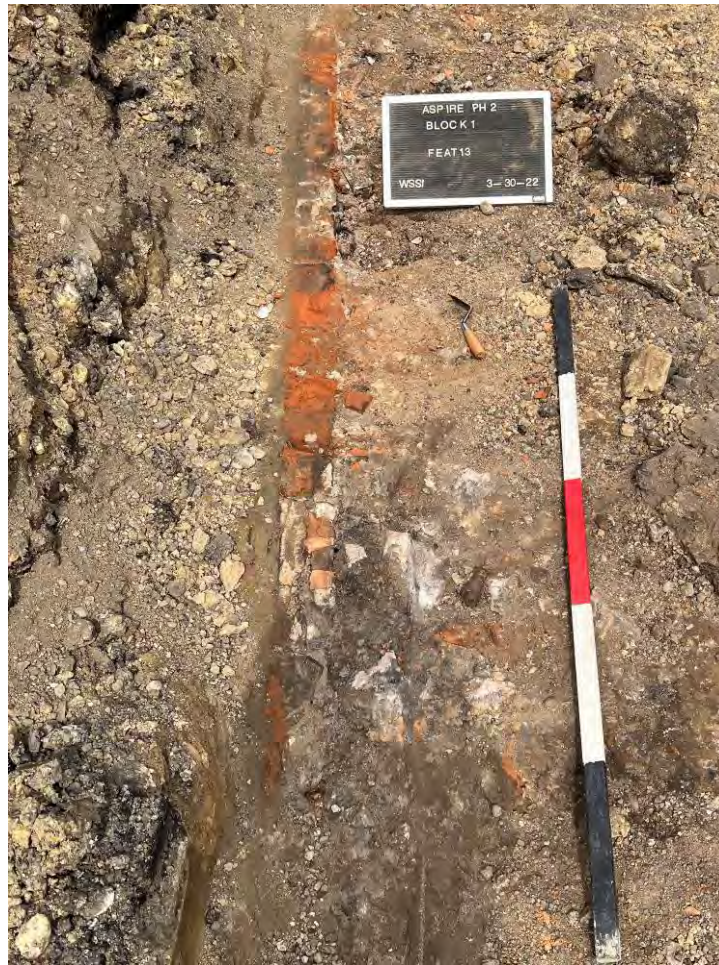
**Figure 43: Feature 13  
Looking East**

The visible brick courses are roughly in the correct location for the western lehr oven, according to the 1912 Sanborn (see Figure 32). The bricks are also parallel with Feature 2 on the eastern side of the factory building. However, this brickwork was not nearly so well preserved as Feature 2; the remains of the feature provided no clear indication of its use. The fill surrounding the feature was dense with rubble and destruction fill; no artifacts were recovered. The feature was survey located and recorded. No further work was conducted on this feature.

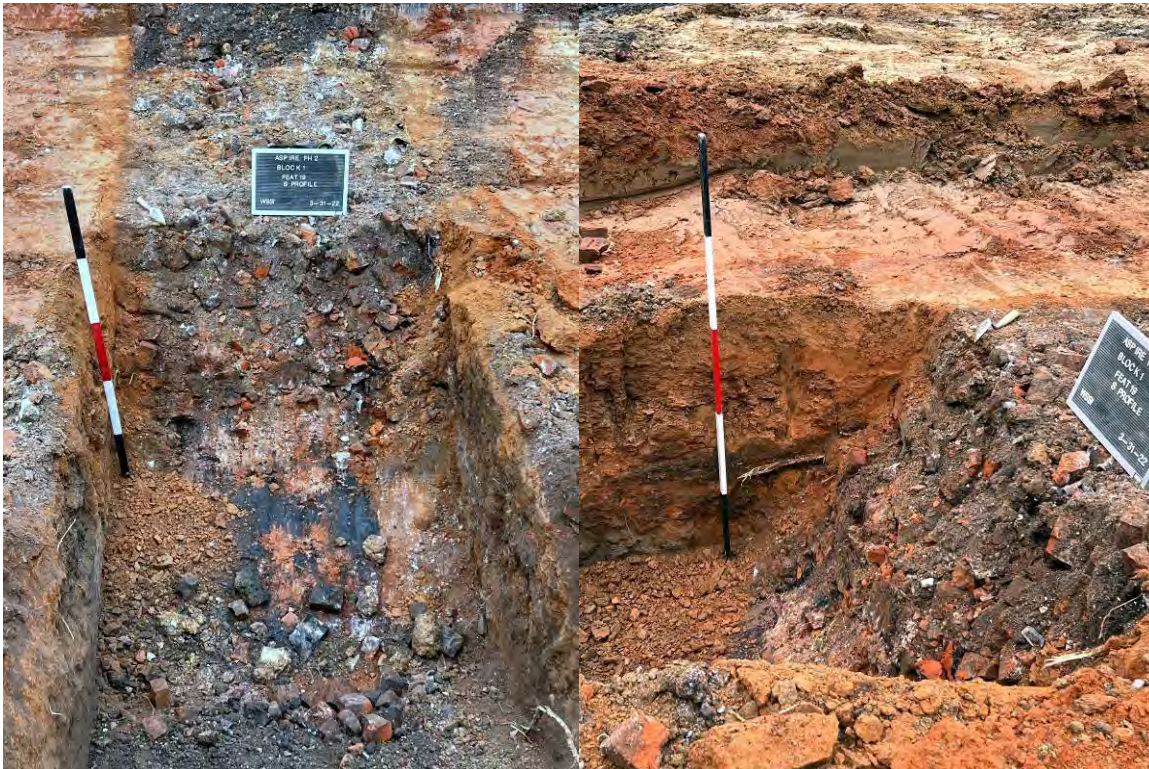
**Figure 44: Feature 19 South Bisection Profile  
Facing North and East**

The profile (Figure 44) revealed approximately 3 feet of feature fill and a cut in the surrounding clay along with degraded bricks, suggesting that the trench was originally lined with brick. Feature 19 is interpreted as the remains of an old flue associated with the gas producer that was located directly to the north according to the 1912 Sanborn map.

The feature was survey located and documented. No further work was conducted on this feature as was not relocated during construction monitoring; therefore, its exact relation to Features 39 and 44 at deeper elevations, cannot be confirmed. It is not known if the trench was likely infilled after it collapsed; whether the collapse was caused by a fire or abandonment is unknown.

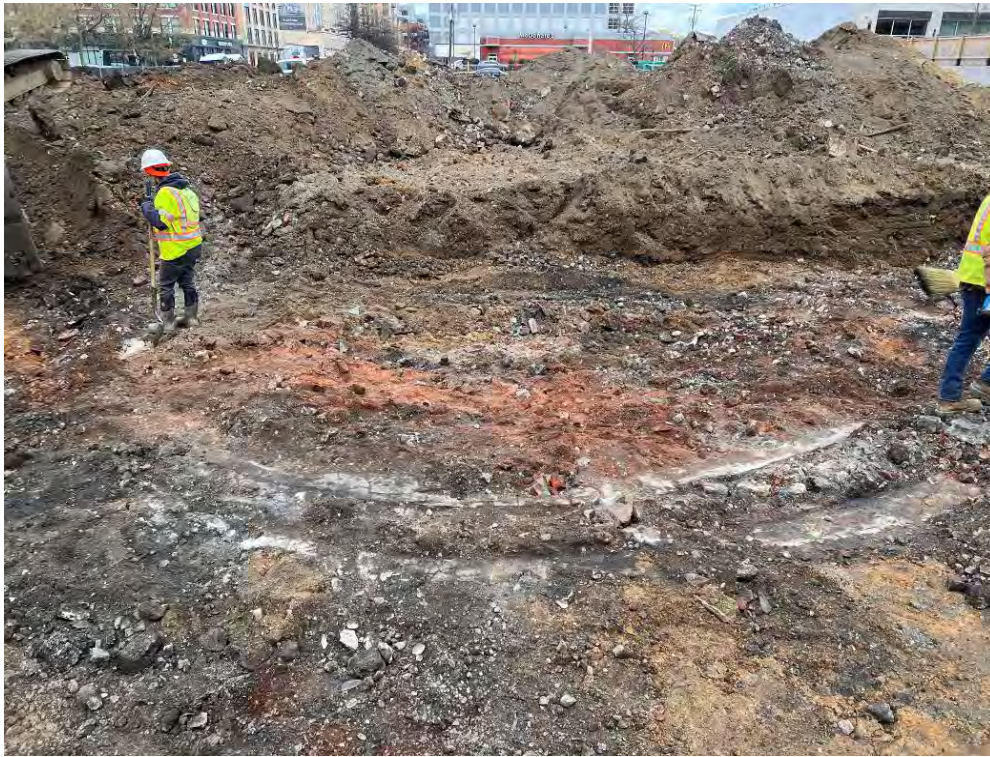
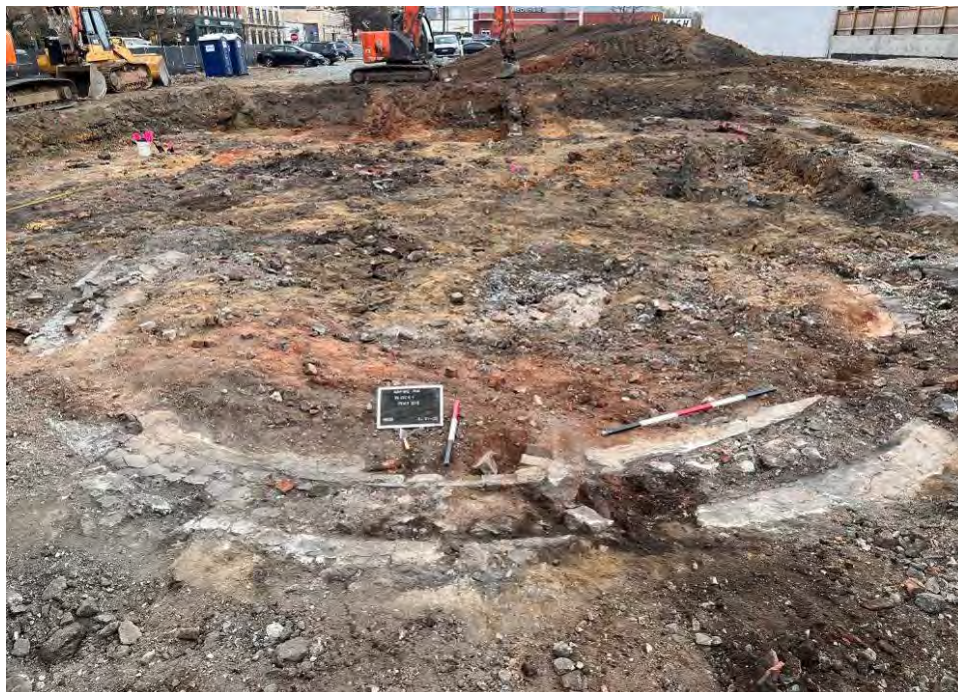
**Figure 45: Feature 20 Overview, View to North**

Centrally located at the southern end of the factory, Feature 20 is a curved concrete and brick foundation that corresponds to the curved wall of the working end of the furnace. This is visible on the 1912 Sanborn map (see Figure 32). The feature measures 25 feet across from the interior western and eastern edges and is generally 3 to 3.5 feet wide (Figure 45 and Figure 46). This end of the furnace appears to be constructed of brick with a layer of concrete on the inside and outside of the structure. Both terracotta and metal pipes of various sizes ran through the walls to allow for ventilation of the furnace (Figure 47).

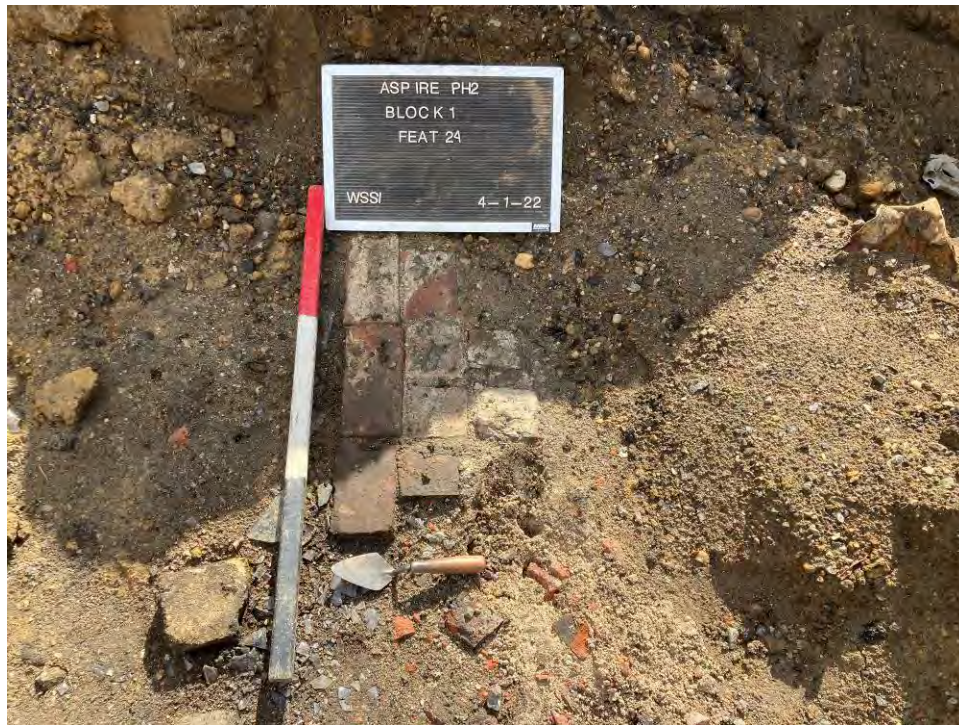
**Figure 48: Feature 24 Plan View  
View to East**

Feature 24 is a row of bricks running east and into the eastern wall of the study area (Figure 48). According to the 1912 Sanborn map, the feature is located in the approximate location of a chimney base on the southeast corner of the property. However, the feature was not situated below a clear destruction layer as were many of the other factory features. It is possible that since this feature was located at the eastern terminus of the property it was not impacted as much by the destruction. However, not enough of the feature was exposed to confirm its purpose. The surrounding soil comprised of fills contained debris and construction rubble.

The feature was identified during the block excavation and was not relocated during construction monitoring. The feature was survey located and recorded. No further work was conducted on this feature.

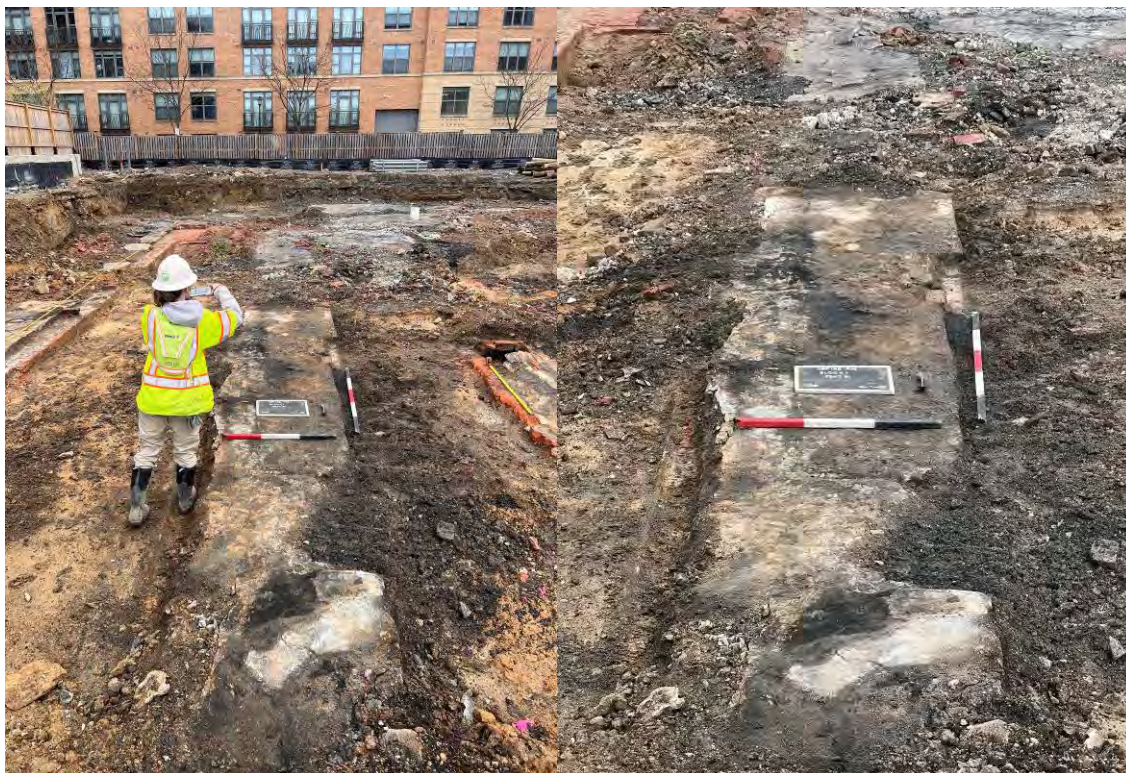
**Figure 49: Feature 31  
View to South**

Feature 31 is a concrete foundation on eastern side of the site that is parallel to Feature 2 and measures 23 by feet (see Figure 32). Based on the pattern of disturbance on the east and west side of the feature, it is likely that Feature 31 continued south another 20 feet under, with section of heavy disturbance in middle. The concrete foundation may have been underneath Feature 1, the floor of the factory (Figure 49).

Because Feature 31 was found under the destruction layer and at the same elevation as Features 1 and 2, it is likely associated with the Alexandria Glass Works factory. Based on the 1921 Sanborn map, the feature could be associated with the eastern lehr oven or an interior foundation wall of the factory. Feature 31 is also roughly parallel with Feature 9, a poorly preserved, smaller block of concrete on the western side of the site.

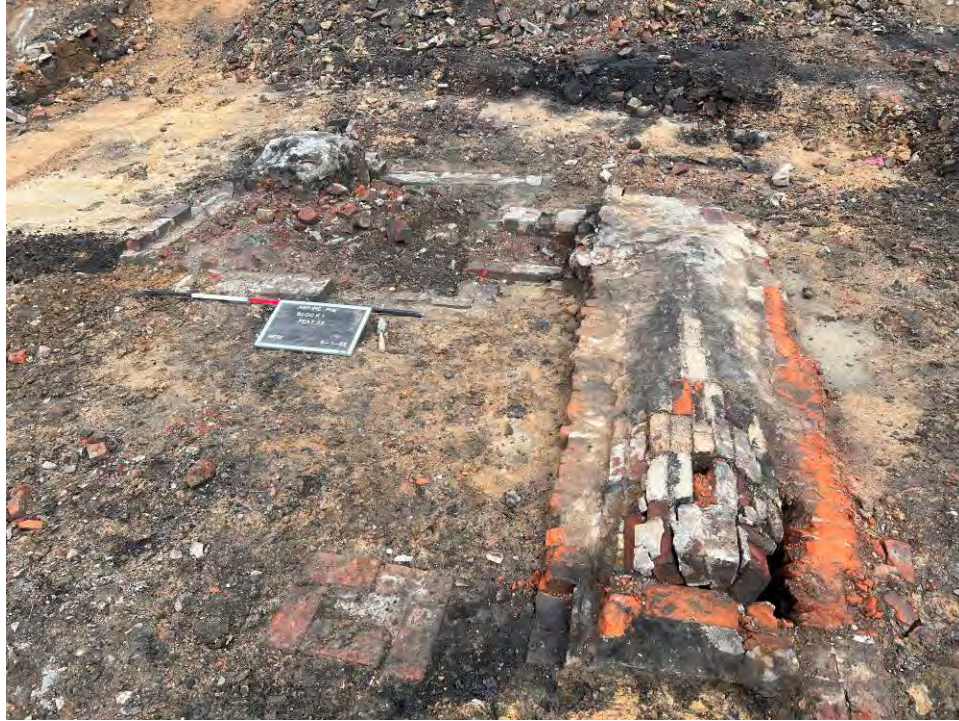
**Figure 50: Feature 32, View to North**

Feature 32 is one of the better-preserved factory-related structures on the site. This intact arched brick tunnel, measuring 10.5 feet (length) by 3 feet (width) by 2 feet (depth), was exposed 5 feet west of and paralleling Feature 31 (see Figure 32; Figures 50-53). The flue curved to the west into a brick lined feature measuring 7 by 7 feet square, with a large 2 by 2-foot concrete block situated in the northwest corner (see Figure 51). This portion of the feature contained brick rubble fill but was not further hand-excavated due to safety concerns. However, the vicinity of feature was mechanically excavated during the garage site leveling, and a large brick block foundation (designated Feature 42) was found directly beneath Feature 32 and is discussed in further below.

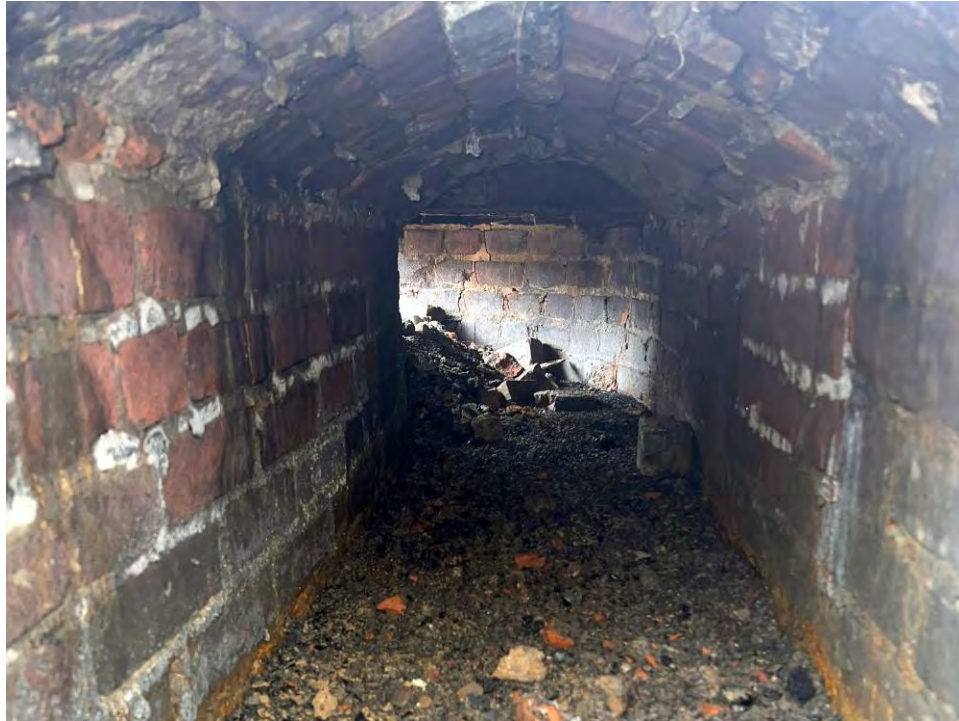
**Figure 52: Feature 32, Interior of Flue Looking North**

Several of the arched bricks at the southern end of the tunnel were removed revealing the interior of the tunnel was free of debris and had a clay floor (see Figure 52). The inside of the tunnel shows a high degree of burning but no built-up residue, which indicates that the feature was well insulated against thermal heat loss (Pfanstiehl et al 1999: 5-26). A buried terracotta pipe was also revealed (see Figure 53), which continued southward toward and presumably beneath the exposed sections of the concrete floor, and likely led to Feature 41, the furnace of the factory. Feature 32 is interpreted as a conveyance tunnel which connected the engine and boiler room to the furnace. The feature was survey located and recorded during block excavation and removed during construction monitoring in order to investigate the deeper layers of historic fill. No further work was conducted on this feature.

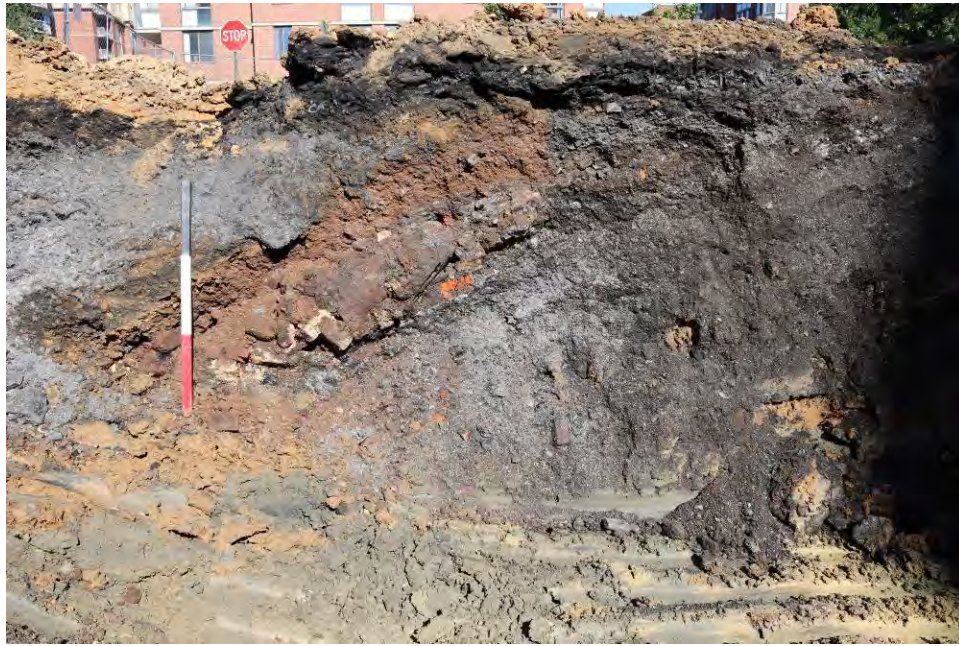
**Figure 54: Feature 35 West Profile**

Feature 35 was the remains of a brick arch that was exposed in the excavation wall during construction monitoring (Figure 54). The northern portion was cut and infilled with the destruction layer. The feature was documented with photographs in anticipation of exposing a more significant and intact portion of the feature as construction excavation monitoring proceeded. However, directly west of the remains of Feature 35 was a series of modern significant disturbances and no further work was possible for this feature.

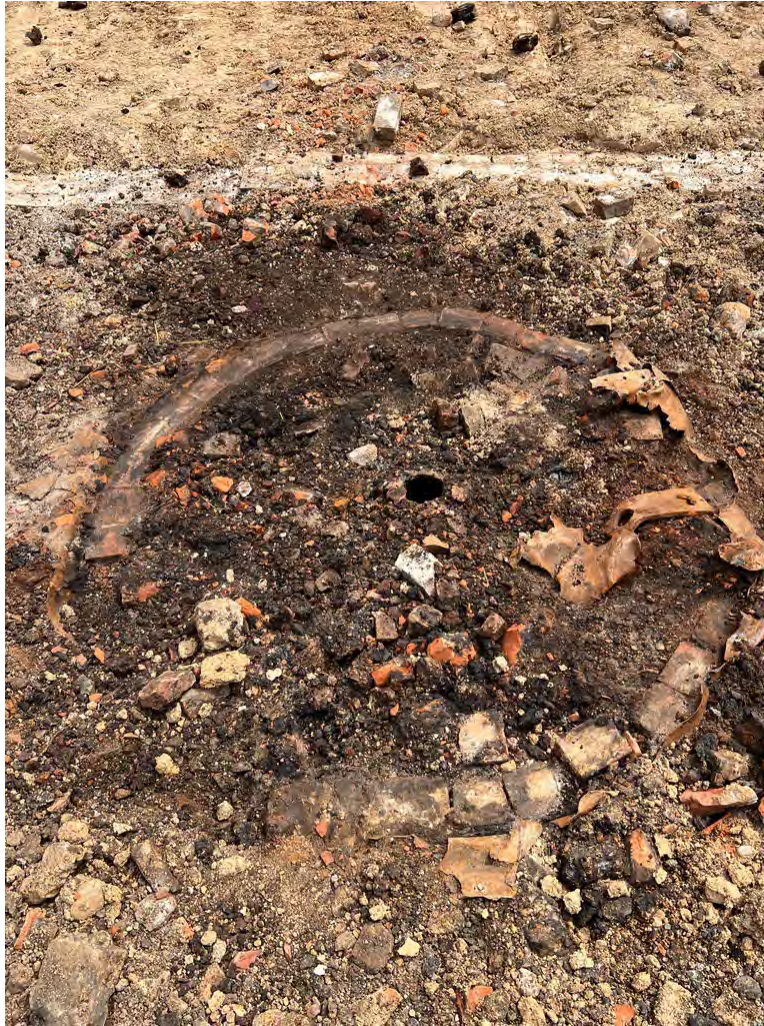
**Figure 55: Feature 37, Detail of Gas Producer  
View to South**

Feature 37 was exposed in the southwest corner of the site, outside of the block excavation area (see Figure 32; Figure 55 and Figure 56). The brick foundation measured 20 by 13.5 feet and was two courses in width. The gas producer was located in the center of this room: a large brick lined circle within the remnants of the metal tank, which appeared to have been constructed of riveted sheet metal, possibly compatible to the Duff Gas Producer (Figure 57). In the center of the metal ring was a lead pipe which was filled with an oily liquid. The fill on the interior of the foundation contained a significant amount of tar, especially inside the tank. No evidence of the water pan was observed beneath the foundation; however, a considerable amount of a liquid tar substance was removed.

This feature is one of the two gas producers for the Alexandria Glass Works factory. Tar residue within the fill of the feature is most likely the result of gas production and supports this conclusion. The producer would have been connected to the furnace through conveyance tunnels, which were not located during excavation.
