# Aspire Alexandria

(1112 First Street)

## Documentary Study & Archaeological Evaluation

Final Report

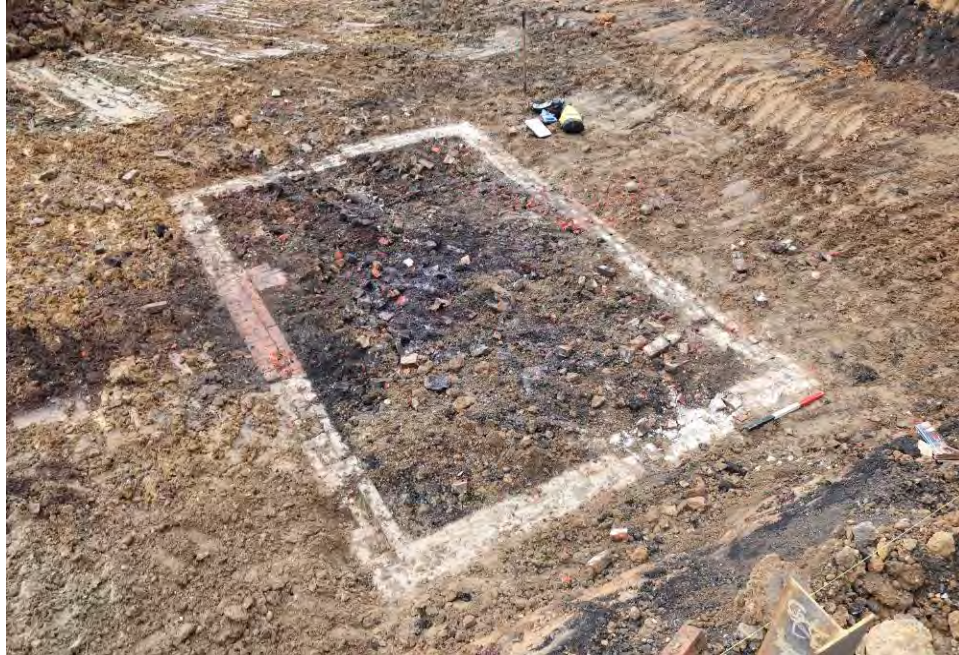
**Figure 56: Feature 37, Gas Producer Room  
View to Southeast**

Feature 37 was exposed in the southwest corner of the site, outside of the block excavation area (see Figure 32; Figure 55 and Figure 56). The brick foundation measured 20 by 13.5 feet and was two courses in width. The gas producer was located in the center of this room: a large brick lined circle within the remnants of the metal tank, which appeared to have been constructed of riveted sheet metal, possibly compatible to the Duff Gas Producer (Figure 57). In the center of the metal ring was a lead pipe which was filled with an oily liquid. The fill on the interior of the foundation contained a significant amount of tar, especially inside the tank. No evidence of the water pan was observed beneath the foundation; however, a considerable amount of a liquid tar substance was removed.

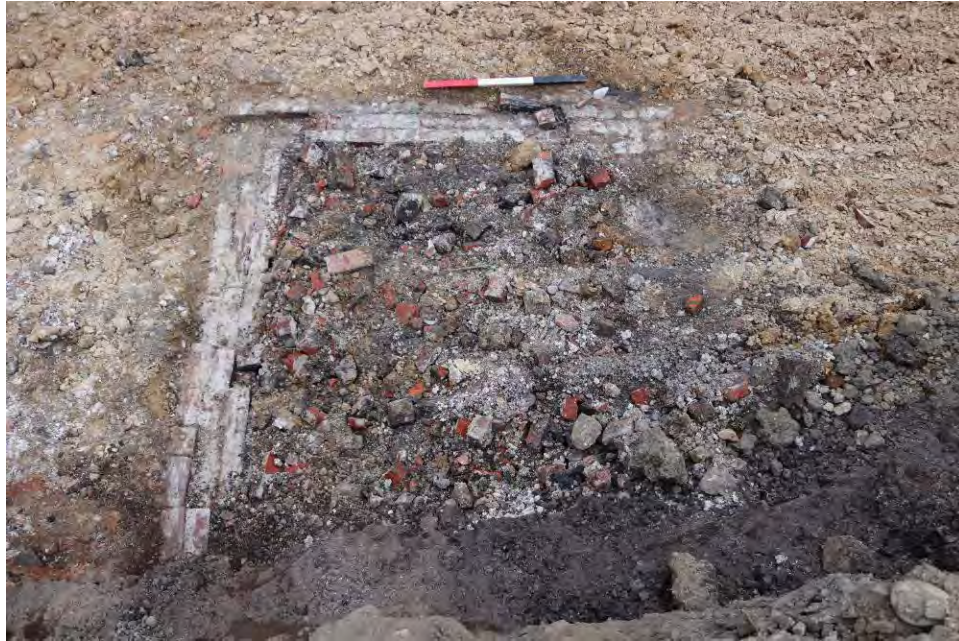
**Figure 58: Feature 38, View to West**

Feature 38 is a partial brick foundation measuring 10 by 7.5 feet (Figure 58). The feature abuts the western wall of the furnace, Feature 41, which is discussed below (Figure 59). The Sanborn maps of the property do not depict this feature, but it was likely part of the furnace (see Figure 32).

It is possible that the feature represents a regenerator, which was a chamber on the side of a continuous furnace used to capture the excess heat from the furnace (Pfanstiehl et al. 1999; 5-21). However, these systems require a regenerator on each side of the furnace; no such matching foundation was found on the east side of the furnace during this excavation.

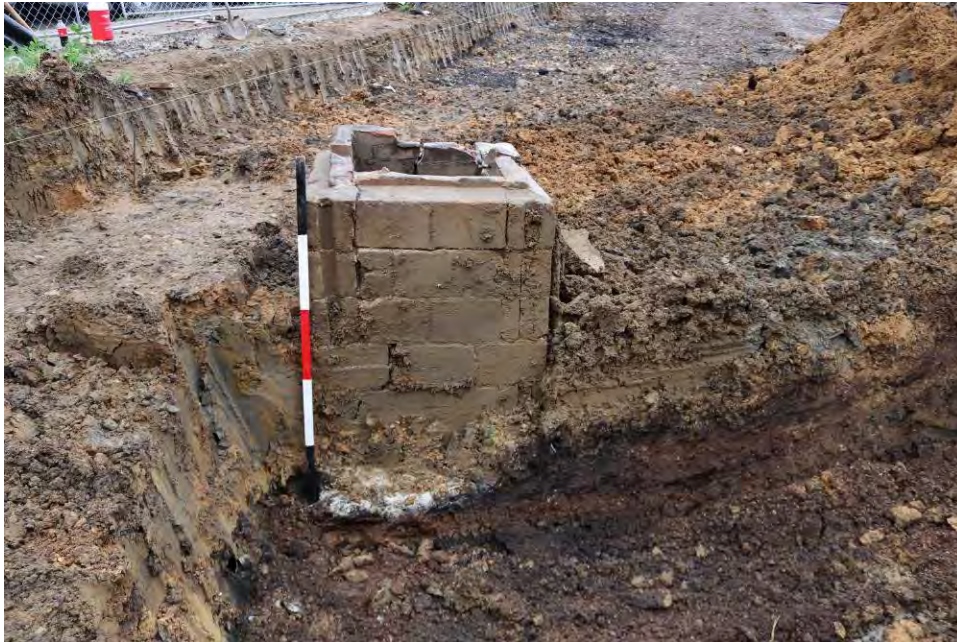
**Figure 60: Feature 40  
View to Northwest**

Feature 40 is the remains of a chimney stack in the far southwest corner of the site and is aligned at a roughly 45-degree angle to the rest of the features on the south (see Figure 32). The stack measures 3.15 by 3.25 feet and is roughly 5 feet in height (Figure 60). The exterior of the stack is constructed of large, interlocked cement bricks topped with two course of smaller red bricks that have three perforated holes. The interior was lined with cement, as evidenced by exposed pebbles (Figure 61).

The feature was located in in vicinity of the southwest chimney stack of the Alexandria Glass Works factory, as shown on the 1912 Sanborn map. The chimney appears to have been added between 1907 and 1912 and is identified as a 22-foot iron chimney stack. Feature 40 is interpreted as the remains of the interior base of the chimney, after the stack was removed.

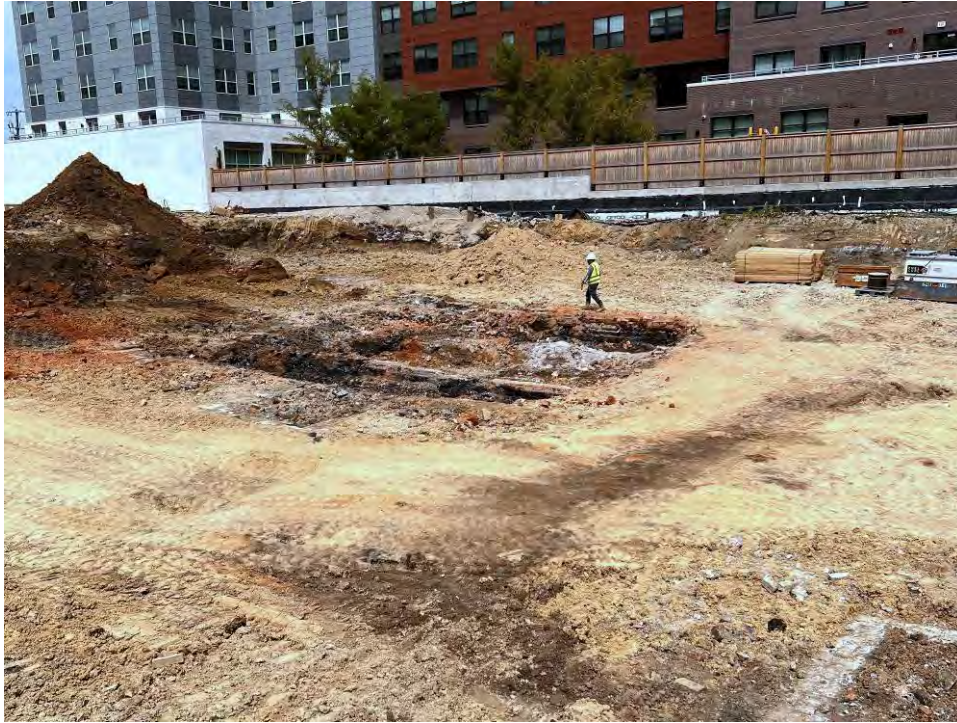
**Figure 62: Overview of Feature 41 from Feature 37  
View to Northeast**

The foundation overall measured 36 by 36 feet, but was divided into three bays, with the central bay measuring 12 feet wide and the two side bays measuring 9 feet in width (Figures 62-64). A large section of melted glass was attached to the eastern interior wall. An additional brick foundation extended to the north end of the feature; however, it was damaged during excavation and was not relocated.

This exposed section of the foundation was located at approximately 37 feet in elevation, roughly five feet below the working level of the furnace (Feature 2) and the factory floor (Feature 1), which sat at approximately 42.5 feet in elevation. The fills at the base of the block excavation consisted of primarily brick rubble; however, a large area of disturbance measuring approximately 15 by 15 feet was identified in the northwest portion of the excavation area, and overlying Feature 41. This area was designated Feature 30 but was not investigated due to the visible presence of potentially hazardous materials within the soils. The feature was survey located and recorded, but no further work was conducted.

Feature 41 fits the description of a continuous tank, which historic research indicates the Alexandria Glass Works factory used. The feature was survey located and recorded; no additional work was conducted.

The large three-bay brick foundation (Feature 41) of the Alexandria Glass Works tank furnace was located on the lower level of the factory during our archeological investigation (see Figure 82). It measured 36 by 36 feet overall, with the central bay measuring 12 feet wide and flanked by two 9-foot-wide side bays. The “working end” of the furnace was located on the upper level and consisted of the semi-circular concrete and brick foundation (Feature 20) that was much larger than was depicted on the Sanborn maps.

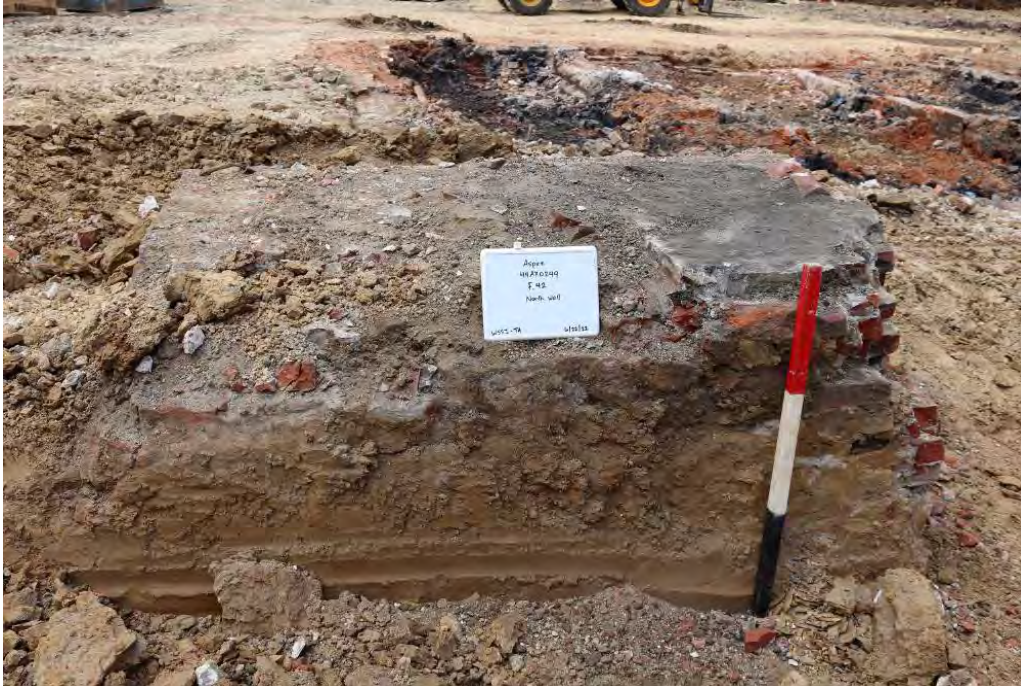
**Figure 65: Feature 42  
View to South**

Two large brick square block foundations, designated Features 42 and 43, were found 5.75 feet off the northeast corner of Feature 41, the furnace foundation (Figure 65 and Figure 66). Each feature measured 7 by 7 feet by approximately 3.3 feet in height. The top of Feature 42 was in better condition than Feature 43 and consisted of smooth concrete surface (see Figure 65). The features are approximately 8 feet apart.

The 1912 Sanborn map shows the two features were in the vicinity of the engine and dynamo room of the glass factory. Given their large size, Feature 42 and Feature 43 could be platforms for heavy machinery, and some metal (bolts?) or other fasteners were observed. Additionally, Feature 42 is situated directly below the brick lined square portion of Feature 32, and presumable was the “floor” or based of the feature (see Figure 32). The two block foundation features were survey located and documented.

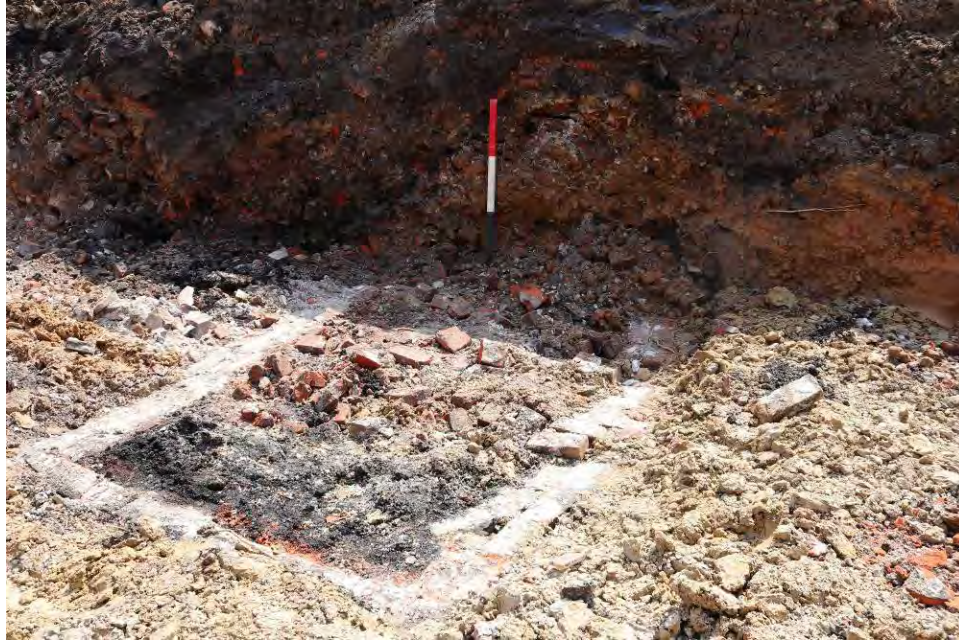
**Figure 68: Feature 39A, Southwest Corner of Flue  
View to Northeast**

Feature 39A consists of the remains of a brick vaulted flue that was located adjacent to the room containing the factory’s second gas producer, Feature 44 (Figure 67). The arched brick ceiling of the flue had collapsed and was only partially visible in the fills over the foundation during the initial machine excavation (Figure 68 and Figure 69). It is not clear if the flue extended the entire length of the 30-foot foundation, as a circular opening (Feature 39B) measuring approximately 4.2 feet in diameter was exposed in the floor at the eastern end of the feature (Figure 70 and Figure 71).

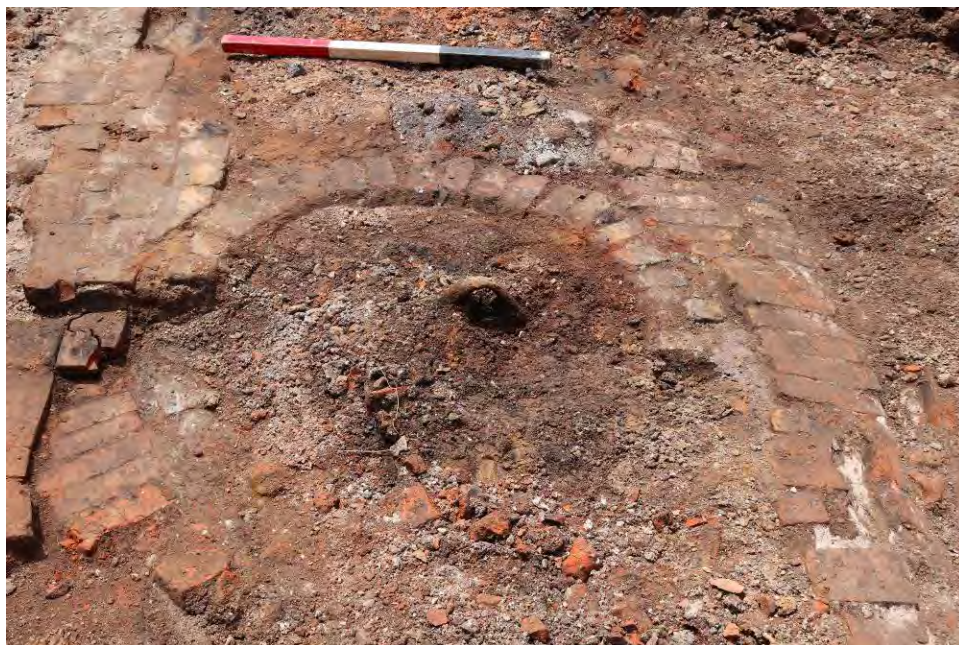
**Figure 71: Feature 39B, Possible Gas Flue Access  
View to West**

This circular feature is similar to the “gas flue access” documented at the Virginia Glass Company excavations which was used for maintenance access to the flue (Pfanstiehl et al 1999: 8-11; 8-13). Two of the bricks in the floor on the east side of the access opening were stamped “POWHATAN” (Figure 72) Another brick was stamped “... EECH CREEK” (Figure 73) and was likely produced at the Beech Creek factory in Pennsylvania (1900-1944), which produced refractory brick for various industries, including glass factories (Albertveron 2007).

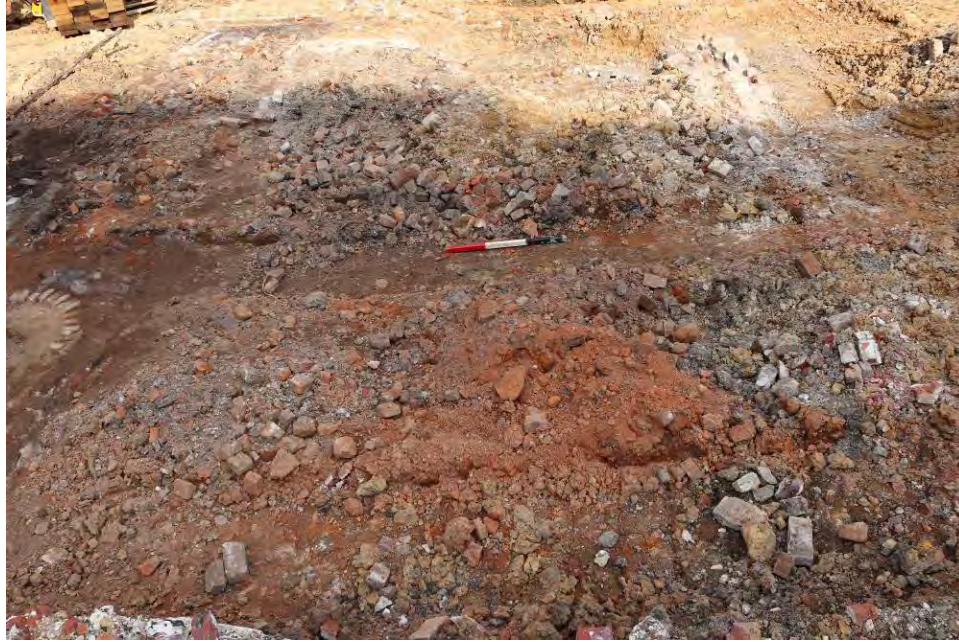
**Figure 75: Feature 44 Overview  
View to West**

Feature 44 was a brick foundation adjacent to Feature 39 that measured approximately 17.5 by 30 feet (Figure 75). The floor of the room was exposed at 7.6 feet below the top of the foundation (Figure 76). According to the 1912 Sanborn map, this was the location of the second gas producer in the factory. A circular brick foundation was partially exposed in the center of the floor, surrounded by a sandy matrix and it is not clear if the entire floor had been paved. The excavation was too deep to allow for safe visual inspection of the floor. The northern wall of Feature 44 was also the northern end of the main factory building.

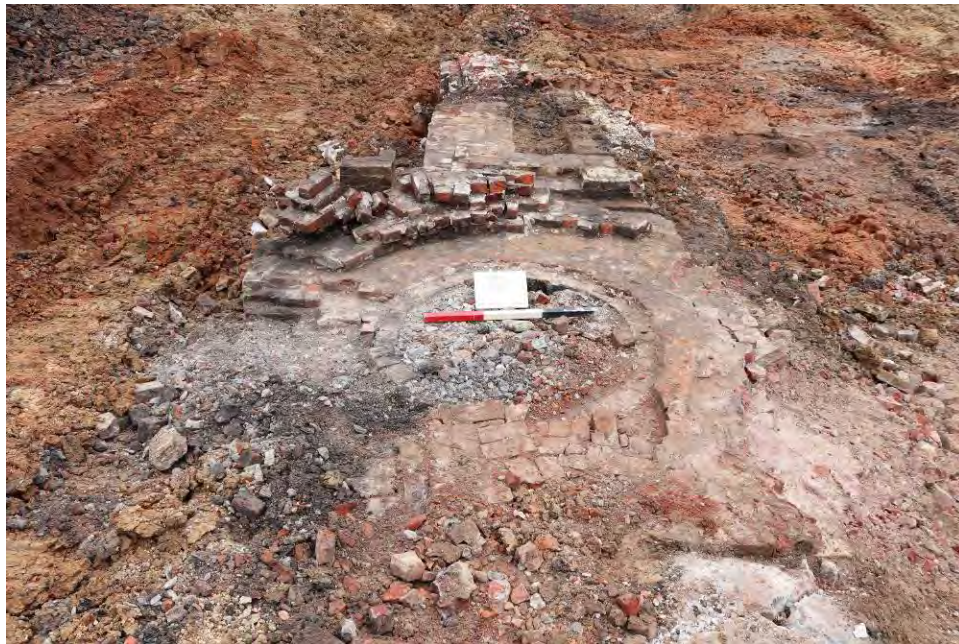
**Figure 77: Features 45 and 46 Overview,  
View to South**

The foundation of the main brick smokestack, designated Feature 45A, was located during the garage excavation monitoring. The feature was covered with brick and glass destruction rubble (Figure 77 and Figure 78). The foundation measured approximately 10 by 9.6 feet and the circular opening in the floor of the foundation was 4 feet in diameter. The remnants of a second circular ring were documented along the south side of the feature, which was 5 brick courses high, and possibly extended entirely around the smaller interior opening. A brick vaulted air flue (Feature 45B) was located beneath the smokestack and was exposed in profile during the excavation of Feature 44 (Figure 79).

These features are found in the same approximate location as the 60-foot brick chimney stack at the northern end of the factor, as shown on the 1907 and 1912 Sanborn maps (see Figure 67). No further work was conducted on the features after the documentation.

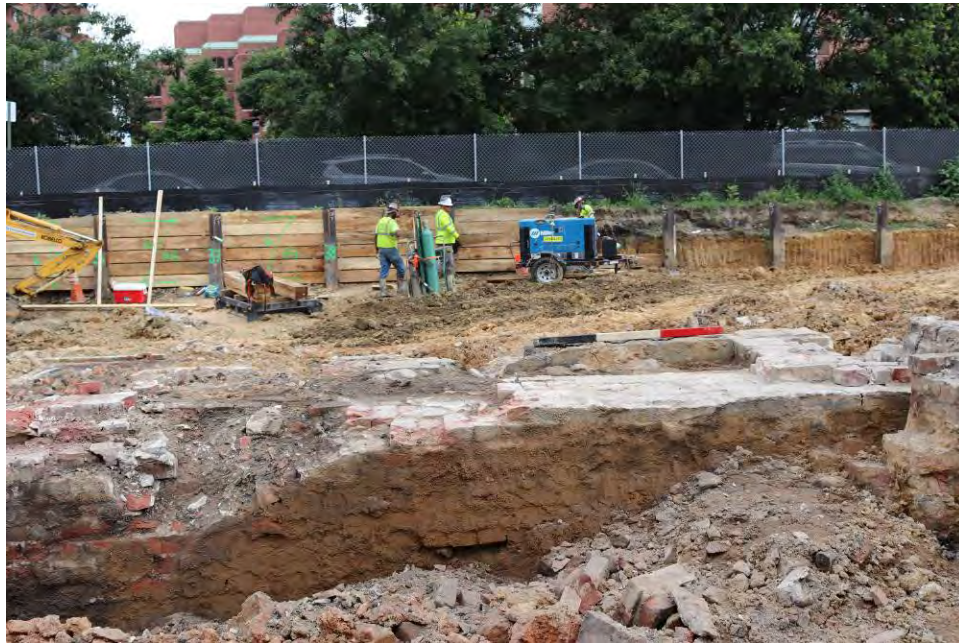
**Figure 80: Feature 46  
View to West**

Feature 46 is a brick foundation wall that abuts Feature 45 and extends southward from the east central portion of the smokestack foundation (Figure 80; see Figure 67). The section of the wall that was exposed measured about 15 feet in length and 2.1 feet in width. A brick pier, measuring 1.1 by 1.1 foot was located off the northeastern corner of this foundation. A second brick foundation wall ran parallel to Feature 46, separated by a one-foot gap that was filled with destruction rubble. A four-foot section of this second wall abutting the western side of the smokestack foundation was constructed of cinderblock, which was the construction material for Tony's Auto foundation – and which is shown in this location on our base map (Figure 81). It is possible that portions of the earlier brick foundations were reused during construction of the later 20<sup>th</sup> century building and infilled with cinderblock.

Feature 46 matches the location of the horizontal steam boilers in the northern part of the factory building. The 1907 and 1912 Sanborn maps show the boilers resting on a brick floor or enclosed by brick walls, which is similar to the other 3 glass factories in Alexandria.
