**FINAL REPORT**

**ARCHEOLOGICAL EVALUATION OF THE ADDITION  
TO 111 N. ALFRED STREET AT SITE 44AX96  
IN ALEXANDRIA, VIRGINIA**

**Daniel Koski-Karell  
Karell Archeological Services  
Post Office Box 342  
Washington, D.C. 20044**

**12 December 2002**

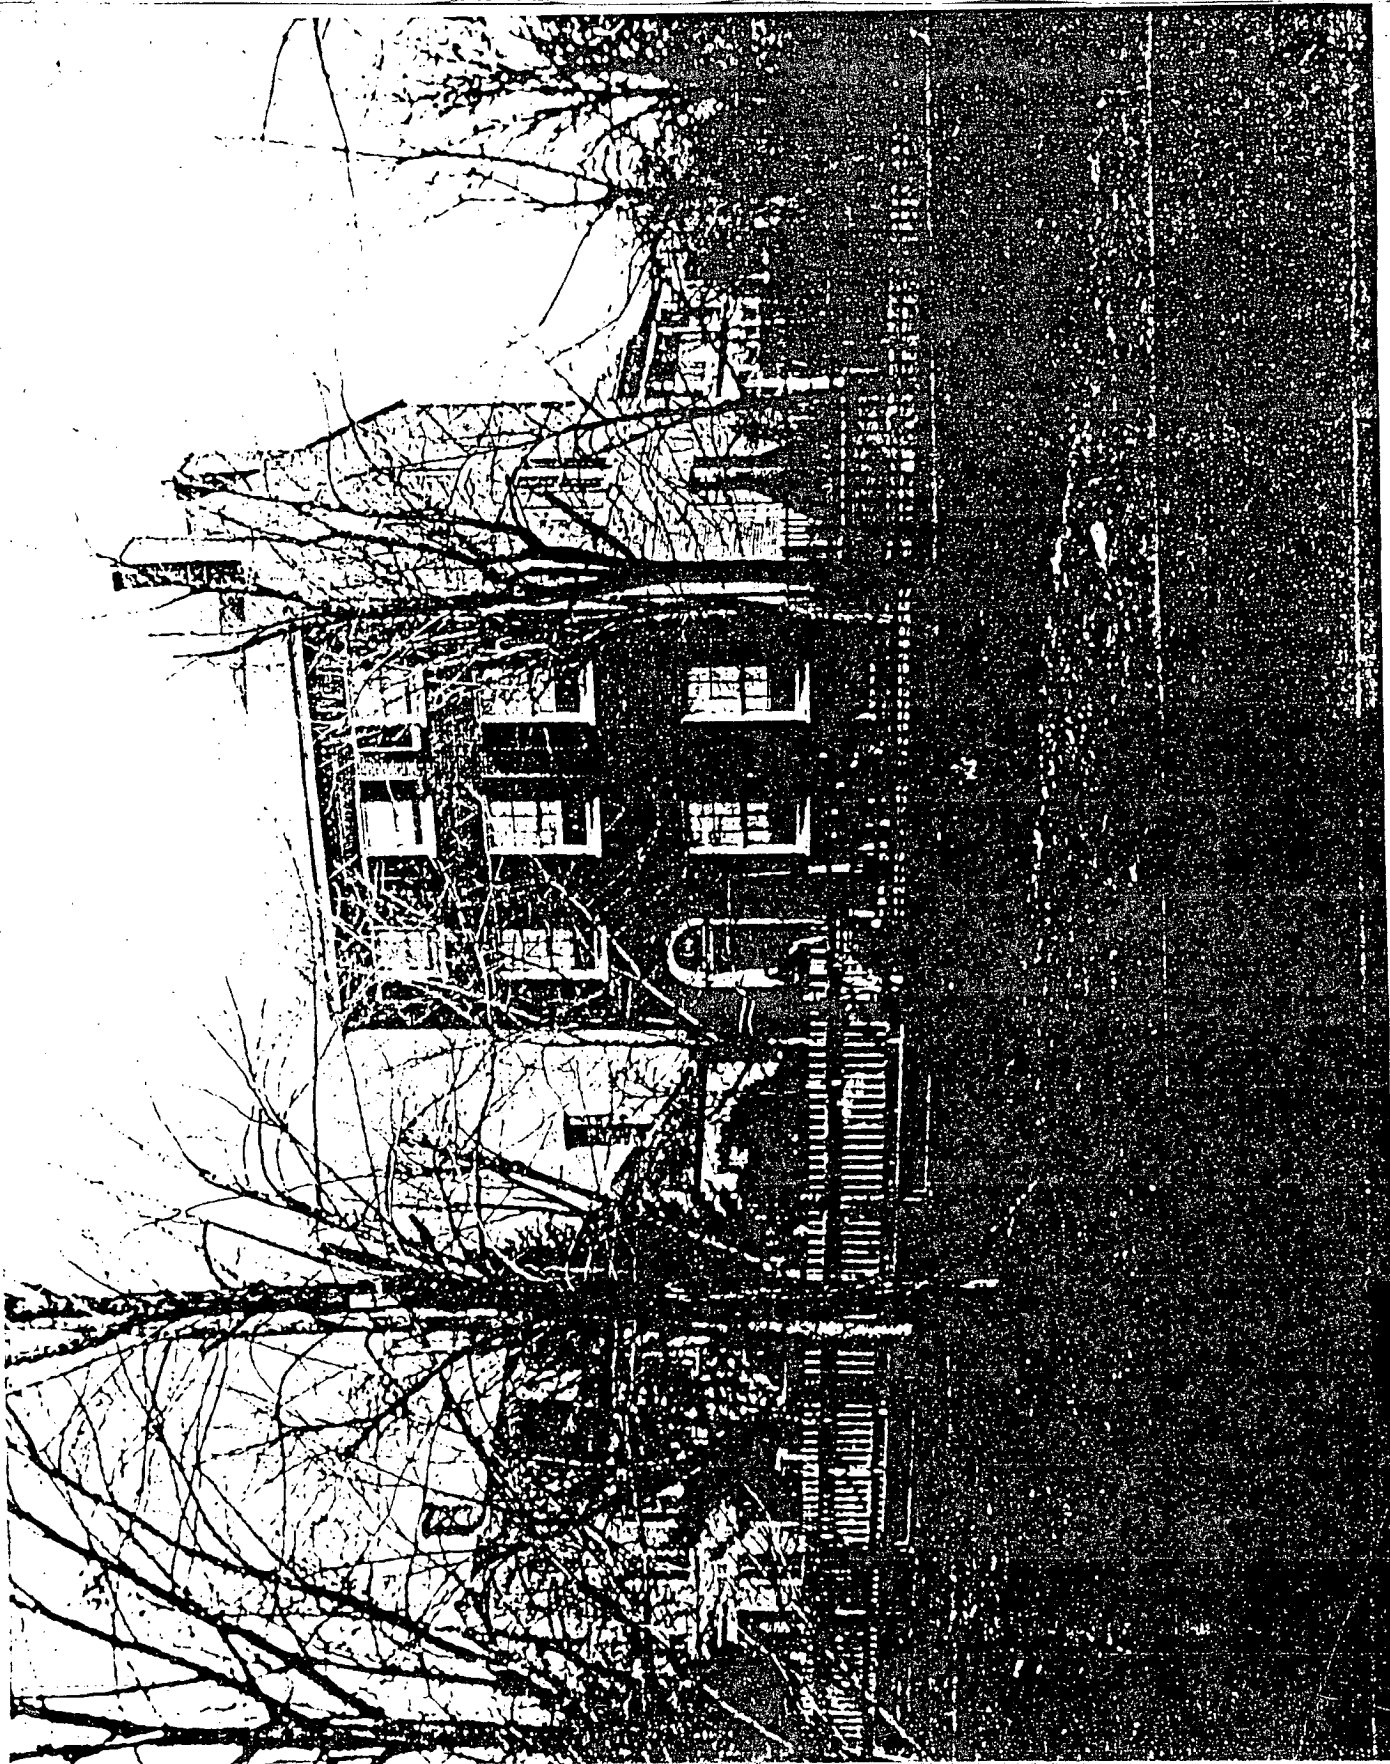
Figure 2. Nineteenth Century Photograph of 111 N. Alfred Street

The addition is designed to resemble a two story-tall frame porch that formerly occupied its location. That porch appears in a middle to late nineteenth century photo of the house (see figure 2).

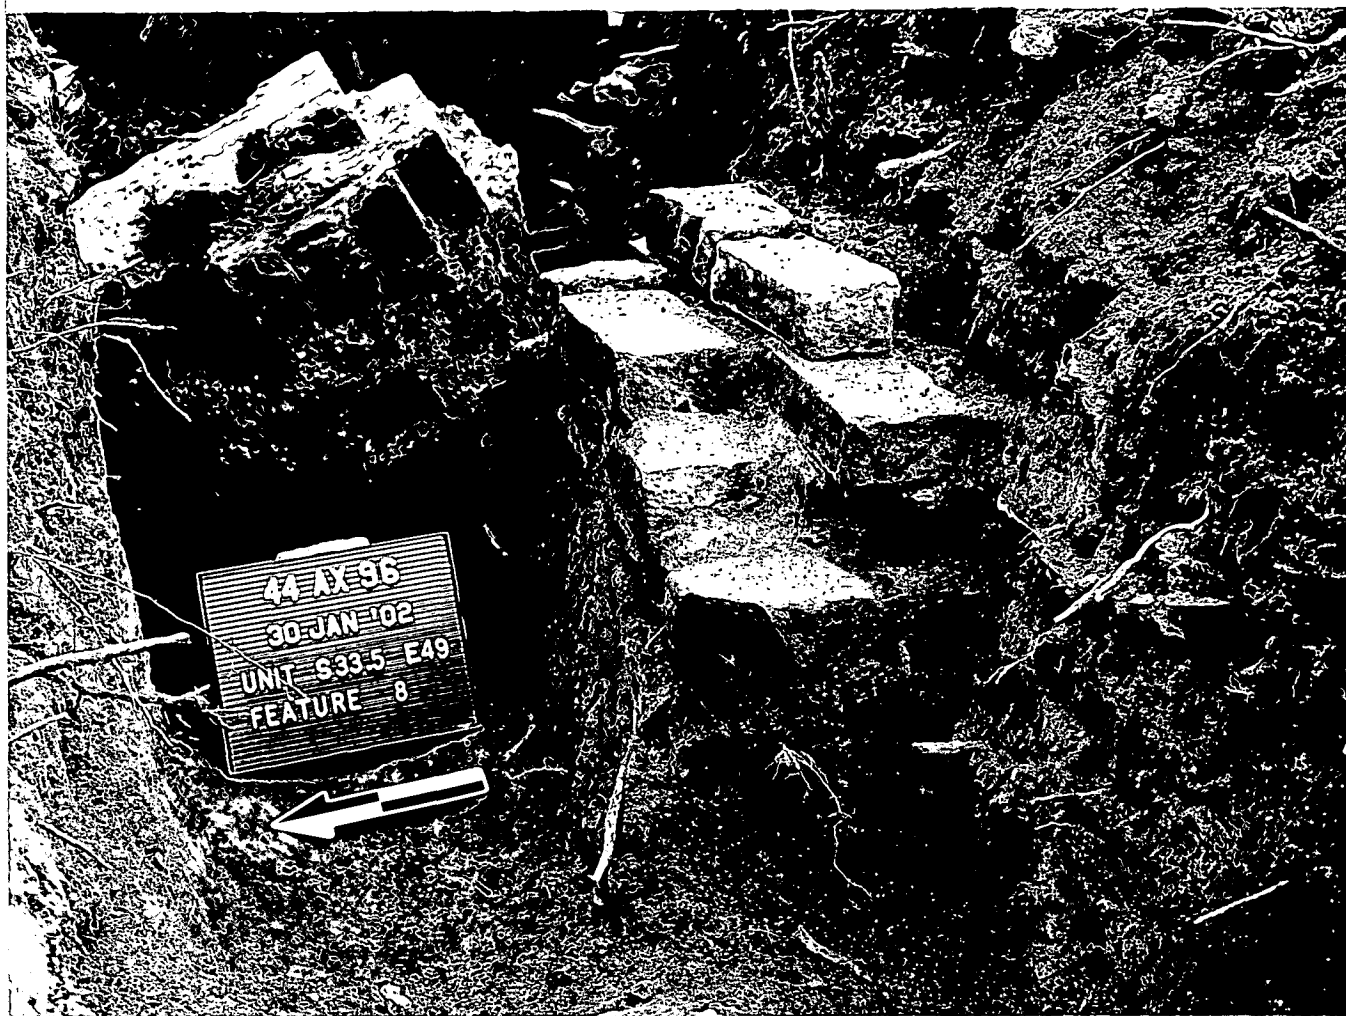
## 12. Profile of Unit S33.5 E49, South Wall

A vertical profile drawing of the southern wall of S33.5 E59 is provided as Figure 12. The surface consists of a layer of mixed topsoil for most of its length, with the eastern end consisting of a layer of asphalt paving over a layer of gravel mixed with soil at its base. Underneath this are two layers of mixed fill soil. The upper fill layer extends from the base of the gravel down to the upper part of the two brick footings for the former frame porch that stood on this side of 111 N. Alfred Street. The second fill later extends from there down to the base of the brick wall that is below the level of the porch footings. Both these layers of mixed fill contain nineteenth century artifacts.

The upper fill layer containing nineteenth century artifacts may contain soil deposited at this location during the twentieth century. Since this soil layer is above the level of the frame porch's masonry footings, it appears to have been deposited after the frame porch was dismantled.
