Fort Ward
Alexandria, Virginia

Exploratory Excavation
of the Northwest Bastion

by Edward McM. Larrabee
Contracting Archaeologist

August 28, 1961

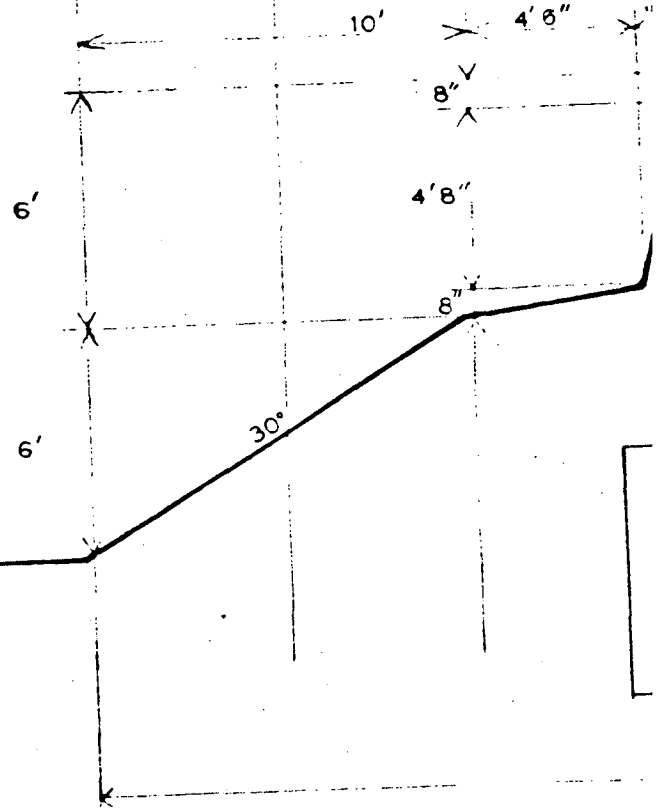
The bottom of the Filling Room depression was a deposit of this mixed brown fill at least 4 ft. deep, as tested by auger below the floor of our trench. At the front end of this section the distinctively colored strata appeared, but were somewhat broken. The same was true at the back, in Square 10. The strata there ran level and then sloped down into Square 9 to the front. The width of the disturbed area was between 13 ft. and 15 ft. The wooden structure of the Filling Room must have rested within this area. However, the condition of the disturbed strata and the absence of any trace of wood suggested that the timber structure had been dug out and removed.

PROFILE OF FILLING ROOM as excavated & as surveyed, 1865

No artifacts of any significance were found in this trench, nor any structural features other than those shown in the profile. The profile, however, revealed the location of the Filling Room, and the construction of the earth fill which covered it.

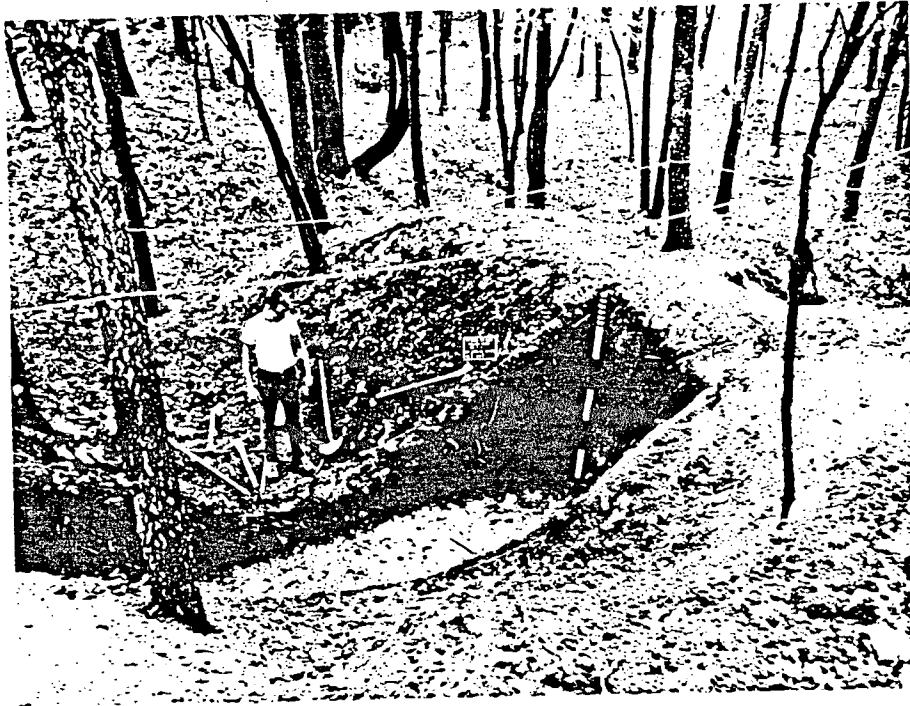
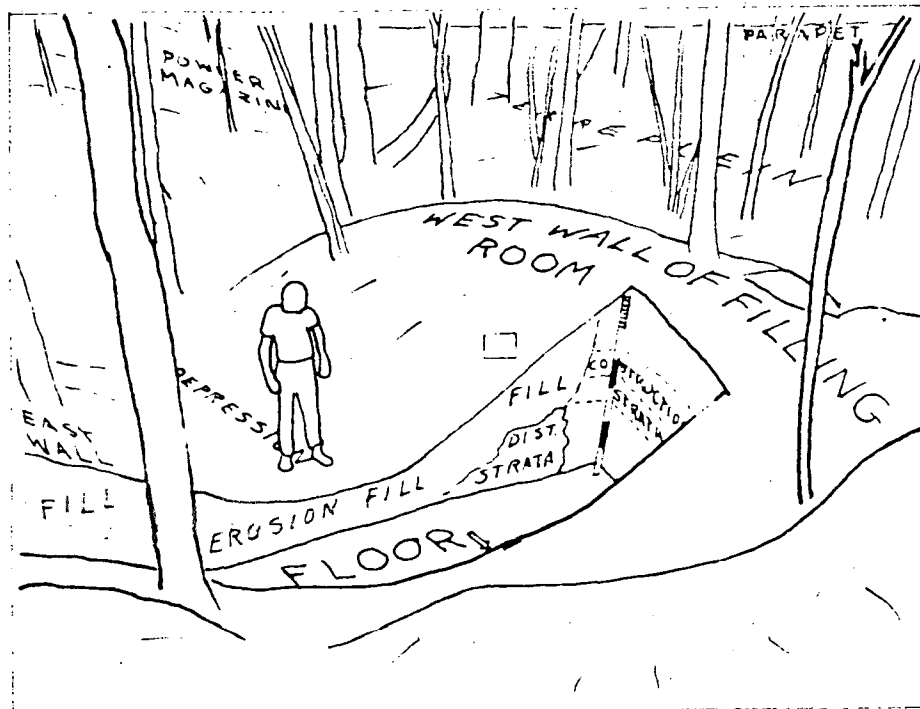
DIAGRAM OF PLATE III
TEST TRENCH ACROSS FILLING ROOM DEPRESSION

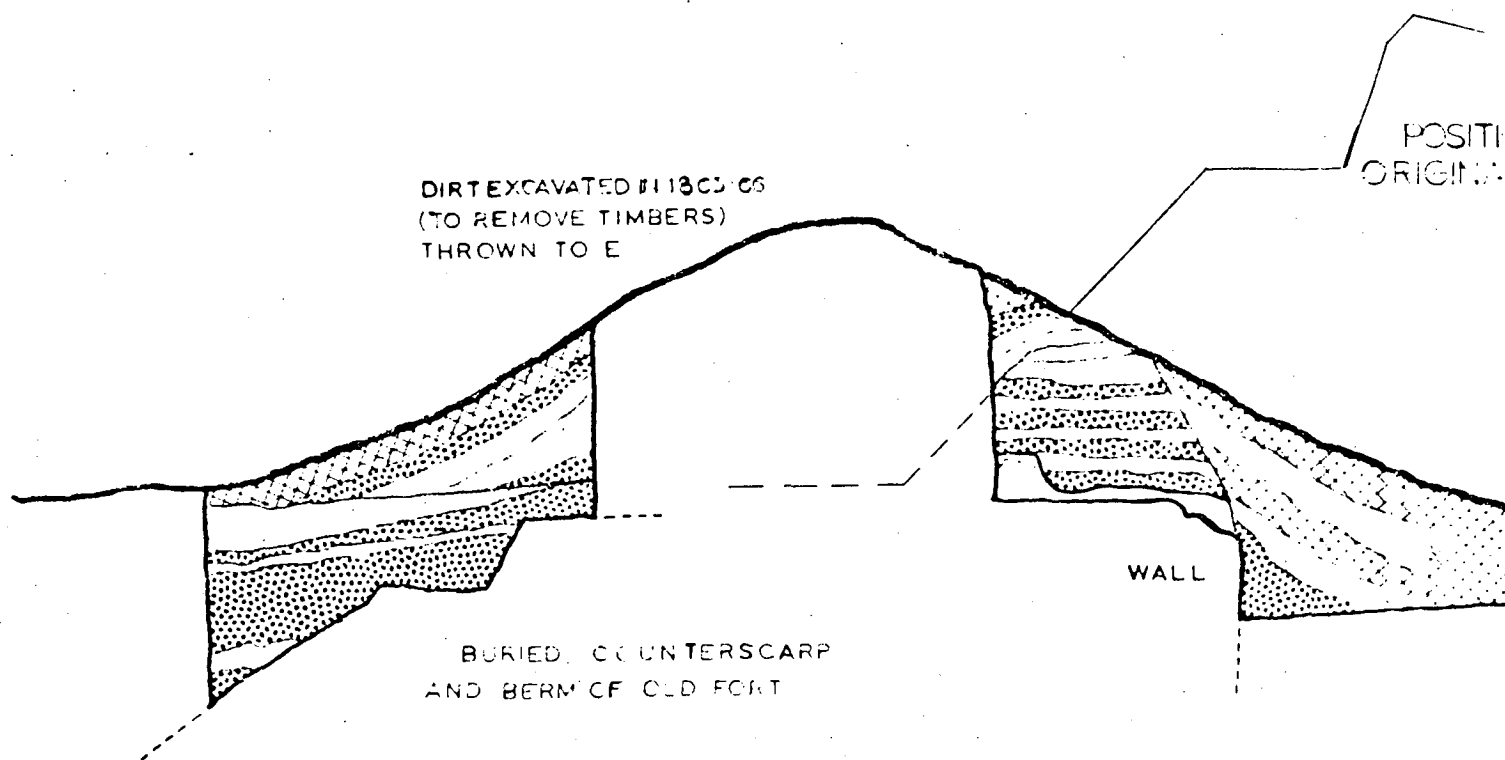
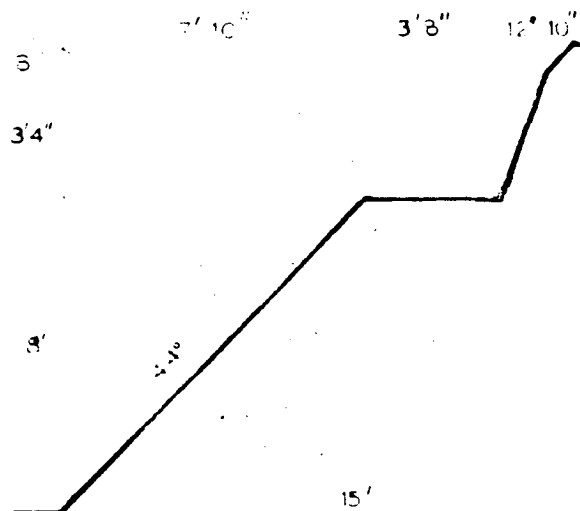
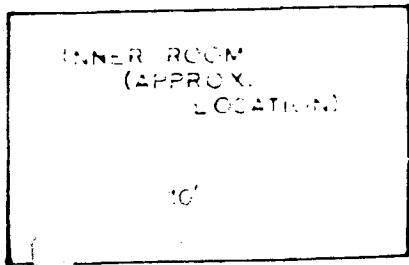
as excavated, 1961, & as surveyed, 1865
drawing no. 7

Within Square 4 we found a vertical wall cut into the undisturbed soil. The floor of this military excavation was 8 ft. below the original ground surface. At least another 5 ft. of earth is packed on top of the original surface now. At one time there must have been perhaps twice that much. The wall was very slightly undercut, but presented a flat surface, so that the bottom was perhaps 3 in. W of the top.

In Squares 8 and 9 another wall was found, although it was not as sharp as that at the front of the Magazine. The entire natural stratigraphy of the Fairfax soil was well preserved here, with tamped horizontal layers of fill above it. At the top of Square 9 the tamped construction strata were no longer distinct. There seemed to be a buried surface of the tamped fill, slanting down to the E. The distance between the front and back walls cut into the undisturbed soil was 21 ft. at the original surface level. Since both walls were slightly undercut, they were probably about 22 ft. apart at floor level, 8 ft. or 9 ft. below the original surface.

PROFILE OF POWDER MAGAZINE

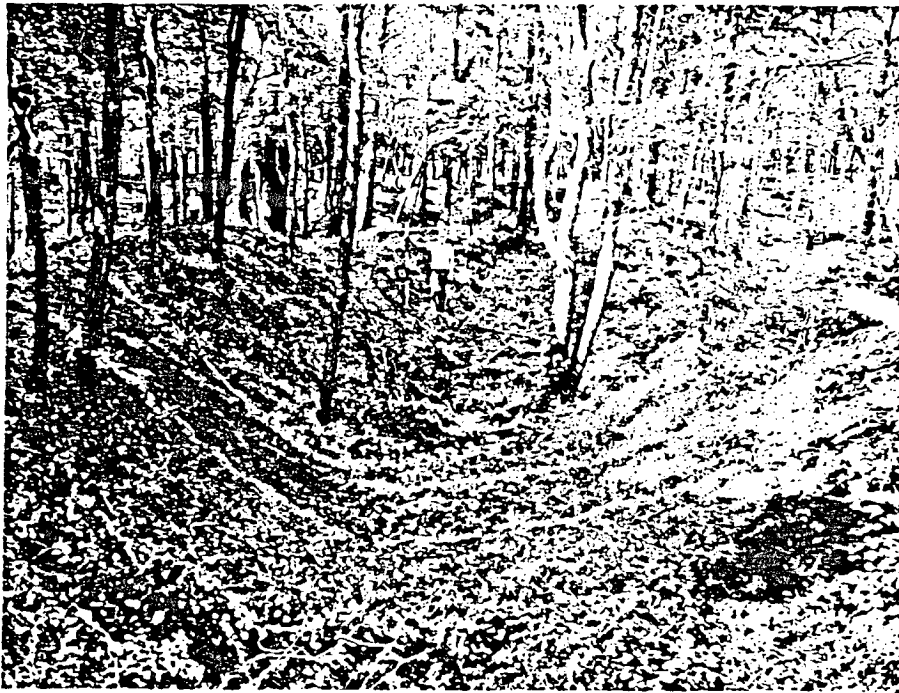
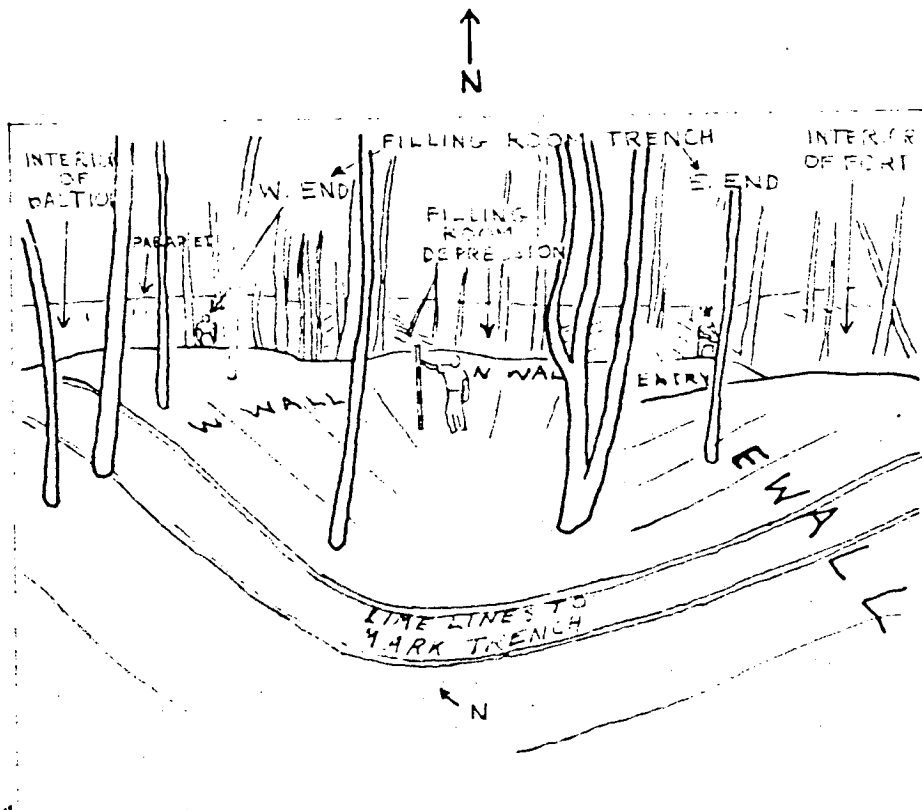
DIAGRAM OF PLATE IV
POWDER MAGAZINE DEPRESSION MARKED
FOR EXCAVATION

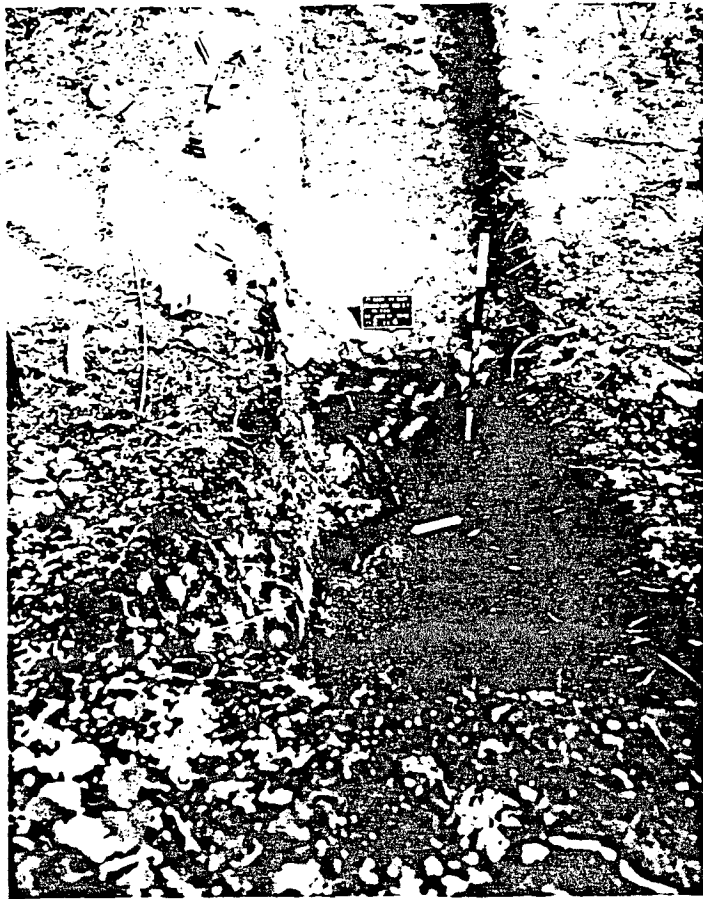
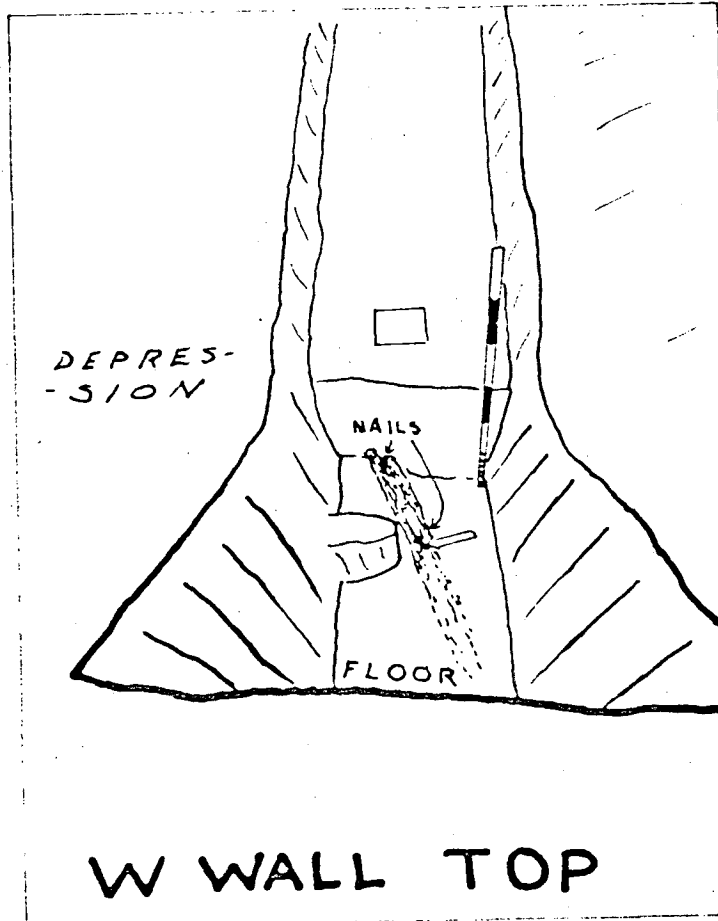
PLATE VI
28 JUNE 1961
15:15
F.P. 2, Ex. 4

DIAGRAM OF PLATE VI
ROTTED BEAM AT W
END OF POWDER
MAGAZINE TRENCH

A rotted beam, the only piece of wood found in situ, was uncovered while clearing the floor. This was apparently a half-round split log, about 6 in. in diameter, lying with the flat side up. Two 8 in. cut nails were found driven through it, point up. It was across the trench at an angle, so that only 8 ft. were uncovered. The fragmentary condition made it unclear whether it was once longer. The E end of the beam was resting higher than the W end. Presumably the flat side of the log had once rested against the earth wall to retain it. When other wood was removed and the earth cover fell in, the top of this log was forced away from the wall to its present position.

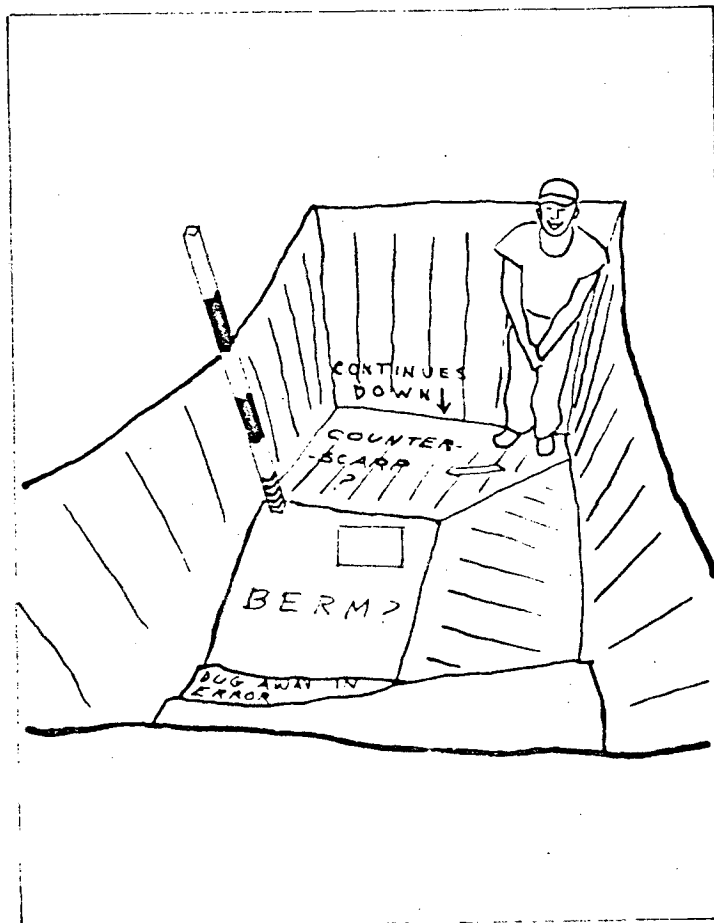
PLATE VII

BURIED DITCH OF OLD
FORT AT E END OF
POWDER MAGAZINE
TRENCH

An extremely interested feature was found in the bottom of Squares 12 and 13. The original surface had been cut away through the hardpan to produce an 18 in. step and a 40° slope down toward the E. This step and slope were later buried by a thick layer of red subsoil. We did not cut through this early excavation, but removed the red subsoil fill and cleared the step and slope. The slope continued down into Square 14, which we did not dig. Consequently we do not know the full depth of the buried feature.

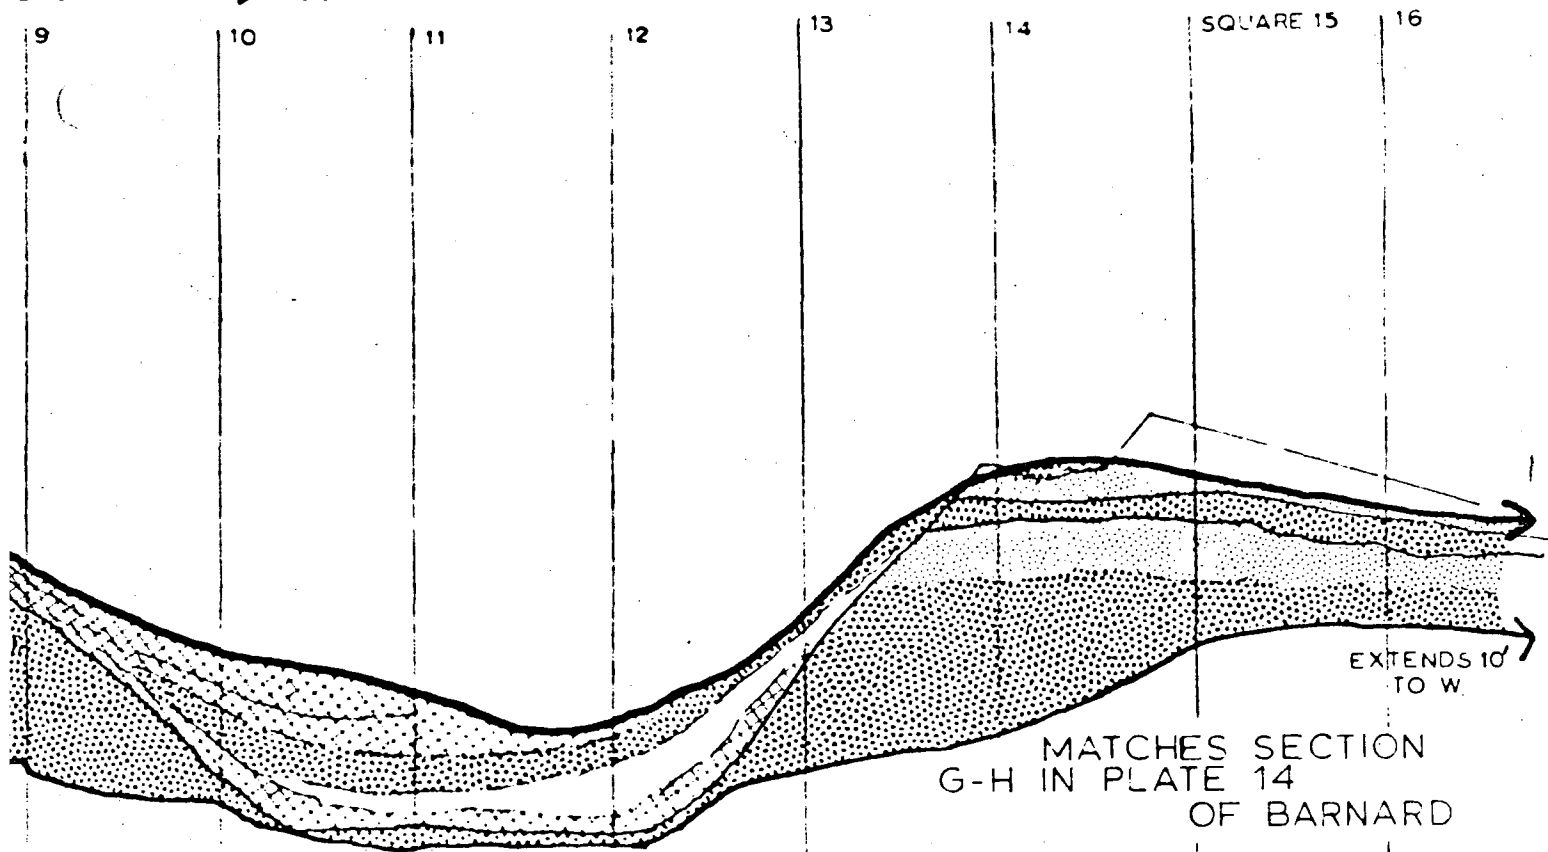
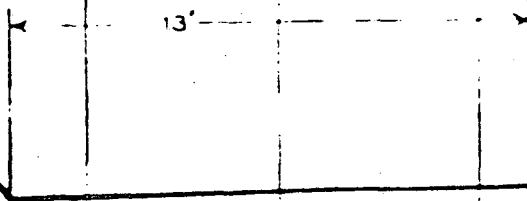
PARAPET & DITCH
as excavated, 1961, & as
surveyed, 1865 drawing no. 5

The inner end of the trench showed the ramped earth of the S side of the gun platform along the N face of the trench. This platform had been disturbed when the timbered floor was removed, so that we found a line of excavation along the center of our trench. From 13 ft. to 16 ft. W of the E end of our trench, an area of deep disturbance was visible along the S face. This cut about 18 in. below the surface which had been the banquette tread. At the W end of this disturbance were stratified construction layers. A surface was cut rising at an angle of more than 60° to the present surface. The deep disturbance was interpreted as the excavation for the buried bottom of the vertical poles which revetted the breast-height at the time of timber removal. The pole revetment probably rose at about a 75° or 80° angle and loose dirt was packed between the poles and the more stable 60° slope of the construction fill. The top of the breast-height (pole revetment and 16 in. sod topping), which is synonymous with the crest of the interior slope and of the superior slope, was about 2 ft. 6 in. above the present surface here.

(1865 SURVEY FIGURES FOR DITCH AND COUNTERSCARP DIFFERED FROM 1961 MEASUREMENTS)

Most of the crest of the glacis slope had been eroded, so that it was impossible to determine its original height from purely archeological evidence. The general surface of the glacis slope was quite clear, however, and was very close to the slope today. This glacis had apparently been carefully built up, since the original top soil had been removed, down to the hardpan and then 18 in. of dirt packed on top of it and sloped down to the W, to bring the entire glacis slope within the direct line of fire from the superior slope of the parapet.

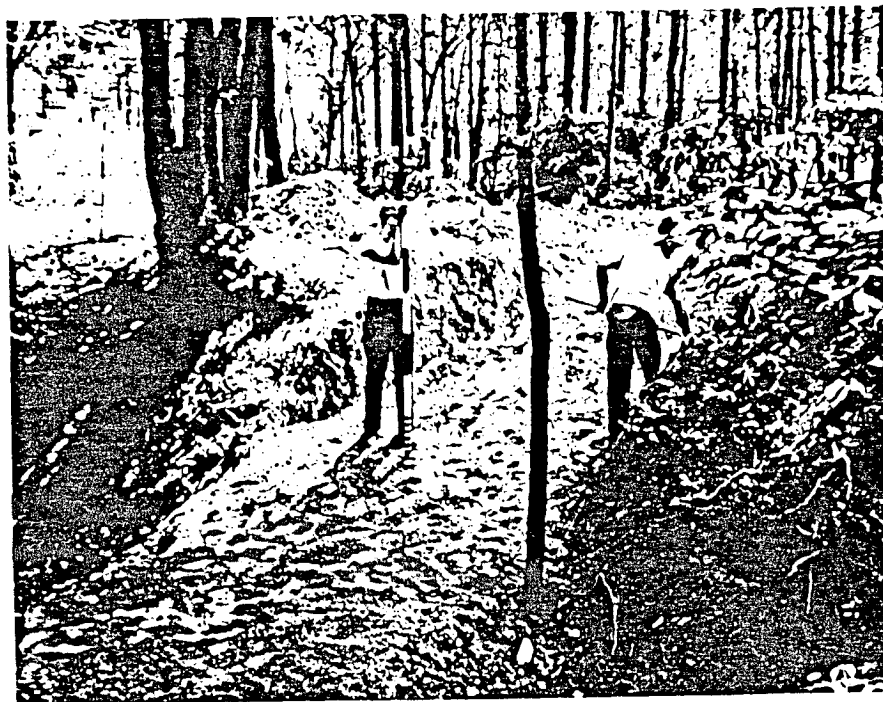
PLATE VIII

20 JUNE 1961 15:30 35mm ROLL I, Ex. 8
WIDE TRENCH AND RAMP CUT THROUGH
GLACIS AND COUNTERSCARP

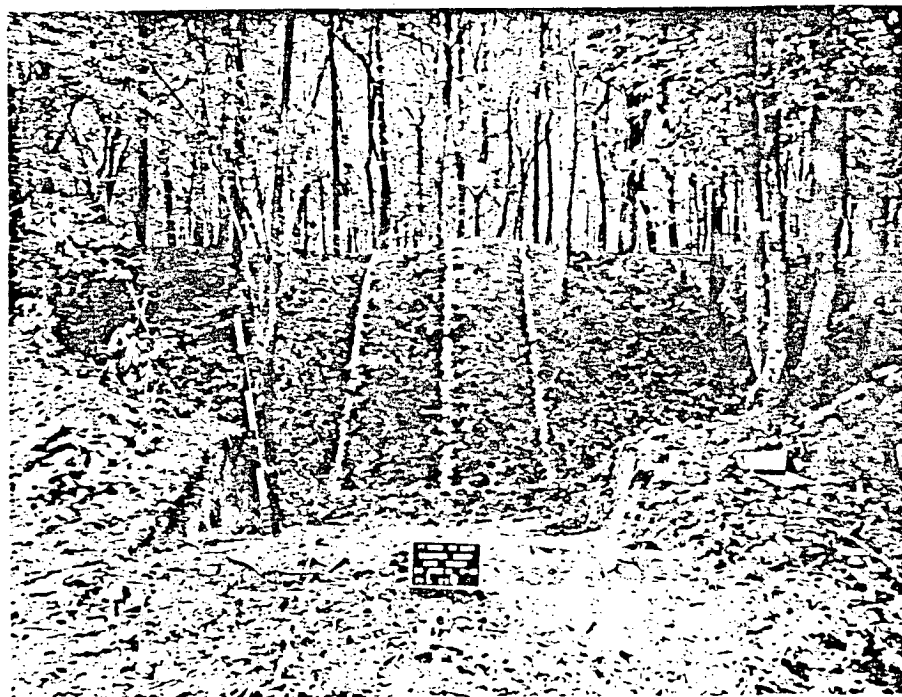
PLATE IX

23 JUNE 1961 8:45 F.P. I, Ex. 8
PARAPET AND WIDE TRENCH THROUGH COUNTERSCARP
SEEN FROM GLACIS. WHITE LINE ON LEFT RUNS ACROSS GUN EMBRASURE
DEPRESSION IN TOP OF WALL

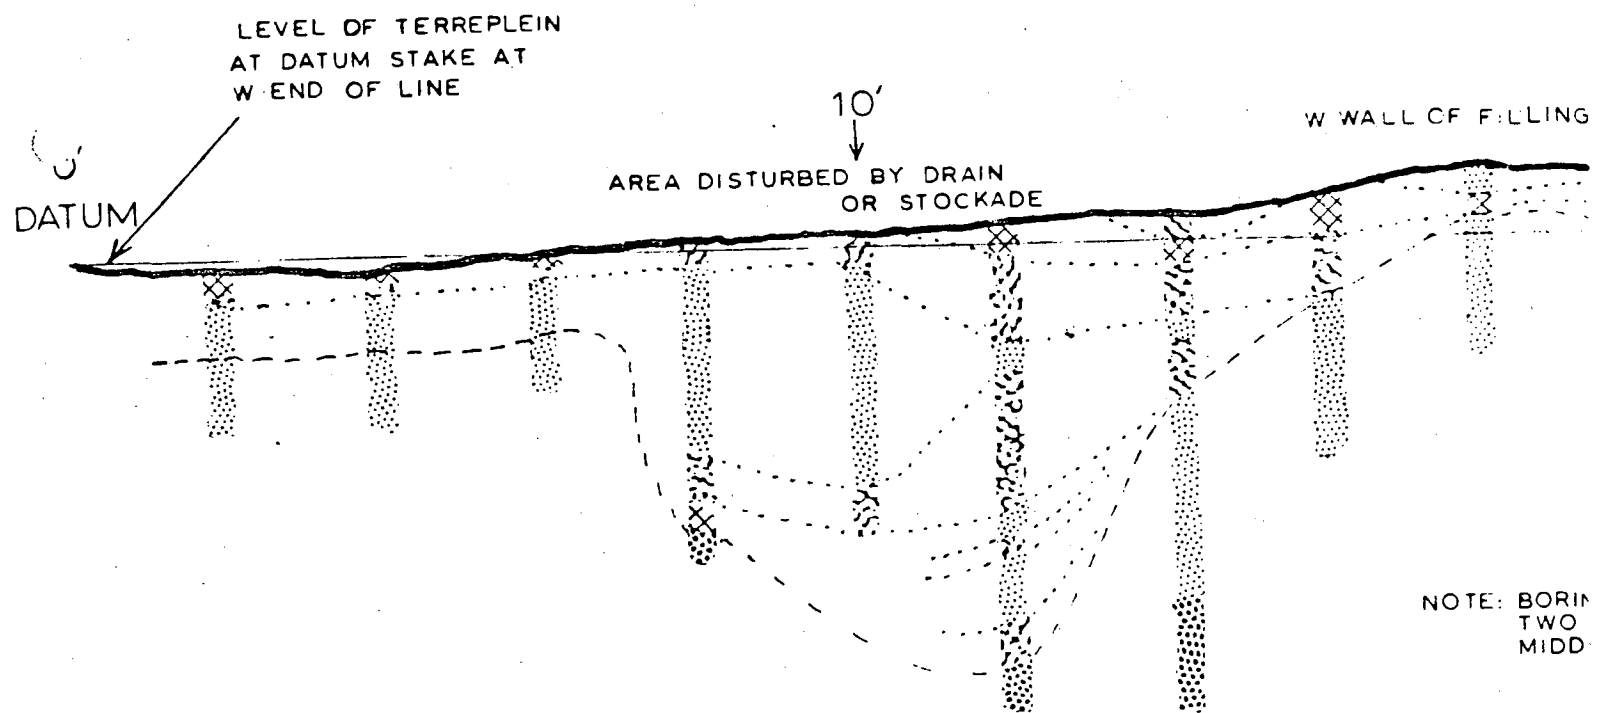
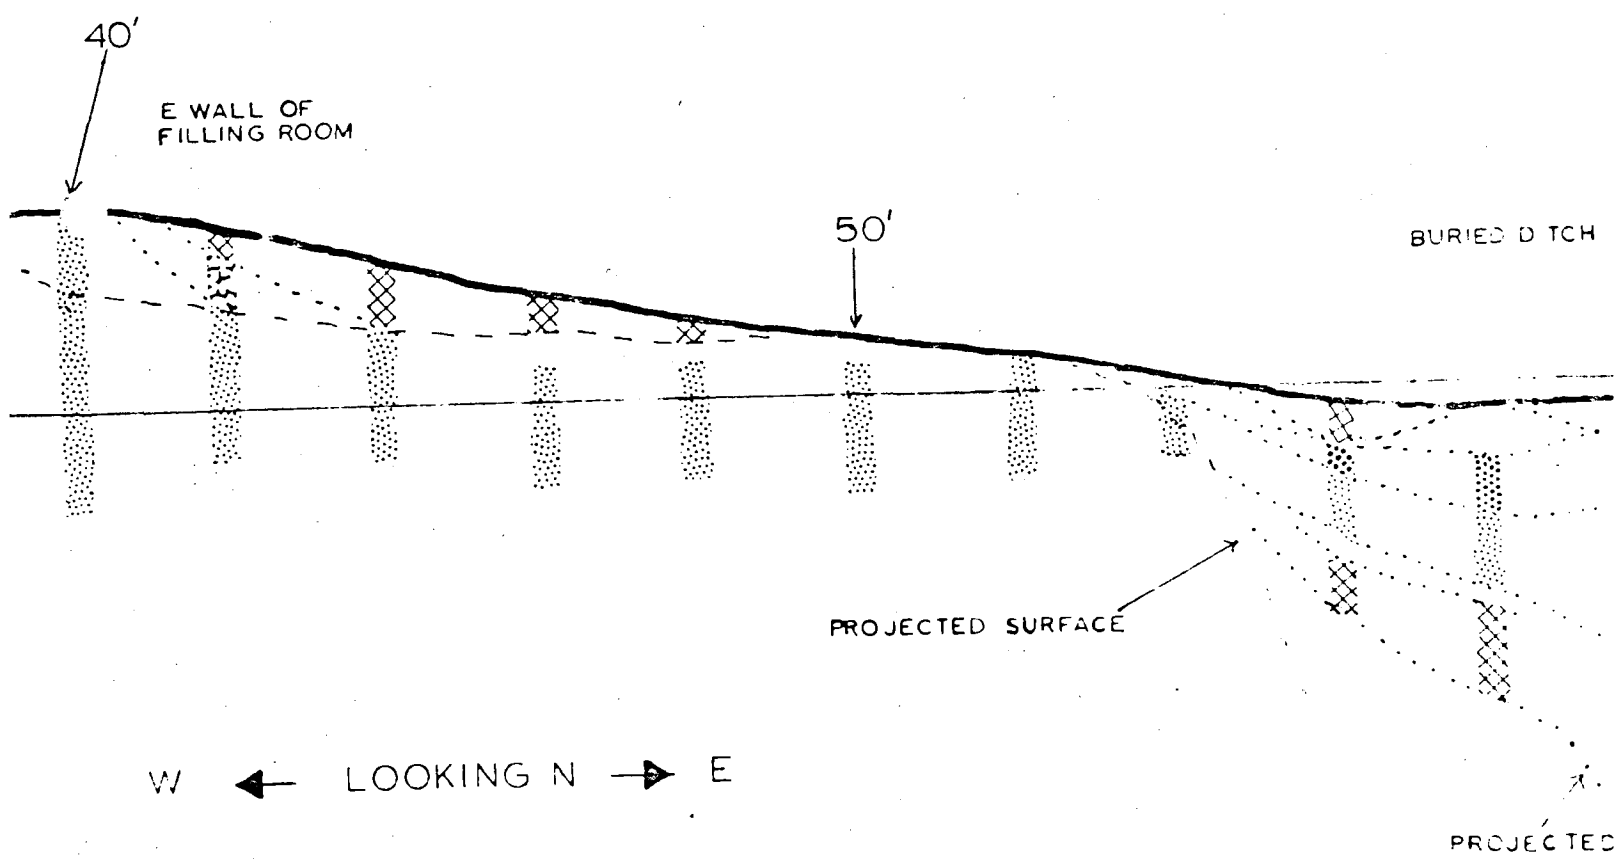
PROFILE OF AUGER

The disturbed areas were by the entrance of the Filling Room (30 ft. from the W end of the line) and where the auger line crossed the buried ditch of the old fort (56 ft. to 68 ft. from the W end of the line.) Another area of disturbance was detected from 8 ft. to 14 ft. from the W end, in front of both the Filling Room and Powder Magazine. The most likely explanation for this is that the wooden box drain located N of this point drained under here. It is possible that the palisade suggested in Historic Plan 170-134 ran here, and was dug out. This palisade would have completely closed the gorge of the bastion. The slopes, counterscarp and scarp of the buried ditch behind the fort were clearly evident from the readings.

A line 80 ft. long approximately E-W was marked with lime. It ran along the narrow gap between the S end of the Filling Room and the N end of the Powder Magazine, paralleling the test trenches N and S of it. At 2 ft. intervals cross bars were marked with lime. The holes were bored until rock, roots, or hard pan made it impossible to turn the auger. Depth of holes ranged from 8 in. to 96 in. Each sample (representing from 3 to 4 in.) of soil was placed on paper separate from the preceding sample. These samples were described as to color, mixture, and consistency, and then the holes were refilled.

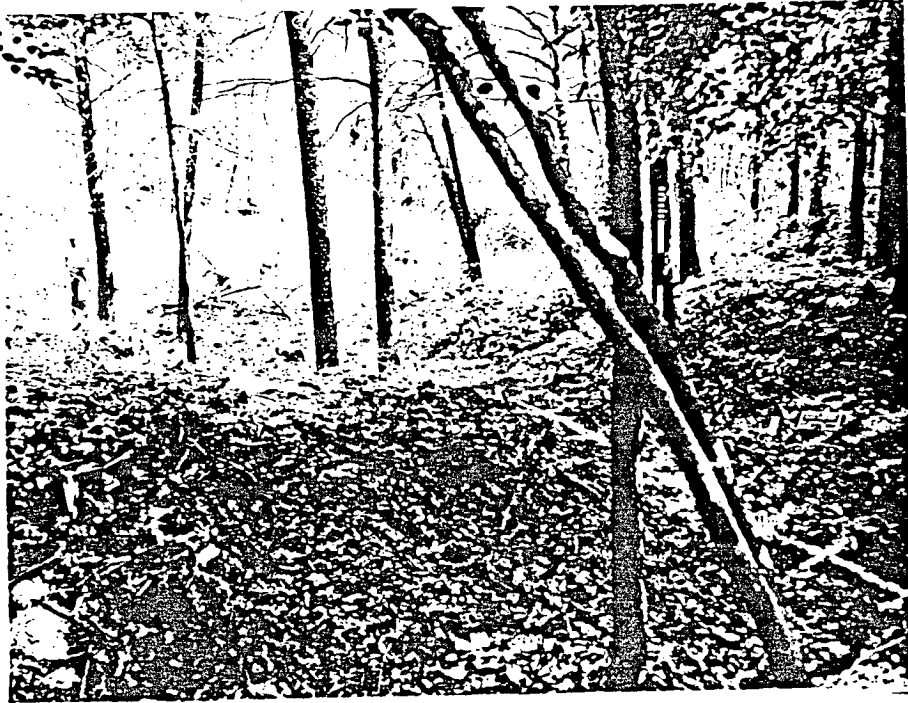
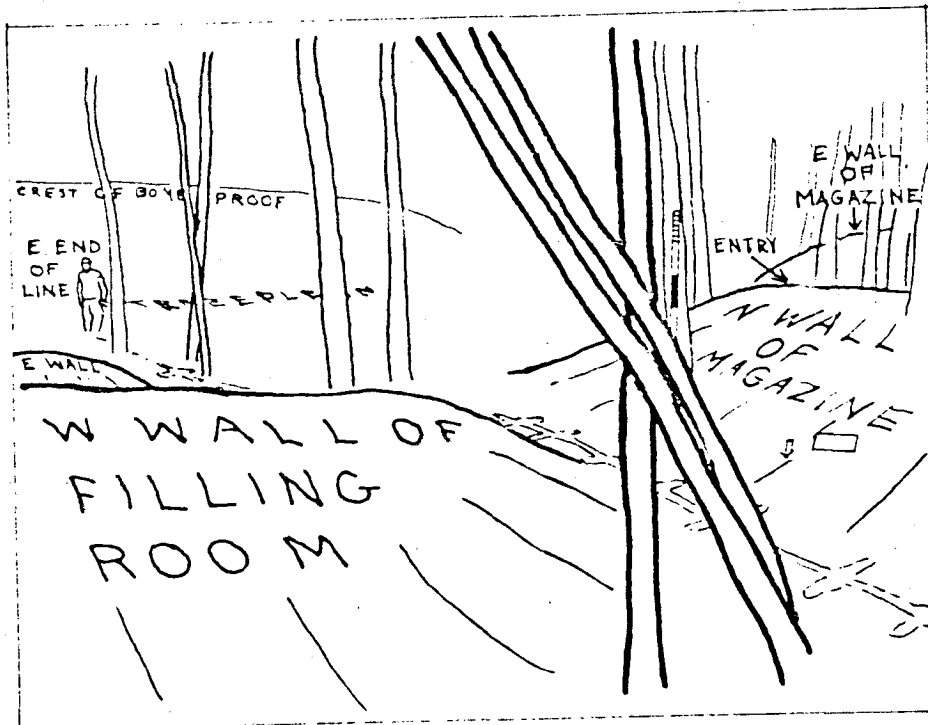
PLATE XIV

AUGER TEST LINE MARKED BEFORE BORING

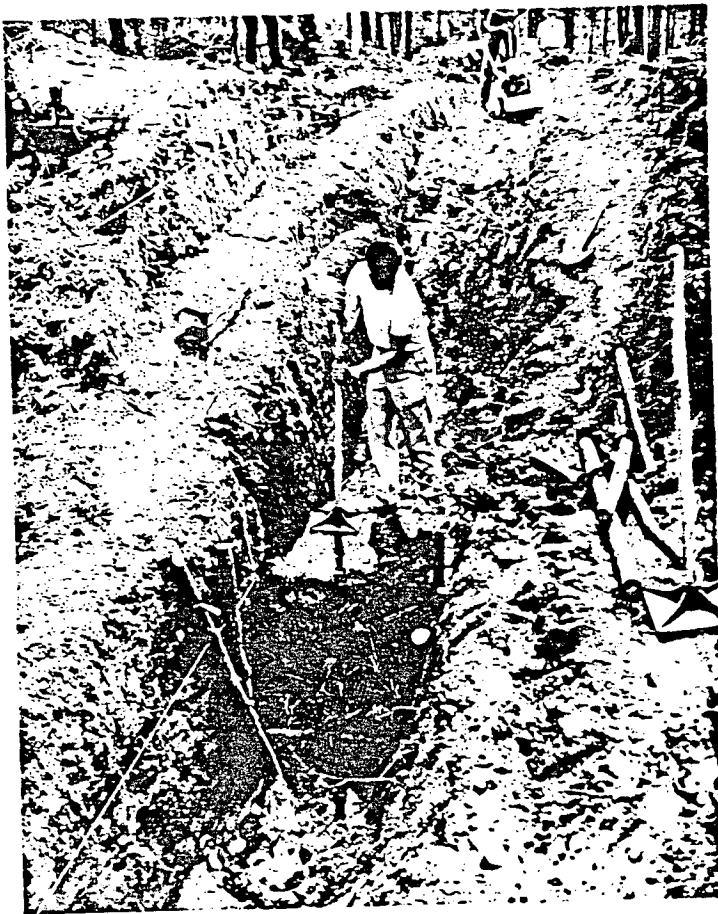
HAND TAMPING
BEHIND WALL OF
SOD BLOCKS IN
COUNTERSCARP

The surface of the scarp-exterior slope we built by pegging long rolls of sod at the bottom, and packing dirt behind them as we unrolled them up the slope. Otherwise we could not make the dirt stay where it was thrown. The narrowness of the restored section here (2 ft.) was a particular disadvantage on the upper part of the slope. Here our restored section projected beyond the present eroded surface, and the sides of our section tended to fall away. Also we found that it was very difficult to work on the exterior slope, even now, since it was too steep for a person to keep his balance. This is why the military engineering handbooks of the day specified that slopes should be built up as a series of steps to the desired steepness. They were cut smooth only at the final stage of construction.

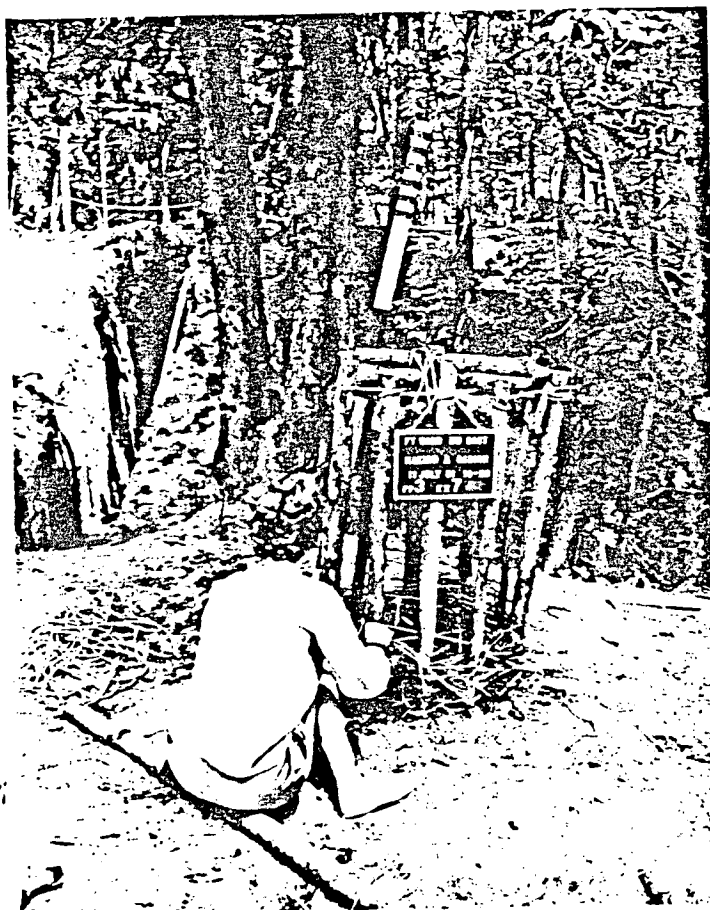
WEAVING A
WICKER GABION
FOR THE GUN
EMBRASURE

Besides restoring the profile of the parapet we rebuilt the southern half of the gun embrasure. To do this we built three gabions. Each made of nine 1½ in. poles driven into the ground in a 2 ft. circle. Then twigs or withes were woven between these to make a circular tube 30 in. high of basket work. Six gabions were needed but we found it was too much work to make them. The construction of each gabion required nearly six man-hours of labor, due to our need to experiment and to the absence of suitable material. The forest cover of the site has changed considerably in a century. Consequently we made only three gabions, and simulated the other three with snow-fence. The six gabions were then set up along the S cheek of the embrasure, lined with a skin of turf, and filled with dirt.

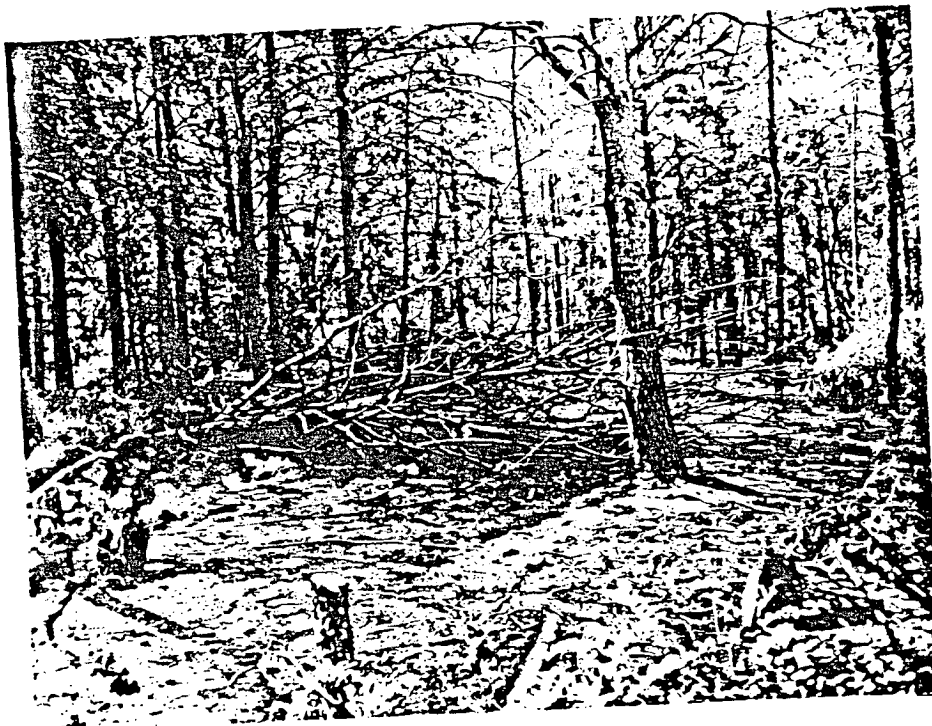
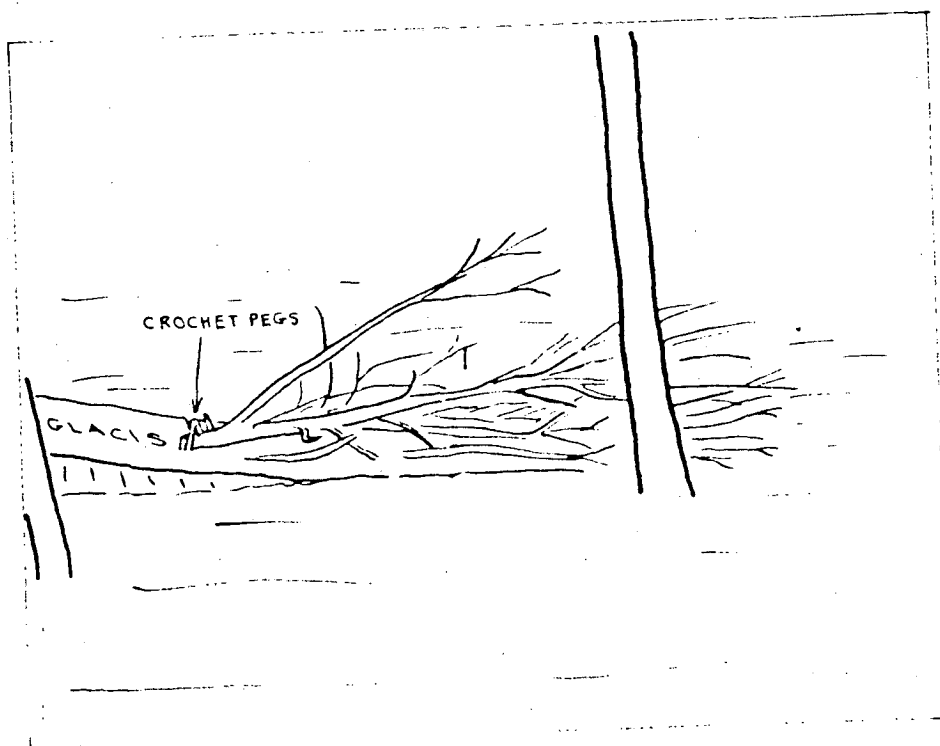
DIAGRAM OF PLATE XVIII
ABATTIS IN PLACE ON GLACIS SLOPE

To complete the restoration we placed suitable forked tree sections on the glacis slope. Oak made the best material for this wood entanglement. These trees were cut off a few feet below a main fork, and that butt end was placed toward the fort, about 7 ft. down the glacis slope. All leaves, twigs, and small branches were cut off to leave large branches with sharp points. The forked sharpened branches were intertwined with the branches of trees on either side, to make a section of the abattis which once surrounded the entire fort.

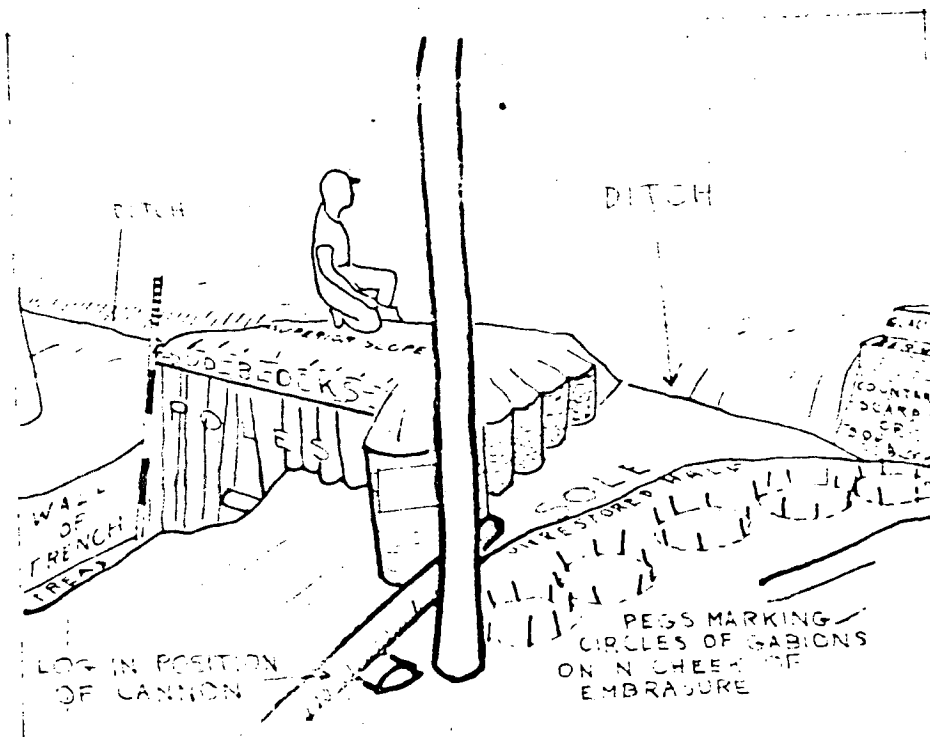
DIAGRAM OF PLATE XIX
RESTORED GUN EMBRASURE AND BREAST-HEIGHT

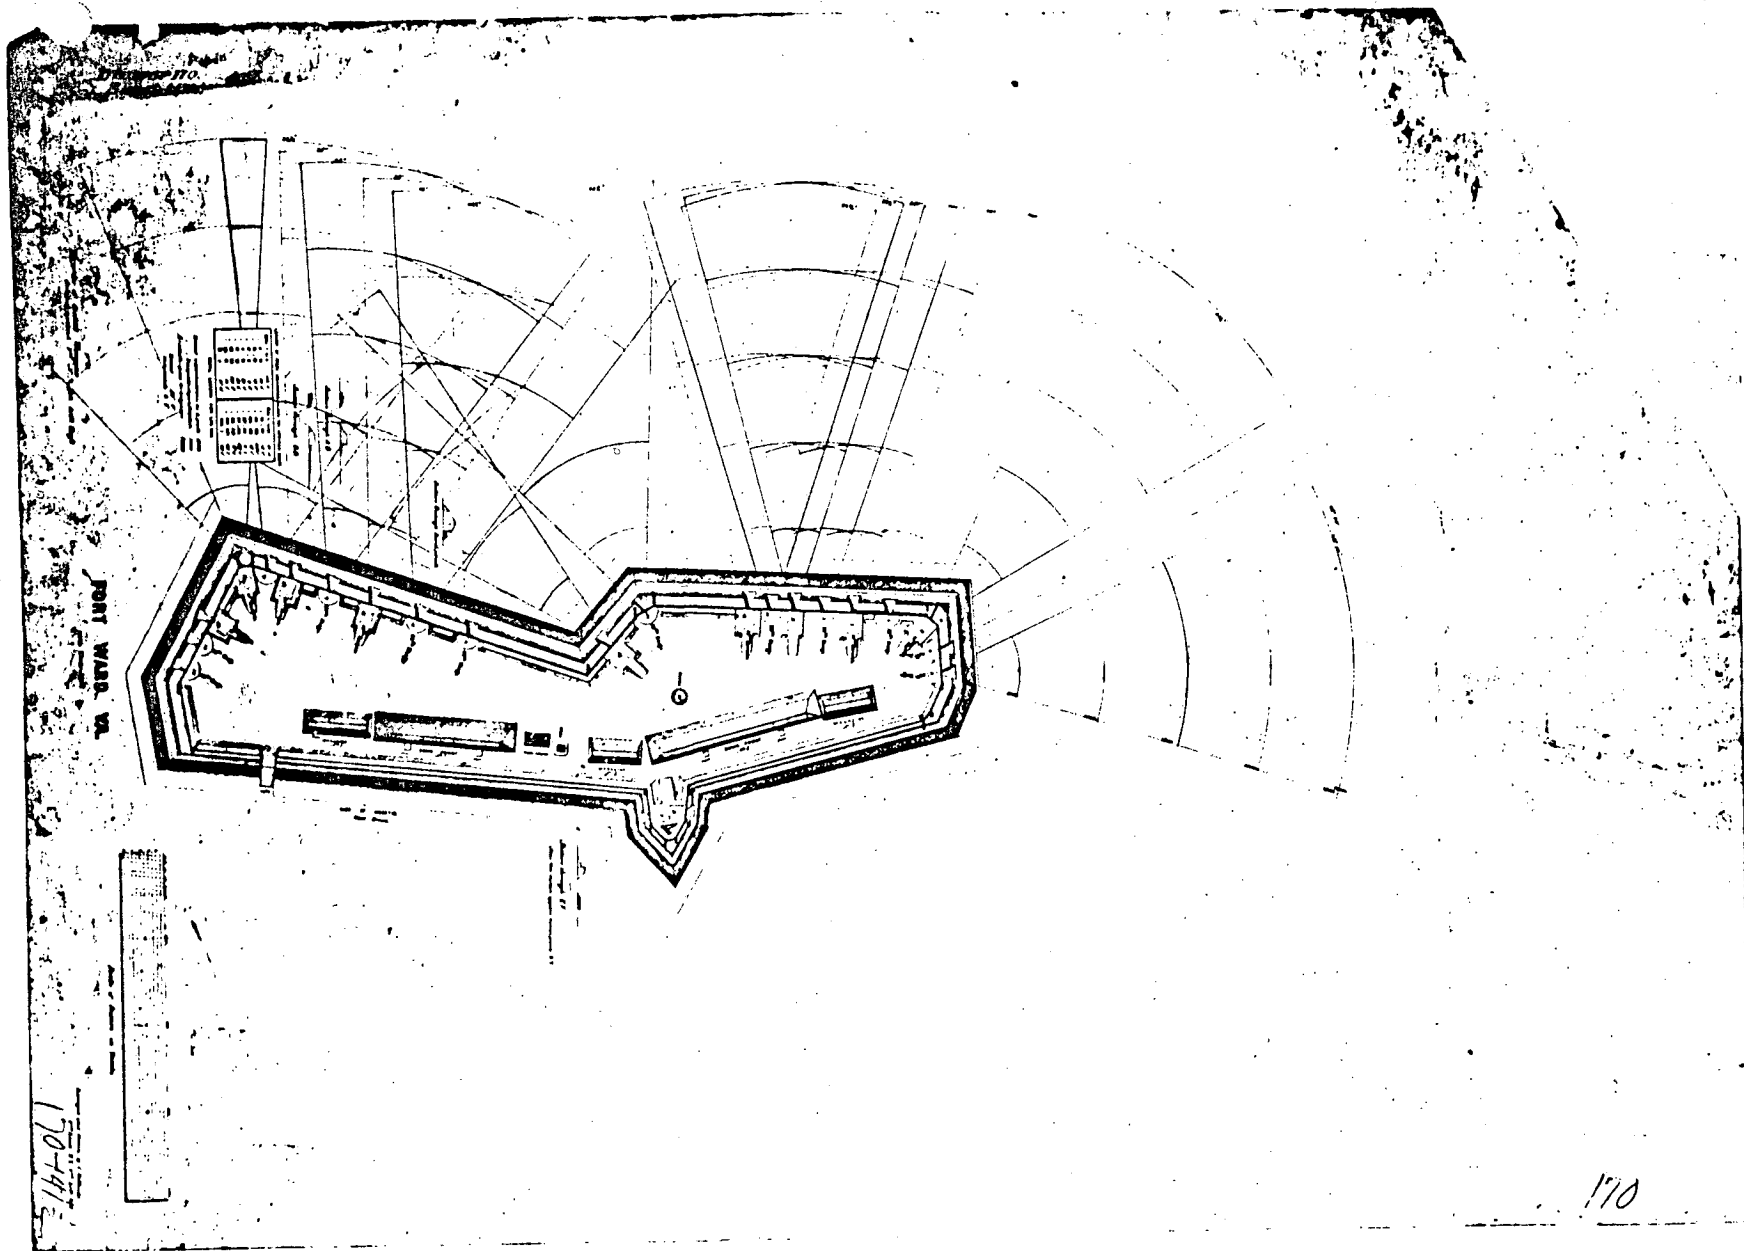
8. Historic Drawing No. 170-141. Plan of Old Fort (early stage: possibly Spring 1862) N is to Upper R
