Fort Ward
Alexandria, Virginia

Exploratory Excavation
of the Northwest Bastion

by Edward McM. Larrabee
Contracting Archaeologist

August 28, 1961

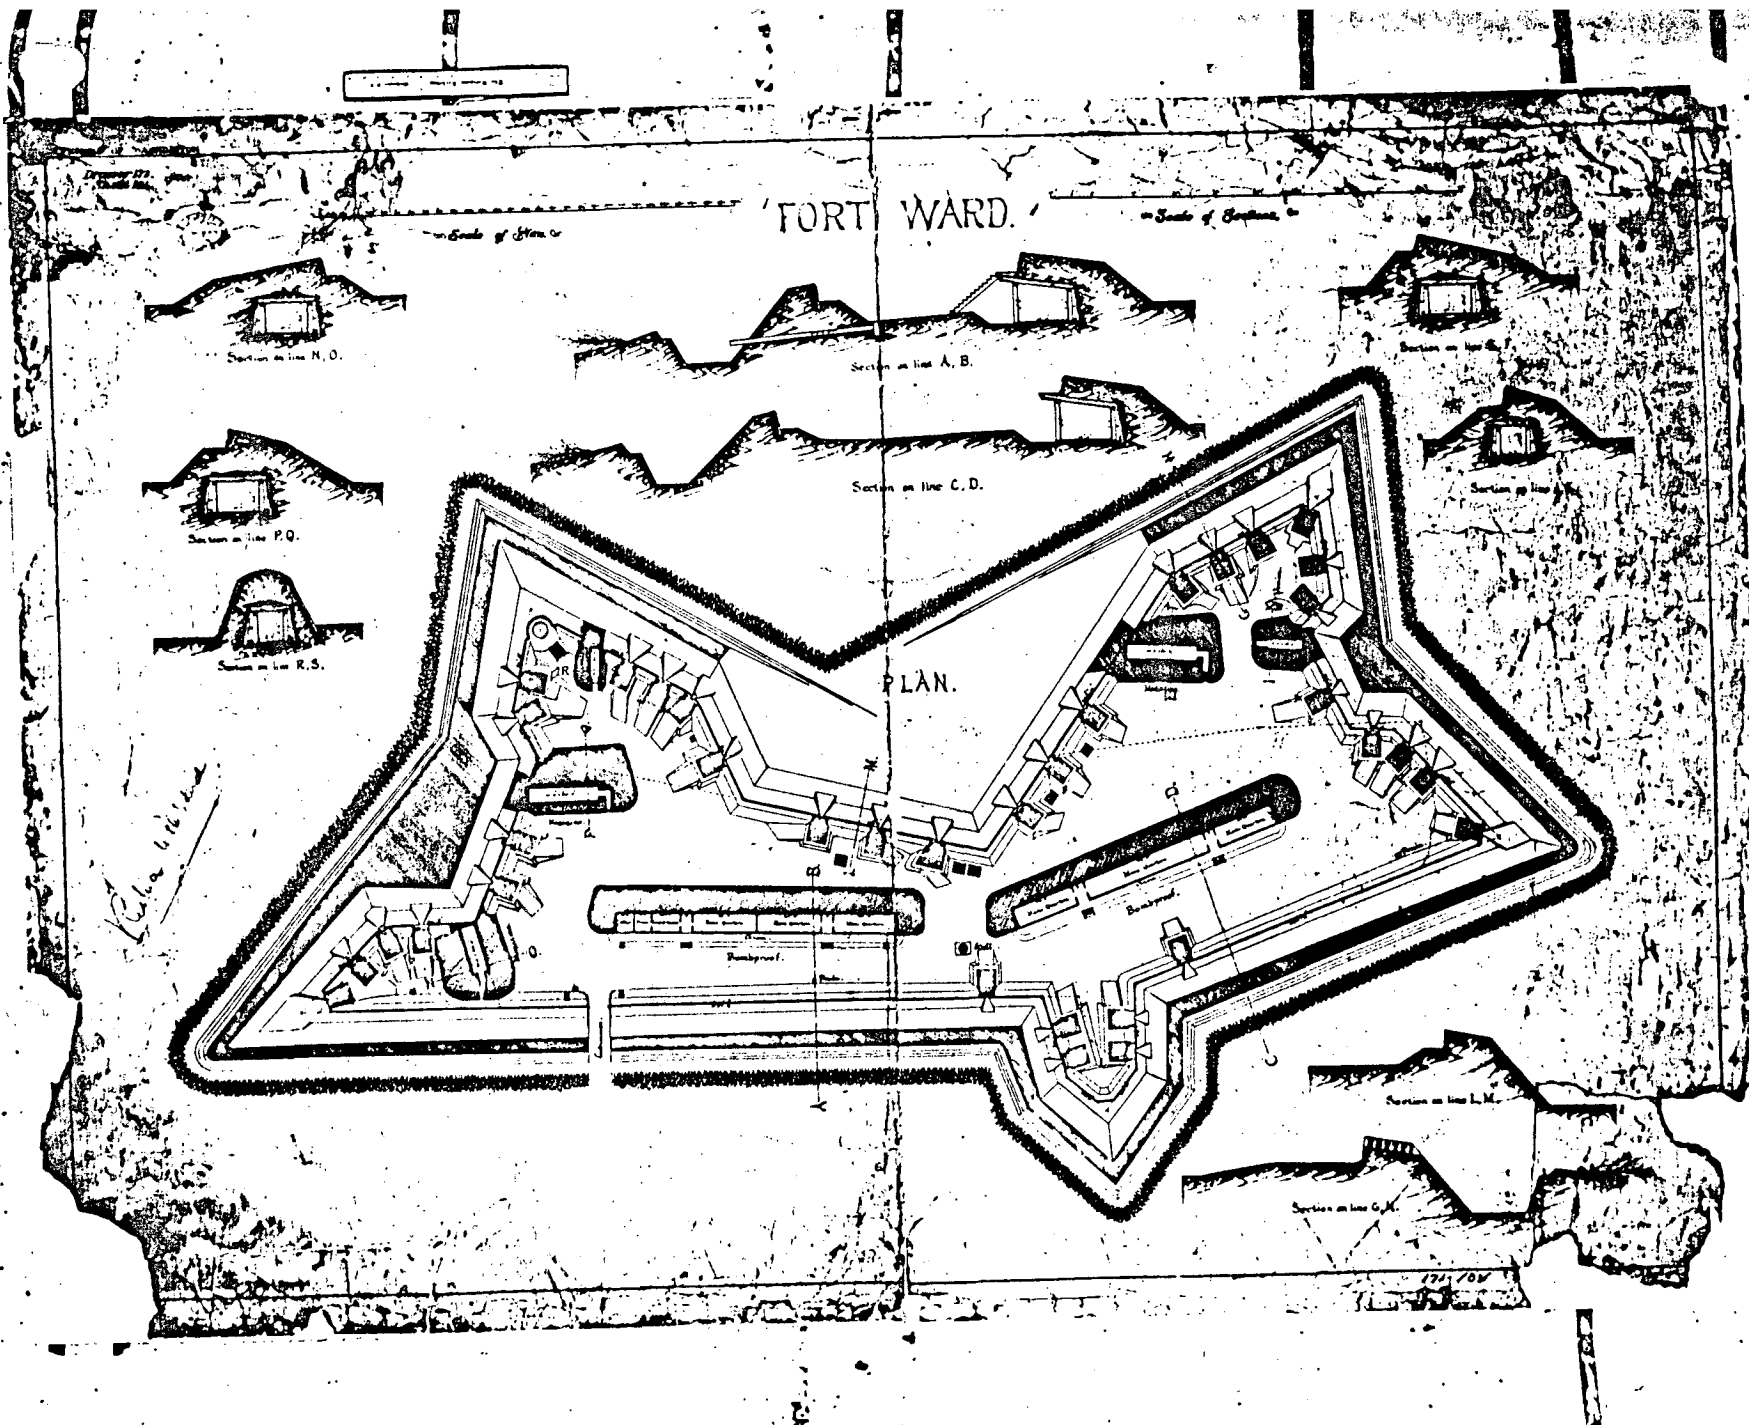
10. Historic Drawing No. 171-104 Plan of New Fort (Finished: 1865) N is to Upper Right

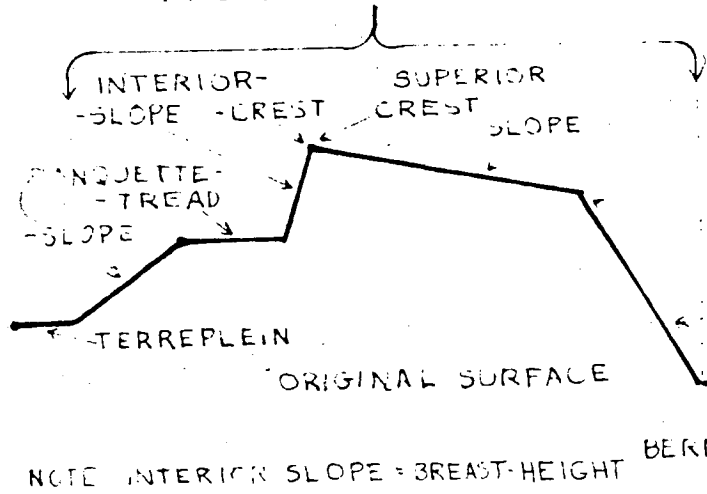
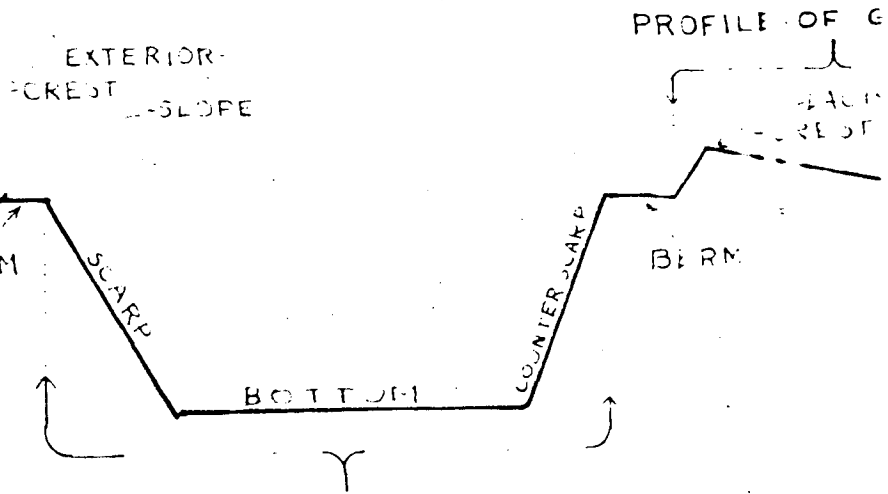
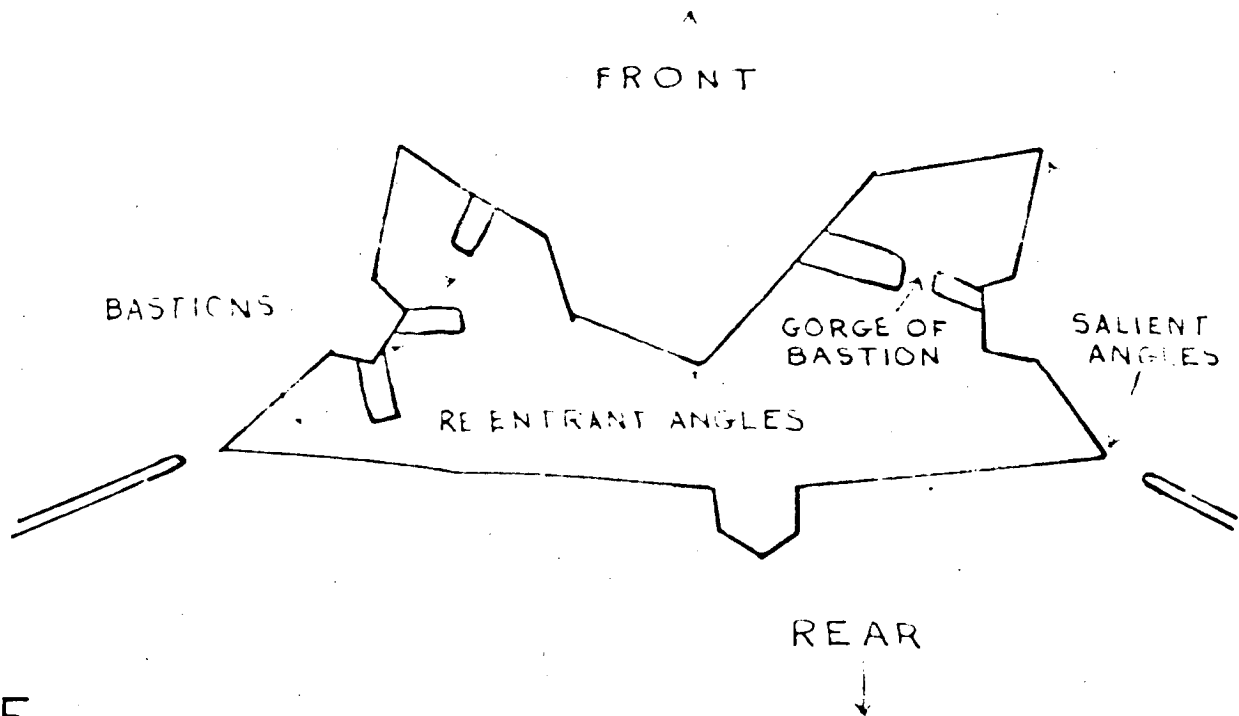
DRAWING NO. 11

MAIN WALL PROFILE AS SPECIFIED BY MAHAN (ca. 1850)

PROFILE AS MODIFIED DURING WAR (FT WARD - 1865)

DRAWING TO ILLUSTRATE
TERMINOLOGY OF
WAR MILITARY ENG

PROFILE OF BURIED ROOM AND CONSTRUCTION OF REVETMENT

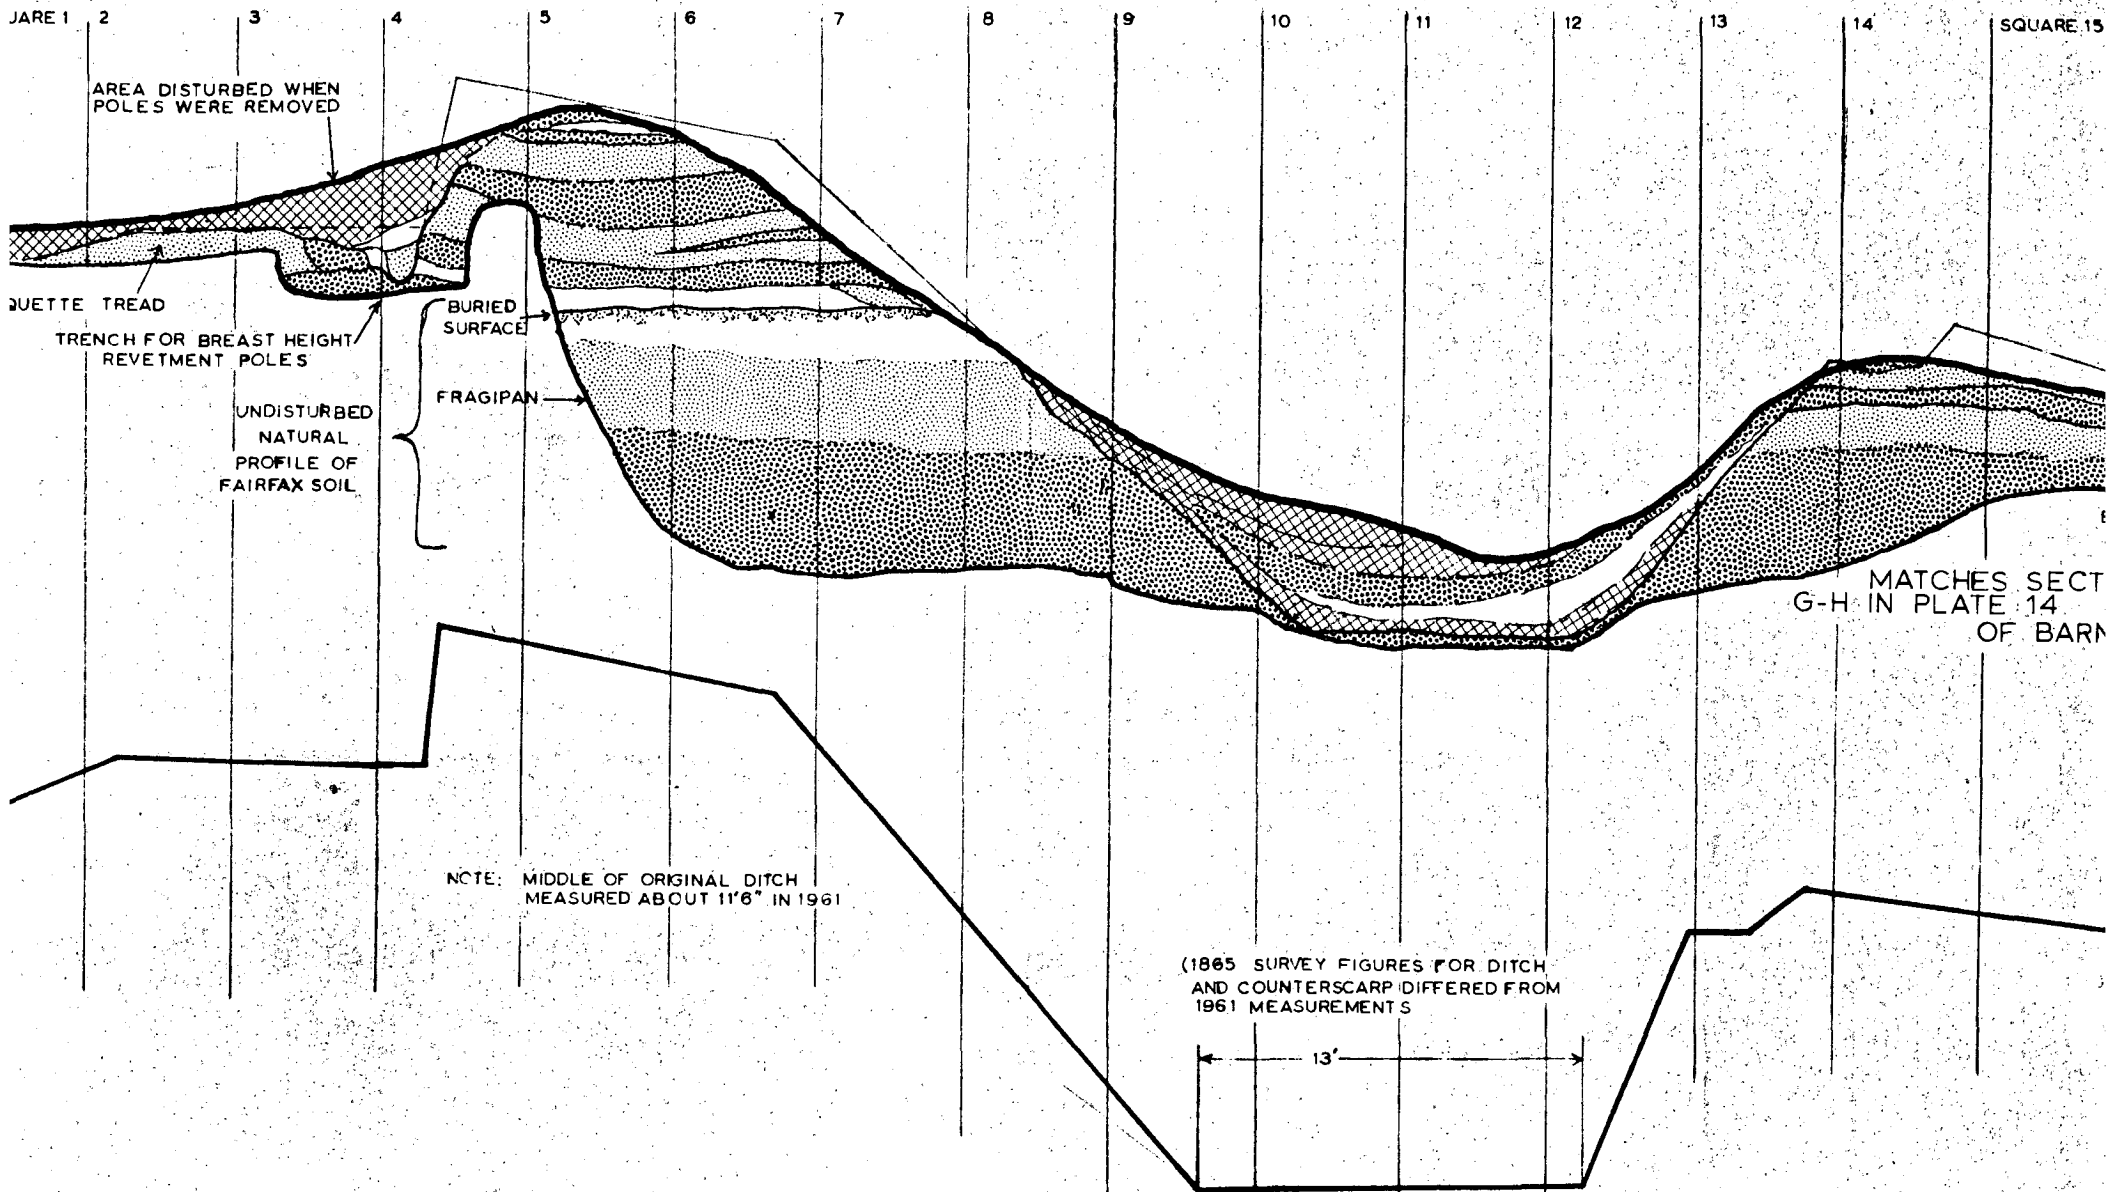
PARAPET & DITCH
as excavated, 1961, & as
surveyed, 1865 drawing no. 5

e ← PARAPET & DITCH LOOKING SOUTH → w
