# "THE RECEPTACLES WERE EMPTIED OF THEIR CONTENTS"

Archaeological Testing of Area II-B  
of the Carlyle Property and  
Excavation of the Shuter's Hill Brewery Site  
(44AX35), Alexandria, Virginia.

**"The Receptacles Were Emptied of Their Contents":  
Archaeological Testing of Area II-B of the Carlyle Property  
and Excavation of the Shuter's Hill Brewery Site (44AX35), Alexandria, Virginia.**

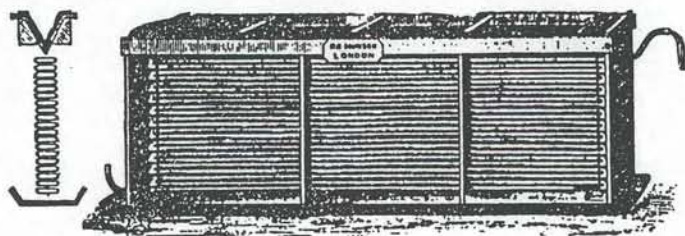
**BAUDELLOT'S  
IMPROVED  
BEER REFRIGERATOR.**

B: Improved version of Baudelot's 1856 wort cooler.  
Source: The Western Brewer, June 1880

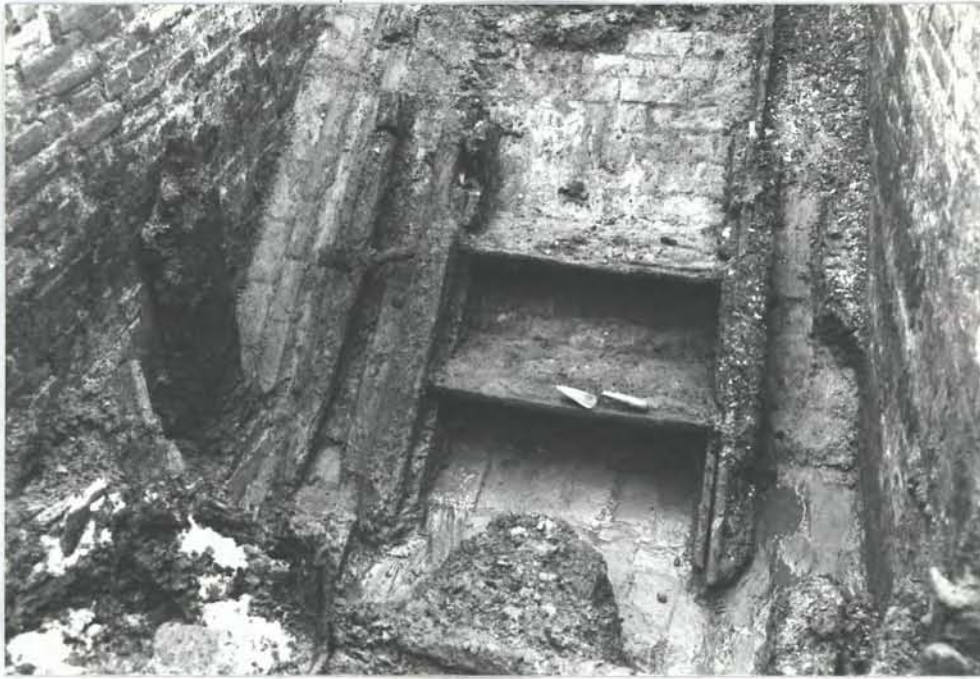
Structure 2 interior showing stairs and barrel ramp, facing east

As with Structure 1, Structure 2 was filled with 7-8 feet of water (*Plate 5*). This drained as Structure 1 was pumped out, allowing excavation to continue. The presence of the water combined with the deposition of the clay fill when the bottom part of the structure collapsed resulted in excellent conditions for the preservation of organic material in the lower (west part) of Structure 2. The remains of wooden steps were exposed along with two parallel wooden beams extending up the ramp alongside the steps (*Plate 6*). These beams are interpreted as a barrel ramp. The kegs and barrels would be

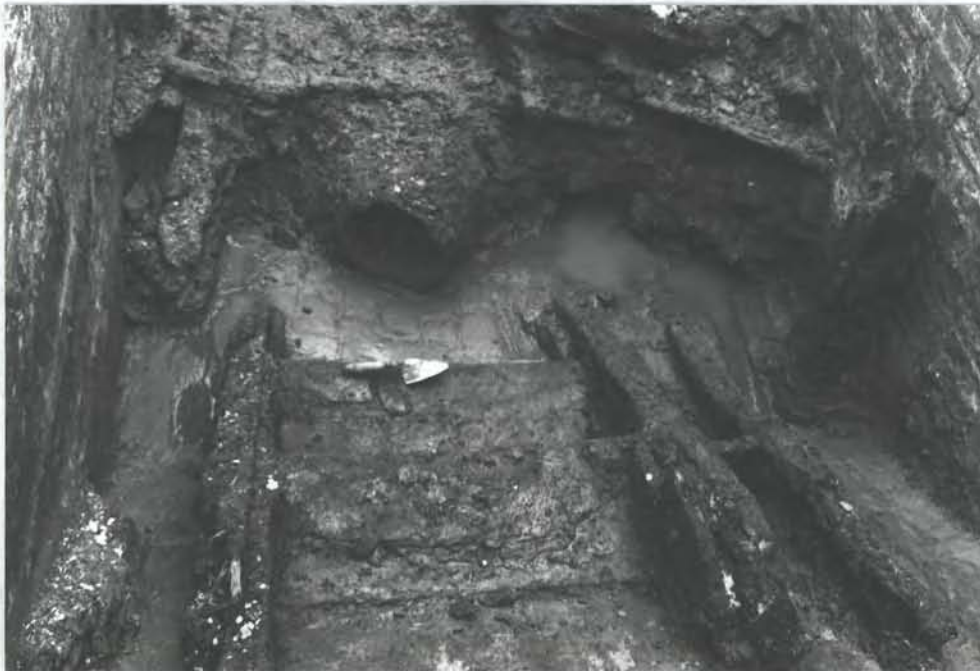
Structure 2 interior, showing keystone, stairs, and barrel ramp, facing west

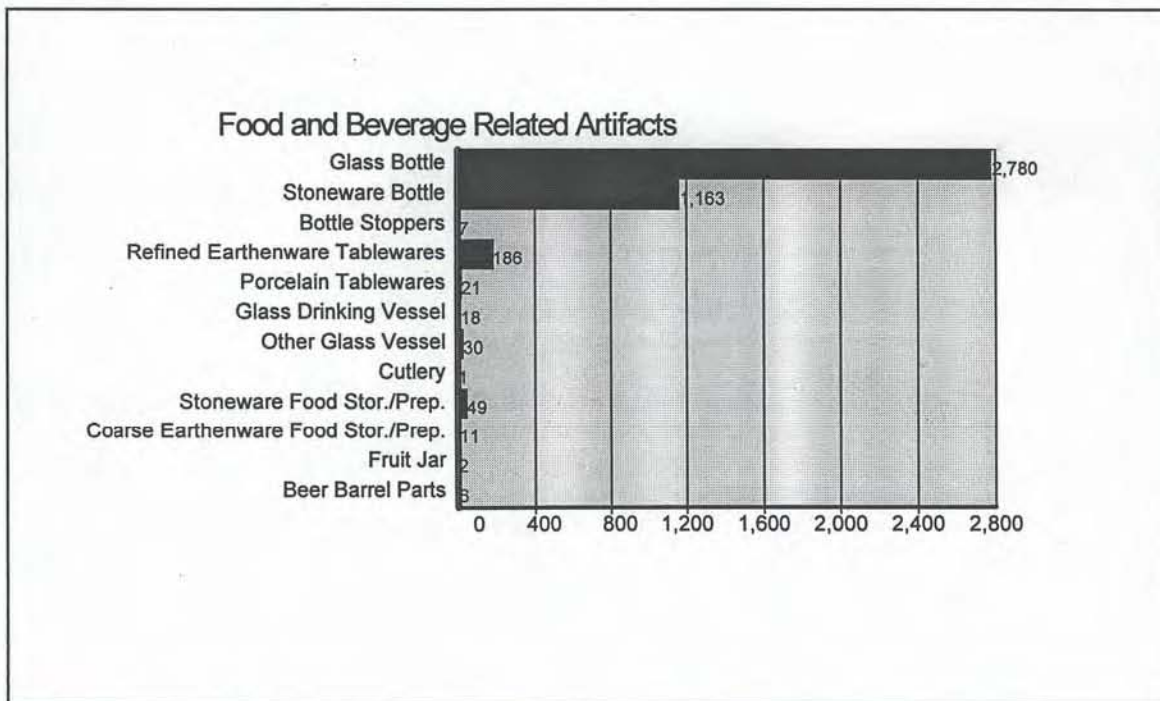
Figure 41.: *Frequencies of food and beverage related artifact types*

The artifacts in the Food and Beverage Related group (n=4,274) accounted for 63% of the 44AX35 assemblage. The proportions of the various artifact classes within this group strongly reflect the activities carried out at 44AX35 (Figure 41). Bottle fragments accounted for 92% (n=3,943) of the assemblage. Of these, 71% (n=2,780) were glass bottle sherds and 29% (n=1,163) were stoneware bottle sherds. Seven bottle stopper parts were also recovered. Only 7% of the Food and Beverage Related assemblage was not related to the storage of liquids.
