CHAPTER 4

MINI MASTER PLANS

EDUCATIONAL ADEQUACY ASSESSMENT

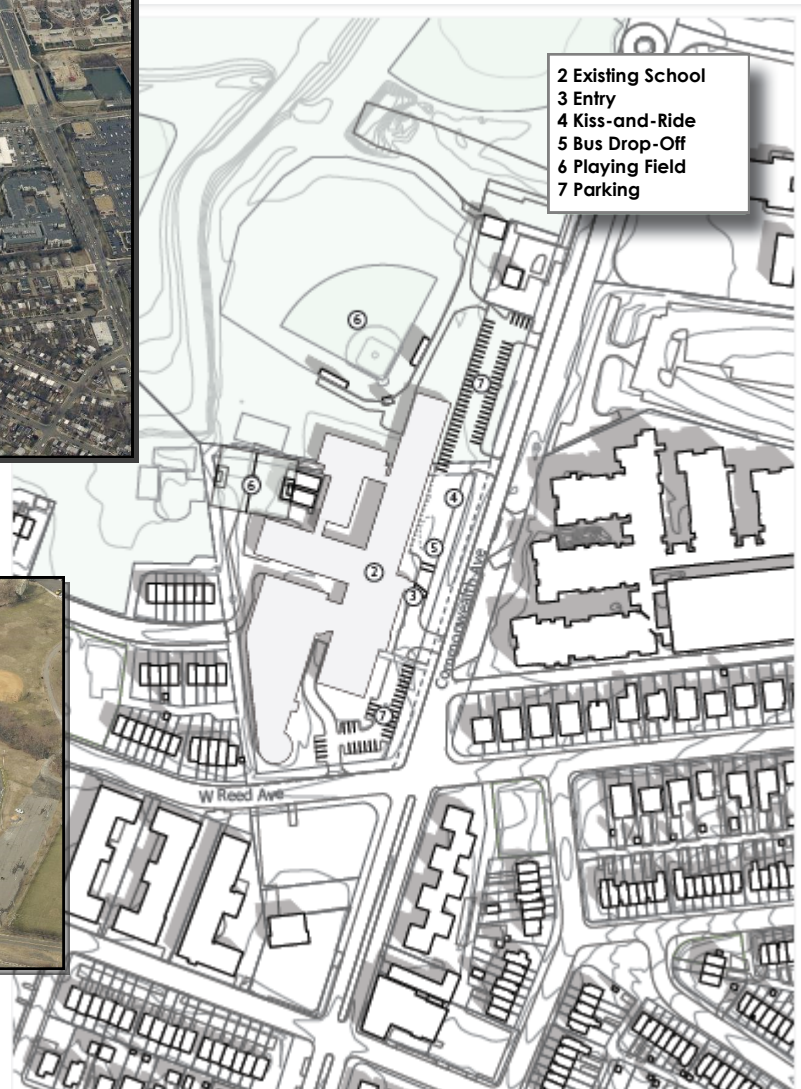
Cora Kelly

Master Plan Concept with renovation within current footprint

- **Reconfigure** the existing building to ensure the core classrooms meet the recommended size requirements outlined in the educational specifications (\$19.1M).

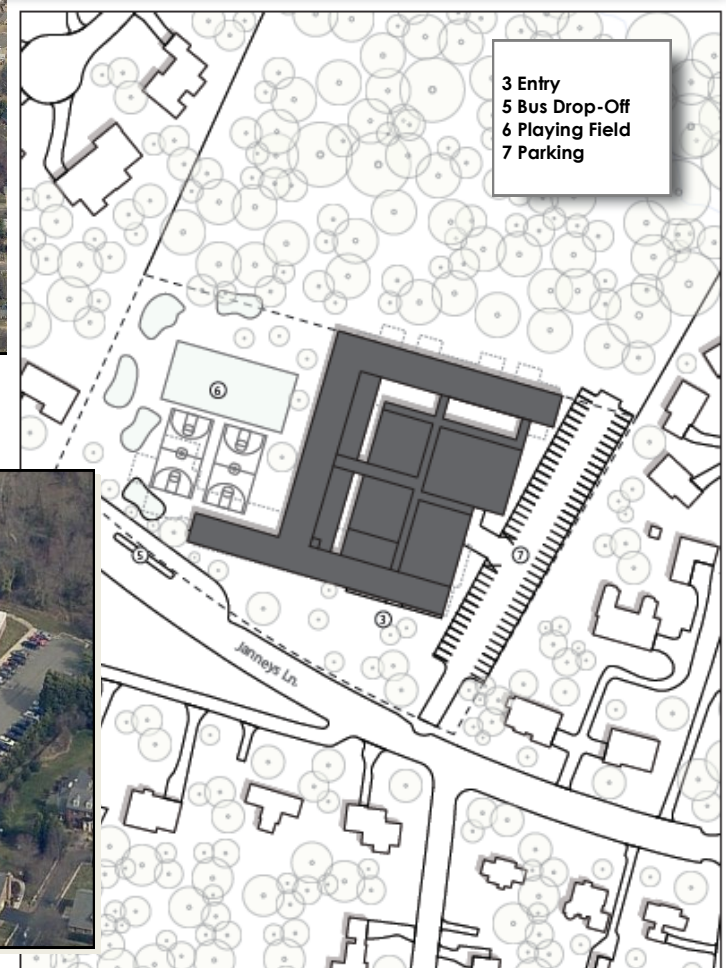
Douglas MacArthur

Master Plan Concept
School Replacement

- **Consider** a total school replacement. This should address additional square footage supporting projected utilization and address deficient key organizational adjacencies while maximizing open space at the existing site (\$37.0M).

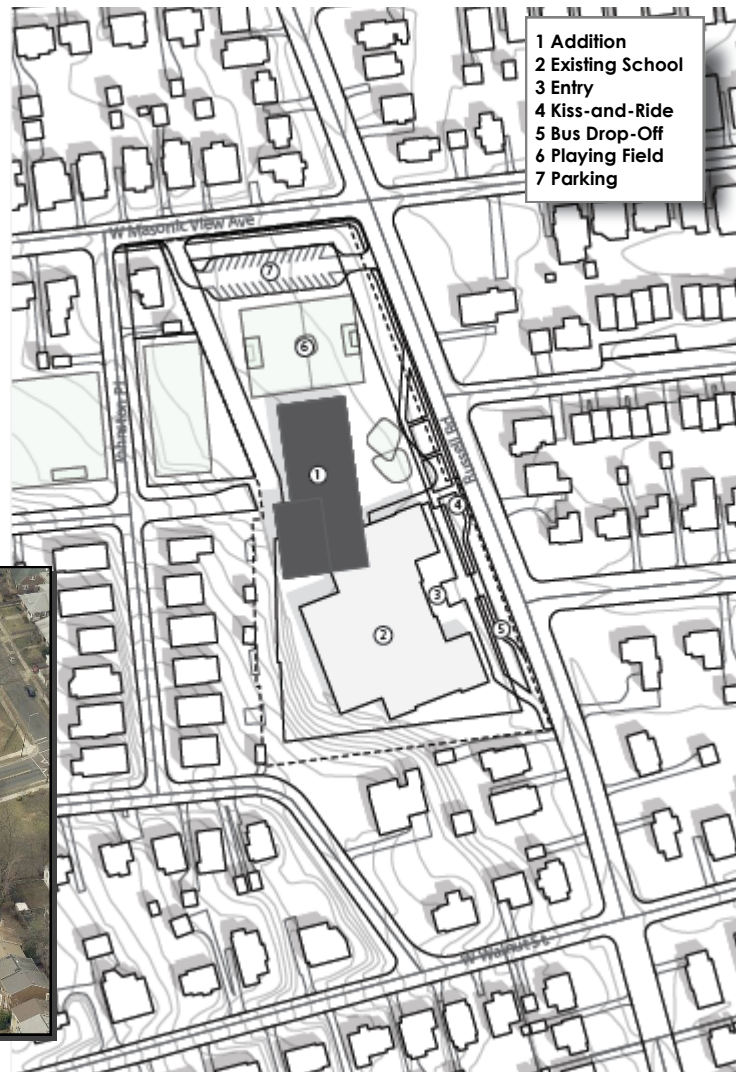
Master Plan concept showing potential second-level addition

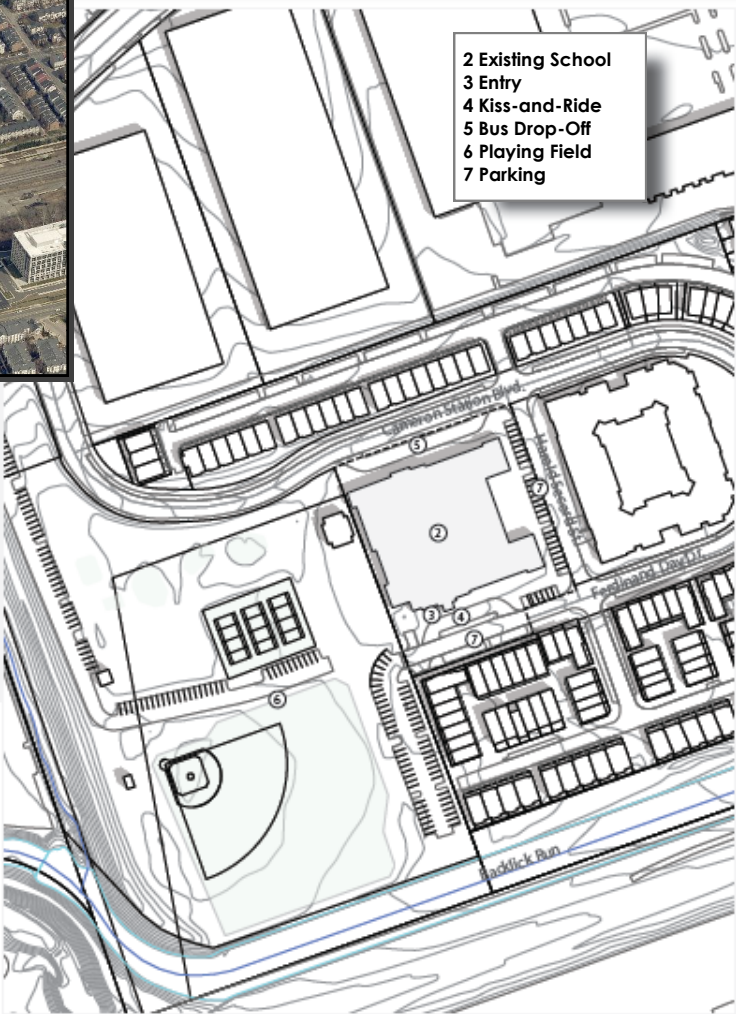
Master Plan concept showing renovations within the existing school footprint only.

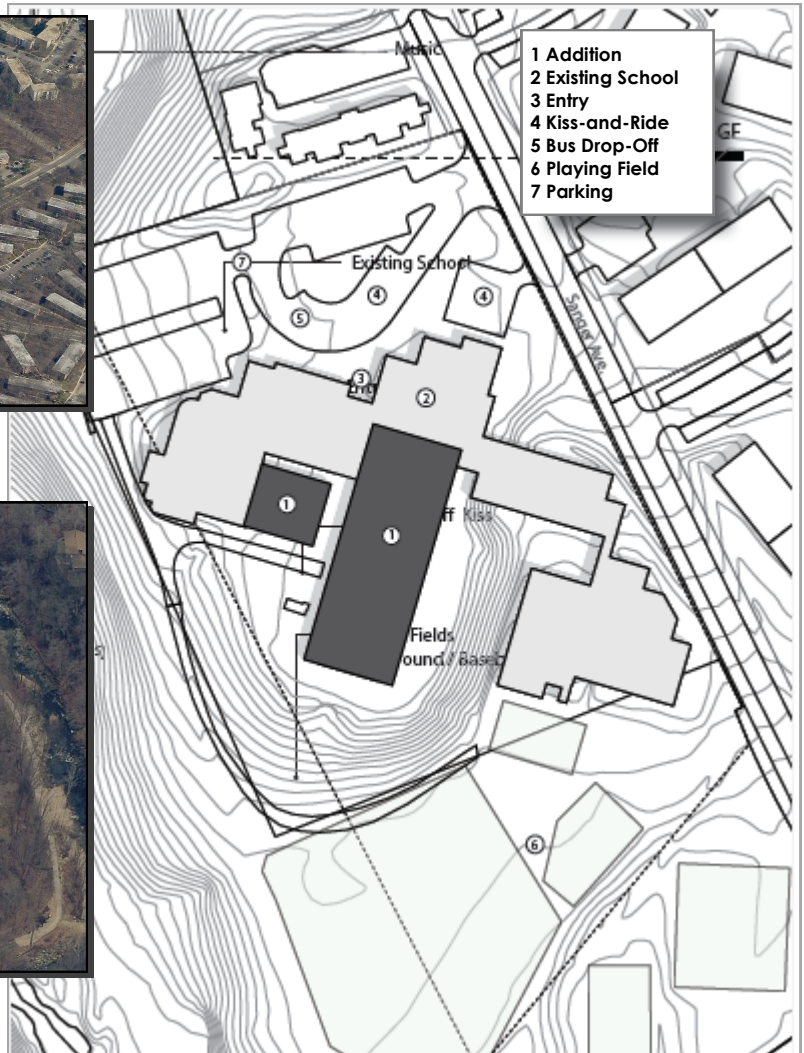
Master Plan concept showing potential enlargement of south wing and media center addition.
