Francis C. Hammond Middle School

4646 Seminary Road, Alexandria, VA 22304

Key Findings

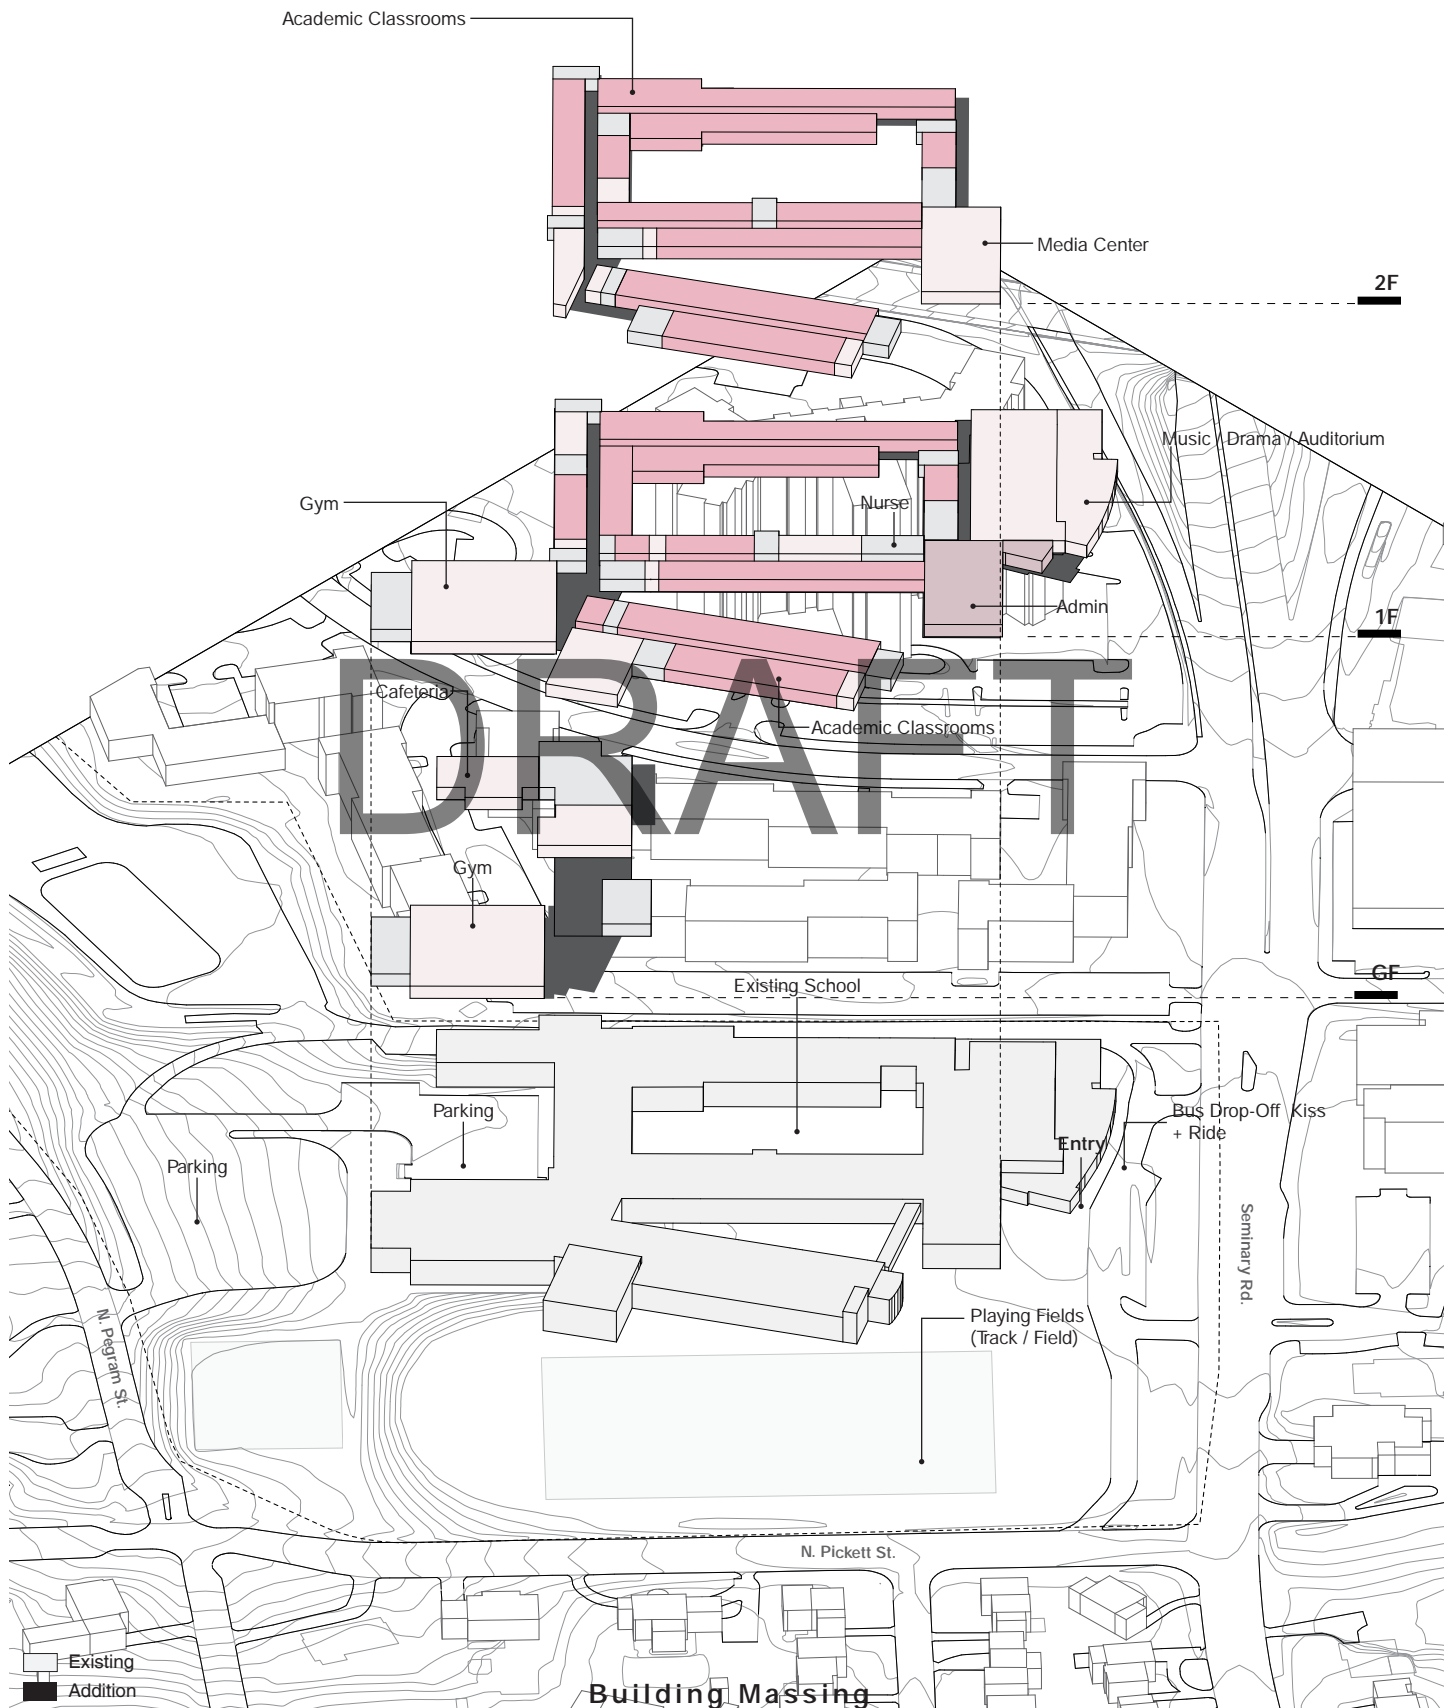
Program Isometric

- Classrooms (Core + Speciality)
- Administration
- Shared Spaces
- Playing Fields
- Support
- Circulation
