Fort Ward Park

Facility Study and Recommendations

- ▶ Prepared by Paul Lombardi R.A.
- ▶ Department of Recreation Parks and Cultural Activities
- ▶ City of Alexandria
- ▶ October 16th , 2008

Building Inspection

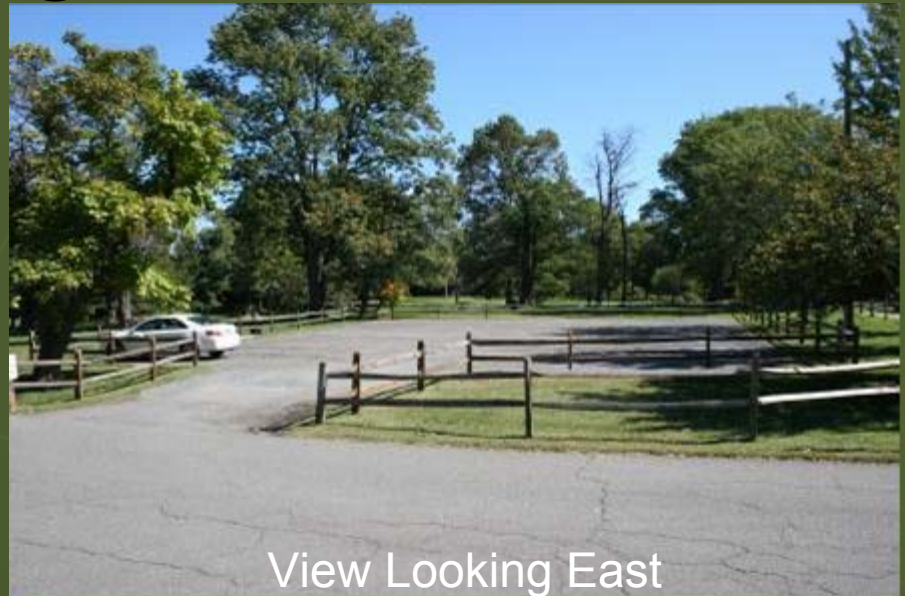
View Looking East

- ▶ The parking lot on the east side of the park directly upon the entrance from West Braddock Road to be enlarged. Currently the lot can be utilized by 18 cars. The surface is currently pervious gravel. It is intended to double the size of the parking lot to approximately 36 cars and is to include the appropriate ADA compliant spaces. Paving of this lot will be determined based on storm water runoff concerns.

Design Consideration for Expansion of Parking Lot 1. Electrical transformers should be screened from parking lot and street.

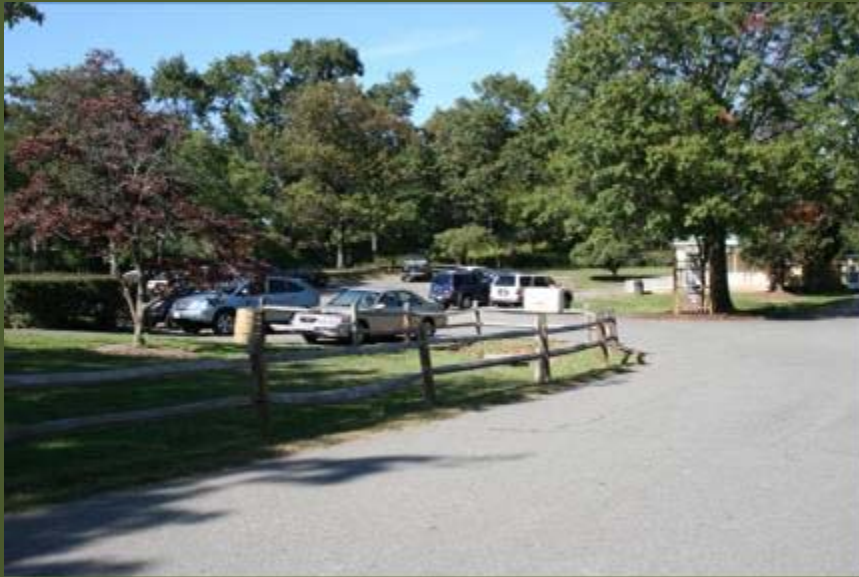
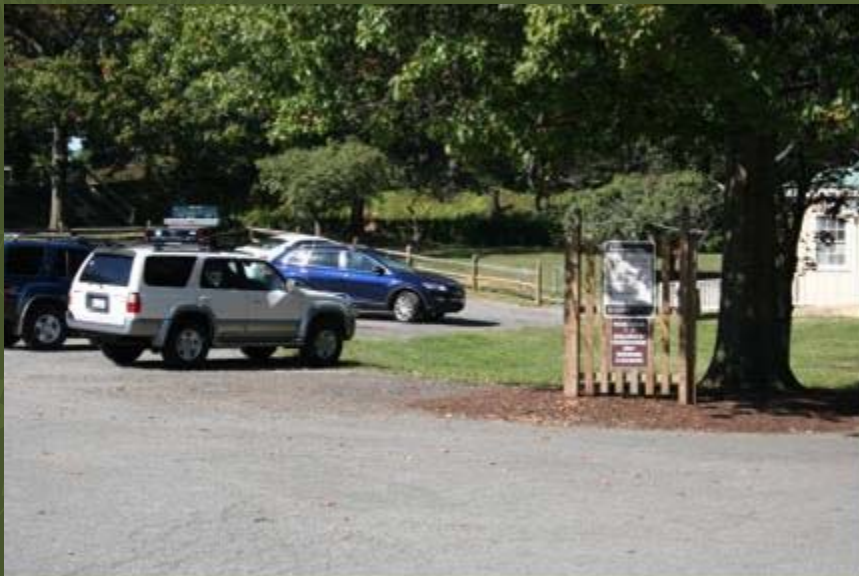
- ▶ This lot is between the Fort ward Museum and the Restroom/ RPCA structure. It is being proposed to extend peninsulas to clearly define the entrance and exit to the parking lot. This will more clearly define the areas of parking while controlling vehicular patterns which will provide a safer environment for pedestrians. This lot should also be considered to be paved due to its usage by museum patrons year round and the need to keep the museum's interior clean. Storm water impact should be considered for this decision.

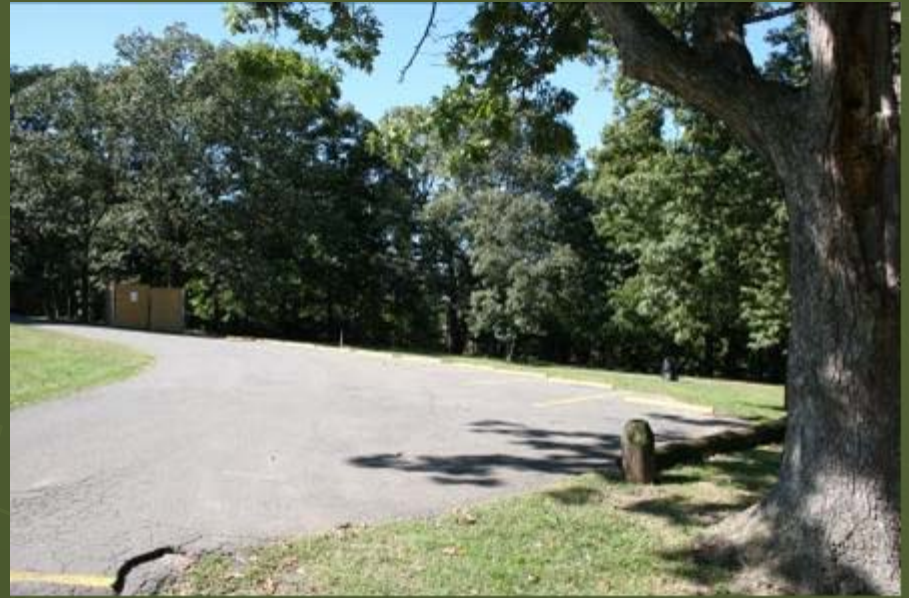
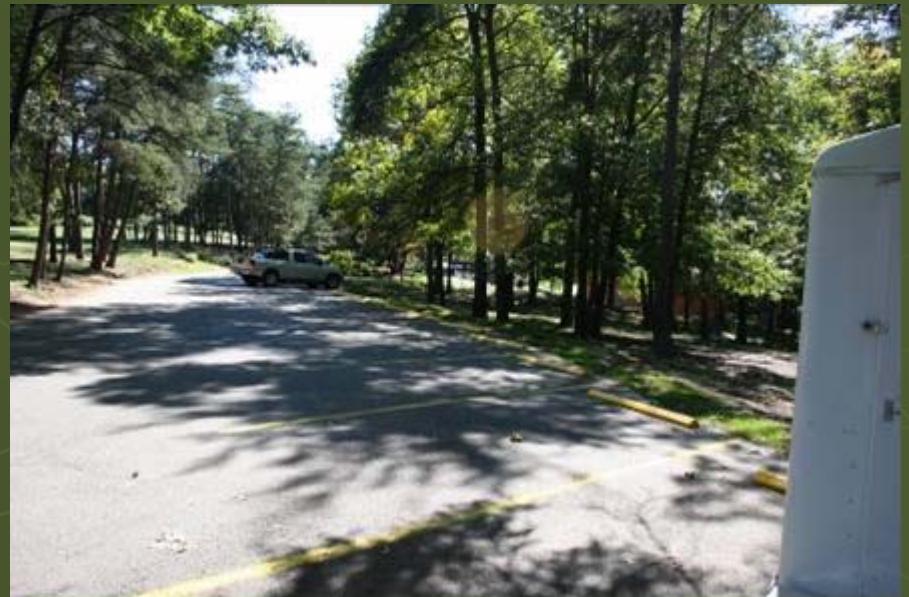
- ▶ This area is directly adjacent to the roadway, near proposed pavilions 3&4. Currently the parking is along the west side of the roadway. It serves the picnic areas 6&7. It also is situated close to the seasonal restroom 2 which is the point of discussion further in this report. It is being proposed to provide additional 18 parking spaces along the east side of the roadway in this area. This will conveniently facilitate the usage of the proposed pavilions and the Amphitheatre.

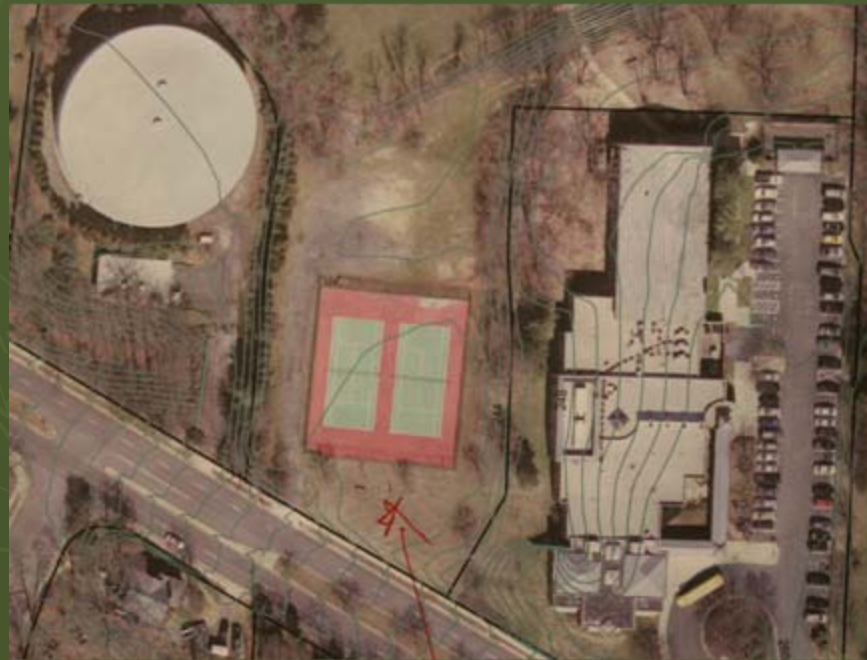
Existing Conditions

Proposed Relocation of Tennis Courts with provisions for new parking lot along West Braddock Road

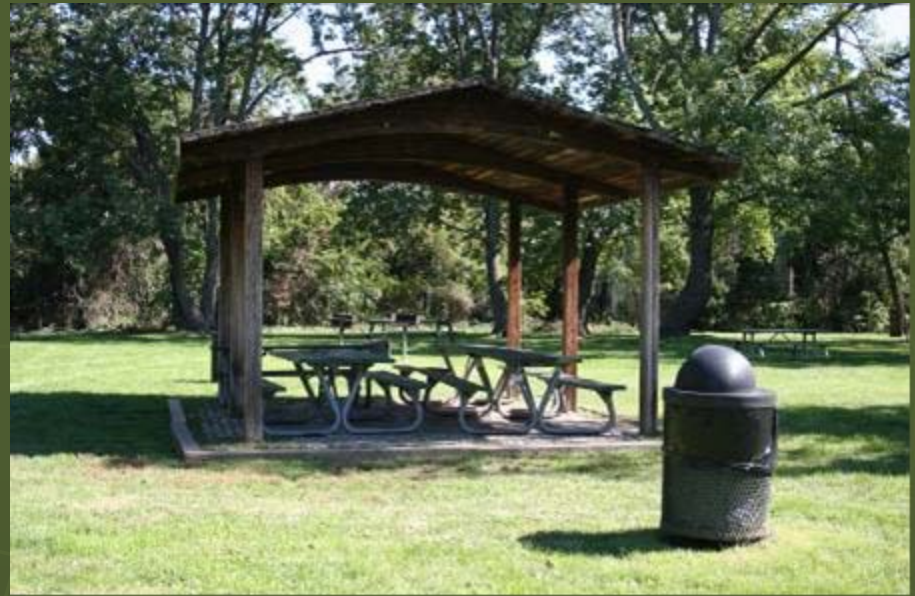
Pavilion to be Removed

- ▶ Pavilion 1 (proposed) is currently a wood frame structure approximately 35 years of age. The pavilion sits on an irregular brick slab and it situated along the eastern property line near existing residences. It is being proposed to remove the existing structure and relocate a new pre-fabricated metal 16' x 24' structure on a new concrete slab to the west of the current location. This will reduce the amount of interference to the adjacencies during times of utilization.

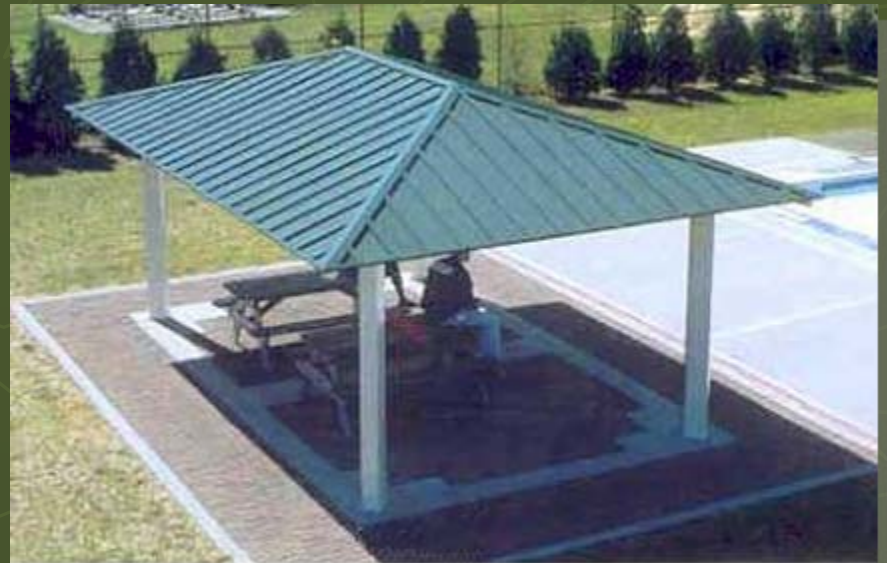
RAM 16 x 24 MR

New Pavilion to be Erected

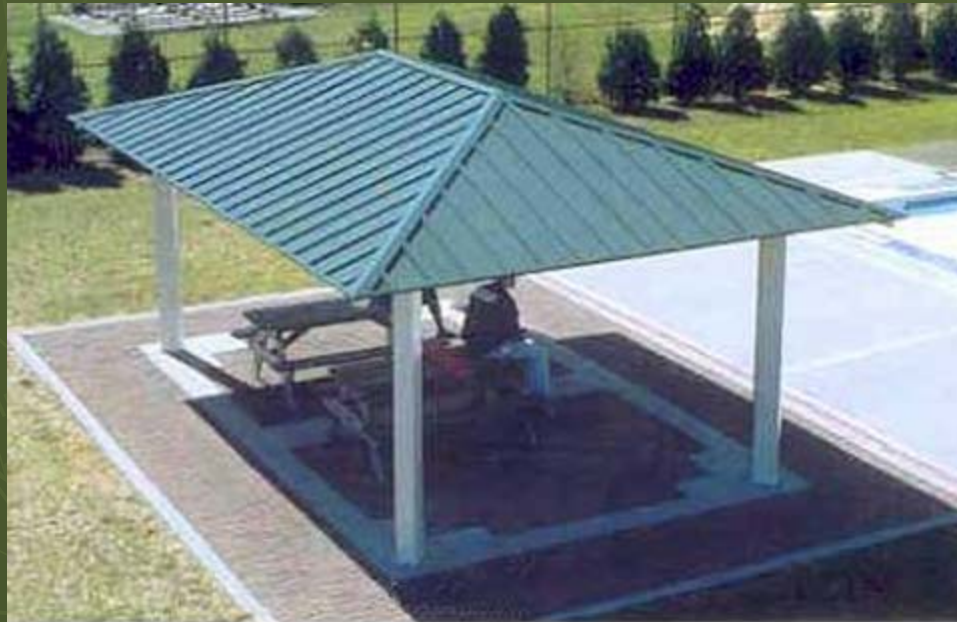
RAM 16 x 24 MR

- ▶ Pavilion 2 (proposed) will be located in the former location of picnic table 2&3 which have been removed. This will also be a pre-fabricated metal 16'x24' structure on a new concrete slab. It is located in the vicinity of a parking area along the roadway.

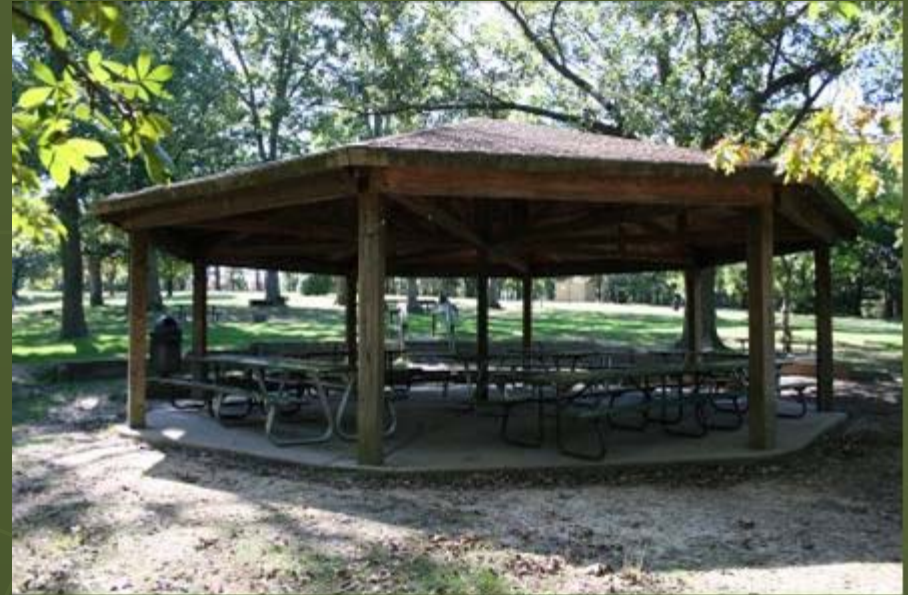
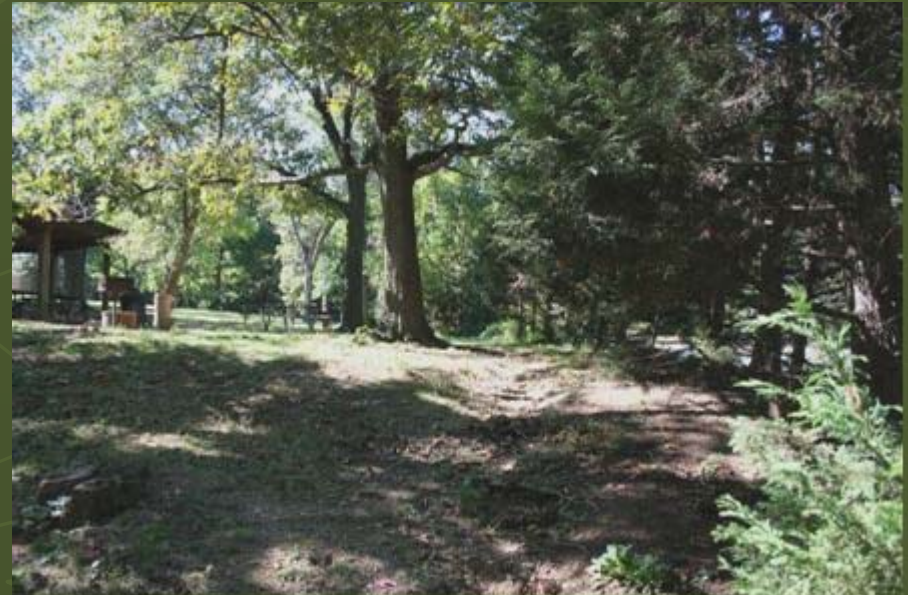
View of Area @ Pavilion 3

- ▶ Large Pavilion 3 is an existing structure, this octagon is the largest of the rentable pavilions it has the capacity to entertain 100 people. The structure is in relatively good condition and is currently being actively maintained.

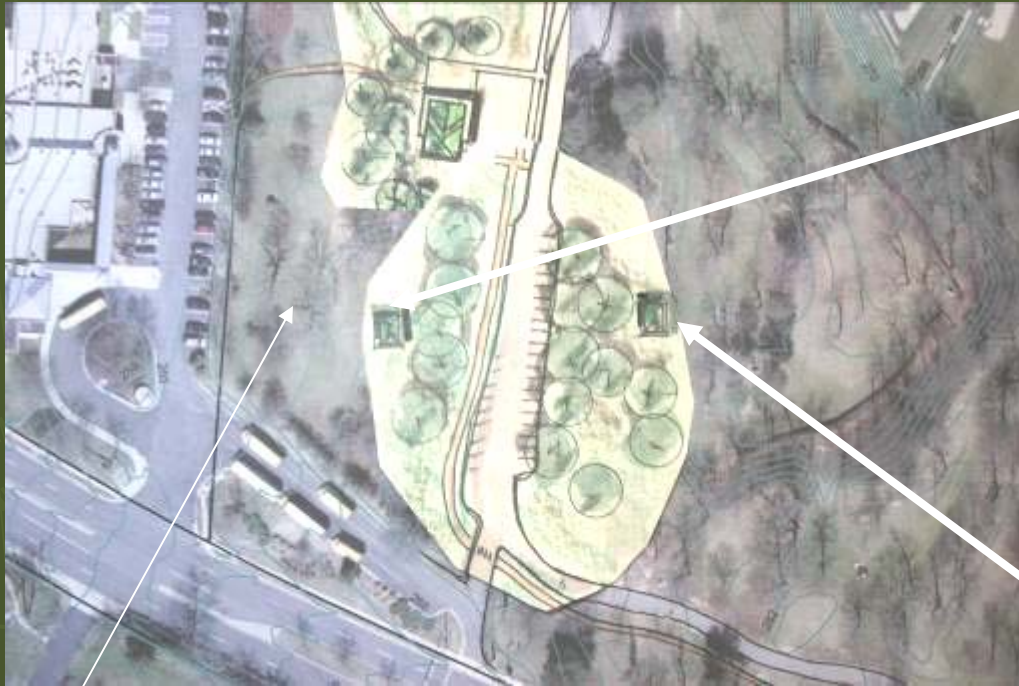
- ▶ Pavilion 4 is a proposed structure along the west side of the park, adjacent to the road and south of the restroom 2 structure. It shall be typical to the other newly erected pavilions.

- ▶ Pavilion 5 is a proposed will be a newly erected structure along the east side of the roadway directly adjacent to the newly expanded parking area along the roadway.

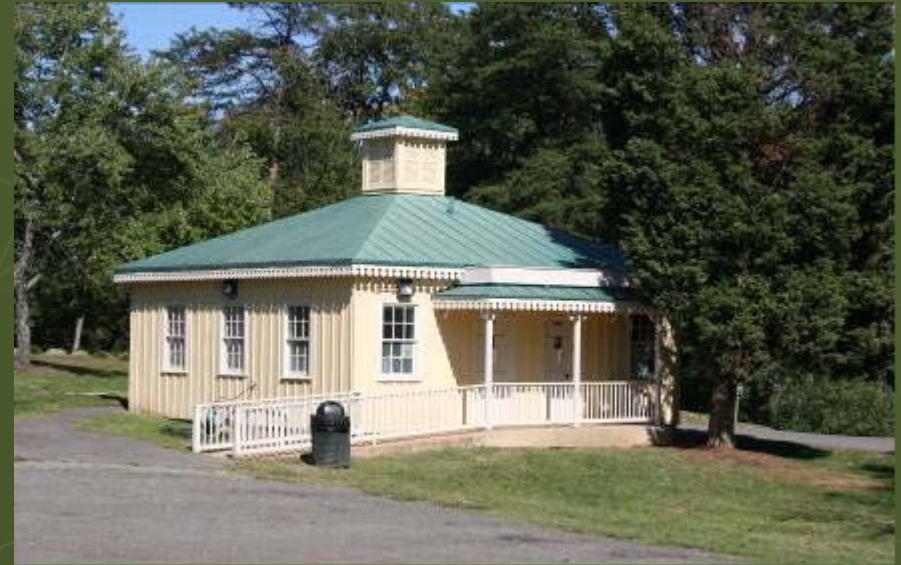
Restroom 1

- ▶ This structure located near the main entrance tot the park is an approximately 40 year old structure which houses a men's and a woman's restroom, administration office for the Department of Recreation and a storage room. The building is currently being considered for renovation to bring the restrooms into ADA compliance. The cost of this renovation is \$65,000 and is to include entirely new fixtures and finishes within the space. The office area has recently been upgraded and the storage area is currently being utilized by OHA. The structure is in good condition with a newly installed HVAC system. Some drainage issues exist around the structure but appear to be managed properly.

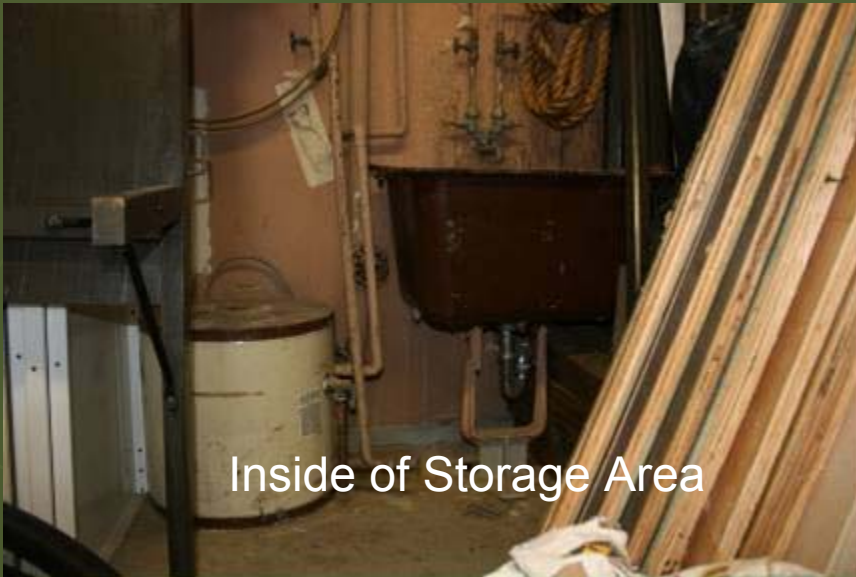
Inside of Storage Area

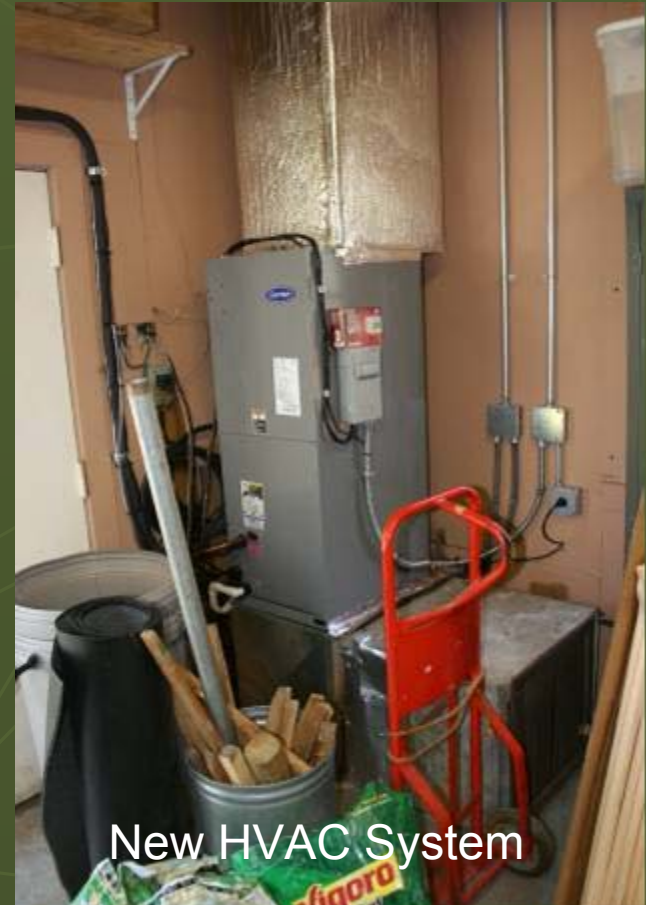
New HVAC System

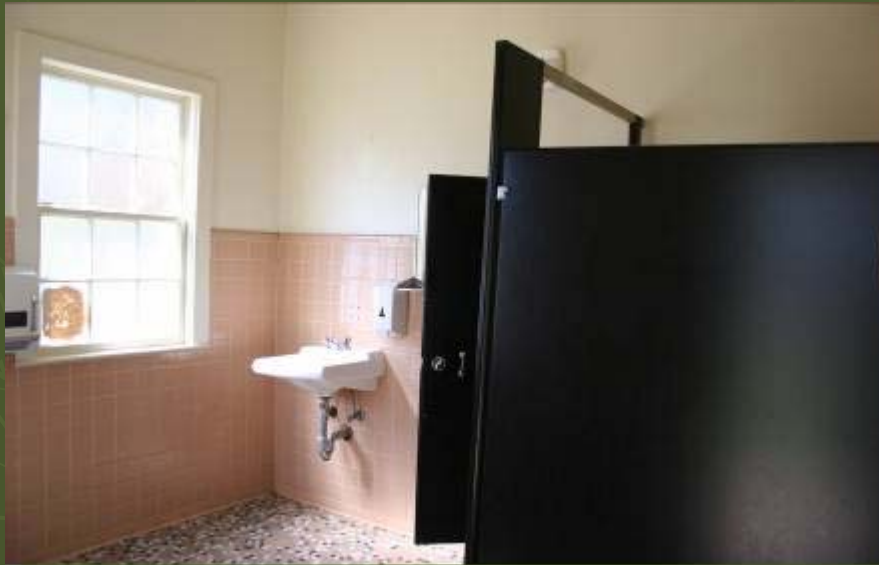
Existing Restroom Interior- Woman's Room

Proposed Restroom Renovation for ADA compliance and upgrade of existing facility

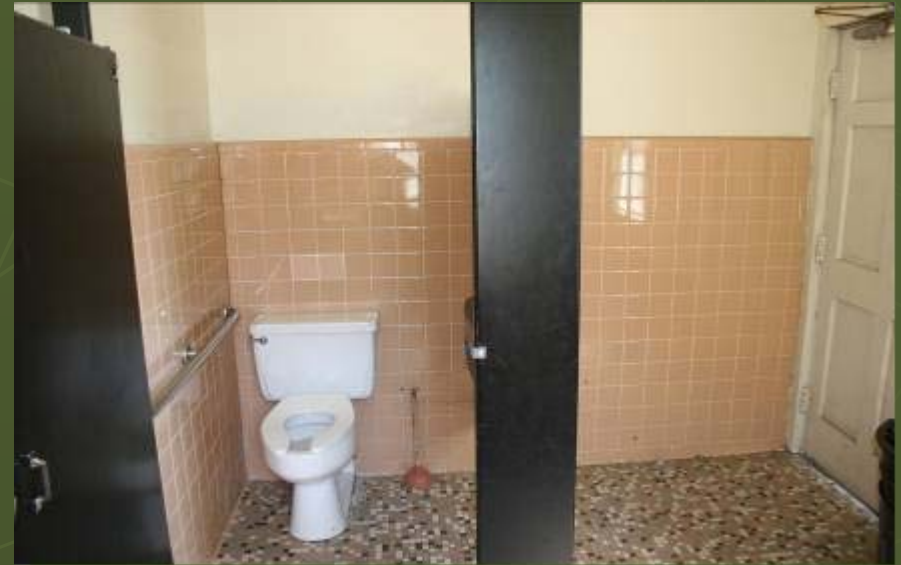
Existing Restroom Interior Men's Room

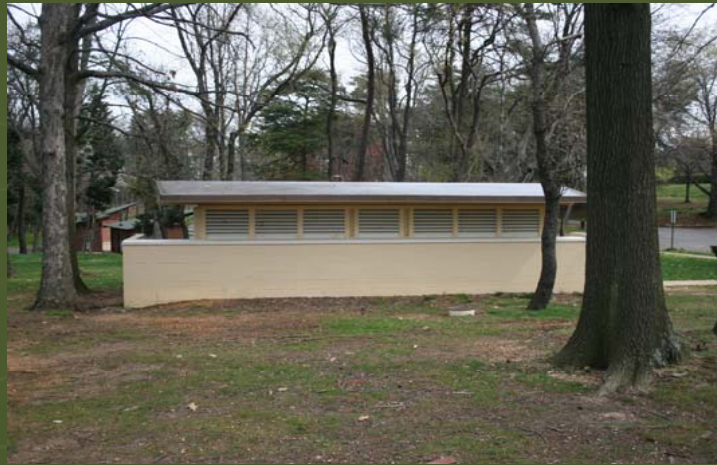
Fort Ward Bathroom 2

- ▶ Fort Ward Restroom Pavilion
- ▶ Fort Ward, Alexandria, Virginia
- ▶ Friday, April 11, 2008
- ▶ Weather: Sunny, 70 Degrees
- ▶ No precipitation within 12 hr period prior to inspection
- ▶ Paul J. Lombardi R.A., RPCA
- ▶ City of Alexandria

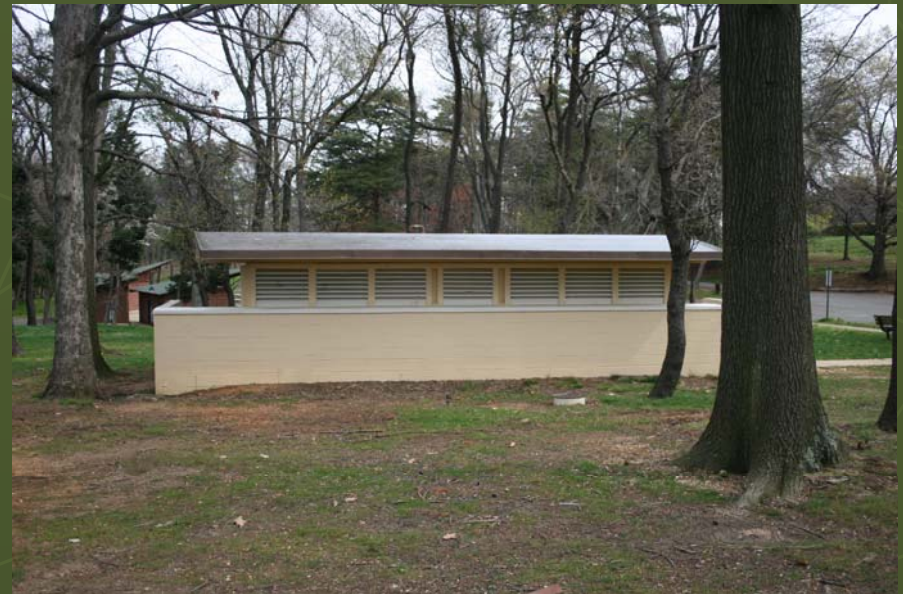
FIGURE 1 VIEW NORTH

- ▶ View of side of restroom pavilion looking north. Masonry appears to be in good condition. The wood louvers have screen behind them to prevent insects from entering the restroom. Low sloping gable has projected eaves for coverage over restroom entrances. There were no apparent signs of settlement or cracking. The louver is in good condition and has been painted several times. The area appears to drain well.

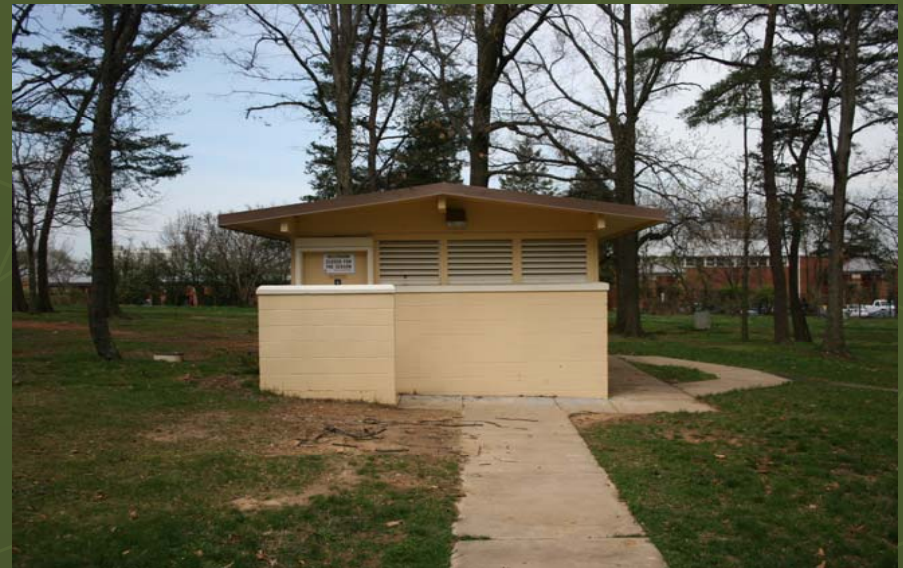
FIGURE 2 VIEW WEST

- ▶ View of restroom pavilion looking west. This is the men's room entrance. The masonry is painted and in good condition. Projecting the ridge beam as well as end headers supports the low sloping gable roof. The louvers have been painted. The louver section closest to the entry door has hornets nest within the wooden slat of the louver (picture attached). The concrete walkway is in fair condition and has been painted near the entrance of the structure. The fascia is aluminum and in fair condition.

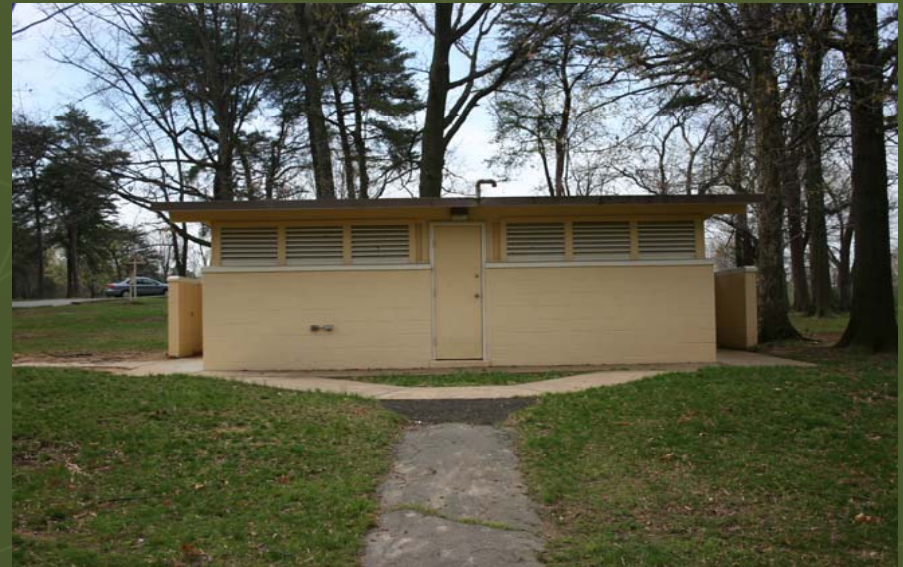
FIGURE 3 VIEW SOUTH

- ▶ View of restroom pavilion looking south. This view is of the service area between the wet walls of the men's and woman's restrooms. The door is in poor condition and should be replaced. There are electrical GFI outlets mounted on the outside of the building. The walkway in the foreground is in poor condition and would be heavily utilized by patrons of the amphitheatre and sports field. The block and louvers are in typical condition to the surrounding sides.

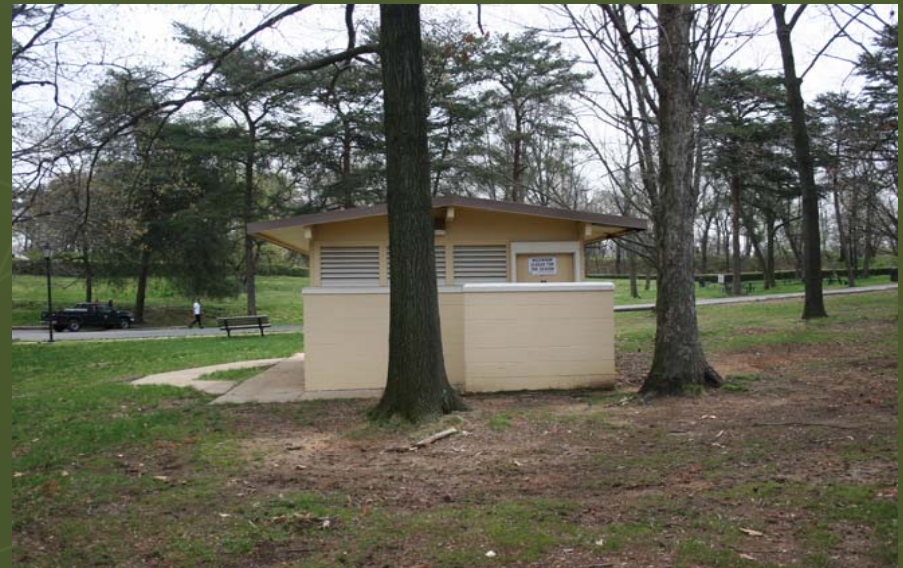
FIGURE 4 VIEW EAST

- ▶ View of restroom pavilion looking east. This view is of the men's room entrance. The drainage is away from the unit, and the block and wood slats are typical to the surrounding sides. There are two quite noteworthy trees in the immediate vicinity to the building that should be taken under consideration for safety. The door to the men's room is in poor working condition and should be replaced.

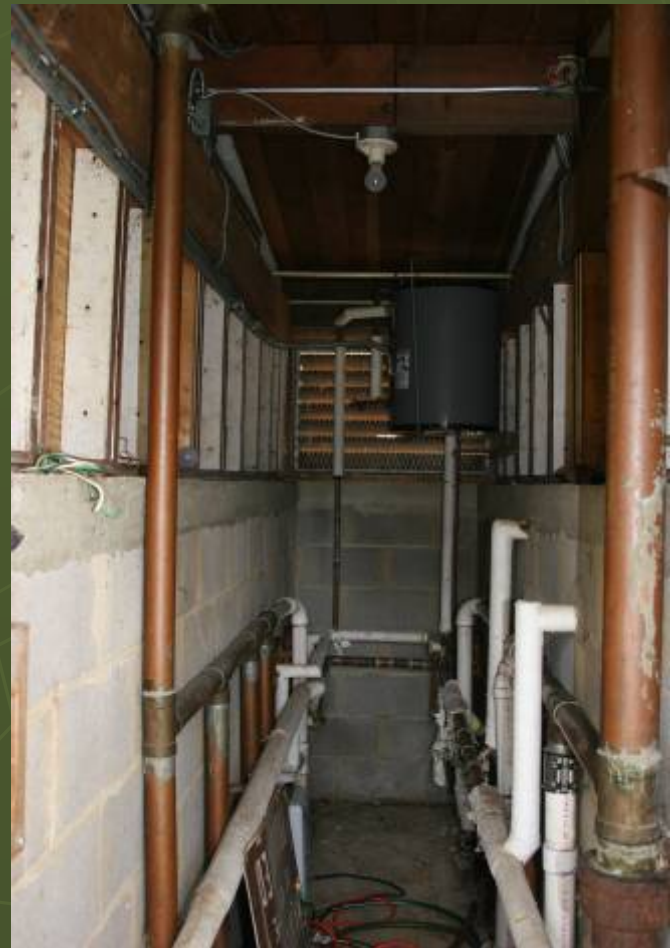
FIGURE 5 SERVICE AREA

- ▶ View of service area between men's and woman's restrooms. This area is an unconditioned space. It contains an electric hot water heater, electrical service panel, water supply lines and waste lines. The area is also used for storage. A portable space heater and extension cord appears to have been utilized to heat the space during cold periods of time. There are several uninsulated pipes and evidence of repairs utilizing PVC pipes to the existing copper lines. Open junction boxes and exposed wires exist and should be addressed by a licensed professional or qualified person. The electrical panel is rusting and modestly powered. There are no signs of leaks or odors. The space has an abundance of rodent droppings and should be abated.

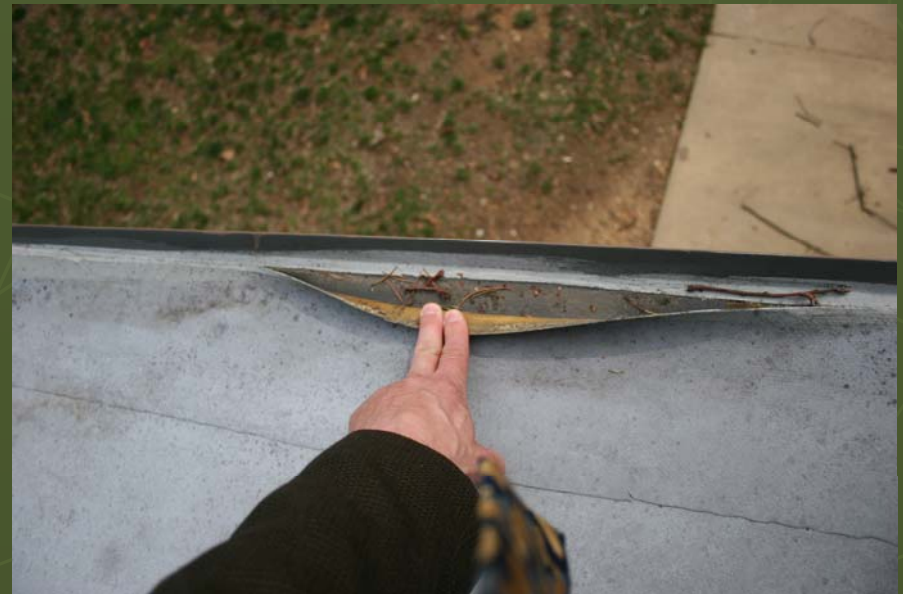
FIGURE 8 ROOF EDGE

- ▶ Typical edge of roof assembly allowing
- ▶ Water entry to soffit

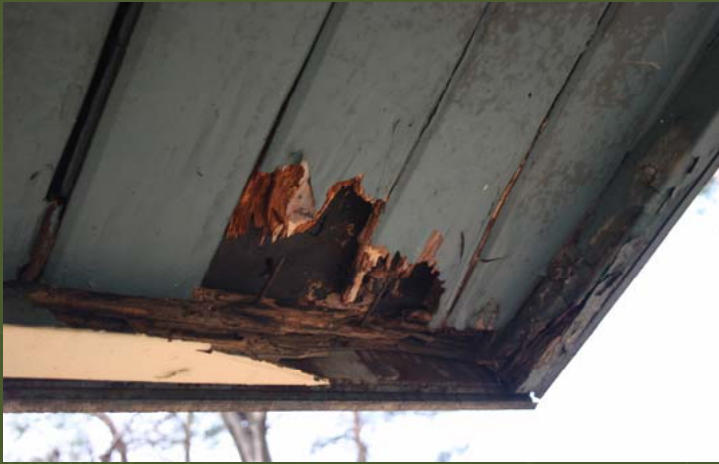
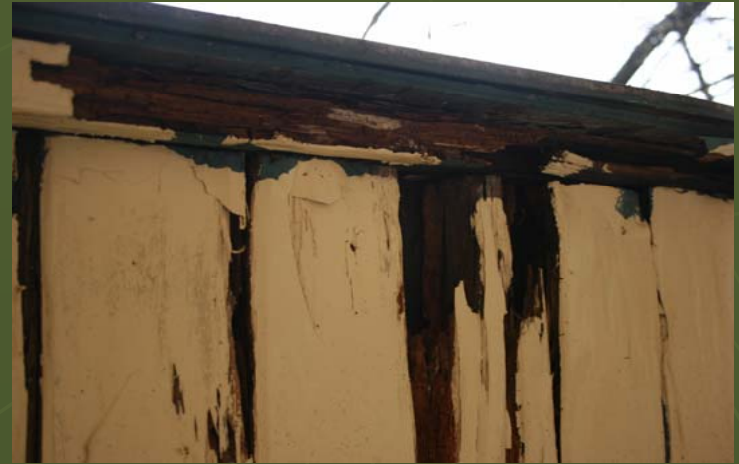
▶ FIGURE 9

- ▶ Water infiltration from roof edge causing rot and possible carpenter ant infestation.

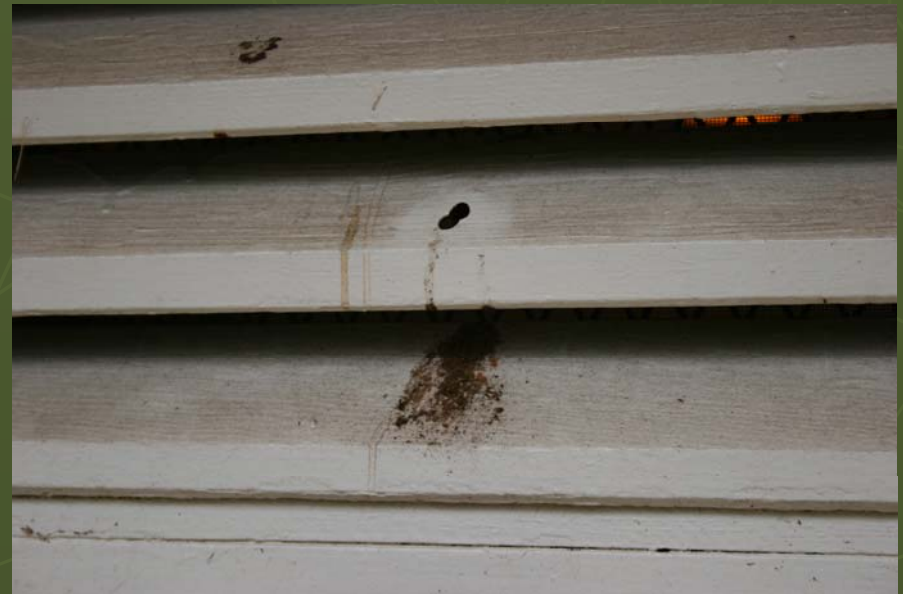
FIGURE 11

- ▶ View of hornet's nest located within wood slat of building.
- ▶ This is located directly adjacent to the women's room entrance.
- ▶ Hive was active at time of inspection. Immediate action should be taken.

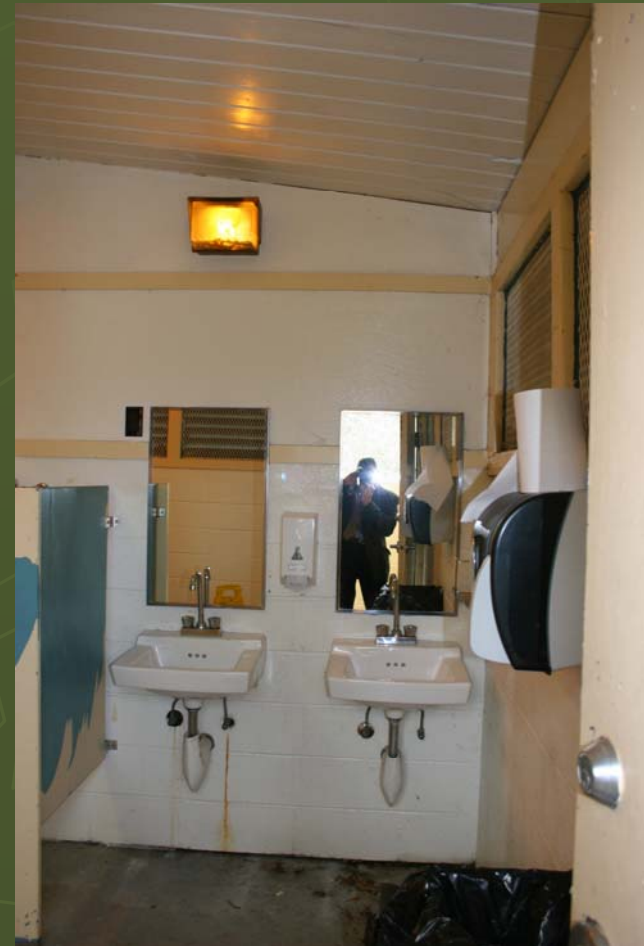
FIGURE 12 MEN'S ROOM

- ▶ View looking into men's restroom. Paint has significantly peeled from all stall separations. There is evidence of leaking and rust staining the painted block wall, but was not evidenced at the time of inspection. One of the wall mirrors should be secured to the wall. The floor has been painted and is in poor condition and aesthetically unpleasing. The fixtures are in working condition. The fixture count may be underestimated during times of performances at the amphitheatre. The lighting is minimally adequate and should be upgraded.

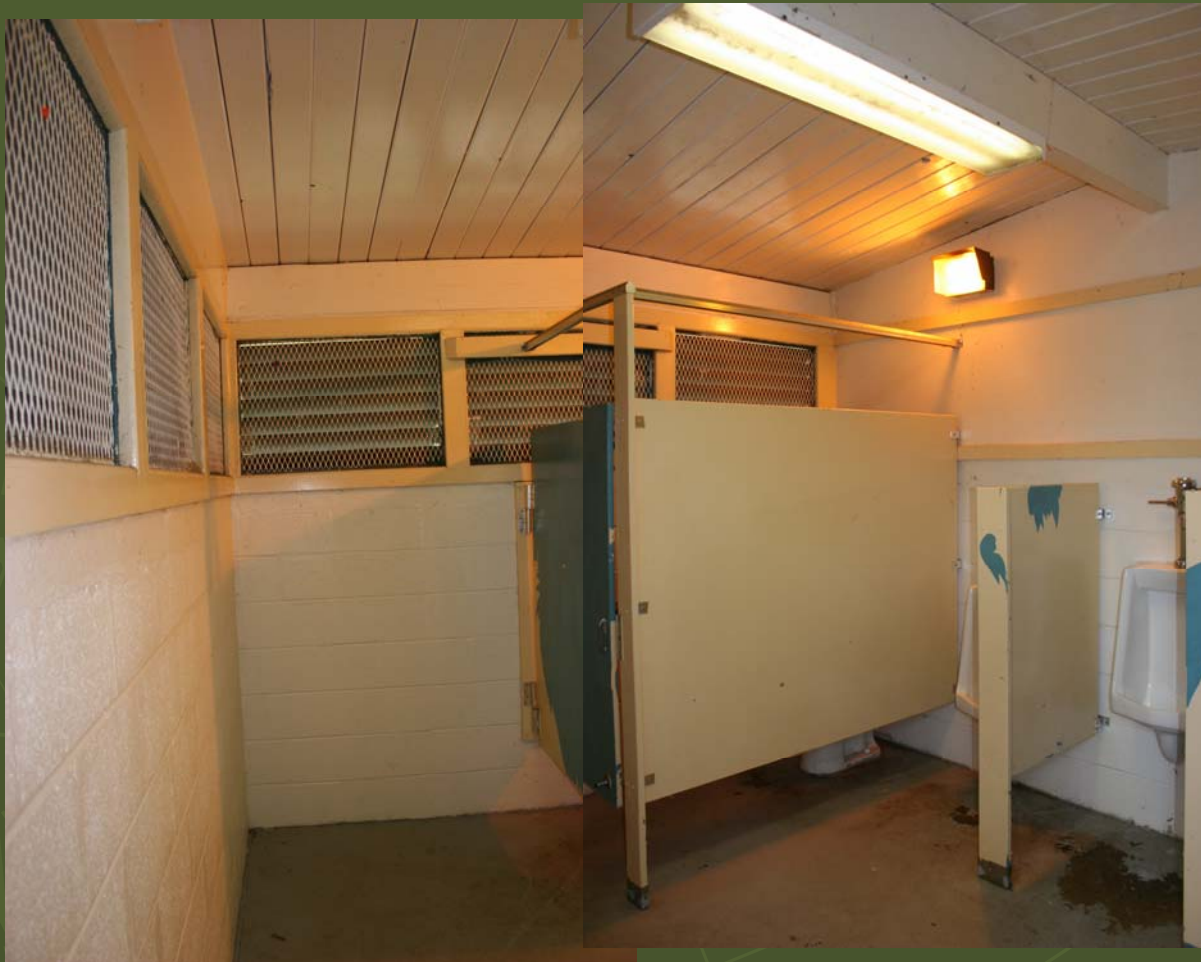
FIGURE 13 & 14

View into men's room. Note T&G ceiling is continues into exterior soffit , this may cause additional concern for repair of exterior wood rot and possible insect infestation issues. Block is in good condition.

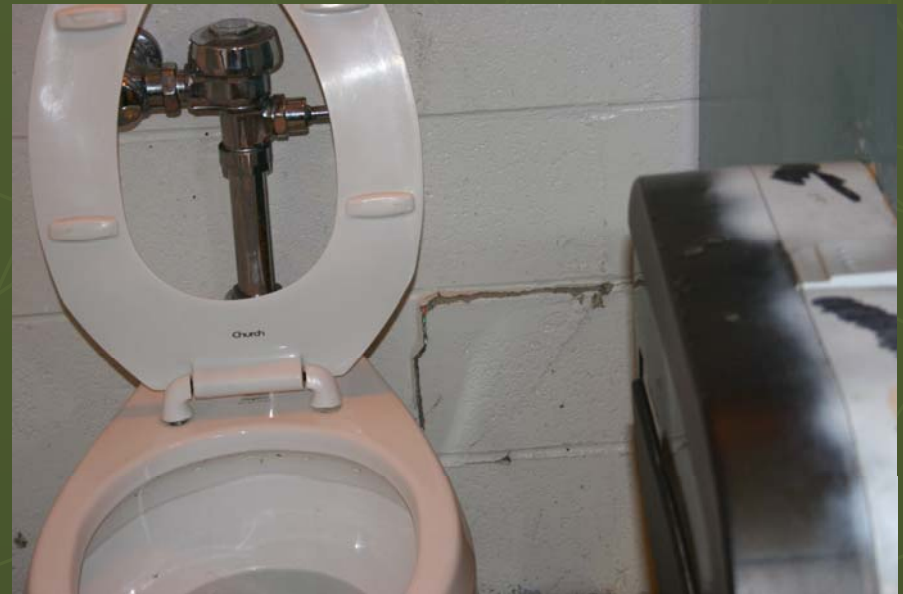
FIGURE 15 CMU DAMAGE

- ▶ **View of damaged CMU.** This block is adjacent to the service area, the back of the block had been chopped out during a repair to a waste line. There is no great issue but it should be addressed. It has been mentioned that several flush valves have been stolen. It should be considered to eventually replace the unit to a less susceptible one. Signs of paint vandalism are evident.

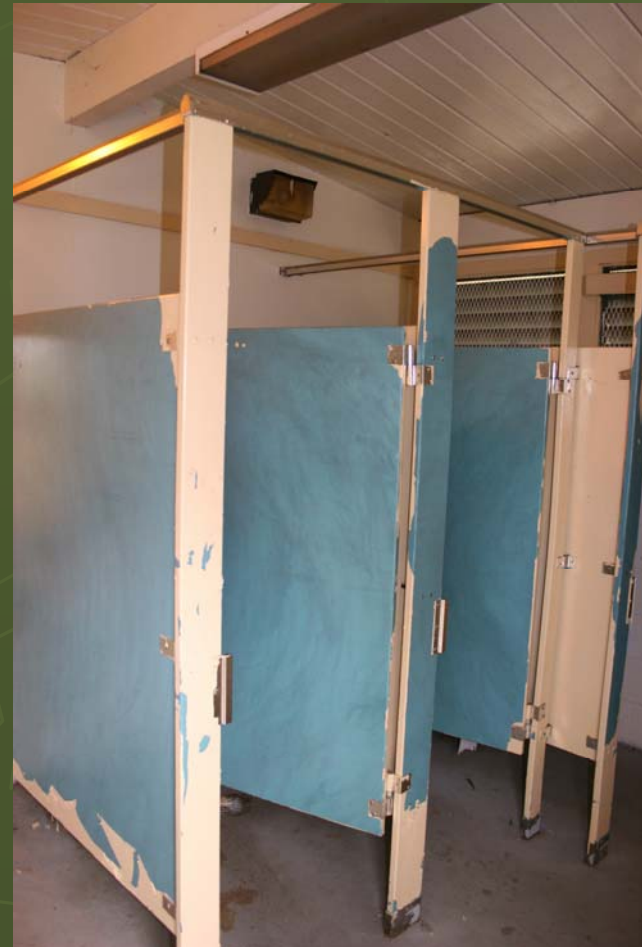
FIGURE 16 Woman's Room

- View of woman's restroom stalls. Note paint peeling from surrounds. Proper paint is to be utilized. Lighting is inadequate and floor paint is peeling and unsightly. Fixtures are in working condition but are worn.

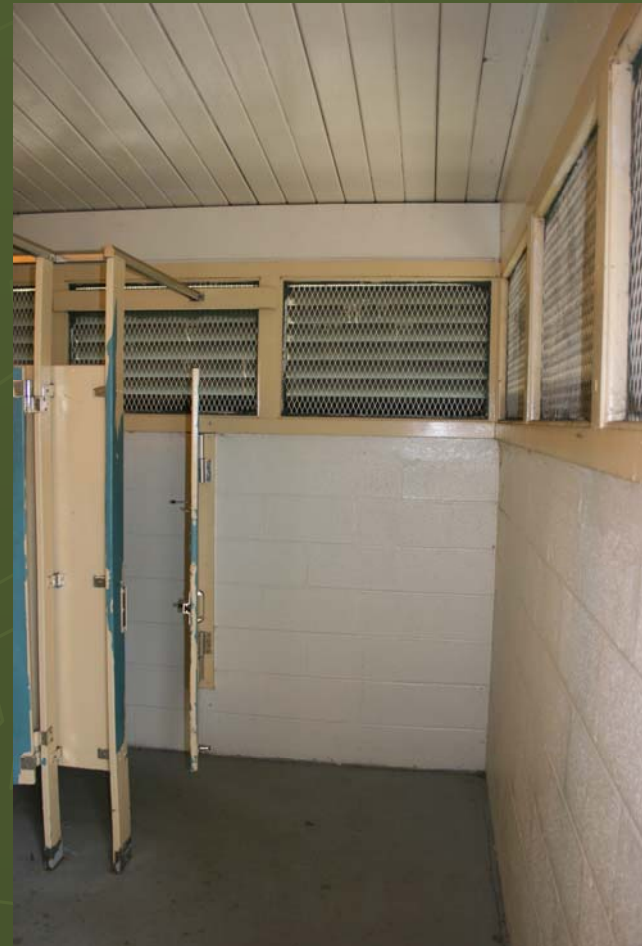
FIGURE 17 Woman's Room

- ▶ **View into woman's restroom. Block is in good condition. There are concerns with roof as stated previously due to continuation of T&G material to the outside**

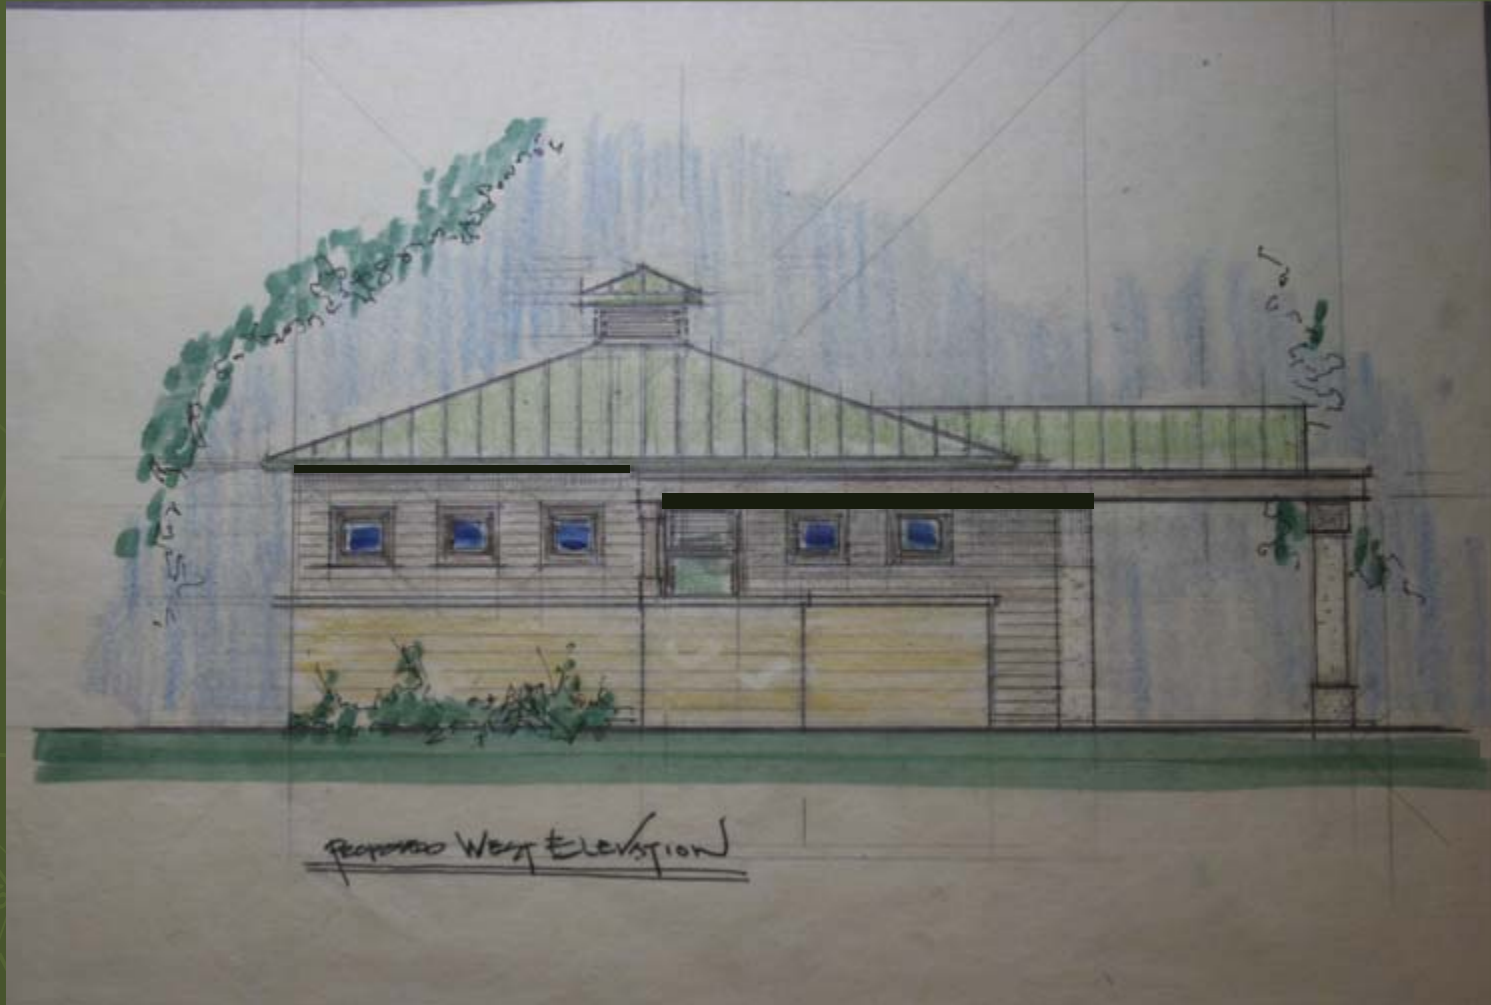
Proposed West Elevation

- ▶ The restroom structure located near the amphitheatre and sports field in Fort Ward Park is a structure in need of repair, major renovation or reconstruction. The needs of the public can not be achieved with this seasonal building. The restroom if assumed to be in conjunction with the amphitheatre as a place of assembly is insufficient. In addition, the newly constructed sports fields at Fort Ward are not equipped with restrooms or shade structures. The field will have nearly year round usage. The vending machines will create revenue. This structure will serve as a connecting point between the park , amphitheatre patrons, field athletes and spectators rather than a 40 year old seasonal restroom.
