Fort Ward Park

Facility Study and Recommendations

- ▶ Prepared by Paul Lombardi R.A.
- ▶ Department of Recreation Parks and Cultural Activities
- ▶ City of Alexandria
- ▶ October 16th , 2008

Building Inspection

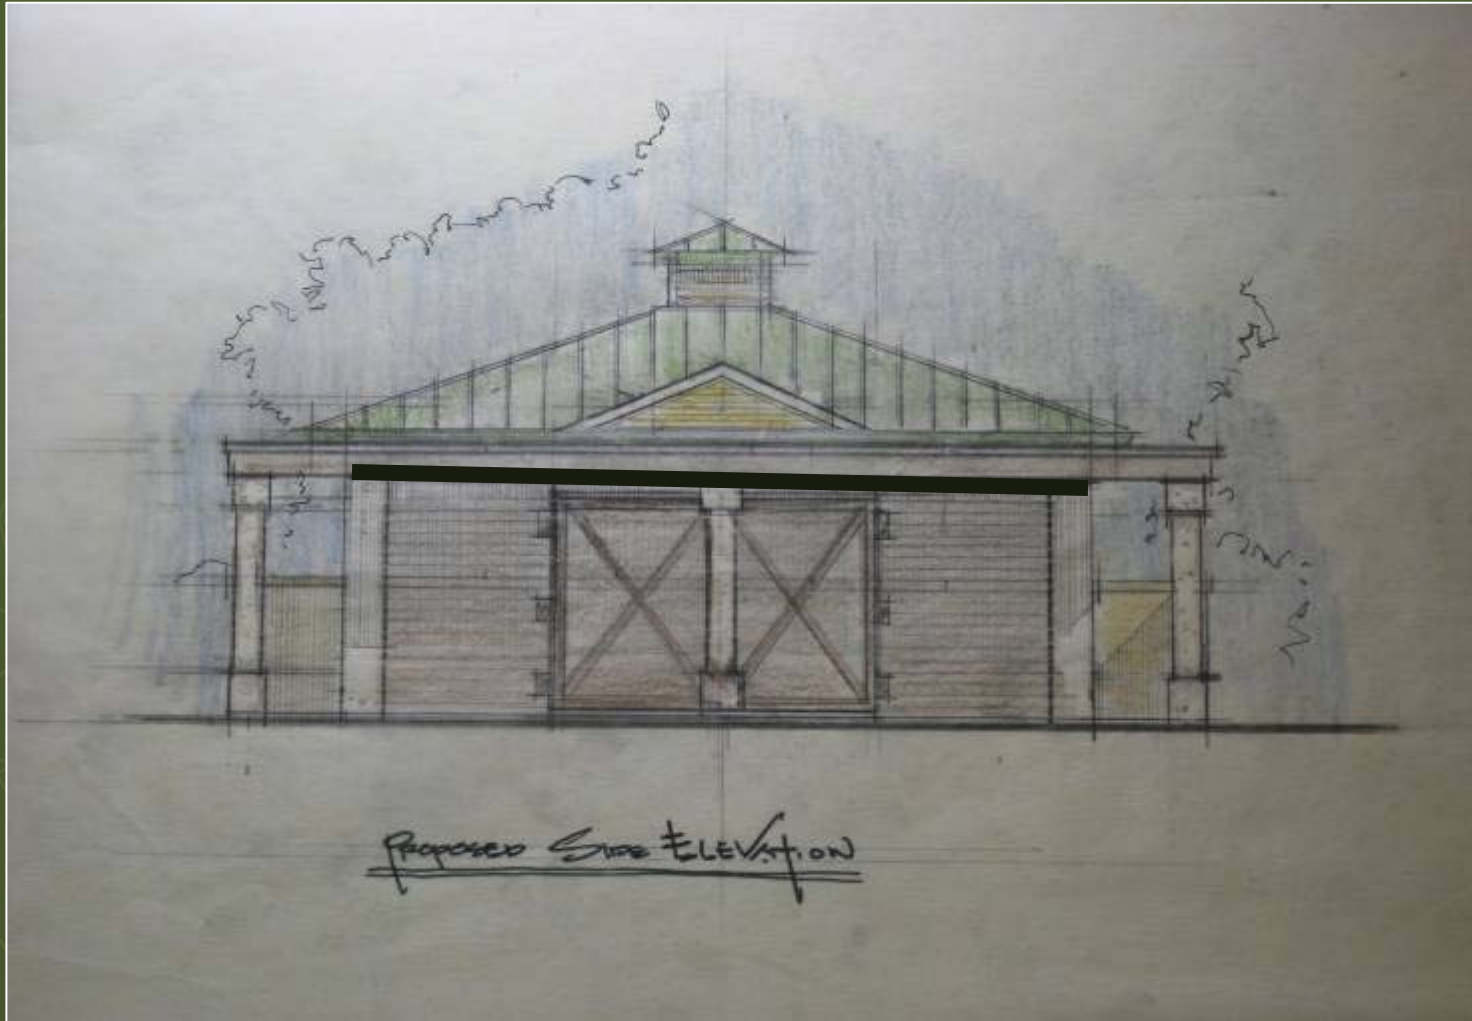
Proposed Side Elevation

- ▶ The restroom structure located near the amphitheatre and sports field in Fort Ward Park is a structure in need of repair, major renovation or reconstruction. The needs of the public can not be achieved with this seasonal building. The restroom if assumed to be in conjunction with the amphitheatre as a place of assembly is insufficient. In addition, the newly constructed sports fields at Fort Ward are not equipped with restrooms or shade structures. The field will have nearly year round usage. The vending machines will create revenue. This structure will serve as a connecting point between the park , amphitheatre patrons, field athletes and spectators rather than a 40 year old seasonal restroom.

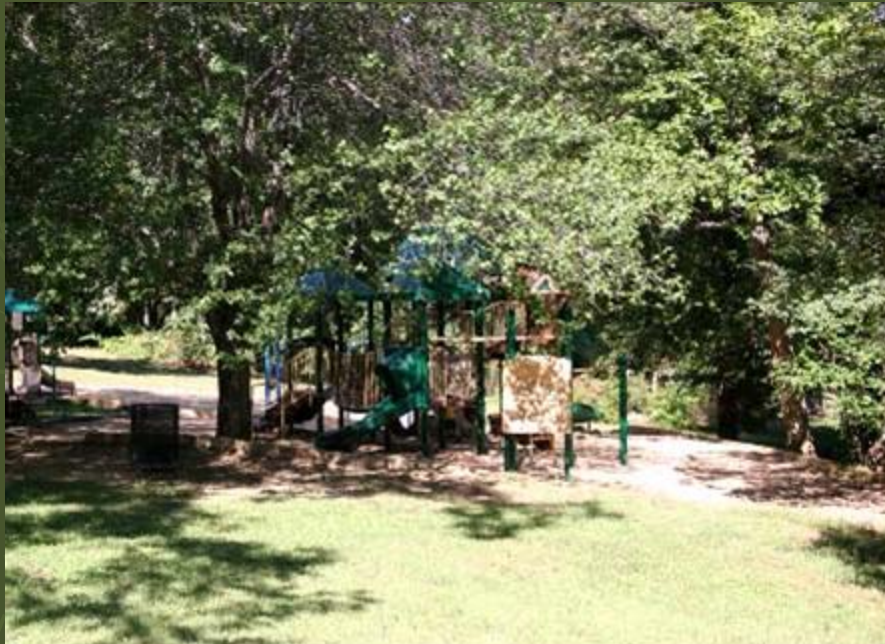
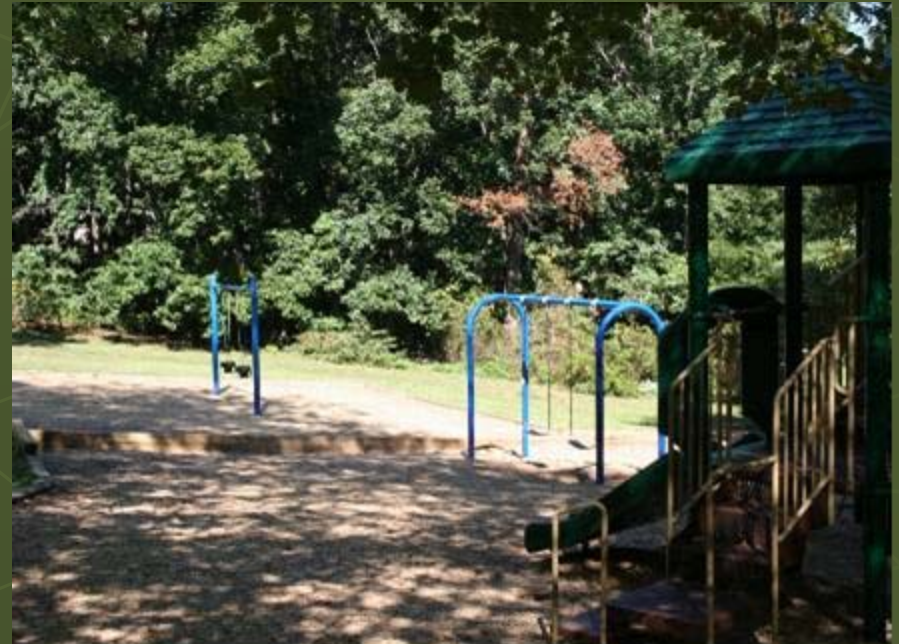
This playground is a recent addition to the park replacing a deteriorated wooden type. It is proposed to be relocated in order to comply with ADA requirements for accessibility and should receive a new rubberized surface. It should also be noted that the new location will not be within a drainage flow area. It shall be located closer to the parking area and further from the residential adjacencies.

Playground to be Relocated

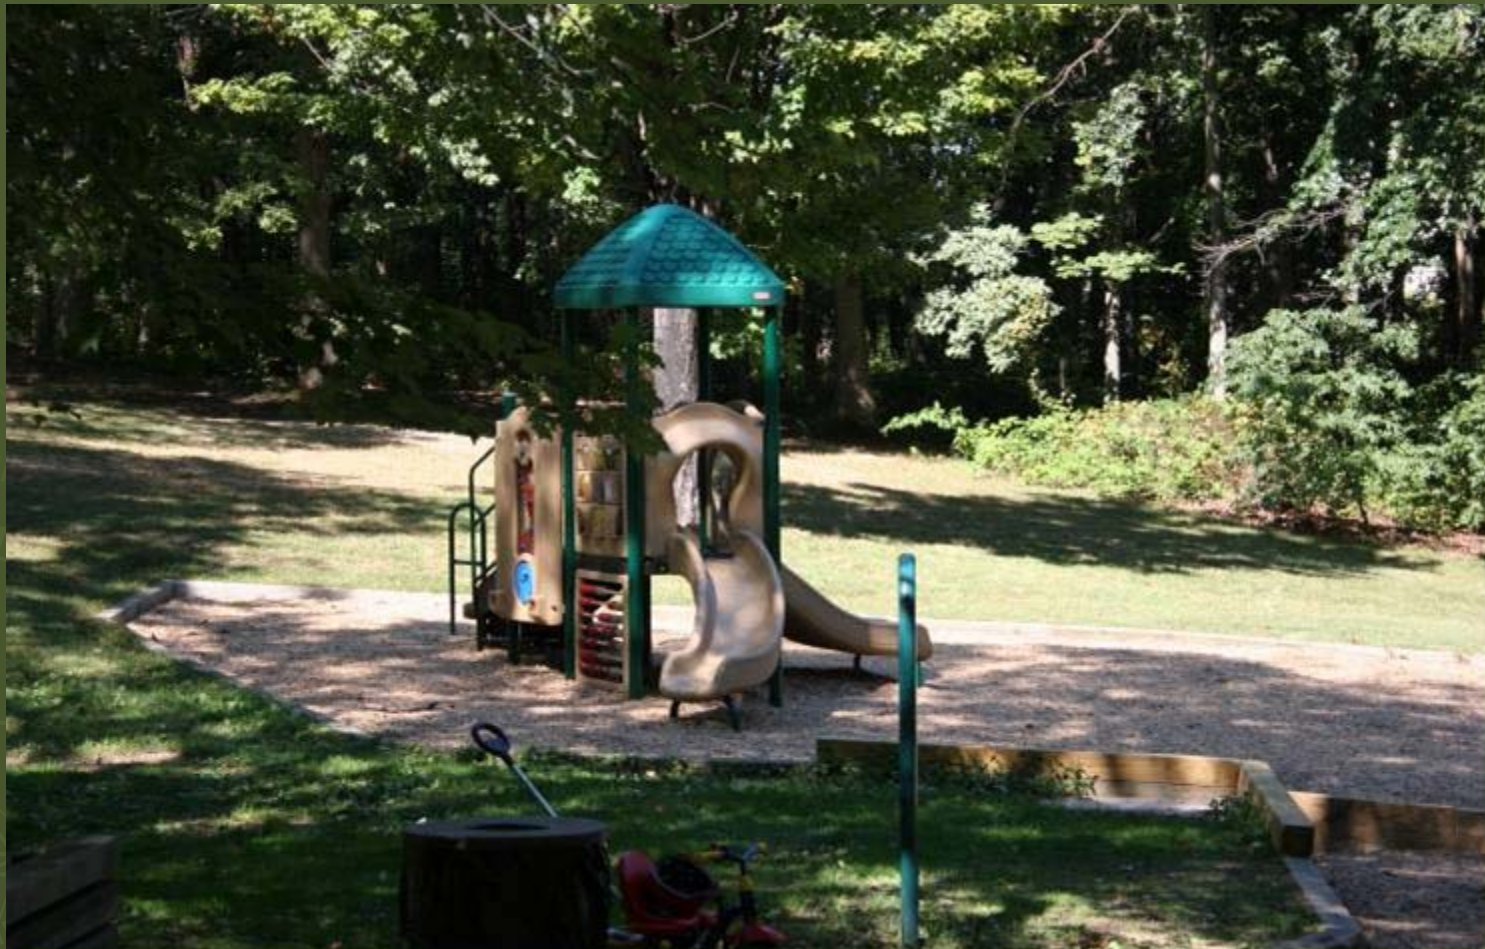
Playground Relocation

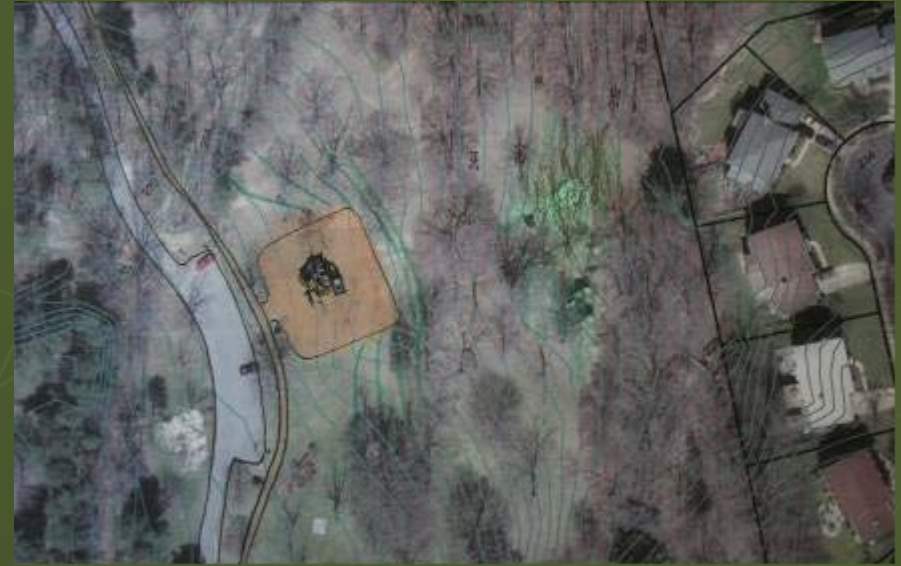
Proposed Location (1) Near
Parking with ADA accessibility
and Rubberized Surface

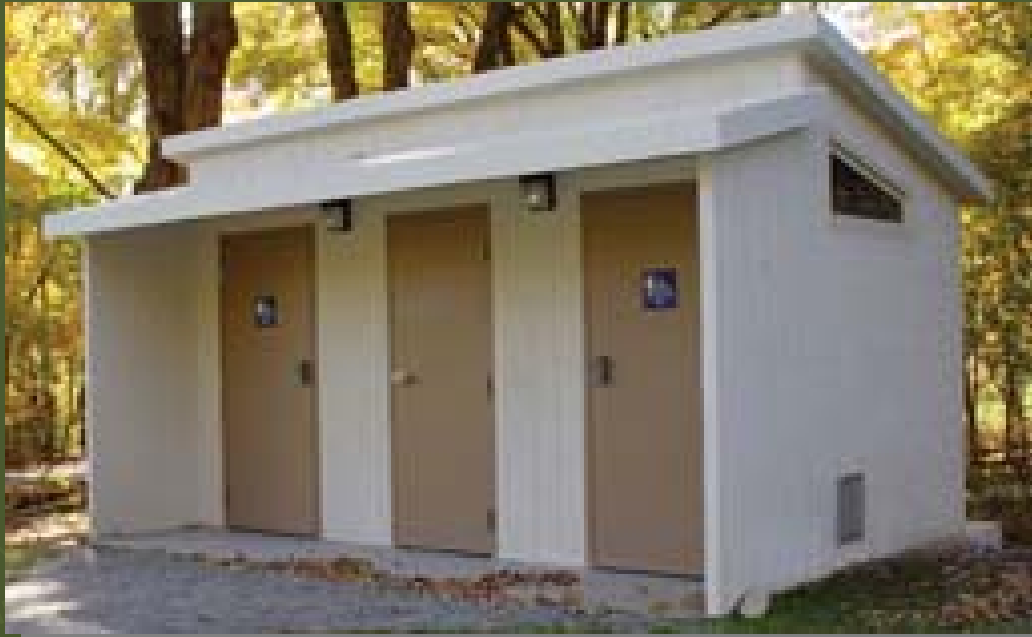
Prefabricated restroom to be located in the Northern part of the park near the large pavilion and within reach of the Fort Ward sports field

Prefabricated Concrete ADA compliant restroom

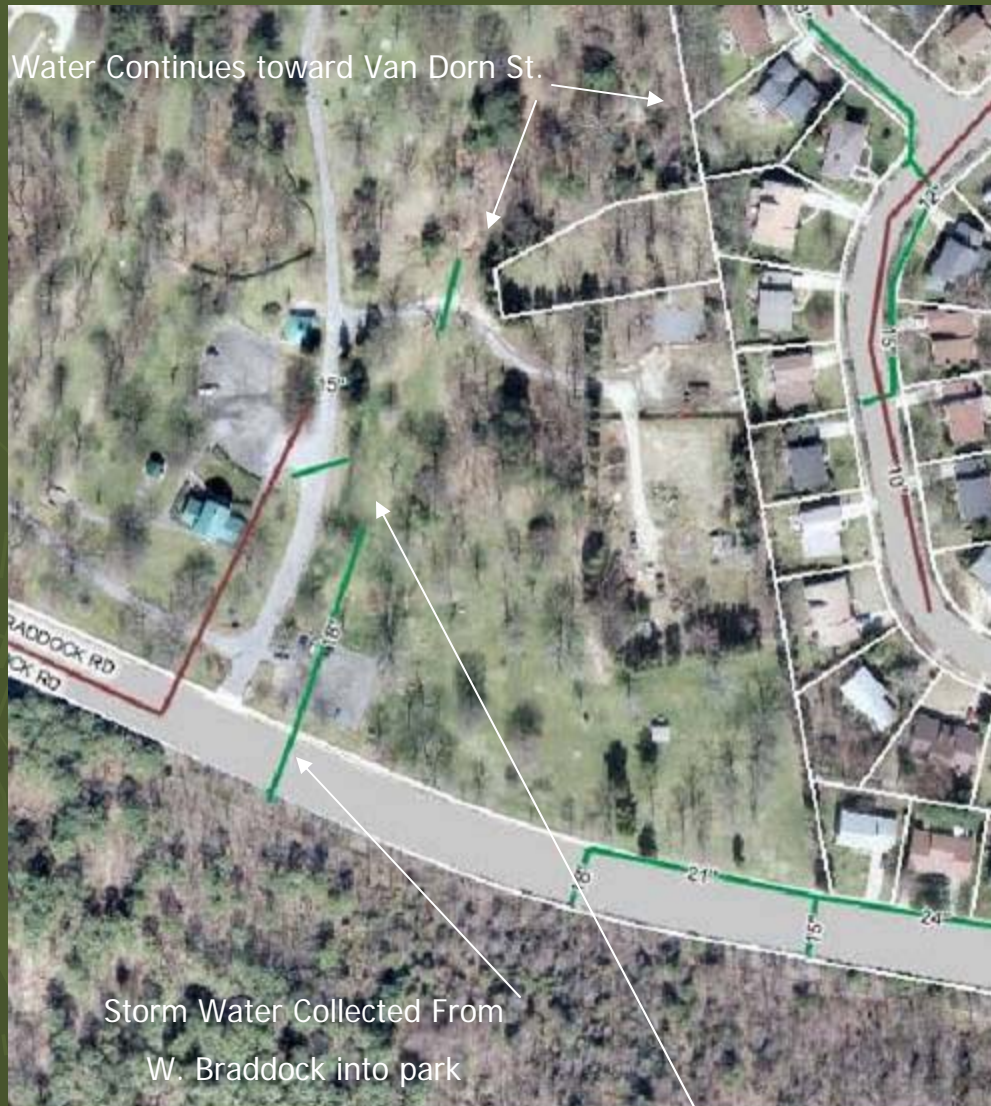
Isolated Map of Drainage Concern 1

The 18" storm sewer shown leading from West Braddock road into Fort Ward Park should be dealt with. It is providing storm runoff from West Braddock road directly into the park. The water then drains naturally through the park with little absorption. Some of the neighboring residences have diverted the storm water to prevent property damage. It finally terminates in drainage ditches and storm structures near Van Dorn Street.

- ▶ Divert Storm water to downstream facilities within West Braddock Road
- ▶ Connect catch basins directly to nearest storm facility
- ▶ Provide storm water detention area
- ▶ Provide storm water bio-retention area
- ▶ Provide storm water retention area
- ▶ Provide storm water retention via underground drywell structures

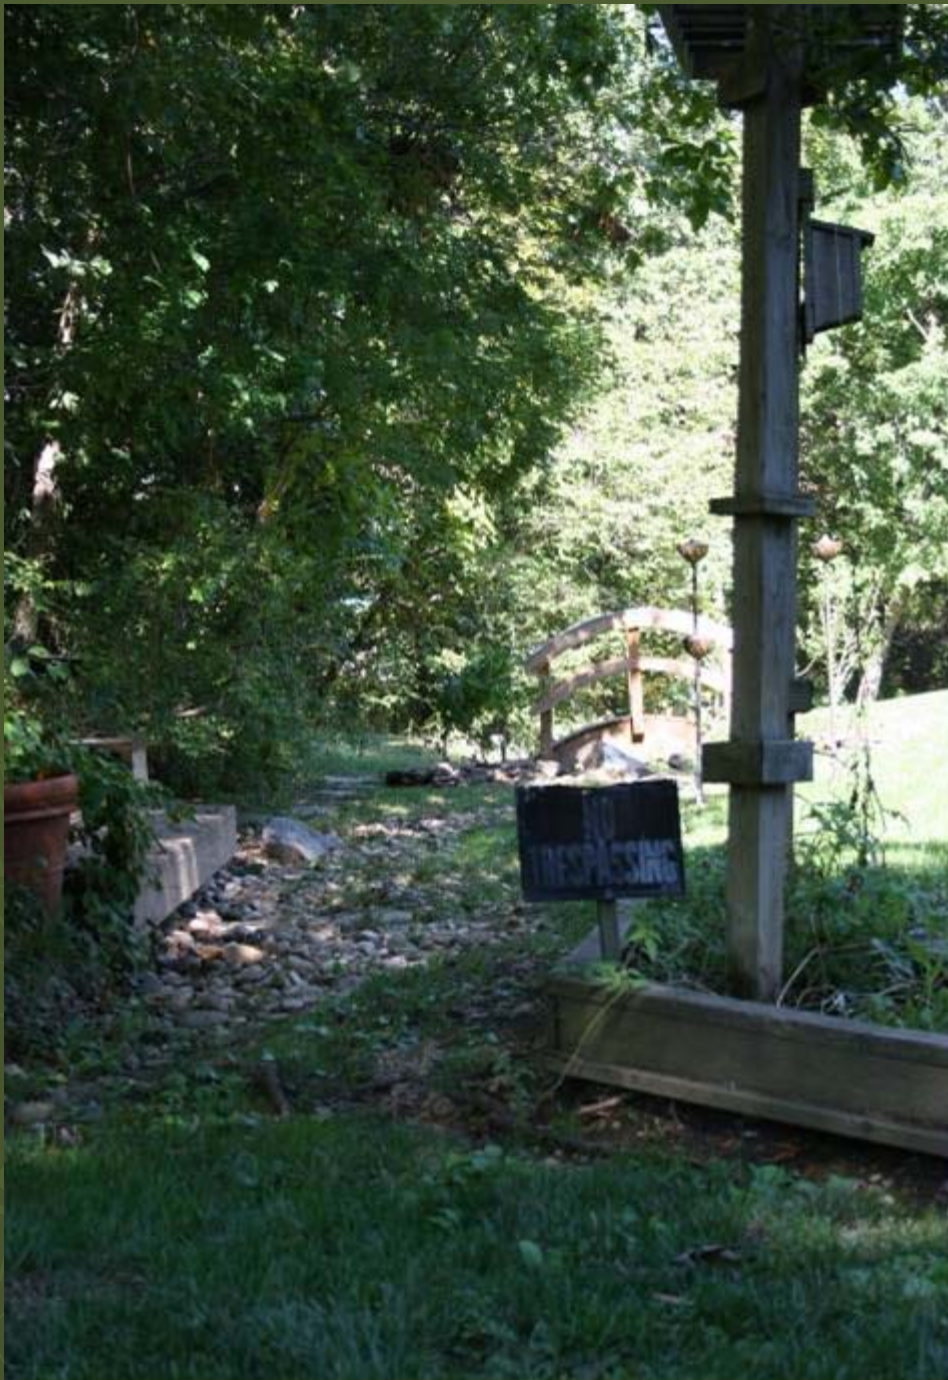
This depicts an area of storm water flow through an residential adjacency. Storm water should be reduced and contained appropriately.

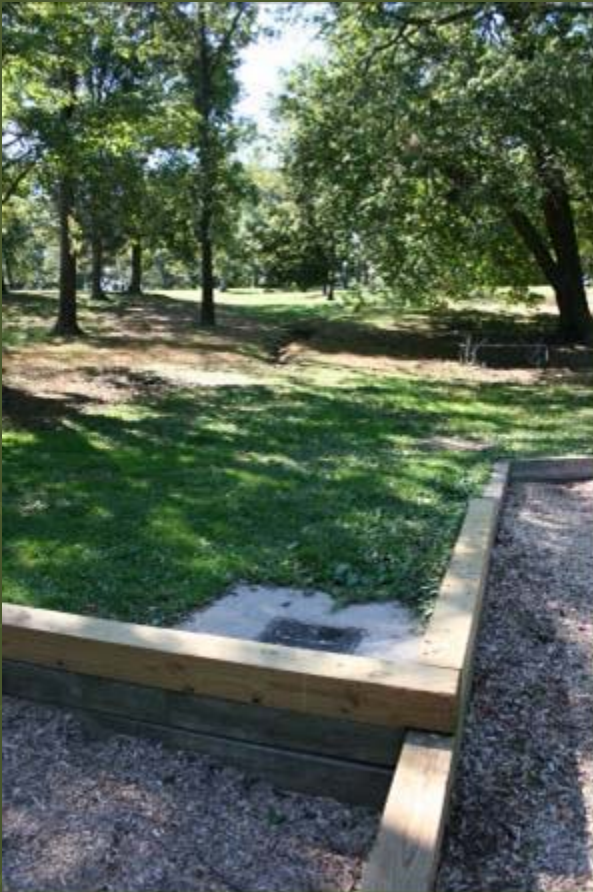
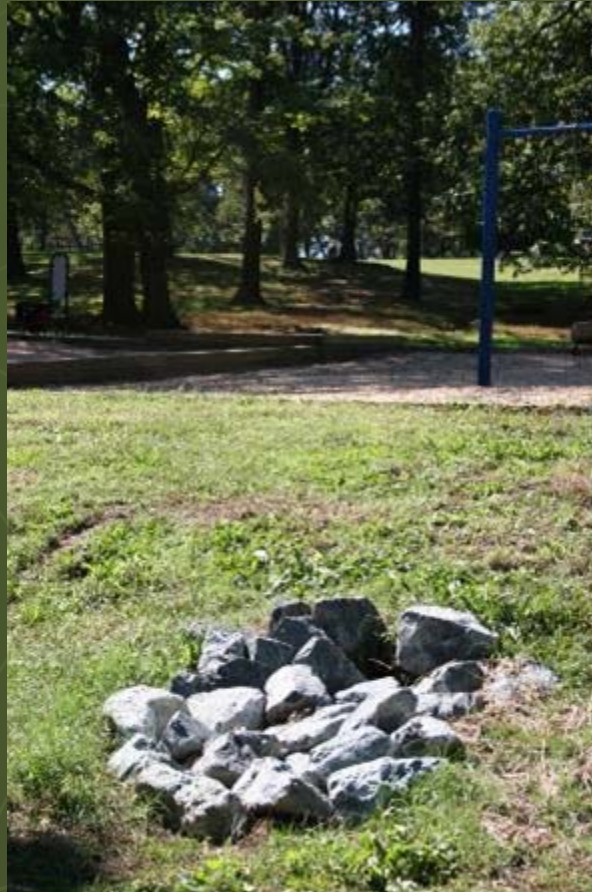
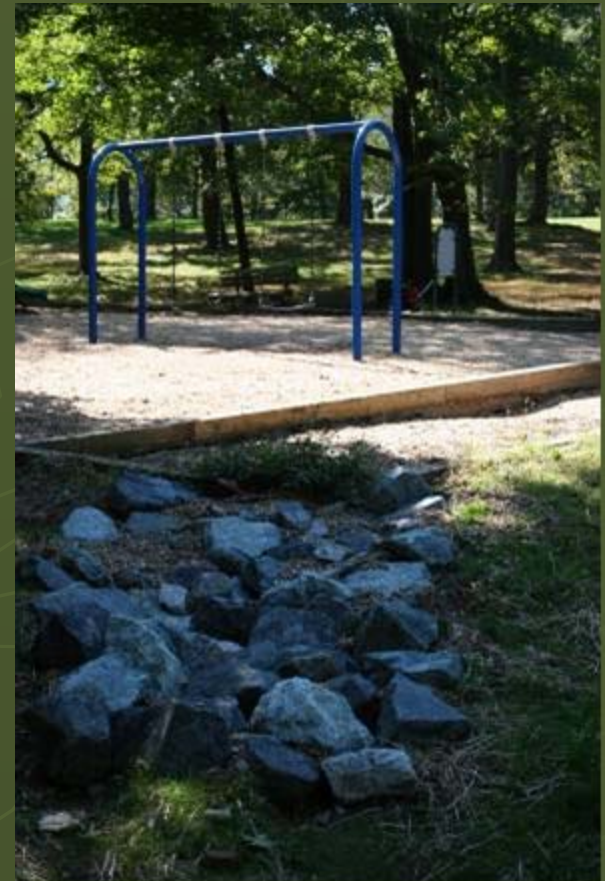
Inadequate Drainage Around Playground

Drainage Features

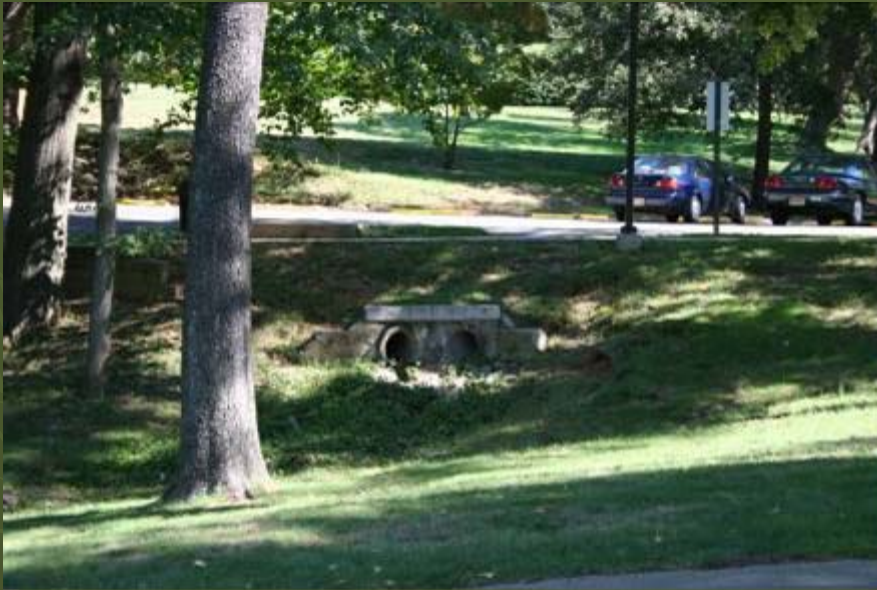
Storm Outlet From Fort Area
Significantly Contributing to Storm
Water Condition at Sports Field

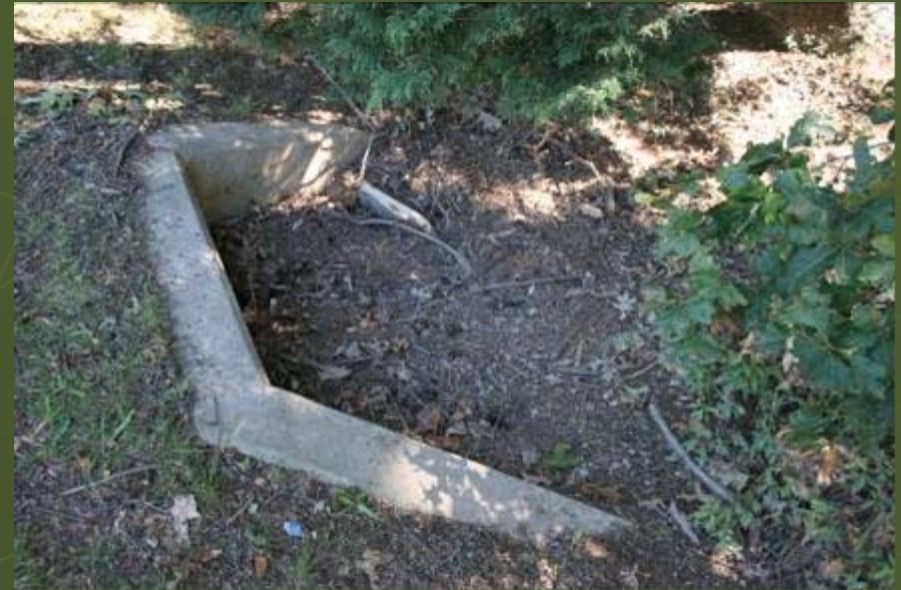
Debris Collecting on Inlet

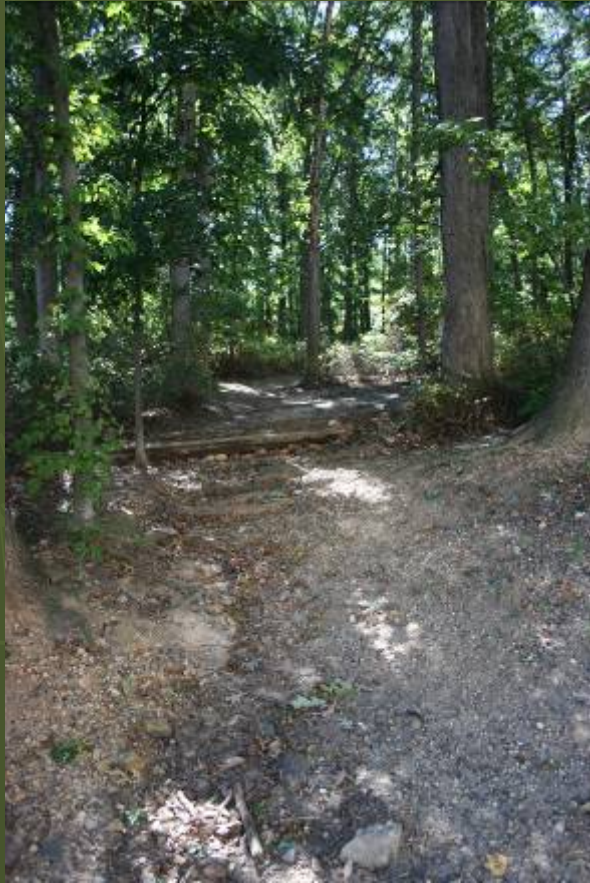
One of Several Drainage/Access Paths
@ Van Dorn ST

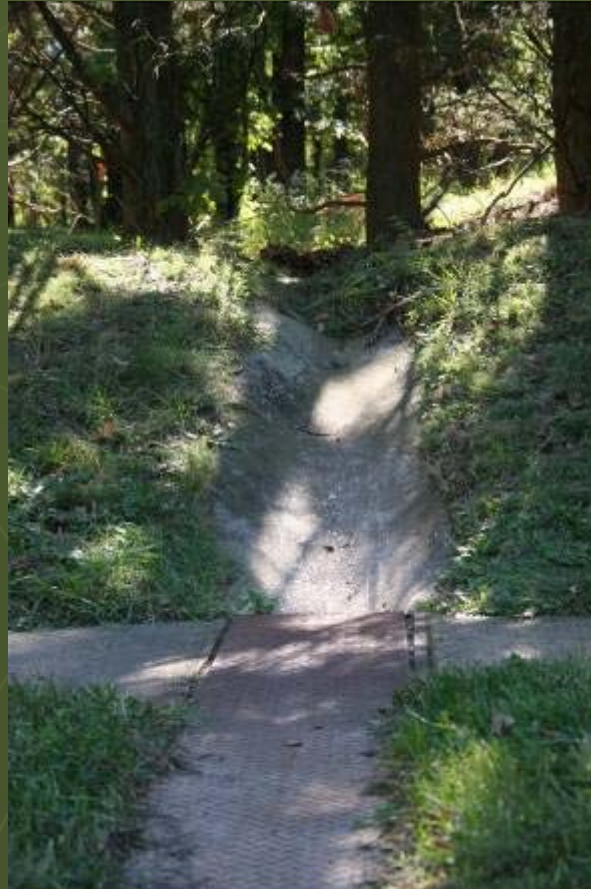
Trough From Park Under Sidewalk @
Van Dorn St.

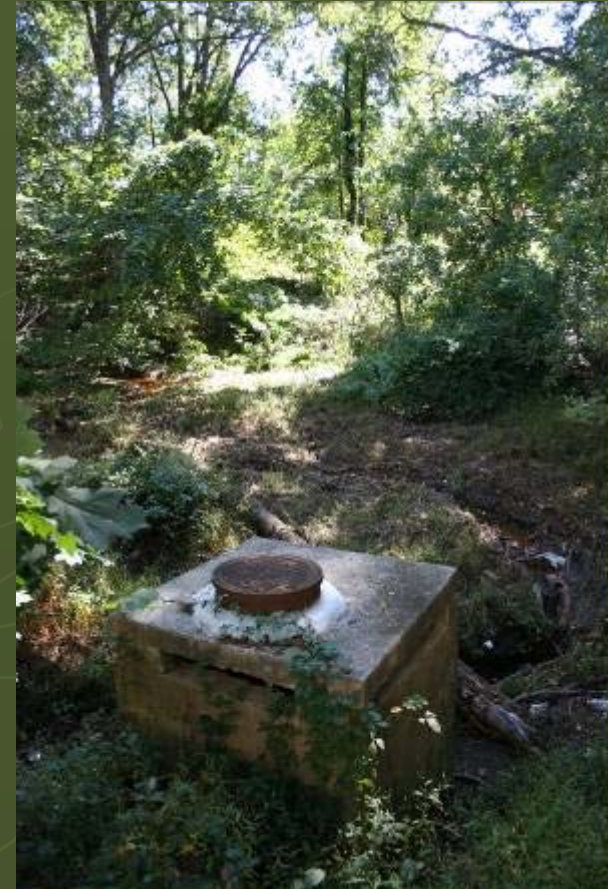
Final Termination Point @ Van Dorn St
