## 8. Overview of Tectonic Setting, Fault Systems, and Seismic Hazards in the City of Alexandria, Virginia

by Tony Fleming, 2016

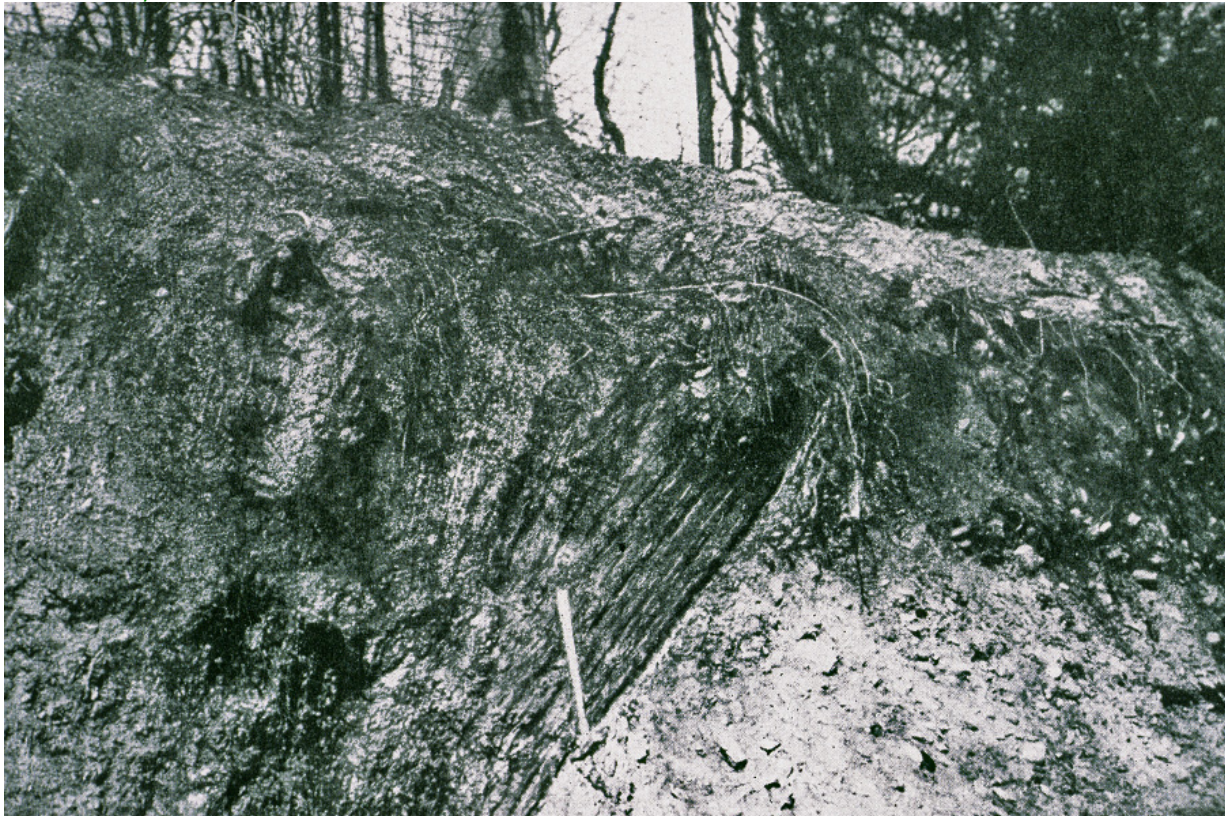
*Figure 8-1. Darton's fault, on Adams Mill Road by the National Zoo, Washington, D.C. The head of the hammer lies on the fault plane, along which banded Paleozoic mylonite of the Rock Creek shear zone (left) is thrust over terrace gravel of late Tertiary or Pleistocene age (right). This is the first of several relatively young faults that Darton recognized in the District; it is still exposed today in an enclosure erected by the Smithsonian Institution with the encouragement of the local geological community shortly after the photo was taken (Bassler, 1940). Photo by N.H. Darton, circa 1925, courtesy of the U.S. Geological Survey.*

In some places, post-Cretaceous faults occur within older, Paleozoic and(or) Mesozoic fault zones that have been reactivated. Darton's fault (fig. 8-1), located by the National Zoo and discovered in 1893, is a good example, and is still visible today (Darton, 1950). Other young faults have been recognized more recently within the Rock Creek shear zone (Fleming and Drake, 1998 and Fleming, unpublished data), and there are other examples from elsewhere in the region, such as the Everona fault (Bobyarchick, 2015) and potentially parts of the Stafford fault system (Mixon and Newell, 1977; 1982; Mixon and others, 2000). Powars and others (2015) summarize the regional evidence for this relationship.

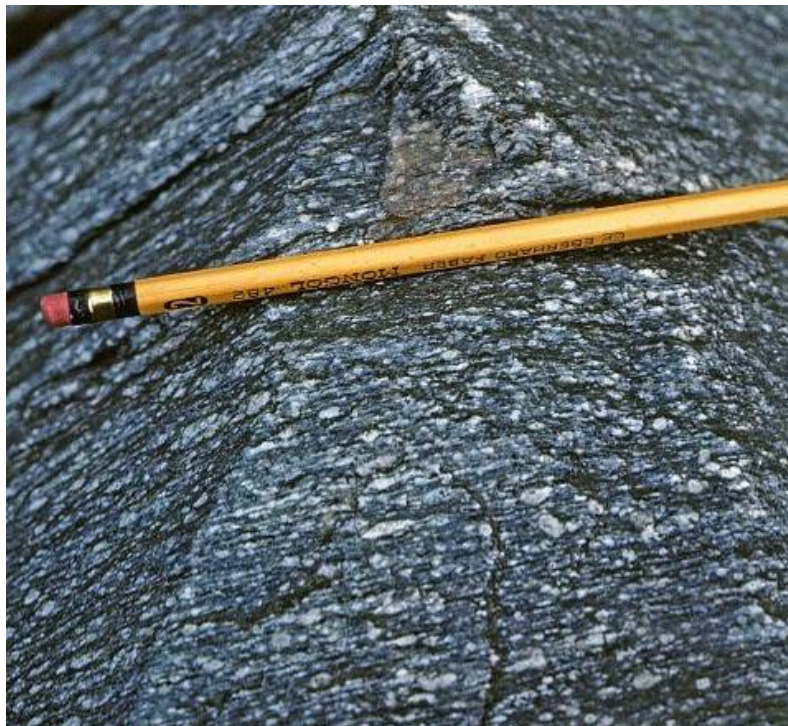
Figure 8-4. Spotted mylonite from the Rock Creek shear zone, Melvin Hazen Valley Park, Washington, DC. The dark colored part of the mylonite consists of ultra-fine grains that were severely reduced in size and welded together during fault motion, producing an almost glassy, appearance. The “spots” are remnants of original quartz and feldspar grains in the parent rock that survived the milling process; many are severely flattened and some are rotated. This mylonite formed at a temperature of about 550° C and a depth of several miles (Fleming and Drake, 1998). Photo by Tony Fleming.

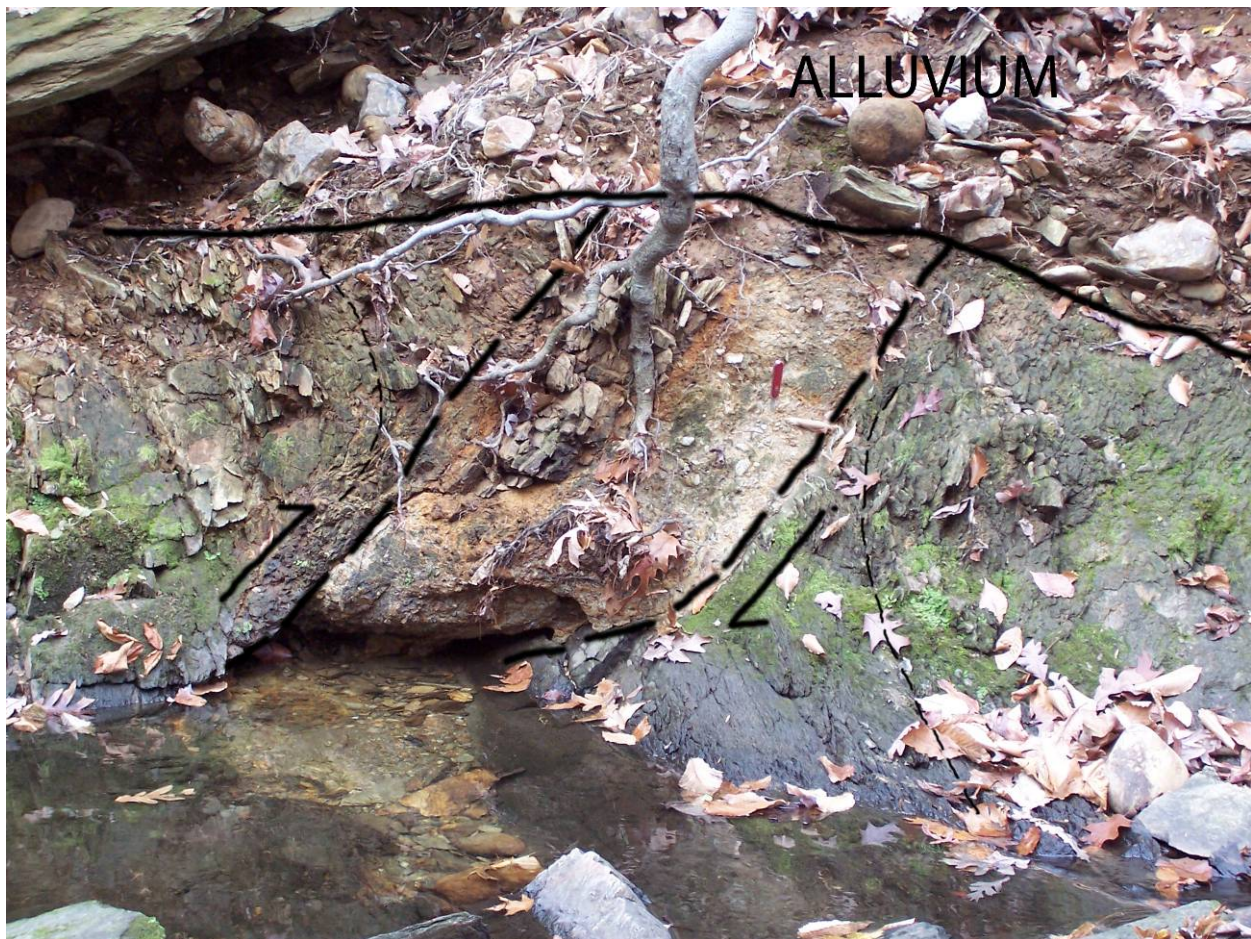
Figure 8-5. Brittle fault cutting Paleozoic metamorphic rock along Broad Branch, Rock Creek Park, Washington, DC. The long-dashed lines outline the walls of the fault, arrows show sense of motion. The interior of the fault is composed of gouge and breccia. Gouge is fine, powdery or clayey material ground up by fault motion, while breccia consists of angular fragments of the surrounding rock. Rotation of the foliation in the wallrock adjacent to the fault (shown by small dashed lines) is known as “drag” and gives a clear indication of the direction of fault motion. Photo by Tony Fleming.

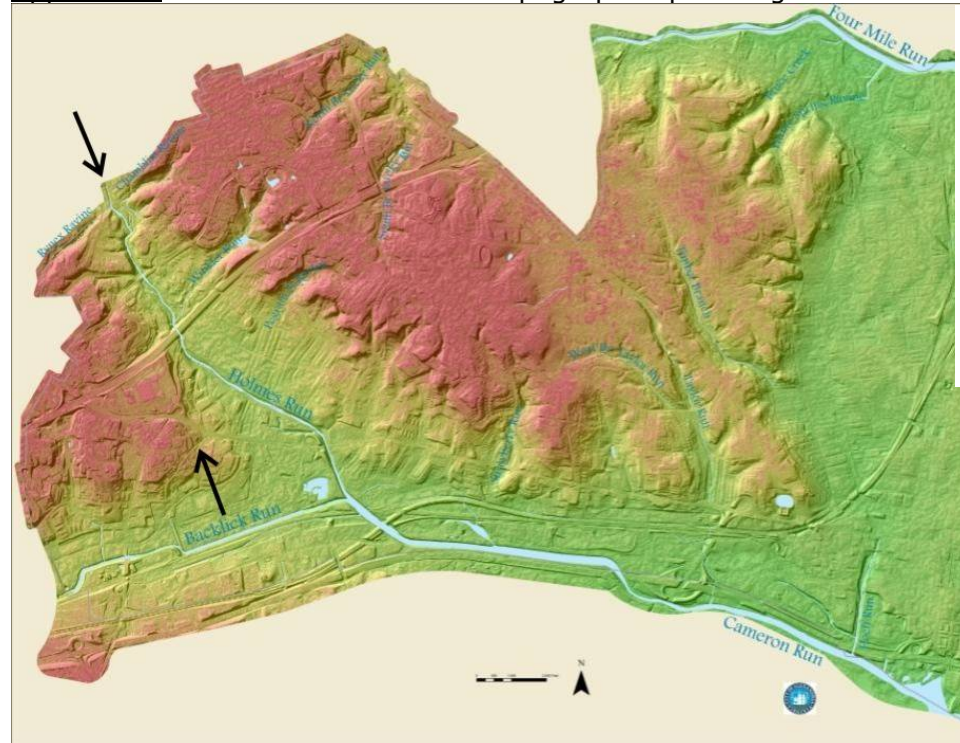
*Figure 8-11.  
Topographic  
lineament (between  
arrows) along  
Holmes Run Gorge,  
as seen on the  
Alexandria digital  
elevation model.*

**Appears on:** Annandale 7.5-minute topographic quadrangle and Alexandria DEM (fig. 8-11)

**Discussion:** Strong, straight topographic lineament oriented at N18W trends slightly oblique to the walls of Holmes Run Gorge. Approximately the southern third of the lineament is defined by a series of sharp, straight bluffs on the west rim of the gorge, mostly developed on the Potomac Formation. The northern part is defined by the straight *thalweg* of the bedrock gorge. Upstream of about Beauregard Street, the walls of the gorge and its tributaries have numerous rectilinear aspects suggestive of fracture- or joint-controlled valley walls. The lineament is spatially associated with at least three places (sites 8, 9, and 10) characterized by short, steep gradients on the bedrock surface. None of these bedrock slopes are sufficiently tall to be evident at the scale and bedrock contour interval in plate 3. Instead, they are suggested by site specific data.

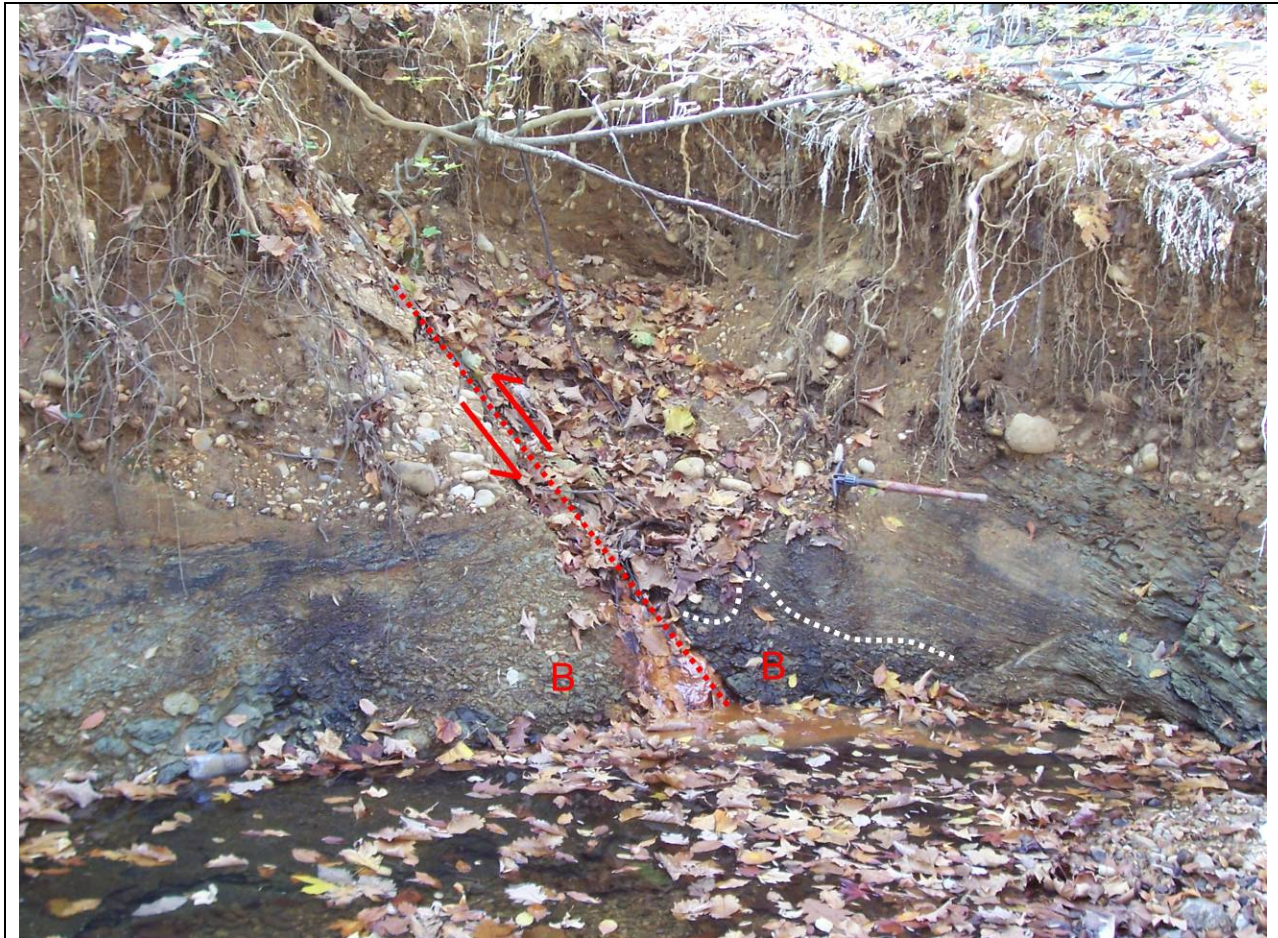
Figure 8-15. Reverse fault in Potomac Formation silty clay at Clermont Woods Park, Fairfax County. The fault plane and sense of motion are indicated by the red dotted line and arrows. The clay adjacent to the fault is brecciated (B), with fragments commonly rotated by fault motion from their original positions. Contorted strata are visible to the right of the fault plane, with small recumbent folds (white dotted line) indicating the sense of motion. Photo by Tony Fleming.

Discussion: This reverse fault is exposed on the west bank of the main ravine, immediately below an old road grade that crosses the stream next to the confluence of a small tributary. The fault plane strikes N40E, dips 40 NW and is accompanied by a zone of breccia and rotated strata that give the sense of fault motion (figure 8-15). Slickensides on the fault plane point nearly straight down dip. The exposed part of the fault is entirely within silty clay of the Potomac Group that occurs at in the same interval and at about the same distance off the base of the formation as the Arell clay member on the north side of Cameron Run. Banded clay is thrust over massive olive green clay that is very similar in appearance to the Arell clay member. A profuse amount of ground water was seeping from the fault zone during every visit to the site made by the author. No distinctive marker beds are available to determine the amount of offset along the fault.
