## Murray-Dick-Fawcett House Historic Structure Report

Report by Glavé & Holmes Architecture for the Office of Historic Alexandria,  
City of Alexandria, Virginia | April 19, 2024

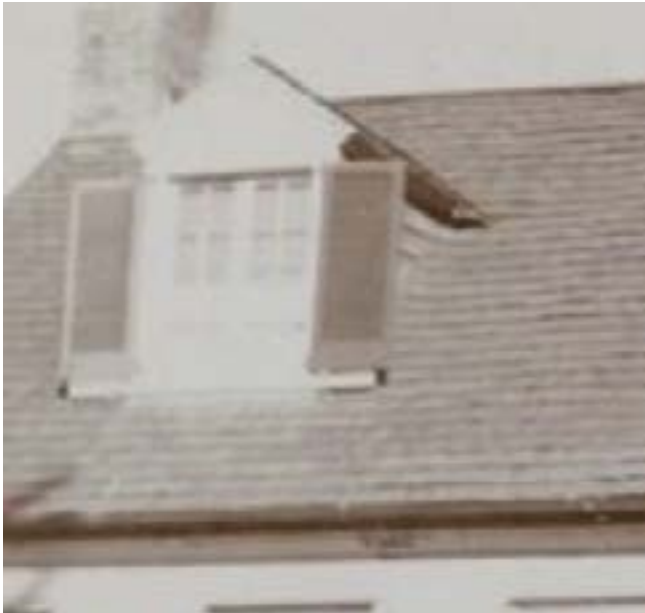
Figure 4a. - Historic Photo from the early 20th c shows the western dormer on the south front with the shutters.

The pair of chambers in the attic was lit by two dormers on the south front, two casements in the west gable and a single six-light casement in the east gable. The west gable windows flank the chimney in the west wall. Dormers as wide as these and filled with pairs of casements are very unusual and these were fitted with shutters that were held out to each side of the dormers by a board at sill level to which iron shutter dogs were attached (see Figure 4a).

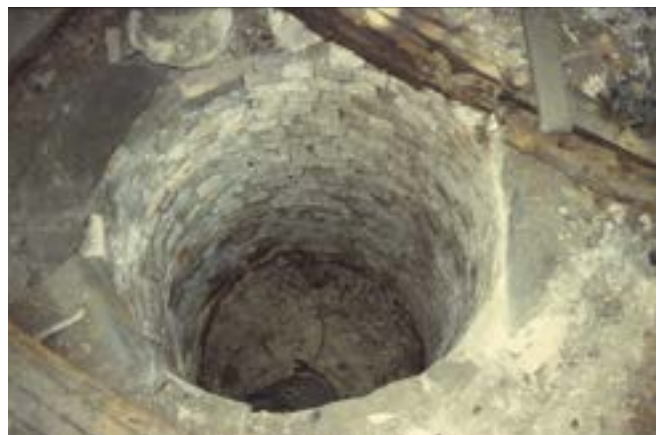
Figure 4d. - Well, Photograph during archaeology in the 1772 cellar, 2000, Alexandria Archaeology [AX187\_FR\_16].

have been expected if it was used for living accommodation or workspaces.<sup>25</sup> The 1774 cellar contains a partially-filled brick-lined well of unknown construction date (the feature has not been excavated).

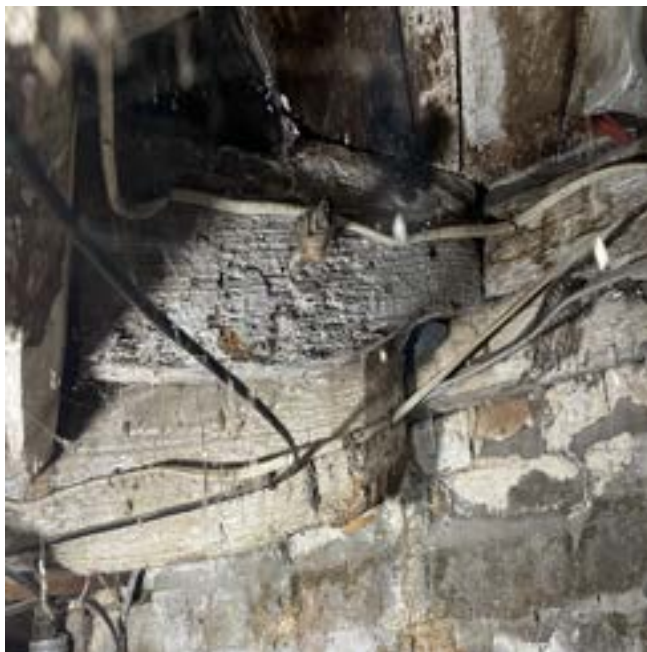
Figure 5a. - Junction of diagonal framing for the chimney with the sill in the NW corner of the 1784 addition.

The sequence of construction and alterations within envelope of the 1784 addition is complex. The original exterior door to the north remains in place within the addition. Evidence in the first floor-floor framing indicates that the NW room in the addition (Room 105) was heated by a diagonal chimney in the NW corner. A similar chimney may have heated the NE room (Room 107), but, unlike the NW room, there is no physical evidence for this. In spite of a reference to the existence of three chimneys in Murray's

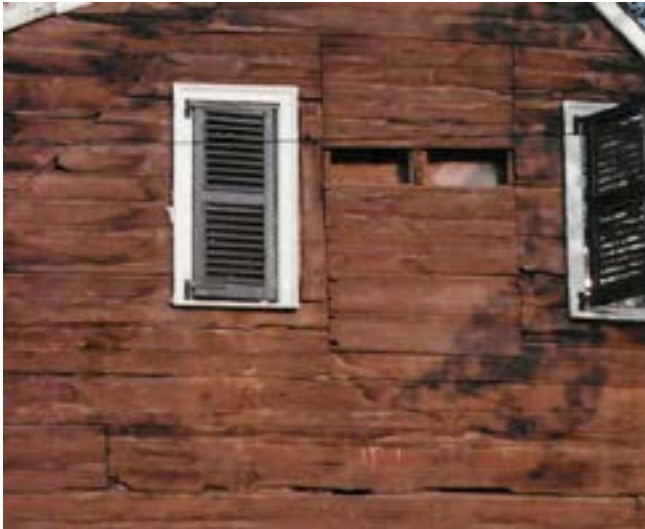
Figure 5d. - West gable during 2002 removal of weatherboard. Note the large square patch behind the chimney (Bierce Collection).

The fact that no fireplace was mentioned for the two rooms on the second floor could be interpreted to mean that the small coal grate in the upstairs west chamber was added after 1792. This might be connected to the large square patch in the west gable and the very rough form of the chimney in the upper room, which appears not to have been part of the original plan for the house. This patch predates the beaded weatherboarding which was added over the original flush boards on the west and south faces of the 1774 and 1784 sections of the house. The weatherboards were added c. 1816 when the front door was relocated to the east end. The question of the dating of various kinds of weatherboards in Alexandria is difficult to resolve, since relatively few early frame houses survive. Certainly the flush weatherboards were nearly unique to the area on both sides of the Potomac in the 18th century.<sup>13</sup> Houses like the

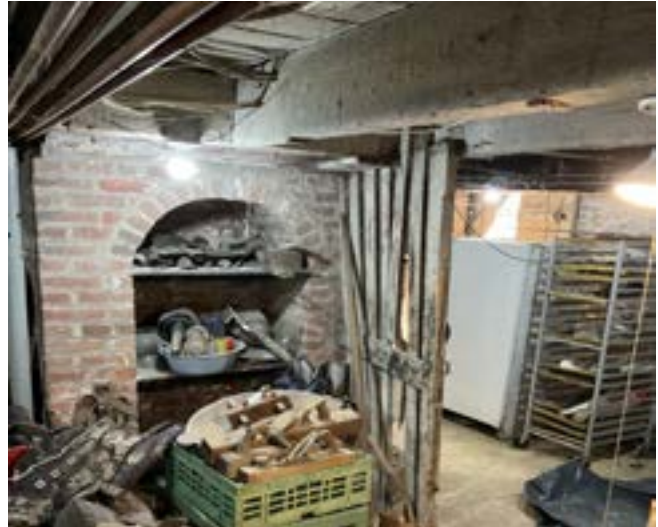
The diagonal chimney, also without a deep foundation to support it, was removed at the same time. A new vaulted brick interior chimney base was added on the north between the joists. Bricks supporting the hearth curve out from the chimney to rest against an added timber header. The added header is not notched into the floor

Figure 6a. - Added chimney base in the 1784 Cellar from the south.

structure, but is supported on ledgers nailed to the face of the flanking joists.

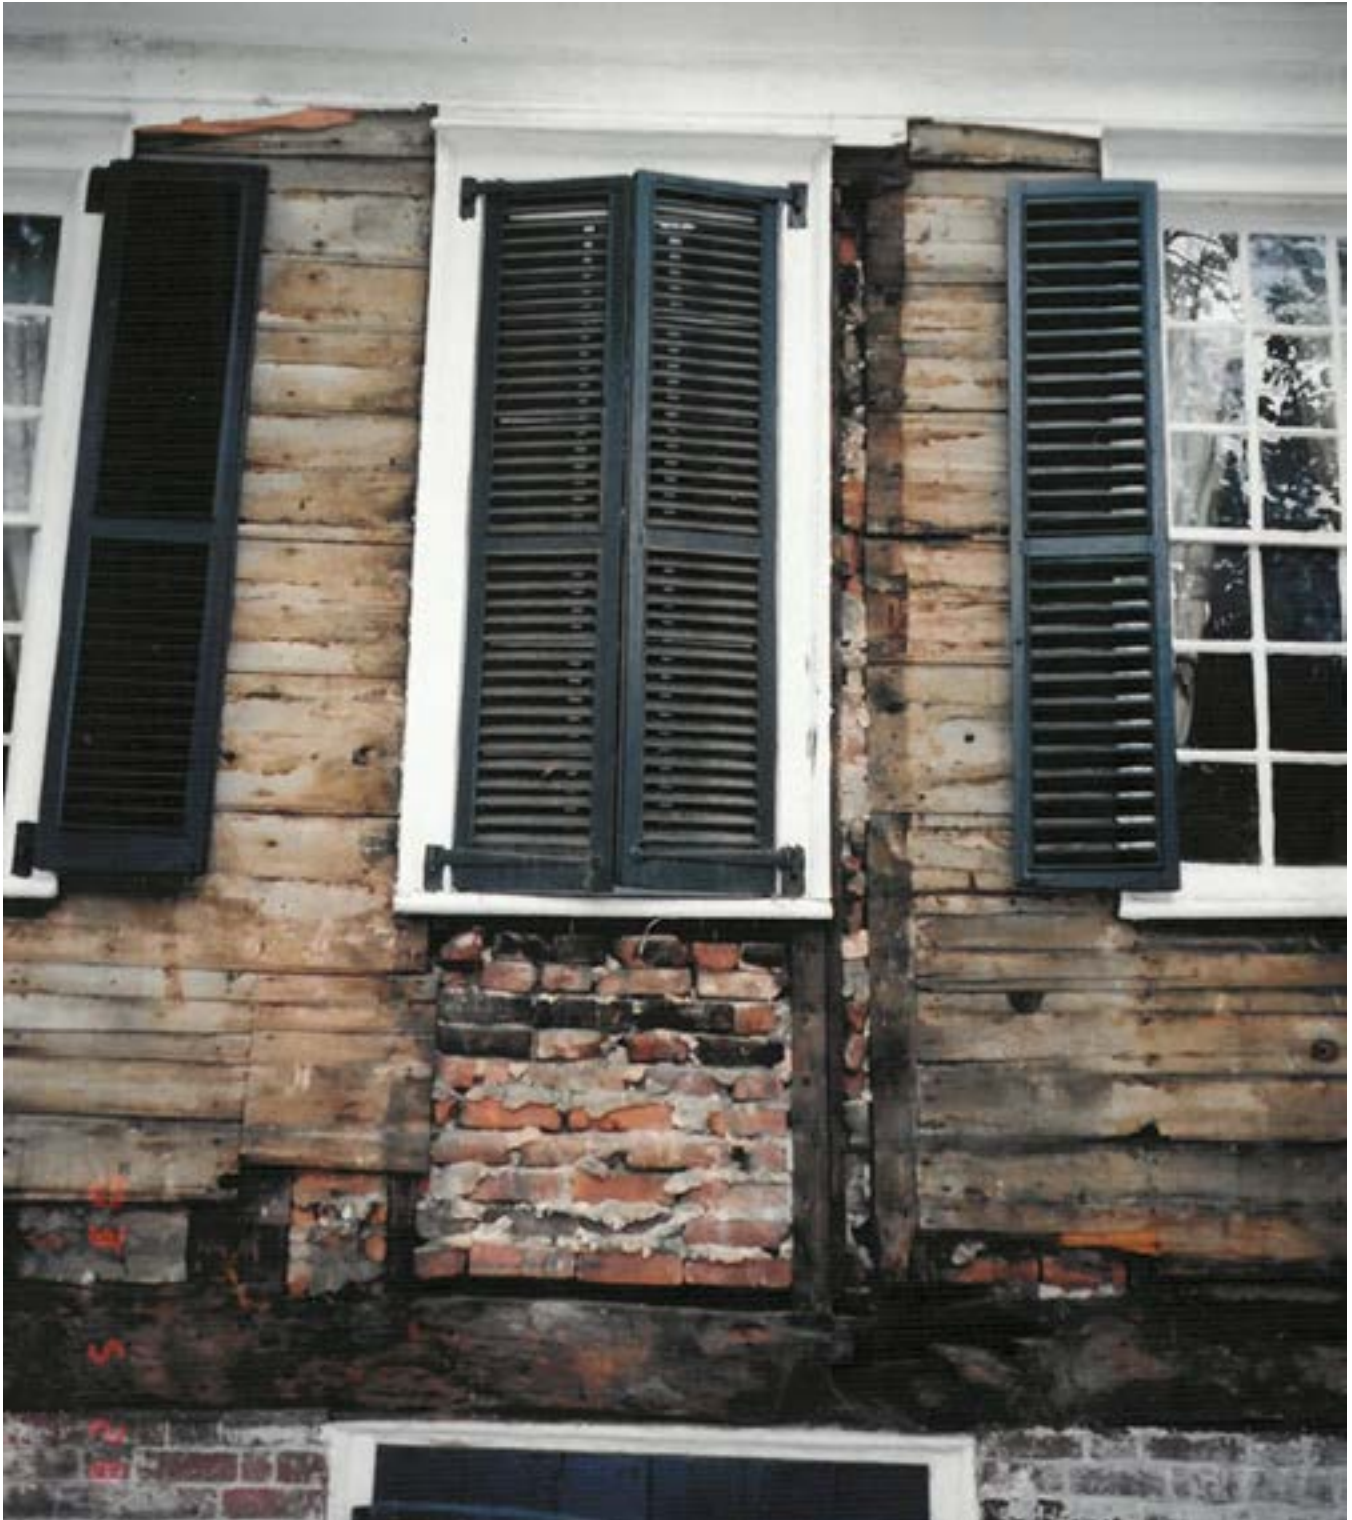
Looking at record photographs from 2002, it is possible to see how after the south door was removed and the narrower window frame installed (shifted to the west within the original opening), the lower part of the door was filled with additional brick filling (later known as nogging- a typical use for salmon brick). Then the original wide flush siding was patched, and the entire south and west walls covered with new, 5"-6" beaded weatherboards to conceal the patches, deteriorated flush boarding, and the exposed filling in the former doorway. The dark vertical lines visible on the boards are where the door frame extended over them. The door was not centered on the south front but it was centered over the cellar doorway. It is also possible to see that the door head still survived in 2002 above the added window.<sup>31</sup>

Figure 8d. - Former door location in center of south front during restoration of 2002, showing door post to right of the inserted right-hand window post (Bierce Collection, Historic Alexandria). The former door was centered over the cellar door, indicating that the brick foundation and cellar door predate the installation of the window above.

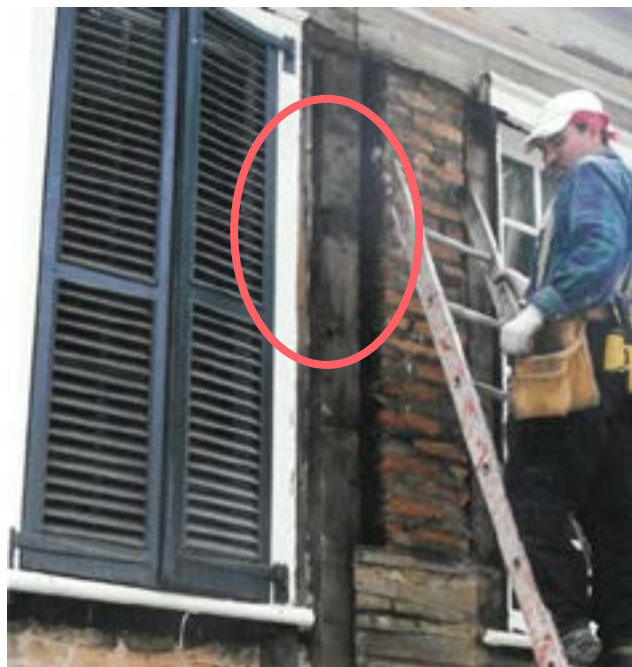
Figure 8f. - South front during restoration in 2002. The location of the bevel for the door head can be seen on the intermediate post that originally served as the door post near the top rung of the ladder (Bierce Collection, Historic Alexandria).

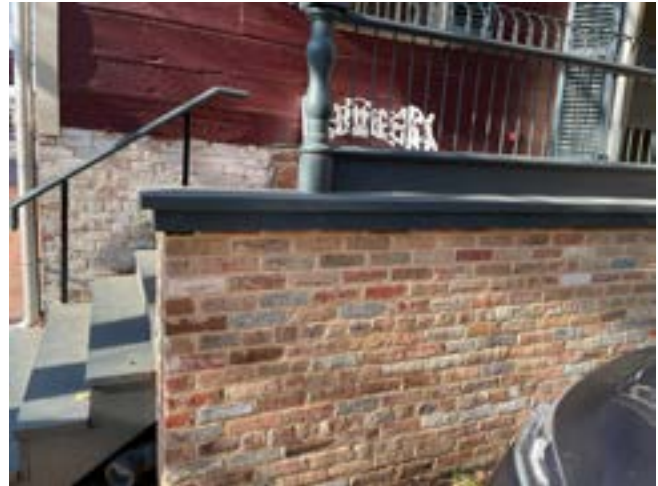
Figure 8h. - 2023 Reconstructed stoop [G&H].

The entire east extension, including the portico, the NE Chamber, and the Closet or Storeroom, stands on a continuous four-course American bond foundation that extends down to the current sidewalk. This foundation may have been extended down when the grade of the lot to the east appears have been lowered in the 1850s when the house there today was built. The section to the south supporting the stoop had been reconstructed at least twice and was laid in running bond using Portland cement. Its condition was poor, having been overturned by street tree roots growing toward the porch downspout. This wall was reconstructed with lime mortar in 2023, matching the original four course bond, as shown in figure 8i. Excavation for the

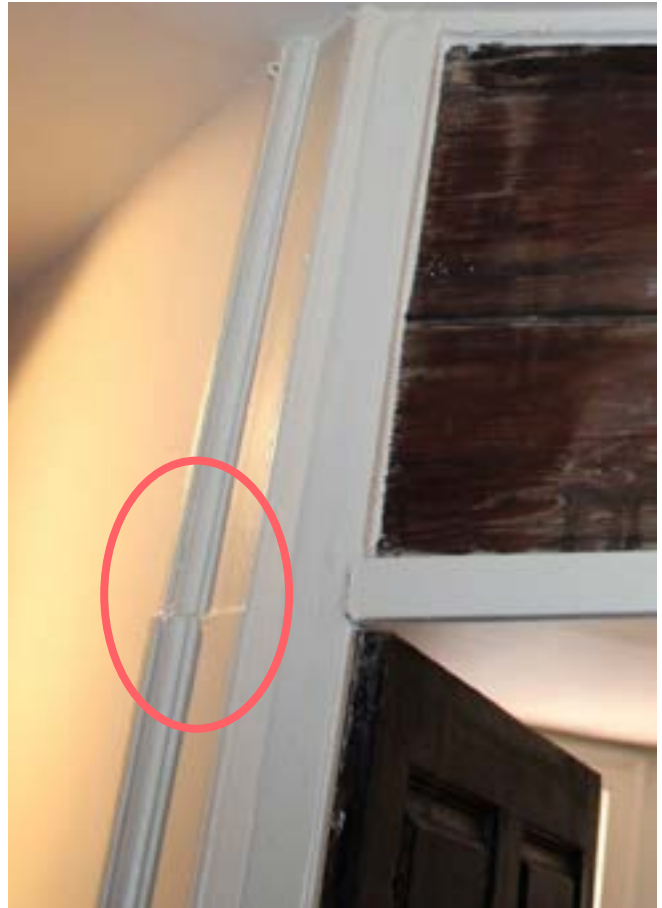
Figure 8n. - North jamb of the door from the NE Chamber to the passage looking NE. Note the 1784 door jamb to the left with a seam at door head height. It was extended to the ceiling when the door was reinstalled at a 45 degree angle.

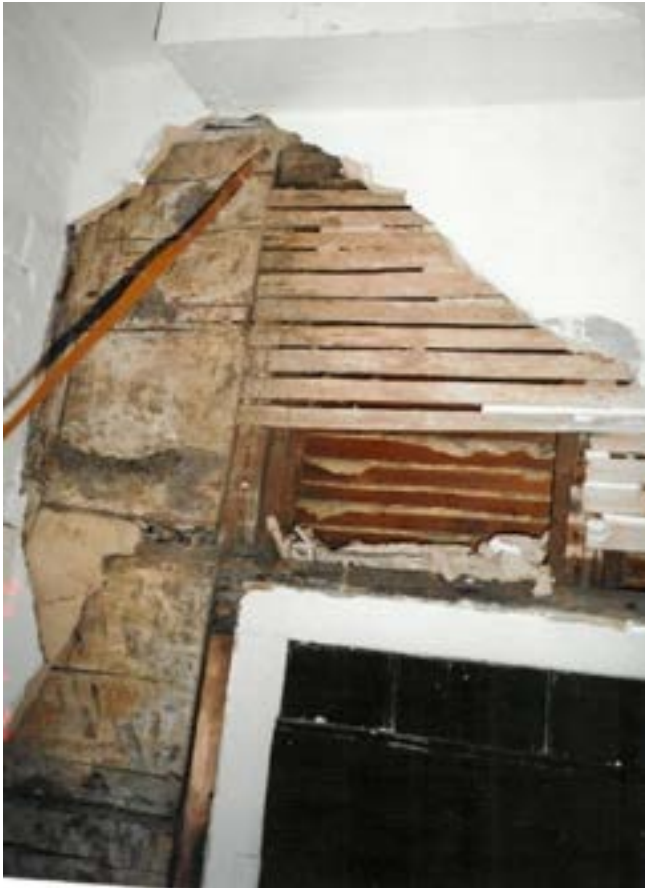
Figure 9f. - 2002 Photo from N of the former window in the N wall of the NW Room from the enclosed porch showing the inserted door and scored flush board and plaster (Bierce Collection, Historic Alexandria).

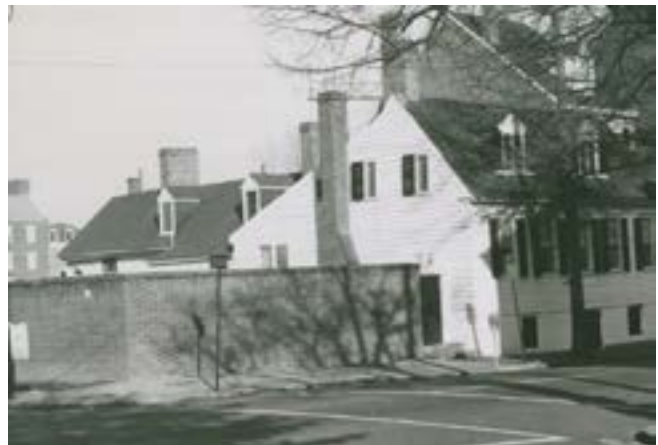
Figure 10f.- Murray-Dick-Fawcett House in 1975 showing the brick wall and garage before the construction of the courthouse (Special Collections, Alexandria Library). This photo also shows the chimney on the west wall from the 20th century boiler in the basement. The chimney was removed in 2002 by the former owner, who also lowered the brick garden wall by approximately 12".

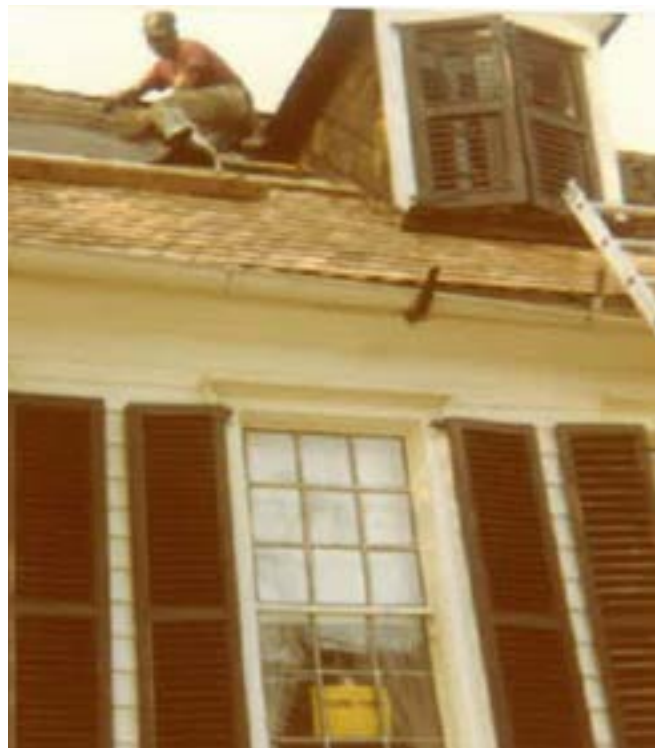
Figure 10j. - Reroofing the south slope of the 1774 roof shown in 1981 photo [Family Collection].

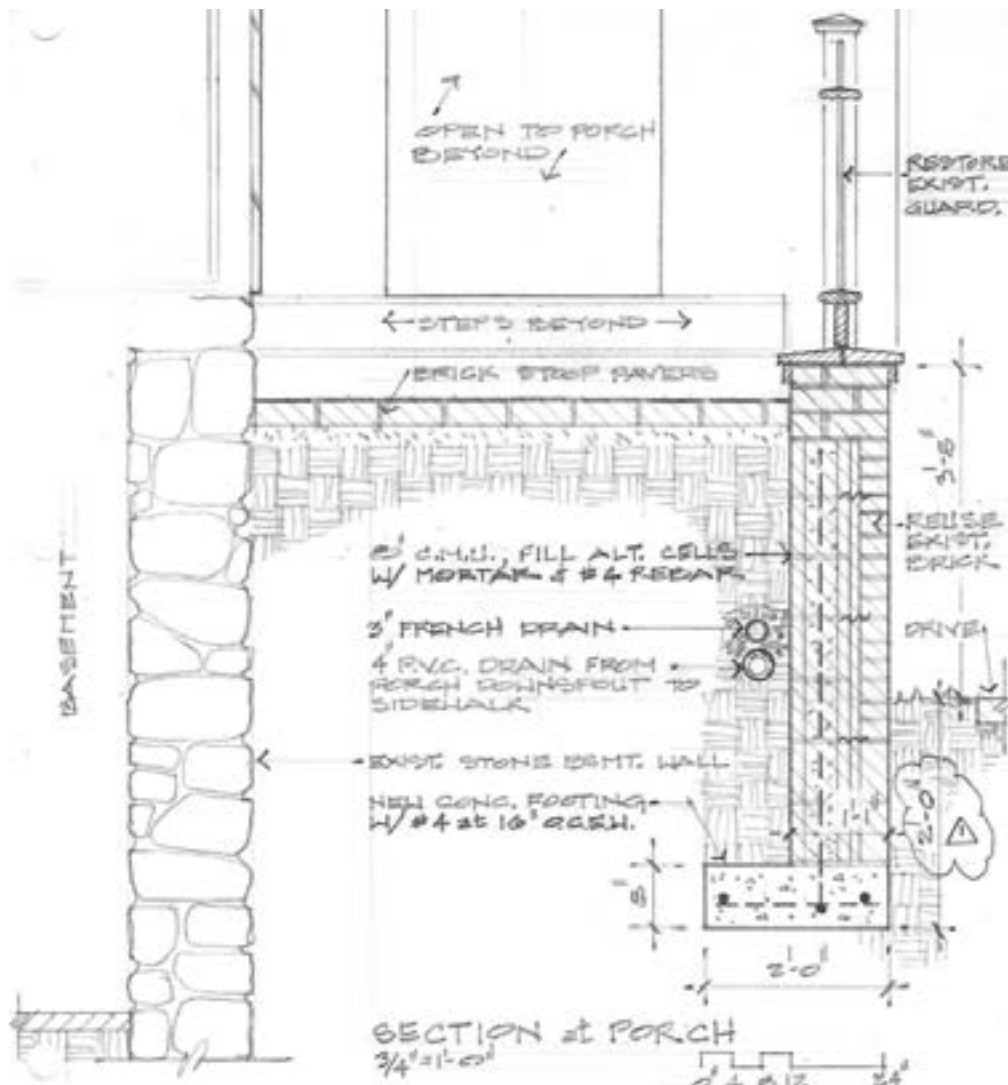
Figure 12b. - Al Cox, Section detail showing stoop and porch foundation repairs revised 10 Oct. 2022.

- The siding, benches, framed openings, and louvered blinds of the east portico were disassembled and repaired and reinstalled.
- The paved area in front of the east portico was rebuilt using the existing brick paving. A new structural concrete footing was installed below the porch retaining wall and the brick wall, guardrail and wood steps were repaired.

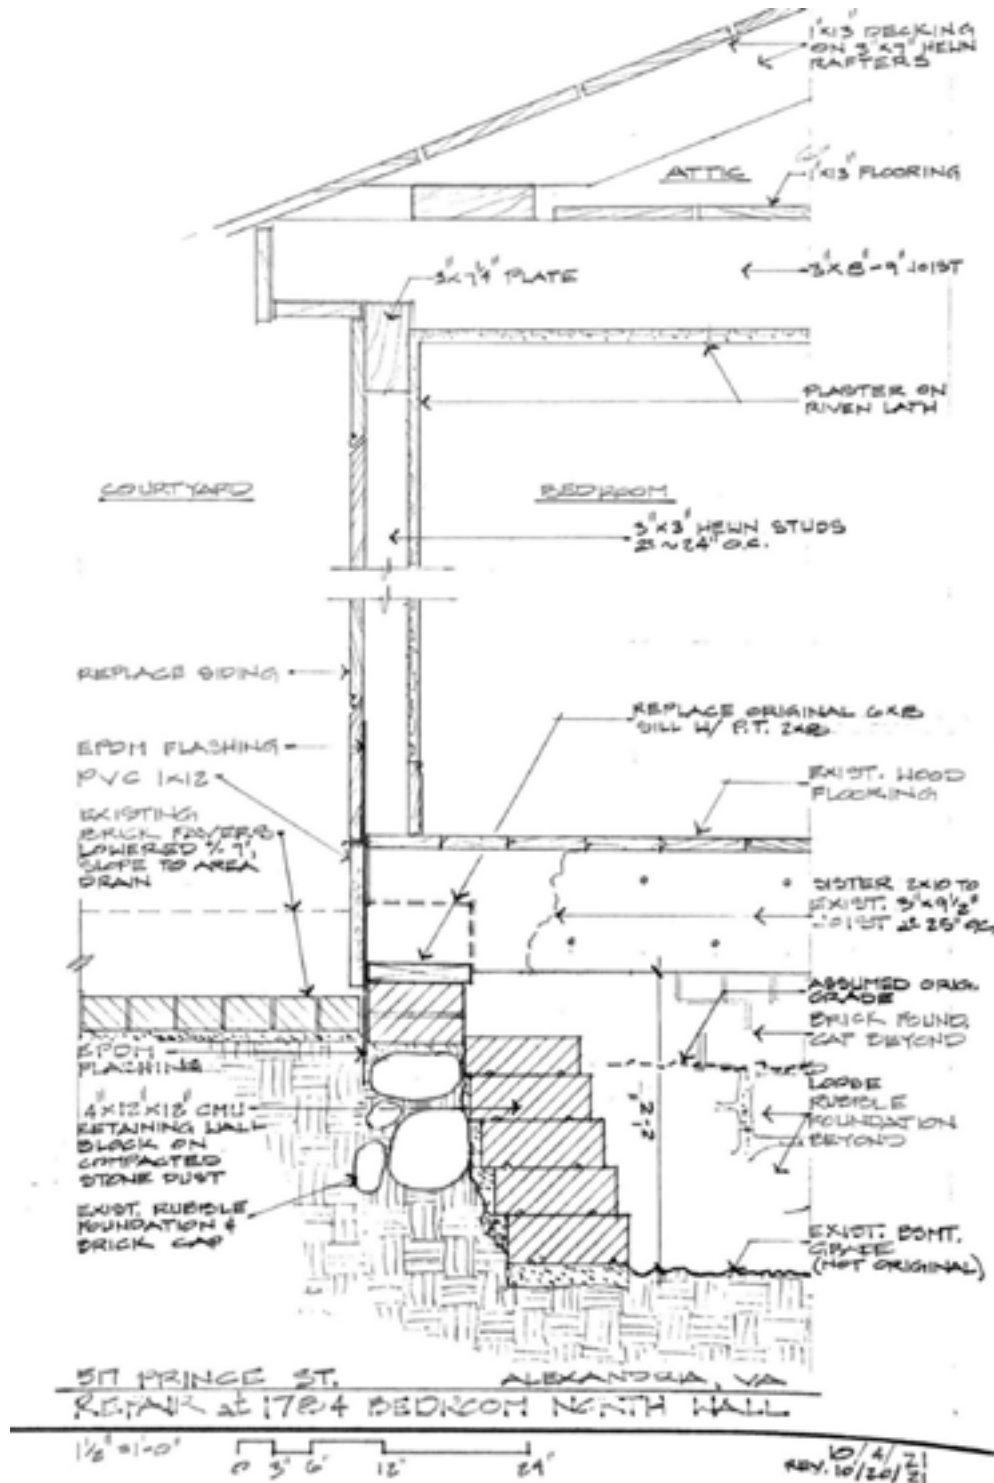
Figure 12c. - Al Cox, Section Drawing for Repair of North Wall of NE Chamber

- West flush siding removed and new Sapele boards to match in texture over 1/2" plywood
- The north wall and outer section of the ceiling joists of the NE Chamber were rebuilt. Portions of the wall and rafters of the northwest corner of the NW Chamber were repaired.

- The north wall siding on the NE Chamber was repaired and one moisture-damaged window was restored.
- Any brick nogging exposed during siding repairs was stabilized using lime mortar.

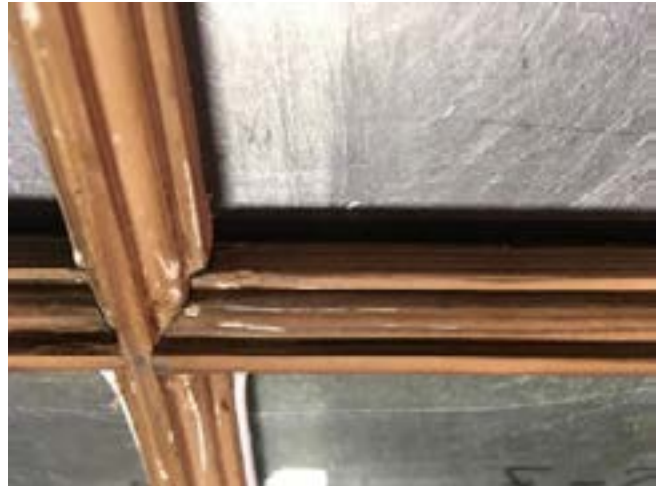
Figure 15a. - Interior detail of muntin. Typical south window sash during restoration.

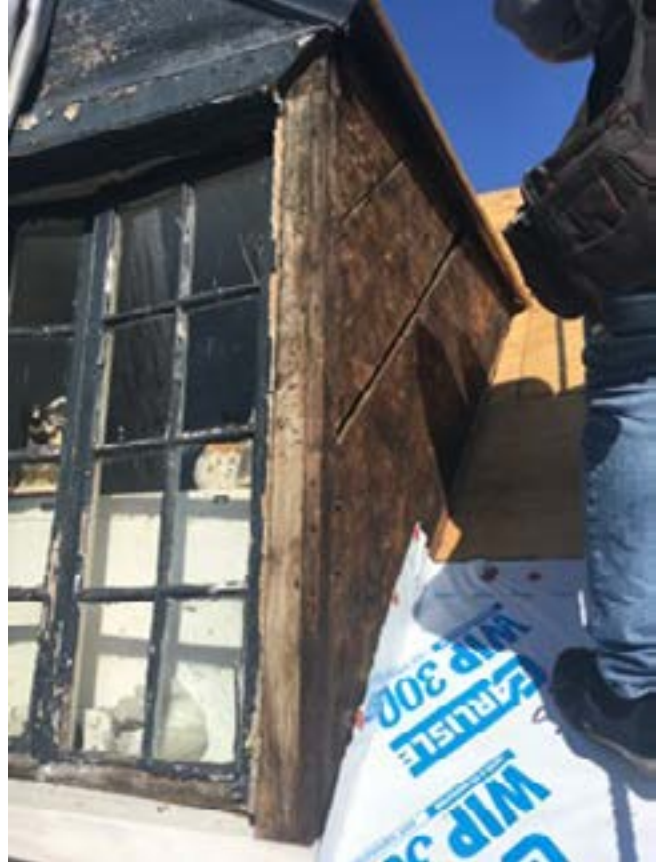
Figure 15d. - Typical south dormer showing original diagonal sheathing that shows no signs of any covering other than shingles.

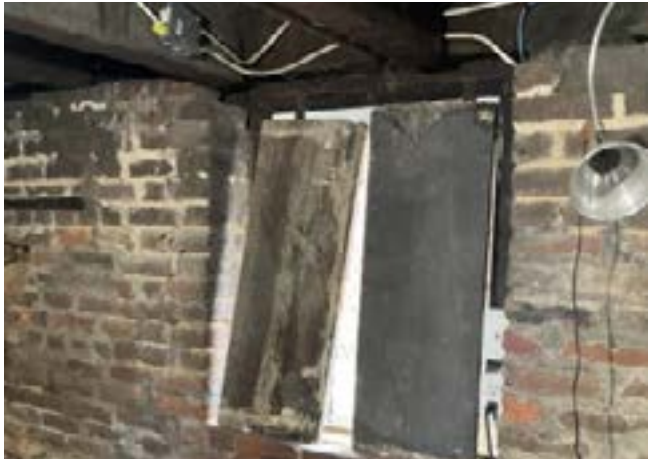
Figure 15g. - Interior of south wall at east bay.

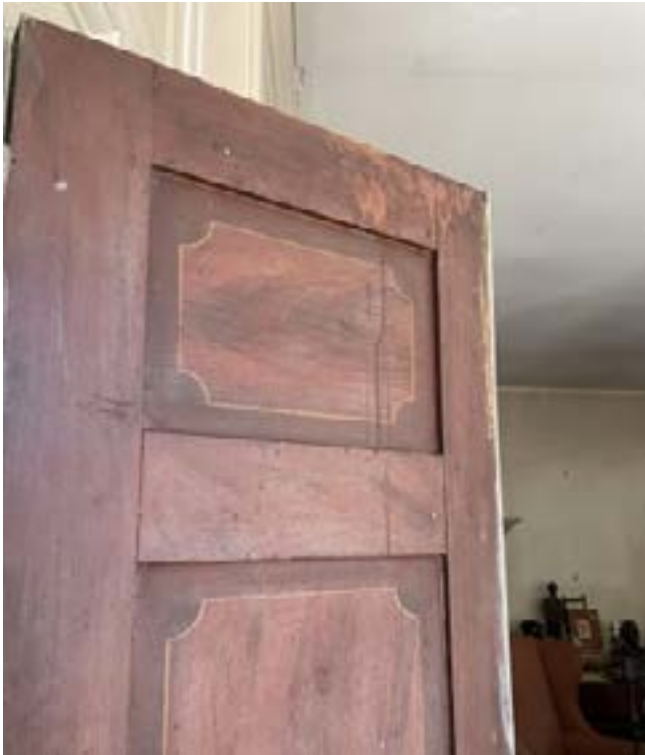
Figure 15i. - Decorative graining on the interior of the southern cupboard door in the Hall.

shelves and intact decorative graining on the interiors of the doors.

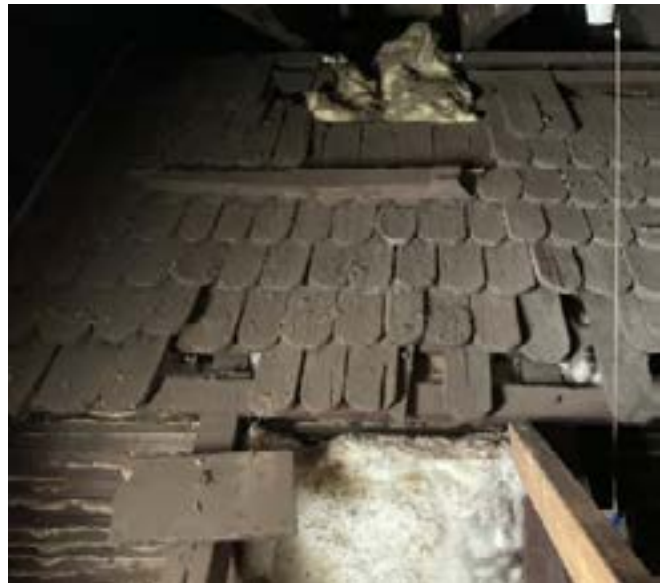
Figure 15s. - Attic of the 1784 Section looking south at the original section of original shingle roof.

- Secure floor boards in the walk space and improve access to the attic space for future maintenance and interpretation.
- Relocate duct work as appropriate.
- Clean, accession, and/or deaccession the material left in the attic.
- Improve wiring and lighting.

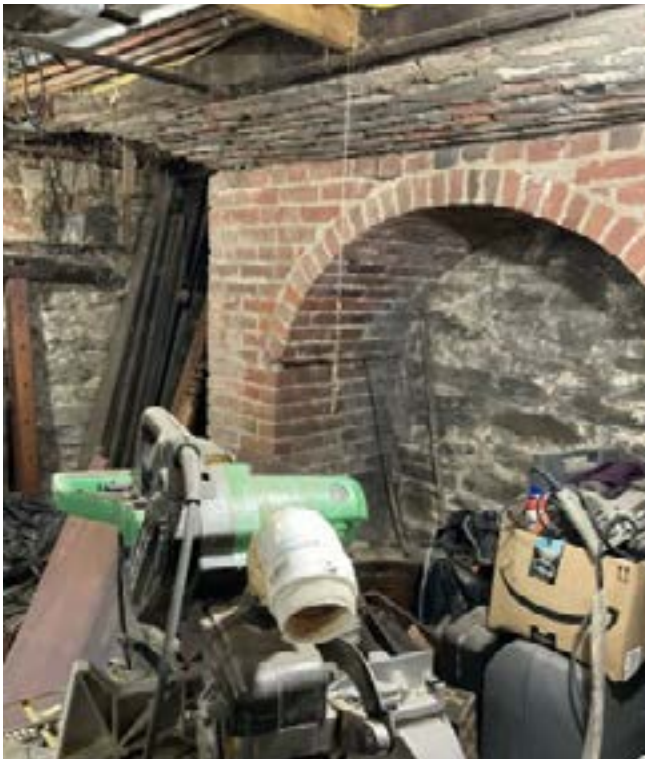
Figure 15t. - 1797 Cellar. Base of Kitchen fireplace looking northwest.

- **Masonry: Clean, repair, and/or replace damaged masonry units and mortar joints using best practices and historic lime mortar formulations designed to match the original mortar in strength, texture, and color.**
- **Structure: Make structural repairs. Follow directions of structural engineer to reinforce and repair any cracks, support the floor joists, and ameliorate other structural issues.**
- **Flooring: Retain the modern brick floor.**
- **Lighting Fixtures: Reuse existing fixtures or replace as recommended by engineer.**

- **Wiring:** Remove nonfunctional wiring and rewire as recommended by engineer.
- **Plumbing.** Remove nonfunctional plumbing.
- **Enlarge the basement entry on the west side to improve access to cellar. Coordinate monitoring/excavations by Alexandria Archaeology, Office of Historic Alexandria.**

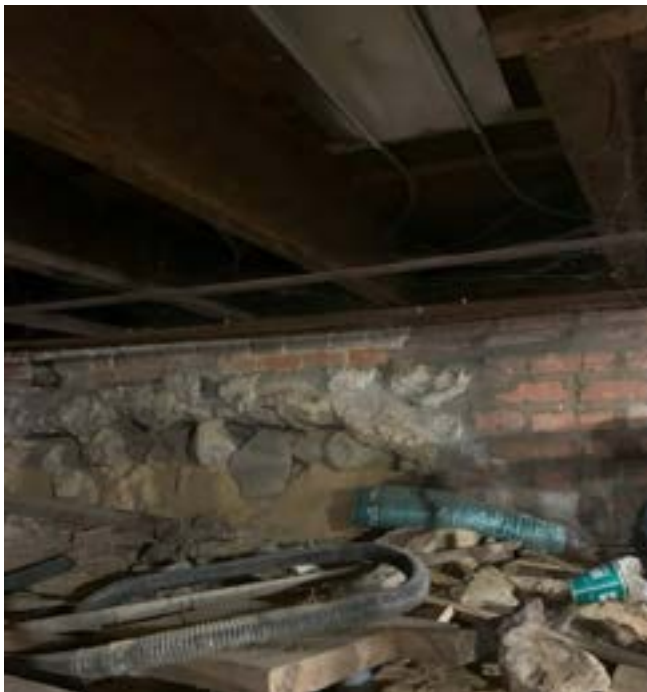
Figure 19c. Foundation below the east end of the 1874 section looking south (Room 003)

This area will require underpinning to re-establish proper bearing and prevent continued movement in the foundation walls. This area will eventually require underpinning to reestablish proper bearing and prevent continued

movement in the foundation walls. Underpinning work should be done in small segments to protect the original stone foundation assembly. This could also be constructed with a course of cmu between the existing foundation wall and concrete underpinning to prevent contact between poured concrete and historic stone.

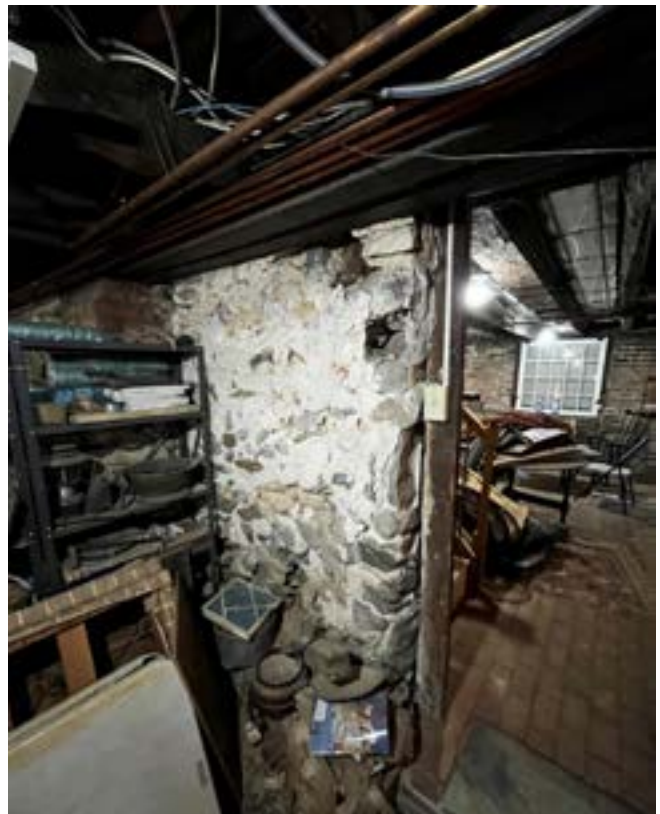
Figure 19d. west jamb of the door between the 1784 and 1774 sections looking south (Room 104)

Holes and locations where the stone has lost mortar or is continuing to move should be repaired using a historically appropriate mortar. Where the area has been previously repaired with cementitious mortar, it may be advisable to pursue removing this to prevent further damage to the existing historic material long term; however, due to this being in the interior of the structure, it should be protected from moisture and freeze-thaw issues that lead to deterioration of historic masonry in contact with modern mortar.

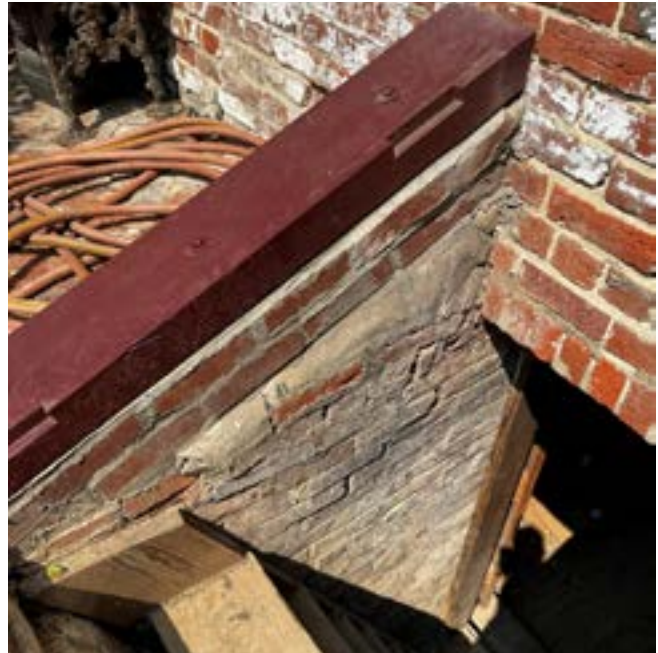
Figure 19e. 1797 wing, west stair, north side of cellar stair bulkhead looking northeast.

The cracks in the retaining wall should be repaired with an appropriate mortar and monitored for future movement.

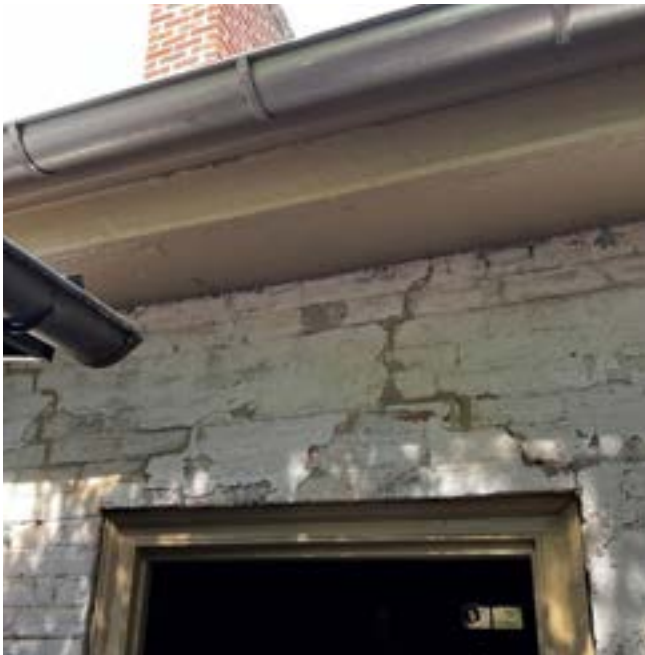
Figure 19f. Doorhead at the Smokehouse (Room 15) door looking west.

Consideration should be given to removing previous repointing with cementitious material and replacing it with historically appropriate

mortar as part of a masonry repair effort. The failed lintel on the east wall will need to be repaired, and it may be advisable to repair the sagging lintel on the west wall as well. Drainage issues were addressed in 2002 and 2022 with gutters and underground drain lines, which should help prevent additional damage to this wall.

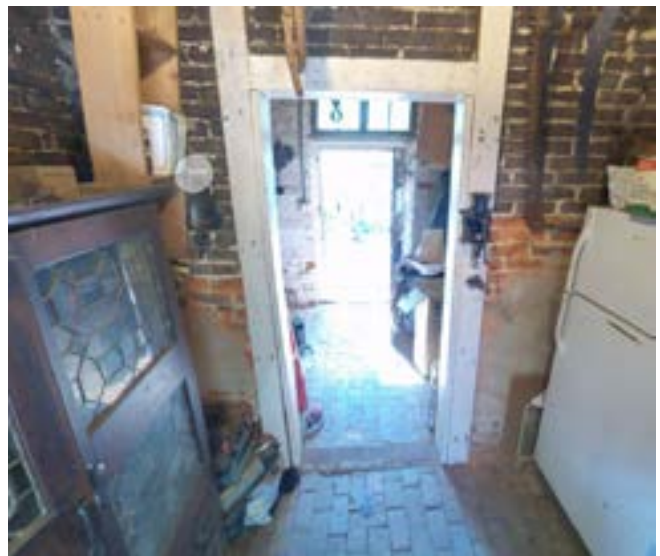
The interior single-wythe wall between the smokehouse and service room has spalling brick on the lower third (Figure 19h, image taken from Prologue building scan). There appears to have been a coating on this lower segment that trapped moisture in the wall, while the upper section of the wall was exposed (evidenced by patterns of smoke residue). There also appears to have been repairs made to the wall with a cementitious mortar. A similar pattern is observable on the service room side in areas where paint is damaged due to issues with the brick behind it.

Figure 19h. Door between the Smokehouse (Room 114) and the Service Room (Room 115).

It is atypical to have load-bearing, single-wythe brick masonry walls, as this results in a very slender element that is prone to buckling and issues with out-of-plane movement.

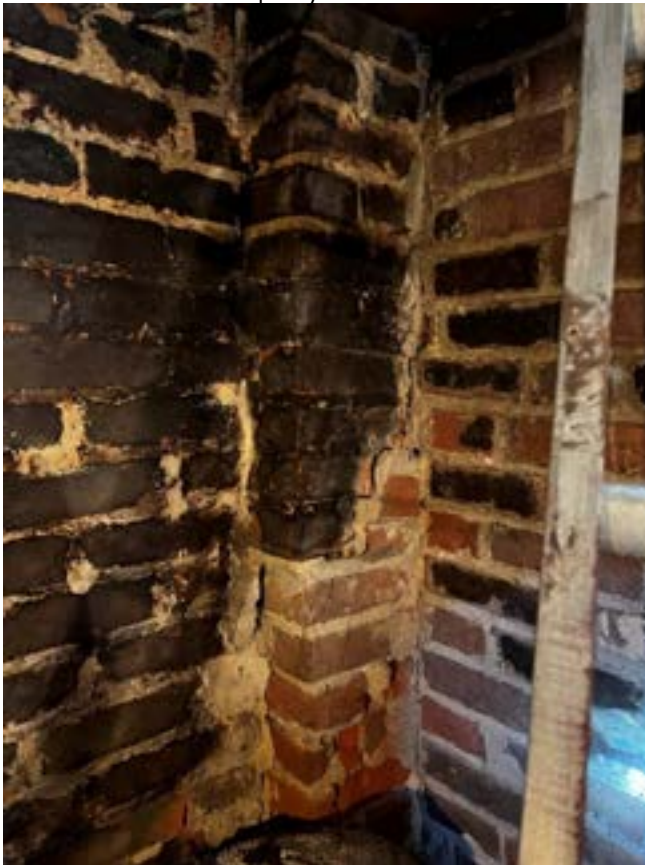
privies, there is a hollow brick flue connected to a chimney rising from the roof above. This flue, which probably ventilated the privy vault, has an offset diagonal crack, indicating the movement at its base (Figure 19i). This is likely due to the noted issues at the privy vault.

Figure 19i. Flue in the northwest corner of the Smokehouse (Room 115) looking northwest.

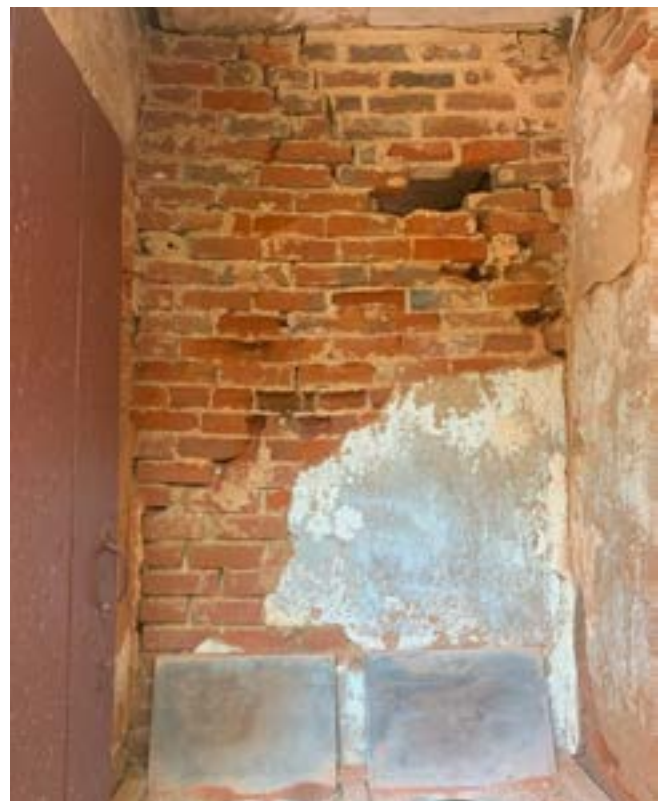
The interior privy walls are suffering from significant masonry issues (Figure 19j). In many locations, there are holes in the walls where bricks have been lost. Many of the bricks are spalling from apparent water infiltration. The walls also appear to have some movement occurring at the base, likely due to deterioration of the supporting structure.

Figure 19j. Interior of West Privy (Room 116) looking east.

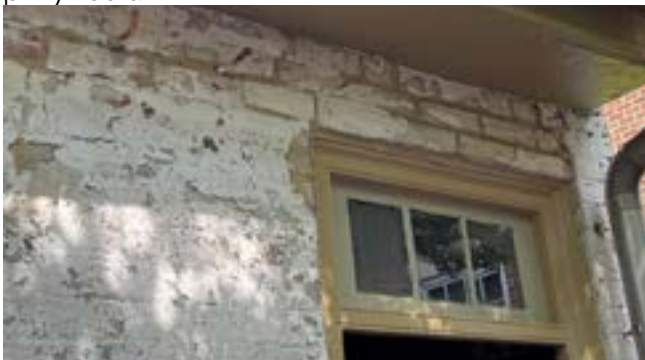
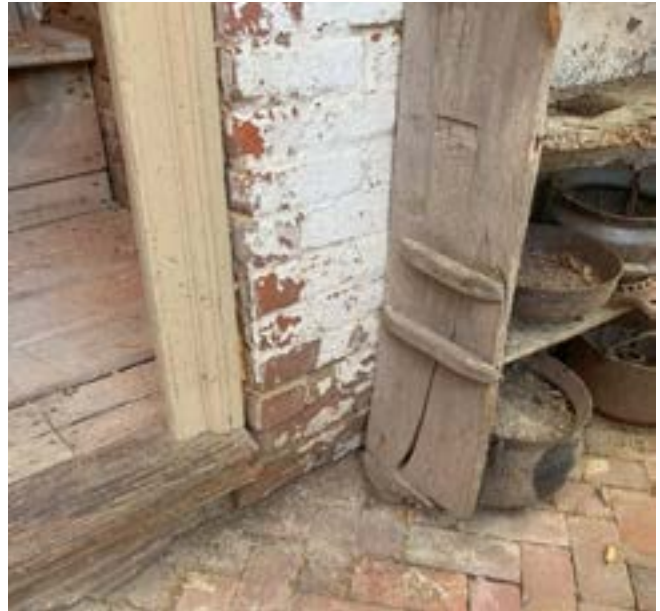
The exterior walls of the privy show evidence of deterioration as well as movement. There are spalling bricks and mortar loss in several areas. Some sections of the walls have been repaired with cementitious material, which can worsen damage to the brick over time. In some of these areas, the repaired sections are moving together, causing cracking in the surrounding masonry (figure 19k). In addition, at the northwest and northeast corners, the walls are bowing (figure 19l). This may be related to the work that occurred when the alley was lowered, or from movement in the foundations adjacent to the privy vault.

Figure 19k. Head of door to East Privy (Room 118) looking northwest.

Figure 19l. West Privy, south jamb of door looking southeast.

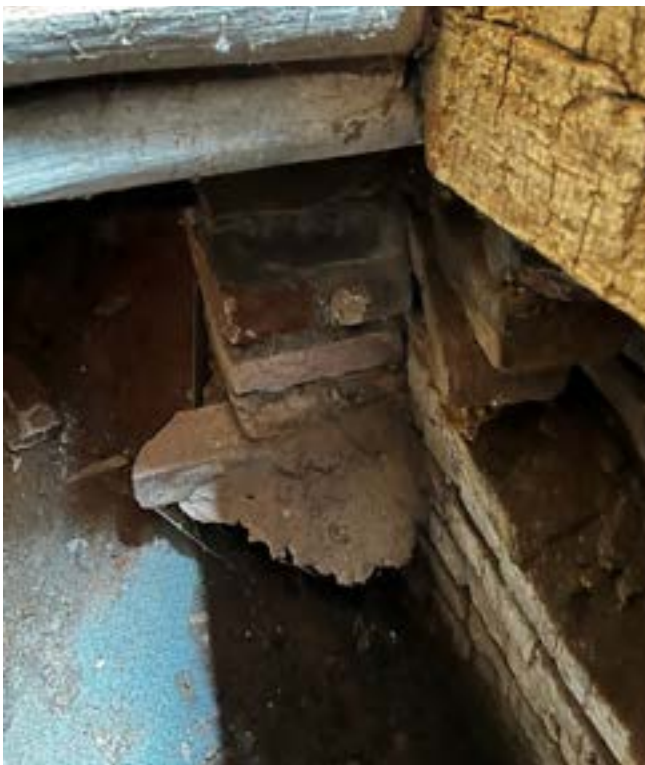
Figure 19m. North Privy with floor removed looking to northwest.

This area will require repair to stabilize the vault as well as provide support for the walls above. This could occur through a retrofit of the structure, which would avoid as much excavation as possible, or through preserving most of the

original structure and re-establishing the bearing condition, which would likely require the input of an archaeologist. This needs further investigation and conversation to determine the best course of action. This work should be done in conjunction with repairs to the interior and exterior masonry damage that is related to this movement.

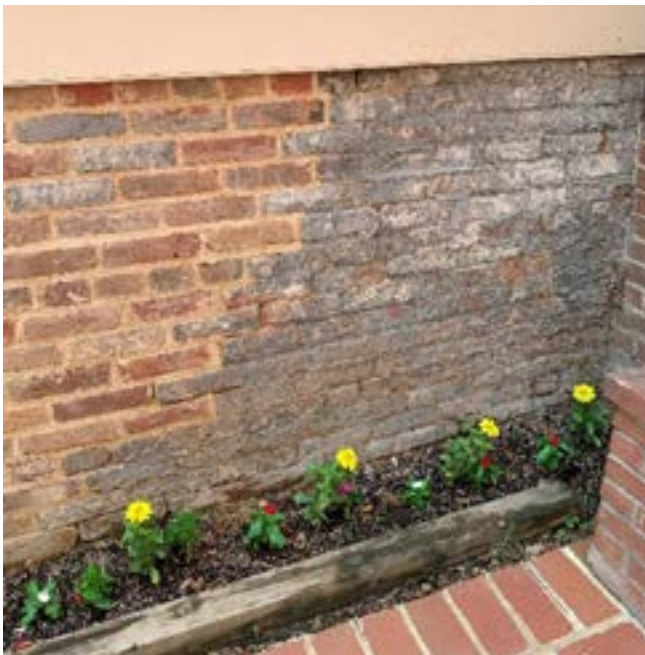
Figure 19o. East side of the 1816 extension looking east.

This area should be monitored to determine if wall deterioration is an ongoing issue, or has been resolved with repairs.

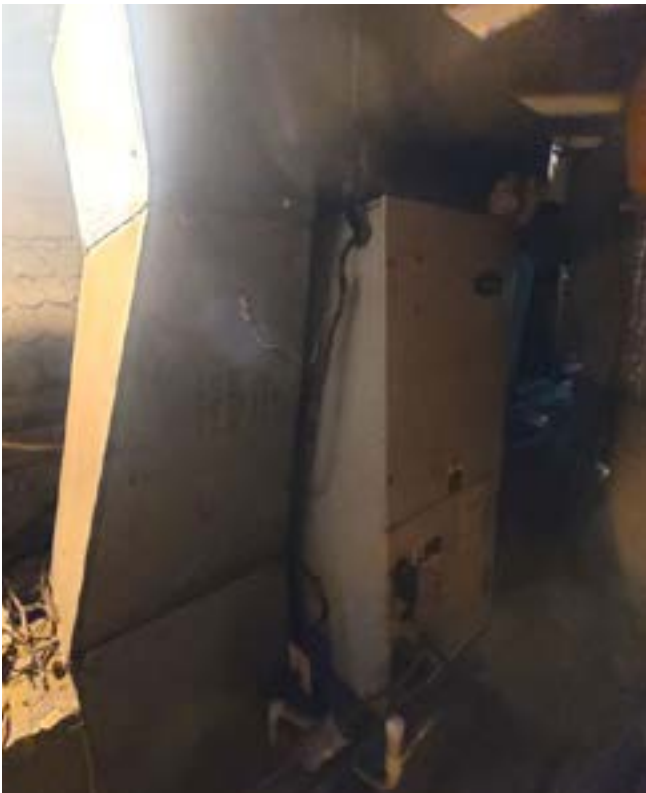
Figure 20h. - Existing Air Handling Unit - System 2 in the Attic

This air handling unit in Figure 20h is a Carrier, Model FK4CNF002. It serves the Southern half of the house. The HVAC registers connected to this system and serving the living/parlor area (Rm 104) can be seen in Figure 20i.

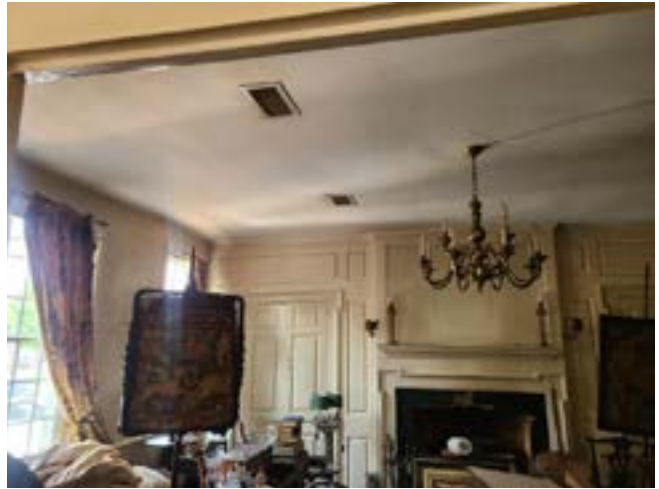
Figure 20i. - HVAC Registers in the Living/Parlor Area (Rm 104) Ceiling

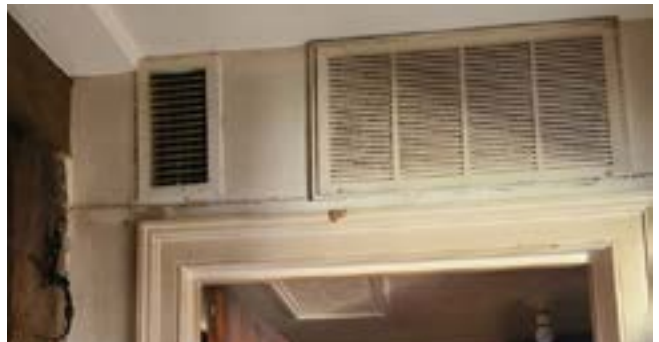
The third HVAC system (the second of the two (2) roof mounted air-cooled condensing units) is a Carrier, 1 1/2-ton, Model 38TKB018300 unit. This air-cooled condensing unit is paired with the third air handling unit, located directly below in the ceiling of the bathroom area (Rm 119). The supply and return grilles to this unit can be seen in the Figure 20j

Figure 20j. - Supply and Return Grilles to HVAC System 3

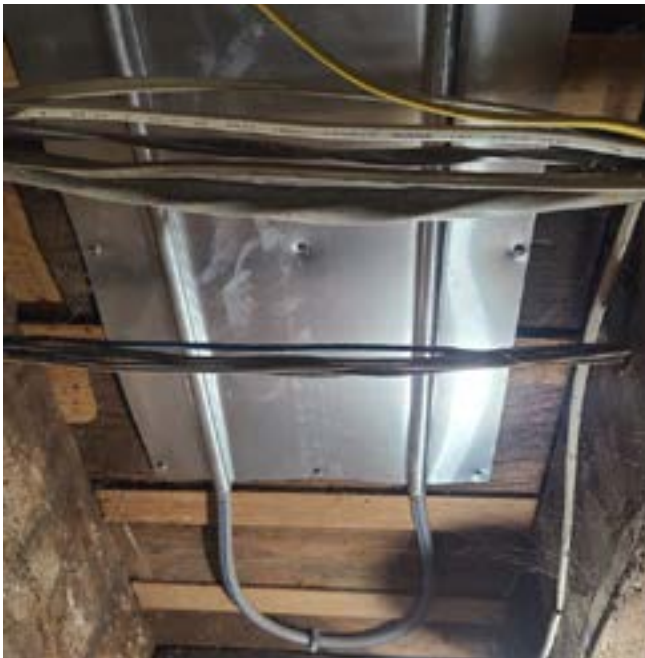
The below-floor radiant heating system is installed in between the floor joists throughout the Cellar. This system provides heat to the upper first floor.

Figure 20k. - Underfloor Radiant Heating System

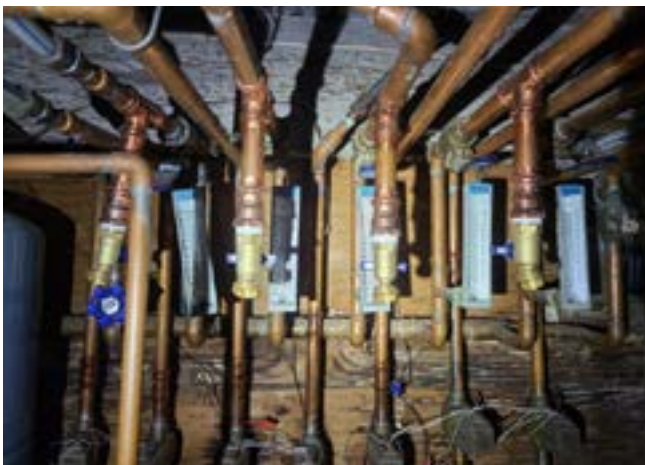
Many of the piping systems installed in the Cellar are copper piping, with either soldered joints, or "Pro-Press" type, mechanically crimped fittings

Figure 20l. - Copper Zone Piping Serving Radiant System
