## Murray-Dick-Fawcett House Historic Structure Report

Report by Glavé & Holmes Architecture for the Office of Historic Alexandria,  
City of Alexandria, Virginia | April 19, 2024

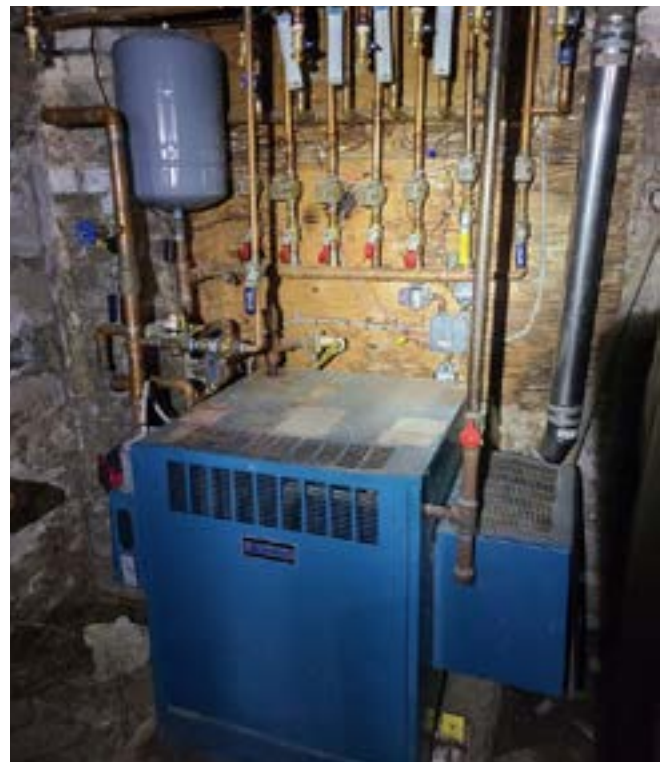
Hot water to the radiant floor heating system is supplied by a Burnham, gas fired hot water boiler, Model PXG-2006AWNI, located in Room 002 of the 1784 section of the Cellar. The boiler was manufactured in May of 1997. The hot water boiler has an input of 164,000 BTUH, with a DOE output of 138,000 BTUH. The boiler efficiency has an Annual Fuel Utilization Efficiency (AFUE) of 84.6%. This is not a very efficient unit by today's standards, and the boiler should be replaced along with any renovation project.

Figure 20m. - Hot Water Boiler in the Cellar

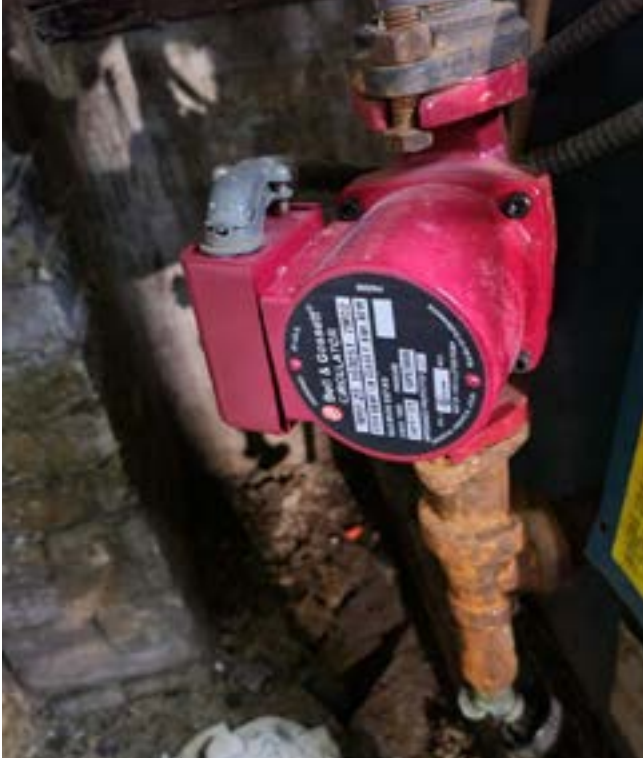
A Bell and Gossett Circulator, Model NRF-22 103251 7M02 circulates hot water through the radiant floor heating system. Any future hydronic system within the house will need to be freeze-proofed in order to survive a power outage during the winter.

Figure 20n. - Radiant Heating Circulation Pump

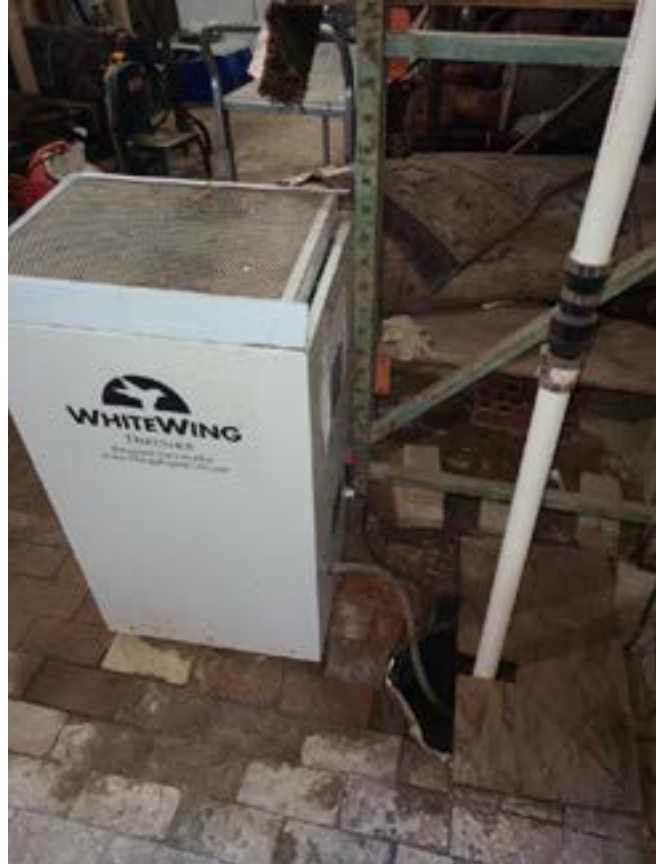
Figure 20p. - Dehumidifier Adjacent to Sump Pump

A portable dehumidifier is located adjacent to storm water crock on the West side of the 1797 section of the Cellar, evidence of a higher than desired moisture level. The crock is equipped with a submersible pump.

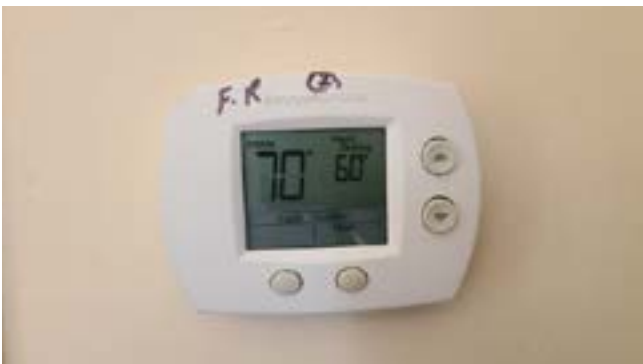
Each radiant heating zone is controlled through its own zone valve and an associated Honeywell room thermostat.

Figure 20o. - Typical Hydronic Zone Room Thermostat

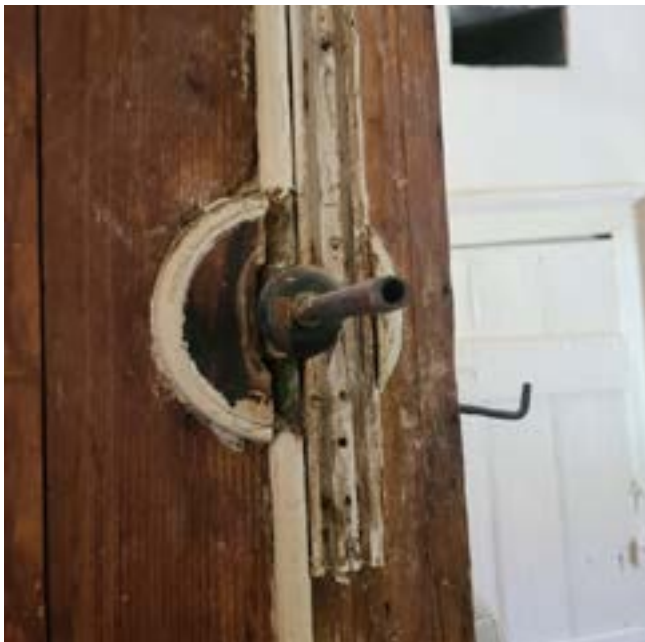
Figure 20q. - Possible Remnants of a Gas Lighting System (Room 106)

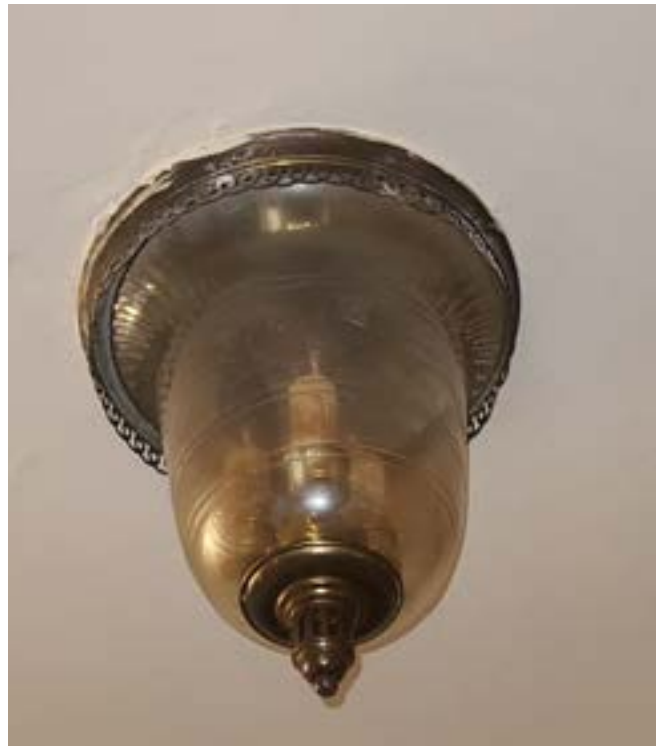
Figure 20s. - Ceiling Mounted Fixture

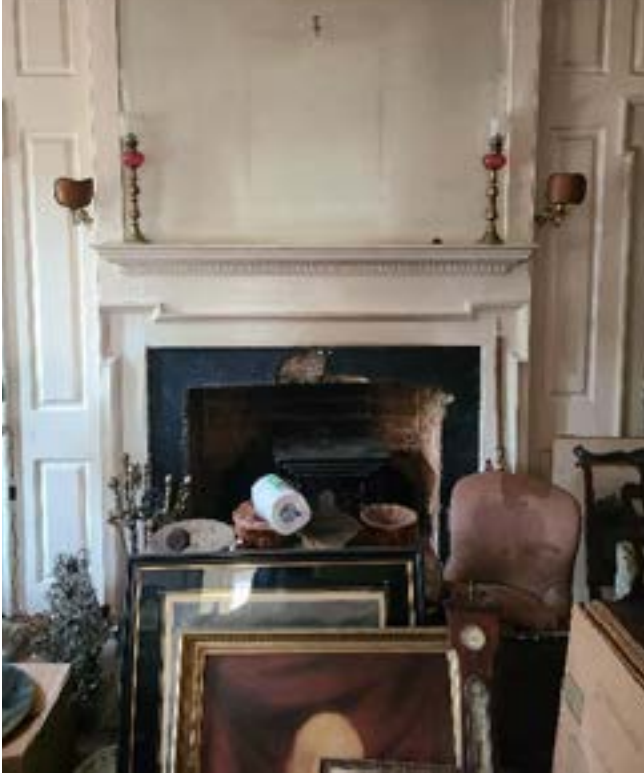
Figure 20t. - Gas Wall Sconces with Early Paper Shades (Room 104)

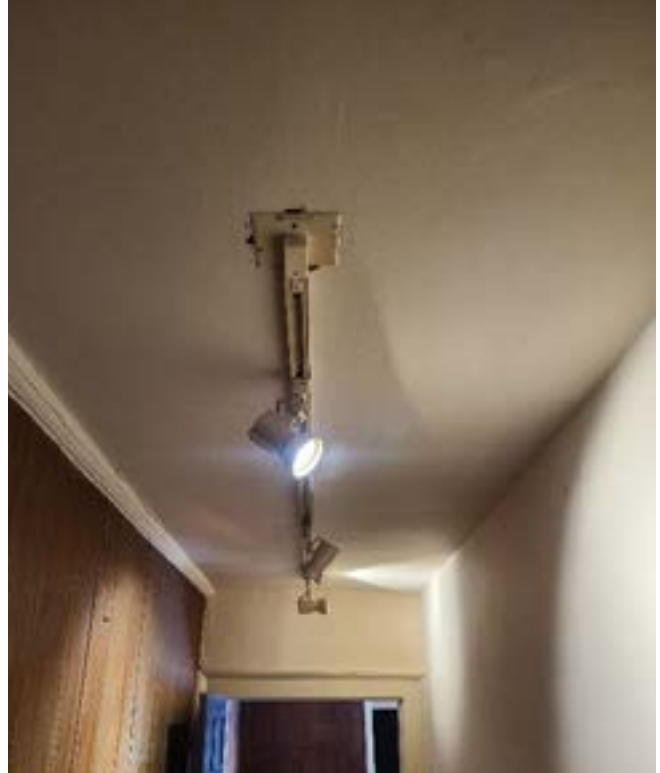
Figure 20v. - Track Light in Corridor 106

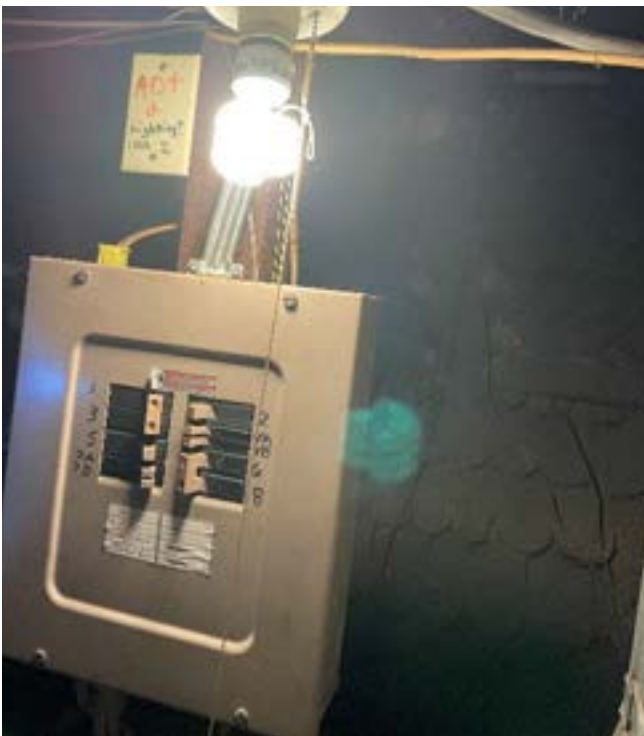
Figure 20u. - Light fixture in the Attic

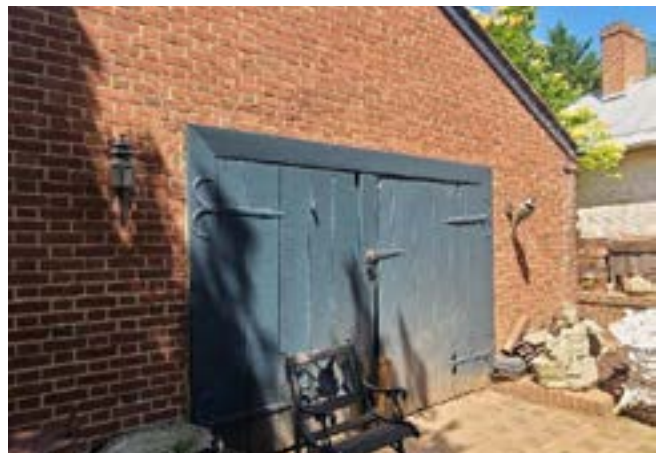
Figure 20w. - Exterior Wall Sconces – Garage

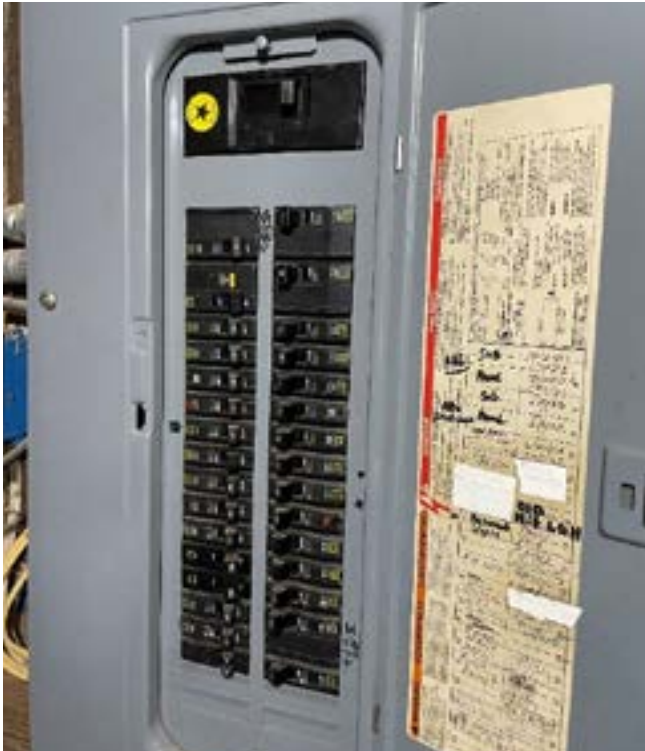
Figure 20x. - Main Panelboard in the Cellar

If it is decided that artificial lighting is required for the use of the facility and the HVAC system will be kept/updated, the electrical system for the MDF House will need to be updated. We recommend providing new wiring wherever possible and testing any existing wiring to be considered to remain. If the MDF House is classified as a commercial building, the load centers would need to be replaced with panelboards with bolt-on circuit breakers.

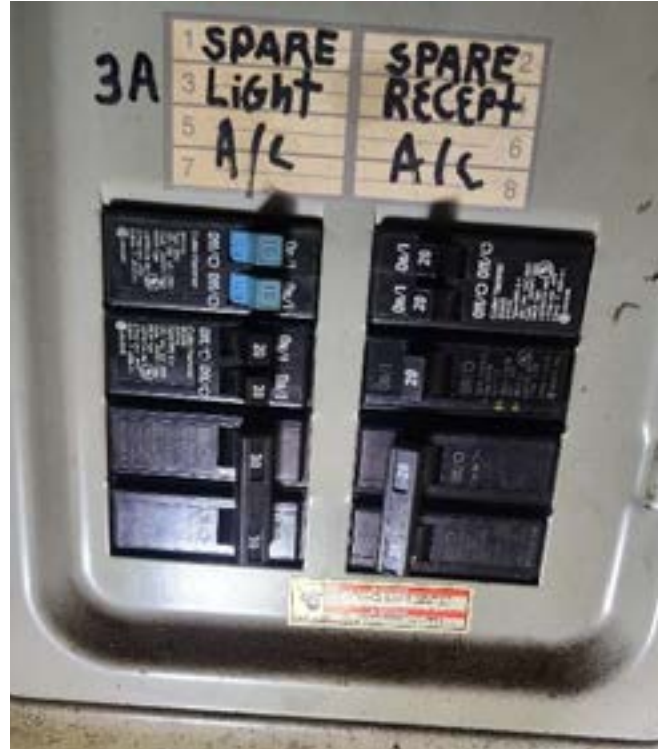
Figure 20z. - Panelboard located in Attic above Service room (Rm 114)

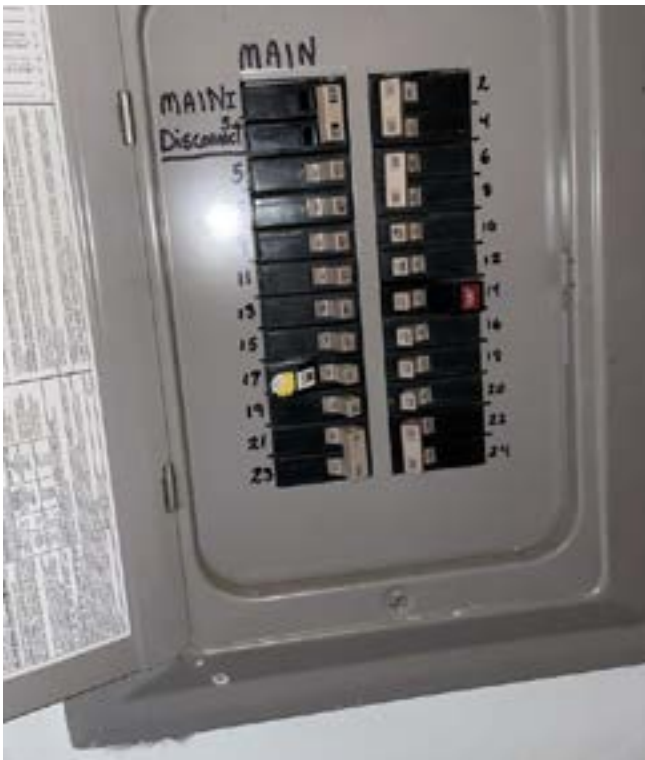
Figure 20y. - Panelboard Located in Corridor 112

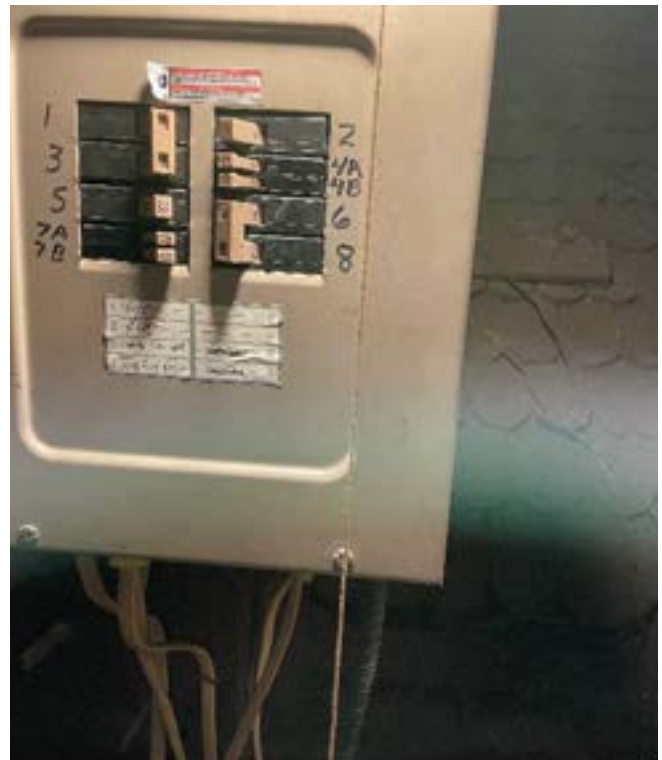
Figure 20aa. - Panelboard Located in the Attic

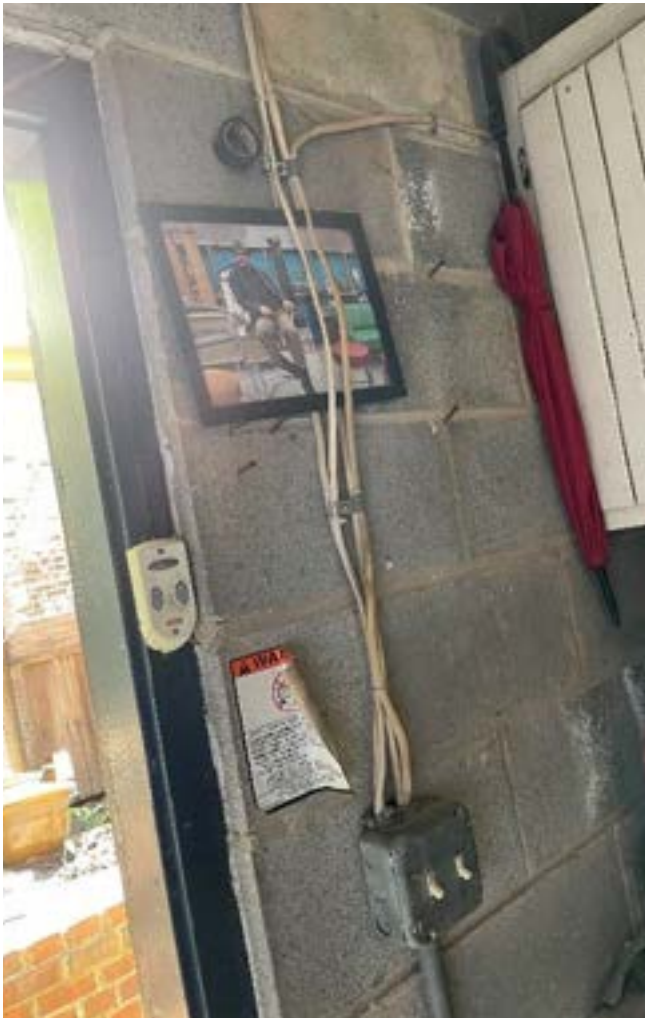
The Garage has two (2) circuits providing power to the door opener and a GFCI receptacle. These circuits originate from the main distribution panel located inside the Cellar. If the intent is to create a welcome center in the Garage with a kitchen and restrooms, a new electrical service will need to be provided. In that case we would suggest bringing the new electrical service to the garage and feeding the panelboard in the Cellar from the new service. The existing incoming electrical service to the House could then be disconnected and removed.

Figure 20ab. - Incoming Branch Circuits to equipment in the Garage.

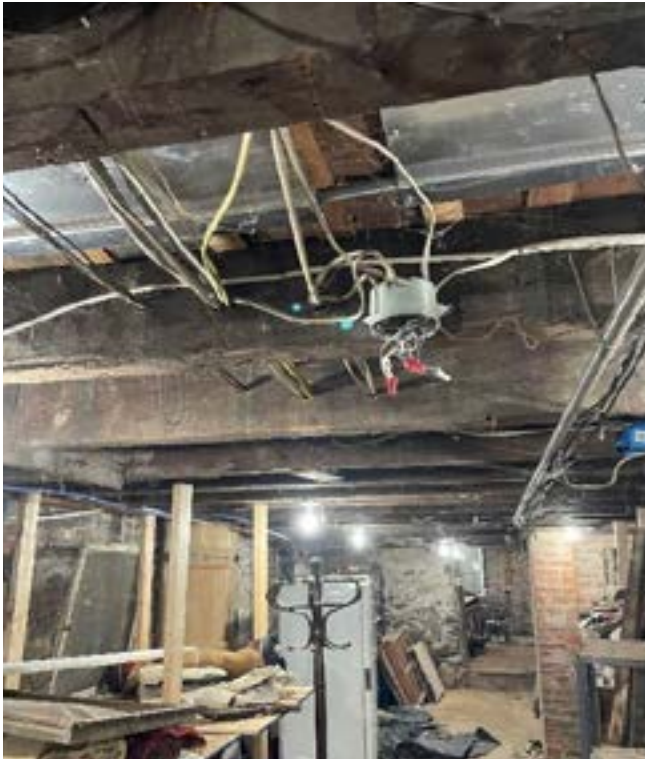
Figure 20ad. - Exposed Wiring in the Cellar

If the basement becomes accessible to the public for occasional tours, all the exposed wiring (see Figure 20ad.) would need to be replaced with metal flexible conduit or installed in conduit.

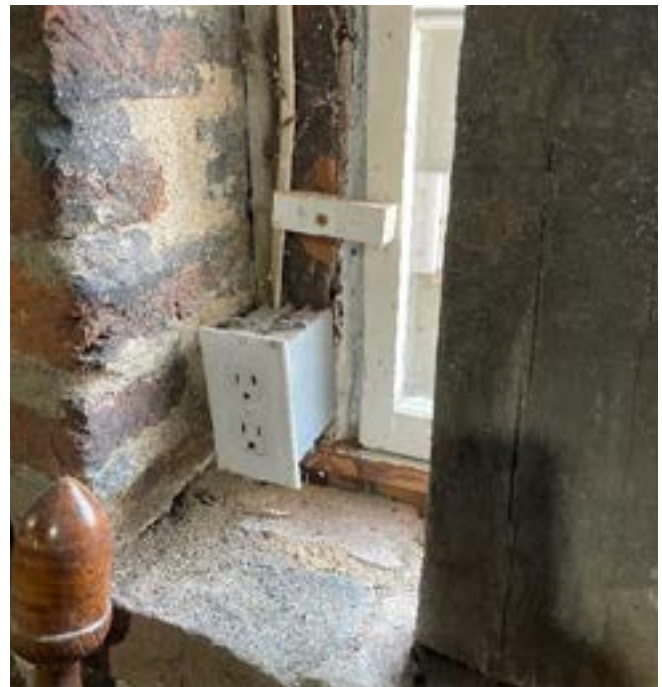
Figure 20af. - Receptacle in the Cellar

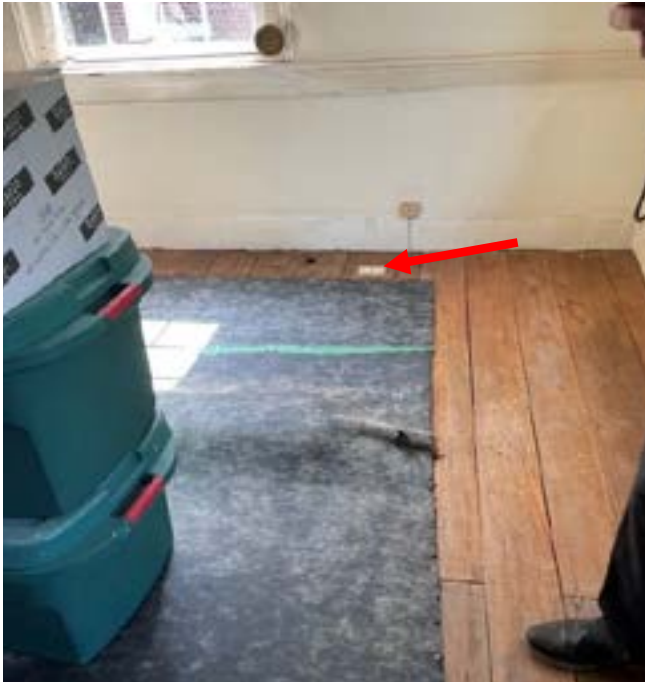
Figure 20ag. - Floor Receptacle in the Chamber

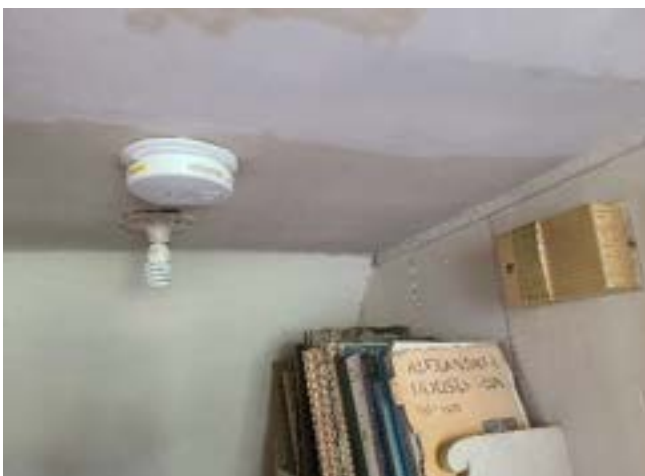
There are smoke detectors in the MDF House, typically in the rooms and the corridors. Smoke detectors are not period appropriate, however the addition of a fire alarm system to tie into the sprinkler system recommended in the plumbing section of this document may be a necessity.

Figure 20ah. - Smoke Detector in Bedroom

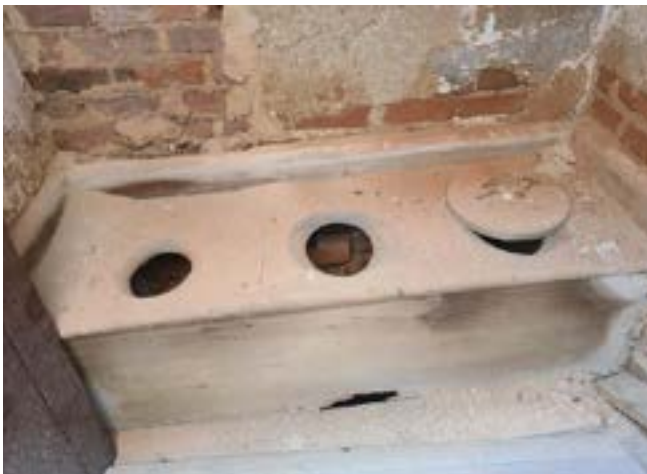
Figure 20ai. - One (1) of the Three (3) Privies

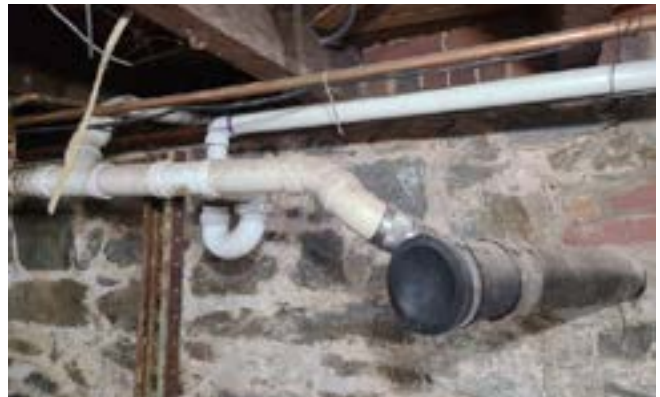
Sanitary piping in the Cellar is either newer PVC piping or cast-iron piping. An earlier sanitary line ran across the Cellar from the midpoint of the structure on the east side in a northwesterly direction toward the existing garage. At some point more recently, the existing sanitary line was diverted from running across the ceiling of the Cellar. This sanitary line was capped just inside the east wall of the Cellar, and a new sanitary line was redirected on the outside along the East wall of the existing house and around the North end of the existing house, where it tied back into the existing sanitary lateral heading in a Northwest direction toward Saint Asaph Street. Other than changing the sanitary pipe caps from rubber to cast iron, these sanitary piping changes could main as they are, as they are not significant to the MDF house.

Figure 20aj. - Redirected Sanitary Line in Cellar

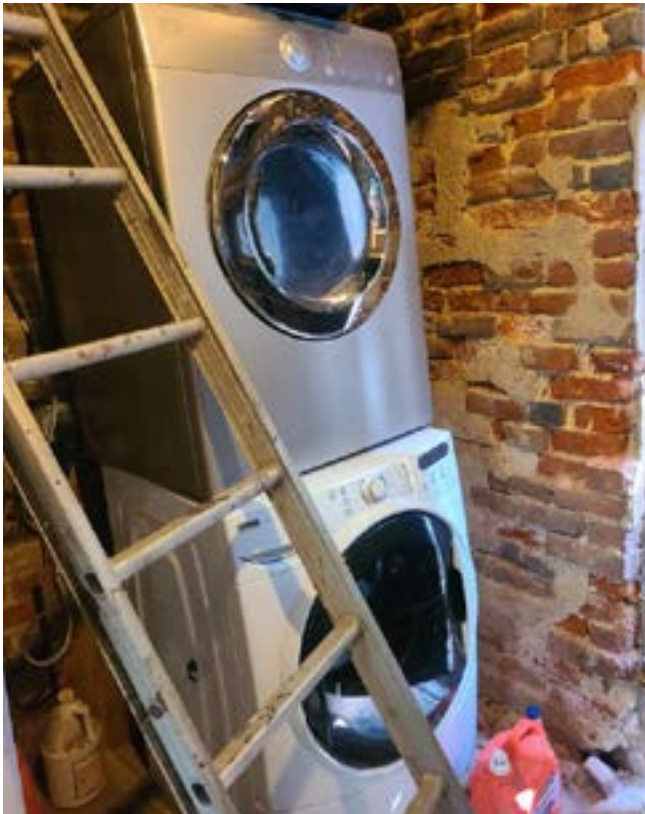
Figure 20ak. - Existing Washer & Dryer in the Smoke House (Rm 115)

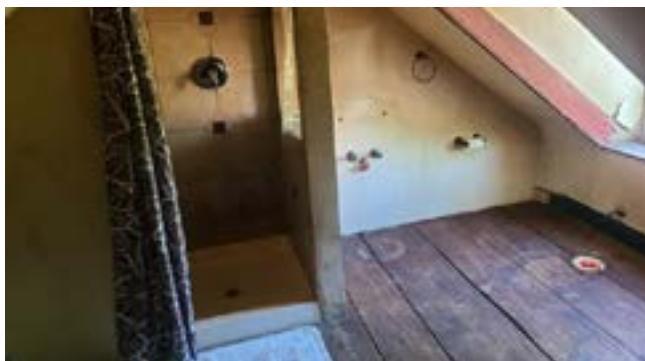
Figure 20al. - Shower and Demolished Plumbing Fixtures - Second Floor

A number of plumbing fixtures have been removed, but for any existing plumbing fixtures that have not already been removed, new plumbing fixtures and piping should be installed at the time that programming changes occur.

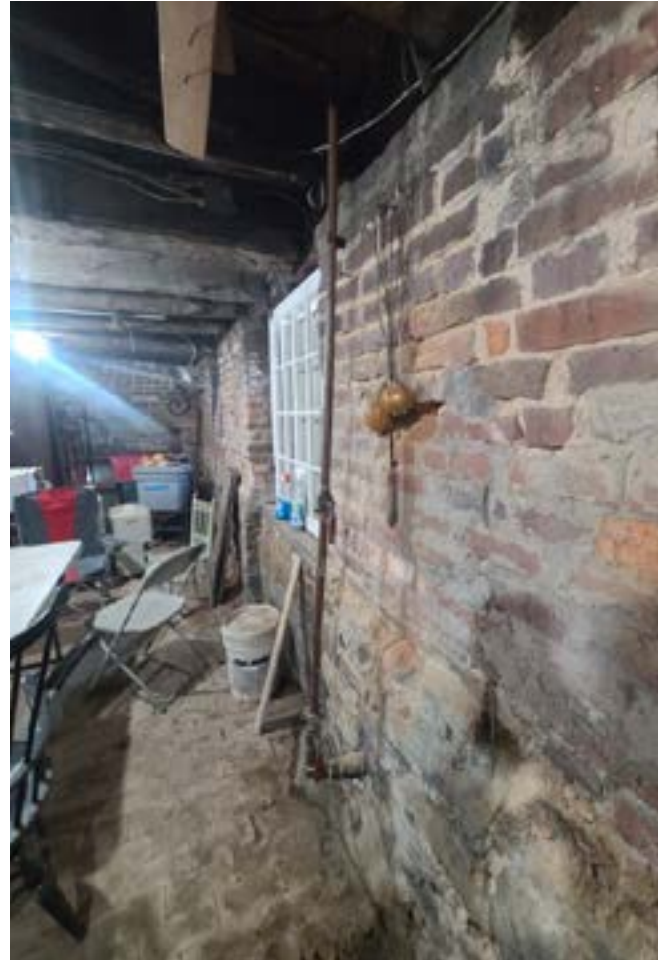
The domestic cold-water service enters the South wall in the Cellar. This service would need to be upsized if a sprinkler system is added to the MDF House.

Figure 20am. - Incoming Domestic Water Service

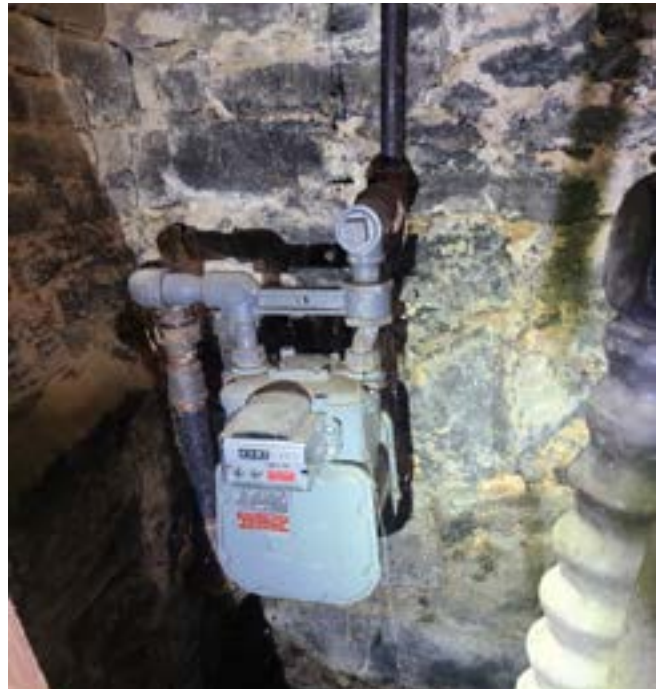
The natural gas meter associated with the existing gas service is located in the Cellar. Natural gas serves the existing gas fired boiler. If the boiler is removed and replaced with a heat pump or geothermal system, then the modern gas piping should be removed throughout the house since it is not original to the house.

Figure 20ap. - Existing Natural Gas Meter in Cellar

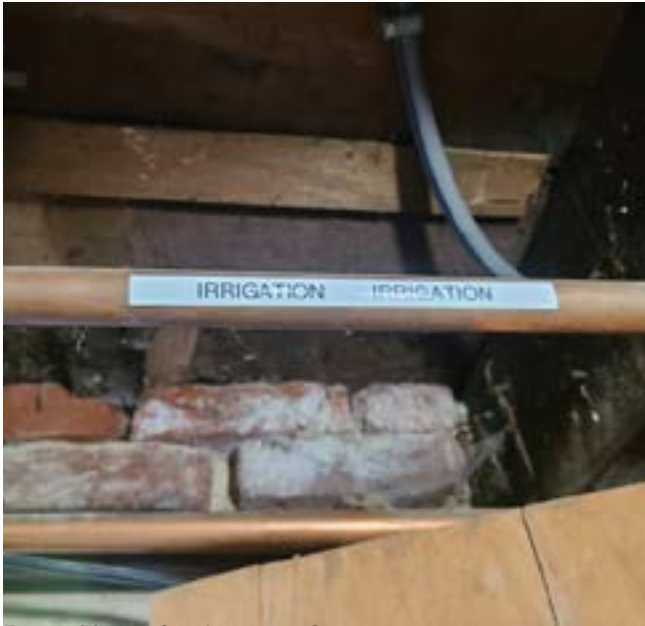
There is an existing site irrigation system that originates in the Cellar of the MDF House. The age and condition of the system and its piping is unknown.

Figure 20aq. - Site Irrigation System

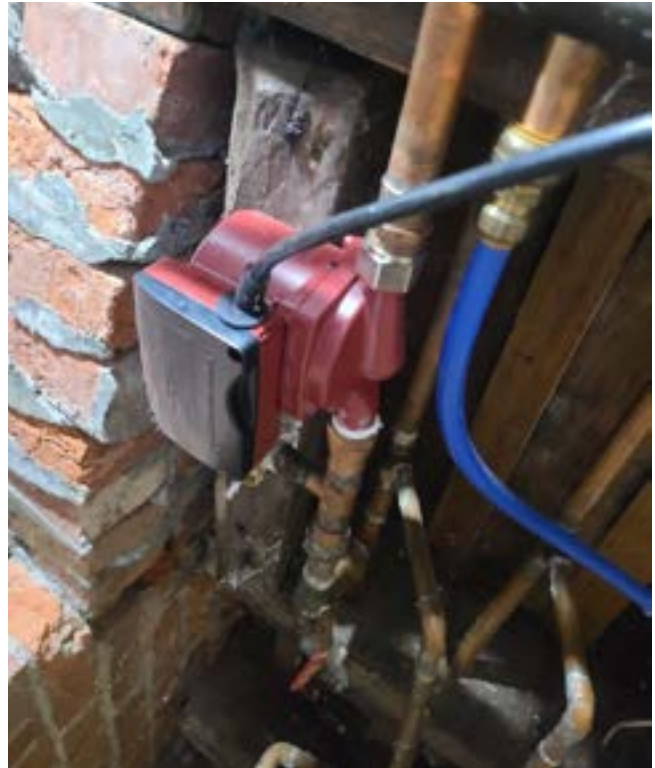
Water is circulated through the hot water recirculating line using a Grundfos, inline circulation pump that appears to be in good condition.

Figure 20ar. - Domestic Hot Water Inline Recirculation Pump
