Murray-Dick-Fawcett House Historic Structure Report

Report by Glavé & Holmes Architecture for the Office of Historic Alexandria,
City of Alexandria, Virginia | April 19, 2024 (REVISION 1)

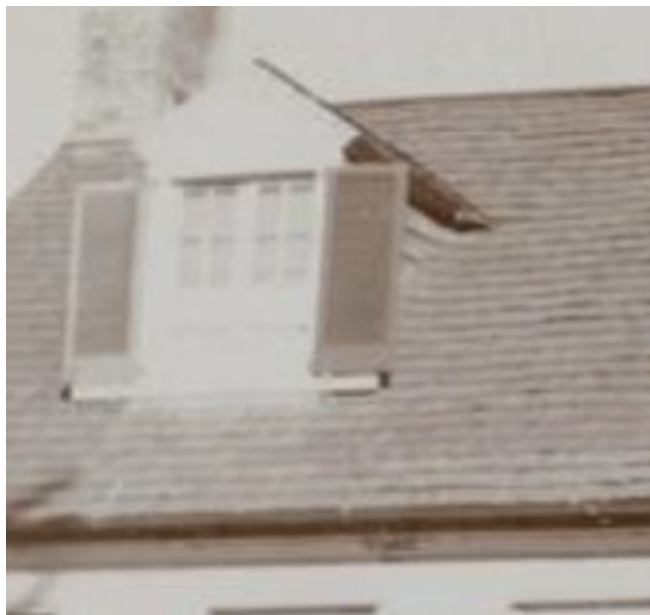
Figure 4a. - Historic Photo from the early 20th c shows the western dormer on the south front with the shutters.

The pair of chambers in the attic was lit by two dormers on the south front, two casements in the west gable and a single six-light casement in the east gable. The west gable windows flank the chimney in the west wall. Dormers as wide as these and filled with pairs of casements are very unusual and these were fitted with shutters that were held out to each side of the dormers by a board at sill level to which iron shutter dogs were attached (see Figure 4a).

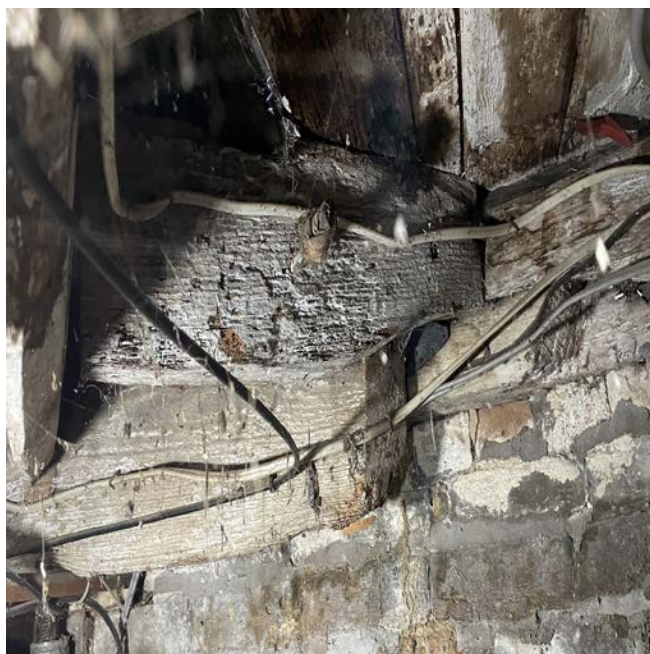
Figure 5a. - Junction of diagonal framing for the chimney with the sill in the NW corner of the 1784 addition.

The sequence of construction and alterations within envelope of the 1784 addition is complex. The original exterior door to the north remains in place within the addition. Evidence in the first floor-floor framing indicates that the NW room in the addition (Room 105) was heated by a diagonal chimney in the NW corner. A similar chimney may have heated the NE room (Room 107), but, unlike the NW room, there is no physical evidence for this. In spite of a reference to the existence of three chimneys in Murray's

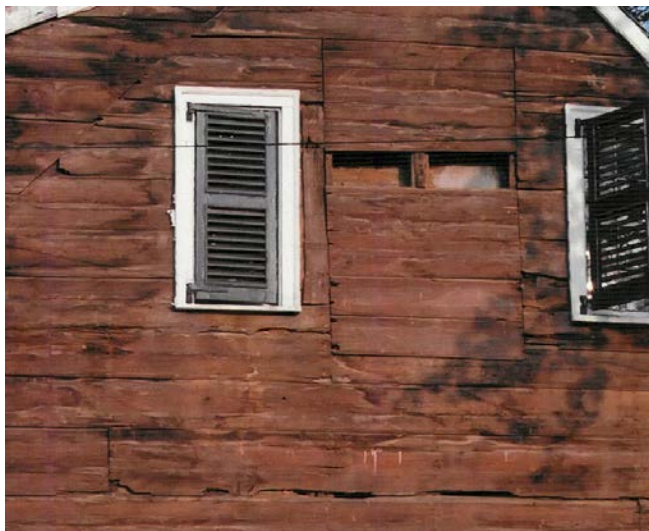
Figure 5d. - West gable during 2002 removal of weatherboard. Note the large rectangular patch behind the chimney (Bierce Collection).

The fact that no fireplace was mentioned for the two rooms on the second floor could be interpreted to mean that the small coal grate in the upstairs west chamber was added after 1792. This might be connected to the large square patch in the west gable and the very rough form of the chimney in the upper room, which appears not to have been part of the original plan for the house. This patch predates the beaded weatherboarding which was added over the original flush boards on the west and south faces of the 1774 and 1784 sections of the house. The weatherboards were added c. 1816 when the front door was relocated to the east end. The question of the dating of various kinds of weatherboards in Alexandria is difficult to resolve, since relatively few early frame houses survive. Certainly the flush weatherboards were nearly unique to the area on both sides of the Potomac in the 18th century.¹³ Houses like the

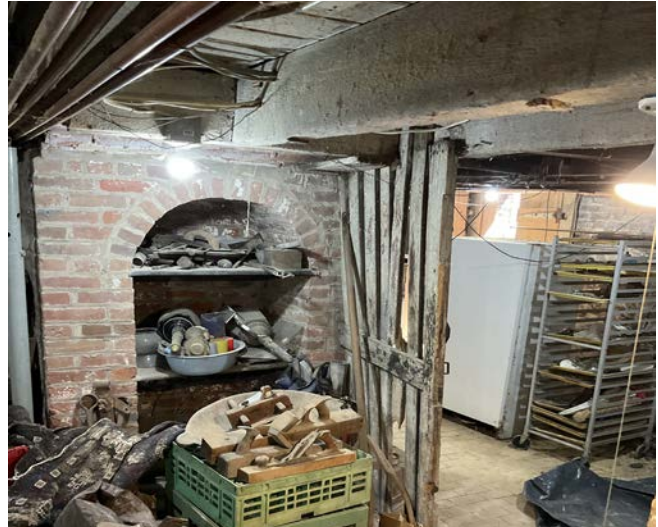
The diagonal chimney, also without a deep foundation to support it, was removed at the same time. A new vaulted brick interior chimney base was added on the north between the joists. Bricks supporting the hearth curve out from the chimney to rest against an added timber header. The added header is not notched into the floor

Figure 6a. - Added chimney base in the 1784 Cellar from the south.

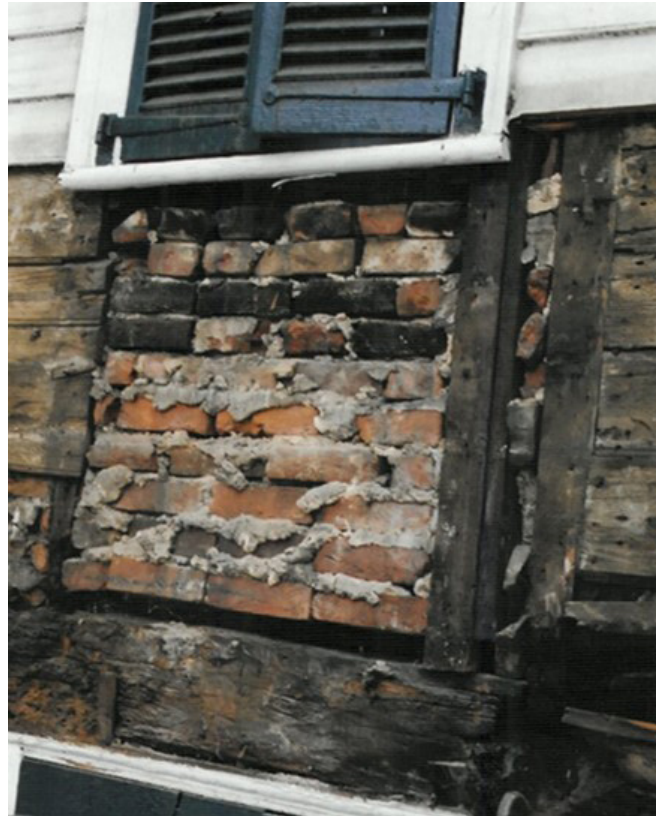
Looking at record photographs from 2002, it is possible to see how after the south door was removed and the narrower window frame installed (shifted to the west within the original opening), the lower part of the door was filled with additional brick filling (later known as nogging- a typical use for salmon brick). Then the original wide flush siding was patched, and the entire south and west walls covered with new, 5"-6" beaded weatherboards to conceal the patches, deteriorated flush boarding, and the exposed filling in the former doorway. The dark vertical lines visible on the boards are where the door frame extended over them. The door was not centered on the south front but it was centered over the cellar doorway. It is also possible to see that the door head still survived in 2002 above the added window.³¹

Figure 8c. - South front during restoration in 2002 showing the added brick filling or nogging below the added window sill with the added window post to the right (Bierce Collection, Historic Alexandria). Alexandria).

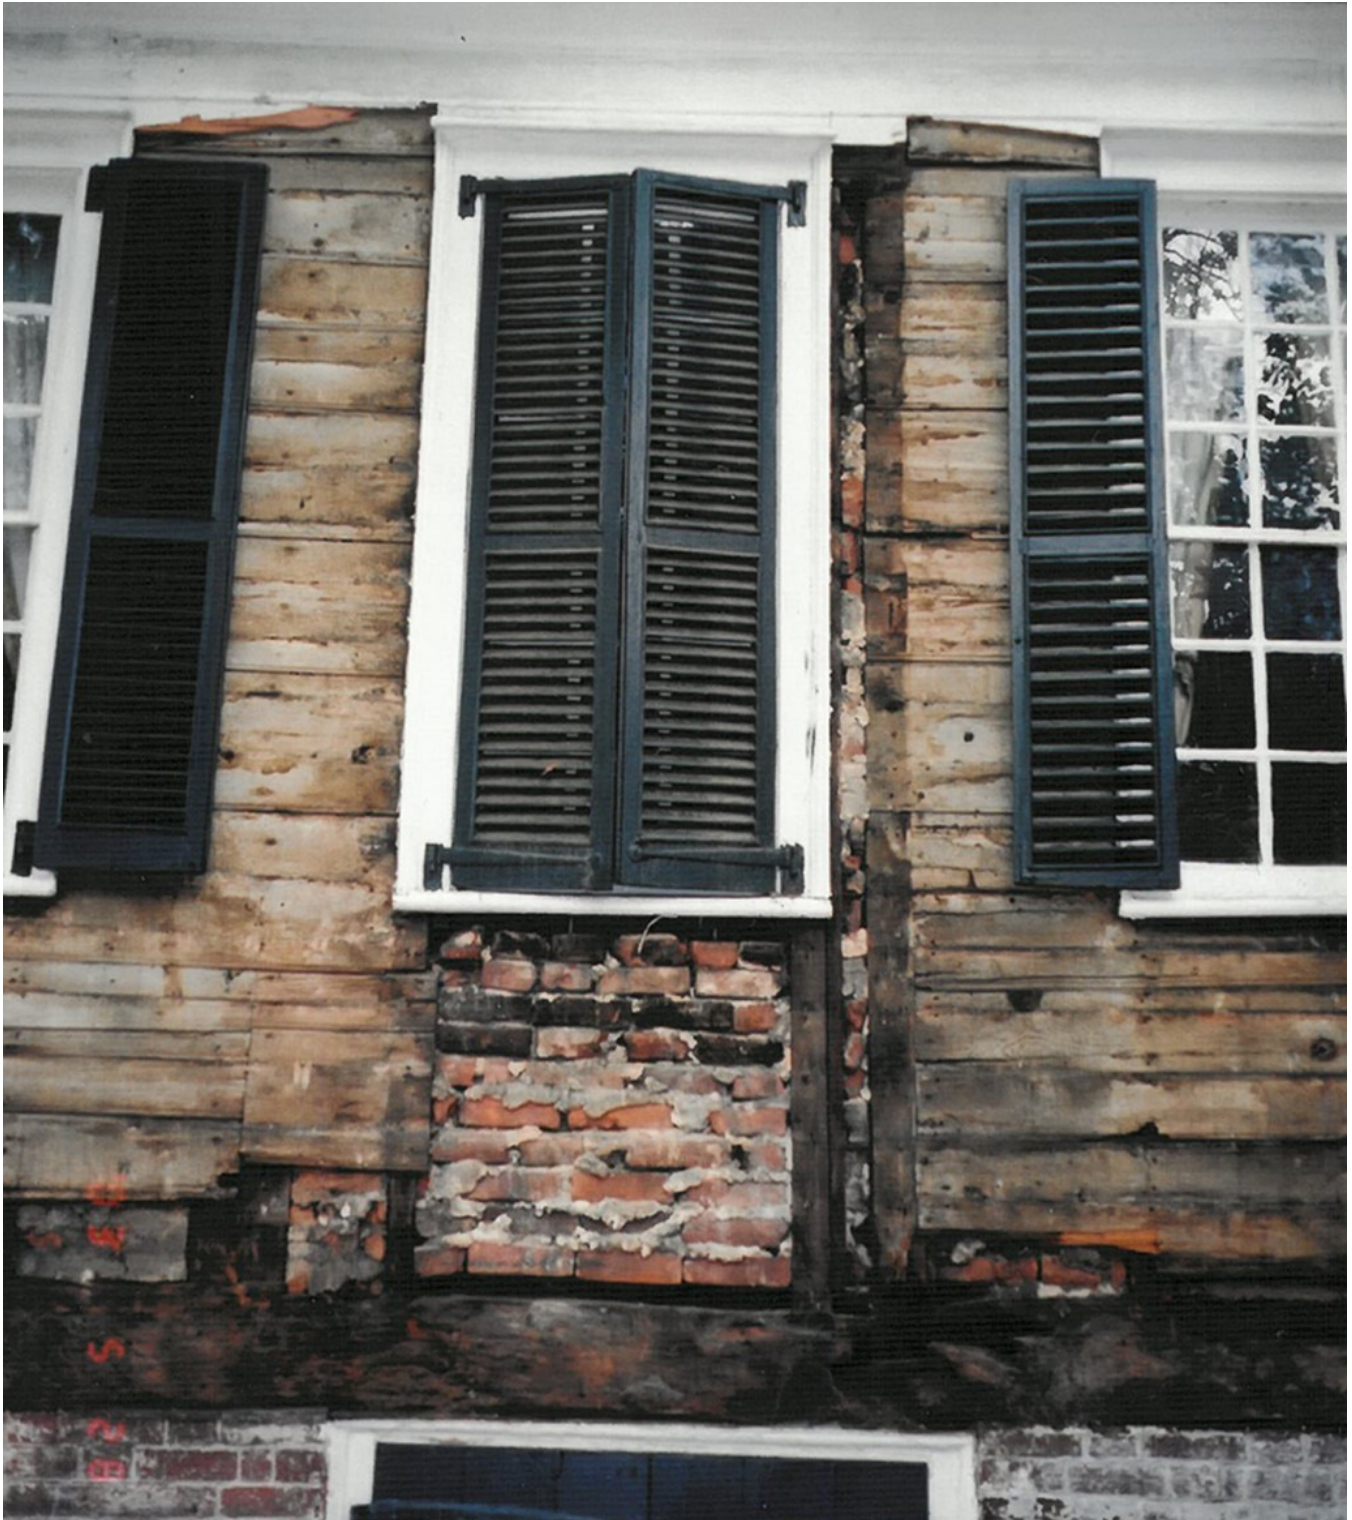
its door posts, the added window posts in the former door location may have been relocated from elsewhere in the house. Since, however, the original door, unlike the new window, was quite closely aligned with the cellar entry below, it would seem that the brick foundation was added at some point before the door was moved, probably at the time the street was lowered.

Figure 8d. - Former door location in center of south front during restoration of 2002, showing door post to right of the inserted right-hand window post (Bierce Collection, Historic Alexandria). The former door was centered over the cellar door, indicating that the brick foundation and cellar door predate the installation of the window above.

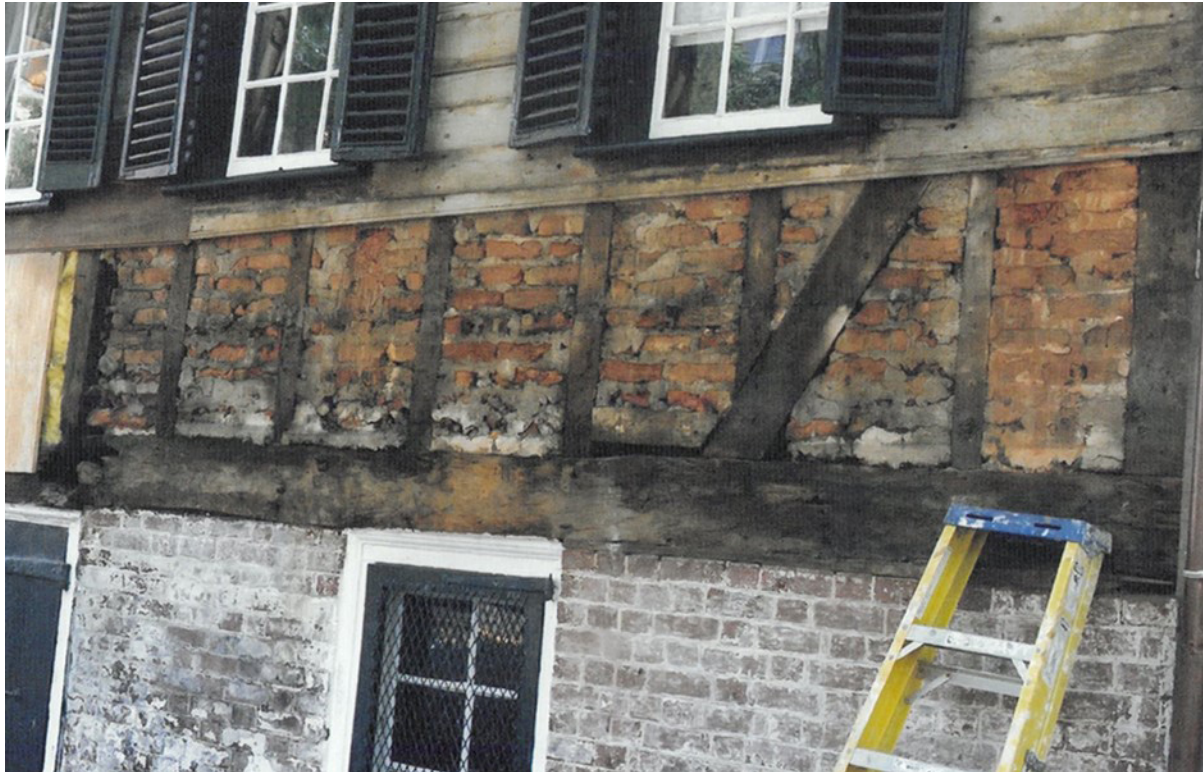
Figure 8e. - Right side of the south front in 2002 showing brick-nogged traditional Chesapeake framing including angled down brace to the right (Bierce Collection, Historic Alexandria).

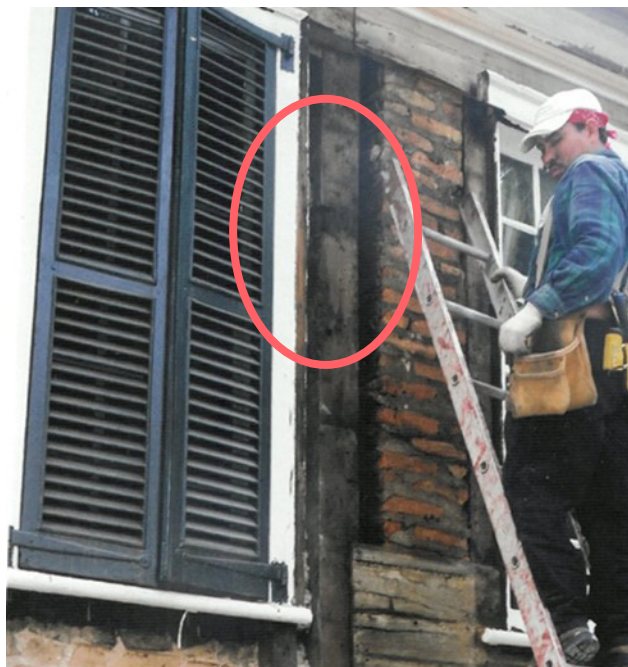
Figure 8f. - South front during restoration in 2002. The location of the bevel for the door head can be seen on the intermediate post that originally served as the door post near the top rung of the ladder (Bierce Collection, Historic Alexandria).

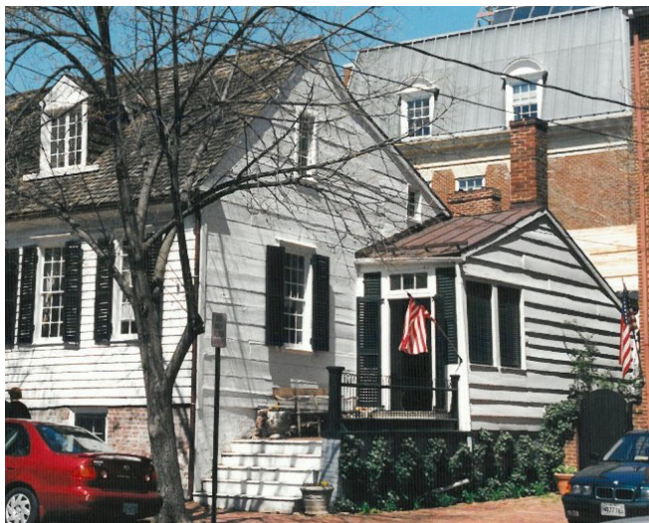
Figure 8g. - View from 2002 showing the continuous wide beaded siding on the east end of the east extension (Bierce Collection, Historic Alexandria).

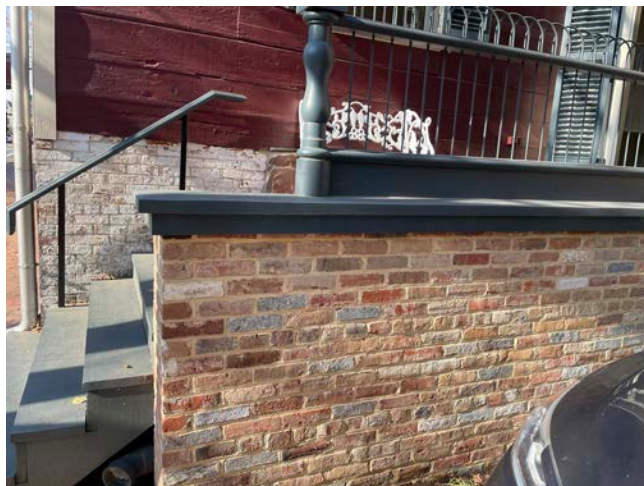
Figure 8h. - 2023 Reconstructed stoop [G&H].

The entire east extension, including the portico, the NE Chamber, and the Closet or Storeroom, stands on a continuous four-course American bond foundation that extends down to the current sidewalk. This foundation may have been extended down when the grade of the lot to the east appears have been lowered in the 1850s when the house there today was built. The section to the south supporting the stoop had been reconstructed at least twice and was laid in running bond using Portland cement. Its condition was poor, having been overturned by street tree roots growing toward the porch downspout. This wall was reconstructed with lime mortar in 2023, matching the original four course bond, as shown in figure 8i. Excavation for the

foundation repair was performed by Alexandria Archaeology.³³

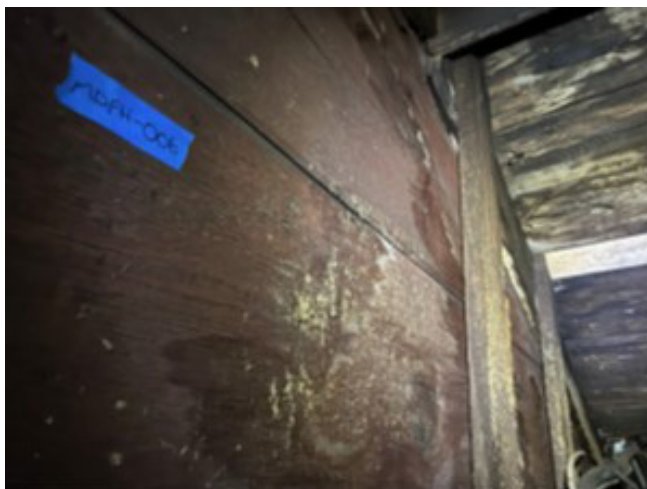
Figure 8i. - Original paint on the east exterior wall of the 1784 section seen from within the attic of the east extension of c1816.

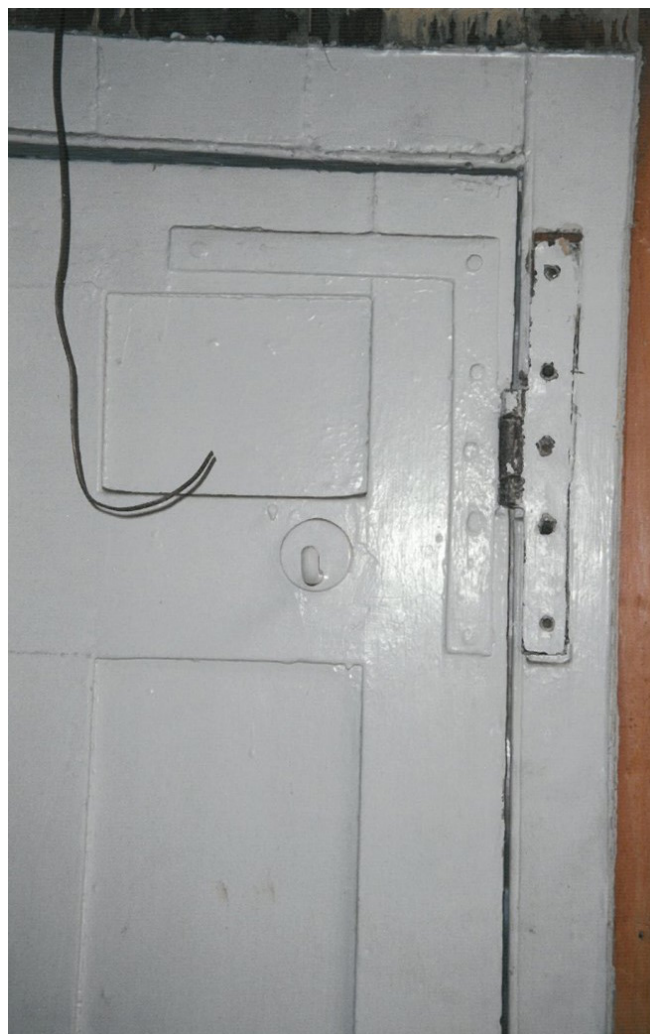
Figure 8j. - 2002 photo from the north of the door between the closet and the NE Chamber showing the back of the beaded vertical board partition and "HL" door hinge in place (Bierce Collection, Historic Alexandria).

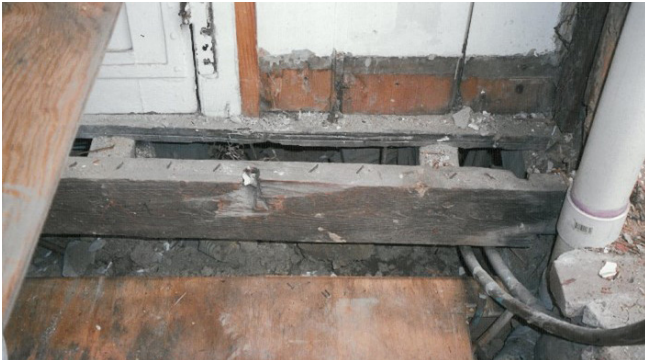
Figure 8l. - 2002 photo from the north of the vertical board wall between the closet and the NE Chamber. The floor joist is hewn (Bierce Collection, Historic Alexandria).

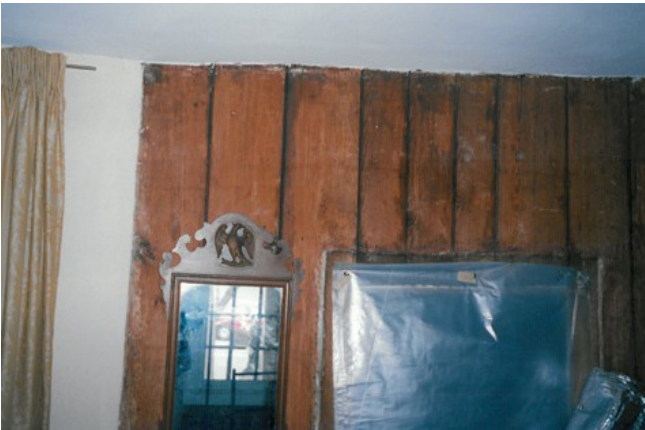
Figure 8m. - 2002 photo from the south of the vertical board partition between the NE Chamber and the adjoining closet, showing vertical board partition, original door location with the door and trim removed (Bierce Collection, Historic Alexandria).

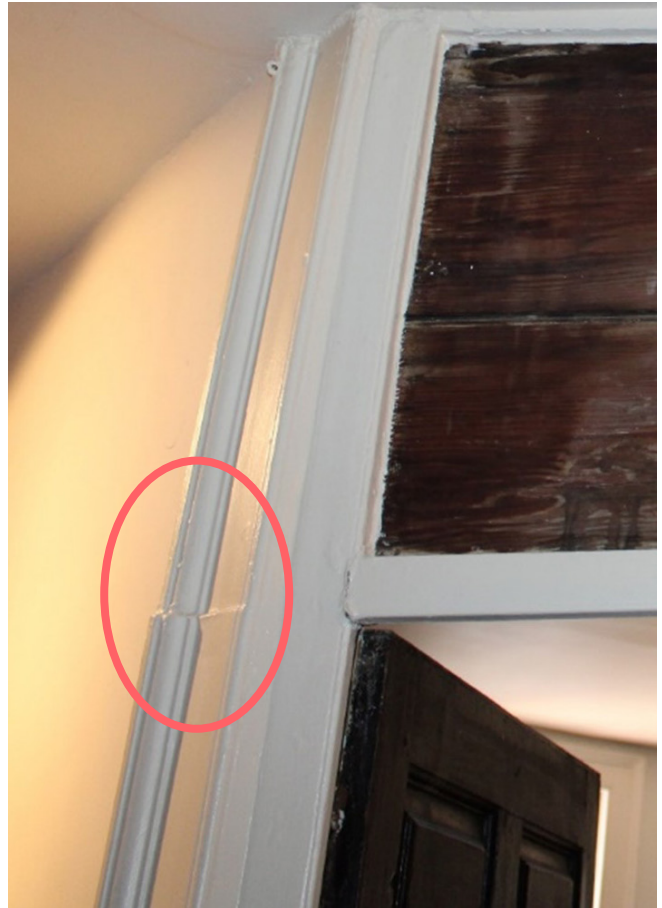
Figure 8n. - North jamb of the door from the NE Chamber to the passage looking NE. Note the 1784 door jamb to the left with a seam at door head height. It was extended to the ceiling when the door was reinstalled at a 45 degree angle.

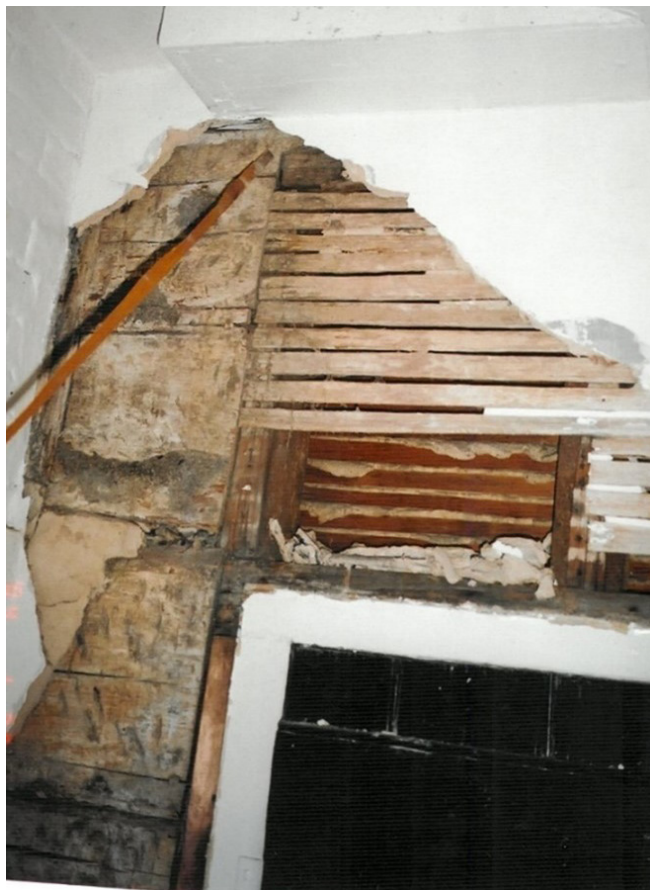
Figure 9f. - 2002 Photo from N of the former window in the N wall of the NW Room from the enclosed porch showing the inserted door and scored flush board and plaster (Bierce Collection, Historic Alexandria).

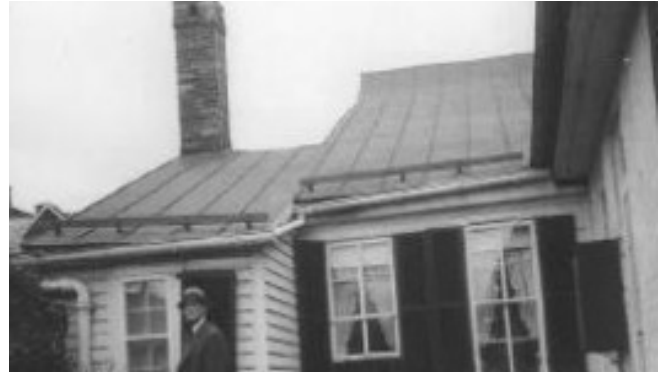
Figure 9g. - Snow brake irons supporting wooden board shown on the north slopes of the 1784 and 1816 sections in c1960, Historic Alexandria, Alexandria VA.

shingles on the south front through the 20th century, probably to self-consciously enhance the building’s historic appearance.²² A receipt from S. P. Devaughan, copper, tin, and sheet iron worker, “to take off old shingle roof, and for stripping same” . . . “Will put on the roof with the old style brand of tin” including twelve gutter hooks and 14 snow break irons”. The snow breaks, which appear to have been restricted to the 1784 and 1816 sections, survived until recent reroofing on the north eave of the 1784 addition where the long “catslide” roof could have accumulated a lot of snow.²³ They show up in historic photographs from the north and south. The snow guards on the north slope were no longer in place when the roof was replaced in 2021. The few brackets that were present in 2021 were reused to restore the wood snow guard above the entry to the east porch.²⁴

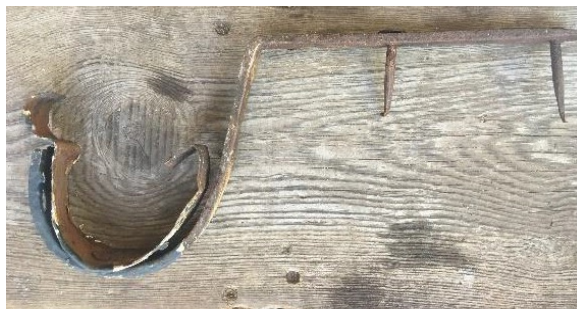
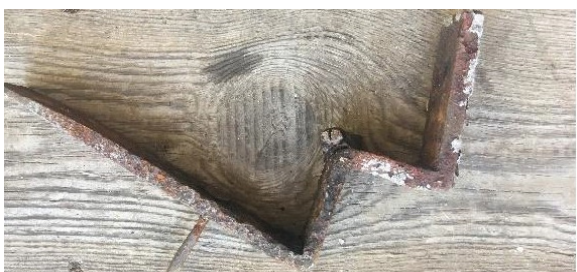
Figure 9h. - Snow brake iron (below) and gutter hanger (above), c1889 from the house, referred to in the J. Wallace Hooft receipts quoted in Shuman 2023, 67. Photos 2022 from Historic Alexandria, Alexandria VA.

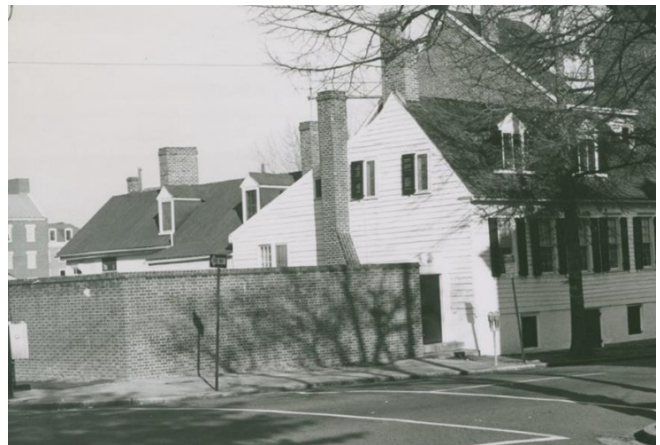
Figure 10f.- Murray-Dick-Fawcett House in 1975 showing the brick wall and garage before the construction of the courthouse (Special Collections, Alexandria Library). This photo also shows the chimney on the west wall from the 20th century boiler in the basement. The chimney was removed in 2002 by the former owner, who also lowered the brick garden wall by approximately 12".

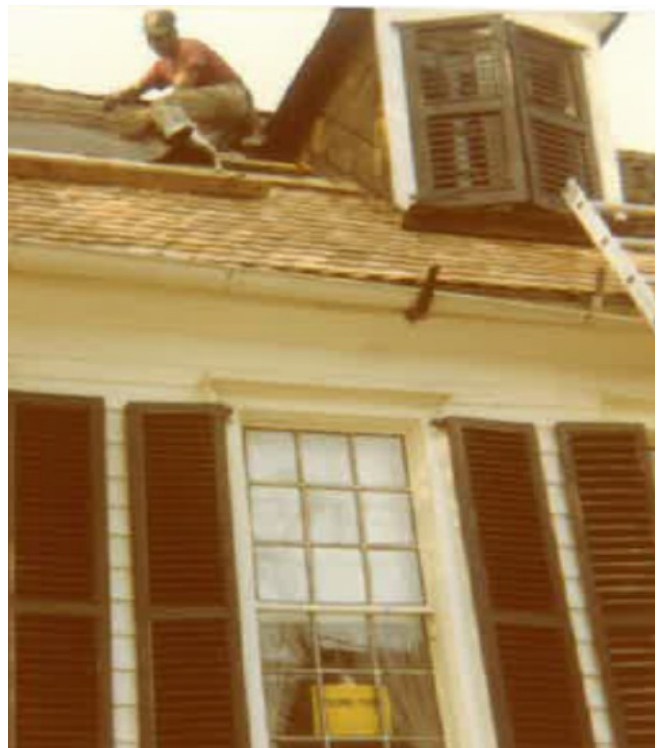
Figure 10j. - Reroofing the south slope of the 1774 roof shown in 1981 photo [Family Collection].

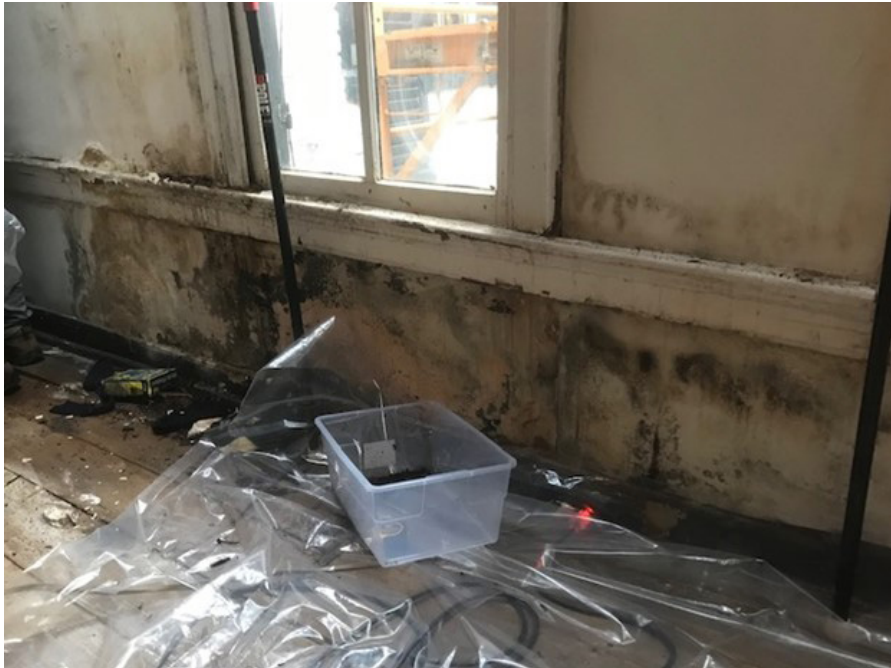
Figure 12d. - Al Cox, Photo of south face of north wall in NE Chamber before reconstruction, 2022.

- West flush siding removed and new Sapele boards to match in texture over 1/2" plywood
- The north wall and outer section of the ceiling joists of the NE Chamber were rebuilt. Portions of the wall and rafters of the northwest corner of the NW Chamber were repaired.

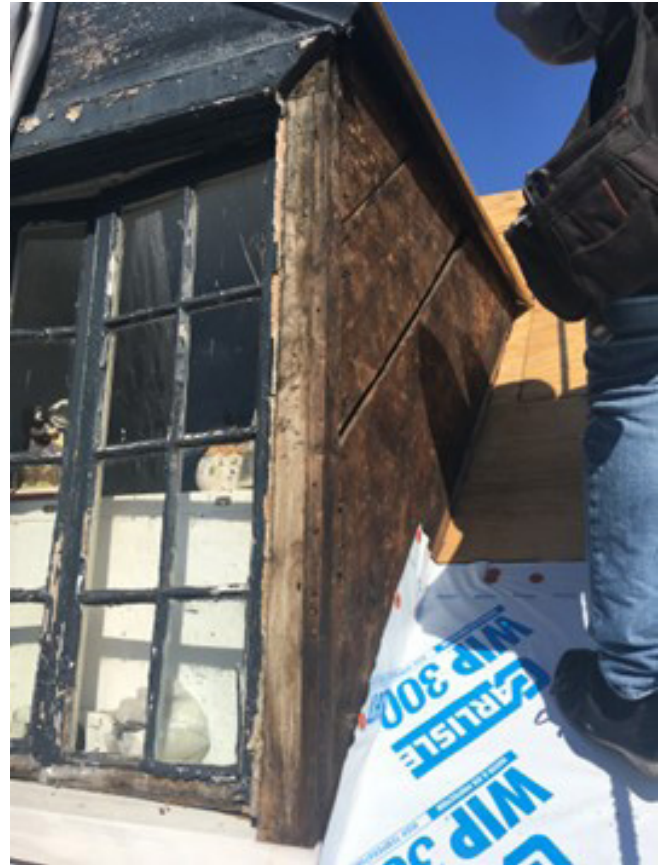
Figure 15d. - Typical south dormer showing original diagonal sheathing that shows no signs of any covering other than shingles.

- **Repair or replace damaged masonry units and mortar joints using best practices and historic lime mortar formulations designed to match the original mortar in strength, texture, and color.**
- **Consider whether to repaint or clean and remove paint from brick.**
- **The remaining shutters should be repaired or rebuilt and installed in historic locations, including on the south dormers.**

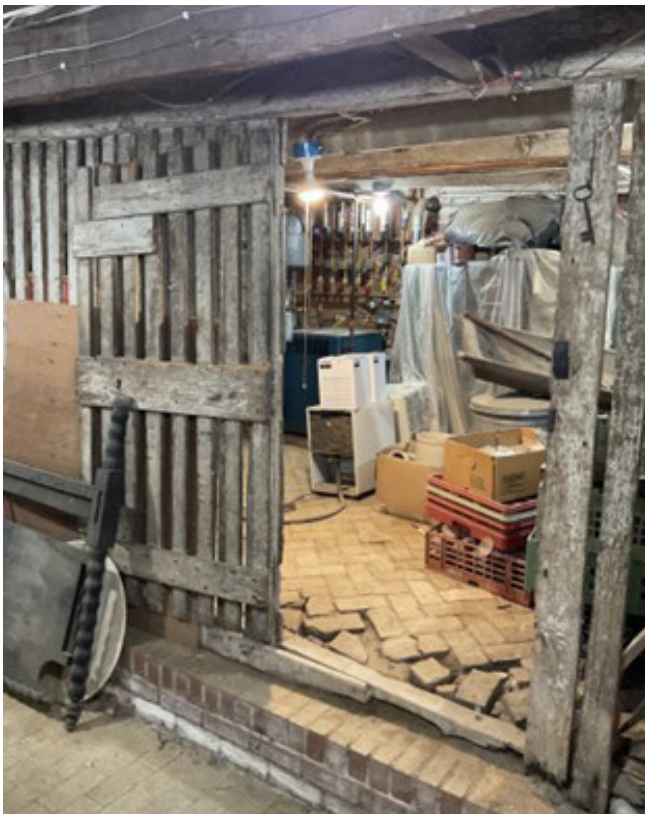
Figure 15k. - 1784 Cellar, slat partition looking southwest into the "Milk Room."

- Use hand-operated tools to remove as much cement mortar as possible.
- Clean, repair, and/or replace damaged masonry units and mortar joints using best practices and historic lime mortar formulations designed to match the original mortar in strength, texture, and color.
- Make structural repairs. Follow directions of structural engineer to reinforce and

repair any cracks, support the floor joists, and ameliorate other structural issues. Preserve the evidence in the framing of the former corner chimney.

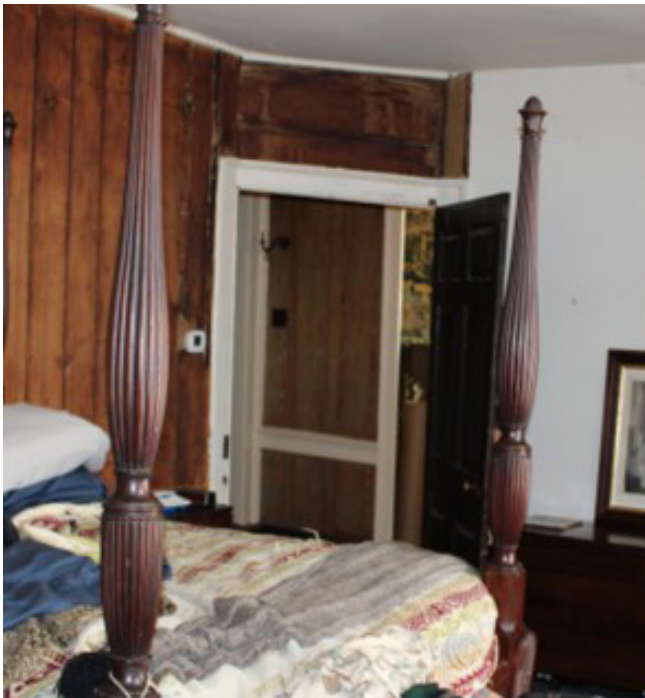
Figure 15r. - Room 107 showing angled door to the Back Passage (Room 106).

- **Demolition:** Remove all of the existing plumbing fixtures and finishes. Include the water and sanitary drain pipes that run through the yard and the cellar of the back building.
- **Framing:** Review and preserve original framing members in place.
- **Ceiling and Walls:** Level the ceiling framing and finish, if that can be done without damaging any remaining original plaster. If leveling is not practical, then the new flat ceiling needs to be blended into the existing ceiling.
- **Trim:** Touch up damaged paint until a decision has been made to restore a historic paint scheme. Add new finishes in the Store Room- probably plaster or gypsum wallboard, depending on evidence on structural members.
- **Window and Door Trim:** Add new window and door trim based on evidence in wall framing and historic photographs.

- **Floor in Room 107:** Clean and even out finish by rotary buffing the floor gently and treating with an appropriate wax. Do not sand unless necessary.
- **Floor in Room 108:** Remove tile floor and

subfloor in former store room. Reconstruct historic floor to match adjacent flooring.

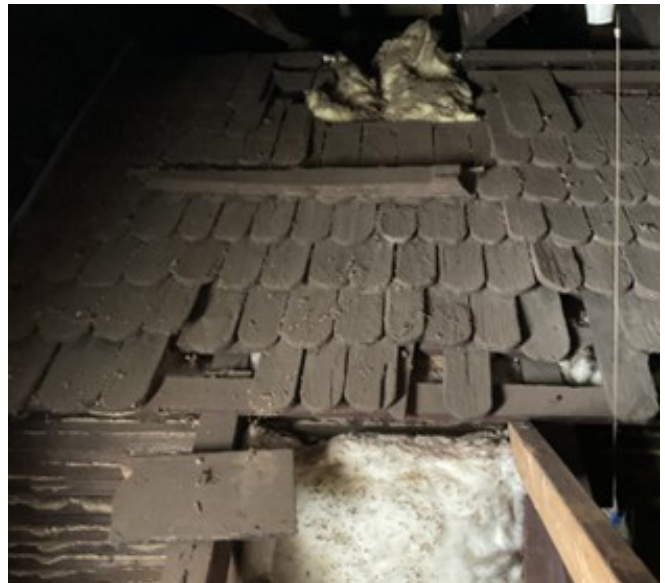
Figure 15s. - Attic of the 1784 Section looking south at the original section of original shingle roof.

- Secure floor boards in the walk space and improve access to the attic space for future

maintenance and interpretation.

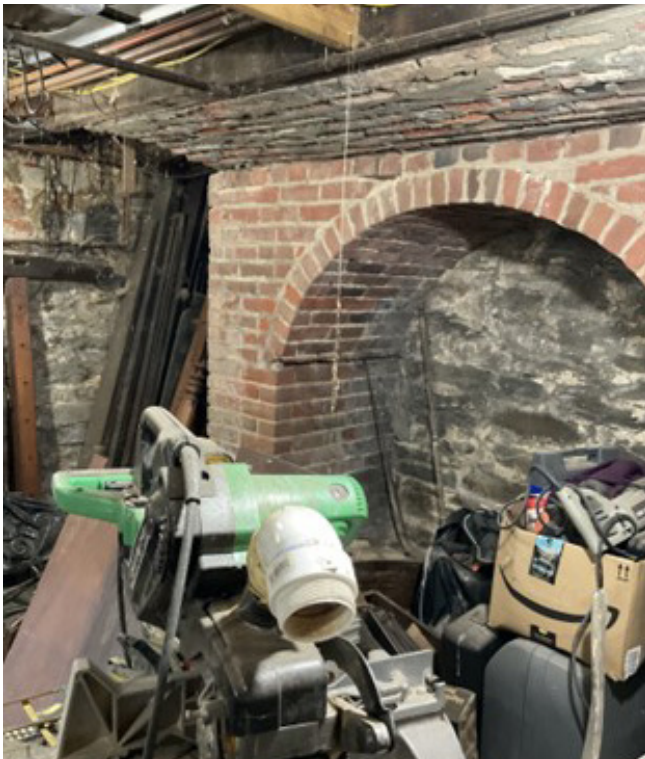
Figure 15t. - 1797 Cellar. Base of Kitchen fireplace looking northwest.

directions of structural engineer to reinforce and repair any cracks, support the floor joists, and ameliorate other structural issues.

- **Wiring:** Remove nonfunctional wiring and rewire as recommended by engineer.
- **Plumbing.** Remove nonfunctional plumbing.
- **Enlarge the basement entry on the west side to improve access to cellar. Coordinate**

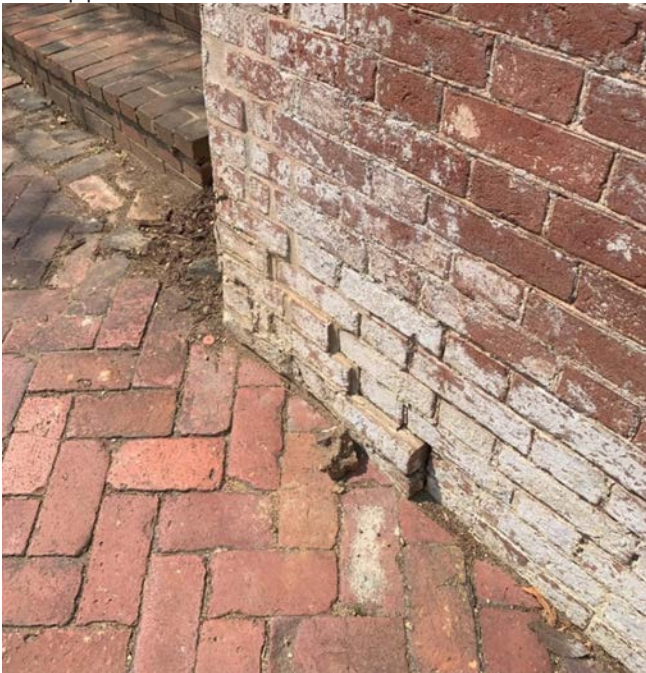
Figure 19a.

On the exterior southwest corner of the original structure, cracking was observed in the original foundation wall at the transition between stone and brick (figure 19a). In addition, along the south wall, the cracking continued through the brick with an offset. At the interior of this corner, the foundation work appeared to be in good condition. The movement observed is likely due to differential movement between the two materials at this location.

At this location, the cracks should be repaired with an appropriate mortar matching the existing mortar. Samples of the existing mortar should be tested for composition and strength properties, and a mock-up should be constructed to confirm the appearance.

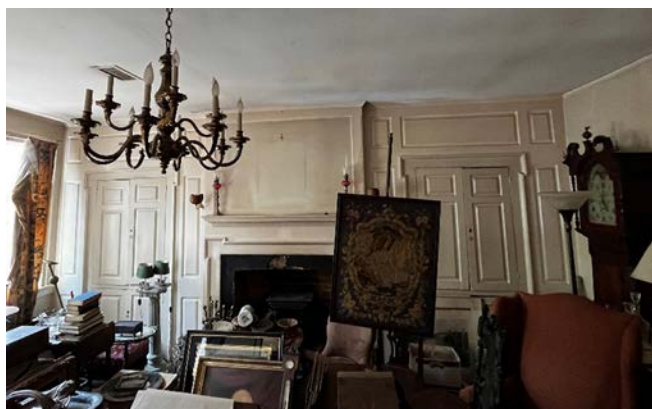
Figure 19b. - (Room 104)

There was also plaster damage along the south wall of room 104. This appeared to be due to moisture. The exterior walls were also recently repaired in this area due to water infiltration.

Plaster should be repaired in areas where water infiltration is confirmed as no longer active. See architectural recommendations for guidelines on historically appropriate plaster repairs. The area on the main floor should be monitored to confirm that there is not an active leak.

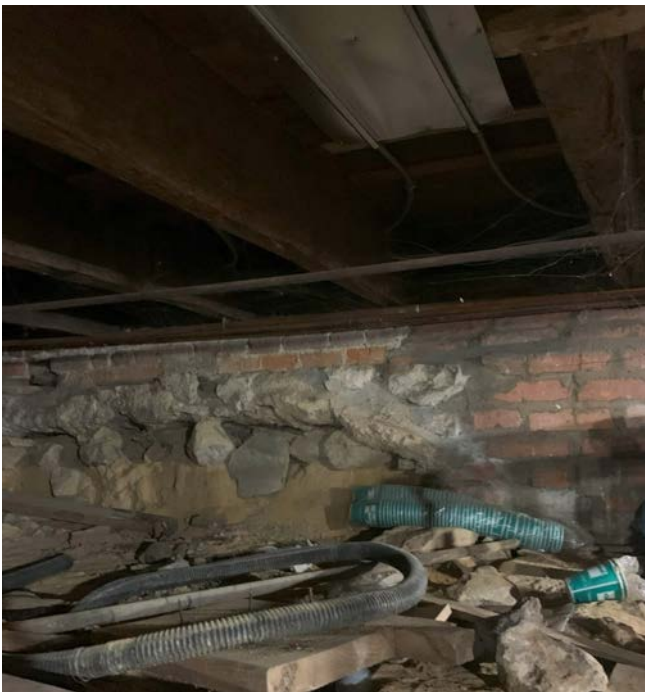
The foundations of the east and south walls of the crawl space have areas that appear to have been undermined during the lowering of the interior grade (figure 19c). The foundation walls are constructed of brick on what would have been above grade, with rubble stone below. The base of the rubble stone foundation walls is visible in the current condition, and the wall shows evidence of movement.

Figure 19c. Foundation below the east end of the 1874 section looking south (Room 003)

This area will require underpinning to re-establish proper bearing and prevent continued movement in the foundation walls. This area will eventually require underpinning to reestablish proper bearing and prevent continued

movement in the foundation walls. Underpinning work should be done in small segments to protect the original stone foundation assembly. This could also be constructed with a course of cmu between the existing foundation wall and concrete underpinning to prevent contact between poured concrete and historic stone.

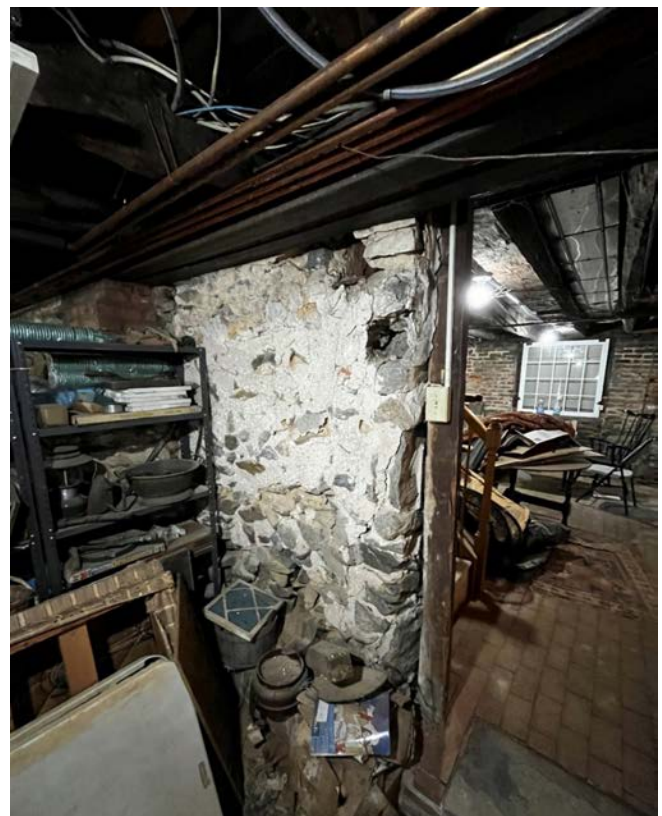
At the intersection of the original structure and the 1784 addition, the original stone wall is intact and visible on the south side of the area labeled as Room 003. This wall appears to have been repaired with a mortar containing cementitious material (Figure 19d). In addition, portions of the wall are suffering from mortar loss and continued movement. Repairs with cementitious mortar are not recommended for historic walls of this nature.

Figure 19d. west jamb of the door between the 1784 and 1774 sections looking south (Room 104)

Holes and locations where the stone has lost mortar or is continuing to move should be repaired using a historically appropriate mortar. Where the area has been previously repaired with cementitious mortar, it may be advisable to pursue removing this to prevent further damage to the existing historic material long term; however, due to this being in the interior of the structure, it should be protected from moisture and freeze-thaw issues that lead to deterioration of historic masonry in contact with modern mortar.

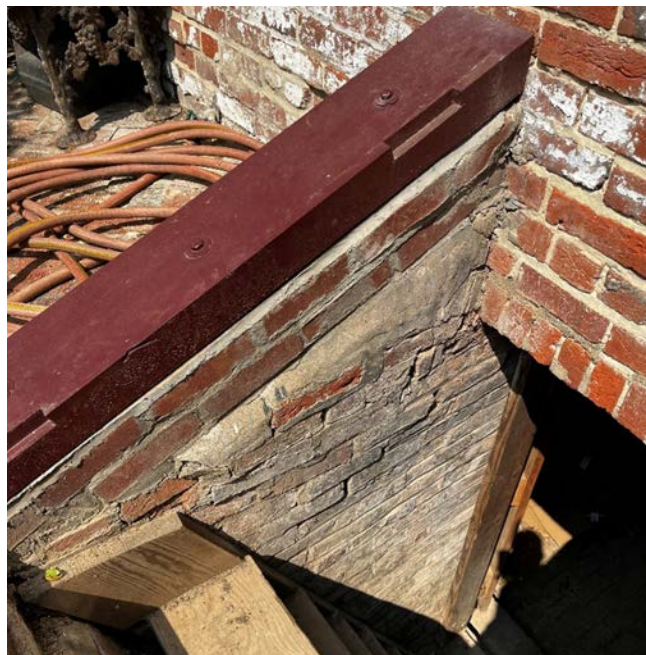
Figure 19e. 1797 wing, west stair, north side of cellar stair bulkhead looking northeast.

The cracks in the retaining wall should be repaired with an appropriate mortar and monitored for future movement.

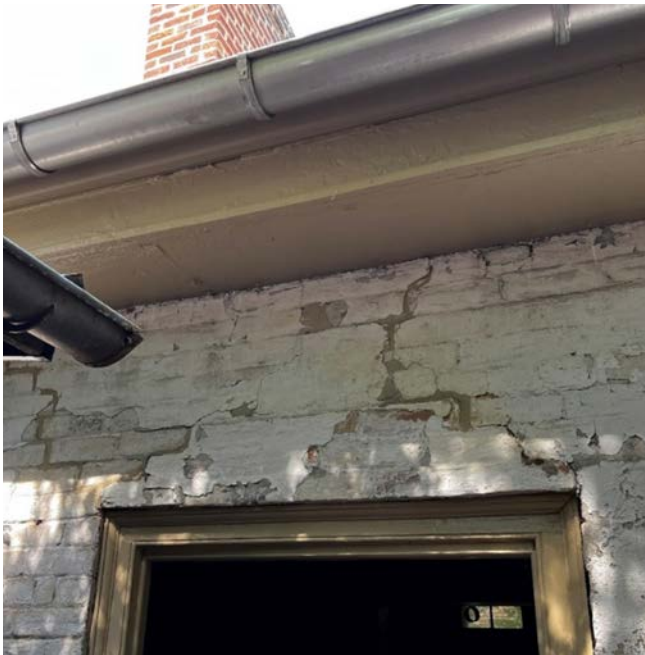
Figure 19f. Doorhead at the Smokehouse (Room 15) door looking west.

Consideration should be given to removing previous repointing with cementitious material and replacing it with historically appropriate

mortar as part of a masonry repair effort. The failed lintel on the east wall will need to be repaired, and it may be advisable to repair the sagging lintel on the west wall as well. Drainage issues were addressed in 2002 and 2022 with gutters and underground drain lines, which should help prevent additional damage to this wall.

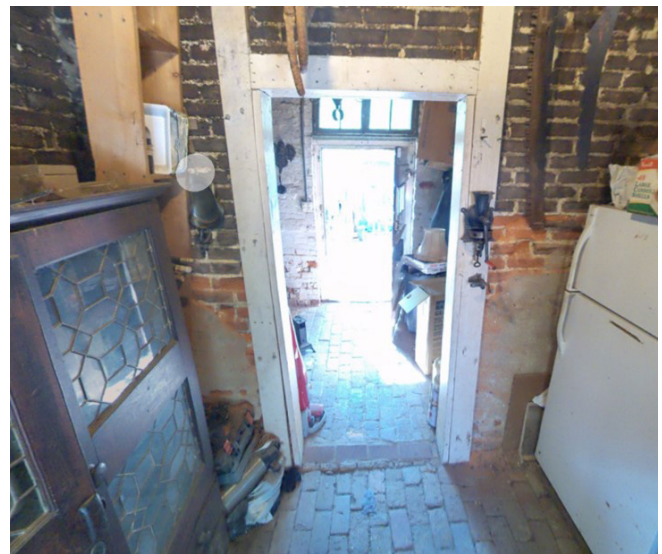
The interior single-wythe wall between the smokehouse and service room has spalling brick on the lower third (Figure 19h, image taken from Prologue building scan). There appears to have been a coating on this lower segment that trapped moisture in the wall, while the upper section of the wall was exposed (evidenced by patterns of smoke residue). There also appears to have been repairs made to the wall with a cementitious mortar. A similar pattern is observable on the service room side in areas where paint is damaged due to issues with the brick behind it.

Figure 19h. Door between the Smokehouse (Room 114) and the Service Room (Room 115).

It is atypical to have load-bearing, single-wythe brick masonry walls, as this results in a very slender element that is prone to buckling and issues with out-of-plane movement.

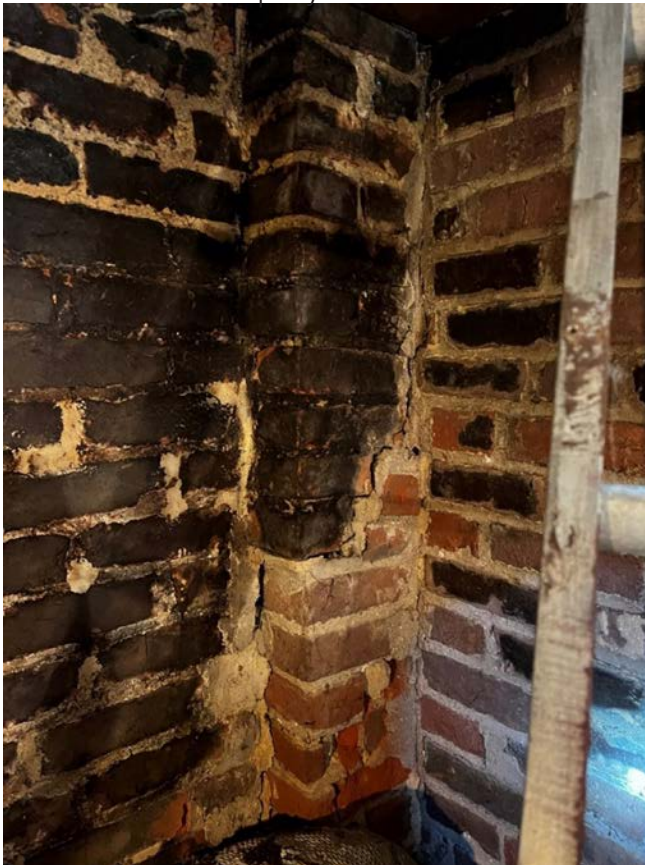
privies, there is a hollow brick flue connected to a chimney rising from the roof above. This flue, which probably ventilated the privy vault, has an offset diagonal crack, indicating the movement at its base (Figure 19i). This is likely due to the noted issues at the privy vault.

Figure 19i. Flue in the northwest corner of the Smokehouse (Room 115) looking northwest.

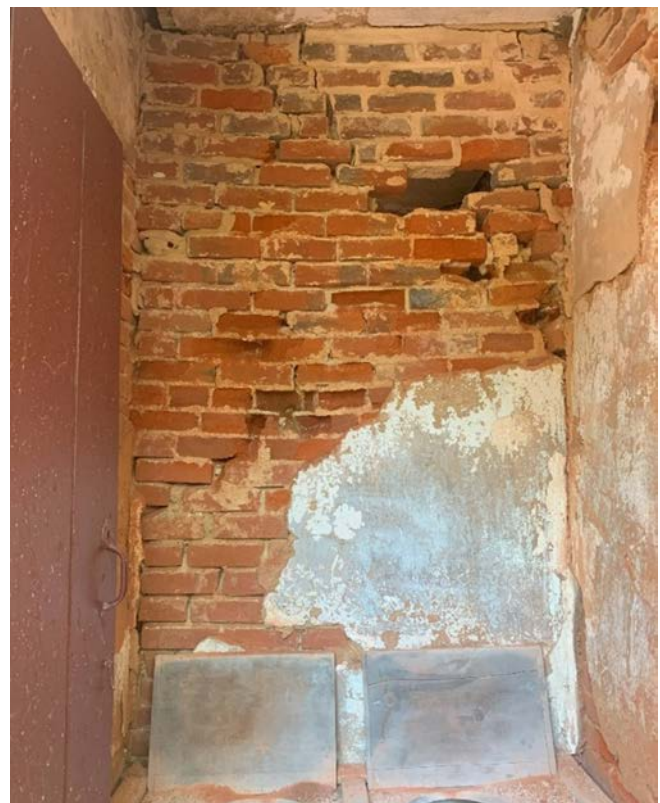
The interior privy walls are suffering from significant masonry issues (Figure 19j). In many locations, there are holes in the walls where bricks have been lost. Many of the bricks are spalling from apparent water infiltration. The walls also appear to have some movement occurring at the base, likely due to deterioration of the supporting structure.

Figure 19j. Interior of West Privy (Room 116) looking east.
