Murray-Dick-Fawcett House Historic Structure Report

Report by Glavé & Holmes Architecture for the Office of Historic Alexandria,
City of Alexandria, Virginia | April 19, 2024 (REVISION 1)

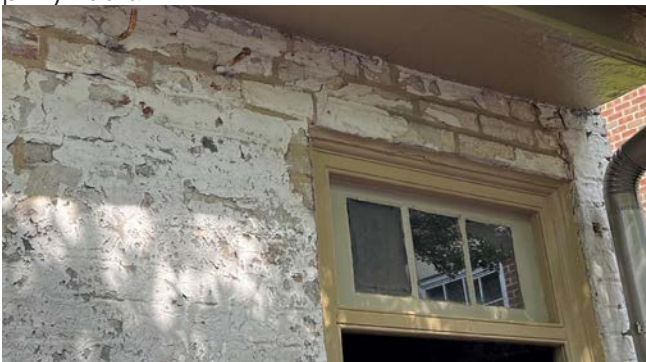
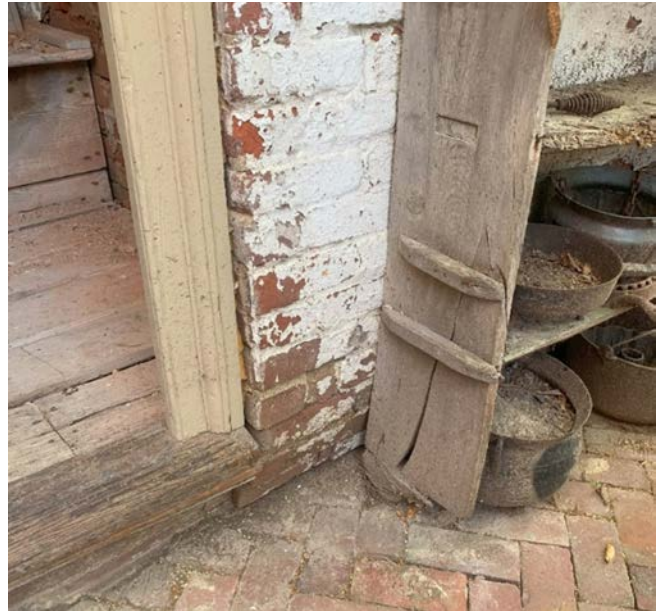
The exterior walls of the privy show evidence of deterioration as well as movement. There are spalling bricks and mortar loss in several areas. Some sections of the walls have been repaired with cementitious material, which can worsen damage to the brick over time. In some of these areas, the repaired sections are moving together, causing cracking in the surrounding masonry (figure 19k). In addition, at the northwest and northeast corners, the walls are bowing (figure 19l). This may be related to the work that occurred when the alley was lowered, or from movement in the foundations adjacent to the privy vault.

Figure 19k. Head of door to East Privy (Room 118) looking northwest.

Figure 19l. West Privy, south jamb of door looking southeast.

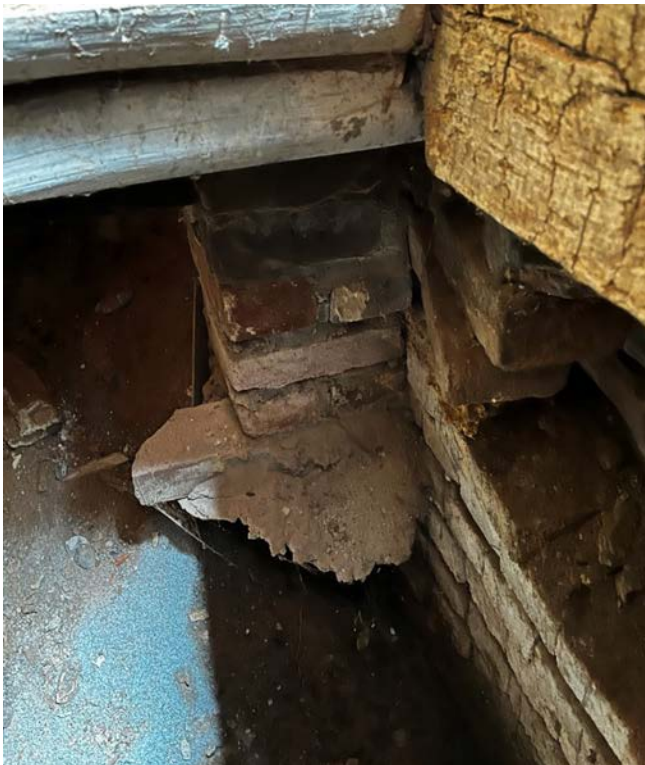
Figure 19m. North Privy with floor removed looking to northwest.

This area will require repair to stabilize the vault as well as provide support for the walls above. This could occur through a retrofit of the structure, which would avoid as much excavation as possible, or through preserving most of the

original structure and re-establishing the bearing condition, which would likely require the input of an archaeologist. This needs further investigation and conversation to determine the best course of action. This work should be done in conjunction with repairs to the interior and exterior masonry damage that is related to this movement.

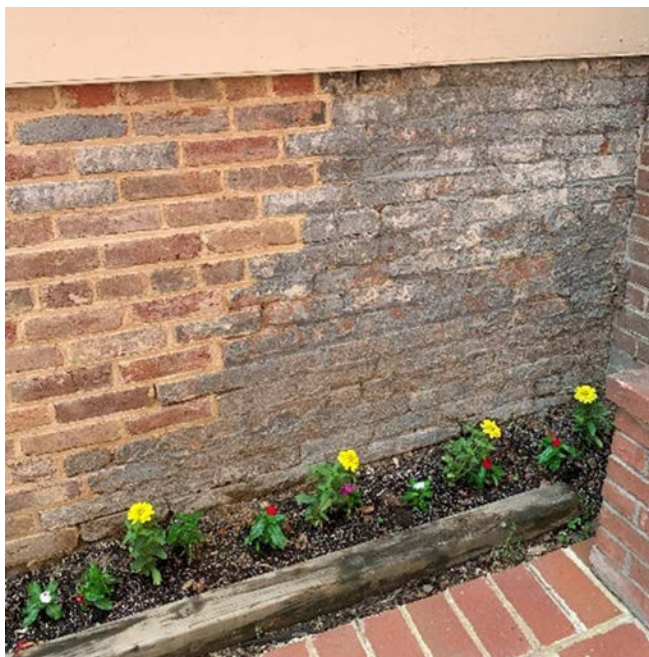
The current entry porch was noted by the team on site as having been recently rebuilt with a modern foundation wall and footing. At the intersection between the new and existing foundation walls, a crack has formed in the brick, and the area is experiencing some mortar loss.

Figure 19o. East side of the 1816 extension looking east.

This area should be monitored to determine if wall deterioration is an ongoing issue, or has been resolved with repairs.

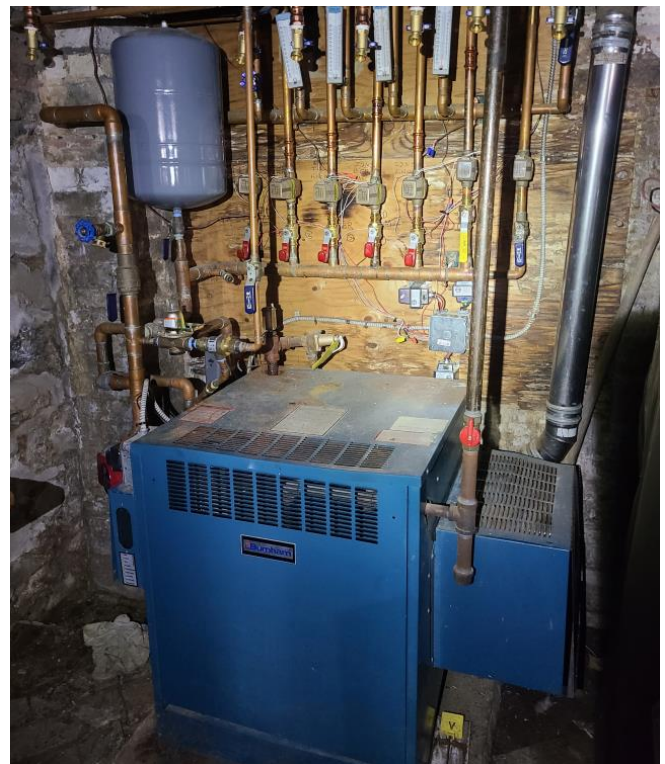
Hot water to the radiant floor heating system is supplied by a Burnham, gas fired hot water boiler, Model PXG-2006AWNI, located in Room 002 of the 1784 section of the Cellar. The boiler was manufactured in May of 1997. The hot water boiler has an input of 164,000 BTUH, with a DOE output of 138,000 BTUH. The boiler efficiency has an Annual Fuel Utilization Efficiency (AFUE) of 84.6%. This is not a very efficient unit by today's standards, and the boiler should be replaced along with any renovation project.

If the existing Cellar were to remain as an existing storage area (and not a public circulation space), then the existing radiant heating system could remain, since this type of system provides a comfortable environment if the system is sized appropriately. The current radiant flooring heating loop will likely not require replacement for another eight (8) to ten (10) years from the date of this report, although the hot water boiler should be replaced within the next five (5) years.

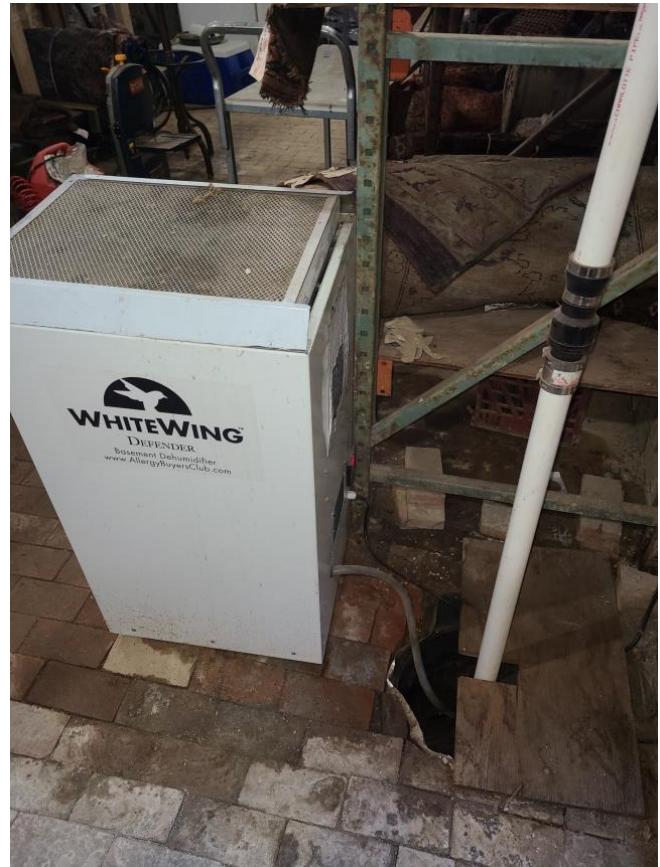
Figure 20p. - Dehumidifier Adjacent to Sump Pump

A portable dehumidifier is located adjacent to storm water crock on the West side of the 1797 section of the Cellar, evidence of a higher than desired moisture level. The crock is equipped with a submersible pump.

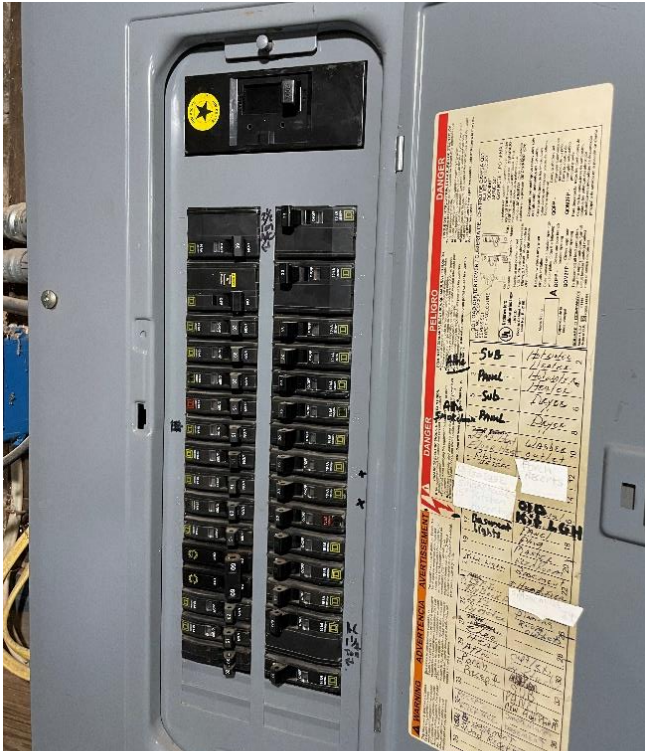
Figure 20x. - Main Panelboard in the Cellar

If it is decided that artificial lighting is required for the use of the facility and the HVAC system will be kept/updated, the electrical system for the MDF House will need to be updated. We recommend providing new wiring wherever possible and testing any existing wiring to be considered to remain. If the MDF House is classified as a commercial building, the load centers would need to be replaced with panelboards with bolt-on circuit breakers.

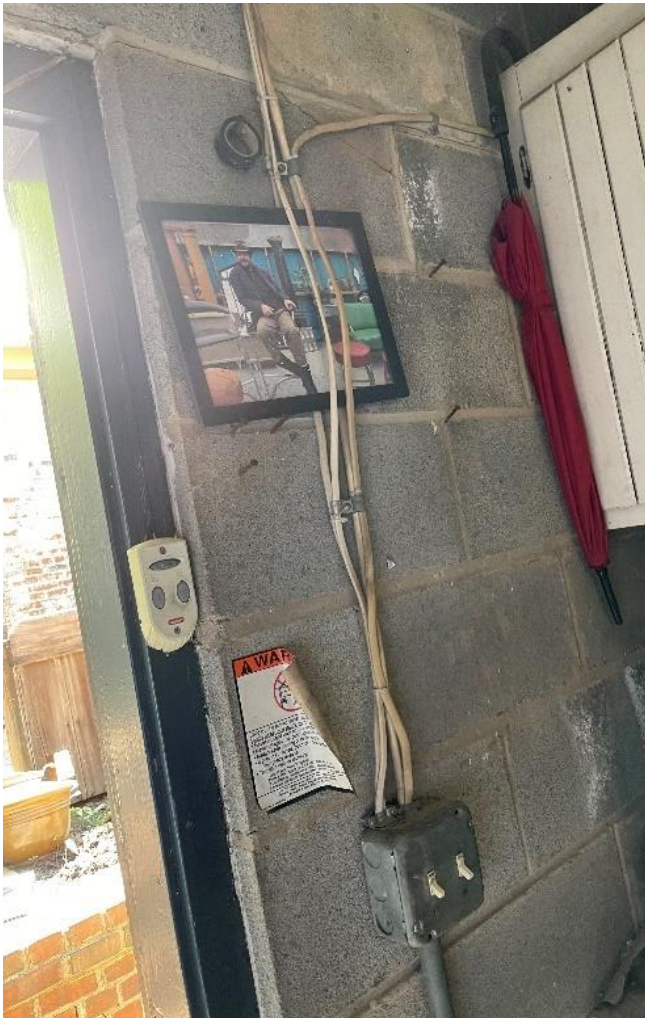
The Garage has two (2) circuits providing power to the door opener and a GFCI receptacle. These circuits originate from the main distribution panel located inside the Cellar. If the intent is to create a welcome center in the Garage with a kitchen and restrooms, a new electrical service will need to be provided. In that case we would suggest bringing the new electrical service to the garage and feeding the panelboard in the Cellar from the new service. The existing incoming electrical service to the House could then be disconnected and removed.

Figure 20ab. - Incoming Branch Circuits to equipment in the Garage.

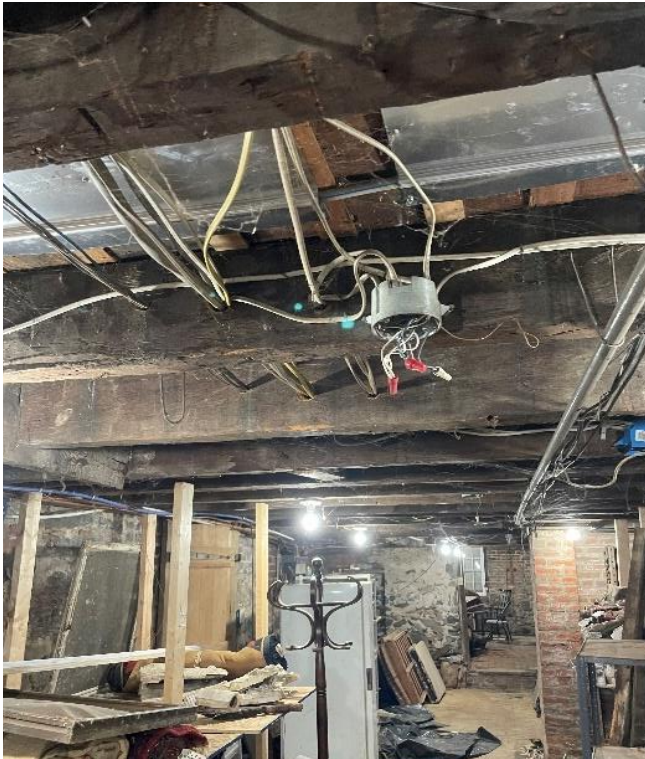
The branch circuit wiring in the MDF House, if required to remain to support the new programming, will need to be properly supported and protected. Where branch circuit wiring is found to be damaged or found to be unprotected and subject to future damage, it will be replaced with either metal flexible conduit, or replaced with new wiring in conduit. Most of the exposed wiring is located in the Basement, attics, and in the Garage.

Figure 20ad. - Exposed Wiring in the Cellar

The planned work should include as a minimum providing cover for all open junction boxes in the MDF House and Garage, and providing conduit where wiring will remain exposed.

If the basement becomes accessible to the public for occasional tours, all the exposed wiring (see Figure 20ad.) would need to be replaced with metal flexible conduit or installed in conduit.

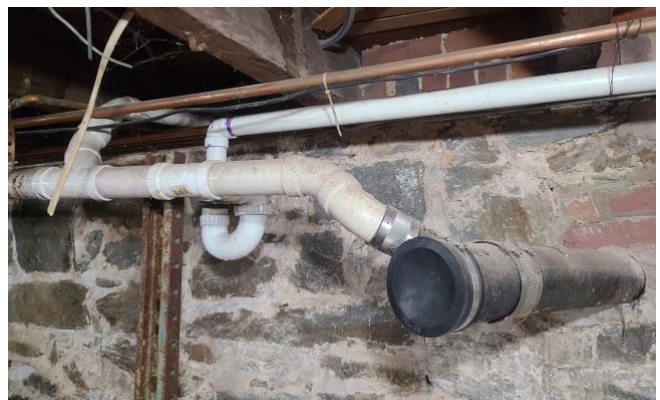
Sanitary piping in the Cellar is either newer PVC piping or cast-iron piping. An earlier sanitary line ran across the Cellar from the midpoint of the structure on the east side in a northwesterly direction toward the existing garage. At some point more recently, the existing sanitary line was diverted from running across the ceiling of the Cellar. This sanitary line was capped just inside the east wall of the Cellar, and a new sanitary line was redirected on the outside along the East wall of the existing house and around the North end of the existing house, where it tied back into the existing sanitary lateral heading in a Northwest direction toward Saint Asaph Street. Other than changing the sanitary pipe caps from rubber to cast iron, these sanitary piping changes could main as they are, as they are not significant to the MDF house.

Figure 20aj. - Redirected Sanitary Line in Cellar

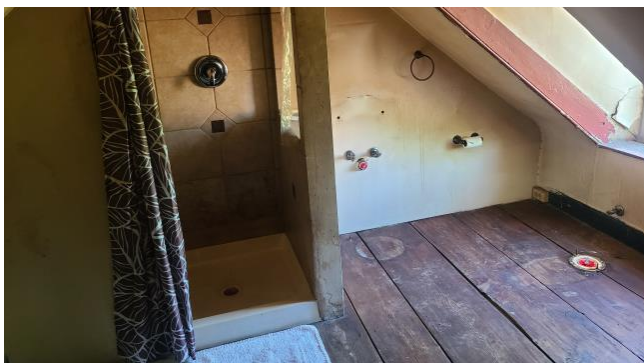
A number of plumbing fixtures have been removed, but for any existing plumbing fixtures that have not already been removed, new plumbing fixtures and piping should be installed at the time that programming changes occur.

Figure 20al. - Shower and Demolished Plumbing Fixtures - Second Floor

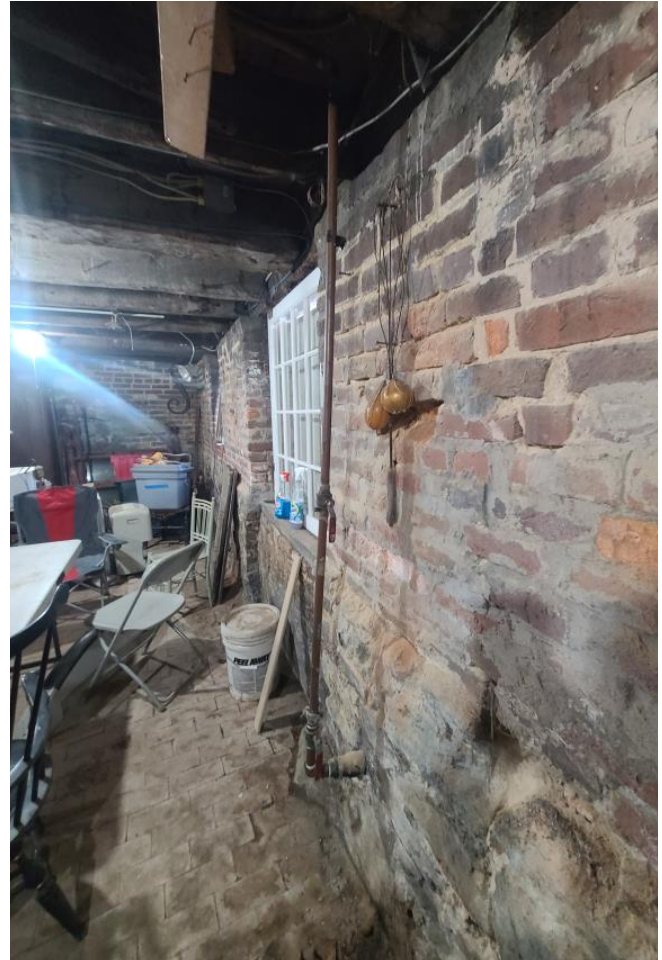
The domestic cold-water service enters the South wall in the Cellar. This service would need to be upsized if a sprinkler system is added to the MDF House.

Figure 20am. - Incoming Domestic Water Service

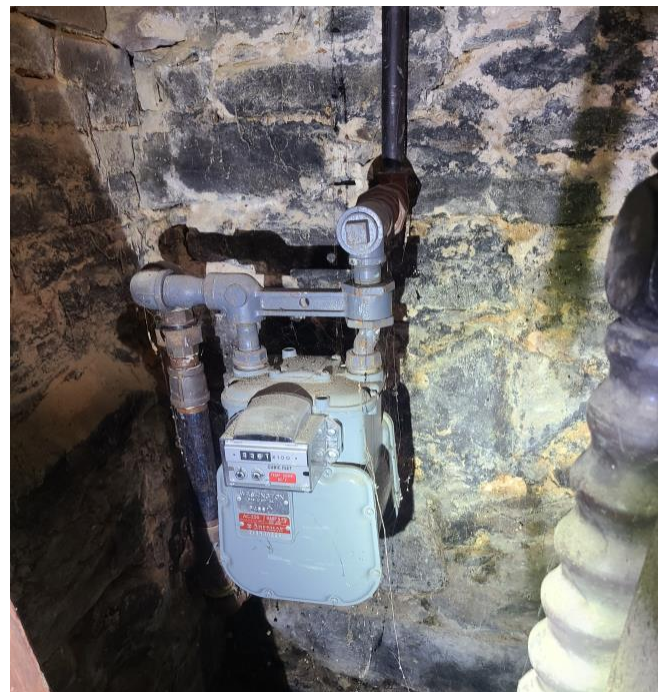
The natural gas meter associated with the existing gas service is located in the Cellar. Natural gas serves the existing gas fired boiler. If the boiler is removed and replaced with a heat pump or geothermal system, then the modern gas piping should be removed throughout the house since it is not original to the house.

Figure 20ap. - Existing Natural Gas Meter in Cellar

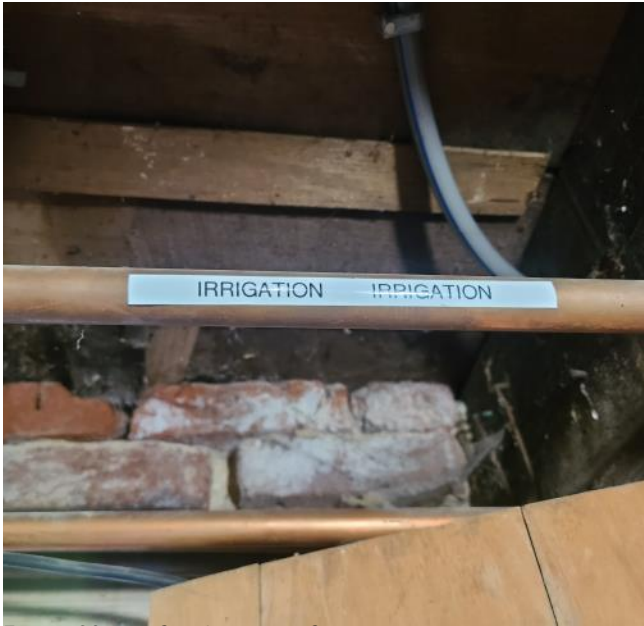
There is an existing site irrigation system that originates in the Cellar of the MDF House. The age and condition of the system and its piping is unknown.

Figure 20aq. - Site Irrigation System

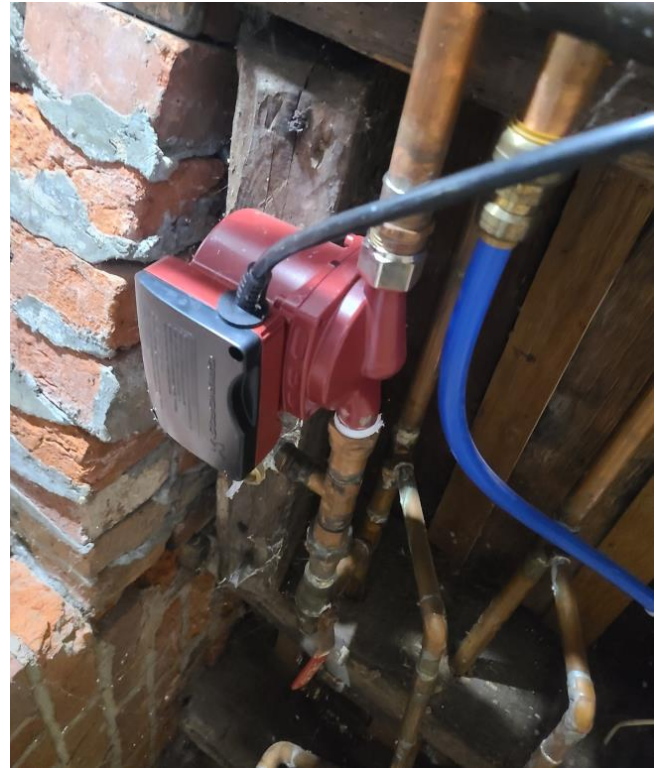
Water is circulated through the hot water recirculating line using a Grundfos, inline circulation pump that appears to be in good condition.

Figure 20ar. - Domestic Hot Water Inline Recirculation Pump
