# 1315 DUKE STREET HISTORIC STRUCTURE REPORT

Alexandria, Virginia 22314

## FINAL REPORT

June 30, 2021

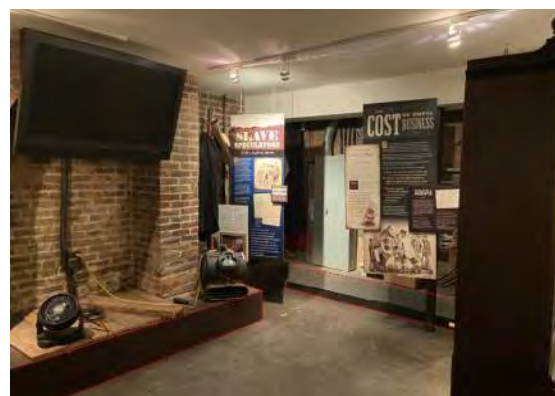
The foundations of 1315 Duke Street are a combination of brick, masonry, and concrete. At the oldest portion, the South Block, building foundations are below-grade brick retaining walls with corbelled brick foundations. During the 1980s renovation, the basement floor was also lowered approximately 1'-8" and a new 4" concrete slab was installed. Drawings from this time show a new excavation below the assumed elevation of the original brick footings (**Figure 2C-01**). A new concrete curb was placed directly inside the brick foundations to prop the existing brick footings around the new excavation without underpinning. This curb continues around the large masonry fireplaces visible in the basement (**Figure 2C-02**).

**Figure 2C-2:** Museum, Room 001, looking southeast

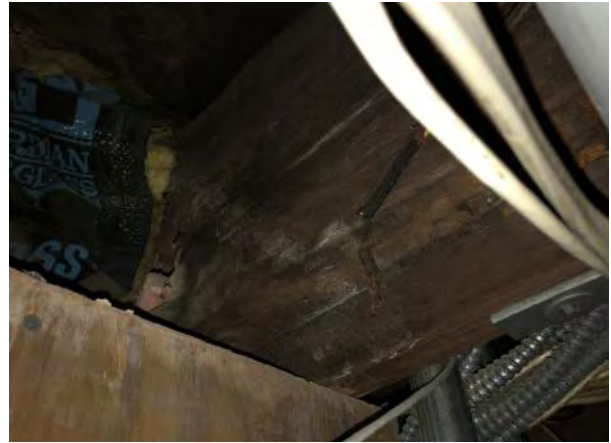
**Figure 2C-4:** Joist end visible from basement. Note the poor condition of the joists near the end.

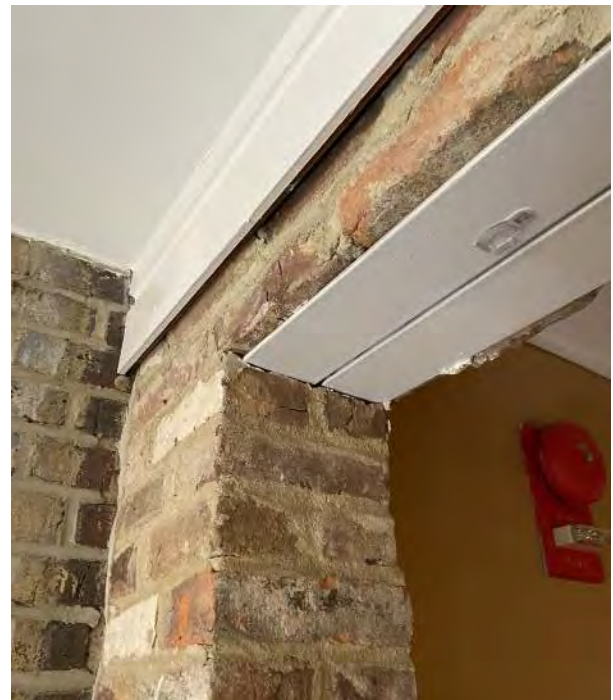
Exterior brick walls have also been enclosed within the present structure due to the building's history of modification and expansion. At the corridor with elevators and restrooms, new masonry openings have been added and modified in previous renovations. At these openings, steel angle lintels have been added to support the masonry above (**Figure 2C-12**).

**Figure 2C-12:** New masonry opening with steel angle lintel.

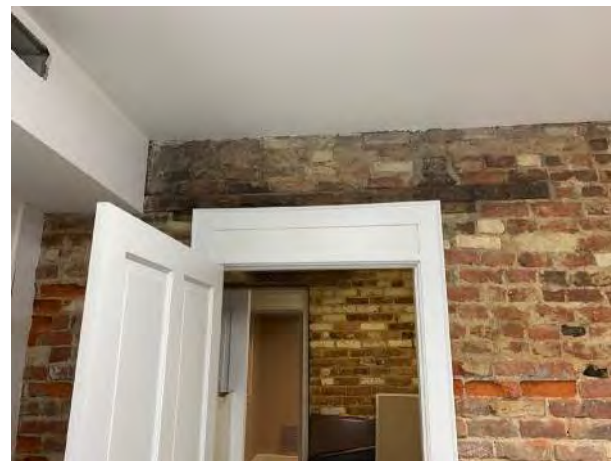
While buildings of this age were not designed with a designated lateral system, the brick and CMU masonry walls provide lateral resistance against wind and seismic forces. In addition to the exterior walls (and enclosed former perimeter walls), brick masonry walls are present within the basement of the South Block and at the first floor of the North Block (**Figure 2C-13**). While these walls are not load bearing, all interior masonry

**Figure 2C-13:** First floor brick demising walls between Rooms 112, 114, and 116. These walls were plastered over in early 2020 but the City of Alexandria.

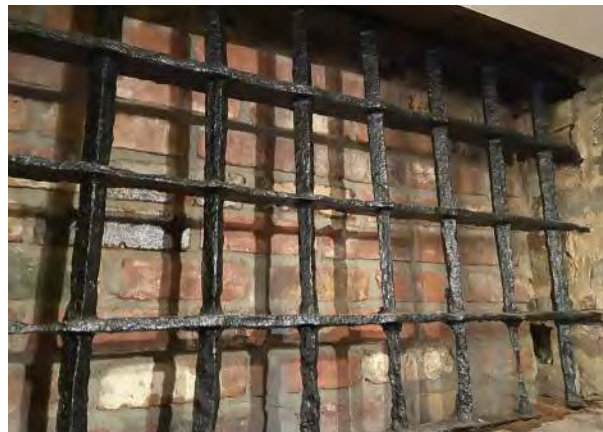
Within the basement, wrought iron grating is also present within the previous windows openings that have been enclosed with brick (**Figure 2C-14**). The horizontal bars appear to be hooked downward and embedded within the masonry wall to anchor the grating.

Figure 2C-14: Wrought iron grating within basement

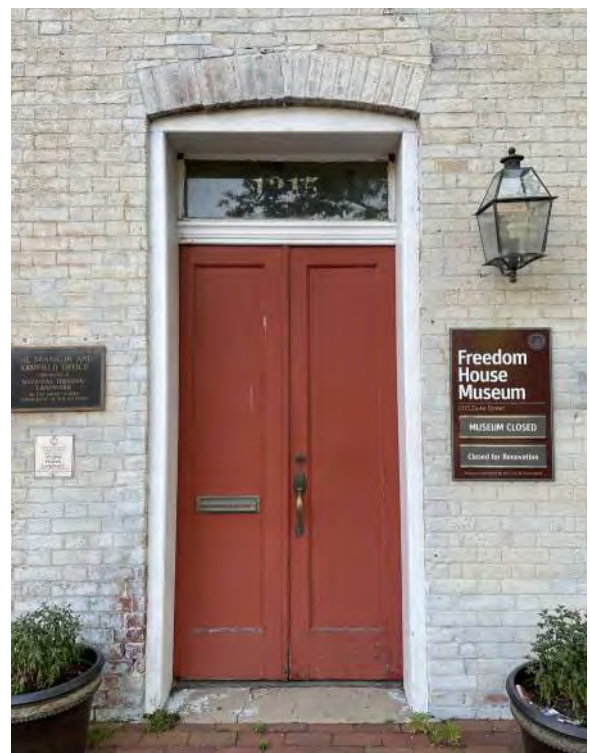
**Figure 2D-3:** Primary historic entry does not comply with accessibility standards and required modifications to provide equal access.

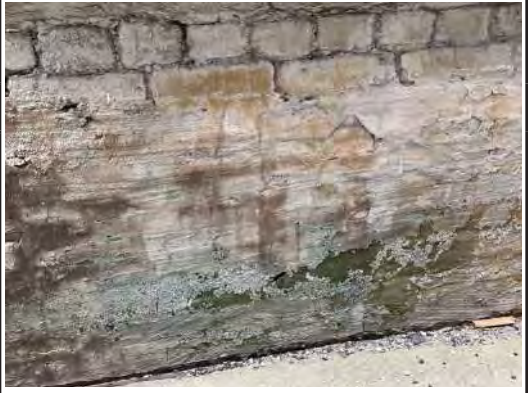
SYMBOL	CONDITION	LOCATION	EXAMPLE IMAGE
BRICK MASONRY	BIO-GR	Biological Growth	West Facade where delaminated cementitious parging has retained moisture against the brick facade

DESCRIPTION		POTENTIAL CAUSES	
	Unwanted growth or infestation of fungi, algae, microbes, or plants that may result in organic staining and bio-deterioration of the pore structure of the masonry.		Biological growth is associated with excess moisture in protected areas and is related to fluctuations in temperatures. It often occurs where there is not adequate drainage of rainwater. It also provides the perfect environment for insect and animal infestations and may indicate elevated moisture levels within the substrate.

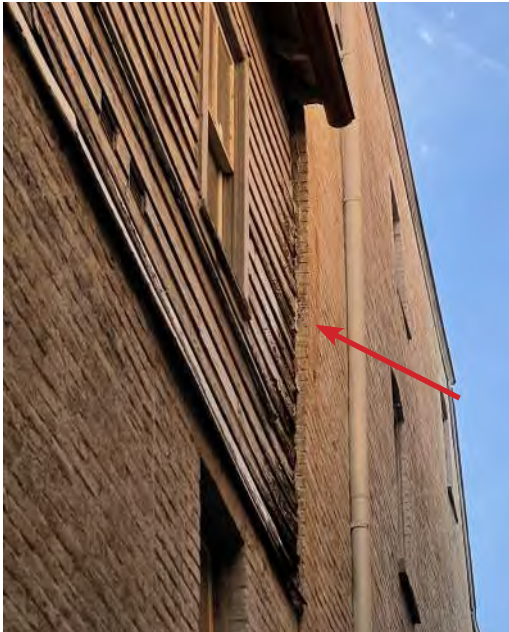
BRICK MASONRY	SYMBOL	CONDITION	LOCATION	EXAMPLE IMAGE
	DIS-B	Dislocated Brick	west elevation of third floor framed addition to Central Passage and North Block  Upper courses of brick at Chimney #1 and Chimney #2

DESCRIPTION		POTENTIAL CAUSES	
	Brick units that have shifted out of plumb or are not level.		Dislocation of the brick units may be caused by differential movement within the masonry wall or deterioration of adjacent mortar caused by excessive penetration of moisture within the wall.

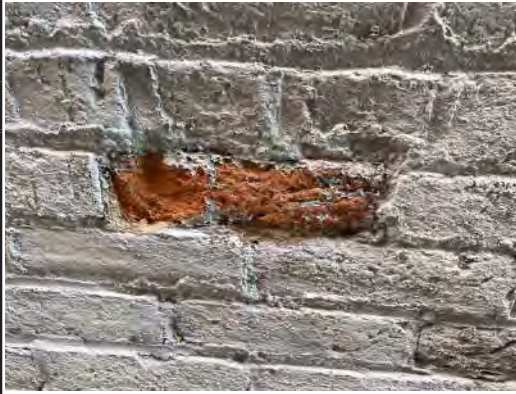
BRICK MASONRY	SYMBOL	CONDITION	LOCATION	EXAMPLE IMAGE
	SP-B	Spalled Brick	east and west elevations of South Block; west and north elevations of North Block

DESCRIPTION		POTENTIAL CAUSES	
	Detachment of brick fragment from brick unit.		Spalled bricks may be caused by pressure within wall, expansion of embedded ferrous elements or from repair materials that are overly hard in comparison to the surrounding substrate.

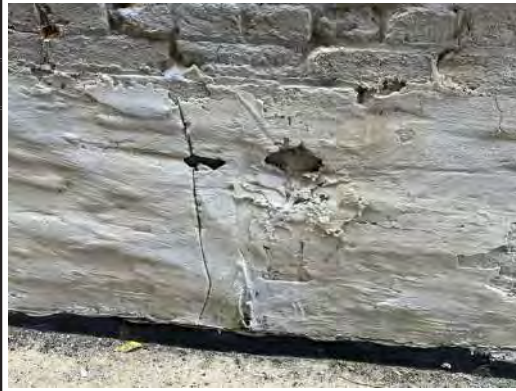
BRICK MASONRY	SYMBOL	CONDITION	LOCATION	EXAMPLE IMAGE
	ICP	Incompatible Patch	parging along base of east and west elevations of South Block

DESCRIPTION		POTENTIAL CAUSES	
	Previous repair of the masonry which is physically or aesthetically incompatible with the historic fabric.		Previous penetrations through the brick which have been abandoned have required patching. The patching materials are not sympathetic to the historic fabric and may fail as a result of improper testing of the repair system or a misunderstanding of the long-term effects of the repair from weathering.

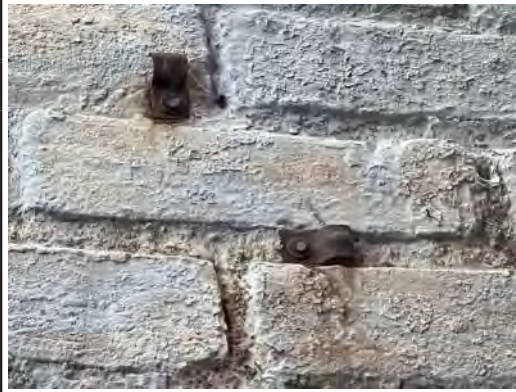
BRICK MASONRY	SYMBOL	CONDITION	LOCATION	EXAMPLE IMAGE
	FMA	Ferrous Metal Anchor	south, east, and west elevations of South Block

DESCRIPTION		POTENTIAL CAUSES	
	Ferrous metal strips set into mortar joints to surface mount materials to the brick masonry.		Prolonged exposed to water will cause ferrous metals to rust and deteriorate. The rusting and corrosion of the metal will cause mortar loss and possible spall of the brick.

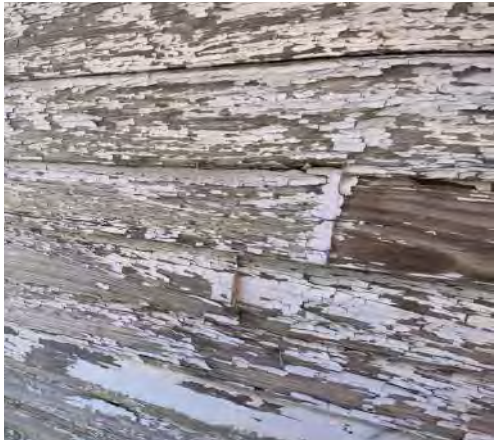
WOOD	SYMBOL	CONDITION	LOCATION	EXAMPLE IMAGE
	PTL-W	Paint Loss on Wood	west and north elevations of third floor framed addition to Central Passage and North Block; east elevation of 1985 Addition

DESCRIPTION		POTENTIAL CAUSES	
	Failure of paint coating, which acts as a protective sacrificial layer against weathering. The loss of paint exposes the wood substrate to moisture penetration, deterioration and eventually will lead to wood rot		Most paint coatings fail due to age and weathering. In some cases, when the substrate is not prepared correctly or is too wet, the coating cannot maintain a bond and will fail. Paint loss is most severe at areas of high weathering, such as window sills, base of frames, projecting elements and horizontal members.

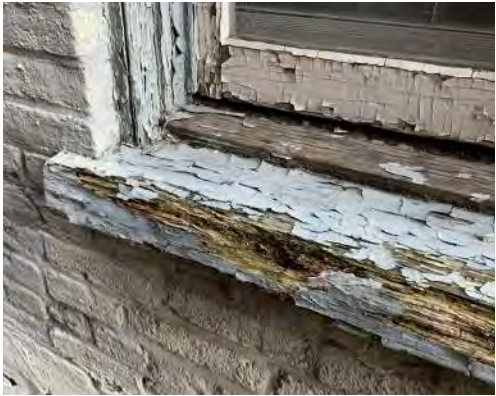
WOOD	SYMBOL	CONDITION	LOCATION	EXAMPLE IMAGE
	WD-R	Wood Rot	all wood window sills

DESCRIPTION		POTENTIAL CAUSES	
	Decay of wood substrate, eventually leading to failure and loss of material. This process is accelerated by moisture, fluctuations in temperature and poor maintenance.		Failure of protective paint coating and prolonged exposure to direct weathering.

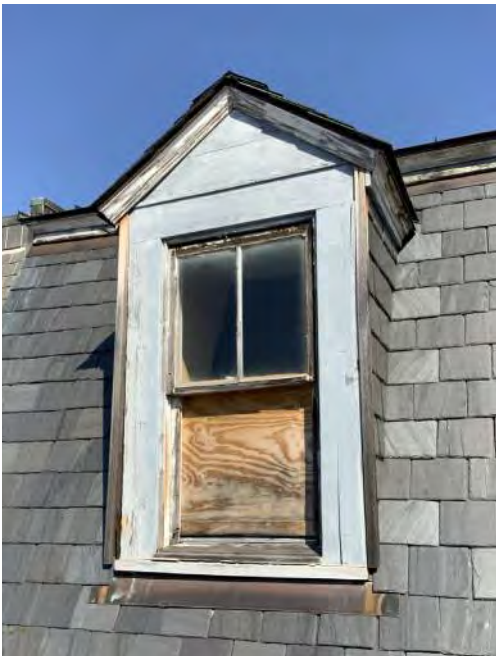
WOOD	SYMBOL	CONDITION	LOCATION	EXAMPLE IMAGE
	MIS-W	Missing Wood Element	window 401 at South Block

DESCRIPTION		POTENTIAL CAUSES	
	Missing component of wood members at window and door frames and trim.		Severe wood rot will eventually lead to disintegration of material and result in the loss of the element.

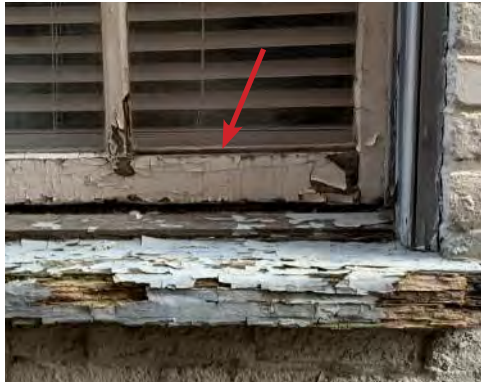
WOOD	SYMBOL	CONDITION	LOCATION	EXAMPLE IMAGE
	<b>MIS-GP</b>	Missing Glazing Putty	All windows, excluding windows in 1985 Addition

DESCRIPTION		POTENTIAL CAUSES	
	The glazing putty that seals the edges of the existing glazing panes is cracked and missing in many locations		Continuous weathering leads to breakdown and drying out of the putty material, leaving these areas vulnerable to moisture penetration.

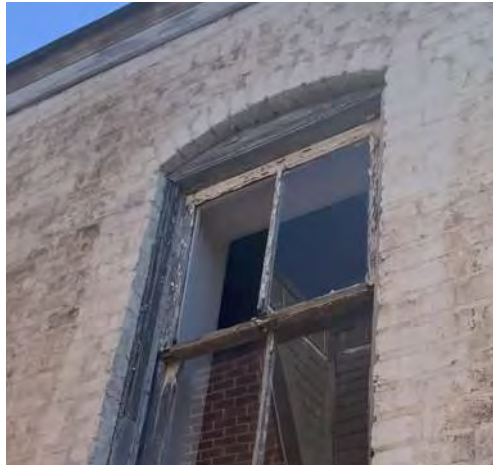
WOOD	SYMBOL	CONDITION	LOCATION	EXAMPLE IMAGE
	<b>BRK-P</b>	Broken or Missing Glazing Pane	Window 411 at West Facade

DESCRIPTION		POTENTIAL CAUSES	
	Broken or missing glazing in window lites.		Impact from debris can result in broken glazing.

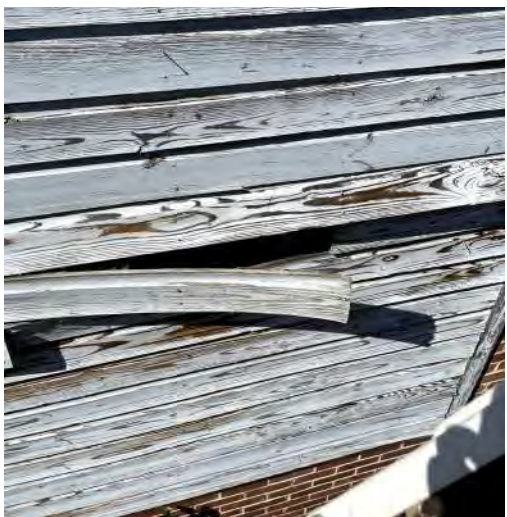
WOOD	SYMBOL	CONDITION	LOCATION	EXAMPLE IMAGE
	<b>DIS-W</b>	Detached Wood Element	West Facade of 1985 Addition

DESCRIPTION		POTENTIAL CAUSES	
	Bowing and detached wood siding		Moisture build-up within exterior wall assembly results in delamination and detachment of building materials

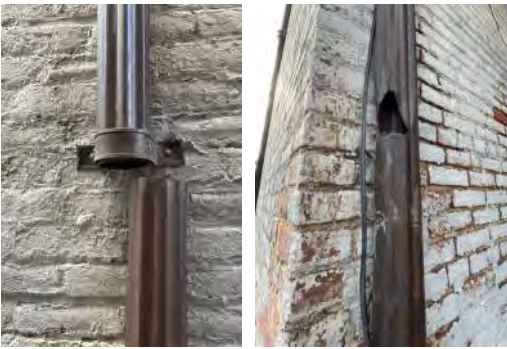
METAL	SYMBOL	CONDITION	LOCATION	EXAMPLE IMAGE
	<b>MTL-D</b>	Damaged Downspouts	West Facade of North Block

DESCRIPTION		POTENTIAL CAUSES	
	Detached and damaged downspouts		impact damage resulting in detached or damaged copper downspouts

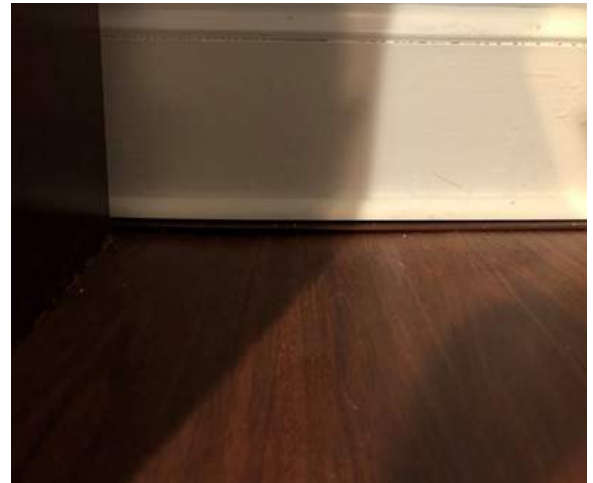
Displacement of the stair has translated into nearby floor areas. The most prominent example of this can be seen at the corridor wall of the second floor office where the floor sags toward the east and a gap is evident at the baseboard trim (**Figure 2D-5**).

**Figure 2D-5:** Gap evident in baseboard trim at second floor office, opposite the corridor wall from Stair 1.

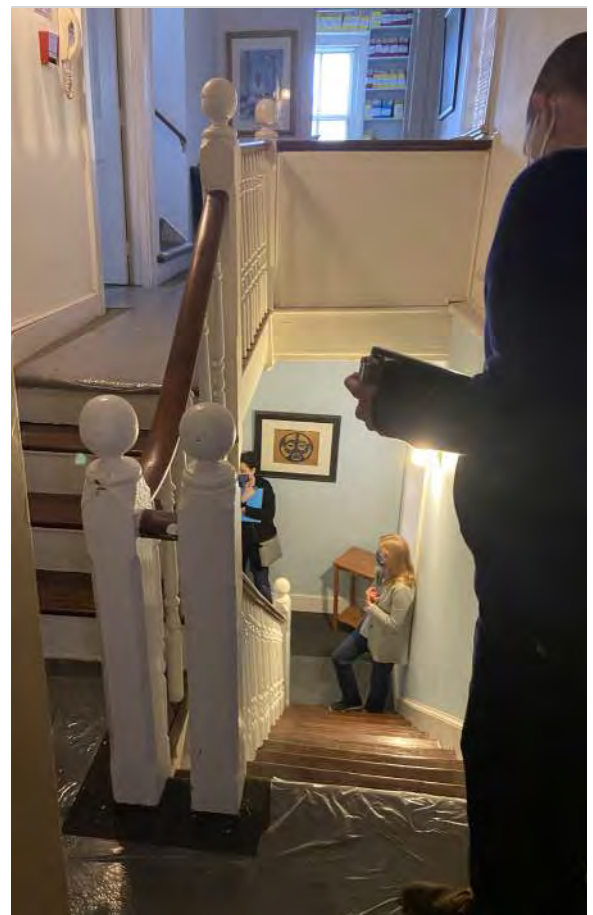
The stairs and stair landings at Stair 1 (**Figure 2D-6**) exhibit significant deformation. The stair runs were observed to be displaced and twisting down and to the east, and the adjacent landing and corridor framing sags toward the stairs. This displacement can likely be attributed to undersized or inadequate framing for the stair openings and the second and third floors. Deformation is exacerbated by creep of the wood framing

**Figure 2D-6:** Stair 1 deformation, looking south from the landing between the second and third floors.

over time through seasonal cycles. Additionally, the displacement of the stairs may be related to the location of bearing walls. The loads imparted by bearing walls may have caused displacement of the joists because the walls do not stack. This sag caused by the bearing walls could have been the catalyst in stair deformation or added to issues with the framing at the stair openings. The worst deformation was noted at the third floor, suggesting that the deflection may compound as one moves up the building. (**Figure 2D-7**).

See Recommendation section for additional discussion surrounding the stair displacement and recommended further investigation.

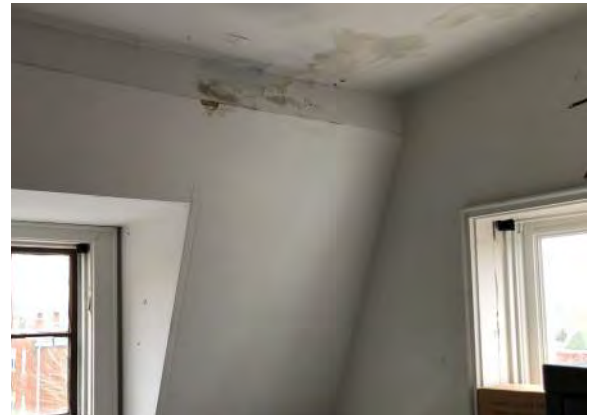
The roof framing is assumed to be in fair to good condition given limited observations and the absence of deformation or excessive water infiltration. Some bubbling and staining of plaster were noted in localized areas. A larger area of damage was found in the northeast corner of the South Block, within the mansard roof (**Figure 2D-8**). This suggests that water may be leaking through gaps or through a saturated masonry wall and may be causing old or active rot of the roof rafters. Displacement and mortar loss of this corner was also noted from the exterior, as described in the following section.

**Figure 2D-8:** Staining and bubbling of drywall finish in northeast corner of mansard roof within Office 403 in the South Block.

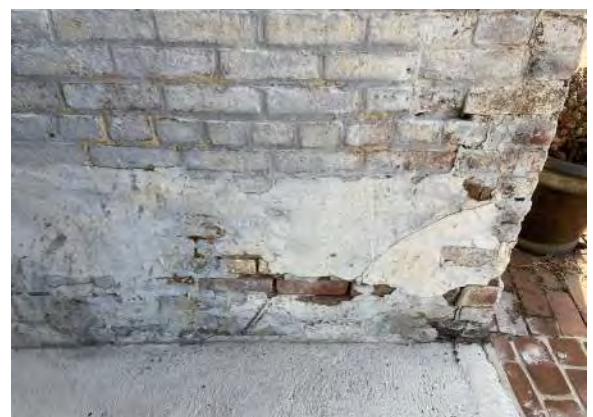
**Figure 2D-10:** Failed parge coat and mortar loss near grade at southwest corner of South Block

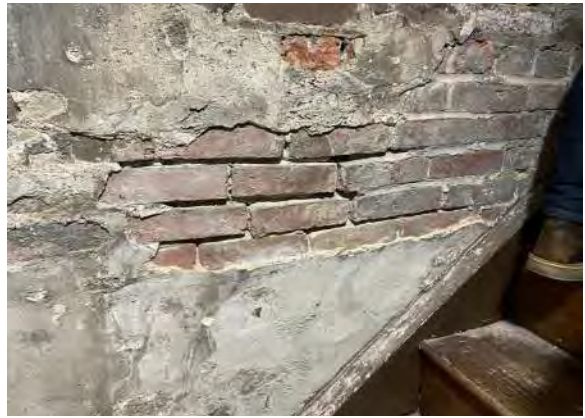
Brick masonry exterior walls are in fair to poor condition, predominantly due to the loss of mortar or previous improper repointing mortars. Significant mortar loss was noted at the north elevation of the North Block and around both north corners of the historic South Block. At the west elevation, the mortar loss is concentrated at the lower third of the wall, and a failing parge coat has been applied to the lowest courses (**Figure 2D-10**). A parge coat was also applied at the basement interior and is failing near the interior basement stair. Significant mortar loss is also evident at this location (**Figure 2D-11**).

**Figure 2D-11:** Failing parge coat observed at east wall of Basement at Stair 1, located along west foundation wall.

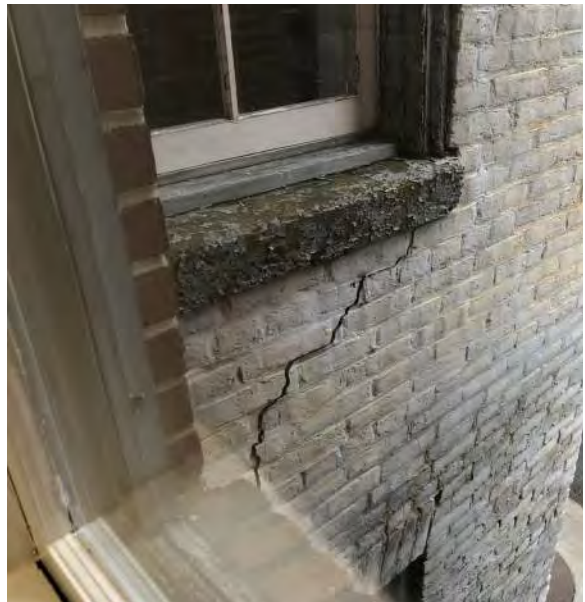
Large cracks were noted at the northeast corner of the North Block. Here, hairline to 3/8" vertical and step cracks were observed (**Figure 2D-12**) alongside significant mortar loss near the base of the structure. The cracking may be attributable to mortar loss causing displacement of the brick, localized settlement of this corner, a previous seismic event, or a combination of these factors. There is a nearby manhole cover, so settlement could have been caused or worsened by nearby utilities.

**Figure 2D-12:** Large crack at east return of North Elevation, located under masonry opening 219 of the North Block.

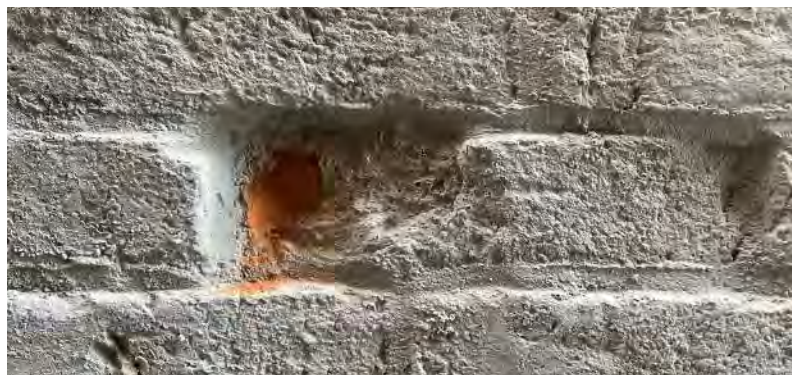
Hard repair mortars have been installed in previous renovation and repair campaigns. These hard mortars are incompatible with the soft historic brick and the historic lime mortars. The incompatibility in strength and hardness can cause spalling of the brick face (**Figure 2D-13**). This was observed at a few locations of previous repairs along the west elevation.

**Figure 2D-13:** Spalled brick face at west elevation.

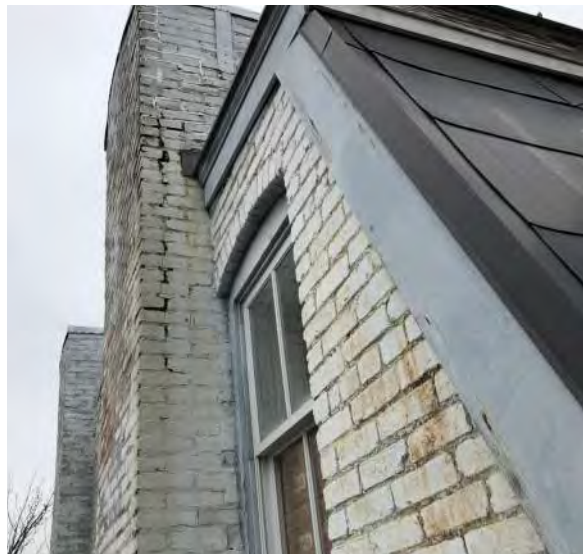
The east elevation was largely inaccessible due to the building's proximity to the property line, but the upper portions could be viewed from grade at the rear alley and from the roof of the 1985 Addition. Upper portions of the east elevation, including the chimneys, are in poor condition. Upper portions of the brick wall and the chimneys appear to be bowing and mortar loss is evident at the chimneys (**Figure 2D-14**). The laser scans indicate the chimneys have displaced up to 4" out-of-plane. Light colored previous repairs are also evident, suggesting that

**Figure 2D-14:** Upper portion of east elevation of South Block; Note the poor condition of Chimney #2 and the prior repairs.

previous mortar loss and cracking is an ongoing issue. Damaged finishes were also observed at the building interior near this location, so it seems likely water infiltration is also an issue here. Existing cracking or open joints will worsen over time through freeze-thaw cycles.

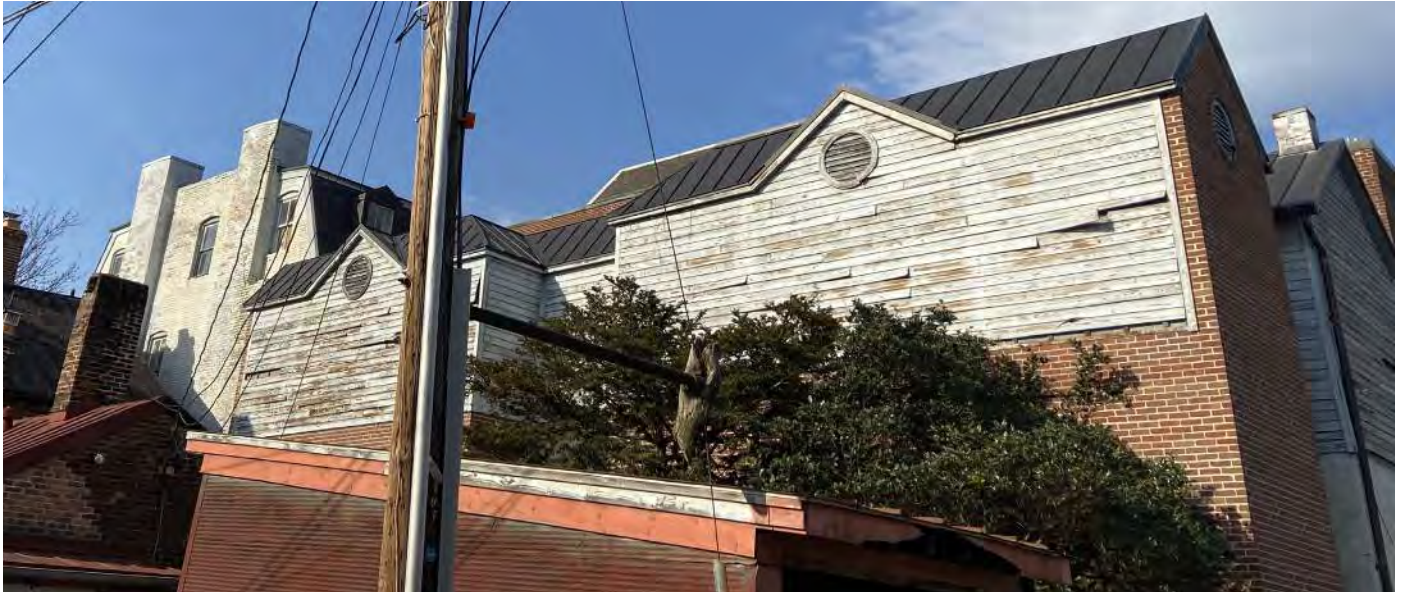
**Figure 2D-15:** Overall view of east elevation as seen from the rear alley.

Exterior walls of the 1985 Addition are generally in good condition, except for the horizontal board sheathing and siding which is beginning to fail (**Figure 2D-15**).

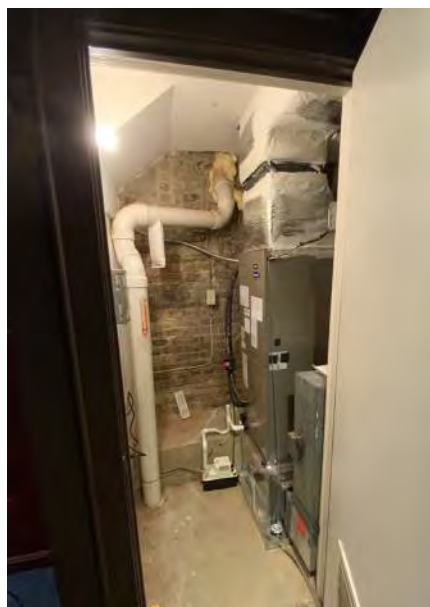
A floor-mounted condensate return pump adjacent the basement unit is tied to both coil condensate and drain pan (**Figure 2D-19**). On other floors, condensate drain piping is sloped to a floor drain located in each closet.

**Figure 2D-19:** AHU-1 with condensate return pump located in basement mechanical closet

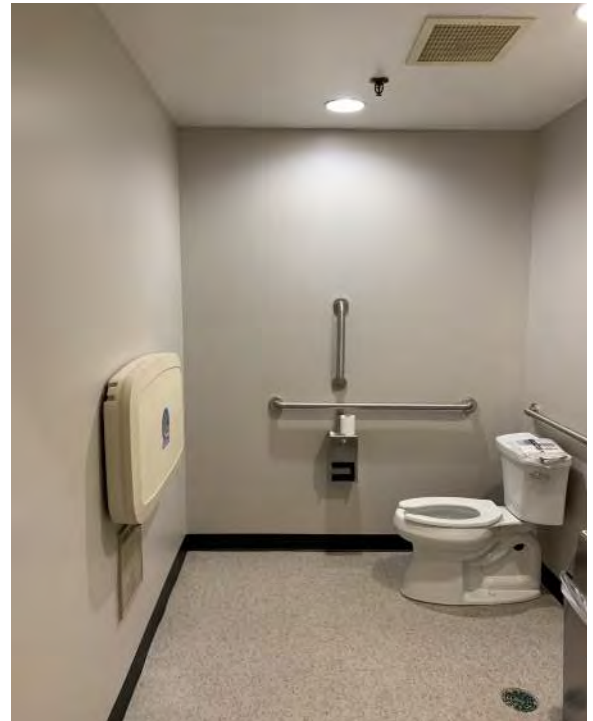
Toilet rooms include a water closet, lavatory, and floor drain, with one second floor restroom containing a shower. All are in varying states of functionality and age as the spaces undergo remodeling. On the first floor, Restrooms 106 and 108 were recently remodeled to include automatic faucets, ADA compliant fixtures, and insulated water and drain piping (**Figure 2D-22**). Restrooms 208, 306, and 308 located on the second and third floors in deteriorated condition.

Figure 2D-22: Restroom 106 located on the first floor.

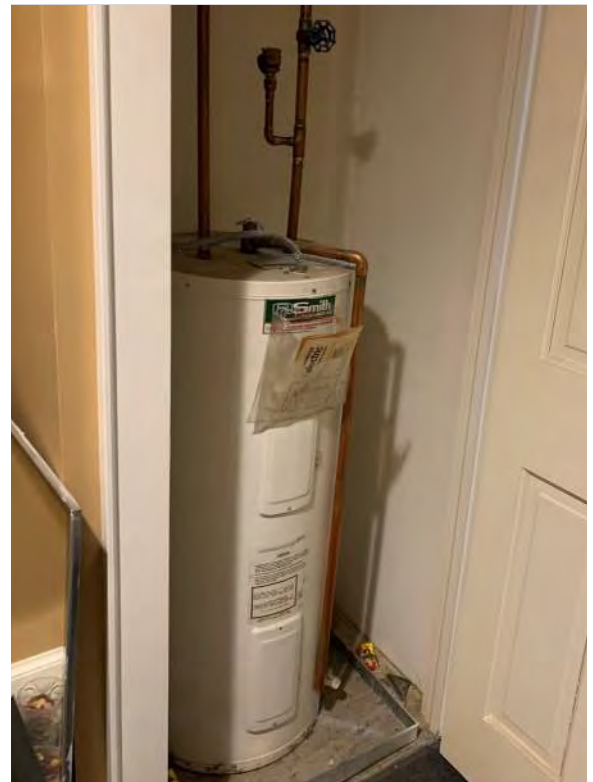
On the second floor, a 30-gallon electric water heater manufactured by A.O. Smith is located on a drain pan a closet adjacent to second floor toilet rooms (**Figure 2D-23**). The water heater appears to be 20-30 years old and is beyond end of life. Domestic water pipe insulation in the water heater closet is deteriorated as well.

Figure 2D-23: Domestic hot water heater.

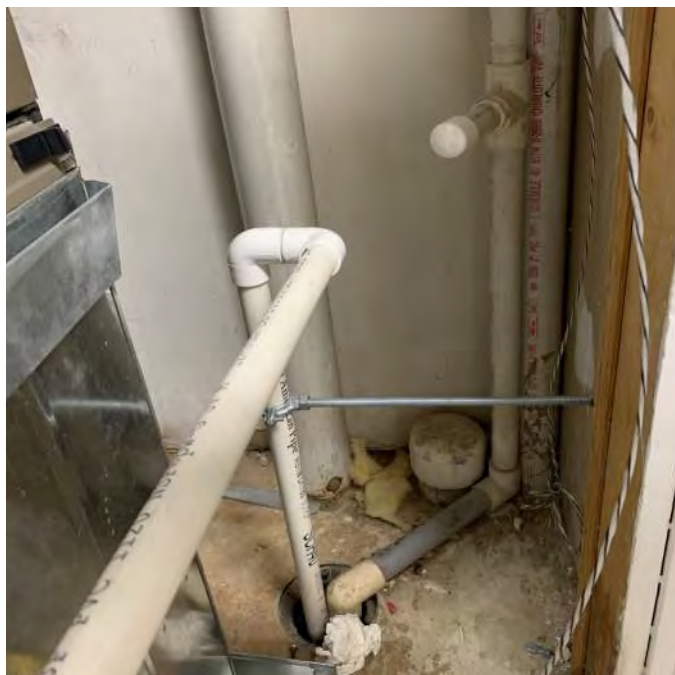
Floor drains are located in toilet rooms and mechanical closets. A sump pump or basement-level sanitary drain was not observed at the site visit. Sanitary pipe material is PVC in much of the building (**Figure 2D-24**), with some cast iron on the first floor. A sewer smell was observed at the mechanical closets during the course of the site visit.

**Figure 2D-24:** Sanitary drain pipe and floor drain in mechanical closet

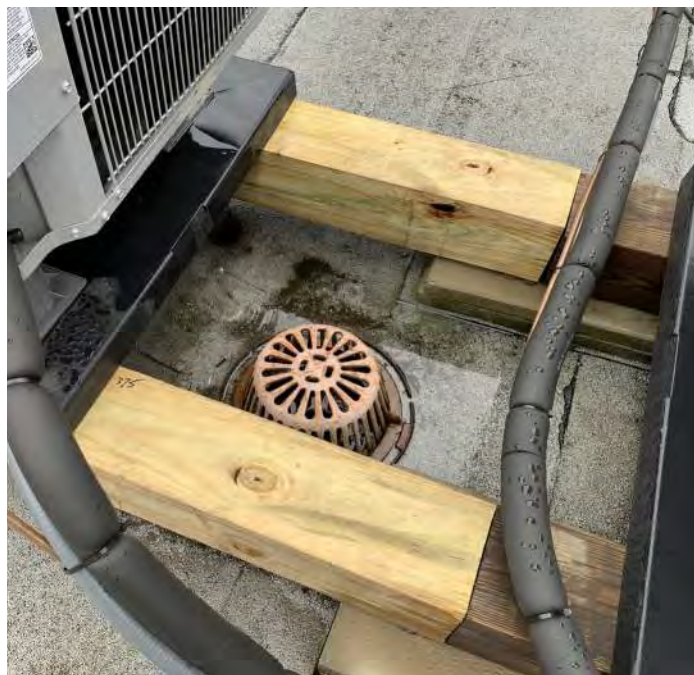
Roof drains are protected from damage by mechanical equipment supports and are in good condition (**Figure 2D-25**).

**Figure 2D-25:** Existing roof drain.

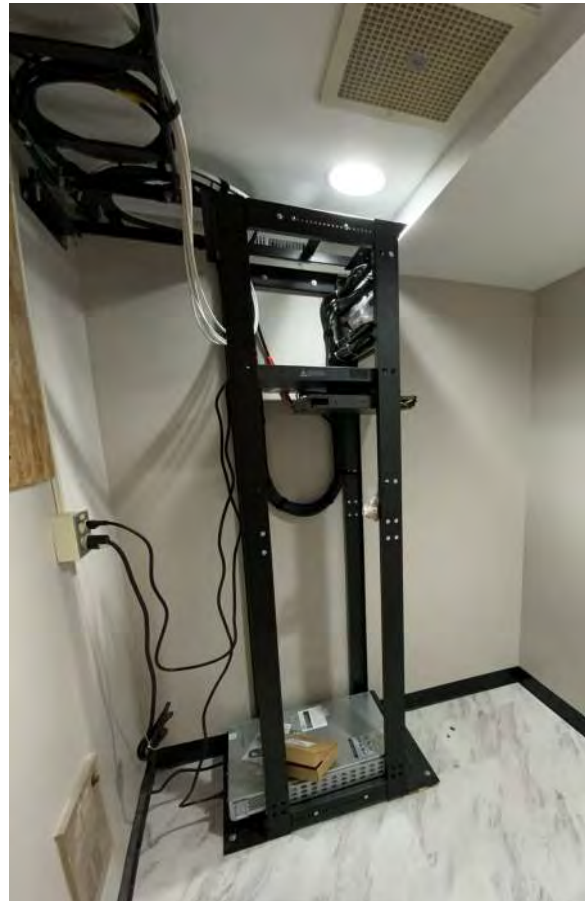
On the second floor, a toilet room has been converted to a server room (**Figure 2D-21**). The existing connection to the toilet exhaust fan may not provide adequate cooling or dehumidification for sensitive server equipment. A new supply duct has been routed to provide additional cooling for the IT server closet. If additional load is added to the room supplemental cooling or additional supply air should be provided.

The existing technology service enters the east side of the building on the first floor. There is some existing rack mounted technology equipment on the second floor which is in a room that appears to have been previously used as a restroom (**Figure 2D-28**). There appears to be some outdated patch panels open to the exhibit area on the basement level (**Figure 2D-29**).

Figure 2D-28: Existing IT rack on second floor.

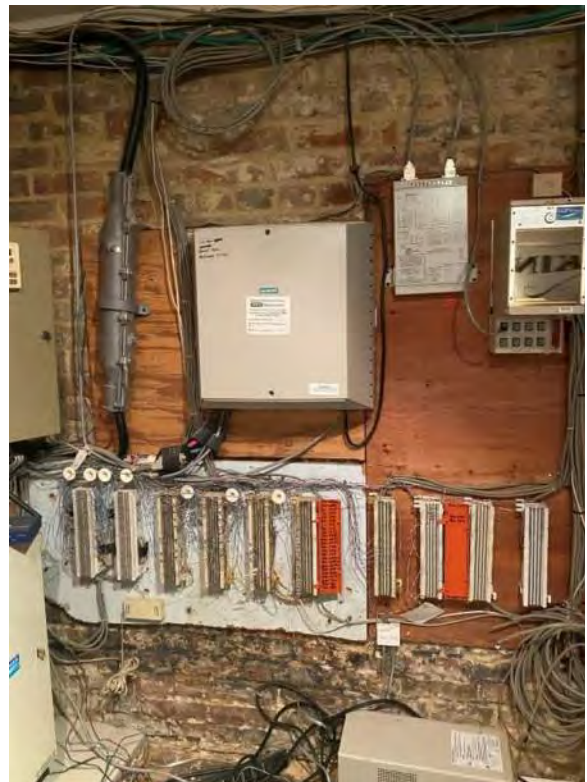
Figure 2D-29: Basement level patch panels.

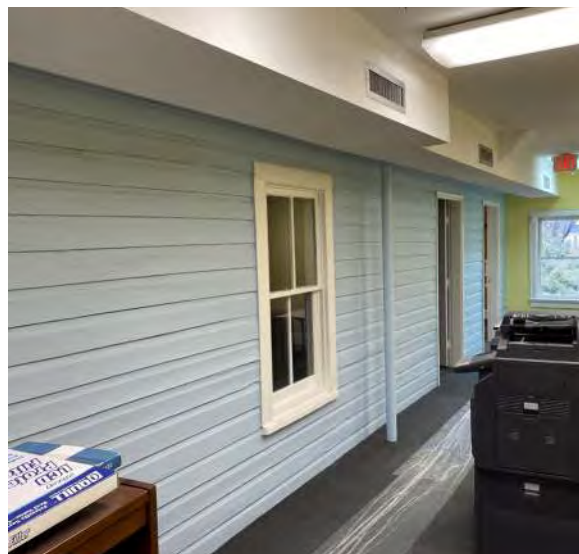
Wood siding is installed as a wall finish along the third floor open office area at the back of building (**Figure 2D-30**). It is understood that the wood framed addition at the third floor of the Central Passage and North Block was constructed in 1905 (Period 4B) and included an exterior finish of horizontal wood siding. In the October 1937 building permit records, it is documented that this wood siding was replaced. Portions of this exterior wall cladding was later enclosed within the interior of the building when the 1985 Addition was completed. The wood finish appears to be an existing historically classified building element and simply cannot be removed without impacting historical significance. The current, applicable International Building Code (IBC) requires minimum Class "B" wall material for interior corridors leading to exits. Standard wood material would not be able to meet the flame spread and smoke development rating parameters for Class B finish. It should be noted that review of the 1985 permit documents indicate fire retardant paint applied to this wood cladding enclosed within the third floor of the 1985 Addition. This application may make the Class B designation possible depending on the type of fire retardant applied and its thickness.

**Figure 2D-30:** Historic wood cladding on third floor wall at Central Passage and North Block.

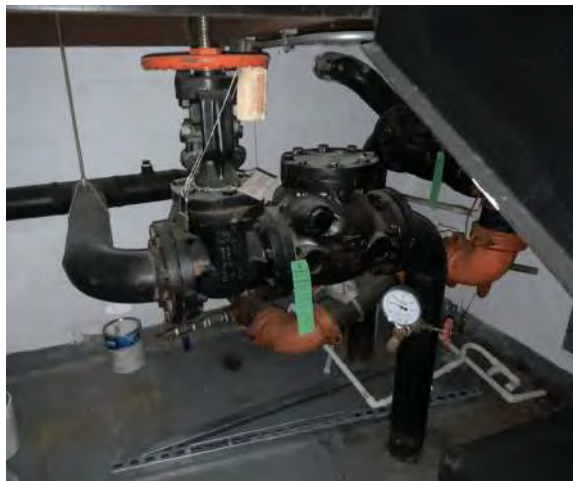
**Figure 2D-31:** Incoming fire service partially obstructed by storage.

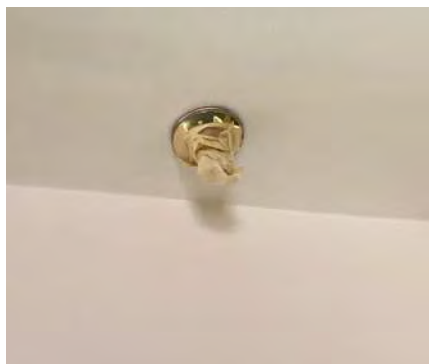
The building sprinkler system overall appears to be in good operating condition; however, several areas in the building have sprinklers installed that do not meet spacing requirements in accordance with NFPA 13, Standard on the Installation of Sprinkler Systems. The sprinkler spacing deficiencies include additional sidewall sprinklers required in corridors/enclosed rooms; sprinklers located too far from a wall for adequate coverage; sprinkler located too far below skylight; and sprinkler covered by tape (**Figures 2D-33, 2D-34, & 2D-35**).

**Figure 2D-33:** Sprinkler head covered by masking tape.

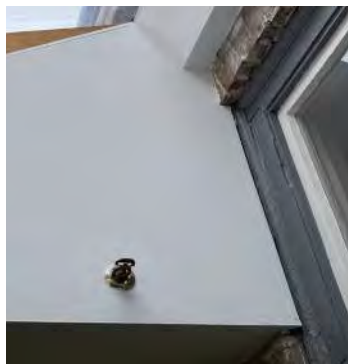
**Figure 2D-34:** Sidewall sprinkler head too far below ceiling.

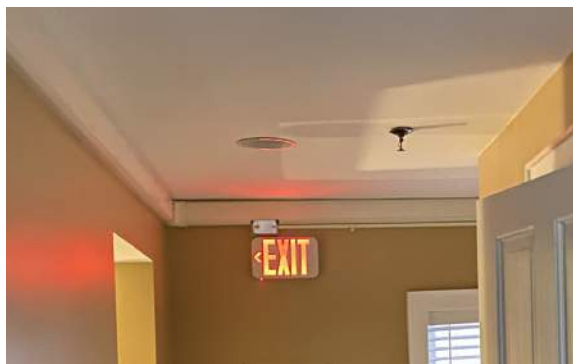
**Figure 2D-35:** Sprinkler head located too far from wall for coverage.

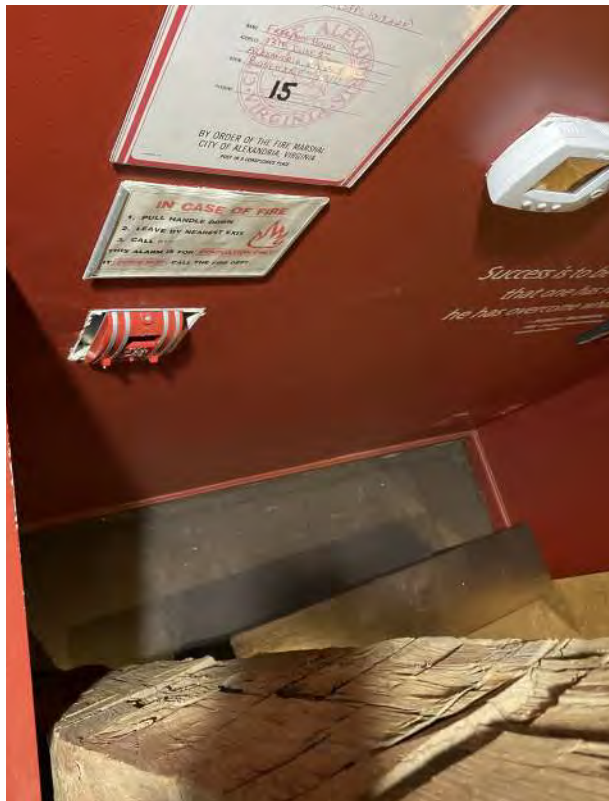
The building fire alarm system overall appears to be in good operating condition; however, several fire alarm deficiencies were observed that do not meet code requirements of NFPA 72, National Fire Alarm Code. The fire alarm deficiencies include, but limited to, not having the master fire alarm control panel located in a protected, more secure room; not having a smoke detector above fire alarm equipment in the Basement Level; a pull station obstructed by an exhibit column next to Basement stairs; and cover plate not present on the water flow switch on sprinkler riser on first floor (**Figures 2D-38 & 2D-39**).

Figure 2D-38: Fire alarm manual pull station obstructed by exhibit at basement level.

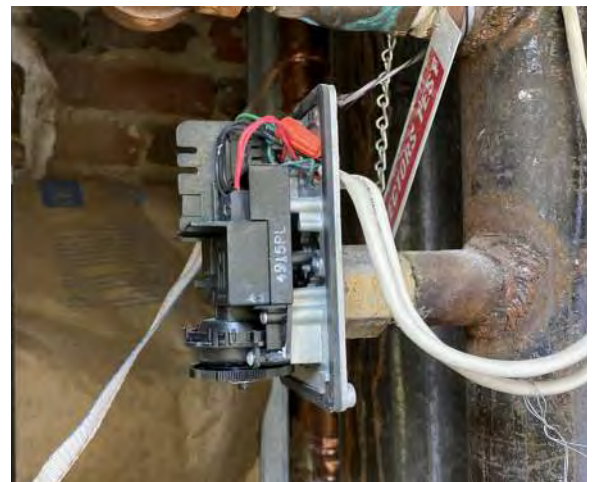
Figure 2D-39: Cover plate missing on water flow switch.

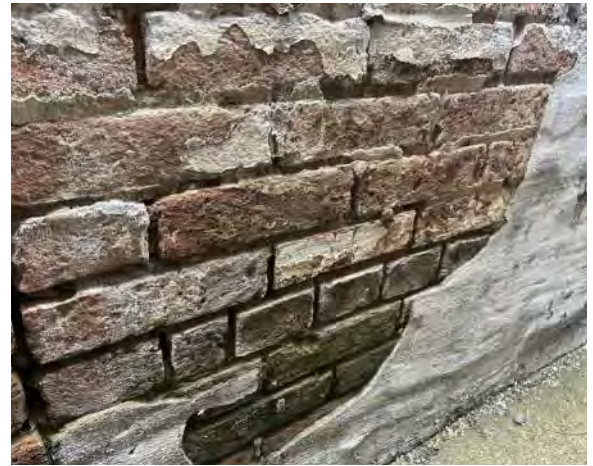
As stated in the condition assessment the exterior brick masonry walls are in fair to poor condition depending on the location. The lower two to three feet of the wall are experiencing significant mortar deterioration and loss likely due to rising damp. In isolated areas this section of wall has been parged, but the parge coat is now failing.

Figure 2E-1: Missing mortar in west alley near grade.

It is recommended that exterior masonry repairs be prioritized. The repairs would include a full repointing of the historic exterior brick and localized repointing of interior areas. The repointing should utilize a softer mortar more compatible with the historic masonry and based on a mix design derived from a mortar analysis. In localized areas where cracks are present the outer wythe may need to be locally rebuilt for one brick on either side of the crack to 'stitch' the wall back together. Local replacement of spalled brick units is also recommended. Continued mortar loss will eventually lead to further masonry distress and additional moisture infiltration.

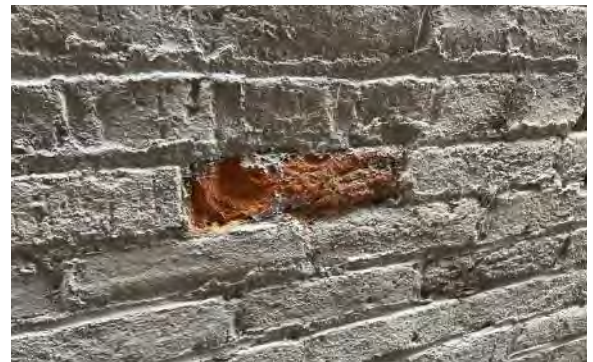
In some isolated areas past repointing campaigns have used a hard Portland cement based mortar. This hard mortar is inappropriate for use with a soft historic masonry and has caused several of the surrounding brick units to spall due to freeze-thaw cycling. Only isolated areas of mortar loss were evident at the interior such as a location near the stairs to the basement.

Figure 2E-3: Spall in brick masonry unit.

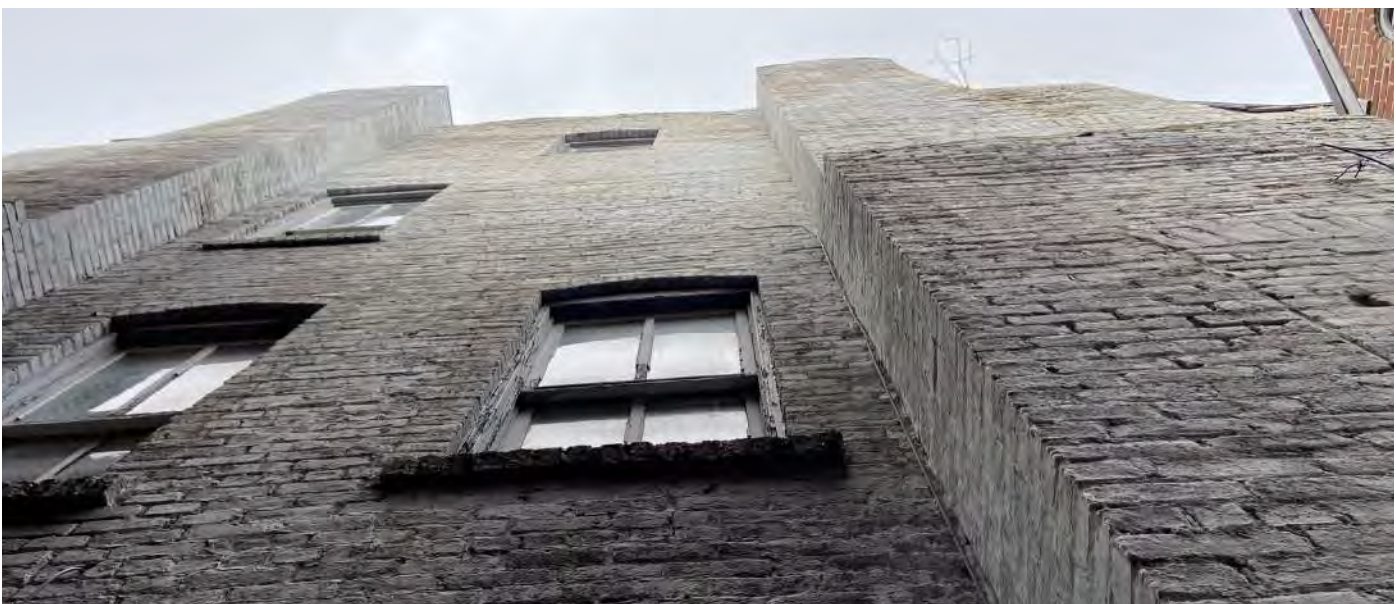
It is recommended that a further study be performed at Chimney #1 and Chimney #2 at the South Block of 1315 Duke Street. It is clear based on site observations that there has been some deformation particularly near the top of chimneys. In addition to performing a lateral analysis to check the chimneys for wind/seismic the study should also have some amount of additional probing and testing performed to better understand what is happening within the masonry assembly especially near the top. It appears likely that some amount of masonry repairs will be

Figure 2E-5: Chimney #1 and Chimney #2 deformation at east elevation.

required along with potential reinforcement. If no longer planned for active use the chimney flues could be filled and reinforced to strengthen the vulnerable elements without impacting the historic appearance.

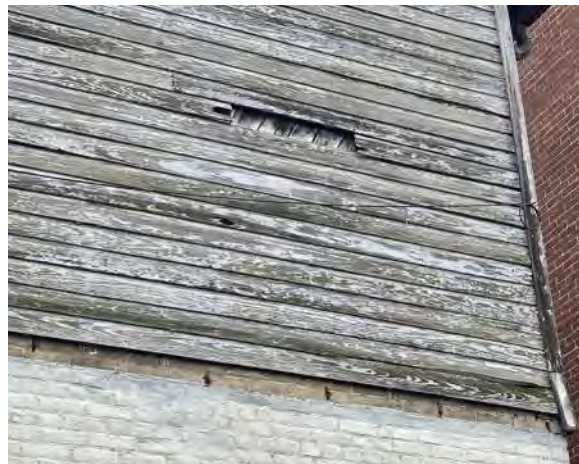
Wood sheathing is present at the exterior of the third floor at both the North Block and at the 1985 Addition. At the historic c. 1902 third floor wood framed addition at the Central Passage and North Block, the siding is deteriorating and falling away from the structure, exposing the underlying wood structure. This exposes the underlying wood structure to increased moisture that will cause material loss. The sheathing at the 1985 Addition is in similarly poor condition; however, it is less of a structural concern as there is a CMU wall behind. In both cases the existing wood sheathing should be repaired and replaced in kind as needed.

Figure 2E-6: Sheathing and siding damage at historic North Block (Period 4B).

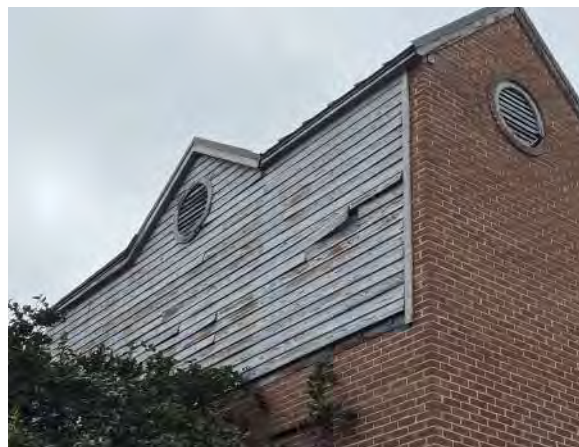
Figure 2E-7: Sheathing and siding damage at 1985 Addition (Period 5).

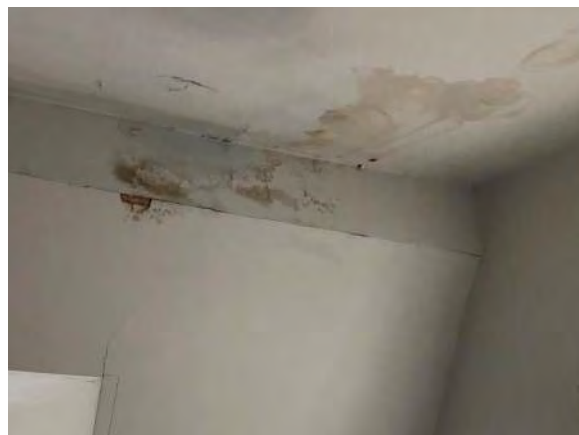
- **Ceiling Finish Above Office 403 in South Block:** Evidence of water infiltration is seen in the drywall ceiling above Office 403. The source of the water should be identified, and proper repairs made to the roof, adjacent flashing, and surrounding masonry. Following these repairs to address the source of the problem the interior finishes should be patched, repaired, and refinished.

Figure 2E-8: Water damage at ceiling in Office 403 on fourth floor/ mezzanine.

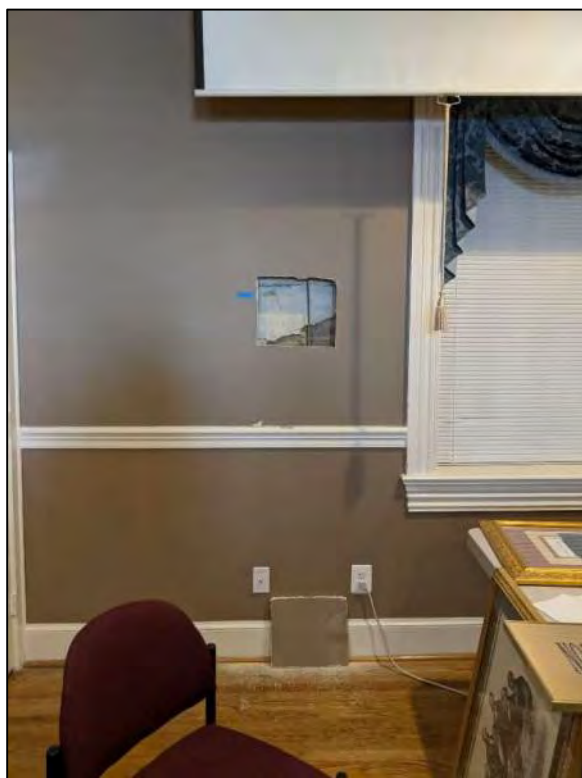
Sample PT-102 removed from probe #3 in the north wall of the South Block contains the most finishes. The first two finishes on the plaster are distemper paints. Distemper paints were often applied to lime plasters while waiting for the lime plaster to fully cure, which could take up to a year. Distemper paints were not affected by the alkalinity of fresh lime plaster and a good bond could be achieved between the wall and the paint.

**Figure 2: Probe #3 at north wall of the first floor, Sample PT-102.**

The earliest finish is a moderate brown (Munsell 5YR 4/4) distemper paint matching Benjamin Moore 1225 “Abbey Brown.” The second finish is a grayish green (Munsell 5G 5/2) distemper paint matching Benjamin Moore 706 “Cedar Mountains.” The sample contains a total of eighteen finishes consisting of gray, green, blue, and yellow oil-based paints terminating in one white modern latex finish.

It is possible that the earliest moderate brown paint dates to c. 1870. This finish is similar to a finish found at Blenheim in Fairfax, VA that is reputed to date to immediately after the Civil War, c.1866.<sup>13</sup> Also, an advertisement for the sale of 1315 Duke Street in 1869 described the building to be “in a dilapidated condition, but it is the intention of the purchaser to repair and convert it next spring into a handsome residence.”<sup>14</sup> So it is likely that early pre-1870 plasters and finishes were deteriorated and replaced soon after the War.

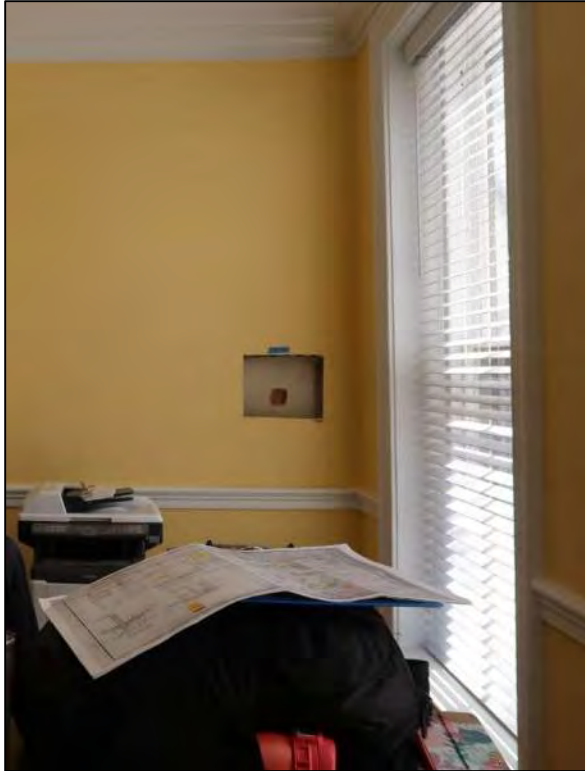
**Figure 3: Probe #2 at east wall of the first floor, Sample PT-101**
