# 1315 DUKE STREET HISTORIC STRUCTURE REPORT

Alexandria, Virginia 22314

## FINAL REPORT

June 30, 2021

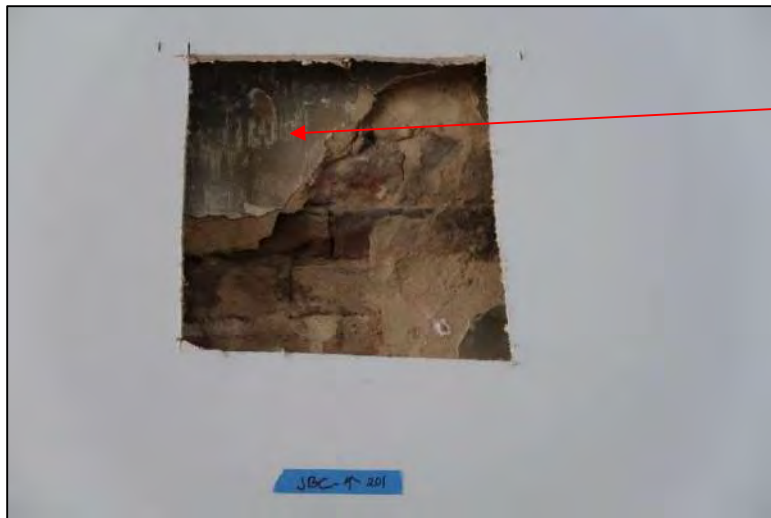
Two plaster finishes were found within probe #6 on the west wall of the second floor. However, only one painted finish was present consisting of a white (Munsell N9.5/) distemper base coat matching Benjamin Moore “White” topped with traces of a pale-yellow finish matching Benjamin Moore 192 “Key West Ivory.” (See arrow in Figure 4 below.) The date of this finish is unknown. It is interesting that there is only one finish present on the plaster. It is possible that later painted finishes failed or were removed, or that the wall contained wallpaper that was removed, prior to being enclosed behind the gypsum board.

**Figure 4: Probe #6 at west wall of second floor, Sample PT-201.**

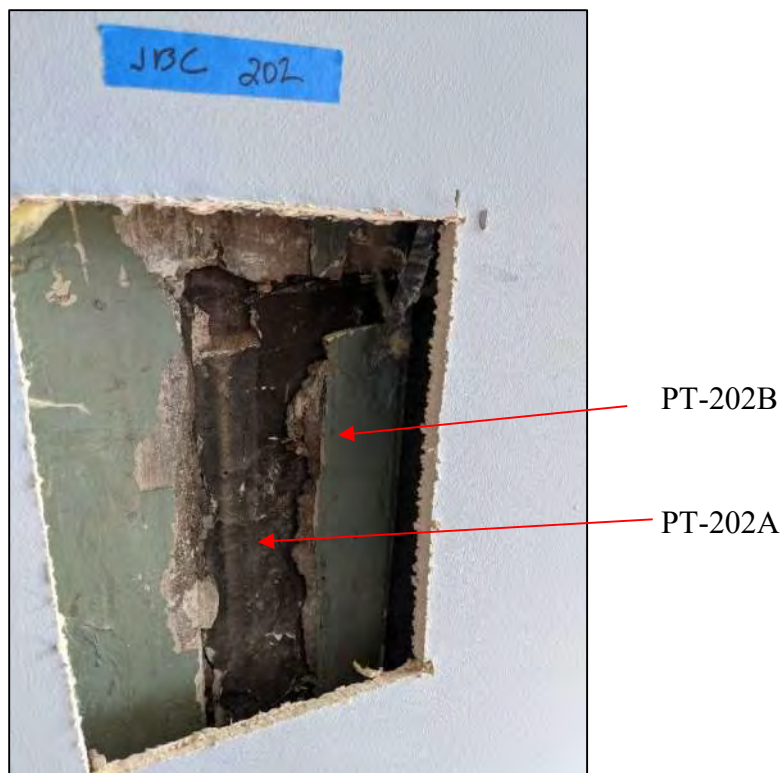
**Figure 5: Probe #5 at second floor fireplace.**

Two plaster finishes were found and sampled from within the second-floor probe at the fireplace (probe #5)—one overlapping the other (PT-202B over PT-202A in Figure 2 above). The configuration and superposition of the two plaster layers suggest that the earlier plaster was covered by a feature mounted to its surface. Note the straight and even sides to the plaster of PT-202B. Existing drawings from building permit #1451 from 1984 show a partition wall in this location, which was scheduled to be removed.<sup>17</sup> The date when this partition was installed is unknown.

Both plasters retained only two painted finishes. The first finish on the lower layer (Sample PT-202A) is a moderate olive brown (Munsell 2.5Y 4/4) paint matching Benjamin Moore 1245 “Sequoia.” The second finish is a grayish yellow green (Munsell 7.5GY 5/2) paint matching Benjamin Moore 468 “Cambridge Green.” The colors of these finishes are close to the first two finishes from the north wall of the first floor; however, the finishes on the sample from the second-floor fireplace are oil-based paints, not distempers.

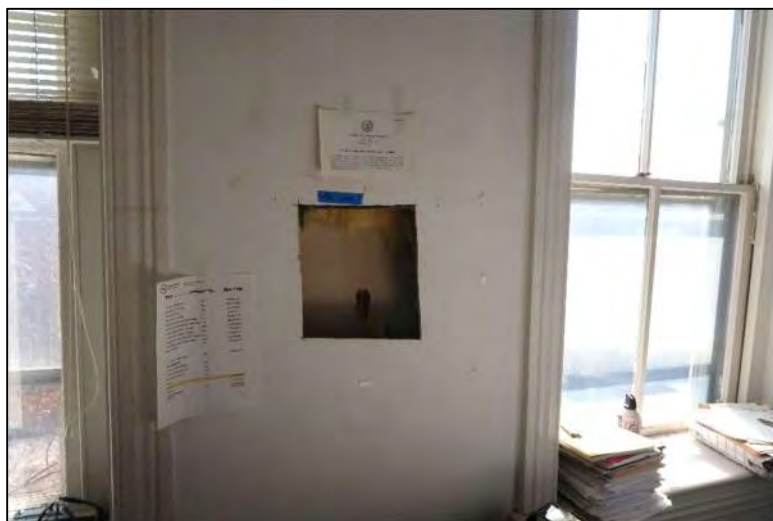
The earliest finishes on the plaster are approximately four to five layers of limewash. The limewashes are yellowish white (approximately Munsell 5Y 9/1) in color matching Benjamin Moore 225 “Chatsworth Cream”. The slightly yellow color suggests that the lime may have been mixed with oil or glue, but further analysis would be required to confirm it. Two plaster skim coats were later applied over the limewash followed by five modern painted finishes. While the date of application for the limewashes is unknown, it was common practice to paint green lime plaster with limewash to finish the walls until the plaster cured. Also, third floor spaces of residential or commercial buildings were usually not public spaces so limewash was an inexpensive way of finishing these utilitarian spaces.

**Figure 6: Probe #10 at south wall of the third floor, Sample PT-301.**

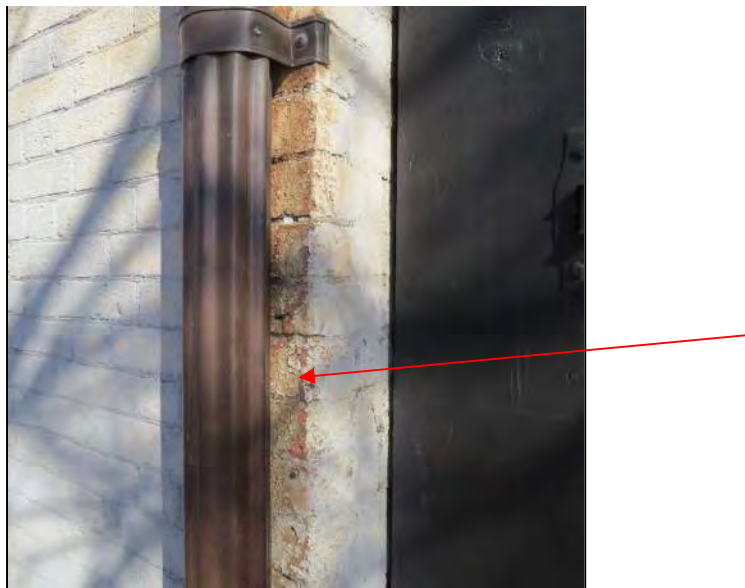
**Figure 7: Location of sample M-1.**

Sample M-1 was removed from the south elevation of the South Block at the east end of the façade near the downspout. The mortar in this location was slightly deteriorated, but it was believed that the presence of the downspout may have deterred repointing in this area.

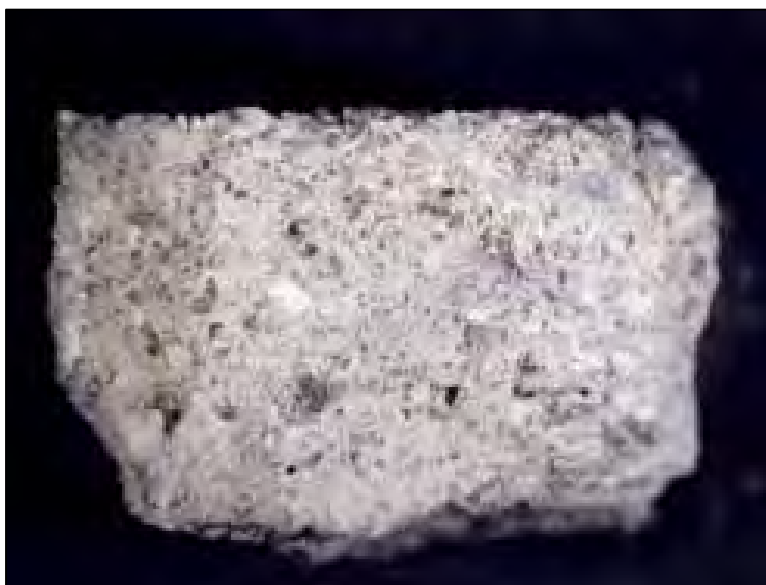
**Figure 8: Sample M-1 under simulated daylight illumination, 7.5x.**

In cross-section the matrix of the mortar is very pale brown (Munsell 10YR 8/2) in color with several small lime blebs and few dispersed air voids. There appears to be a high binder-to-sand

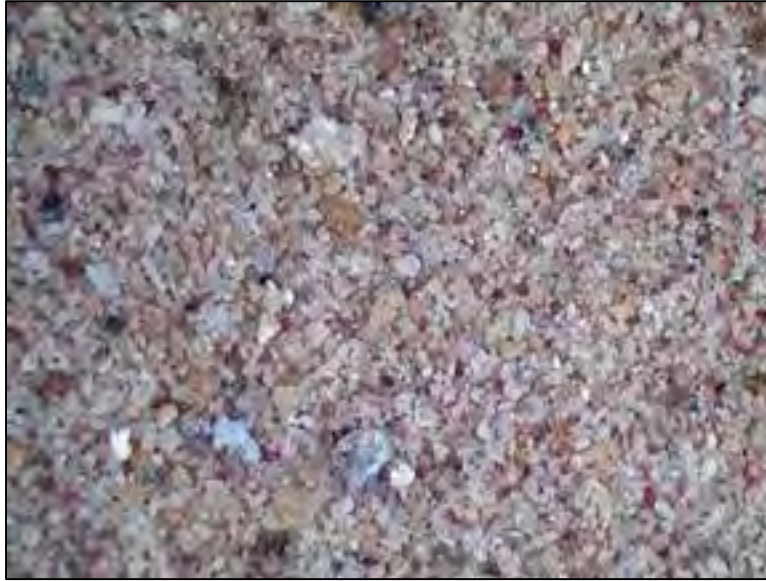
The aggregate from the Sample M-1 is very fine and narrowly graded with the majority of sand retained between the #50 and #100 sieves.

**Figure 9: Sample 1 Mortar sands under simulated daylight illumination, 7.5x.**

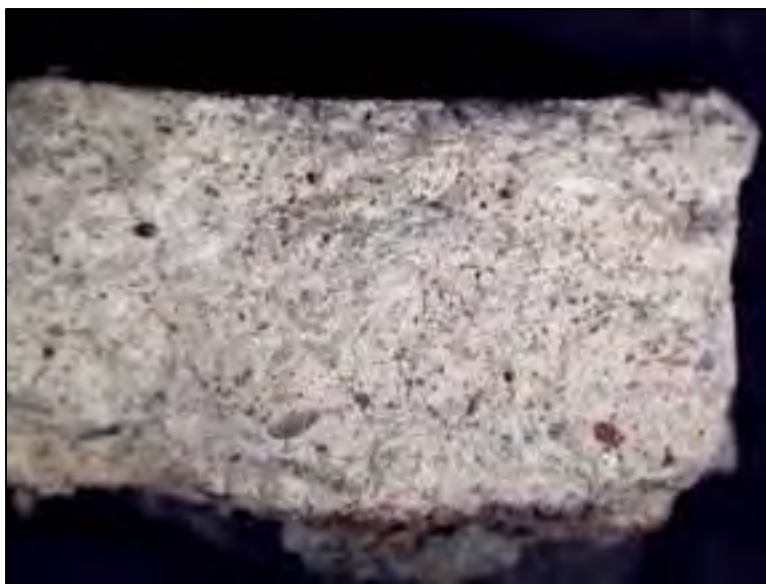
**Figure 11: Sample M-2 under simulated daylight illumination, 7.5x.**

This sample is similar in appearance to M-1. In cross-section the matrix of the mortar is very pale brown (Munsell 10YR 8/2) in color with several small lime blebs and few dispersed air voids. The mortar appears to have a high binder to sand ratio and the sand is well-coated by the binder. On a relative scale of 1 to 5, with 1 being the softest and 5 being the hardest, the mortar has a hardness rating of 2 and was easy to crush.

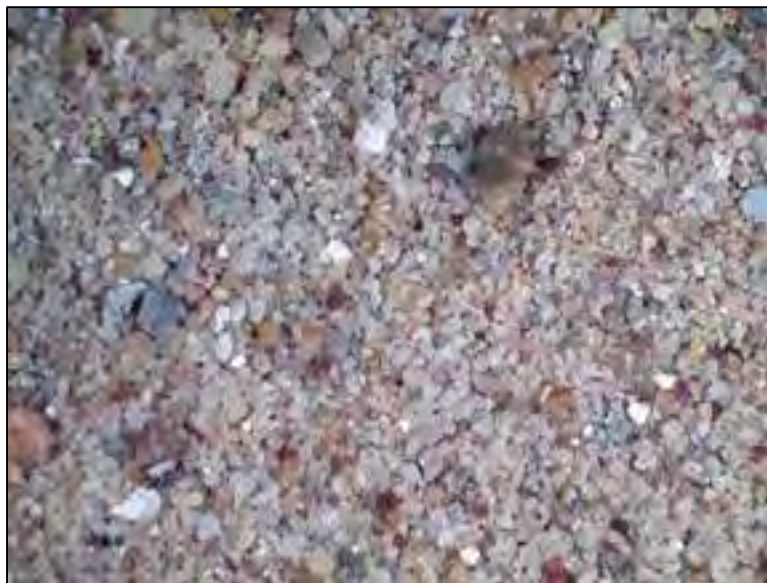
The aggregate from the Sample M-2, like M-1, is fine grained and narrowly graded with the majority of the sand retained by the #50 and #100 sieves.

**Figure 12: Sample 2 Mortar sands under simulated daylight illumination, 7.5x.**

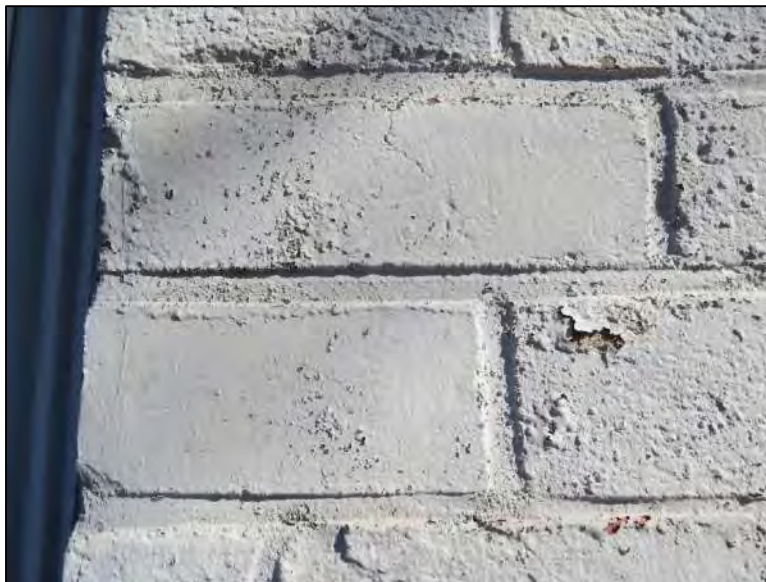
Sample M-3 was removed from the infill adjacent to window 102. The infill bricks have a smoother surface than the other bricks and the mortar joints have a flat profile.

**Figure 13: Detail of mortar at infill around windows. Note the smooth brick and the flat joint profile.**

It is likely that M-3 and M-5 date from the 1985 restoration as photographs from the 1980s before the restoration show deteriorated brick at the bottom of the opening at 105.

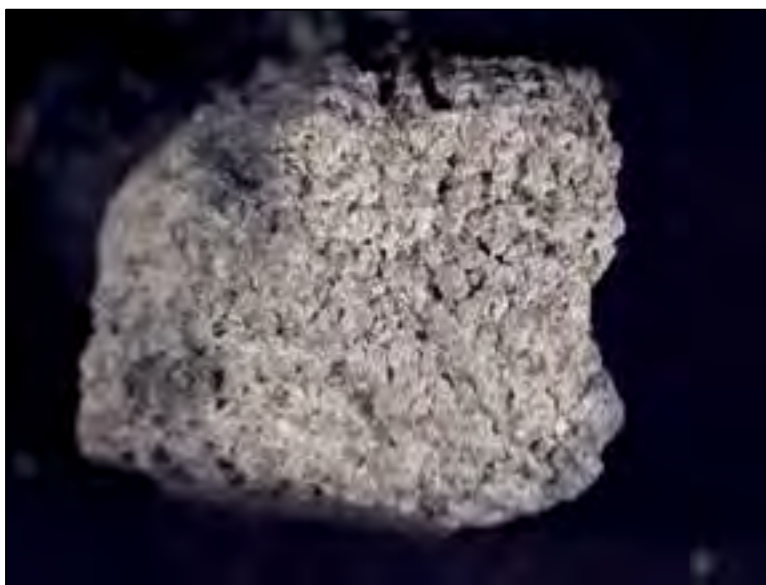
**Figure 14: Sample 3 Mortar under simulated daylight illumination, 7.5x.**

In cross-section the matrix of the mortar is pale yellow (Munsell 2.5Y 8/3) in color with several moderate lime blebs and small air voids. The mortar does not appear well-compacted and the sand is poorly coated by the binder. On a relative scale of 1 to 5, with 1 being the softest and 5 being the hardest, the mortar has a hardness rating of 2.5.

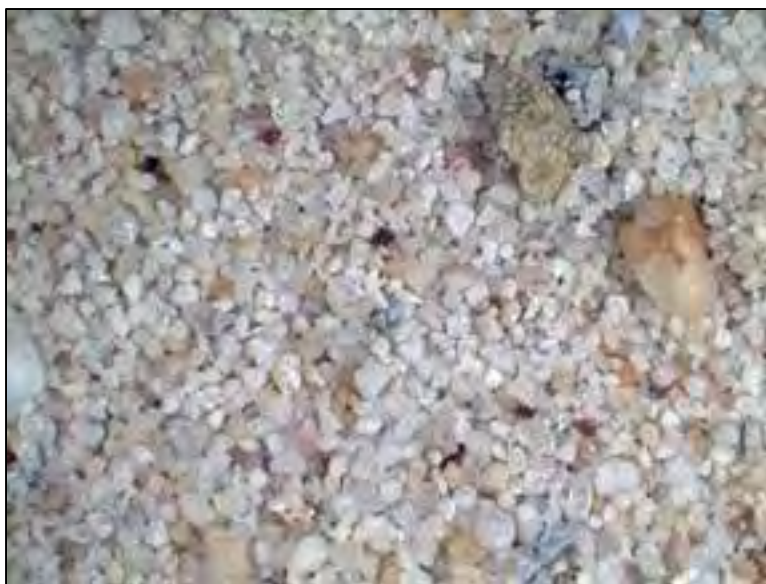
The aggregate from the Sample M-3 well-graded, but slightly outside the limits acceptable for modern, commercially-graded natural sand with a higher proportion of medium-grained aggregate.

**Figure 15: Sample M-3 sands under simulated daylight illumination, 7.5x.**

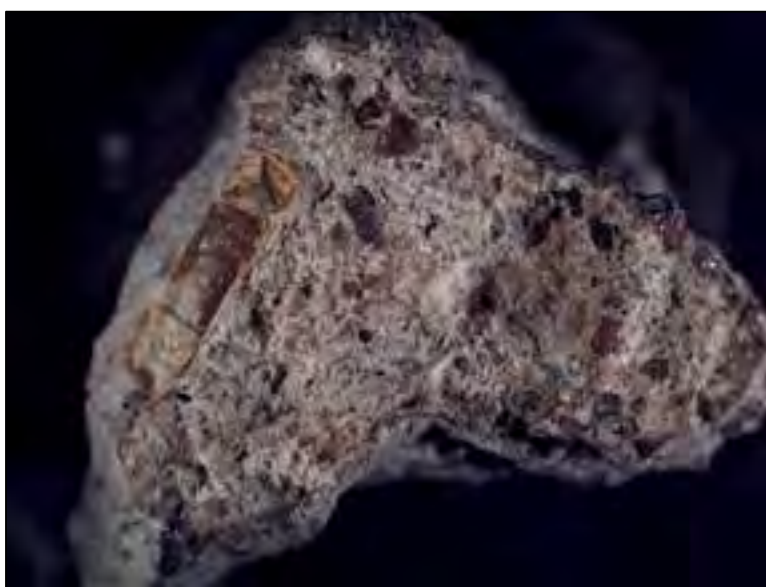
**Figure 16: Sample M-4 under simulated daylight illumination, 7.5x.**

In cross-section the matrix of the mortar is very pale brown (Munsell 10YR 8/3) in color. The mortar has coarse aggregate and some voids. Some of the pores are lined with carbonate material which could indicate moisture passing through the mortar. The sand is well-coated in the binder. On a relative scale of 1 to 5, with 1 being the softest and 5 being the hardest, the mortar has a hardness rating of 4.

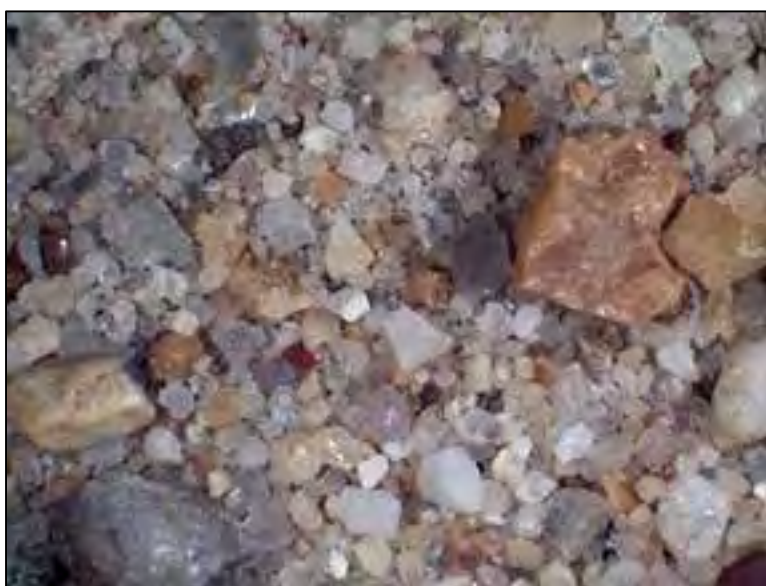
The aggregate from the Sample M-4 is just outside the limits acceptable for modern, commercially-graded natural sand with a higher proportion of course-grained aggregate.

**Figure 17: Sample M-4 sands under simulated daylight illumination, 7.5x.**

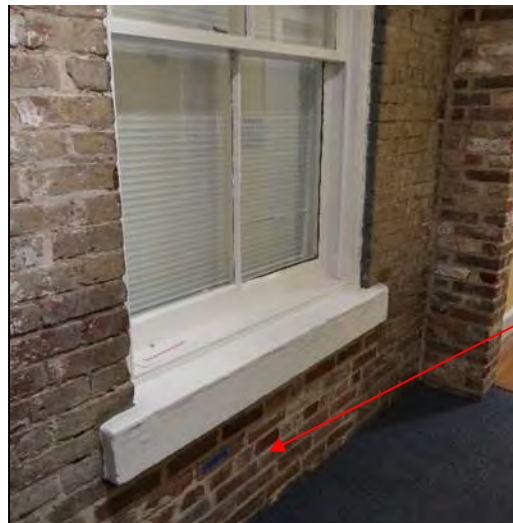
**Figure 18: Location of sample M-5.**

Sample M-5 was removed from under window 105. This is an area of brick infill.

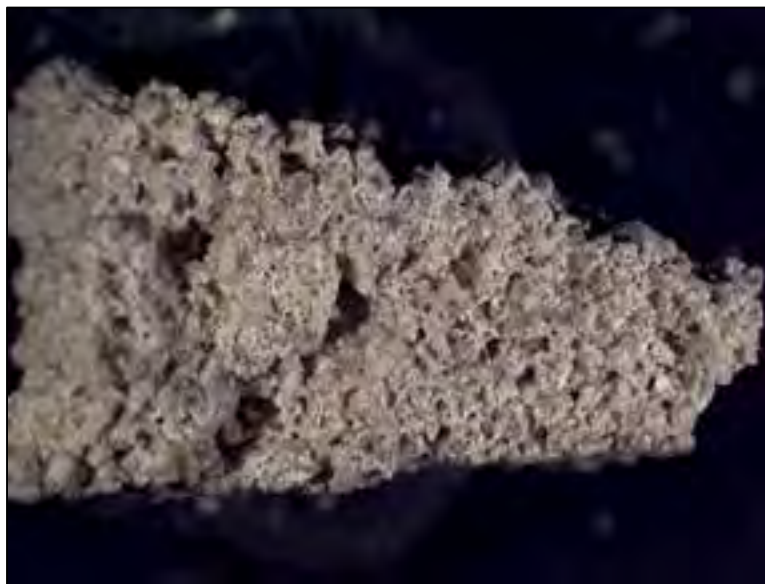
**Figure 19: Sample M-5 under simulated daylight illumination, 7.5x.**

In cross-section the matrix of the mortar is pale yellow (Munsell 2.5Y 8/2) in color with few small lime blebs and frequent dispersed air voids. The sand is poorly coated by the binder. On a relative scale of 1 to 5, with 1 being the softest and 5 being the hardest, the mortar has a hardness rating of 2.

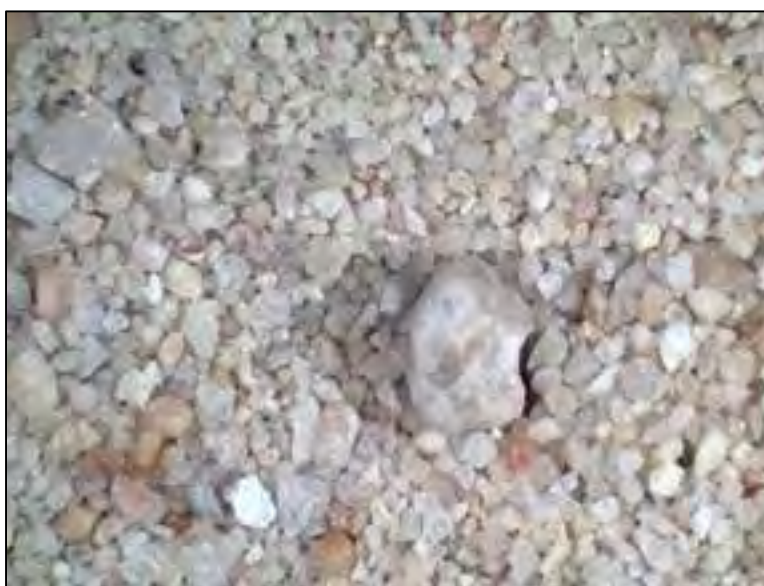
The aggregate from the Sample M-5 is outside the limits acceptable for modern, commercially-graded natural sand with a higher proportion of medium-grained aggregate.

**Figure 20: Sample M-5 sands under simulated daylight illumination, 7.5x.**

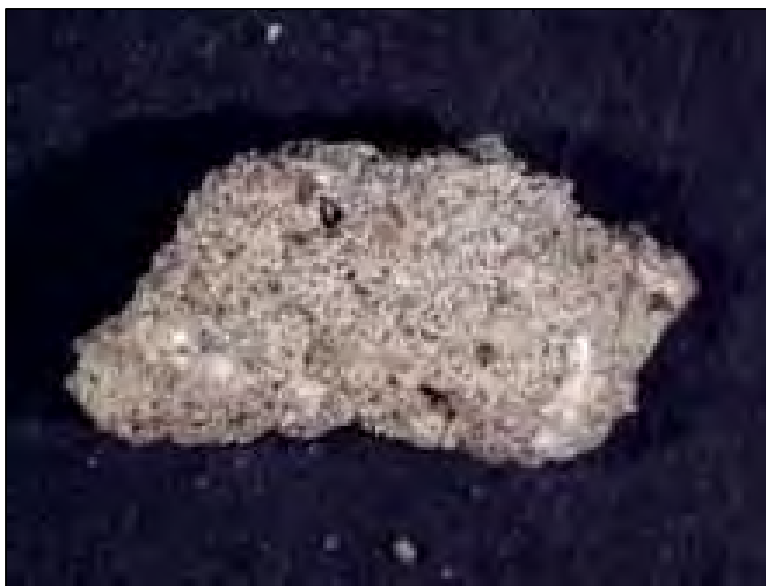
Figure 21: Sample M-6 under simulated daylight illumination, 7.5x.

In cross-section the matrix of the mortar is pale yellow (Munsell 2.5Y 8/3) in color. The mortar is powdery with a soft binder. It has several small lime blebs, few dispersed air voids, and the sand is well-coated by the binder. On a relative scale of 1 to 5, with 1 being the softest and 5 being the hardest, the mortar has a hardness rating of 2.

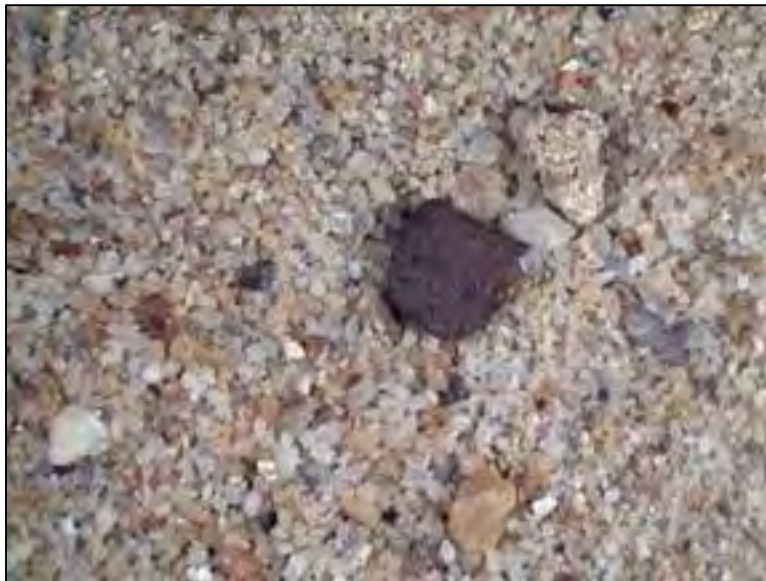
The aggregate from the Sample M-6 narrowly graded with a higher proportion of medium-grained aggregate.

**Figure 22: Sample M-6 sands under simulated daylight illumination, 7.5x.**

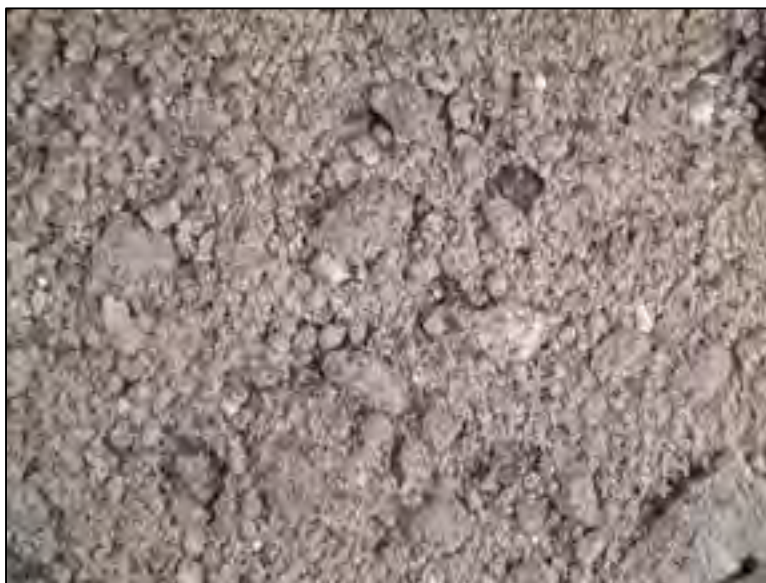
**Figure 23: Sample M-7 under simulated daylight illumination, 7.5x.**

In cross-section the matrix of the mortar is pale yellow (Munsell 2.5Y 8/3) in color. The mortar is powdery in texture with few in-tact pieces and has several small lime blebs. On a relative scale of 1 to 5, with 1 being the softest and 5 being the hardest, the mortar has a hardness rating of 2.

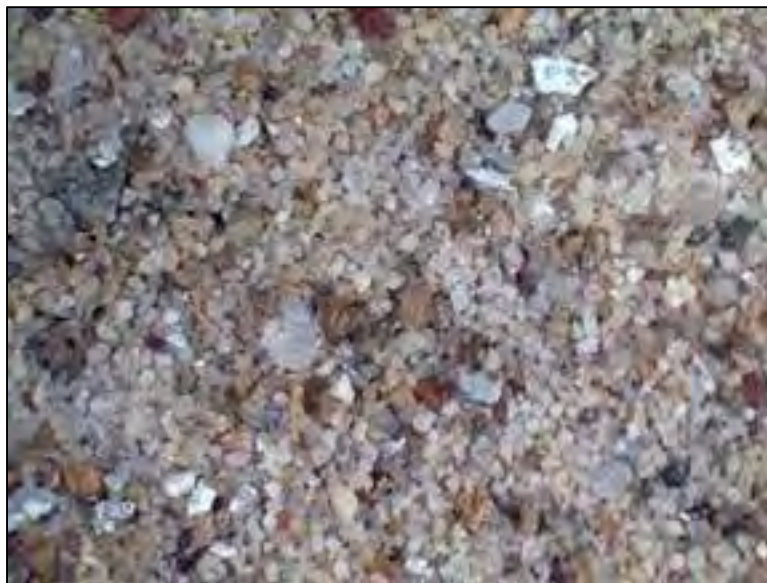
The aggregate from the Sample M-7 is poorly graded with a higher proportion of medium-grained aggregate.

**Figure 24: Sample M-7 sands under simulated daylight illumination, 7.5x.**

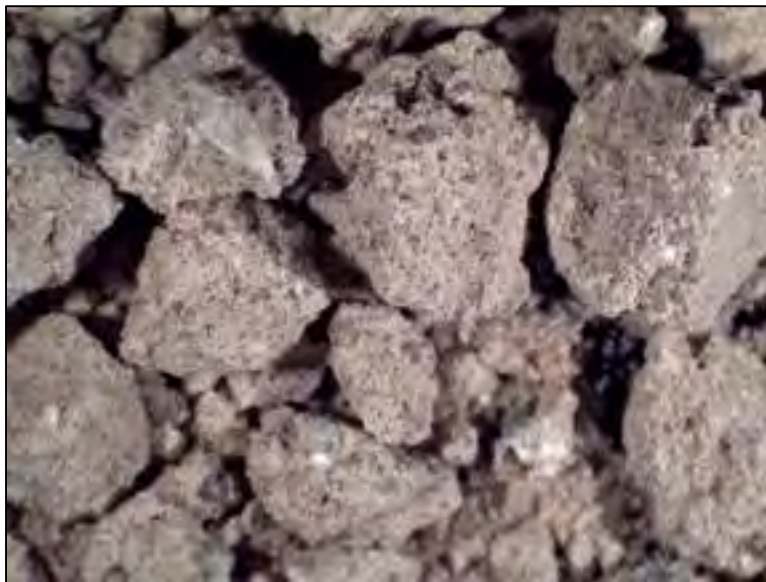
**Figure 25: Sample M-9 under simulated daylight illumination, 7.5x.**

In cross-section the matrix of the mortar is pale yellow (Munsell 2.5Y 8/2) in color. The mortar is powdery, has several small lime blebs, few small air voids, and the sand is well-coated by the binder. On a relative scale of 1 to 5, with 1 being the softest and 5 being the hardest, the mortar has a hardness rating of 2.

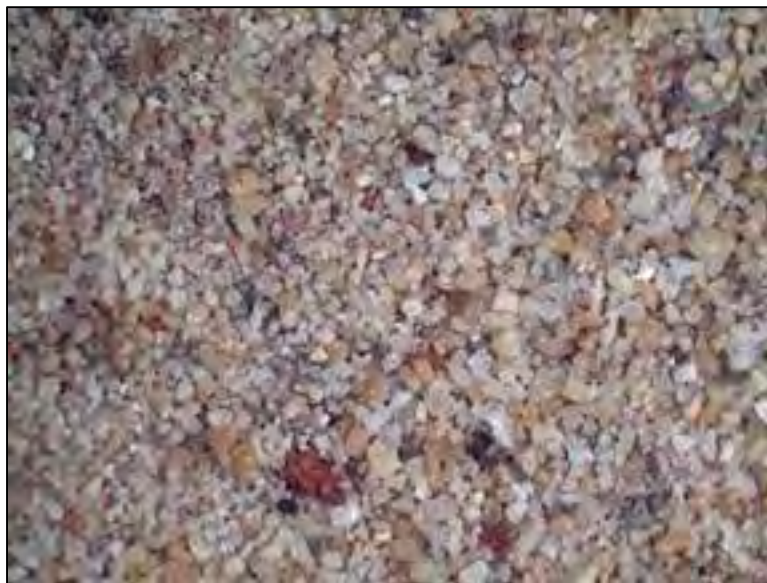
The aggregate from the Sample M-9 Mortar is poorly graded with a higher proportion of medium-grained aggregate.

**Figure 26: Sample M-9 sands under simulated daylight illumination, 7.5x.**

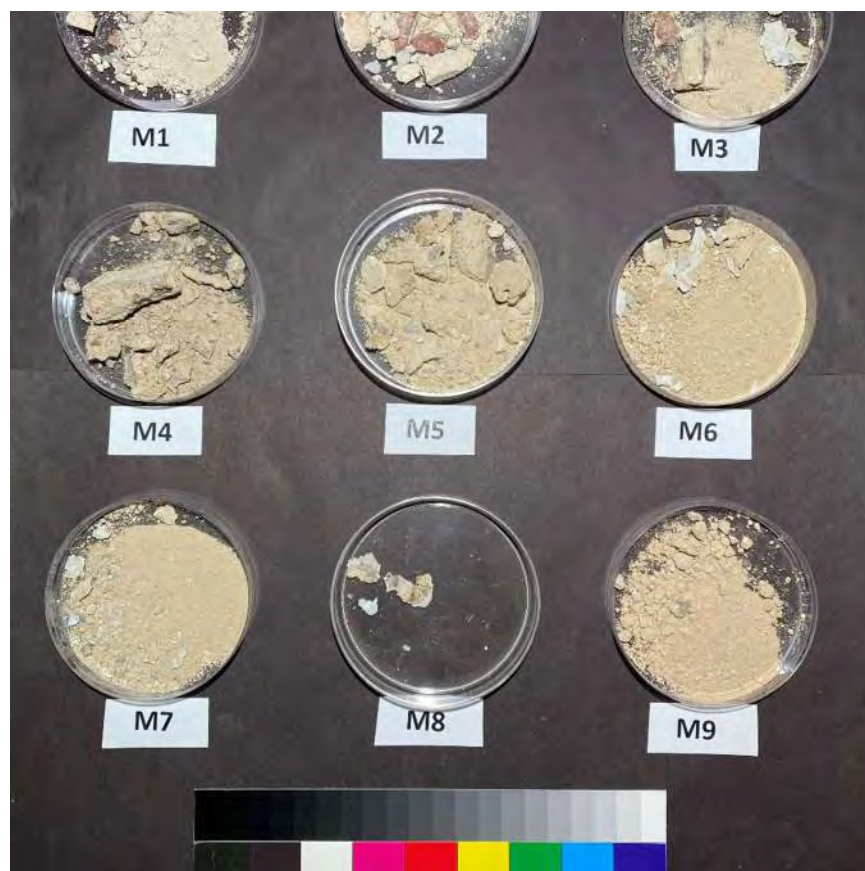
**Figure 27: 1315 Duke Street mortar samples before acid digestion.**

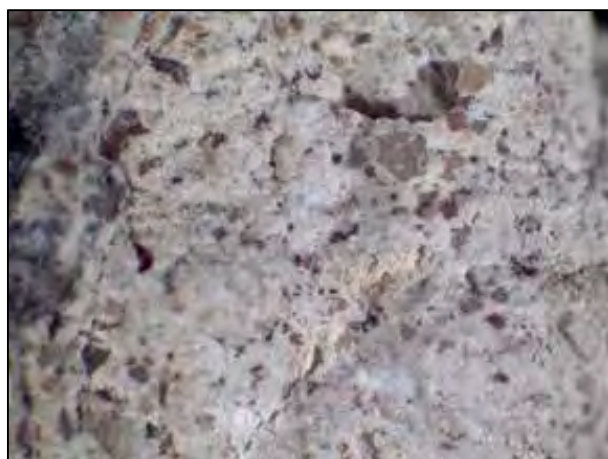
Samples M-1 and M-2 have the same color and texture in hand sample, the component proportions are the same, and the gradation of the sands are nearly identical. These mortars are lime-based with a low sand content which is mostly medium to course-grained. Figures 28 and 29 show the samples in cross-section.

**Figure 28: Cross-section of Sample M-1, 20x**

The exact dates of mortars M-1 and M-2 is unknown. Despite their similarity, Sample M-1 may predate Sample M-2. The surface of Sample M-1 was eroded and contained several layers of paint. The joint tooling of Sample M-2 is very crisp and only contains one layer of paint in most locations. In 1985, there was select repointing of the exterior. Therefore, it is most possible that Sample M-2 is a repointing mortar from the 1985 renovation whose mix is based on Sample M-1, but this is just theoretical.

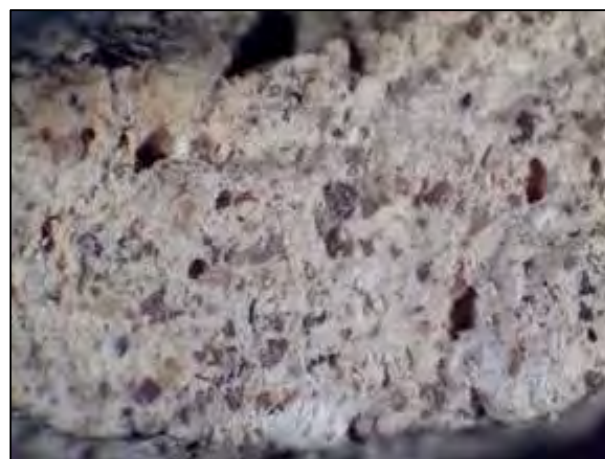
**Figure 29: Cross-section of Sample M-2, 20x.**

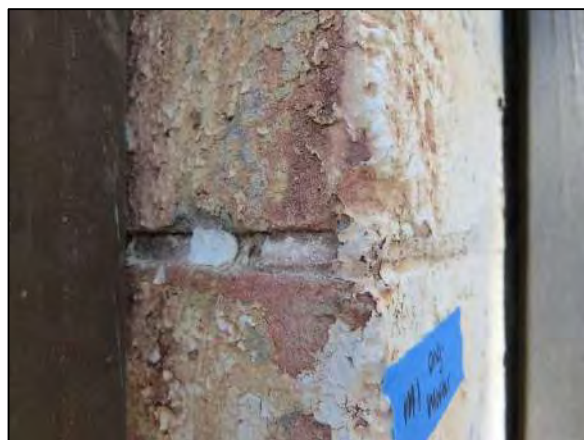
**Figure 30: Location of Sample M-1 behind the downspout.**

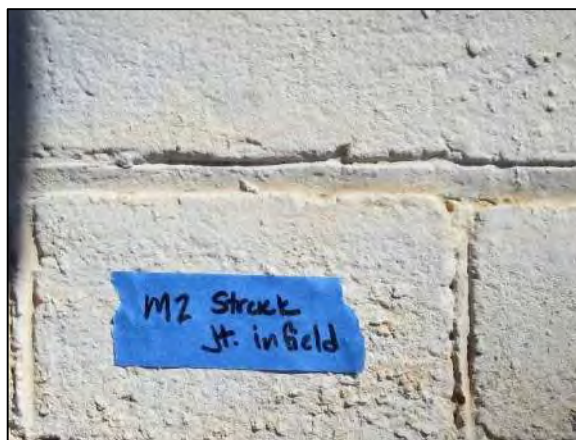
**Figure 31: Location of Sample M-2. Note the crisp joint profile.**

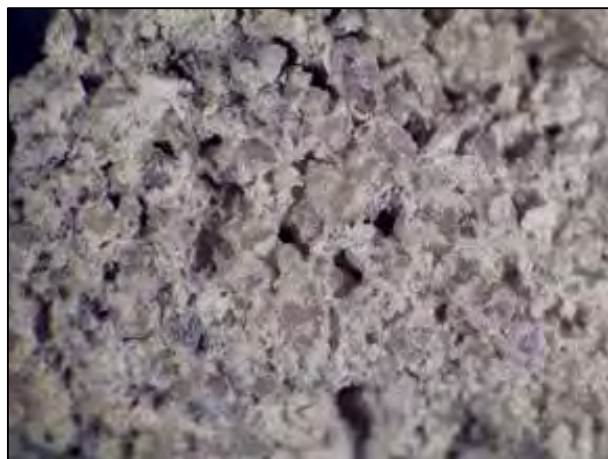
Samples M-3 from the infill around the windows on the south façade of the South Block and M-5 from the infill under window 105 appear to be the same as they both have a poorly compacted texture, pale yellow binder color, and identical component proportions (Figures 32 and 33). The sands have the same mineralogy and gradation. These mortars are lime-based with mostly medium to coarse-grained aggregate.

**Figure 32: Cross-section of Sample M-3, 20x.**

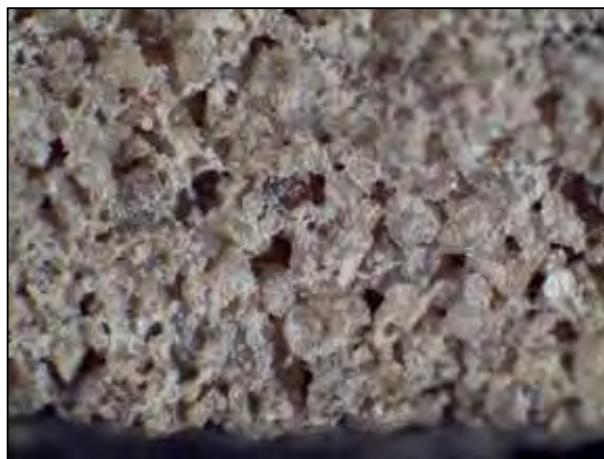
**Figure 33: Cross-section of Sample M-5, 20x.**

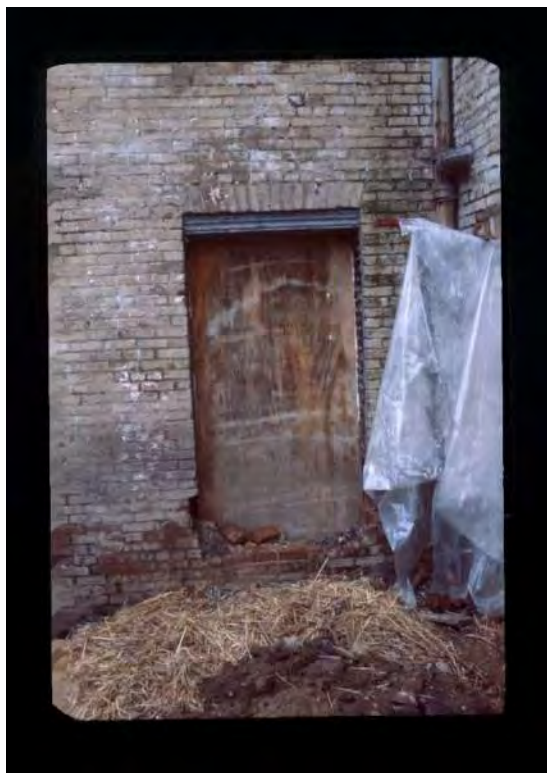
**Figure 34: Image of Window 105 c.1980.**

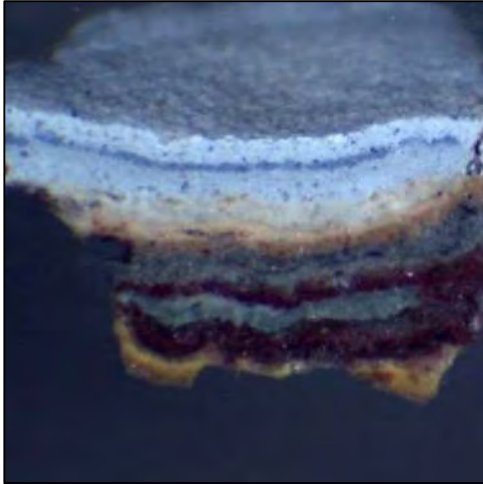
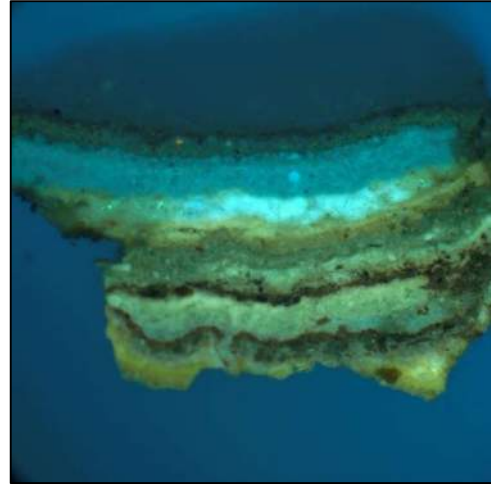
<b>Commercial Match c.1870</b>	<b>F: BM 2092-10</b>	
<b>Munsell Match c.1905</b>		
<b>Commercial Match c.1905</b>		
Comments	No clear evidence of the "PRICE BIRCH & CO/DEALERS IN SLAVES" painted sign is found.

PT-001 Simulated Daylight

PT-001 Ultraviolet Light

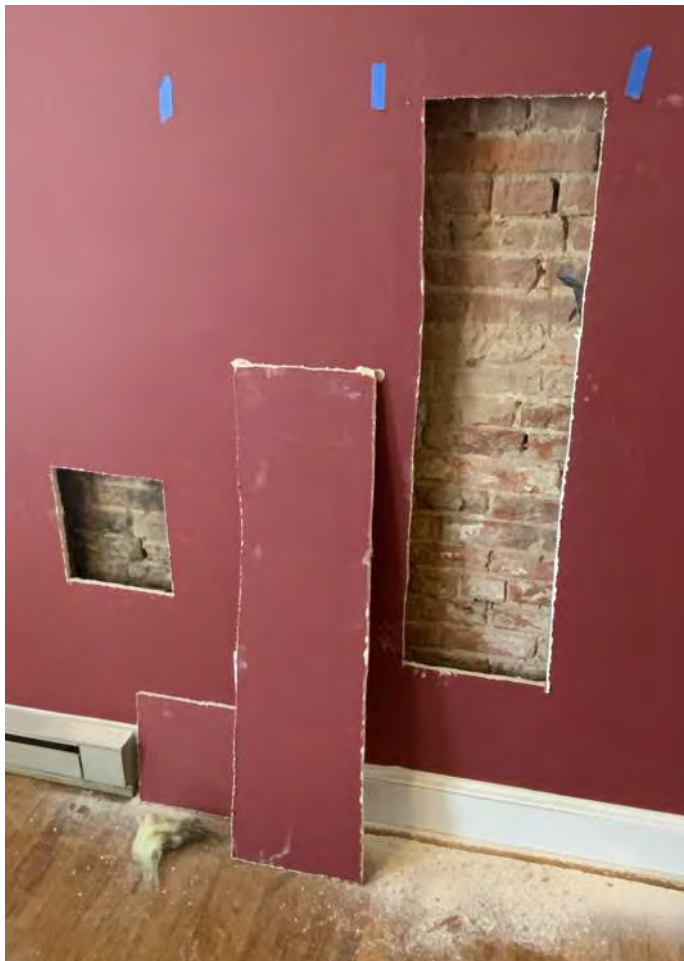
PROBE	LOCATION
#1	Entry Hall 102, West Wall
	<p data-bbox="293 254 461 289"><b>DESCRIPTION</b></p> <p data-bbox="293 302 1523 506">A probe was conducted along the west wall of Corridor 102, between masonry openings 108 and 109. The purpose of this probe was to uncover original plaster finishes within the South Block and locate any evidence to validate the theory that the original stair was located further south. The openings cut into the gypsum drywall finish were approximately 12" x 12" and 12" x 48". The existing drywall was installed on wood studs offset from the brick masonry approximately 1".</p> <p data-bbox="293 548 1523 779">No evidence of original plaster finishes were found. A fragment of wood framing was embedded within one mortar joint and a few cut nails were found within other mortar joints. Though the Historic Finishes Analyses (Appendix A) supports the theory that the existing Stair 1 is not original to Period 1, Period 2, Period 3A or 3B, there was not substantial evidence that the original stair had been located further south in this entry hall. The Historic Finishes Analyses establishes that the existing Stair 1 likely dates to Period 4A (c.1870).</p> <p data-bbox="293 821 1523 884">This probe location coincides with masonry sample M-09 as outlined in the Historic Finishes Analyses (Appendix A).</p>

**Figure PR1-1:** Two (2) openings cut in existing drywall finish along west wall of Corridor 102.

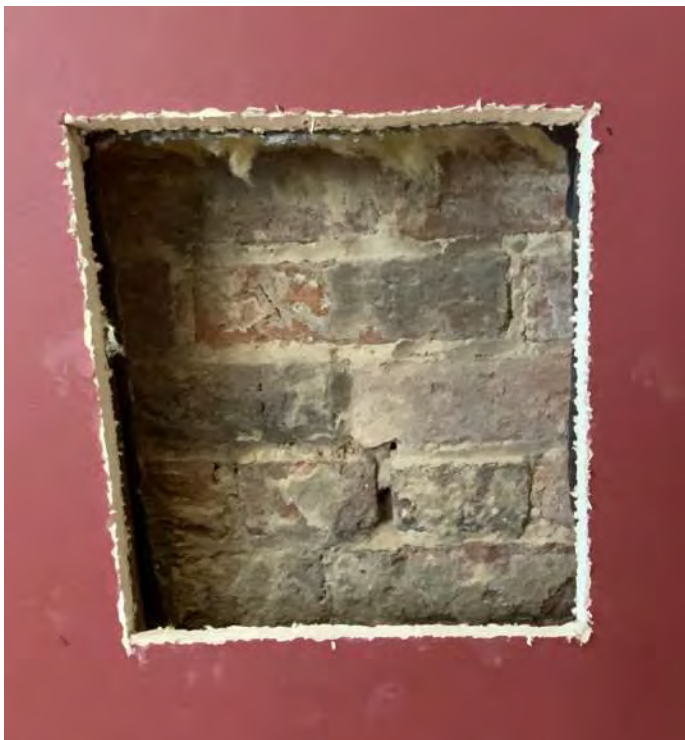
**Figure PR1-3:** One of two openings cut in existing drywall finish along west wall of Corridor 102.

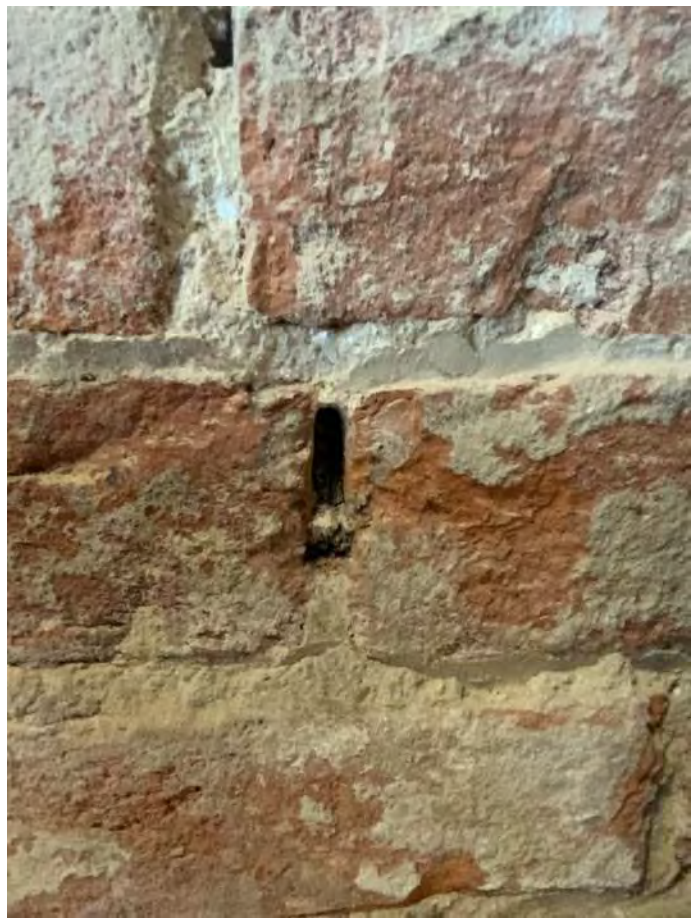
**Figure PR1-4:** Fragment of wood blocking found within the mortar joint.

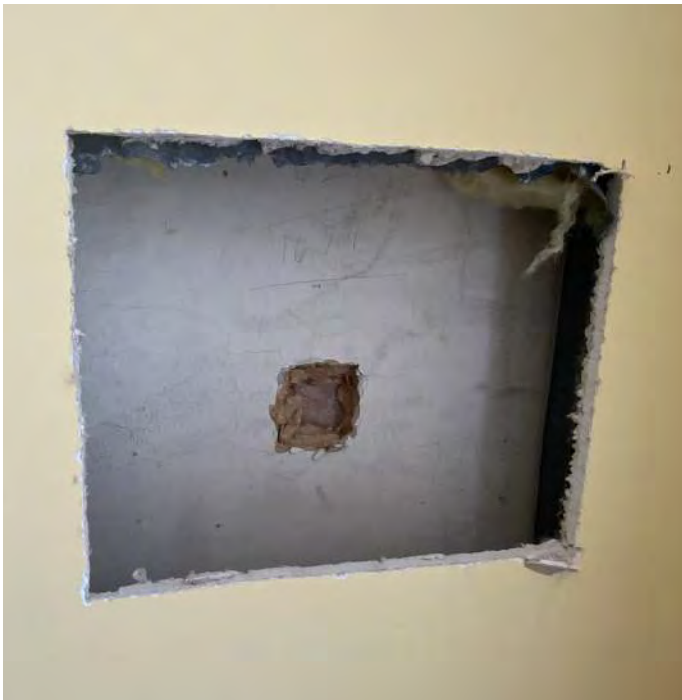
PROBE	LOCATION
#2	Reception 103, East Wall
	<p><b>DESCRIPTION</b></p> <p>Investigative probe #2 was conducted at the east wall of Reception 103, just south of Chimney #1. The purpose of this probe was to locate original historic plaster or other finishes. The opening cut into the gypsum drywall finish was approximately 12" x 12". The existing drywall was installed on 2-1/2" metal studs offset from the brick masonry approximately 1".</p> <p>The existing finish behind the drywall was a wood fiber insulating board used as a plaster base installed against the historic brick masonry, likely installed in the 1920s or 1930s.</p> <p>This probe location coincides with finish sample PT-101 as outlined in the Historic Finishes Analyses (Appendix A).</p>

**Figure PR2-1:** Opening cut in existing drywall along east wall of Reception 103 just south of Chimney #1.

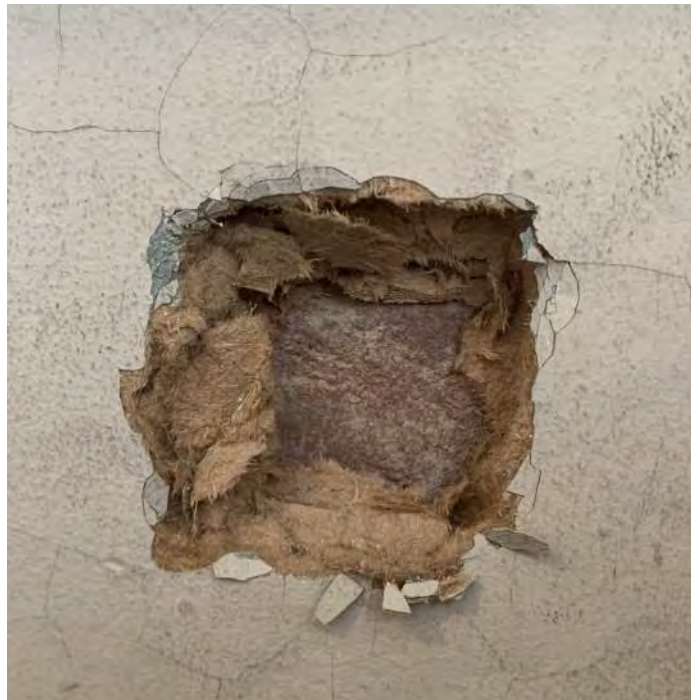
**Figure PR2-2:** Detail photo of wood fiber insulating board installed along historic brick masonry wall.

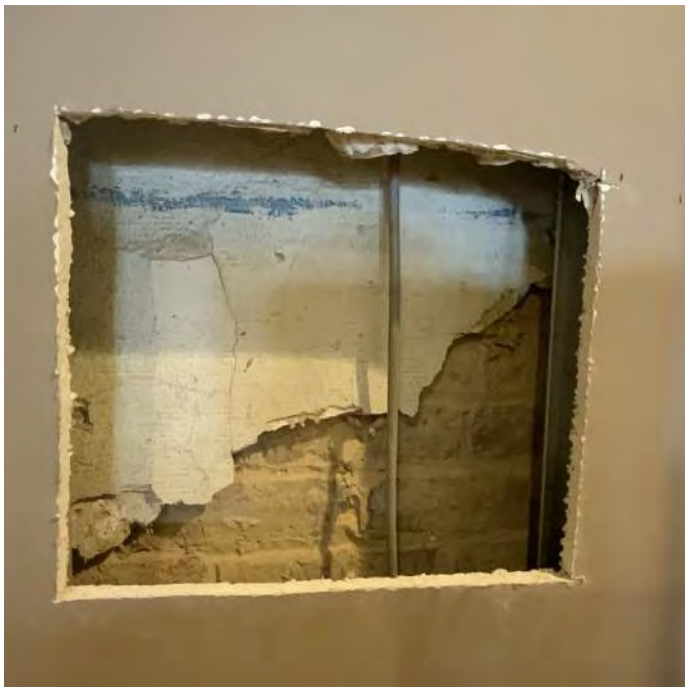
<b>PROBE #3</b>	<b>LOCATION</b> Museum 104, North Wall
	<p><b>DESCRIPTION</b></p> <p>Investigative probe #3 was conducted along the north wall of Museum 104 just west of masonry opening #105. The purpose of this probe was to locate original historic plaster or other finishes. The opening cut into the gypsum drywall finish was approximately 12" x 12". The existing drywall was installed on 2-1/2" metal studs offset from the brick masonry approximately 1".</p> <p>The existing finish behind the drywall was a 3-coat plaster installed against the historic brick masonry.</p> <p>This probe location coincides with finish sample PT-102 as outlined in the Historic Finishes Analyses (Appendix A).</p>

**Figure PR3-1:** Opening cut in existing drywall along north wall of Museum 104 just west of masonry opening 105.

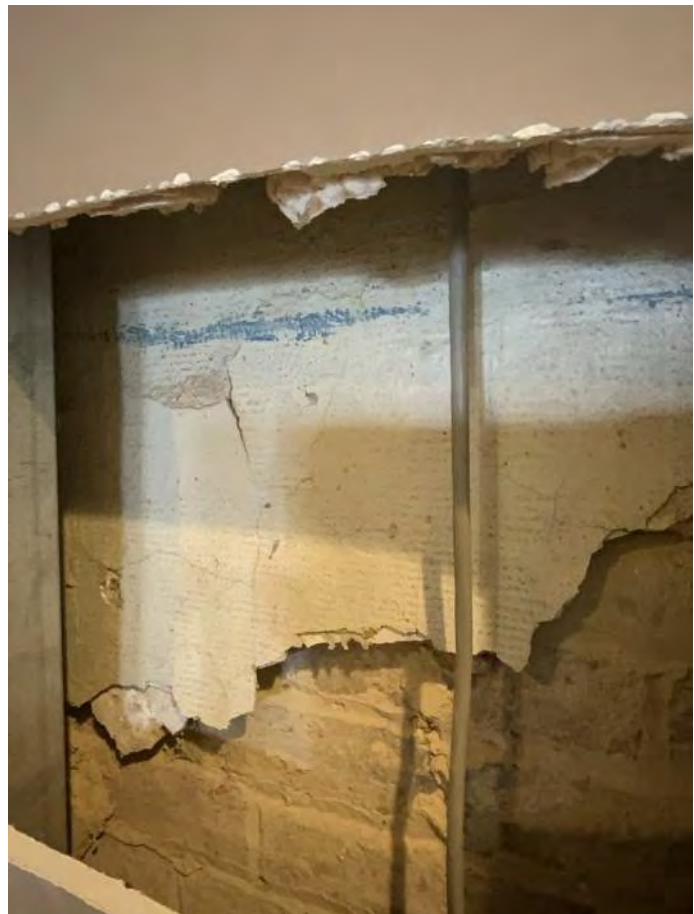
**Figure PR3-2:** Detail of historic 3-coat plaster found behind modern drywall finish.

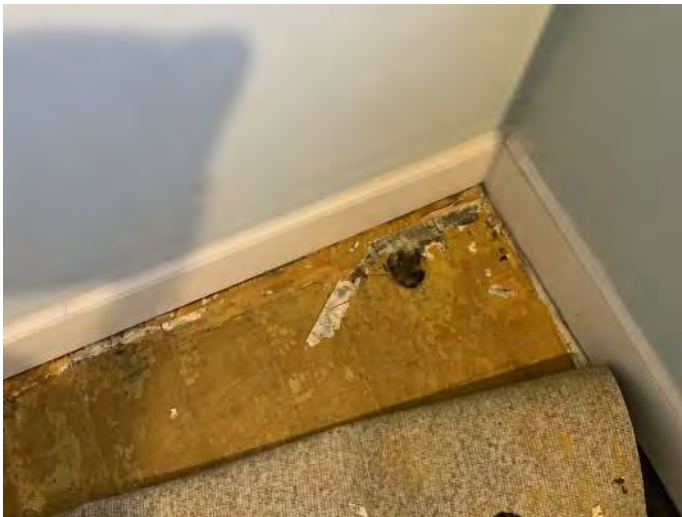
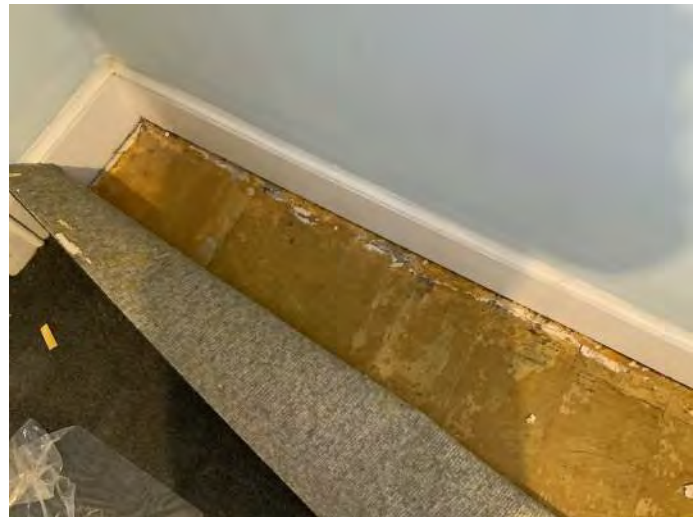
<b>PROBE #4</b>	<b>LOCATION</b> Stair 1, Second Floor
	<b>DESCRIPTION</b> <p>Investigative probe #4 was conducted at the second floor landing of Stair 1. The purpose of this probe was to locate historic wood flooring underneath the existing finishes. The existing carpet was pulled back to reveal the underlying substrate.</p> <p>Random width tongue and groove wood flooring was located beneath the existing carpet. It may be original, but there is limited evidence to determine the age of this flooring. It is also coated in mastic/ adhesive from the carpet and an existing hole in floor may be impact from radiator piping previously removed.</p>

**Figure PR4-1:** Detail of historic wood flooring located under existing carpet .

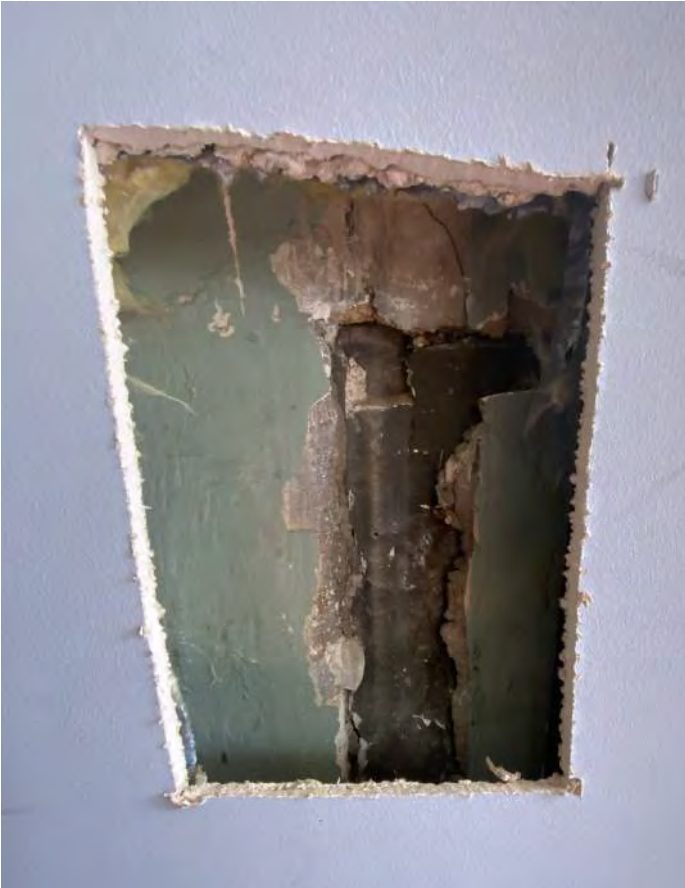
PROBE  #5	LOCATION Conference Room 201, East Wall Chimney
	DESCRIPTION <p>Investigative probe #5 was conducted at the finished surface of Chimney #1 along the east elevation of Conference Room 201. The purpose of this probe was to locate original historic plaster or other finishes. The opening cut into the gypsum drywall finish was approximately 12" x 18". The existing drywall was installed on 2-1/2" metal studs offset from the brick masonry approximately 1".</p> <p>The existing finishes behind the drywall were two (2) campaigns of 3-coat plaster installed against the historic brick masonry. Based upon the condition of the existing top layer of plaster (light green) and discontinuous application it is assumed this location coincides with a demising partition between closets identified in the 1985 Dunston Renovation drawings as an existing partition to be demolished. Also, an earlier plaster finish (dark gray) was located behind the first, which would have continued behind the earlier partition at this location. The existing finishes were not removed to locate the original fireplace location.</p> <p>This probe location coincides with finish samples PT-202A and PT-202B as outlined in the Historic Finishes Analyses (Appendix A).</p>

Figure PR5-1: Opening cut in existing drywall along east elevation of Conference Room 201 at the face of Chimney #1.
