# 1315 DUKE STREET HISTORIC STRUCTURE REPORT

Alexandria, Virginia 22314

## FINAL REPORT

June 30, 2021

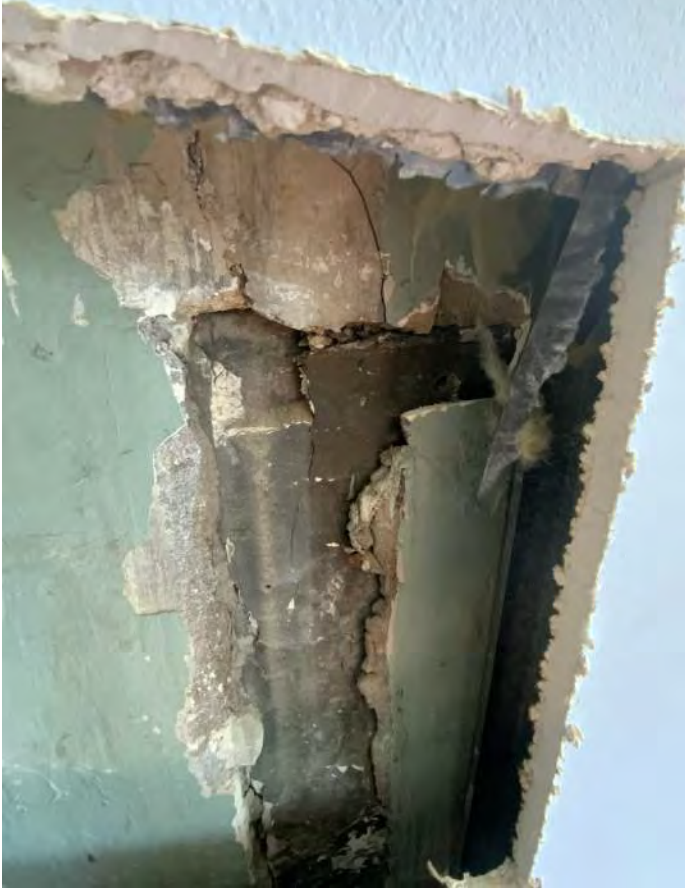
Figure PR5-2: Detail of historic plaster finishes found at investigative probe #5.

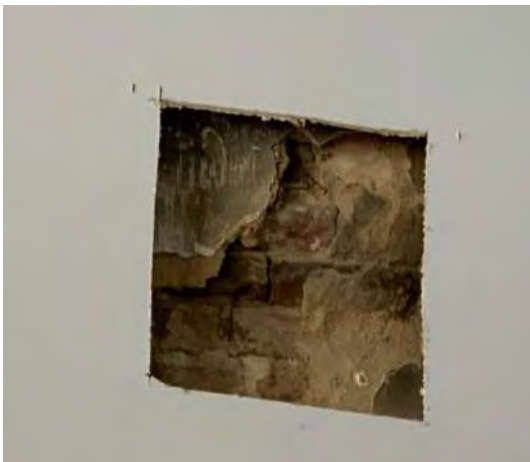
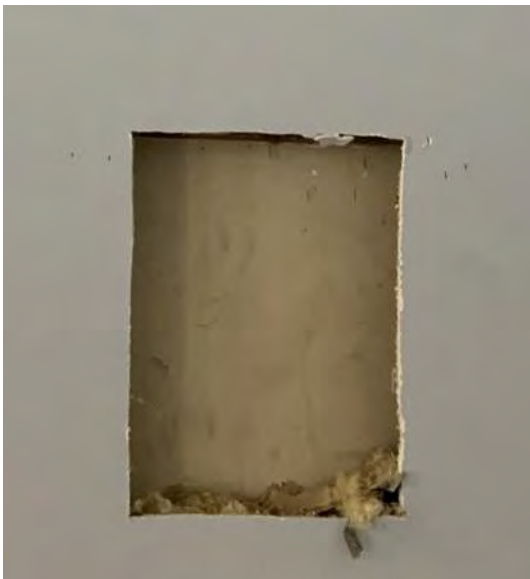
<b>PROBE #6</b>	<b>LOCATION</b> Conference Room 201, West Wall
	<b>DESCRIPTION</b> <p>Investigative probe #6 was conducted along the west elevation of Conference Room 201. The purpose of this probe was to locate original historic plaster or other finishes and look for more information related to the masonry opening 211 infill. The opening cuts into the gypsum drywall finish were approximately 12" x 12" and 12" x 18". The existing drywall was installed on 2-1/2" metal studs offset from the brick masonry approximately 1".</p> <p>The existing finish behind the drywall was a 3-coat plaster installed against the historic brick masonry. The opening at the top of the wall revealed damage to the historic plaster and a detachment of the finish from the historic brick masonry. The lower opening presented an earlier intact plaster finish.</p> <p>This probe location coincides with finish sample PT-201 as outlined in the Historic Finishes Analyses (Appendix A).</p>

**Figure PR6-1:** Upper and lower openings cut in existing drywall along west elevation of Conference Room 201.

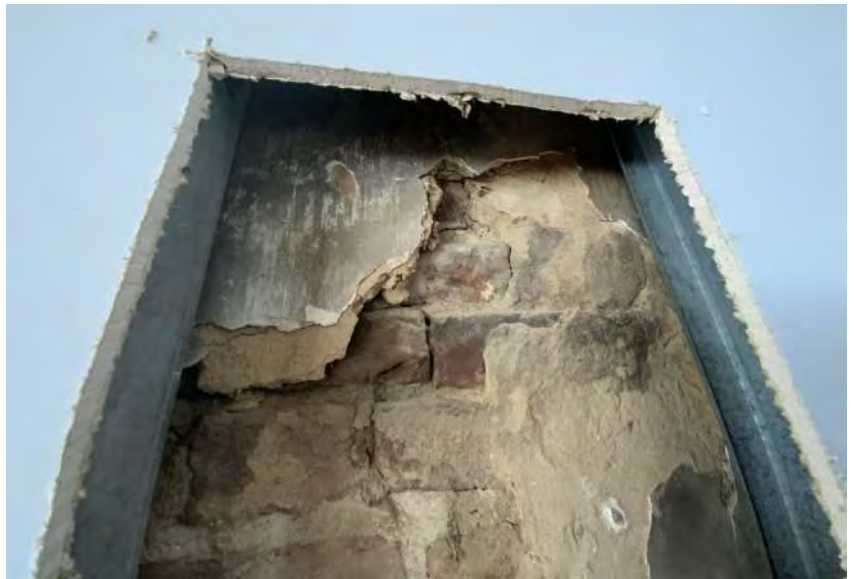
**Figure PR6-2:** Detail of historic plaster finishes found at investigative probe #6.

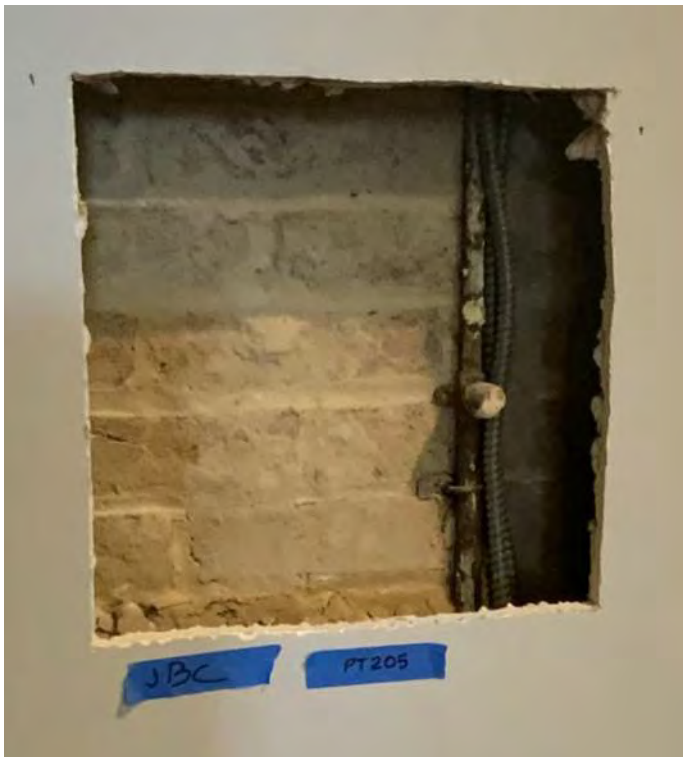
<b>PROBE #7</b>	<b>LOCATION</b> Office 203, North Wall
	<b>DESCRIPTION</b> <p>Investigative probe #7 was conducted along the north elevation of Office 203. The purpose of this probe was to locate original historic plaster or other finishes. The opening cut into the gypsum drywall finish were approximately 12" x 12". The existing drywall was installed on 2-1/2" metal studs offset from the brick masonry approximately 1".</p> <p>No plaster finishes were found directly in the location of the probe, but a historic plaster finish was located lower on the wall. A wood peg was seen and an abandoned electrical conduit was located adjacent to new flexible metal conduits.</p>

**Figure PR7-1:** Opening cut in existing drywall along north elevation of Office 203.

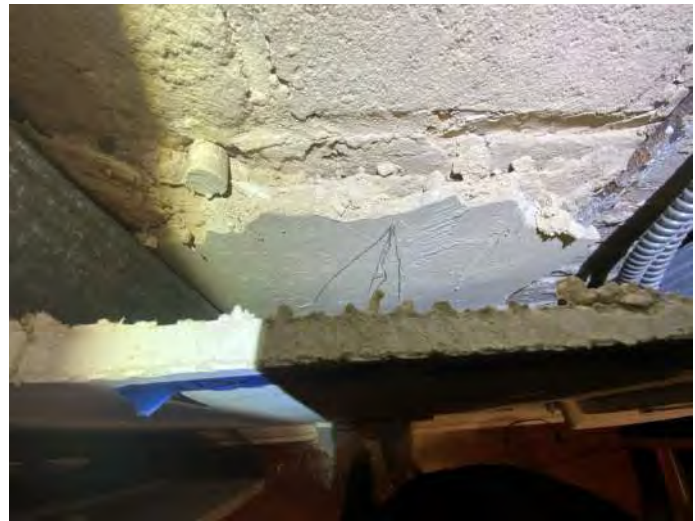
**Figure PR7-2:** Detail of historic plaster finishes found at investigative probe #7.

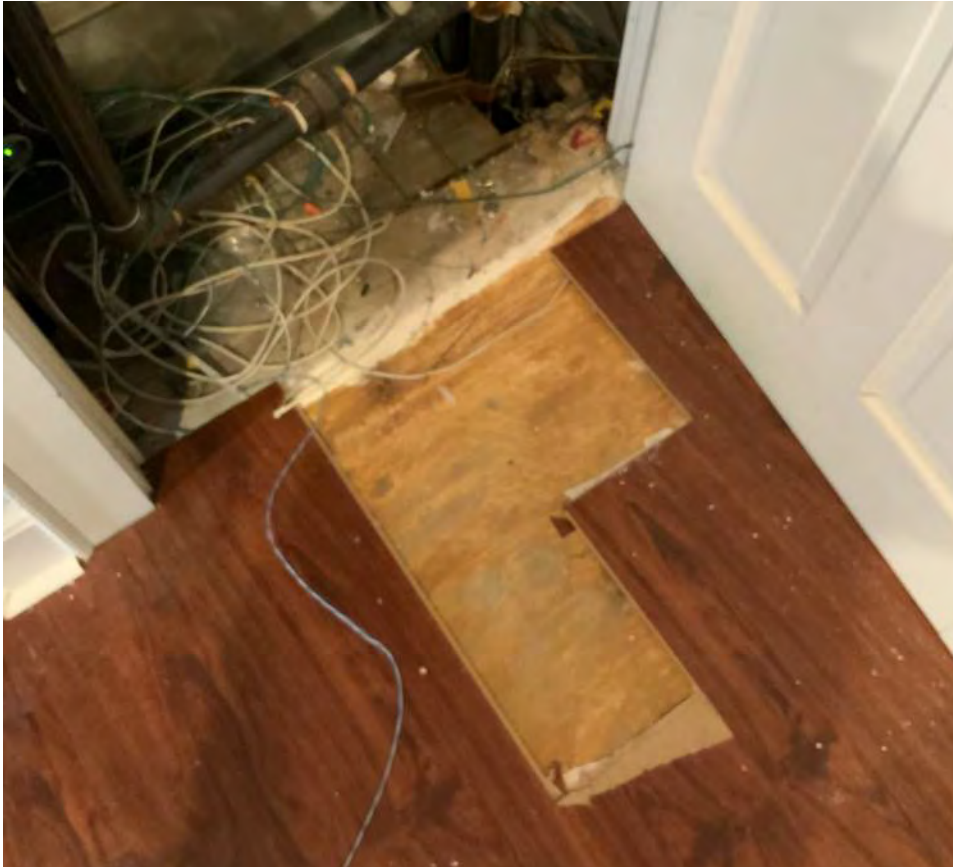
<b>PROBE #8</b>	<b>LOCATION</b> Office 203, Floor
	<b>DESCRIPTION</b> <p>Investigative probe #8 was conducted at Office 203. The purpose of this probe was to locate historic wood flooring underneath the existing finishes. The existing laminate floor was removed to reveal the underlying substrate.</p> <p>The original wood flooring has been replaced with a plywood substrate, but evidence of possible original flooring remains in the adjacent Mechanical Closet 203A.</p>

**Figure PR8-1:** Plywood subfloor uncovered beneath the existing laminate floor. The wood flooring in the adjacent mechanical closet may be original.

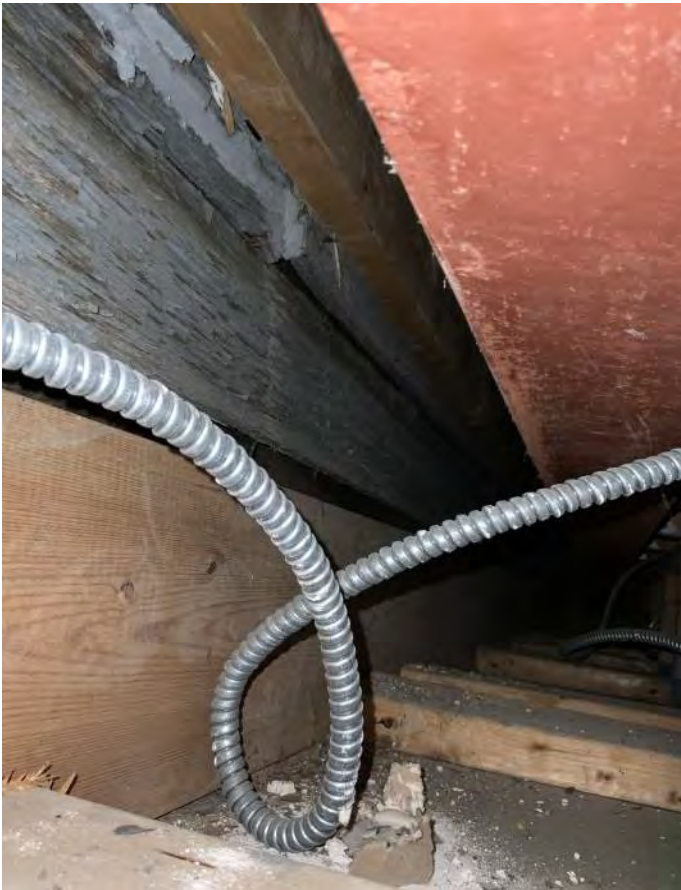
PROBE #9	LOCATION Second Floor Ceiling, Access to Wood Siding
	<p><b>DESCRIPTION</b></p> <p>Investigative probe #9 was conducted along at the second floor ceiling within the 1985 Addition outside Conference Room 212. The purpose of the probe was to locate evidence of the original brick cornice at the North Block. This original brick cornice aligns with the base of the horizontal wood siding at the third floor framed addition at the Central Passage and North Block. The opening cut into the gypsum drywall finish under the steel beam was approximately 8" x 8".</p> <p>The probe did not uncover evidence of the original brick cornice. Based upon the findings of this probe and review of the conditions between the brick facade and wood siding at the north facade of the North Block, it is understood that the original brick cornice was removed when the third floor framed addition was constructed during Period 4B (c.1905).</p> <p>However, this probe did allow access to an older portion of the wood siding which had not been recently repainted. The existing wood siding was installed in 1937 per historic permit #2415. It is assumed this remaining portion of wood siding has not been repainted since the 1985 Addition was constructed and has remained protected.</p> <p>This probe location coincides with finish sample PT-207 as outlined in the Historic Finishes Analyses (Appendix A).</p>

**Figure PR9-1:** View within probe #9 looking north locating the steel beam installed during the 1985 Addition and the remaining wood siding installed in 1937 per Permit #2415.

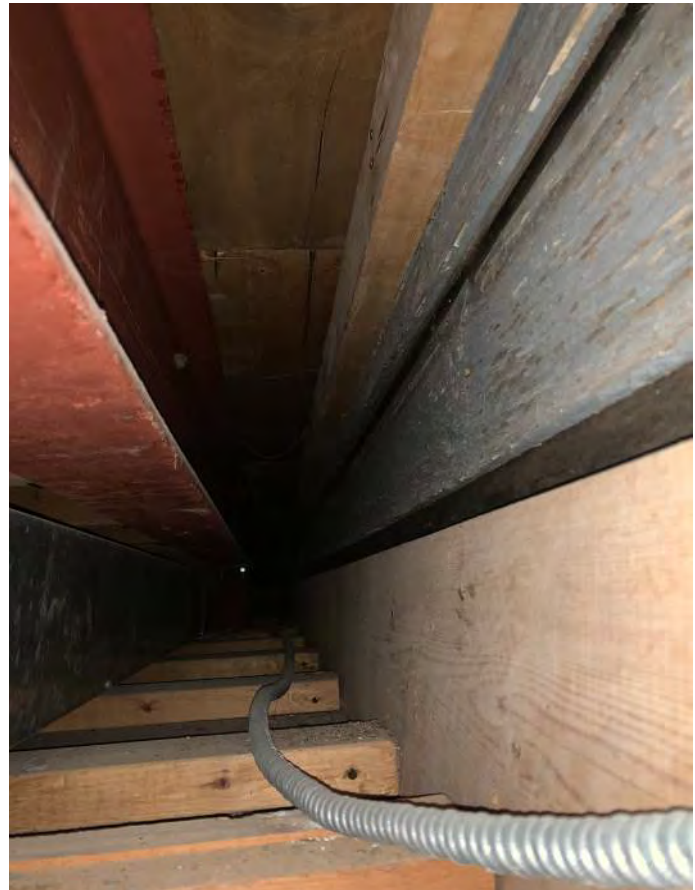
**Figure PR9-2:** View within probe #9 looking south locating the steel beam installed during the 1985 Addition and the remaining wood siding installed in 1937 per Permit #2415.

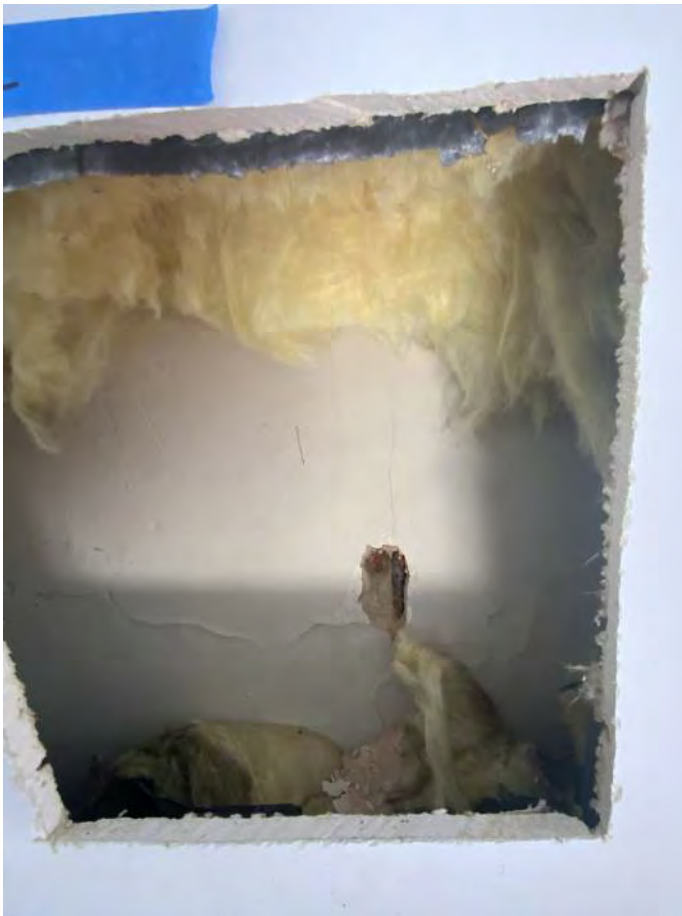
<b>PROBE #10</b>	<b>LOCATION</b> Office 302, South Wall
	<b>DESCRIPTION</b> Investigative probe #10 was conducted along the south wall of Office 302 between masonry openings 302 and 303. The purpose of this probe was to locate original historic plaster or other finishes. The opening cut into the gypsum drywall finish was approximately 12" x 12". The existing drywall was installed on 2-1/2" metal studs offset from the brick masonry approximately 1".  The existing finish behind the drywall was a 3-coat plaster installed against the historic brick masonry. Removal of a small area of the plaster uncovered a metal conduit embedded in the historic plaster.  This probe location coincides with finish sample PT-301 as outlined in the Historic Finishes Analyses (Appendix A).

**Figure PR10-1:** Opening cut in existing drywall along the south wall of Office 302.

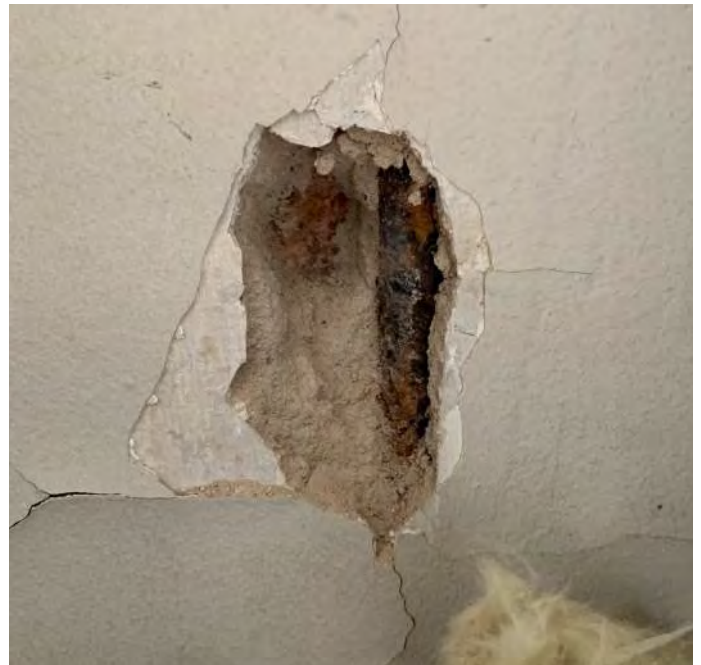
**Figure PR10-2:** Detail of historic plaster finishes found at investigative probe #10.

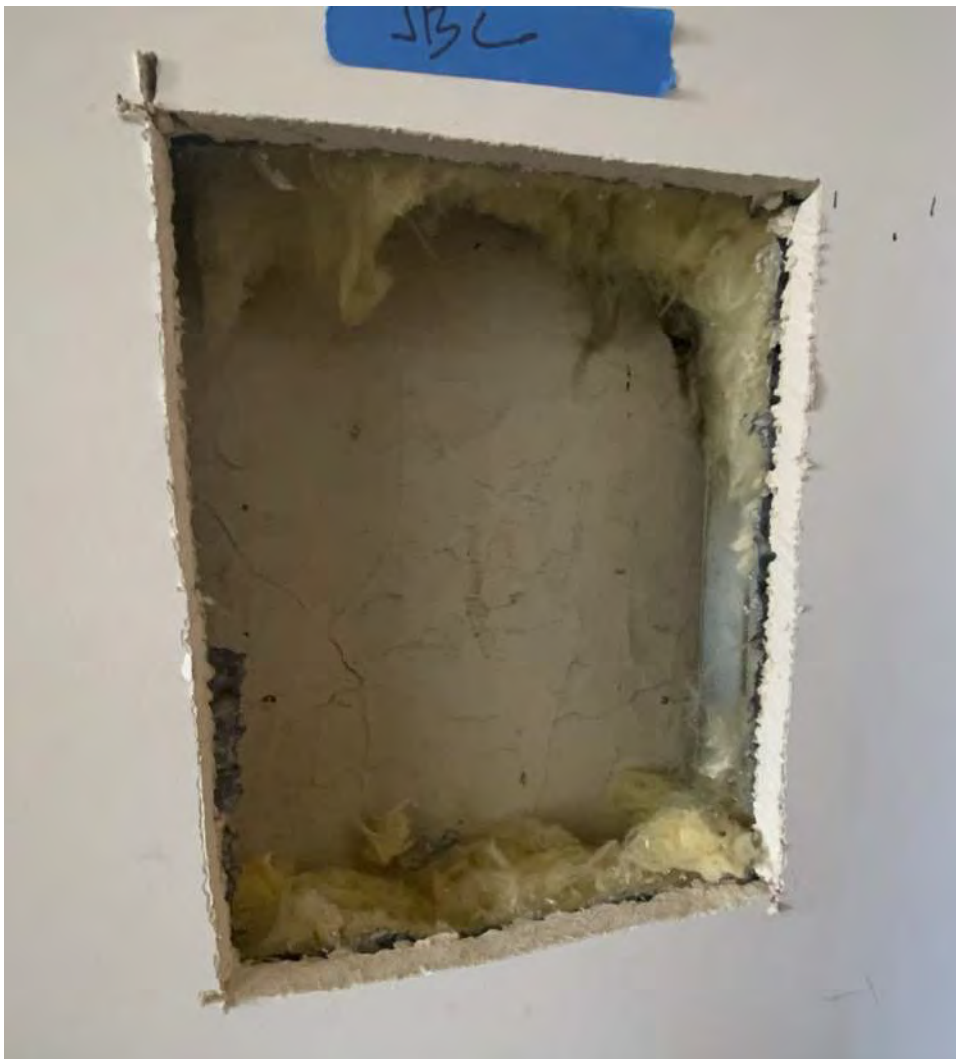
<b>PROBE #11</b>	<b>LOCATION</b> Corridor 303, West Wall
	<b>DESCRIPTION</b> <p>Investigative probe #11 was conducted along the west wall of Corridor 303 adjacent to masonry opening 308. The purpose of this probe was to locate original historic plaster or other finishes. The opening cut into the gypsum drywall finish was approximately 12" x 12". The existing drywall was installed on 2-1/2" metal studs offset from the brick masonry approximately 1".</p> <p>The existing finish behind the drywall was a 3-coat plaster installed against the historic brick masonry.</p>

**Figure PR11-1:** Opening cut in existing drywall along the west wall of Corridor 303.

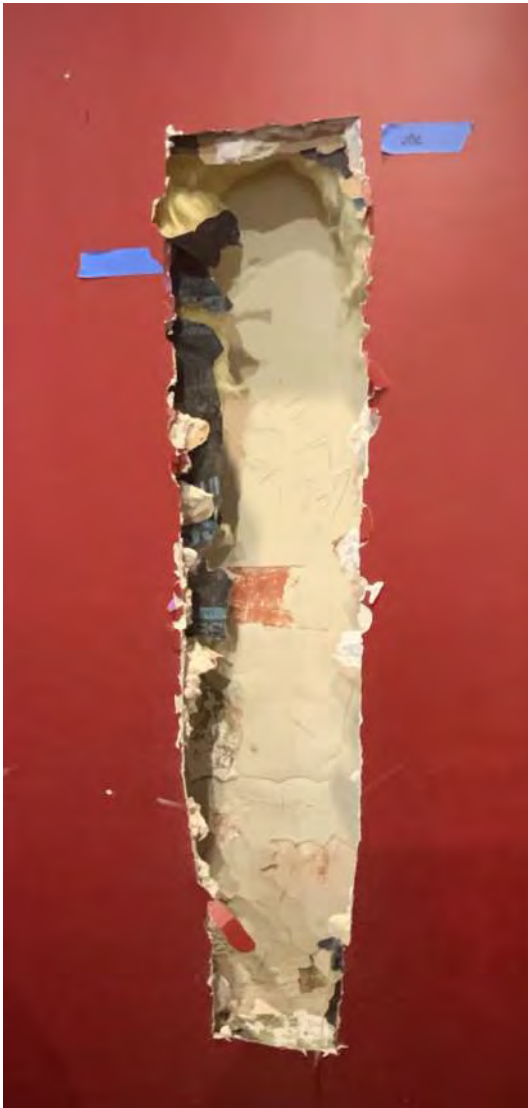
<b>PROBE #12</b>	<b>LOCATION</b> Office 304, East Wall at Chimney #2
	<b>DESCRIPTION</b> Investigative probe #12 was conducted at the finished surface of Chimney #2 along the east elevation of Office 304. The purpose of this probe was to locate original historic plaster or other finishes. The opening cut into the gypsum drywall finish was approximately 12" x 60". The existing drywall was installed on 2-1/2" metal studs offset from the brick masonry approximately 1".  The existing finish behind the drywall was a 3-coat plaster installed against the historic brick masonry. The existing finishes were not removed to locate the original fireplace location at Chimney #2.

**Figure PR12-1:** Opening cut in existing drywall along the east wall of Office 304 at Chimney #2.

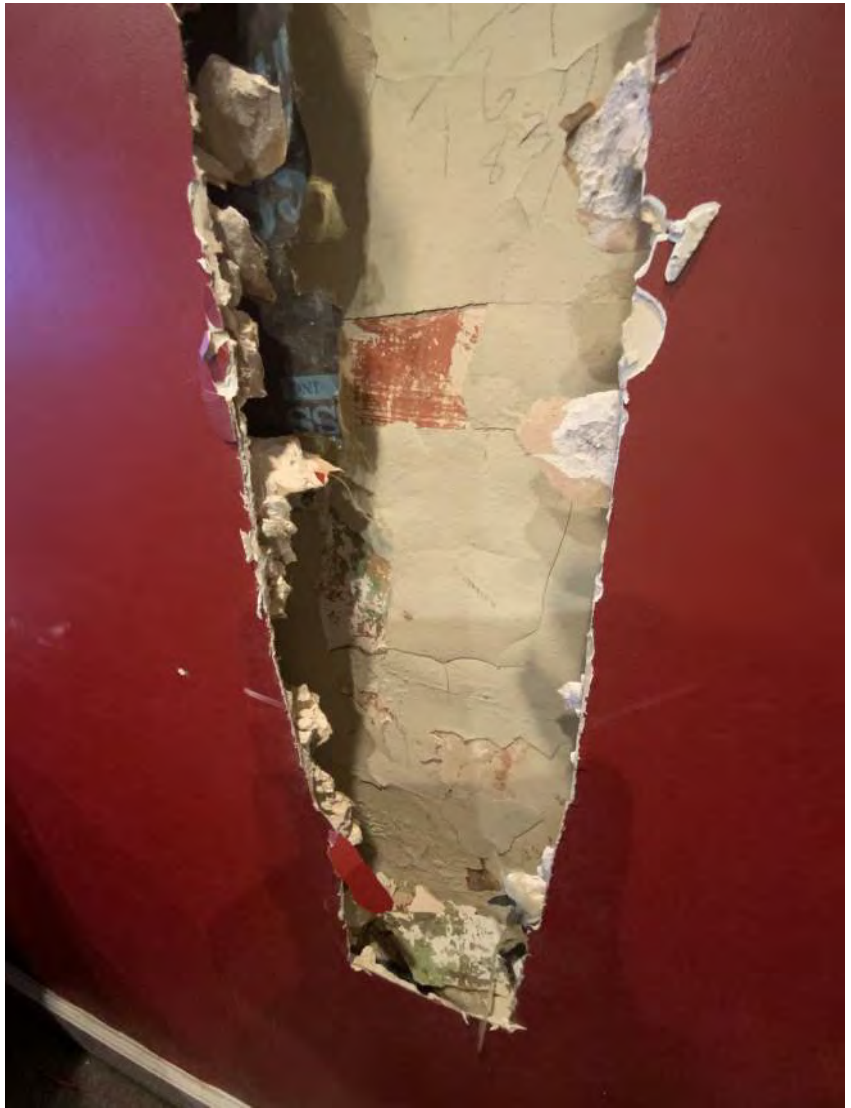
**Figure PR12-2:** Detail of historic plaster finishes found at investigative probe #12.

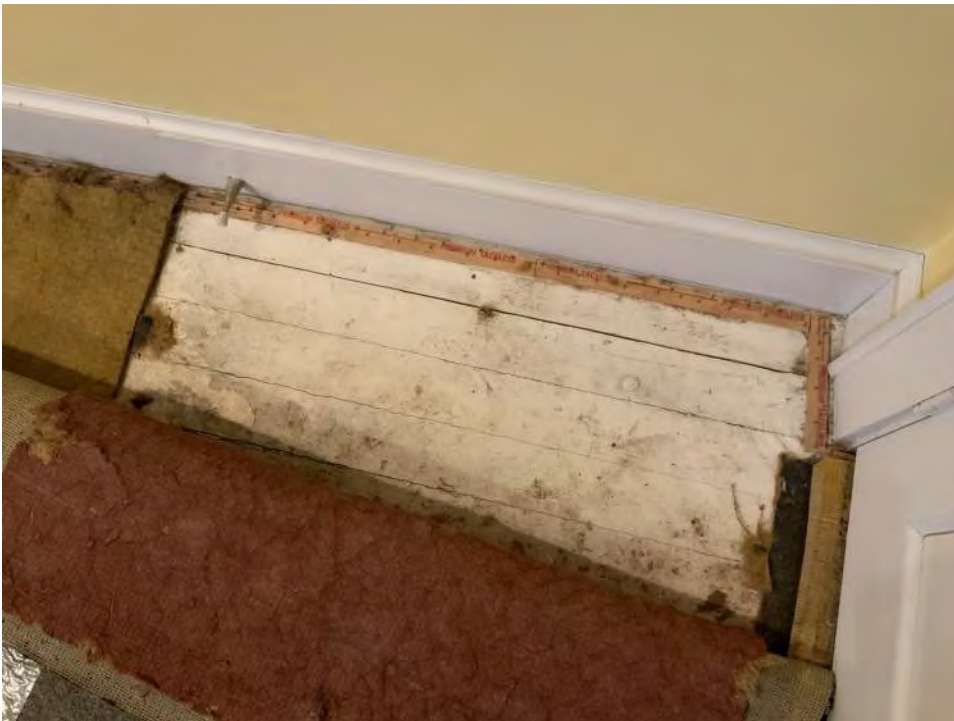
<b>PROBE #13</b>	<b>LOCATION</b> Office 304, Floor
	<b>DESCRIPTION</b> <p>Investigative probe #13 was conducted within Office 304. The purpose of this probe was to locate historic wood flooring underneath the existing finishes. The existing carpet was pulled back to reveal the underlying substrate.</p> <p>Random width tongue and groove wood flooring was located beneath the existing carpet. It may be original, but there is limited evidence to determine the age of this flooring. It is also coated in mastic/ adhesive from the carpet.</p>

**Figure PR13-1:** Detail of historic wood flooring located under existing carpet .

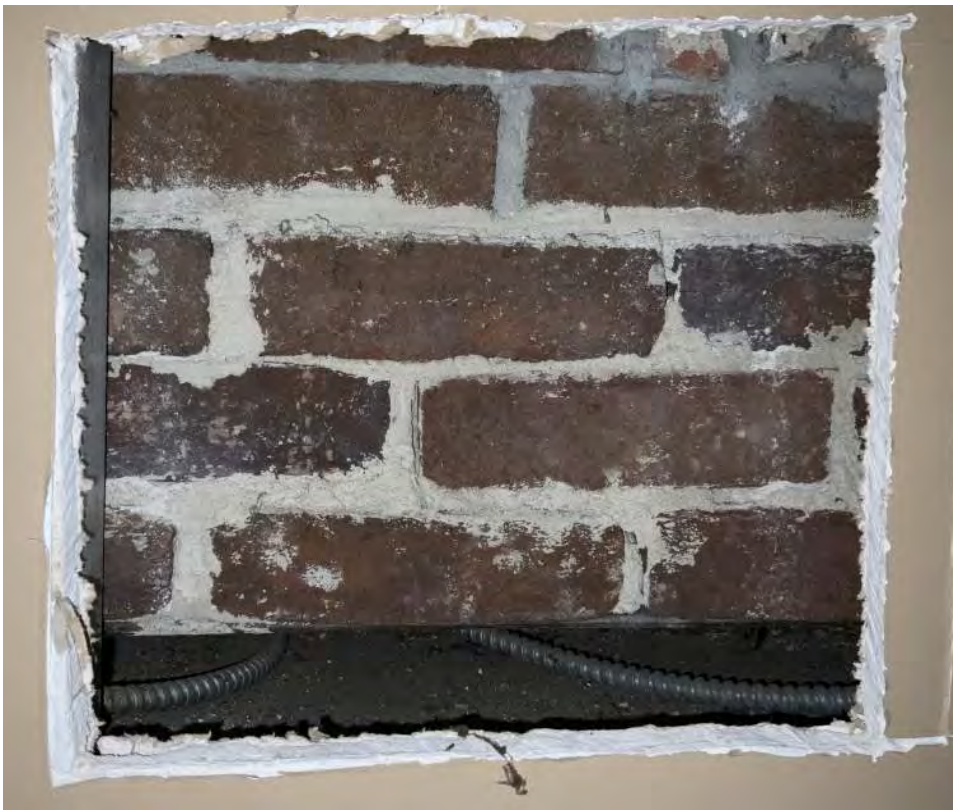
<b>PROBE #14</b>	<b>LOCATION</b> Corridor 305A, South Wall Masonry Opening 308 Lintel
	<b>DESCRIPTION</b> <p>A probe was conducted above masonry opening 308 at the south wall of Corridor 305A. The purpose of this probe was to locate identifying features of a prior window opening at this location. The opening cut into the gypsum drywall finish was approximately 12" x 12". The existing drywall was installed on 2-1/2" metal studs offset from the brick masonry approximately 1".</p> <p>The existing masonry opening is framed by a steel plate lintel and no evidence of a flat jack or segmental brick arch alluding to a historic masonry opening was found. Prior repointing campaigns were also evident.</p>

**Figure PR14-1:** Opening cut in existing drywall along the south wall of Corridor 305A above masonry opening 308.

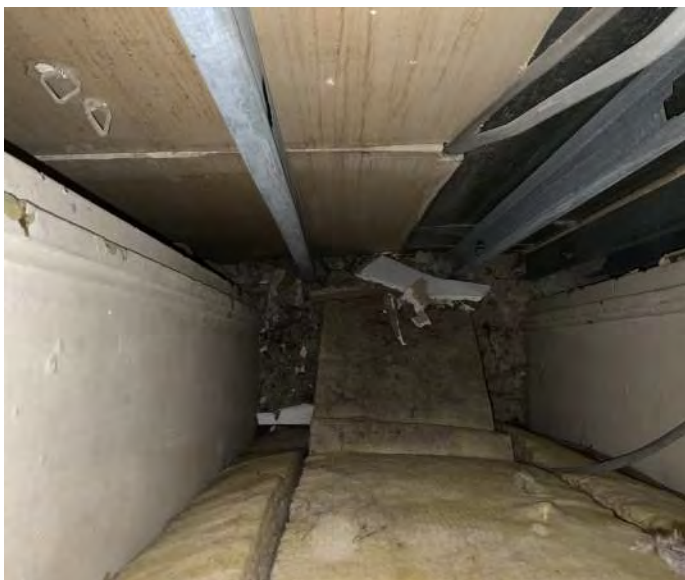
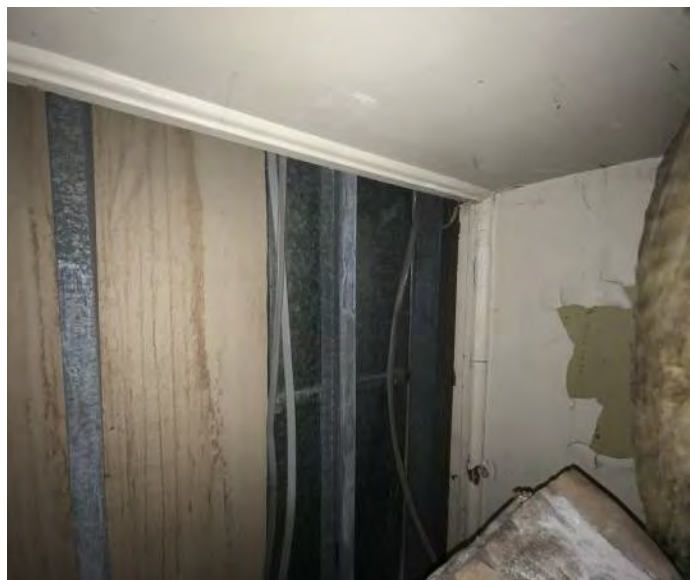
<b>PROBE #15</b>	<b>LOCATION</b> Corridor 305A, South Wall at Concealed Door within North Wall of South Block
	<b>DESCRIPTION</b> <p>A probe was conducted along the south wall of Corridor 305A. The purpose of this probe was to locate a prior door opening at this location which was identified as an existing condition in the demolition drawings of the 1985 Dunston Renovation. The opening cut into the gypsum drywall finish was approximately 12" x 12". The existing drywall was installed on 2-1/2" metal studs offset from the brick masonry approximately 1".</p> <p>The prior door opening at this location was found and the historic wood casing and frame was intact. The door has been removed as the back side of this opening has been blocked by the drywall partition which frames the north wall of Mechanical Closet 304A. This doorway is assumed to date to Period 4A or 4B.</p>

**Figure PR15-1:** Prior door opening located within in the north wall of the South Block.

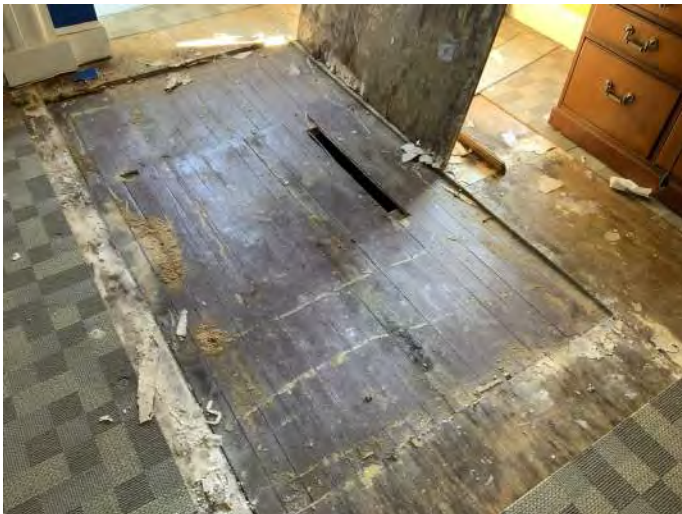
<b>PROBE #16</b>	<b>LOCATION</b> Office 402, Floor
	<b>DESCRIPTION</b> <p>Investigative probe #16 was conducted within Office 402. The purpose of the probe was to uncover original floor finishes. The existing carpet tile was removed which revealed a plywood subfloor beneath. Several screws at the perimeter of a plywood panel were removed to pull up the existing plywood. Historic wood flooring was located under the plywood.</p> <p>Located just southwest of Chimney #1, an access panel was located which included evidence of prior hinges along one side. It is believe this may have been the early access to the attic space prior to period 4B which the mansard roof was added making the attic a larger and more habitable space. In addition to the access panel, an existing floor board was removed to prove access to the wood floor framing below. A few original wood floor joists were present with select wood sistering of the joists.</p>

**Figure PR16-1:** Historic wood flooring uncovered from beneath a plywood subfloor and carpet tile.

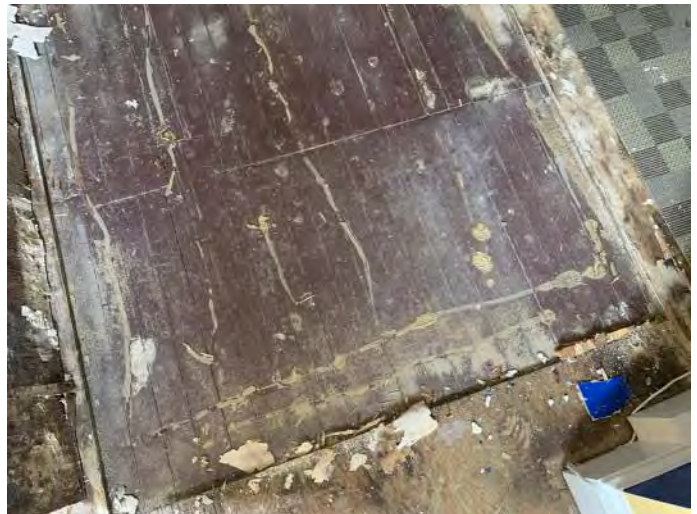
**Figure PR16-2:** Evidence of prior attic access through hinged panel in the floor.

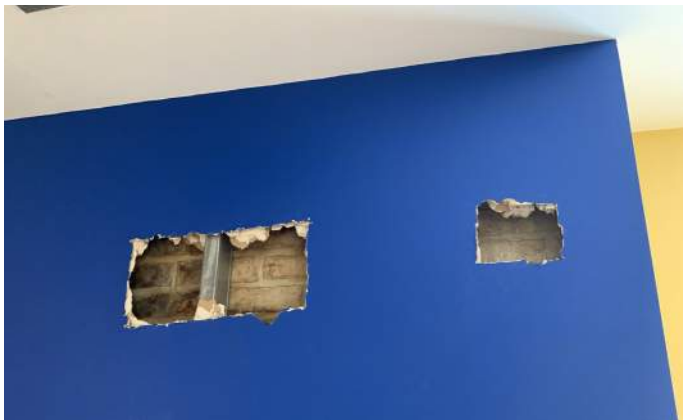
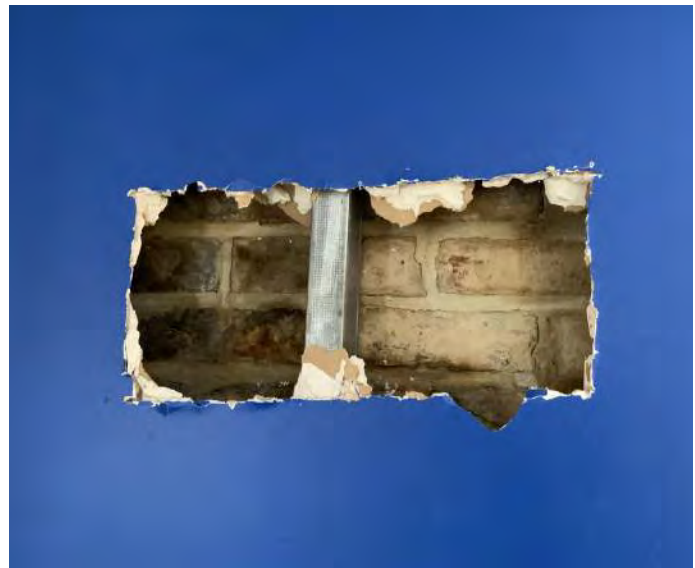
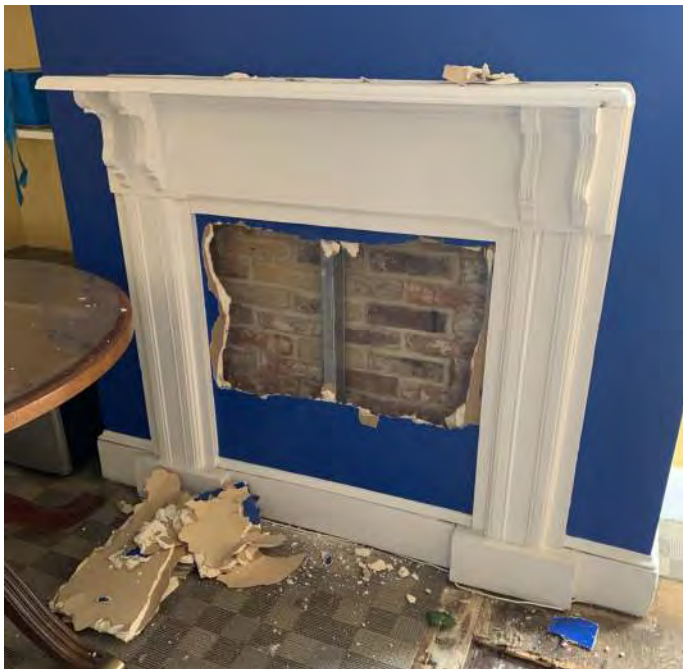
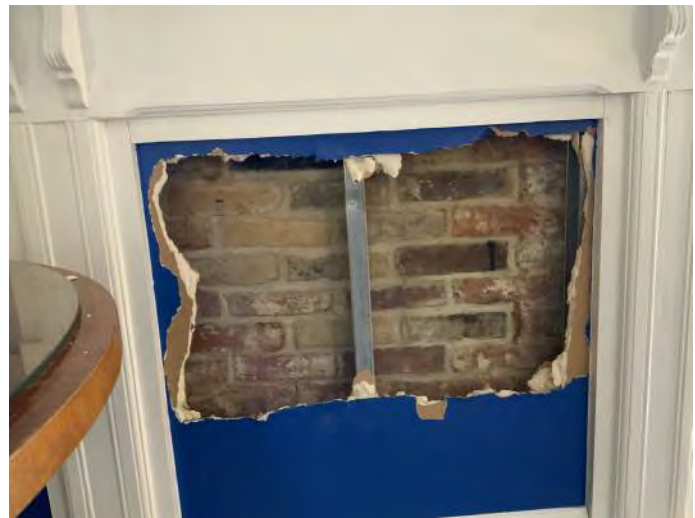
<b>PROBE #17</b>	<b>LOCATION</b> Office 402, East Wall at Chimney #1
	<b>DESCRIPTION</b> <p>Investigative probe #17 was conducted along the east wall of Office 402 at Chimney #1. The purpose of this probe was to locate original historic plaster or other finishes and identify any remaining evidence of the original pitched gable roof framing. The openings cut into the gypsum drywall finish was approximately 8" x 12" and 6" x 6" above the fireplace mantle and surround and 24" x 30" within the fireplace surround. The existing drywall was installed on 2-1/2" metal studs offset from the brick masonry approximately 1".</p> <p>No evidence of original plaster finishes were found. Also no evidence was located of the original roof framing and no original mortar was extant in the masonry of Chimney #1 as a recent repointing campaign was evident.</p>

**Figure PR17-1:** Opening cuts in existing drywall along the east wall of Office 402 at Chimney #1.

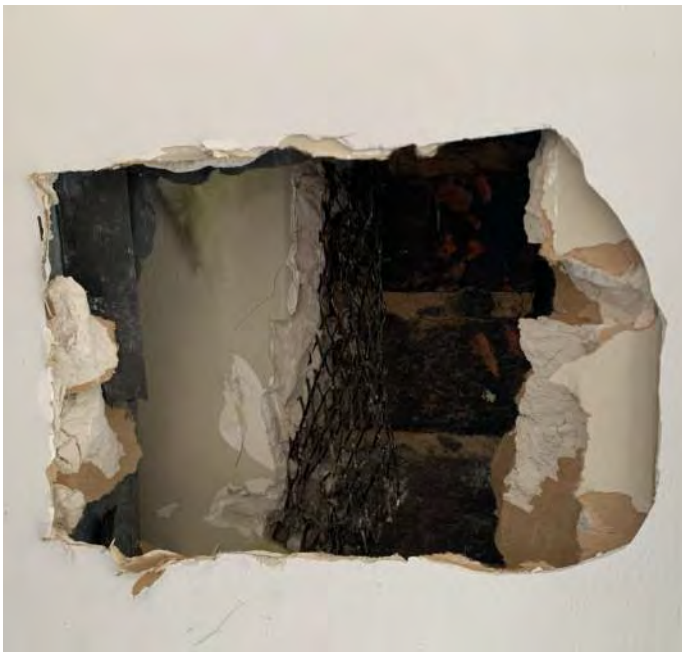
<b>PROBE #18</b>	<b>LOCATION</b> Office 403, East Wall at Chimney #2
	<b>DESCRIPTION</b> <p>Investigative probe #18 was conducted along the east wall of Office 403 at Chimney #3. The purpose of this probe was to locate original historic plaster or other finishes and identify any remaining evidence of the original pitched gable roof framing. The opening cut into the gypsum drywall finish was approximately 6" x 12". The existing drywall was installed on 2-1/2" metal studs offset from the brick masonry approximately 1".</p> <p>A plaster finish on metal lath was identified, but no evidence was located of the original roof framing.</p>

**Figure PR18-1:** Opening cut in existing drywall along the east wall of Office 403 at Chimney #2.

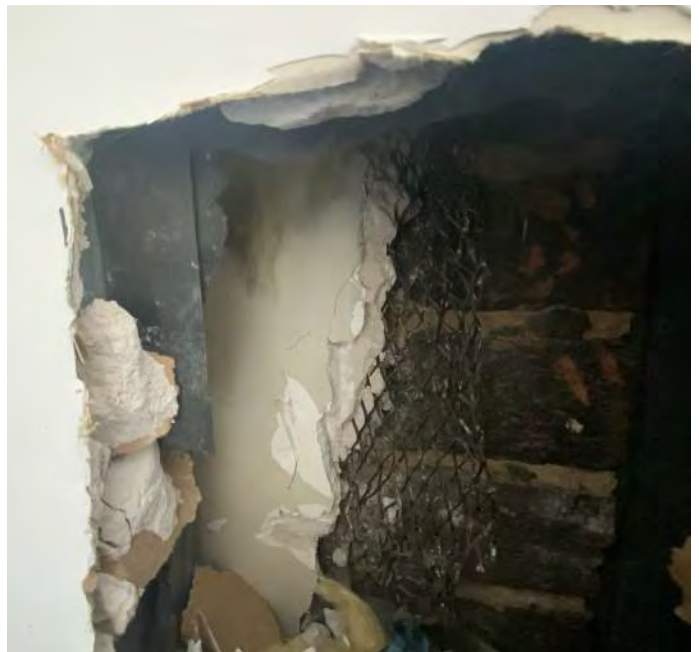
**Figure PR18-2:** Detail of historic plaster finishes found at investigative probe #18.

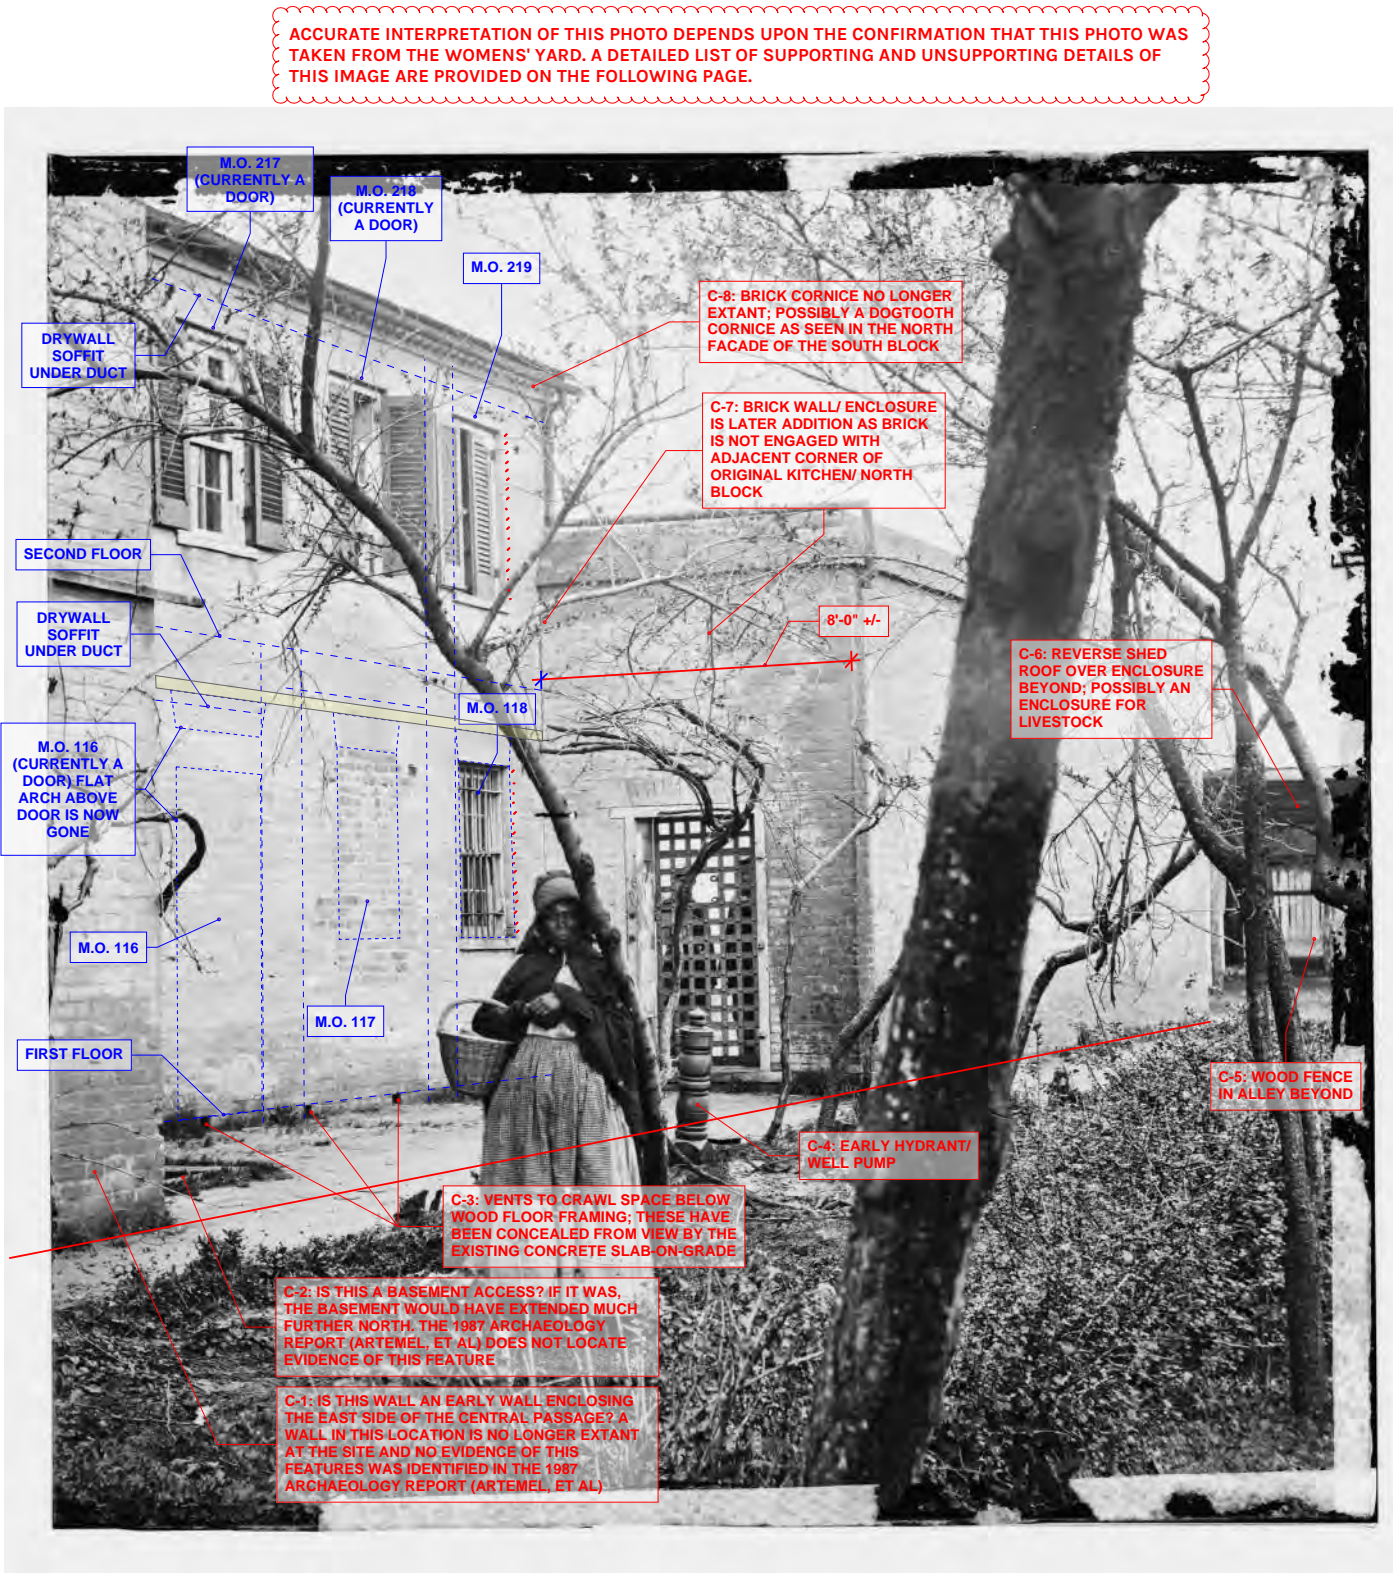
IMAGE C:  
Alexandria, Virginia. Slave pen. Exterior view (presumed)

**DETAILED ANALYSIS OF PHOTO WITH WOMEN CARRYING A BASKET (IMAGE C):**  
The historic photograph of the women carrying the basket has been studied carefully throughout the process of completing this Historic Structure Report. SmithGroup and Robinson and Associates have had many discussions with the City of Alexandria debating whether this image can be credited as a photo taken from within the work yard of 1315 Duke Street with the photographer’s back to the north wall of the Women’s Yard looking northwest towards the east facade of the North Block. There are many features depicted in this photograph which could be identified at 1315 Duke Street, but there are also other aspects which do not align with what we know of the site and the evolution of the structure that can also be verified by historic documents, records, maps, and photographs. The following provides a description of these features and explains what is identified as possible similarities and what seems to contradict our historic understanding of the site and structure.

It should be noted that these characteristics could be associated with many other 19th century outbuildings in the area. Also, upon careful inspection of existing conditions at 1315 Duke Street, it appears that there may not be enough space between the masonry openings in this historic photograph to align with the existing conditions on site. Some of this could be attributed to the perspective and possible distortion of this image, but in many locations specific brick courses can be compared between the photograph and existing conditions that challenge the association of this building with the North Block. It was also difficult to align specific header courses to validate the accuracy of the comparison.

**STAVE PEN OUTBUILDING**  
The north structure seen in this historic photograph with the iron grated door behind the woman is a structure that has not been identified in other historic maps and photographs of 1315 Duke Street during this period. However, the raked brick detail at the top of the wall and the grated iron door do match the features seen at the mens’ and womens’ yard enclosures, and it appears to be open to above, as those yards were, at least in part. It should be noted that no evidence of this structure was identified in the 1987 archaeology report.

It should be noted that no evidence of this structure was identified in the 1987 archaeology report. Also challenging the association of this historic photograph is the placement of the assumed basement access mentioned above. Basement access at this location would imply that the existing basement of the South Block would have been much larger, extending a considerable distance further north. There has been no other evidence uncovered to support this theory. A few historic maps indicate evidence of a Central Passage connecting the South Block to the North Block, but no document identifies a structure that extended this far east.
