# 1315 DUKE STREET HISTORIC STRUCTURE REPORT

Alexandria, Virginia 22314

## FINAL REPORT

June 30, 2021

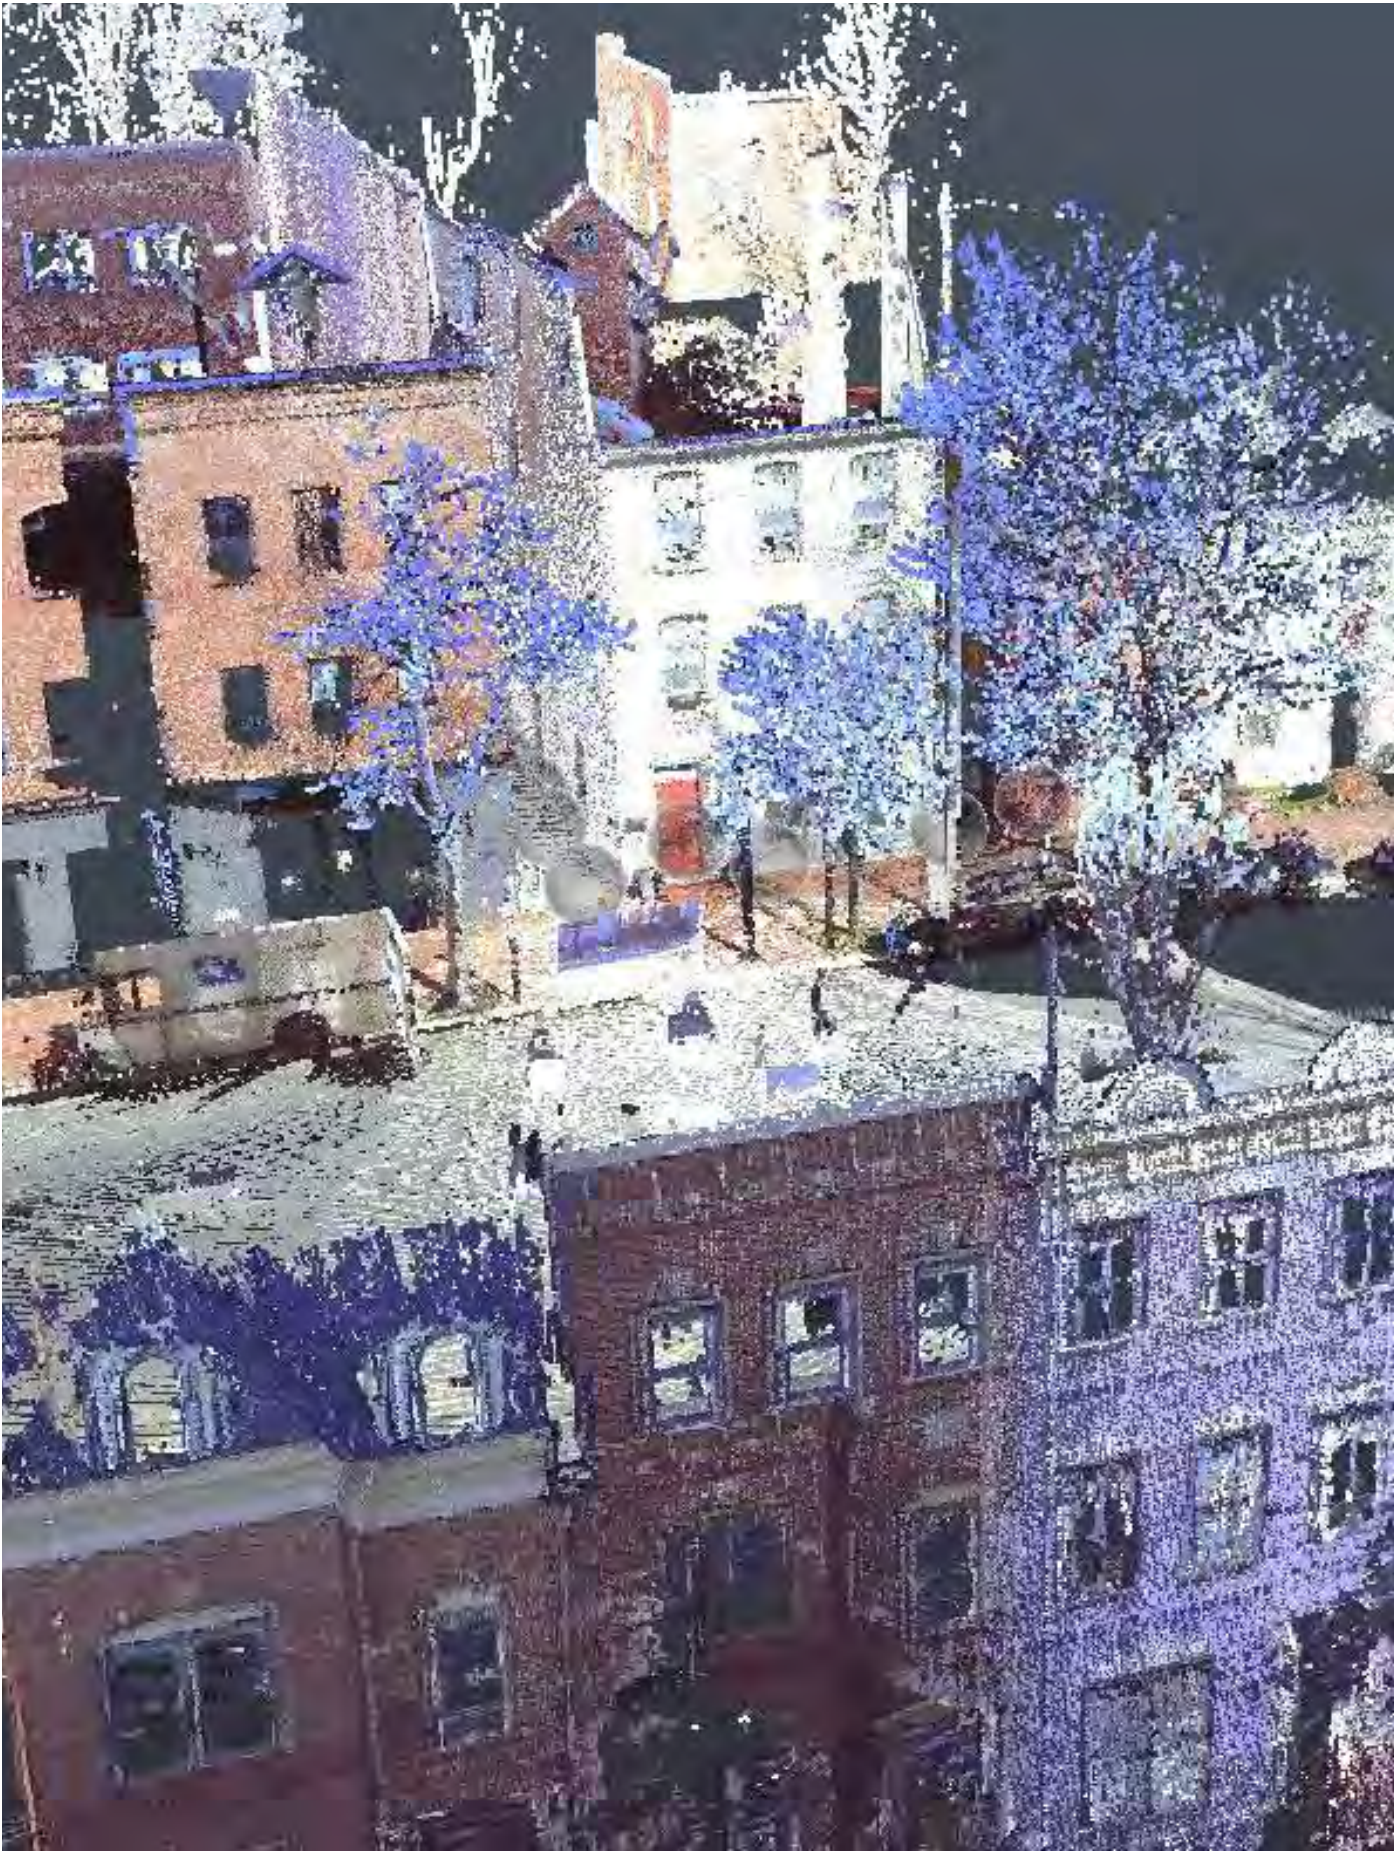
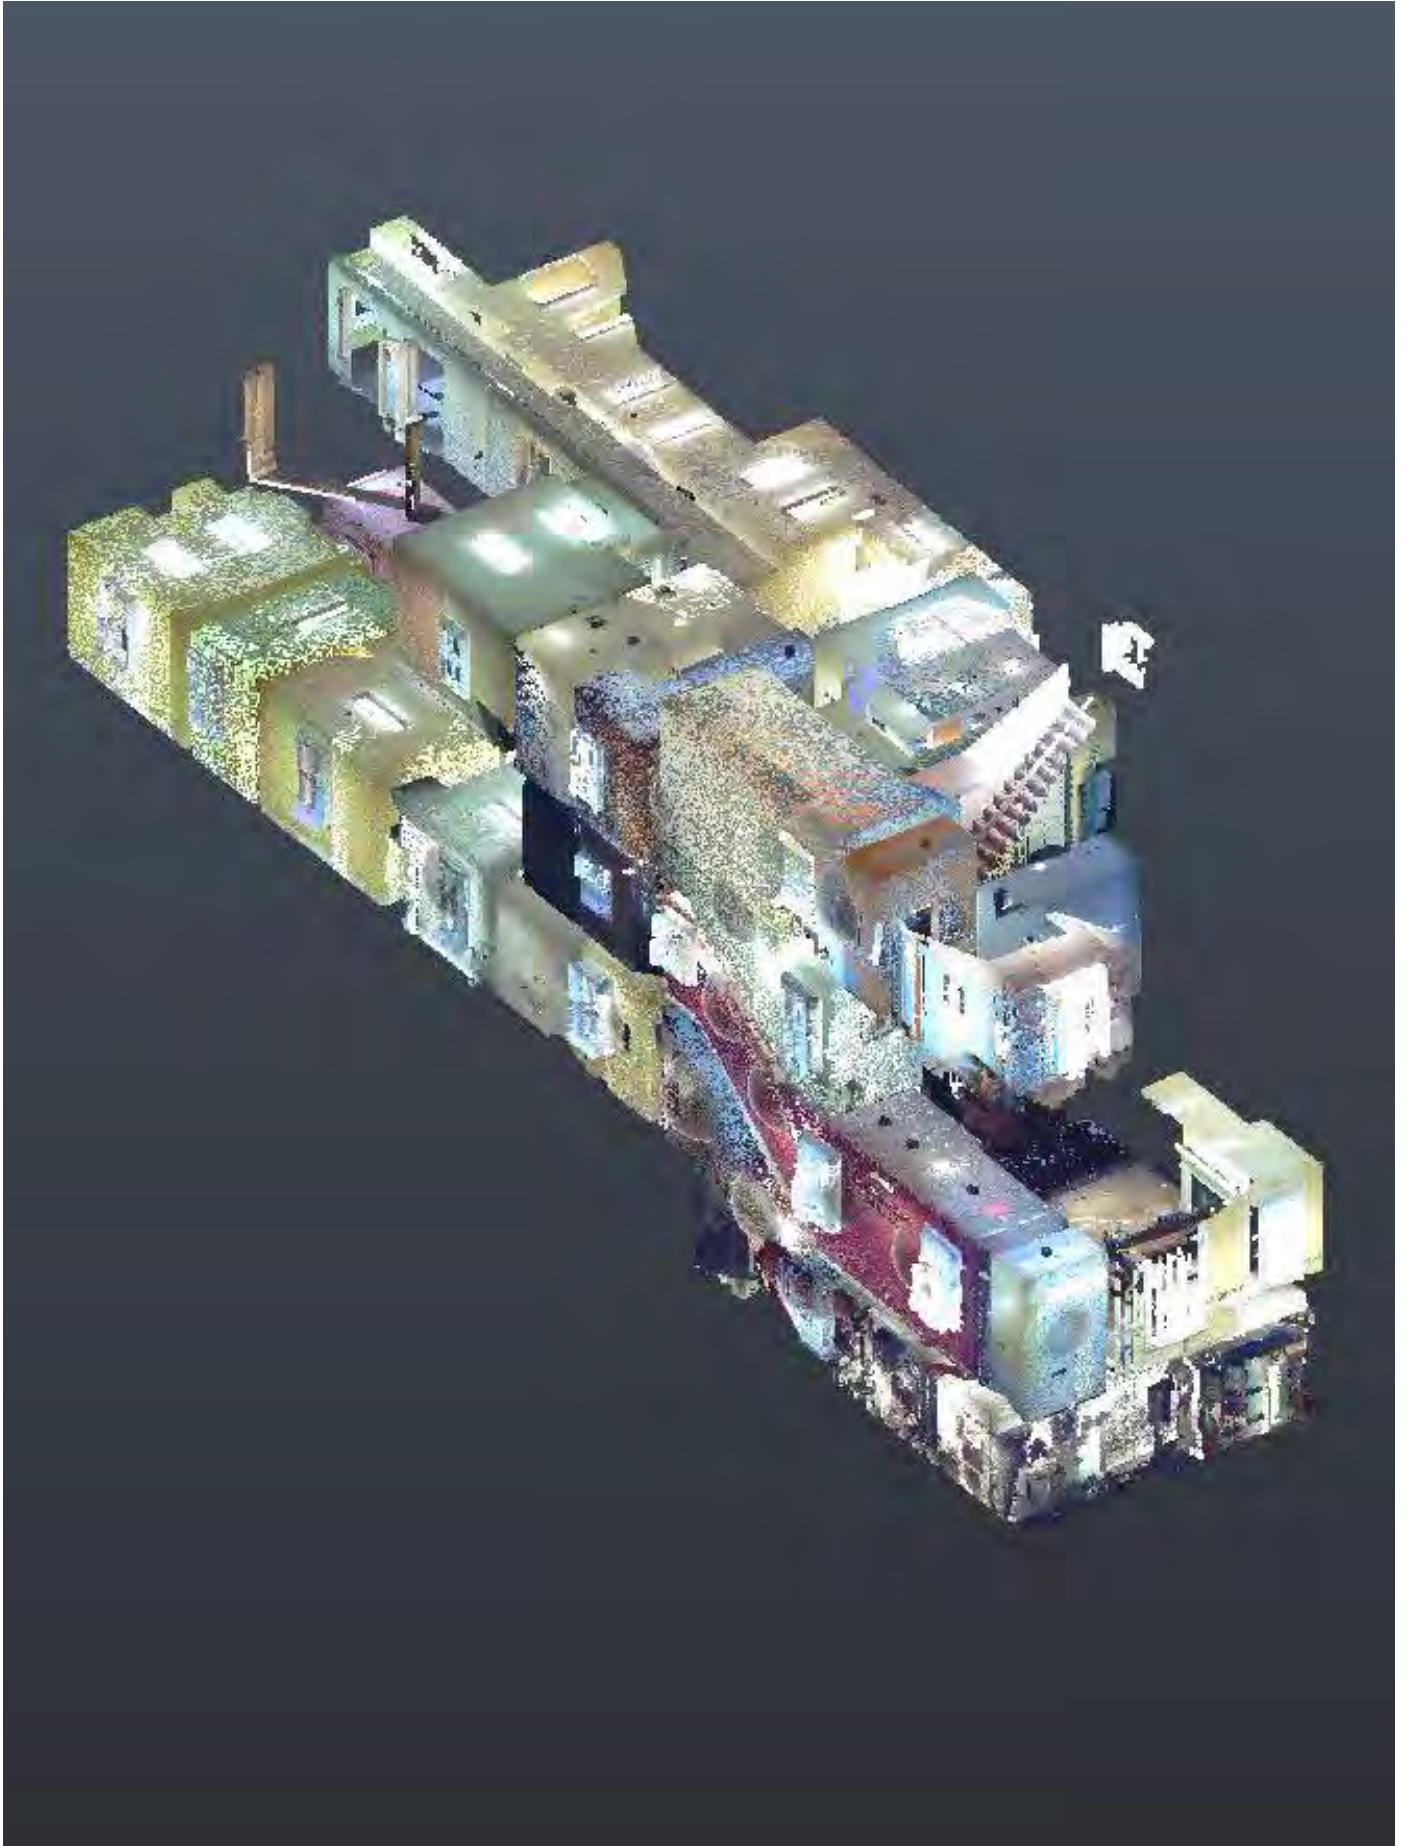
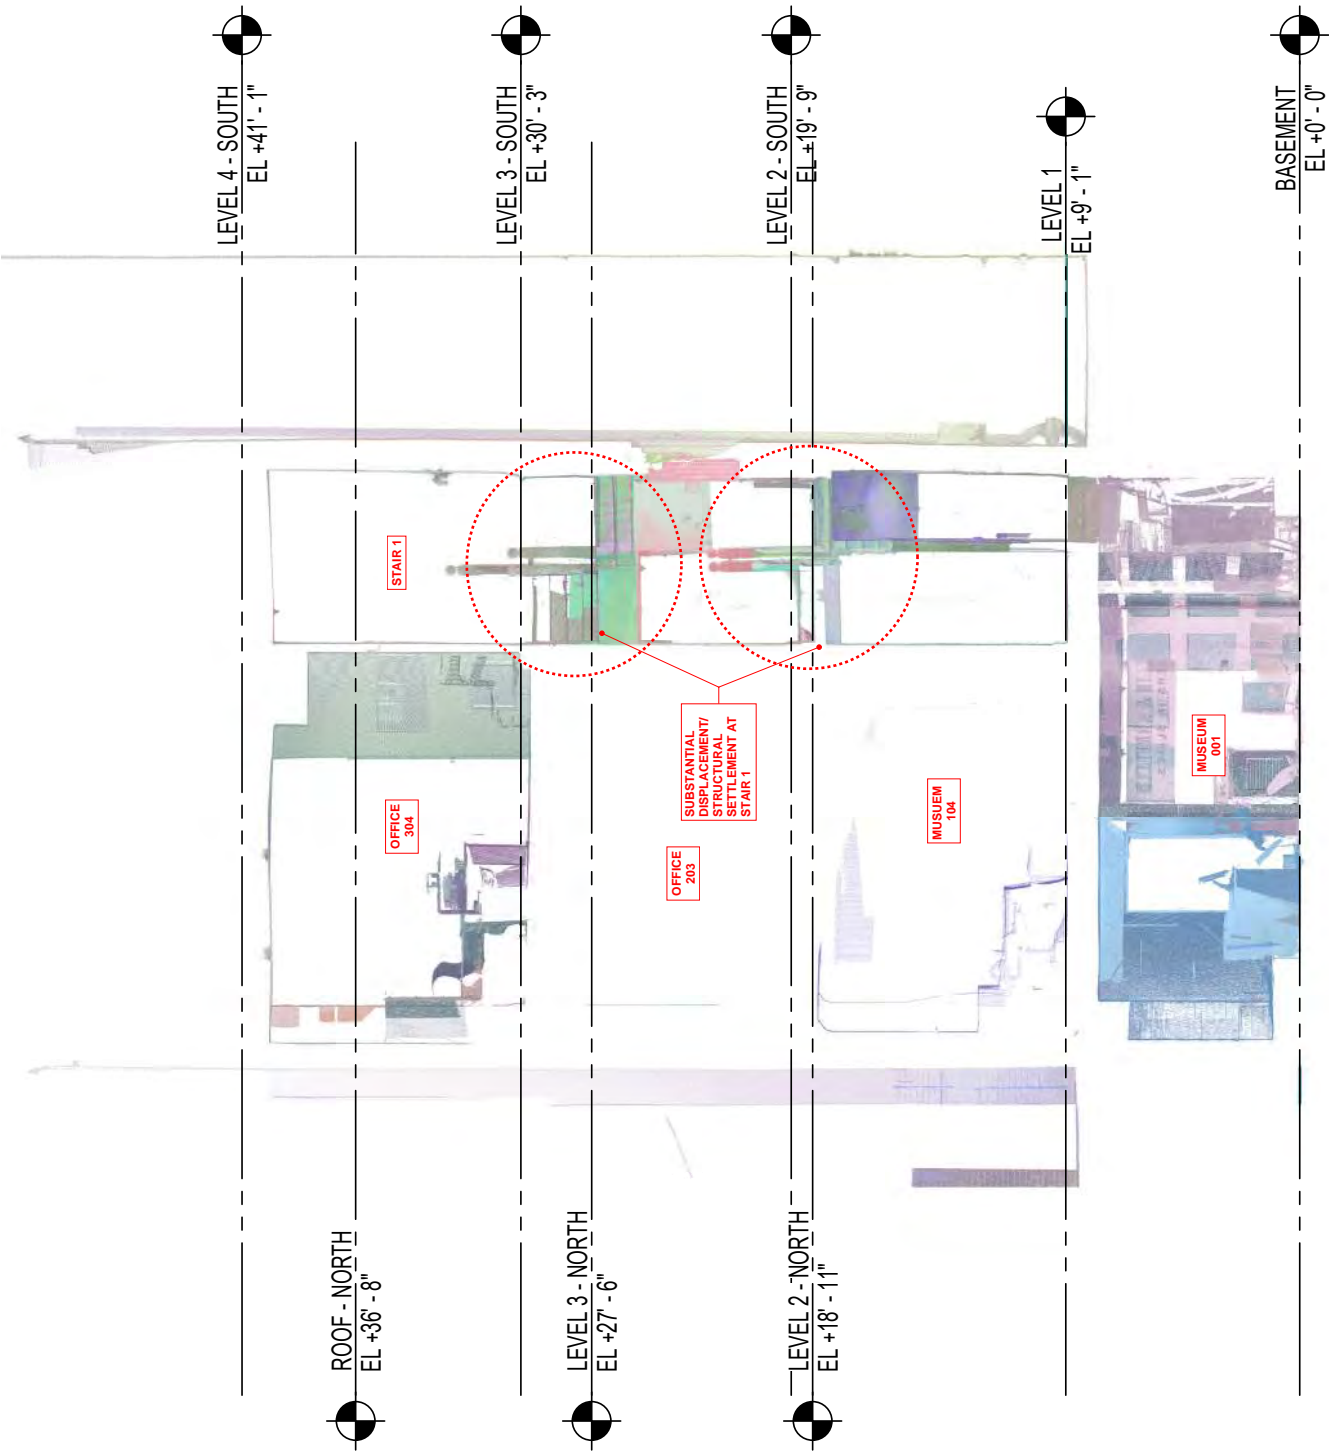
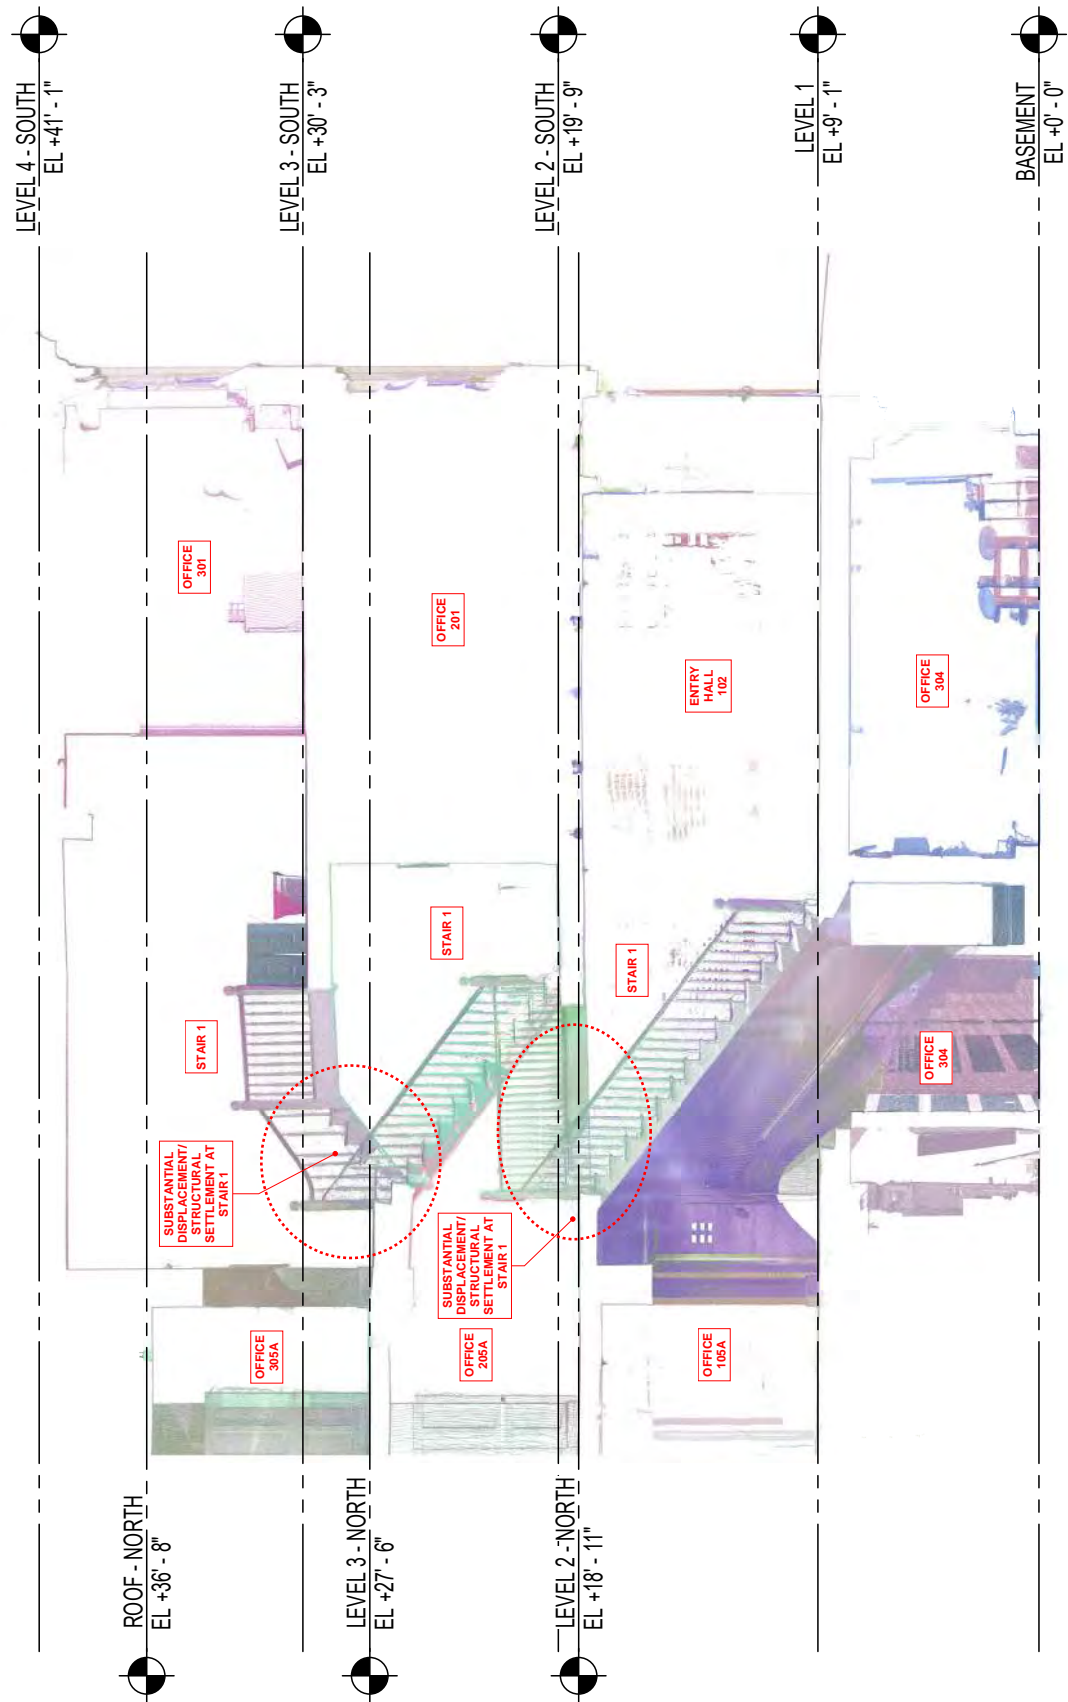
East/ West Section of Point Cloud

One notable finding, which was confirmed with dimensional accuracy in the point cloud, is the structural deformation and deflection of Stair 1. This deformation is very evident on the second and third floor landings of Stair 1. A more detailed description of this condition is provided by Silman in Part 2D of this Historic Structure Report.
