EXHIBITS

EXHIBIT 1:

JOINT TASK FORCE & SUBCOMMITTEE MEETINGS

A2 Services, Inc. Facility Survey of City of Alexandria - City Hall

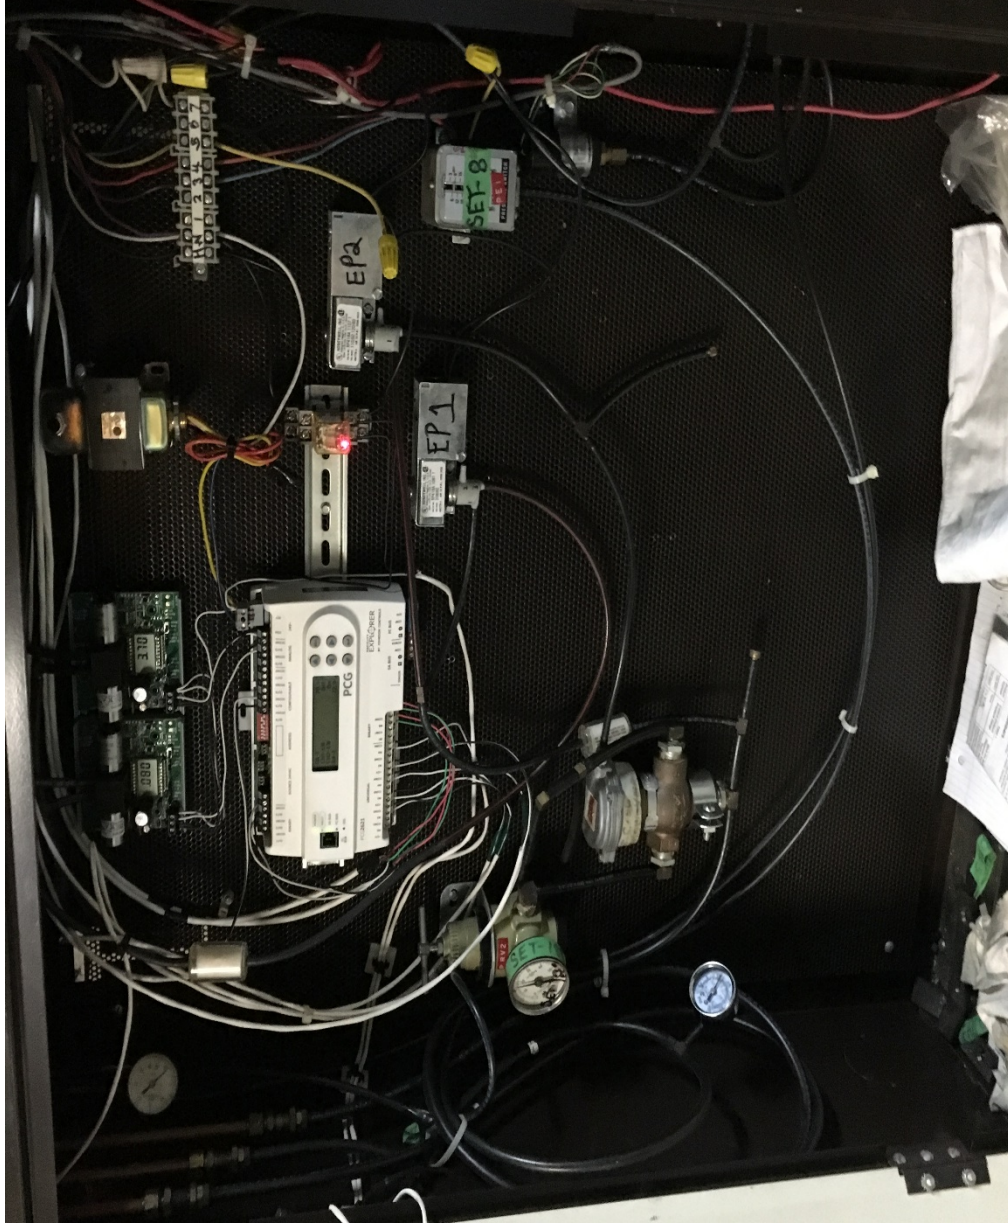
- Finding # - 6. The central plant and air handler controls are pneumatic. The controls are operating but will eventually need to be replaced. There is at least one actuator which should be replaced now. The steam control valve and actuator for the hot water convertor are in poor shape. If this device fails during the winter, the facility will not have heat.

Finding # 6 Photo. The picture is an example of the old pneumatic controls used to operate the boiler room systems and the air handlers systems in the building.

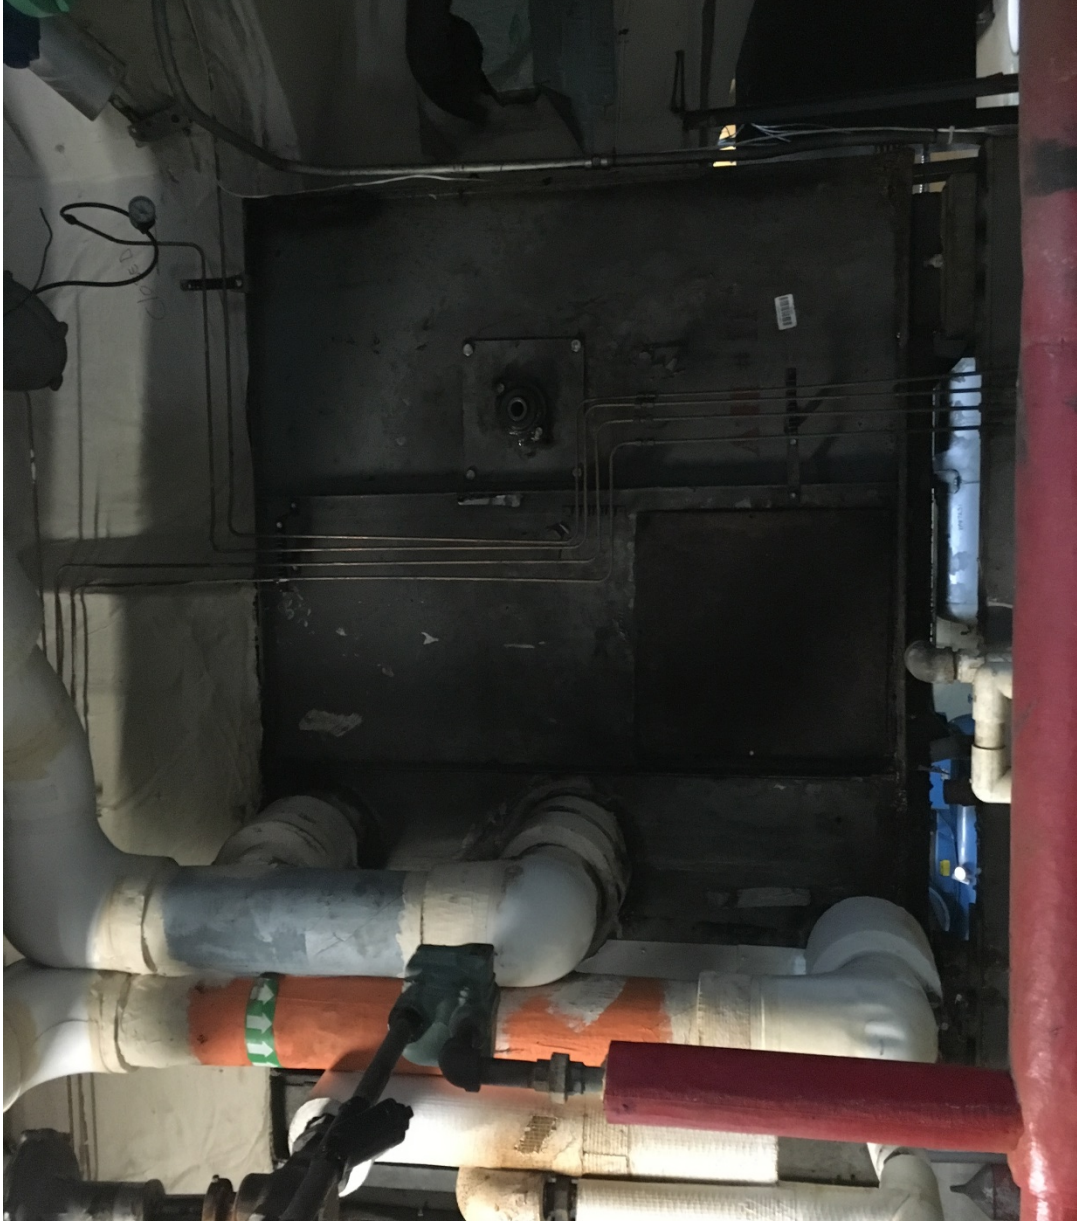
Finding # - 8. The main outside air fan for the building is small and only dumps conditioned outside air into the central corridor of the building. It appears that the fan coils do not have outside air vents and the ceiling hung air handlers do not have outside air fed to them either. This should be further investigated to make sure this finding is correct. The concern is a possibility that the office areas in the building may not be getting good fresh air ventilation.

Finding # 8 Photo. This picture is of the main outside air fan which filters, heats or cools the incoming air for building ventilation.

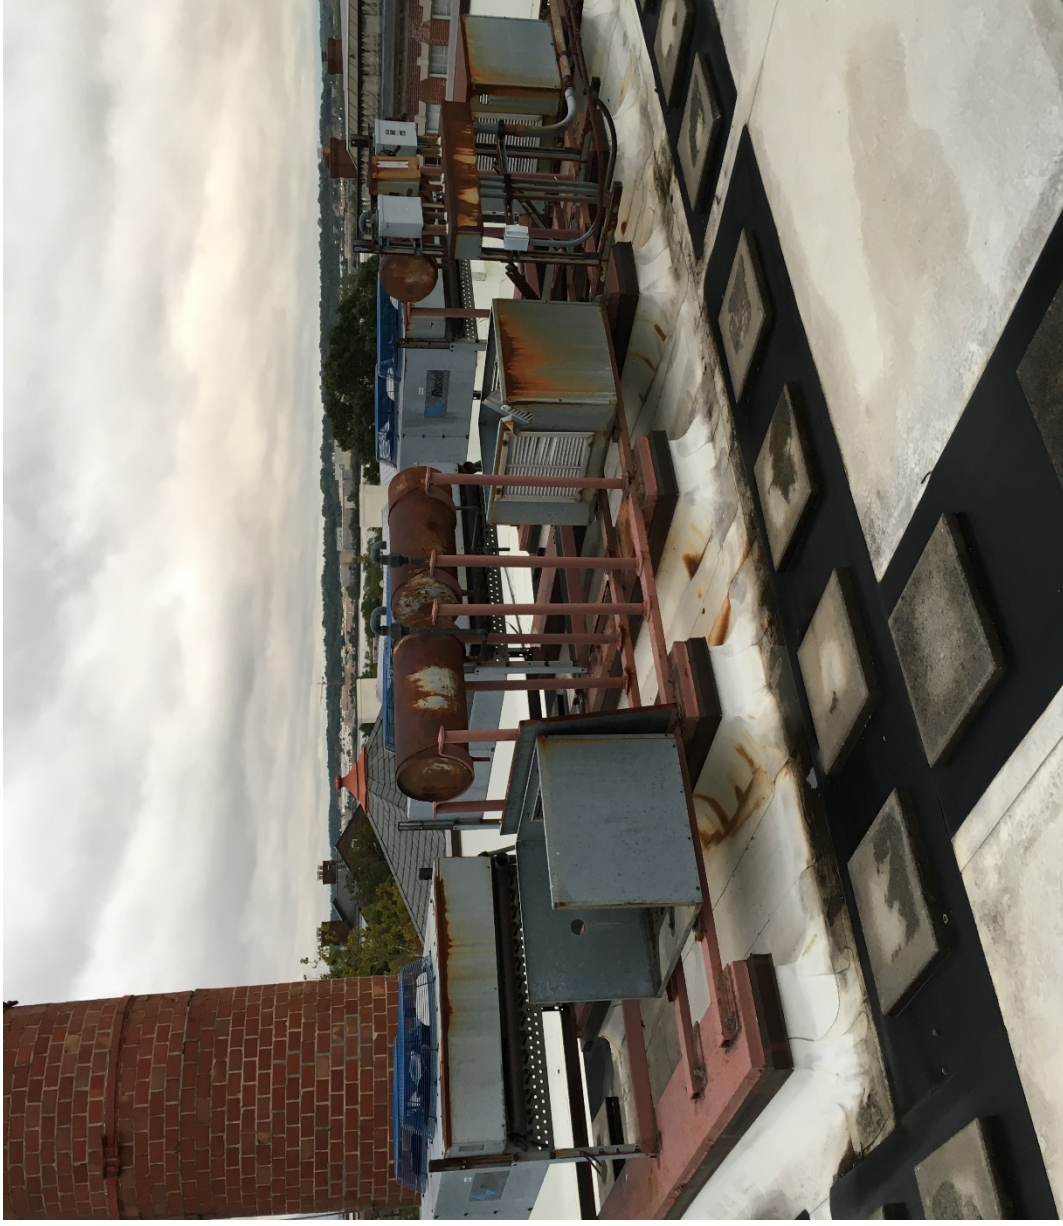
Finding # – 12. Two old dry coolers have been abandoned in place on the roof. This equipment should be removed and the roof penetrations patched and sealed over. This condition may start to cause leaks into the site.

Finding # 12 Photo. This picture notes the old dry cooler equipment abandoned in place.

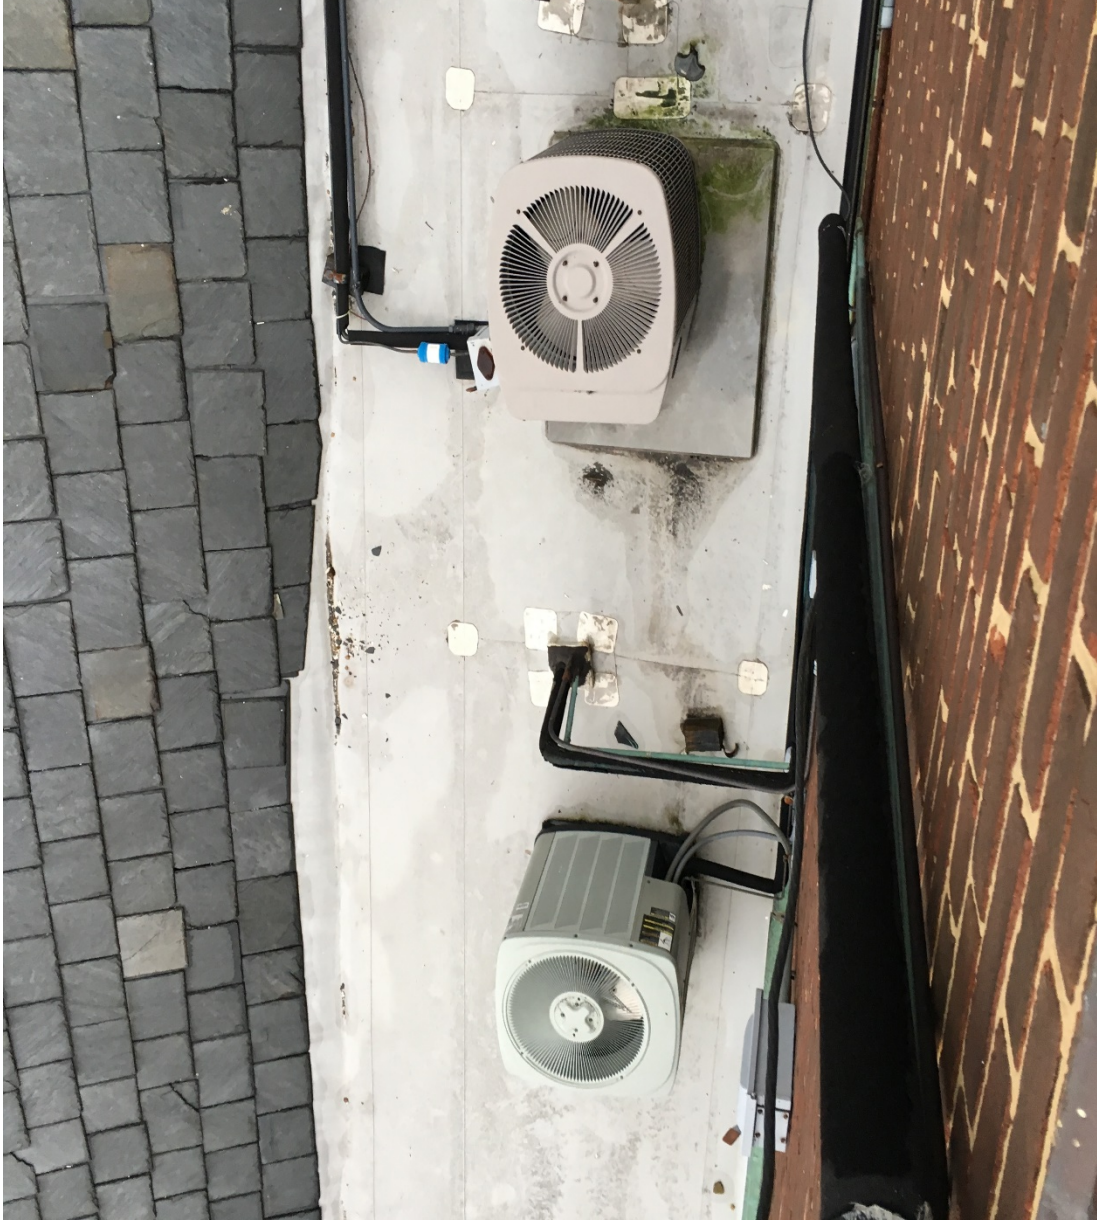
Finding # - 13. There are 24 split system heat pumps which are placed around the building to handle extra heating and cooling requirements in the building. Many of these units are very hard to access for repairs or service.

Finding # 13 Photo. This picture notes the difficult access to the HVAC units.

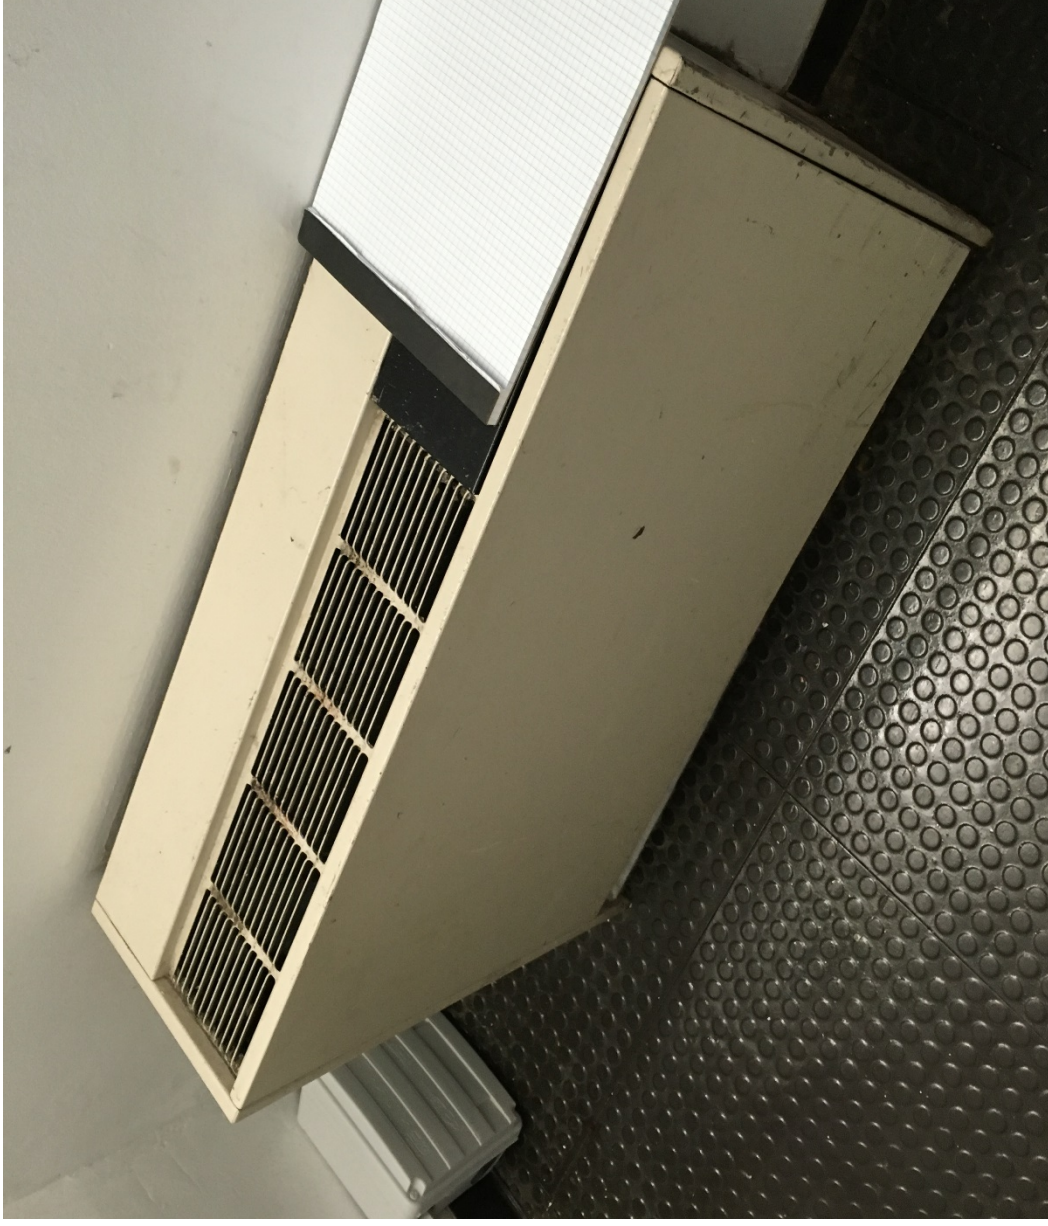
Finding # - 14. There are 180 fan coil units which are located under windows in offices and in areas around the building perimeter. These units need to be serviced and flushed regularly to eliminate condensate leaks. In many offices the staff have furniture in front of this equipment or covered so they cannot operate properly. This condition adds a lot of preparation time to get these units open for service. This equipment also causes condensate leaks in summer. The unit's condensate pans and drains should be flushed 2 to 3 times throughout the summer to eliminate the leaks.

Finding # 14 Photo. This picture is an example of one perimeter fan coil unit. This one is in an entrance way off the courtyard.

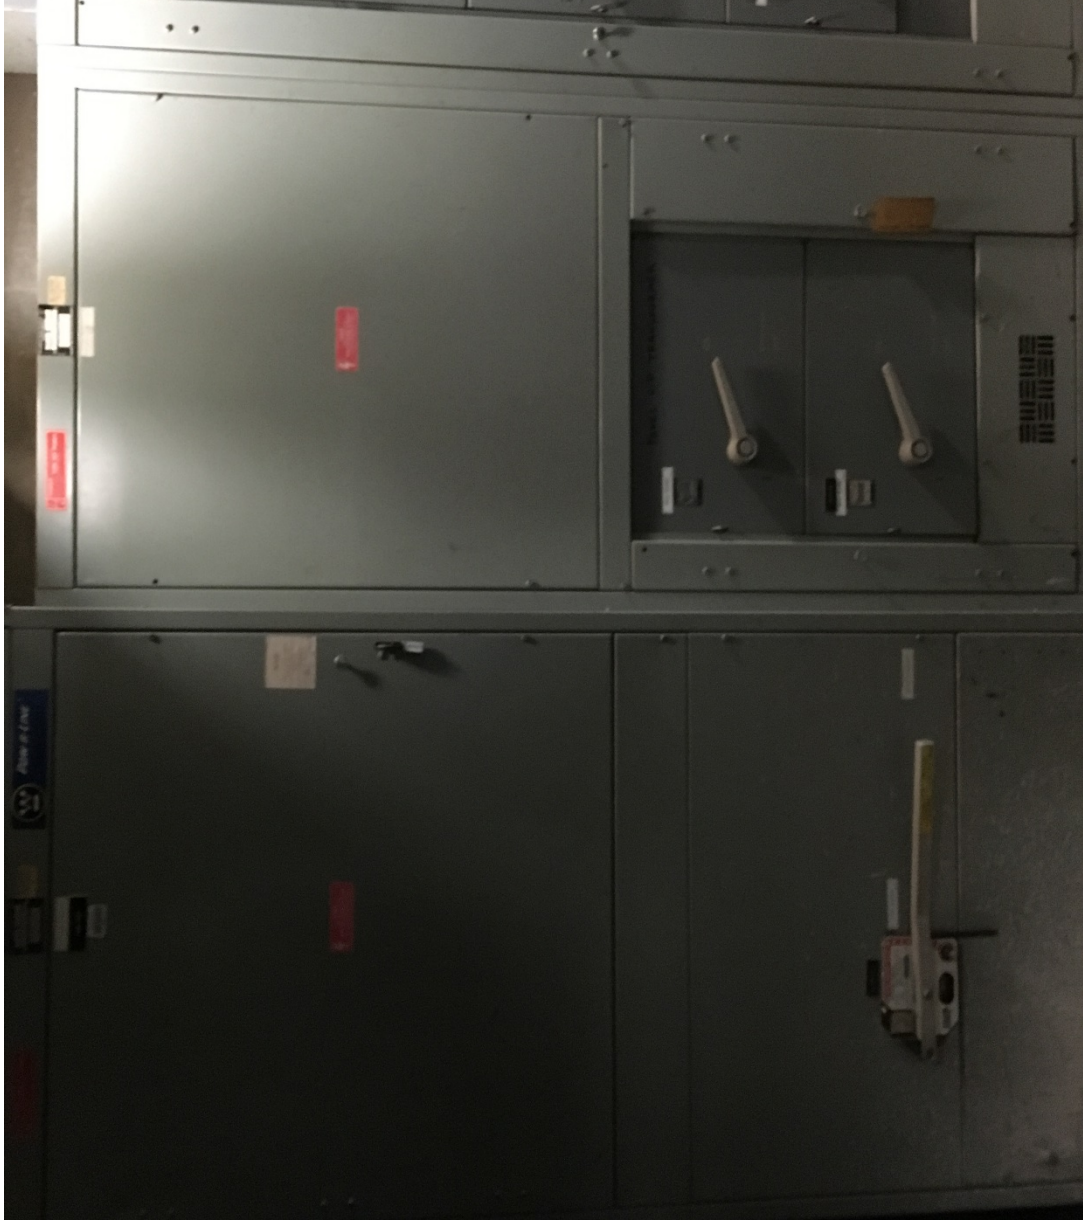
Finding # - 15. The main electrical panels and breakers panels at the site do not look as if they are being tested and serviced. All electrical systems should be thermally scanned with an infra-red camera to identify any overheating components or loose connections. This testing will identify such issues before a failure of the electrical system occurs. A2 recommends that all electrical gear be opened, thermally scanned then cleaned and all terminations checked of tightness every 2 to 3 years at a minimum. This an important risk management task that should be implemented. This maintenance is a code requirement. **REVISION – Per DGS an extensive survey of the electrical gear was performed in 2013-2014. A2 requests a copy of the report. Additionally, per DGS the gear is inspected by the DGS Master Electrician. There is no evidence of these inspections. In the future, A2 recommends that inspections stickers be affixed to the gear to denote the review. Finally, please see the attached electrical maintenance code requirements. The City of Alexandria is required to be in compliance with NFPA 70B.**

Finding # 15 Photo. This picture is an example of one main switch gear which does not look like it has been shut down for cleaning and tighten-up work. Infra-Red testing should also be implemented.

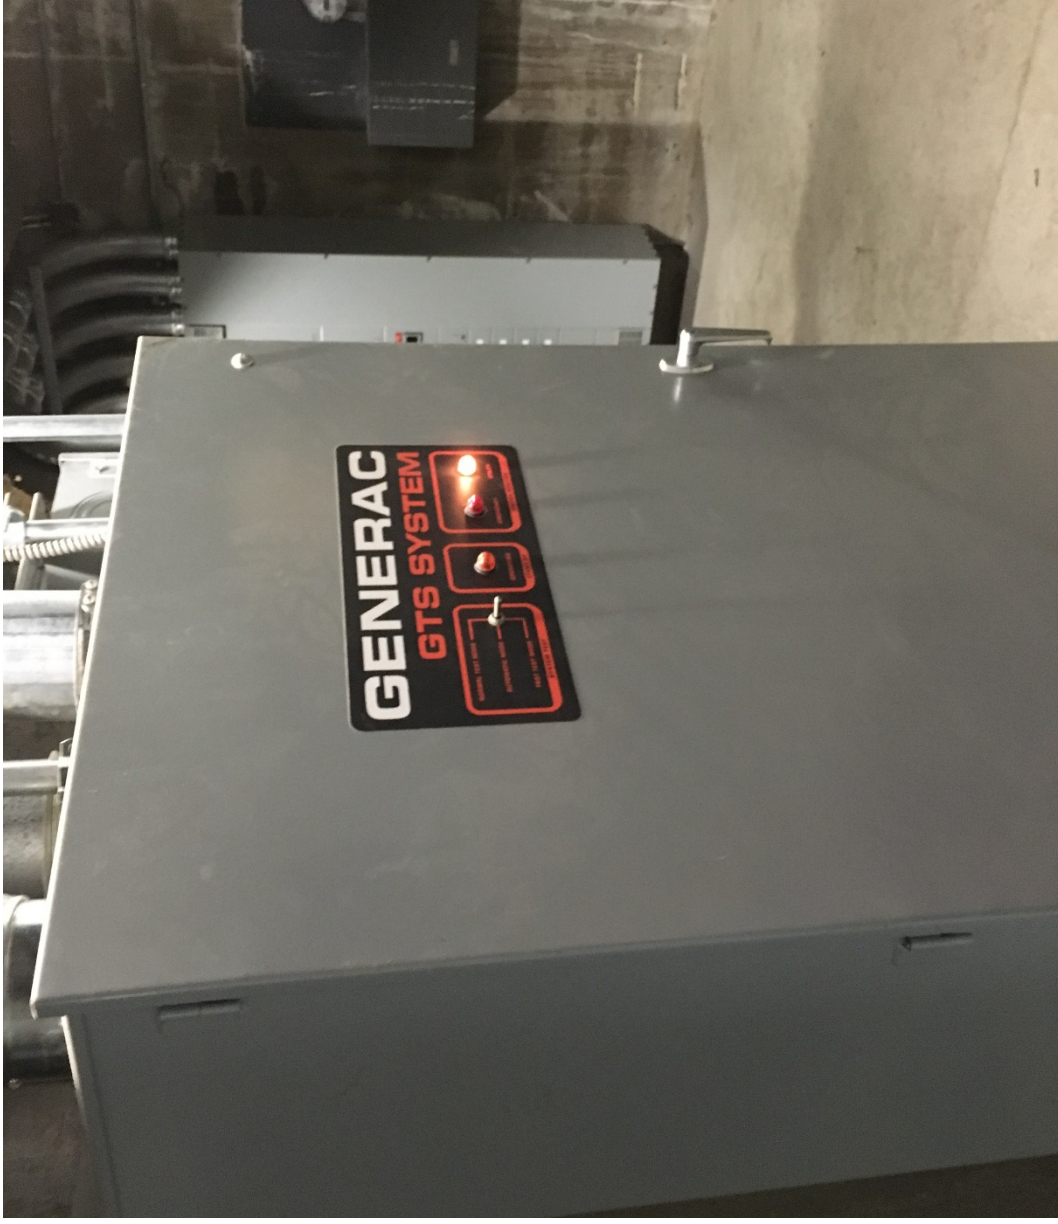
Finding # 16 Photos Continued. This picture is of one of the emergency transfer switches which should be tested.

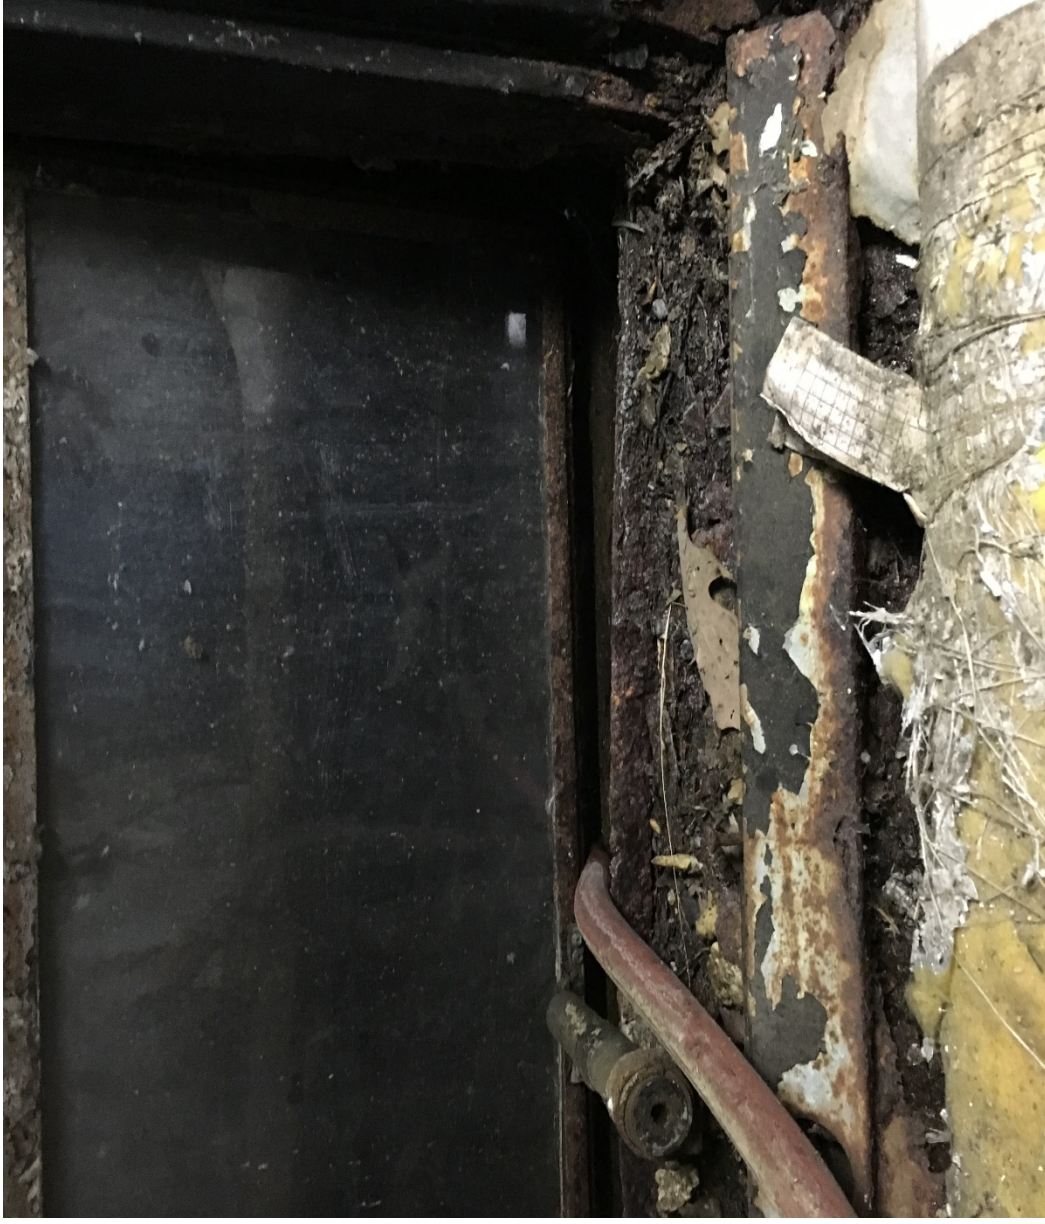
Finding # - 17. The outside air shaft drain outside the boiler room is plugged up allowing water to enter the boiler room through a window. This drain should be snaked or repaired.

Finding # 17 Photo. This picture notes the window where water is entering the boiler room from the outside air shaft.

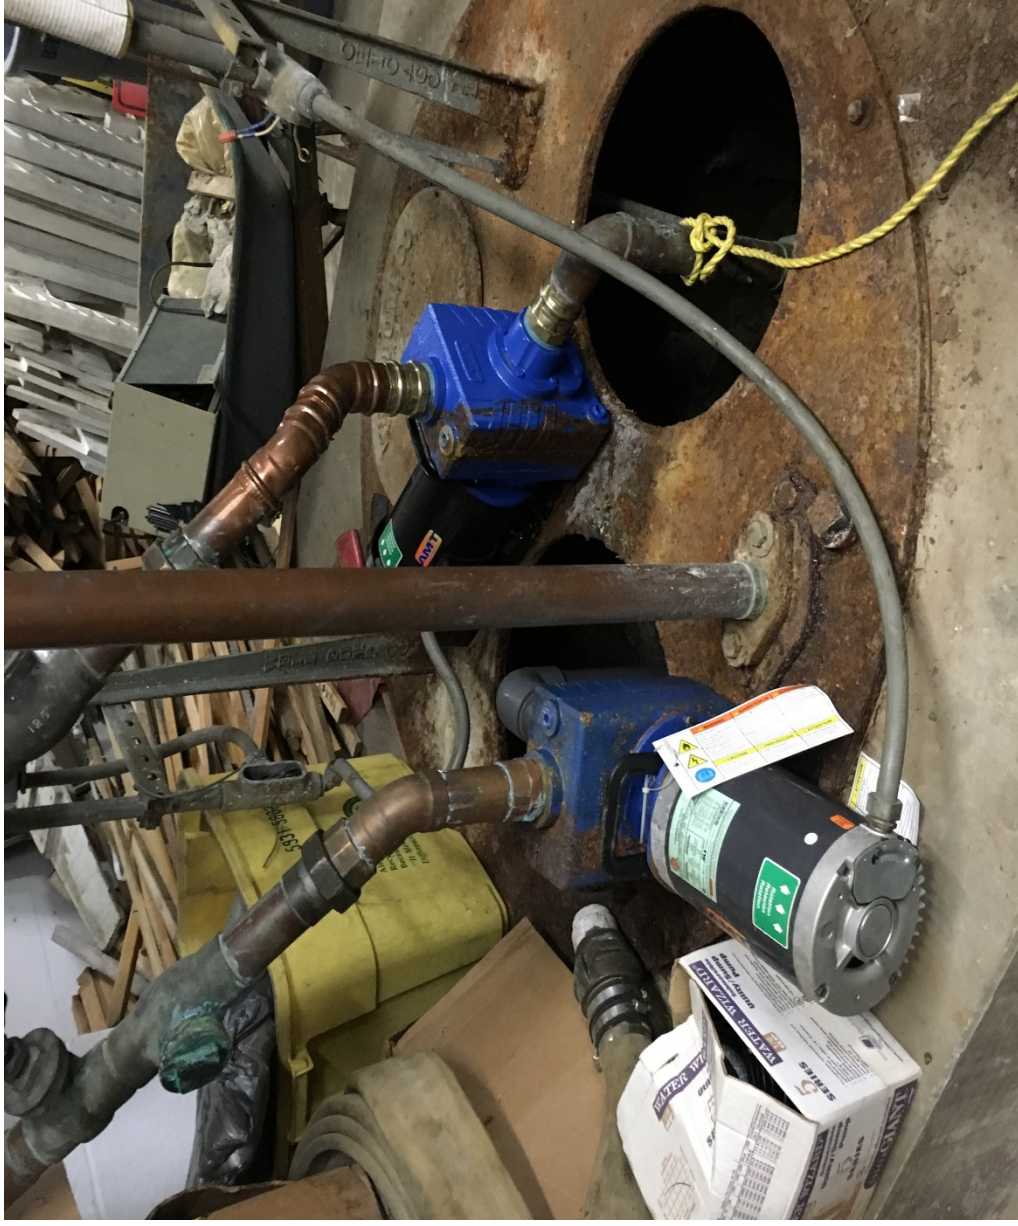
Finding # - 19. Two new sump pumps were recently installed in the upper garage ground water sump. These two pumps are not the correct pump for the application. These two new pumps are standard well pumps with foot valves instead of the correct submersible type pump. The problem is when the foot valve sticks and these pumps loose suction these units will stop pumping.

Finding # 19 Photo. This picture notes the two new pumps being used at the upper garage sump pit. These should have been submersibles.

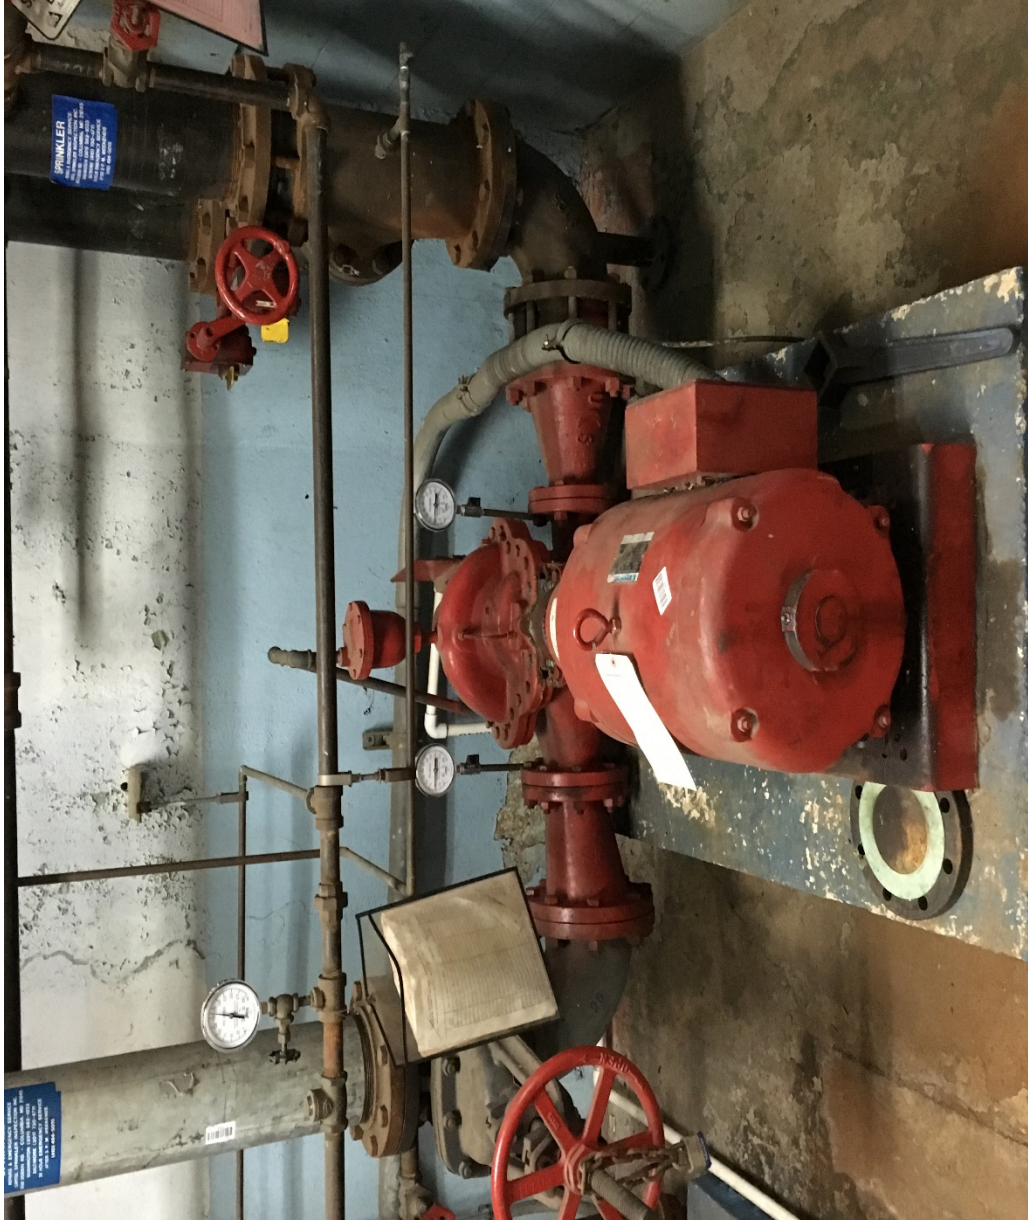
Finding # - 21. The building Fire Pump is located in the boiler room. NFPA code requires that this pump be tested weekly with no flow. An annual flow test to the street is also required. No test tags are shown on the pump showing that this PM was being done. **REVISION - Per DGS an annual inspection had been completed. A2 requests a copy of the report. A2 recommends that the annual test tags be installed to signify the inspection.**

Finding # 21 Photo. This picture notes the fire pump in the boiler room. The pump needs to be tested weekly with no flow and once a year with full flow to the street. This is required to make sure the pump will operate correctly in an actual fire event.

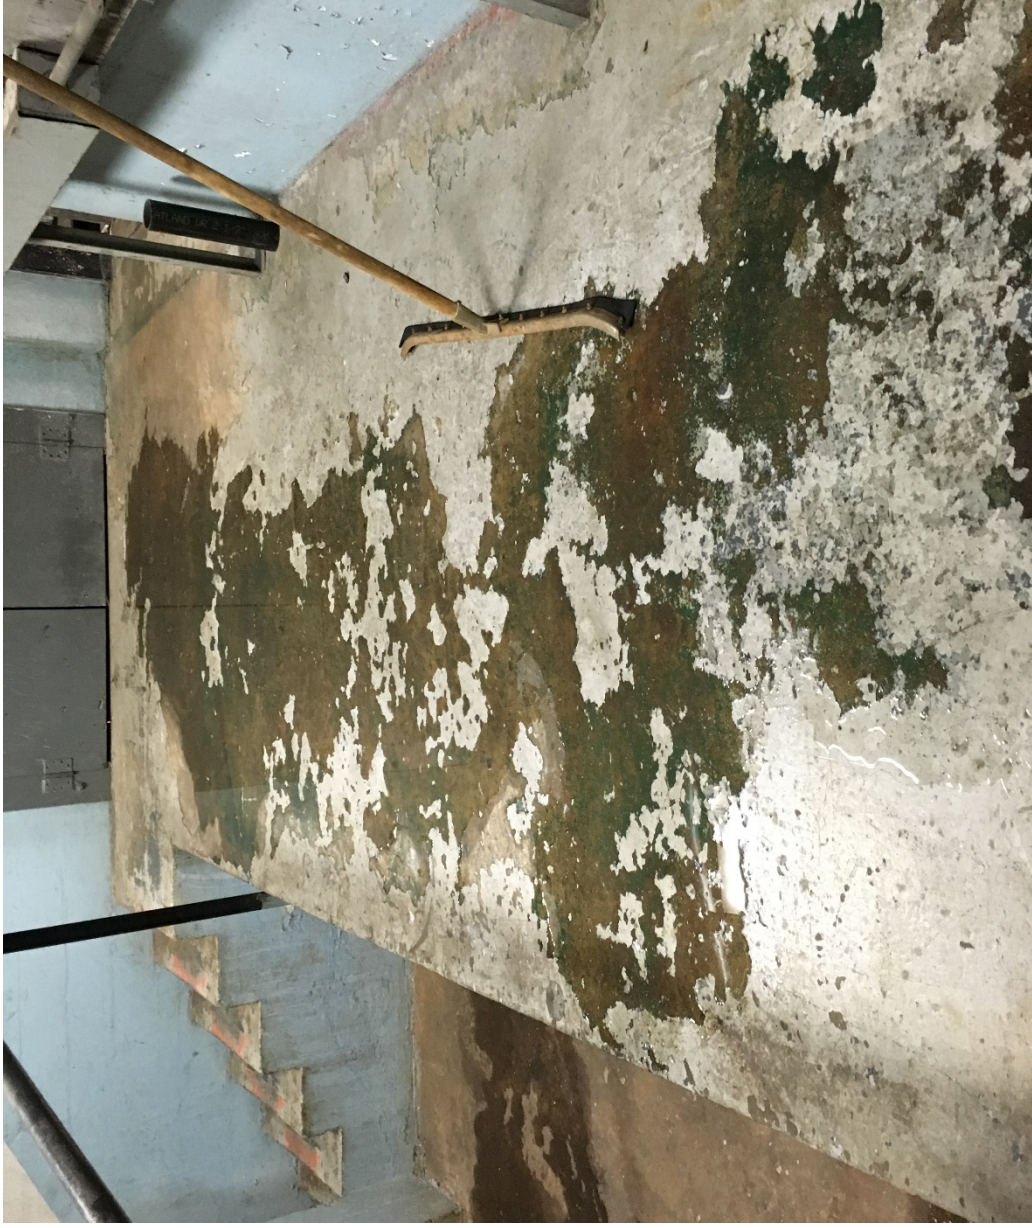
- Finding # - 22. Ground water is entering the boiler room through the floor slab at the boilers causing problems. This should be investigated and corrected. This type of water infiltration will damage the building matt slab.

Finding # 22 Photo. This picture notes the water on the boiler room floor which is coming in through the floor slab.

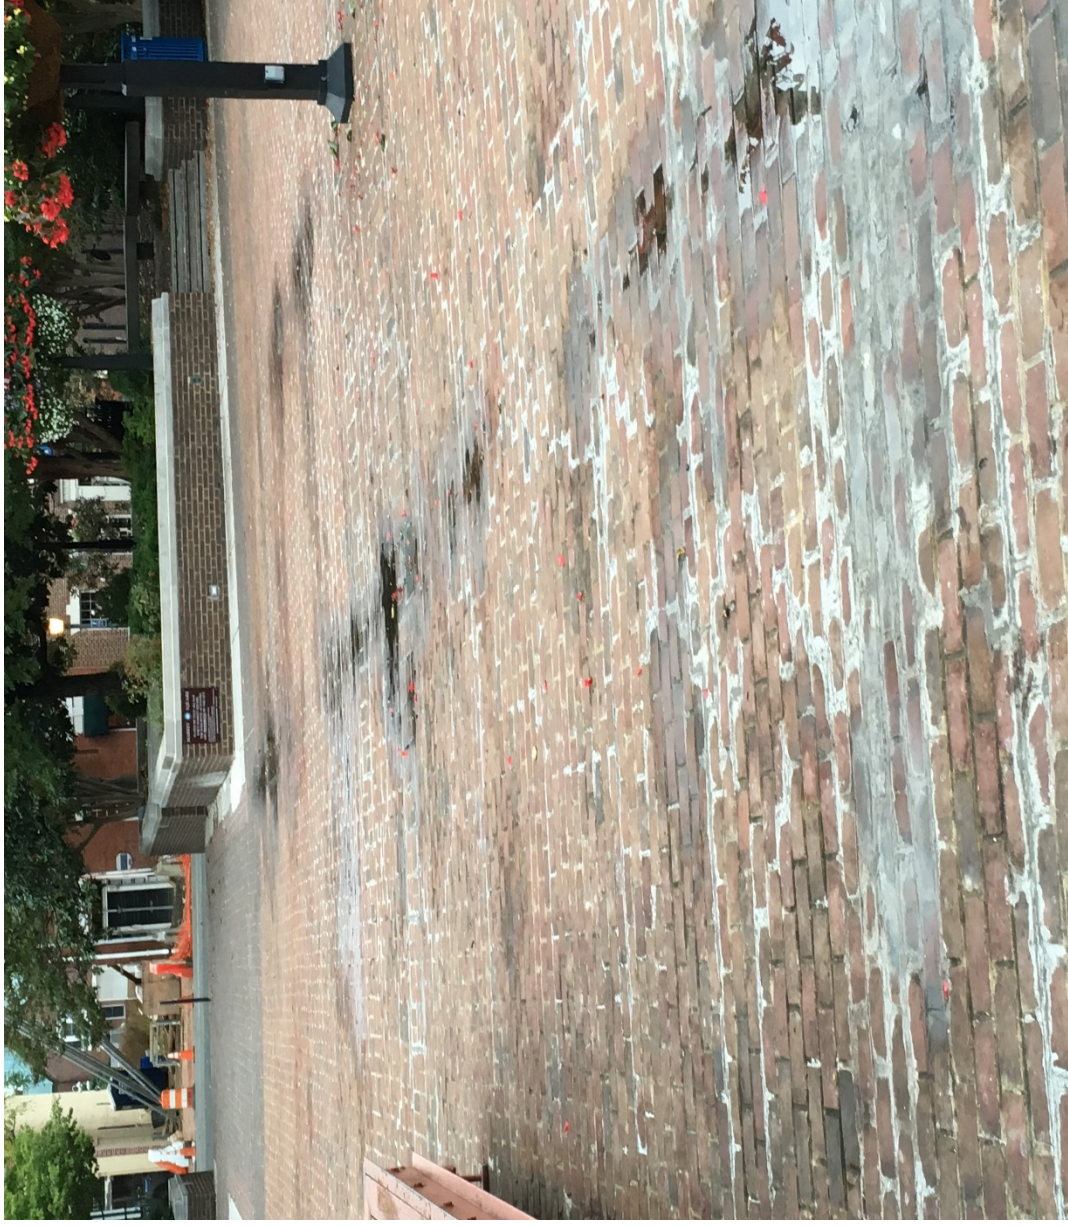
- Finding # - 25. The courtyard brick work has a few areas where it looks as if water is also getting into the garage. The water leaks into the garage are causing noticeable damage.

Finding # 25 Photo. This picture notes a section of the brick work on the courtyard deck which looks to be adding to the water issues in the garage.

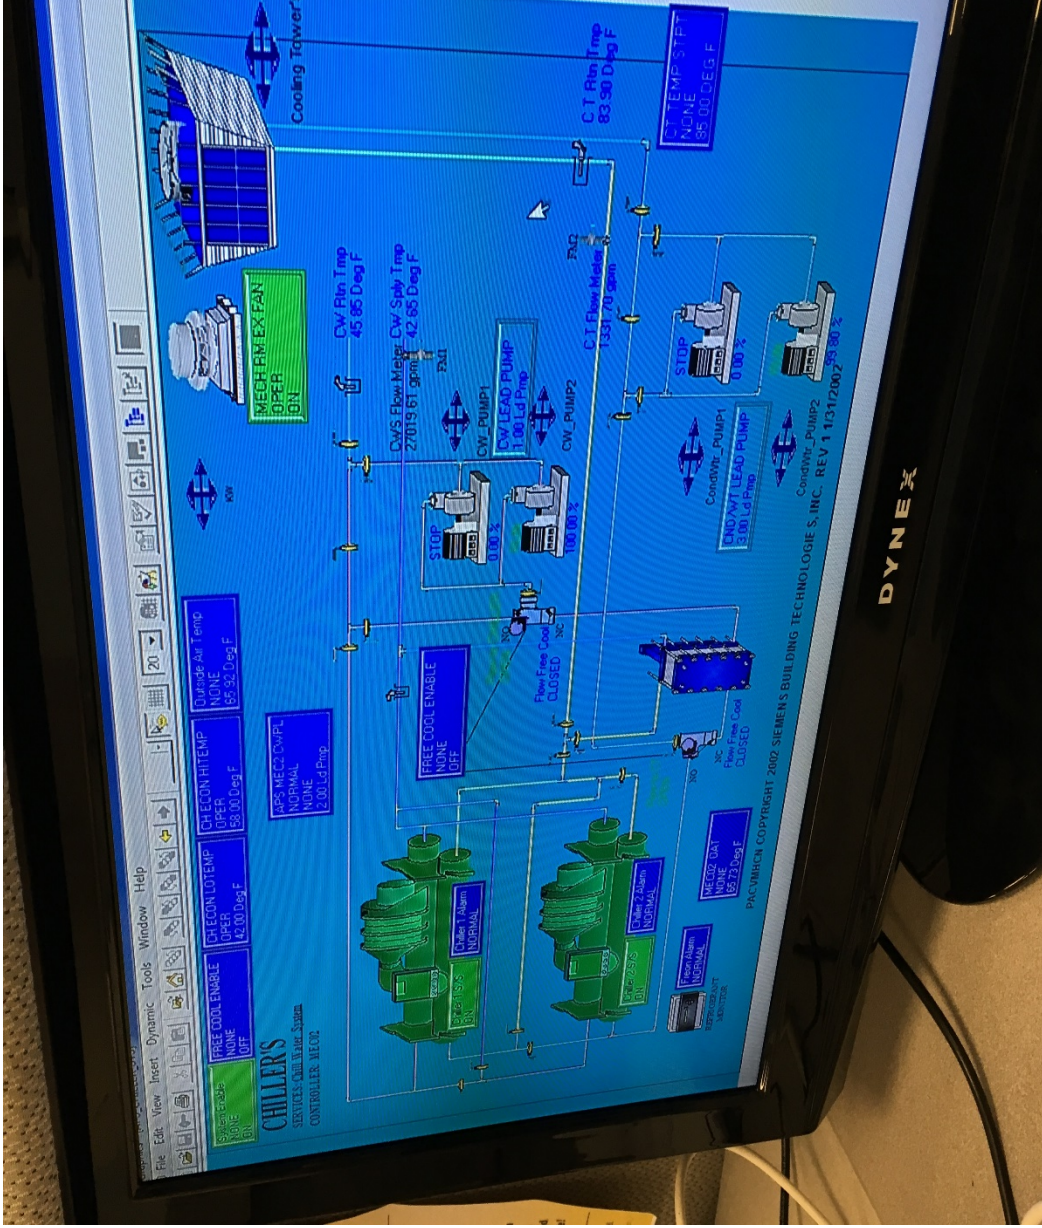
Finding # - 6 This picture notes the chilled water and heating systems differential control via the BAS system. There is no control point for differential pressure. However because the pumps are at 100% speed it appears that there may be a concern with the pump sizing.

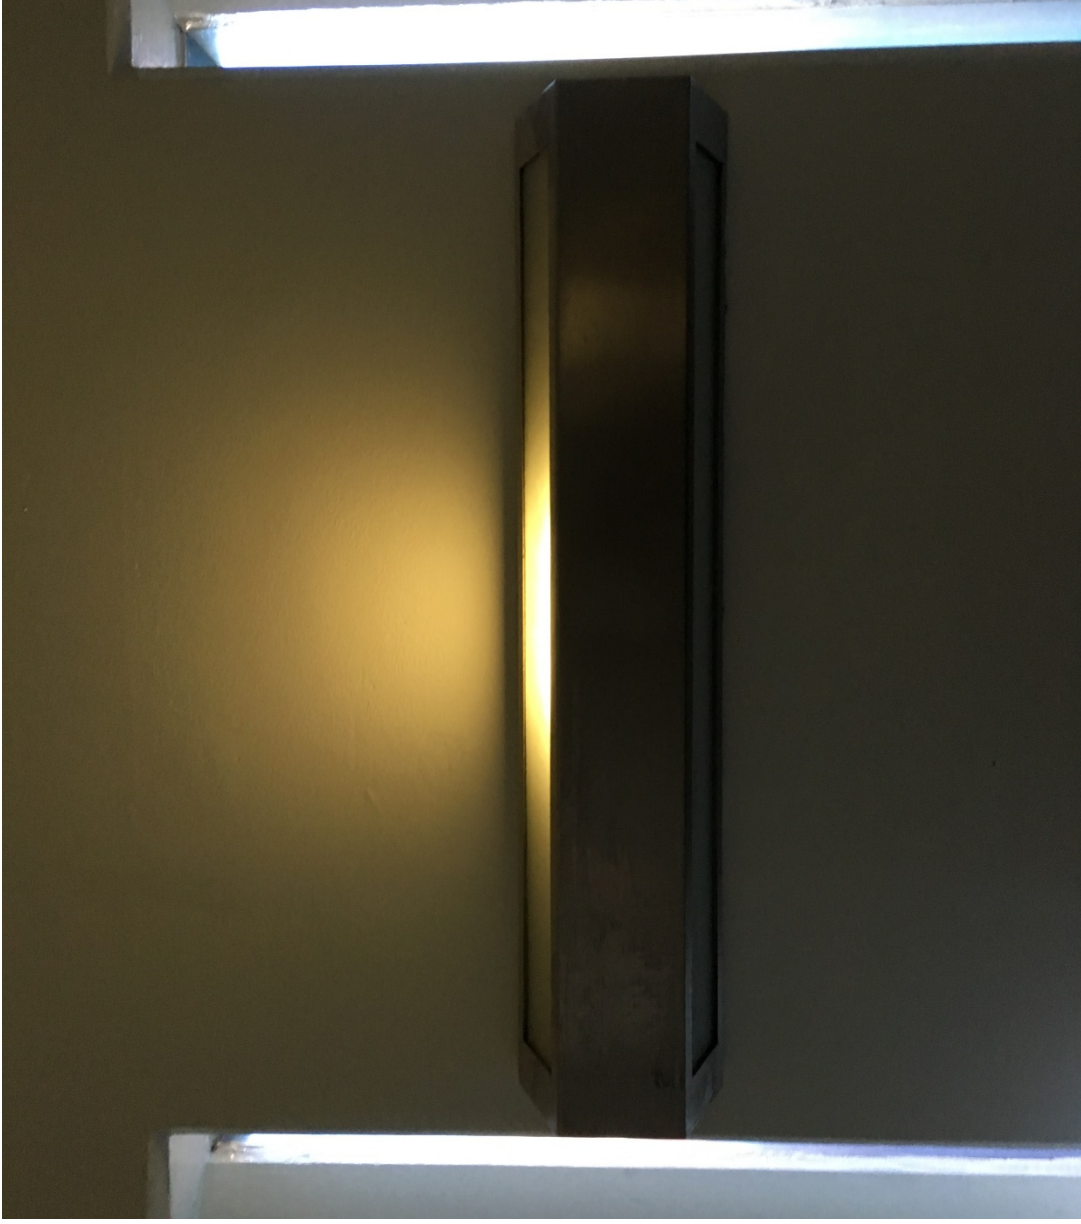
Finding # - 14 The specialized light fixtures in the Cells are outdated. Parts and bulbs are becoming unavailable.

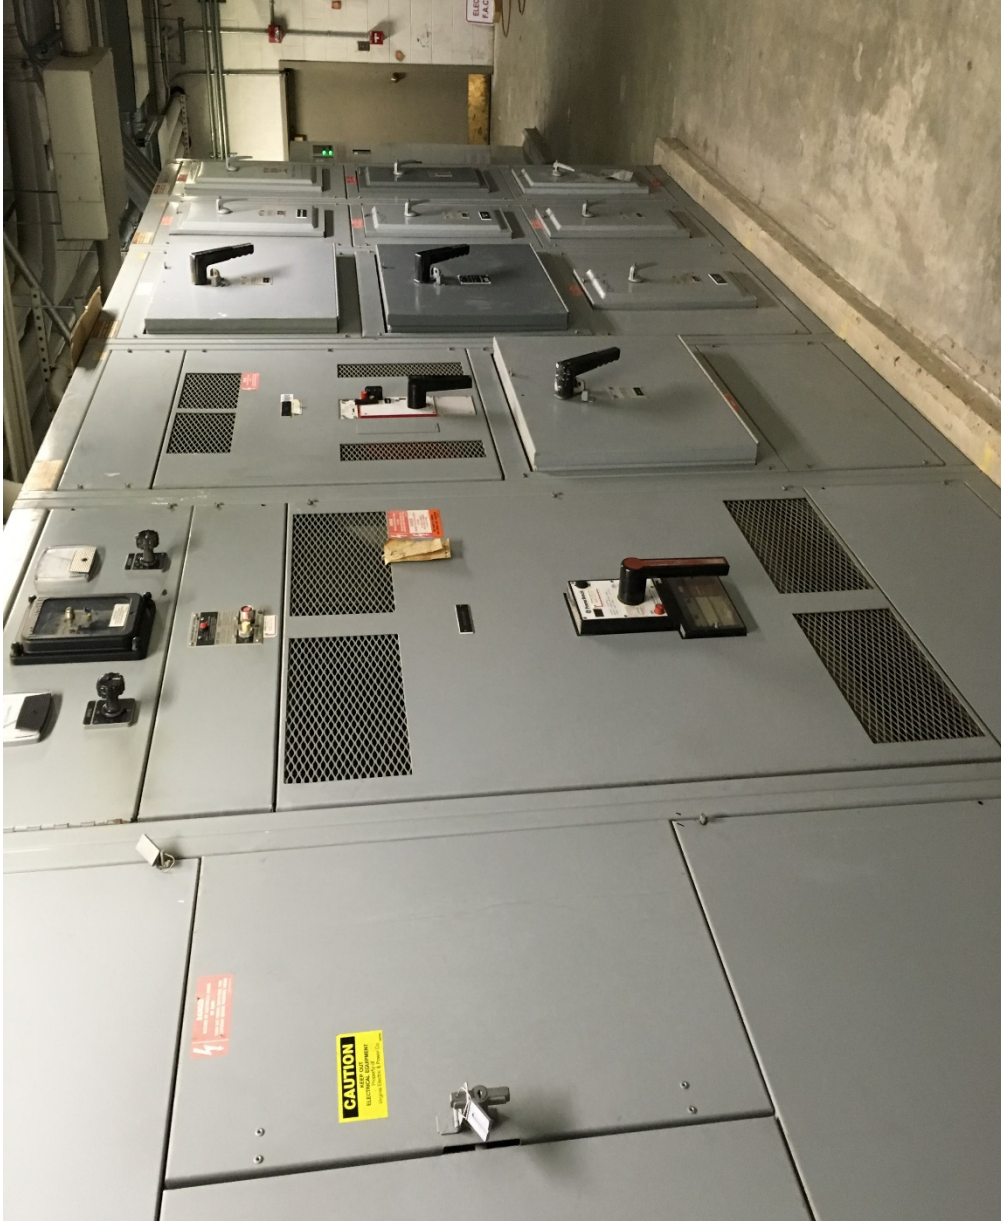
Finding # - 15 There is no inspection stickers noting that the electrical system maintenance has been completed.

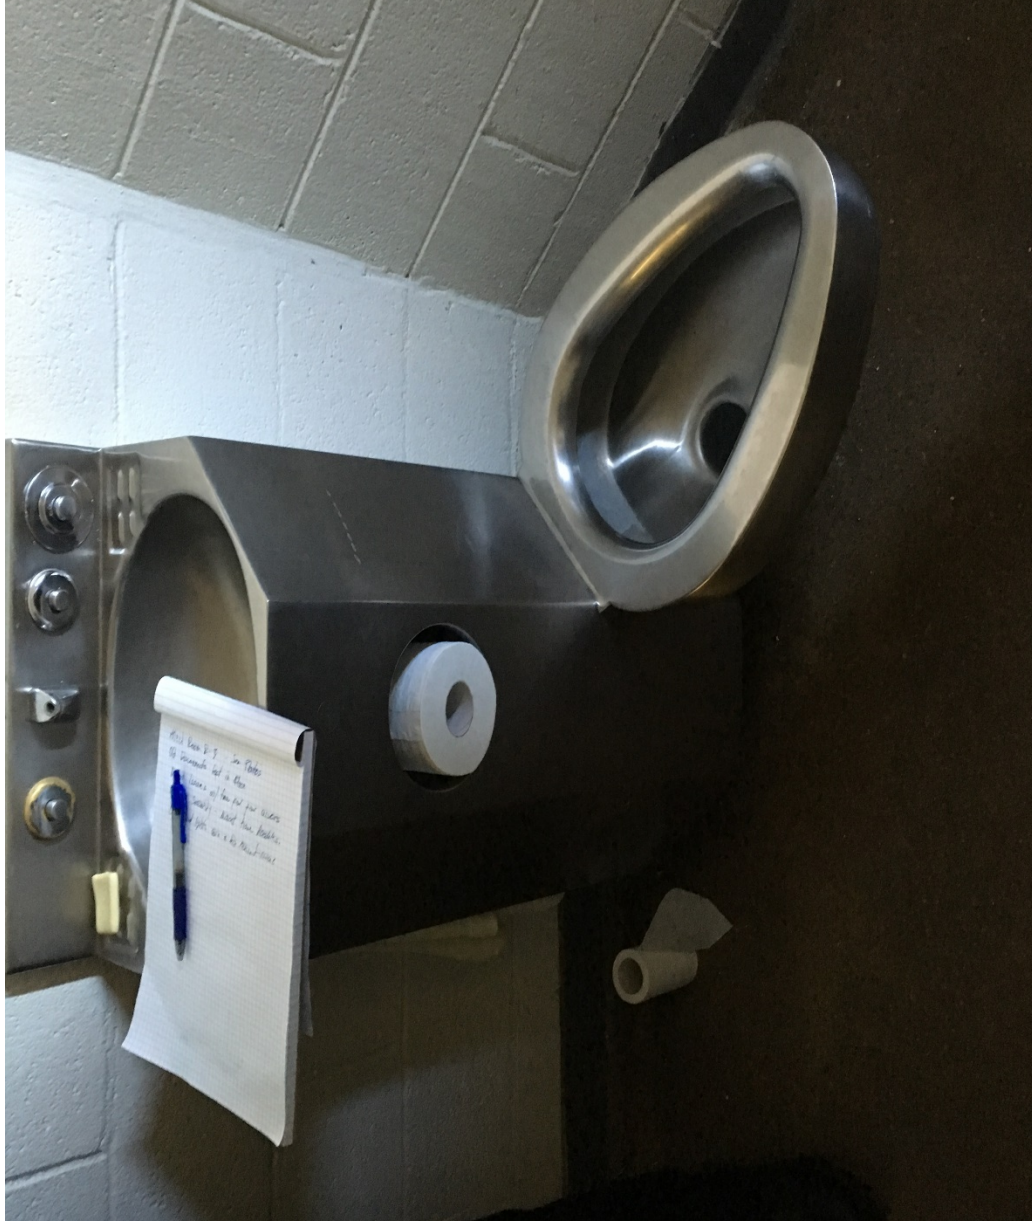
Finding # - 21 This picture is of the toilet sink combination used in the jail cells. It may be possible to retro-fit these with faucets and flush valves that would be off the shelf items.
