EXHIBITS

EXHIBIT 1:

JOINT TASK FORCE & SUBCOMMITTEE MEETINGS

A2 Services, Inc. Facility Survey of City of Alexandria - City Hall

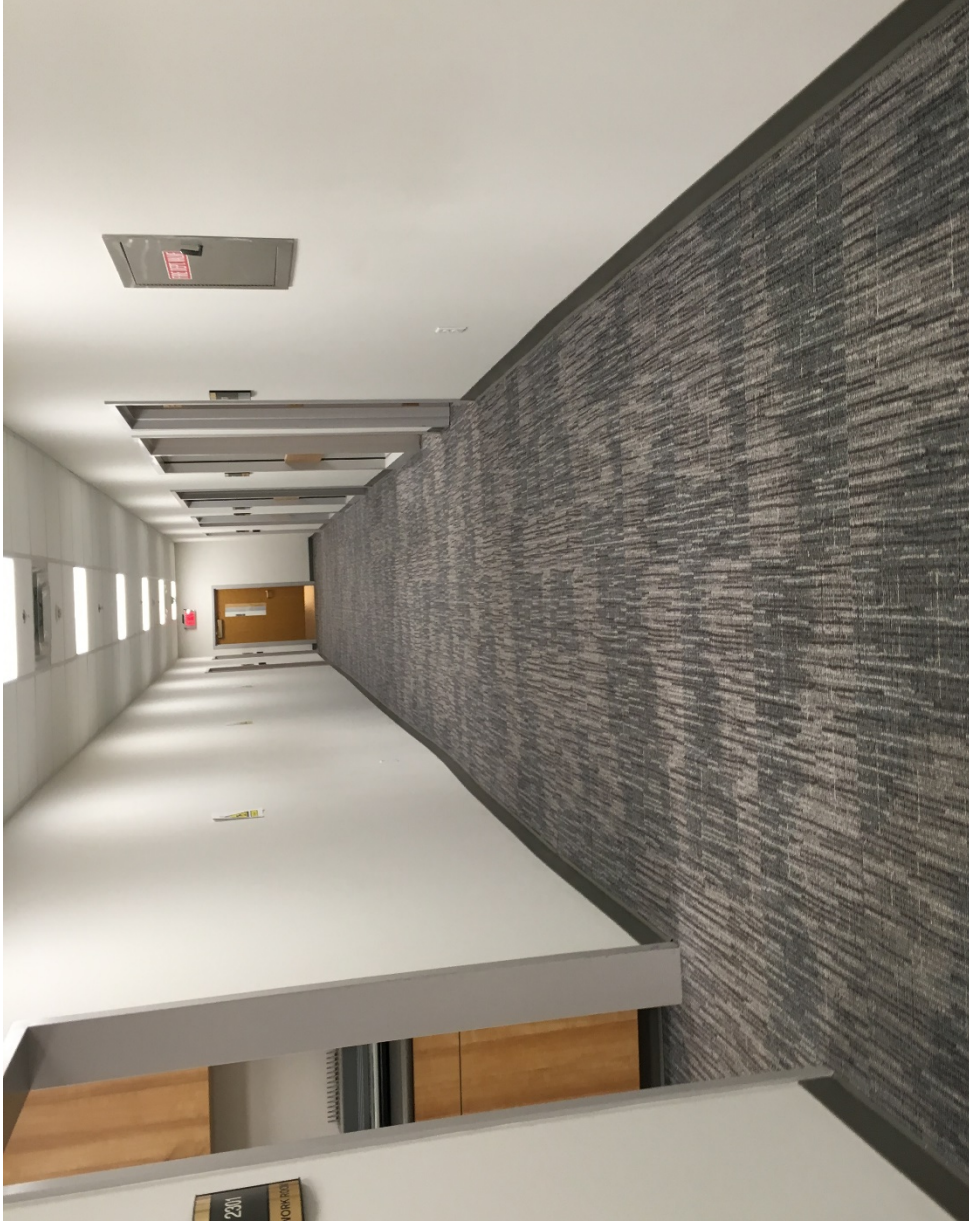
Finding # - 28 This picture is of one area in the sheriff's office building where the concrete floor slabs appear not to be level.

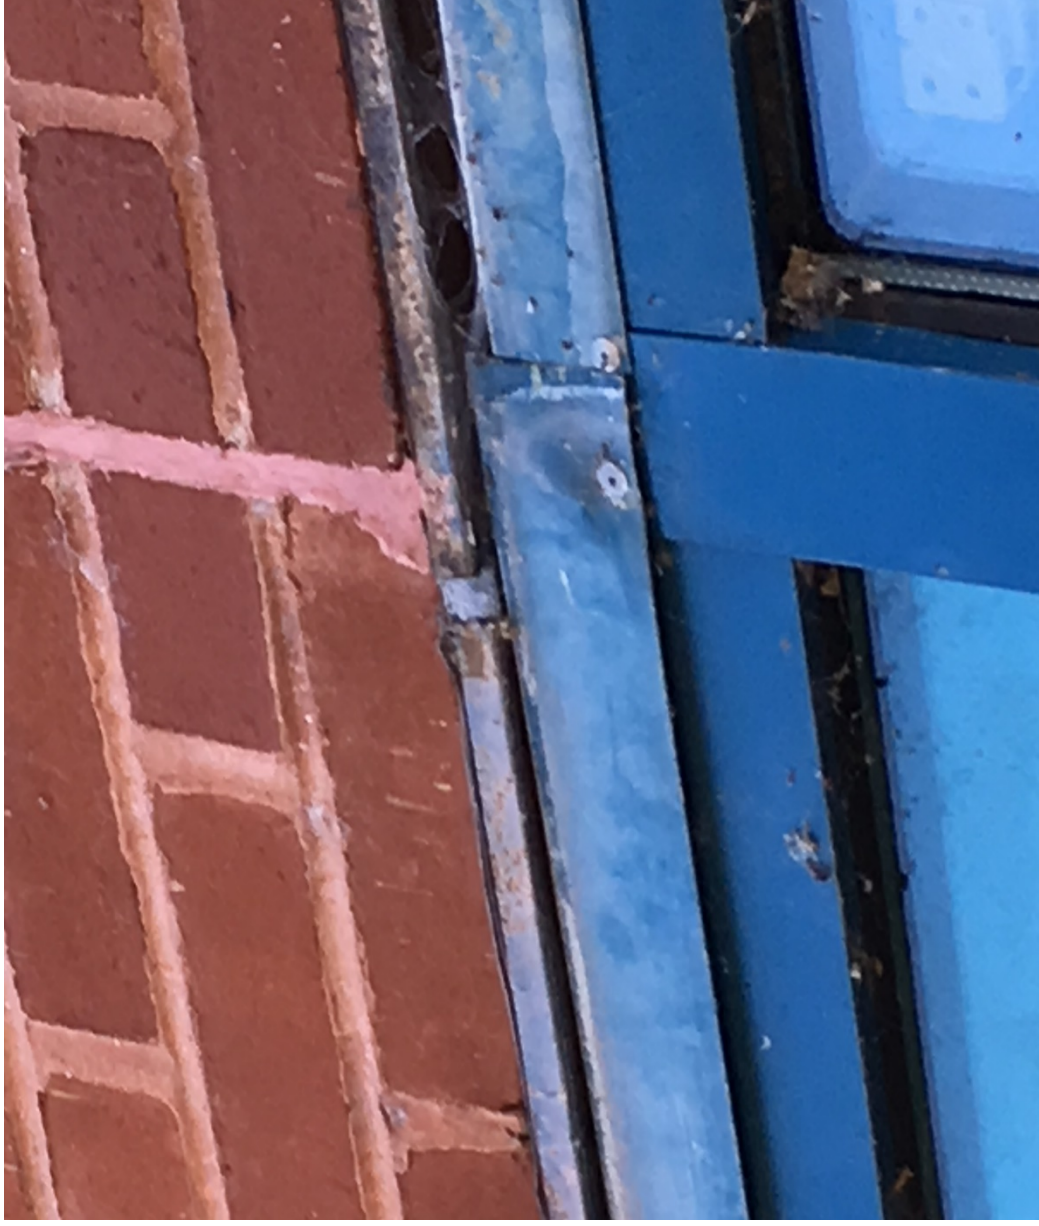
Finding # - 30 This picture notes one section of windows at the north side of the sheriff's office which needs to be caulked to stop water infiltration.

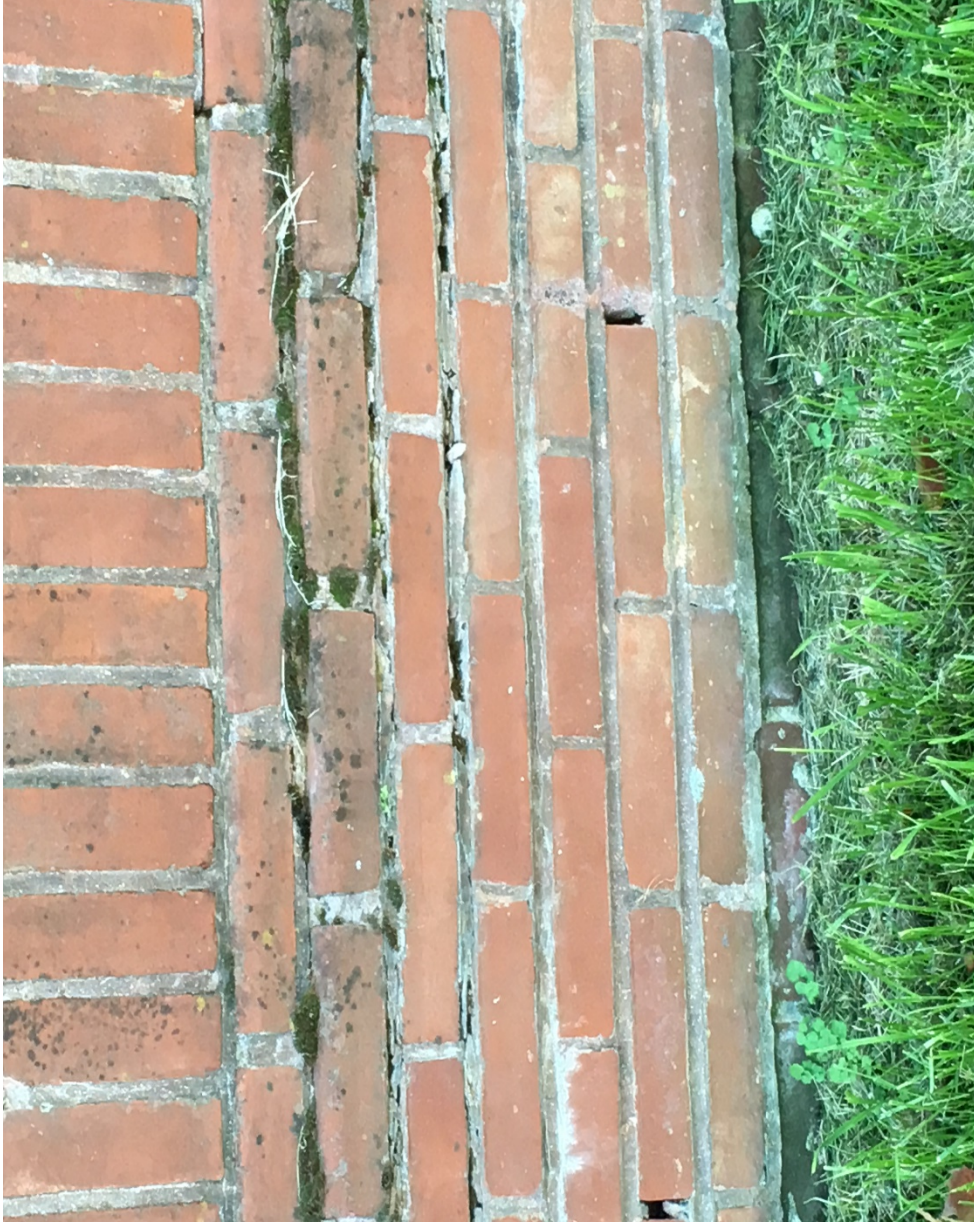
Finding # - 31 This picture is of an area of the brick façade on the north side of the sheriff's building which should be tuck-pointed. This area is just below the window shown above.

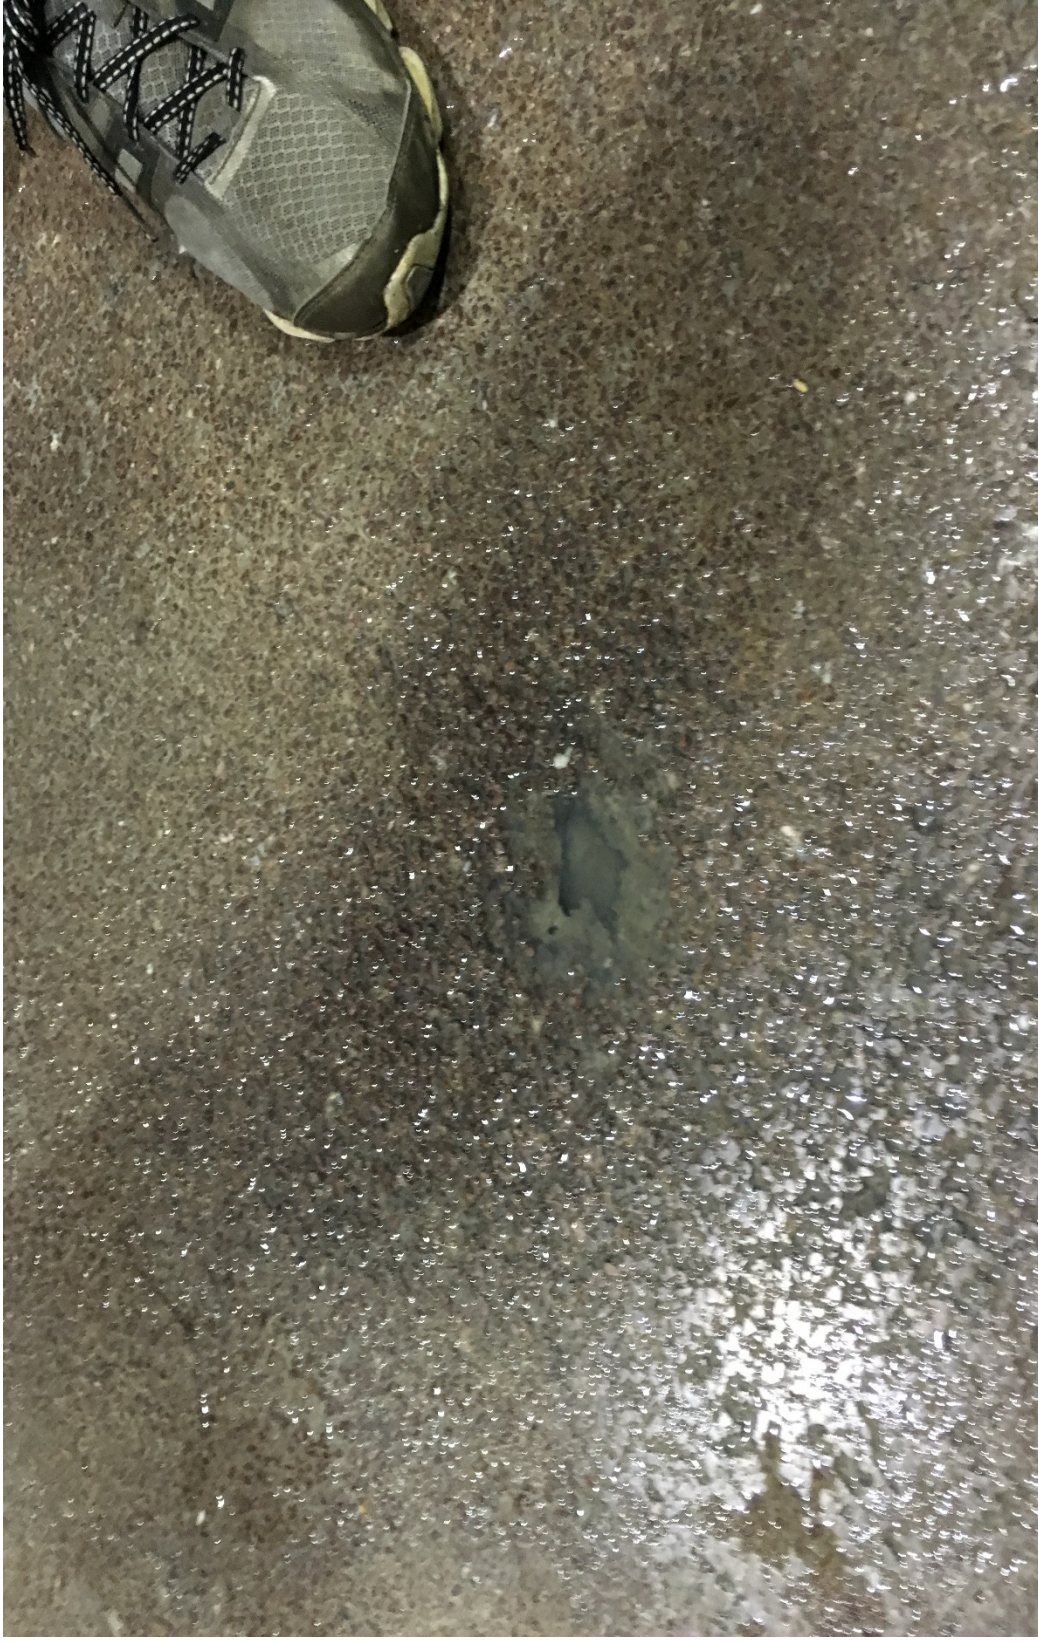
Finding # - 32 This picture is of the epoxy /coating used in the shower stall areas floors which is in need of repair or replacement.

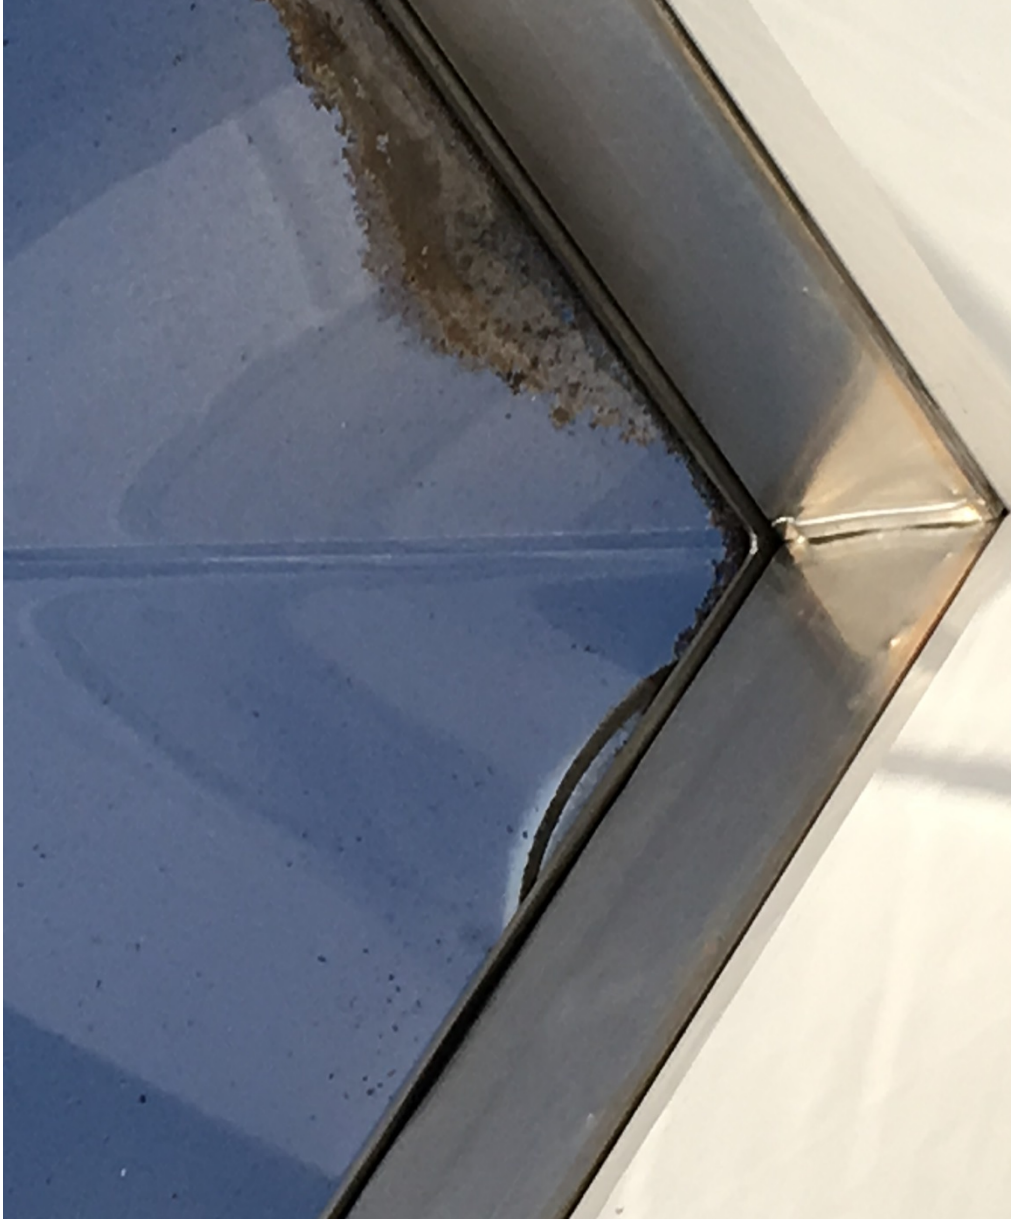
Finding # - 33 This picture is of sheriff's office stairwell skylights which show signs of leaking.

30	One section of windows at the north side of the sheriffs office needs to be caulked to stop water infiltration.	North side of Sheriffs office
	31	Areas of the brick façade on the north side of the sheriffs need to be tuck-pointed.	North side of Sheriffs office
	32	The epoxy /coating used in the shower stall areas floors needs to be repaired or replaced	Shower area floors
33	The sheriffs office stairwell skylights are showing signs of leaking. These should be pulled and resealed.	Sheriffs office stairwells

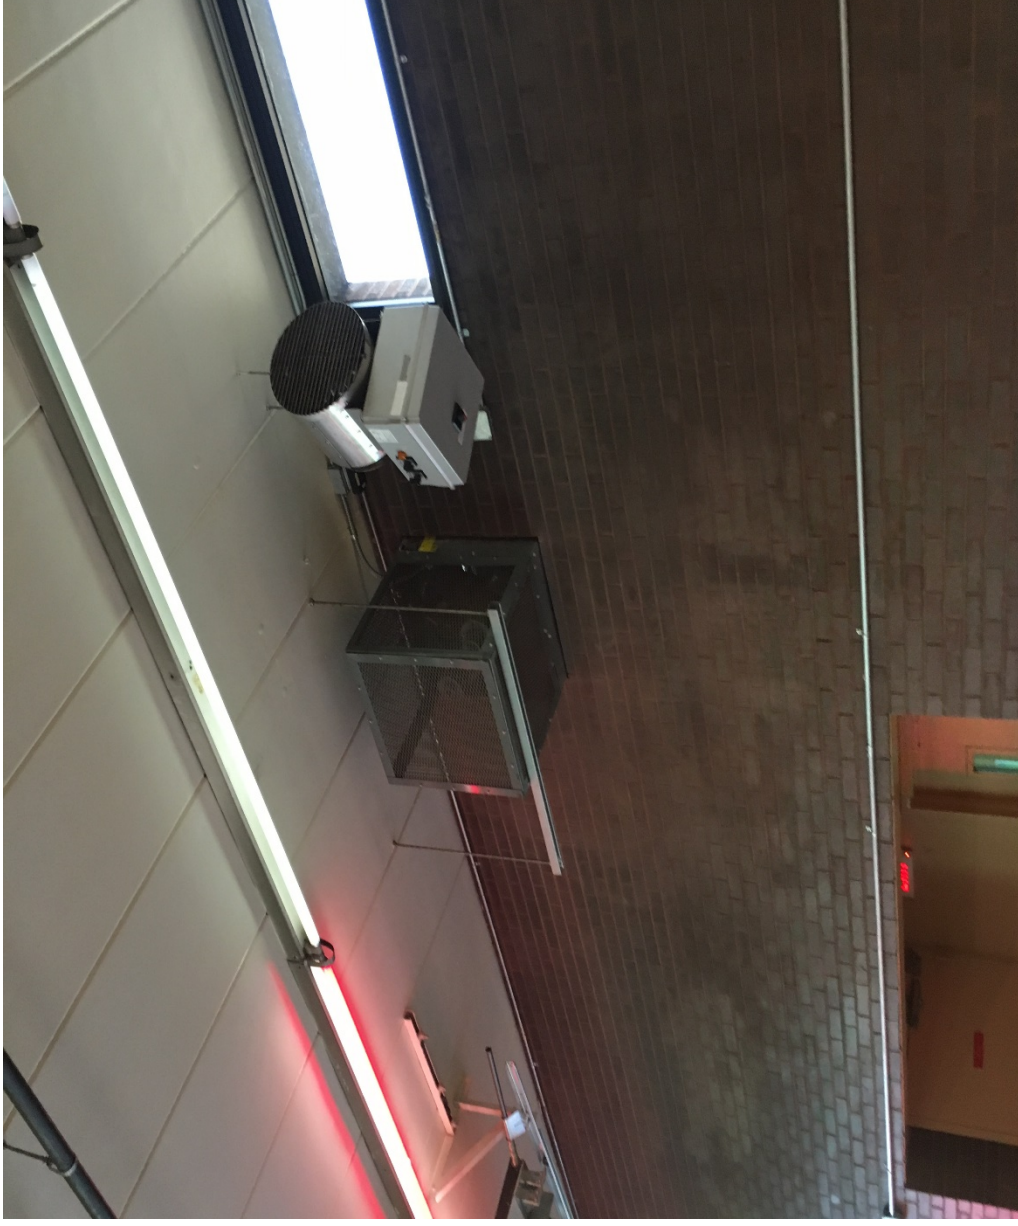
Photo # - 1. This picture is of the wall mounted engine exhaust fan which removes the truck exhaust fumes from the engine bay.

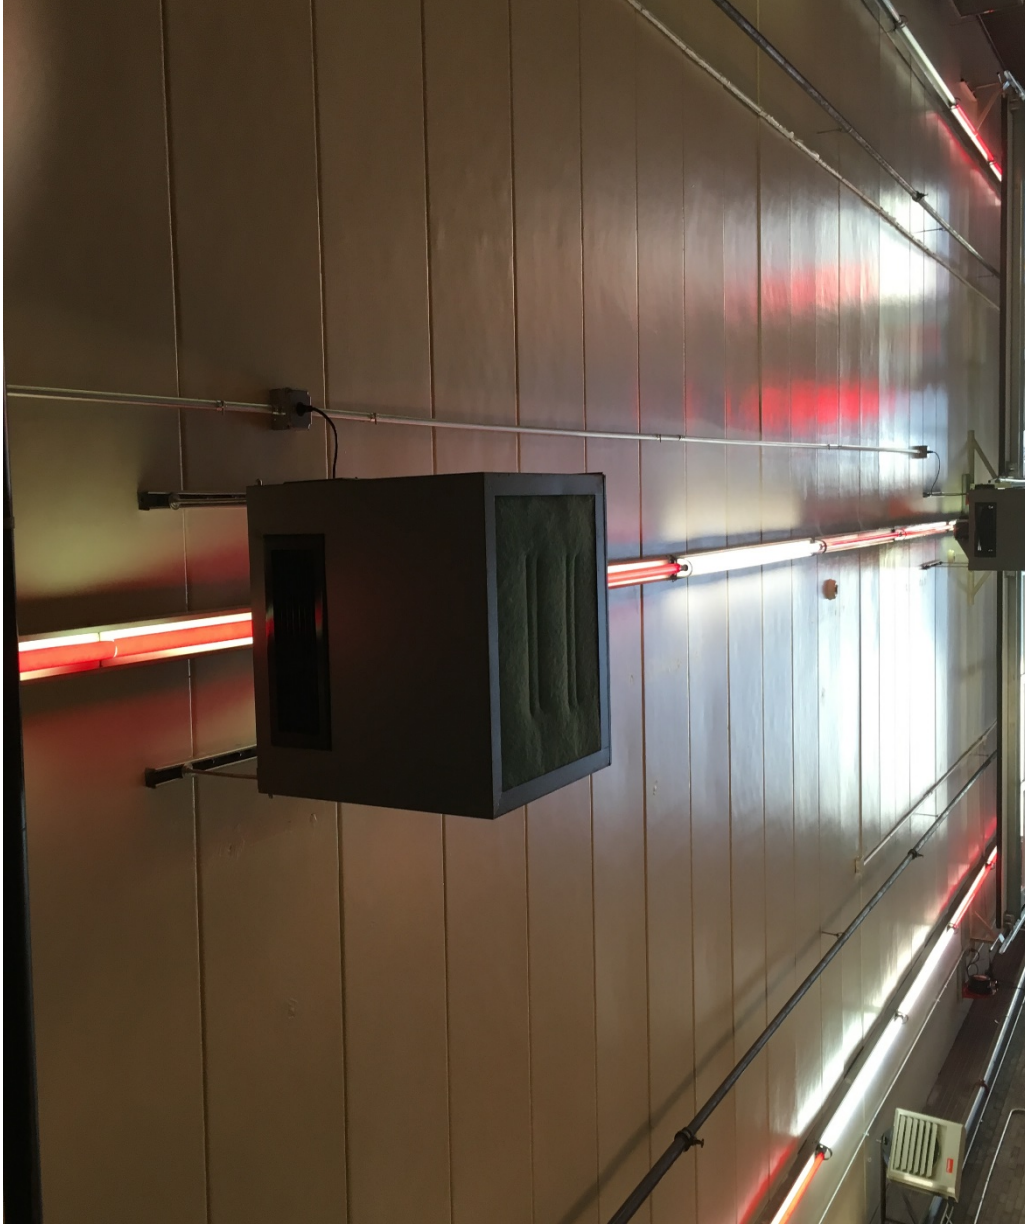
Photo # - 2. This picture is of one of the main electric unit heaters which heat the engine bay area.

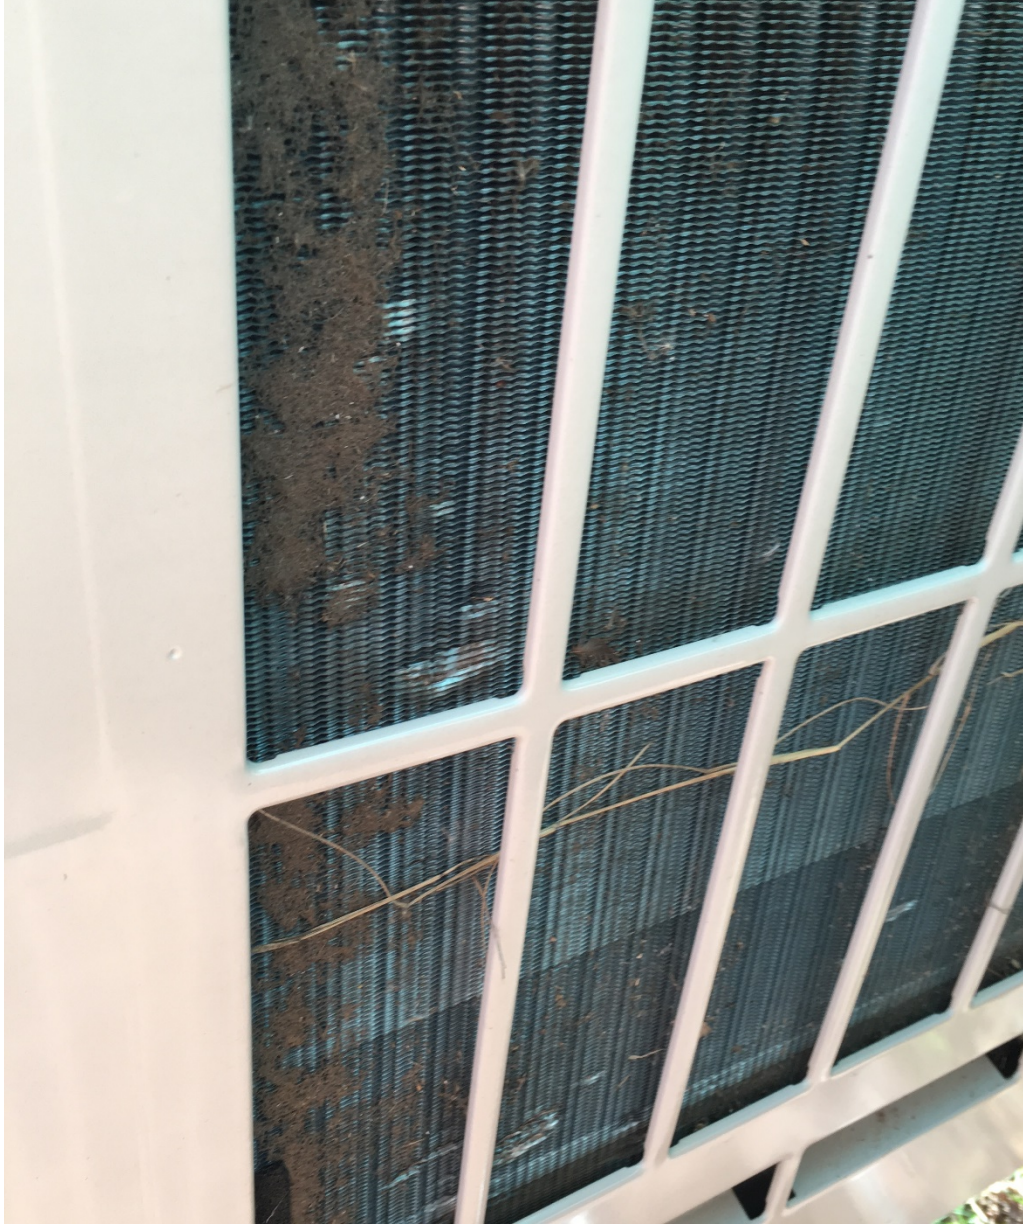
Photo # - 3. This picture is of one of the VRF condensing coils which needs to be cleaned. Clean coils on an air cooled split system is critical to efficient heating and cooling.

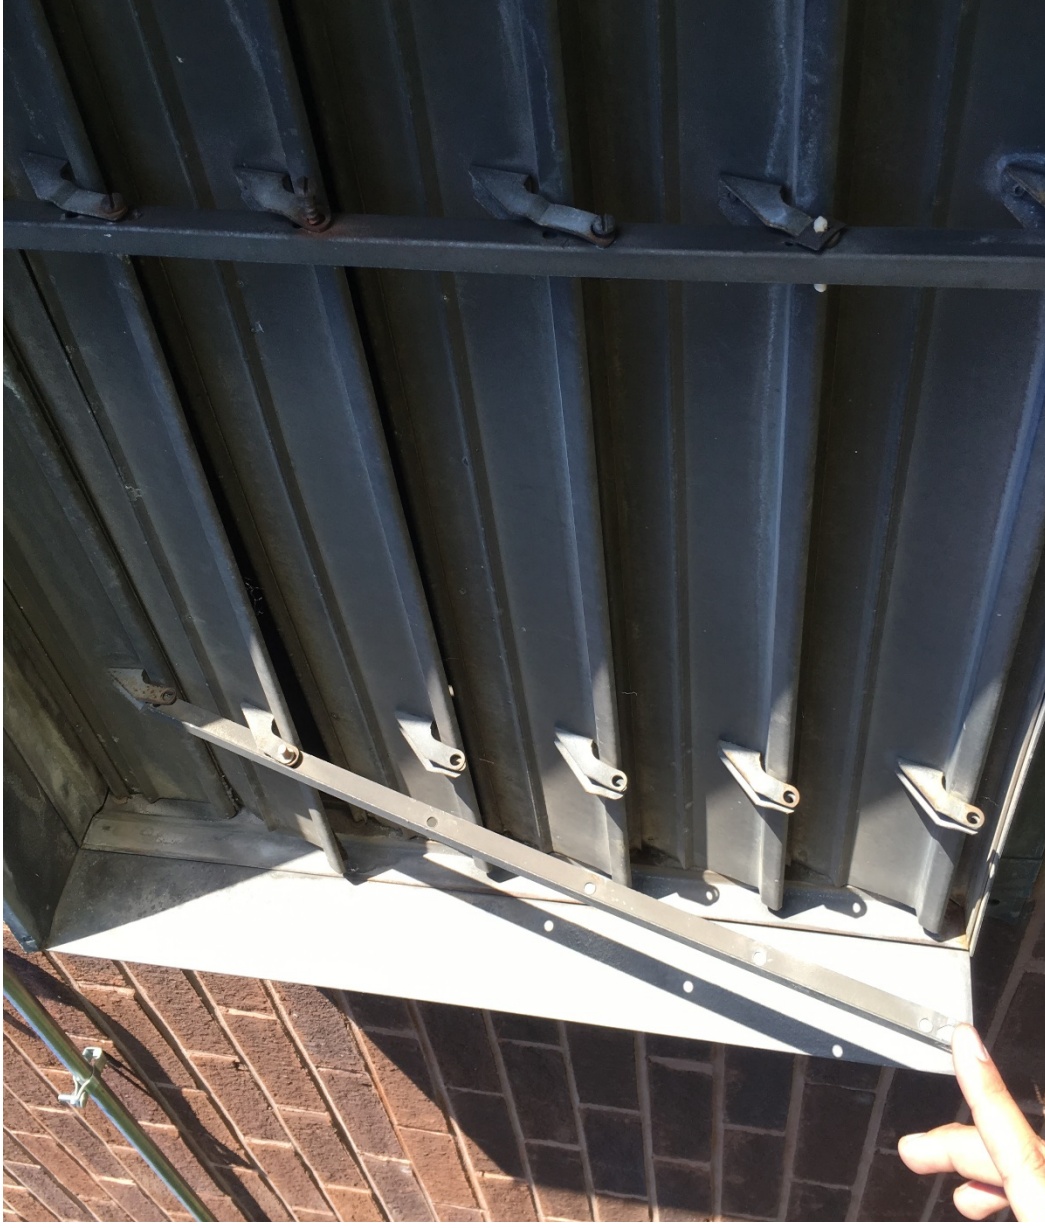
Photo # - 4. This picture is of the mechanical room exhaust fans backdraft damper which is falling apart.

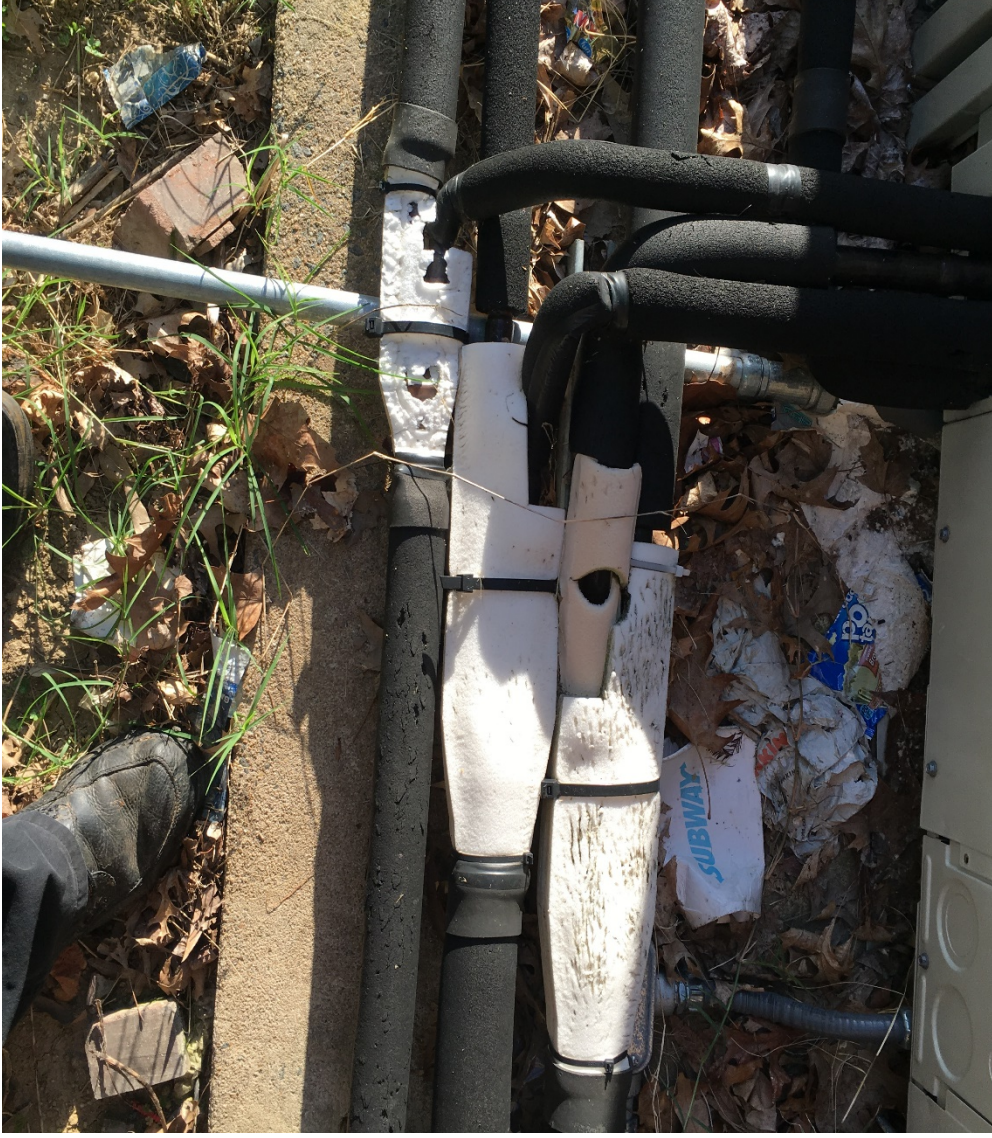
Photo # - 5. This picture notes the refrigerant piping where the thermal insulation has failed. The white sections need to be replaced and then all the outdoor piping needs to be wrapped in vinyl.

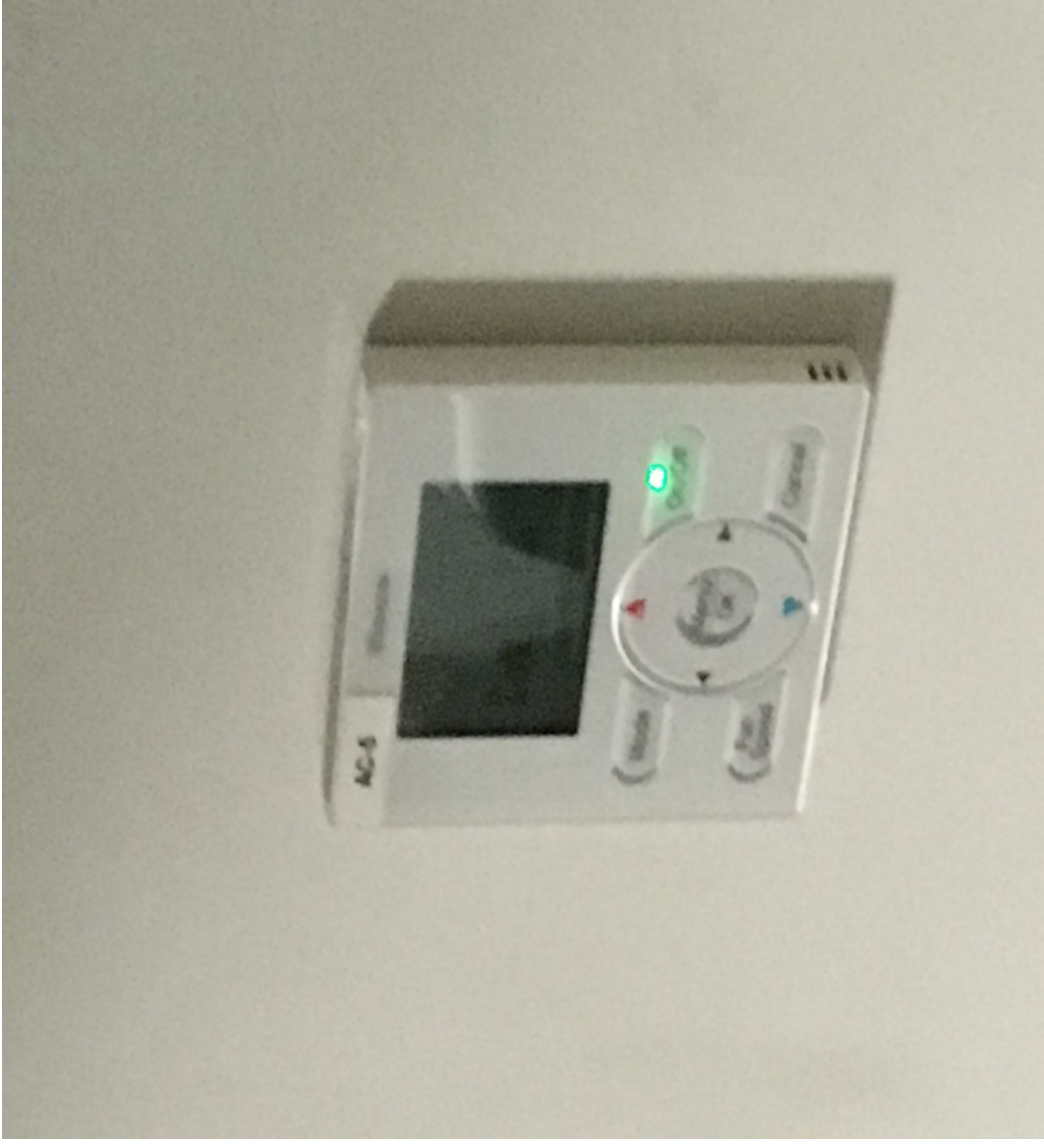
Photo # - 6. This picture is of the thermostat for the weight room which also controls the unit next door in the storage area. Installing one new t-stat on the unit next door will help control temperatures in both areas.

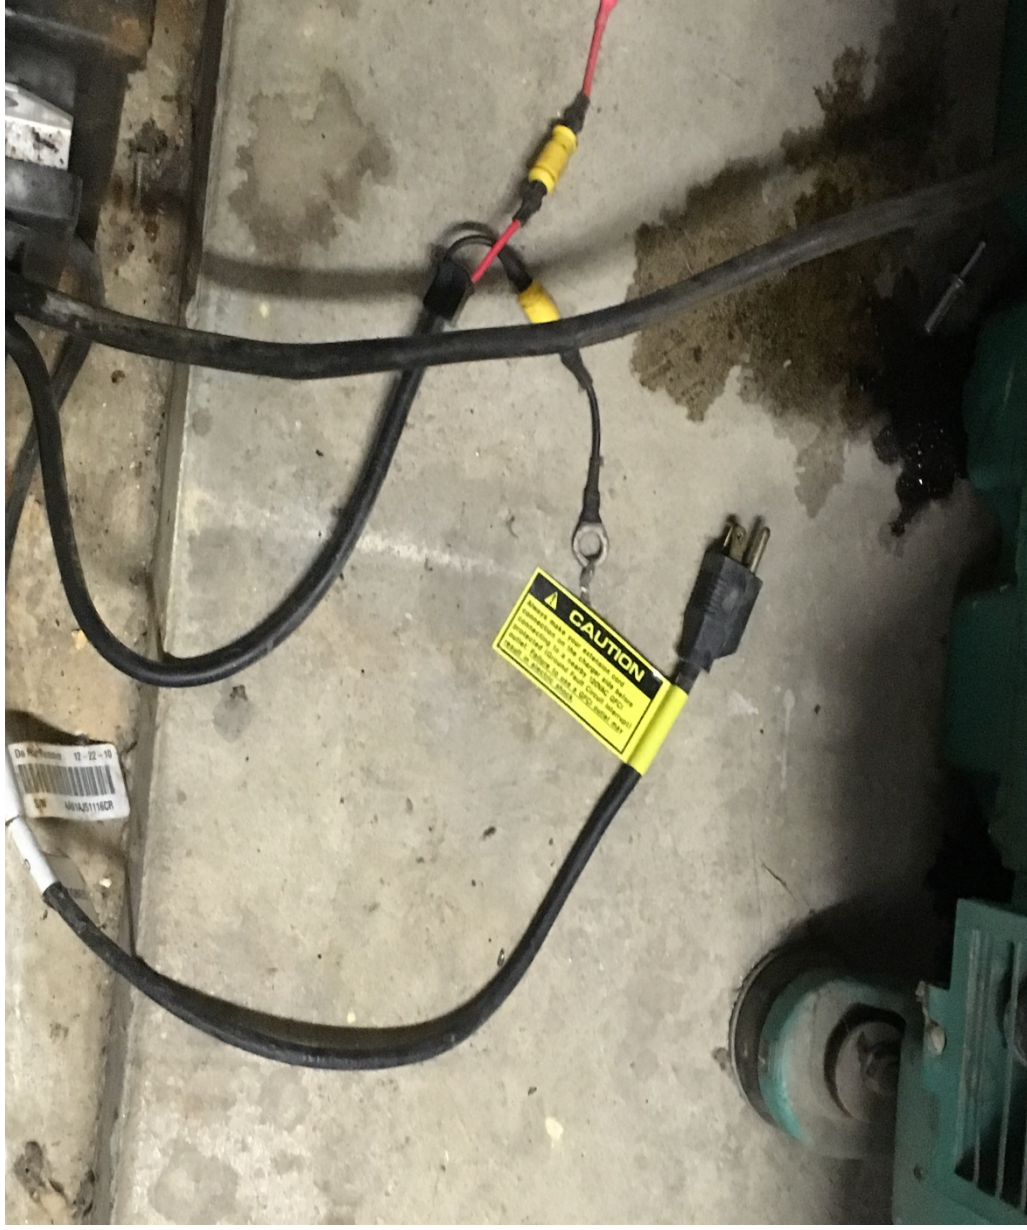
Photo # - 7. This picture is of the power disconnected from the emergency generator battery charger.

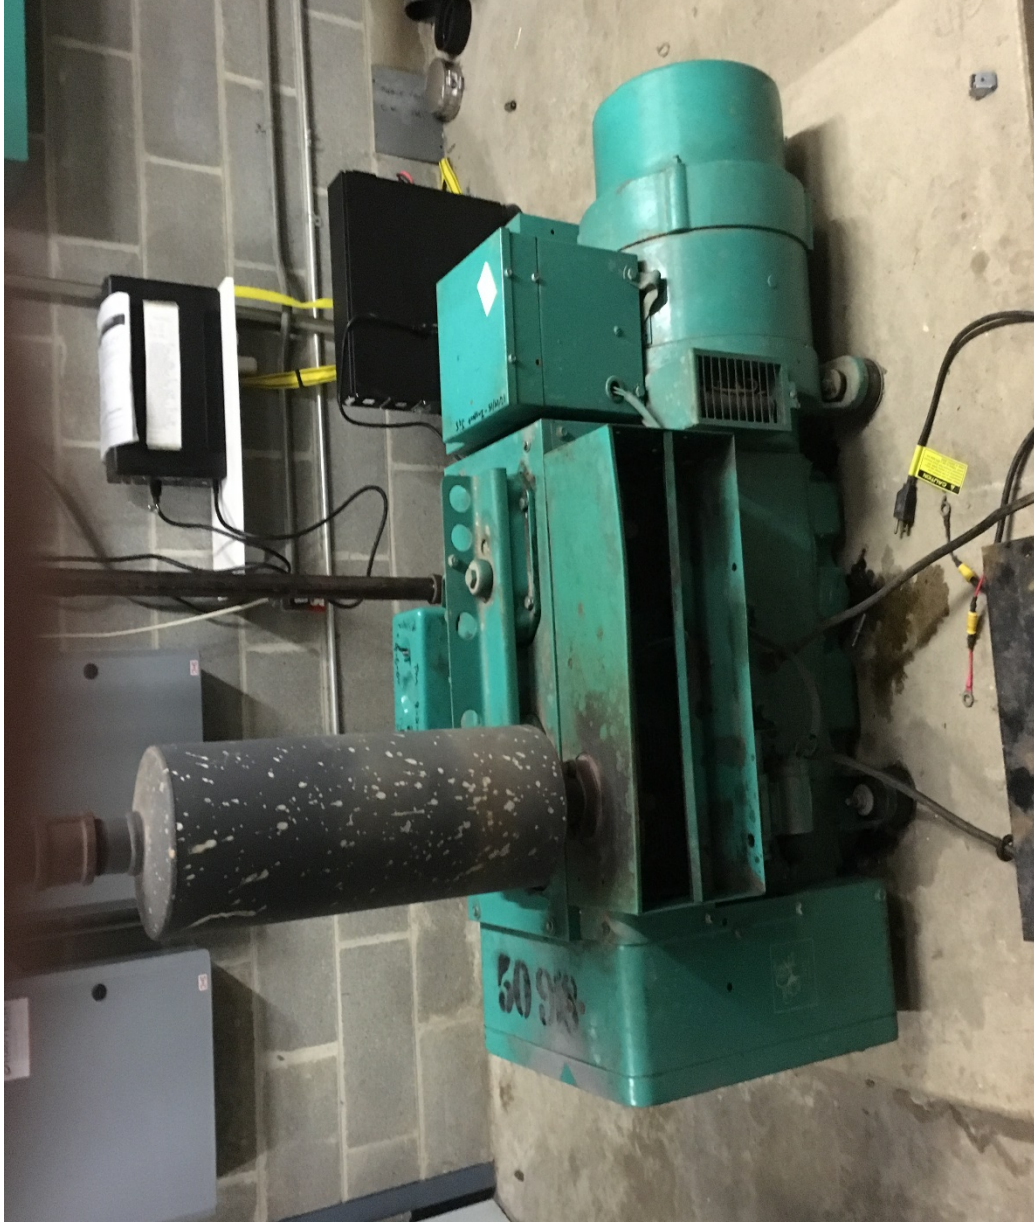
Photo – 8 and 9. This picture is of the gas fired emergency generator. This is not sized to handle the whole facility and has not been tested under load.

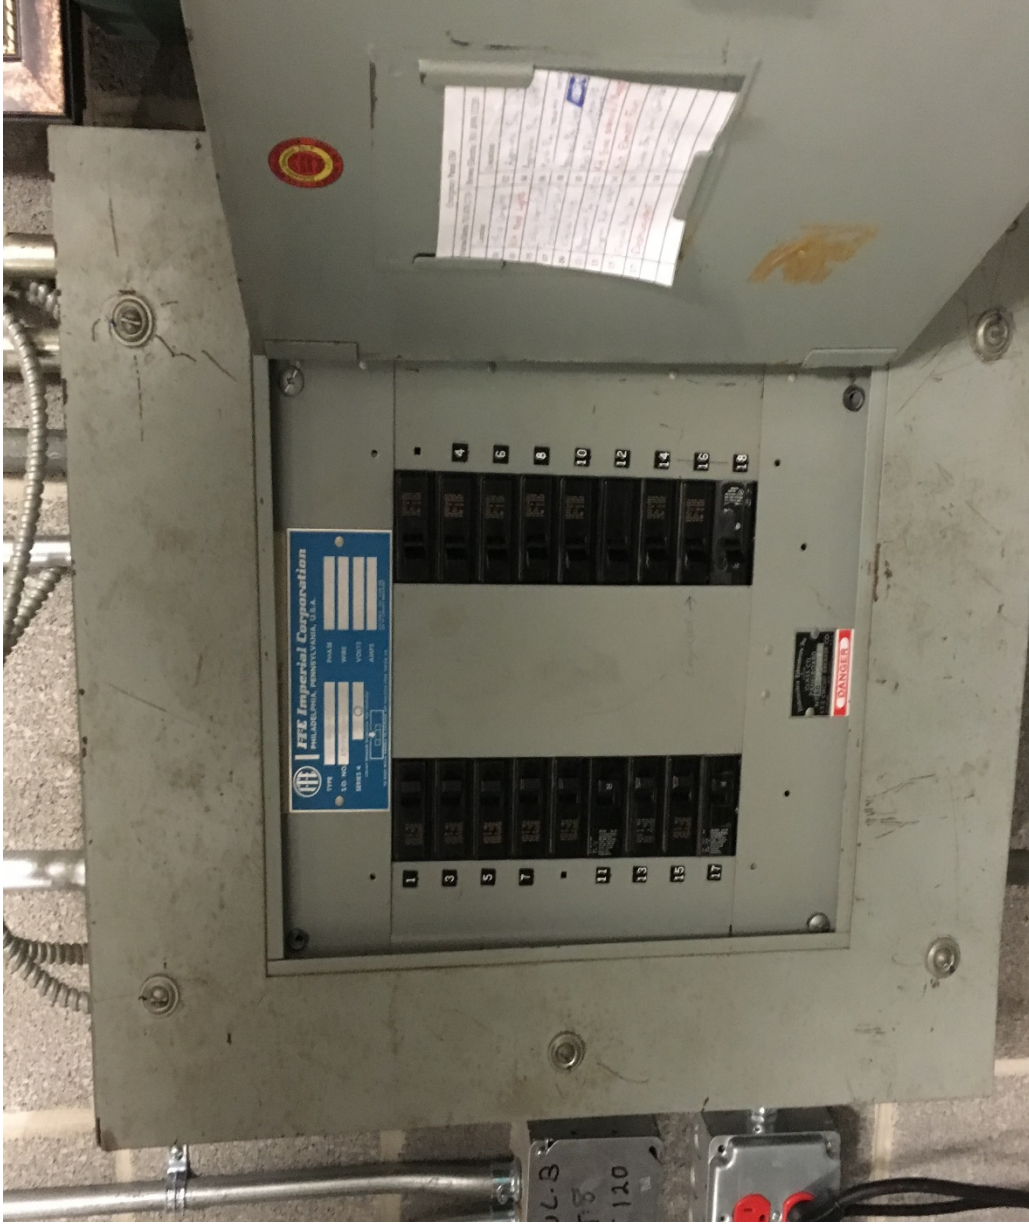
Photo # - 10. This picture is an example of one electric panel which should be thermally scanned, cleaned and tightened up annually.

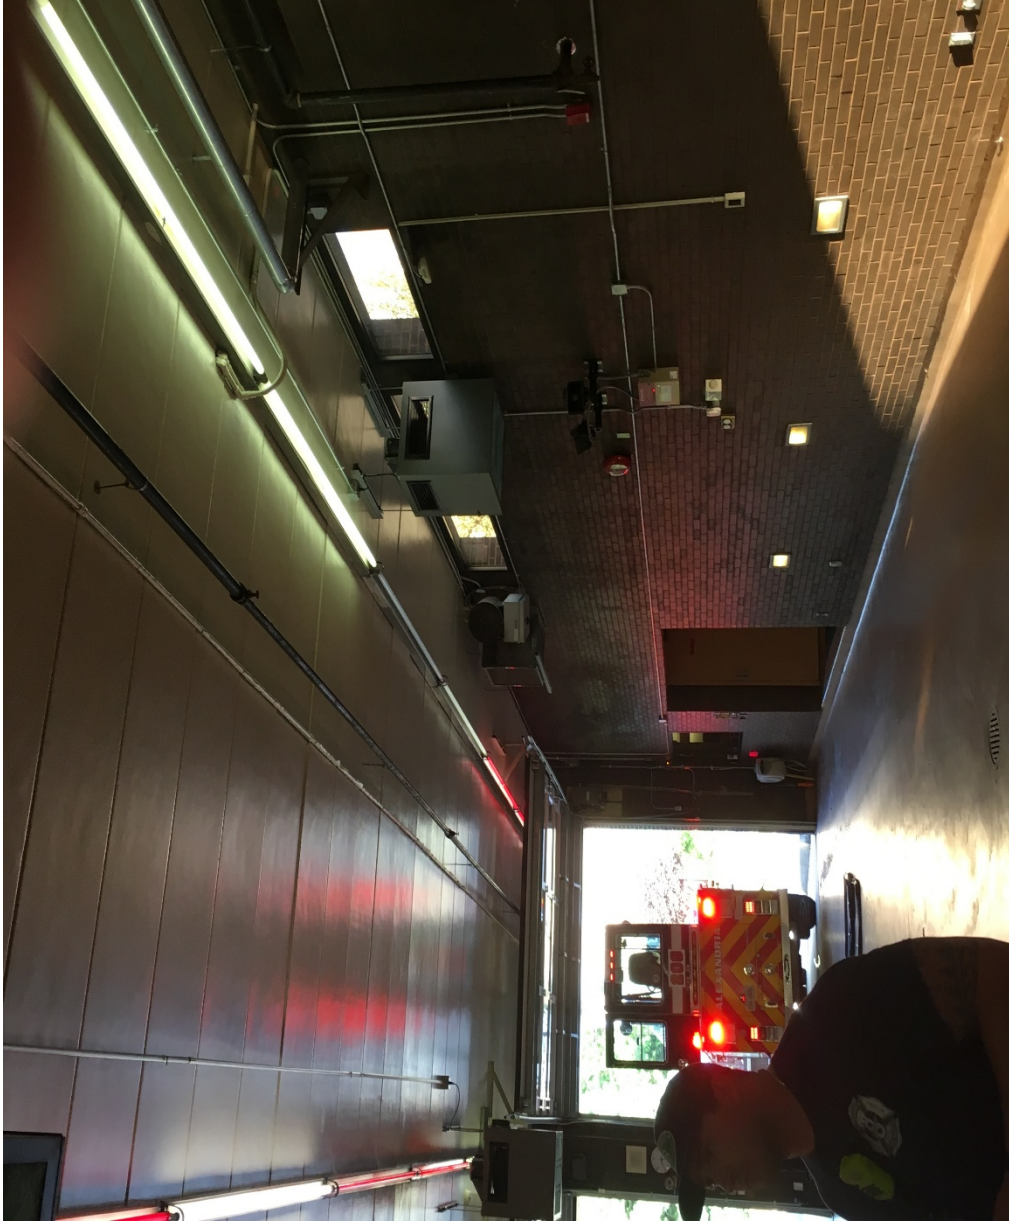
Photo # - 11. This picture is of the engine bay ceiling area where the roof is leaking.

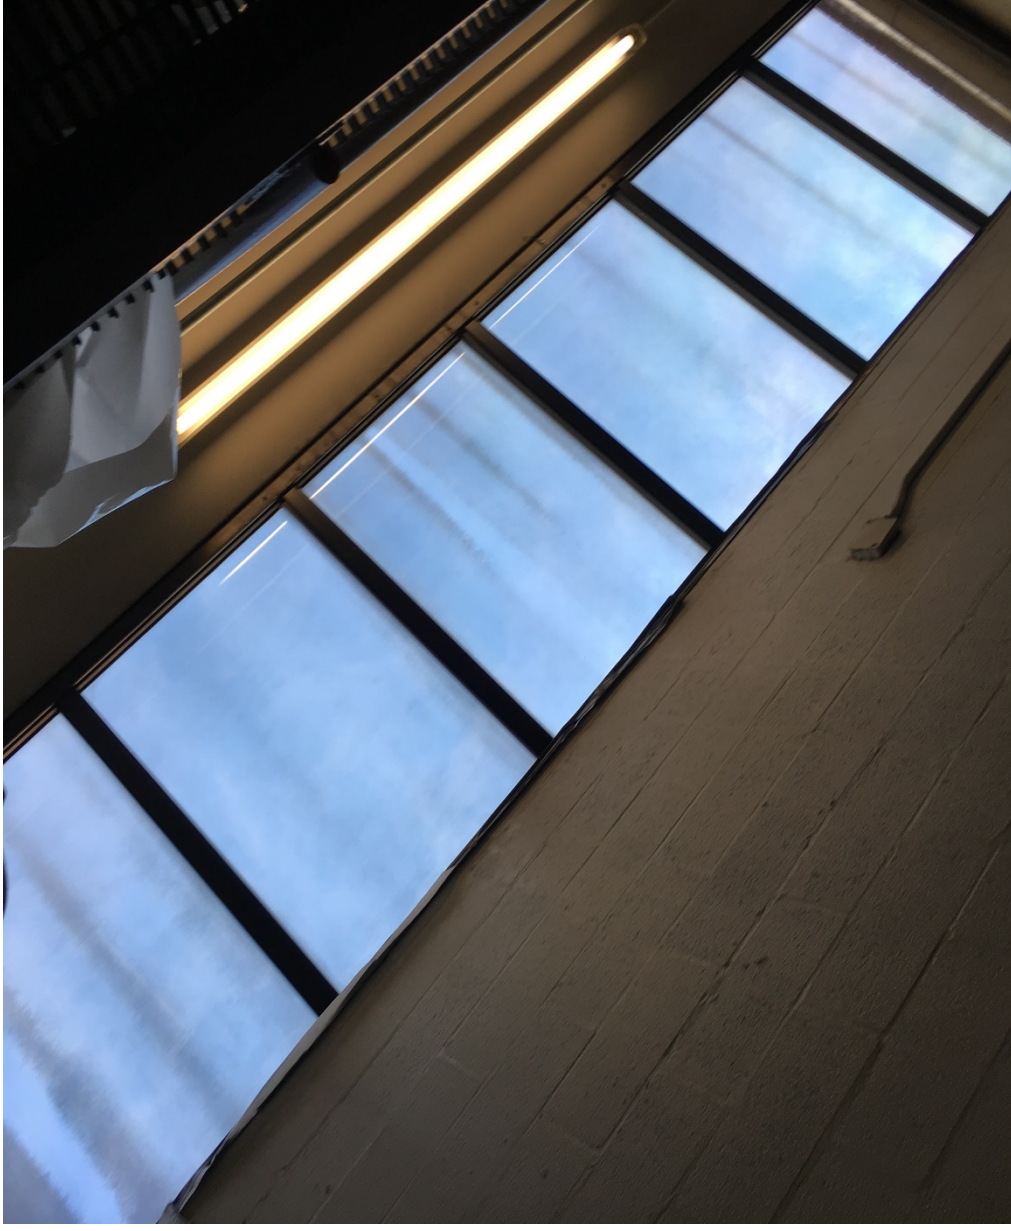
Photo – 12. This picture is of the firemen's equipment and gear room skylight which is leaking on the equipment.

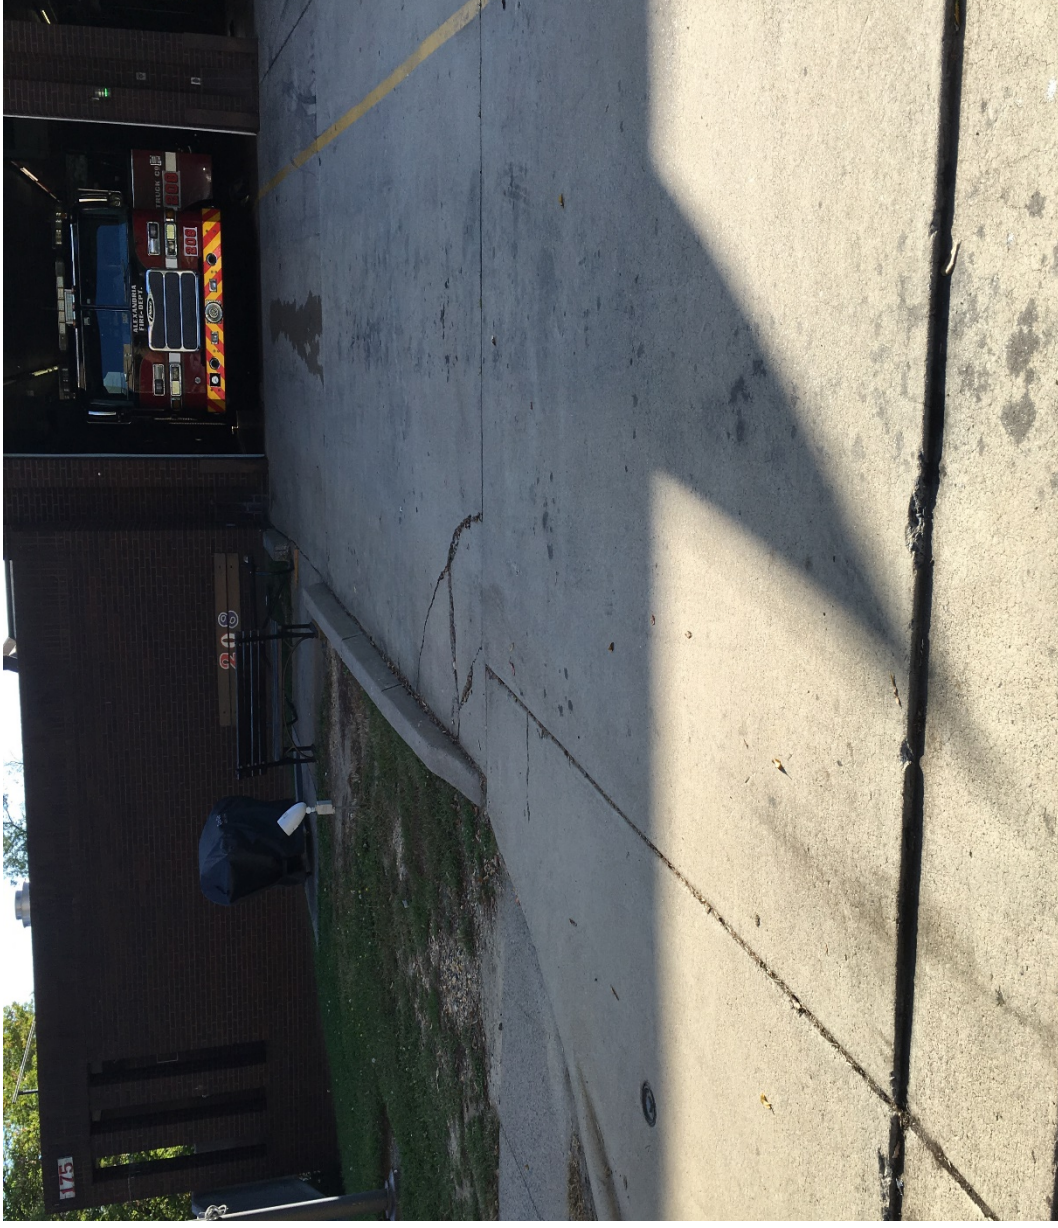
Photo – 14. This picture notes the concrete driveway damage which will need repair.
