EXHIBITS

EXHIBIT 1:

JOINT TASK FORCE & SUBCOMMITTEE MEETINGS

A2 Services, Inc. Facility Survey of City of Alexandria - City Hall

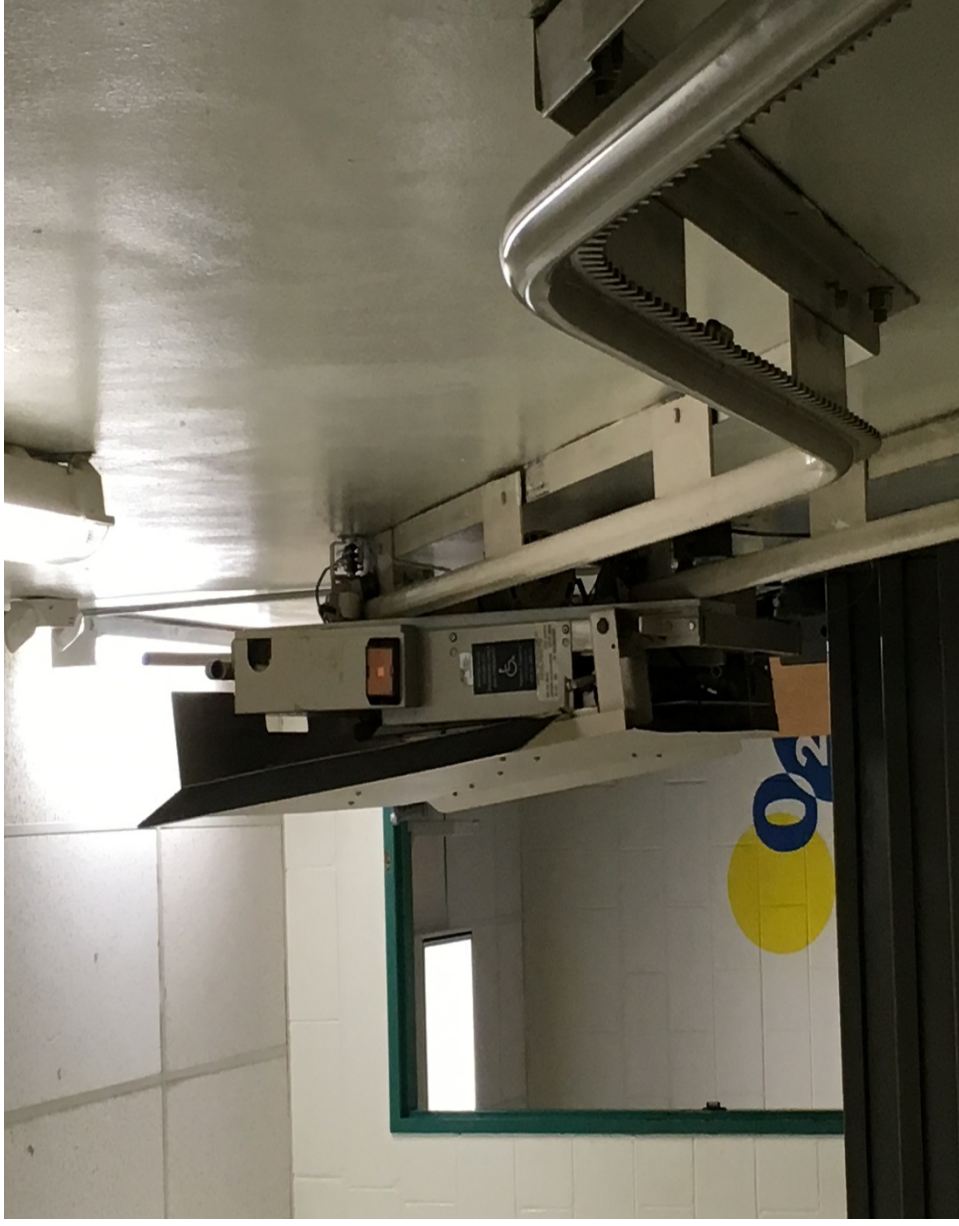
Finding # - 1. This picture shows the failed stair lift which will need to be replaced.

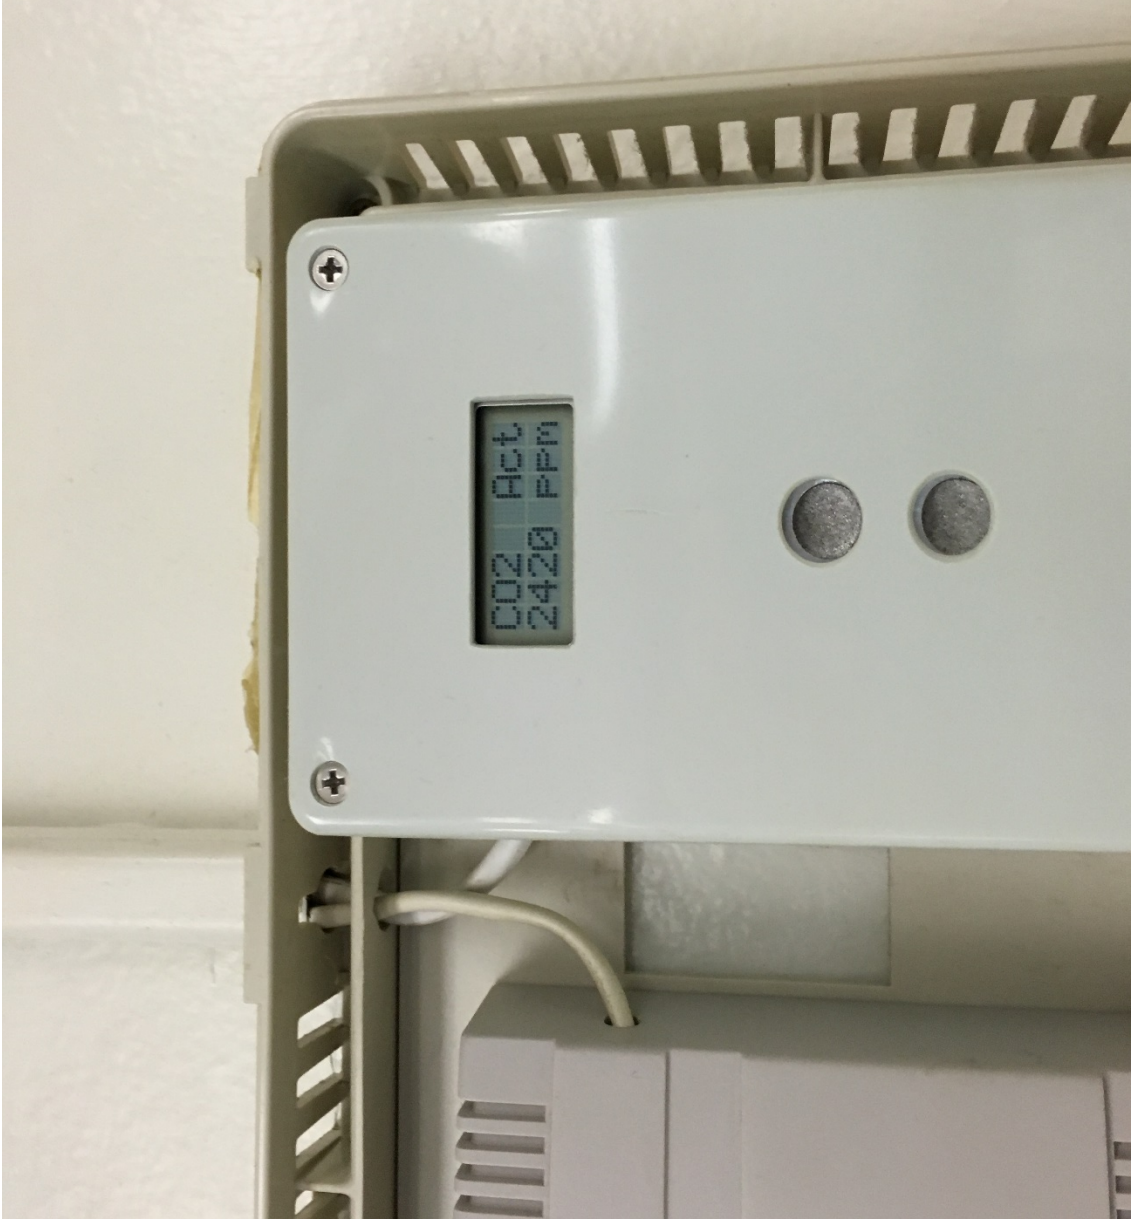
Finding # - 3. This picture shows the CO2 monitor in the 1st floor Art Class.

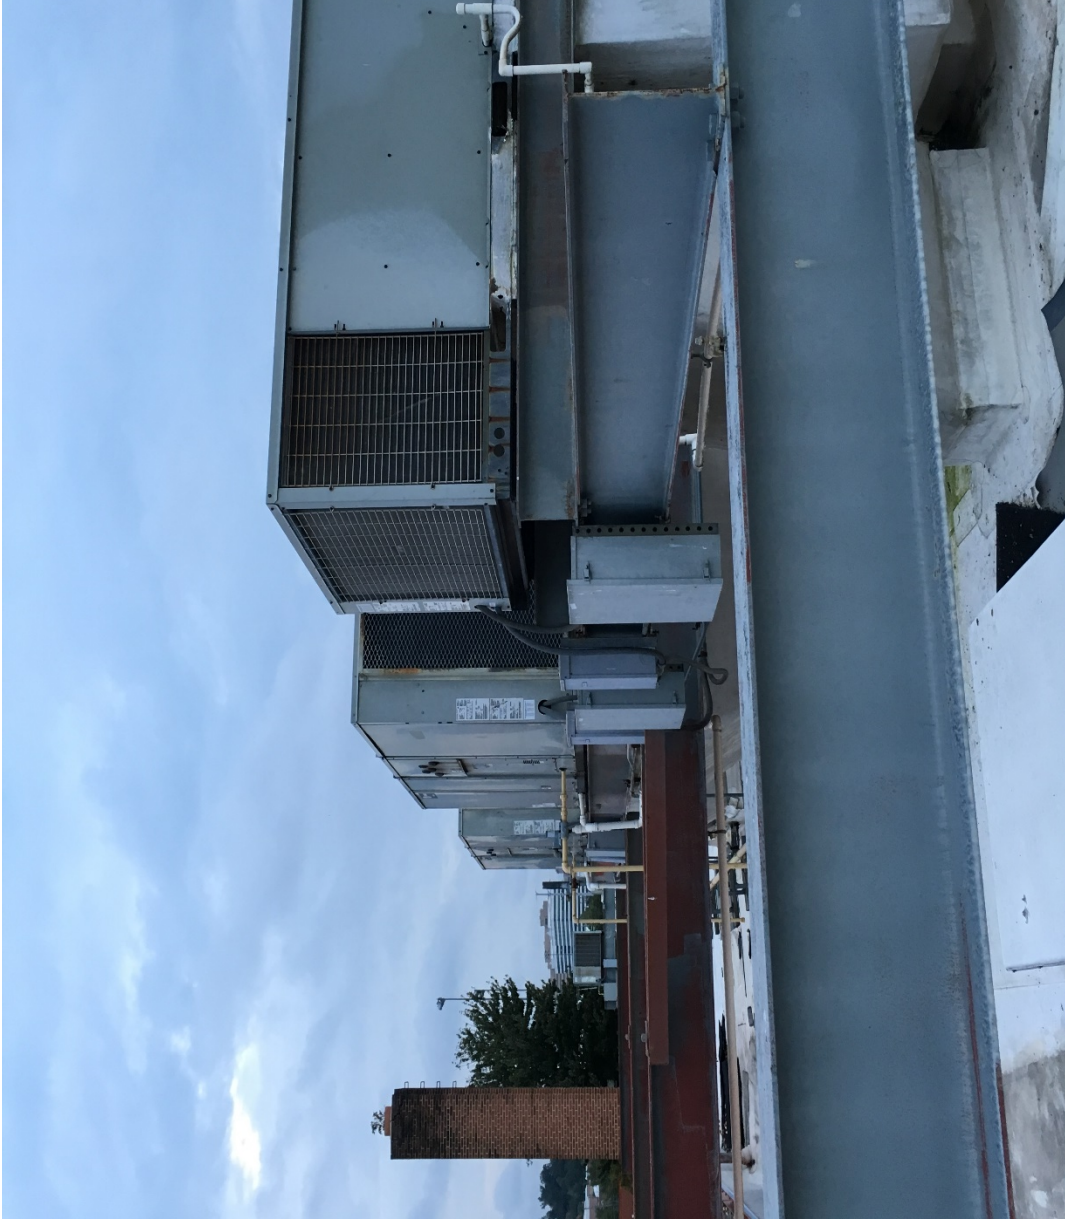
4. The building's roof top units are in poor condition but seem to be operating properly. The building indoor temperatures were quite comfortable when A2 toured the site. The supply air duct work is in very bad condition. The thermal insulation which covers the duct work has failed and in many cases has completely fallen off leaving the metal duct exposed to the weather and outdoor conditions. This does two things. First, it drastically reduces the energy efficiency of the unit while it tries to heat and cool the space. Second, it allows rain to get between the insulation and the duct where it then can enter the building below.

Finding # - 4. This picture is an example of the roof top units at Cora Kelly ES.

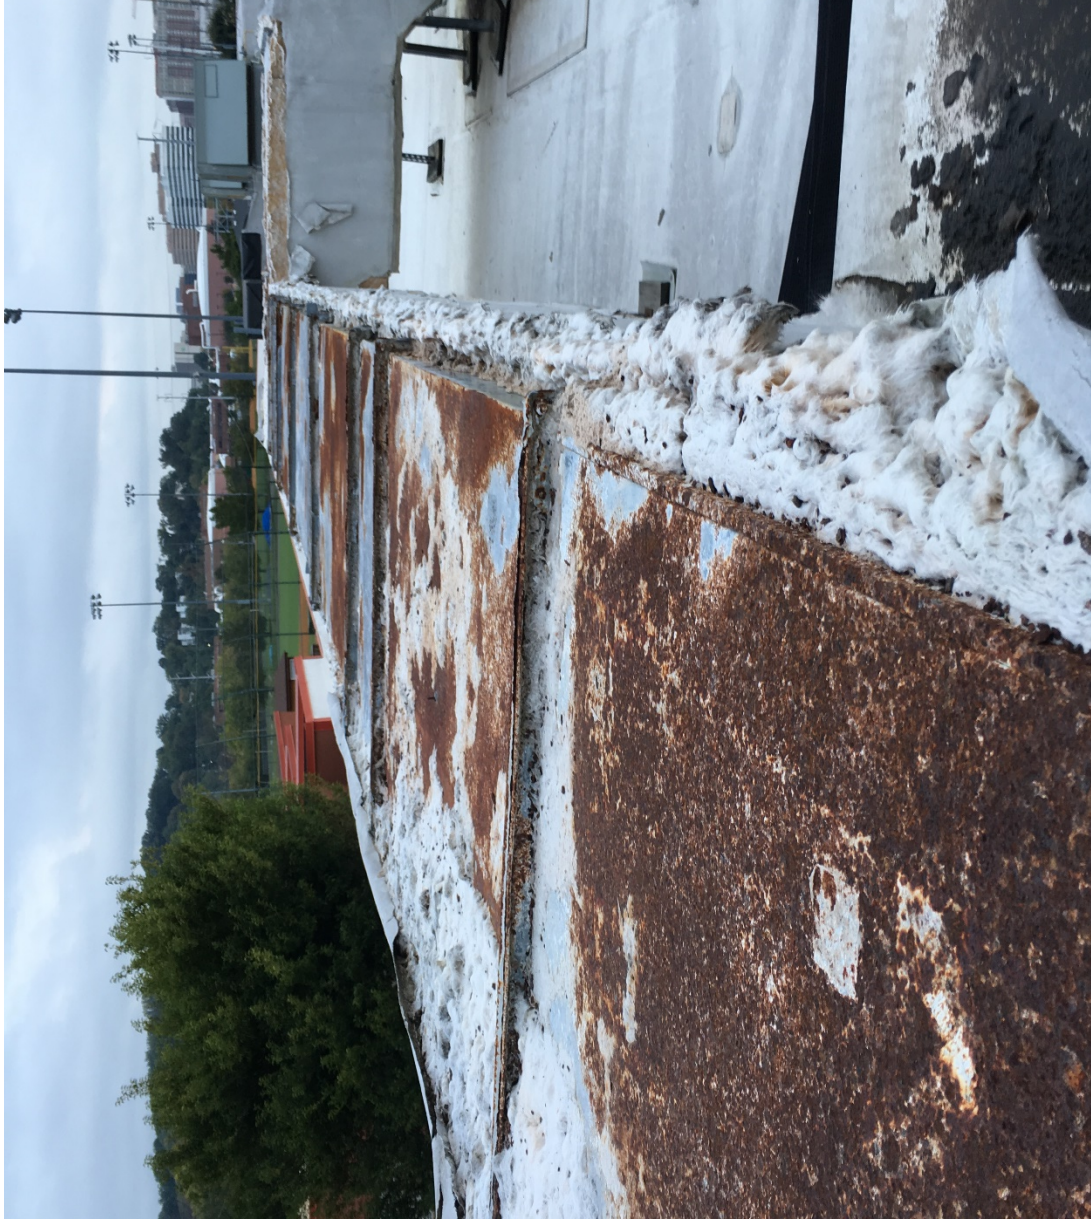
Finding # - 4 & 5. This picture is an example of the roof top units damaged duct work.

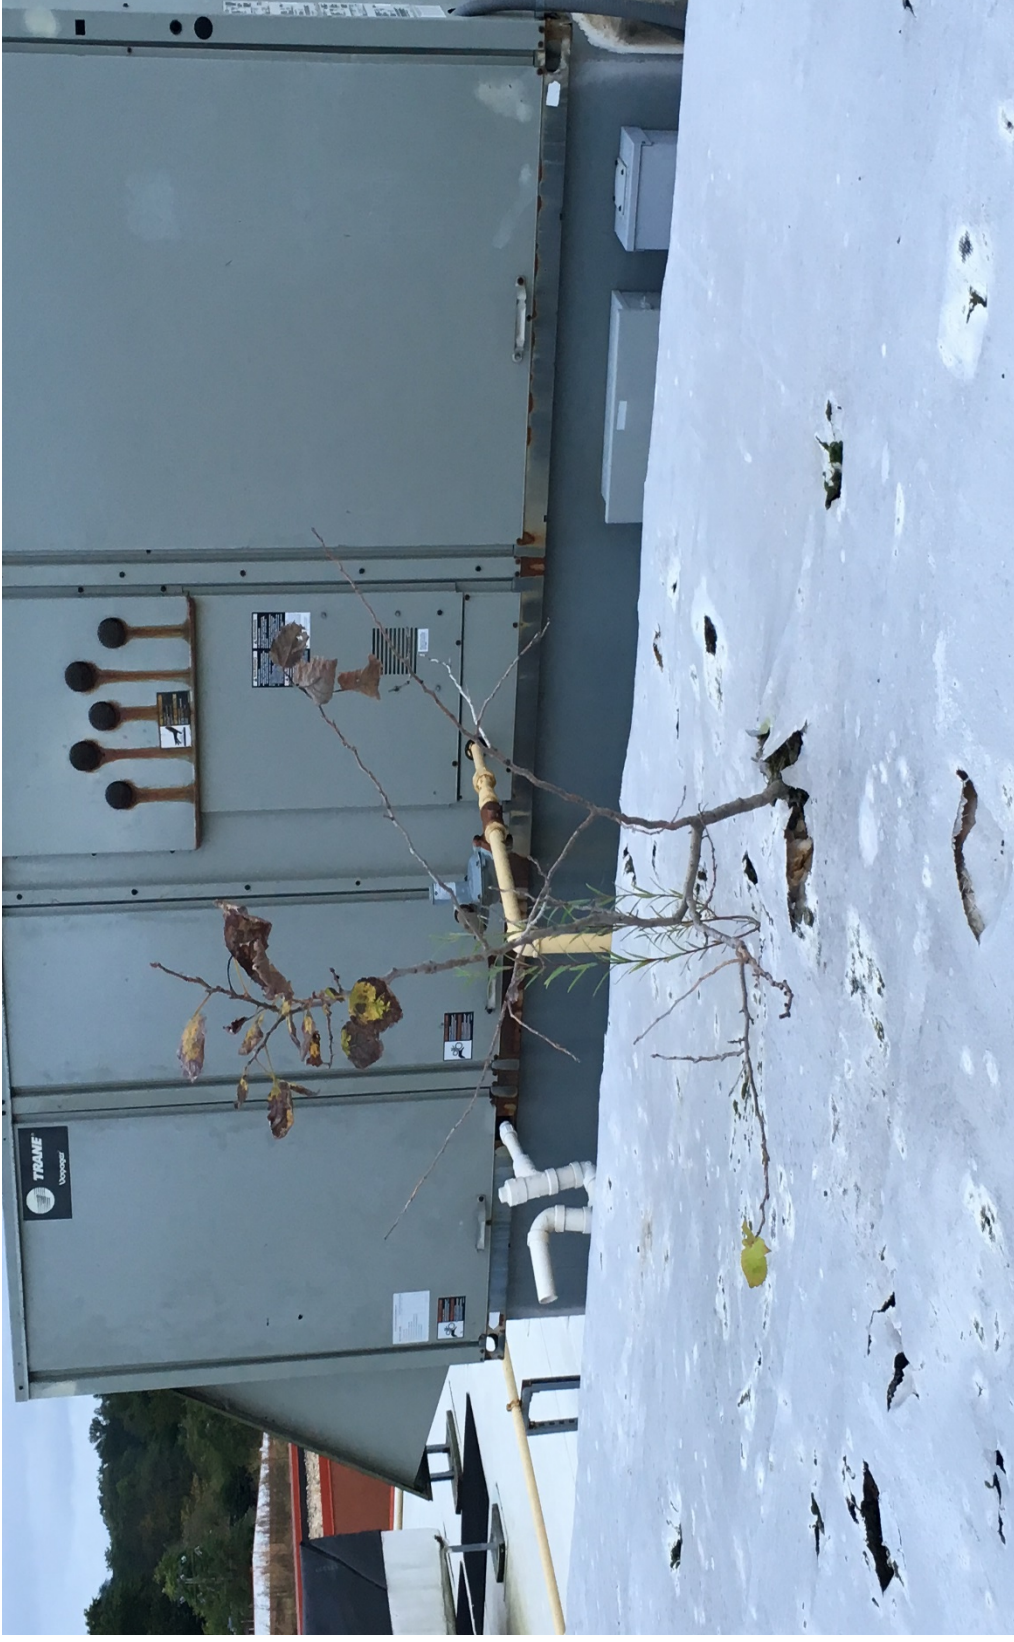
Finding # - 4 & 5. This picture is another example of the roof top units damaged duct work.

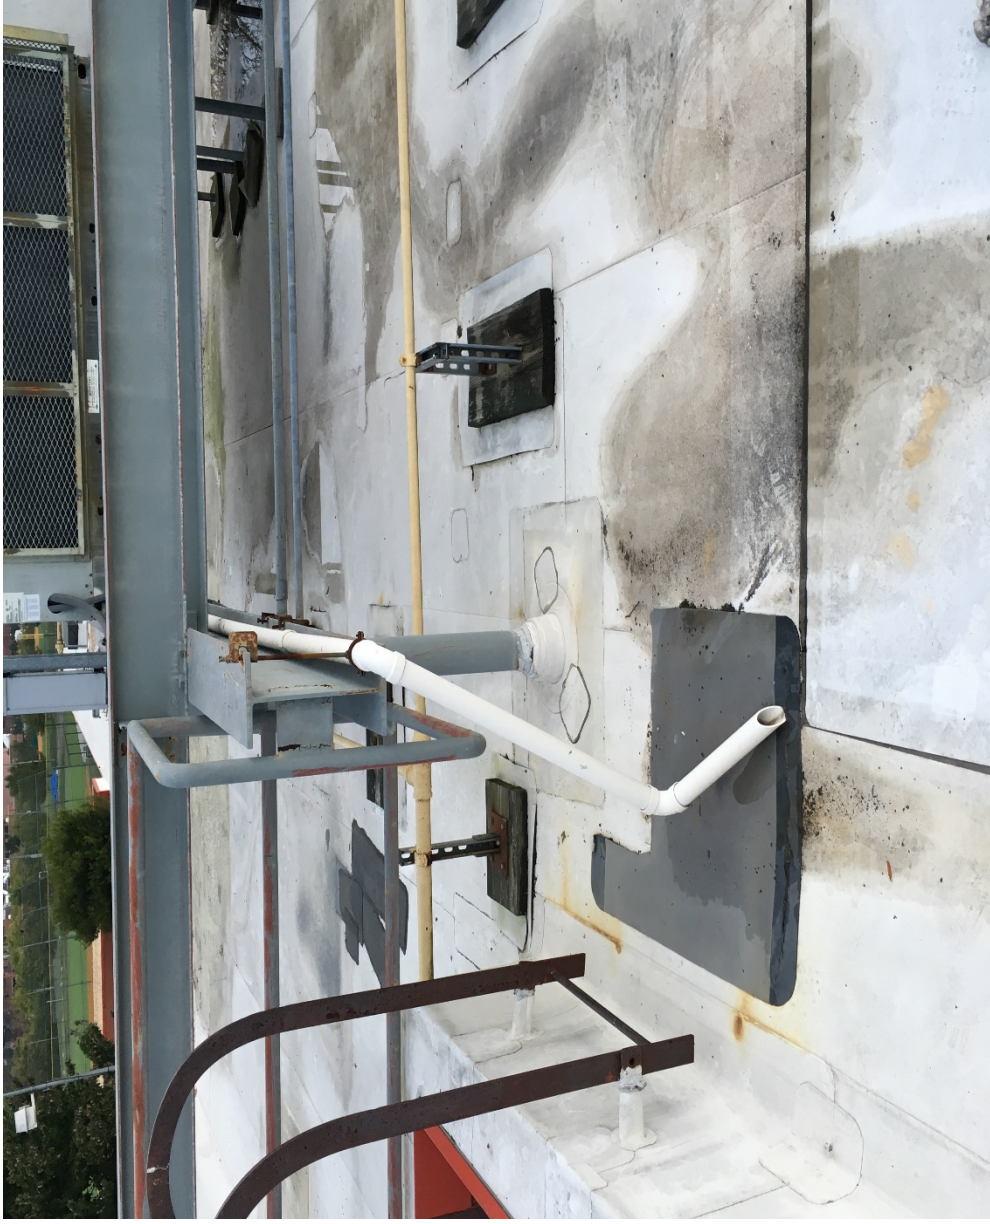
Finding # - 6. This picture notes one condensate drain (the white PVC pipe) simply draining onto the roof. These lines should be run to the nearest roof drain. This would help eliminate water on the roof.

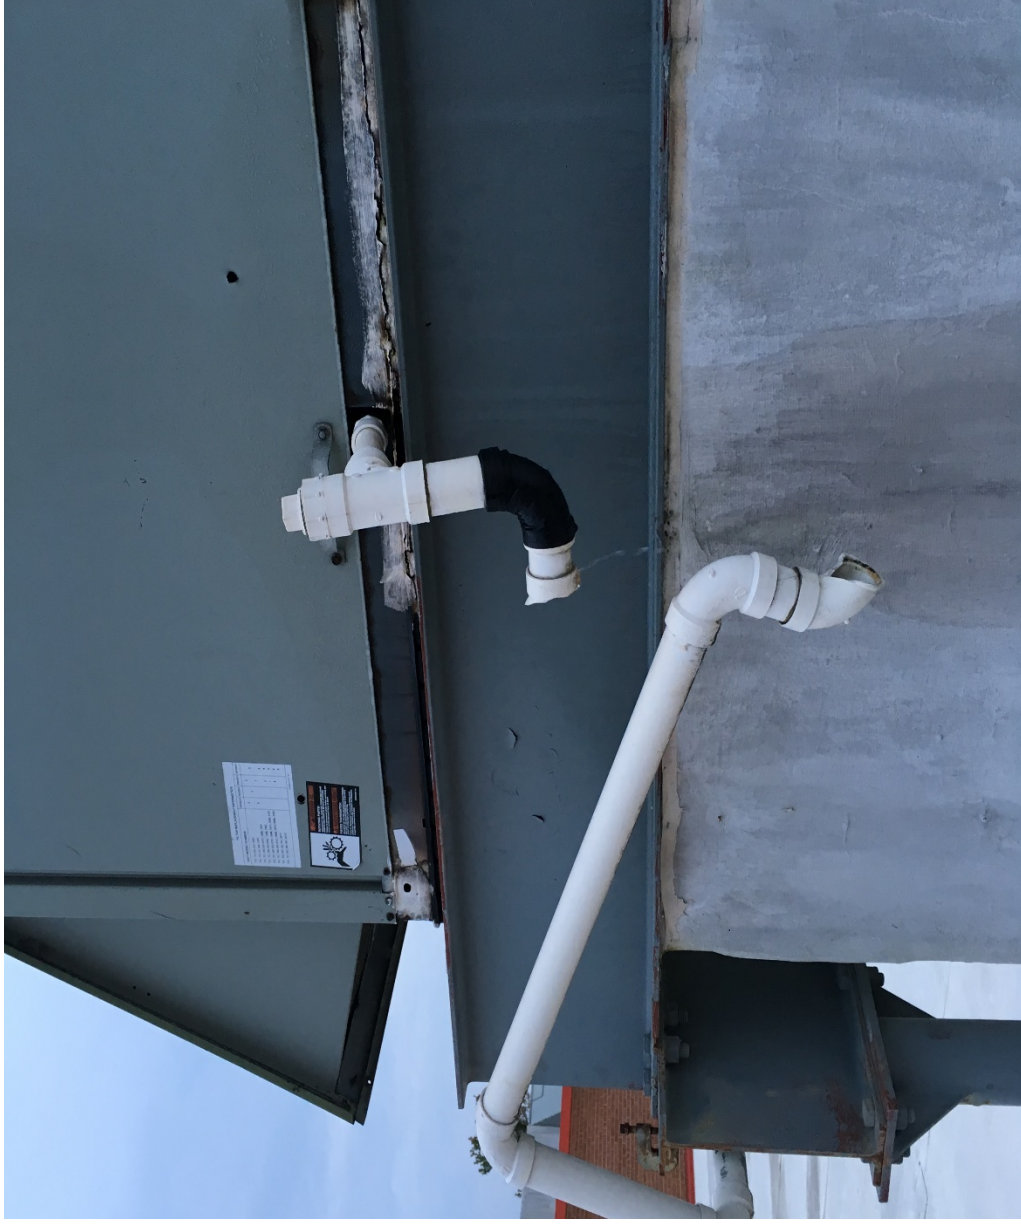
6. The condensate drain on RTU # 12 is broken in half and will need to be repaired.
7. One concern A2 noted while touring the roof was related to the quality of work being done for the school by contractors. One issue previously addressed above was with the condensate drains. It was noted that repair parts such as burnt out fan motors

Finding # - 7. This picture is of a broken condensate line on RTU #-12.

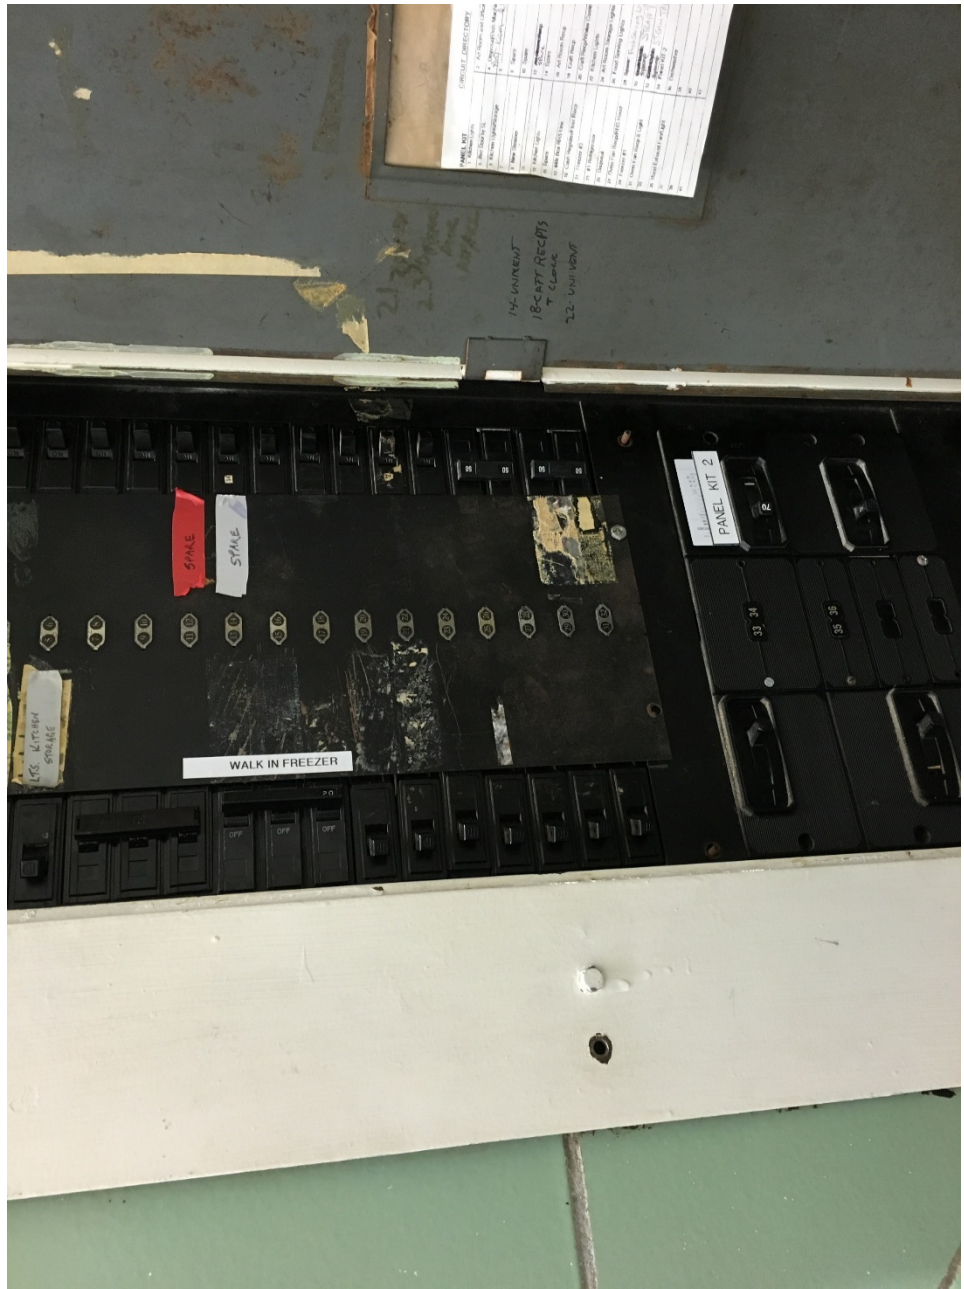
Finding # - 9. This picture is one of the breaker panels in the cafeteria.

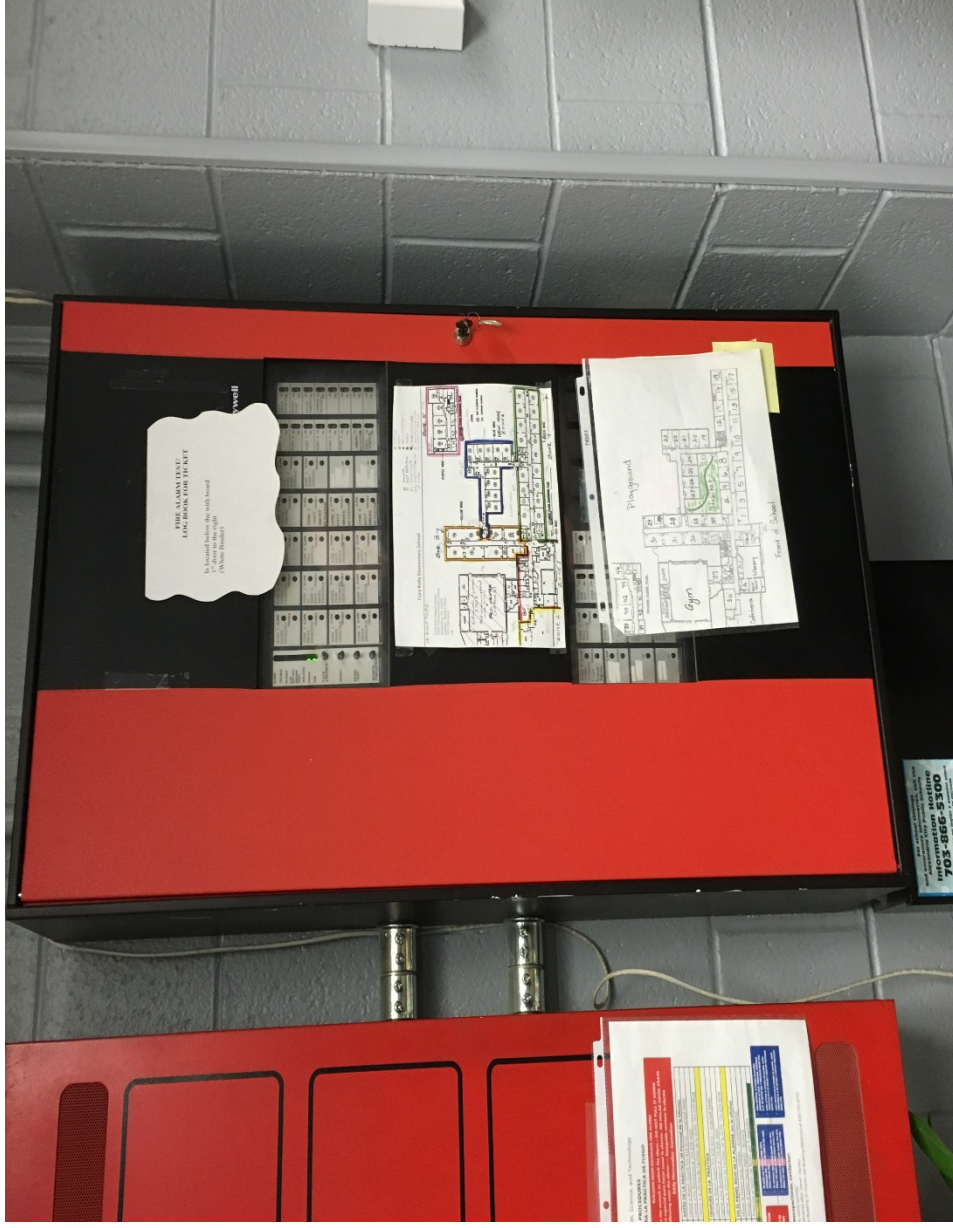
Finding # - 10. This picture is of the fire alarm systems in Cora Kelly E.S. This systems will need to be tied into the new recreation facilities system.

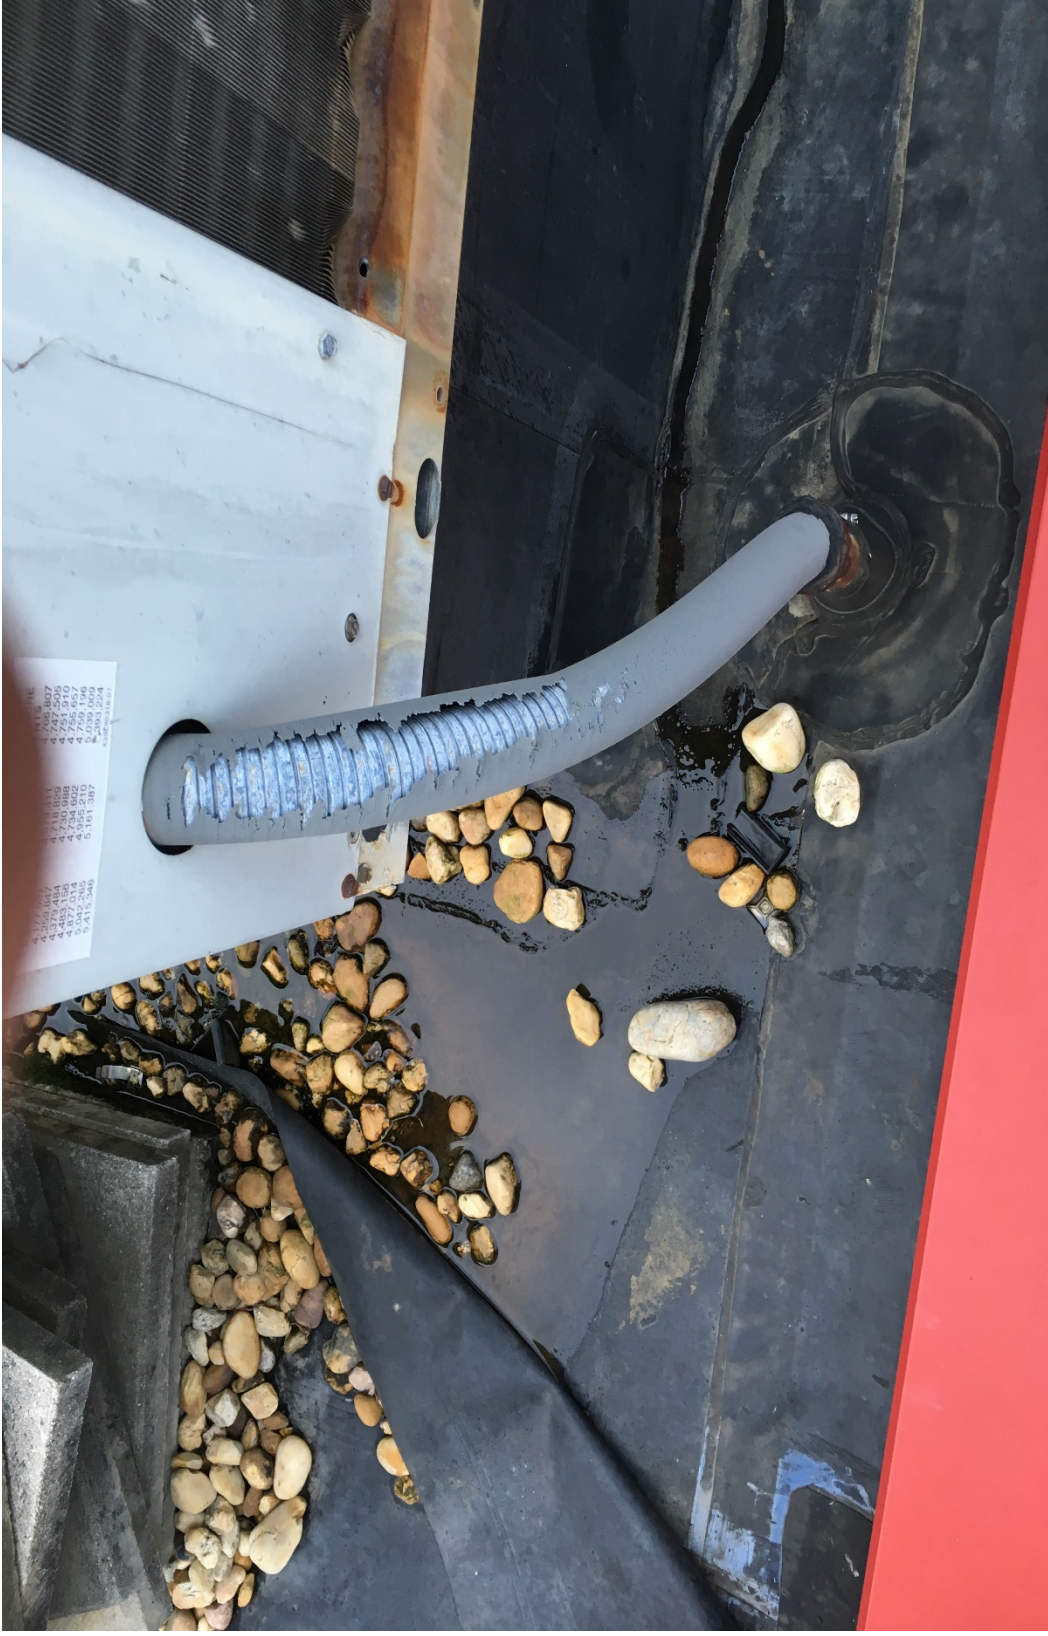
10. The roof top units are fed power through water tight flexible conduits. Several of these electrical feeds have failed and can allow water to get inside the electrical conduit. This is a problem because depending on how the conduit is piped across the ceiling below, water can reach junction boxes and leak out or cause a short circuit and failure of the equipment. A2 recommends that these be repaired.

Finding # - 11. This picture is of one of the failed water tight electrical feeds to a roof top unit.

11	Water tight electrical whips feeding RTU's have failed causing leaks.	Roof
	12	No electrical maintenance is being done. IR testing and torque and cleaning needs to be done.	Electrical systems throughout
<hr/>			
Photo	#	Description of Deficiency/Issues	Location - Floor/Room
PLUMBING	13	The domestic hot water recirculation pumps are not working.	Electric / Mechanical room

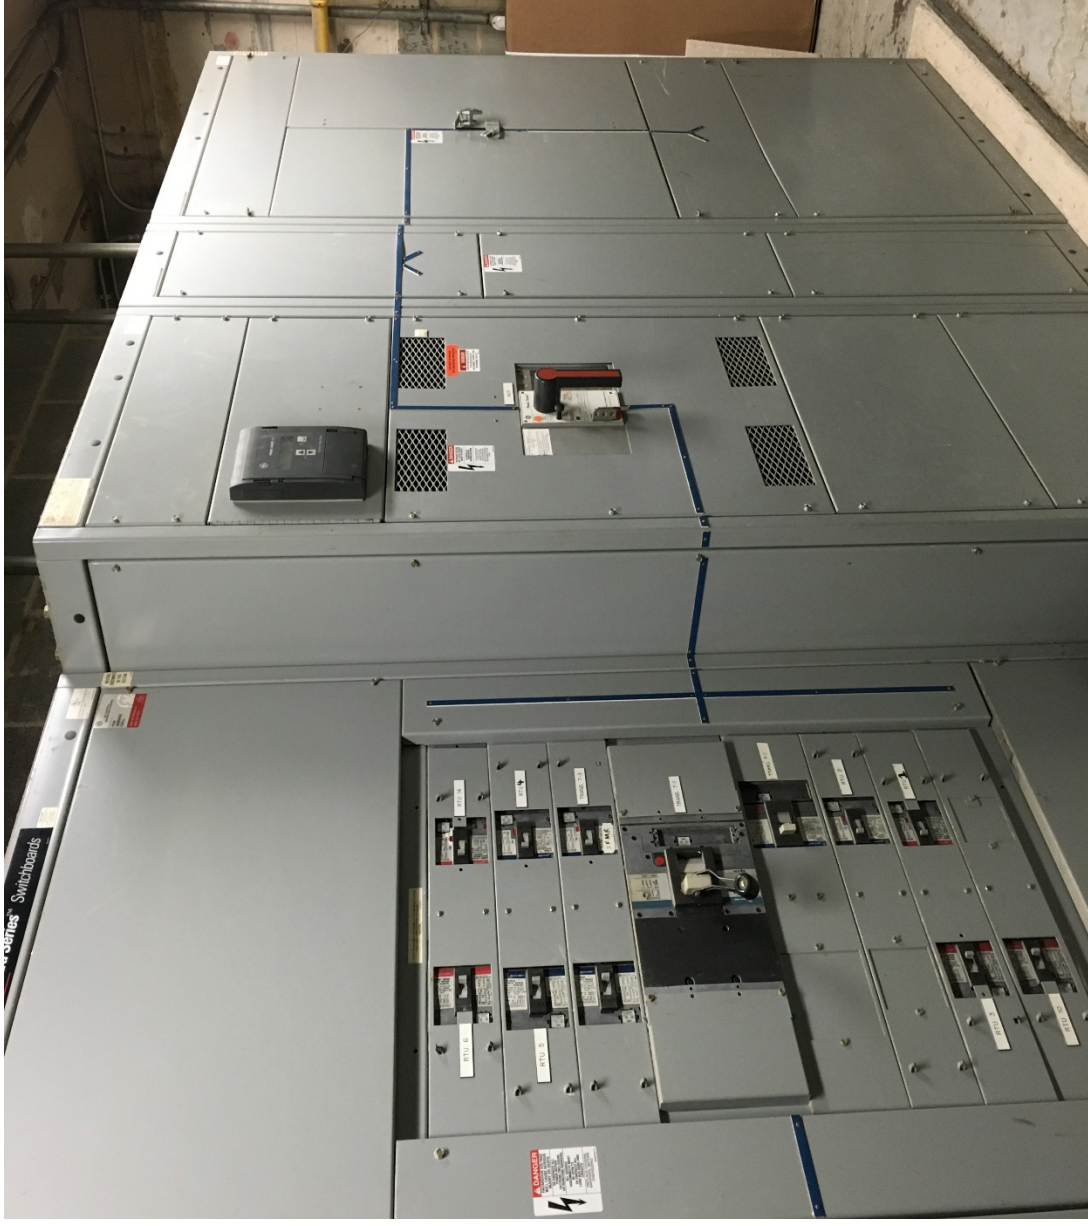
11. The main electrical panel and breakers panels at the site do not look as if they are being tested and serviced. All electrical systems should be thermally scanned with an infra-red camera to identify any overheating components or loose connections. This testing will identify such issues before they cause a failure of the electrical system. A2 recommends that all electrical gear be opened, thermally scanned then cleaned and all terminations checked of tightness on an annual basis. This an important risk management task that should be implemented.

Finding # - 12. This picture is of some of the main electrical gear.

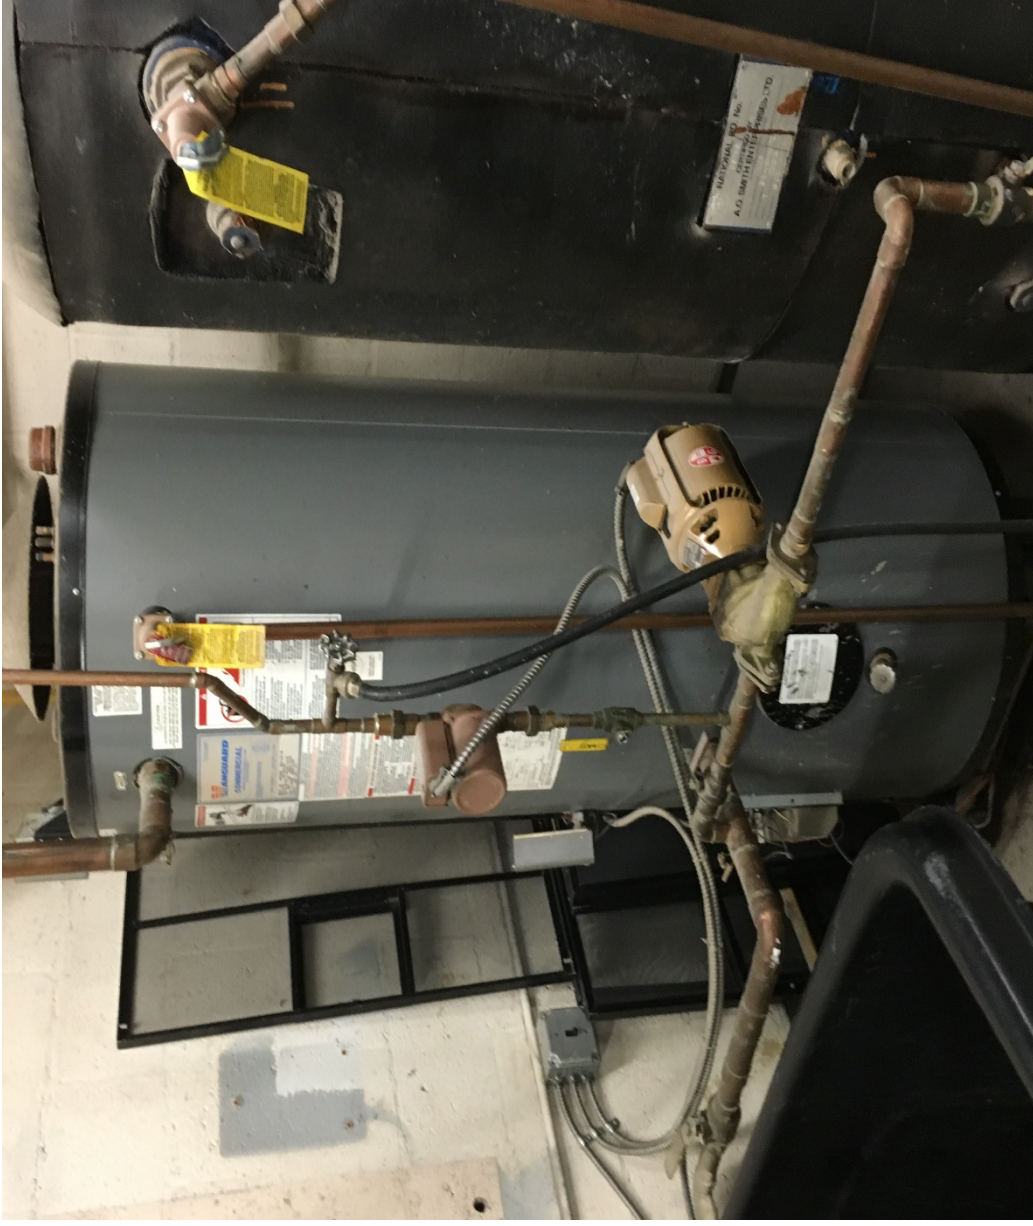
12. The buildings domestic hot water is generated by one 91 gallon capacity gas fired hot water heater. This system also has a 250 gallon hot water storage tank. There are two circulation pumps, one circulates hot water to all the restrooms and sinks in the building while the other circulates water from the heater to the storage tank. Neither of these pumps were running during our inspection. This condition will cause loss of hot water to the buildings hot water fixtures.

Finding # - 13. This picture is of the domestic hot water heater for the site with its storage tank and pumps.

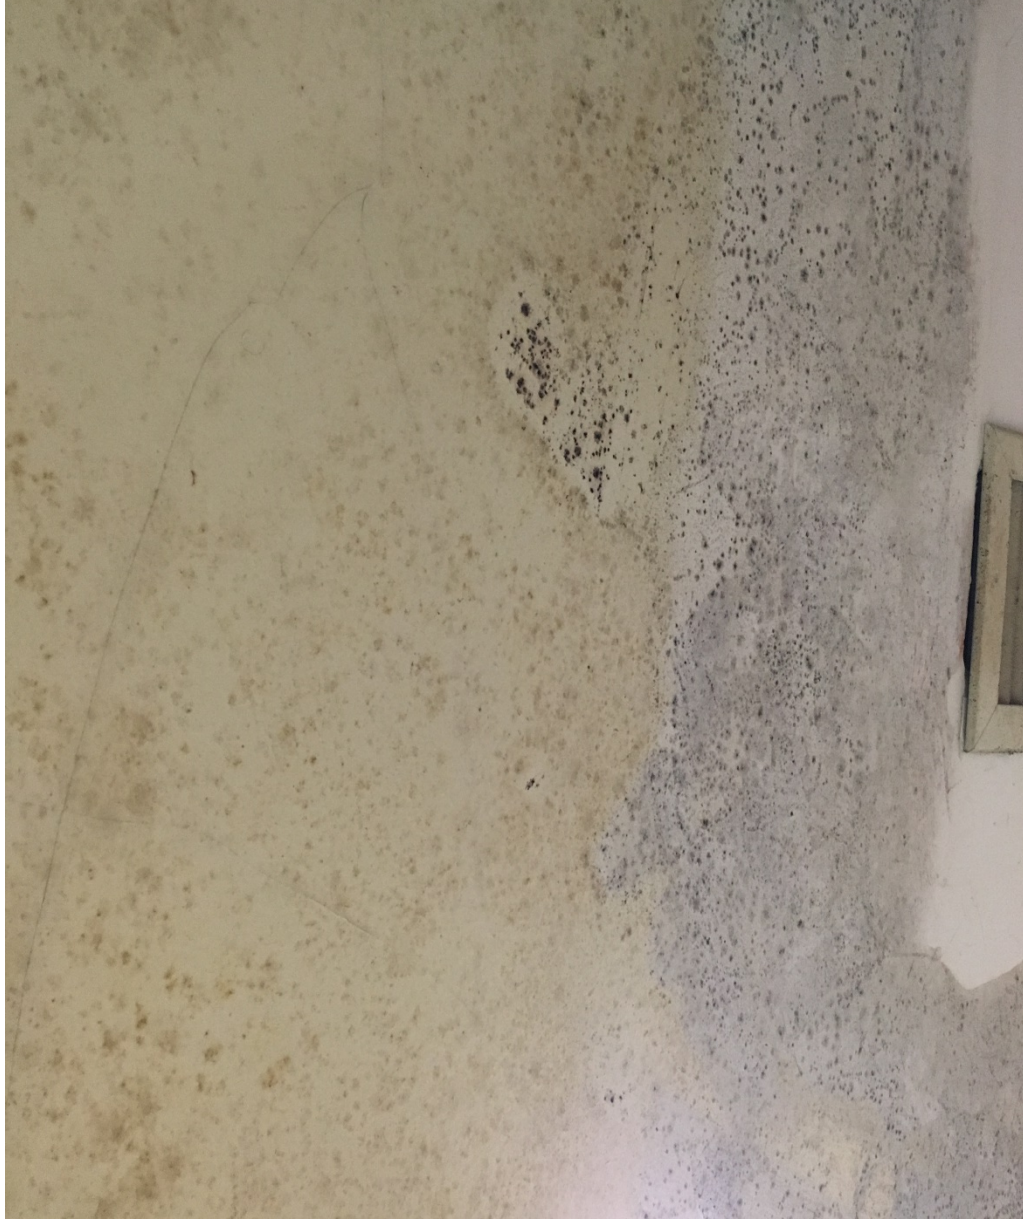
Finding – 14 – This picture of an example of possible micro-biological growth within the walls from water infiltration.

Photo	#	Description of Deficiency/Issues	Location - Floor/Room
STRUCTURAL	14	Water infiltration from the roof and through the walls and around the windows is causing micro-biological growth as shown in this photo.	1st floor janitors closet
	15	Many roof areas where water ponds and cannot drain.	Roof
	16	The main roof is poor condition. Ponding of water and roof penetrations are allowing leaks.	Roof
	17	.Skylights are broken in the 1st floor north corridor	Roof
	18	The screen wall on top of the modular building section is causing leaks into the building.	Roof
	19	Many areas in the building have stained ceiling tile. However you would expect worse conditions after seeing the roof.	Inside the building
	20	Perimeter envelope water infiltration problems.	Perimeter of building
	21	Window caulking has failed in many areas.	Perimeter of building
	22	The Front entrance roof has been damaged.	Front of building

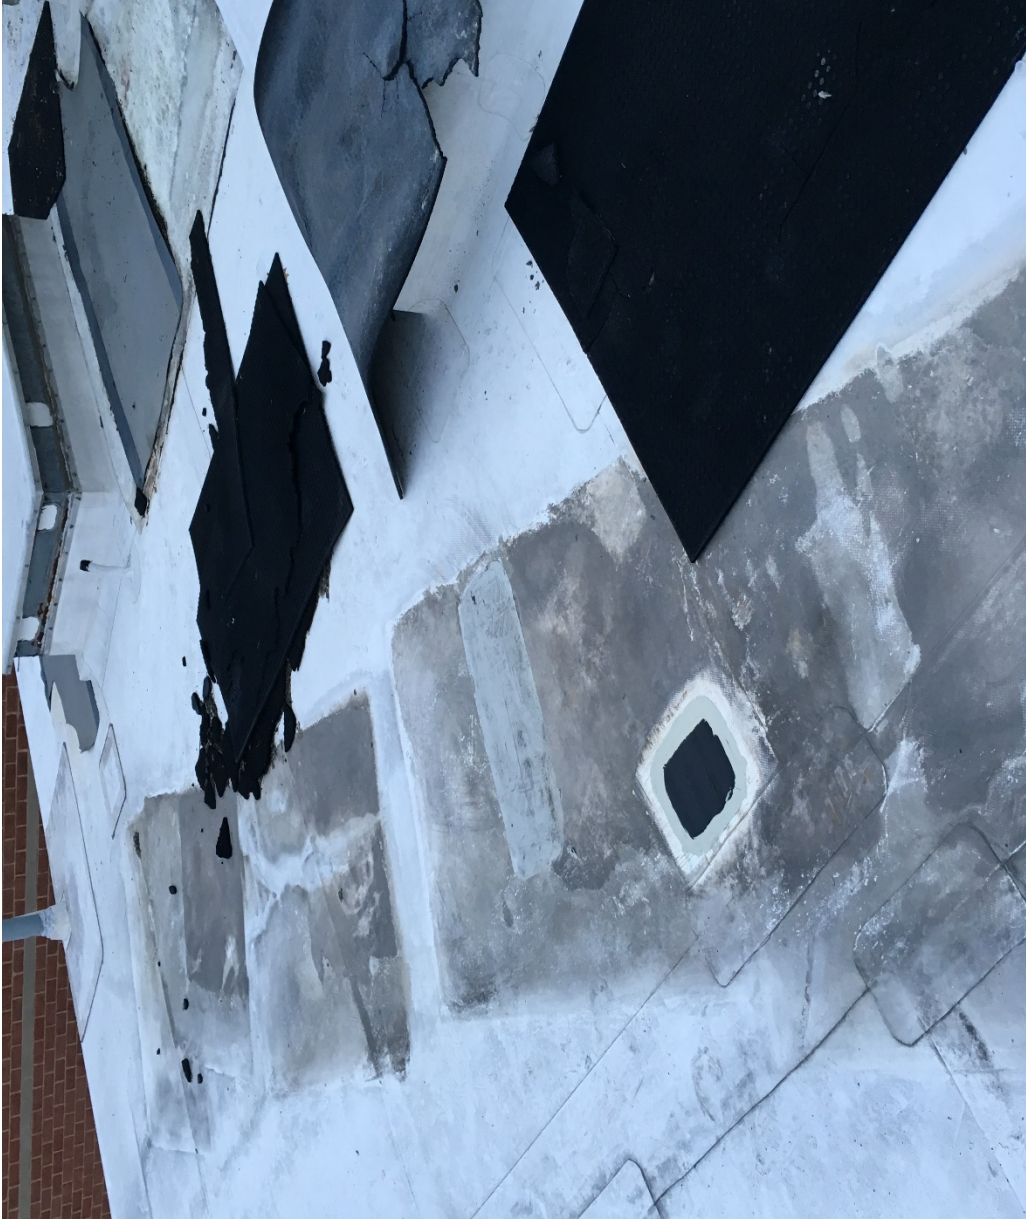
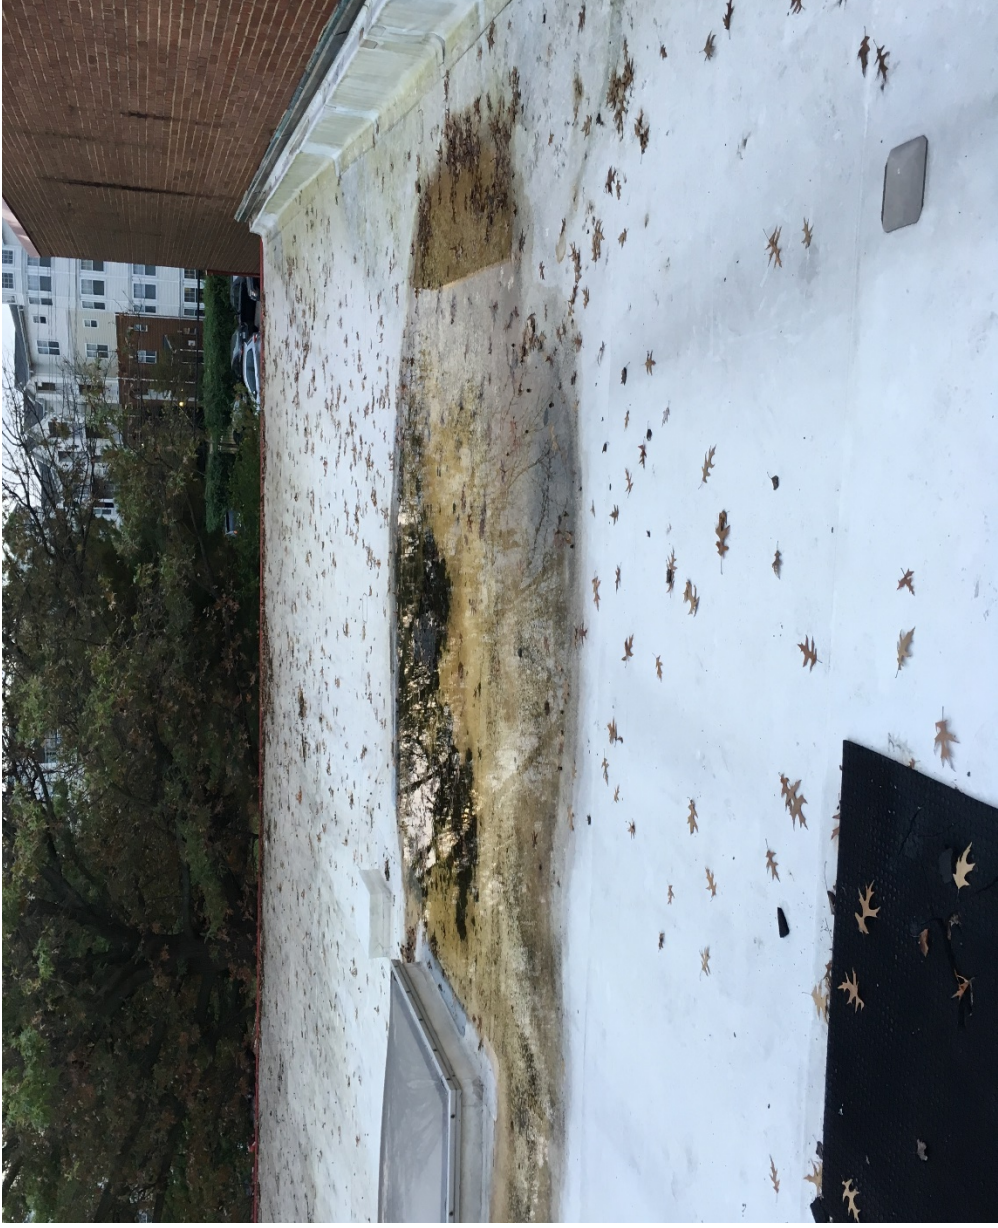
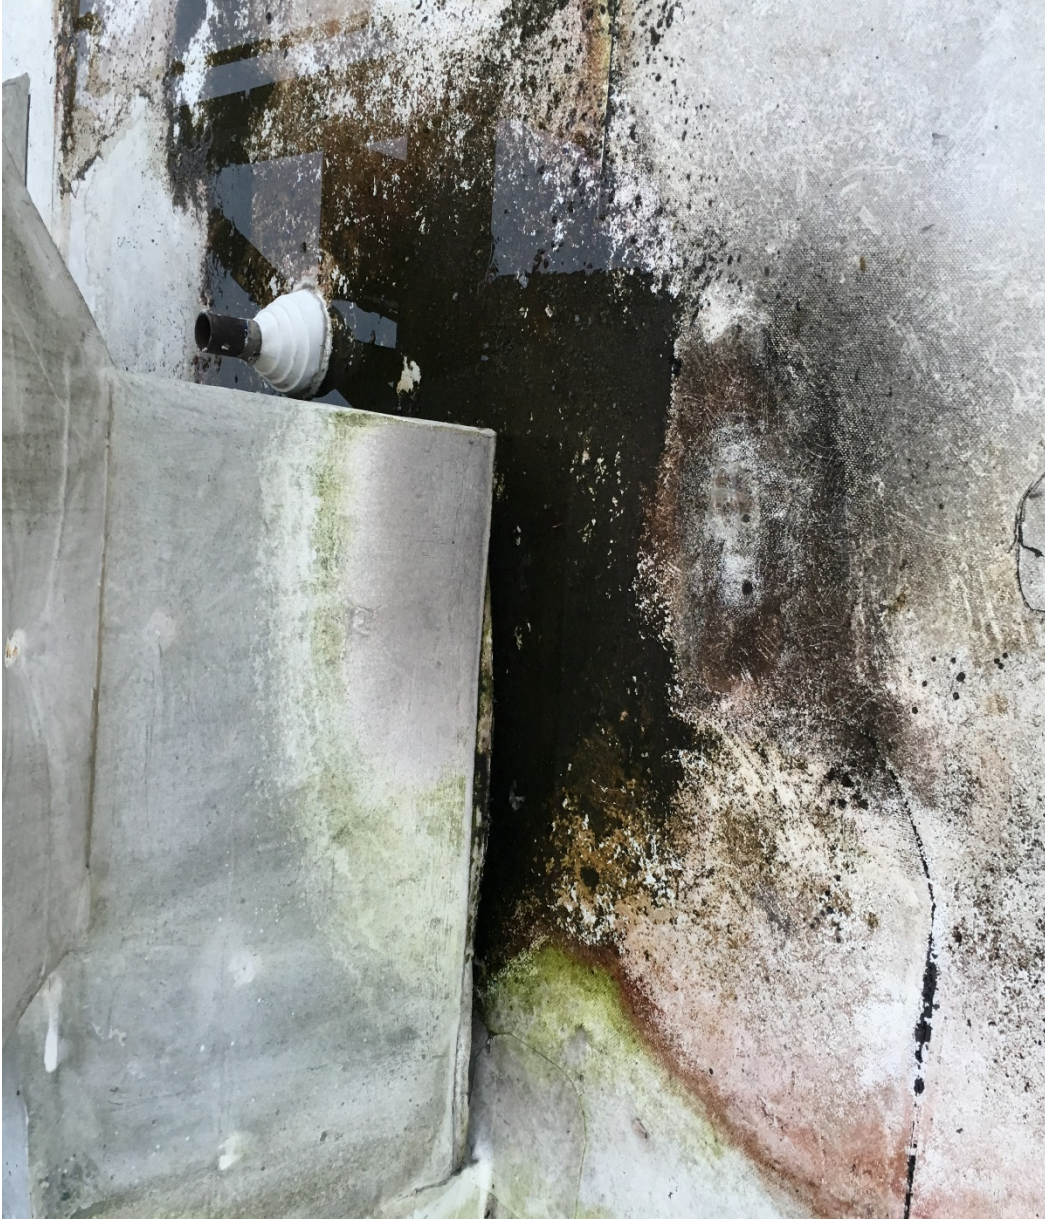
13. Cora Kelly ES has a built-up membrane roof system. As with any large flat roof the water doesn't always get to the roof drains and creates ponds. At Cora Kelly this condition is worse than most. Anytime water is allowed to pond on a roof leakage below will occur. The main roof is in poor condition and because of the ponding and the duct work penetrations there are leaks and water entering the building. In touring the building interior, one can note wet ceiling tiles.

Finding # - 15 & 16. The next set of pictures note the roof condition at Cora Kelly E.S.

Finding # - 15 & 16 continued. This is another view of the roof.

Finding # - 15 & 16 continued. The following is another view of the roof.
