EXHIBITS

EXHIBIT 1:

JOINT TASK FORCE & SUBCOMMITTEE MEETINGS

A2 Services, Inc. Facility Survey of City of Alexandria - City Hall

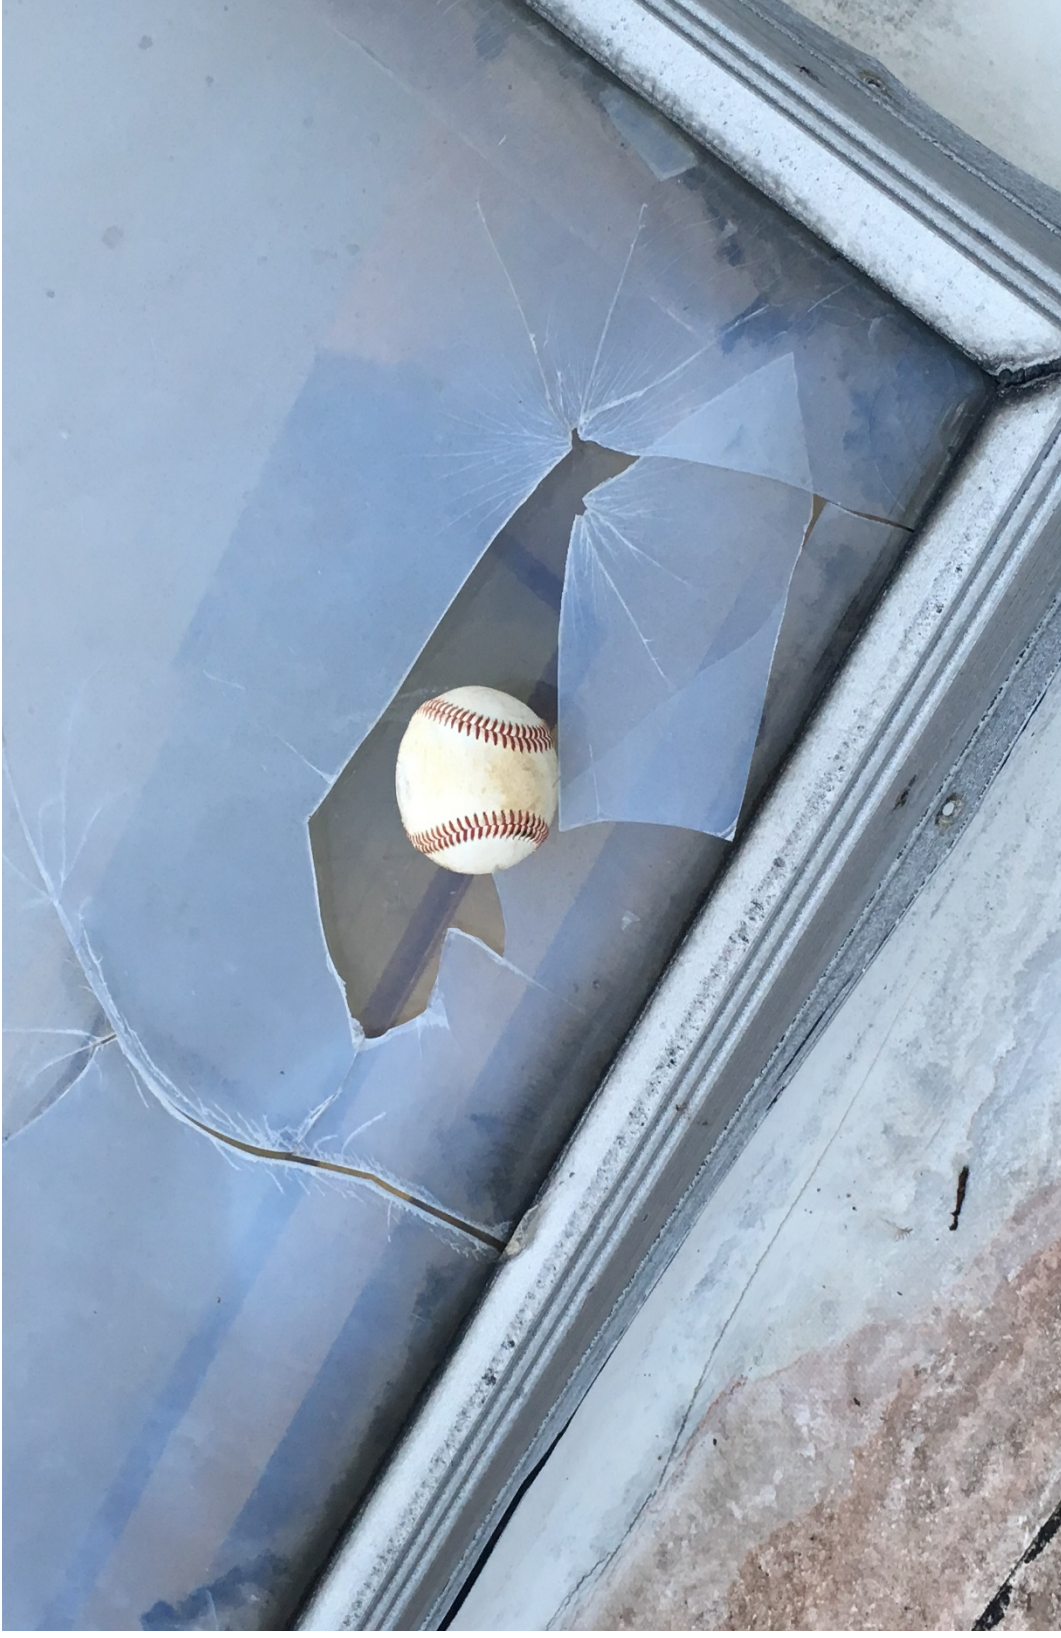
14. Two skylights in the roof near the baseball field are cracked and broken. The students are hitting foul balls which hit the roof and the skylights. Mr. Stallings is looking into having the angled section of fence on top of the back stop modified to help stop this issue.

Finding # - 17. This picture notes one of the broken skylights which are being hit by baseballs.

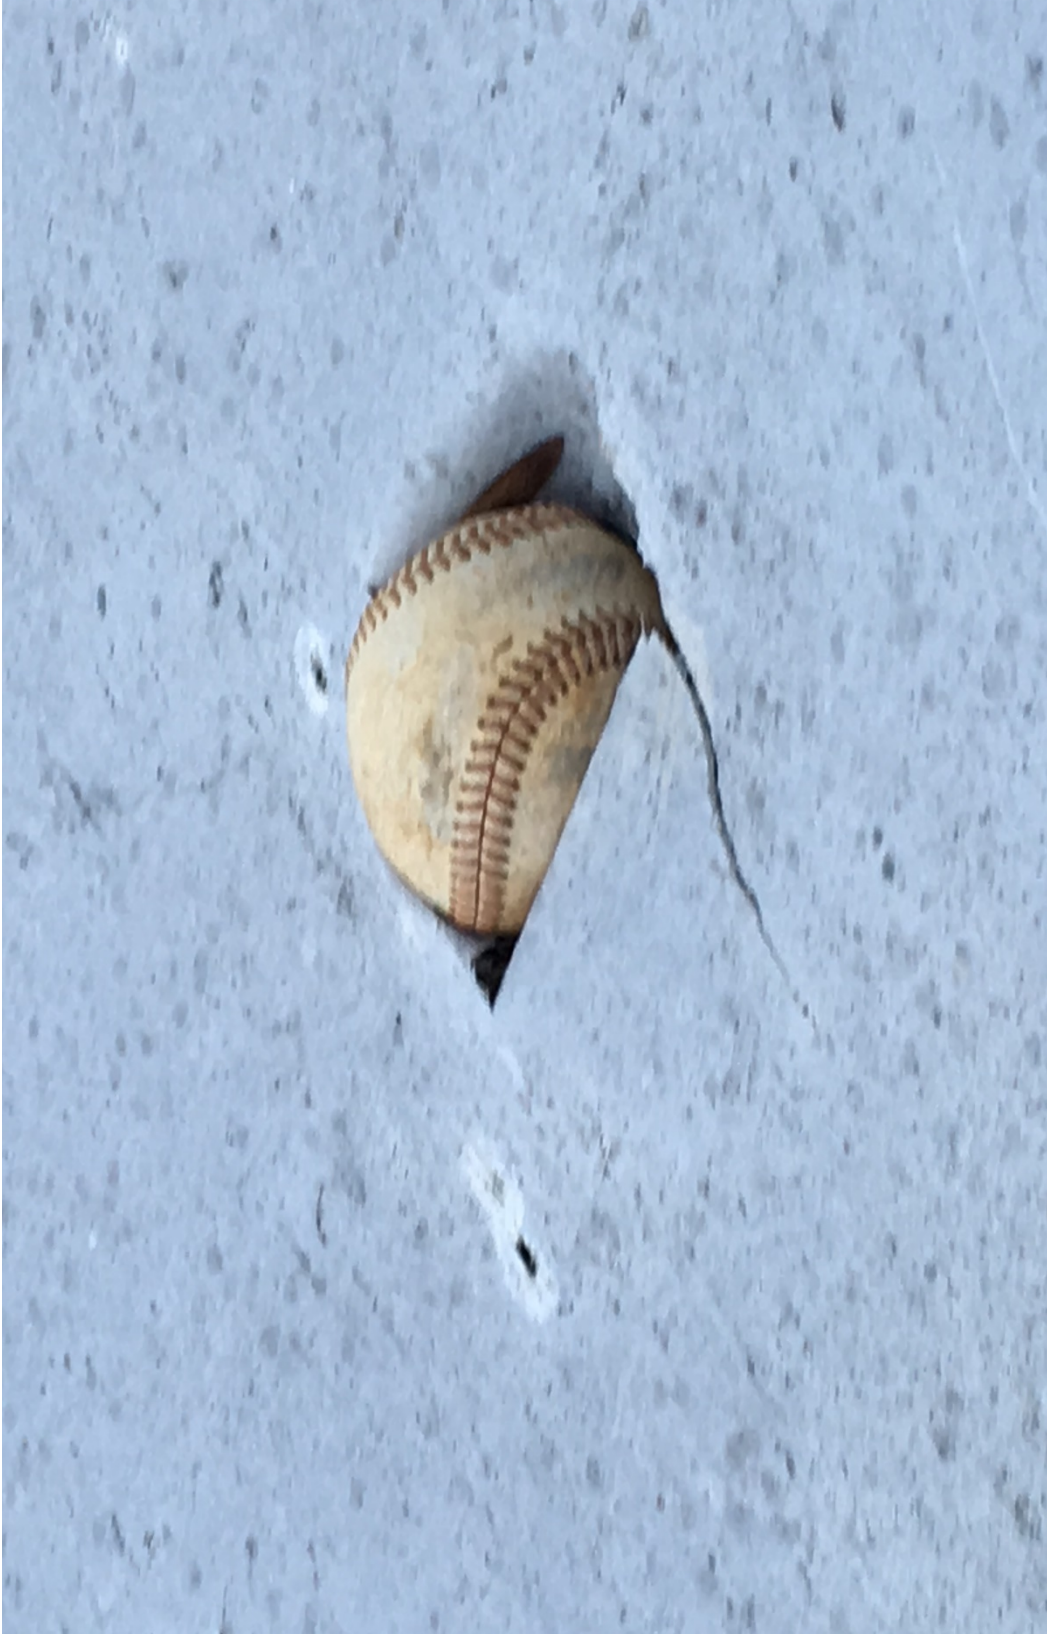
Finding # - 17. This picture is of roof top unit duct work insulation being hit by a baseball.

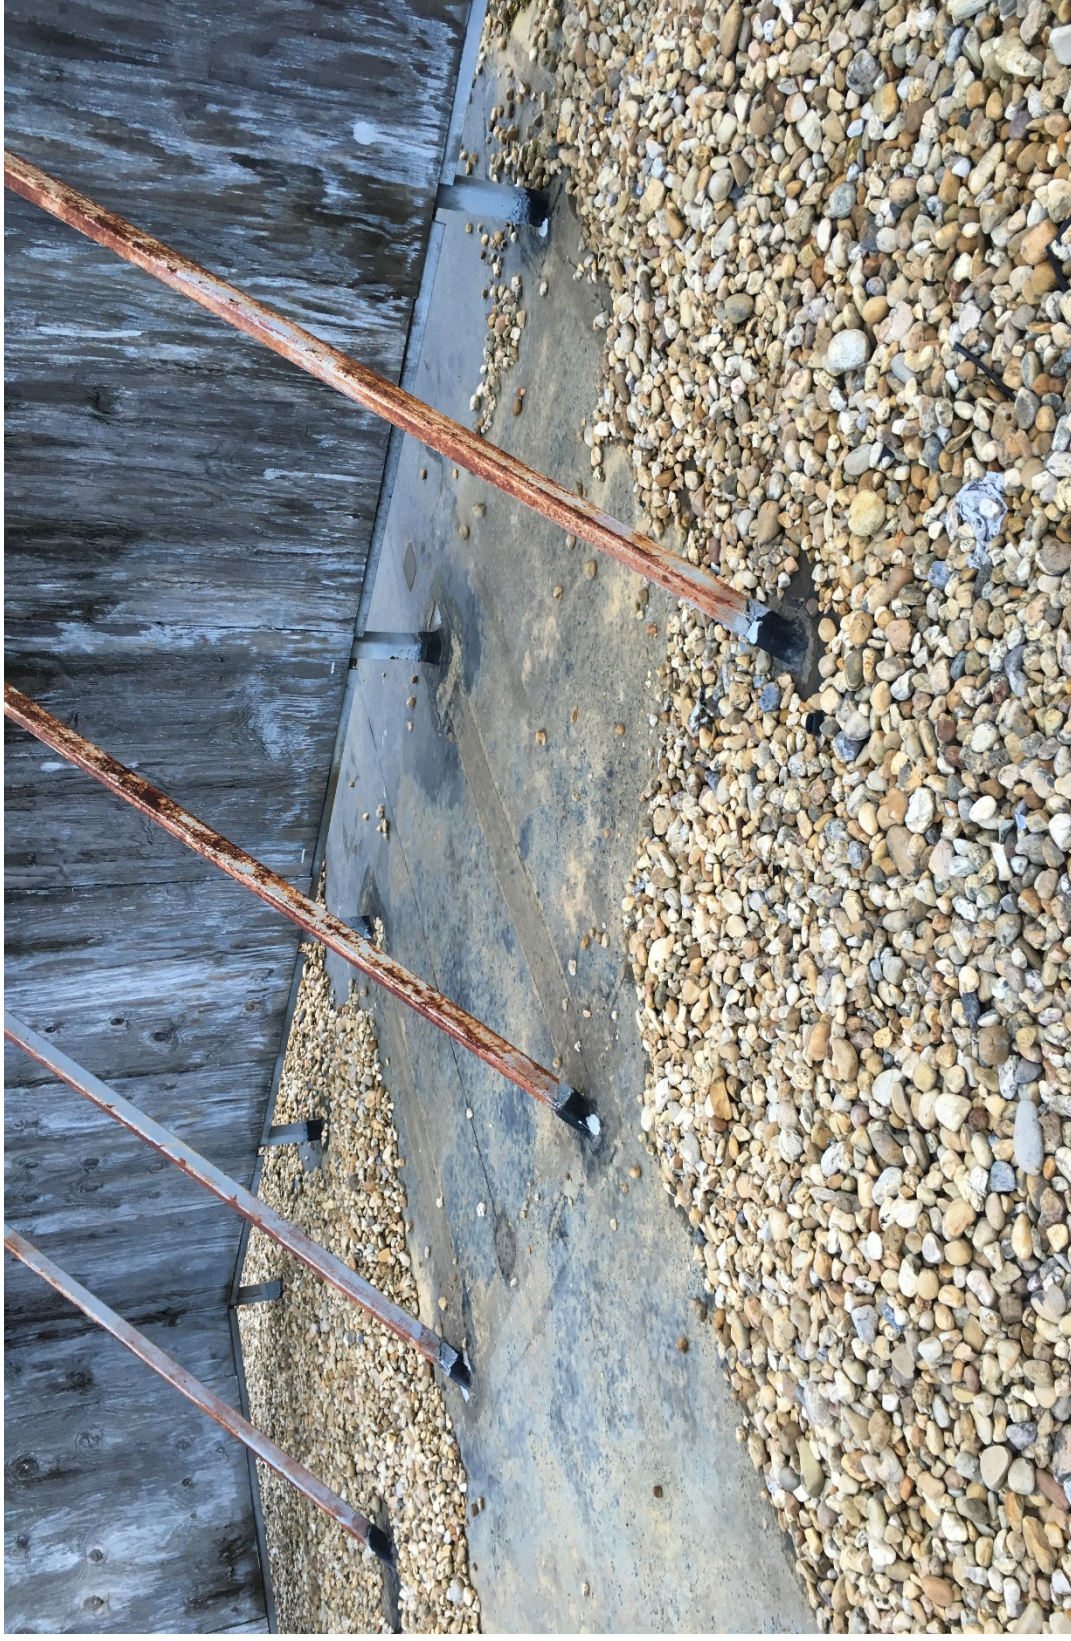
15. There is a screen wall on top of the modular section of classrooms. The steel supports for this wall are causing leaks into the hallway and classes below. It was noted that there is ongoing roof repairs and patches. The entire roof should be replaced.

Finding # - 18. This picture notes the screen wall on the modular section of the building with ongoing roof repairs.

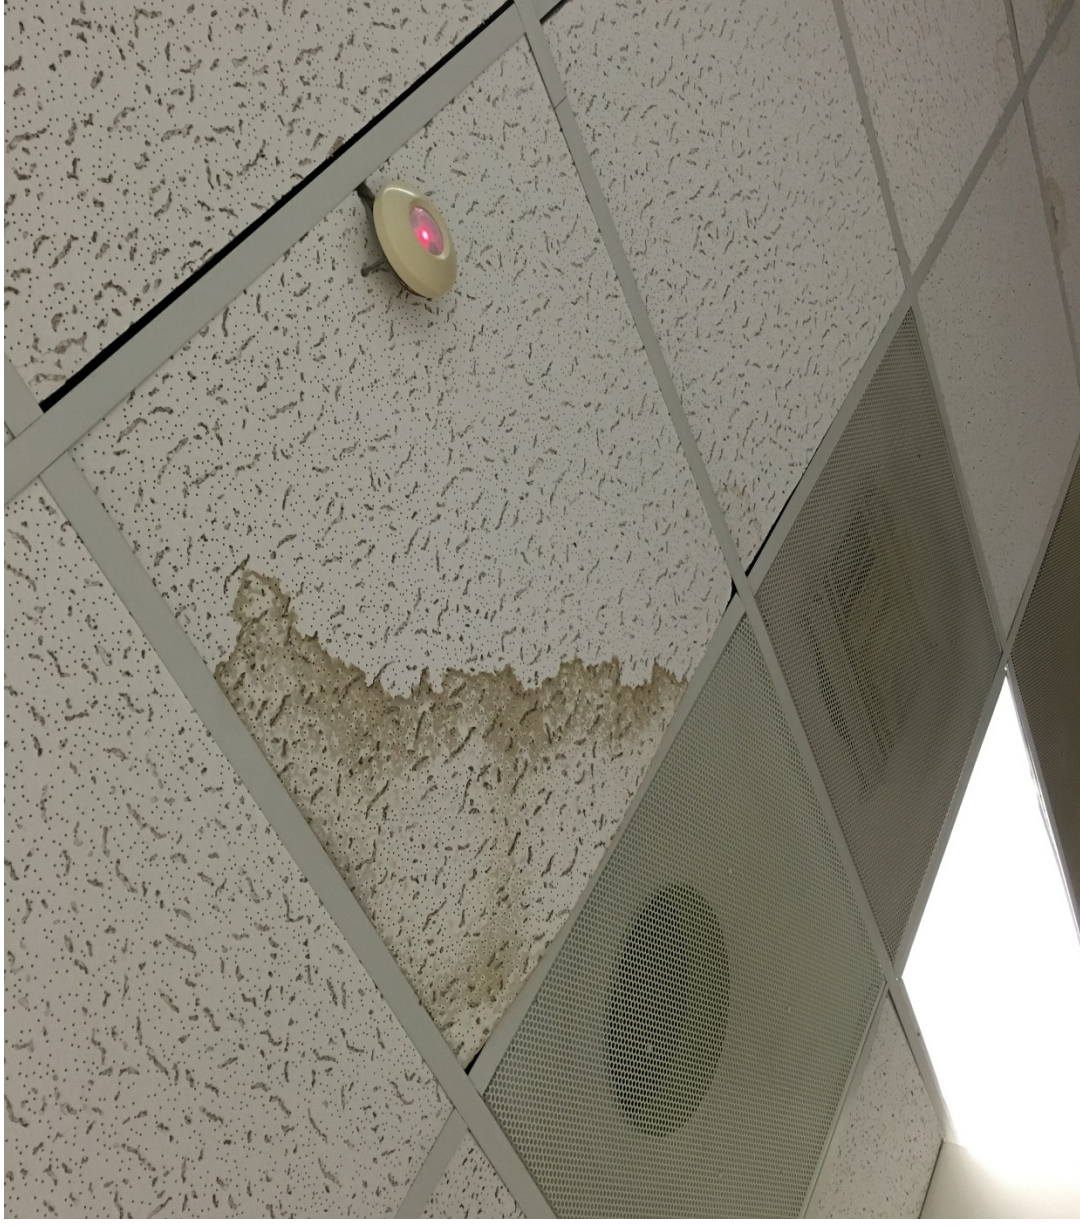
Finding # - 19. This picture is an example of water damaged ceiling tiles.

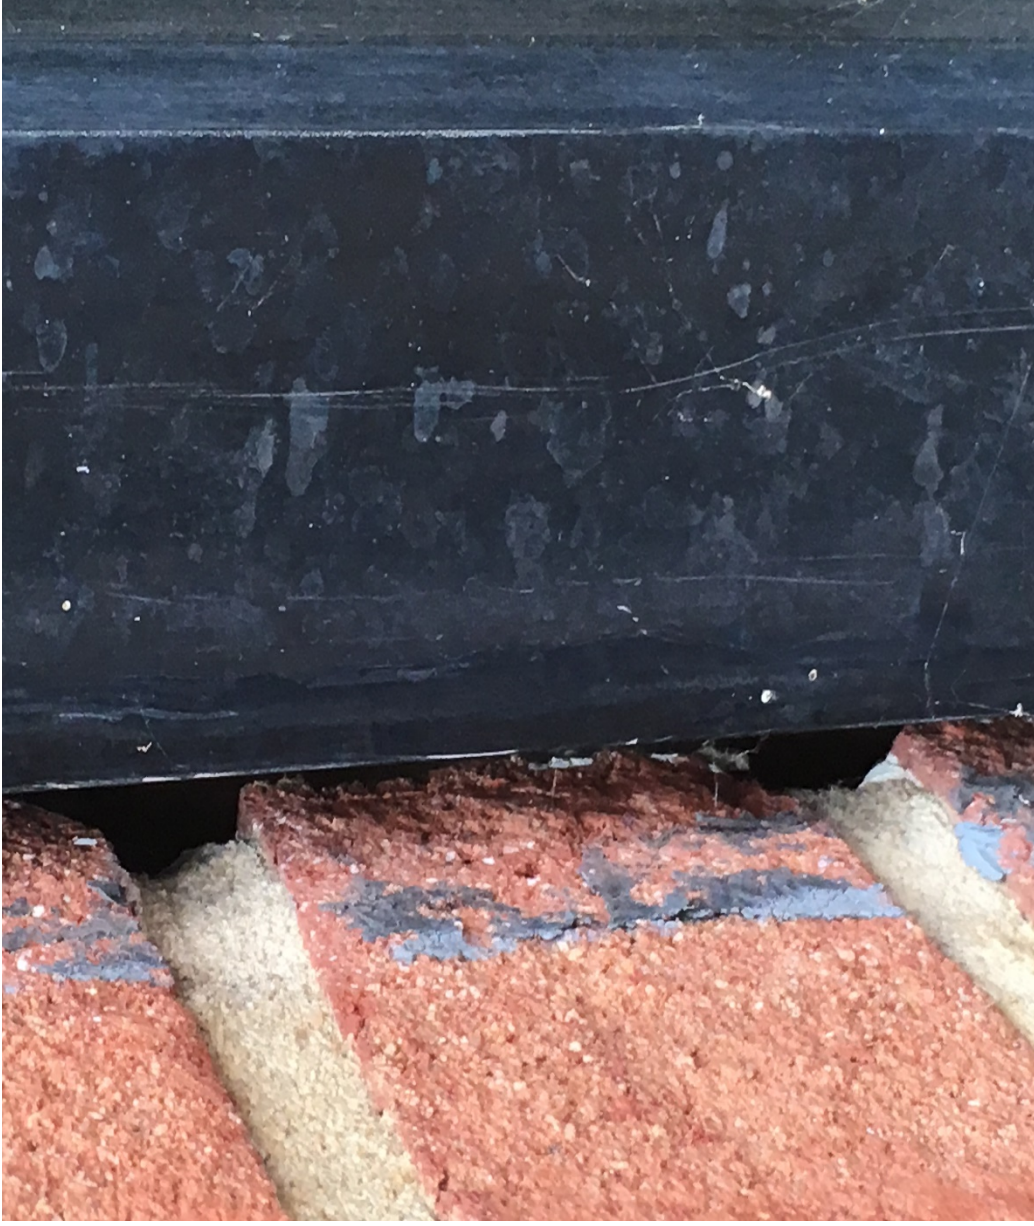
16. The building envelope appears to be a brick over block construction. The brick tuck-pointing condition is good and several sections can be identified as being repaired. A set of casement window systems were installed or inserted in the perimeter walls around the facility and are caulked at the walls. The condition of the window caulk is poor and in some spots the exterior of the building is visible for inside. At this time, perimeter window caulking is needed at this time before increased damage occurs.

Finding # - 20 & 21. This picture is an example of the missing window caulk allowing water entry into the walls.

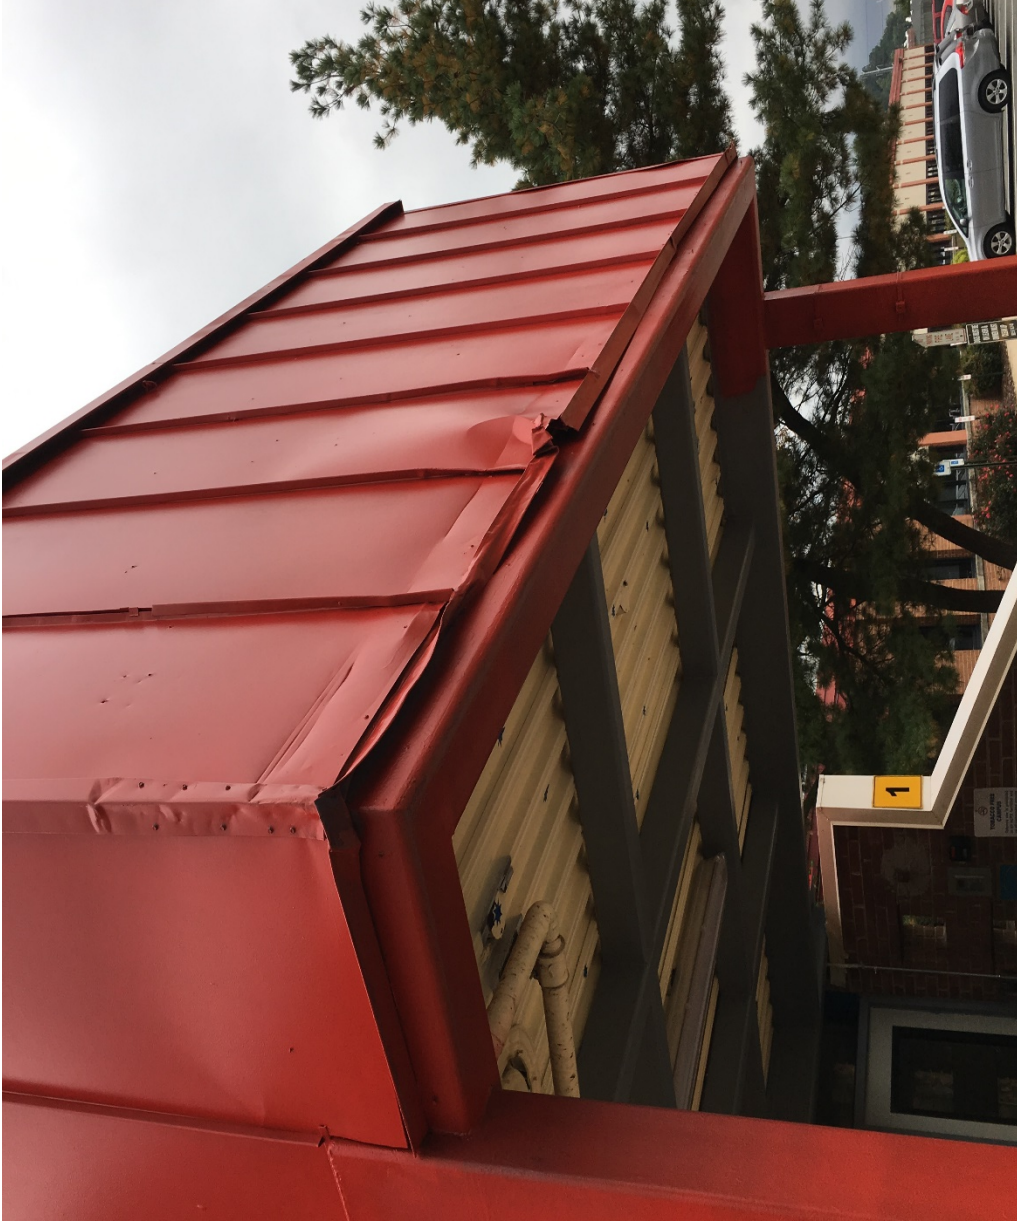
17. The main school entrance roof is damaged where a truck or other vehicle hit and bent the metal covering. This is not causing any water infiltration but is simply aesthetic concern.

Finding # - 22. This picture is of the damaged metal at the schools main entrance.

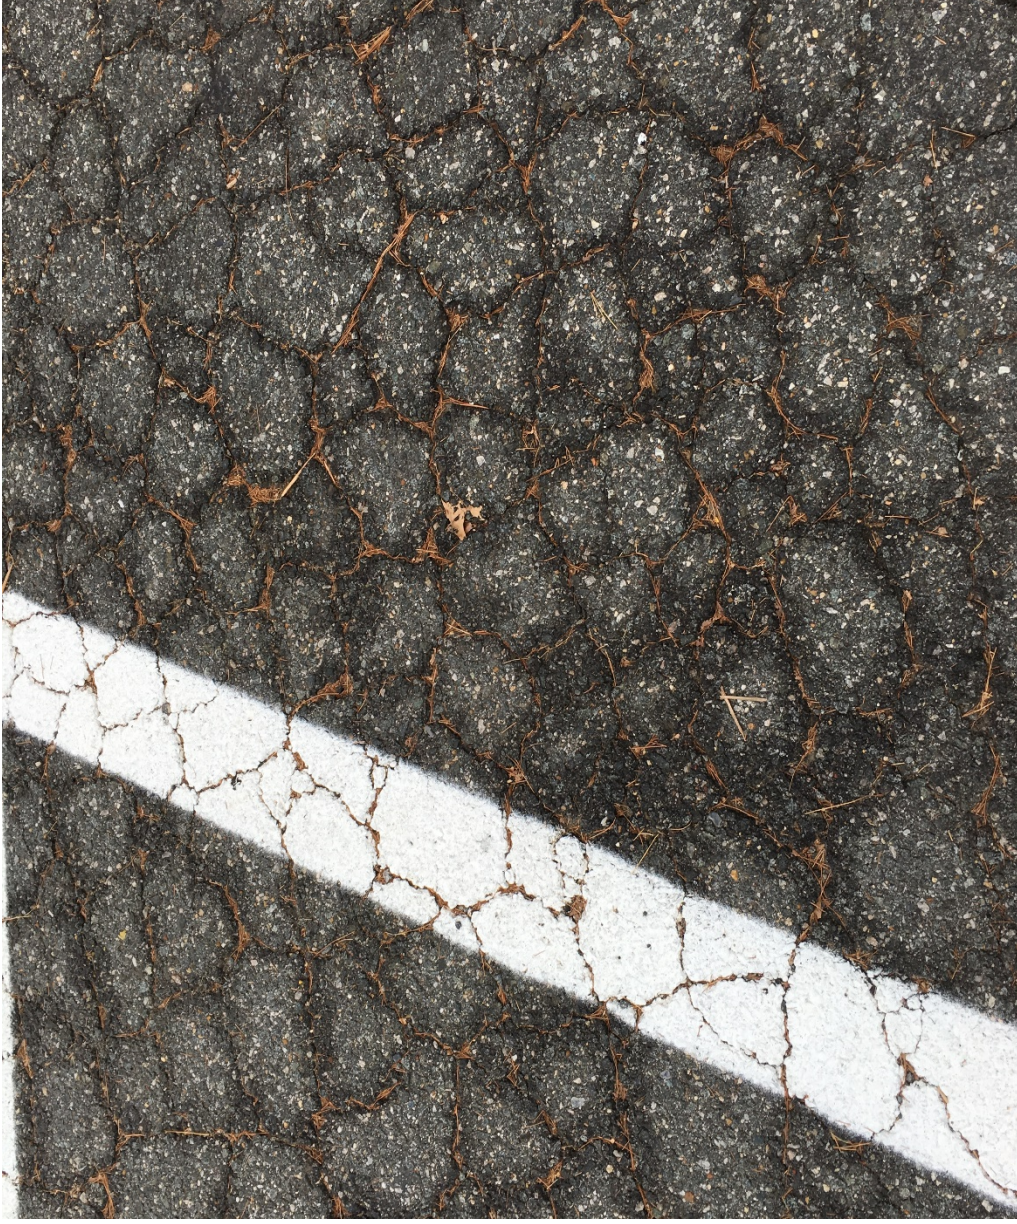
18. The parking lots and asphalt areas around the building were recently restriped. However the asphalt lots themselves are in poor condition and should have at least been liquid sealed before they were striped. The asphalt is spalling and cracked. As rain water gets under the asphalt and freezes it will cause pot holes, also when snow plows hit these areas this winter the asphalt may ripped up requiring larger repairs. Hopefully the lots will make it through this winter season and can be sealed or replaced next summer.

Finding # - 23 & 24. This picture is an example of the asphalt parking lot condition.

23	Asphalt damage at the drive ways and parking lots.	Front of building
	24	Parking lot asphalt damage.	Parking areas
	ARCHITECTURAL	#	Description of Deficiency/Issues
