CONSERVATION ASSESSMENT REPORT
for the
PUBLIC ART WORKS
ALEXANDRIA, VIRGINIA

Prepared for:
Matthew Harwood
Public Art Manager, Office of the Arts
City of Alexandria Recreation, Parks & Cultural Activities
1108 Jefferson Street
Alexandria, VA 22314

Prepared by:
Conservation Solutions, a Division of EverGreene Architectural Arts

REVISED: March 7, 2019

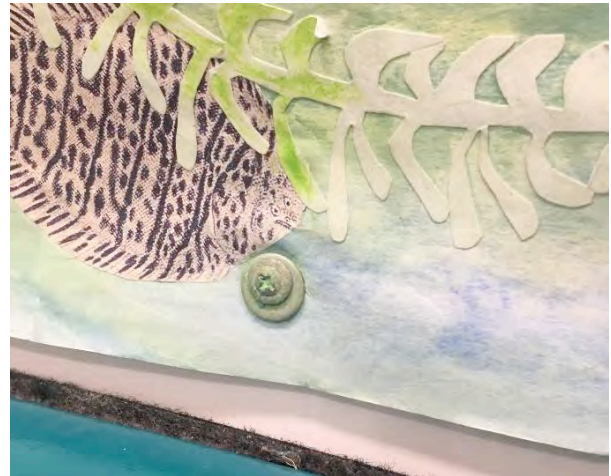
Figure 2. The banner is fastened to the wall with common screw.

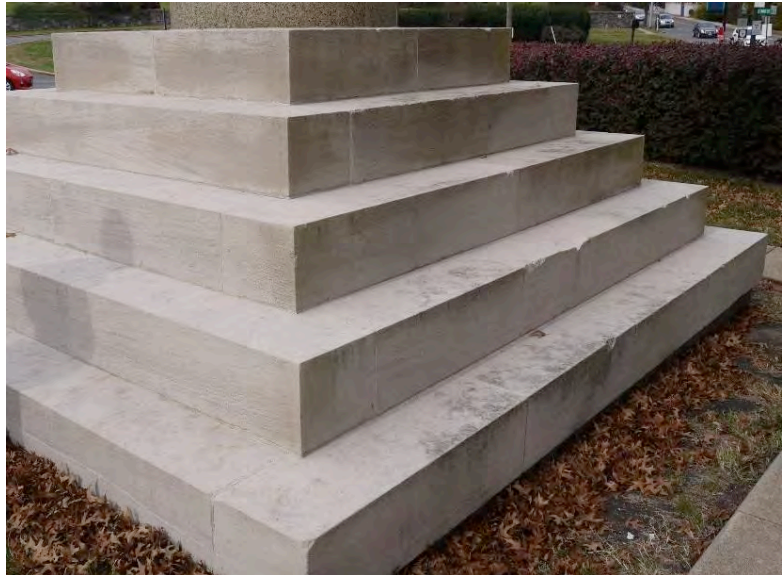
Figure 2. Detail of north elevations of the limestone steps exhibiting atmospheric spoiling and bio growth.

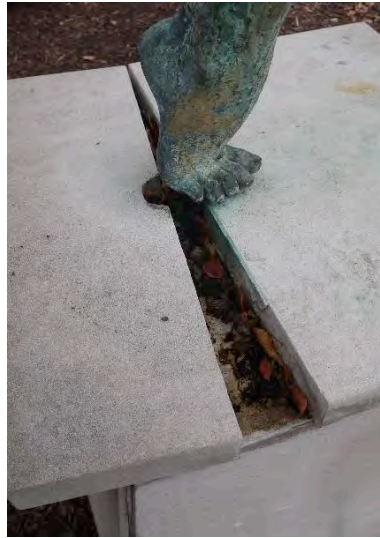
(Left to Right): Figure 1. *Brio* measures 8' in height including plinth. Figure 2. The cast stones of the pedestal have become displaced. Figure 3. Copper staining has discoloured the joints.

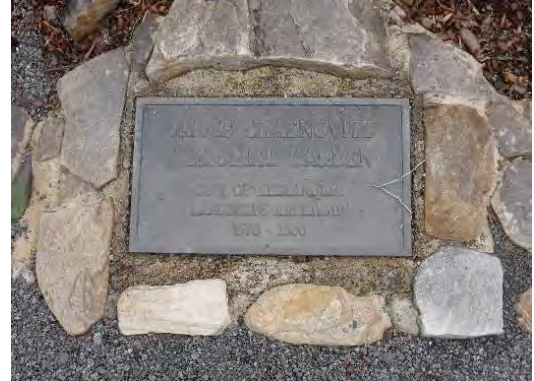
Figure 2. Detail of general soiling and deterioration of plaque.

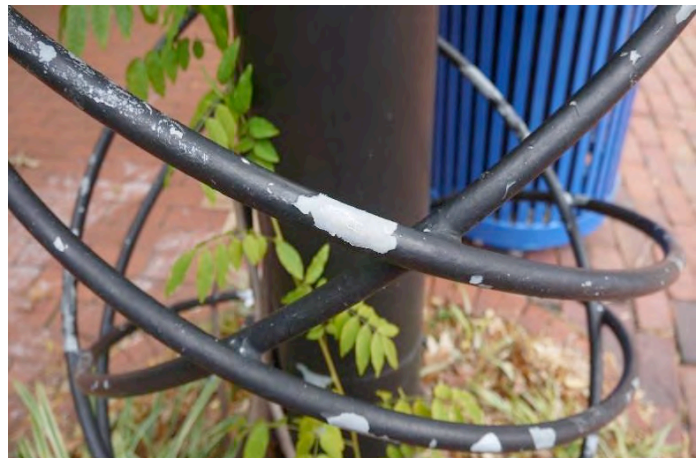
Figure 8. Detail of typical paint loss.

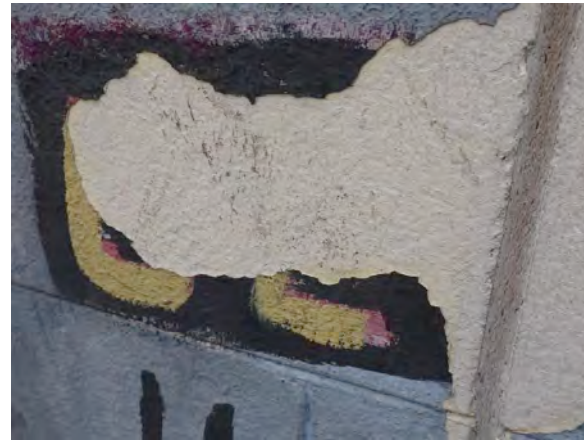
(Right) Figure 4. Flaking of the topcoat reveals the primer underneath.

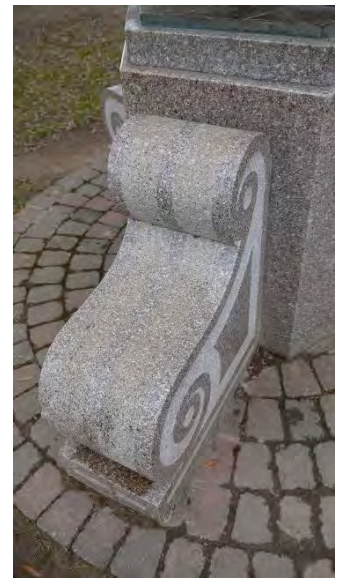
(Left to Right) Figure 1. General view of the Shipbuilder sculpture. Figure 2. Detail of surface corrosion and soiling. Figure 3. General view of decorative granite scroll.

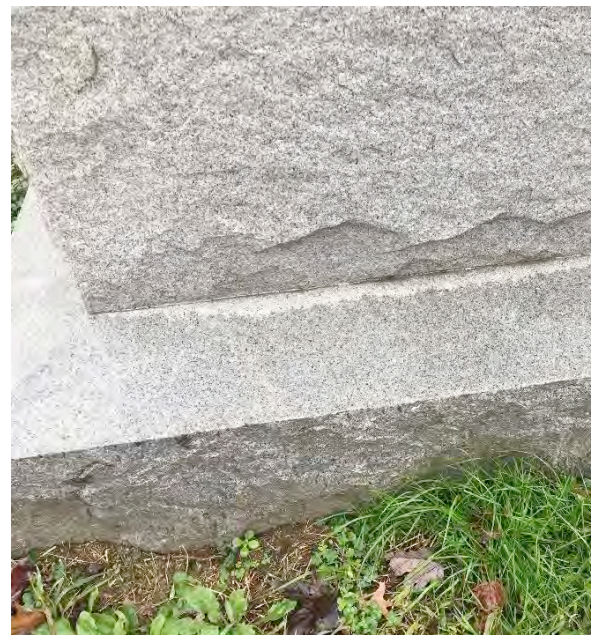
Figure 4. The lead joint between the obelisk and plinth is in excellent condition.

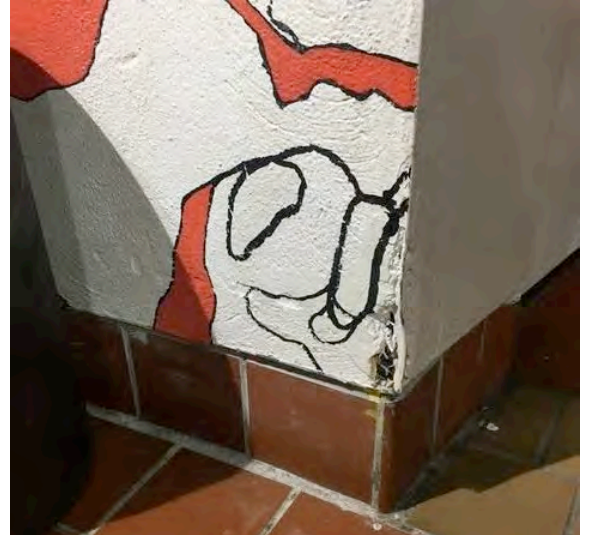
Figure 4. Large abrasion and flaking paint on bottom corner of wall.

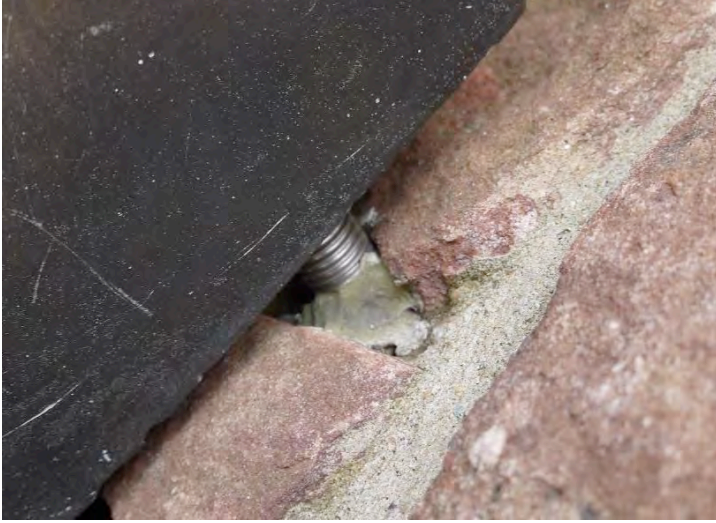
Figure 7. Detail of steel rods and epoxy securing bronze signage to brick, Part A.
