# CHRIST CHURCH

THE HISTORIC STRUCTURE REPORT

CHRIST CHURCH  
ALEXANDRIA, VIRGINIA

John Milner Associates  
309 North Matlack Street  
West Chester, Pennsylvania

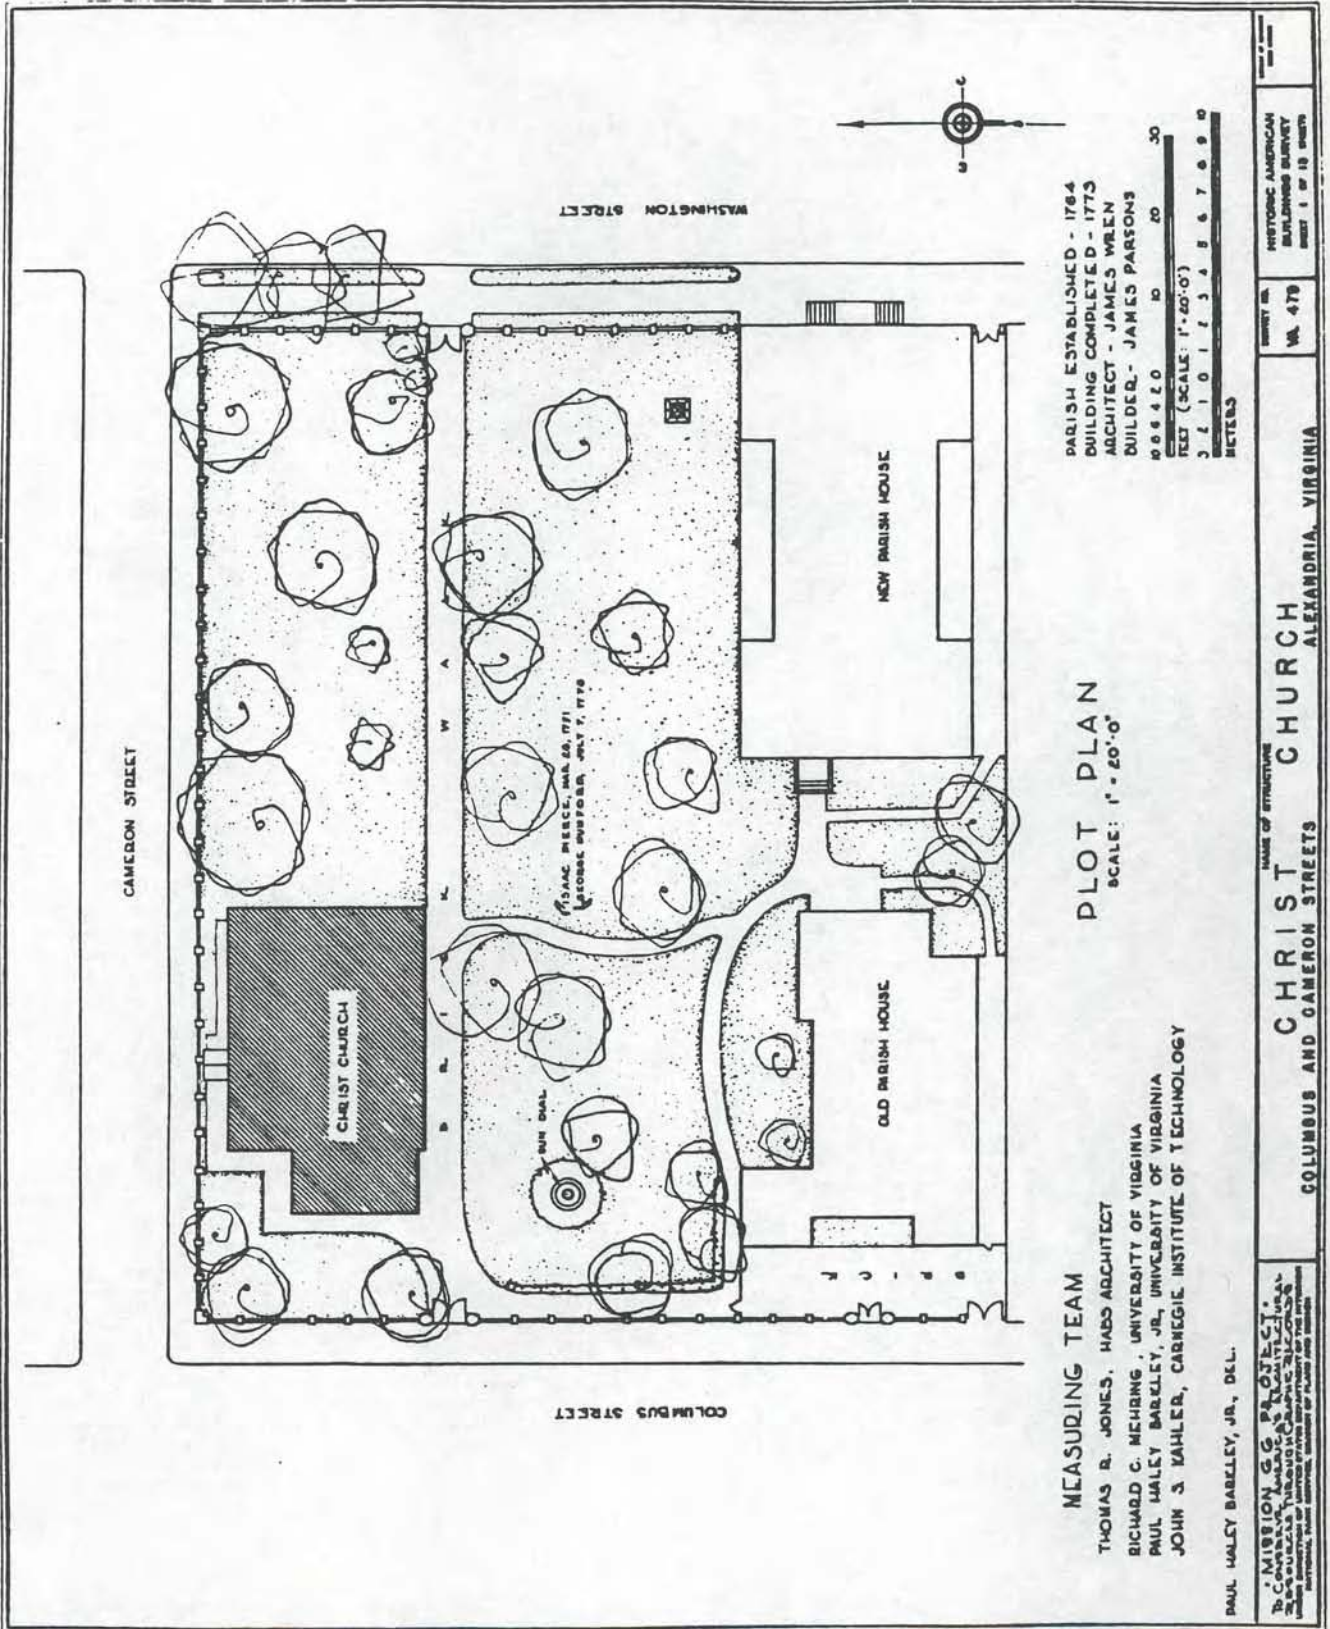
Figure 2

Christ Church, Alexandria, Virginia  
 Courtesy of Historic American Buildings Survey

(See  
Figure 2)

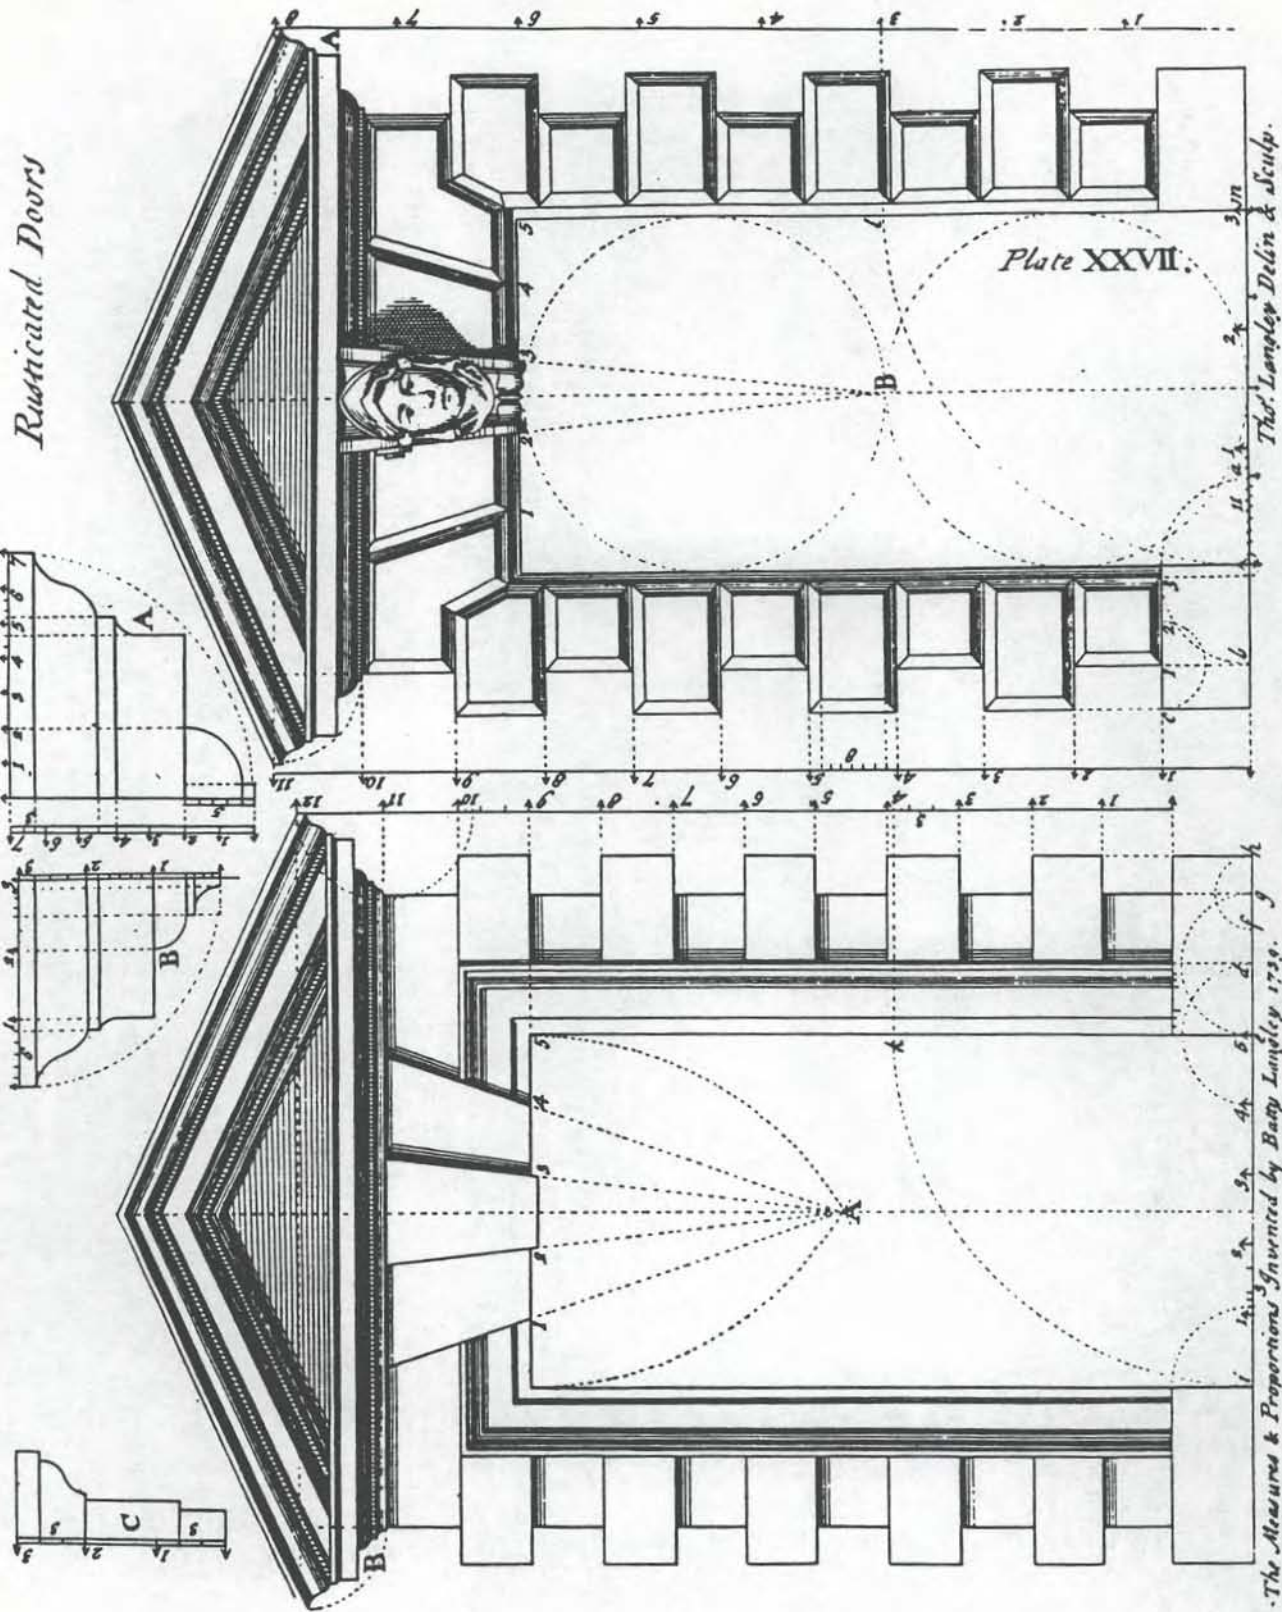
Figure 3

Rusticated Door Frame

(See  
Plate 7)  
(See  
Figure 3)

(See  
Figure 3)

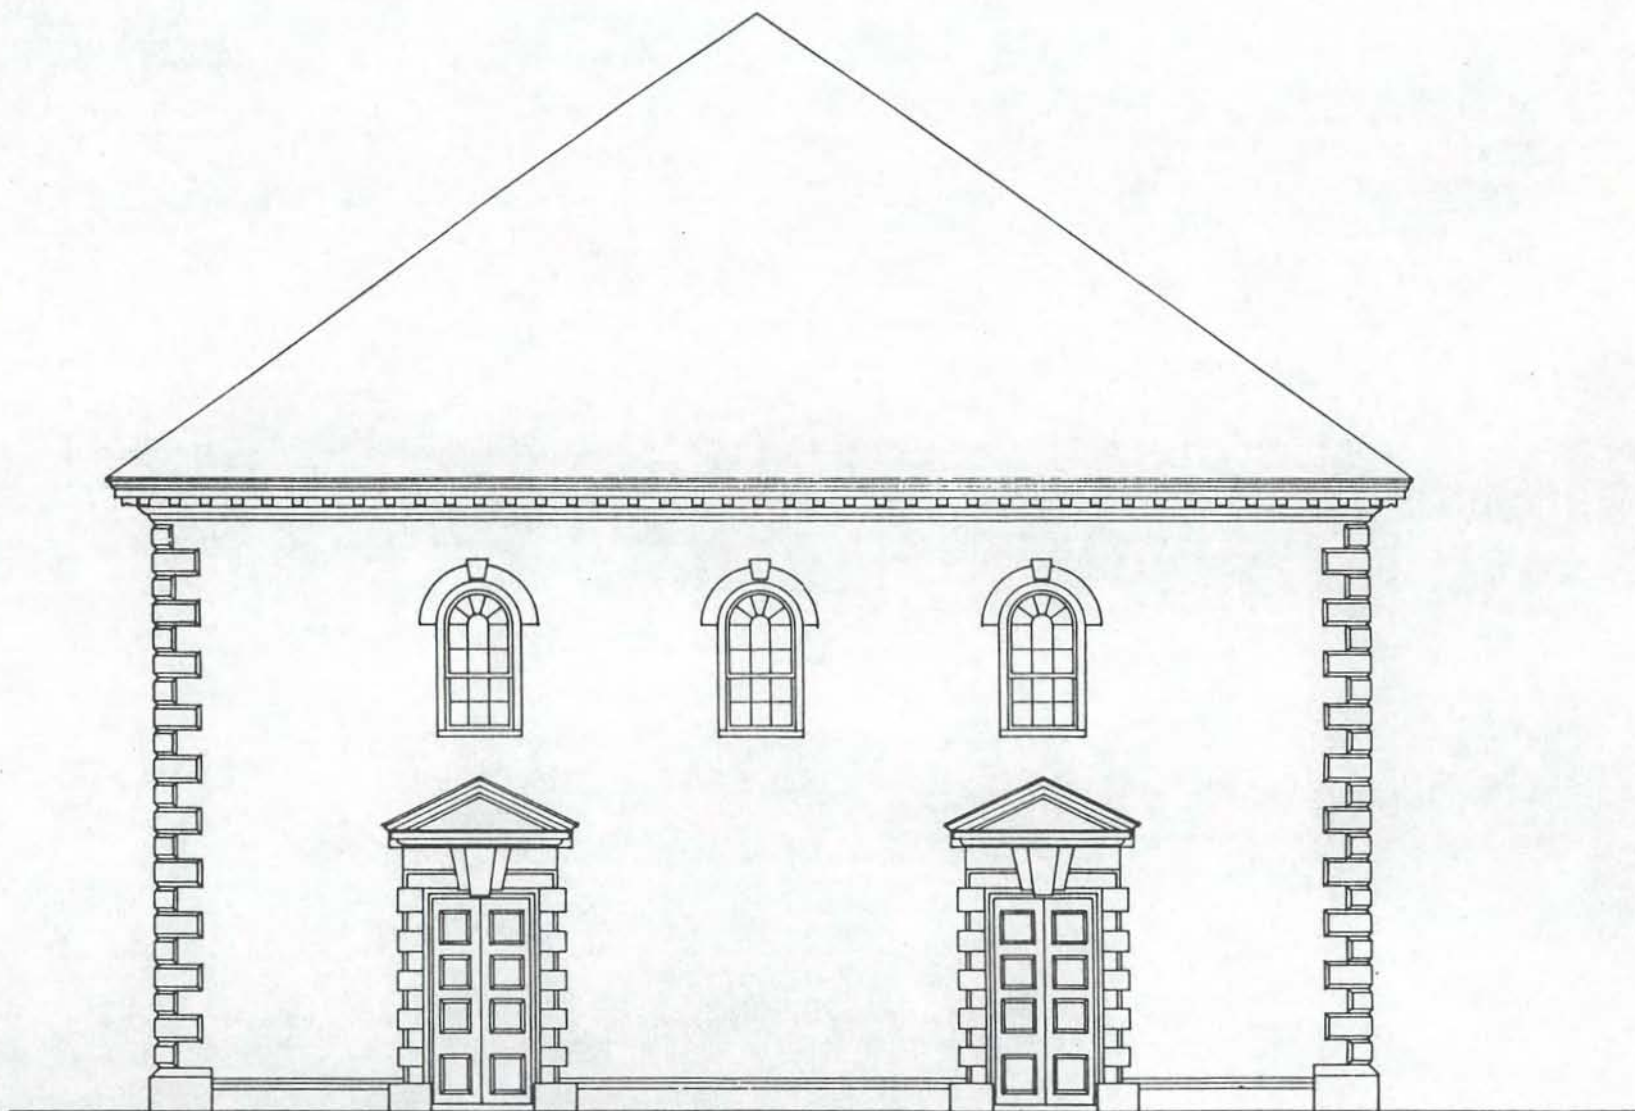
Figure 4

WEST ELEVATION: CIRCA 1773

doors with their rusticated stone surrounds (Gibbs) were in their present location, contrary to popular opinion. The second floor had three round-headed windows. It is uncertain whether there was a window opening between the entrances. The importance of the rusticated door surrounds would be adequate fenestration for this elevation. However, the plan of the Church does not eliminate the possibility of a window in this location. The window would not have conflicted with the pew arrangement; furthermore there is a window at Pohick Church in this location. The placement of a doorway in this location during the nineteenth century eliminated necessary evidence to come to a definite conclusion on this item. (See Figure 4)

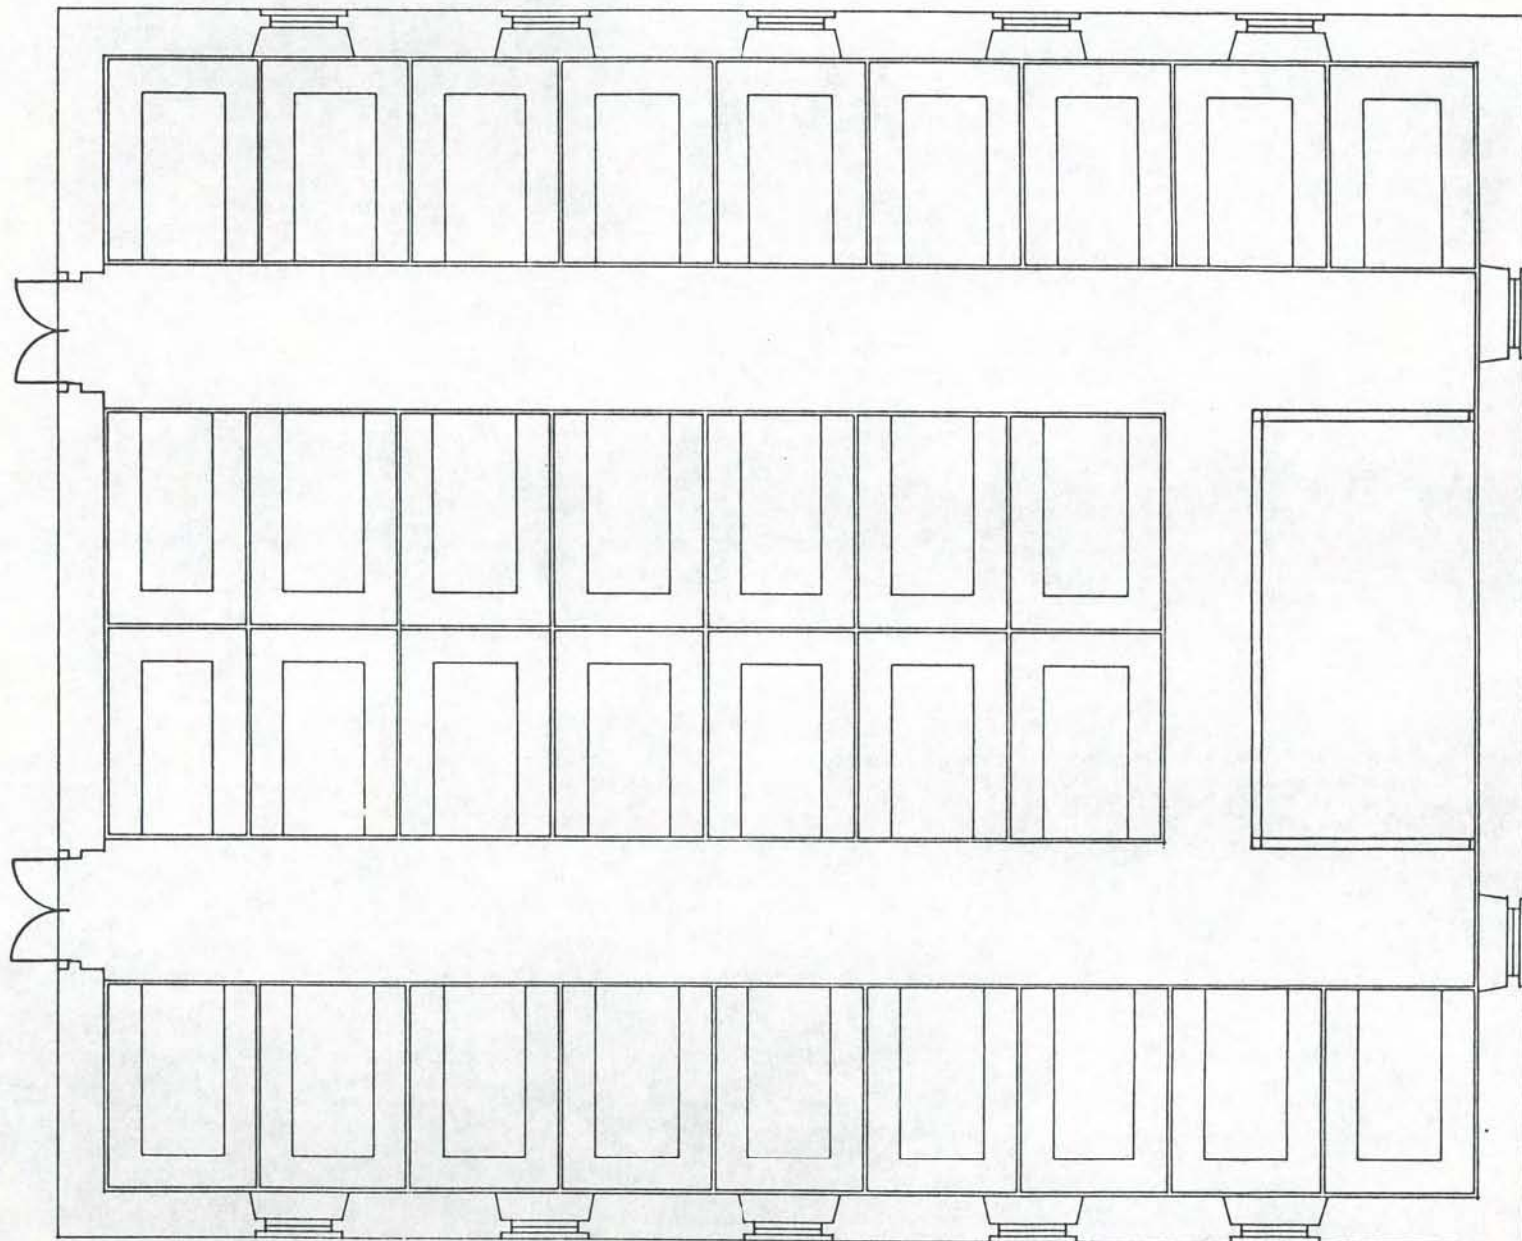
Figure 5

FIRST FLOOR PLAN: CIRCA 1773

The original plan of the Church is of great interest. Though the interior has undergone successive modifications, a good deal of information is evident. The paneled wainscot in the Church clearly marks the location of the pews around the perimeter of the Church. Conjectural restoration of the plan shows thirty-two pews on the ground floor with two aisles running in an east-west direction flanking the chancel. (See Figure 5)

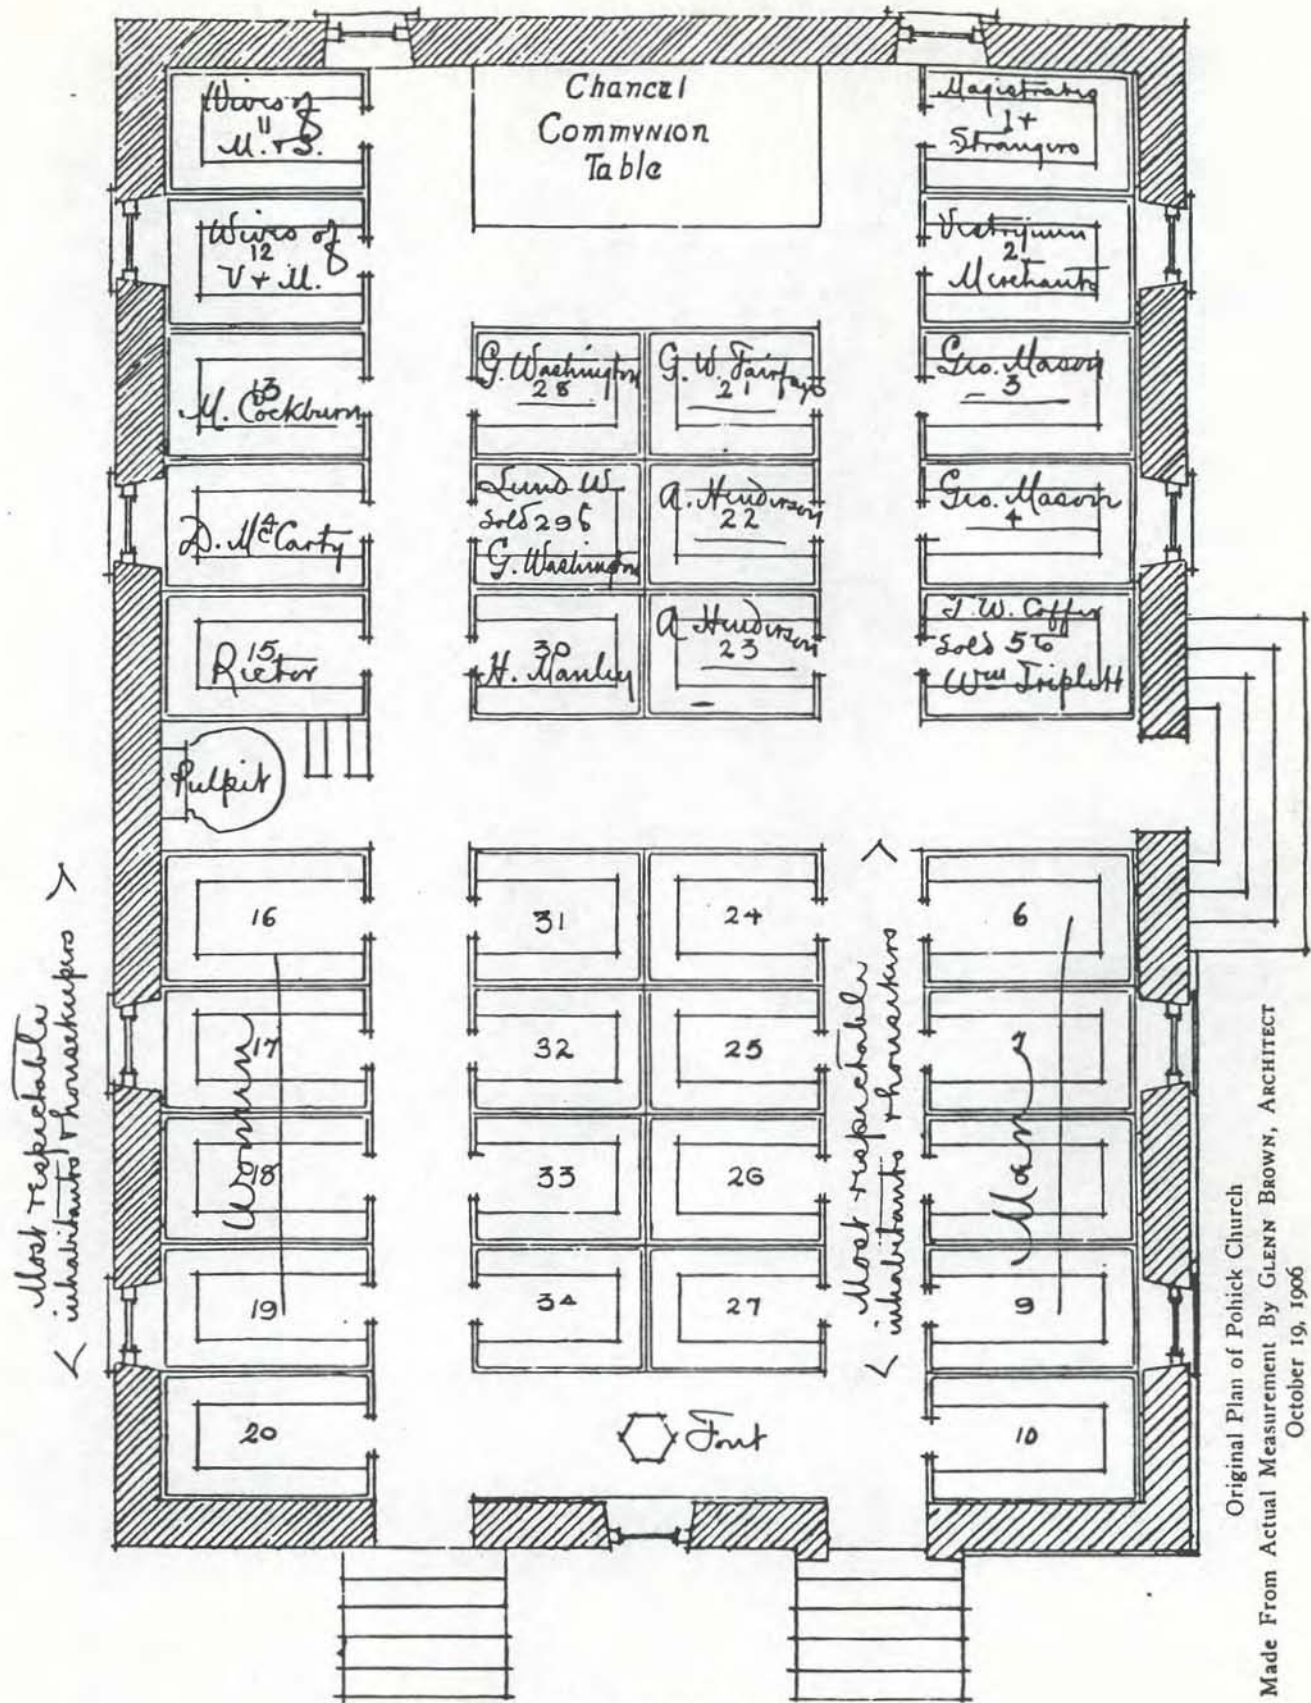
Figure 6

Original Plan of Pohick Church  
 Made From Actual Measurement By GLENN BROWN, ARCHITECT  
 October 19, 1906

Plan of Pohick Church contained in  
 Slaughter, Philip. The History of Truro Parish in Virginia, Philadelphia, 1907.

(See  
Figure 6)

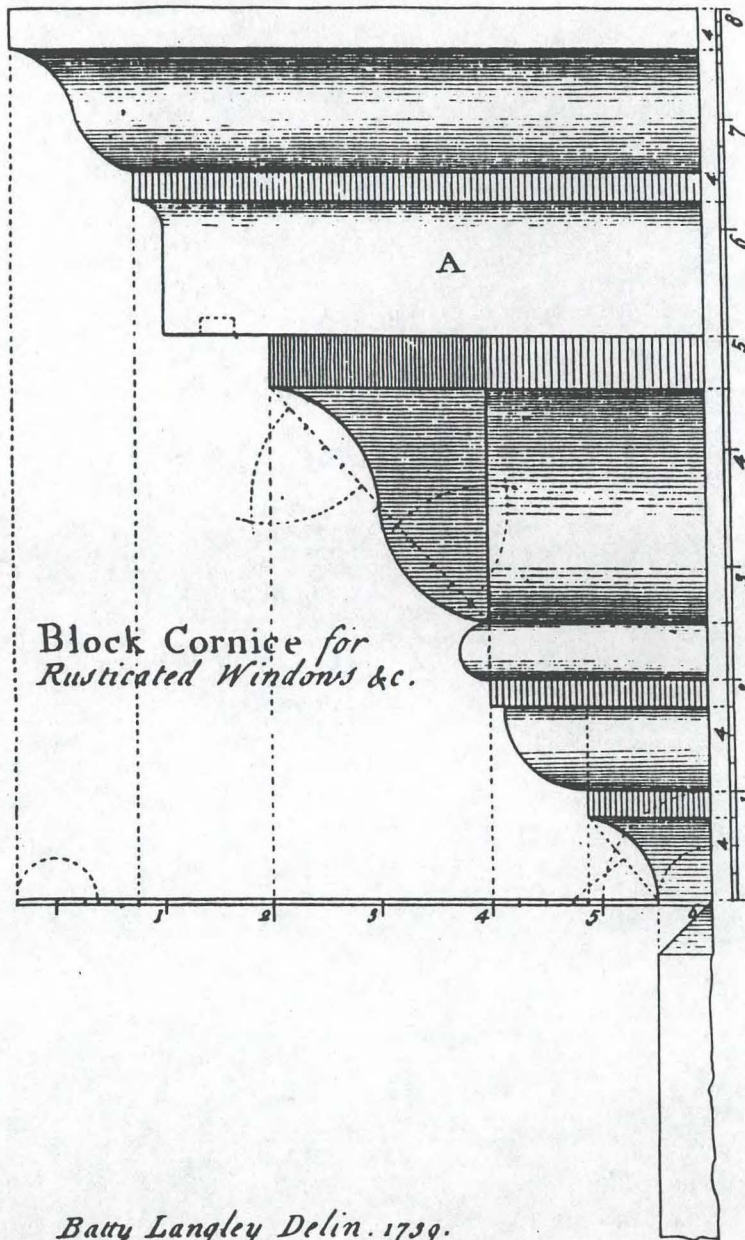
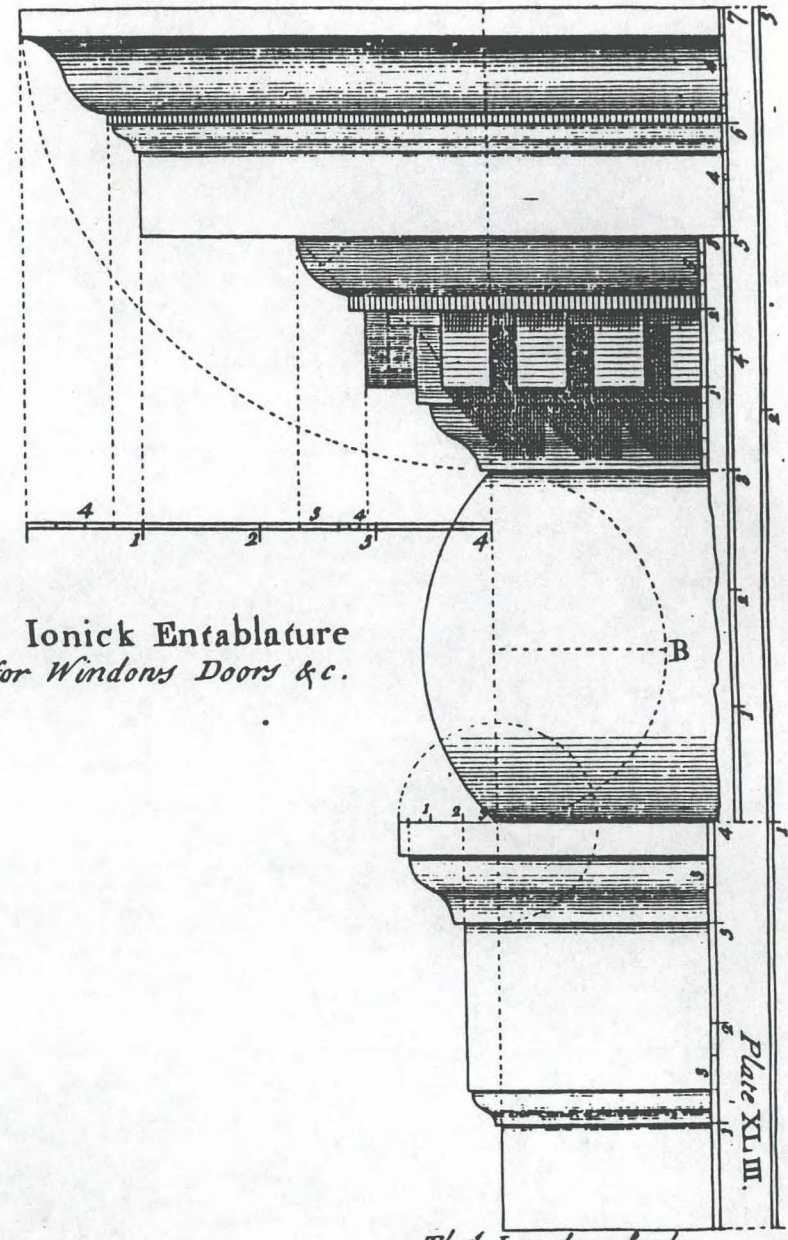
Block Cornice for  
Rusticated Windows &c.

Ionick Entablature  
for Windows Doors &c.

Figure 7 Ionick Entablature for Windows, Doors & c.  
Plate XLIII Batty Langley Builder's Treasury of Designs

(Figures  
7, 8, & 9)

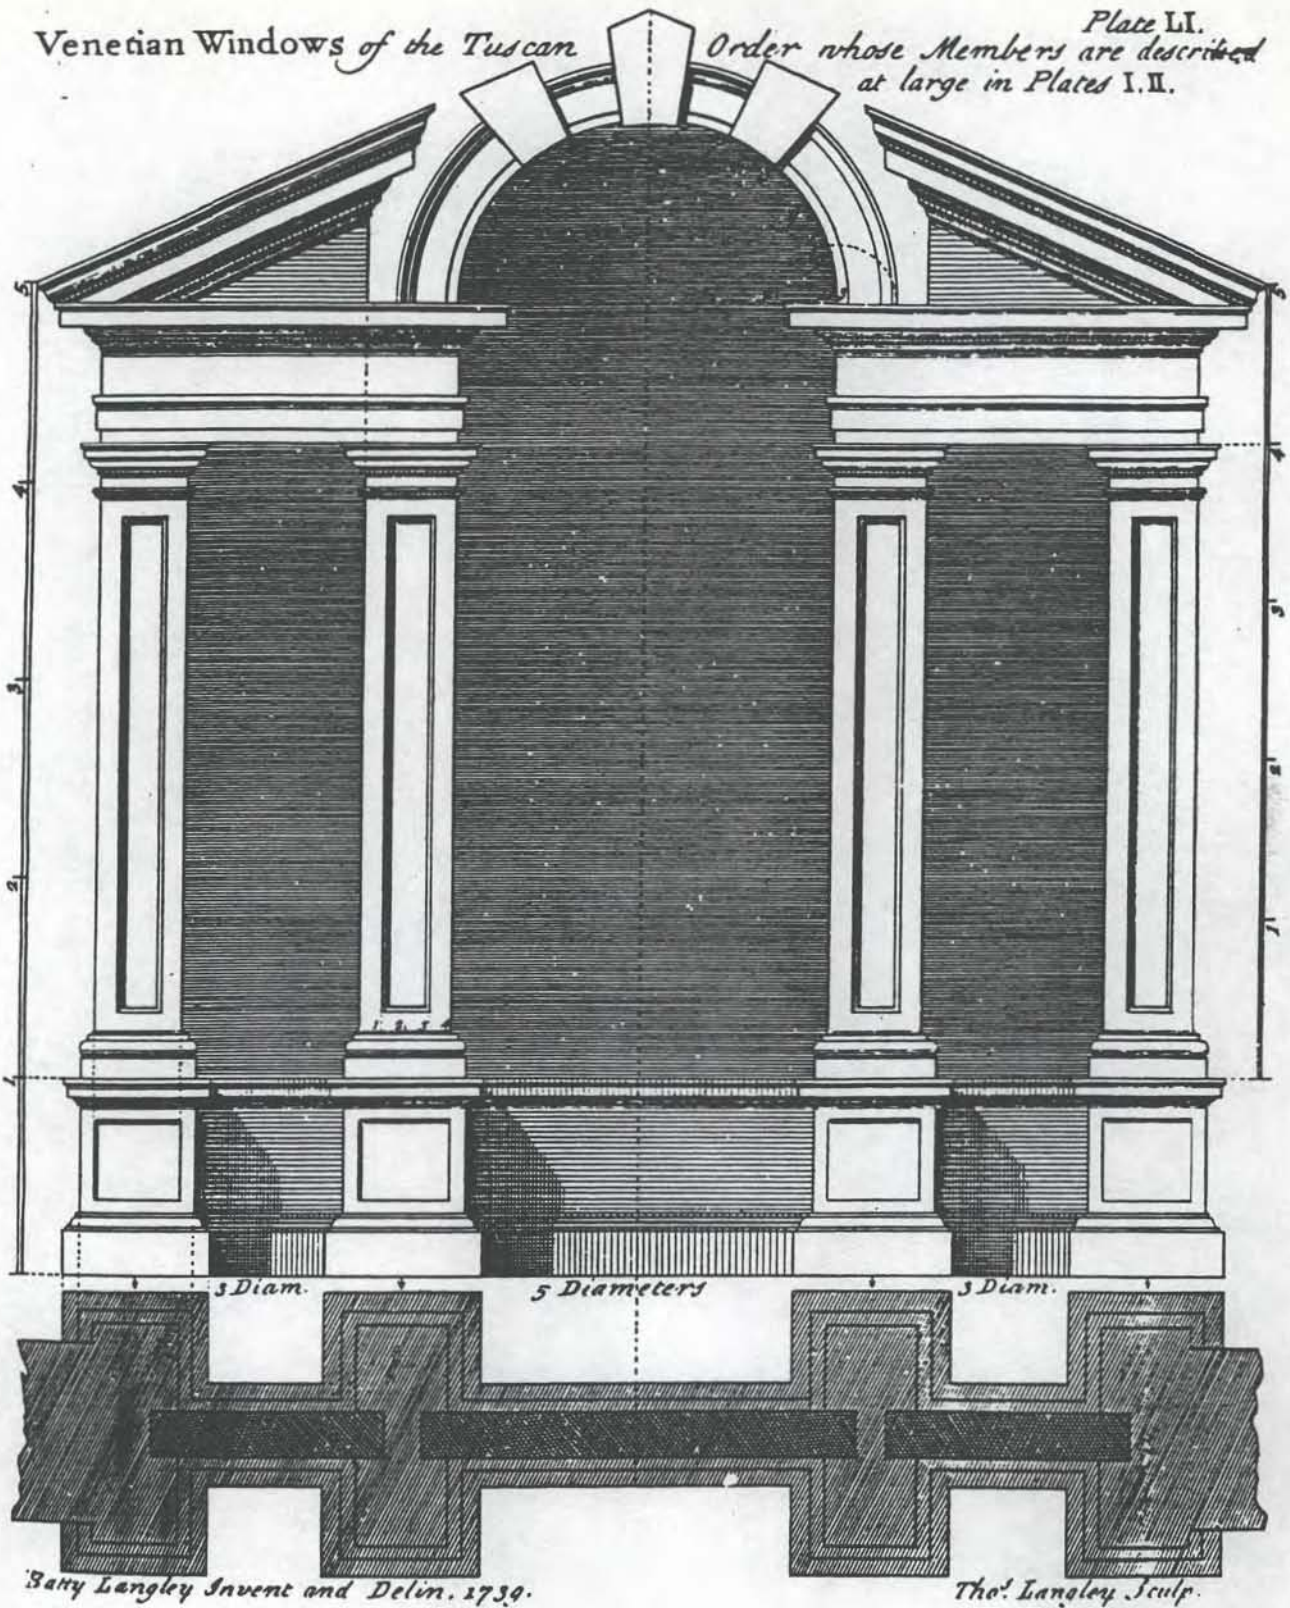
Venetian Windows of the Tuscan Order whose Members are described at large in Plates I. II. Plate LI.

Figure 8 Venetian Windows of Tuscan Order  
 Plate LI Batty Langley Builder's Treasury of Designs

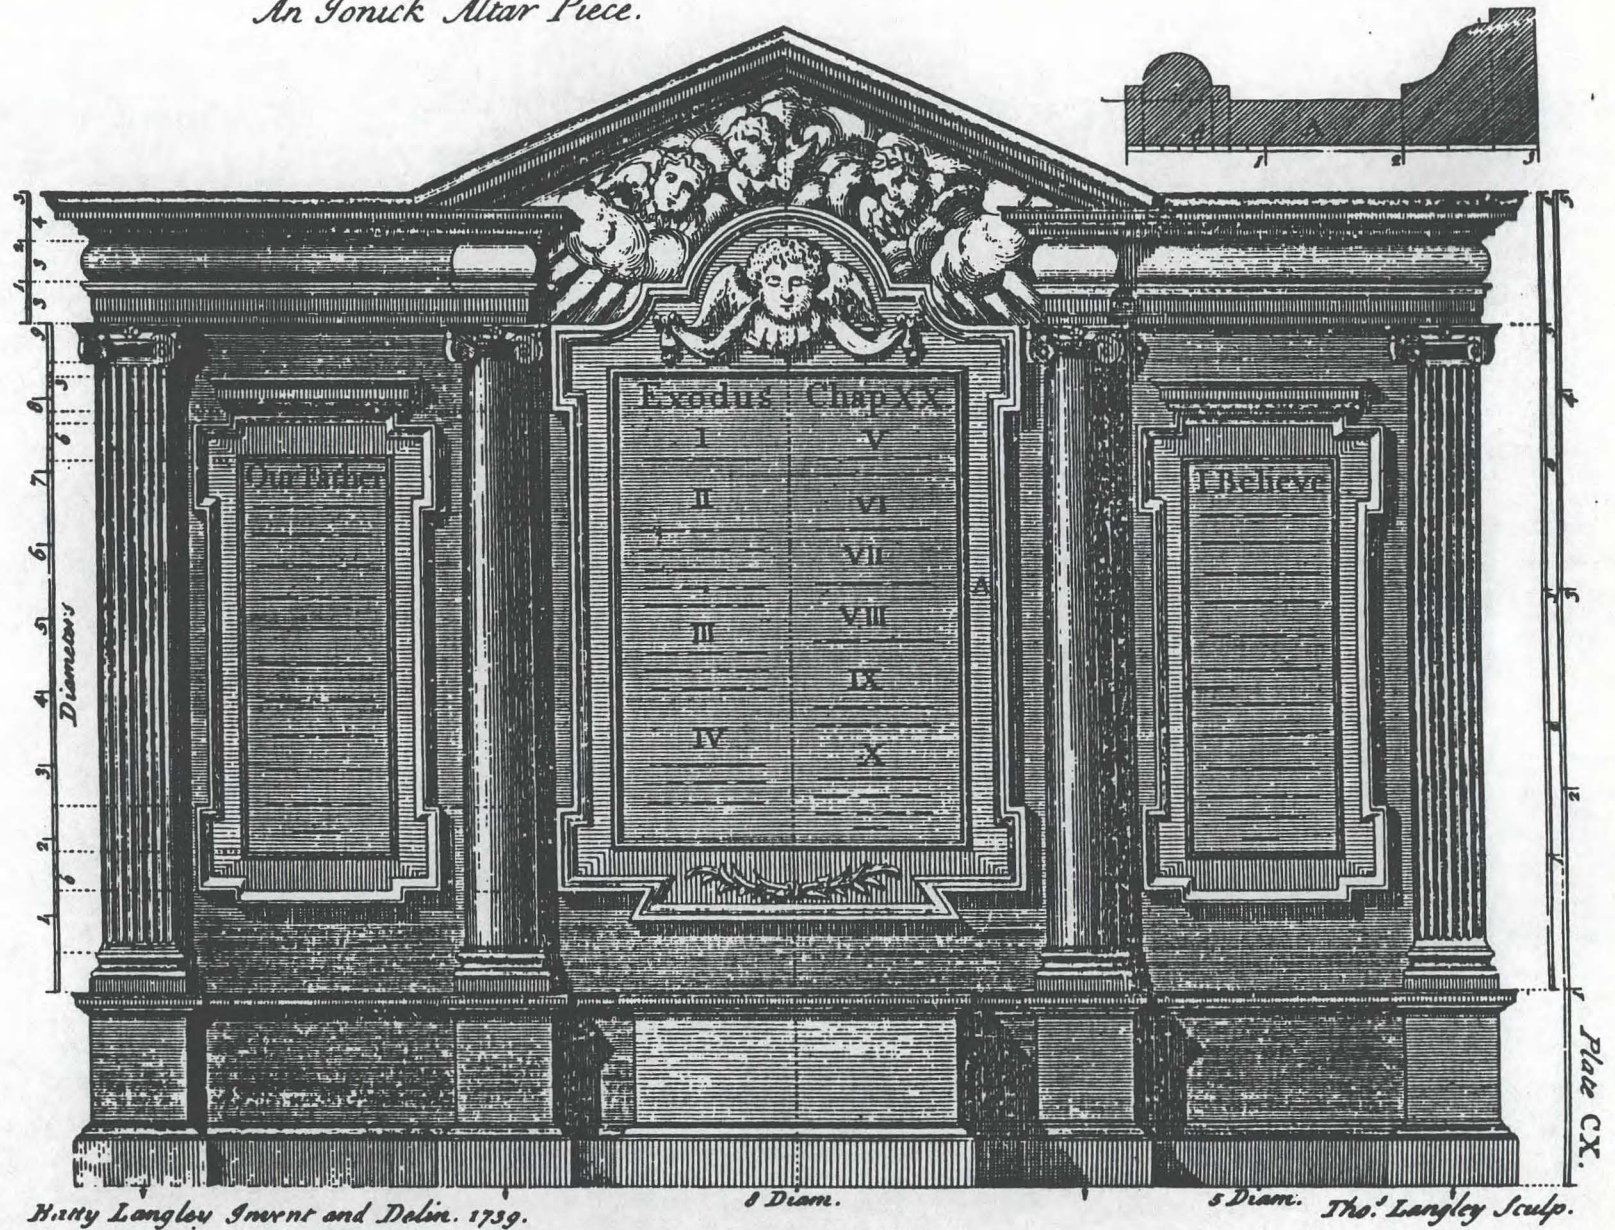
*An Ionick Altar Piece.*

Figure 9 An Ionic Altarpiece  
Plate CX Batty Langley Builder's Treasury of Designs

NOTE: The incorporation of the Lords Prayer and Apostles Creed in tabernacle frames are almost identical to those in Christ Church.

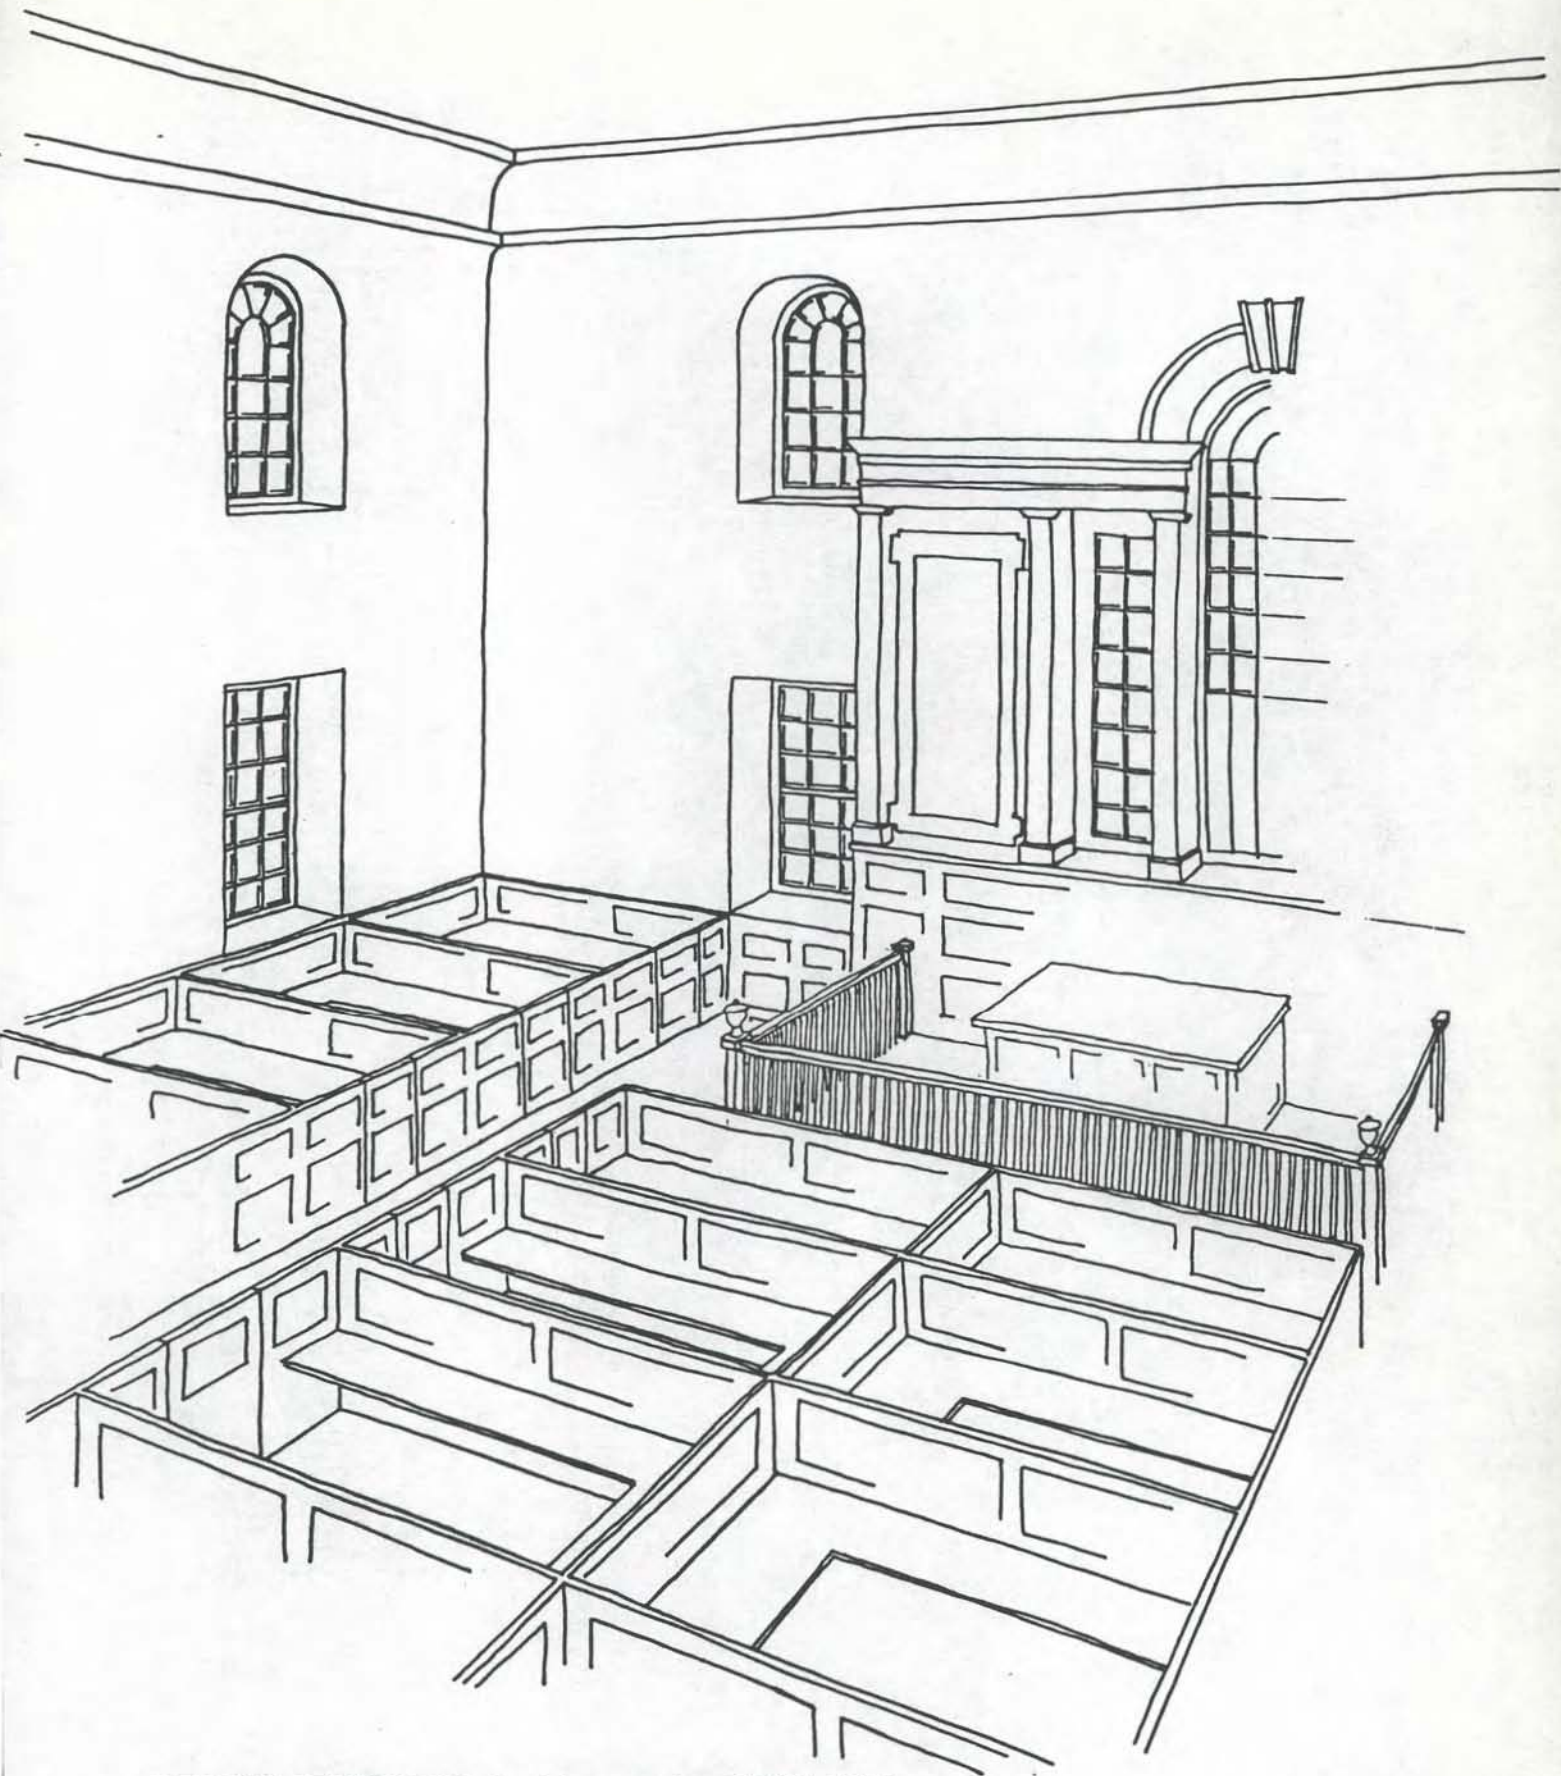
Figure 10

INTERIOR PERSPECTIVE looking east: CIRCA 1773

The space as completed in 1773 was extremely fine. The absence of the gallery created a space far more open than the way the Church appears today. The plaster walls were left unpainted or whitewashed. Millwork, including windows, doors, the chancel rail, and the alterpiece, appear to have been painted a French Grey -- the combination would have been most striking indeed.

(See  
Figure 10)

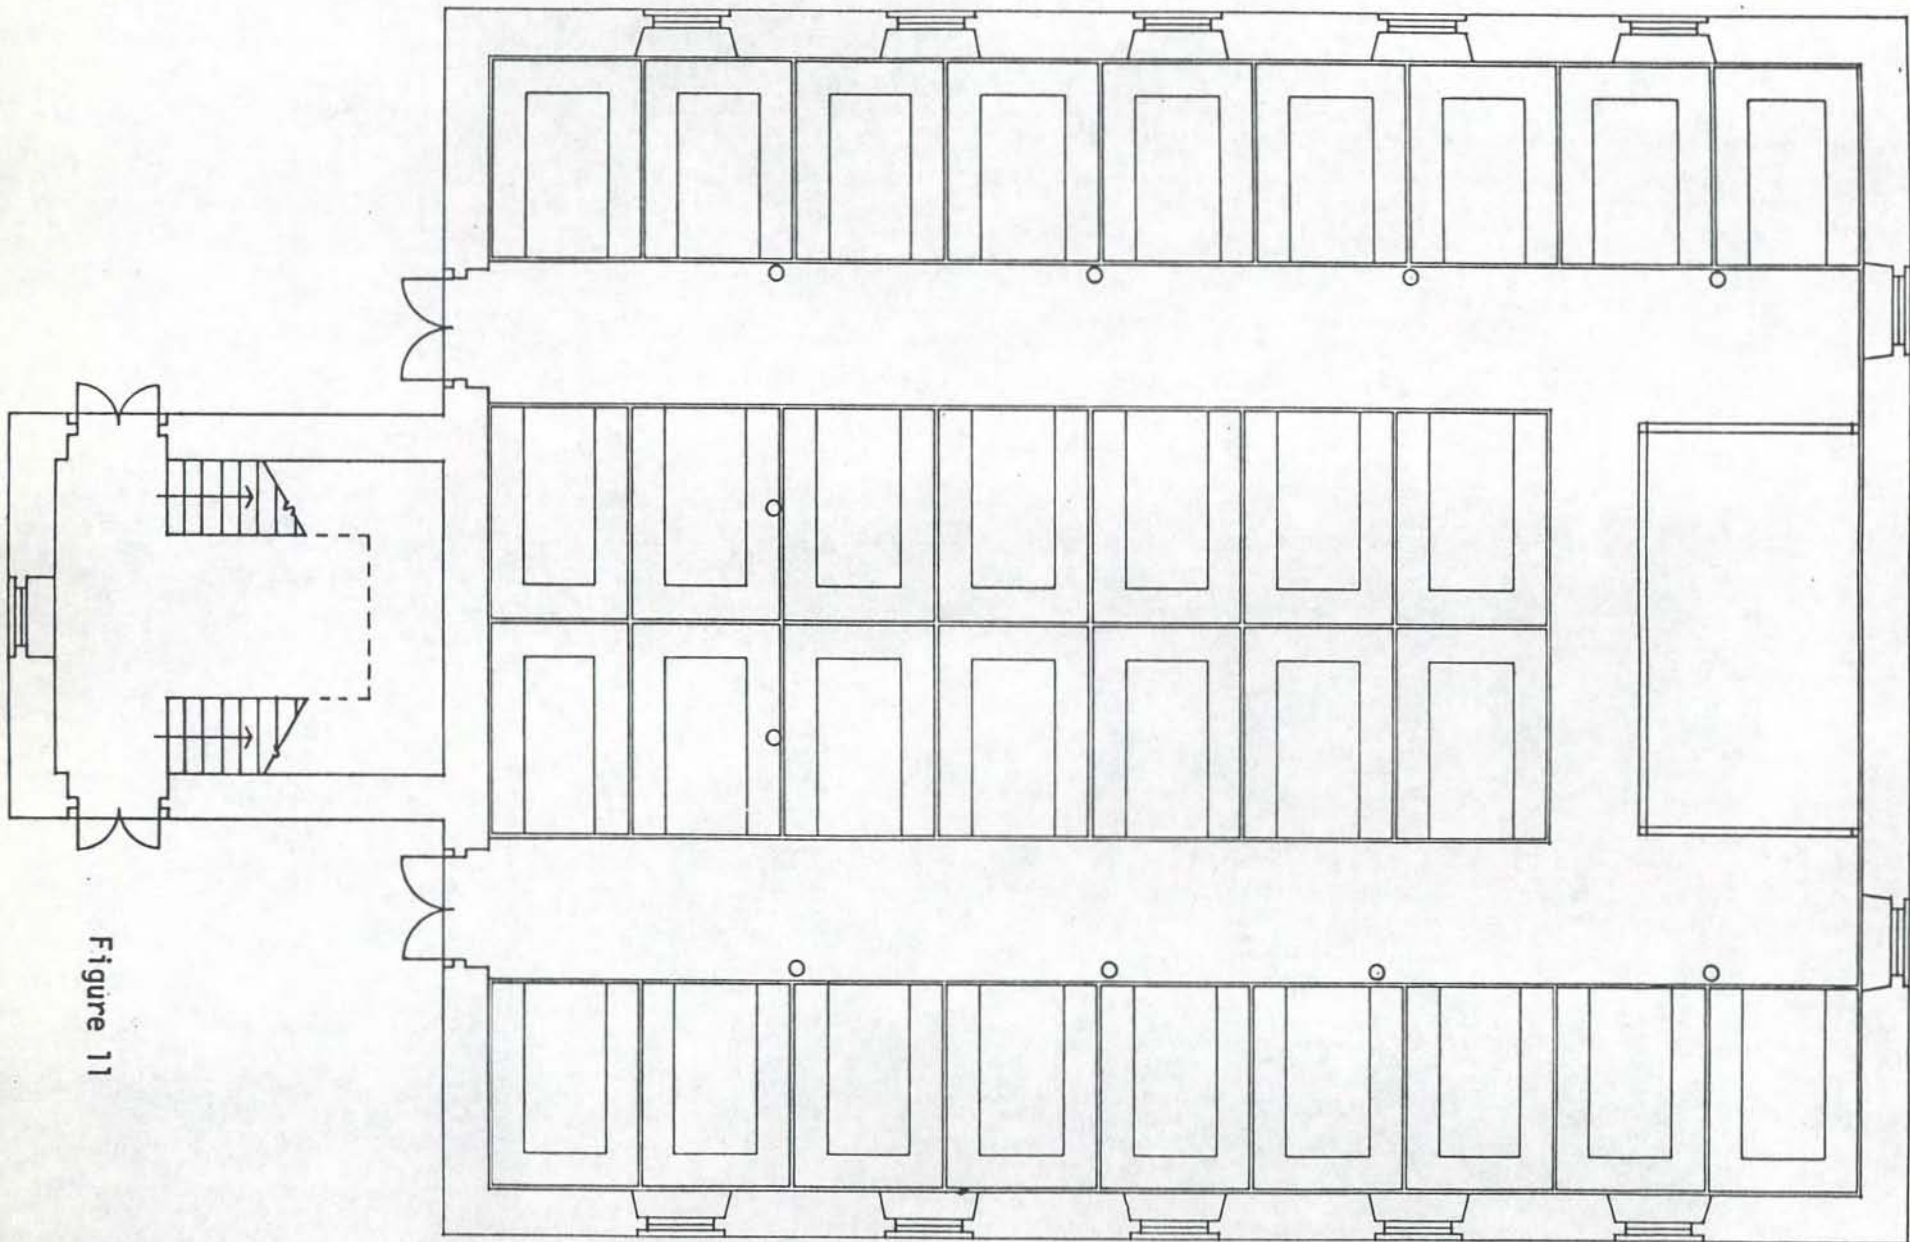
Figure 11

FIRST FLOOR PLAN: CIRCA 1785

The installation of the gallery does not appear to have caused any major changes to the ground floor, though certainly the entire interior of the Church would have been repainted at that time. The columns which carried the gallery were placed in the aisles and, therefore, did not interfere with the pew configuration. The stairs to the gallery were not in the body of the Church and provisions were made for the gallery entrance to be through the tower. The gal-

(See  
Figure 11)
