# CHRIST CHURCH

THE HISTORIC STRUCTURE REPORT

CHRIST CHURCH  
ALEXANDRIA, VIRGINIA

John Milner Associates  
309 North Matlack Street  
West Chester, Pennsylvania

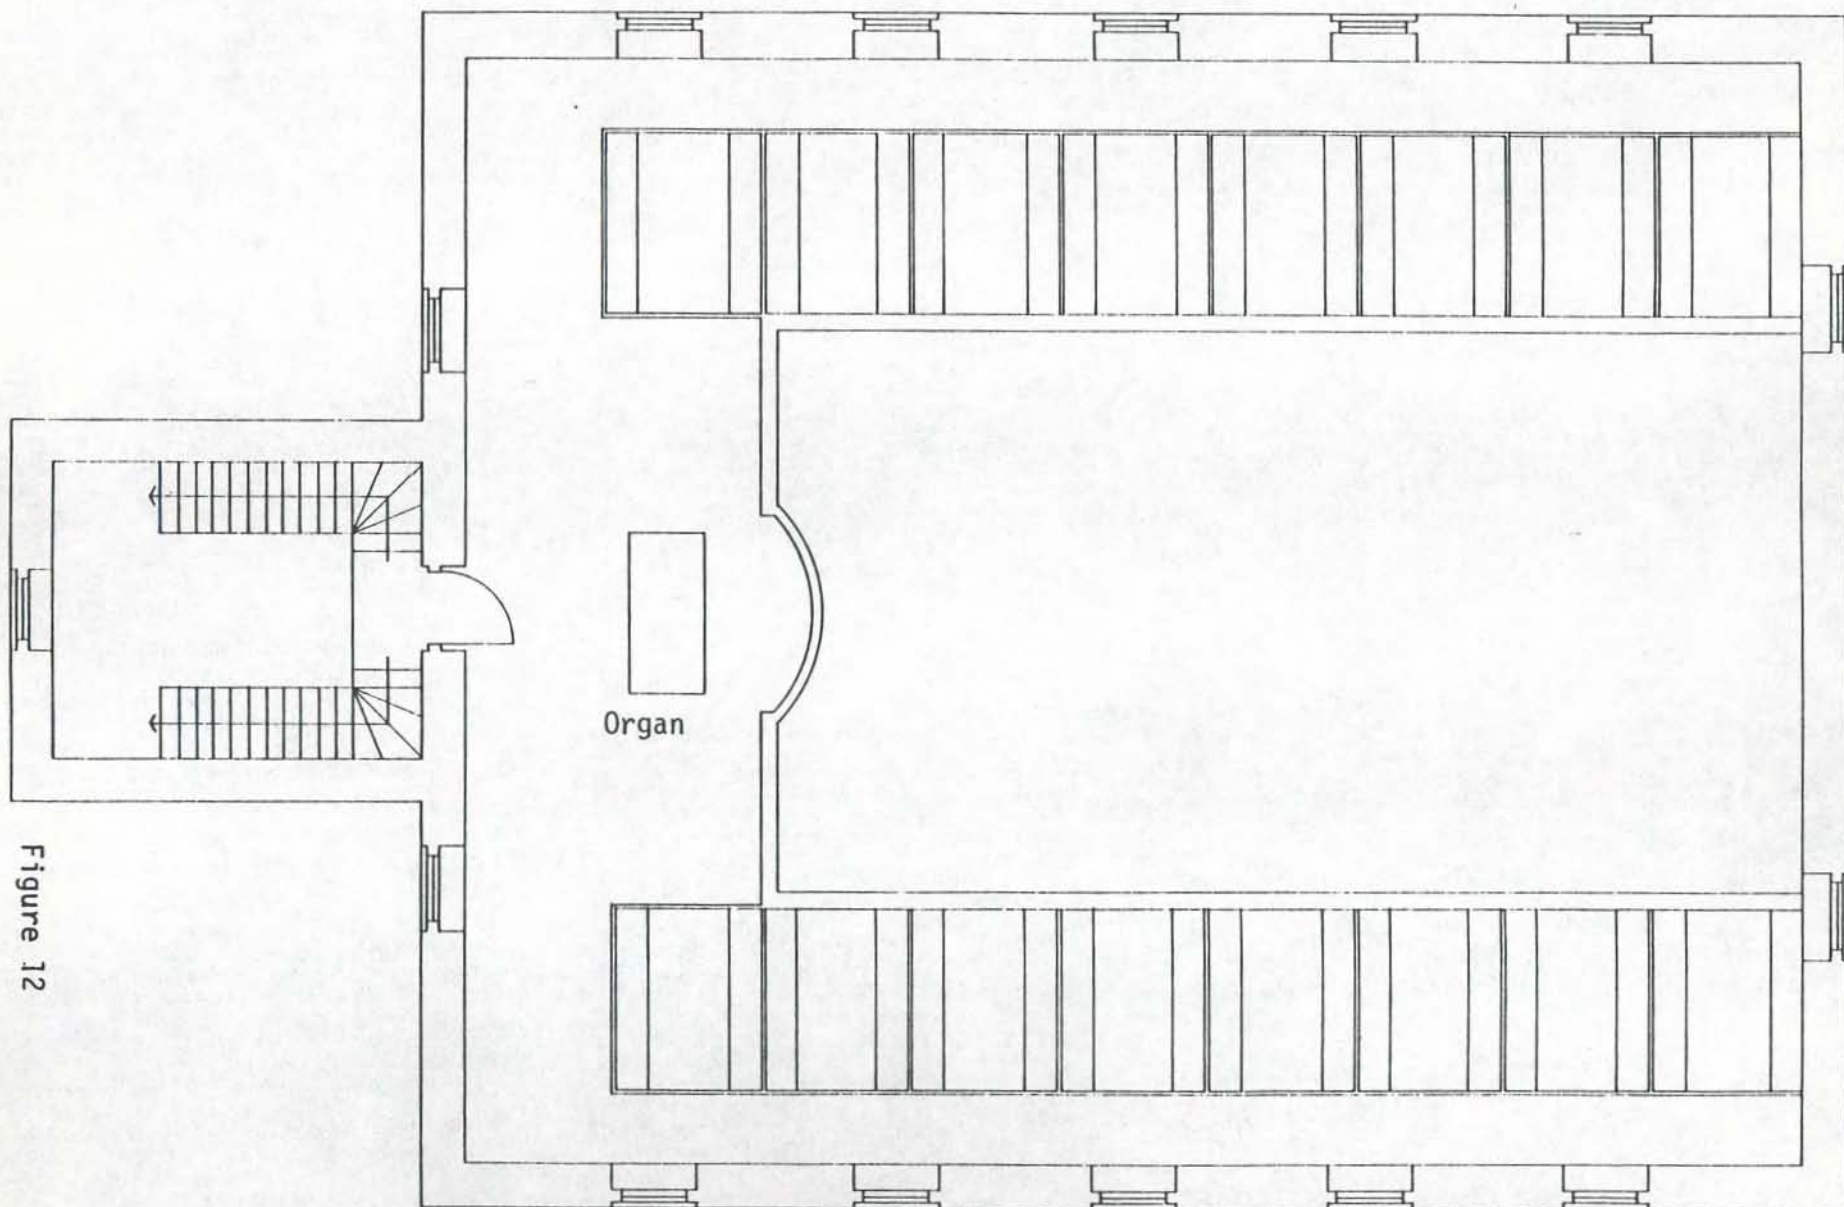
Figure 12

SECOND FLOOR PLAN: CIRCA 1785

(See  
Figure 12)

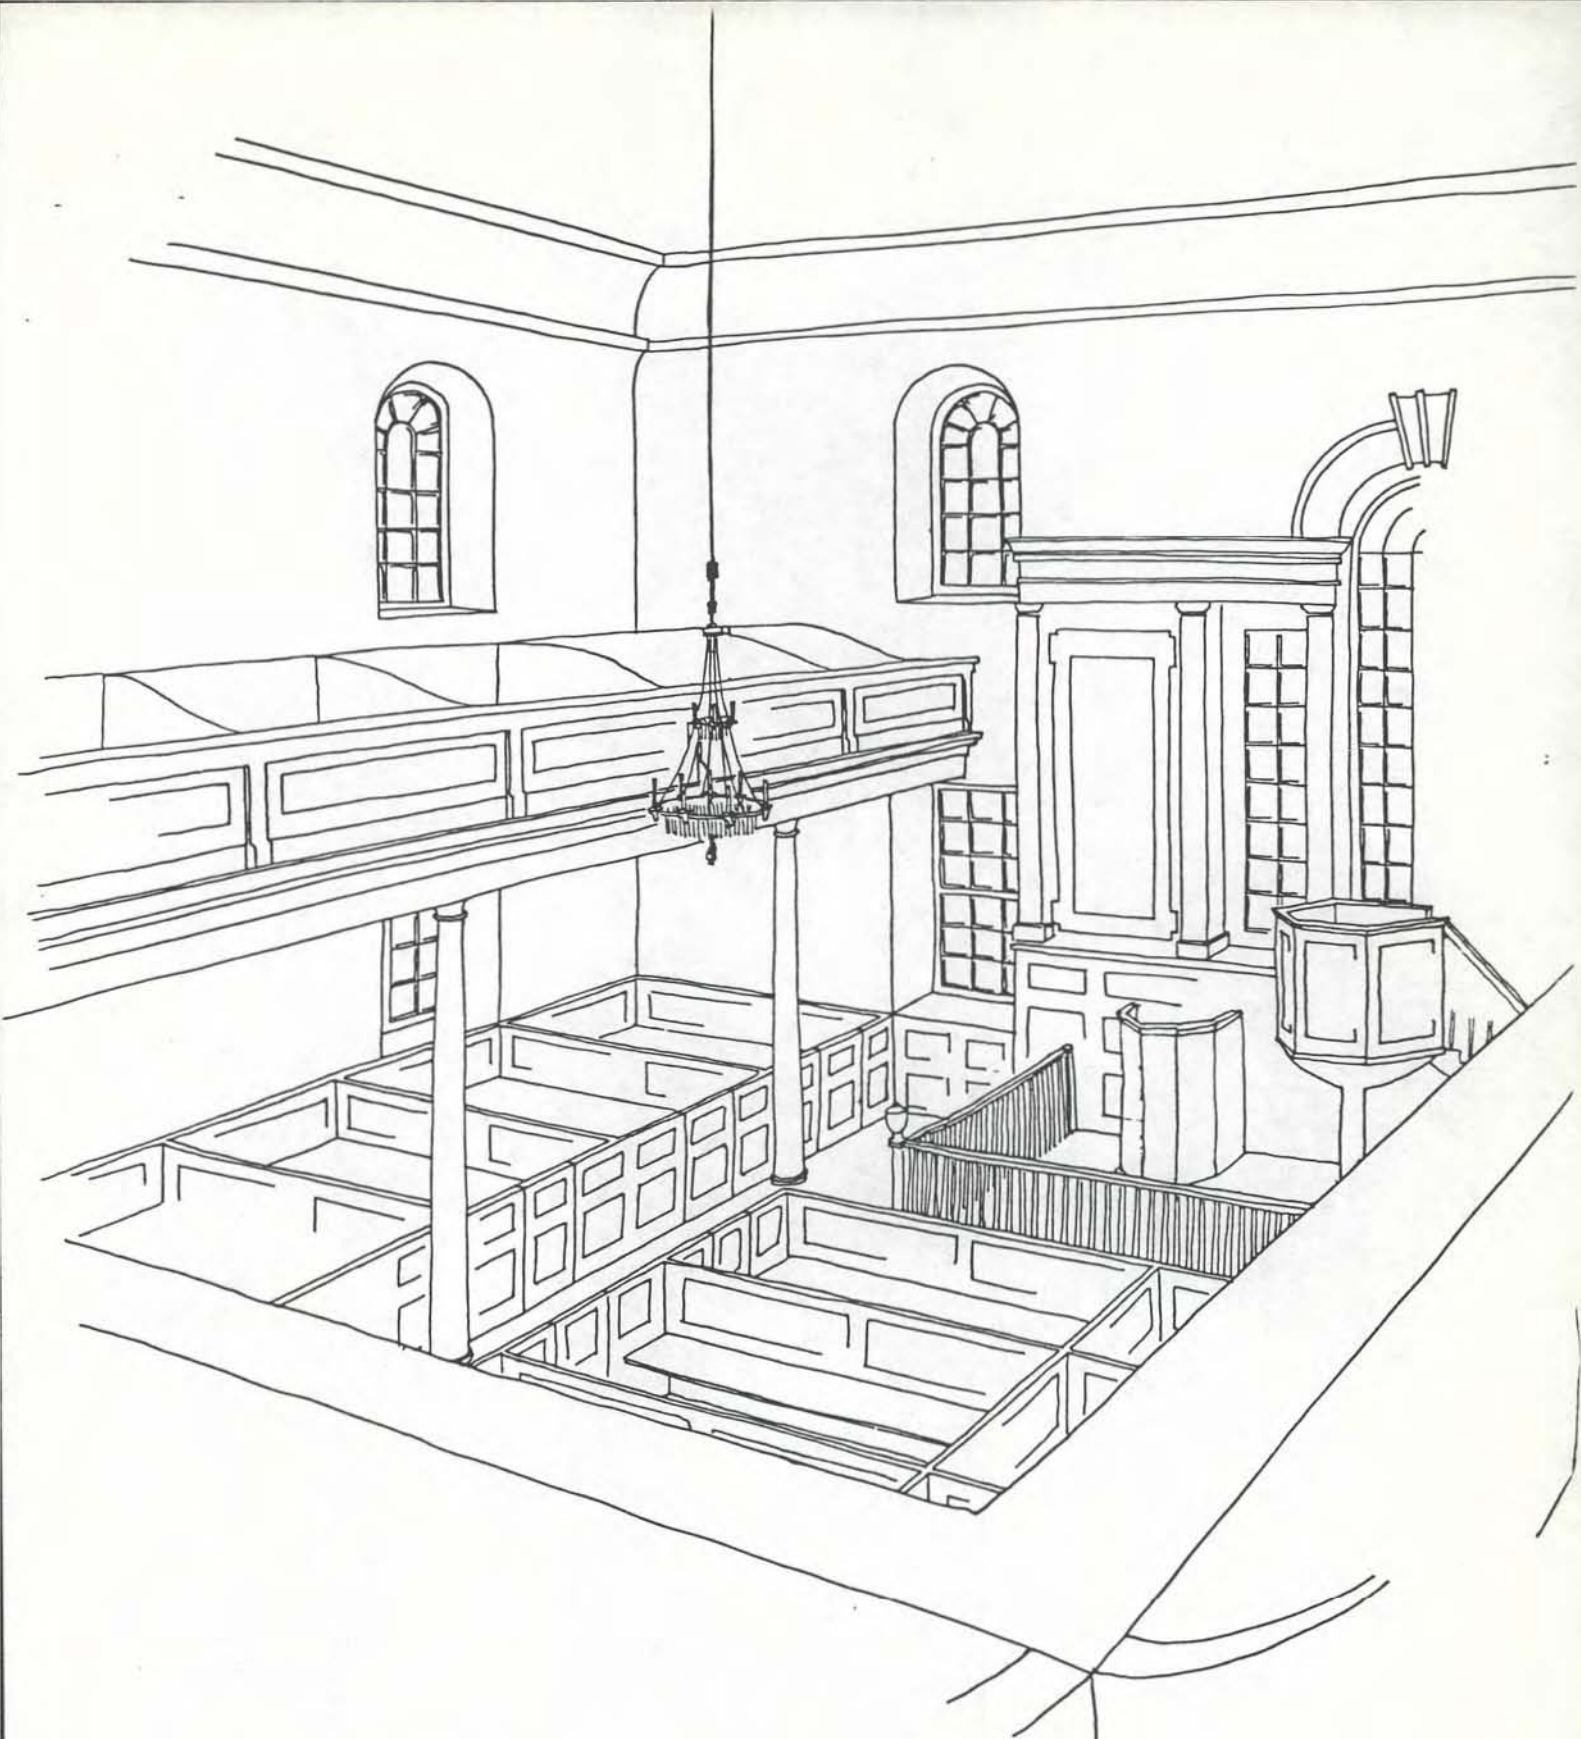
Figure 13

INTERIOR PERSPECTIVE looking east: CIRCA 1785

(See  
Figure 13)

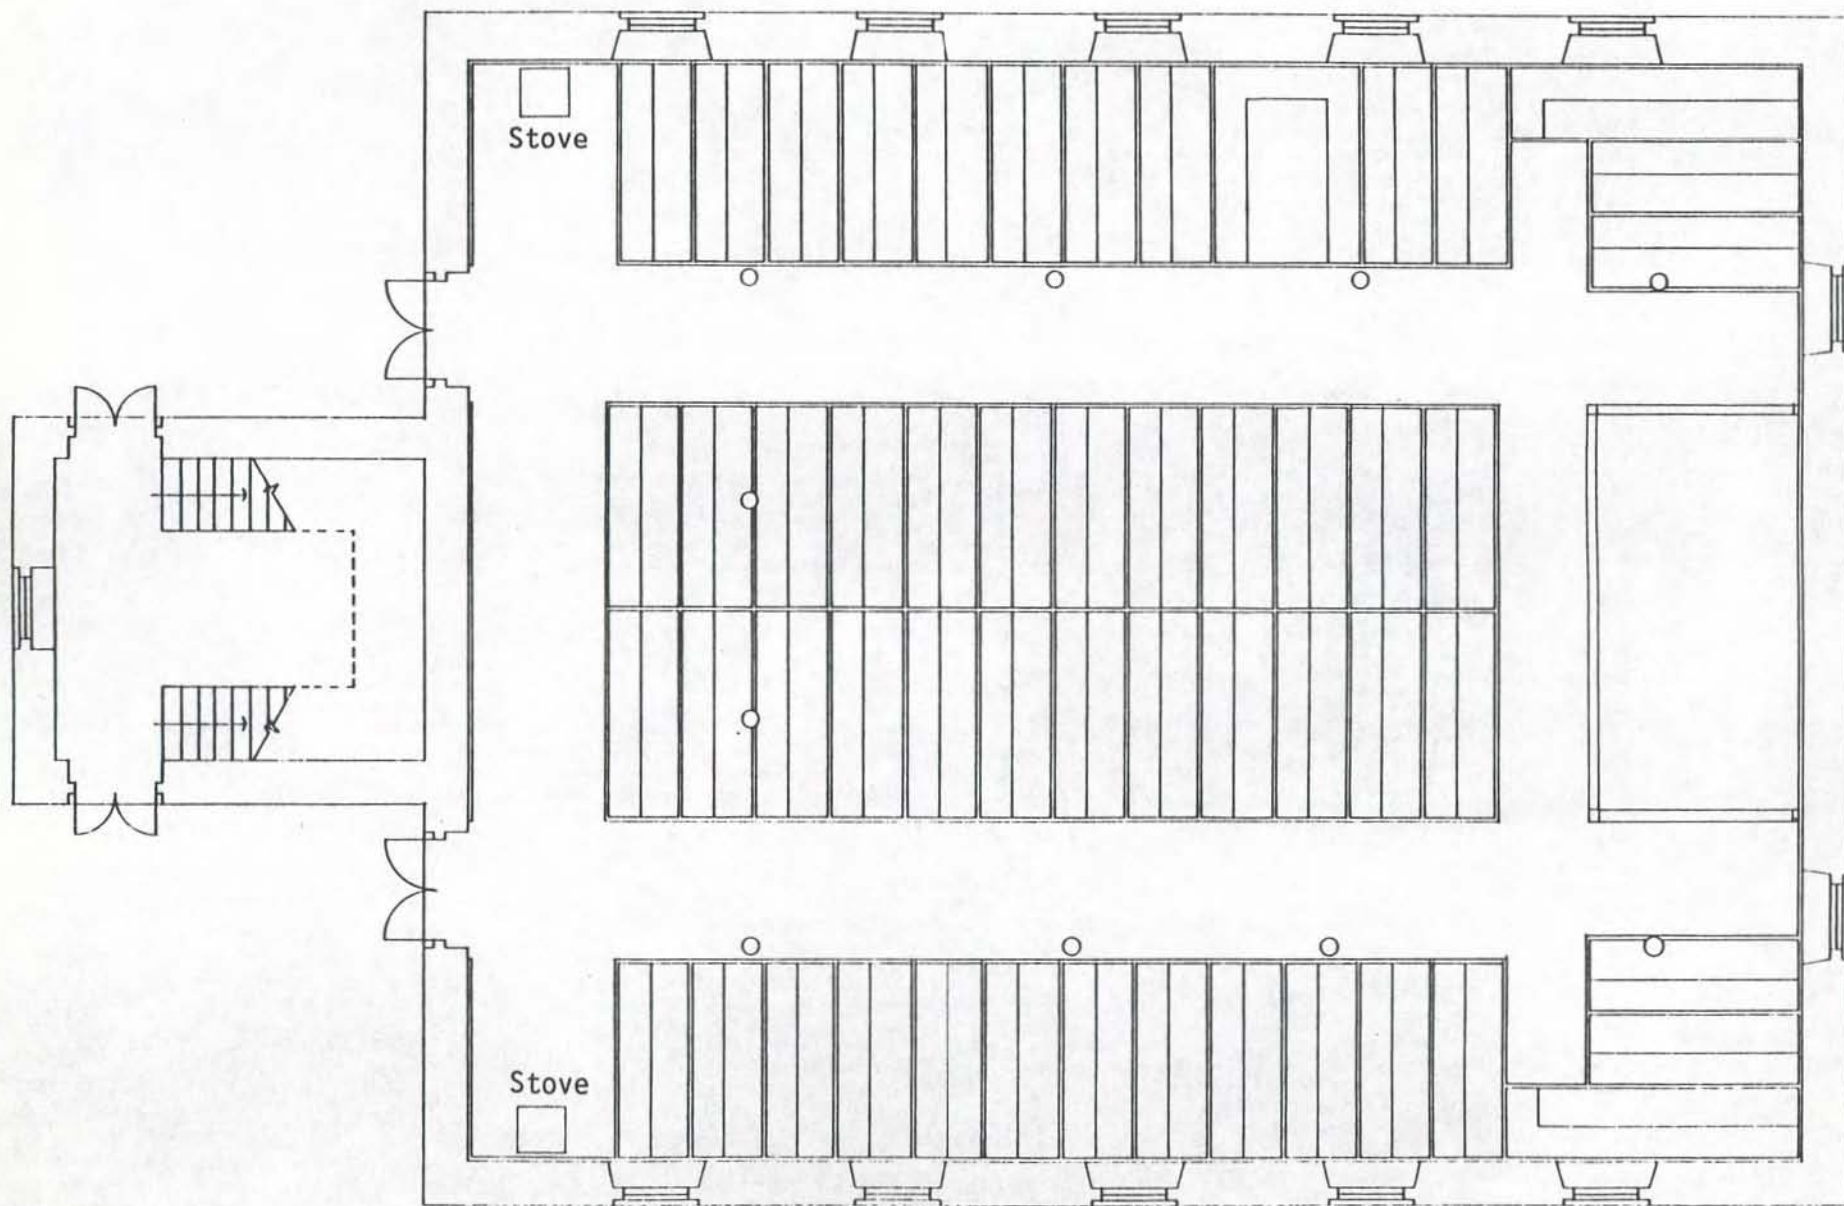
Figure 14

FIRST FLOOR PLAN: CIRCA 1816-21

The tower at its original conception could not have been intended as a vestibule for the first floor because of the lack of the west aisle similar to those in New England meeting houses; one must assume that its major function was access to the gallery. The west aisle in the Church was not cut in until 1811. Furthermore, the change in the aisle seems to have had little to do with the gallery but did serve two distinct purposes. The first was to restrict the use of both doors during inclement weather by allowing congregants to enter one door and then pass through the rear of the Church to the opposite aisle, and second, to accommodate heating stoves and

(See  
Figure 14)

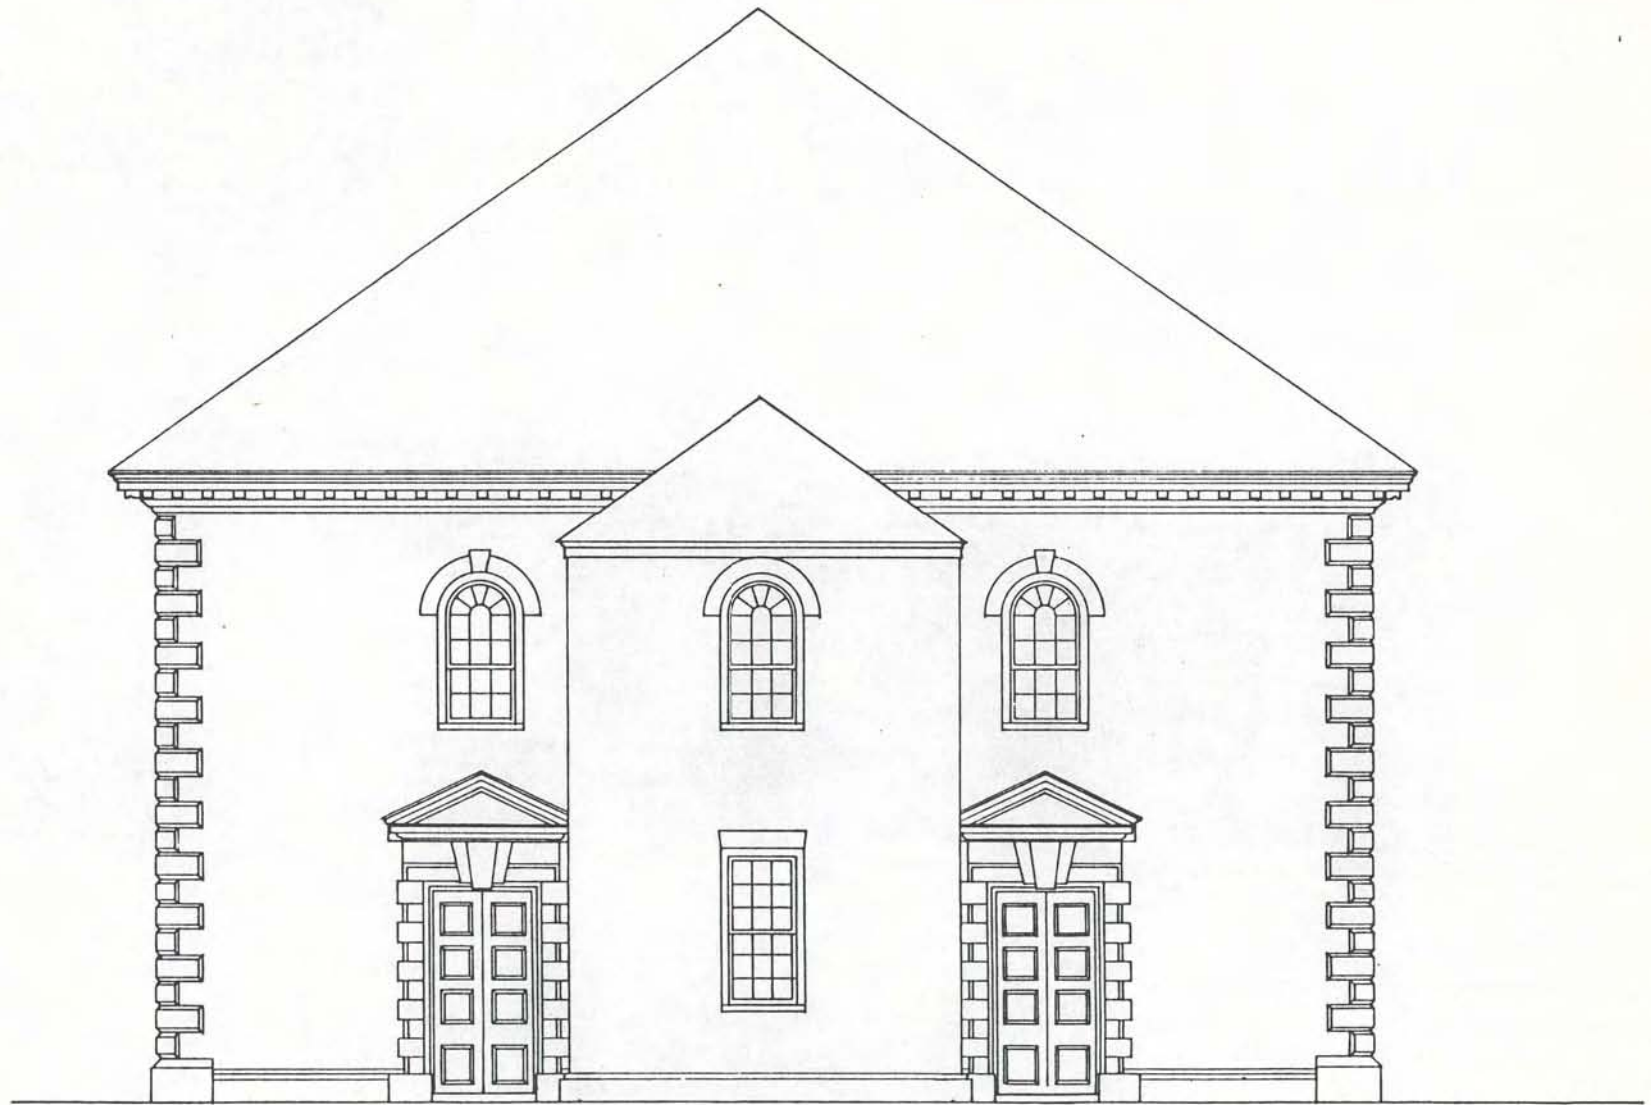
Figure 15

WEST ELEVATION: CIRCA 1785

(See  
Figure 15)

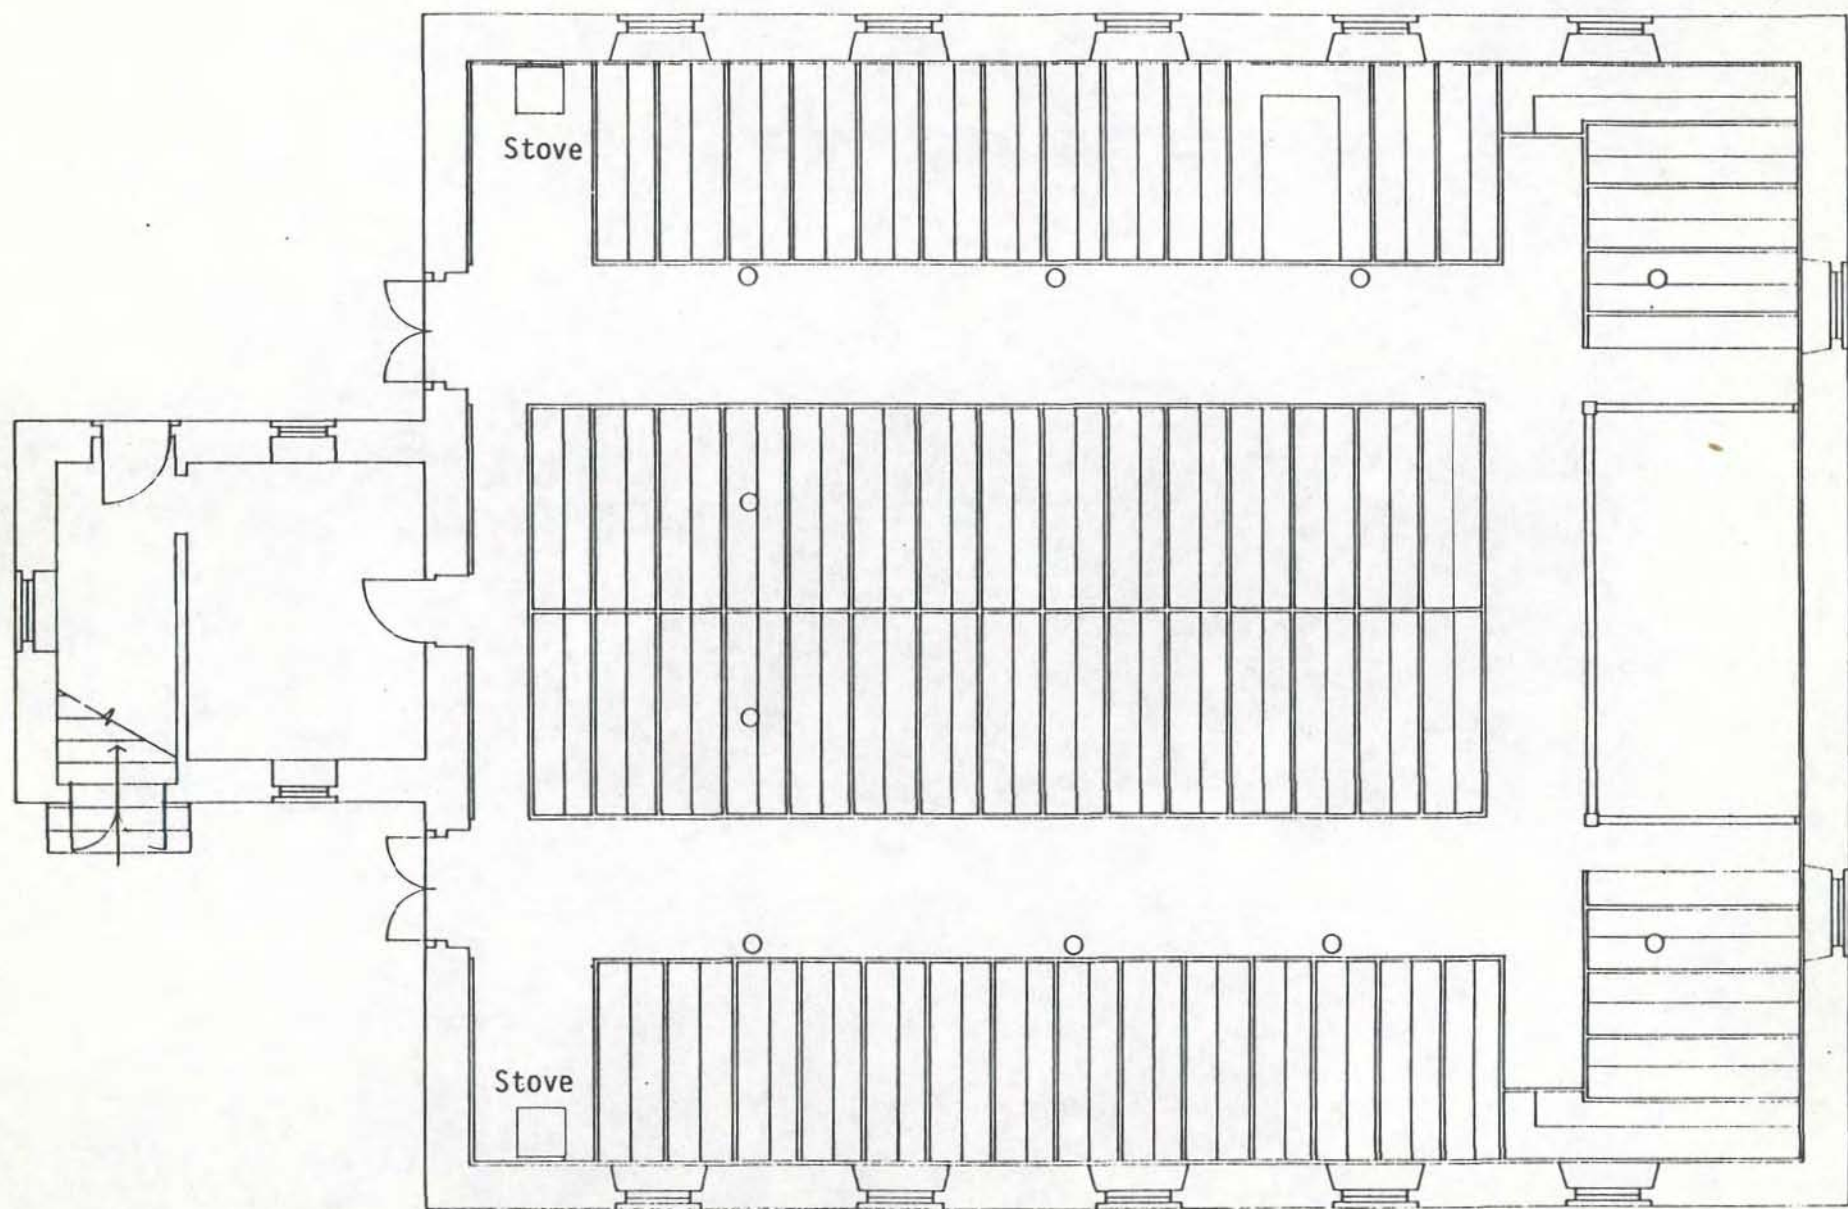
Figure 16

FIRST FLOOR PLAN: CIRCA 1834-40

(See Figure 16)

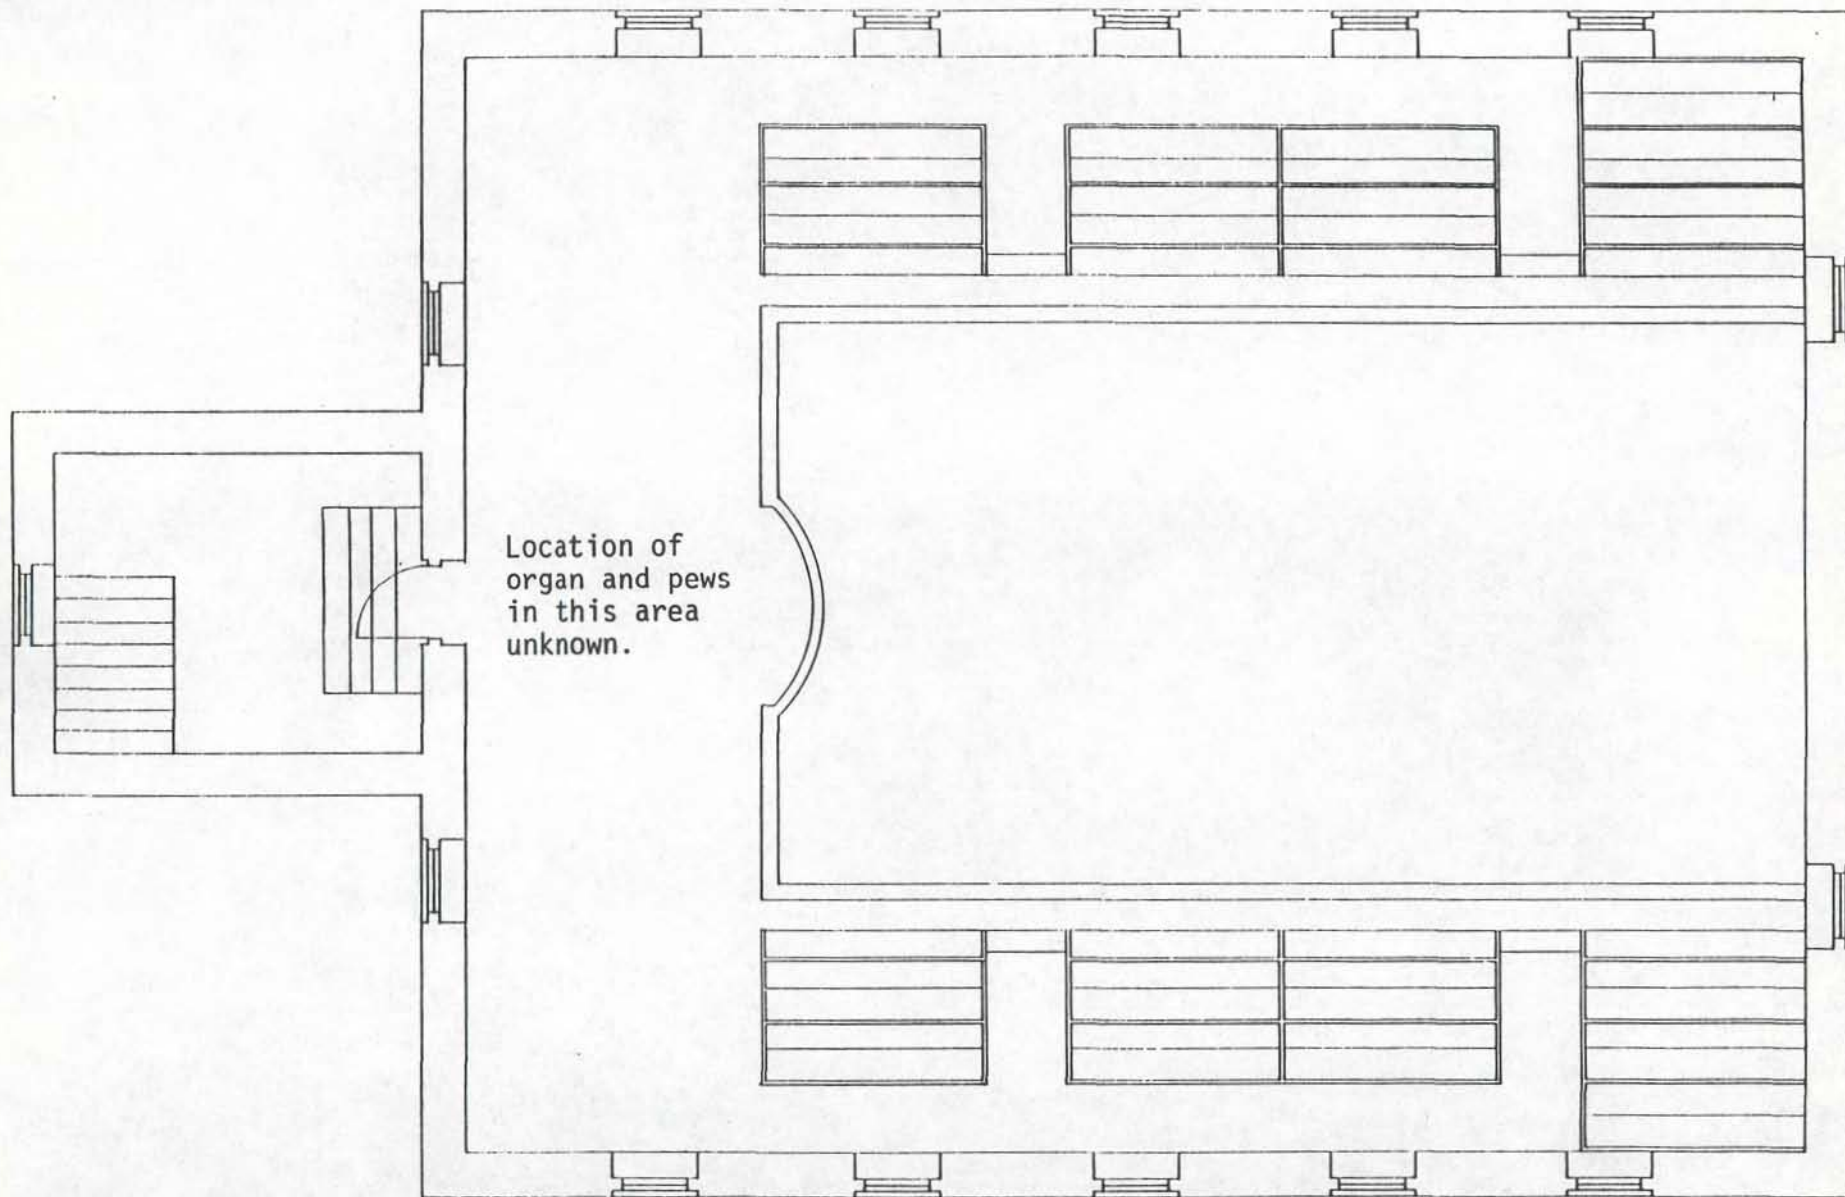
Figure 17

SECOND FLOOR PLAN: CIRCA 1834-40

(See Figure 17)

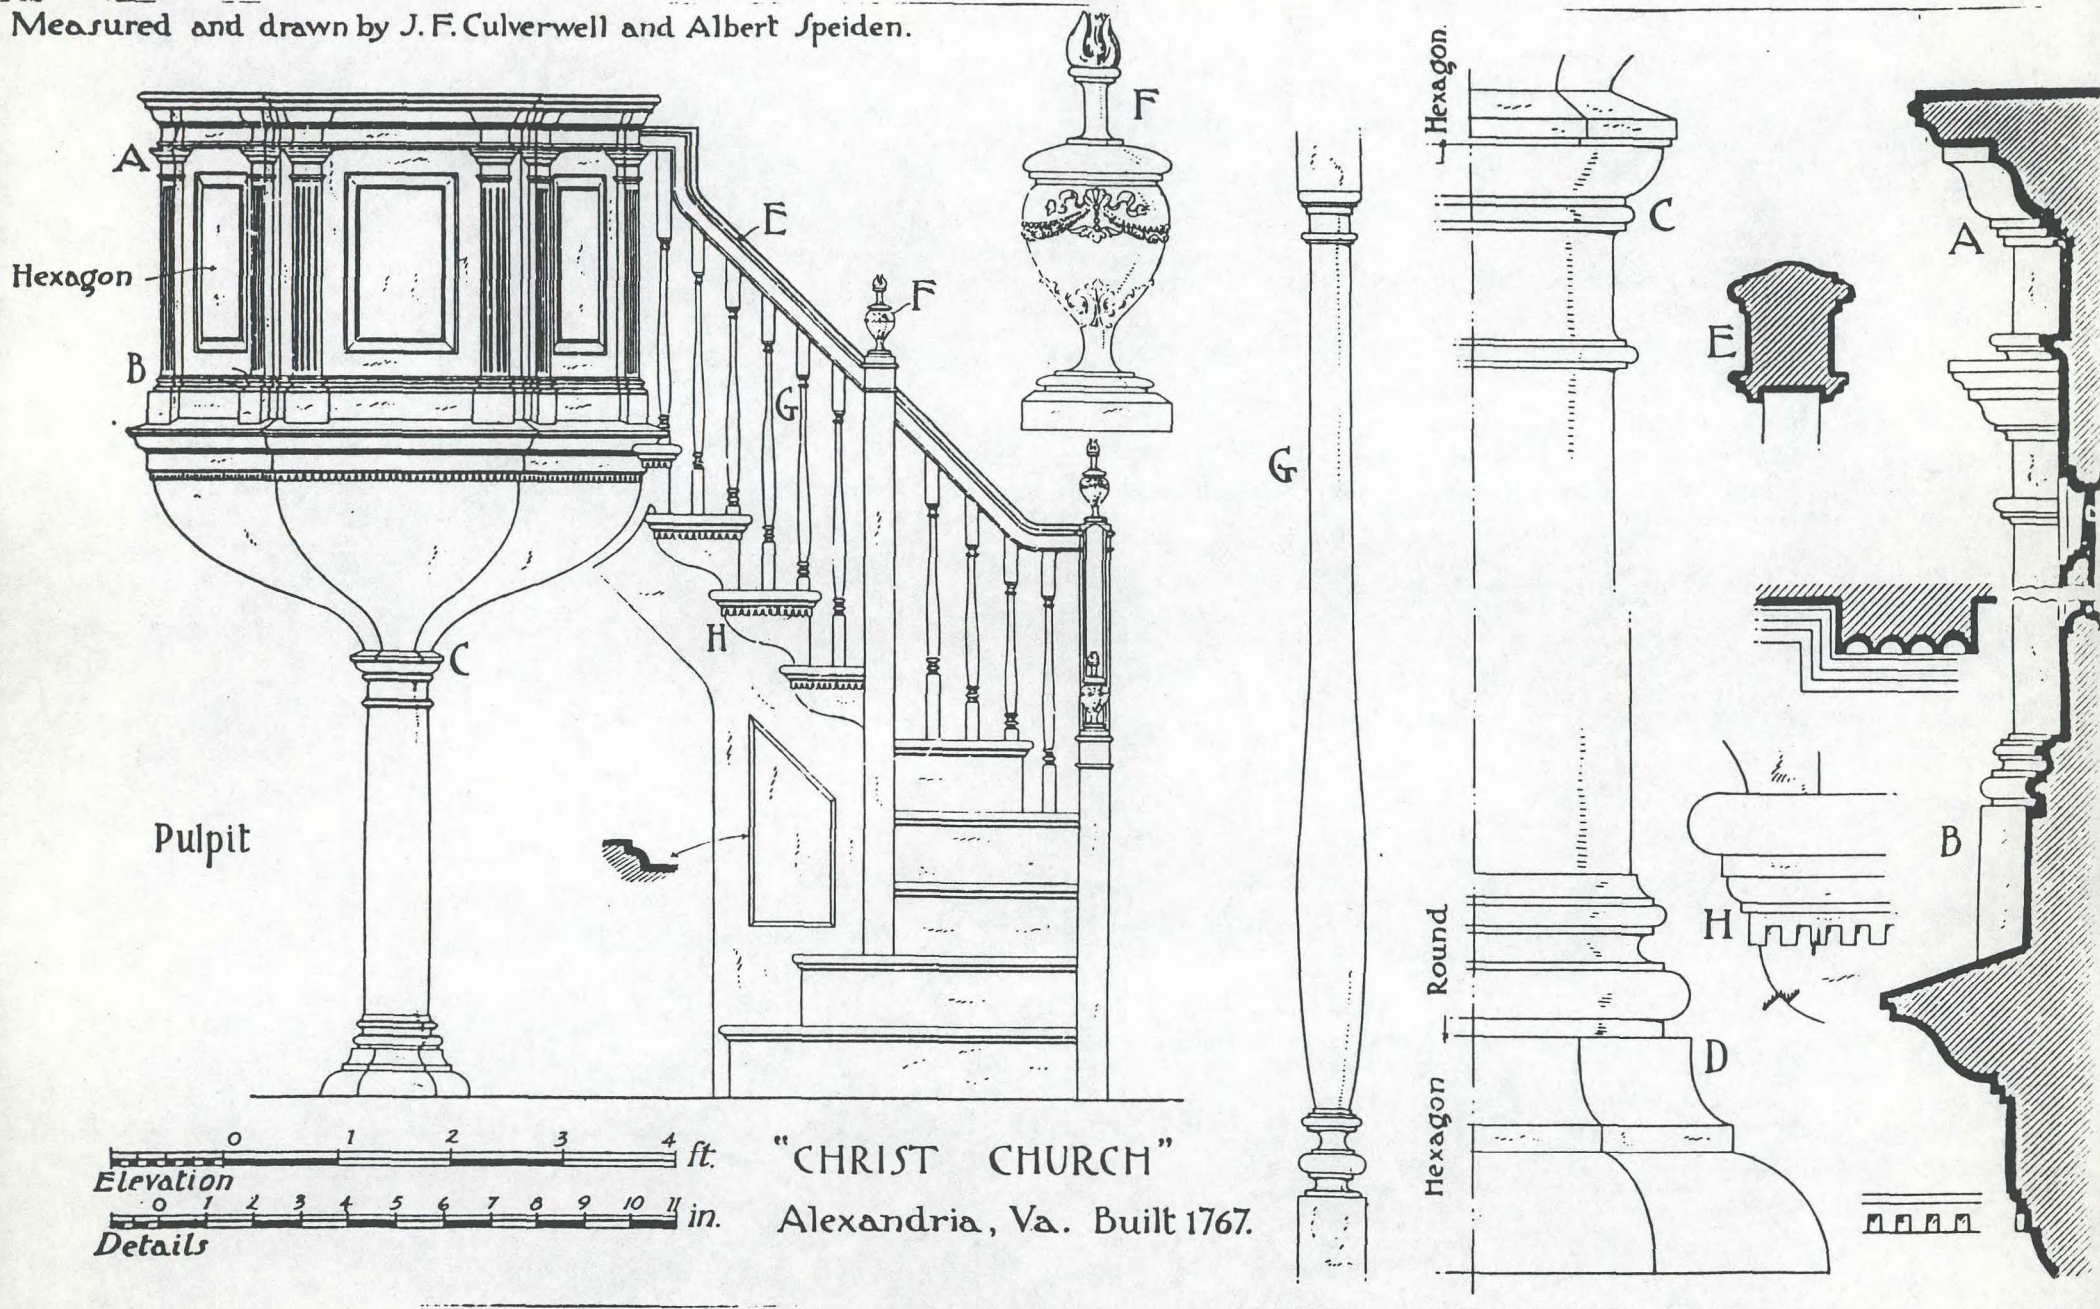
Measured and drawn by J. F. Culverwell and Albert Speiden.

Figure 18 Detail of Pulpit

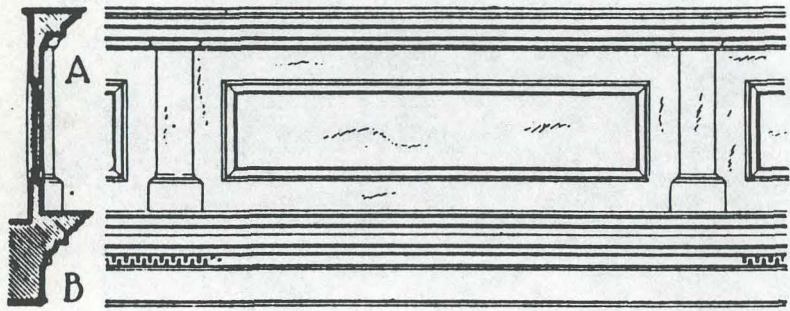
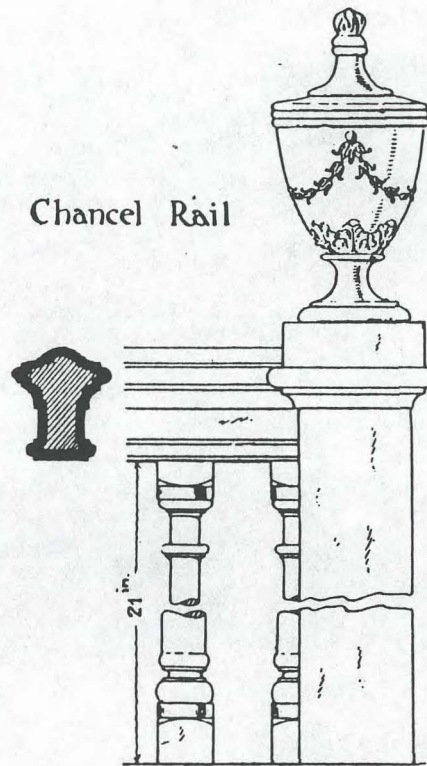
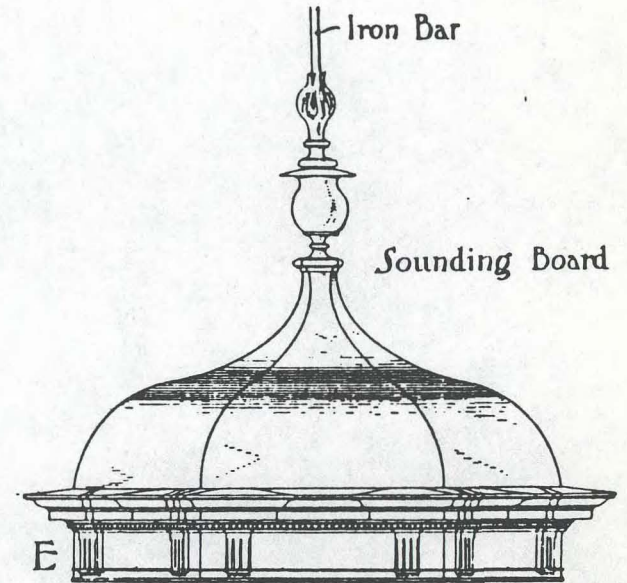
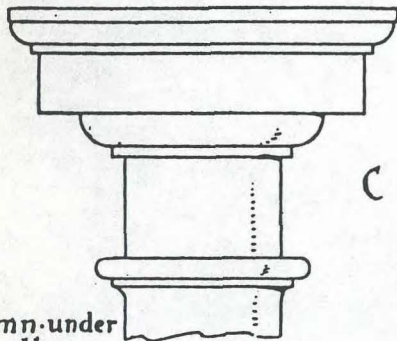
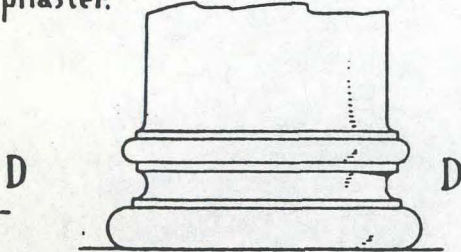
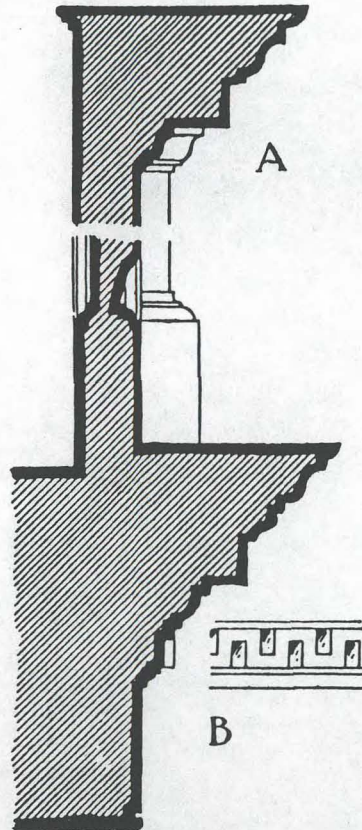
Gallery Front

Chancel Rail

Sounding Board

Figure 19 Detail of Sounding Board and Chancel Rail

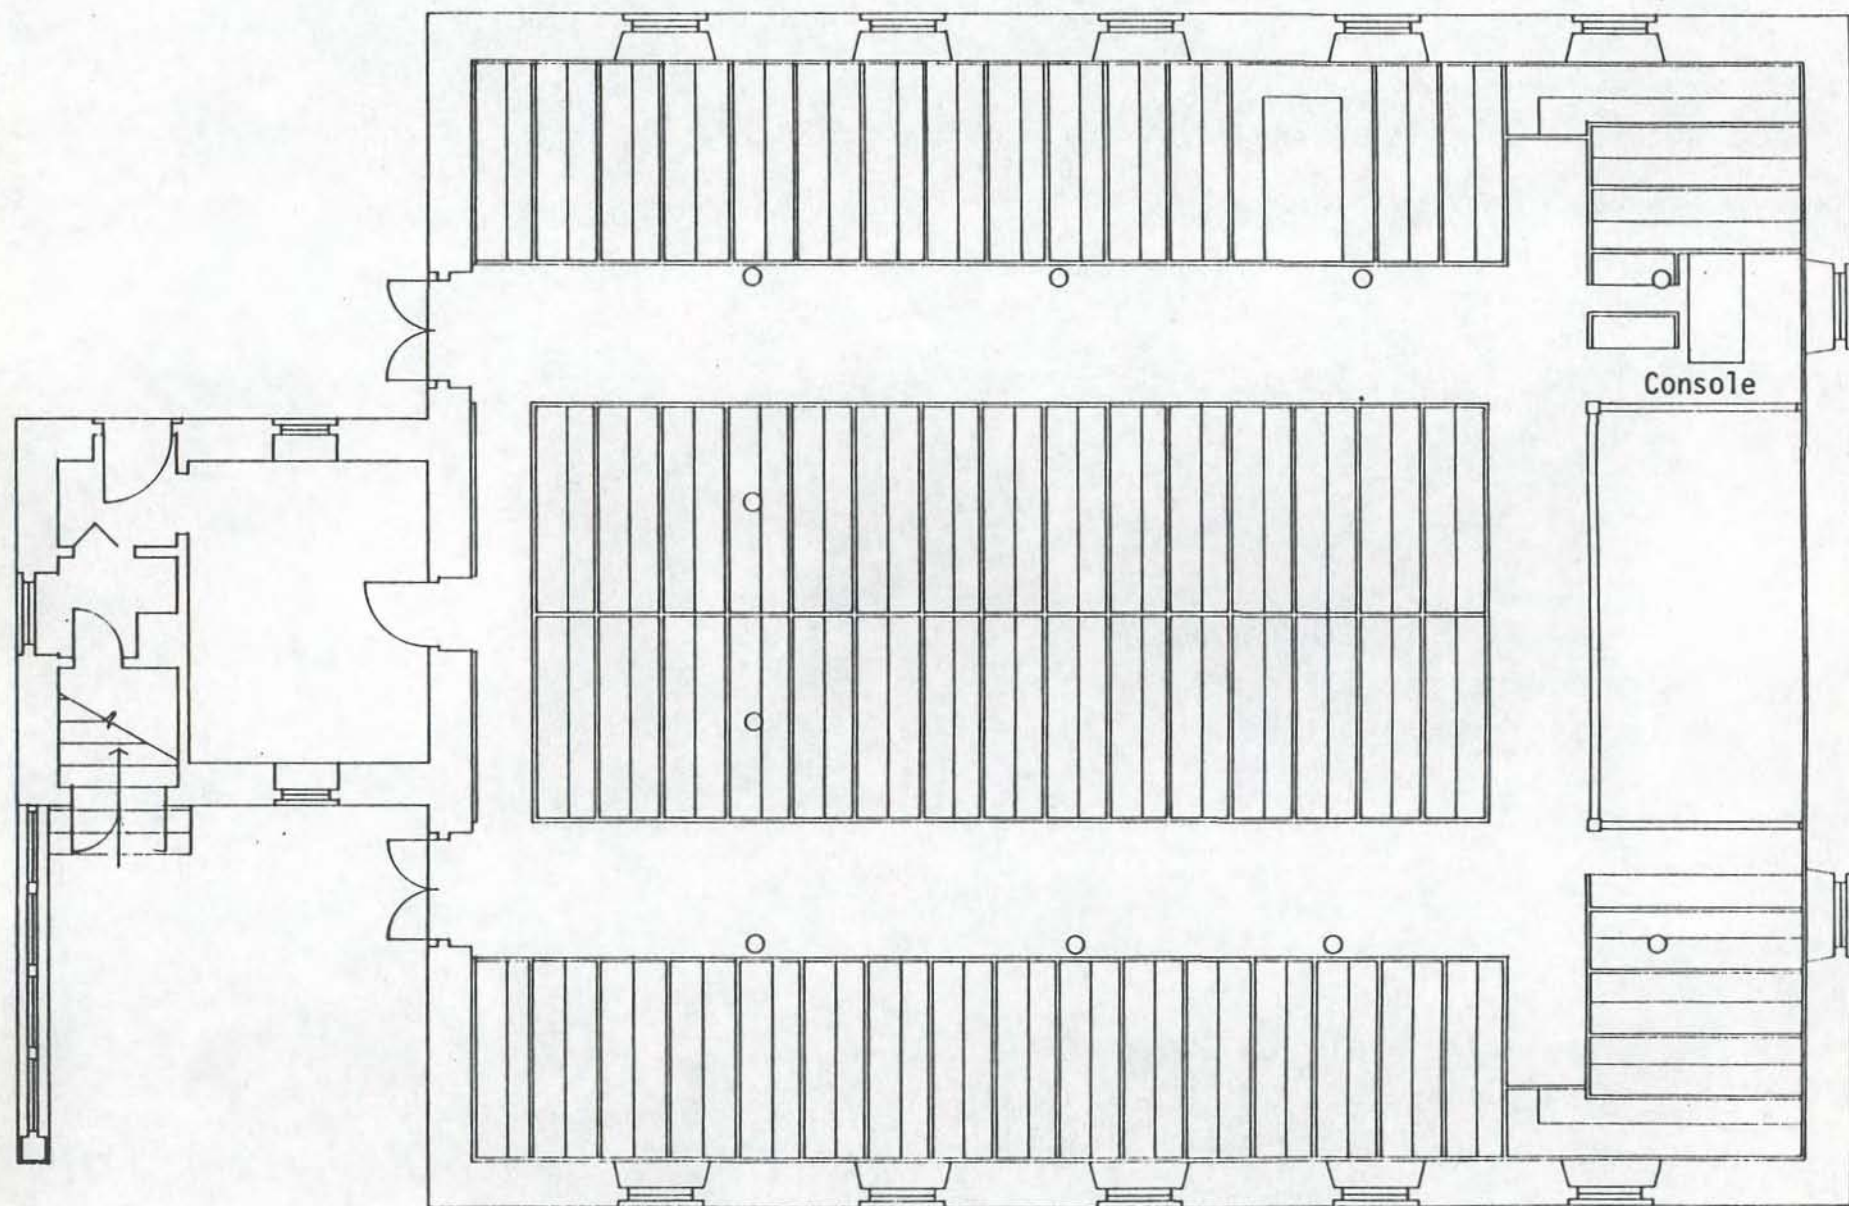
Figure 20

FIRST FLOOR PLAN: CIRCA 1921

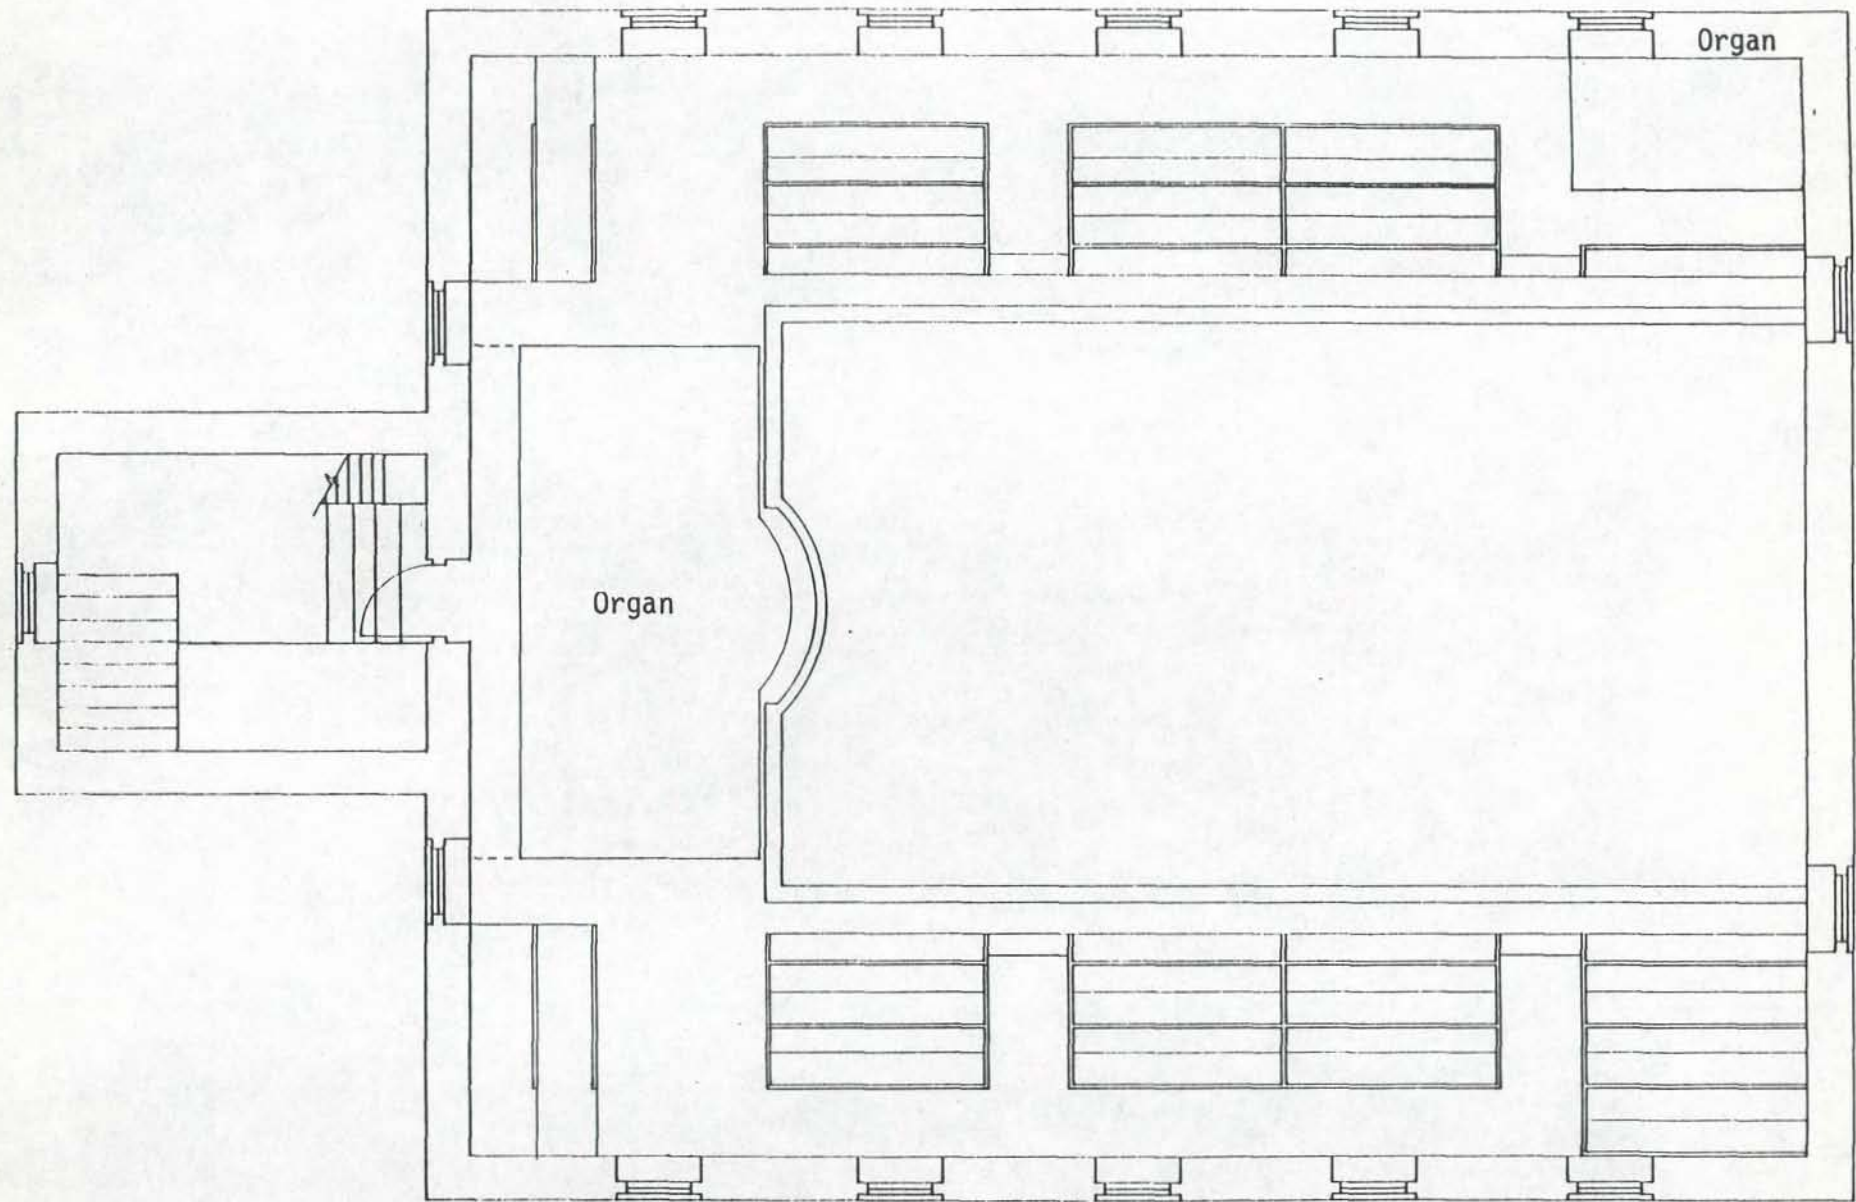
Figure 21

SECOND FLOOR PLAN: CIRCA 1921
