# CHRIST CHURCH

THE HISTORIC STRUCTURE REPORT

CHRIST CHURCH  
ALEXANDRIA, VIRGINIA

John Milner Associates  
309 North Matlack Street  
West Chester, Pennsylvania

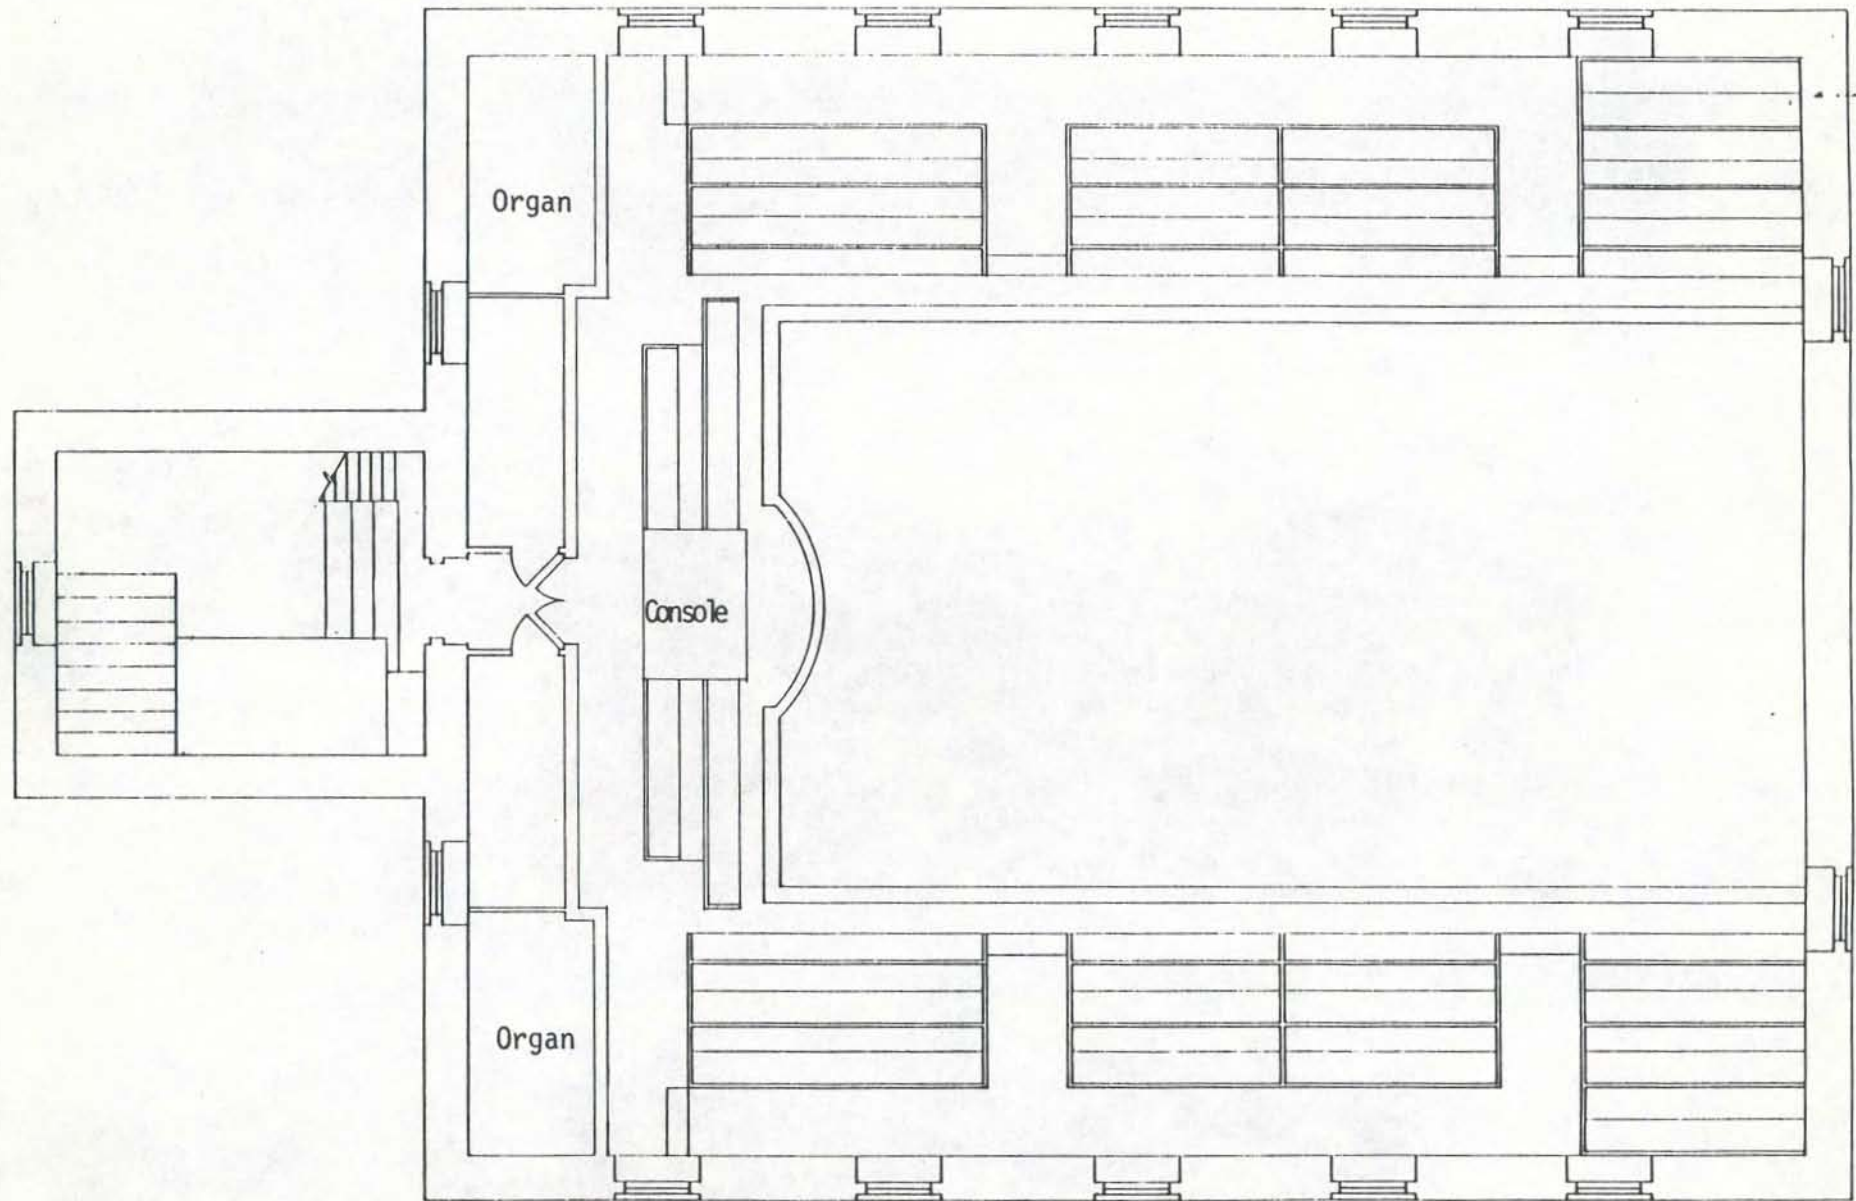
Figure 26

SECOND FLOOR PLAN: CIRCA 1950

(See  
Figure 26)

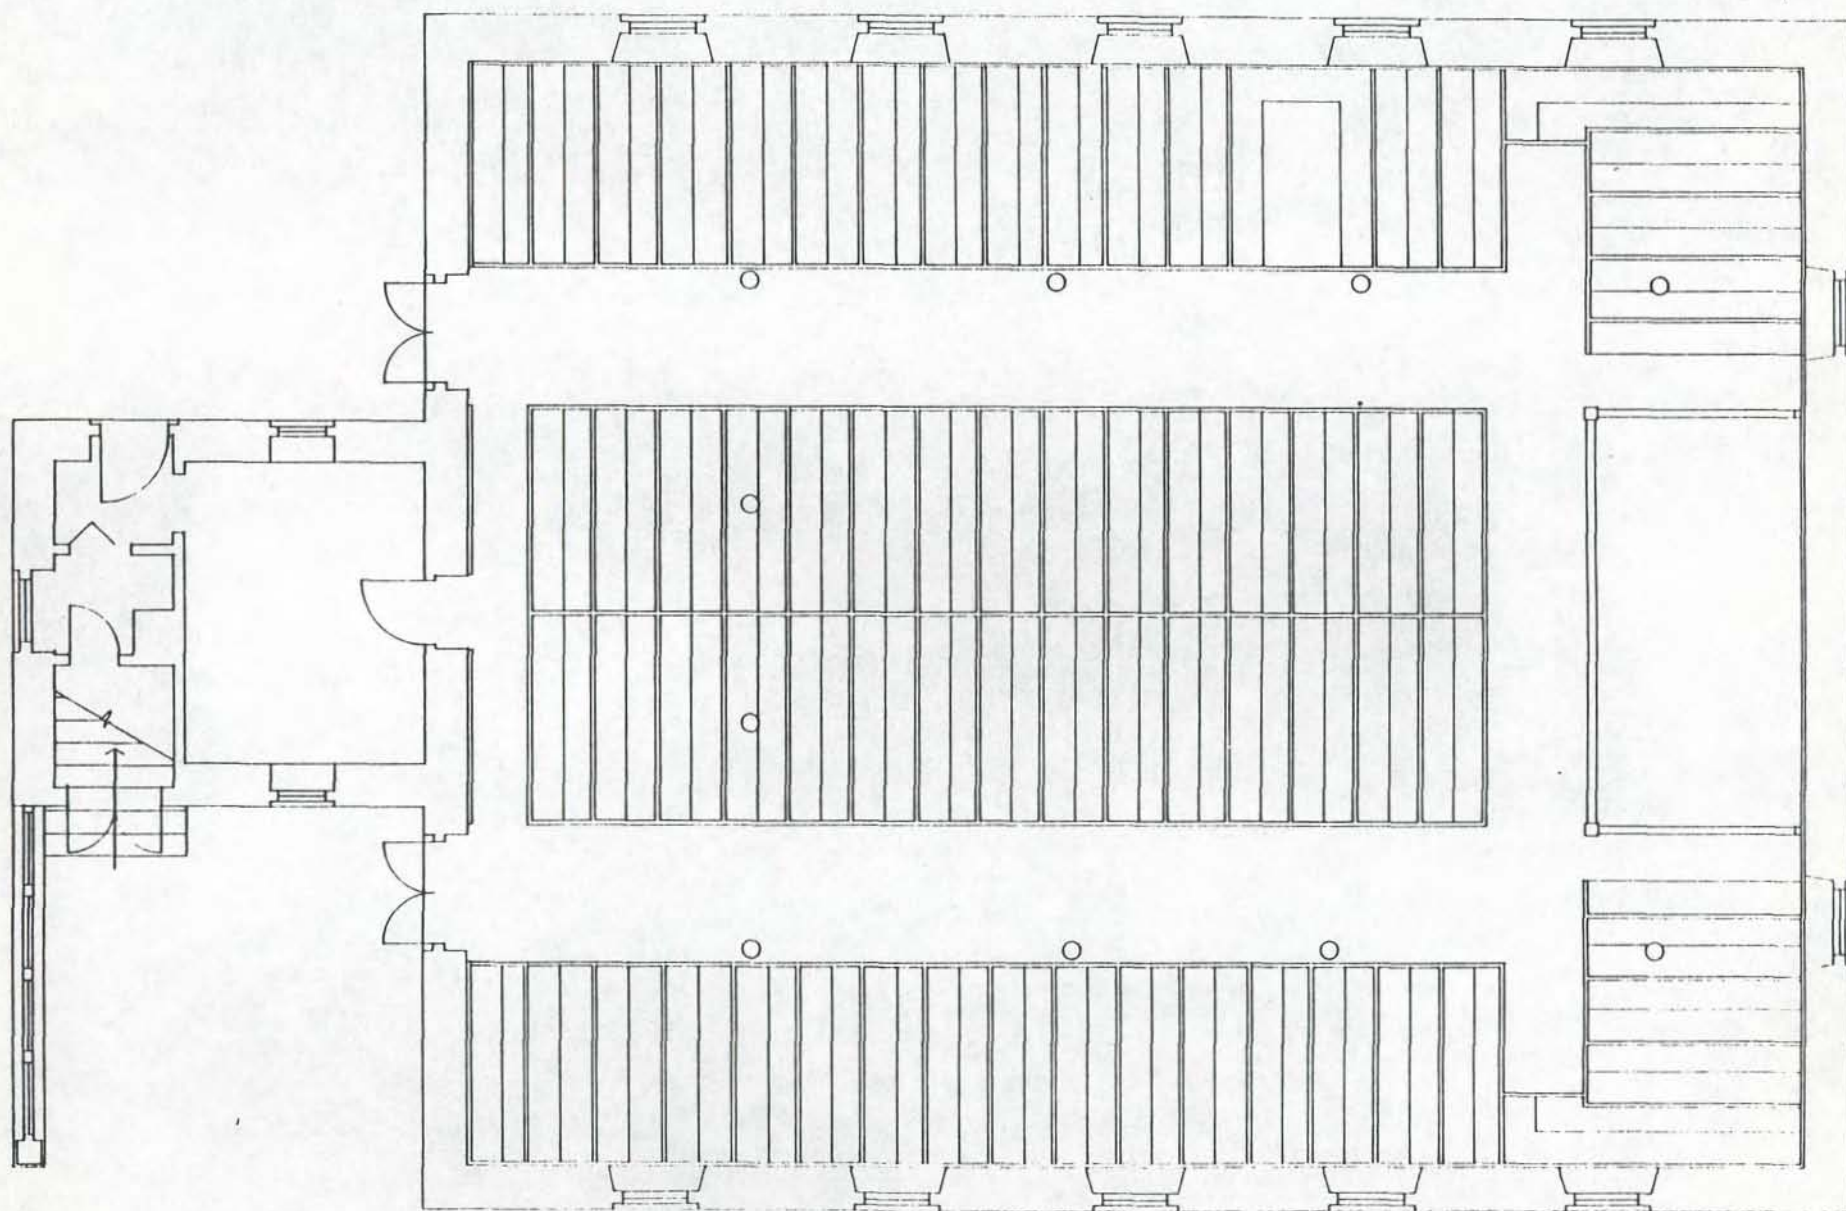
Figure 27

FIRST FLOOR PLAN: PRESENT

(See  
Figures  
27 & 28)

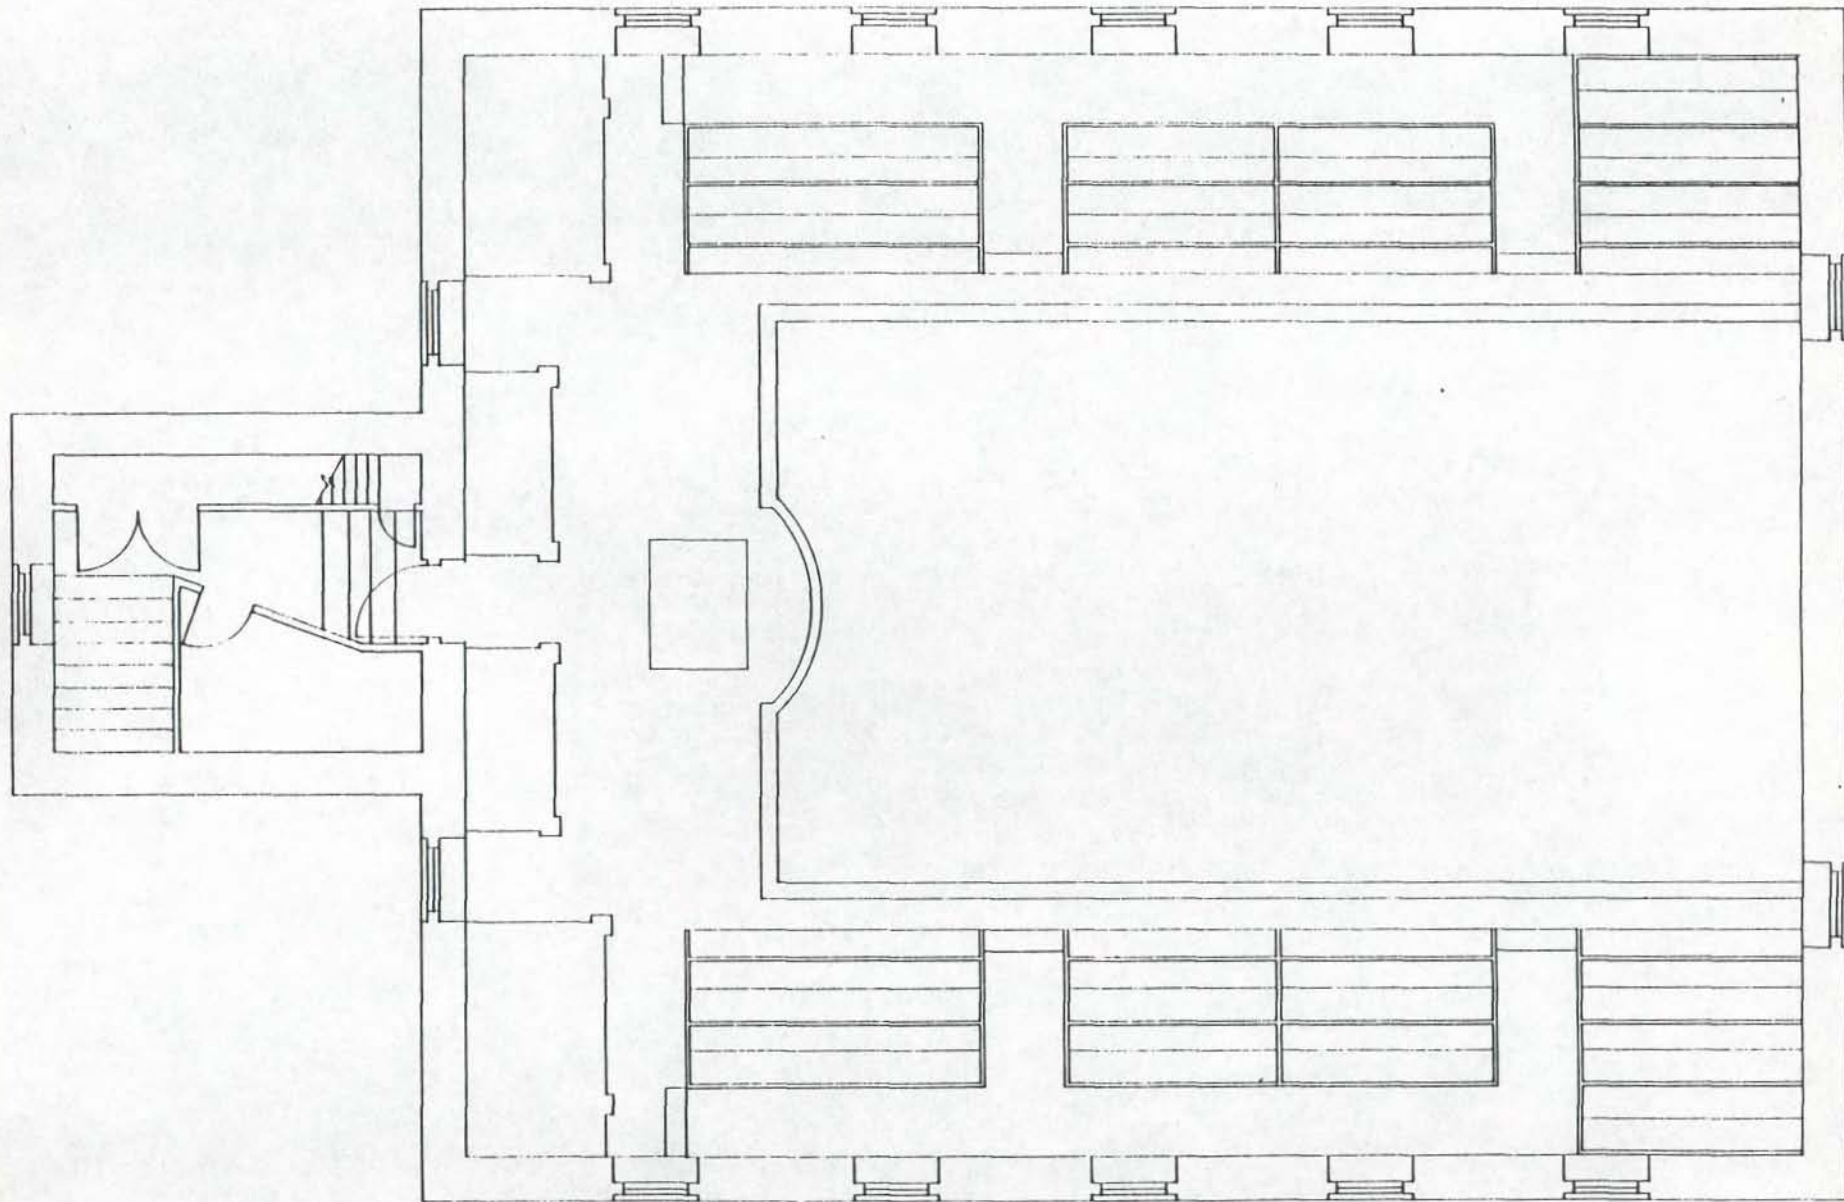
Figure 28

SECOND FLOOR PLAN: PRESENT

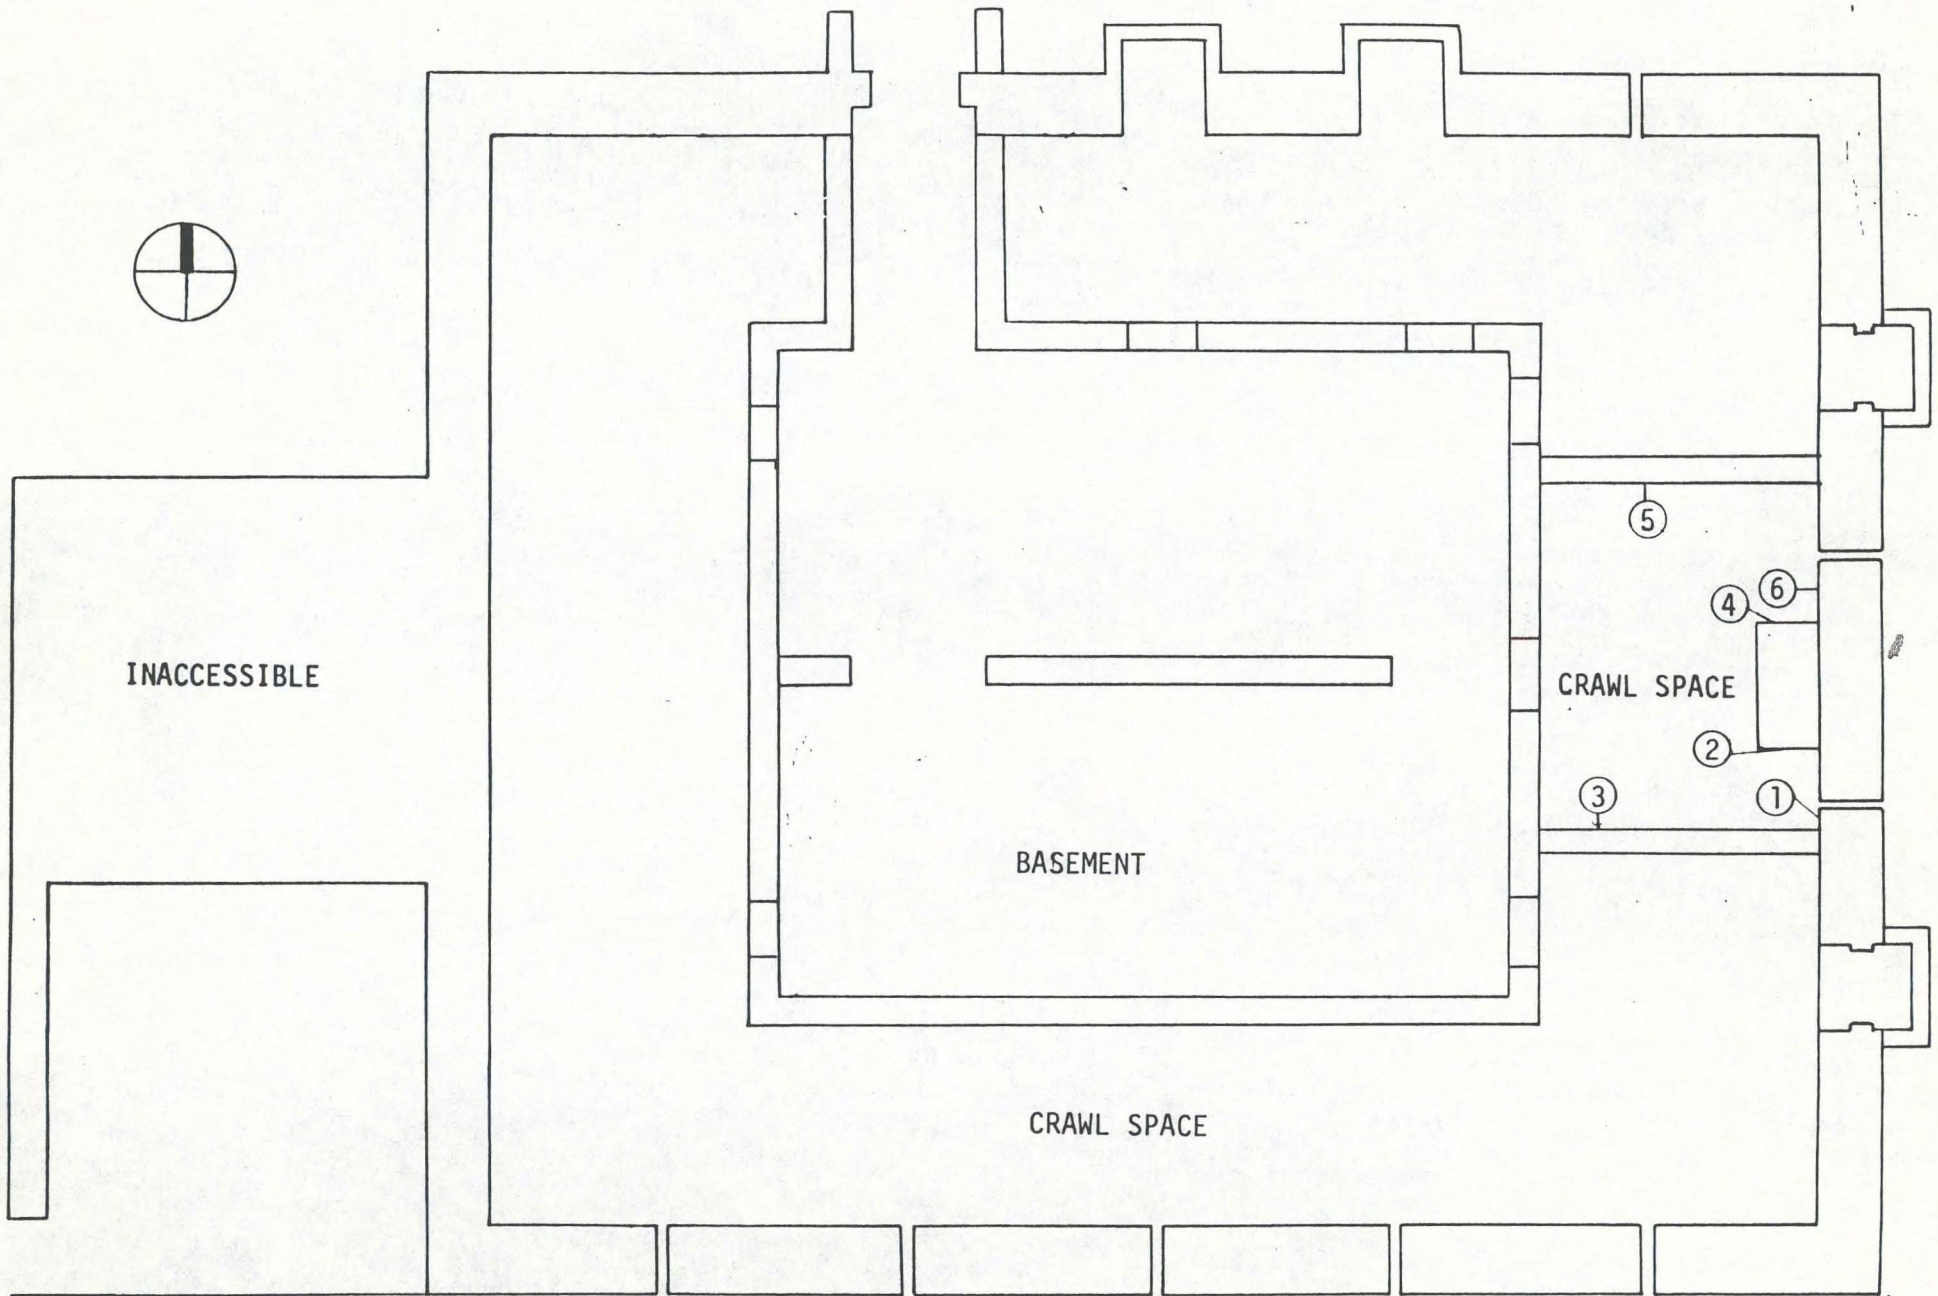
MORTAR SAMPLES LOCATIONS  
8/29/79  
JOHN MILNER ASSOCIATES

BASEMENT  
CHRIST CHURCH  
ALEXANDRIA, VA.

Eight samples of building mortar from Christ Church, Alexandria, Virginia, were subjected to a physical and chemical analysis. Six of the samples were taken from the basement crawl space under the Chancel; two were taken from above the doorway to the vestry room. Chemical analysis involved the use of hydrochloric acid in the manner outlined by Blaine Cliver (1974). Physical analysis involved careful examination with the naked eye and under a low-power microscope for color, inclusions, angularity, hardness, and size. The interpretation of each sample is described on the following pages and should be used in reference with the attached data sheets.
