Virginia Glass Company
Bottle Factory
Phase I and Phase II/III
Archeological Investigations
John Carlyle Square
Site 44AX181
Alexandria, Virginia

Volume I: Text

Dames & Moore Cultural Resources Services 7101 Wisconsin Avenue, Suite 700 Bethesda, Maryland 20814

November 1999

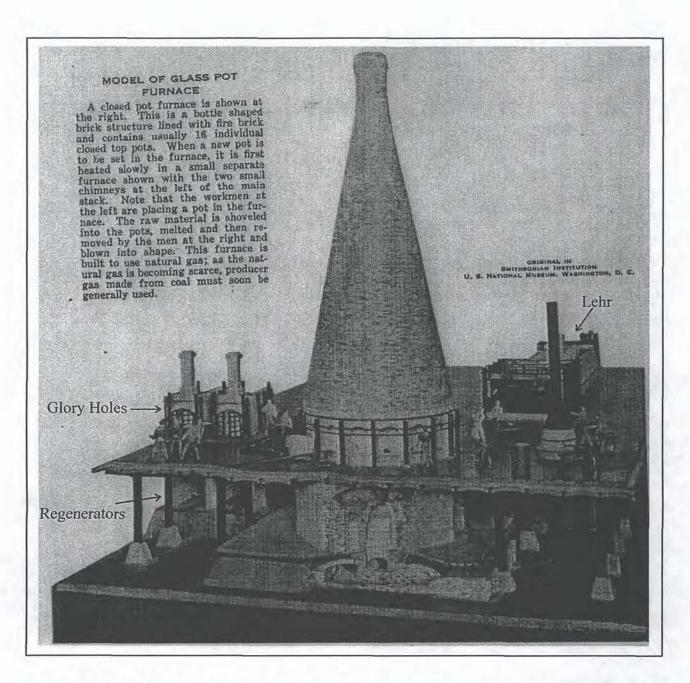
Figure 5-7. Model of a Pot Furnace. NOTE: this furnace contained closed pots and was used for melting flint glass. Pot furnaces for bottles did not use closed pots, and were oblong rather than round. This figure illustrates the cave area beneath the furnace (note regenerators), the glory holes where workers reheated glass (to left) and the lehr where glass was tempered (to right) of furnace. Source: Samuel S. Wyer, *The Smithsonian Institution's Study of Natural Resources applied to Pennsylvania's Resources* 1923, p. 88.

Small by contemporary standards, the pot furnace of the Virginia Glass Company was very likely a direct coal-fired, reverberatory furnace of a type common in glass houses throughout the northeast and mid-west. It is possible that some of the bricks from the early reverbatory furnace were re-used in the construction of later tank furnaces, but there is no direct evidence of such re-use. Built of bricks or blocks (called refractories), these bottle furnaces were generally oblong in shape and consisted of a combustion chamber and a wind passage, commonly known as a cave. Separating the two was a grate that supported the fuel and a "siege" or bench that held the pots. A powerful draft drew air through the cave and through the coal piled on the grate, creating a fire of great intensity. The flames and heat reverberated off the "low, flattened arch" that formed the ceiling of the combustion chamber and played off the pots, heating the batch without touching the glass directly. Bottle furnaces provided an opening along the side for each pot, granting access for gathering the glass and charging the pot, at the same time creating an additional draft that drew the melting flame more directly around the pots (Figure 5-7).

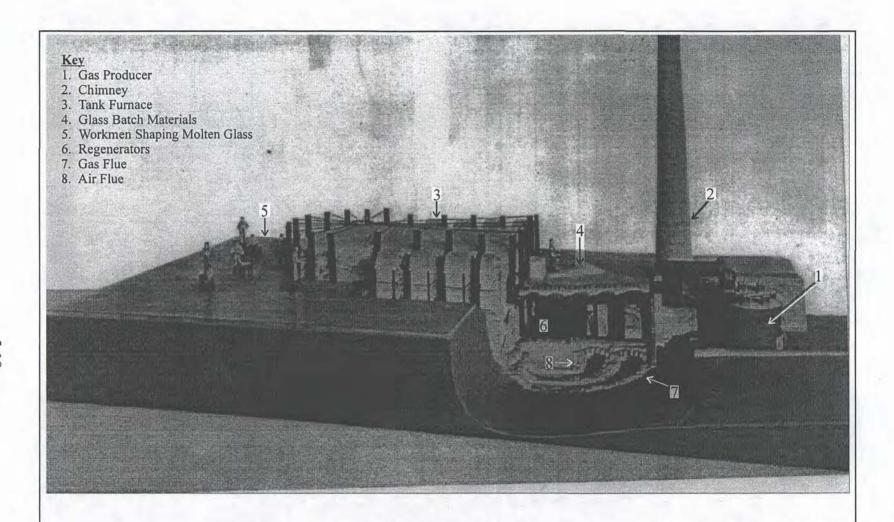
Figure 5-8. Model of a Continuous Tank Furnace with Attached Producer Gas Plant. This was probably modeled on a bottle glass furnace. It is a side-port furnace (where fuel and air enter from the side and flame plays across the batch) with brick regenerators below the side wings of the furnace and working area to the elliptical front. The other type of furnace (an end-port furnace where fuel and air enters from the end and flame plays lengthwise over the batch) is illustrated on the next figure. Note the gas flue coming from the gas producer and air flue from the chimney stack. Source: Samuel S. Wyer, *The Smithsonian Institution's Study of Natural Resources applied to Pennsylvania's Resources* 1923, p. 89.

Two gas producers were located south of the Furnace 1 ventilation system (see Figure 8-3). The producers were fueled by coal to gasify carbon and provide producer gas for Furnace 1 and possibly for Furnace 2. Structurally, the gas producers are iron tanks lined with refractory bricks (refractories) that were connected to the ventilation system of the tank furnace. The refractories formed a circular row to line the tank and were cemented with mortar. One historic model shows an opening in the side of the gas producer where coal could be loaded into the tank (see Figure 5-8).

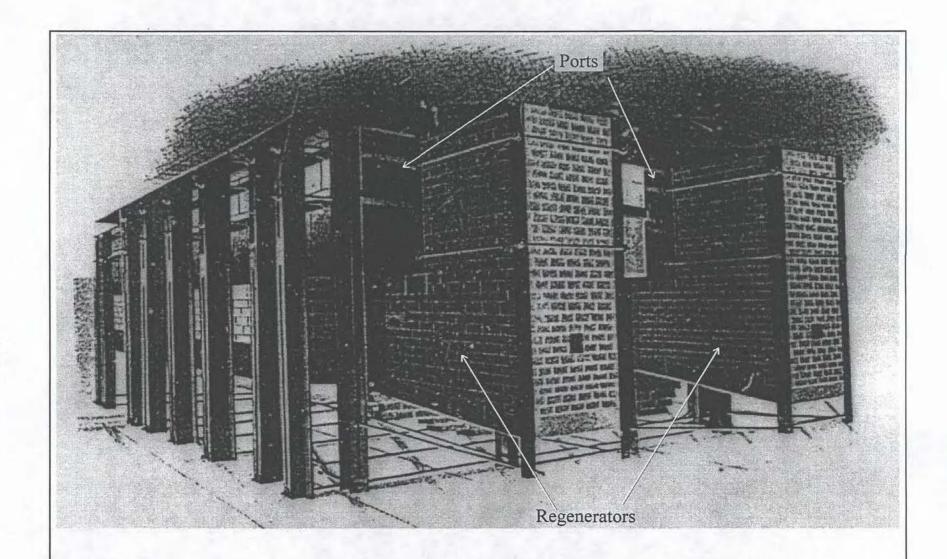
Figure 5-9. End-Port Furnace (where fuel and air entered from the end and flame played lengthwise over the batch), with Regenerator Chambers below Ports. Source: H.L. Dixon, Everything for the Glass House, 1908.

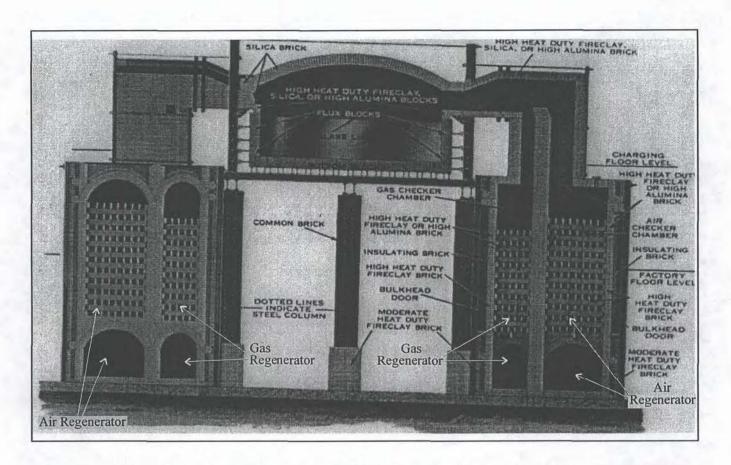
Figure 5-10. Drawing of Glass Furnace Illustrating Different Brick Types Used in Regenerators and Tank Area. This drawing also illustrates the configuration of air and gas regenerators in relationship to the furnace on a side-port furnace in which flames entered the furnace from the side walls. Source: Harbison-Walker Refractory Company, *Modern Refractory Practice*, 1937, p.128.

All indirect-fired melting tanks preheated producer gas and air for combustion as measures of economy. Air and gas combust at the port, shooting flames across the tank above the glass bath (Figure 5-10). Waste gas exhausts from a tank furnace at approximately 2700 degrees Fahrenheit, carrying into the atmosphere potentially usable heat. Tank furnaces utilized one of two different methods of recapturing that heat: regeneration or recuperation. In regeneration, exiting exhaust gases preheated stacked brick regenerators located on the sides of the tank. Intake of fuel and air was alternated from one side of the tank to the other, preheating gas and air as they passed through the regenerators. Recuperation involved the simple transfer of heat between the exhaust flue and incoming air flue, preheating air to approximately 1100-1400

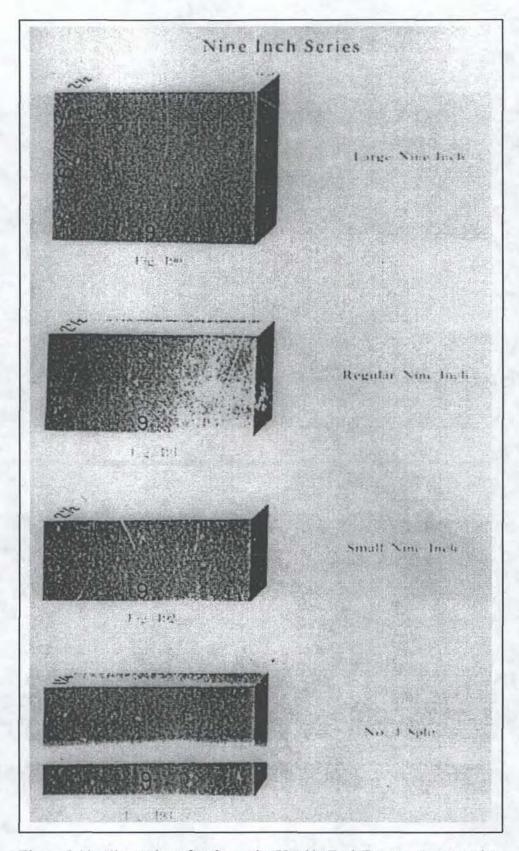
Figure 5-11. Illustration of Refractories Used in Tank Furnace Construction. Source: H.L. Dixon, Everything for the Glass House, 1908.

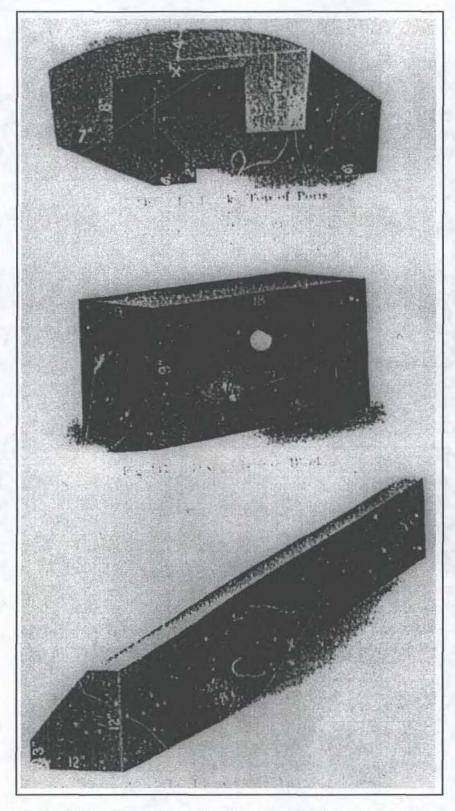
Figure 5-12. Illustration of Refractories Used in Tank Furnace Construction. Source: H.L. Dixon, Everything for the Glass House, 1908.

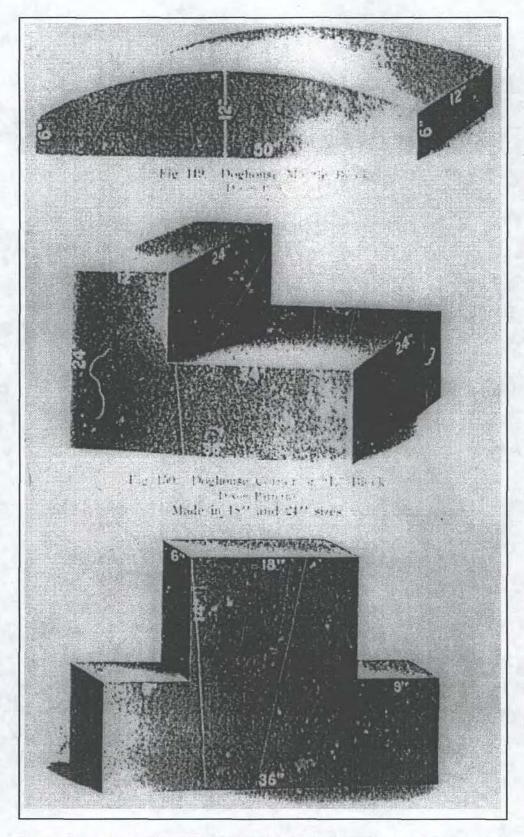
Figure 5-13. Illustration of Refractories Used in Tank Furnace Construction. Source: H.L. Dixon, Everything for the Glass House, 1908.

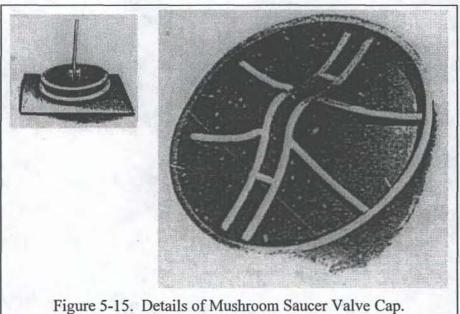
Figure 5-15. Details of Mushroom Saucer Valve Cap. Source: H.L. Dixon, Everything for the Glass House, 1908.

Producer gas was conveyed to furnaces through fire-clay brick tunnels like those uncovered at the Virginia Glass Company site. Fire-clay bricks and blocks are generally called "refractories" in the glass industry. Refractories for gas plants and conveyance tunnels were subject to highly corrosive and abrasive environments. Gas producers contained a constantly replenished and moving fuel charge that had a deteriorating effect on furnace walls, requiring refractory linings to be tough, dense and laid with tight-fitting joints bonded with an appropriate mortar. Hot blast mains and connections were lined with refractory brick backed by an insulating fire-clay brick to prevent radiant loss of heat and ensure gas temperatures high enough to deter formation of tar deposits in mains. Reversing valves redirected air and gas between alternate checker chambers in regenerative furnaces (Figures 5-14 and 5-15) (Harbison-Walker Refractory Company 1937:125-126; Dixon 1908).

The concrete water pipe intrusion had clearly cut through parts of the furnaces; as a result it exposed the profiles of the furnaces' southern walls. Trench 2 bisected Furnace 1 (Feature 5) where brick chambers and a discarded mushroom valve cap (see Section 6) were located. The valve cap was machine debris from the Seimens Reversing Valve that was essential to the operation of the tank furnace. In two of the three brick furnace chambers, a ferrous metal had fused to the bricks on the side and back walls of the chamber. It is possible that the chambers originally contained metal machinery, but no conclusive evidence is available to prove that the Seimens Reversing valve occupied this spot in the furnace. The section of the furnace encountered in Trench 2 had excellent architectural integrity, particularly in the floor area. This feature is described further in Section 8.

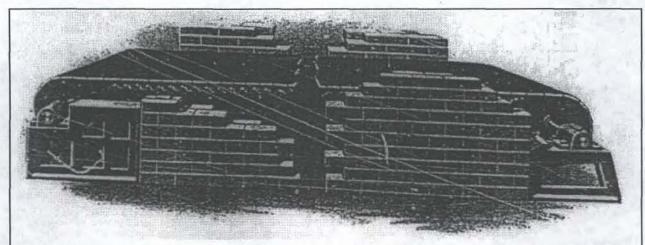
Figure 5-16. Cut-away Section of an Endless Conveyor Lehr. Source: H.L. Dixon, Everything for the Glass House, 1908.

After the bottles emerged from the glory hole, in which tops were fused to bodies, they were transported by carry-in boys, overhead conveyors or other belt mechanisms to annealing ovens or annealing lehrs in which jars and bottles were slowly cooled. Until the 1890s, annealing ovens had dominated the industry. Beginning in that decade, manufacturers rapidly adopted the gas-heated lehr, in which bottles and jars passed through a long, brick, heated chamber for a precise time period before they were removed. The Census claimed that "the new method lends itself more readily to scientific exactness in securing results and, being continuous in operation, makes it possible to handle the increased output of the factory in much less time

and at smaller cost" (Austin 1900). Lehr heat was approximately 1200 degrees Fahrenheit at the mouth, or beginning, and was maintained at a gradually decreasing temperature as bottles passed through various 'zones' before emerging fully annealed at the end. Bottles were placed on iron pans that were pulled through the lehr by a moving belt or endless chain, and were removed by packers who usually inspected the ware before packing it for shipping (Figure 5-16) (Austin 1900:972; Department of Commerce 1917:65-66). The presence of the lehr foundation at the Virginia Glass Company indicates that the bottles were treated to remove internal stresses imparted in the shaping process.

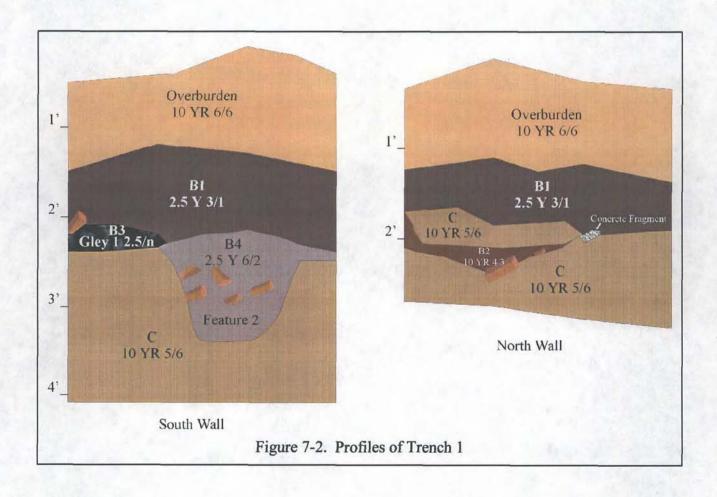
Two robbers' trenches were visible in the north wall profile of Trench 1. The term 'robbers' trench' is used to define an area where bricks or building materials have been removed to be used for another purpose. A robbers' trench can either be back-filled immediately or gradually becomes filled with soils or other fill materials. At the glass factory, the fire bricks in the lehr were a valuable reusable building material that were probably removed for reuse after the final factory fire in 1916. The brick remains of Lehr 1 were visible on the south wall of the trench. The transition between removal of bricks and intact structure would have been somewhere in the middle of the trench. The robbers' trenches and the associated brick feature were numbered Feature 2 (Figure 7-2). The robbers' trench identified in Trench 1 was back-filled with brick rubble and gray sand.

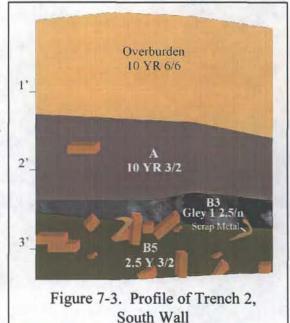
The eastern extent of Trench 2 exposed a section of Furnace 2. The architectural remains (Feature 6) were in poor condition and had collapsed in most areas. However, part of the brick flooring and two sections of wall were solid and intact. One wall constructed of gray fire-brick (Feature 16) was determined to be an interior factory wall. The red brick section was part of the western exterior wall of Furnace 2. The Trench 2 profile illustrates the variations of Stratum B that were noted throughout the trench (Figure 7-3).

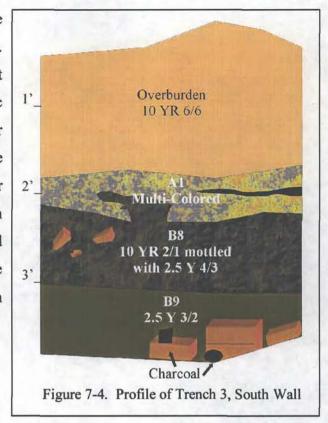
bone fragments and numerous oyster shells were recovered from the southern wall of this trench. Initially, the debris appeared to be a sheet midden of late-nineteenth century historic artifacts. However, Test Unit 3 (which was later excavated in this trench) indicated that the midden did not represent a discrete layer or deposit. Instead, the artifacts were mixed with various fill types from railroad, domestic and glass-factory activities. The Trench 3 soil profile illustrates the complex stratigraphy found in Trench 3 (Figure 7-4).

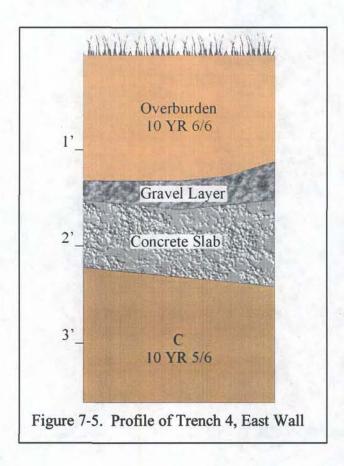
historic fill level was not present and no features or artifacts were recovered. The soil profile of Trench 4 depicts the east wall of the second 25 foot segment excavated (Figure 7-5). It provides an overview of the fill soils for Trench 4.

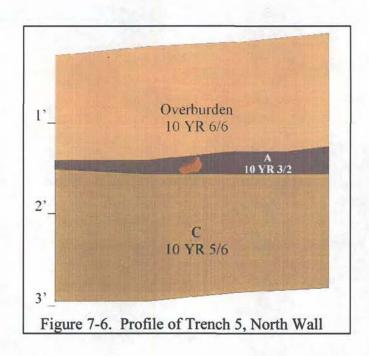
Trench 5 was a small 50-foot trench oriented southwest to southeast to intercept the eastern wall of the factory and to find the remains of the adjacent box factory. This section of the project area contained approximately 1.5 feet of modern fill that was loose silty sand with gravel (Figure 7-6). Modern trash, cinder blocks, buff colored Station Shops bricks and pockets of historic brick rubble were mixed with the Stratum A soils. The red brick rubble only occurred in the western ten feet of the trench. Although the glass factory was the source of the brick, the brick rubble was not considered significant because of the small amount of rubble and the disturbed context. No remains of the box factory were identified.

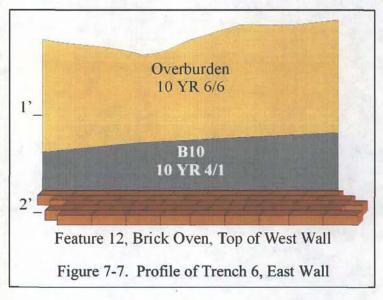
Trench 6 contained approximately 1.3 feet of overburden underlain by rubble fill (Stratum B), which was approximately 6 inches deep to the top of Feature 12 (Figure 7-7). The rubble fill layer in this trench was highly compacted clay with silt. Due to the vertical extent of the feature, subsoil was not reached in this trench. Excavators noted that this trench contained a higher quantity of amber-colored glass in Stratum B than was encountered elsewhere on the site.

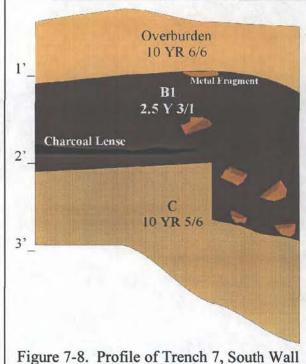
The overburden and Stratum A in Trench 7 were shallow deposits. The subsoil (Stratum C) appeared approximately 1.9 to 2.1 feet below the modern ground surface. The profile shows the lack of depth in the northern portion of the site (Figure 7-8).

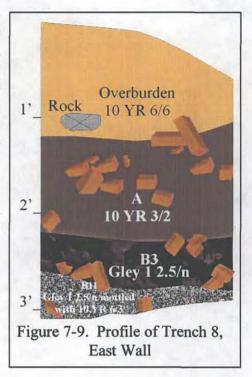
thoroughly in the Phase II/III investigation. Figure 7-9 shows the stratigraphy of Trench 8, which contained a thick burned level that was a dark, glossy black (due to the high charcoal content). In the small area of Trench 8 where a profile could be drawn, subsoil was reached at a depth of between two and three feet.

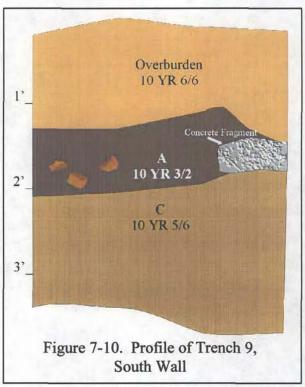
A discrete deposit of burned debris mixed with artifacts appeared in the northeast wall of Trench 9. The deposit was approximately ten feet northwest of the Trench 9 datum stake and was identified at the Stratum B level. It contained an unusual mix of ash, glass, and a high quantity of ceramic artifacts, as well as the gear workings of a clock or timer. The representative soil profile for Trench 9 depicts the south wall (Figure 7-10).

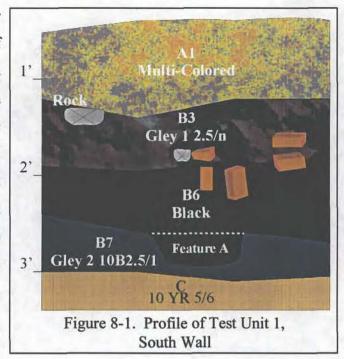
Stratum B-6 was a dense, black layer with a lot of coal, a few fragments of ceramic, and clear, aqua, dark green, and milk glass. A trench that had cut through this level was designated Feature A. The trench cut across the unit floor at this level and was also visible in the south wall of Test Unit 1 (Figure 8-1). Stratum B-7 was a transitional stratum, containing only three fragments of clear bottle glass. The soils consisted of yellow silty clay. Stratum C, appearing five inches below the water table, was the natural, sterile subsoil clay.

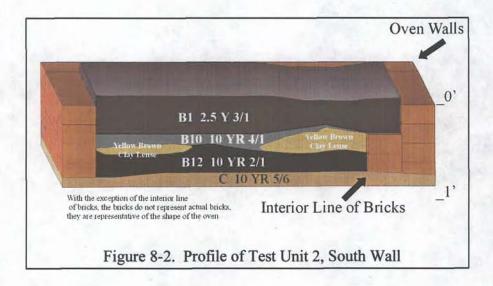
No overburden level was encountered in Test Unit 2 because it had been removed by the backhoe. Stratum B-1 was a historic fill of compact, silty clay that contained a glass button, nails, regular and firebricks, slag, bottle lip/necks and bases, miscellaneous bottle fragments and wood. Stratum B-10 was silty sand with ash; it contained fewer artifacts. Only one bottle lip, one lump glass waster, and a few broken bricks were present at this level. Another row of bricks was found lining the west wall, making the oven opening smaller. Stratum B-12 was also silty sand with ash; this level had higher moisture content than stratum B10. There was a higher quantity of glass, including small glass tubes and filaments, one bottleneck, and a finished embossed amber bottle fragment in this level. Nails, bricks, and ceramics were also recovered. Stratum C was subsoil, which appeared to be directly beneath the oven feature, with no flooring of any type present (Figure 8-2).

Test Unit 2 was placed in the center of the small oven (Feature 12). Prior to initiating test unit excavation, a backhoe was used to clear off the entire feature down to the top level of the brick square. The entire oven opening measured 3.2 feet by 3.2 feet; the test unit bisected this area and measured 3.2 feet by 1.6 feet.

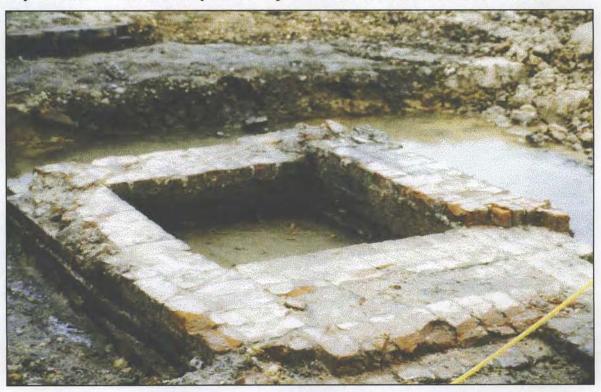
Figure 8-4. The Small Oven, view to the northeast

At the Virginia Glass Company site, one small oven is illustrated on both the 1907 and the 1912 Sanborn maps. The oven, which was uncovered during Phase I investigations, is located west of Lehr 1 and abuts the exterior western wall of the factory (see Figure 8-3). Excavations revealed the base of this brick oven, which was set into dense clay subsoil. Only 13 vertical courses of bricks remained intact (Figure 8-4). It was apparent that any functional aspects of the oven (such as openings, shelves or associated hardware) had been removed during the demolition of the factory. The two combustion chambers of the oven had been back-filled with mixed dense clay fill containing fragmented artifacts associated with the glass factory. The composition of the fill is described in the discussion of Test Unit 2 (see Section 8.1.2).

It was noted during test unit excavation that the oven was constructed of common brick, rather than refractory brick, and it was too small to produce the heat required to melt glass. This immediately narrowed down the possible functions of the small oven. Although the oven seemed to match the description of the type used for preparing melting pots, this oven is located next to Lehr 1 rather than near the melting furnaces. The oven may have served dual purposes, heating the clay melting pots and providing the heat necessary for the intermittent fire polishing of flawed or poorly molded bottles. Bottles would have been fire polished near the lehrs after the

bottles were already formed. The small oven, less than ten feet from Lehr 1, would have been readily accessible. The oven may also have provided the heat for the lehrs themselves.

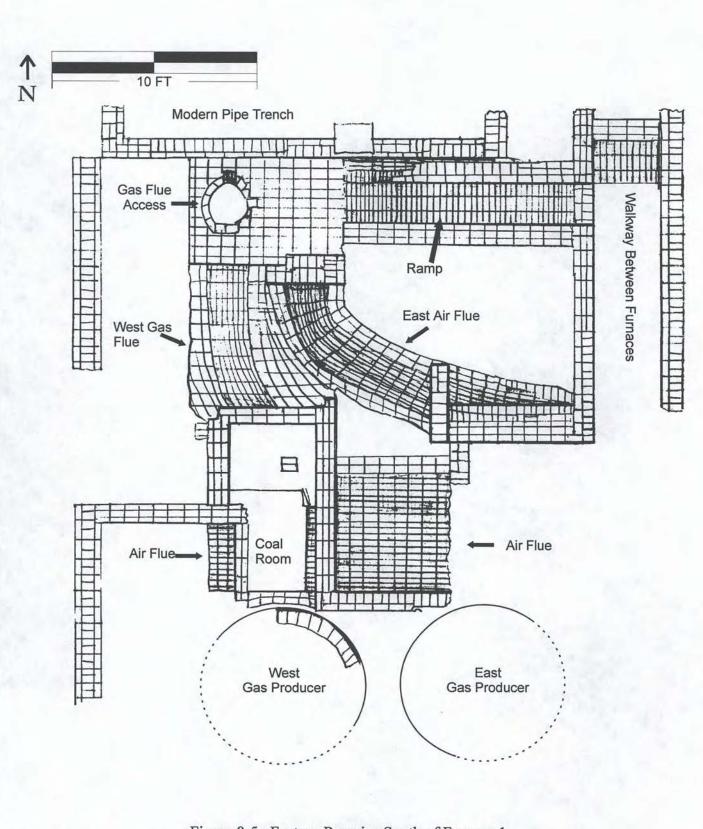
Figure 8-5. Factory Remains South of Furnace 1, Showing Ventilation System, Ramp, Walkway Between Furnaces, and Gas Producer Remains

The northern end of two air flues abutted the south wall of Furnace 1. However, the actual juncture between the flues and the furnace could not be seen. From the surface level, it appeared that the western gas producer was the fuel source for Furnace 1. The ventilation system for Furnace 2 was more deeply buried and the flues were oriented east-to-west. For this reason it is difficult to define the juncture of the ventilation flues with the south wall of the Furnace 2.

The coal room was a rectangular brick room or compartment that was situated between the ventilation flues of Furnace 1 and the western gas producer (see Figure 8-5). The brick room measured approximately nine feet by three feet. The flooring and walls consisted entirely of common brick. On the southern wall of the room was a curved brick wall consisting of a single width of brick that wrapped around the western gas producer. Large chunks of uniformly cut coal were scattered throughout the room and coal dust had blackened the walls and floor. The base of this feature was not reached along the exterior walls, but seven courses were exposed.

As was expected based on documentary resources, the air flues were constructed of refractories. The plan view of the ventilation system (see Figure 8-5) shows the input flue measuring four feet wide, a foot wider than the out take flue. These two flues had been capped evenly by dense red clay (Stratum B13). The red clay created a level ground surface over the vaulting brick.

The machine ramp structure was 12 feet long and 6 feet wide. It was constructed of common bricks that were graded to slope eastward to the walkway between the furnaces. Two elevated tracks for wheels had been constructed out of brick. The ramp floor was constructed of bricks laid on their sides, and the elevated tracks were constructed of three rows of bricks on each side (see Figure 8-5).

In the exposed section of the furnace there were remains of the vaulted input and outake flues that provided the gas and ventilation for the tank furnace (see Section 8.3.3). These flues were brick arches made up of two courses of common bricks laid on their long sides (see Figure 8-5). The source of the intake flue was the gas producers, south of the furnace. The outake flue probably terminated at the chimney.

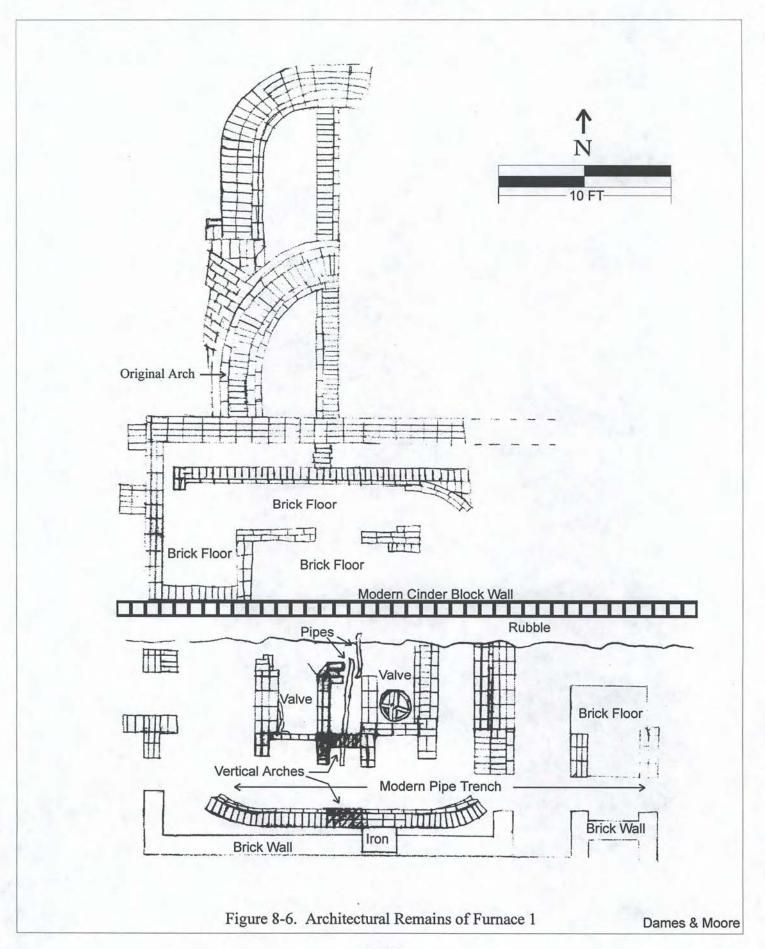
The only remnants of the early pot furnace industry at the Virginia Glass Company site are the foundations of the original pot arches (Figure 8-6). These are labeled the 'furnace working ends' in Plan View A (see Figure 8-3). The term "arch" in this discussion refers to the arch-shaped brick foundations of the furnace, not arched openings where glass workers would have inserted pontils into the melting pots. The functional arched openings were demolished when the factory was razed.

The pot arches are composed entirely of brick bound with decomposed mortar at the upper levels (the first one or two courses), but intact mortar at the lower levels. Furnace 1 has an expanded northernmost secondary arch, which was probably added after the first factory fire (Commoner and Glass Worker 1899). The evidence of this addition is a patchwork of bricks at the juncture of the two arches. The length of the original pot arch was 10.5 feet and the second arch was approximately 10.6 feet. Estimating from the intact side of the pot arch, the arch width for both arches would have been approximately 15 feet.

Like the small oven, the bottom course of the pot arch foundations had been set into thick clay subsoil. A straight wall of bricks, oriented in a line perpendicular with the western wall of the factory, separated refractory chambers within the pot arches. If it were possible to reconstruct the pot arches of the furnace, one would see that melting pots were placed within these chambers during the time this furnace was used for traditional bottle making. When the factory was razed, the chambers had been filled with historic fill, clay and brick rubble.

The activities associated with forming the glass bottles would have occurred at the working end of the melting furnaces. The pot arches would also have been situated at this end of the furnace (see Figure 8-6). This area of the factory would have contained workstations for marvering and molding, and possibly glass workers' chairs where the senior glass workers sat to finish bottles. The brick square remains of one possible workstation, Feature 18, were exposed at the Virginia Glass Company site. The feature was situated northeast of Furnace 2, measured 4.5 feet by 4.6 feet, and consisted of a single row of bricks. Because it had only one course of bricks, it appears to be the base of the feature imbedded in the subsoil that would not have supported much weight. The placement of Feature 18 near the working end of the pot furnace suggests that it may have contained a table or workstation for the glassblowers. It is possible that the square of bricks could have been the foundation of an oven with a glory hole (See Figure 5-8). However, following this premise, one would have expected to find a sturdy foundation and ash or burnt fill similar the deposits found in the small oven. These indicators were not present in Feature 18.

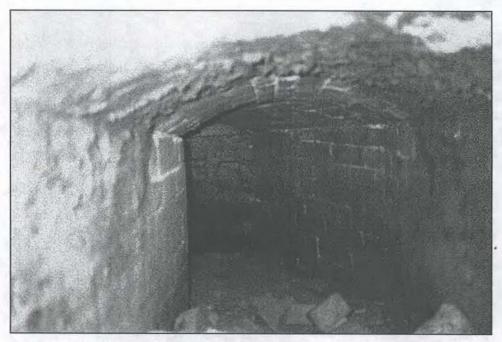
Figure 8-8. Photograph of Ventilation Interior, Showing Internal Flues, Photo Taken from Gas Flue Access, View to the South

indicates the continuation of the large input and out take flues to deeper levels of the ventilation system (Figure 8-8). These intact buried architectural remains were not accessible during the Phase II/III investigation.

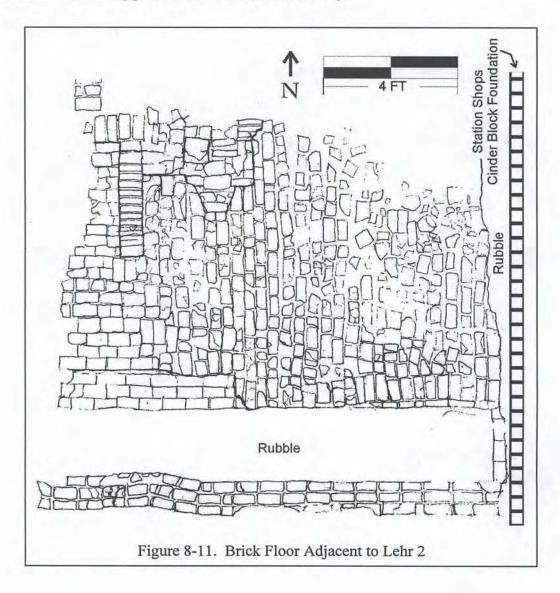
length of Lehr 2 as illustrated on the 1907 Sanborn map. A brick floor was uncovered south of Lehr 2. Labeled Feature 22, it is the only flooring found in the part of the site that is north of the furnaces (Figure 8-11). Bricks were laid as stretchers, and the bricks formed at least two courses. In the eastern section of the floor, the top courses had been pulled away. The entire floor area measured approximately nine feet by fourteen feet. Other sections of the factory may have had similar flooring prior to demolition of the factory.

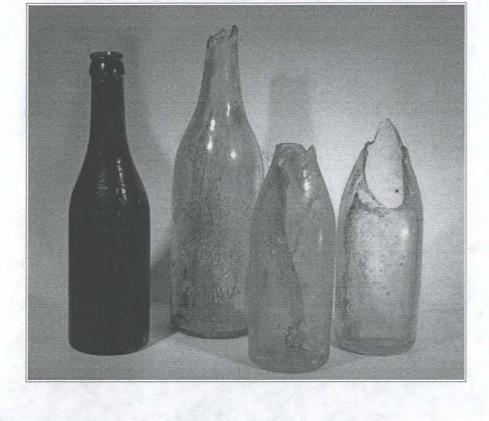
Figure 9-5. Robert Portner Tivoli Beer Bottles

From left to right: Type 11 (Cat. 122), Type 12 (Cat. 123), Type 14 (Cat. 126 and 127)

Beverage Bottles. Three types of Tivoli Portner beer bottles were recovered from factory excavations (Types 11, 12, and 14). Type 11 was machine-made and therefore was not produced by the Virginia Glass Company. The Type 12 Portner bottle was clear with a green tint. The bottle was missing its lip, but included ten inches of the body before the break. The base was circular and three inches in diameter. The Portner Tivoli trade mark was located on the center front of the Type 12 bottle body. The two Type 14 Portner bottles were both missing their lips. These clear bottles included sloped-down shoulders, a cylindrical body that measured between 6.5 inches to 7.5 inches in height to the break, and a 2.5-inch diameter circular base. The Portner Tivoli trade mark was situated on the shoulder of Type 14 bottles. Both the Type 12 and Type 14 Portner bottles appear to have been made in a two-part vertical mold with a separate base. Figure 9-5 includes a photograph of the four Portner bottles, and a drawing of the Type 12 bottle.

diamond "TIVOLI" logo. On the Virginia Glass Company Portner bottles, the lettering curves in an oval shape around the diamond "TIVOLI" (Figure 9-5).

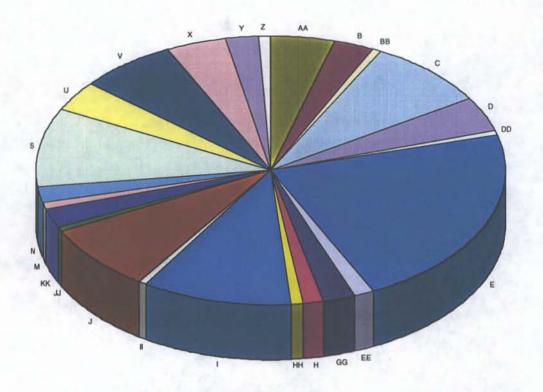
Because the lip/neck typology list was created in order to organize a large number of lip/necks (301 fragments) for analysis, no attempt was initially made to eliminate fragments that were not made at the factory. During analysis, however, it was concluded that fully-automatic, machine-made bottles were not produced at the factory. Therefore, lip/neck types with seams that ran the length of the neck and over the lip (evidence of machine manufacture) were separately characterized as bottles deposited after factory operation ceased. These artifacts are discussed in Section 9.8 and include Types A, F, K, L, O, P, Q, R, T, W, CC, FF, and GG. Several lip/neck types were produced at the factory. Figure 9-8 presents the percentage of each of the factory lip/neck types.

Lip/Neck Type	Count	Percentage	Description
AA	10	4.50%	patent lip, cylindrical neck
В	6	2.70%	prescription lip, scooped shoulders
BB	1	0.45%	down-tooled lip, 2 bead string rims, cylindrical neck
С	19	8.56%	crown finish
D	9	4.05%	bead rounded lip, flattened stirng rim, scooped shoulders
DD	1	0.45%	flanged lip
E	49	22.07%	prescription lip w/req. Bore, cylindriacal neck, ball neck treatment
EE	3	1.35%	down-tooled lip, bead string rim
GG	5	2.25%	bead rounded lip, cylindrical neck
Н	3	1.35%	bead rounded lip, cylindrical neck, ball neck treatment
HH	2	0.90%	up flattened side lip, cylindrical neck
1	23	10.36%	flattened side or town-tooled lip
II	1	0.45%	stopper bore, flattened site lip, cylindrical neck
J	18	8.11%	Perry Davis finish
IJ	1	0.45%	straight lip, cylindrical neck
KK	5	2.25%	burst-off lip, cylindrical neck
M	2	0.90%	short flanged lip, cylindrical neck
N	4	1.80%	flanged lip, cylindrical base
S	21	9.46%	prescription lip w/req. Bore, cylindriacal neck

U	8	3.60%	short flanged lip, tapered neck
V	15	6.76%	internal gasket bore, rounded lip, tapered neck
X	9	4.05%	bead rounded lip, cylindrical neck
Υ	5	2.25%	short flanged lip, slightly bulged string rim, cylindrical neck
Z	2	0.90%	bead rounded lip, v-tooled string rim, cylindrical neck
Grand Total	222	100.00%

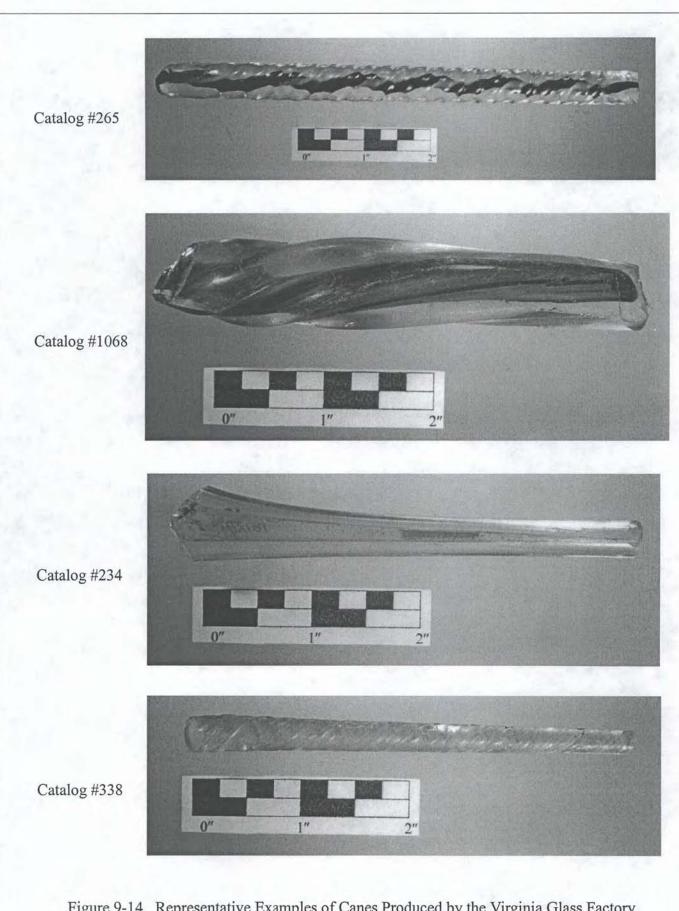
Figure 9-14. Representative Examples of Canes Produced by the Virginia Glass Factory

Glass canes and rods were solid, linear glass fragments used in decorations. Often multiple canes of glass were encased in clear glass, or twisted together. Canes were most often used for stemware (like wine glasses), but also could be used to make marbles or to decorate the tops of wooden canes. Two canes with opaque twists encased in clear glass were found. Although white was the most common color of opaque twists (Jones and Sullivan 1985: 50), the canes found also included red and black. Other canes of glass recovered were simply twisted or incised with lines resembling a twisted pattern. Figure 9-14 illustrates representative canes found during the glass factory excavation.

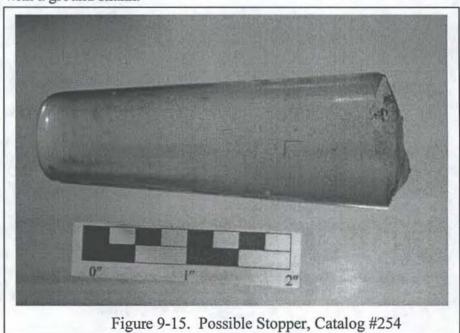
The four glass artifacts catalogued as stoppers from the site were roughly cylindrical, but tapered at one end (Figure 9-15). These items were distinguished from glob-like glass wasters because they were straight, basically symmetrical, and had smooth sides. No stoppers recovered from the excavation included a finial, although a finial may have broken off of the top.

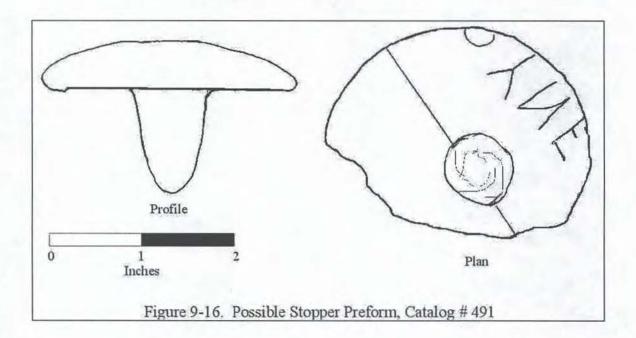
Another common type of artifact recovered from the glass factory site was a possible bottle or stopper preform. Nine artifacts were collected that were cataloged as glass stopper preforms. Each preform consisted of a roughly circular glob of glass with a flat bottom and rounded top; a stopper-shaped, tapered glass glob extended from the flat side. It appears that the bottom projection was formed when glass was poured over something with a roughly 1.5-inch opening. Trail marks on the rounded top of the artifact reveal that glass was added to this side, and that this surface did not touch a mold or other form. The flat side of the circular part often included a seam mark; one artifact also included words, although these words were backwards and did not appear to be intentional (Figure 9-16). These artifacts resembled large 'club sauce'-type stoppers that likewise had a circular, flat or rounded top with a tapered shank. Perhaps these 'preforms' could have been further manipulated or cut to create more even circular tops like the club sauce stoppers. Despite the name, club sauce stoppers were used on a variety of commercial containers (Jones and Sullivan 1985:152). Although the exact function of the artifacts from the glass factory site is not known, they have been cataloged as stopper preforms.

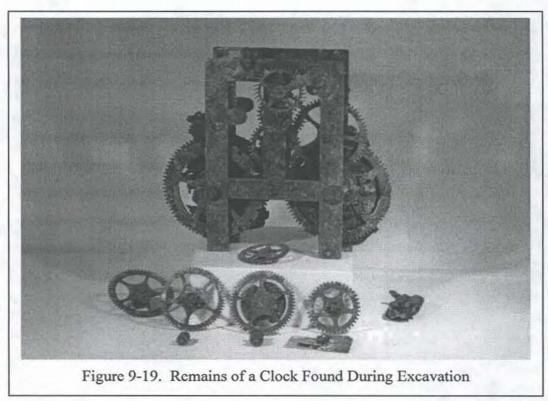
The remains of a chime clock were recovered from factory excavations. The clock had two wind-up springs and one escapement gear. The gears were brass and the shafts and wind-up springs appeared to be steel (Figure 9-19). Clocks were an important part of wage labor operations following the industrial revolution in the nineteenth century. Prior to this time, skilled craftsmen worked to finish entire products; they had to finish a certain number of products in a week, rather than working a certain number of hours each week. Once people started to be paid for their labor time rather than products, managers felt it necessary to keep track of this time, and often installed clocks in the workplace. The presence of a clock at the factory suggests that,

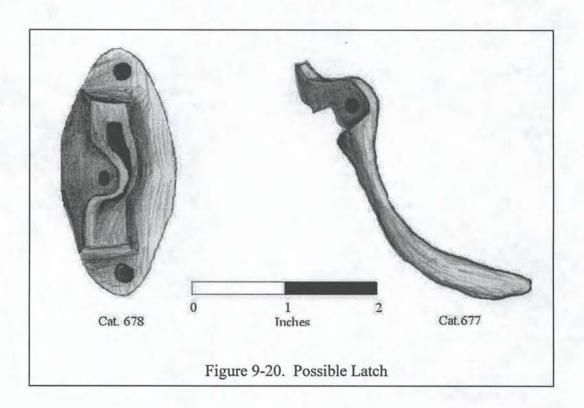
Cables, pipes, metal beams, wire, bolts, brackets, hinges, and other metal fragments may also have been part of the glass making process. One interesting metal artifact that may have been part of the glass factory was a brass device that appeared to have been a latch (Figure 9-20). Pieces of a flat red ceramic tile with a textured, white, painted surface may have been insulation material. Clumps of grog, asbestos, and unidentifiable materials may also have been used for insulation.
