CEMETERY PRESERVATION PLAN

Douglass Memorial Cemetery

44AX140 1421 Wilkes, Alexandria, VA 22314

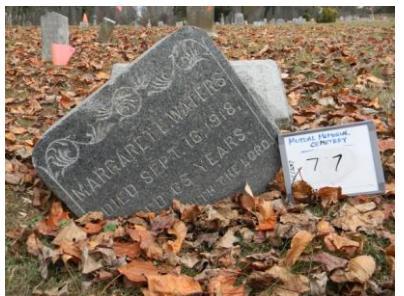
Figure 3: Example of medium condition scoring: fallen, needs to be reset, minimal other soiling or damage.

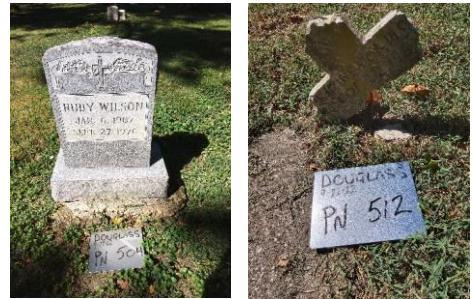
Figure 6: Examples of a high priority monument

• #1, Highest priority: 32 monuments fall into this category. This includes leaning, rocking, or cracking stones that may fall or suffer accidents leading to more damage, or may represent public safety hazards. This work usually requires foundation repairs, reconstruction with pins and mortar, resetting on new pins, or simple straightening.

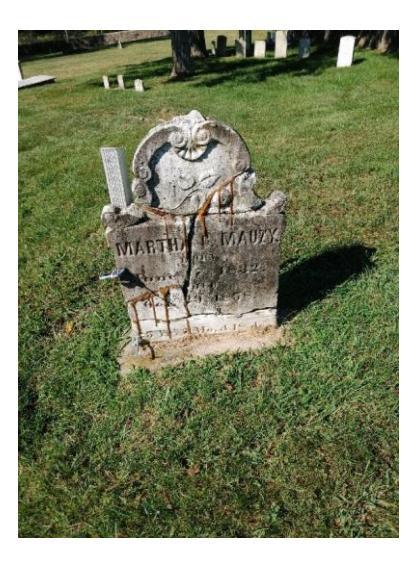
Don't let your gravestones look like this!

Repair, maintenance, or cleaning of gravestones by families or the general public without supervision by a professional conservator should be discouraged. Over-cleaning can destroy fragile surfaces, and inappropriate repair materials (epoxies, caulks, body fillers) can do irreparable damage. Maintenance and repairs should be done in consultation with professional stone conservators.

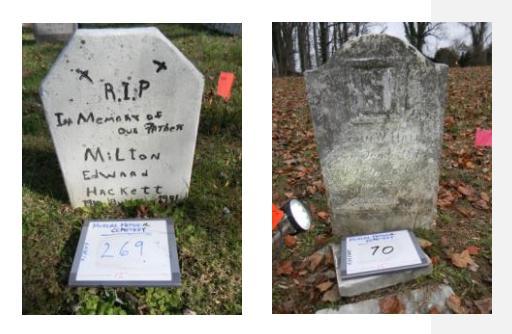
Tablet: A tall, thin gravestone, set either directly into the earth ("earth-fast"), or set into a slotted stone base.

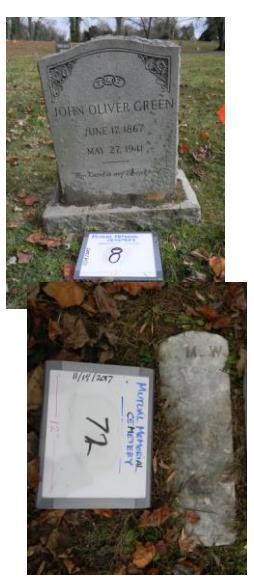
Footstone: Sometimes a miniature version of the related headstone or just a miniature tablet, located at the foot of the burial. Often inscribed with the initials of the deceased.

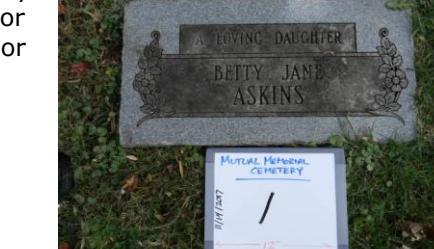
Lawn marker: A rectangular block set directly in the ground with the inscribed surface at or just above grade. It may be installed with or without a foundation.
