Engineering
Science
Report
Neighborhoods
① Four Mile Run
② Potomac Watersfront
③ Potomac Central
④ Slaters Lane
⑤ Braddock

ABSTRACT

The purpose of this study was to inventory the cultural resources present, or potentially present, within the area of the Yard and to identify those resources that possess historical or archaeological significance. Where necessary, recommendations are made for further study and evaluation.

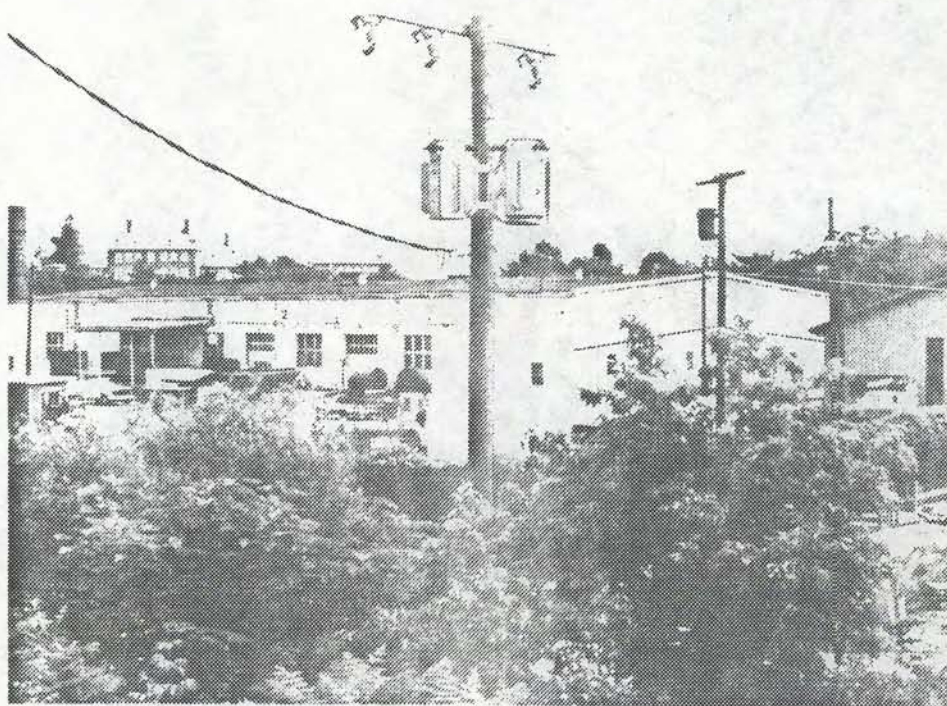
Number 2 (in the Park Service Compound)

This structure may be less than 50 years old.

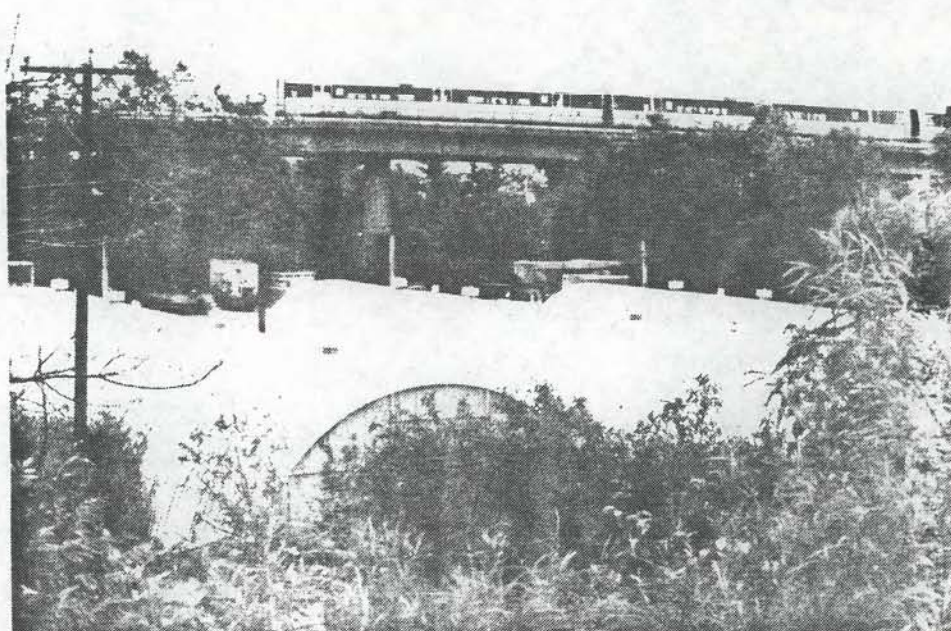
Number 3 (in the Park Service Compound)

The axes of these three adjoining large corrugated metal, arched, unfenestrated Quonset huts run east/west.

This structure may be less than 50 years old.

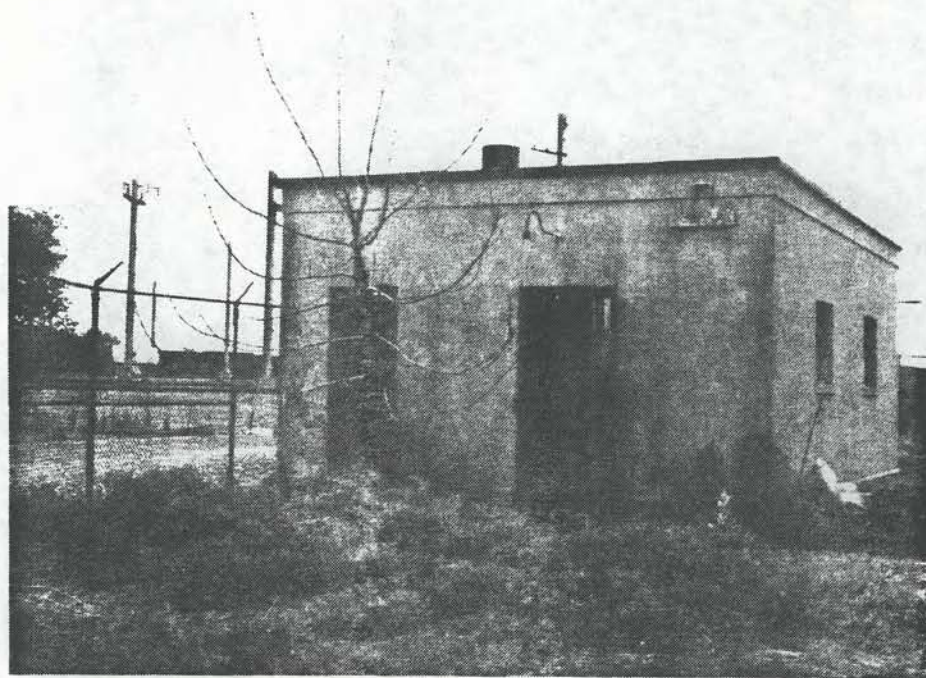
Number 8 (Substation)

This early aggregate concrete building, measuring roughly 30 feet by 20 feet, was probably cast in place. Above the slightly projecting aggregate concrete plinth, the wall is finished with a stucco-like concrete facing. The flat roof, supported by l-beams, projects slightly above the flat concrete cornice. There are two metal doors with four fixed lights located on the north elevation. An identical door on the south has a short length of gutter above it. There are no openings on the east elevation, two six light wooden sash pivot windows on the west and one on the north. Low drains are cut through the foundation at ground level on all elevations. The building is in good condition.

In addition to its general significance as contributing to the functioning of the Yard, this structure is significant within the theme of Architecture and Building Practices as it represents an early use of cast-in-place concrete aggregate, perhaps using the pioneering techniques of John Early, whose plant may have been located in the area.

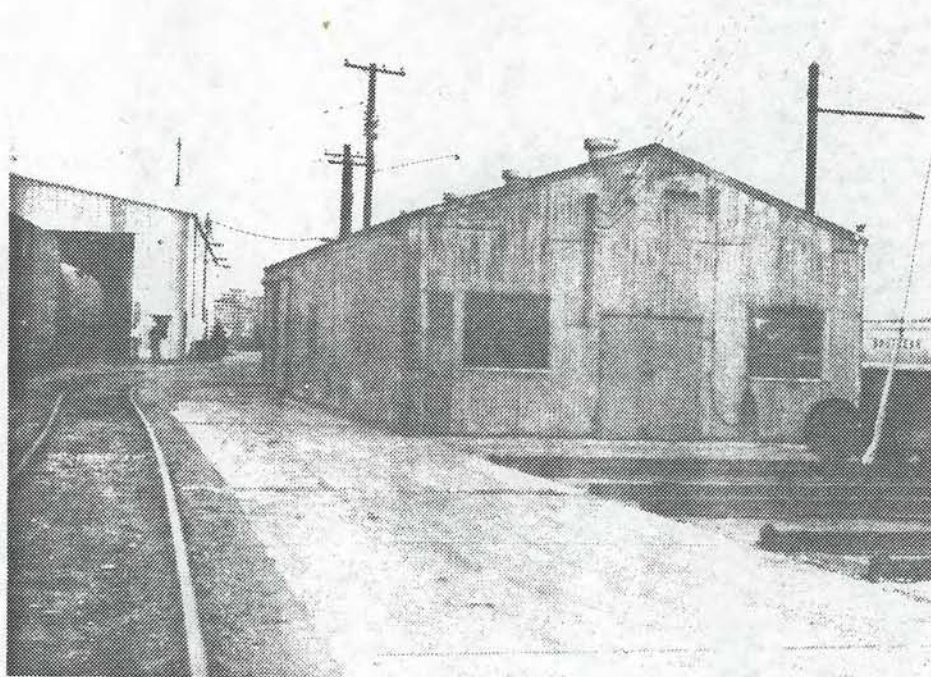
Number 12 (Oil Storage Building)

This 40 foot by 20 foot steel frame building, sheathed in metal panels, rests on a concrete slab and has an east-west metal panel gable roof. There are double solid metal freight doors on the east and west elevations and two 8-light steel sash shed windows on the south. A container trailer resting on a low foundation adjacent to the north wall provides additional space.

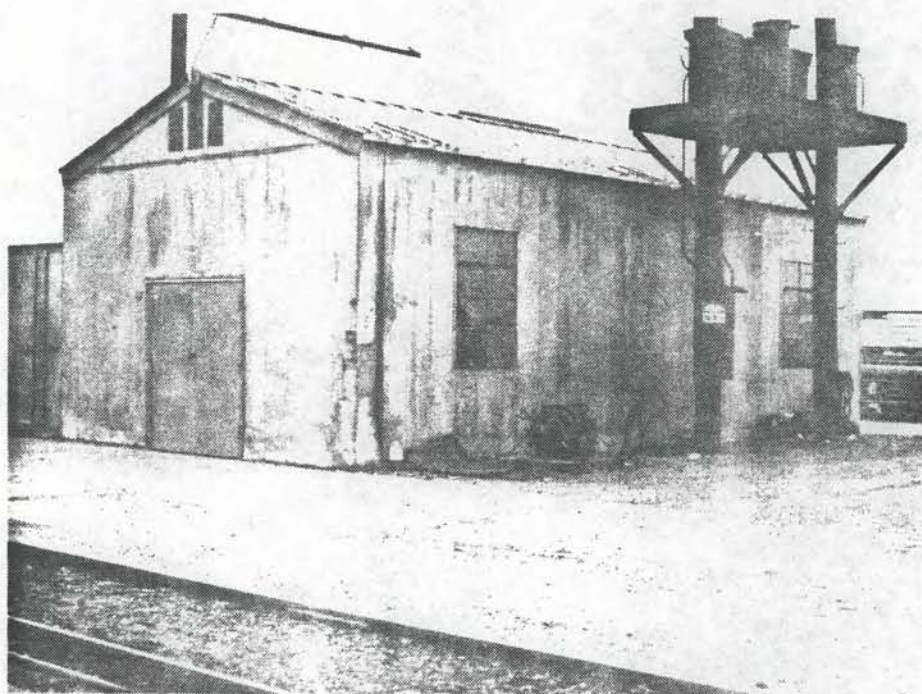
This structure may be less than 50 years old.

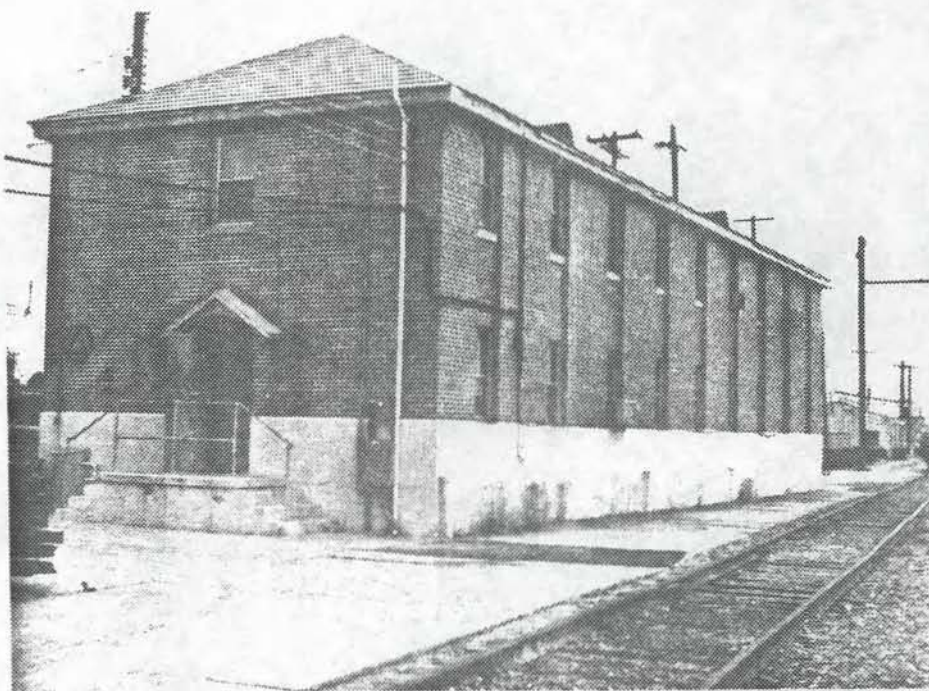
Number 13 (Administration Building)

Built during the 1940s as a car inspectors' building and remodelled in the 1950s for administrative use, this two-story brick structure on a raised concrete platform measures roughly 120 feet by 20 feet. The concrete foundation rises as a plinth to the sill of the first floor windows. There are two semicircular ventilation dormers on the east and west faces of the shallow hipped roof. The east and west elevations are divided into nine bays. On the east, each bay contains a single 6/6 double hung window, with a recessed panel between the first and second floor windows. The center three bays on the west elevation are filled with three doors with single light transoms. The west doors are approached by a concrete platform with four steps at its north and south ends. Solid metal doors with similar shorter platforms are located on the north and south elevations. There is a small pedimented wooden hood above the south door.

This structure may be less than 50 years old.

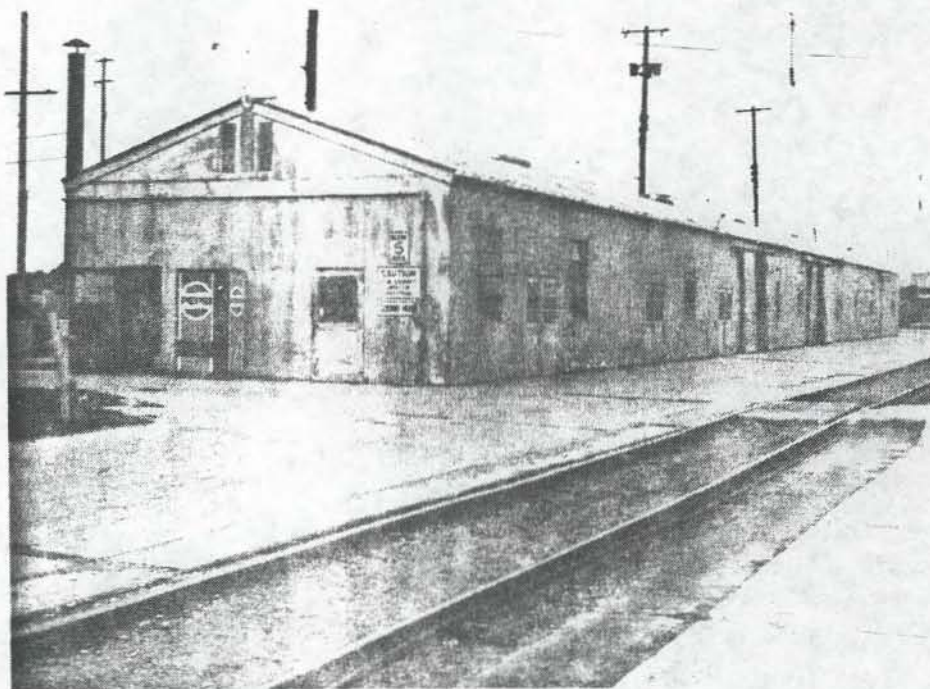
Number 14
(Blacksmith Shop/Storehouse/
Air Room)

This one story, steel panel, building, resting on a concrete slab, measures about 225 feet by 20 feet, and is divided into an air compressor room, a storage area, and a blacksmith shop, from north to south. The slightly gabled metal panel roof has many projecting ventilators. The large awning windows are of steel sash with eight lights and the metal doors also have three lights. There are sliding freight doors on the east and west. There are also three ventilators in the north and south gables.

This structure may be less than 50 years old.

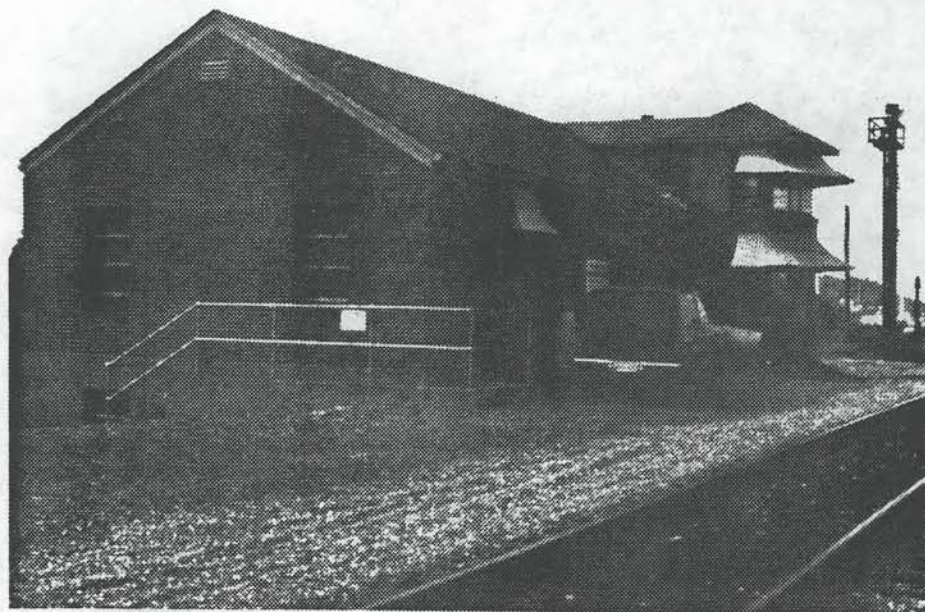
Number 15 (Yardmaster's Office)

Because this 60 foot by 25-foot brick building with slate roof is located on the edge of the northbound hump, its east elevation is one story, while those on the north, west, and south are two. The exposed first floor level is concrete. Fenestration consists of six light and nine light metal frame awning windows. Doors are solid metal. A two story tower, square in plan with a pyramidal roof, projects from the northeast corner. While the tower is also constructed of brick, the color of the brickwork seems to differ from that of the main block of the building. On the first floor of the tower fixed glass and 1/1 light double hung observation windows are located on the north, east and south sides. The second floor observation windows are 6/6 double hung sash and fixed glass. There is one paneled exterior door in the south elevation of the tower, with a boarded window above it. The windows in the tower and two of the three doors on the east elevation have flared metal louvered awnings.

This structure may be less than 50 years old.

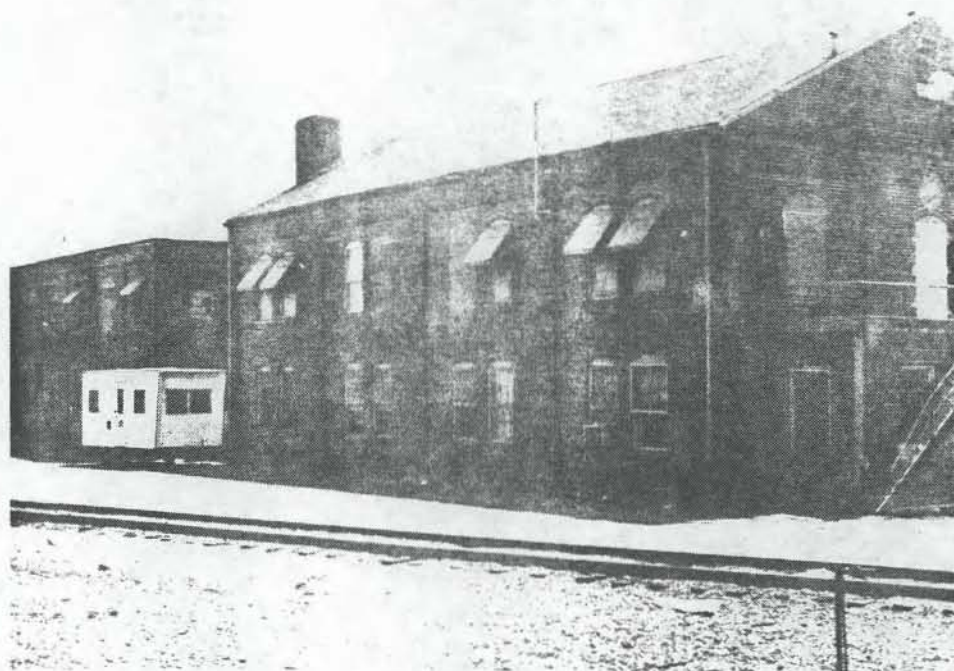
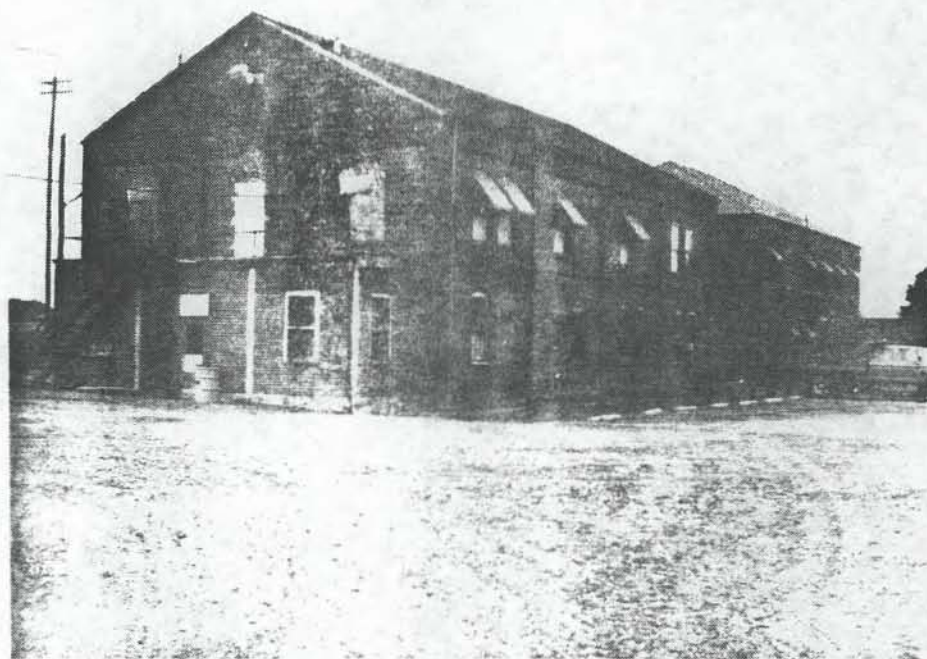
Number 21 (fragment of original Enginehouse)

This small rectangular brick building abuts the north wall of the new Enginehouse. Of brick construction on a concrete slab, the structure has a replacement shed roof sloping towards the east. The west elevation is divided into three bays. The central bay contains the entrance, which is a replacement metal door with a small fixed light. The flanking bays originally contained two tall windows, but have been partially infilled with brick and concrete block. The lower part of each window contains one six light metal framed awning window. The lintels of the door and the original windows are segmental arches of three rows of headers, the sills are probably cement. The west wall rises above the roof as a three-stepped parapet, with a single row of projecting bricks forming a rudimentary cornice. The north wall also rises above the roof to form a flat parapet, and extends about five feet forward from the front of the building toward the west (it was probably originally the end wall of the former machine shop). The four tall windows originally located on this wall, also with segmental arched lintels and cement sills, have been bricked in. Two original sections of the original Enginehouse form the south wall of this portion of the building. Each section is articulated into panels. The top of each panel is decorated with the single row of brick corbelling which seems to have characterized all of the more important Yard buildings dating from the first years of the twentieth century. The south side of the north wall, the surviving machine shop wall, is also so ornamented. A small one story concrete block addition has been added on the east with two, 4 light, metal framed awning windows. A large concrete block chimney is located in the addition against the north wall of the new Enginehouse.

The fragment of the original enginehouse is significant as being one of two structures that may date back to the original foundation of the Yard. The other structure is the bunkhouse.

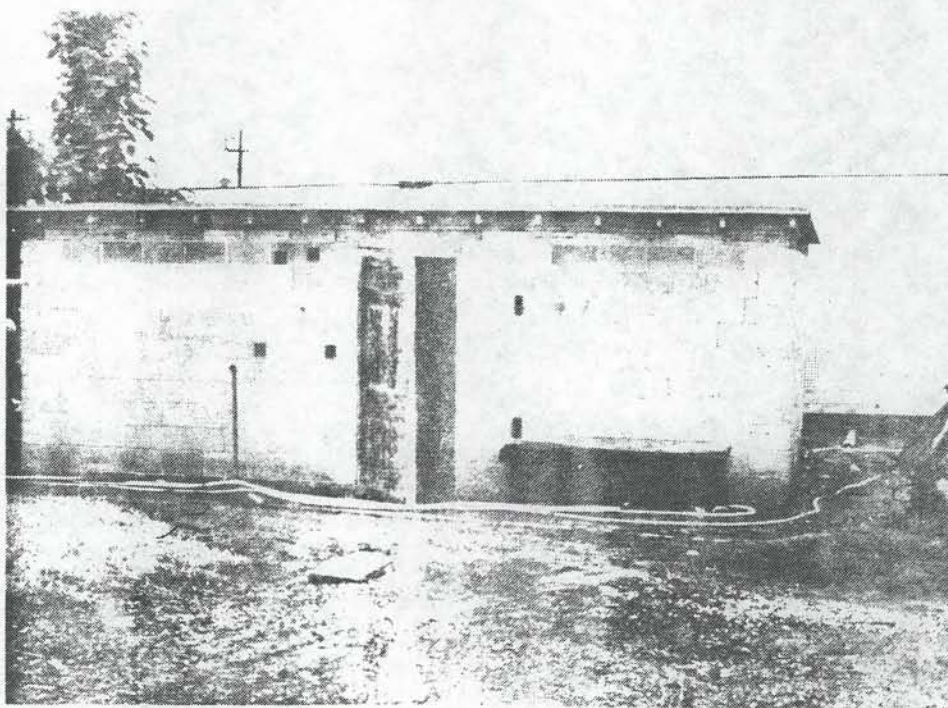
Number 32 (Substation)

This concrete block building has a wood framed shed roof sloping slightly to the north. A wood paneled door is located on the south elevation.

This structure may be less than 50 years old.

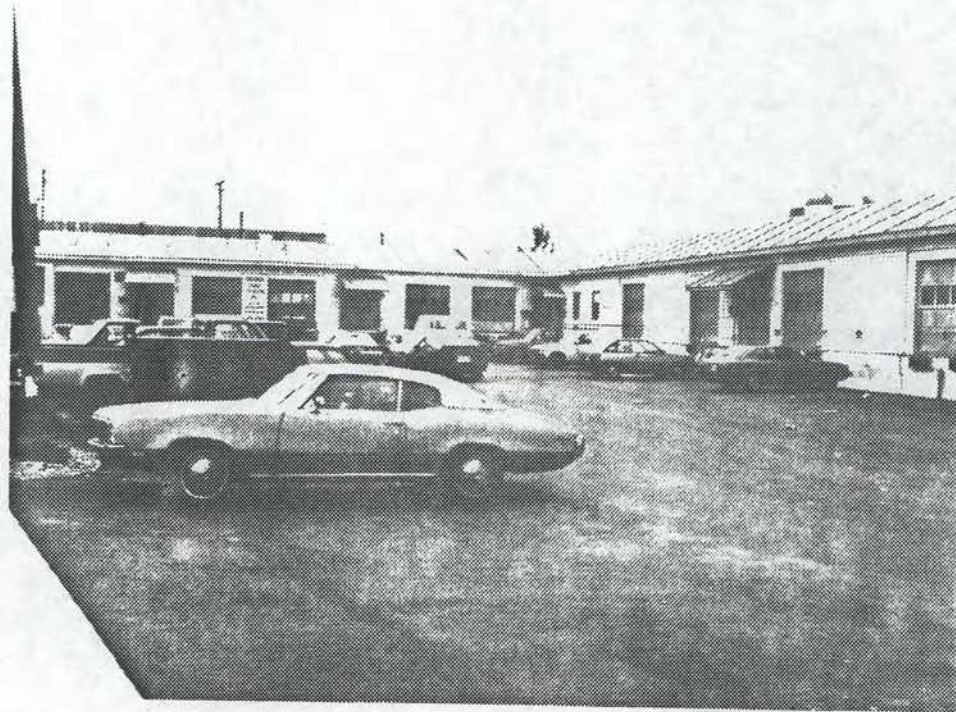
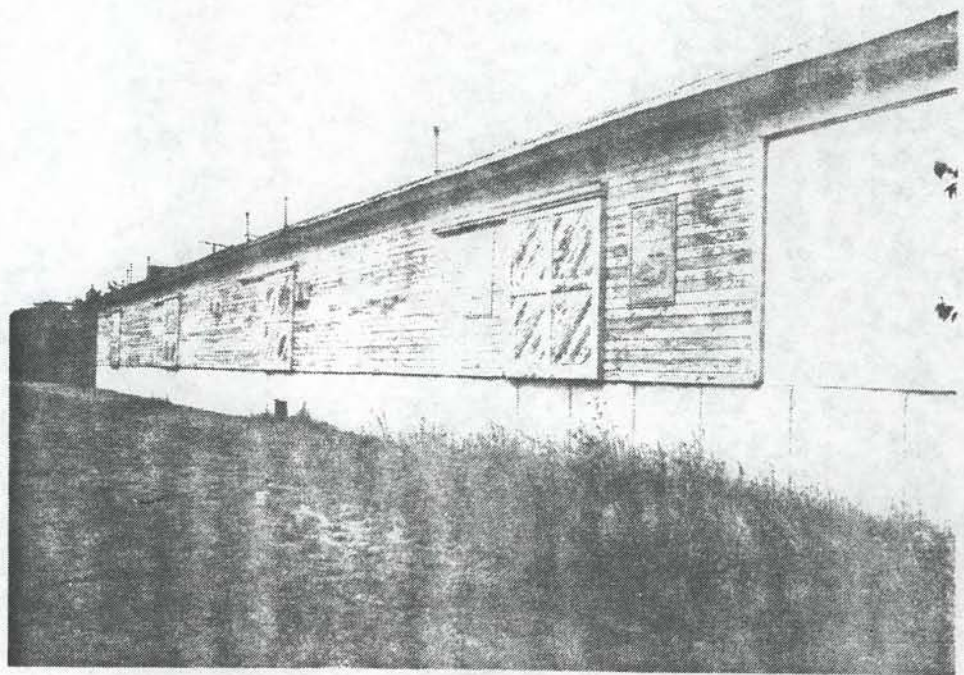
Number 40 (frame warehouse)

The original building is L-shaped. The north part of the north leg probably preserves the original appearance of the whole structure, with its wood siding above a four-foot foundation (now sheathed in sheet metal). The south part of the north leg is also currently covered in sheet metal, but with some wood framing (probably original) exposed at top. The slightly sloping gable roof is covered with sheet tar paper, patched in many places. The west elevation of the north leg has four large sliding wood freight doors (probably original), each with four panels of tongue-and-groove boarding laid diagonally. The south door is flanked by two small windows (boarded), one of which is covered when the door is open. The east elevation of the north wing has been modified by the addition of new pedestrian and freight doors, as has the north elevation of the east leg of the L. The south elevation of the building is now obscured by a recent flat roofed cinder block addition.

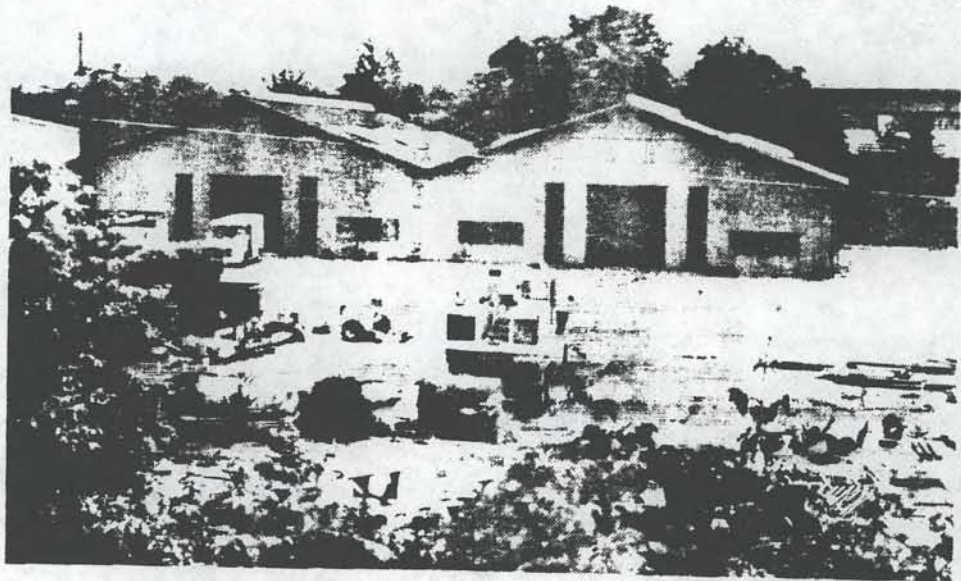
Number 5

This steel-paneled, one story, building, with a shed roof, is built on a concrete slab. There are metal paneled doors on the east and west elevations but no fenestration.

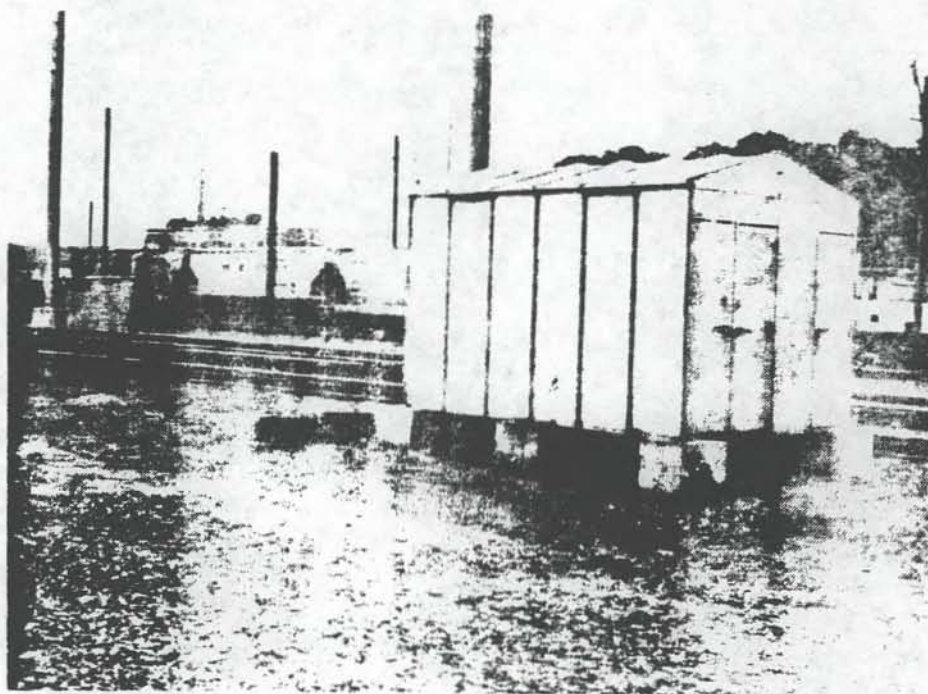
A one story, gable roofed, steel paneled building, this signal shed is set on six concrete blocks. There are no windows, but prefabricated metal locker doors are located on the north and south elevations.

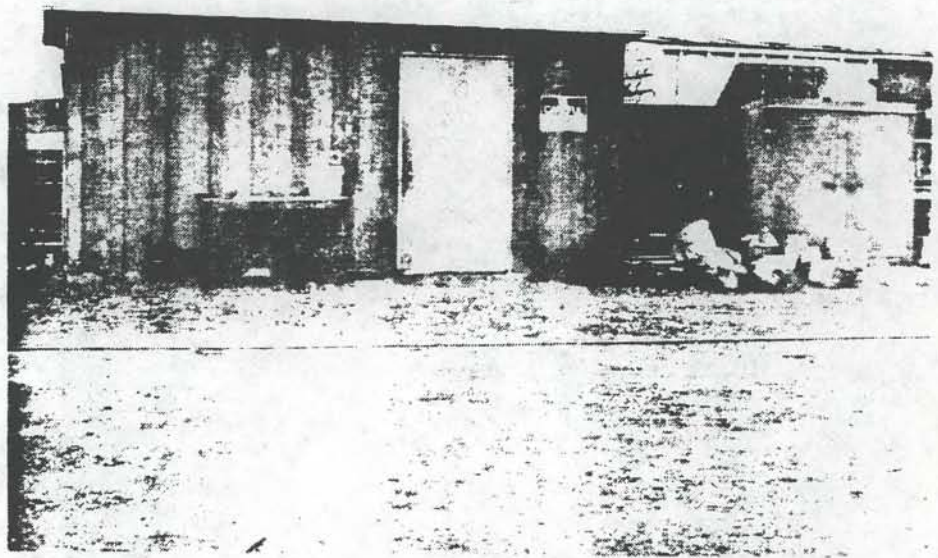
Number 7

This one story rectangular building of Butler metal siding measures roughly 10 feet by 20 feet. It is built on a concrete slab and its shed roof slopes slightly east to west. There is a metal door on the east elevation and a small window on the south.

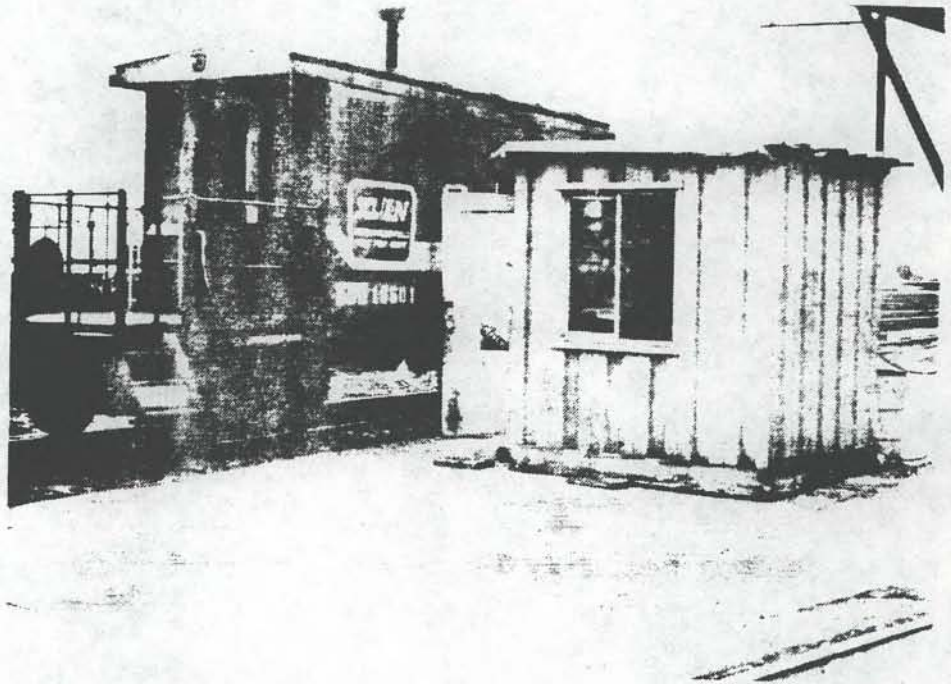
Number 9

This 6 foot by 6 foot one story storage shed, sheathed with Butler metal siding, rests on a raised concrete block. The flat roof is steel paneled. There are small fixed light sliding metal framed windows on the north elevation and a fixed light metal door on the east.

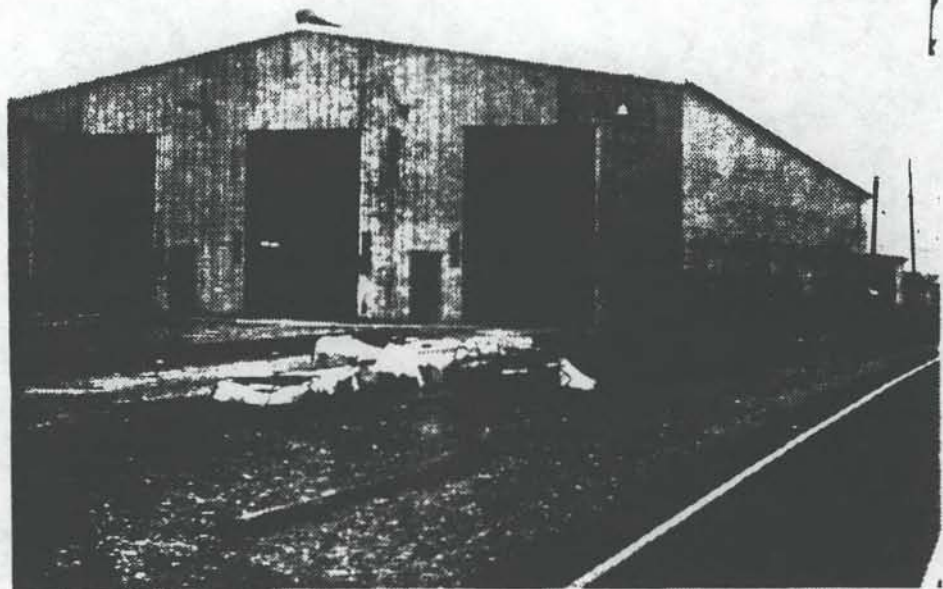
Number 10 (Spot Car Repair Shop)

This 185 foot by 84 foot building has a steel I-beam frame sheathed in Butler metal siding on a concrete slab. It was completed in 1967, replacing two earlier shops serving the east and west sides of the Yard. The building is approximately 20 feet high, with a fiberglass paneled roof, partially translucent. Six powered metal roll-up doors on the north and south elevations provide access to three through tracks set in the concrete slab floor. There are four metal pedestrian doors with 2 fixed lights flanking the roll-up doors on the north and south and a shorter roll-up door on the east. A single pedestrian door is located on the west elevation, opposite the roll-up door. A small one story Butler shed has been added on the west.

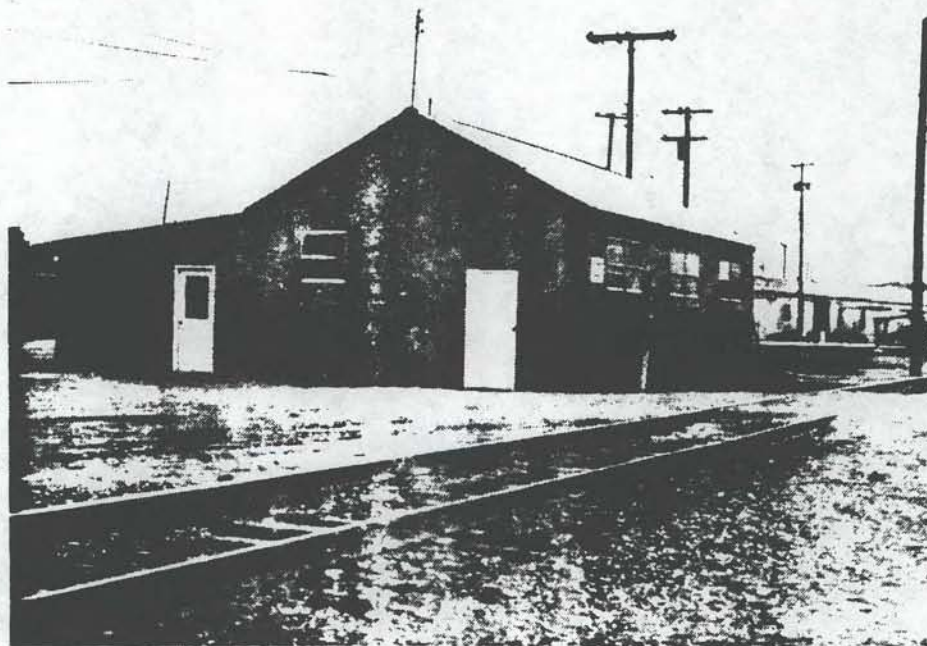
Number 16 (Record Building)

This blue concrete block building consists of two parts. The eastern section, with a gable roof oriented north/south, was probably built first, and the western section, with its corrugated metal shed roof, added at a later date. There are three 1/1 fixed light windows on the east elevation of the eastern part, a solid metal pedestrian door and boarded window on the south, and a roll-up freight door and pedestrian door on the north. The addition has three small louvred windows on the west, a fixed light metal door on the south and a solid door and louvred window on the north.

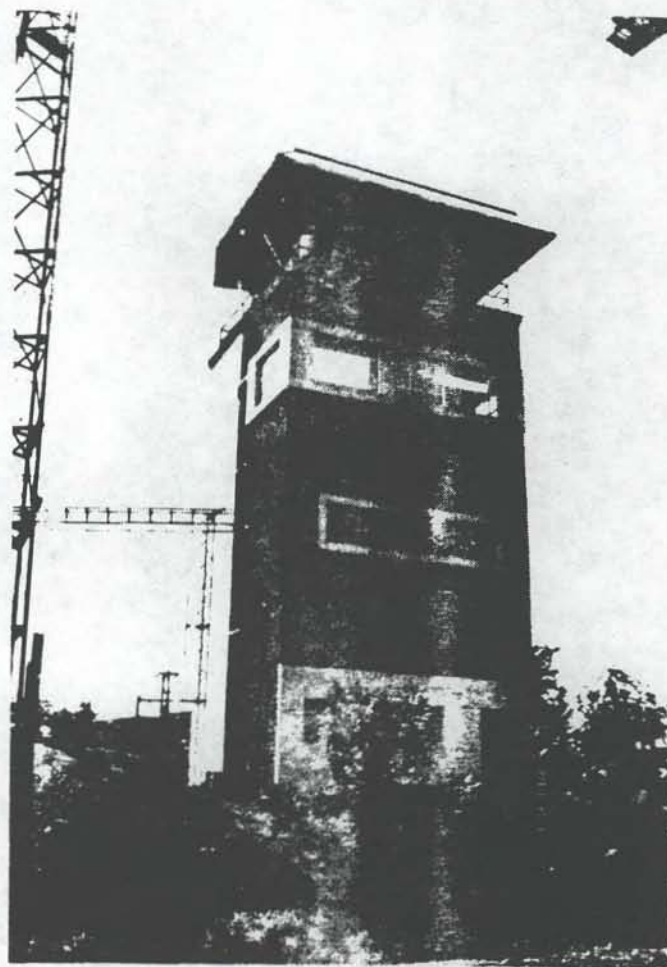
Number 18 (Northbound Control Tower) This four story cast stone and brick structure, completed in 1959, measures approximately 25 feet square. The first three floors form a base for the observation level, with large plate glass windows, on the third floor, and glass block windows set in cast stone frames. Large vertical cast stone panels define the northwest and southwest corners and a single horizontal panel is located at the ground level on the east. The fourth floor consists of an observation room surrounded with angled plate glass windows on all sides. The flat roof projects to shield an open platform surrounded by a metal railing.

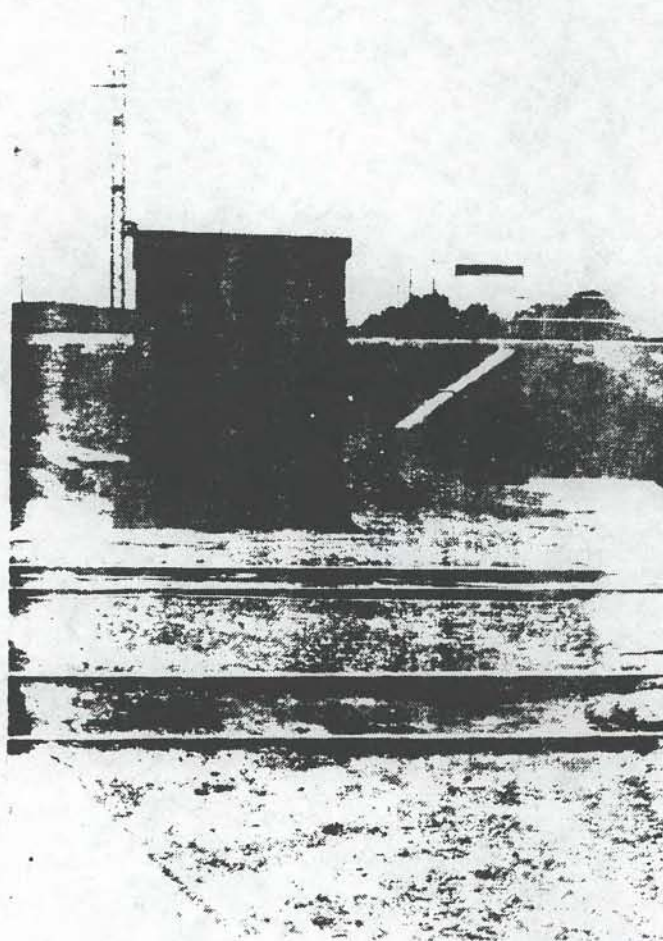
Number 19

This 6 foot by 6 foot concrete block storage shed has a flat roof and rests on a concrete slab. There are no windows, and only a door on the east.

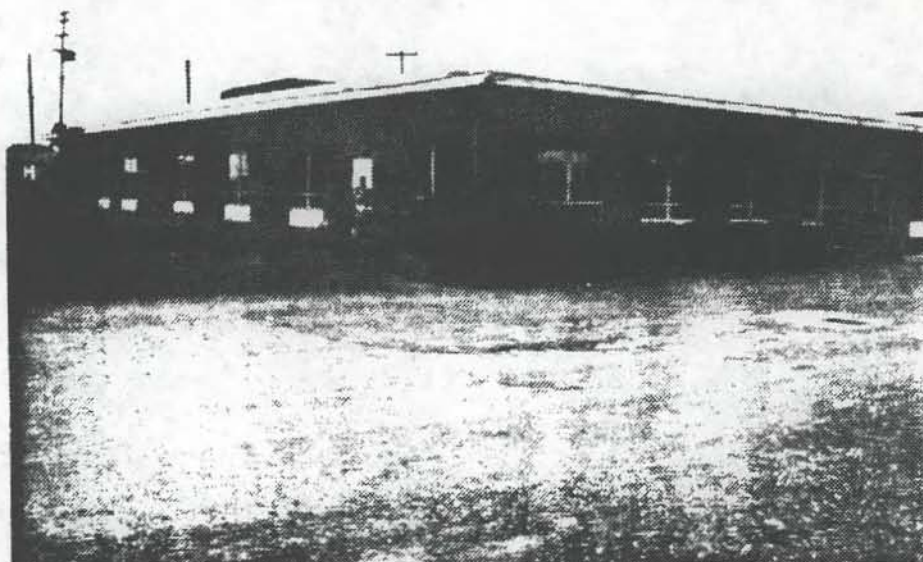
Number 20 (Consolidated Office Building)

This one story, 11,000 square foot building, was constructed in 1962, reportedly using bricks salvaged from the large machine shop which once stood on this site. Built on a concrete slab, the office building has a flat roof, with generously overhanging eaves on all sides. Large, 1/1 light windows, with fixed sash above and small awning sash at the bottom, are grouped in pairs to form nine bays on the east and west and seven bays on the north and south elevations. On the north and west, the windows are set in flat blue and white metal panels, but on the east and south, the panels are omitted and the windows set directly into the brick walls. The center bay on the west contains the main entrance. A small concrete block addition with two small unglazed windows and a metal fixed light door protects the east door on the north elevation facing the adjacent bunkhouse. Except for the double glass entrance doors, all exterior doors are metal with small fixed lights.

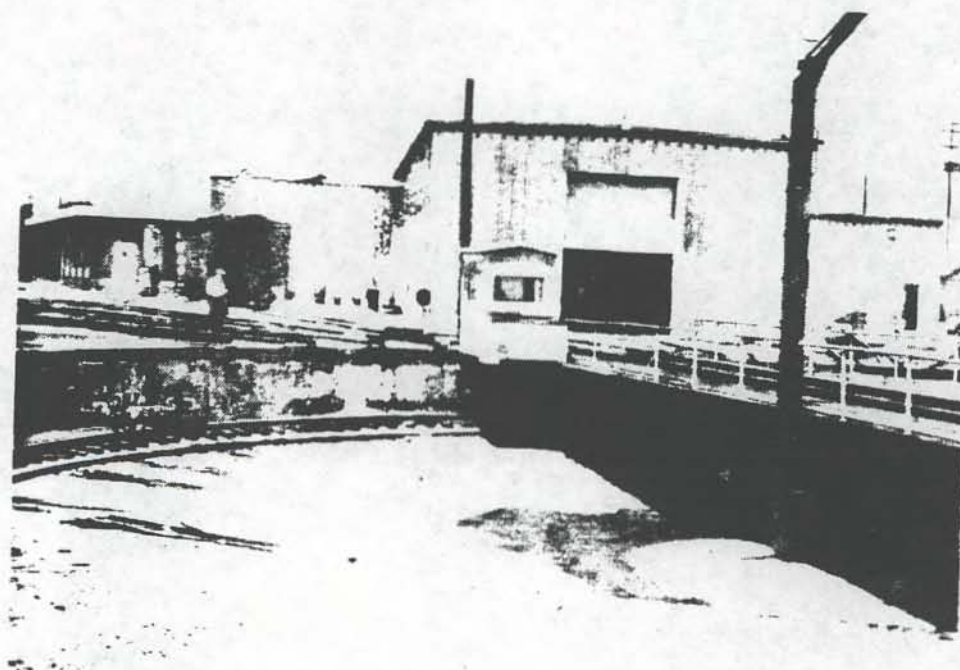
Number 22 (New Enginehouse)

The irregular plan of the main part of this building forms two segments or sections of a many-sided hollow circle with an approximately 75 foot radius; a narrow extension continues the line of the main building towards the east. Two surviving sections of the brick wall of the original Enginehouse serve as the north wall of the 20-25 foot high main building. A brick infilled engine door and pedestrian door, both with segmental-arched lintels are visible on the old walls. The remainder of the building is of Butler metal siding construction. There is a very low pitched gable roof on the main section; that on the extension is flat. Roll-up doors on the south of the main building provide access for engines from the adjacent turntable. Metal roll-up and pedestrian doors are located in the extension.

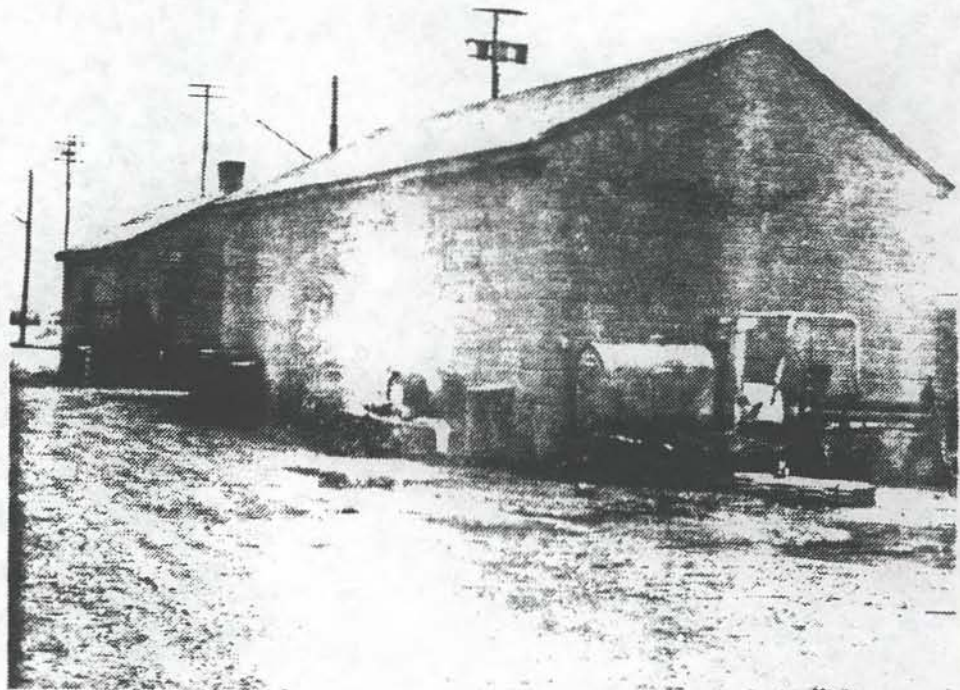
Number 24 (Mechanical Department
Storehouse)

This 40 foot by 20 foot concrete block building has a gable roof running north to south. There is a roll-up metal door on the north. On the west elevation, the three original large openings contain glass block windows in their upper thirds, but the remaining area is infilled with brick and concrete block. There are no openings on the south.

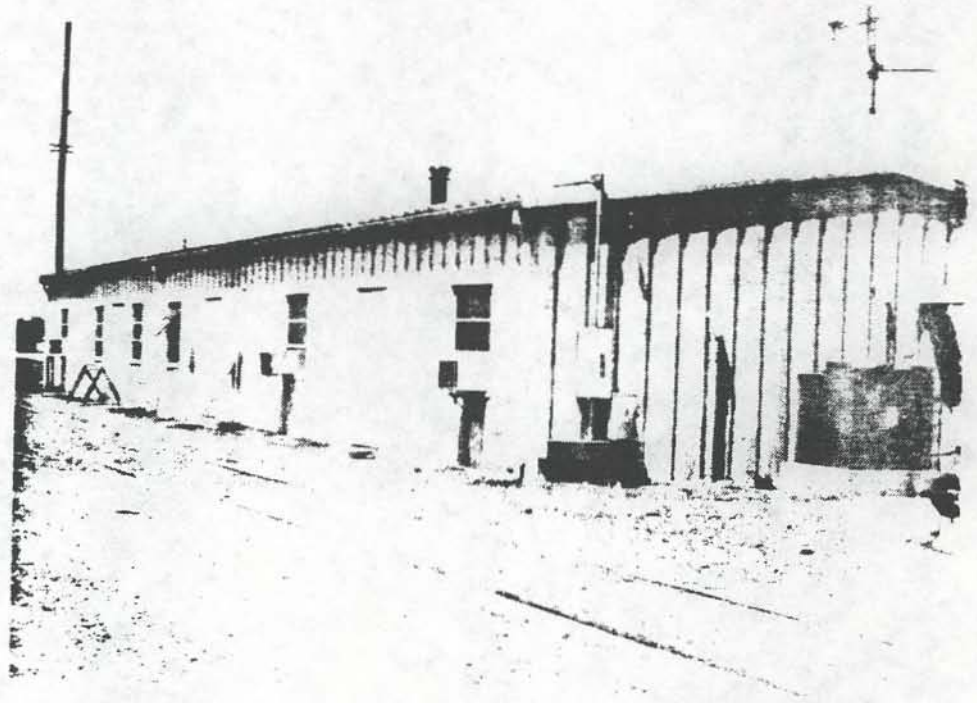
Number 25 (Signals and Communication Building)

This large one story building measures roughly 100 feet by 30 feet. Of Butler metal siding construction, the building is set on a concrete slab, with its low pitched gable roof running on a north/south axis. The west elevation has three solid metal doors and six, two light, metal framed, awning windows. The east elevation also has six windows but only two doors. There is one three light awning window, a metal roll-up door and a solid metal pedestrian door on north.

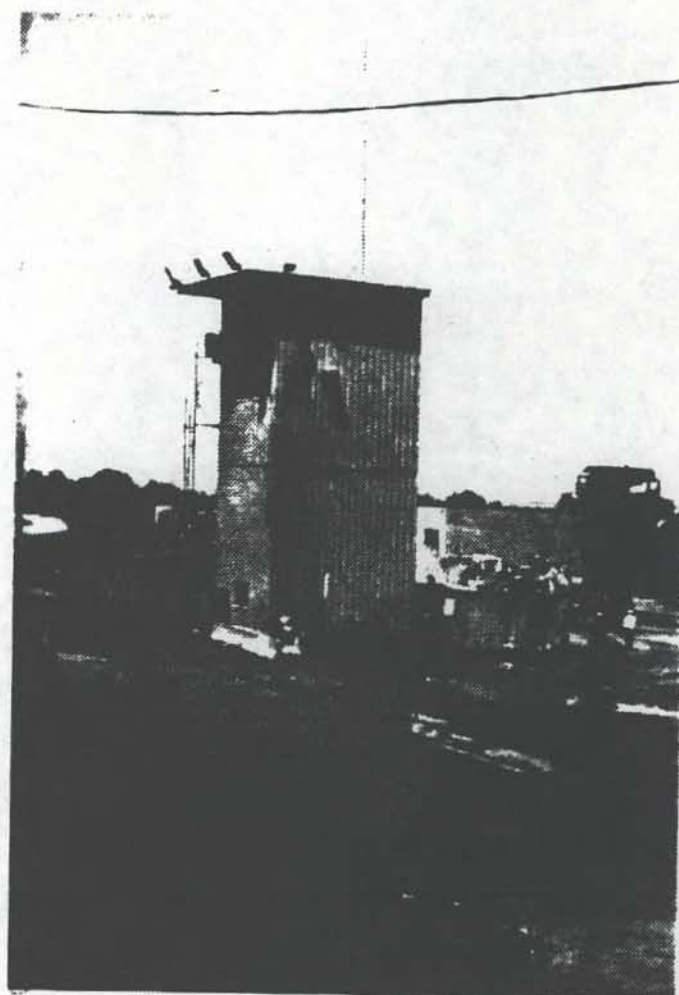
Number 26 (Switch Control Tower)

This approximately forty foot high, Butler metal siding building (measuring about 25 feet by 15 feet) has a concrete slab foundation and a flat shed roof sloping slightly toward the east, with an approximate six feet overhang on the west. The ground level has a single fixed pane window facing west and a metal pedestrian door with single fixed light on the north elevation. The top floor has a single window facing south and two banks of large windows facing west and north. A narrow metal balcony runs just below these windows on the west and north with access provided by a single pedestrian door to the west of the north-facing bank of windows. The floor below has a large fixed light window on the south elevation and banks of four fixed light windows, similar to, but smaller than, those on the floor above, facing west and north. There are no openings on the east elevation. A 20-30 foot communications antenna rises from the east side of the roof.

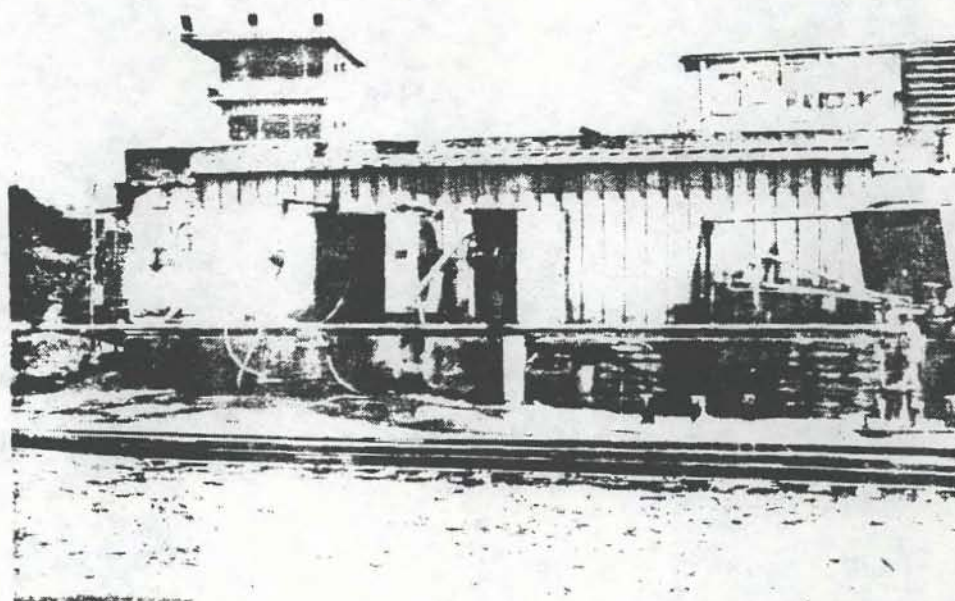
Number 28

This 30 foot by 15 foot building on a raised concrete platform is sheathed with Butler metal siding and has a low-pitched metal paneled roof with its gable running north/south. There are double metal freight doors on the north and south elevations (the doors themselves are missing on the north) and solid metal doors on the west.

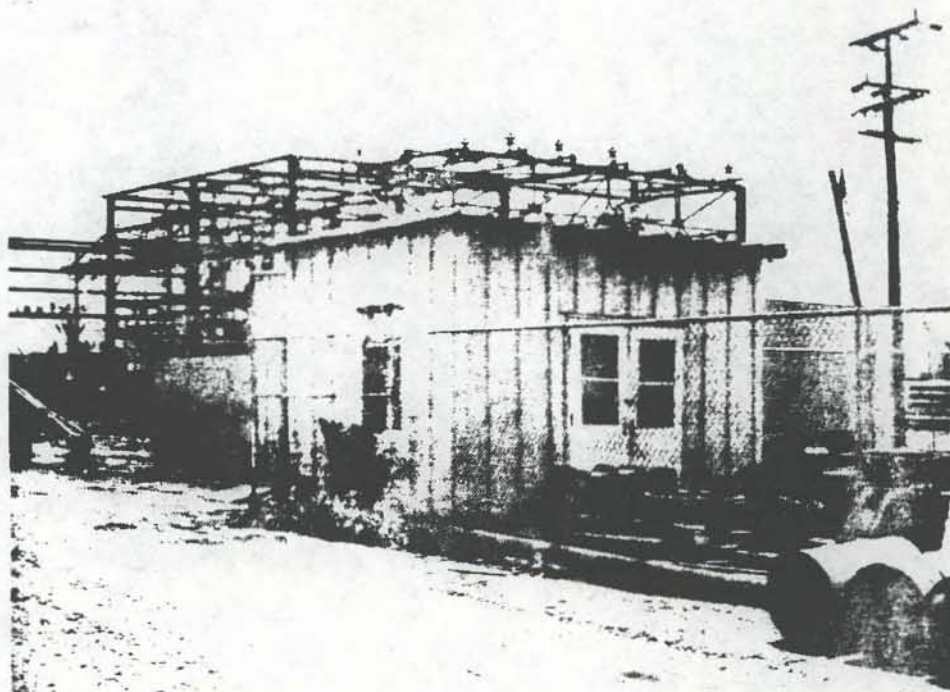
Number 29

The main building, of Butler metal siding construction, has a flat roof and is on a concrete slab foundation. There are double pedestrian doors with two fixed lights on the north, a single window (glazing removed) on the east and a three light window on south. A container trailer to the south is used for additional storage.

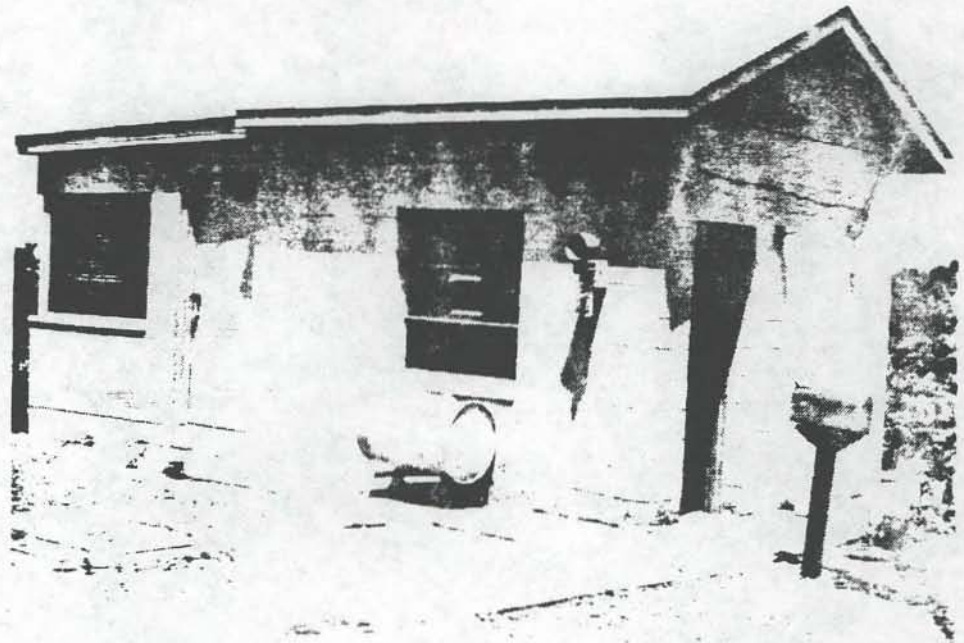
Number 33

The south part of this 10 foot by 13 foot, two part, concrete block building has a shallow pitched gable roof; the roof of the north part is flat. There are solid metal pedestrian doors on the north, west and south elevations of the south part of the building and three light metal framed windows on the west elevation. In the north part, plate glass observation windows are located on the west and north elevations. The east elevation is unfenestrated.
